**COMMONWEALTH
BUILDING SOLUTIONS, LLC**

FIELD REPORT

WESTMORELAND COUNTY HIGH SCHOOL

Date: 02/07/2022
Weather: 39 degrees. Rain - High of 41 degrees today.
Hours Worked: 13:00 – 16:30hrs (3.5hrs) – Site Visit

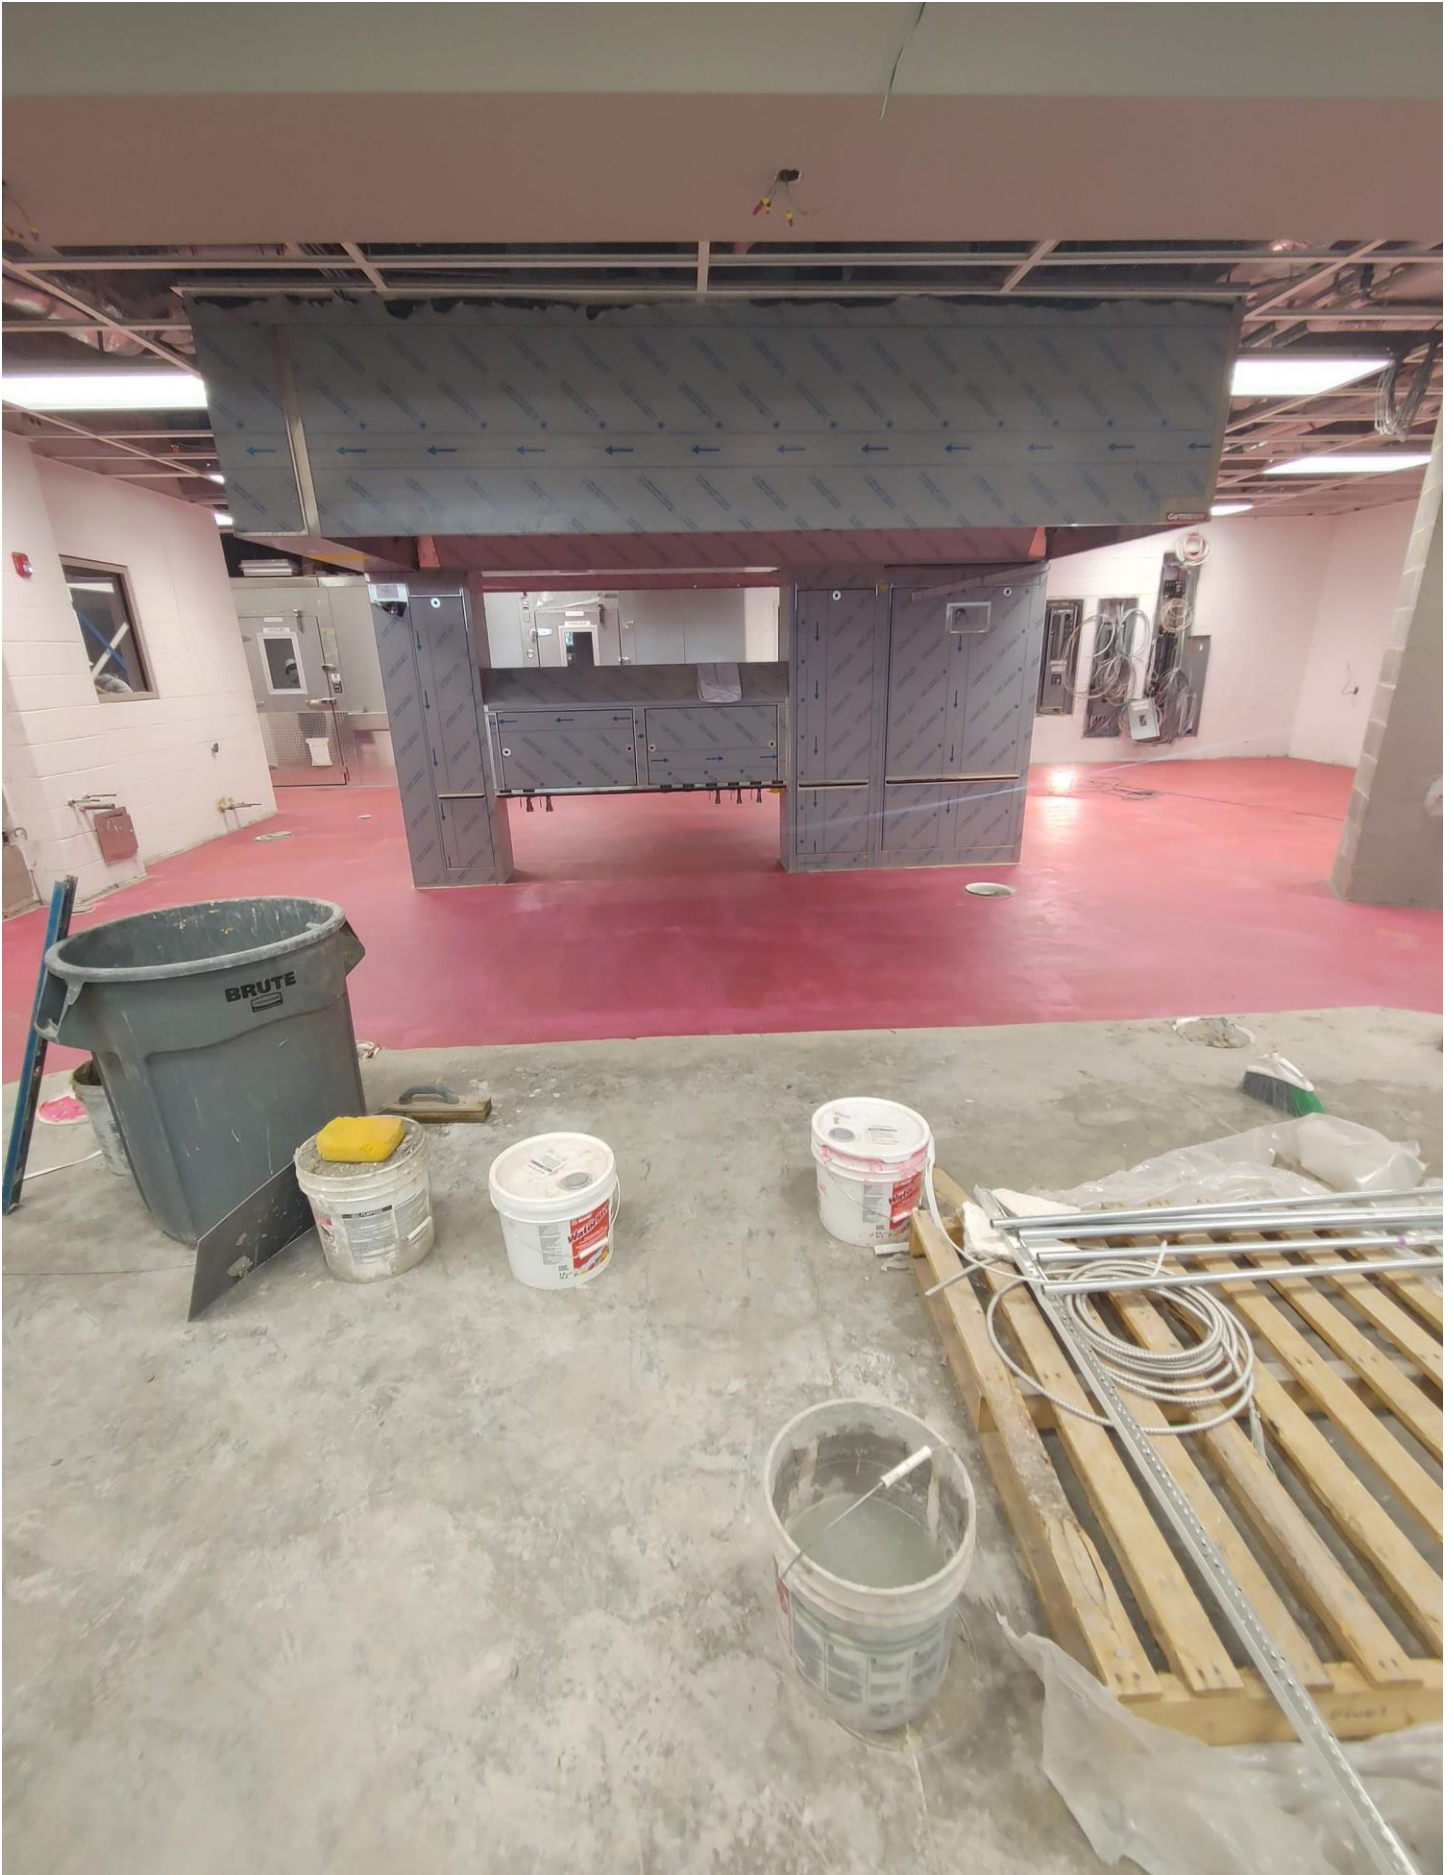
Photo 1 - C102 Kitchen prepped for Quarry Tile.

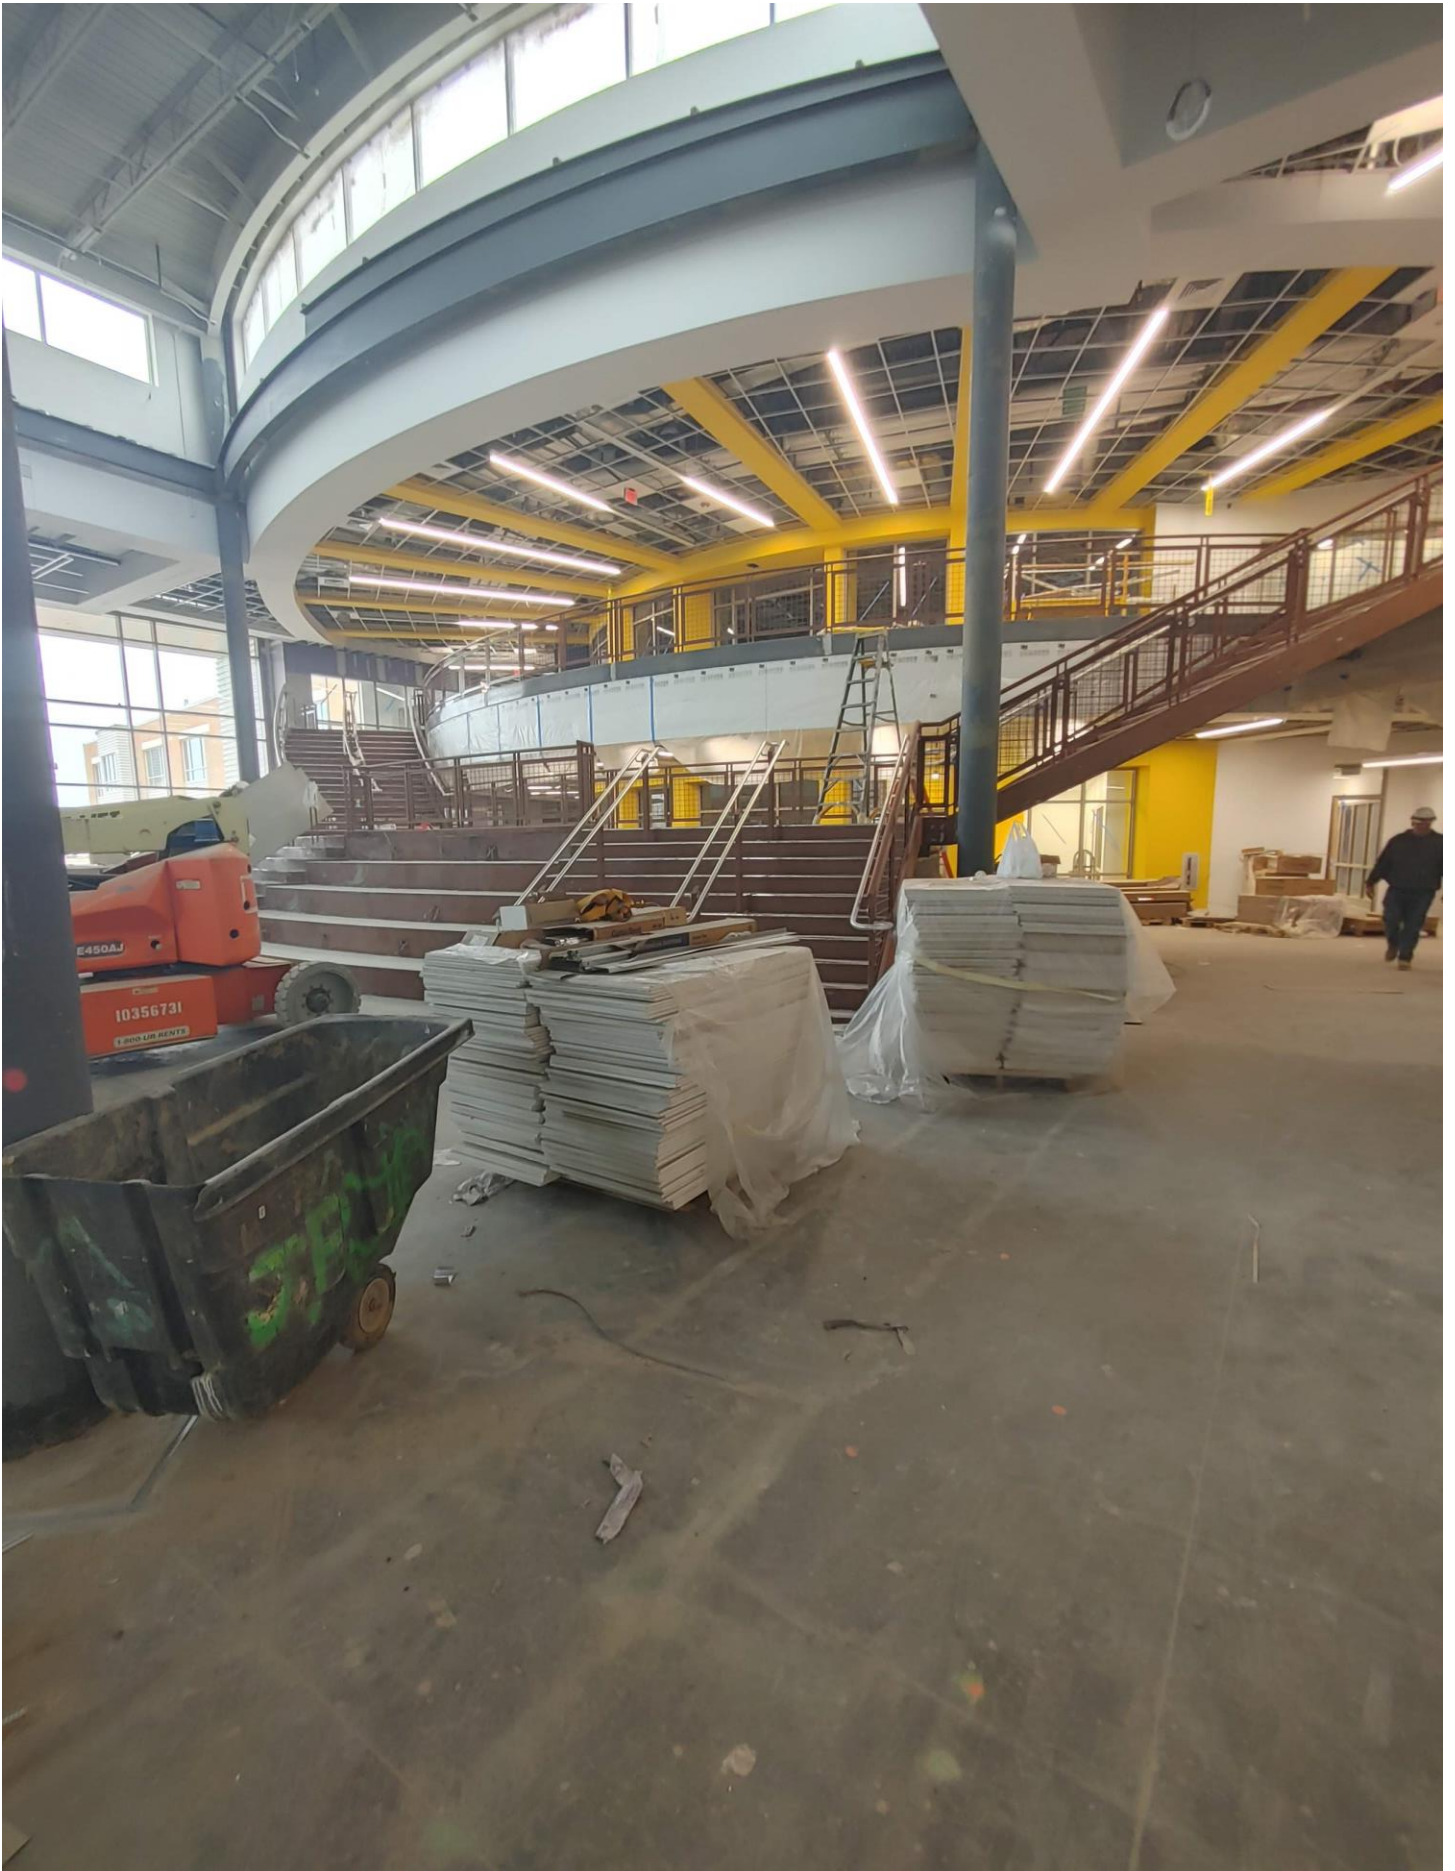
The Sprinkler sub is working in Area C. Painters are prepping and painting the Grand Staircase. They continue to work on the Acoustic Cloud Ceiling around the perimeter of Area C. Metal Panels are also being installed around vestibule C10.

Photo 2 - Grand Staircase being prepped and painted

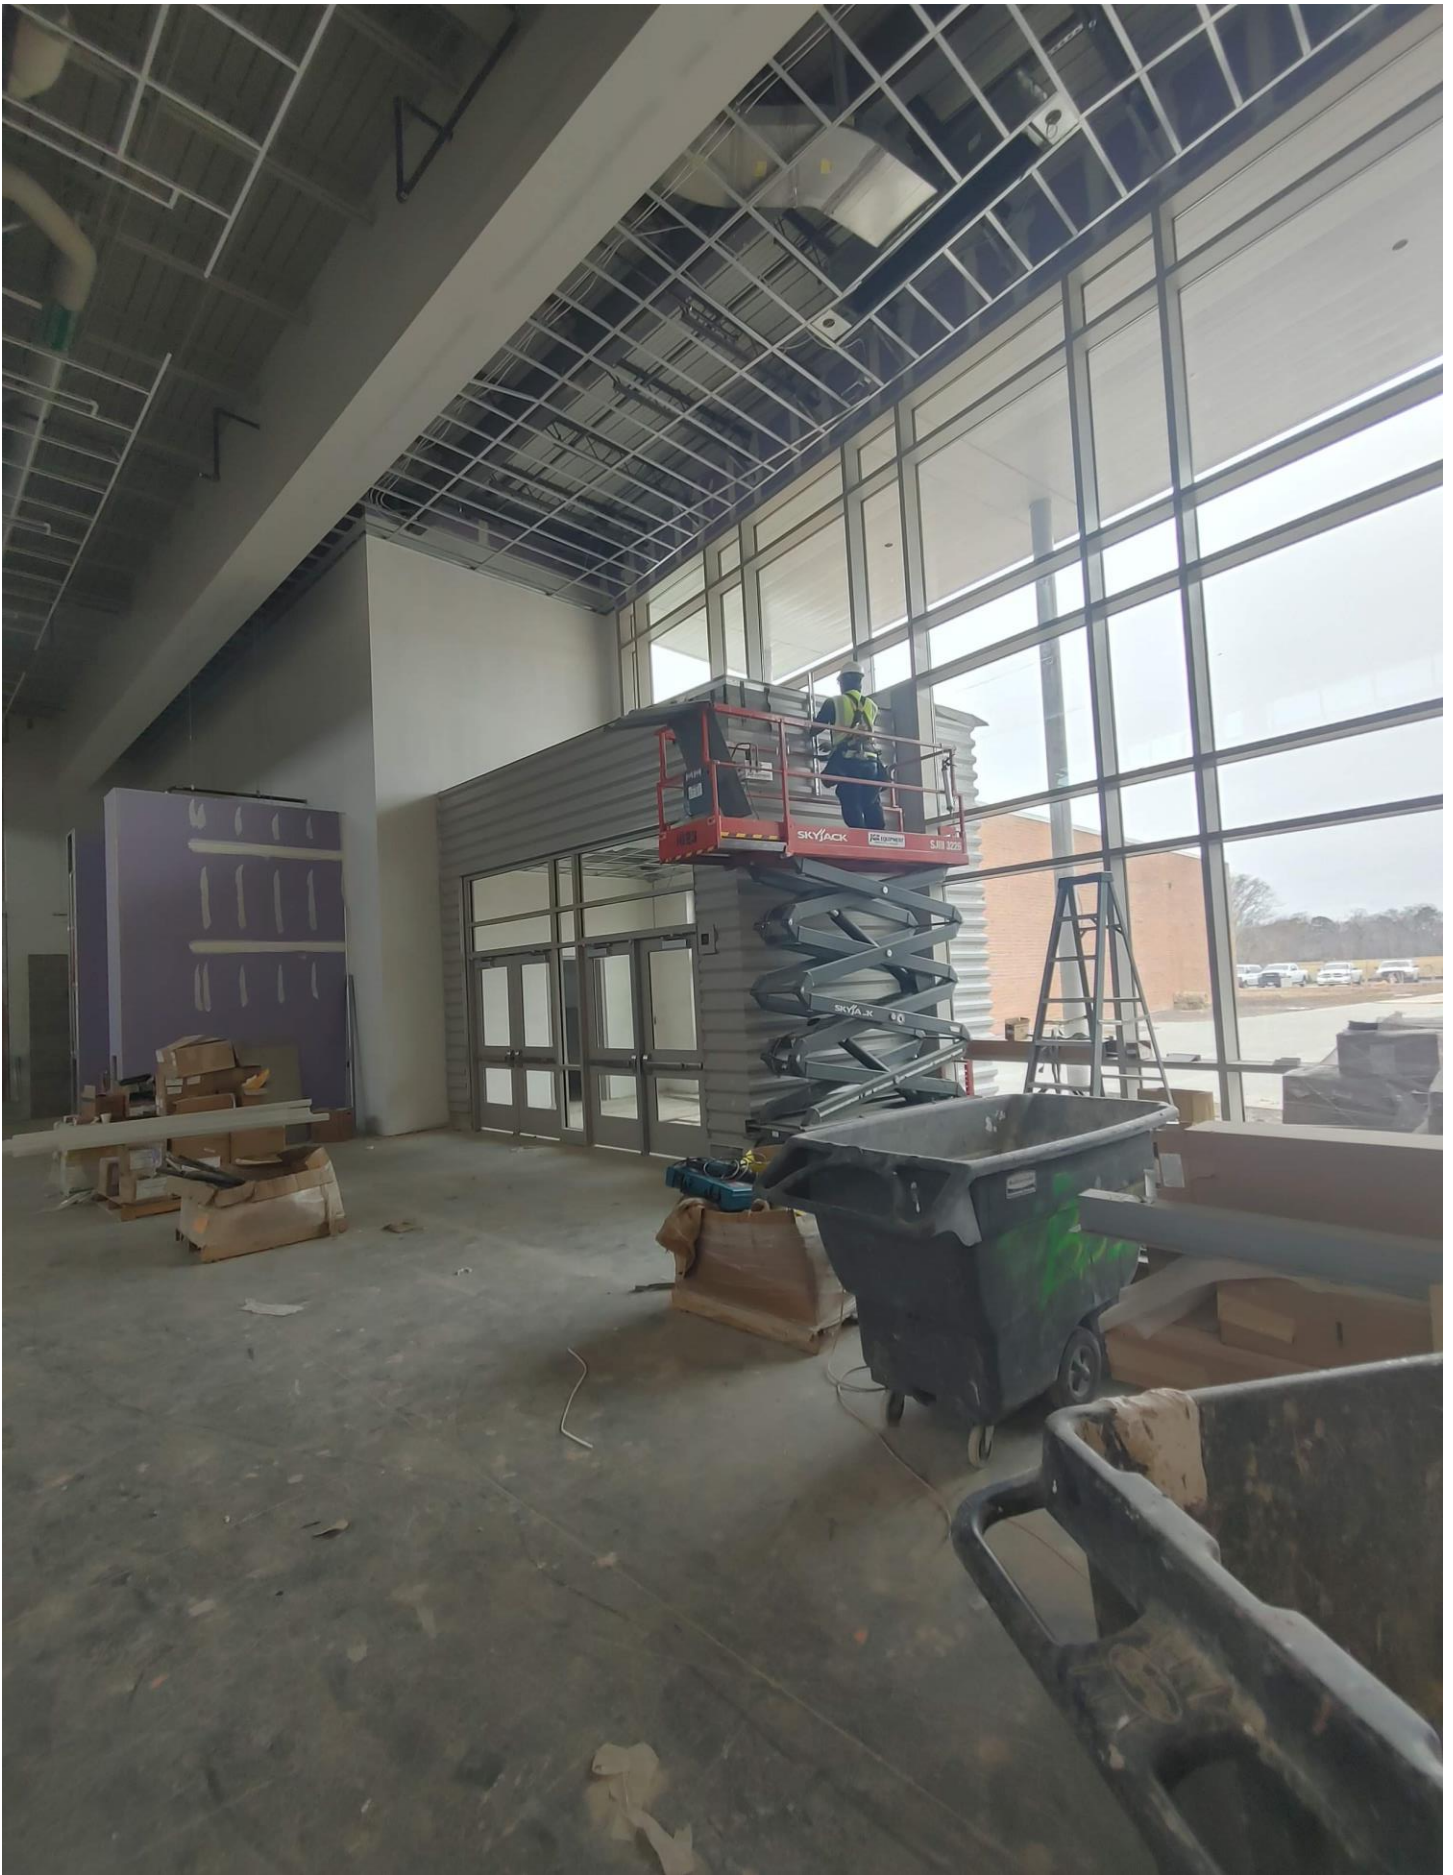
Photo 3 - Metal Panels are being installed on Vestibule C10

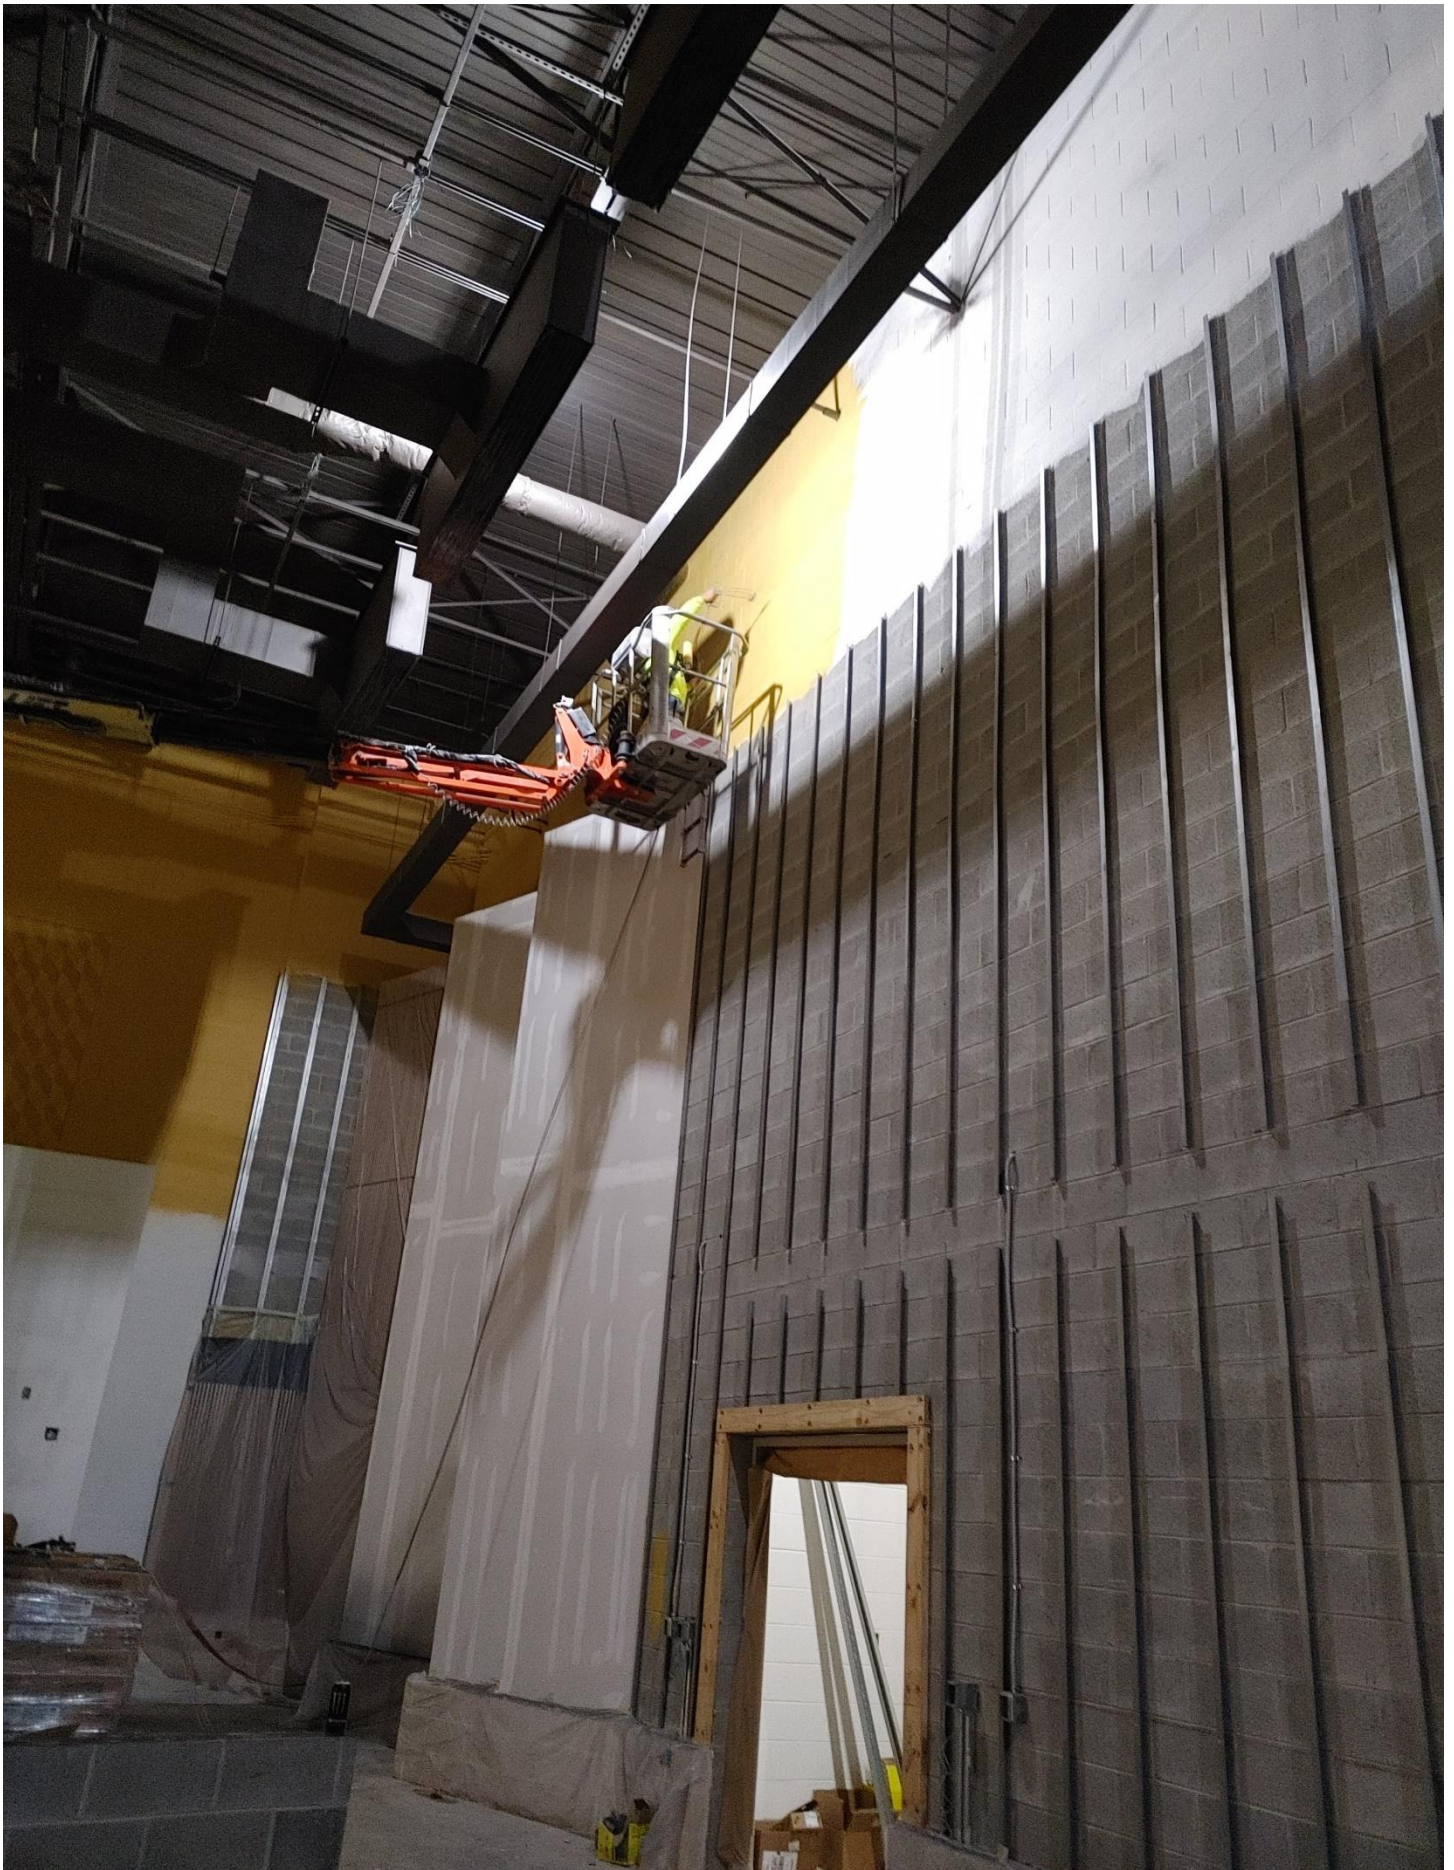
Photo 4 - West wall of Auditorium is being painted.

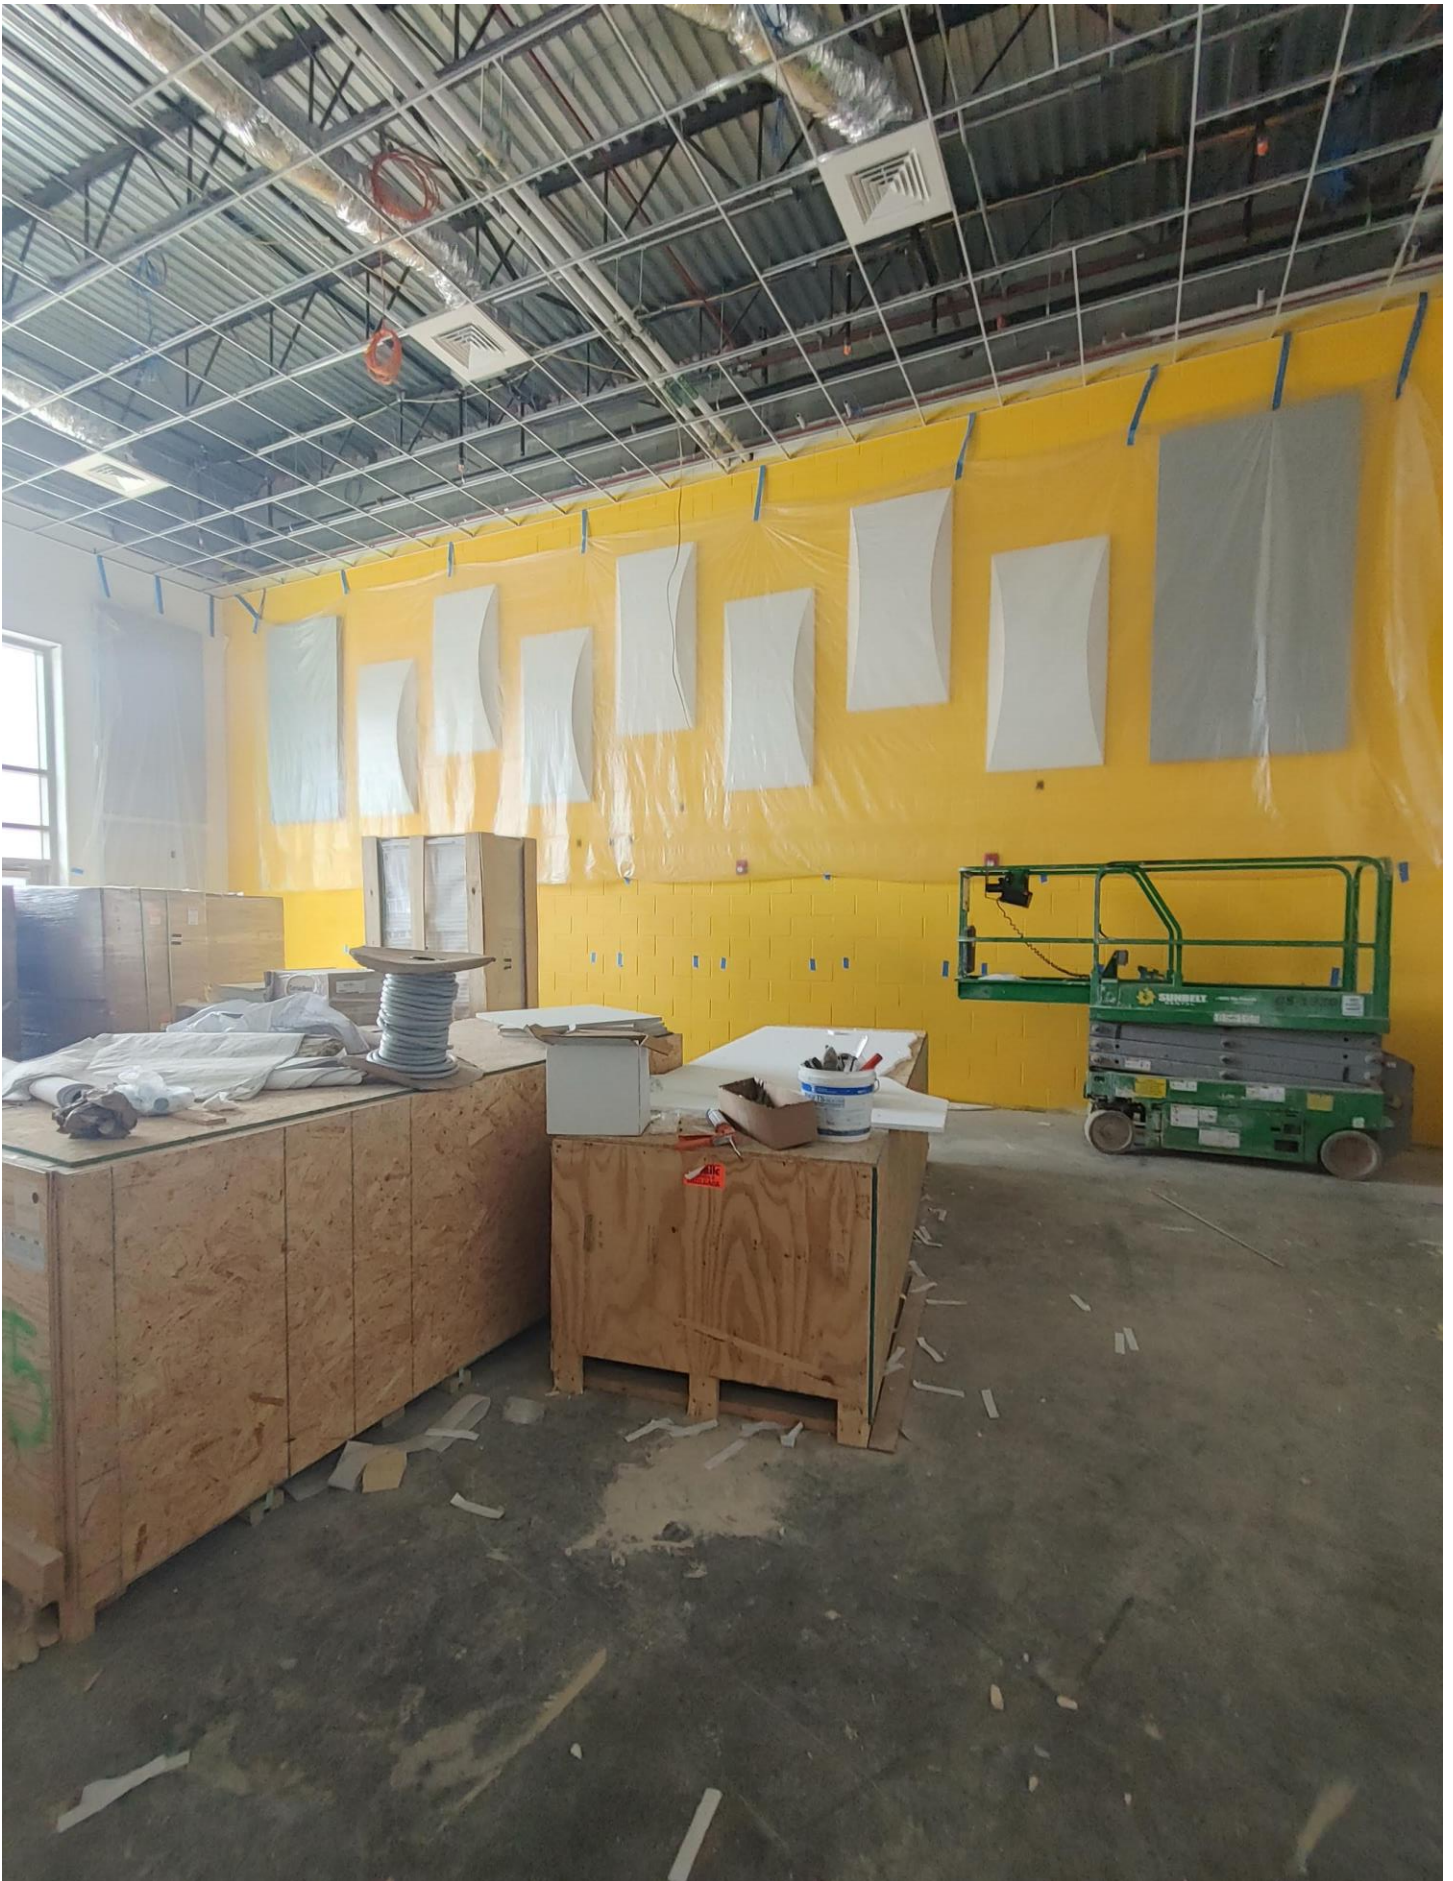
Photo 5 - Acoustical Panels have been installed on the west wall of D122

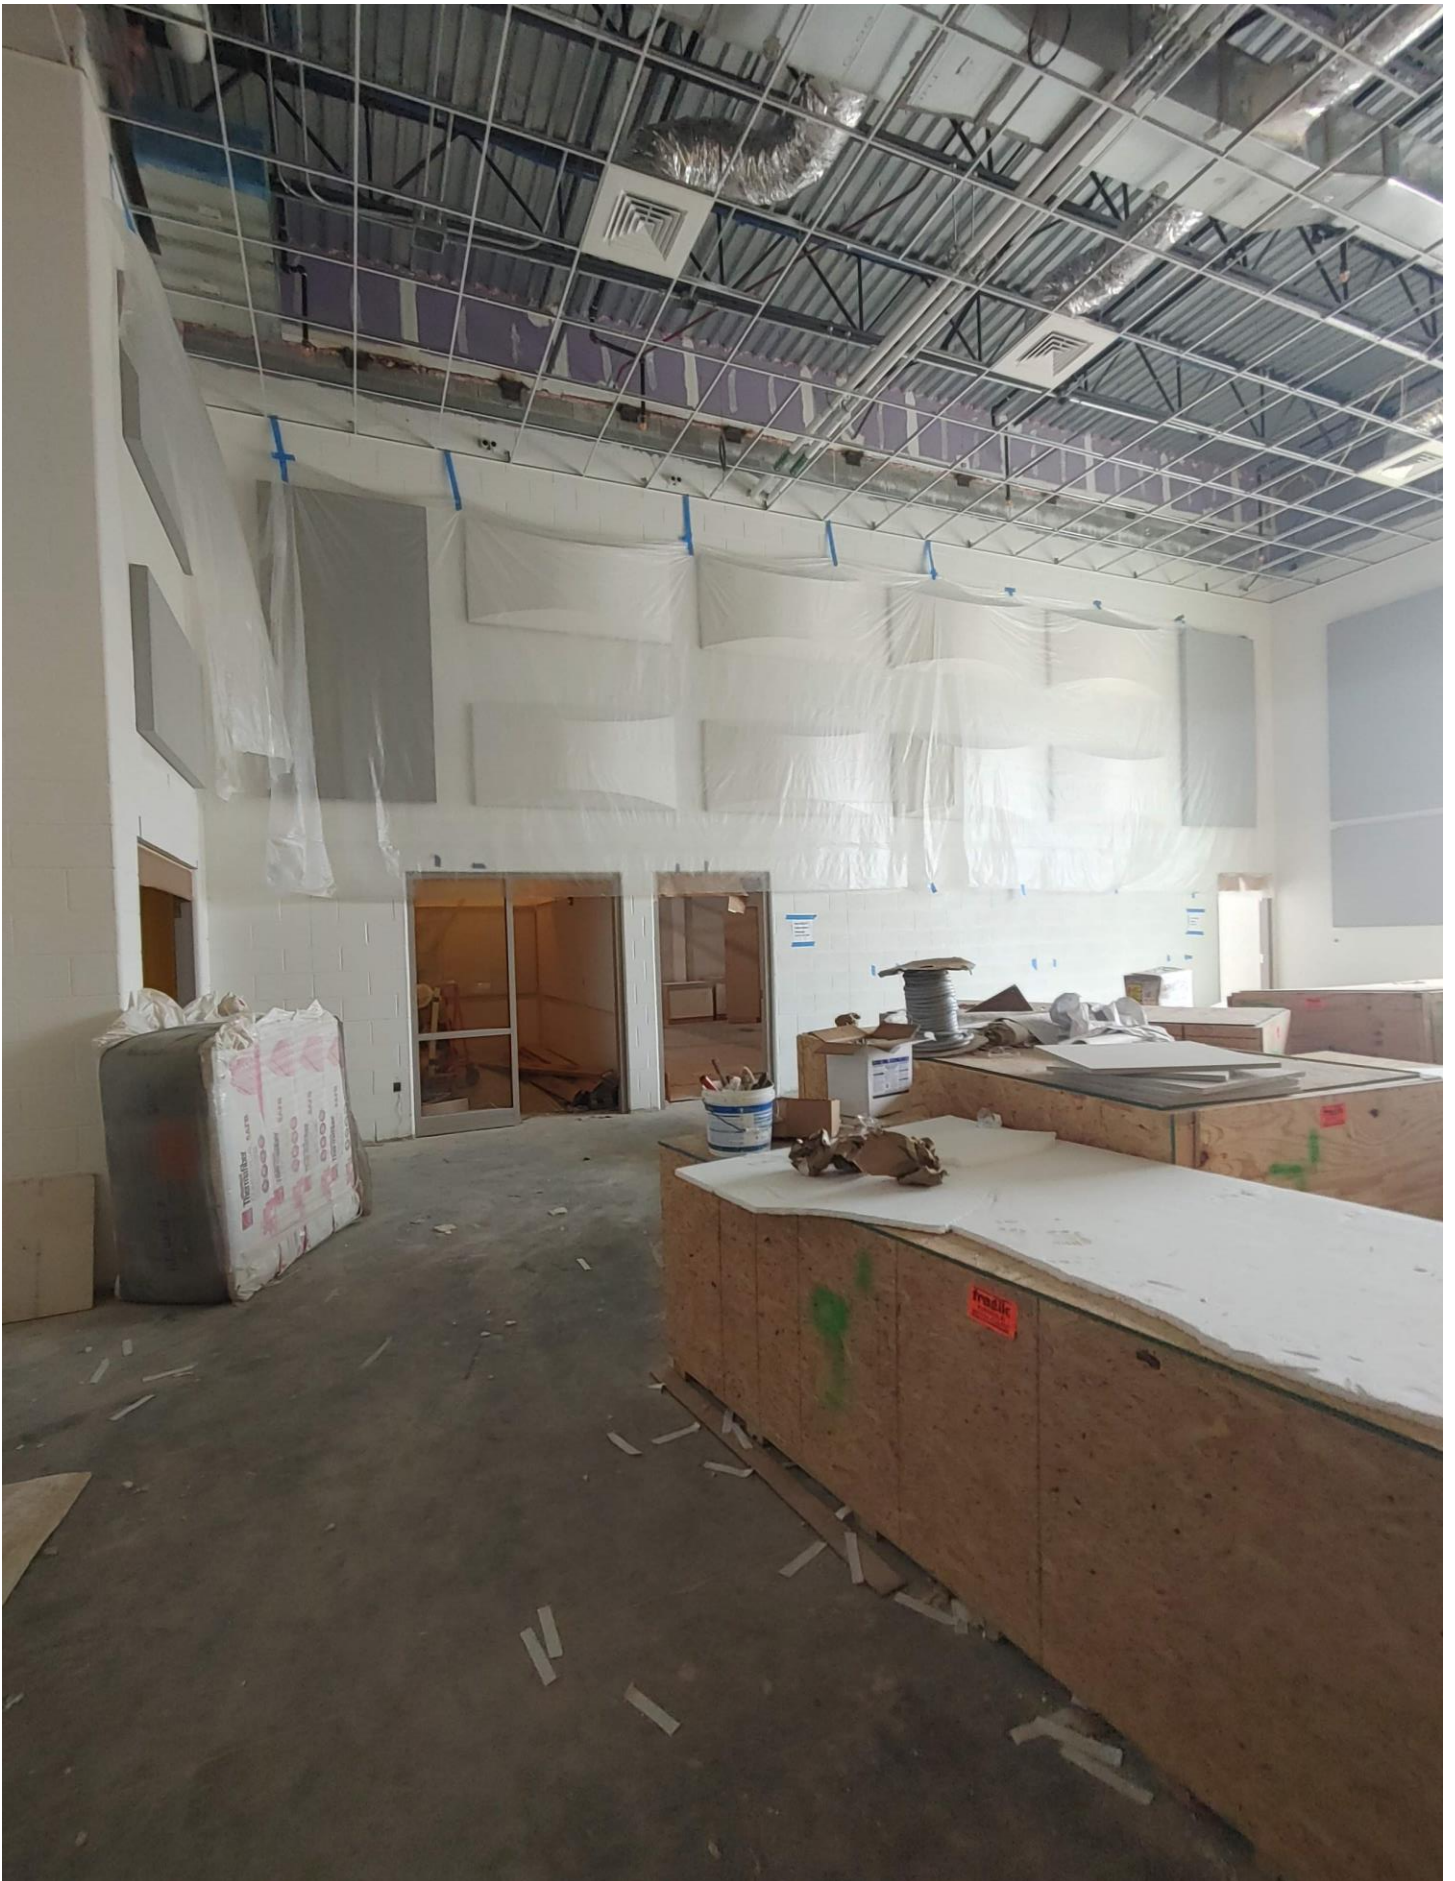
Photo 6 - Acoustical Panels have been hung on the East wall of D122

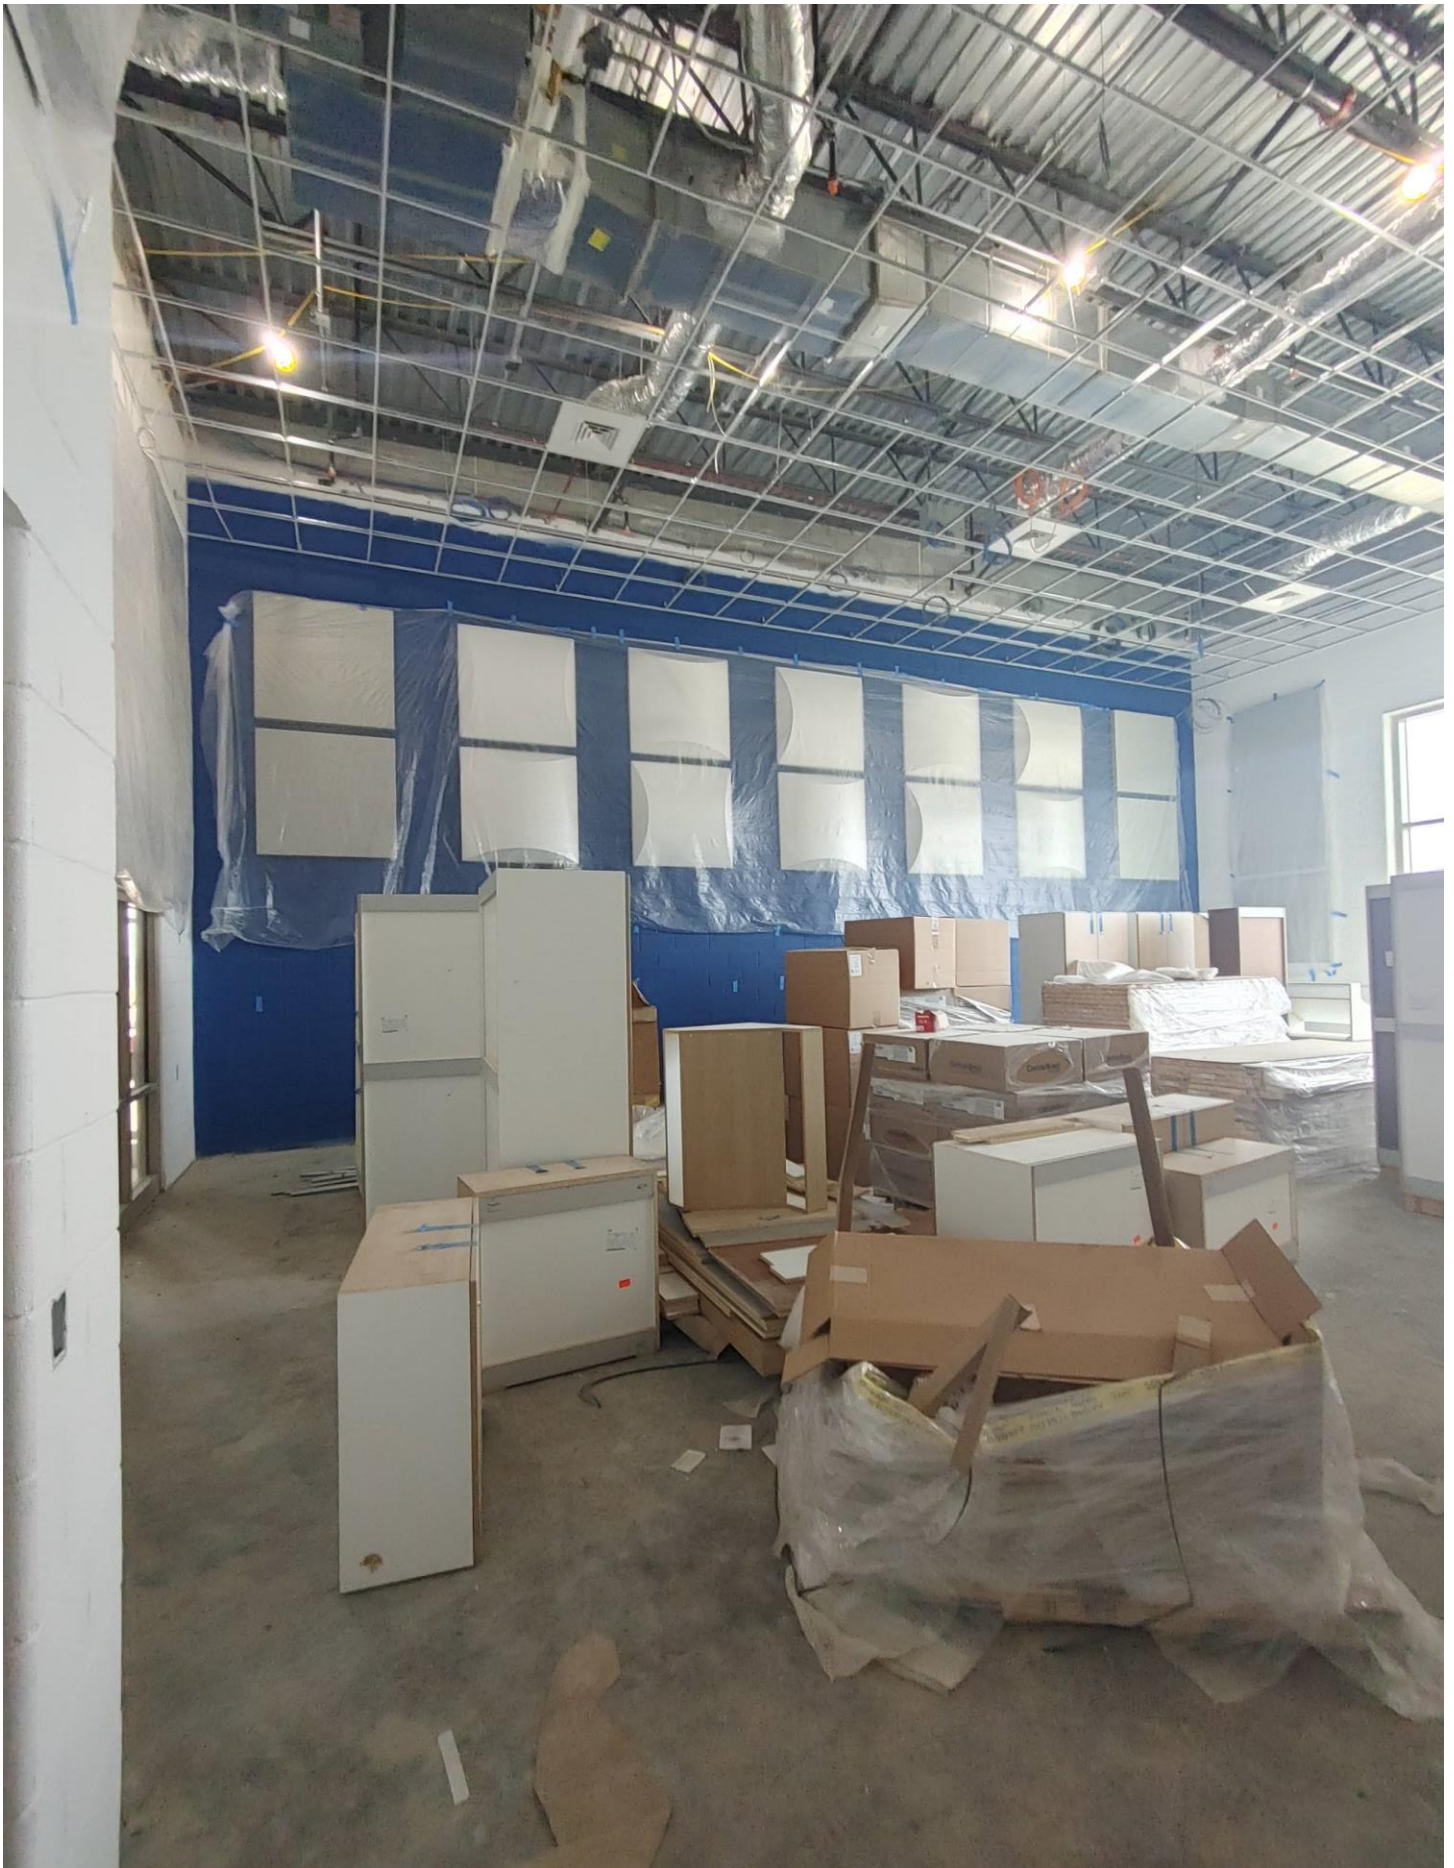
Photo 7 - Acoustical Panes have been hung on the East wall of D127

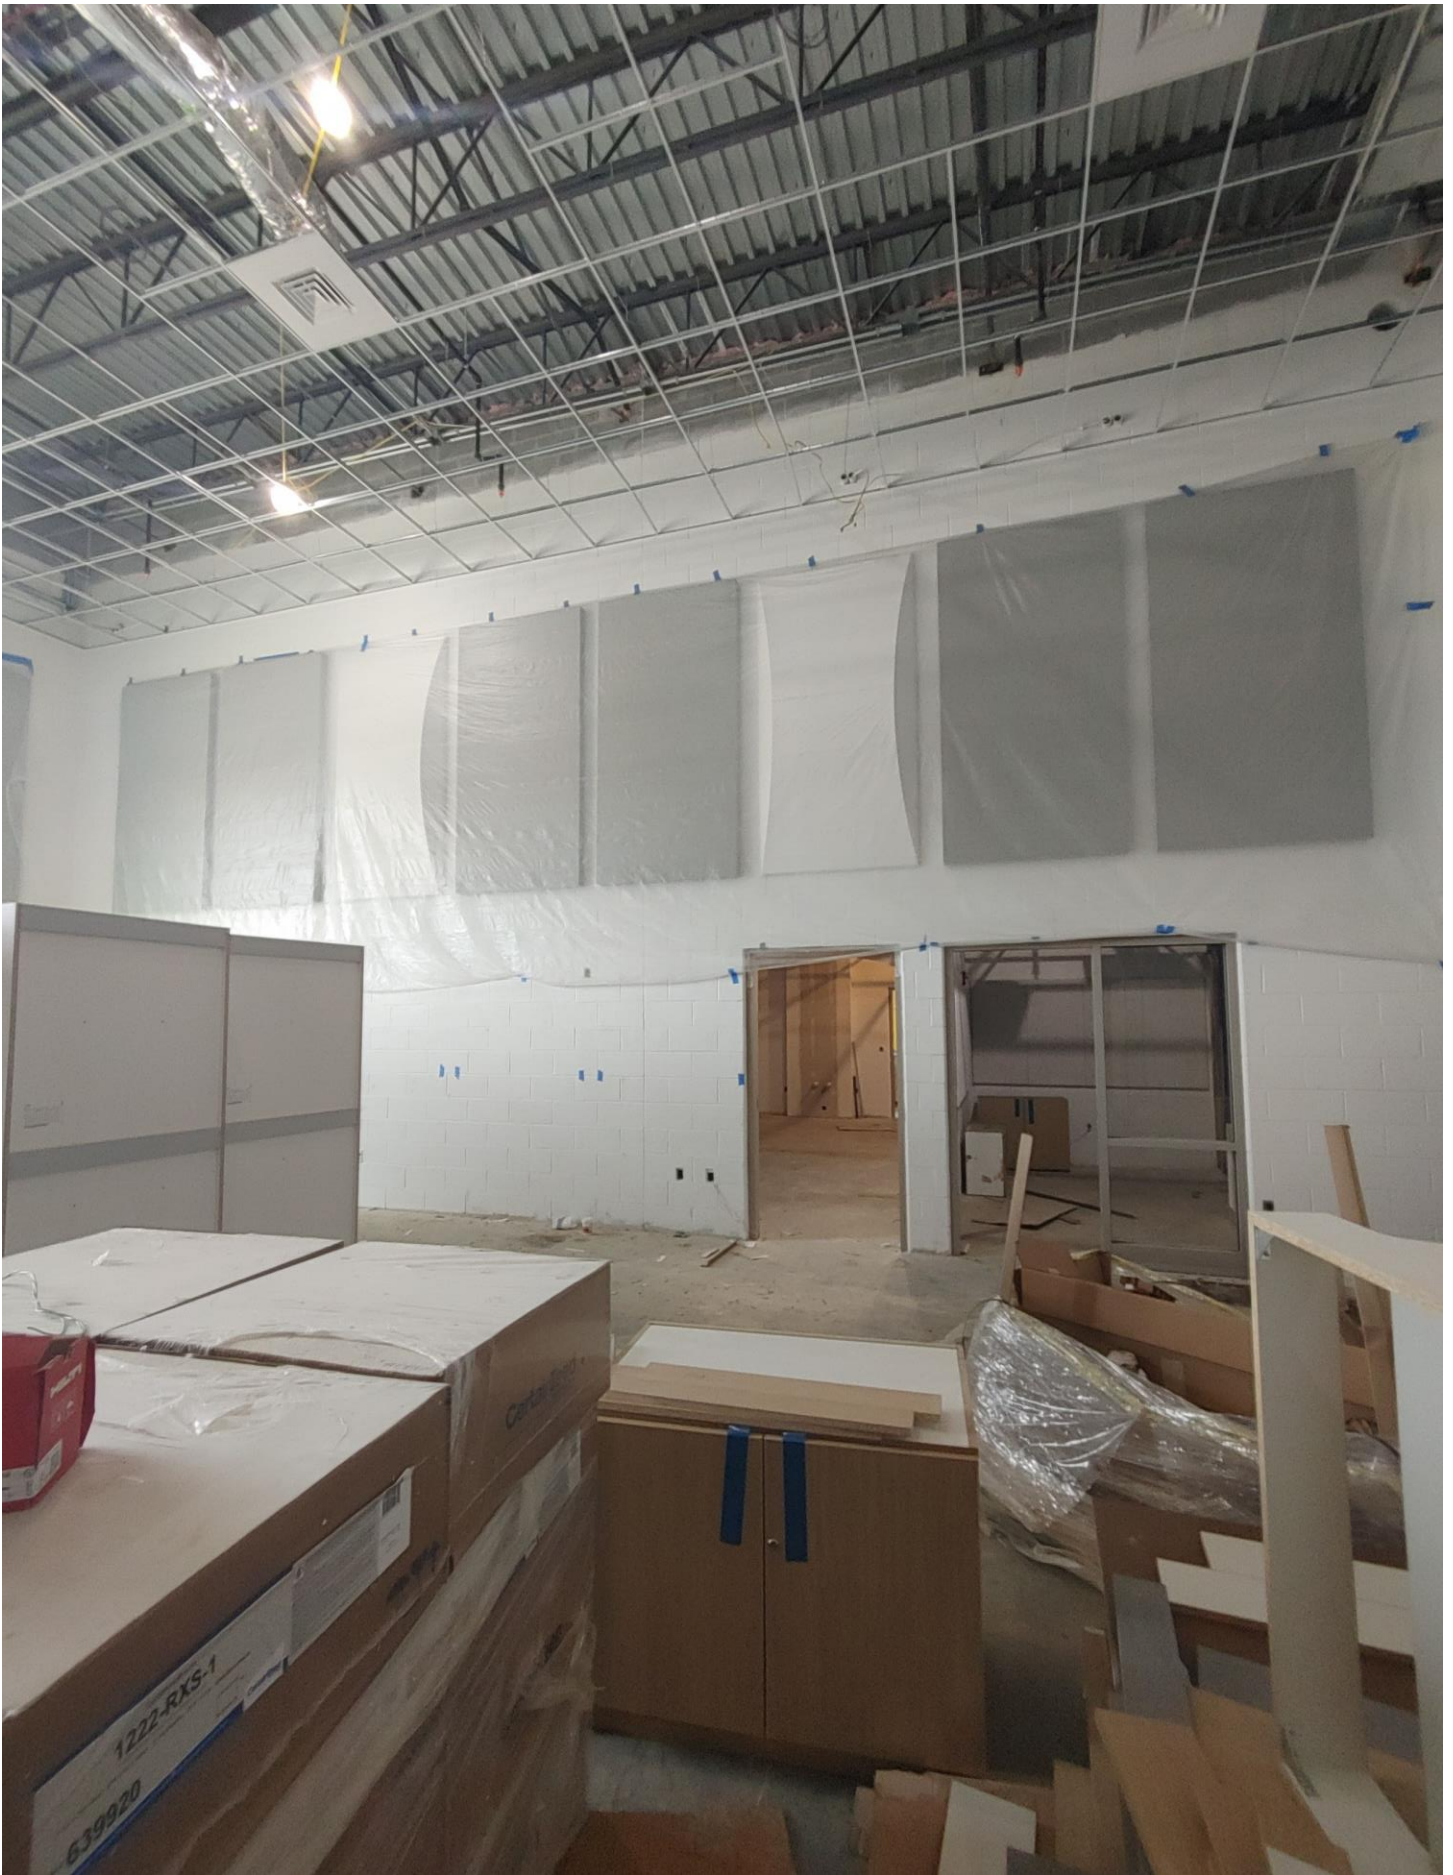
Photo 8 - Acoustical Panes have been hung on the West wall of D127
