**COMMONWEALTH
BUILDING SOLUTIONS, LLC**

FIELD REPORT

WESTMORELAND COUNTY HIGH SCHOOL

Date: 02/07/2022
Weather: 39 degrees. Rain - High of 41 degrees today.
Hours Worked: 13:00 – 16:30hrs (3.5hrs) – Site Visit

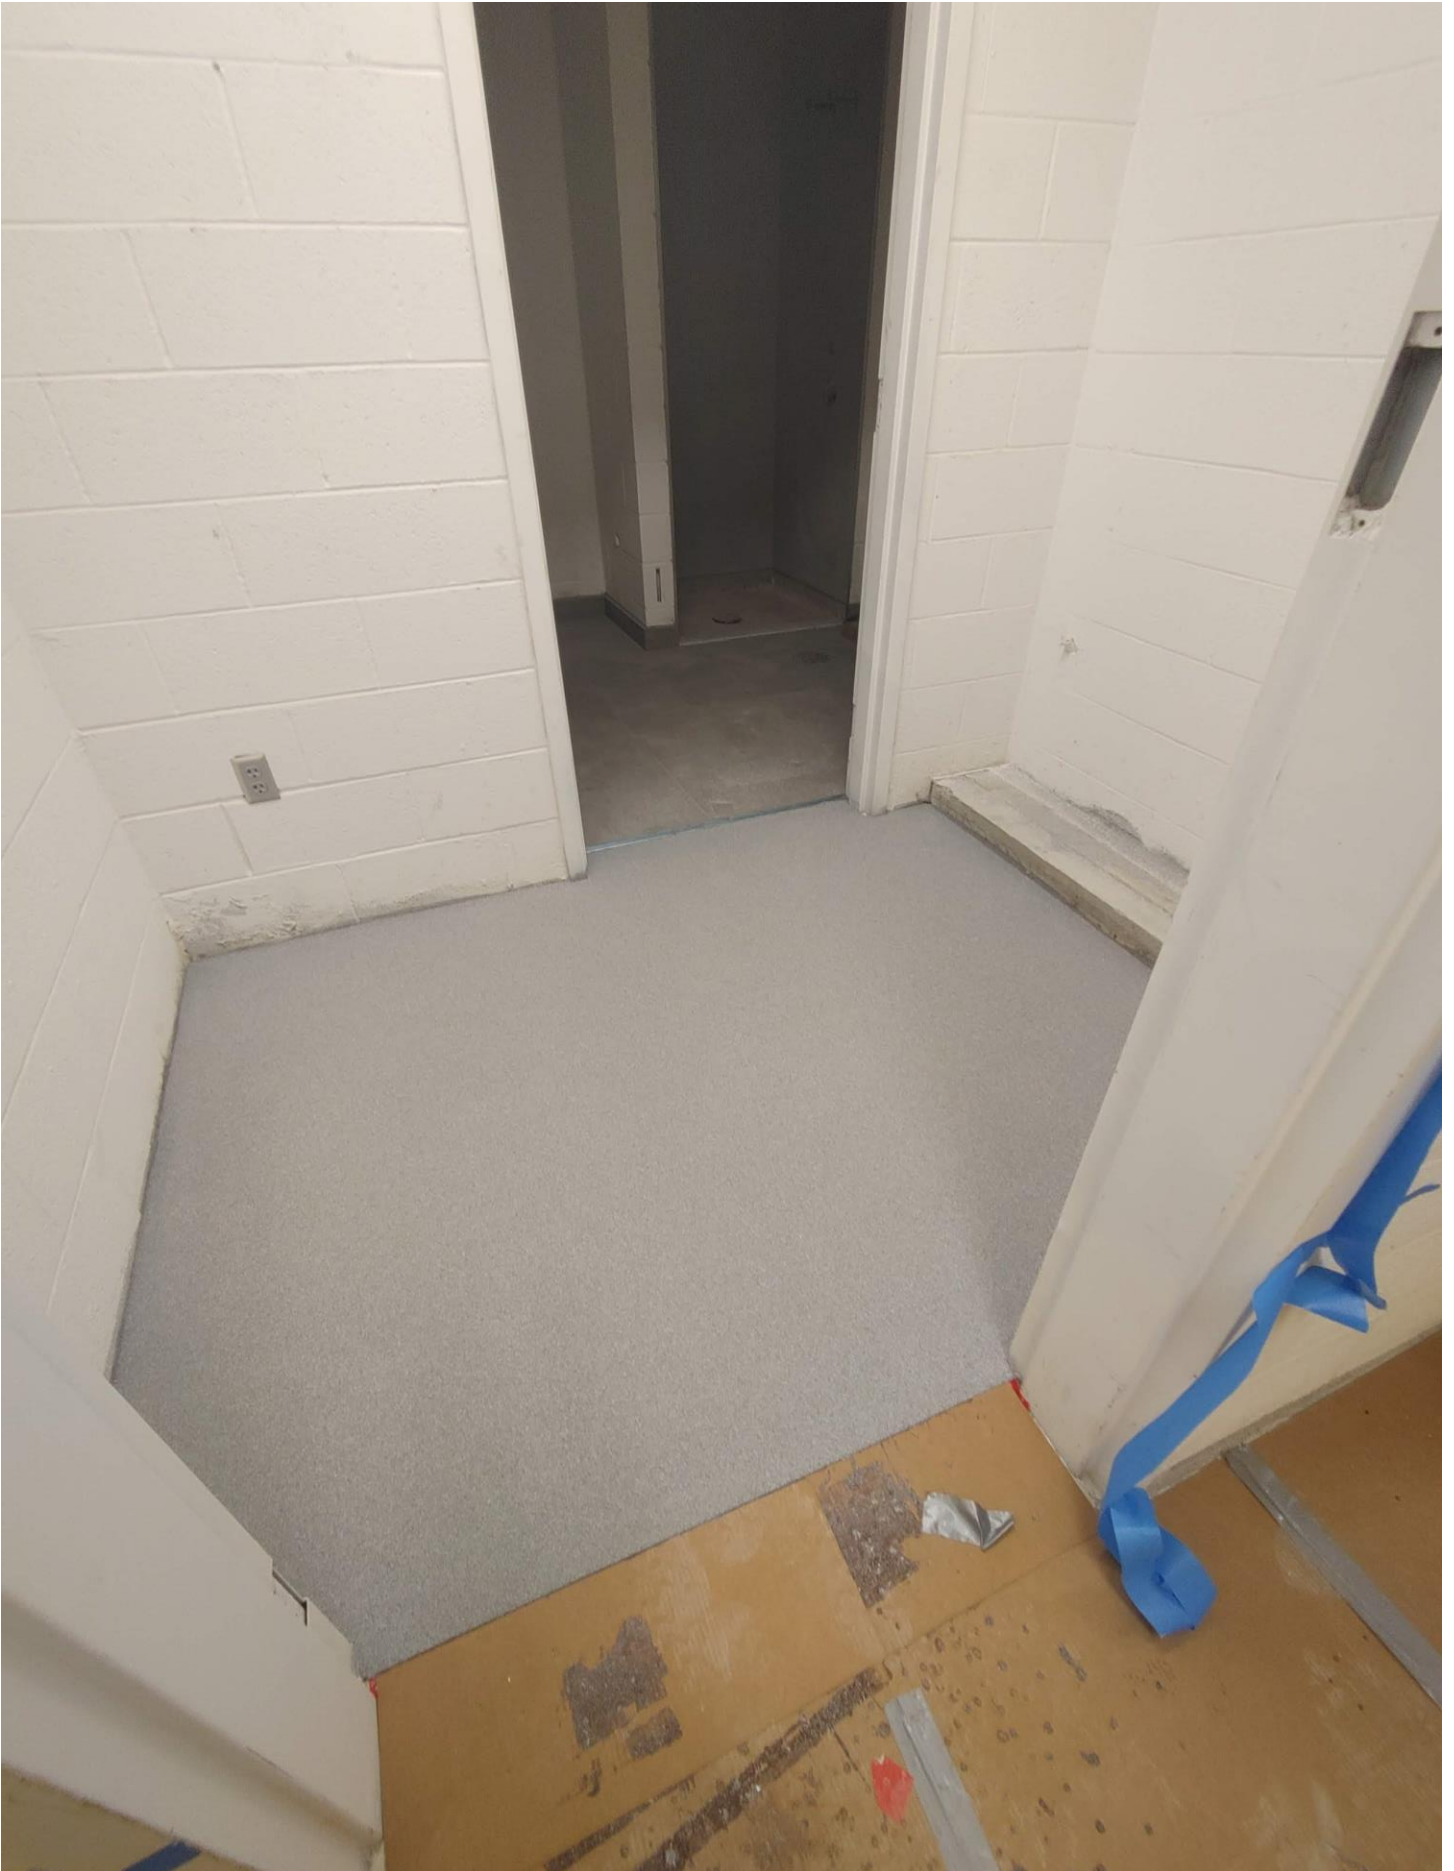
Hodgeman is working on Epoxy floors in E. Rooms E124, E126, E134, E135B, and E136B have been completed. Electricians are working on Emergency Exit Signage .

Photo 9 - Fluid Applied Resinous flooring - Room E134

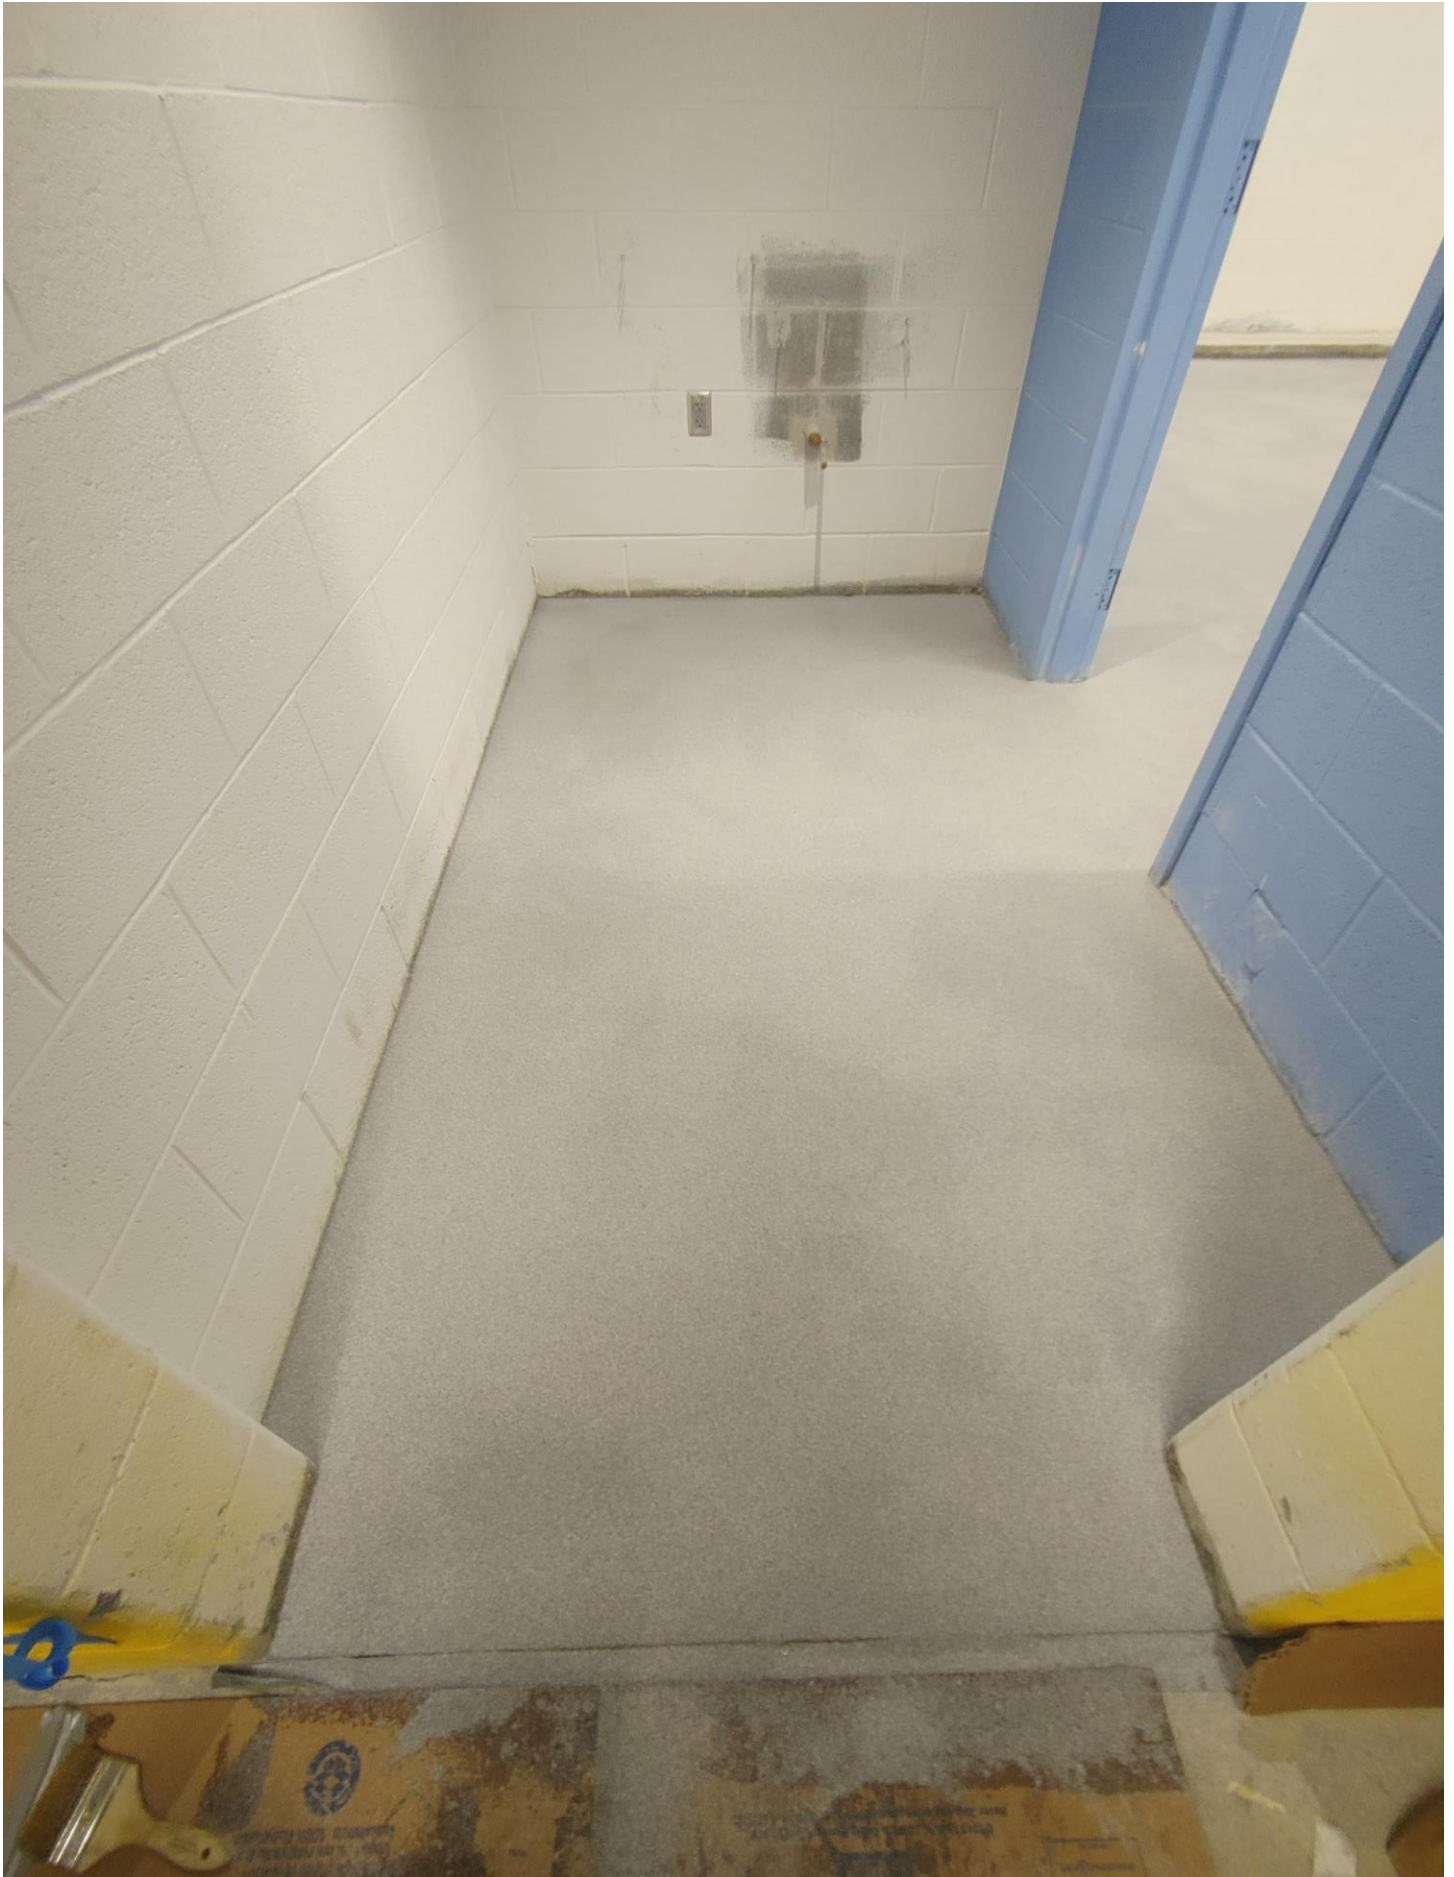
Photo 10 - Fluid Applied Resinous Flooring - Room E135B

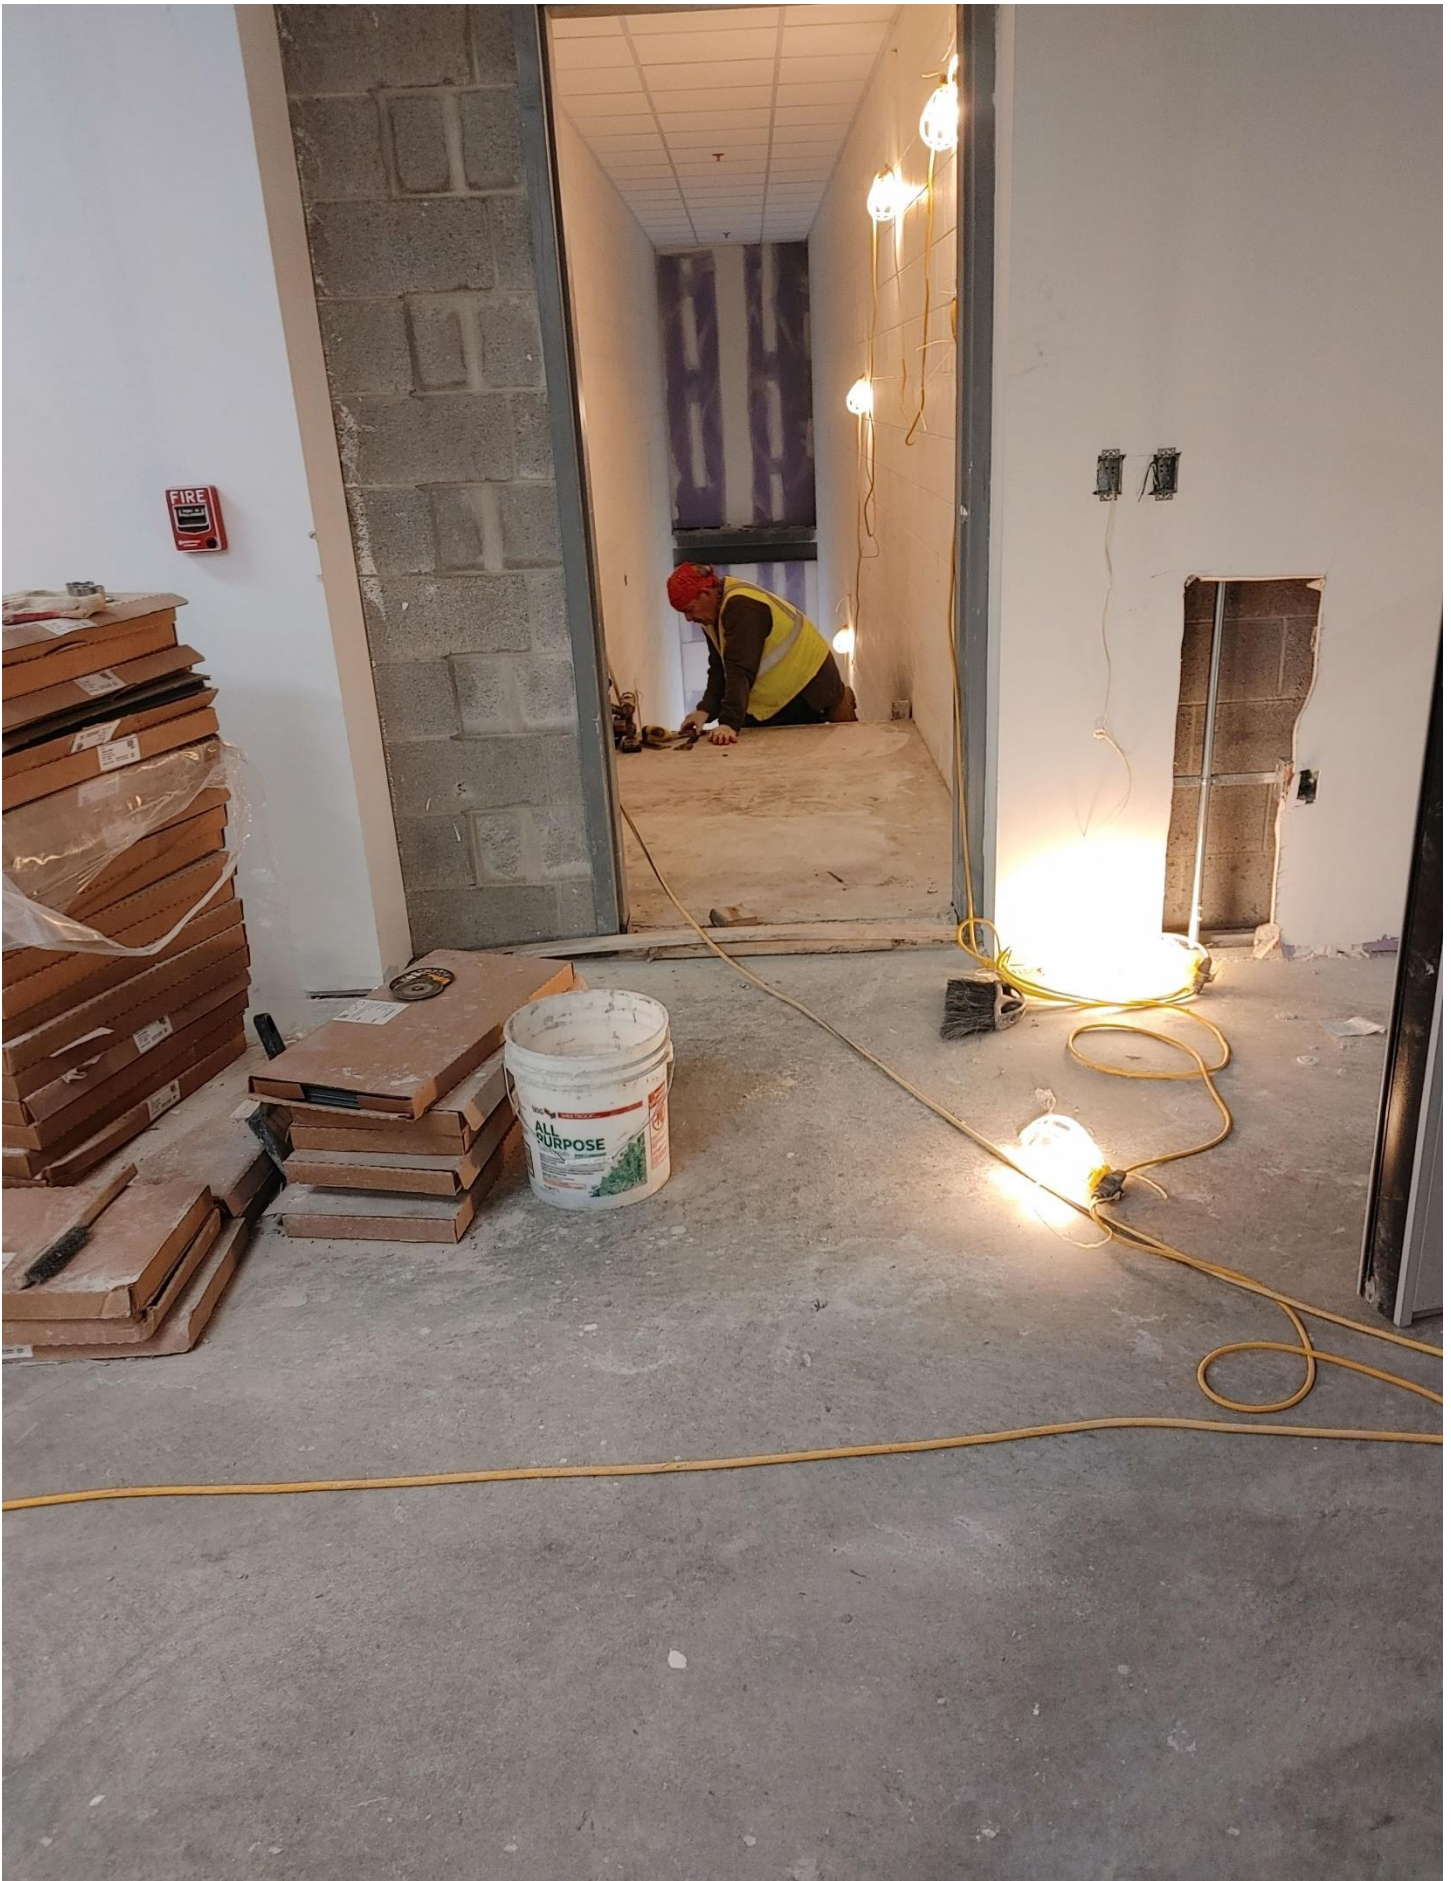
Photo 11 - Concrete Steps and Landings are being poured and finished in Stairwell #4

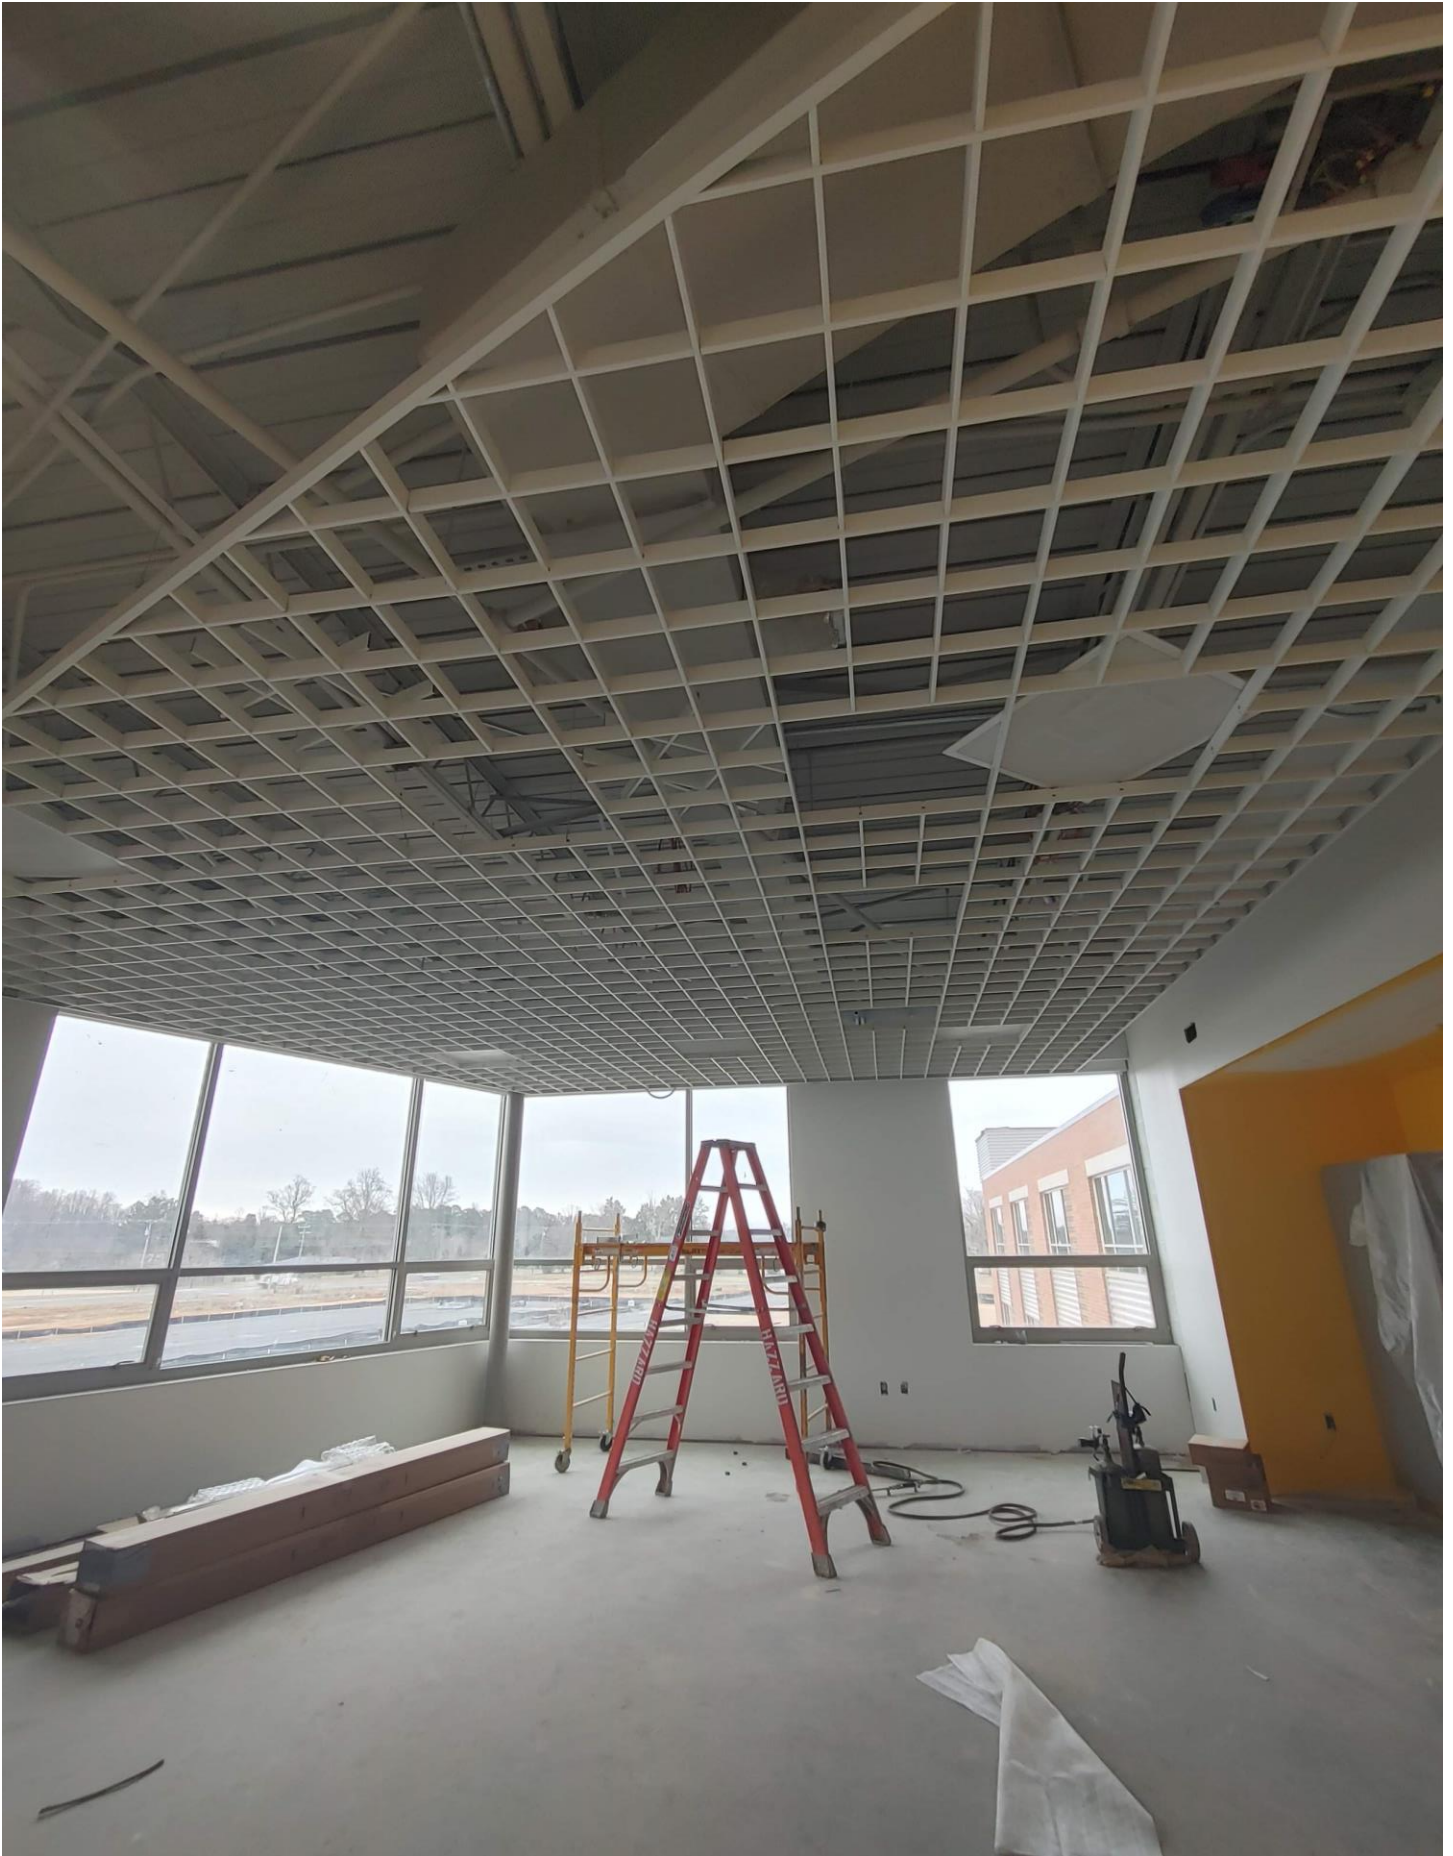
Photo 12 - Open Grid Ceiling in Room A224 has been installed.

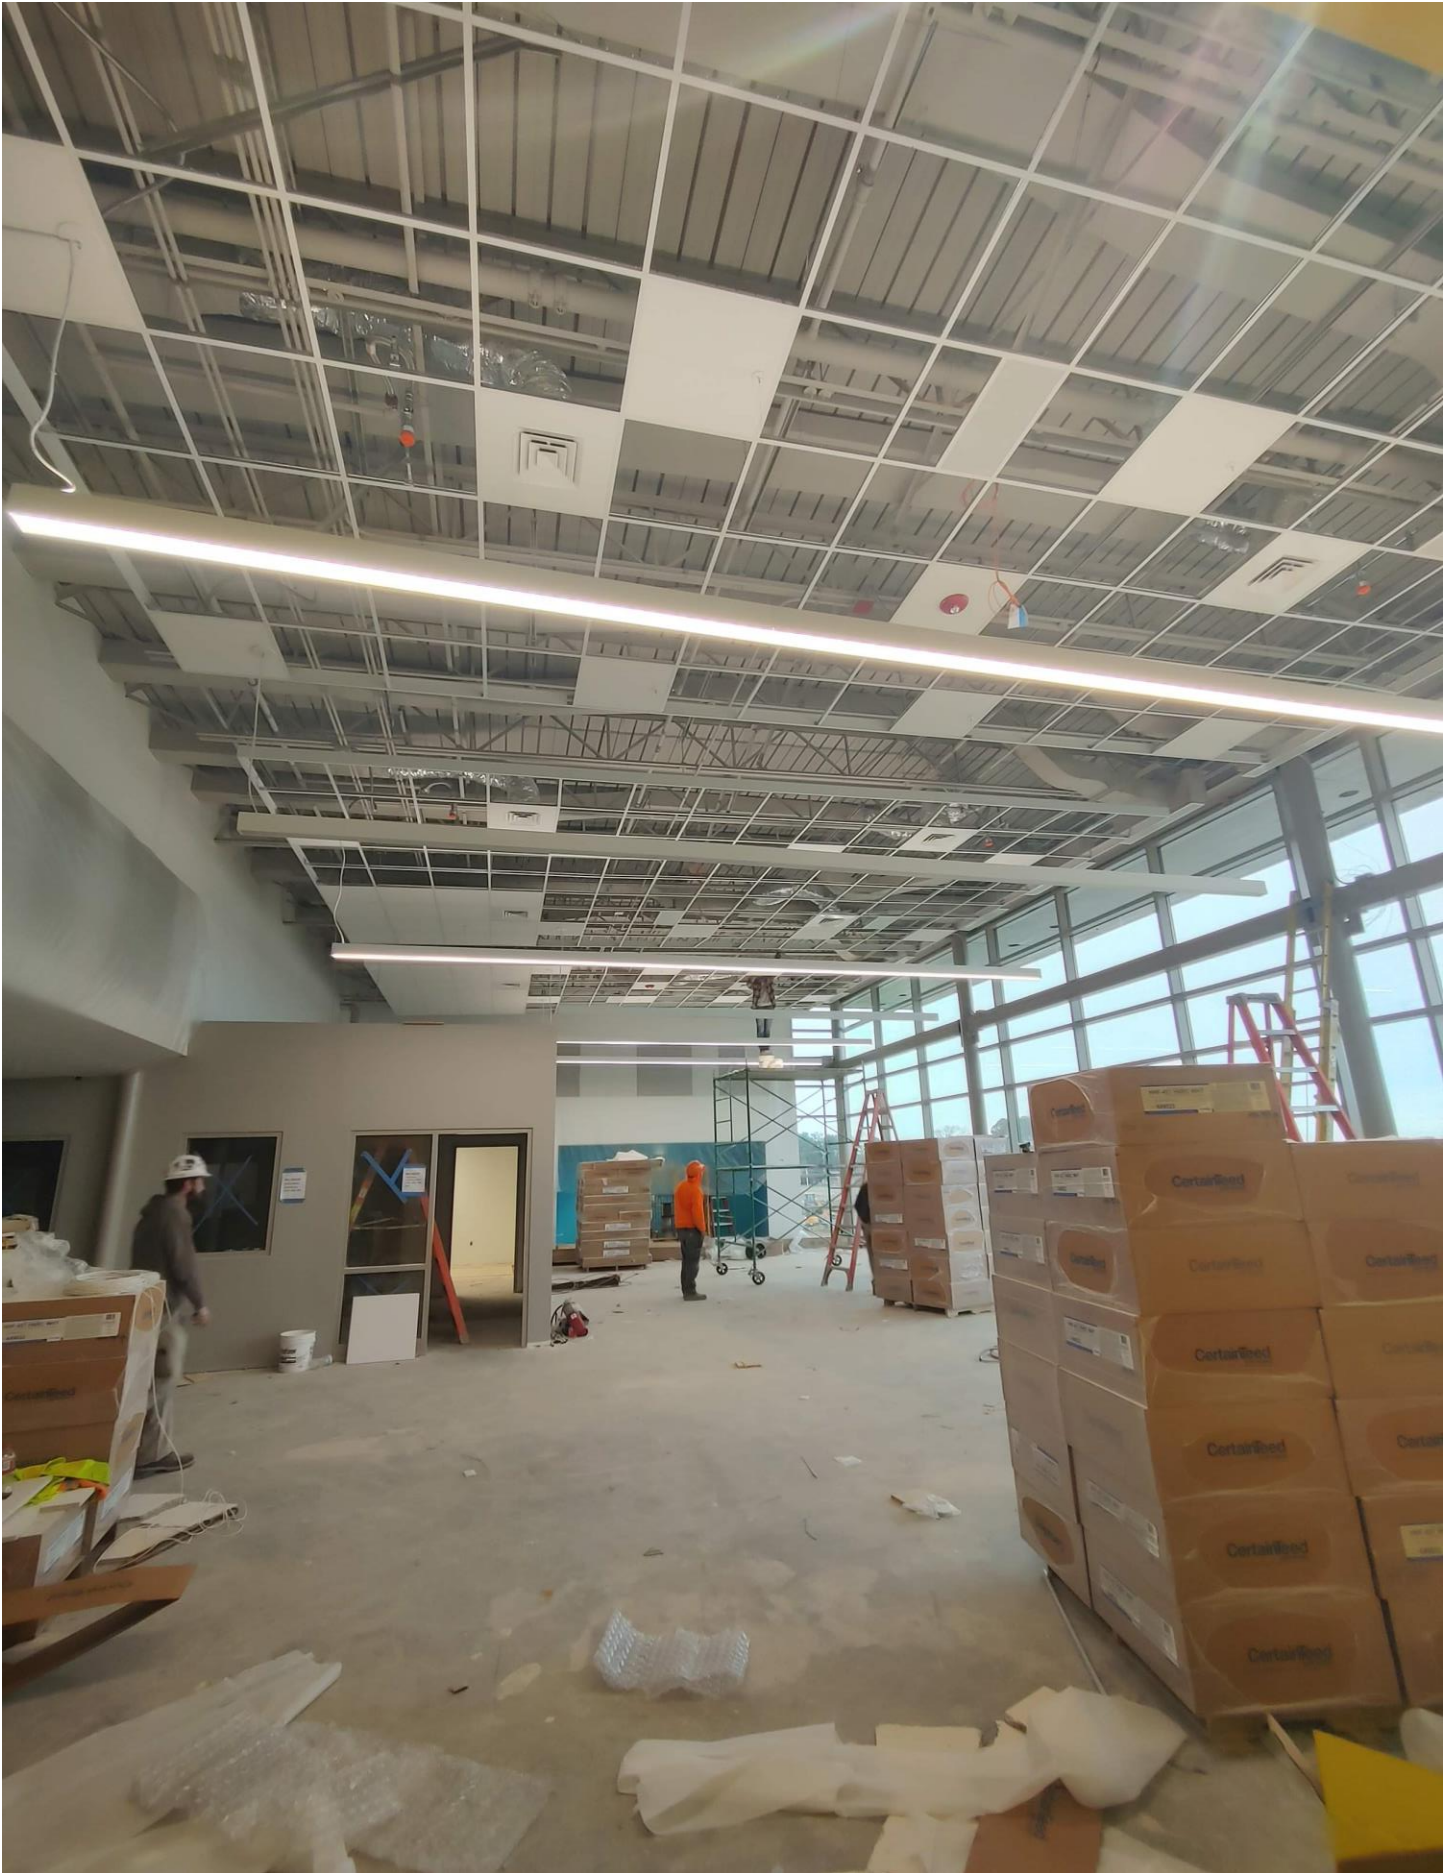
Photo 13 - Lights have been installed in Room A220

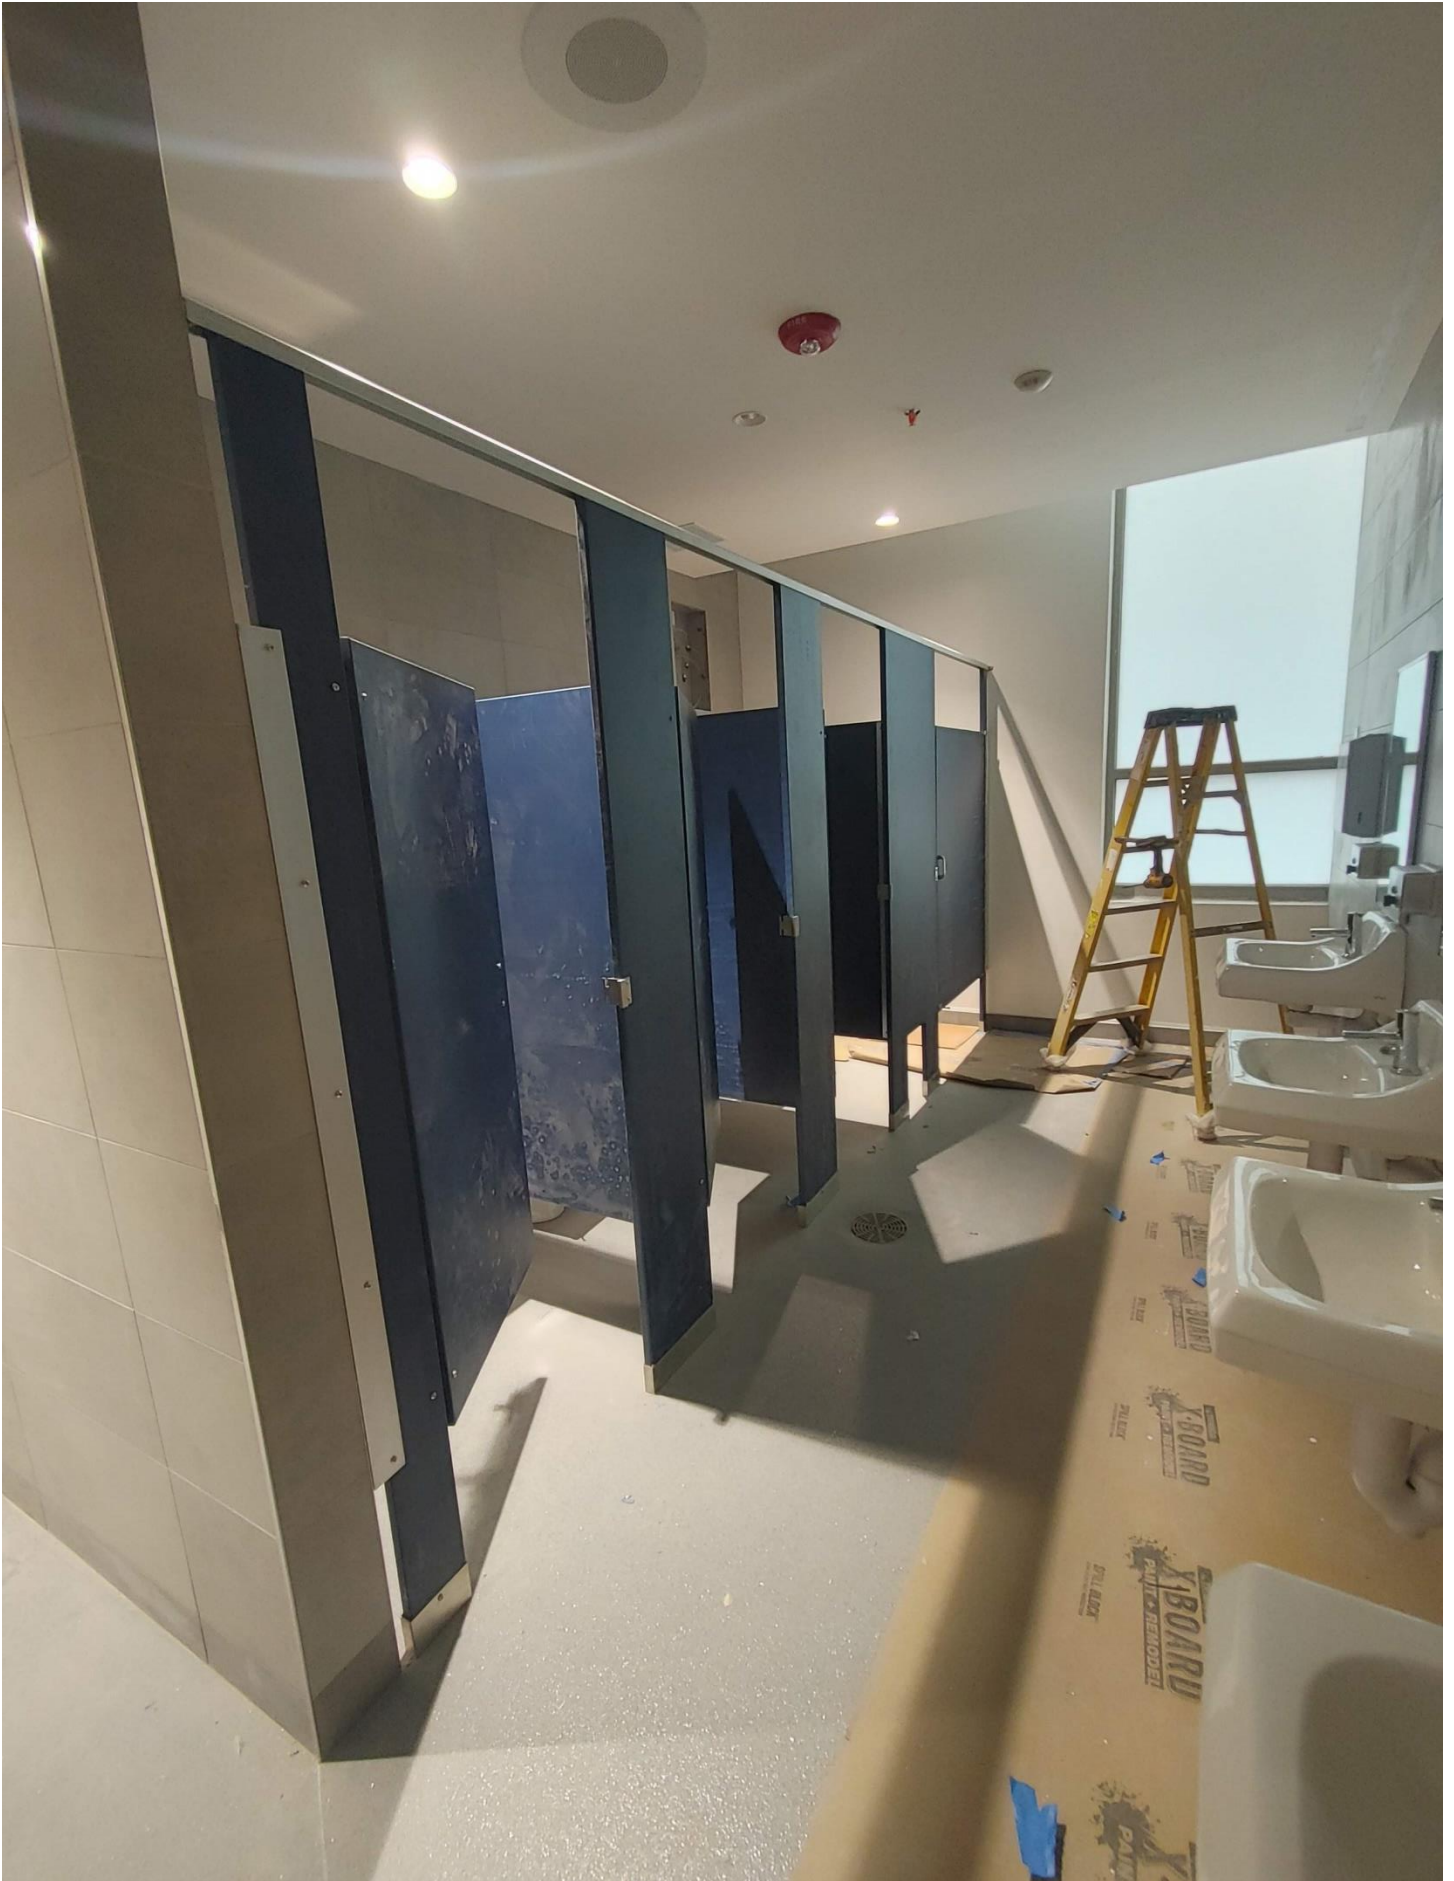
Photo 14 - Toilet Partitions have been installed in B118
