**COMMONWEALTH
BUILDING SOLUTIONS, LLC**

DAILY REPORT

WESTMORELAND COUNTY HIGH SCHOOL

Date: 03/25/2021

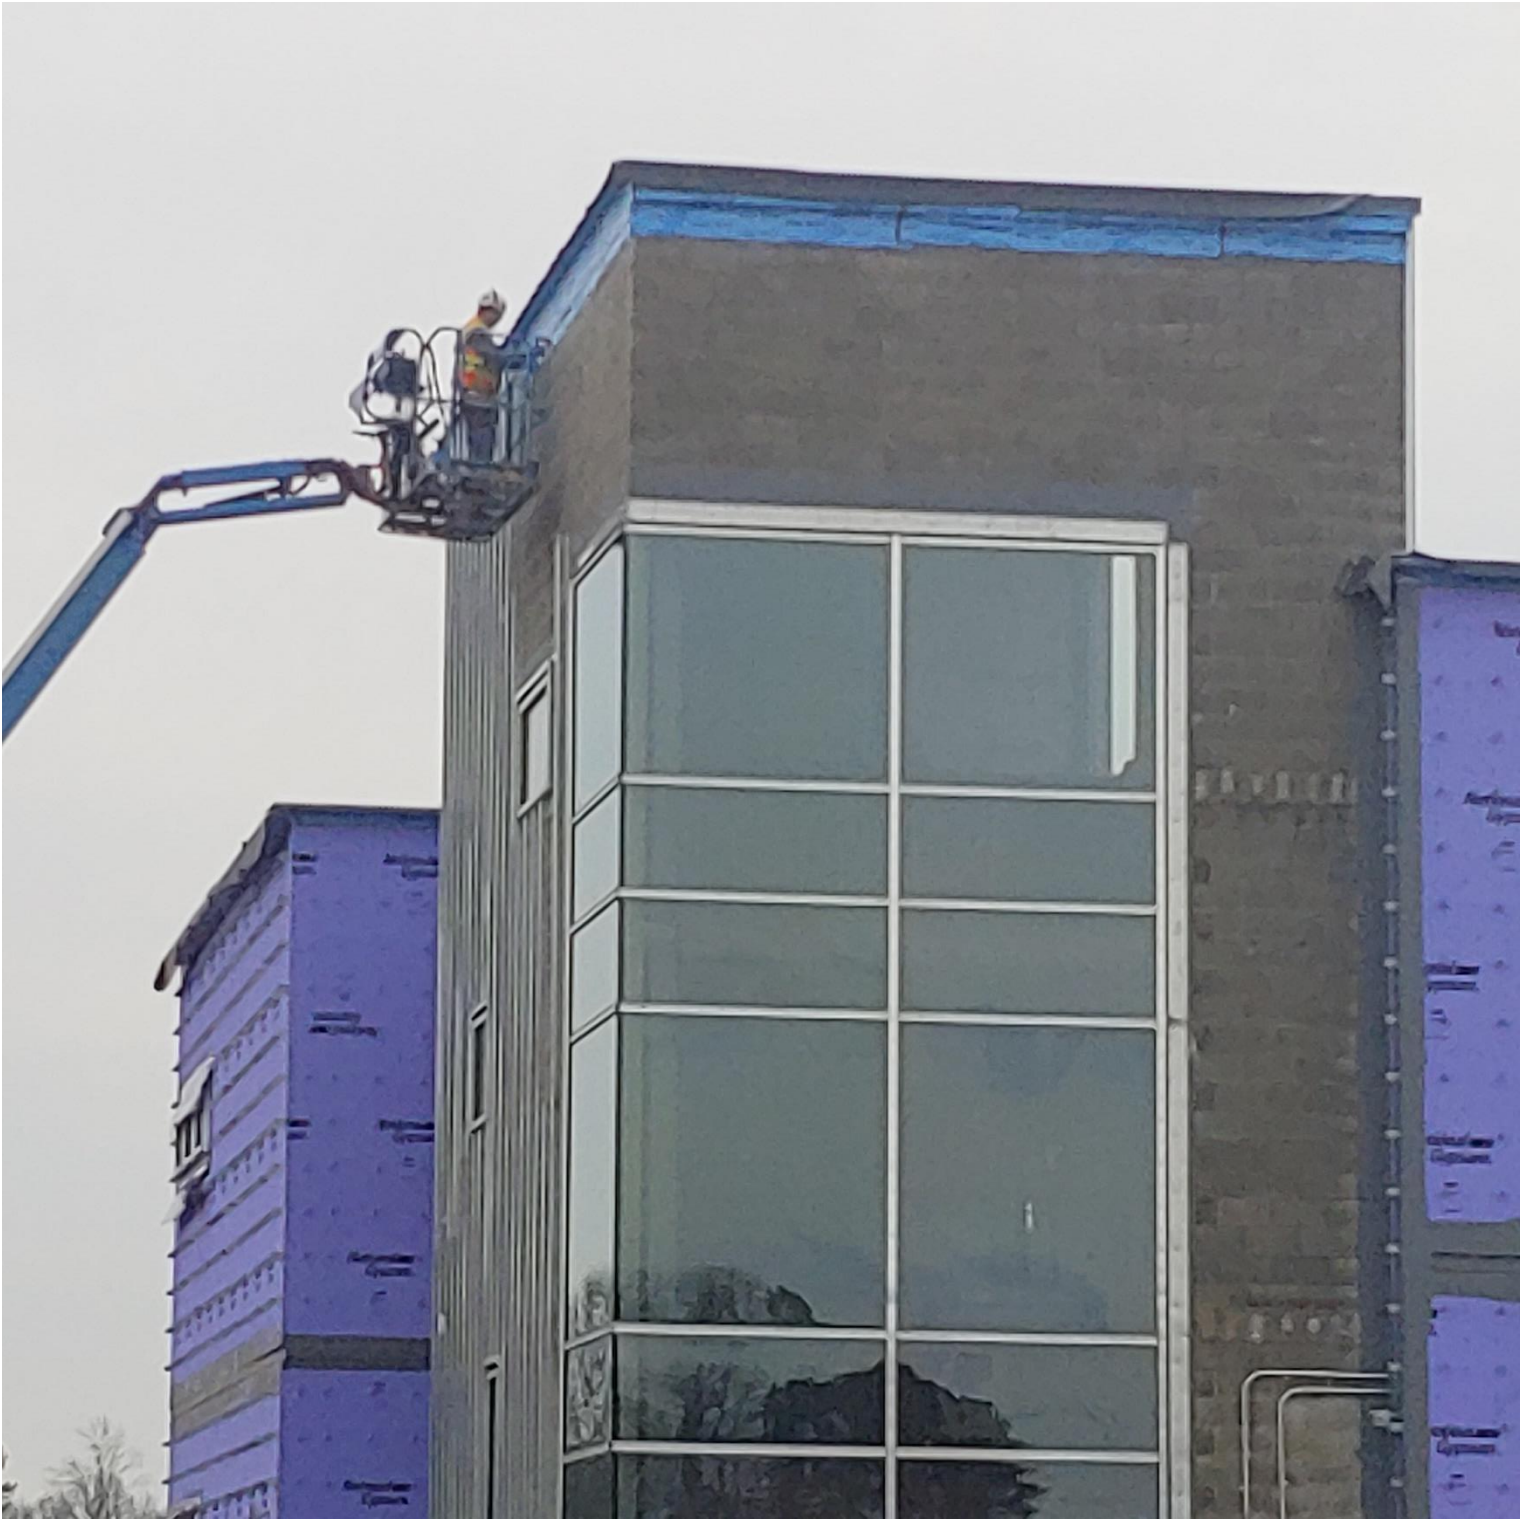
Tailored Foam: Three (3) men are on site today. They are flashing around the knee wall of Stairwell #1 and are flashing in windows on the Northside of Area A. They were able to spray foam a large area on the Southside of Area D on Tuesday.

Photo 2 - Flashing being installed - Stairwell #1

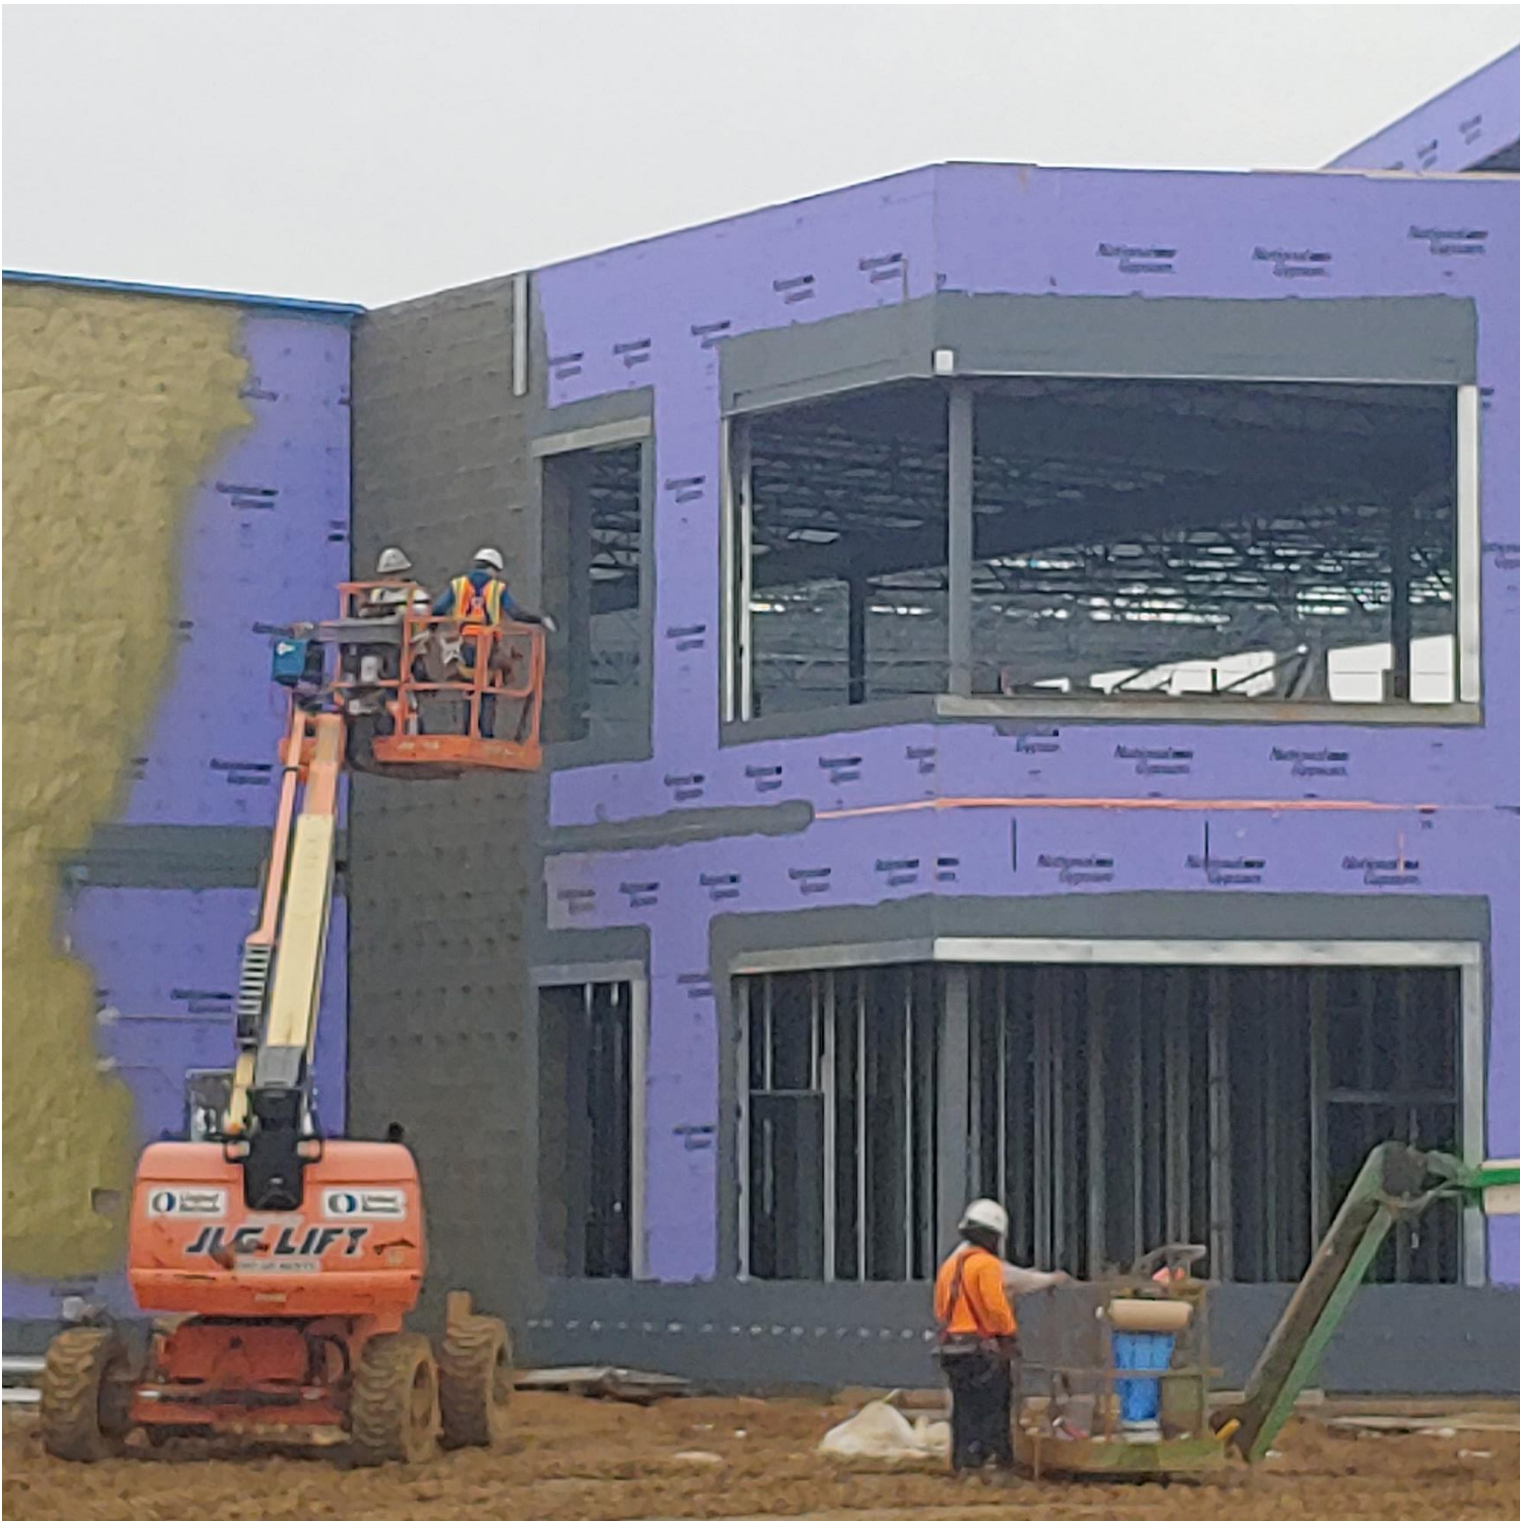
JP Construction: Twelve (12) men on site today. They continue to frame the High roof section in Area A, laying out walls and erecting walls in the Administrative office area of Area a. A crew is also installing Bent Galvanized metal around windows on the Northside of Area A.

Photo 3 - Bent Galvanized Metal being installed for Storefronts on the Northside of Area A

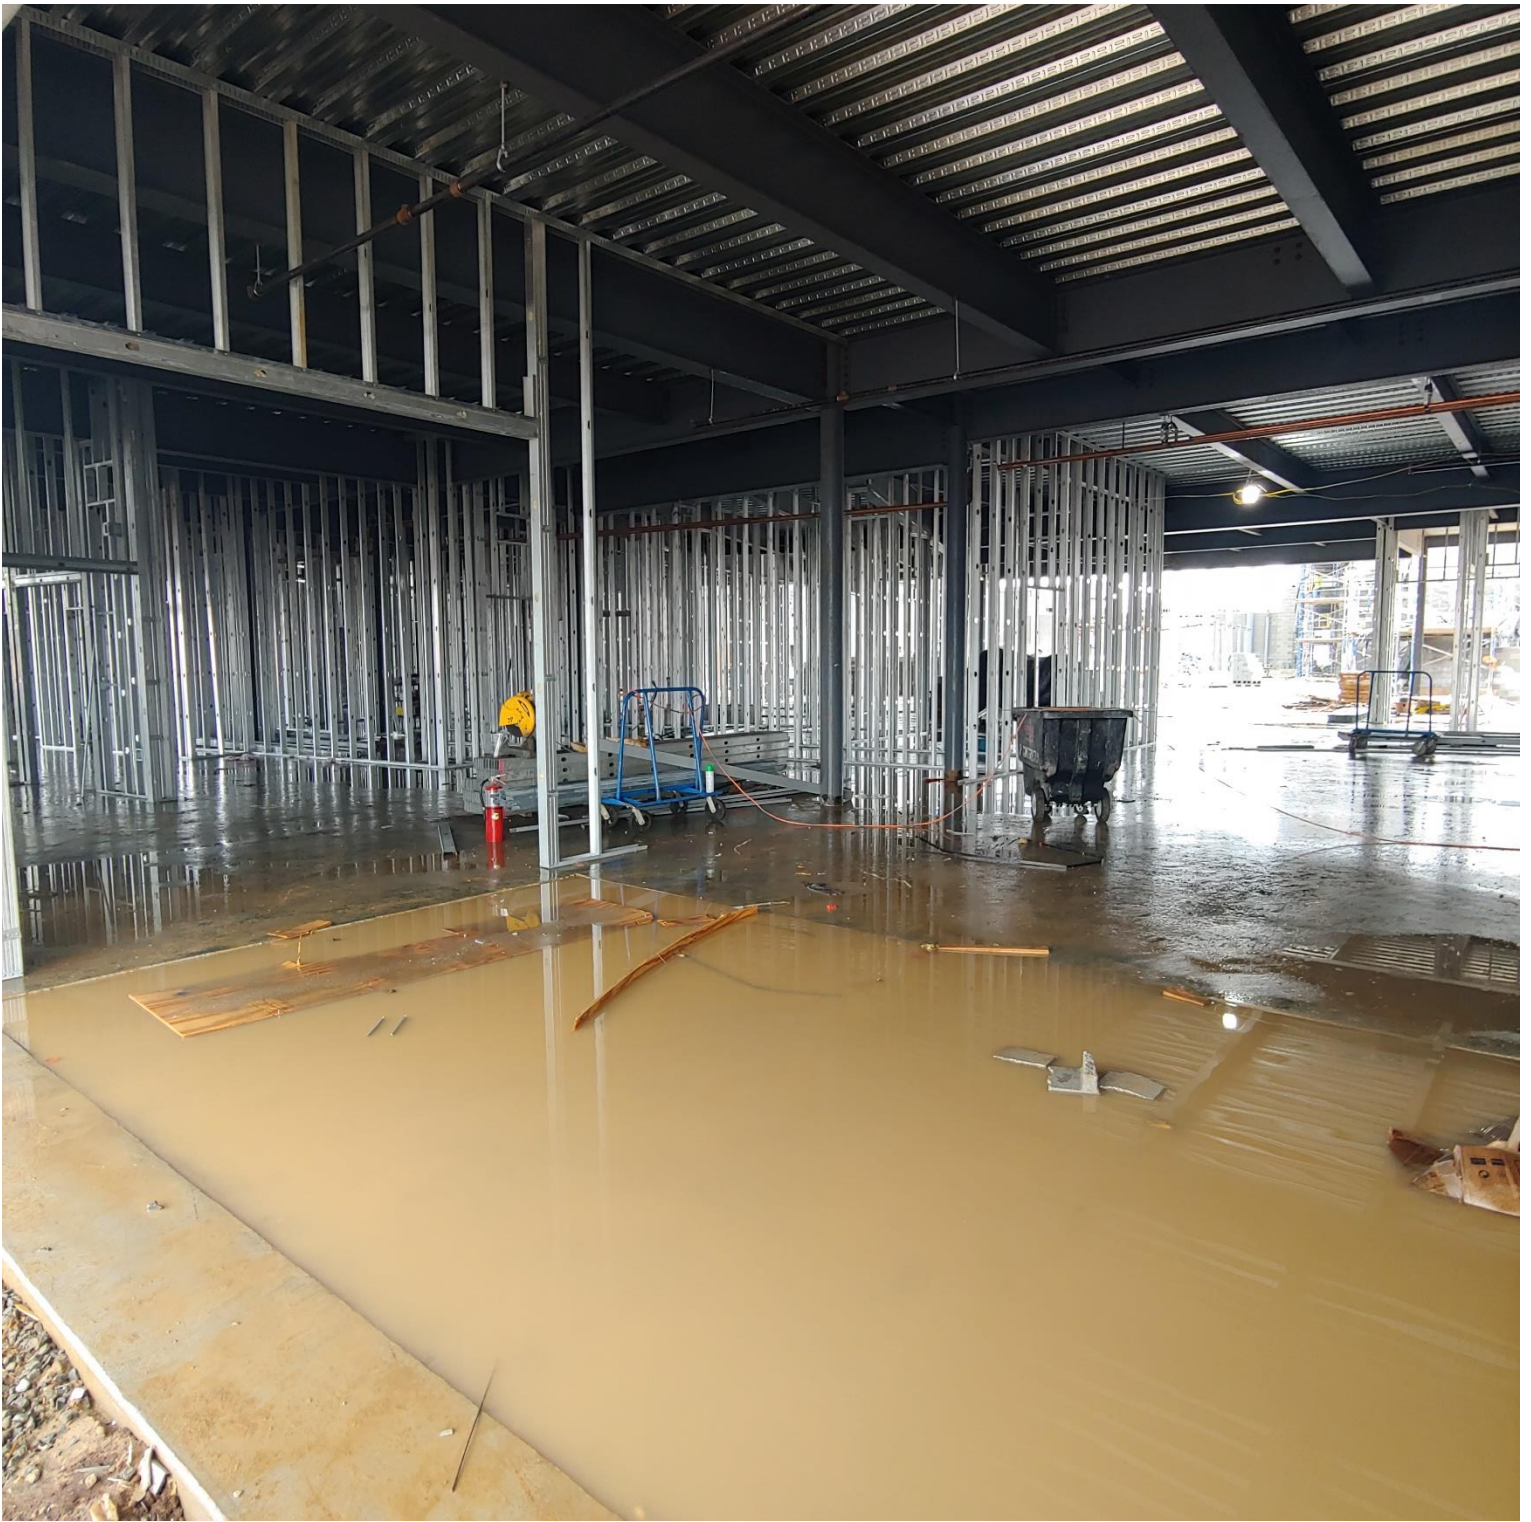
Photo 4 - Framing continues in the Administrative Office area of Area A

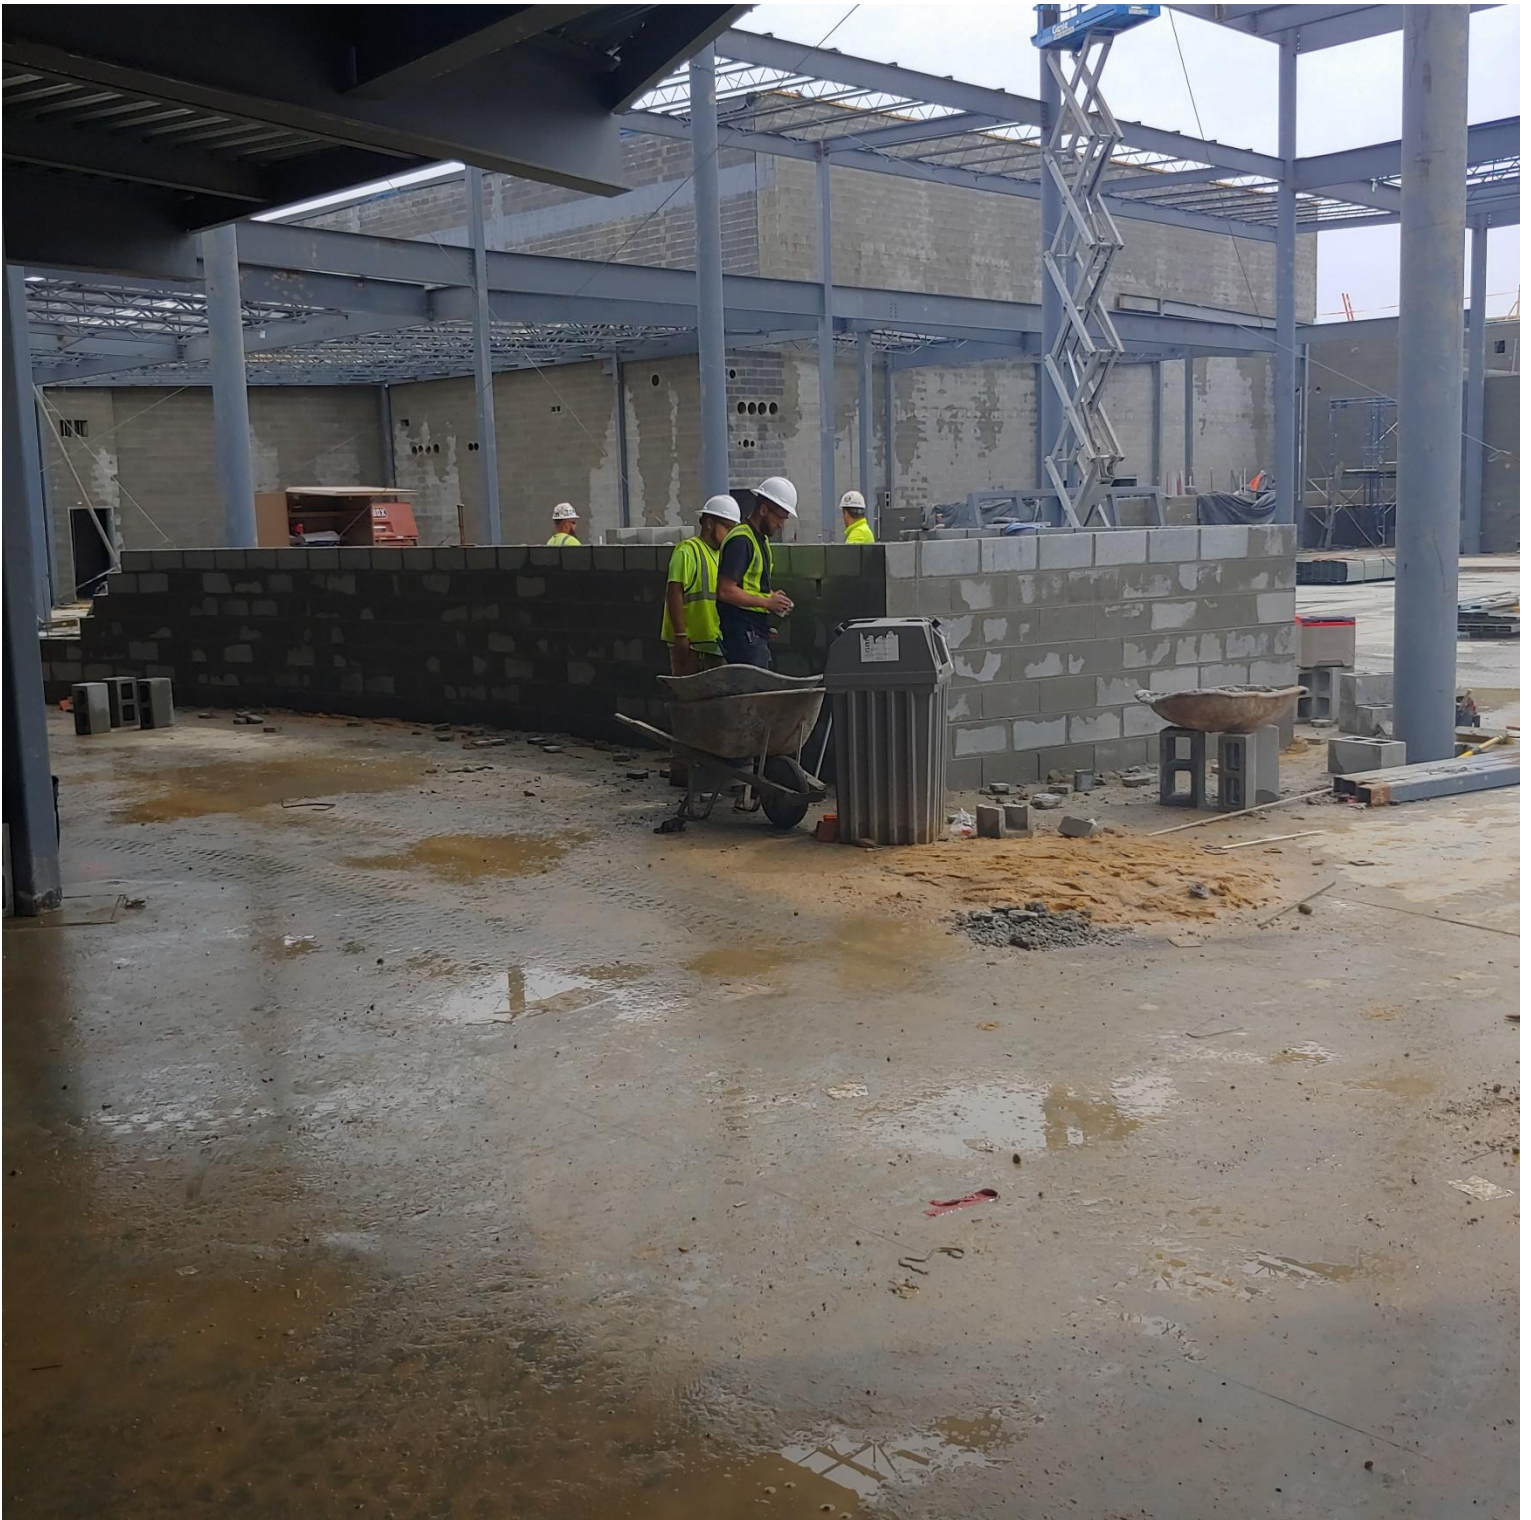
Photo 5 - Stair #3 being constructed

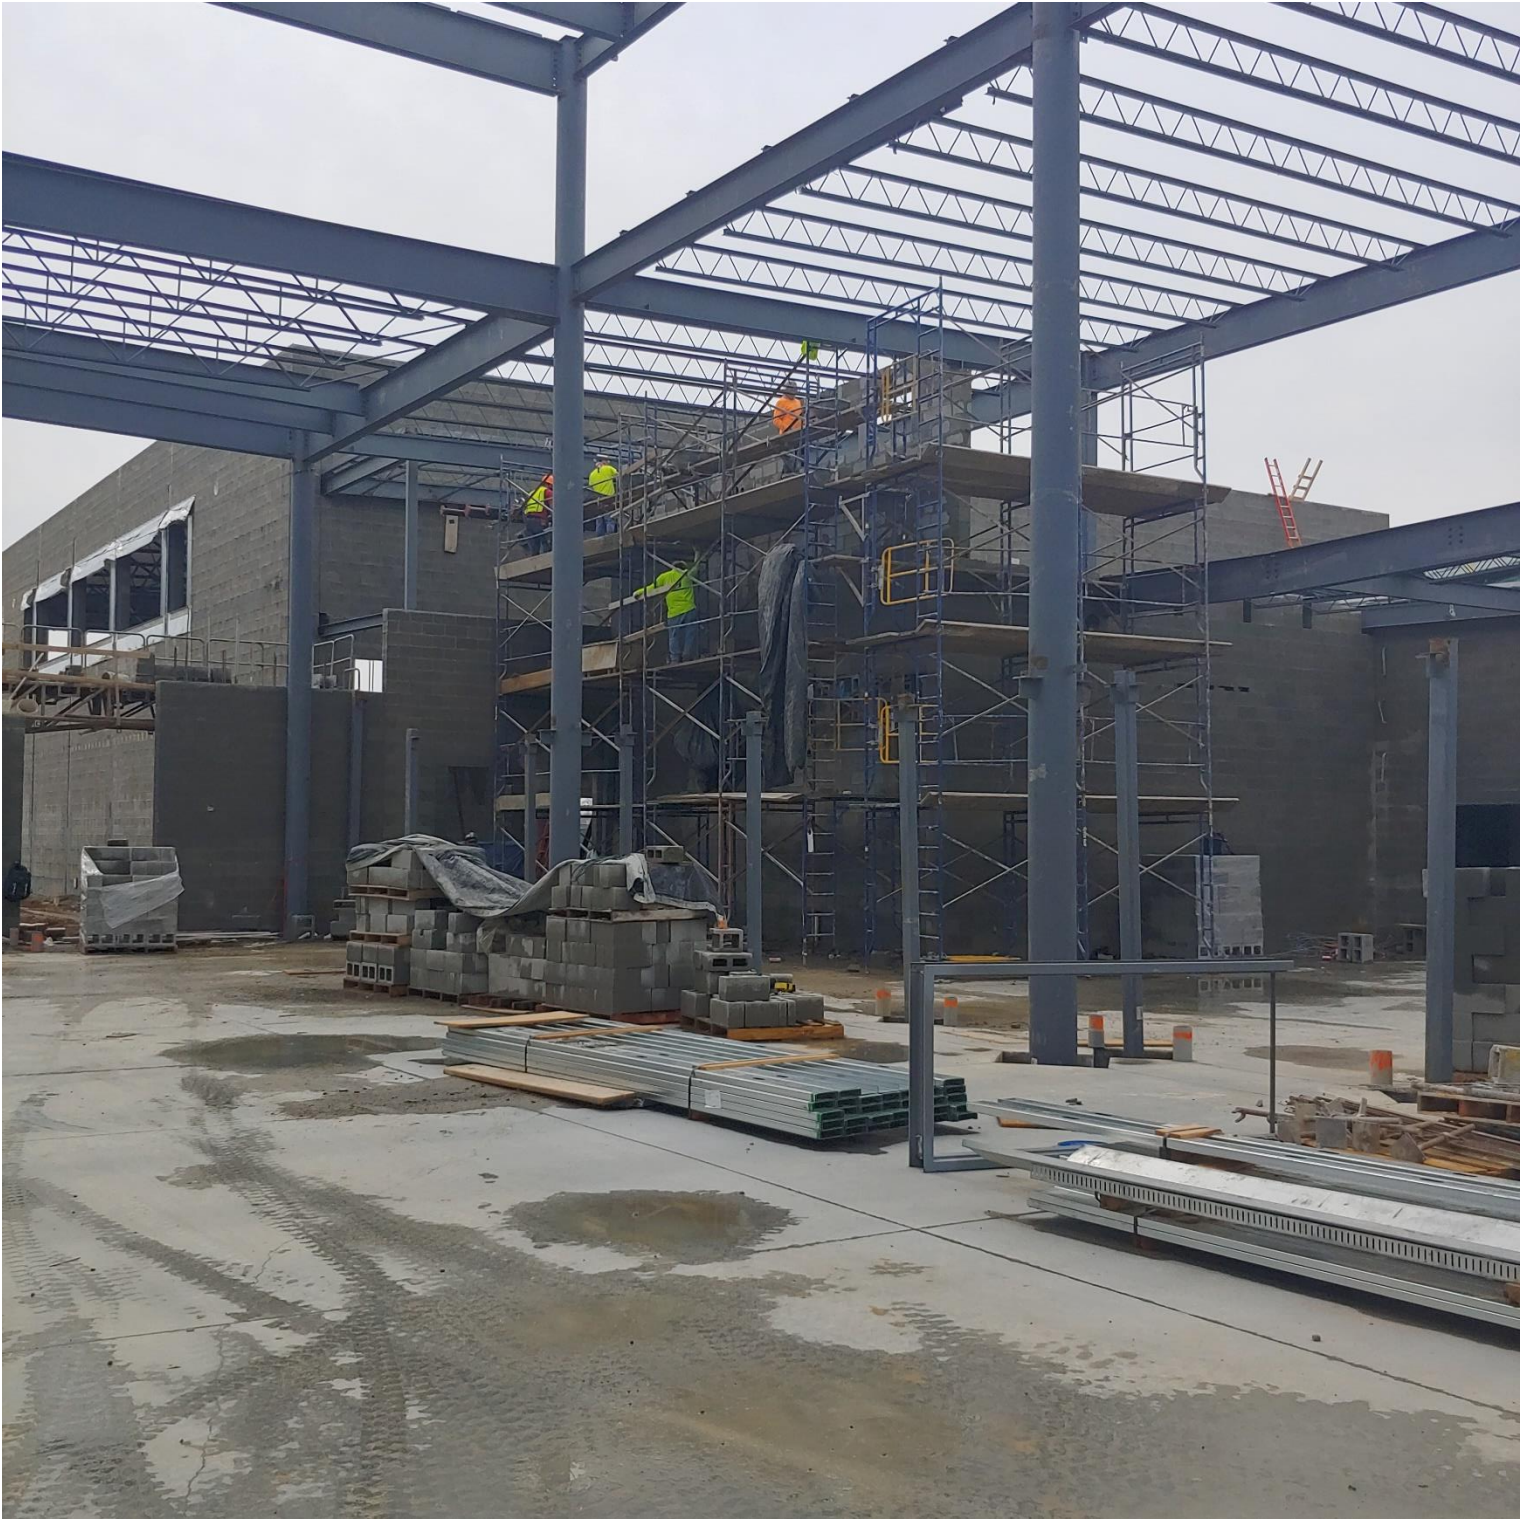
Photo 6 - Block being laid in Area D

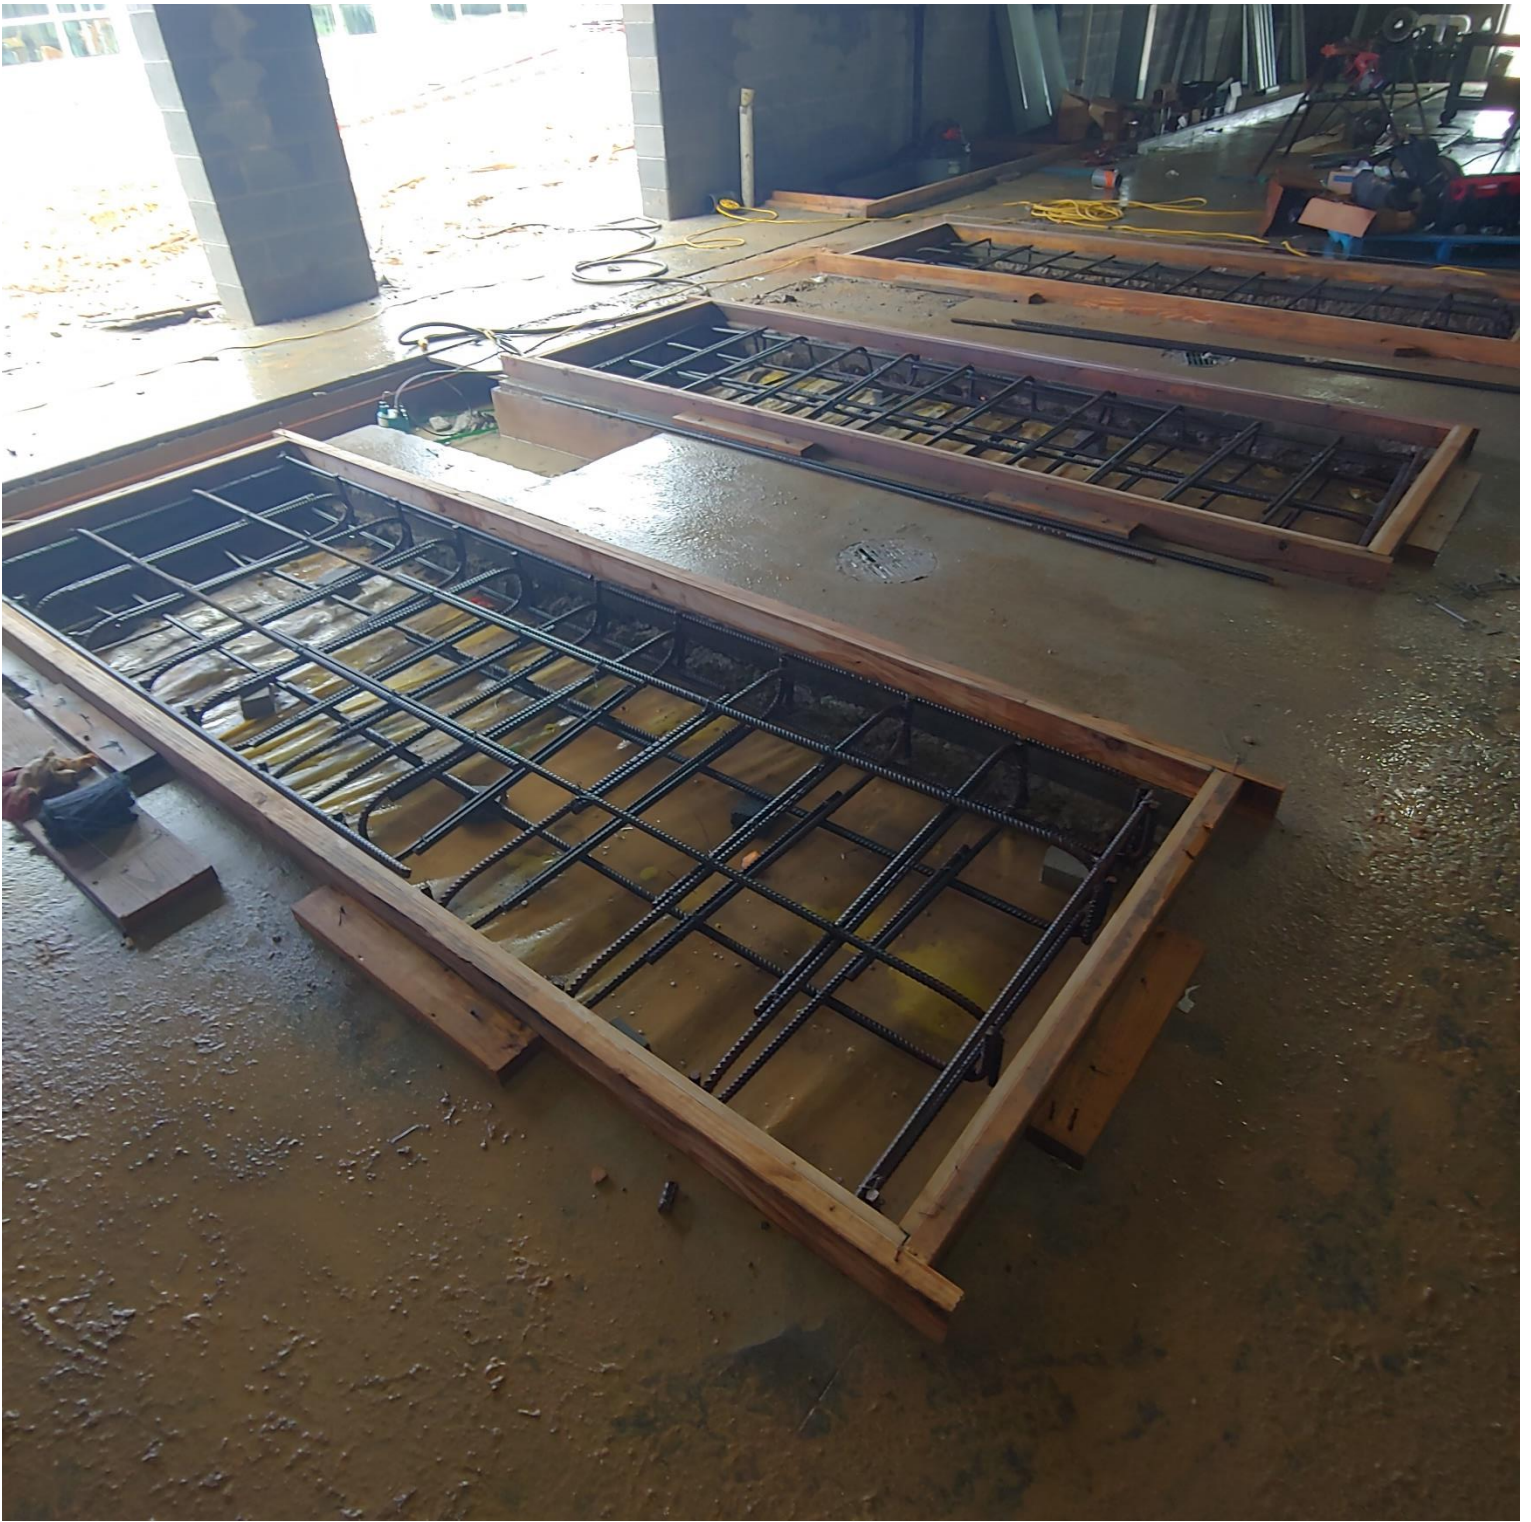
Photo 7 - Steel set in forms for concrete in Mechanical room

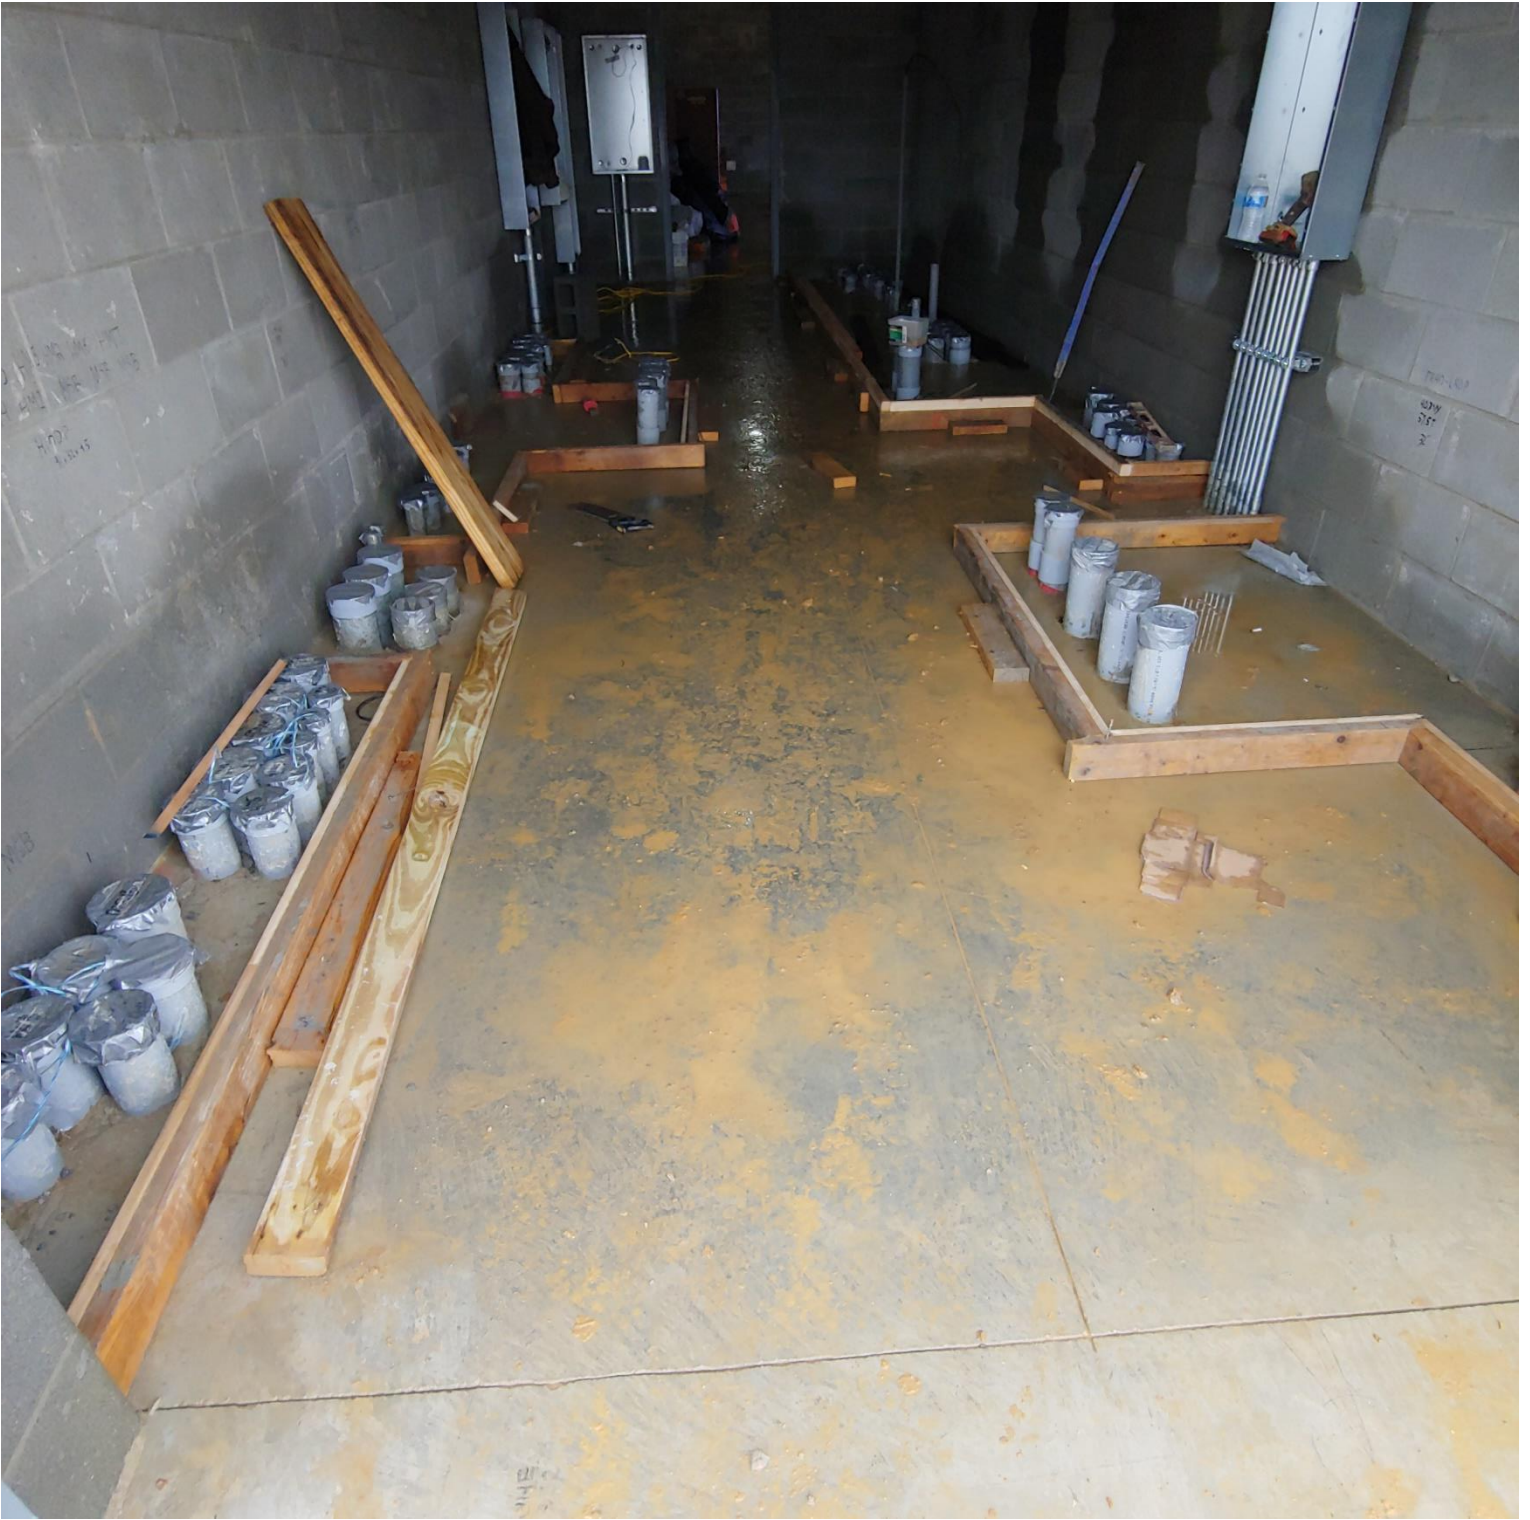
Industrial Concrete: There is one man on site today. Constructing a form around Electrical Conduit for a raised concrete slab in Electrical Room D158.

Photo 8 - Forms being constructed in electrical room for raised slabs
