**DAILY REPORT**

**WESTMORELAND COUNTY HIGH SCHOOL**

Date: 03/31/2021

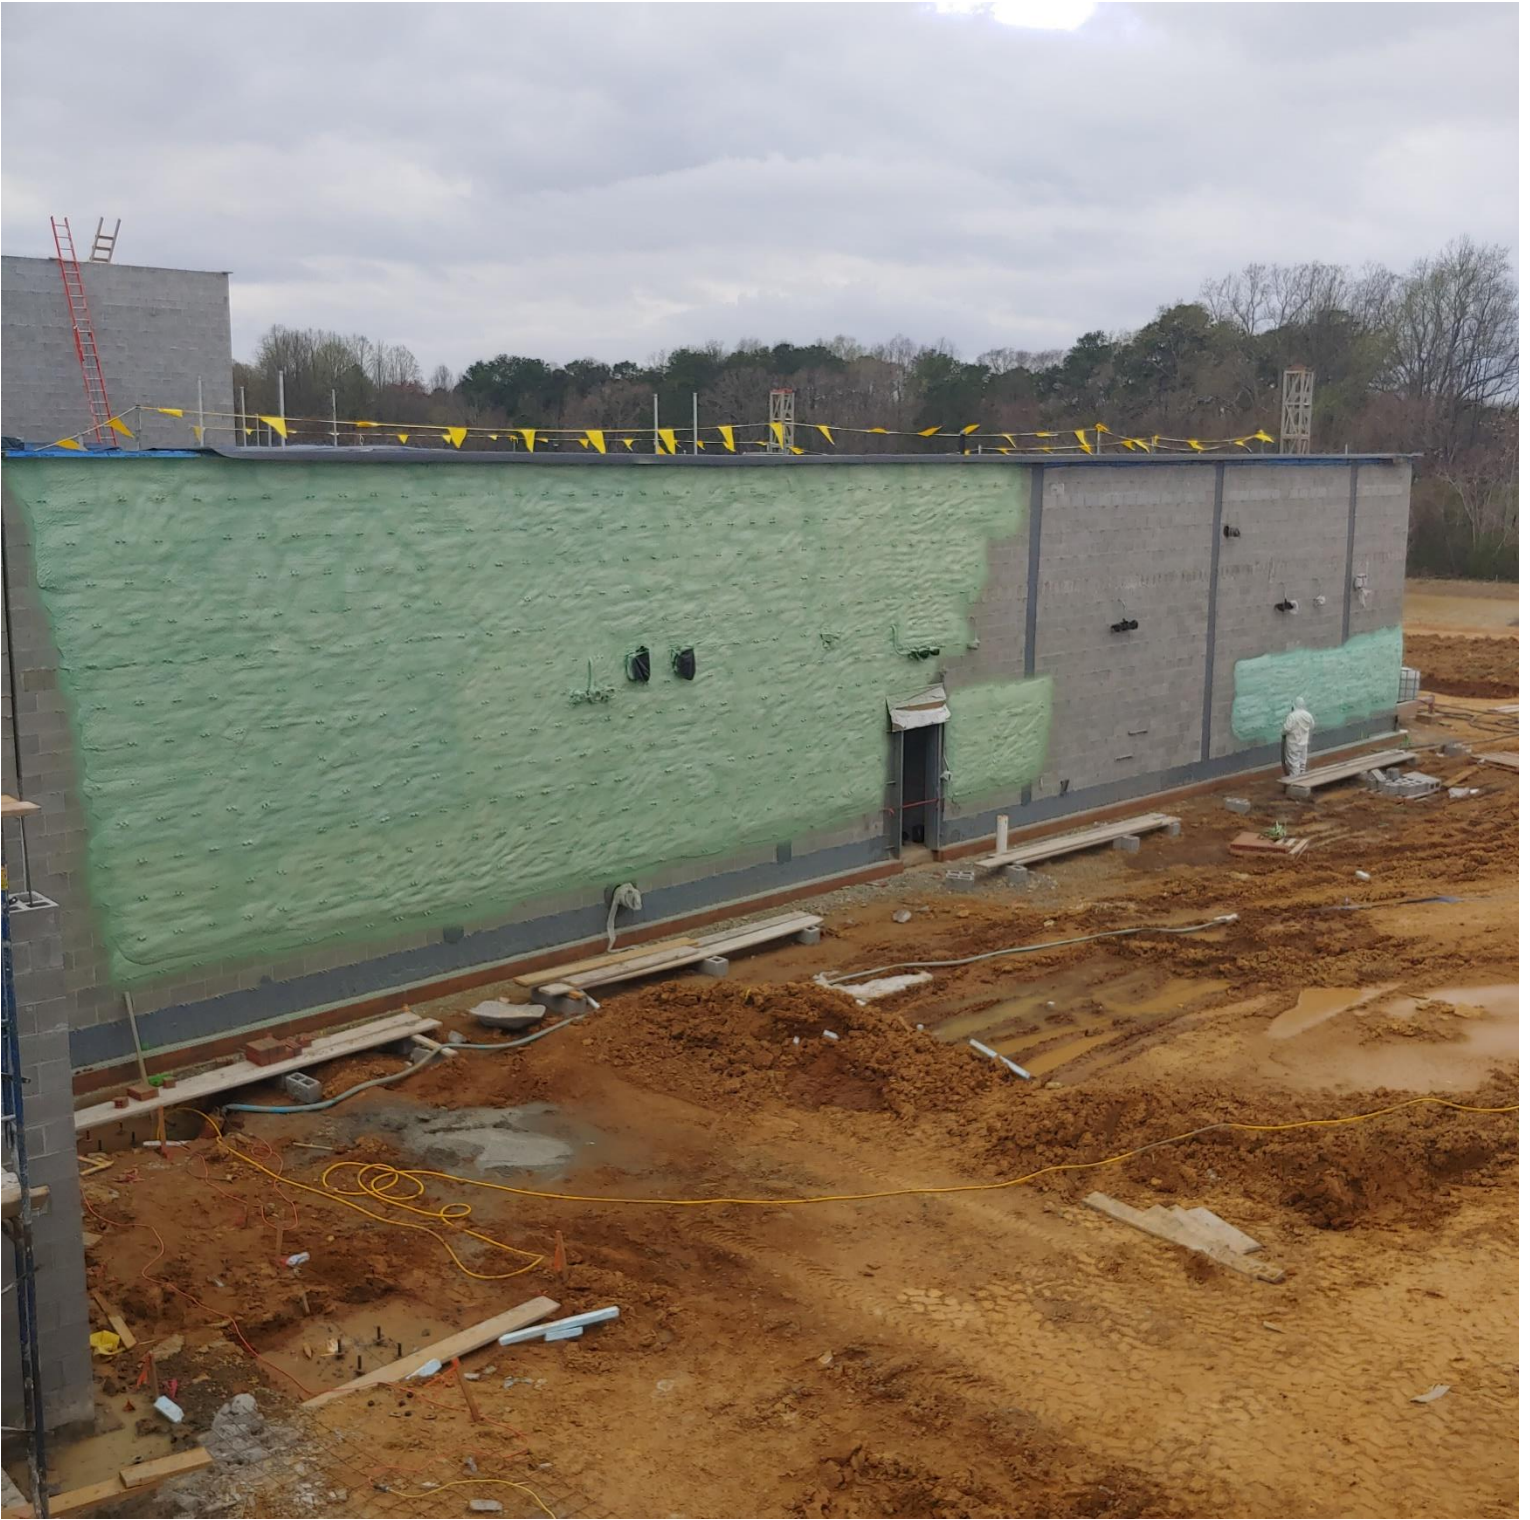
*Photo 1 Spray Foam being applied to the Northside of Area E*

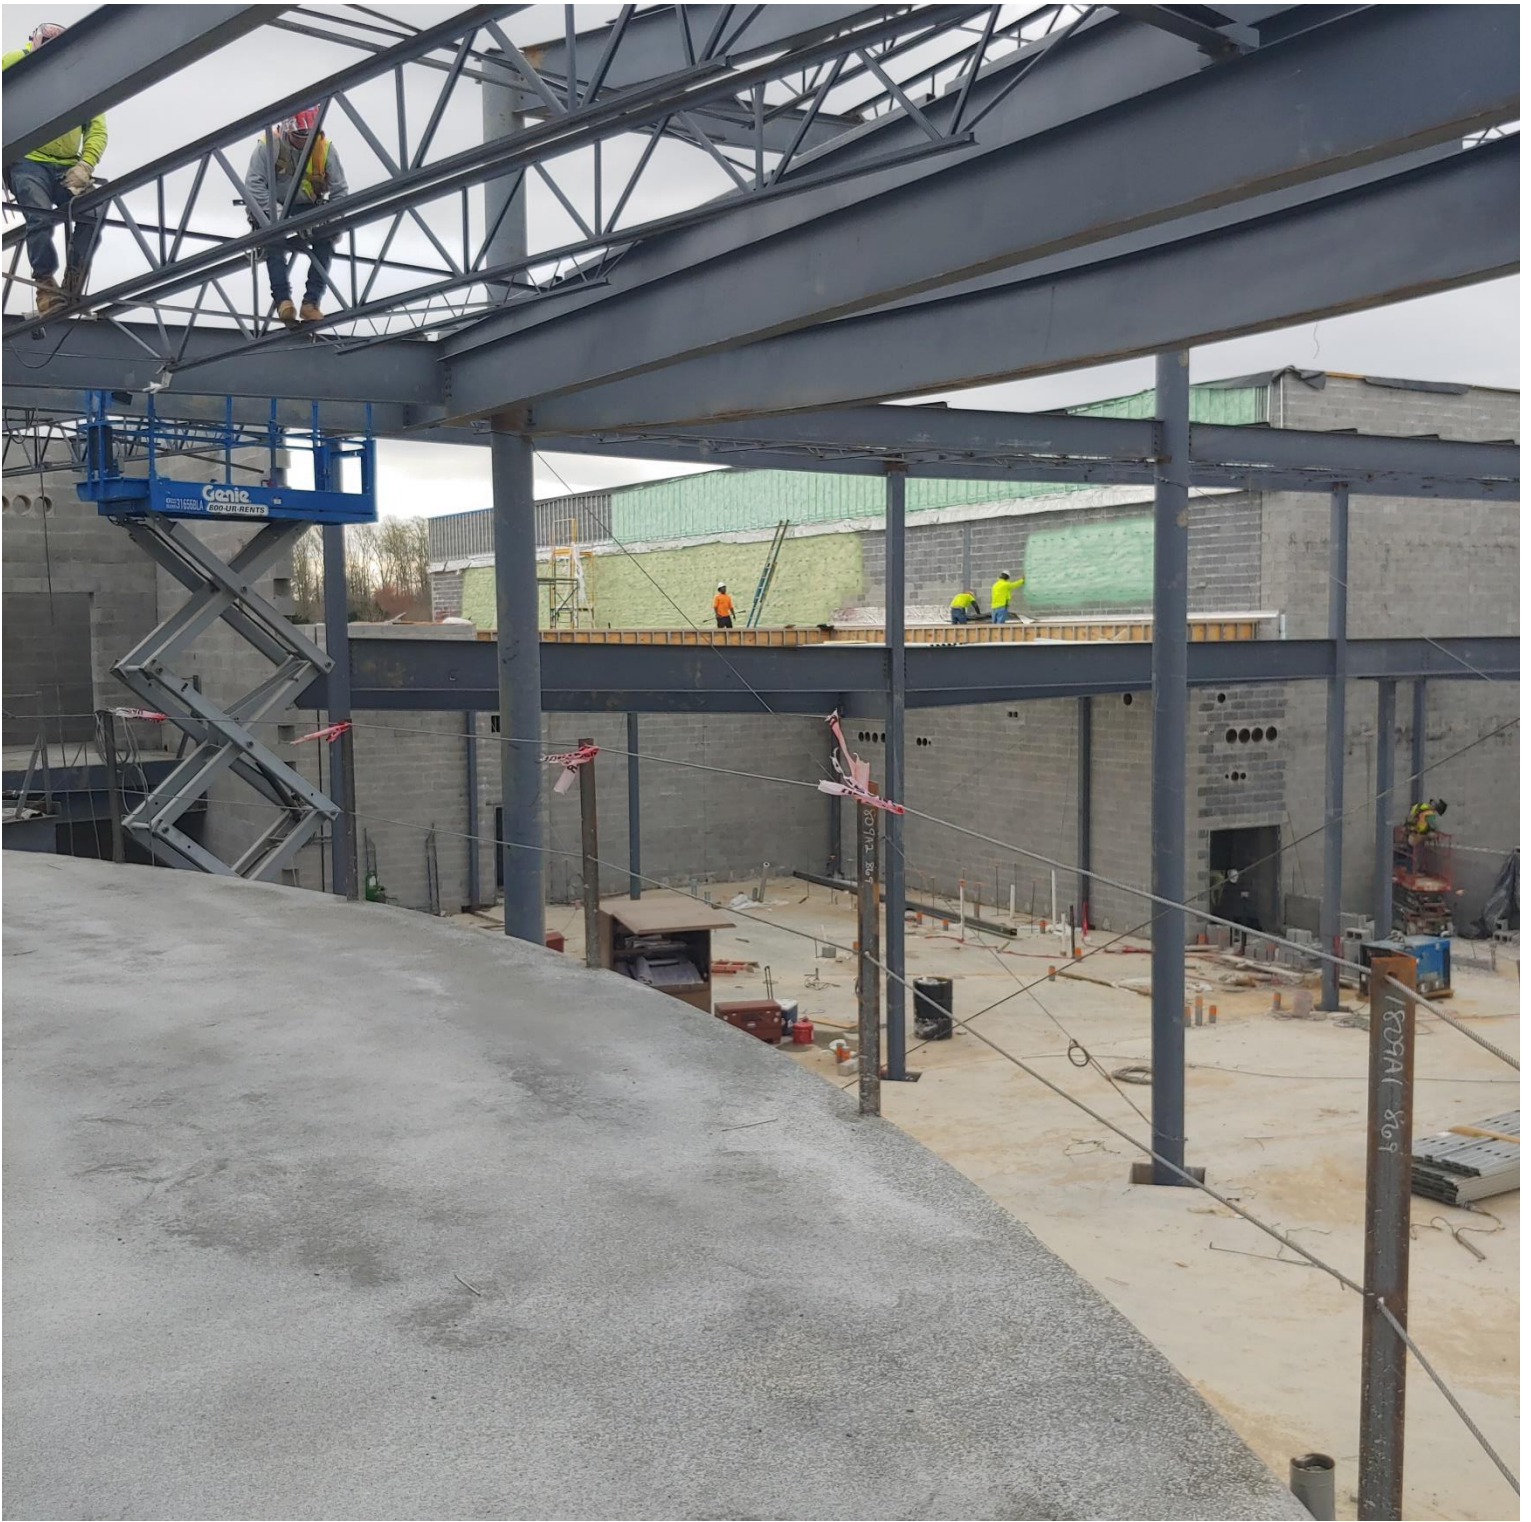
Photo 2 - Lateral Truss Bracing being set and welded in Area A & C. Flashing being installed on the low roof of Area D.

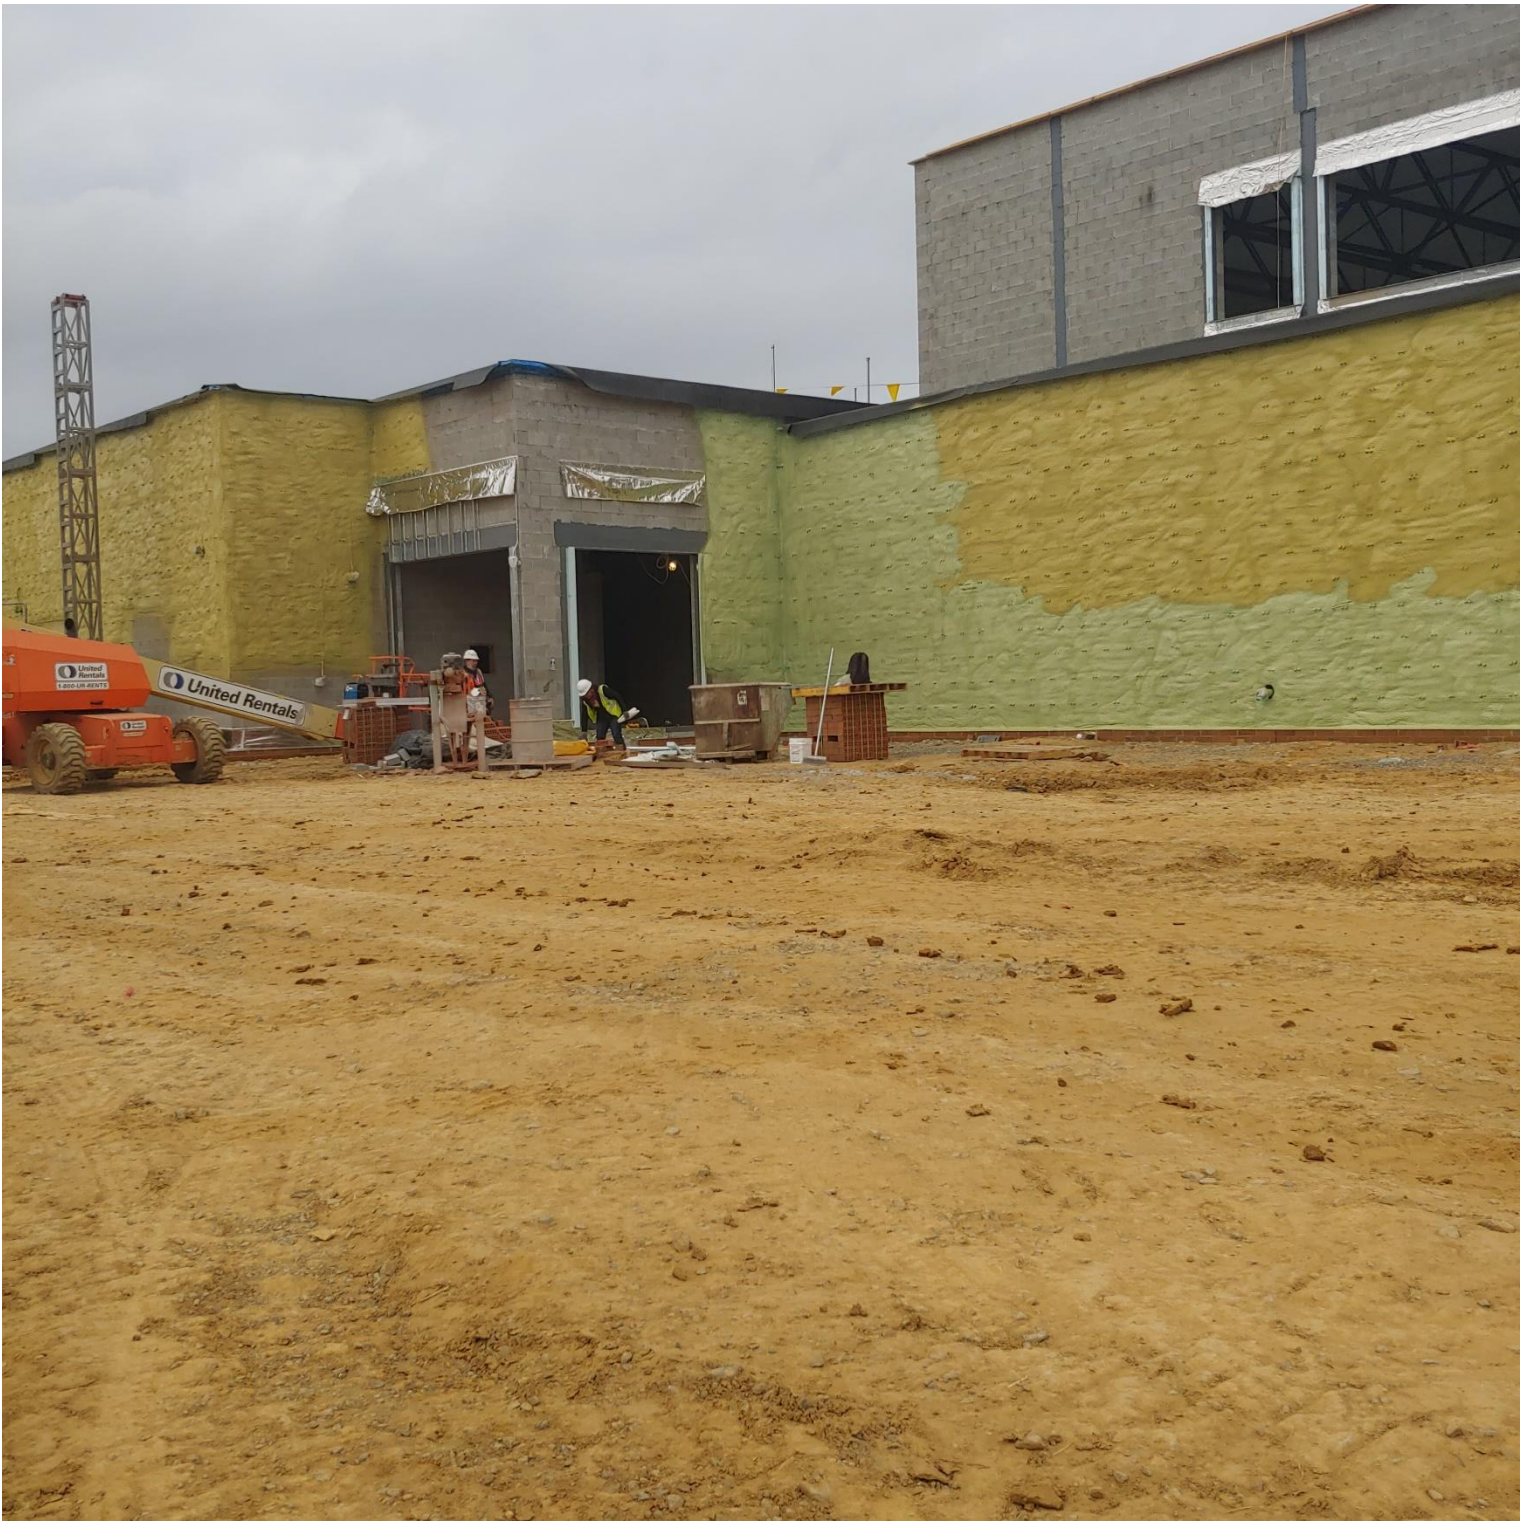
*Photo 3 - Metal studs being installed above Door*

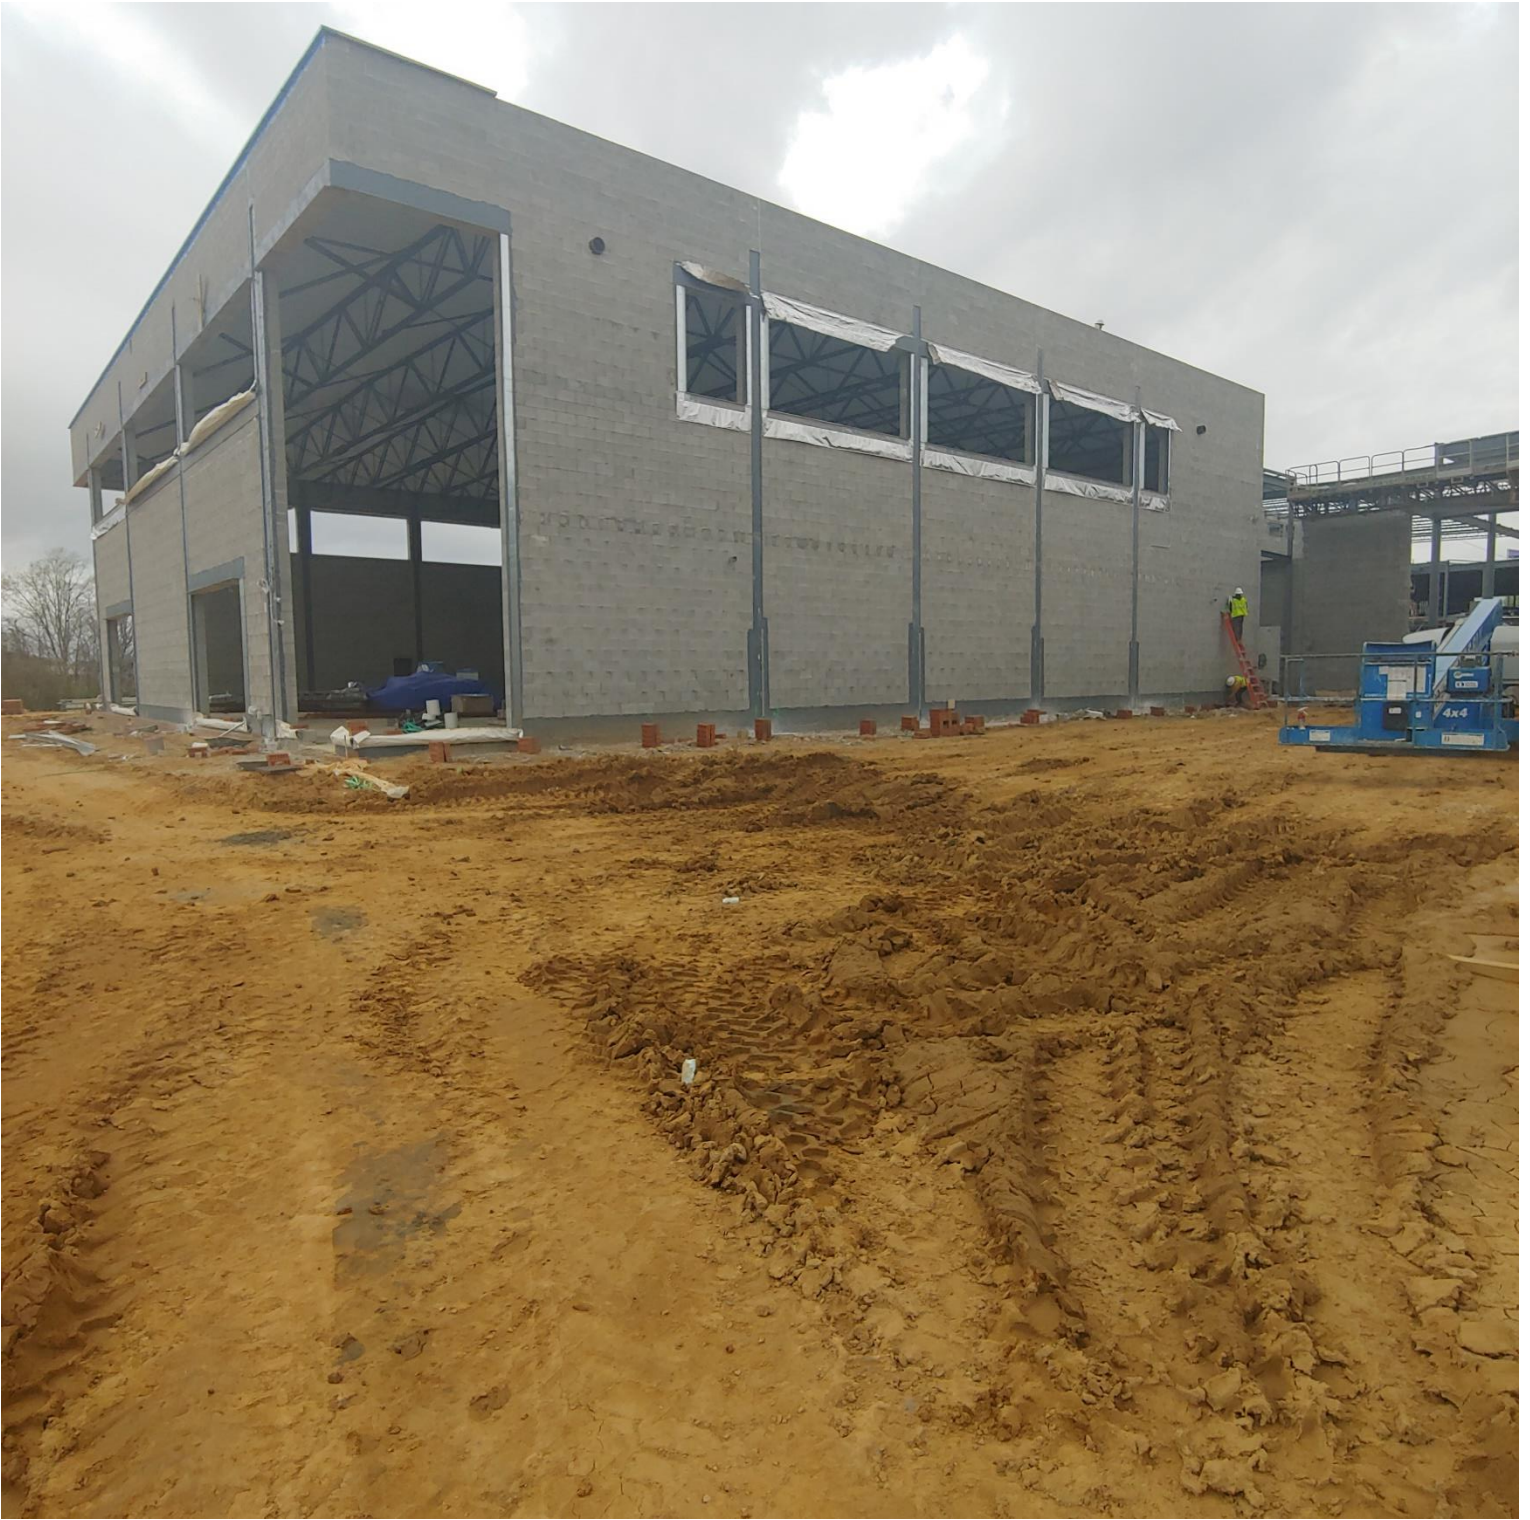
*Photo 4 - Electrician running conduit on the Eastside of Area E for exterior lighting*

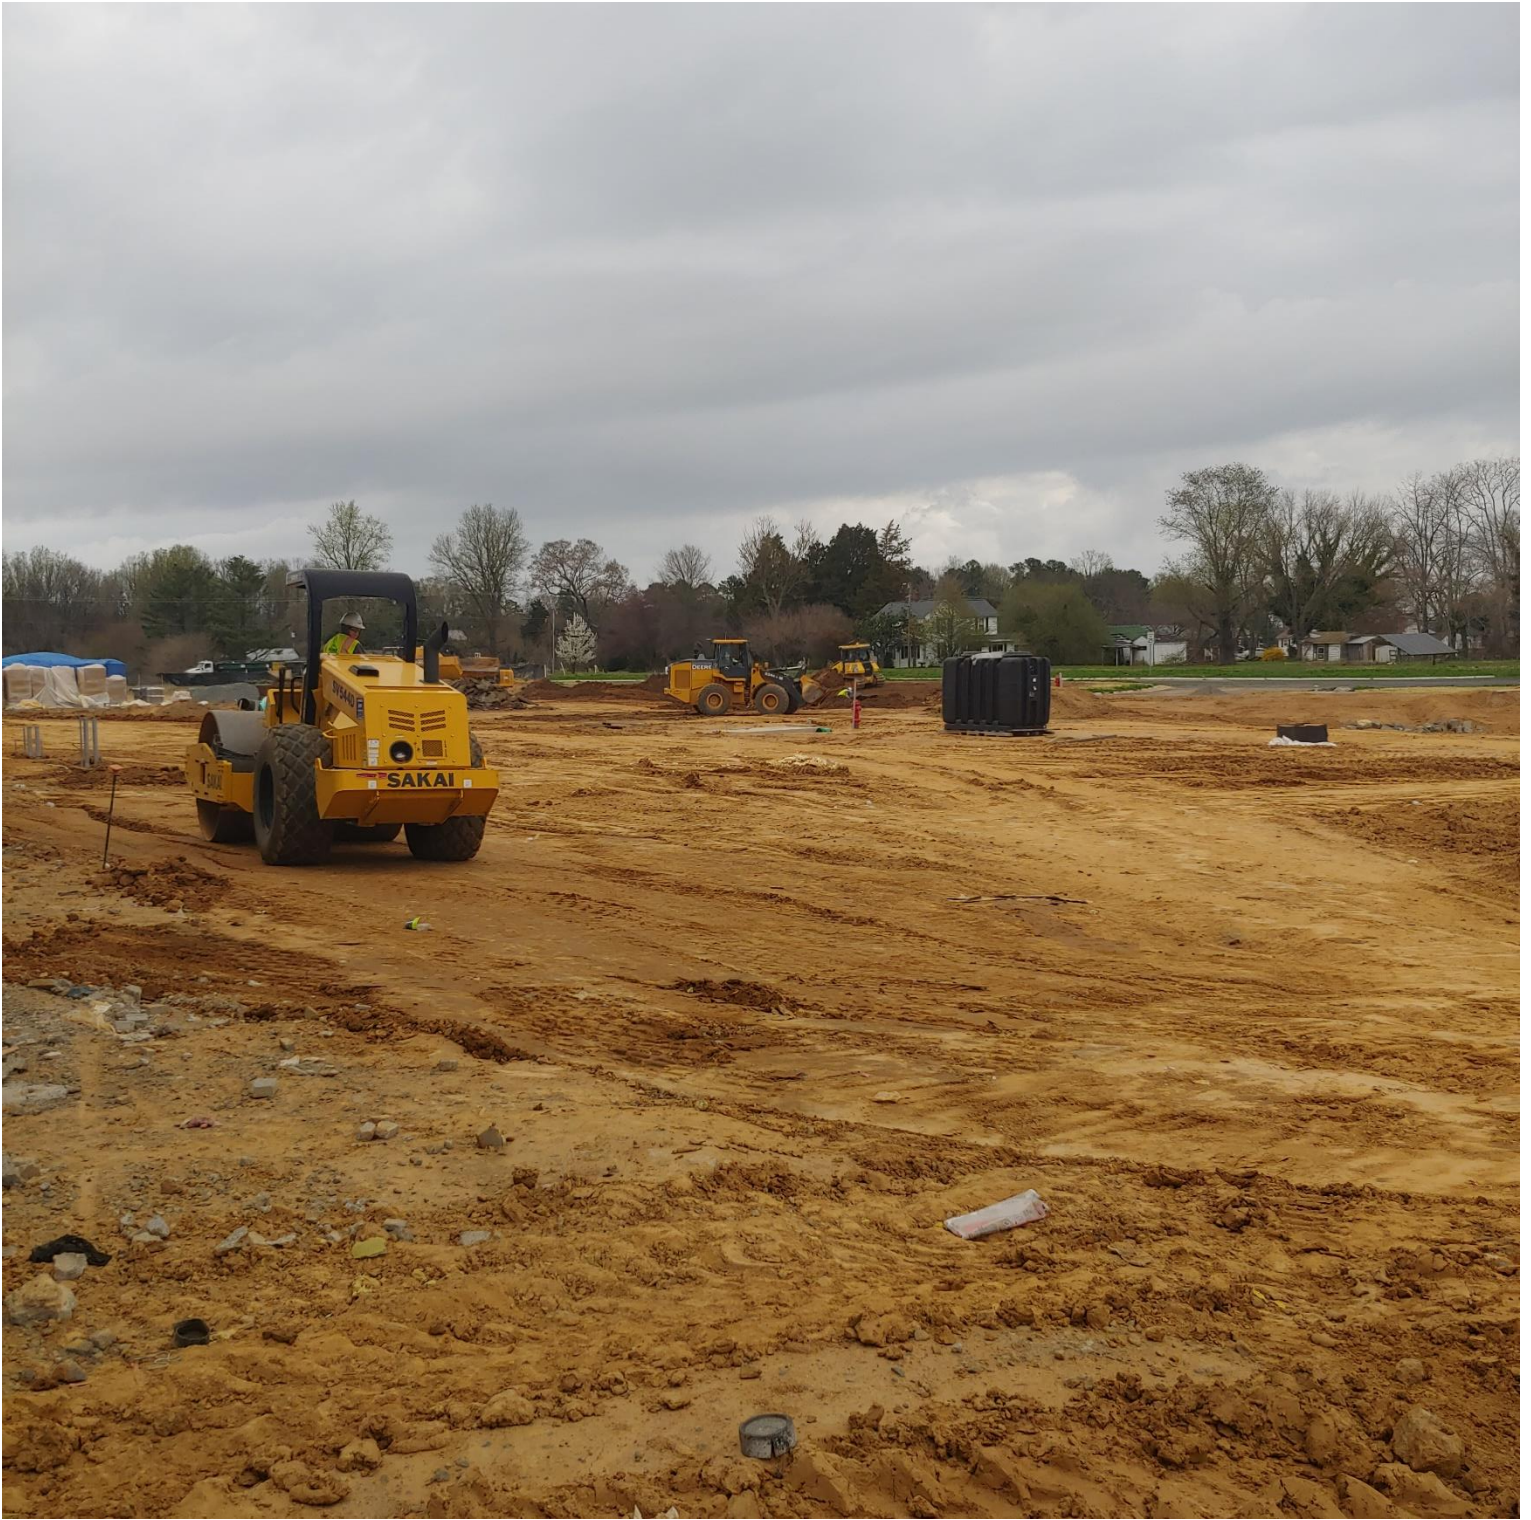
*Photo 5 - Beuchert has begun to grade the Eastside of site.*

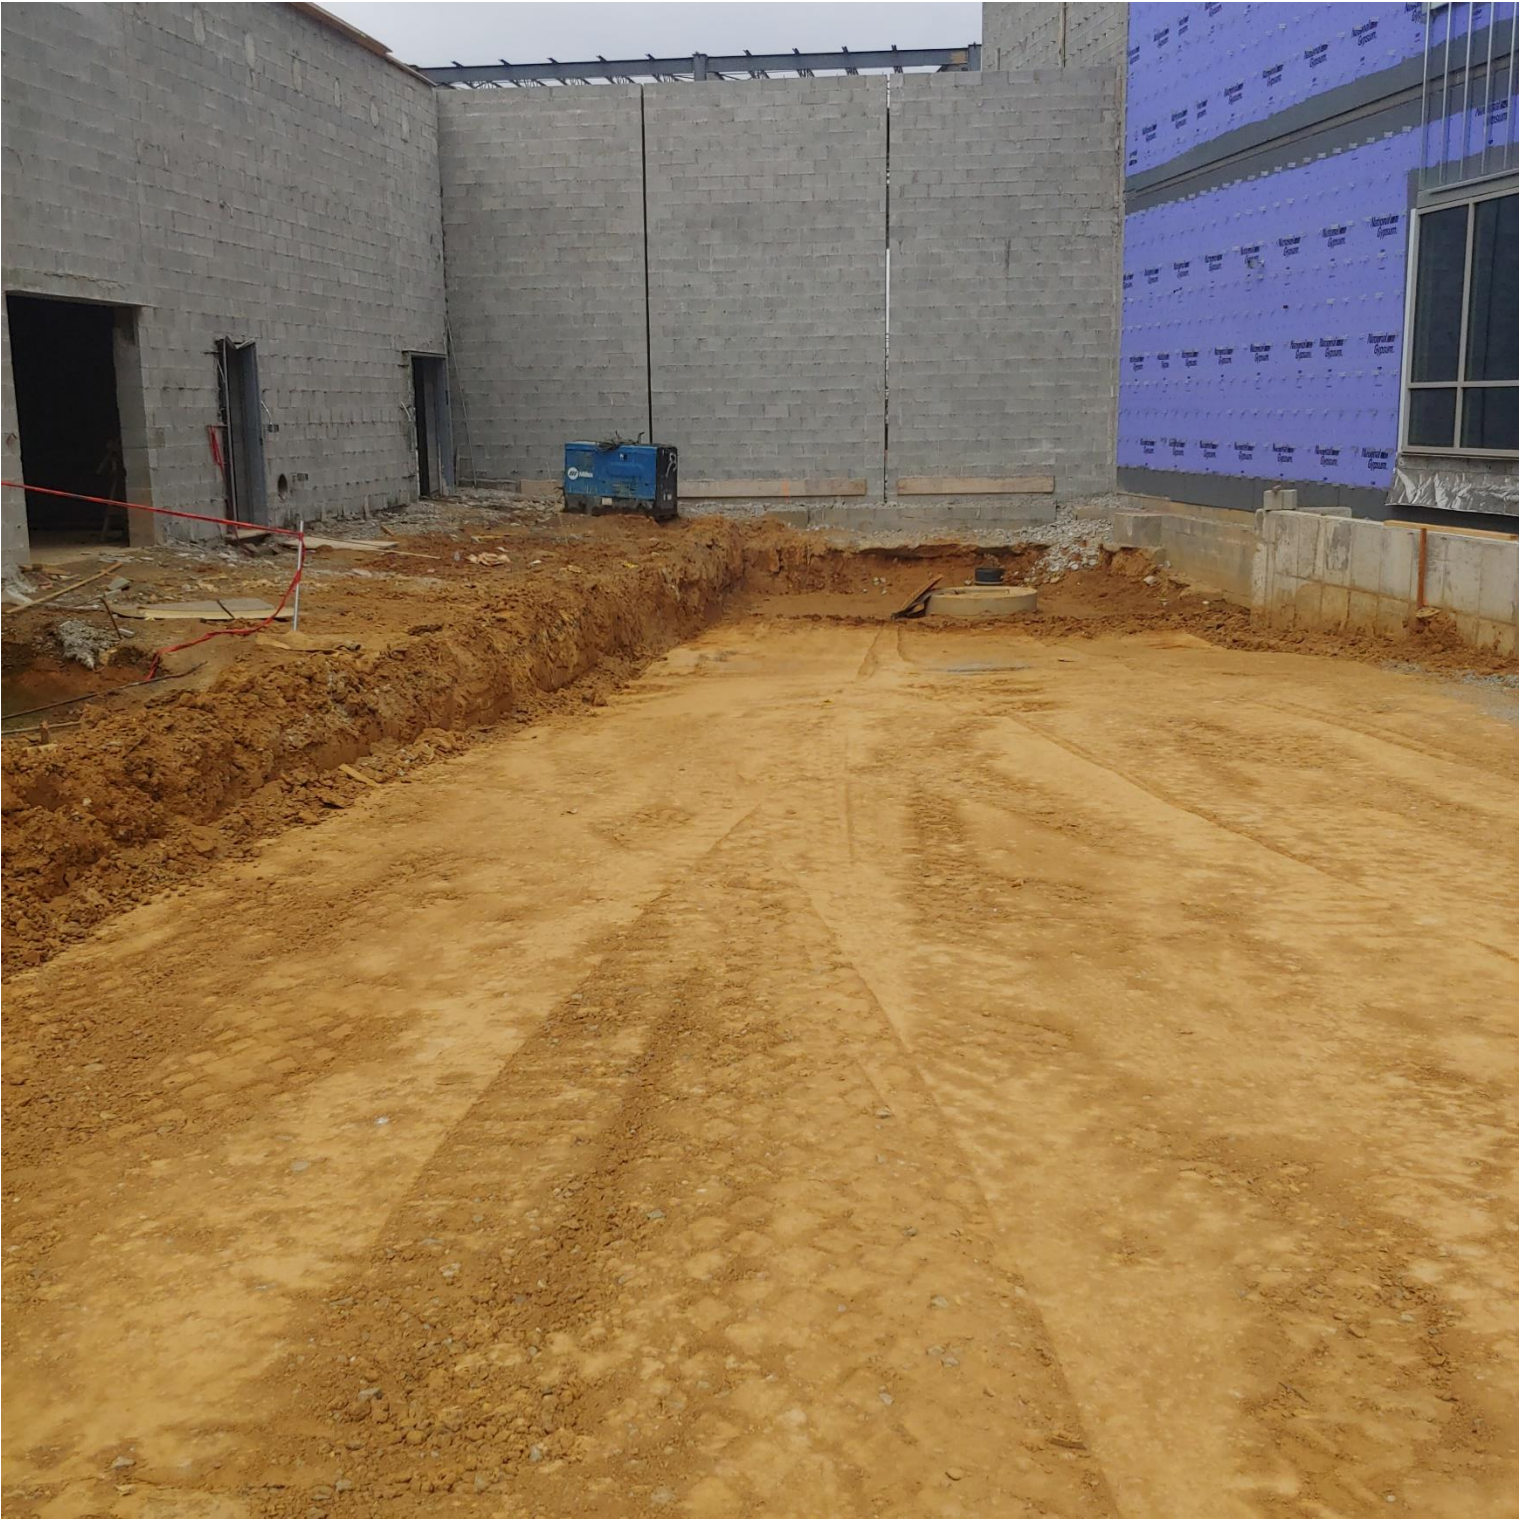
*Photo 6 - Loading Dock Ramp has been rough graded*

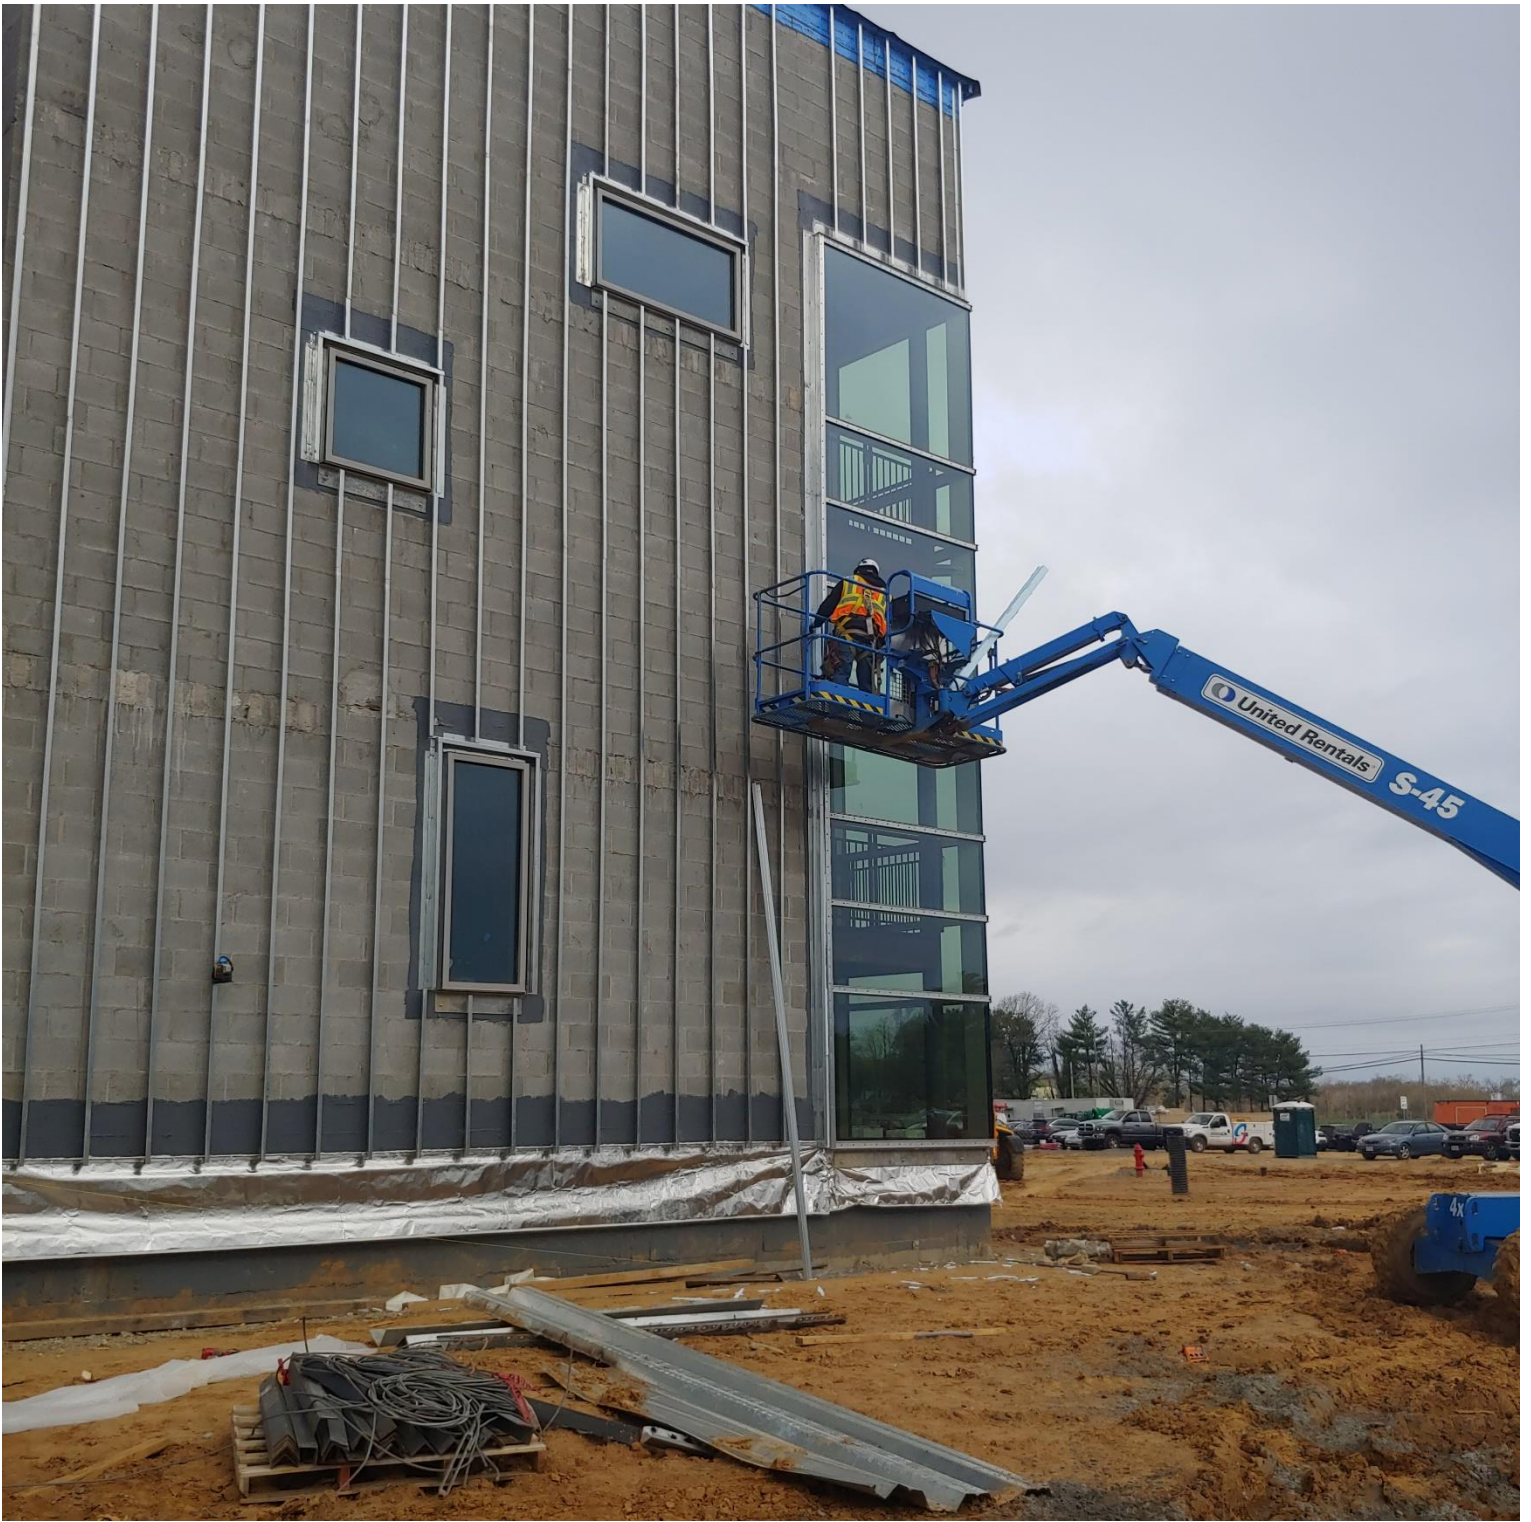
Photo 7 - Foam Board being installed around Storefront
