DAILY REPORT

WESTMORELAND COUNTY HIGH SCHOOL

Date: 04/08/2021

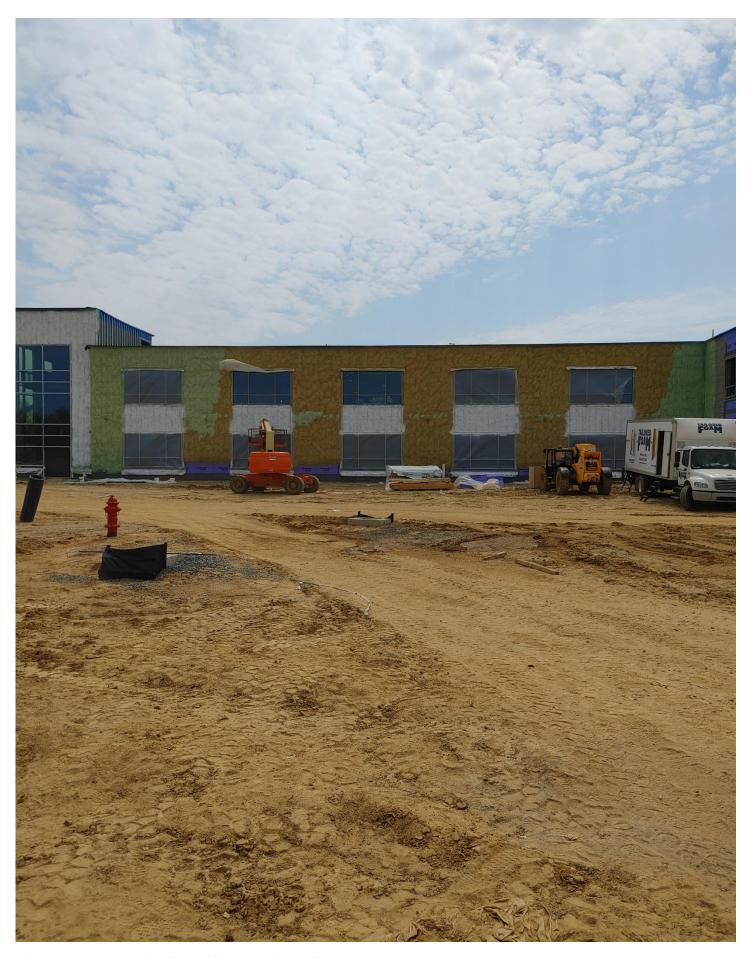
Tailored Foam: Two (2) men are on site today. They are currently spraying the second coating, fire barrier, under the Storefronts on the Northside of Area A.

Photo 1 - Taylor Foam applying fire proofing coat under storefronts

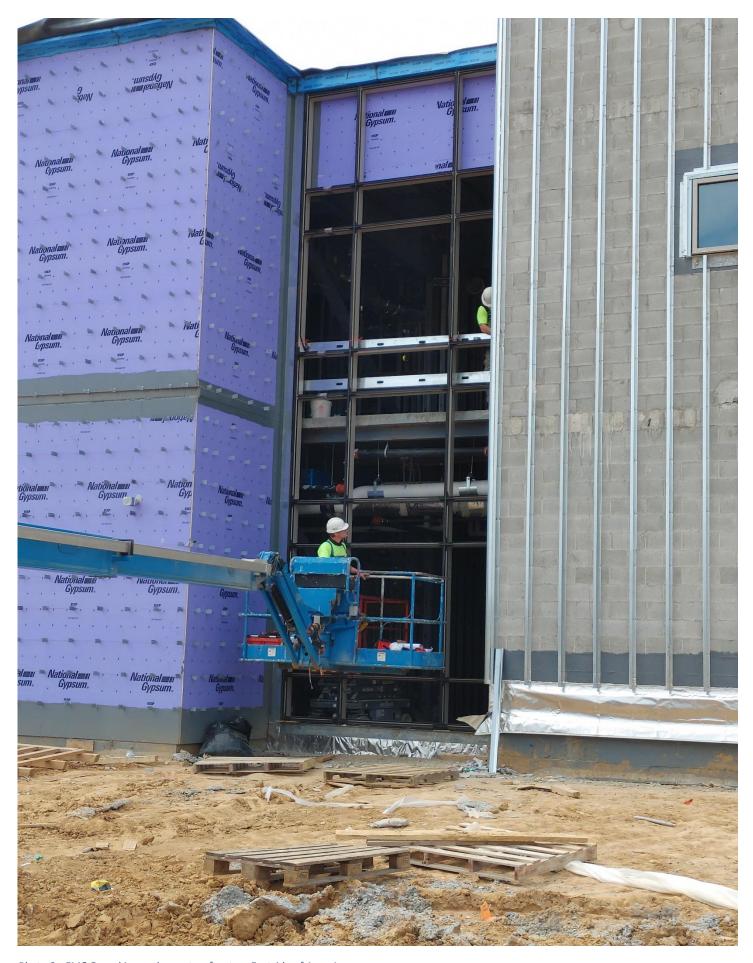
FG & M: Two (2) men are on site. They are working on the large Storefront on the eastside of Area A.

Photo 2 - FM&G working on large storefront on Eastside of Area A

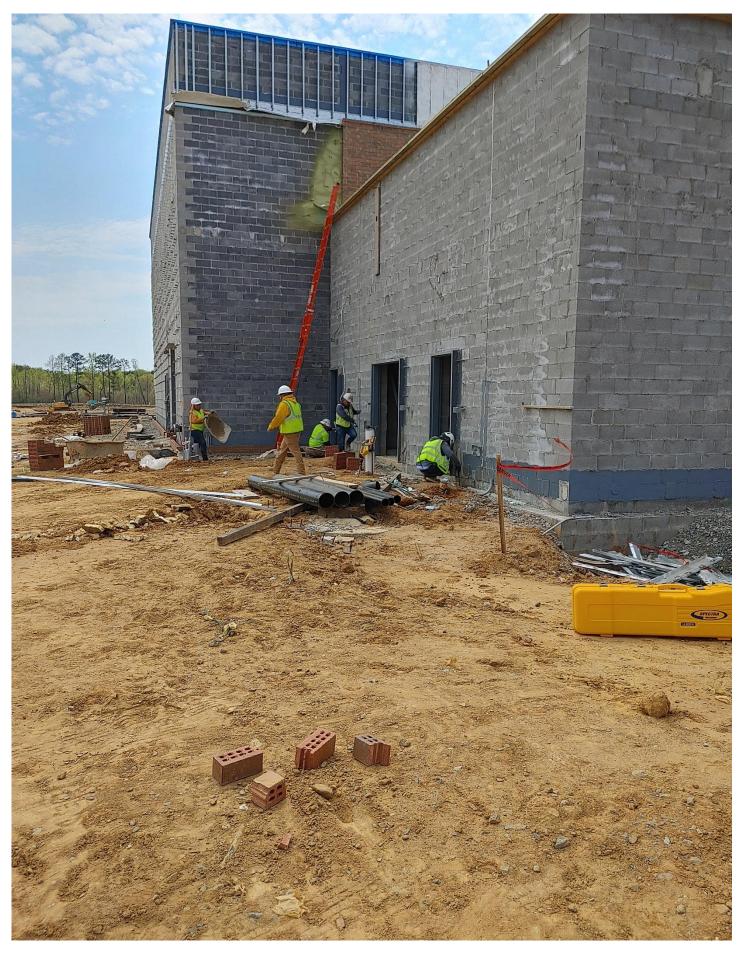
J.D. Long, Masons: Eighteen (18) men are on site. A crew continues to lay brick on the Eastside of Area D. A crew also continues to lay Brick on the Westside of Area E.

Photo 3 - Masons laying brick on the Eastside of Area D

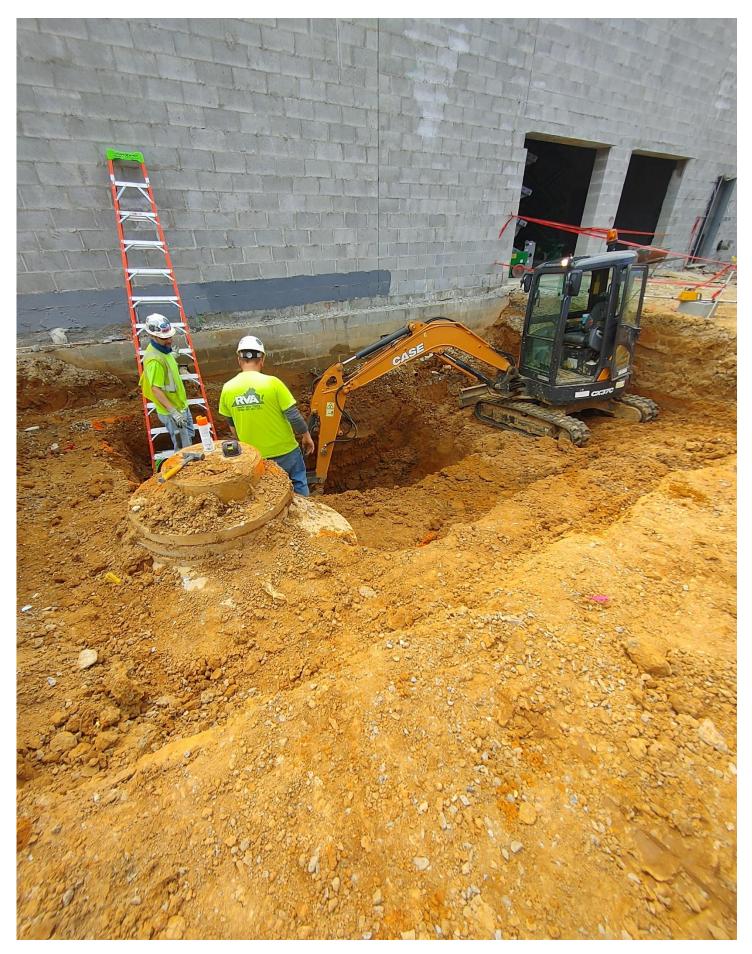
Photo 4 - Excavation has begun for Grease Trap on the Northside of Area D

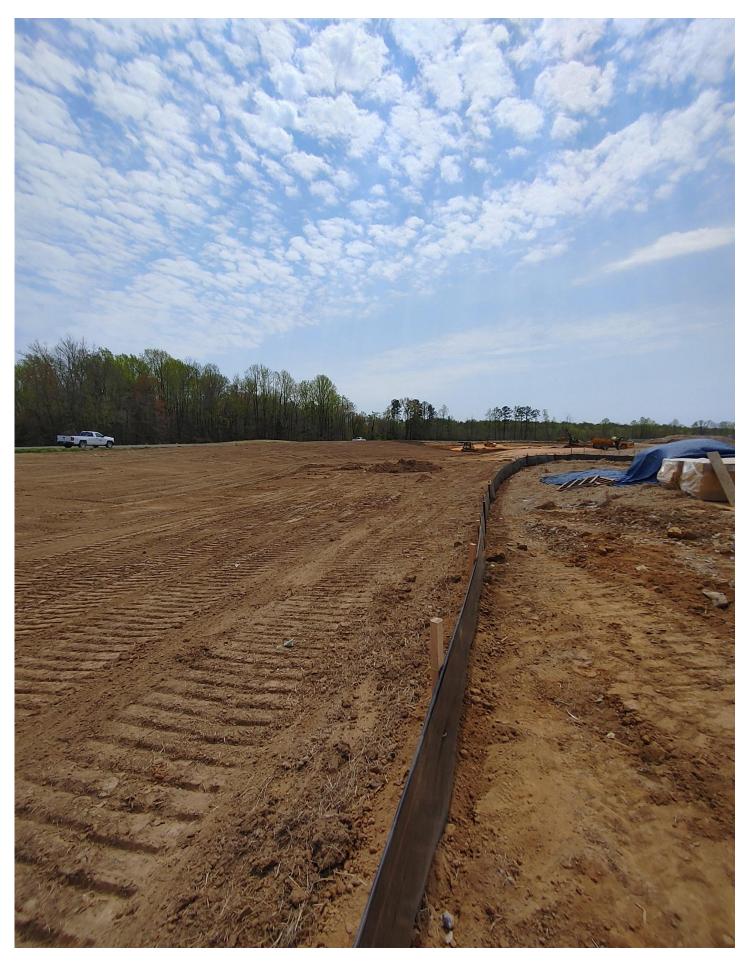
Beuchert Excavation: Five (5) men on site today. They continue to work on the Eastside of the site reshaping the Retention ponds along County Park Drive and have begun stockpiling material on the westside of the site.

Photo 5 - Beuchert continues to work on the Eastside of the site.

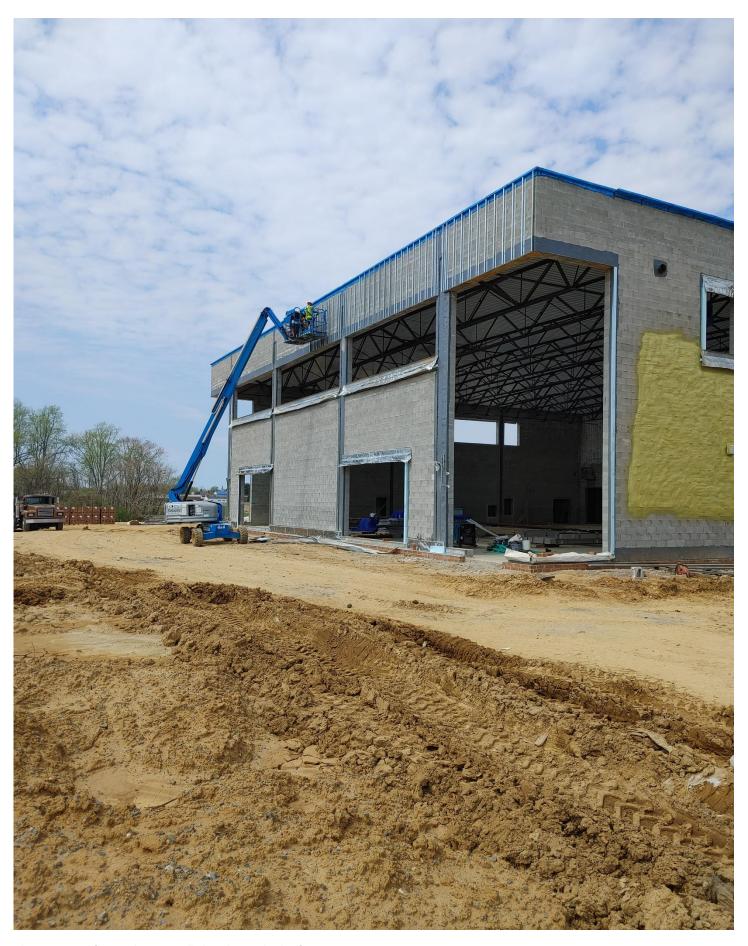
JP Construction: Fourteen (14) men are on site today. They are erecting interior walls in Area A, 2^{nd} floor and framing out the rear exterior wall on the Southside of Area E.

Photo 6 - Metal framing being installed on the Southside of Area E

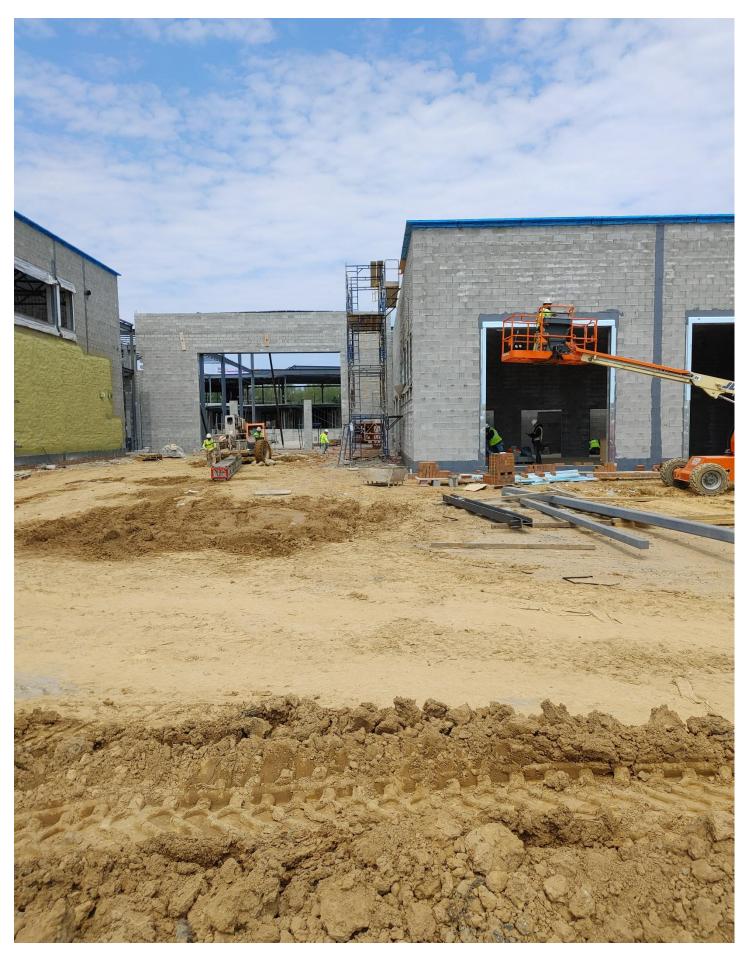
Photo 7 - Fraco Scaffolding being broken down on the Southside of Area C

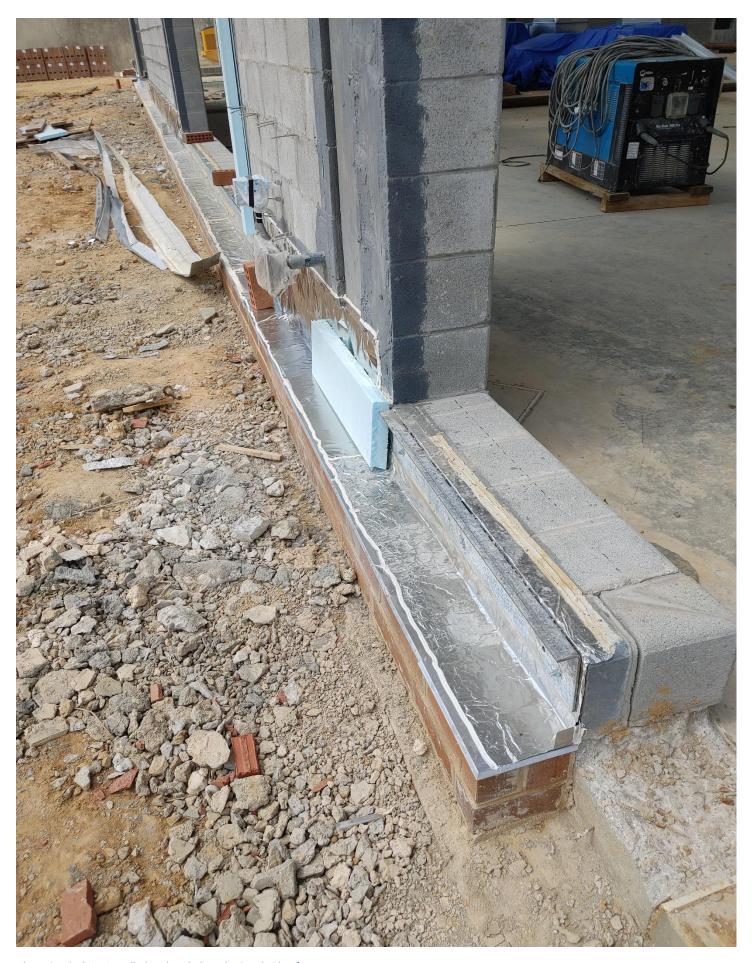
Photo 8 - Flashing installed and sealed on the Southside of Area E

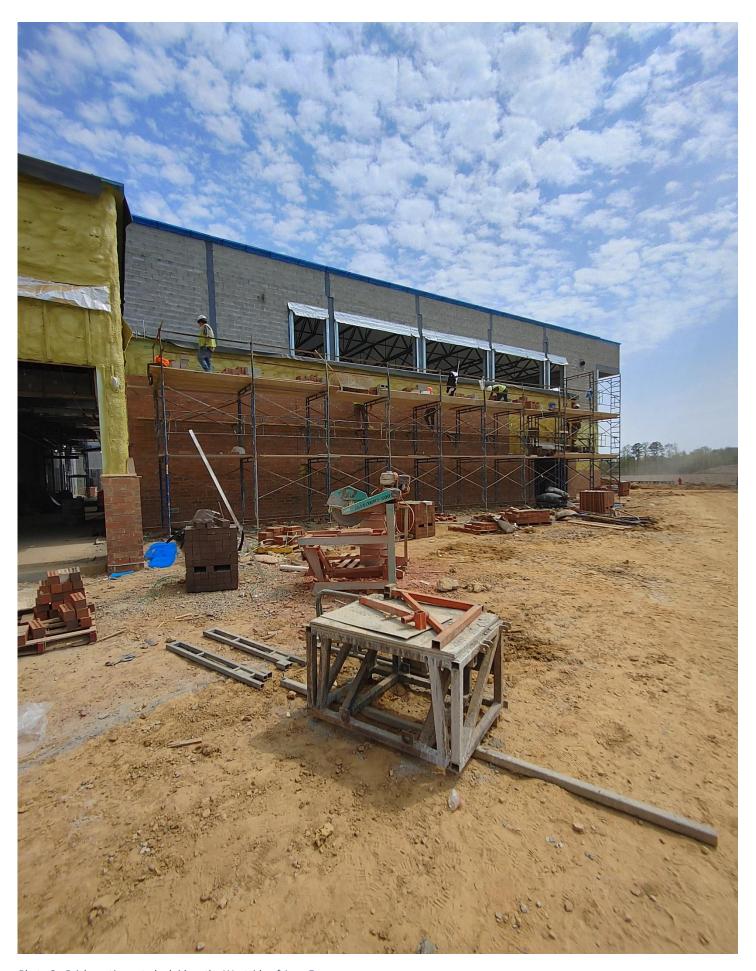
Photo 9 - Brick continues to be laid on the Westside of Area E

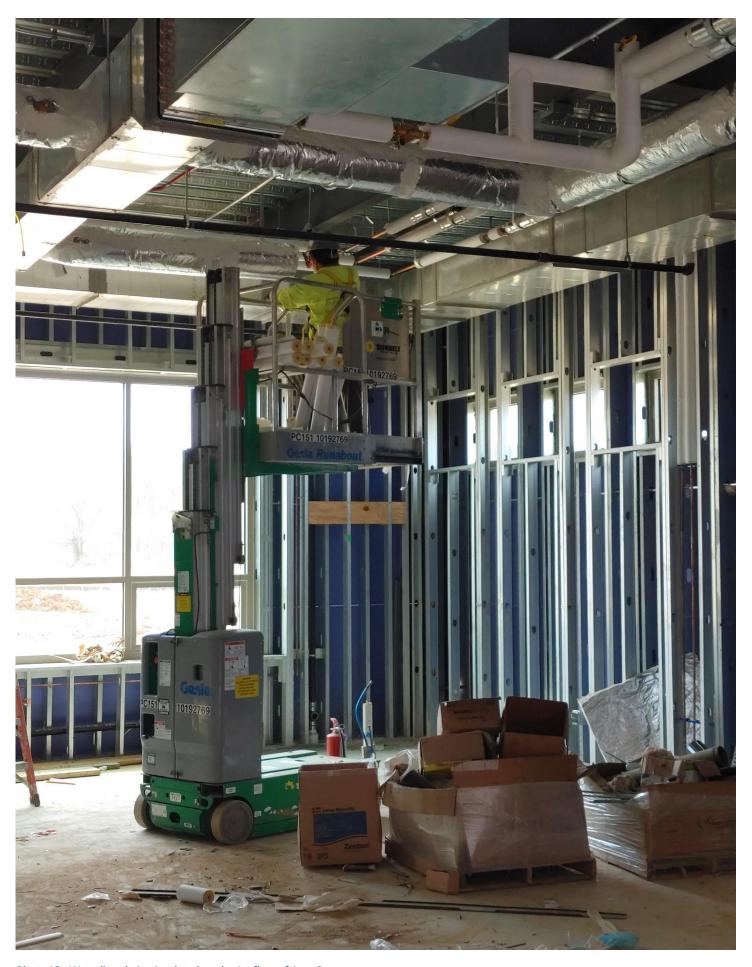
Photo 10 - Waterlines being insulated on the 1st floor of Area B

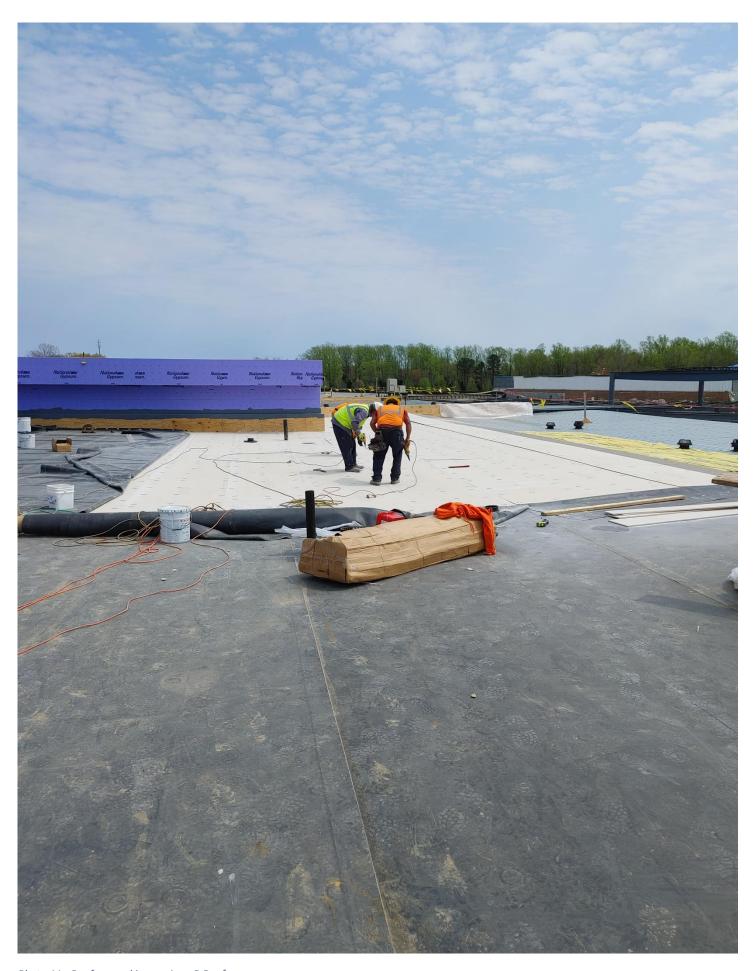
AAR Roofing: Four (4) men are on site today. They are working on the roof of Area B.

Photo 11 - Roofers working on Area B Roof

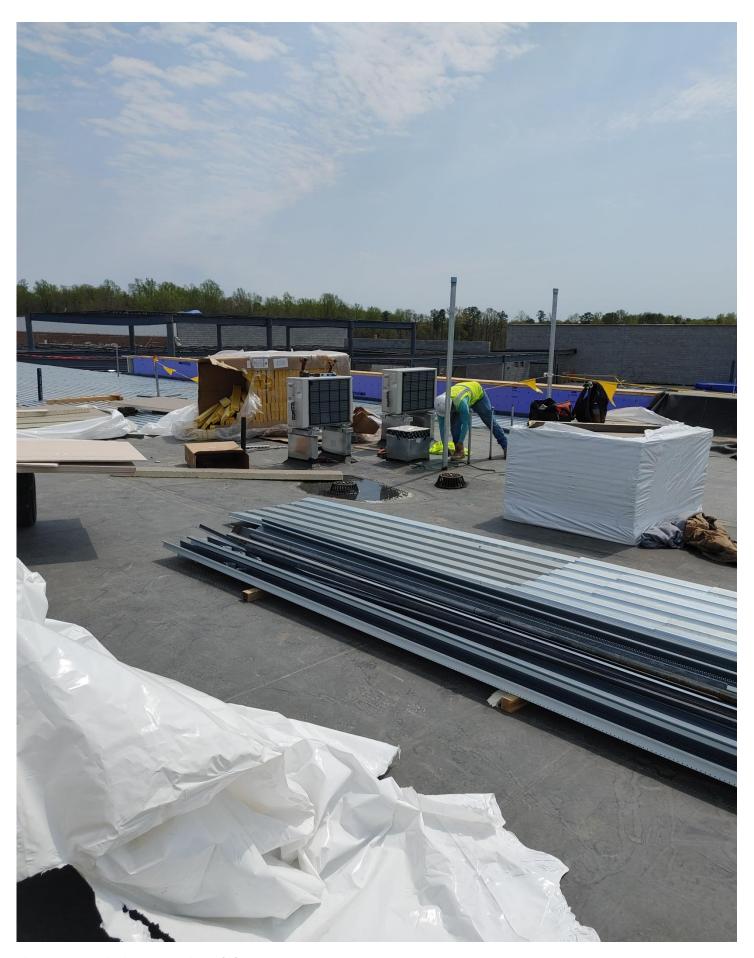
Photo 12 - Mini Splits being set on the roof of Area B

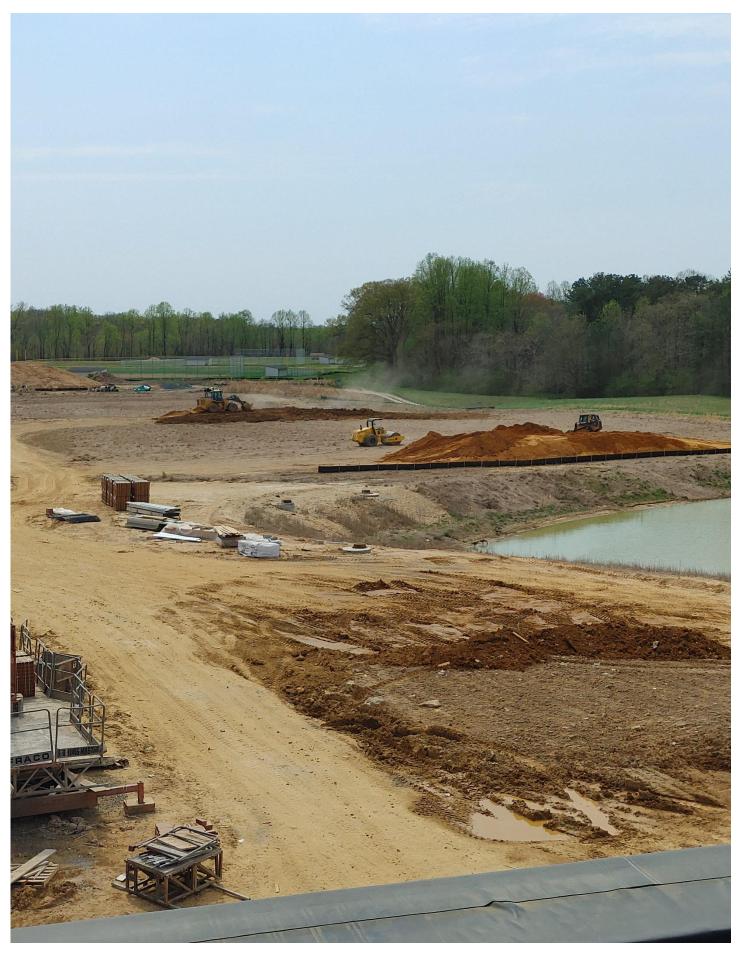
Photo 13 - Beuchert stock piling material on the Westside of the site.
