**COMMONWEALTH  
BUILDING SOLUTIONS, LLC**

**DAILY REPORT**

**WESTMORELAND COUNTY HIGH SCHOOL**

Date: 04/12/2021

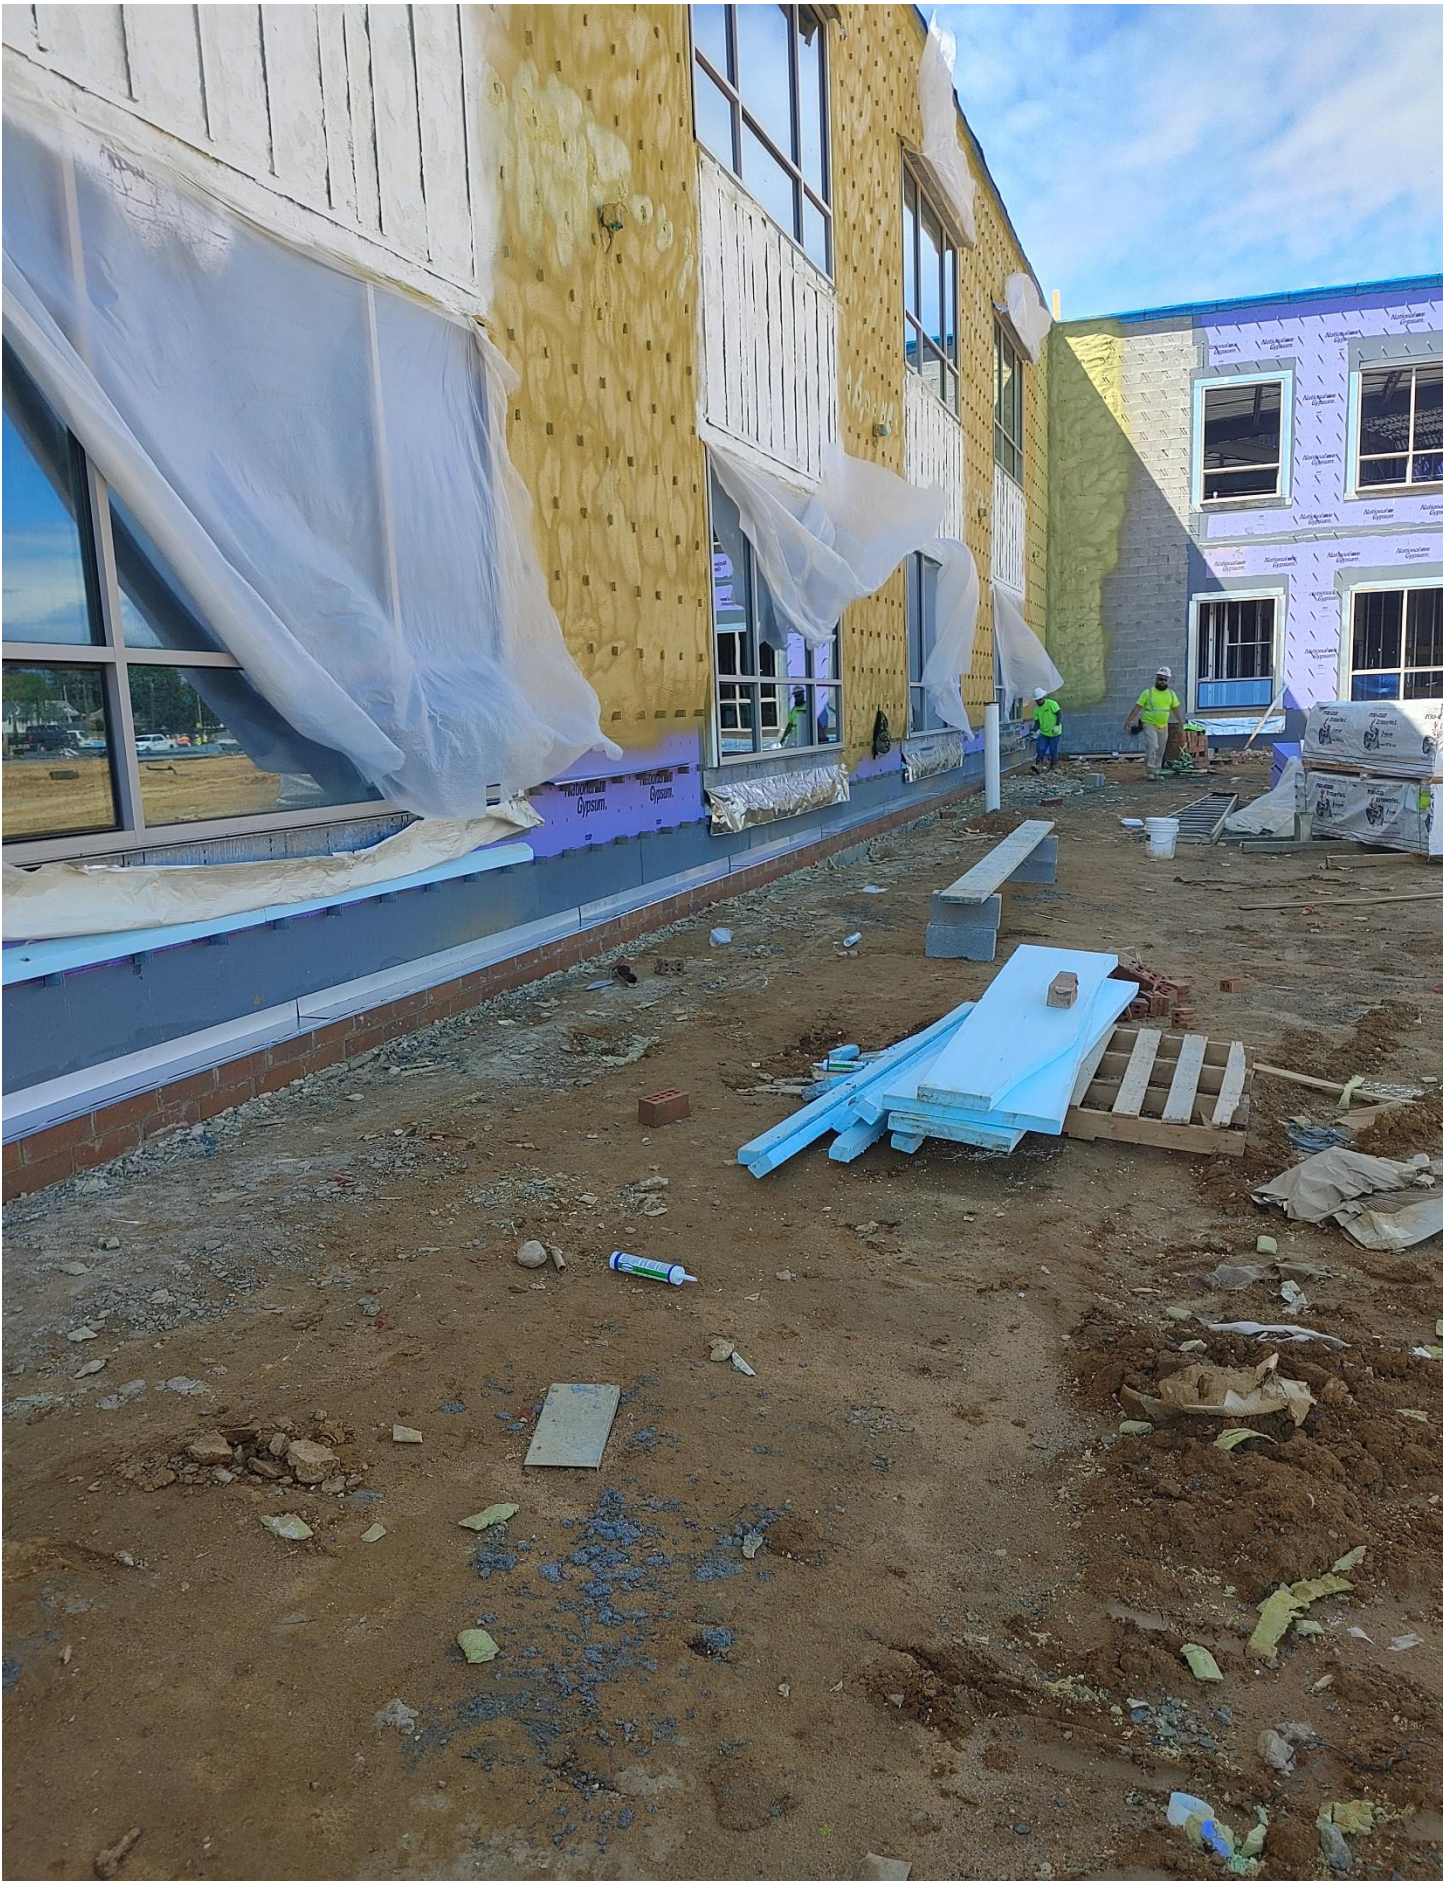
Photo 1 – Flashing being installed on the Northside of Area A

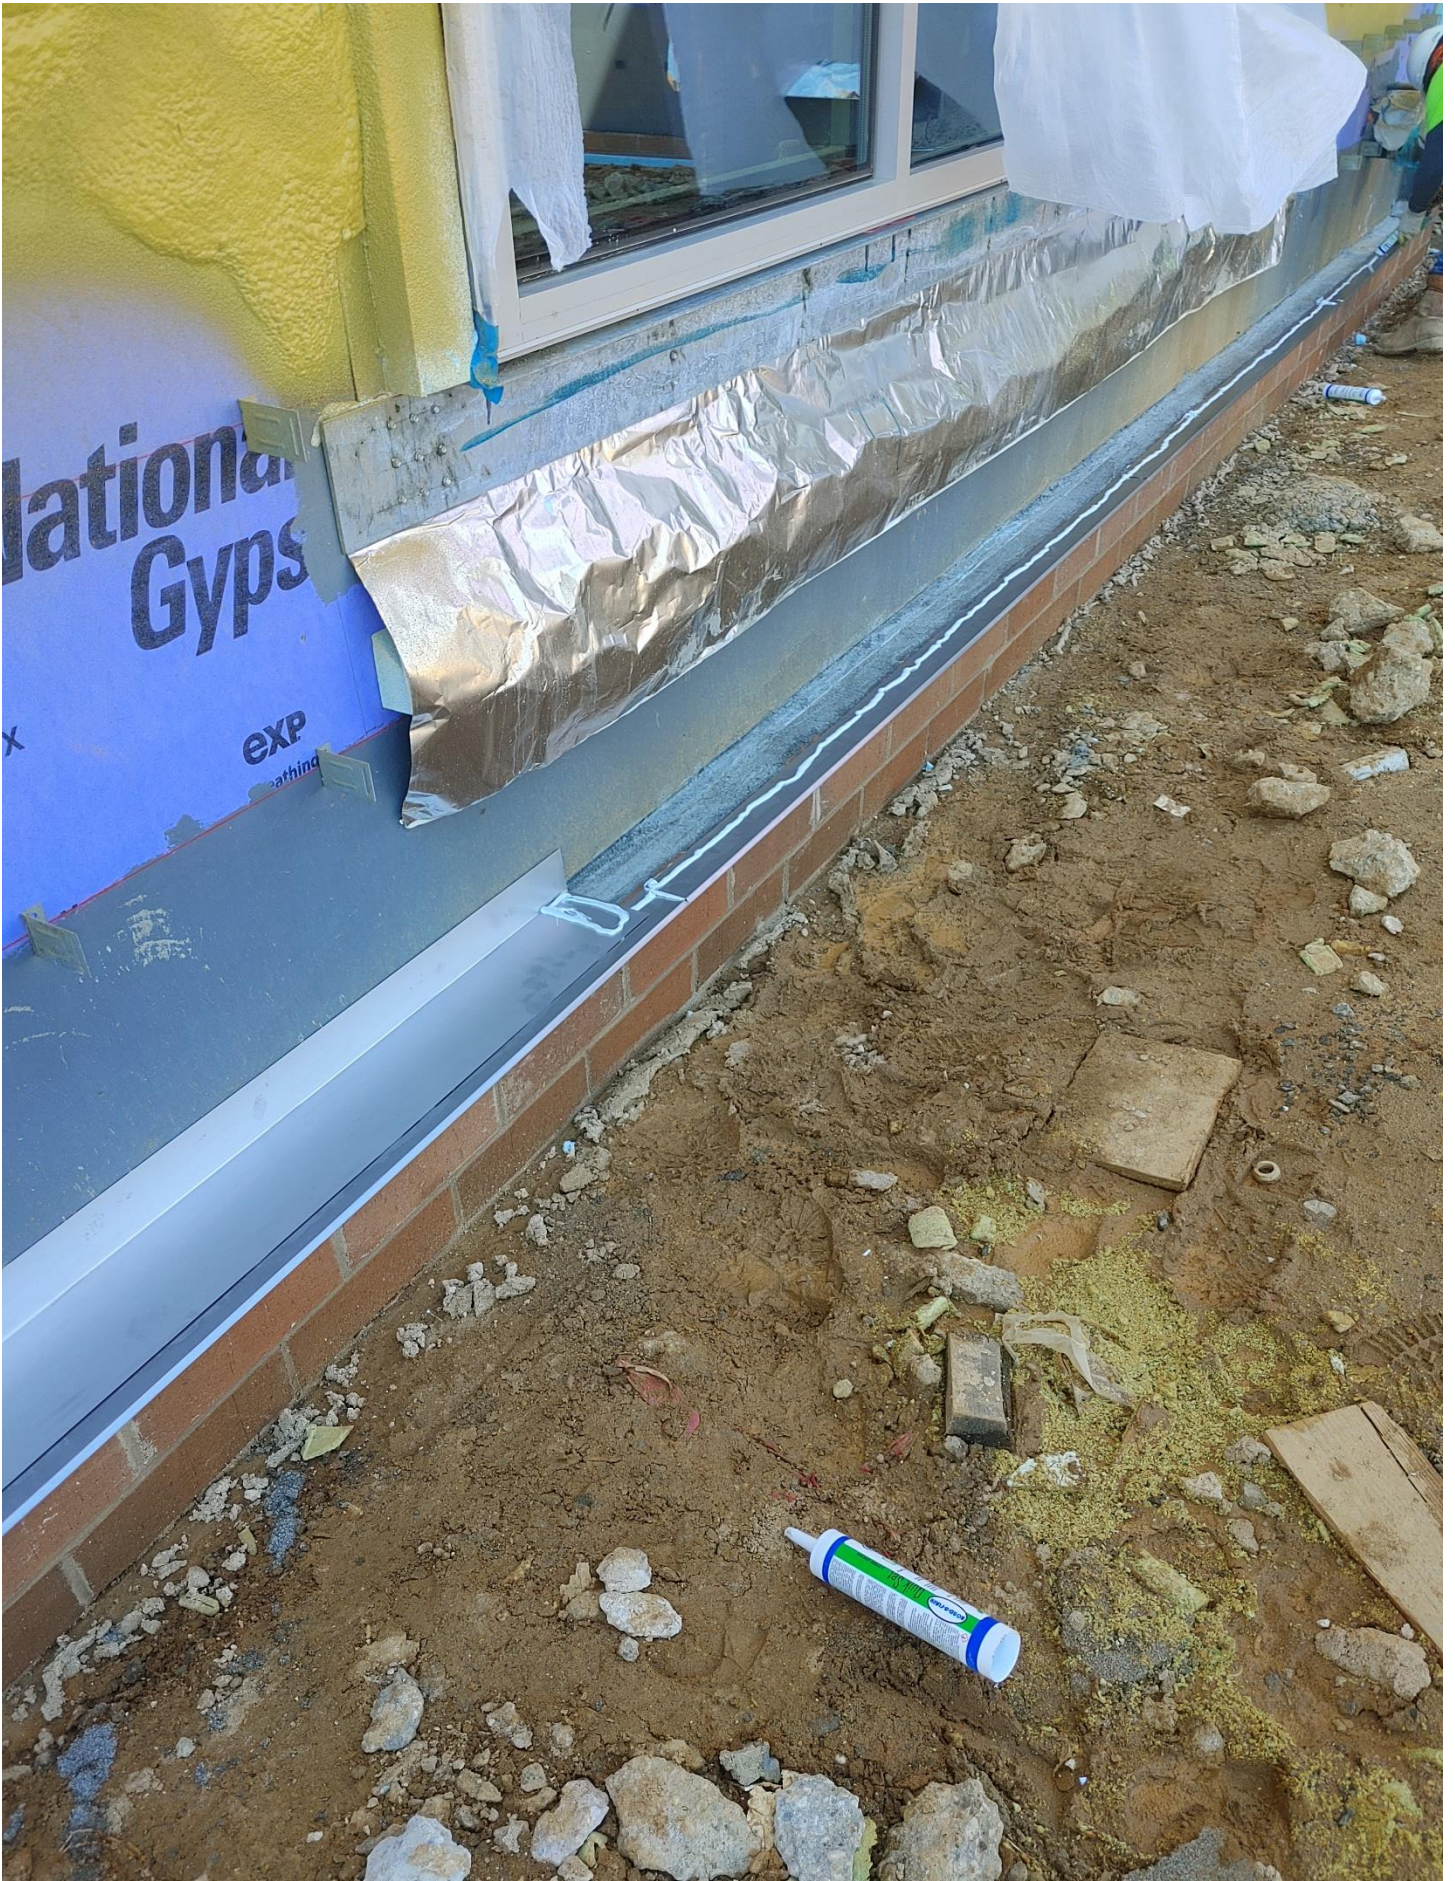
Photo 2 - Adhesive being applied prior to the second part of the flashing is installed on the Northside of Area A

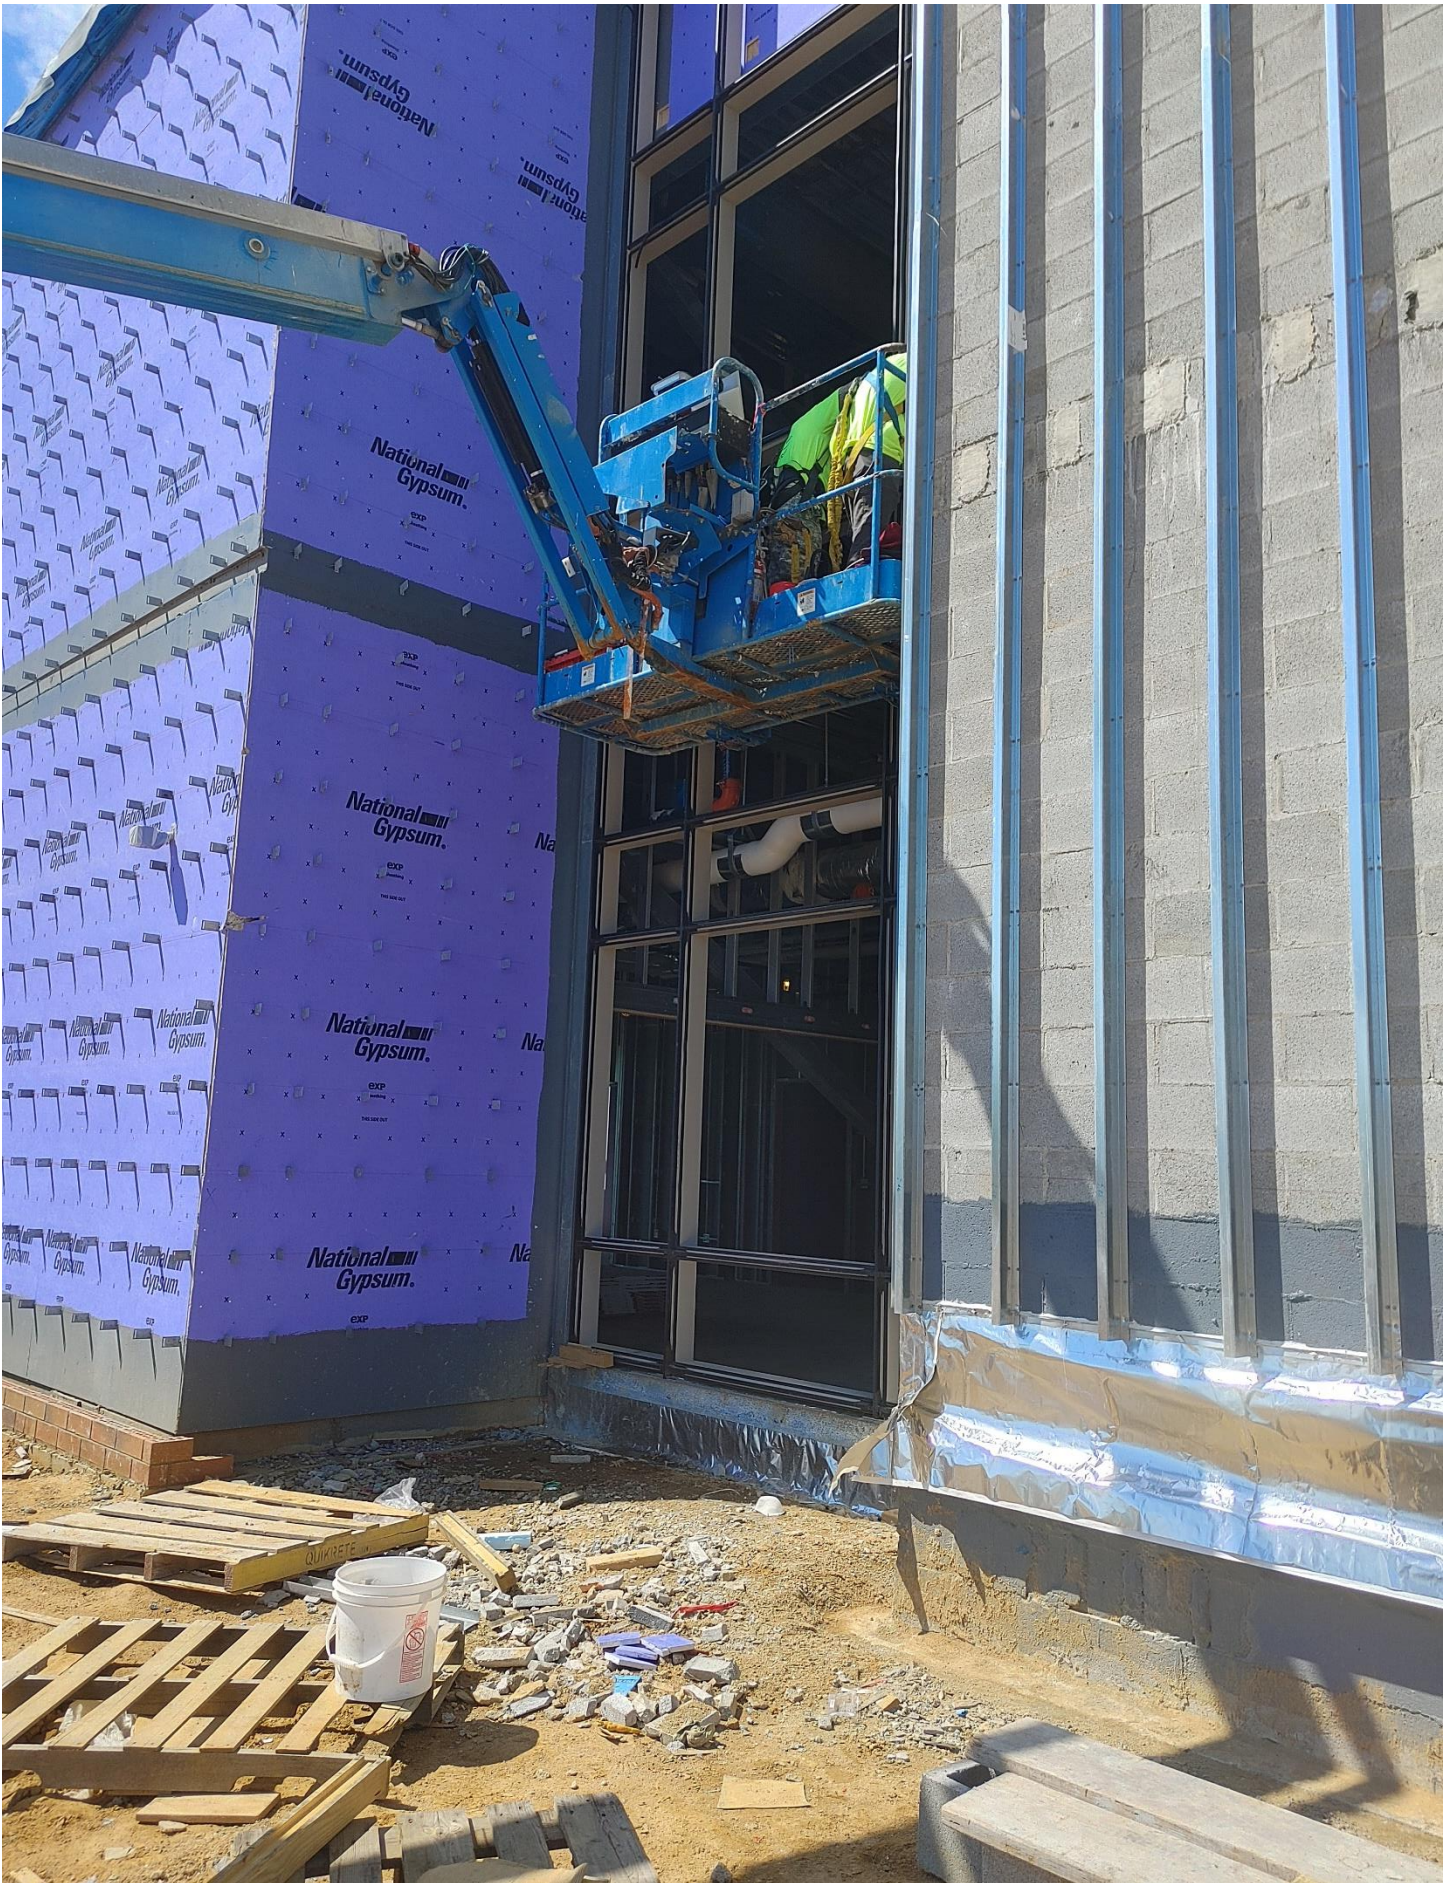
Photo 3 - Fredericksburg Mirror and Glass working on the Storefront on the Eastside of Area A

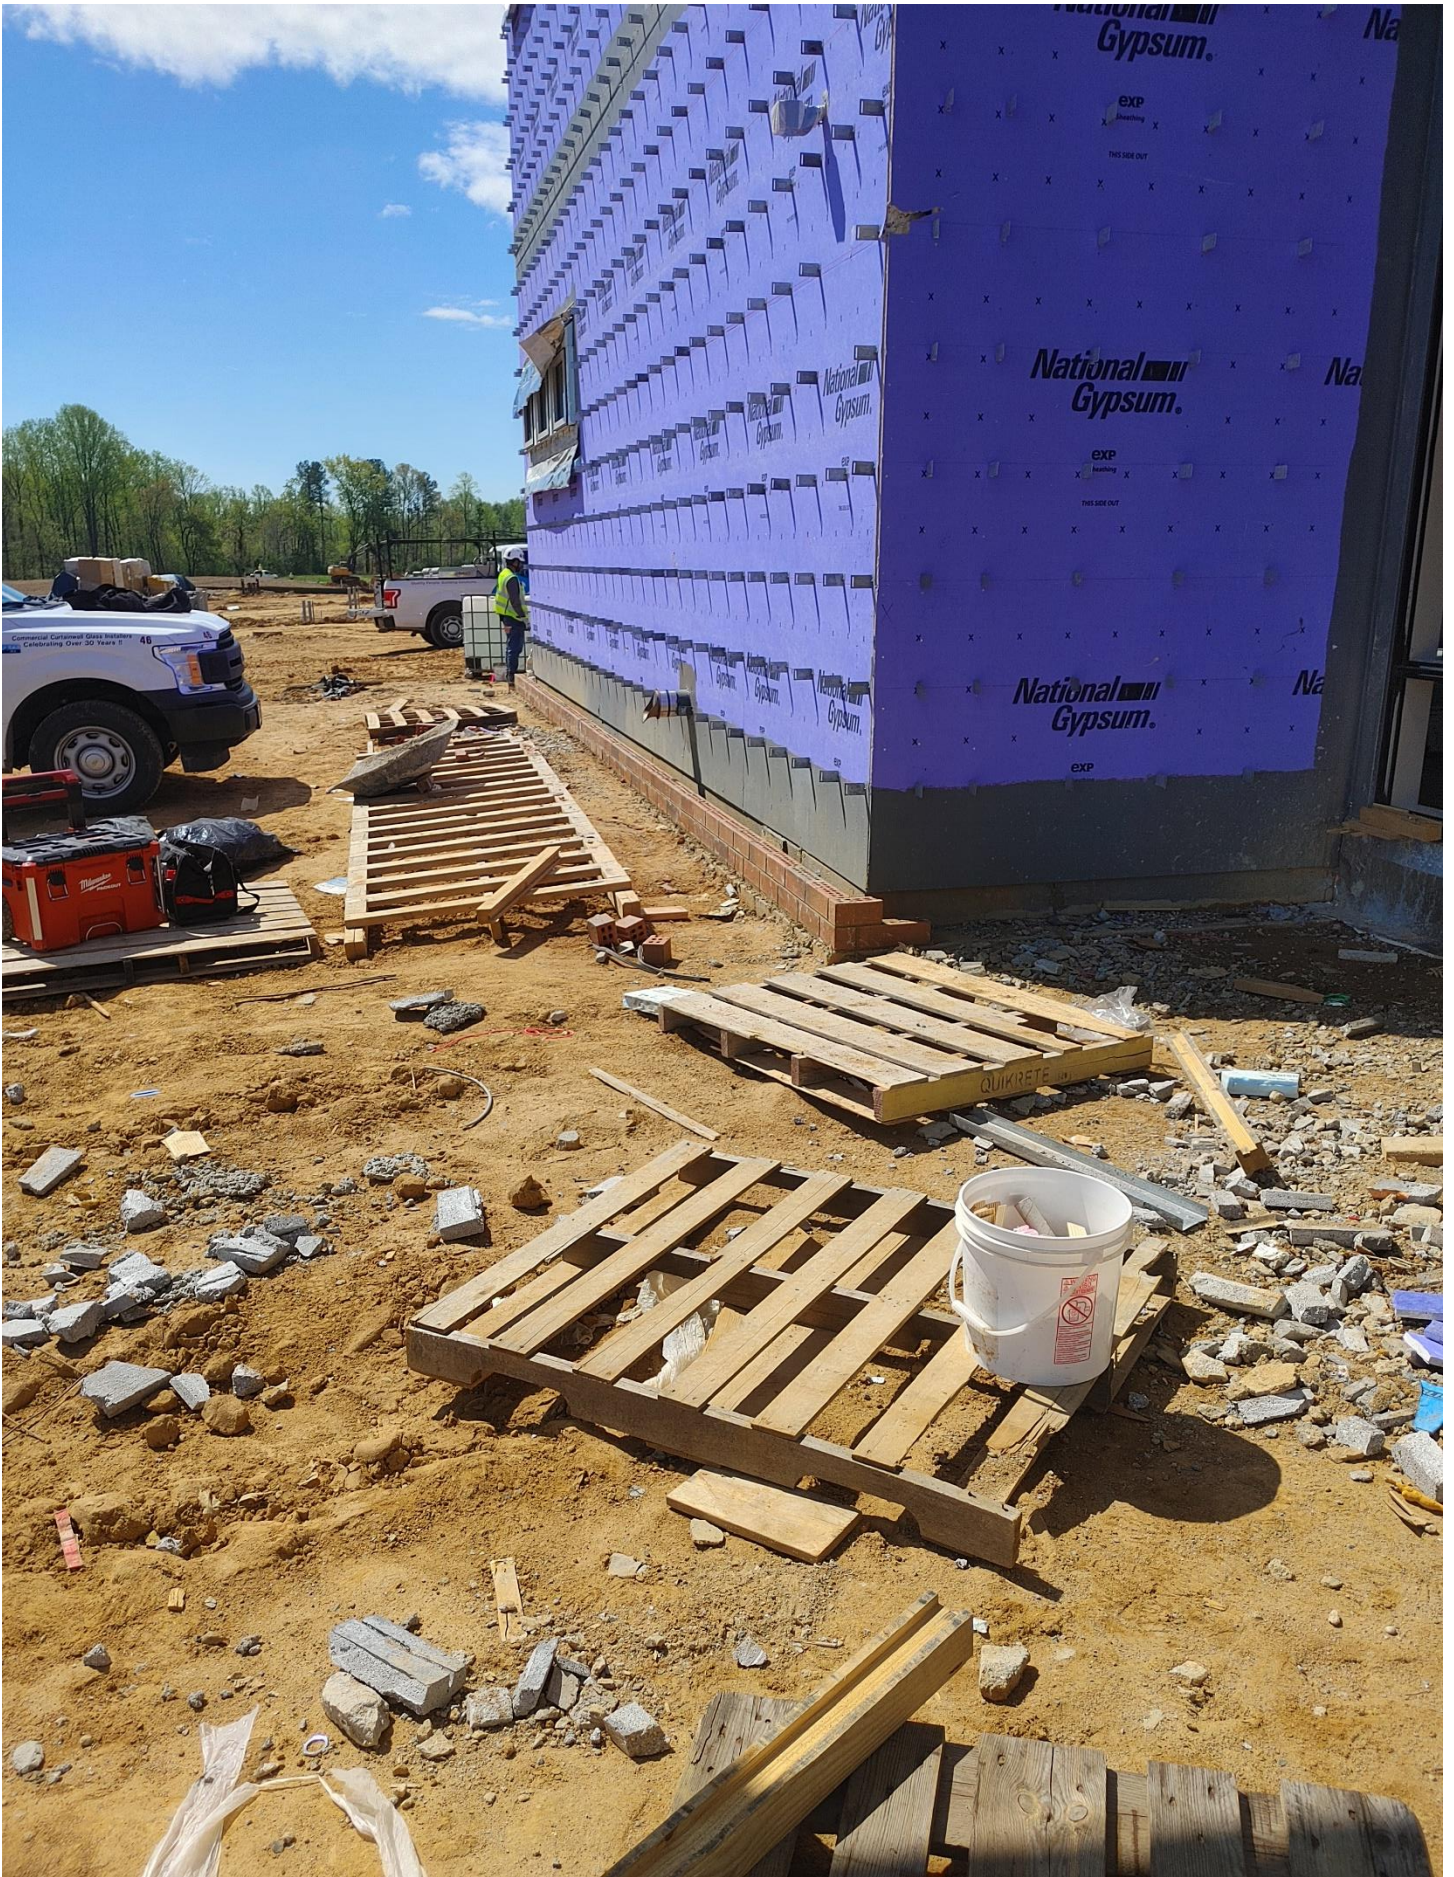
Photo 4 - Brick continues to be laid on the Eastside of Area A

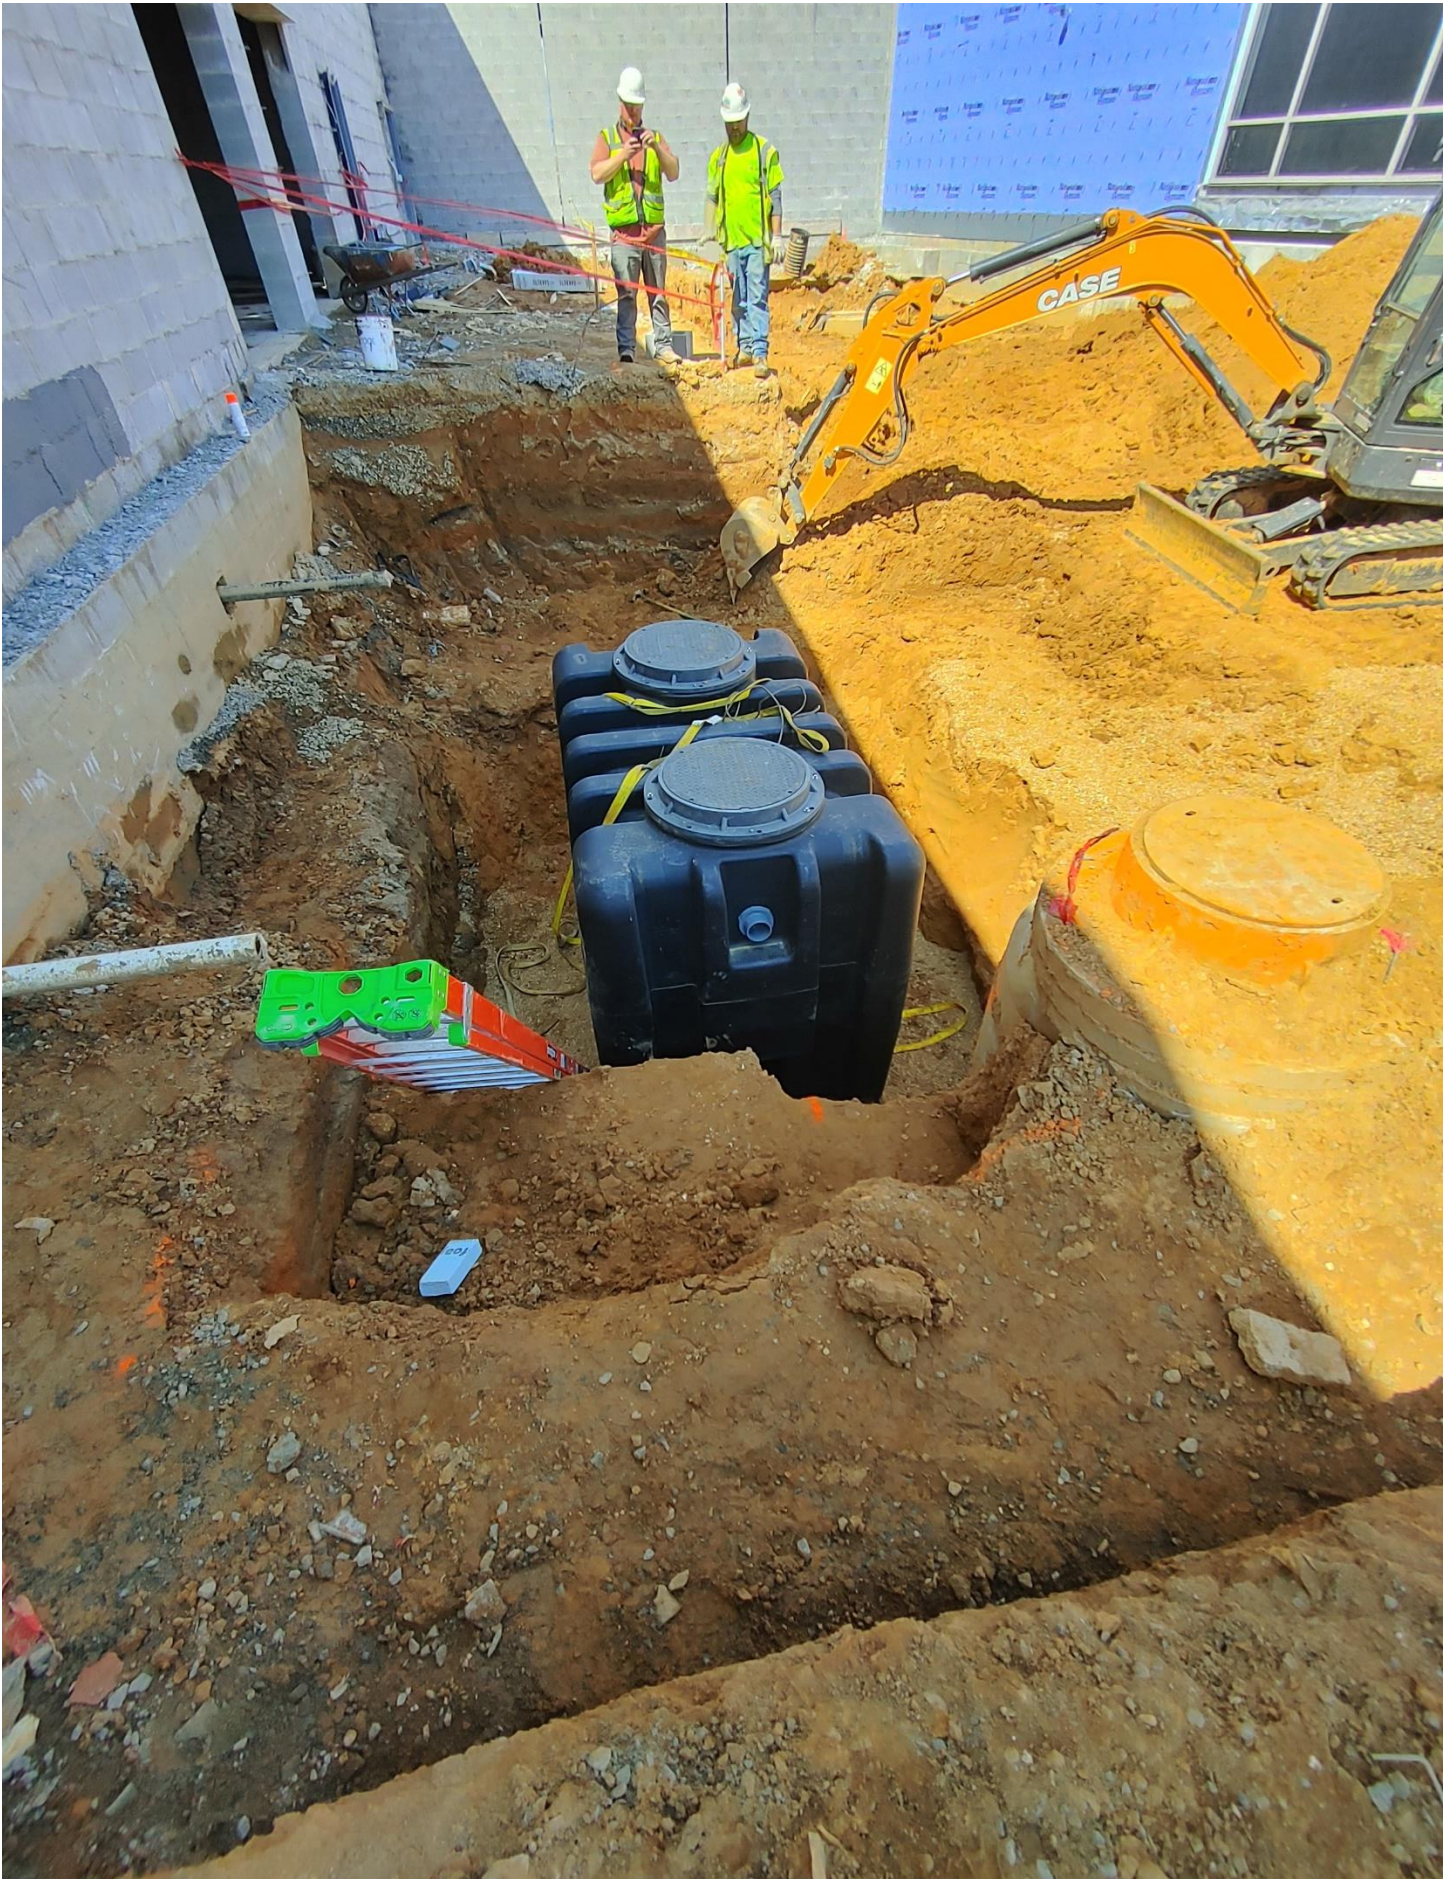
Photo 5 - Grease Trap has been set

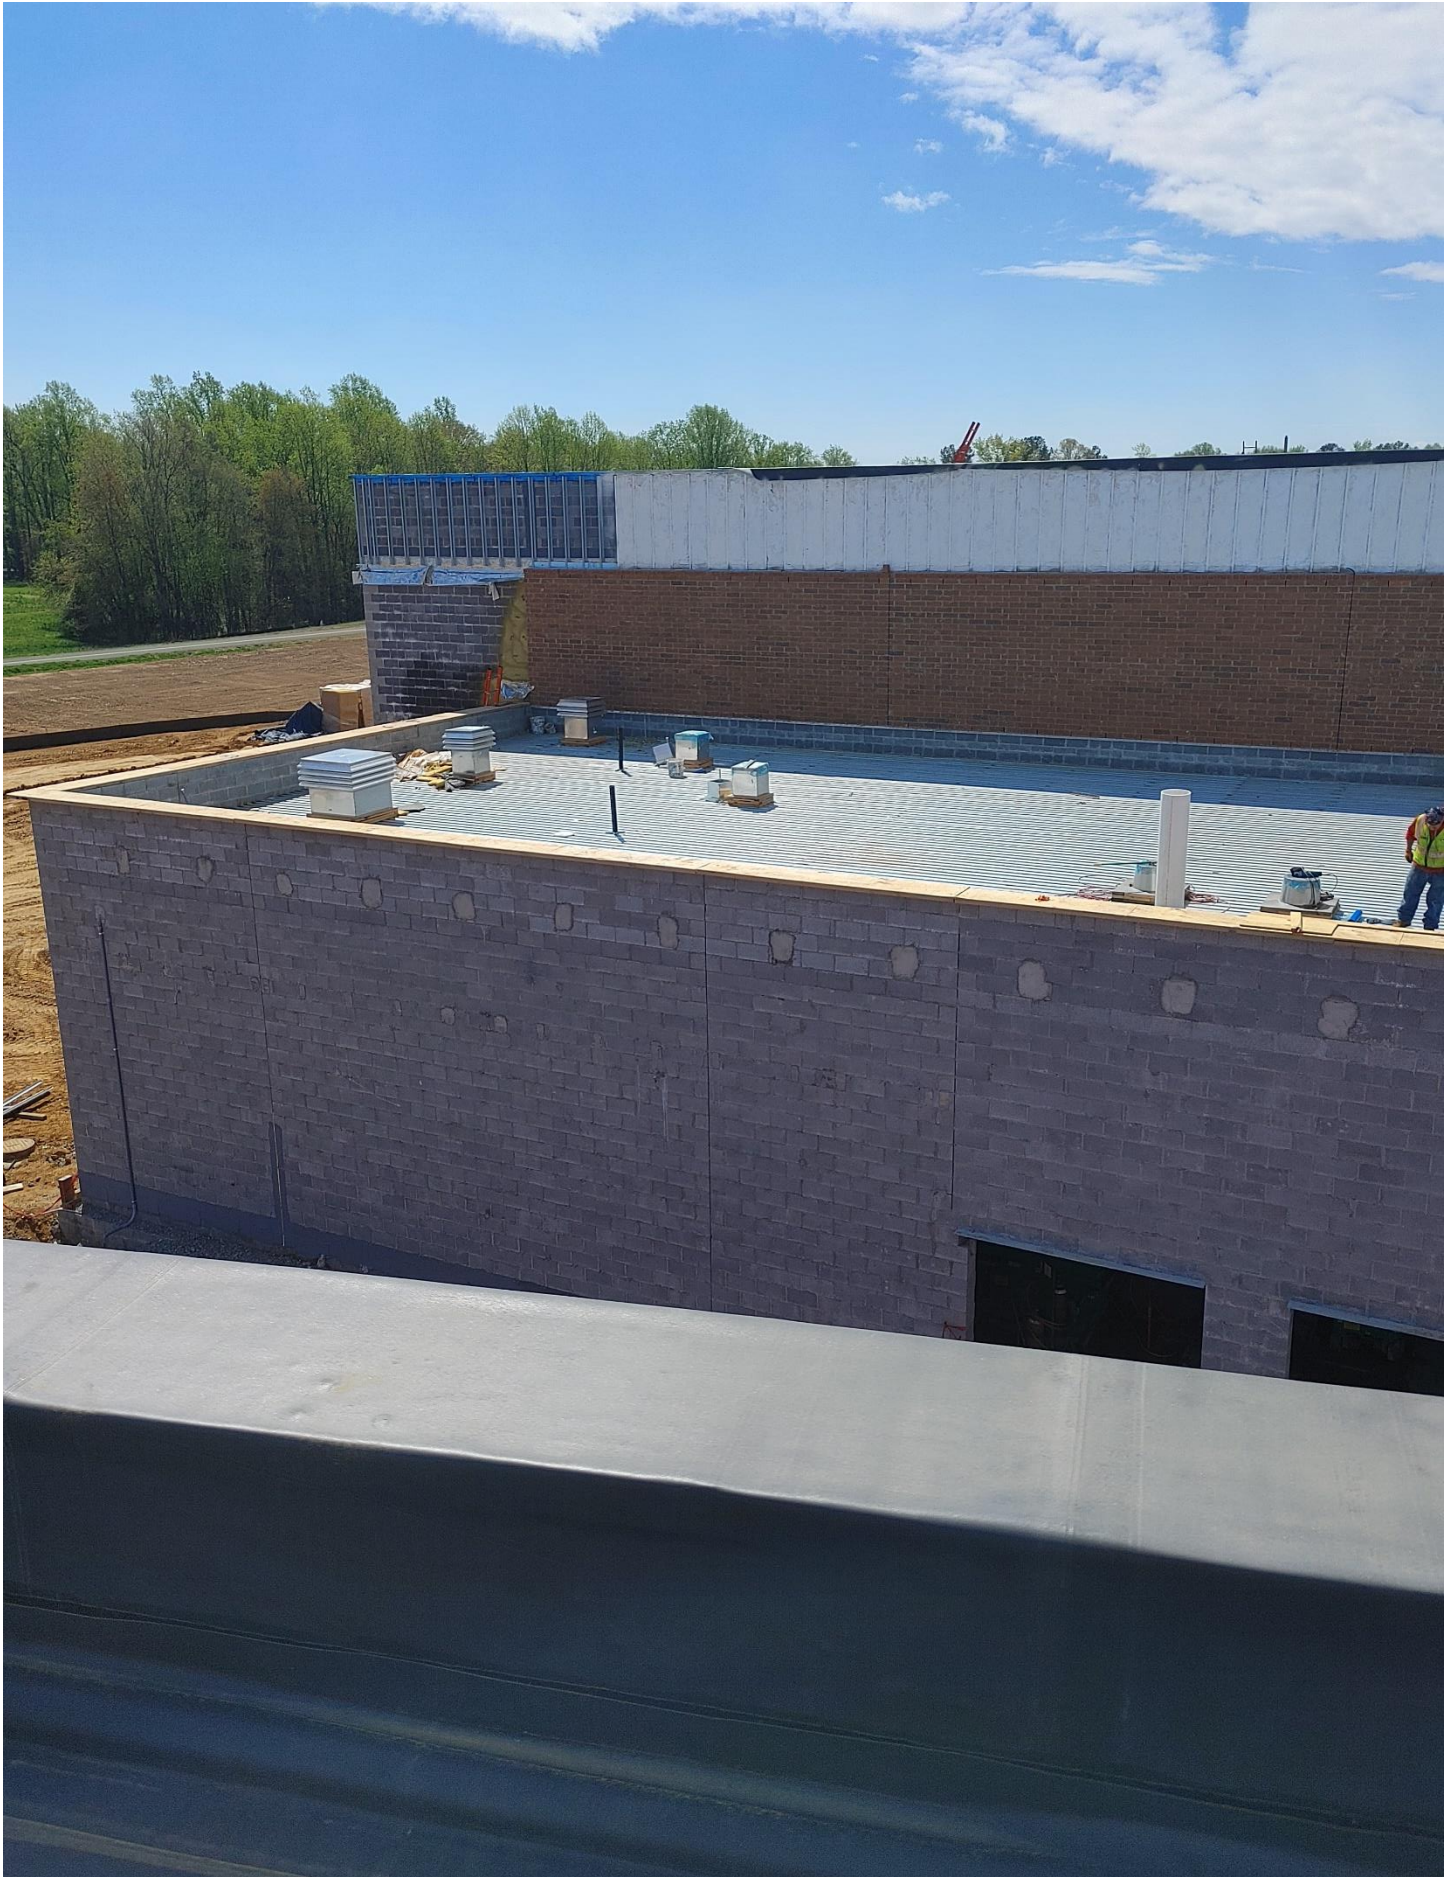
*Photo 6 - Colonial Webb is setting Vent hoods and preparing to set rooftop units.*

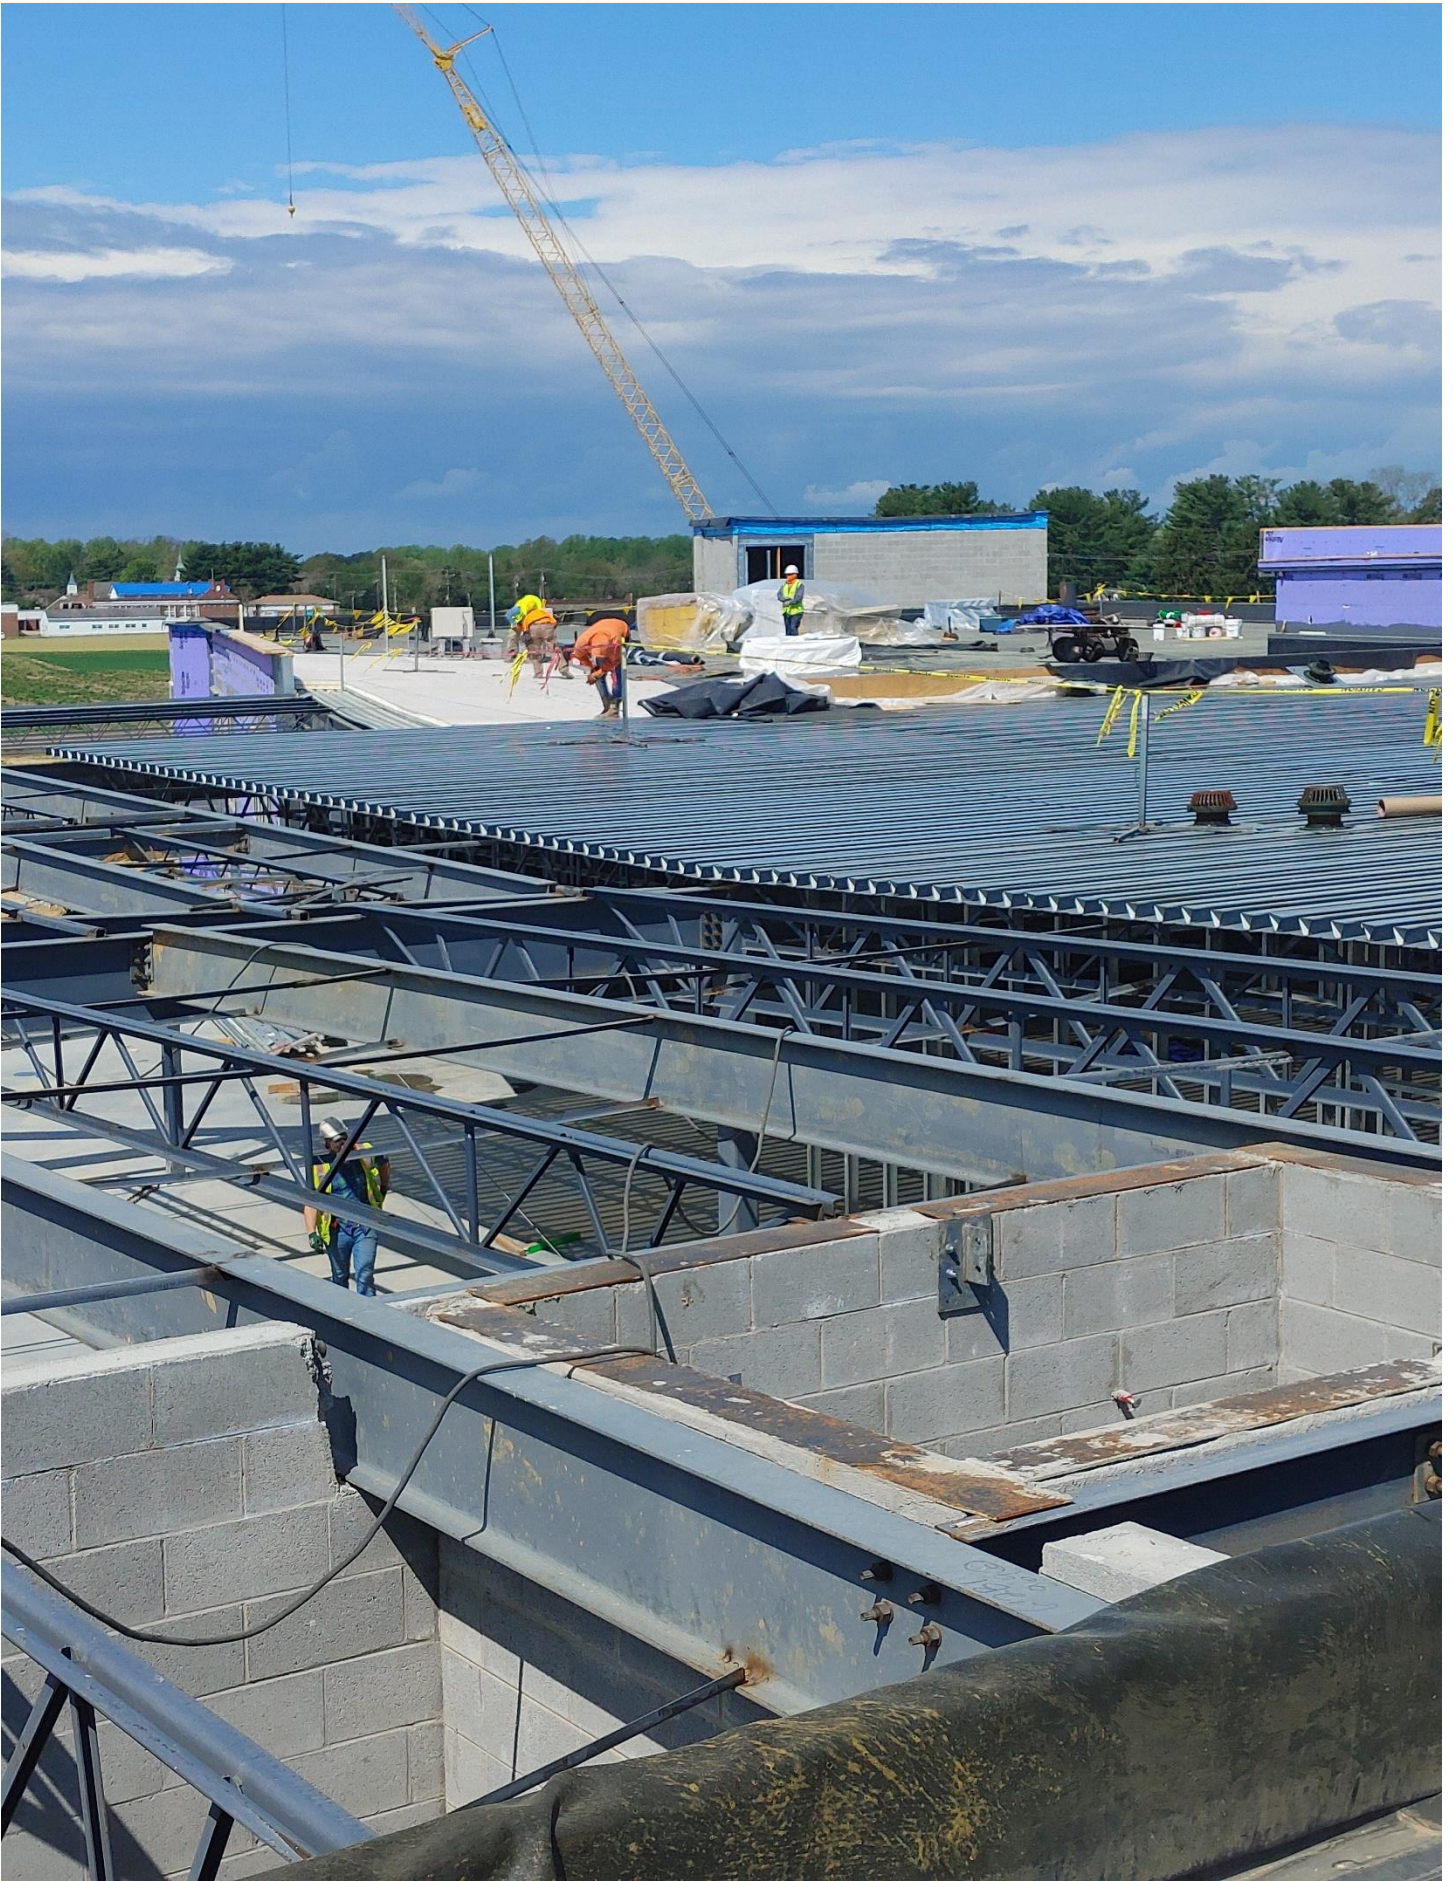
Photo 7 - Roofer continue to work on the roof of Area A

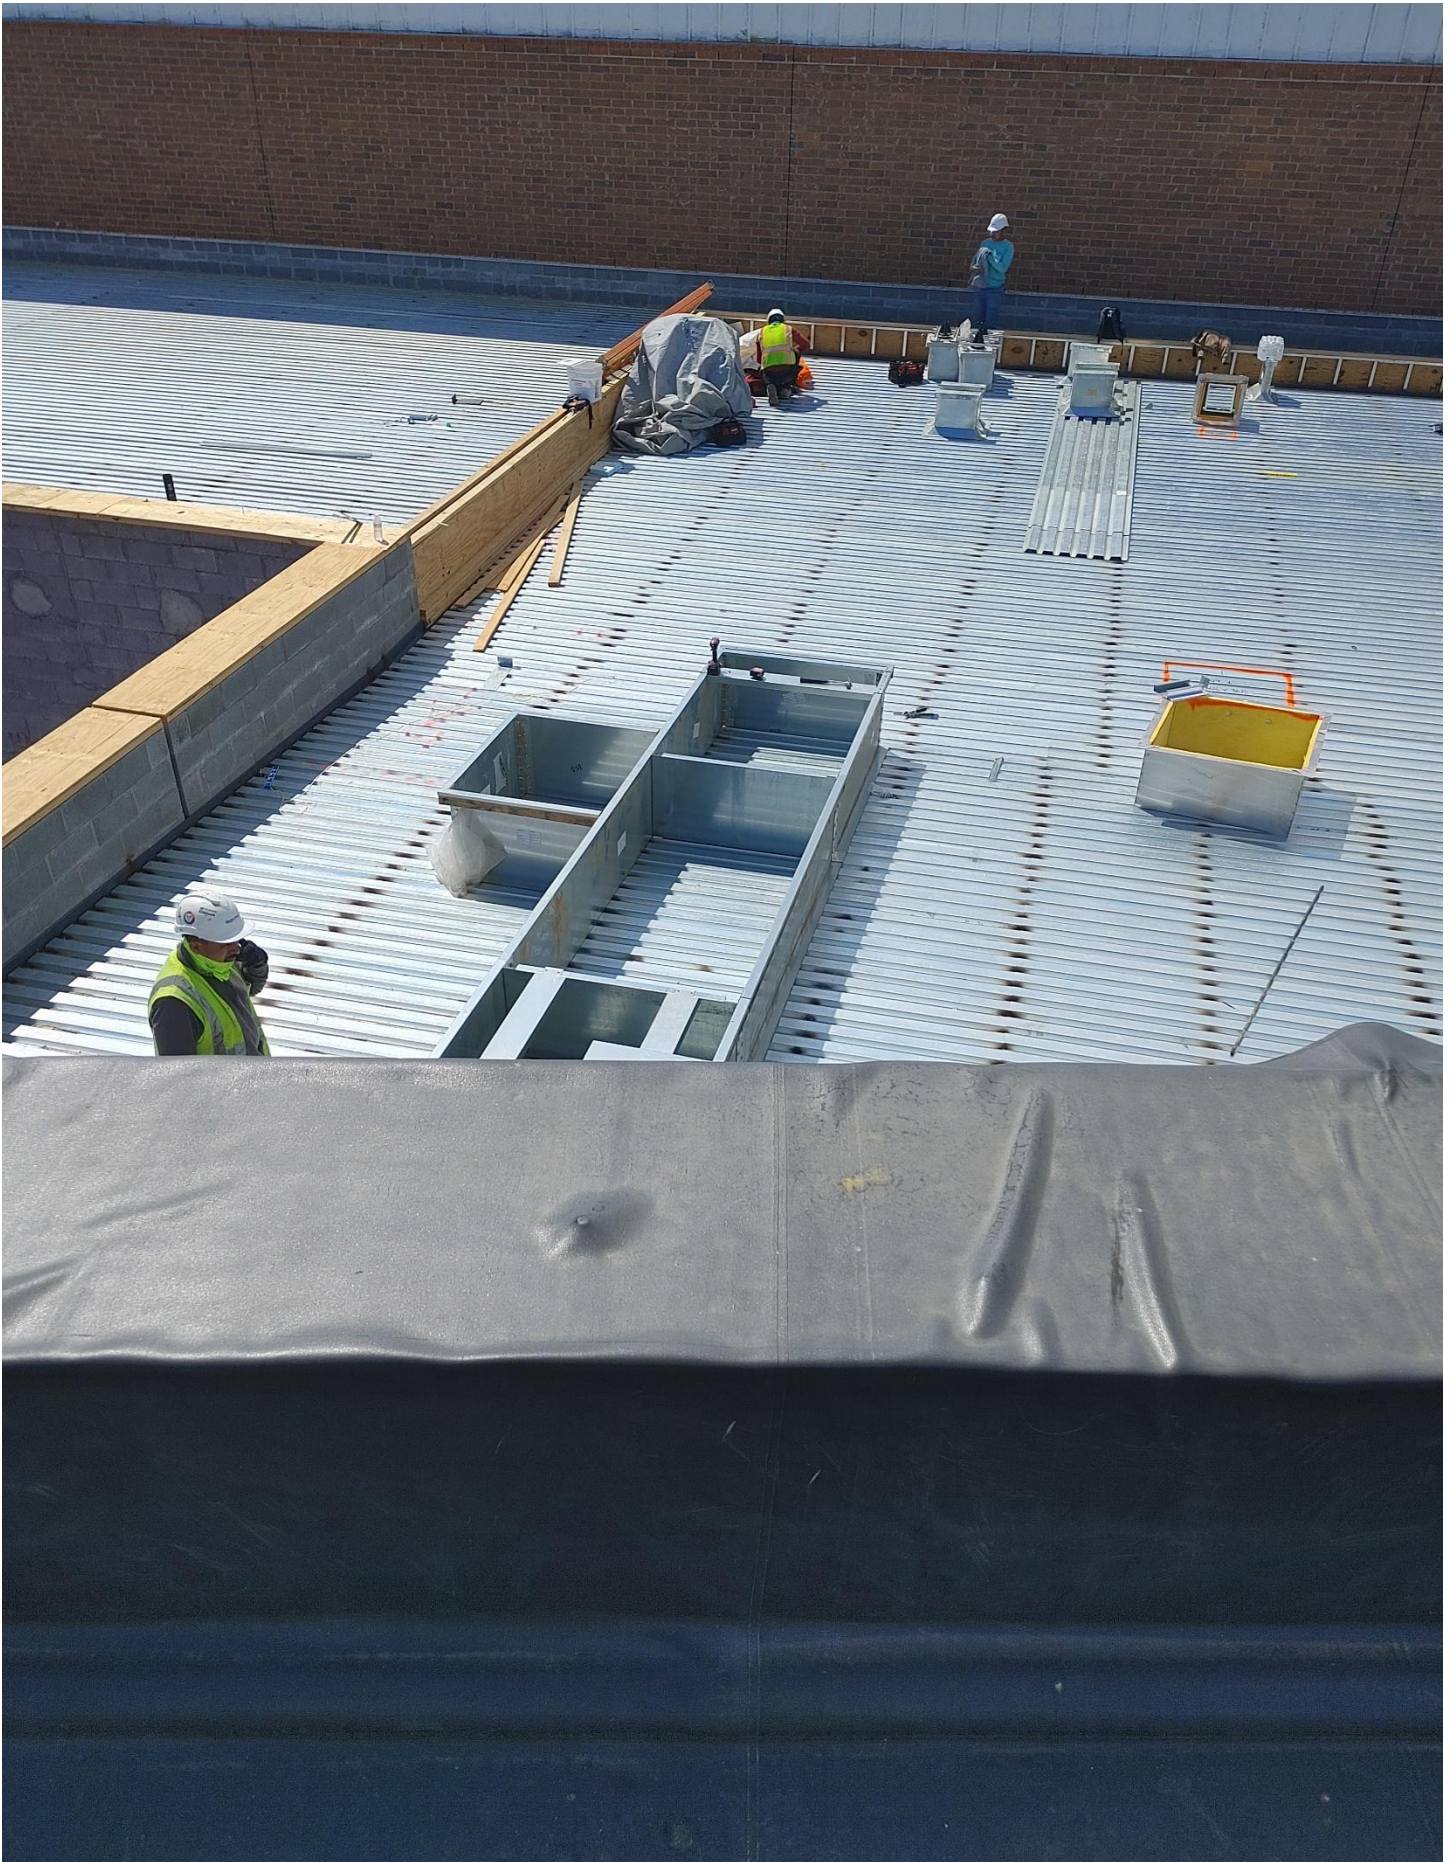
Photo 8 - Colonial Webb working on the low roof of Area D preparing to make penetrations for rooftop units
