**COMMONWEALTH  
BUILDING SOLUTIONS, LLC**

**DAILY REPORT**

**WESTMORELAND COUNTY HIGH SCHOOL**

Date: 04/12/2021

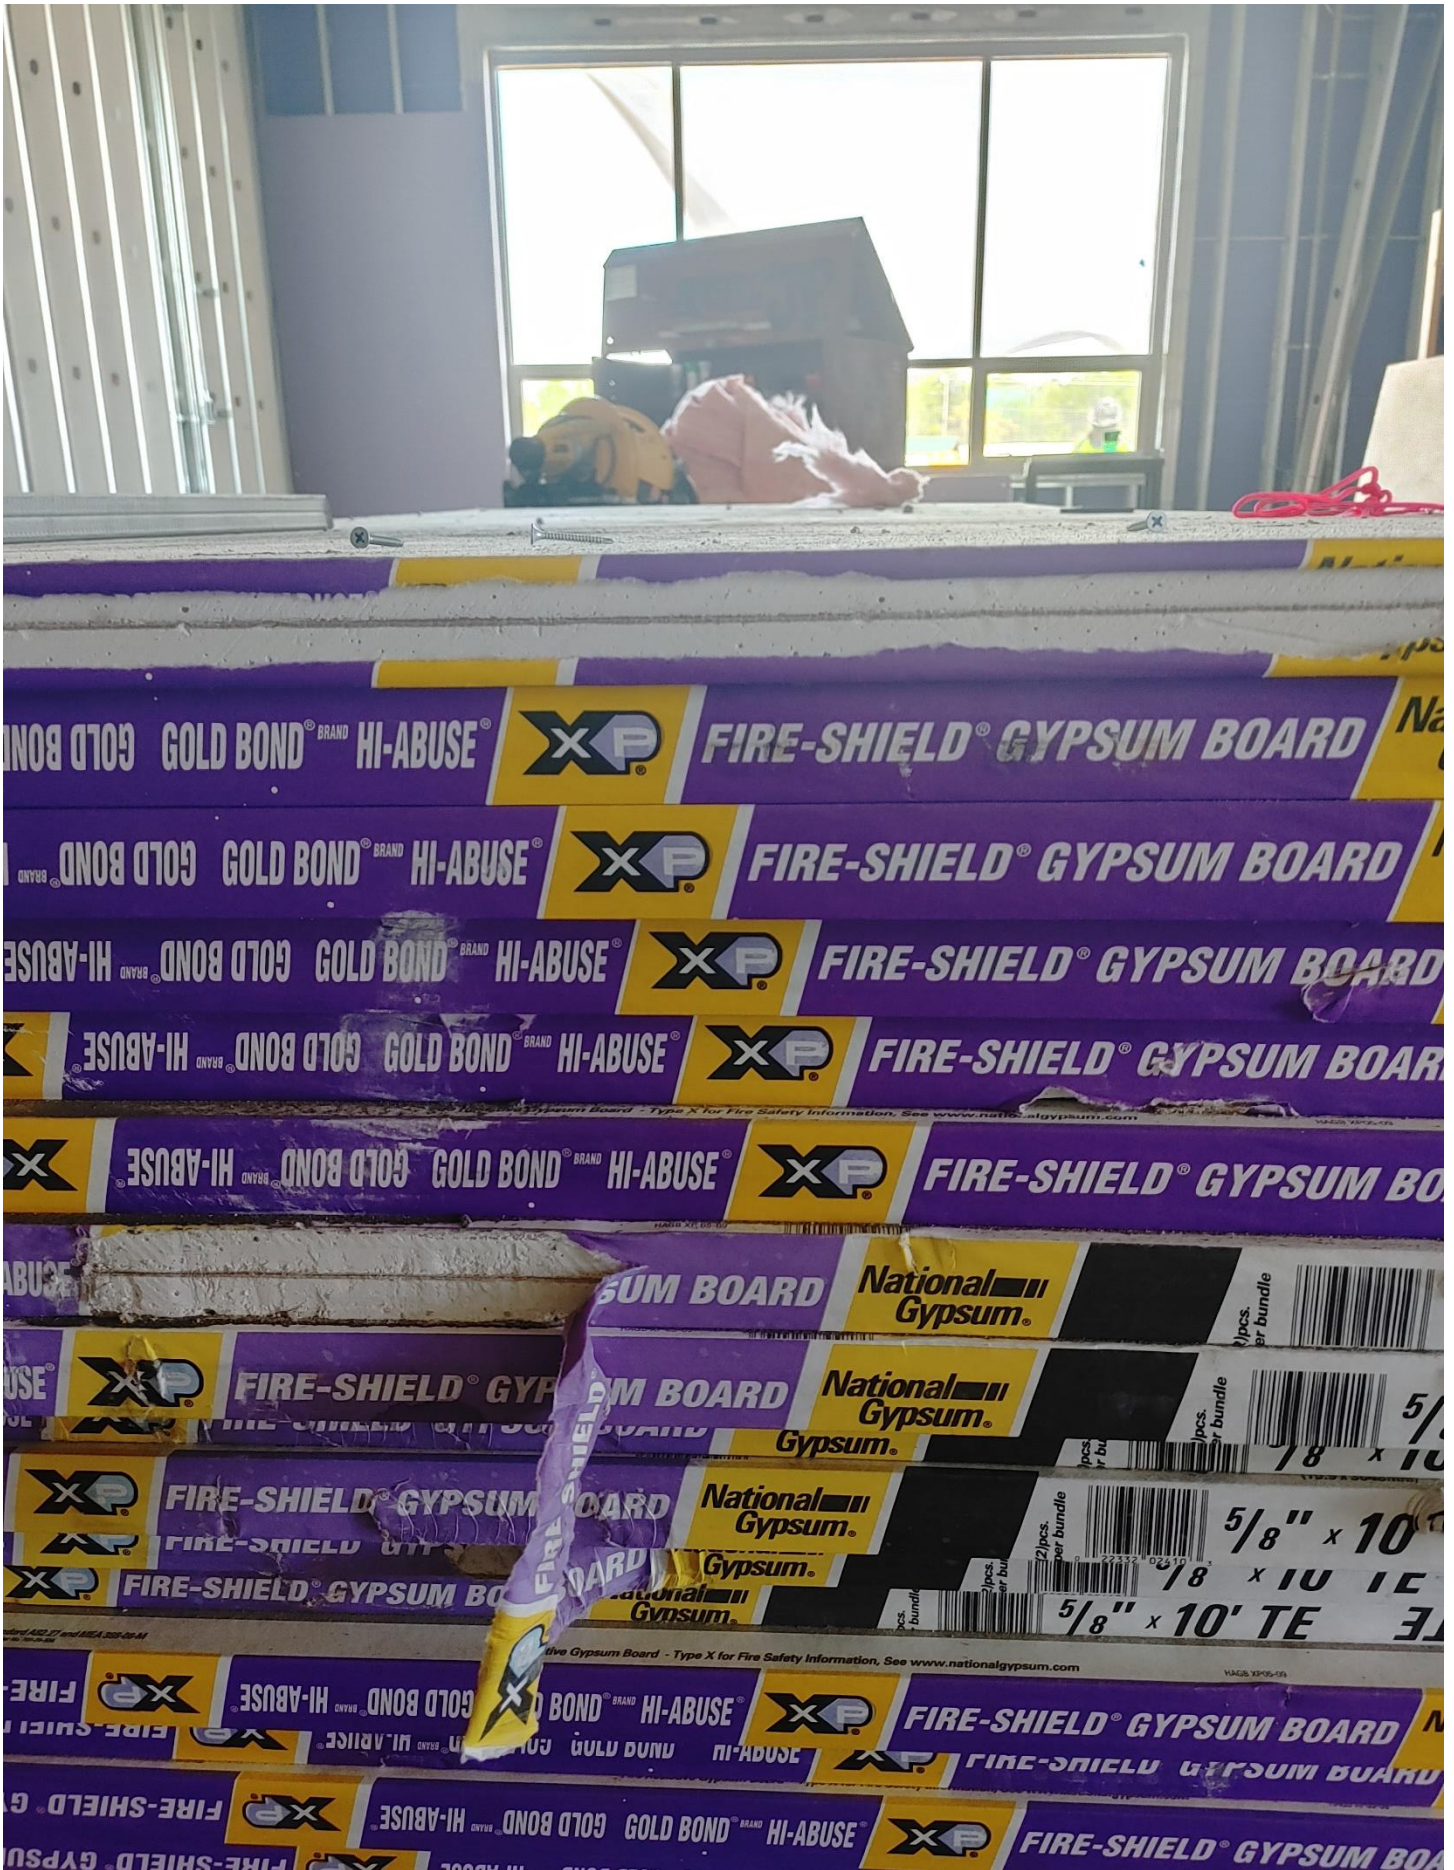
Photo 9 - Hi-Abuse Fire Shield Rock is being hung on the 1st floor of Area A

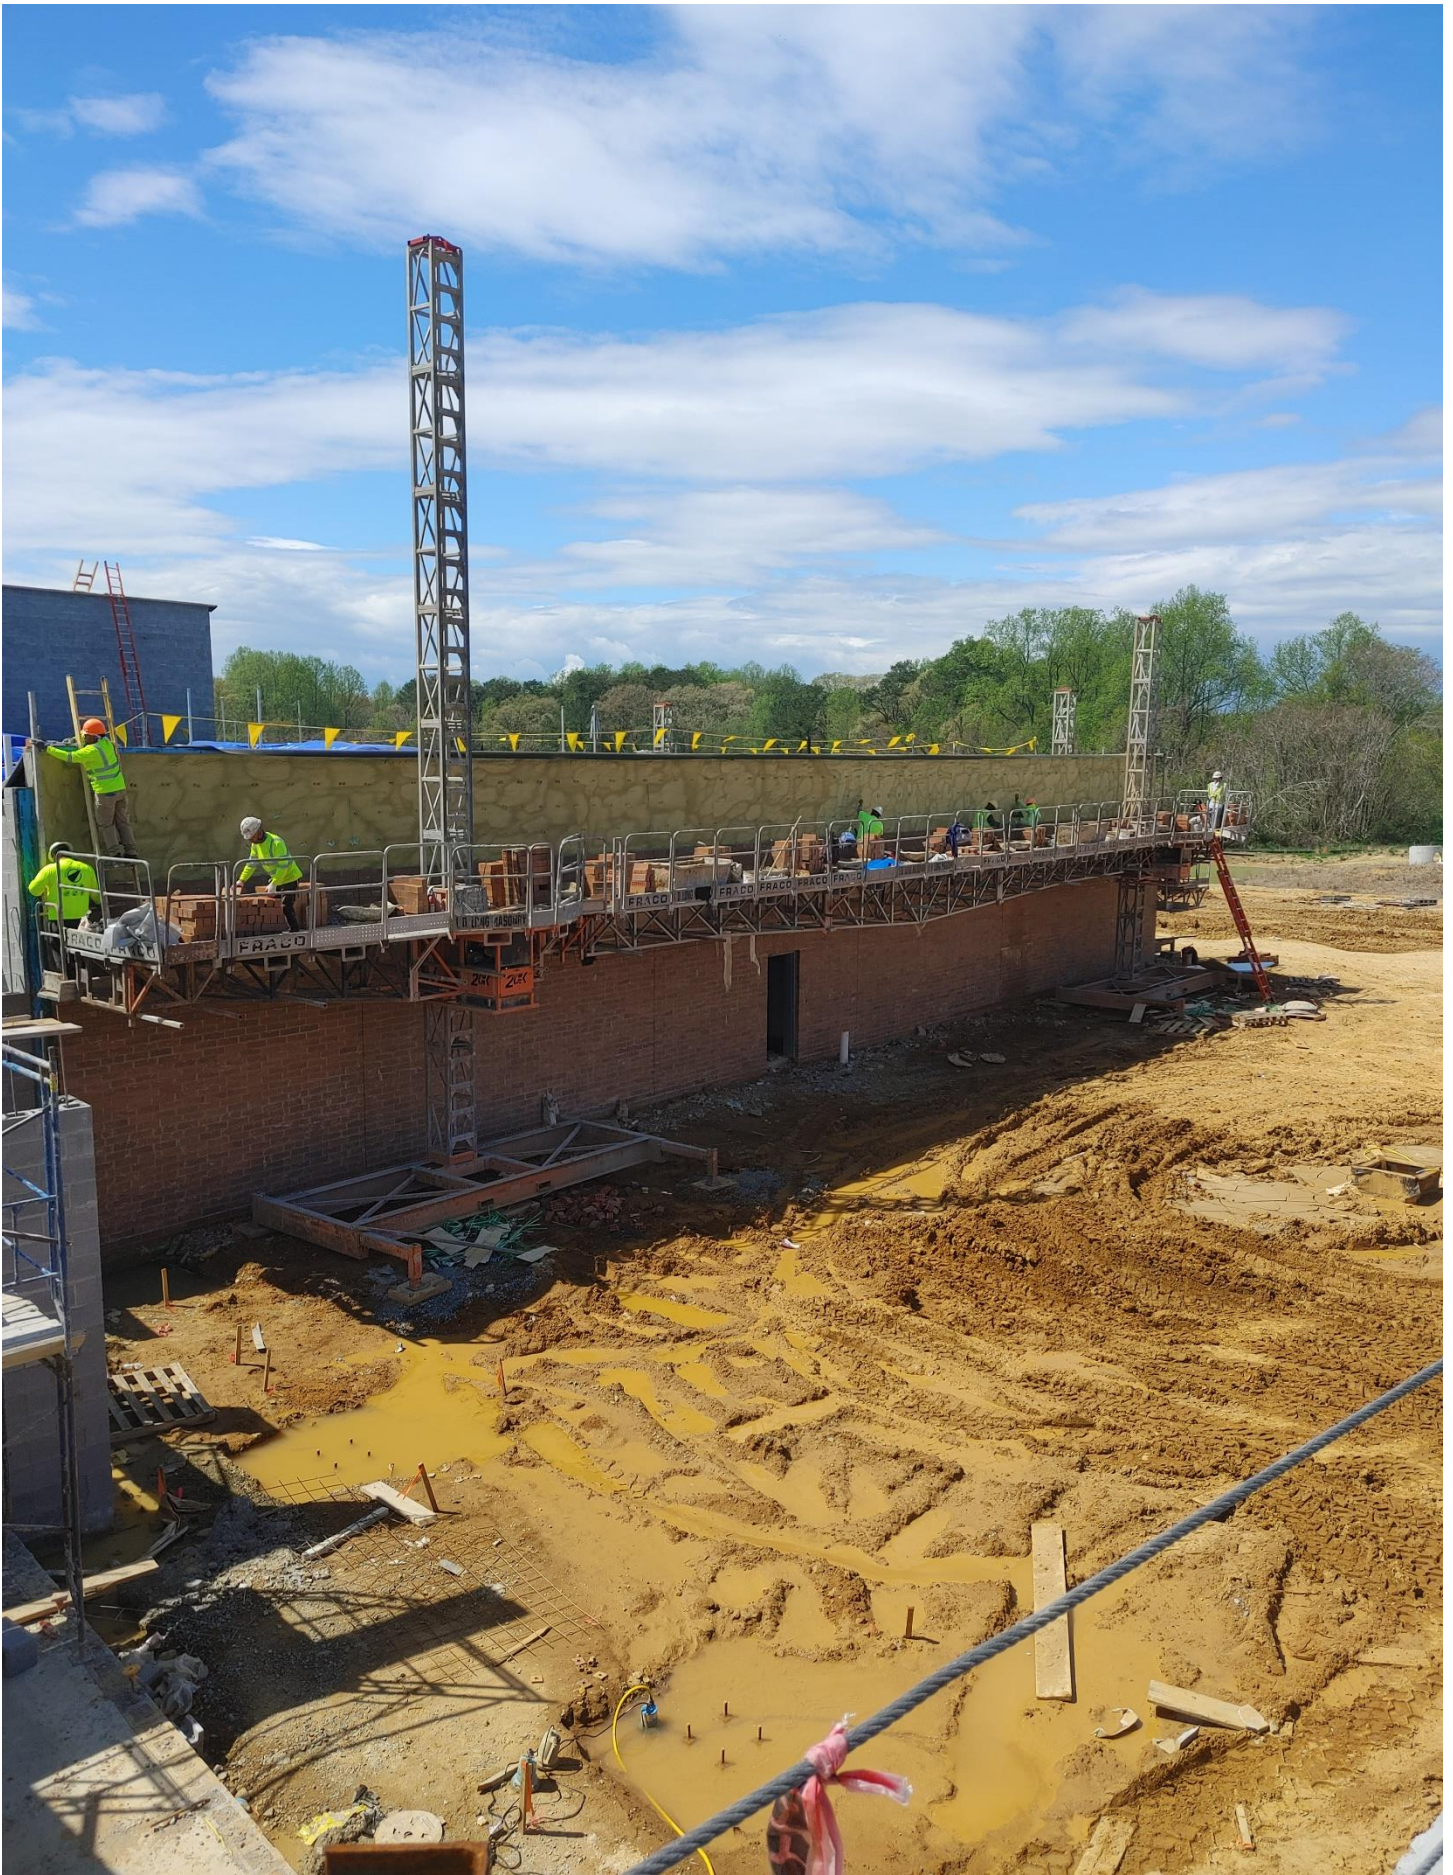
Photo 10 - Brick continues to be laid on the Northside of Area E
