**COMMONWEALTH
BUILDING SOLUTIONS, LLC**

FIELD REPORT

WESTMORELAND COUNTY HIGH SCHOOL

Date: 04/15/2022

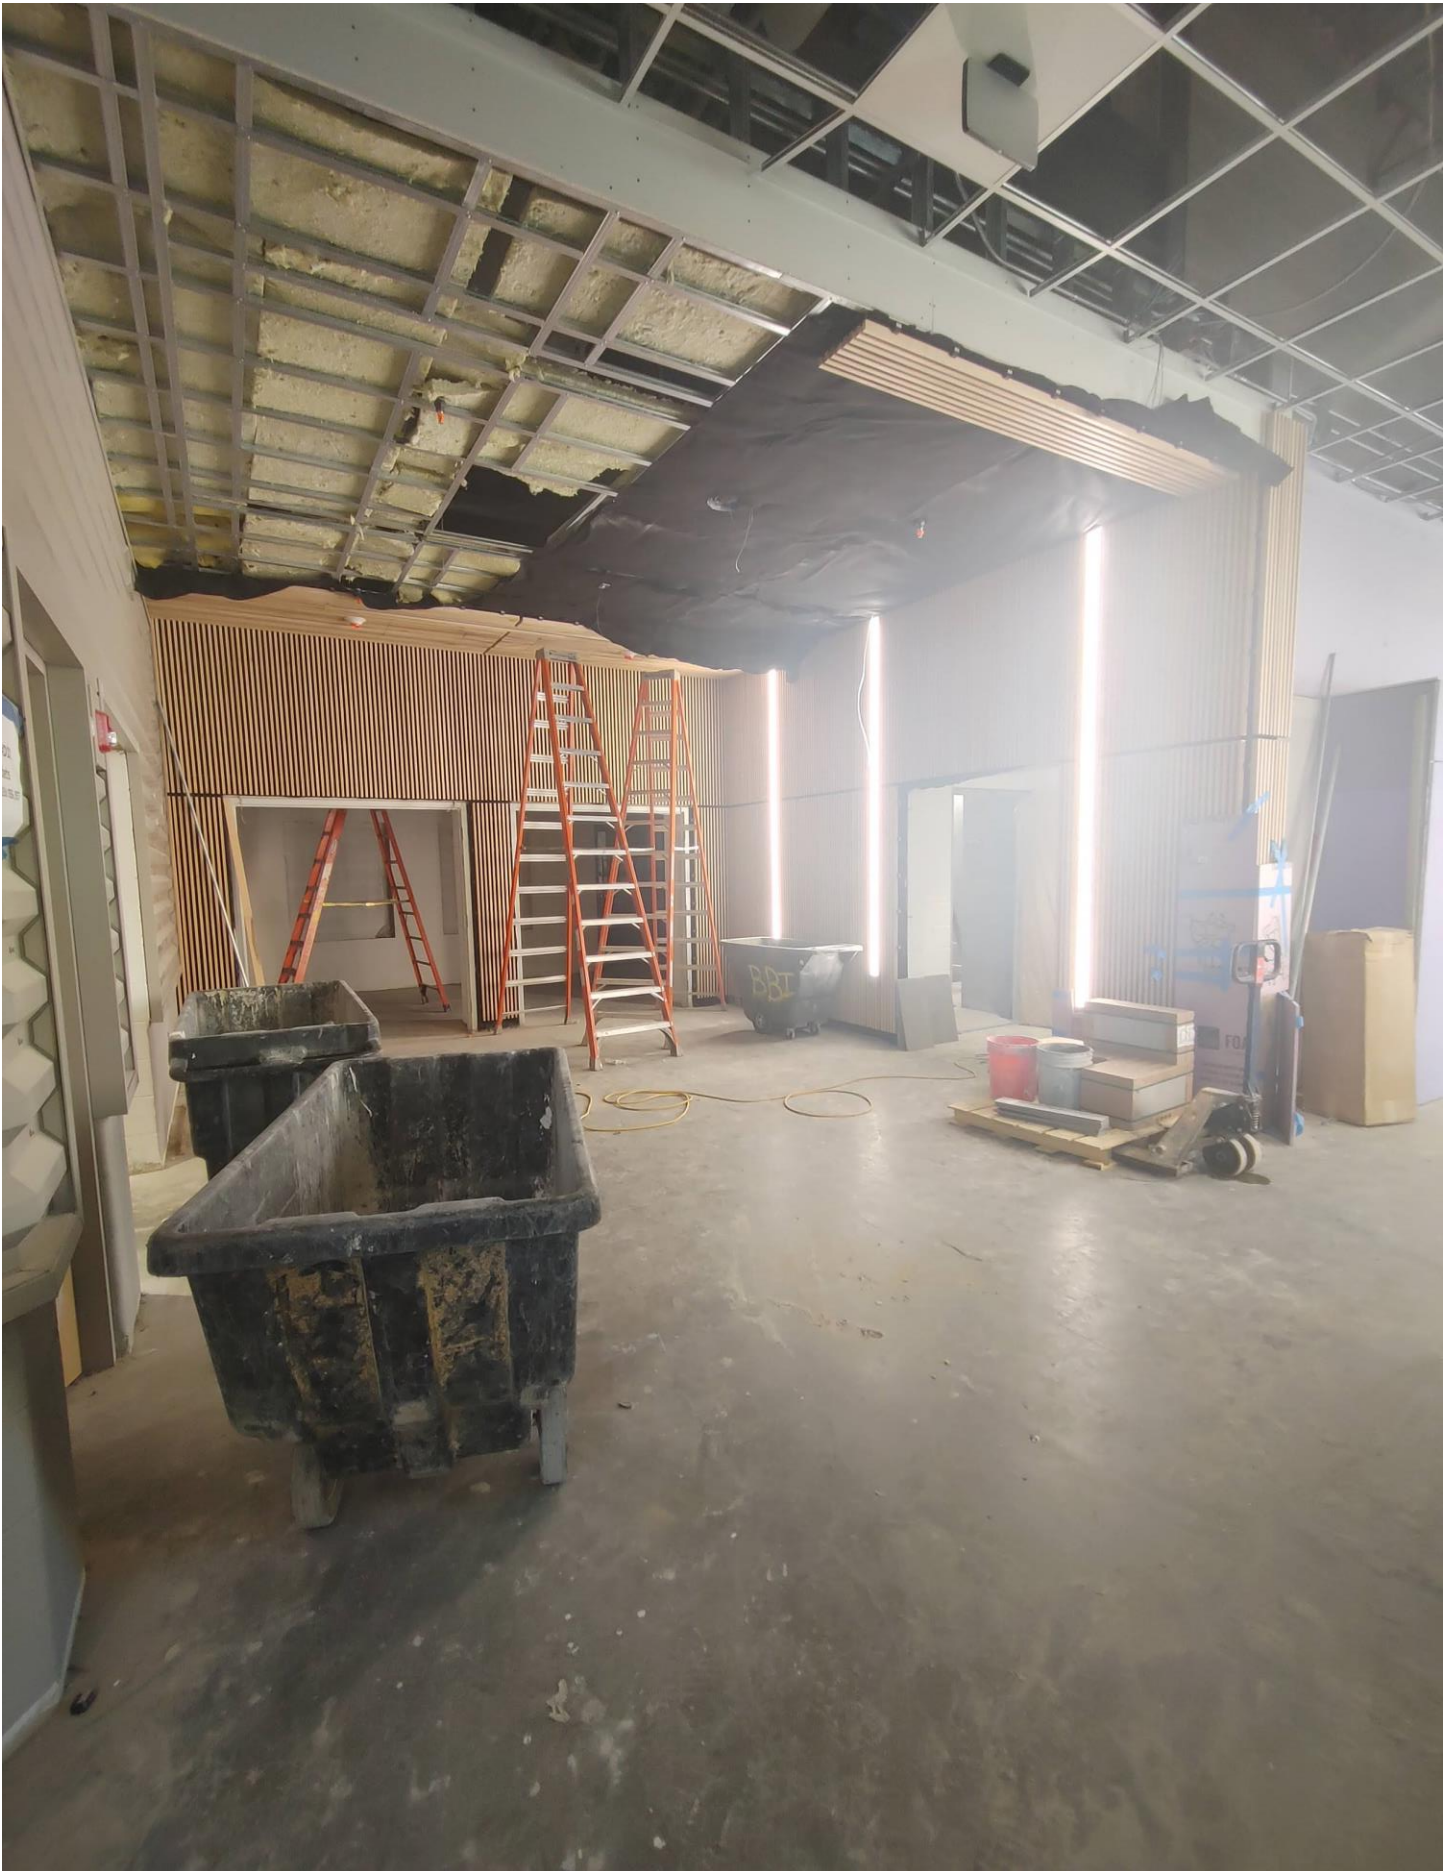
Photo 3 - Wood Wall is being installed outside of Auditorium

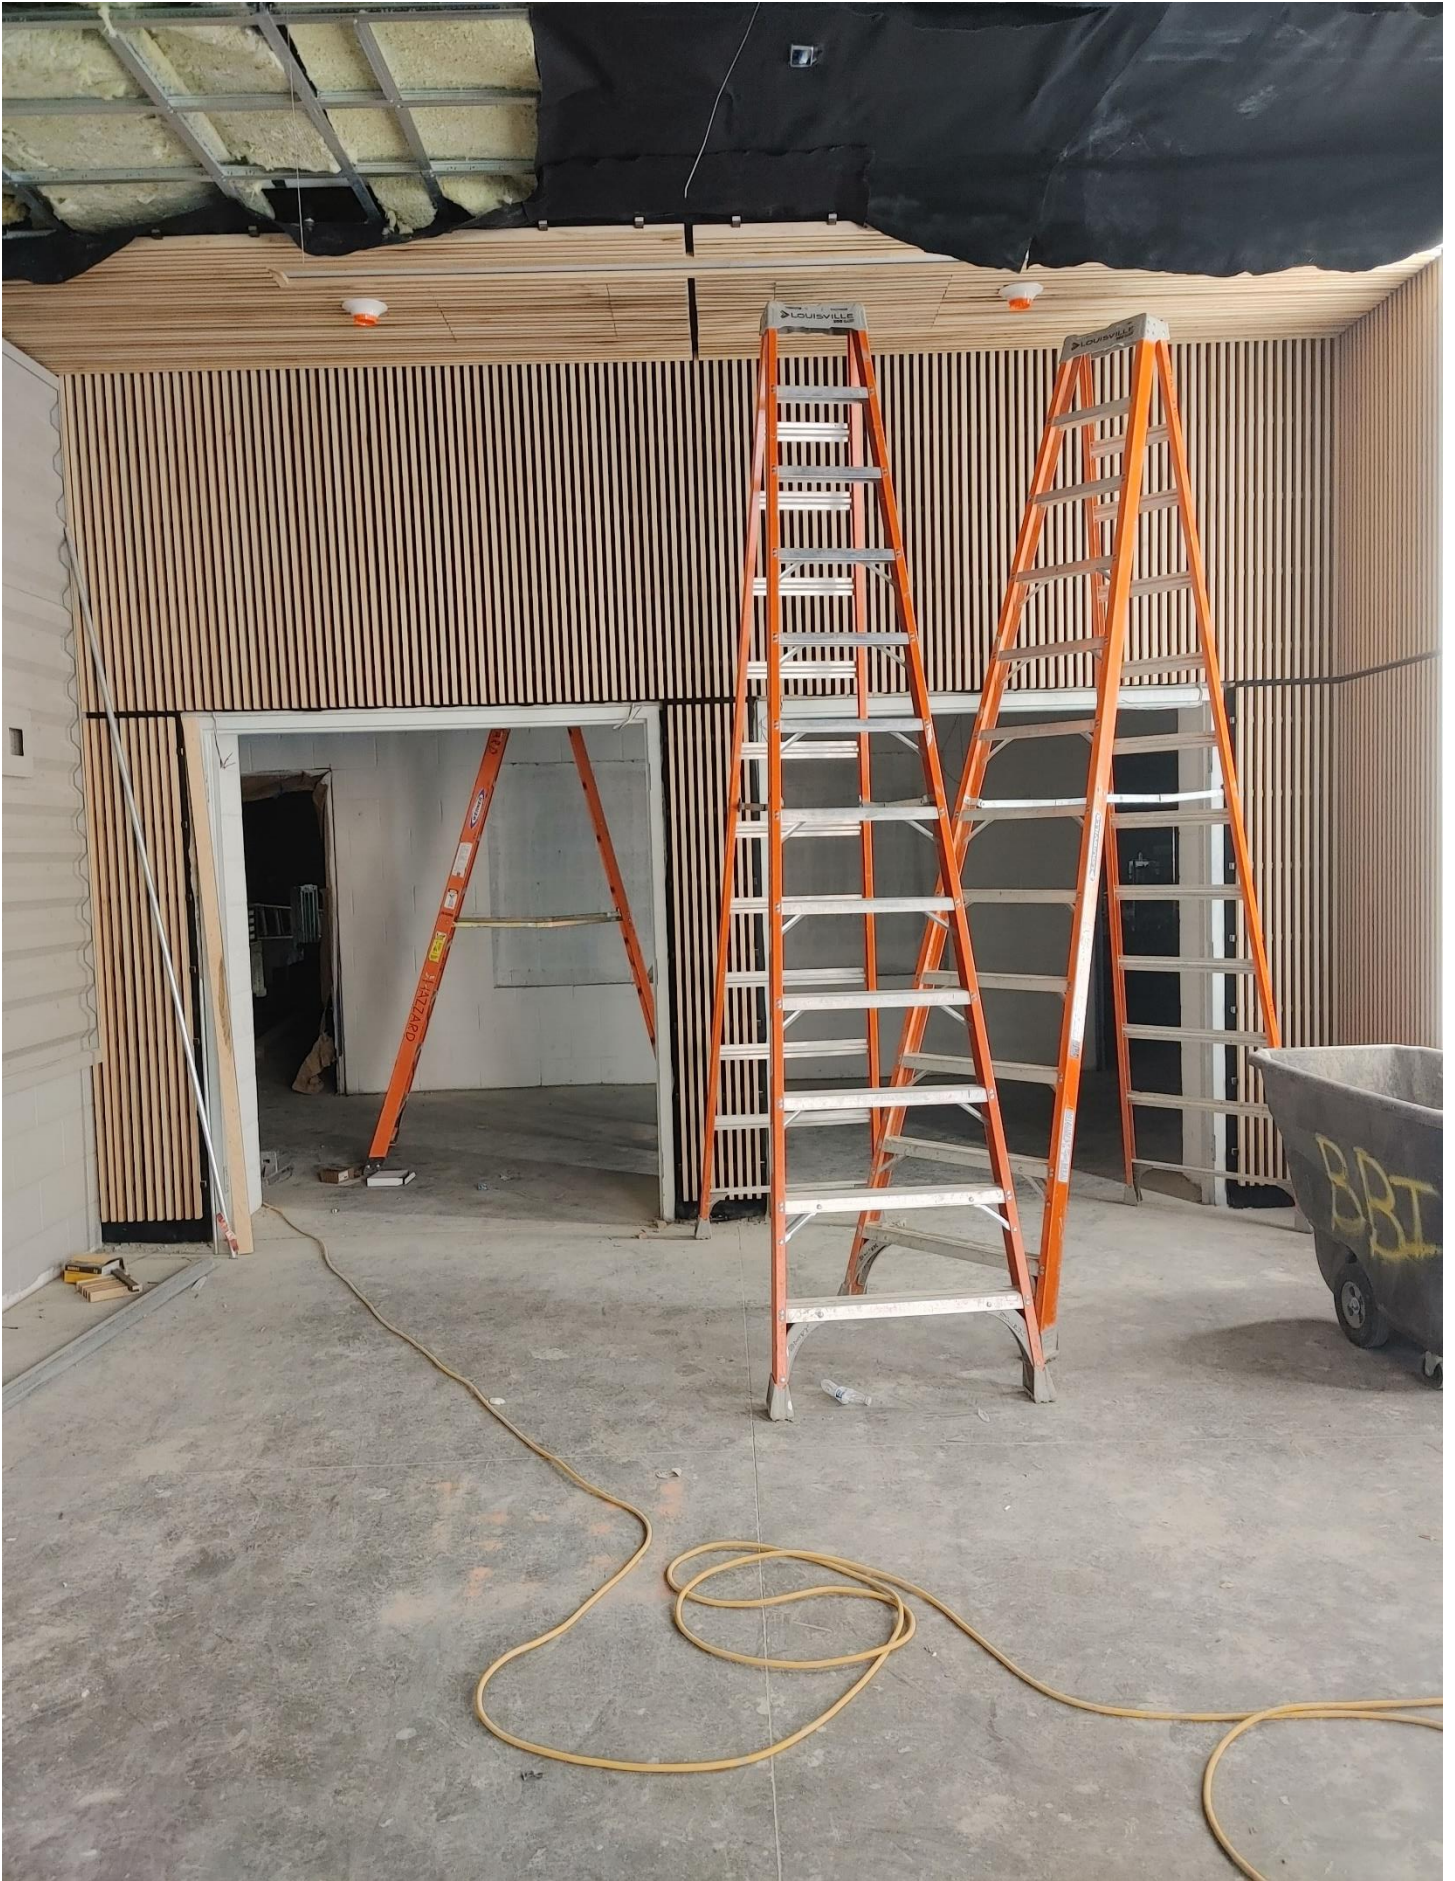
Photo 4 - Wood Wall at Auditorium Entrance

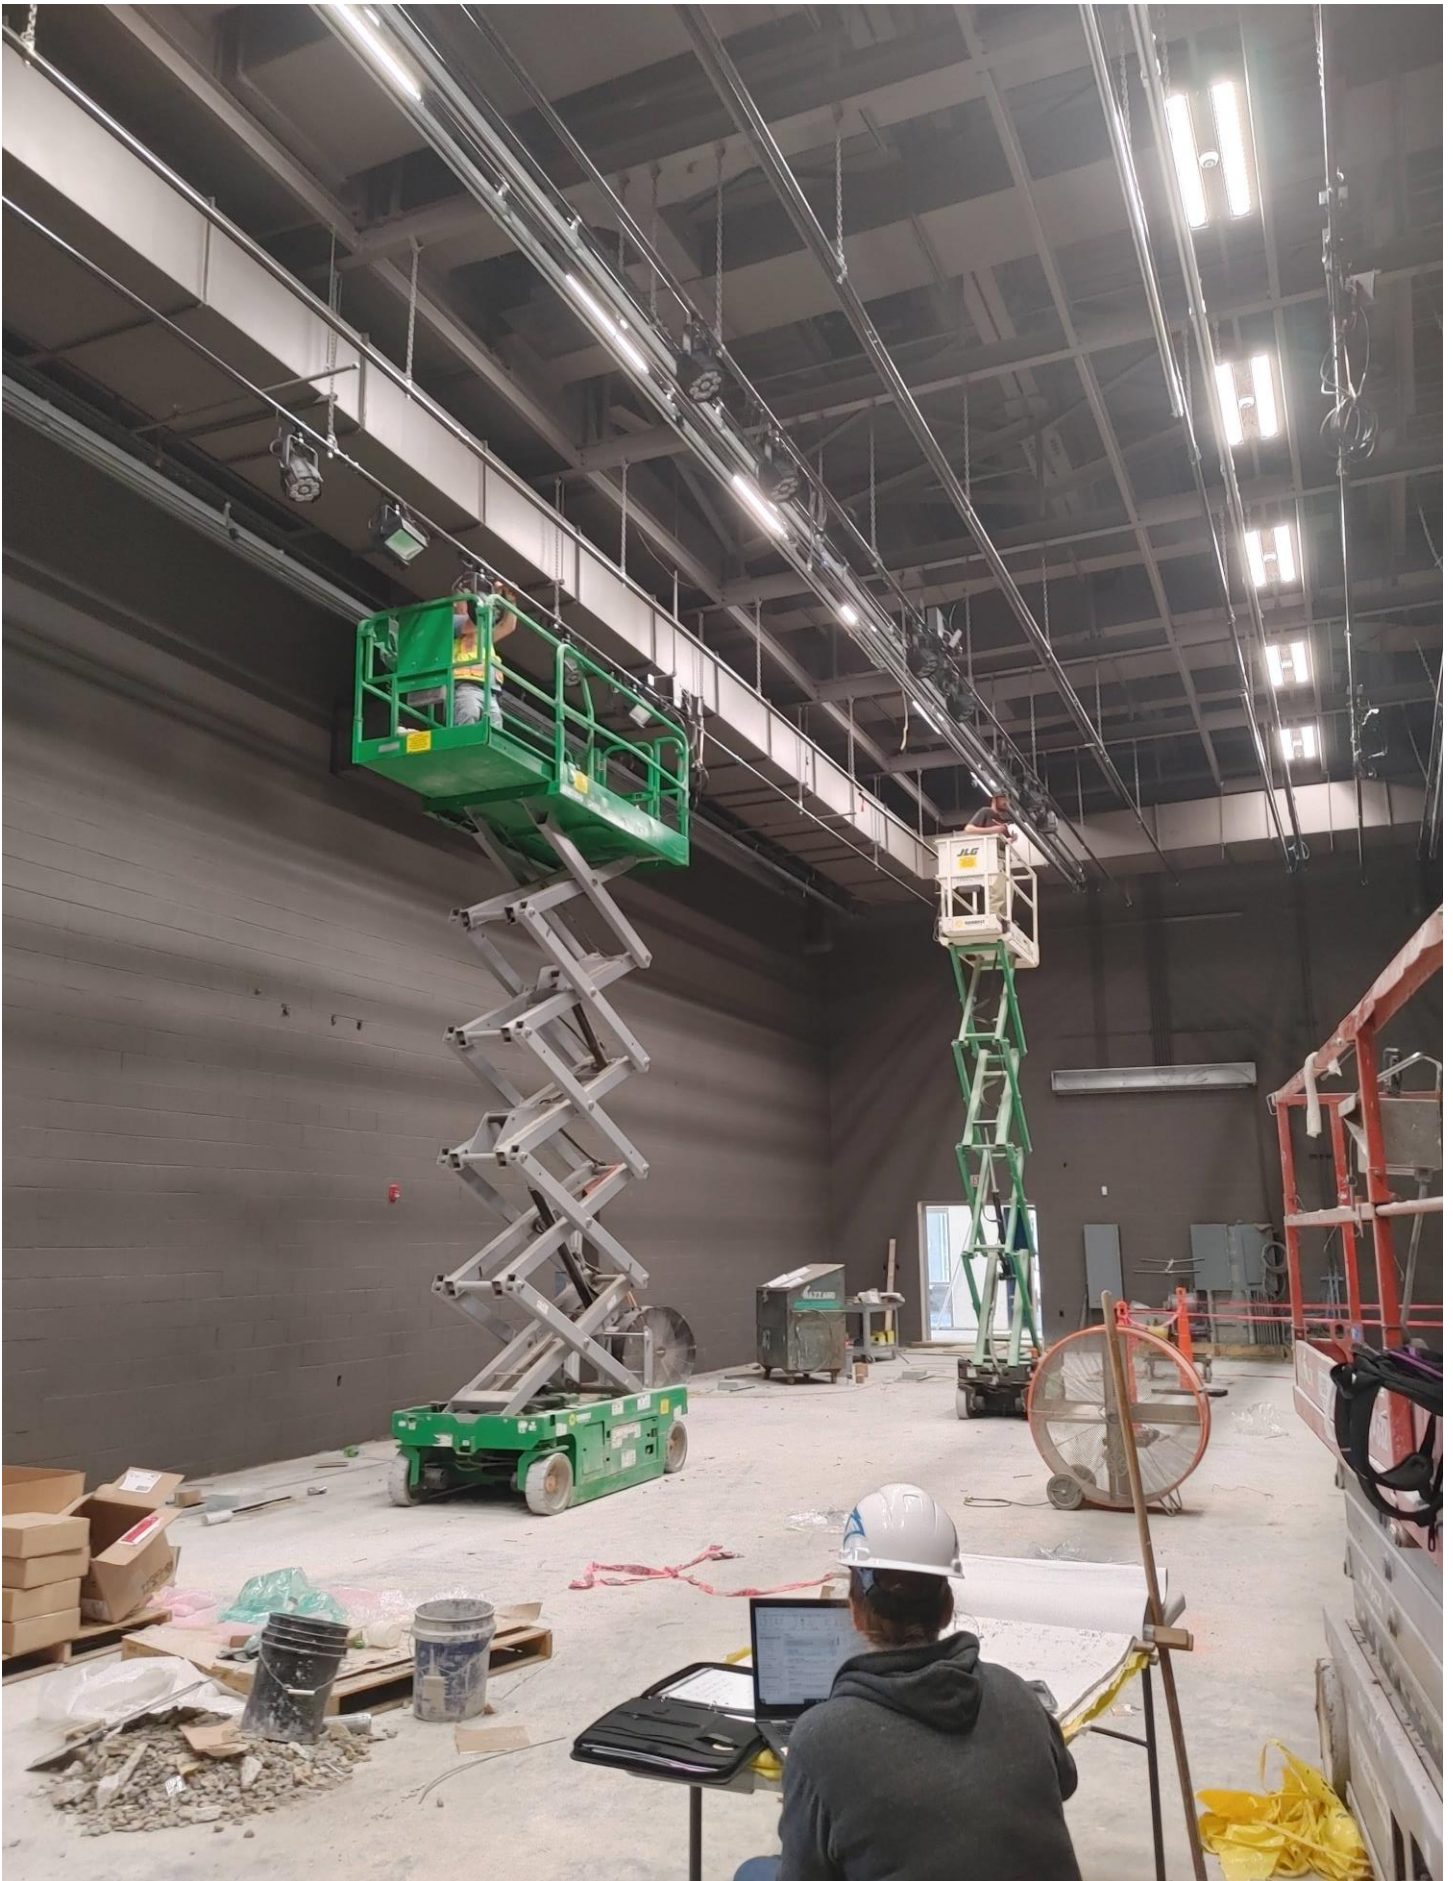
Walked the site. The electricians are installing Stage Lighting in the Auditorium. Paving crew is on site applying the Topping Layer of asphalt in the front parking lot. Counter tops are being installed in Area B. Landscapers are applying Mulch in various locations. One man is installing counter tops in Area C, Student Commons Area. Two men are working on door frame D123.

Photo 5 - Stage Lighting being installed.

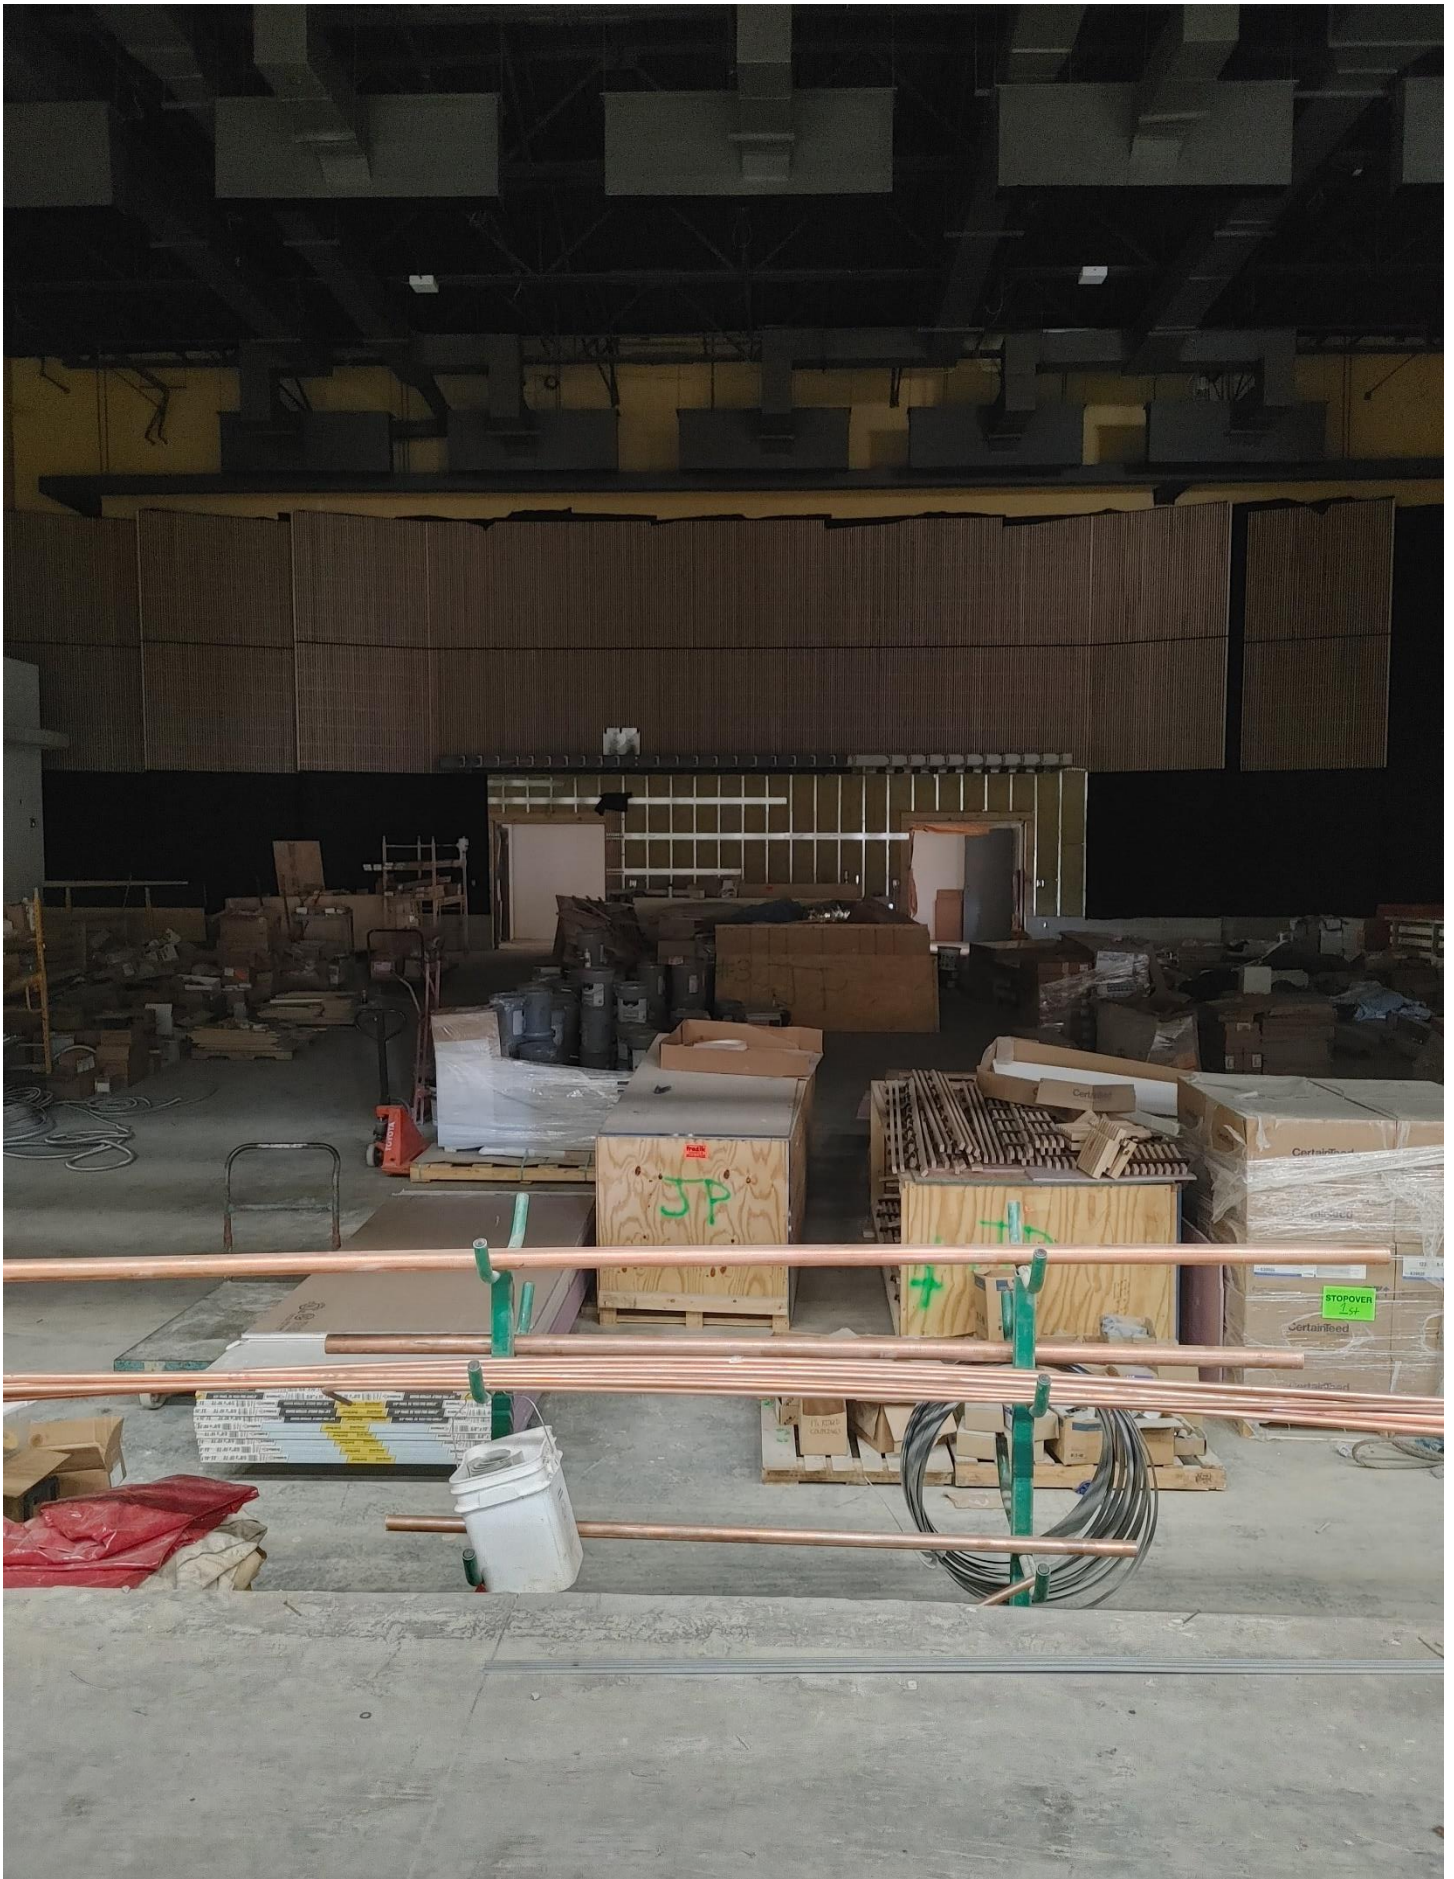
Photo 6 - Wood Wall at rear of Auditorium

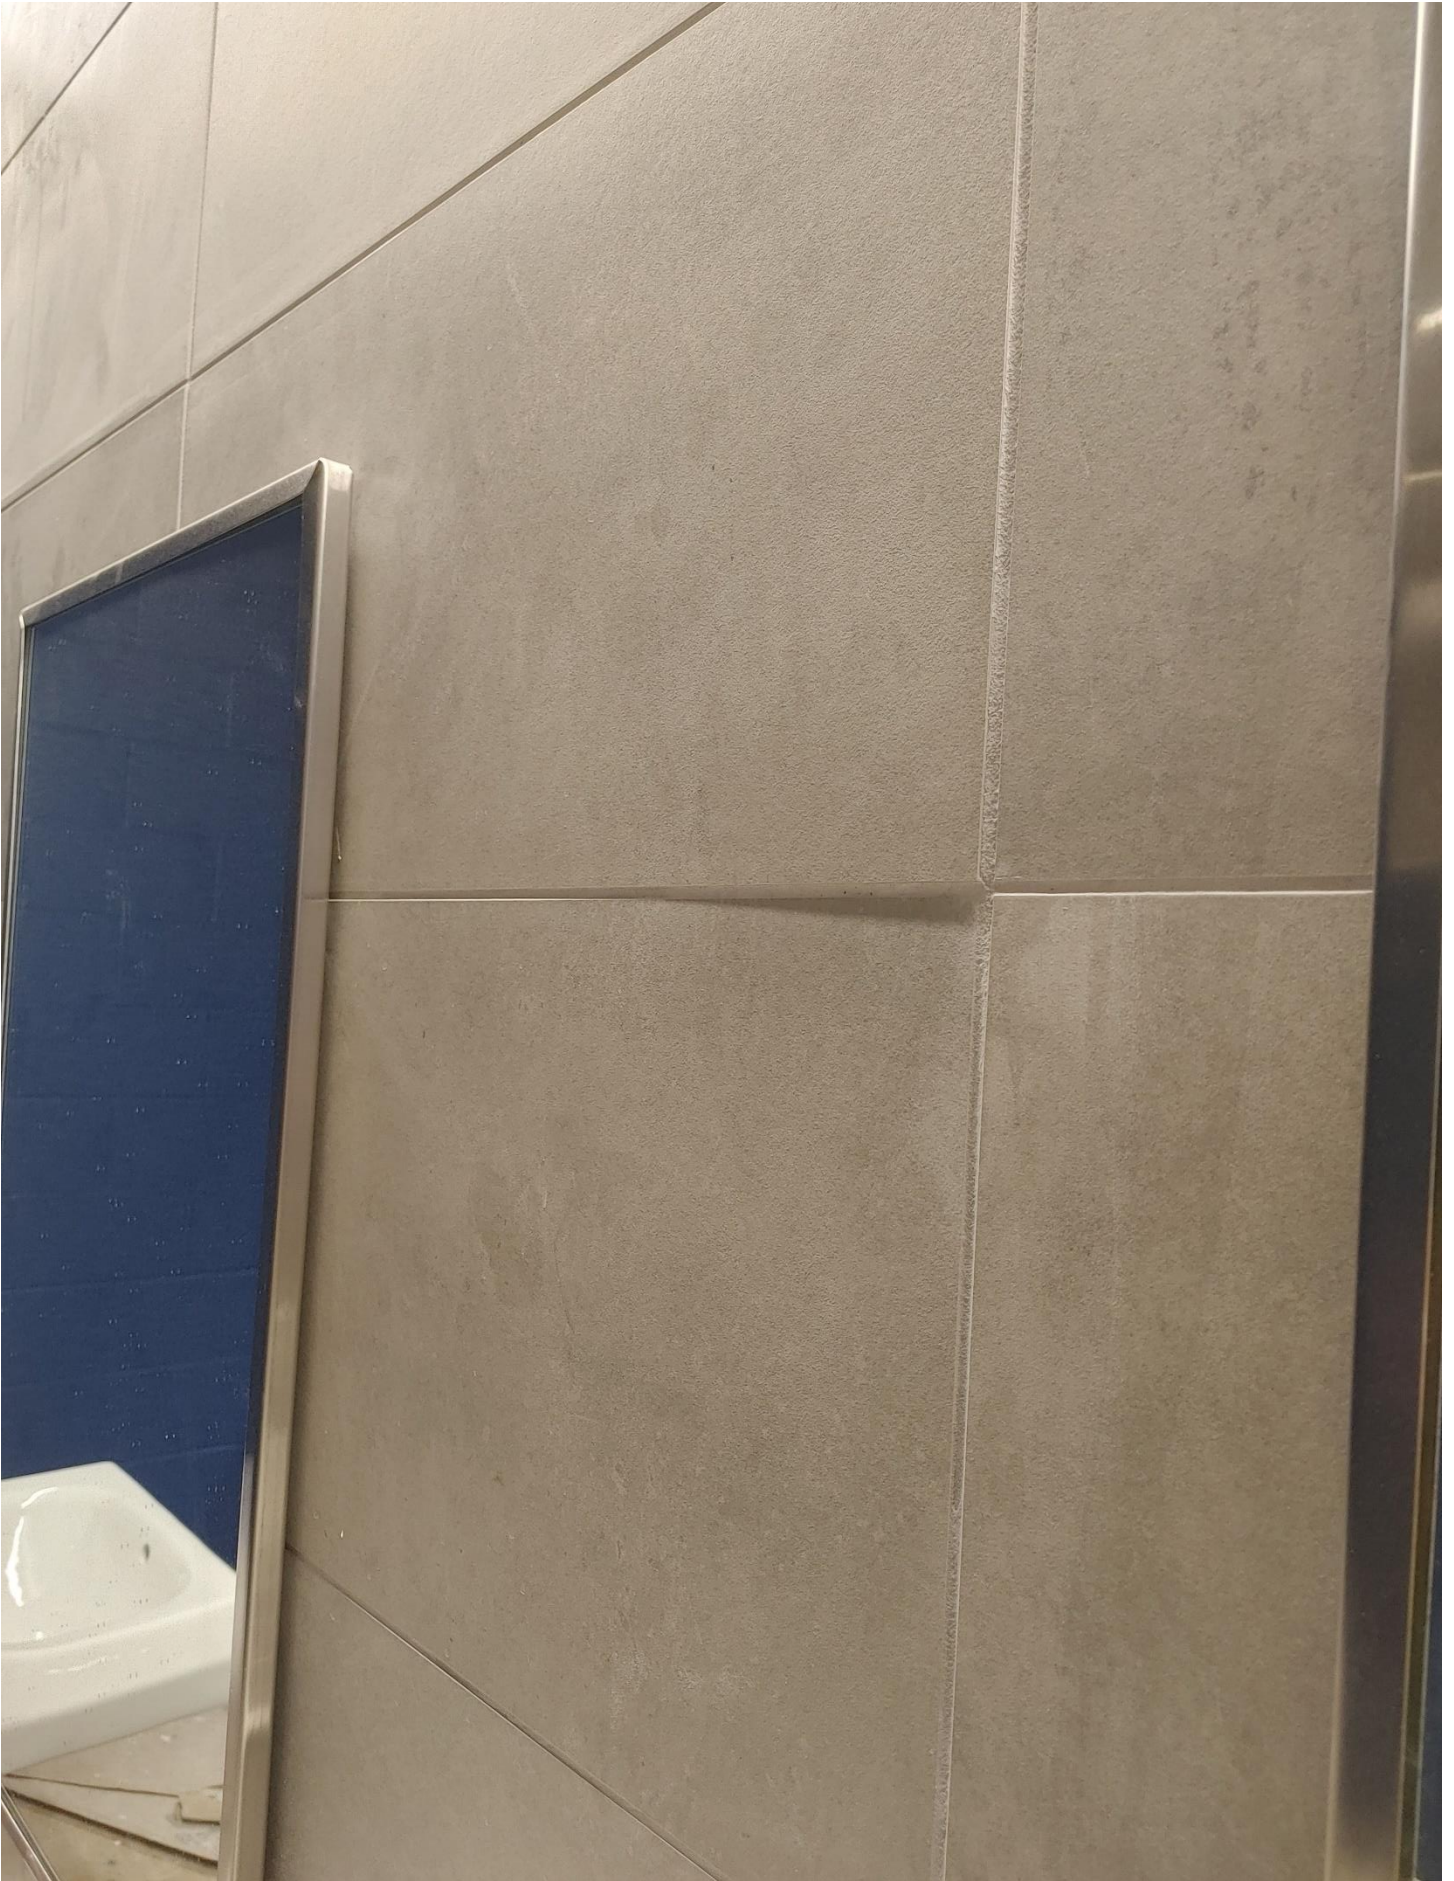
Photo 11 - Tile in Boys Toilet E103 – Several areas will need attention

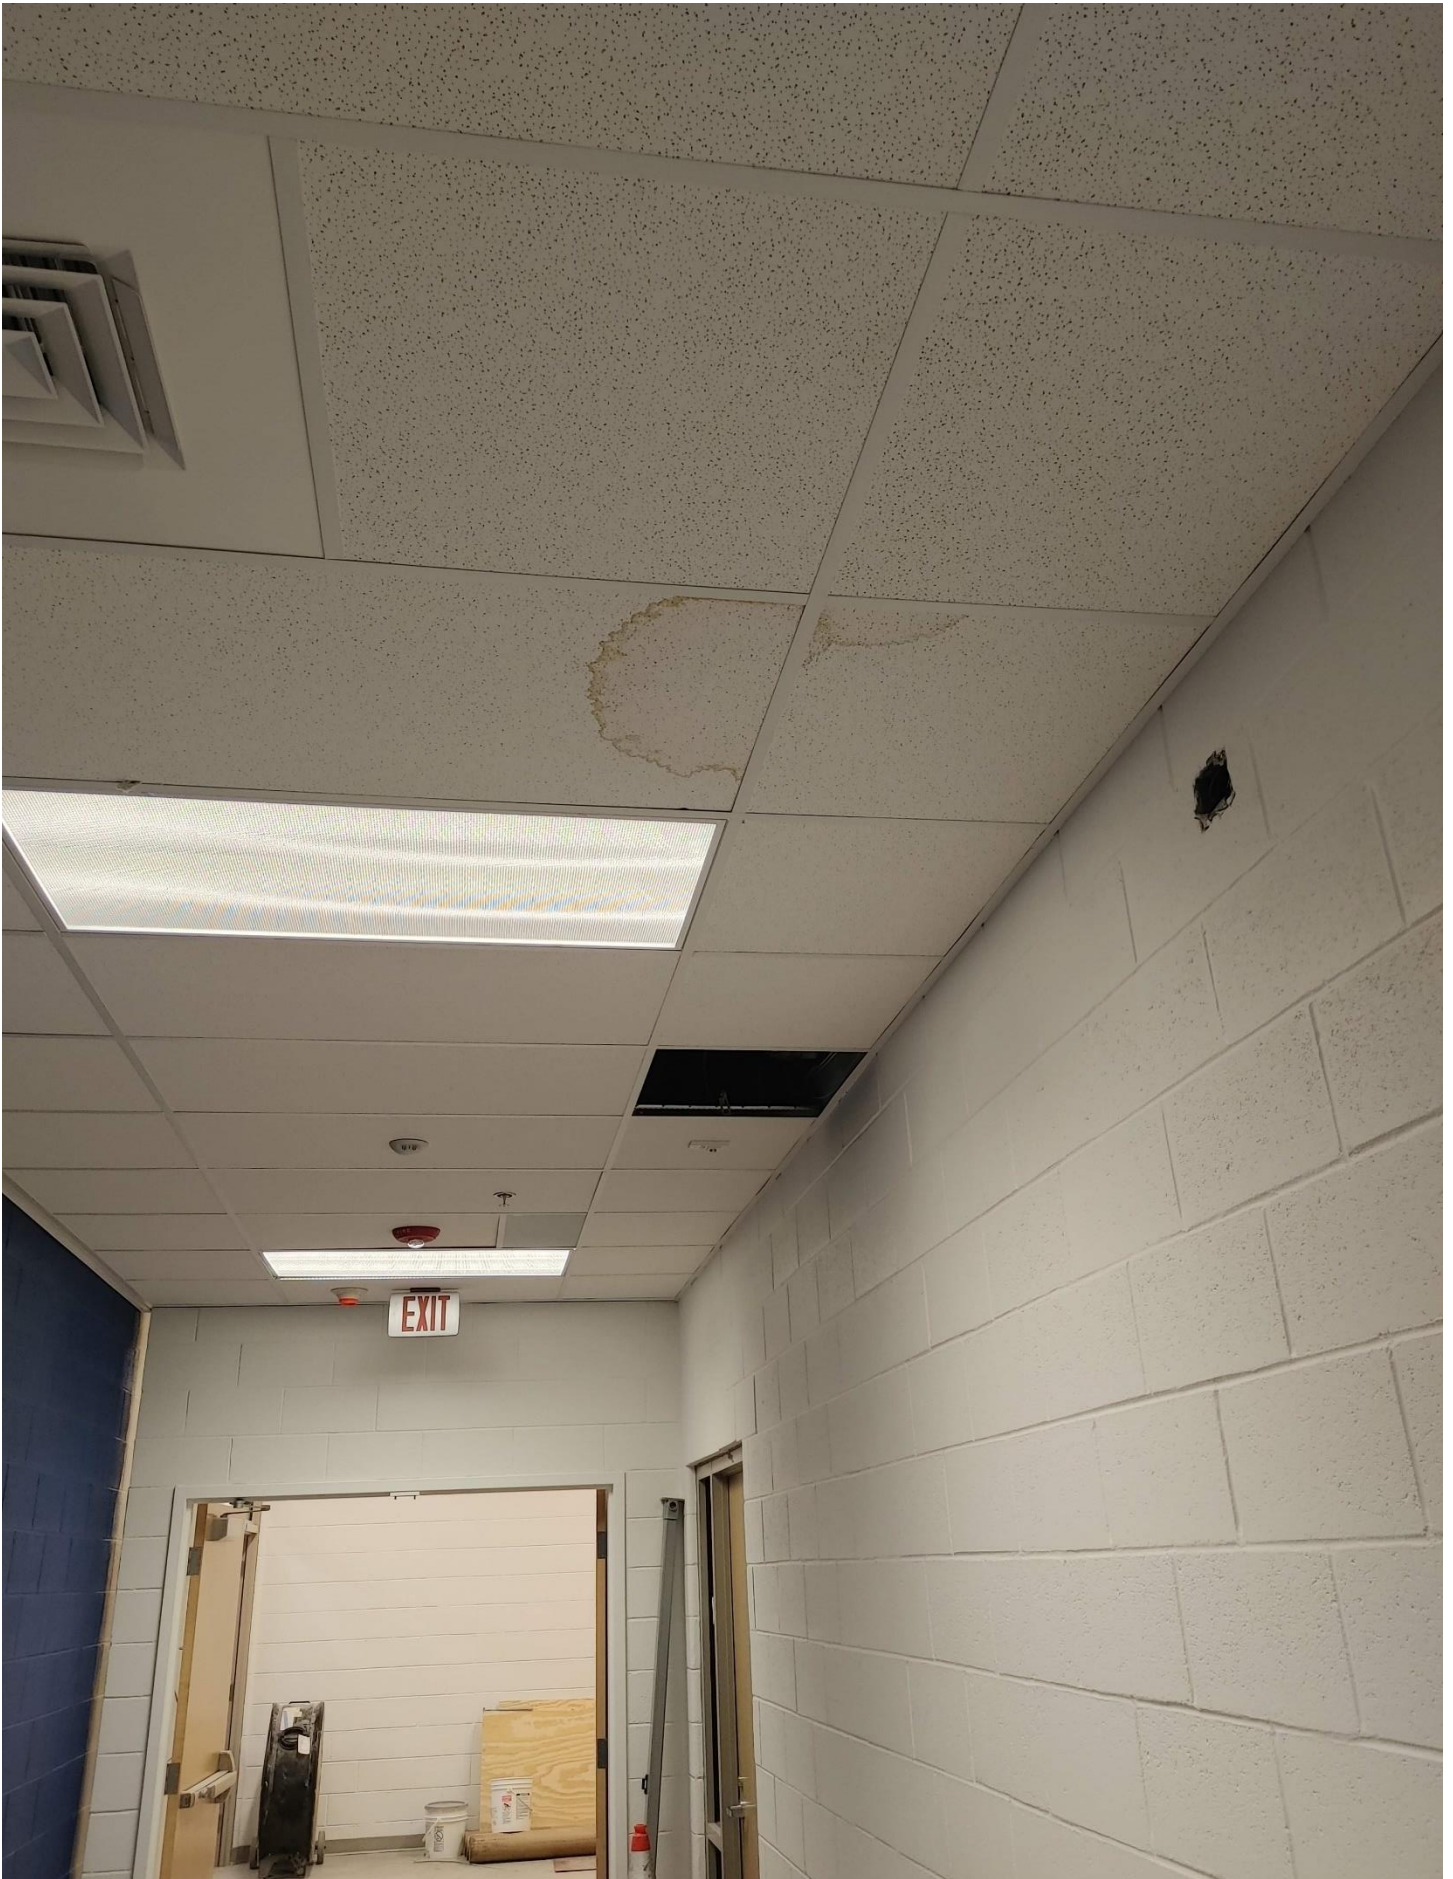
Photo 12 - Discolored Tile in Corridor E12

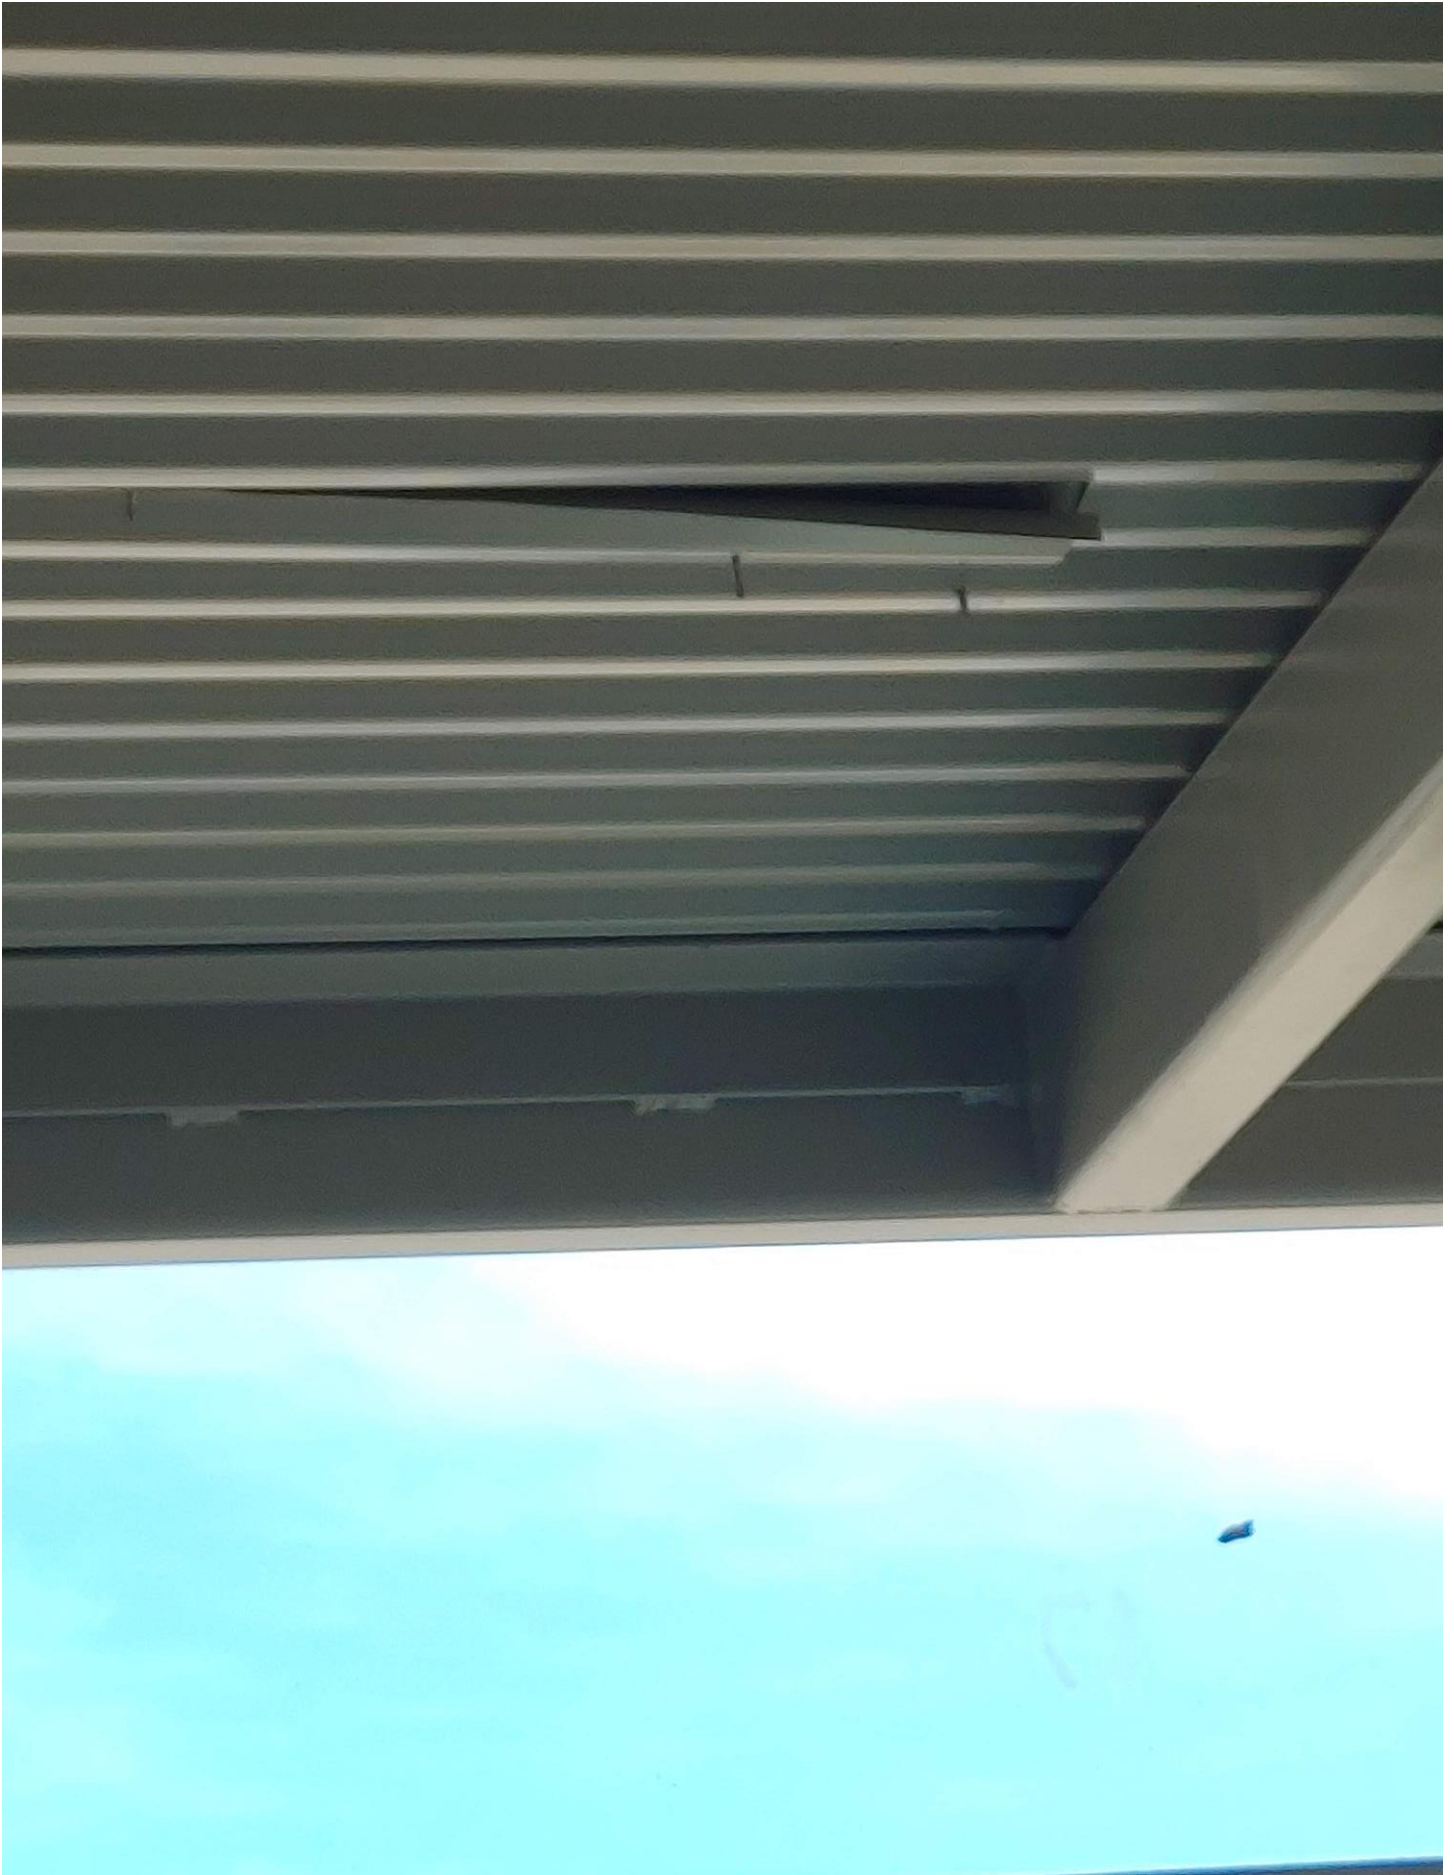
Photo 14 - Metal Pan of second landing in Stairwell #1

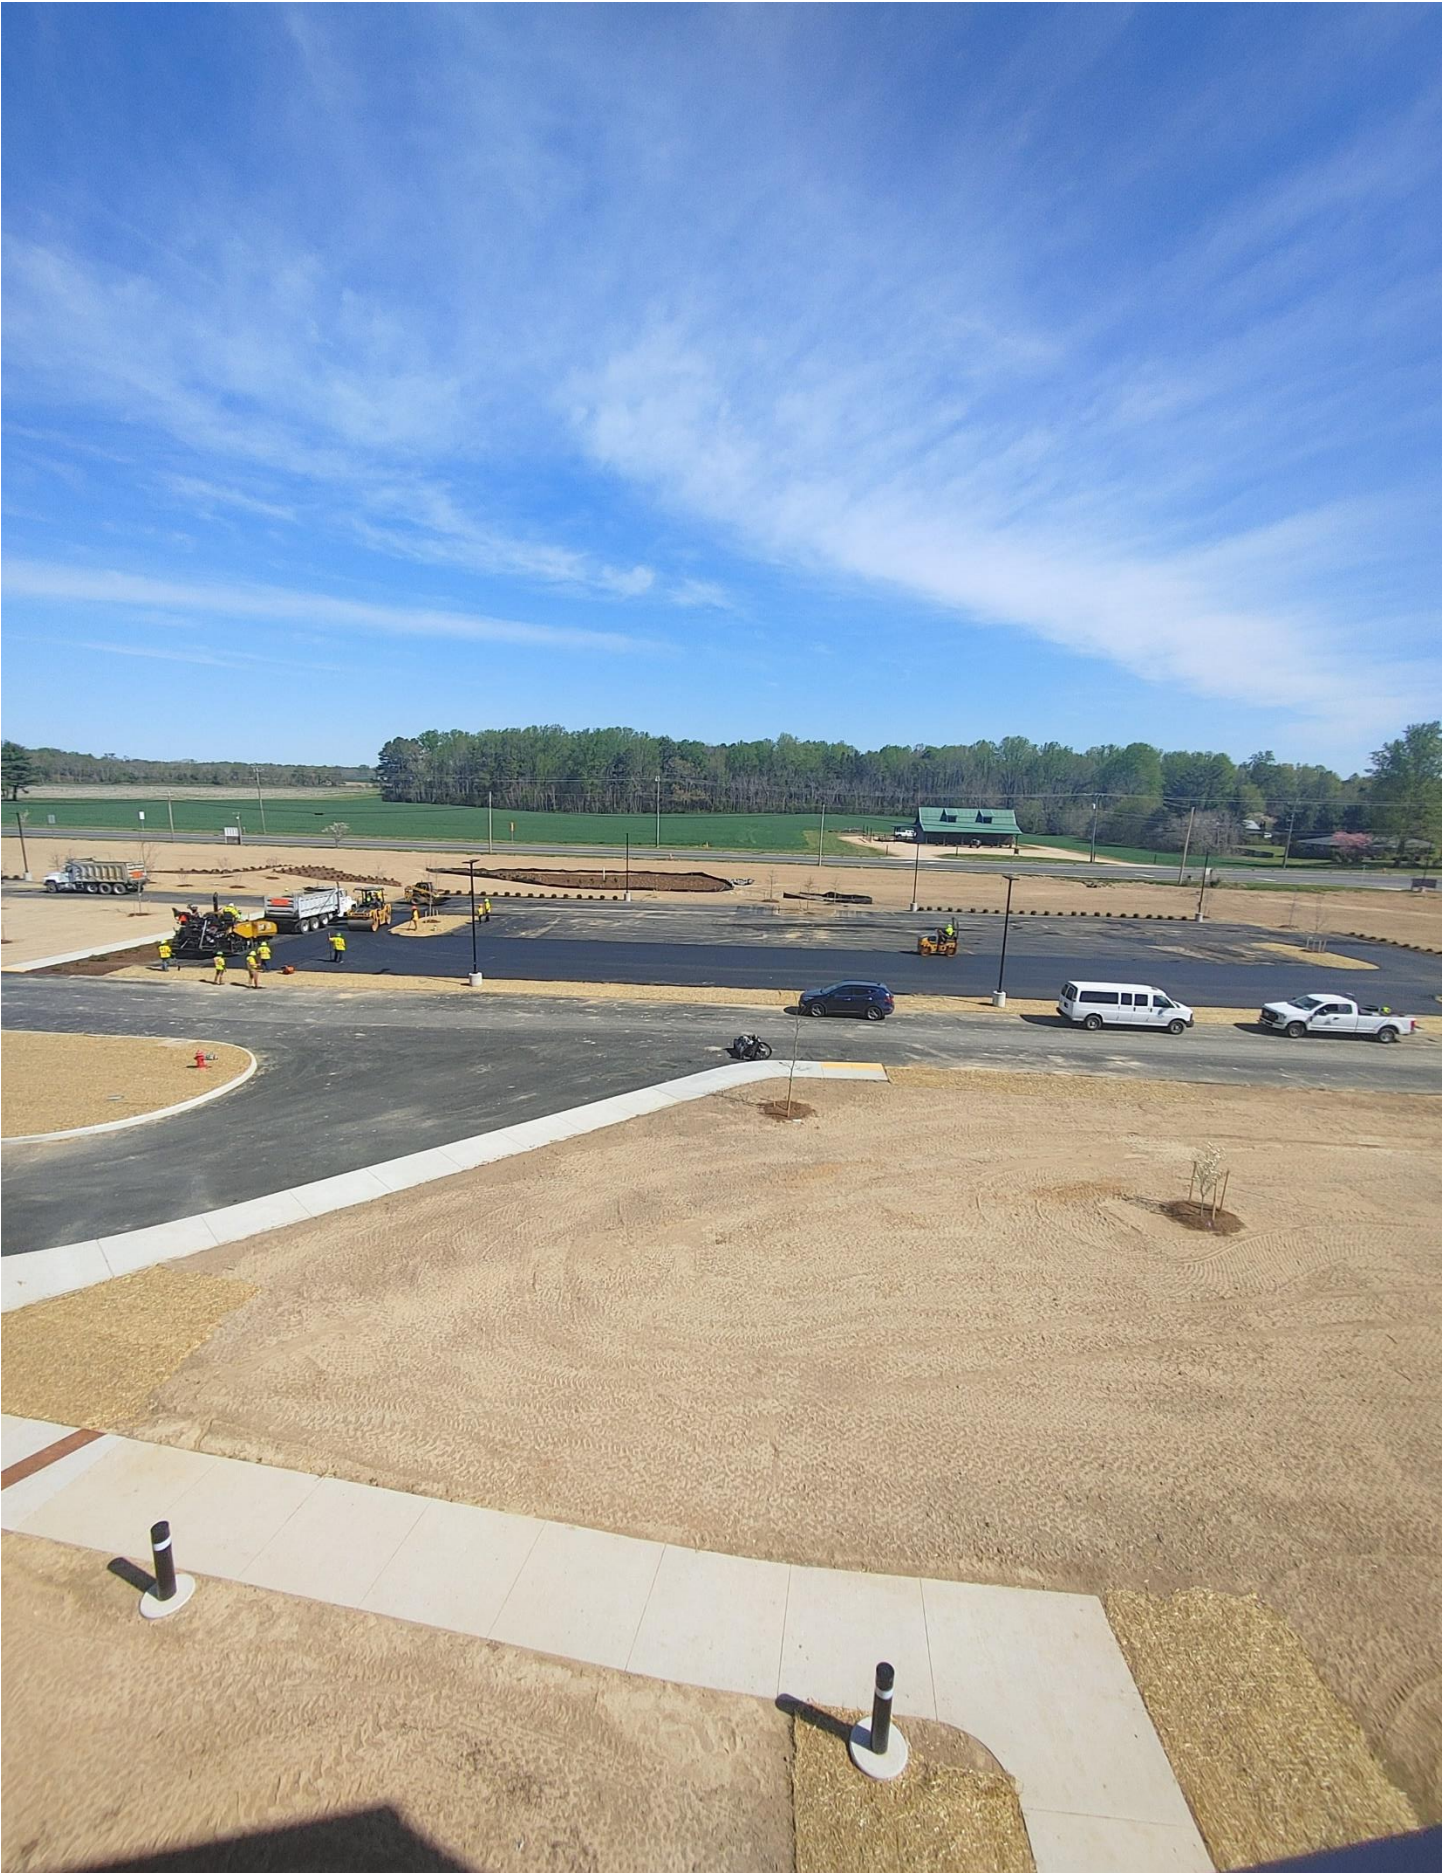
Photo 15 - Topping Layer of Asphalt being laid in the front Parking lot.
