**COMMONWEALTH
BUILDING SOLUTIONS, LLC**

FIELD REPORT

WESTMORELAND COUNTY HIGH SCHOOL

Date: 04/15/2022

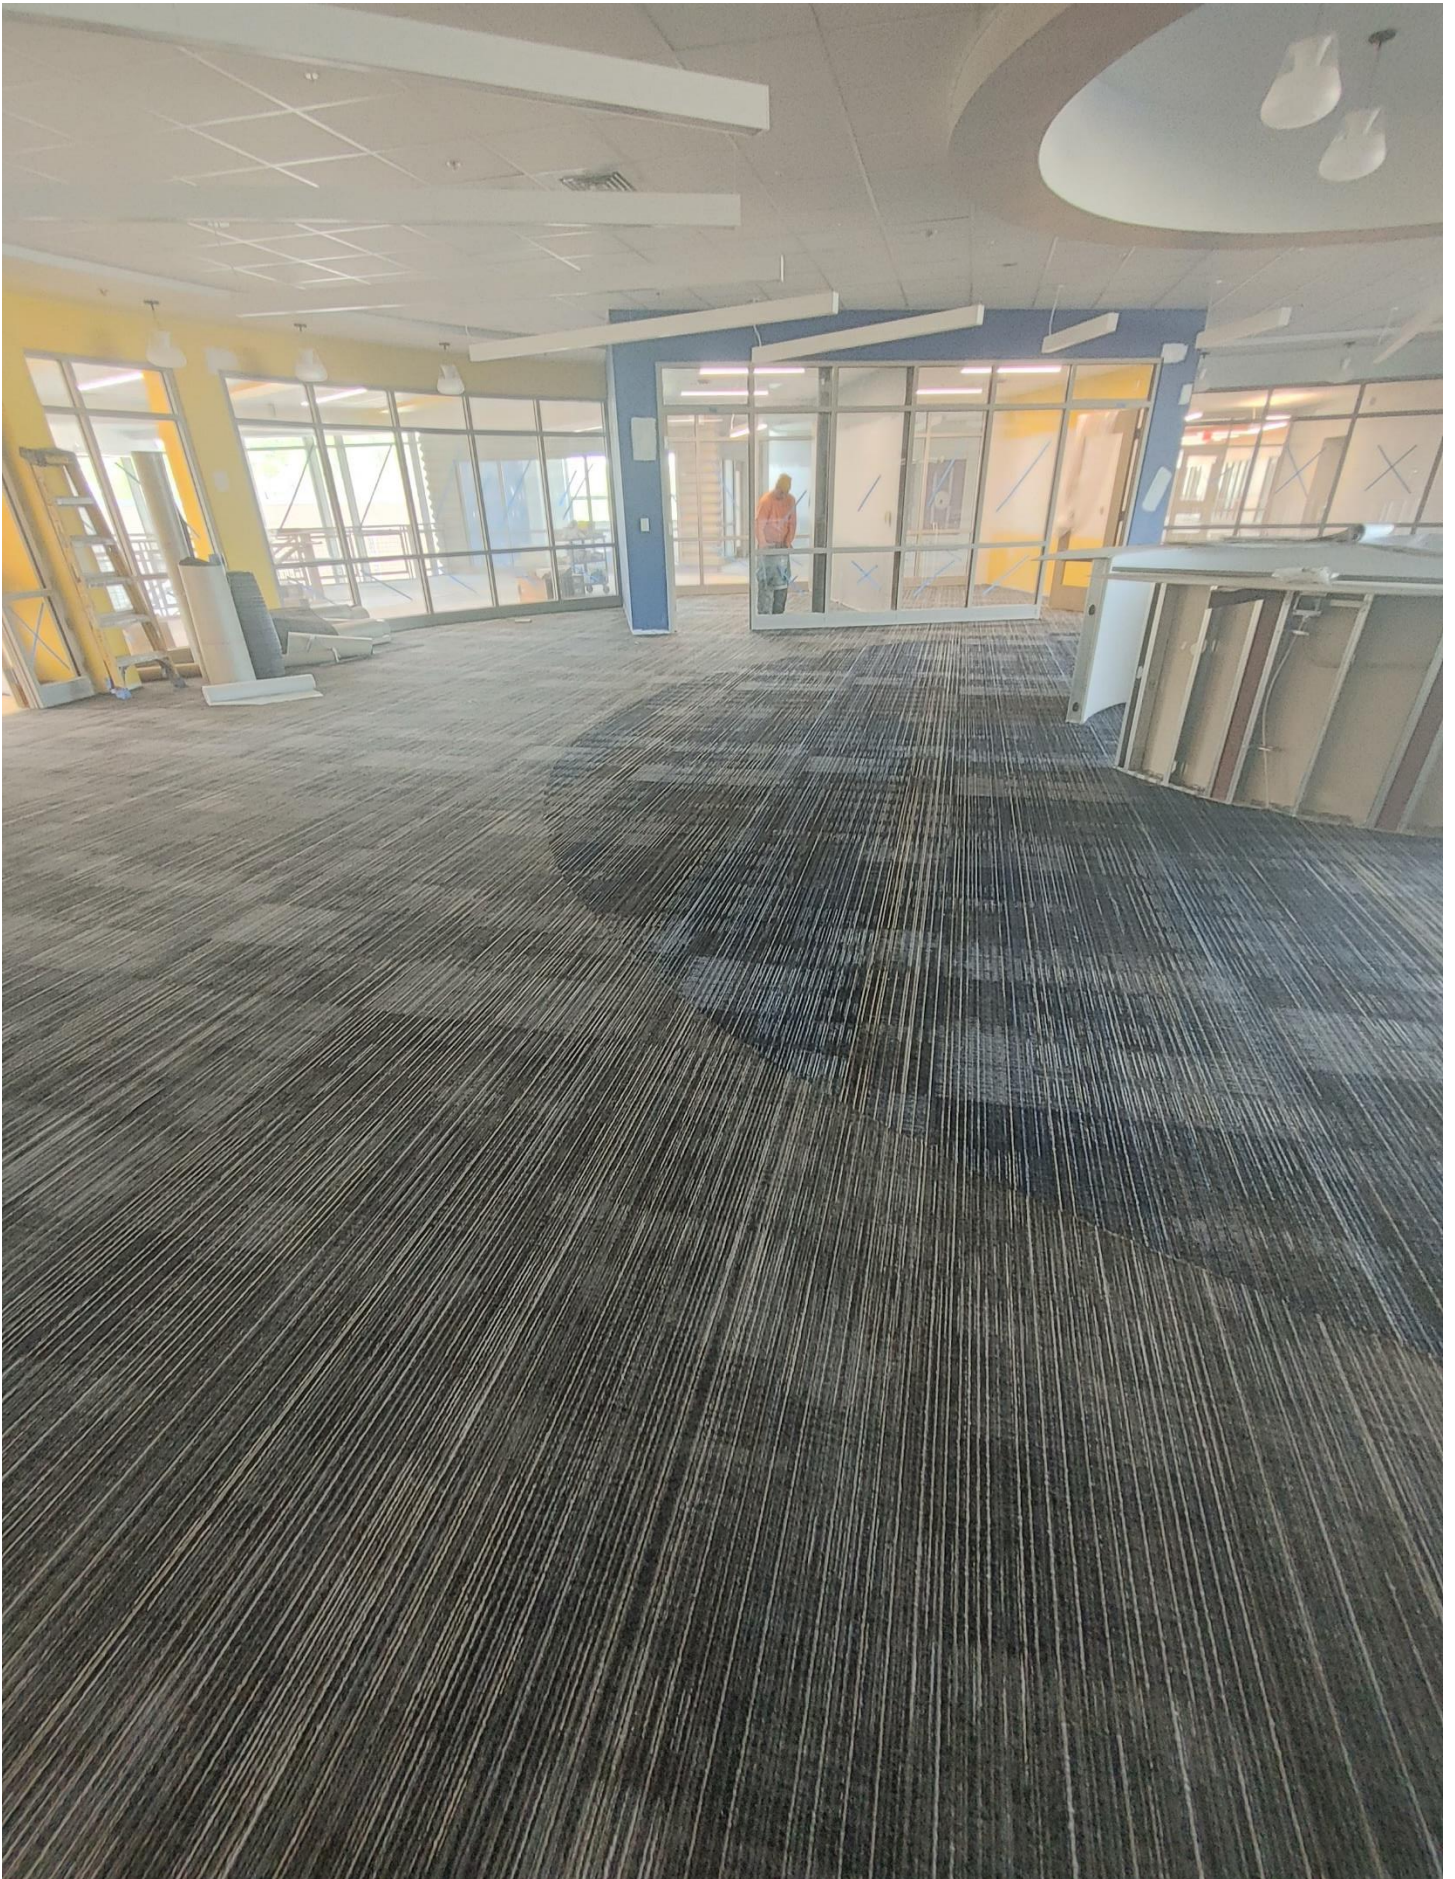
Photo 16 - Carpet has been laid in Area A, 2nd floor- Innovation Commons

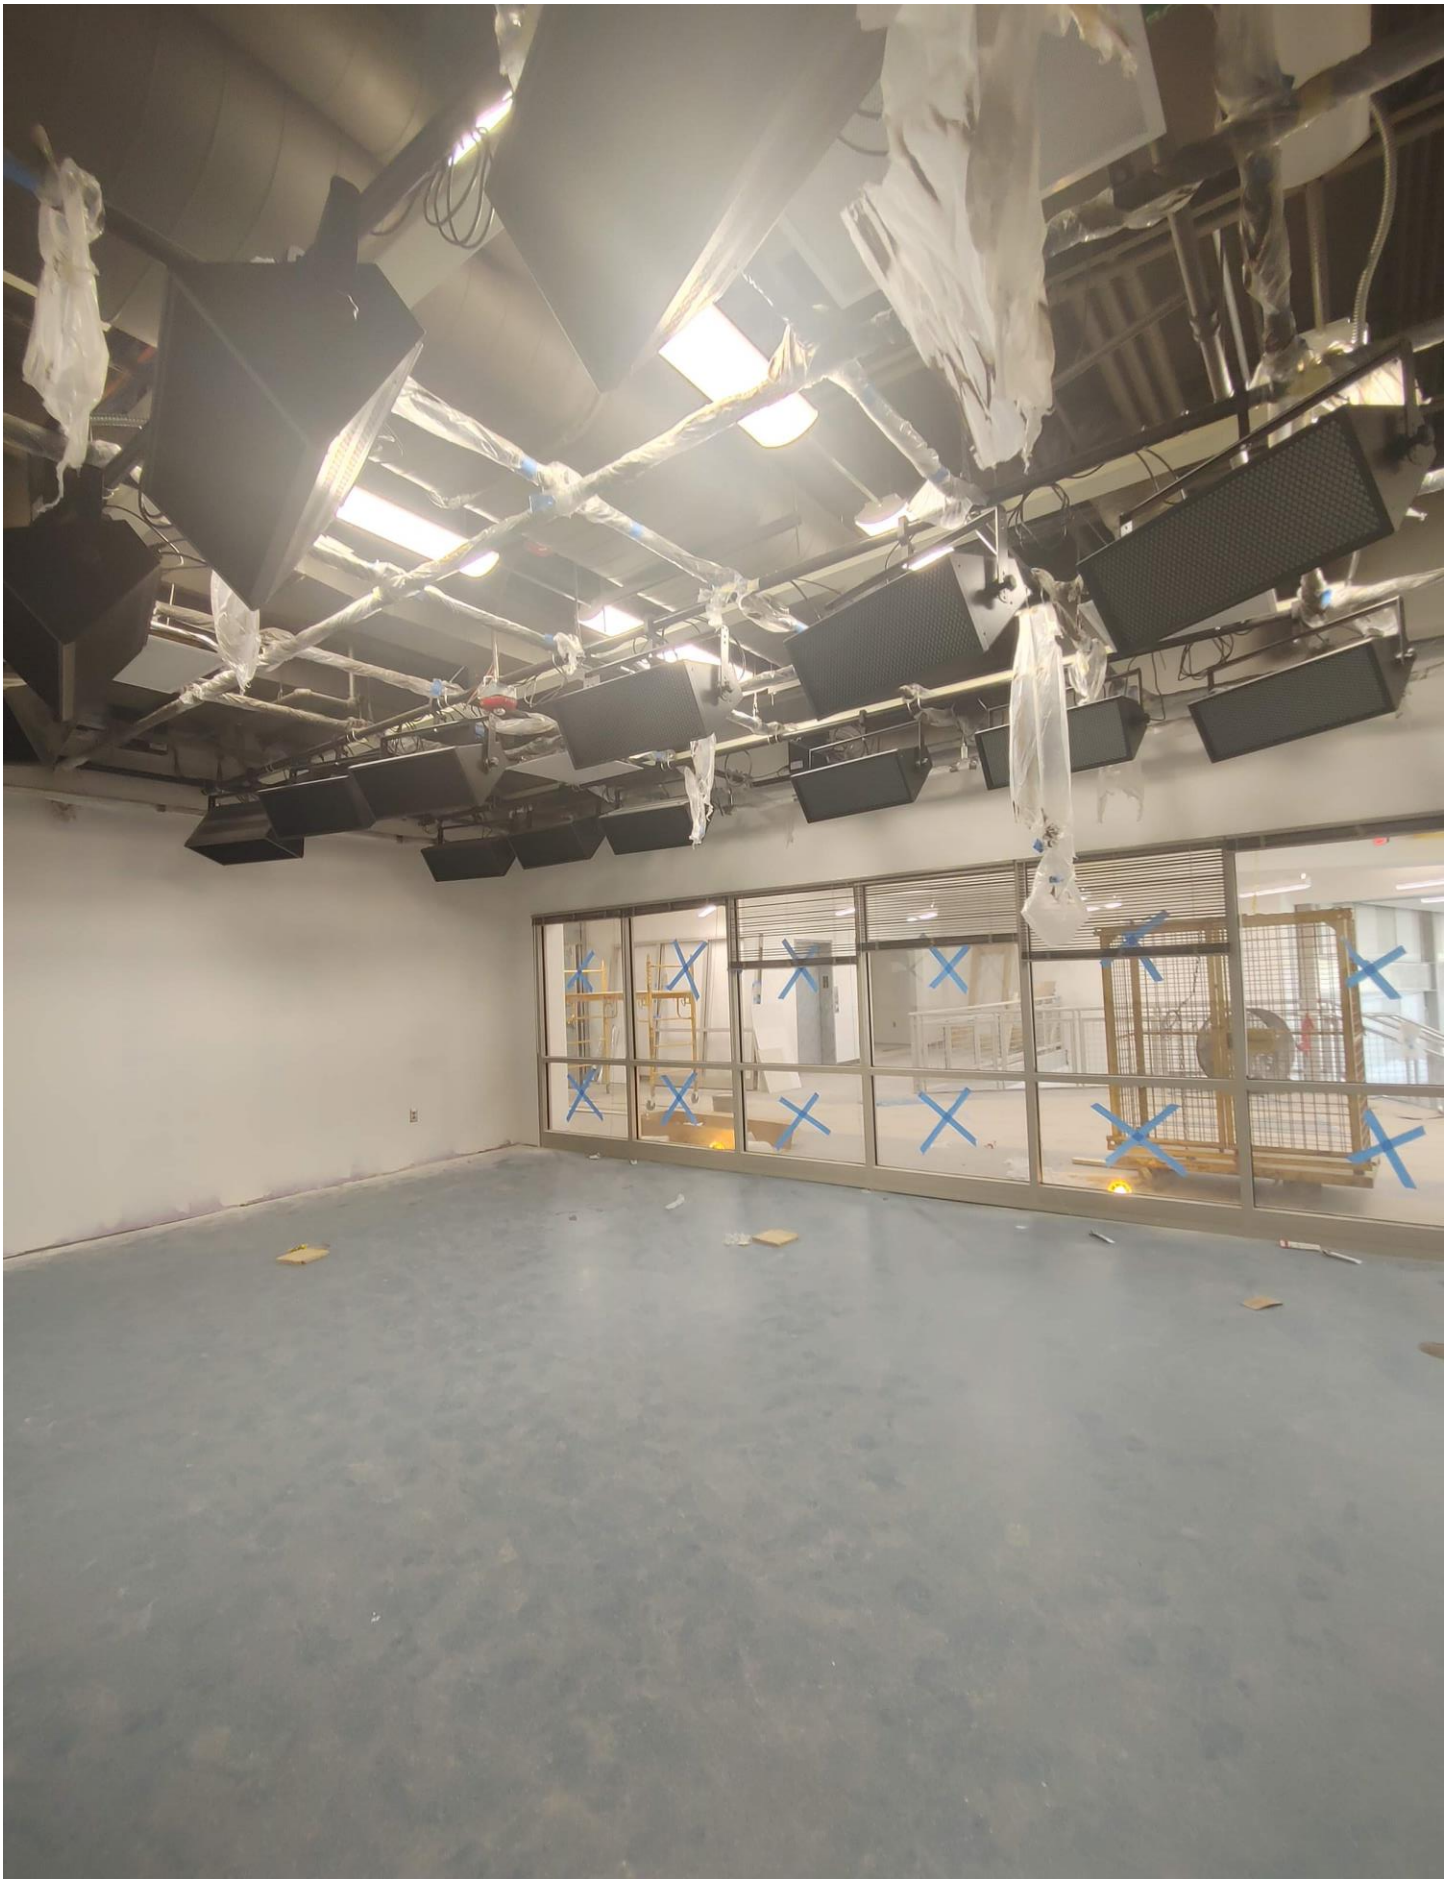
Photo 17 - Equipment installed in A221

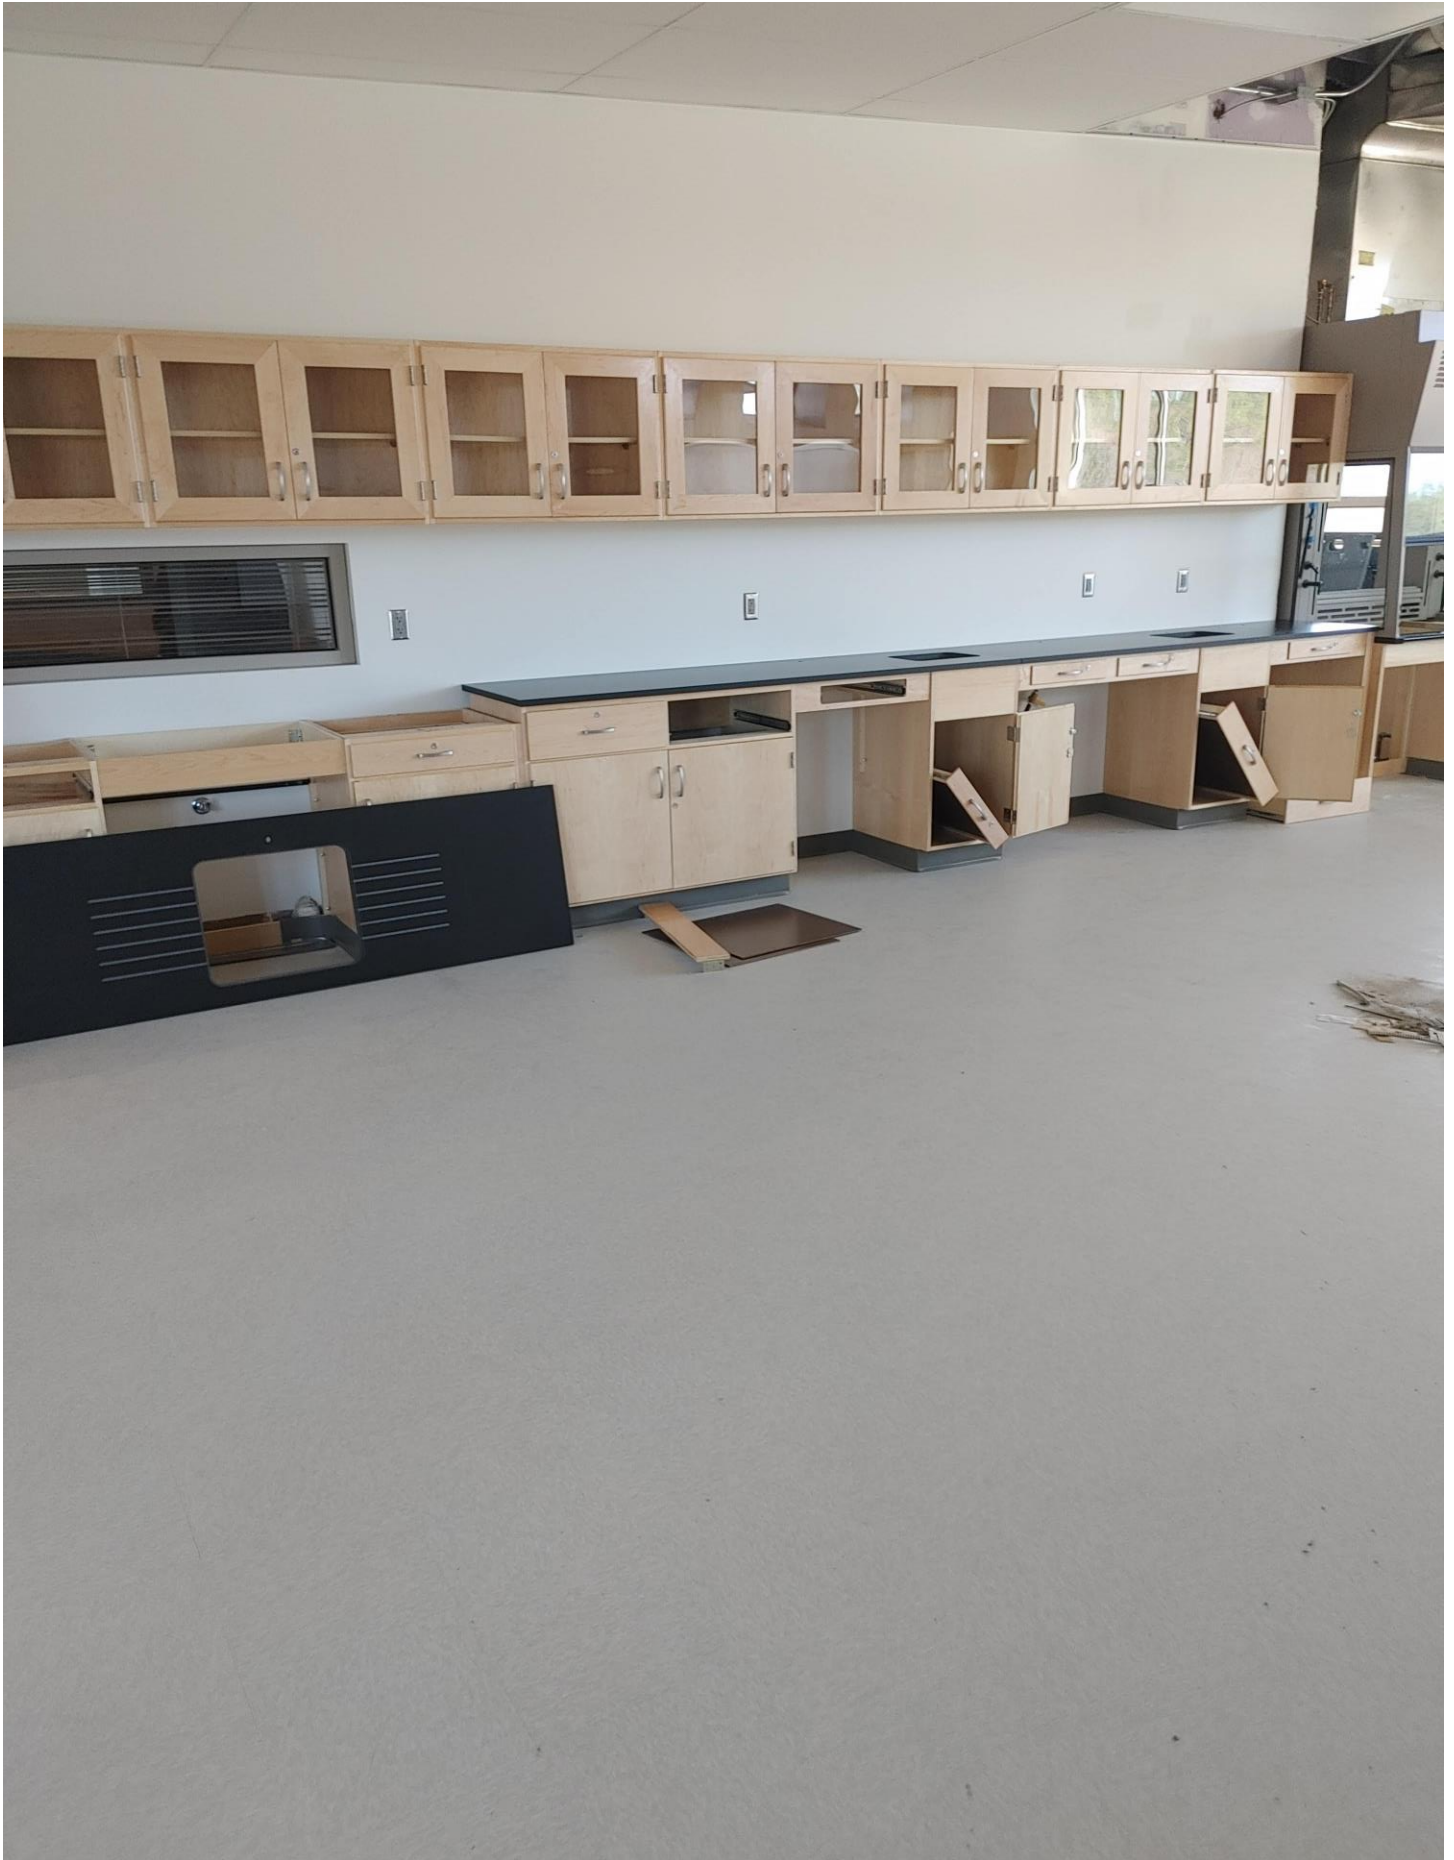
Photo 18 - Counter tops are being installed in Area B, 2nd floor

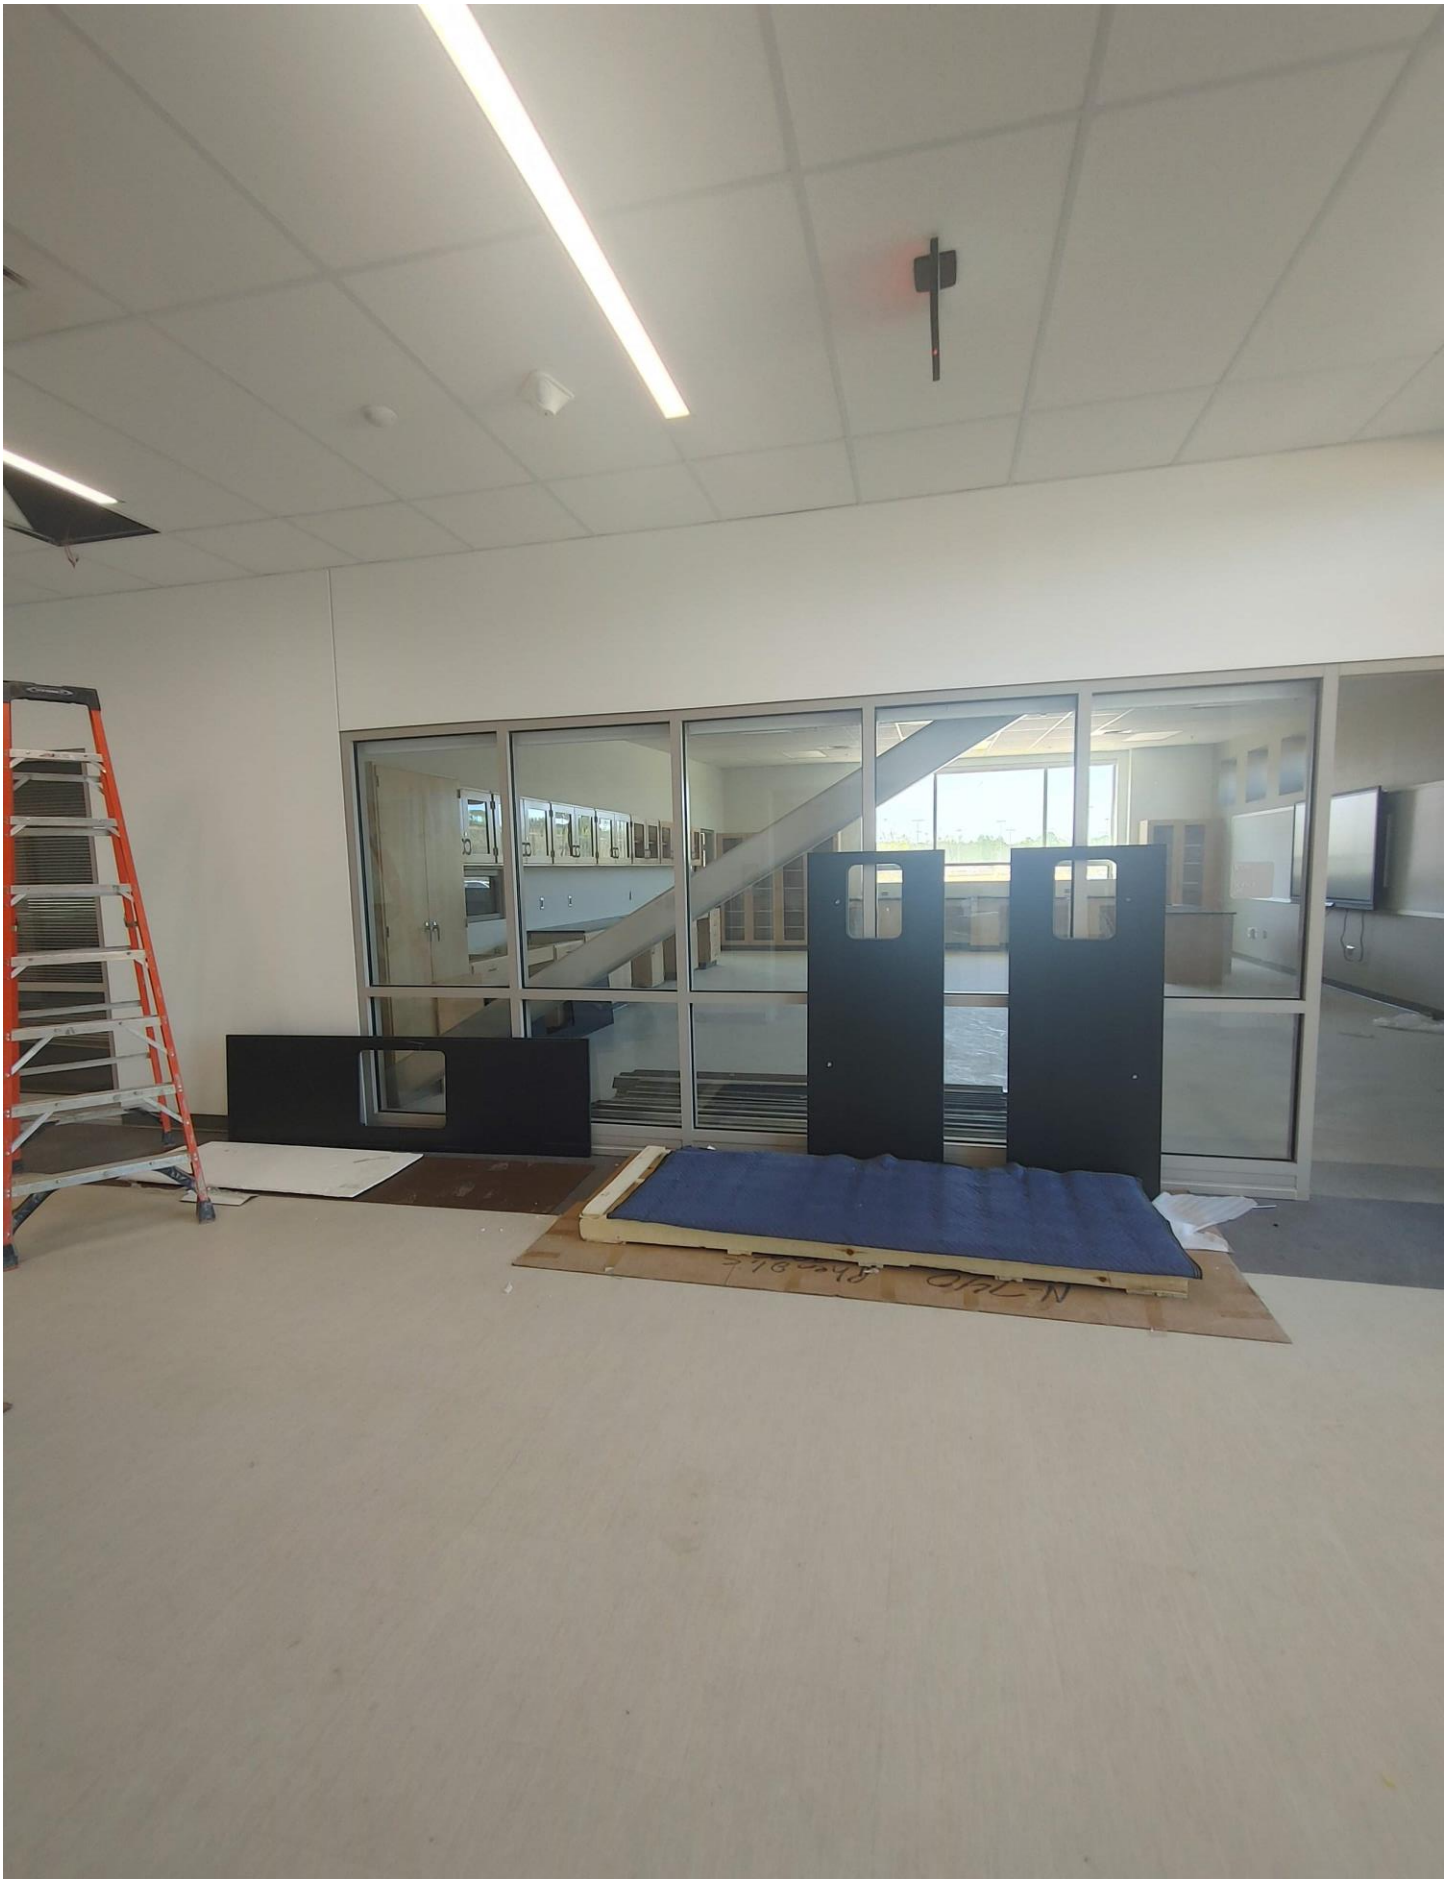
Photo 19 - Counter tops have been staged in Area B, 1st floor
