**DAILY REPORT**

**WESTMORELAND COUNTY HIGH SCHOOL**

Date: 04/22/2021  
Weather: 52 degrees at 12:30hrs. High of 55 degrees today.  
Hours Worked: 12:30hrs – 15:00hrs (2.5hrs) Site Visit.

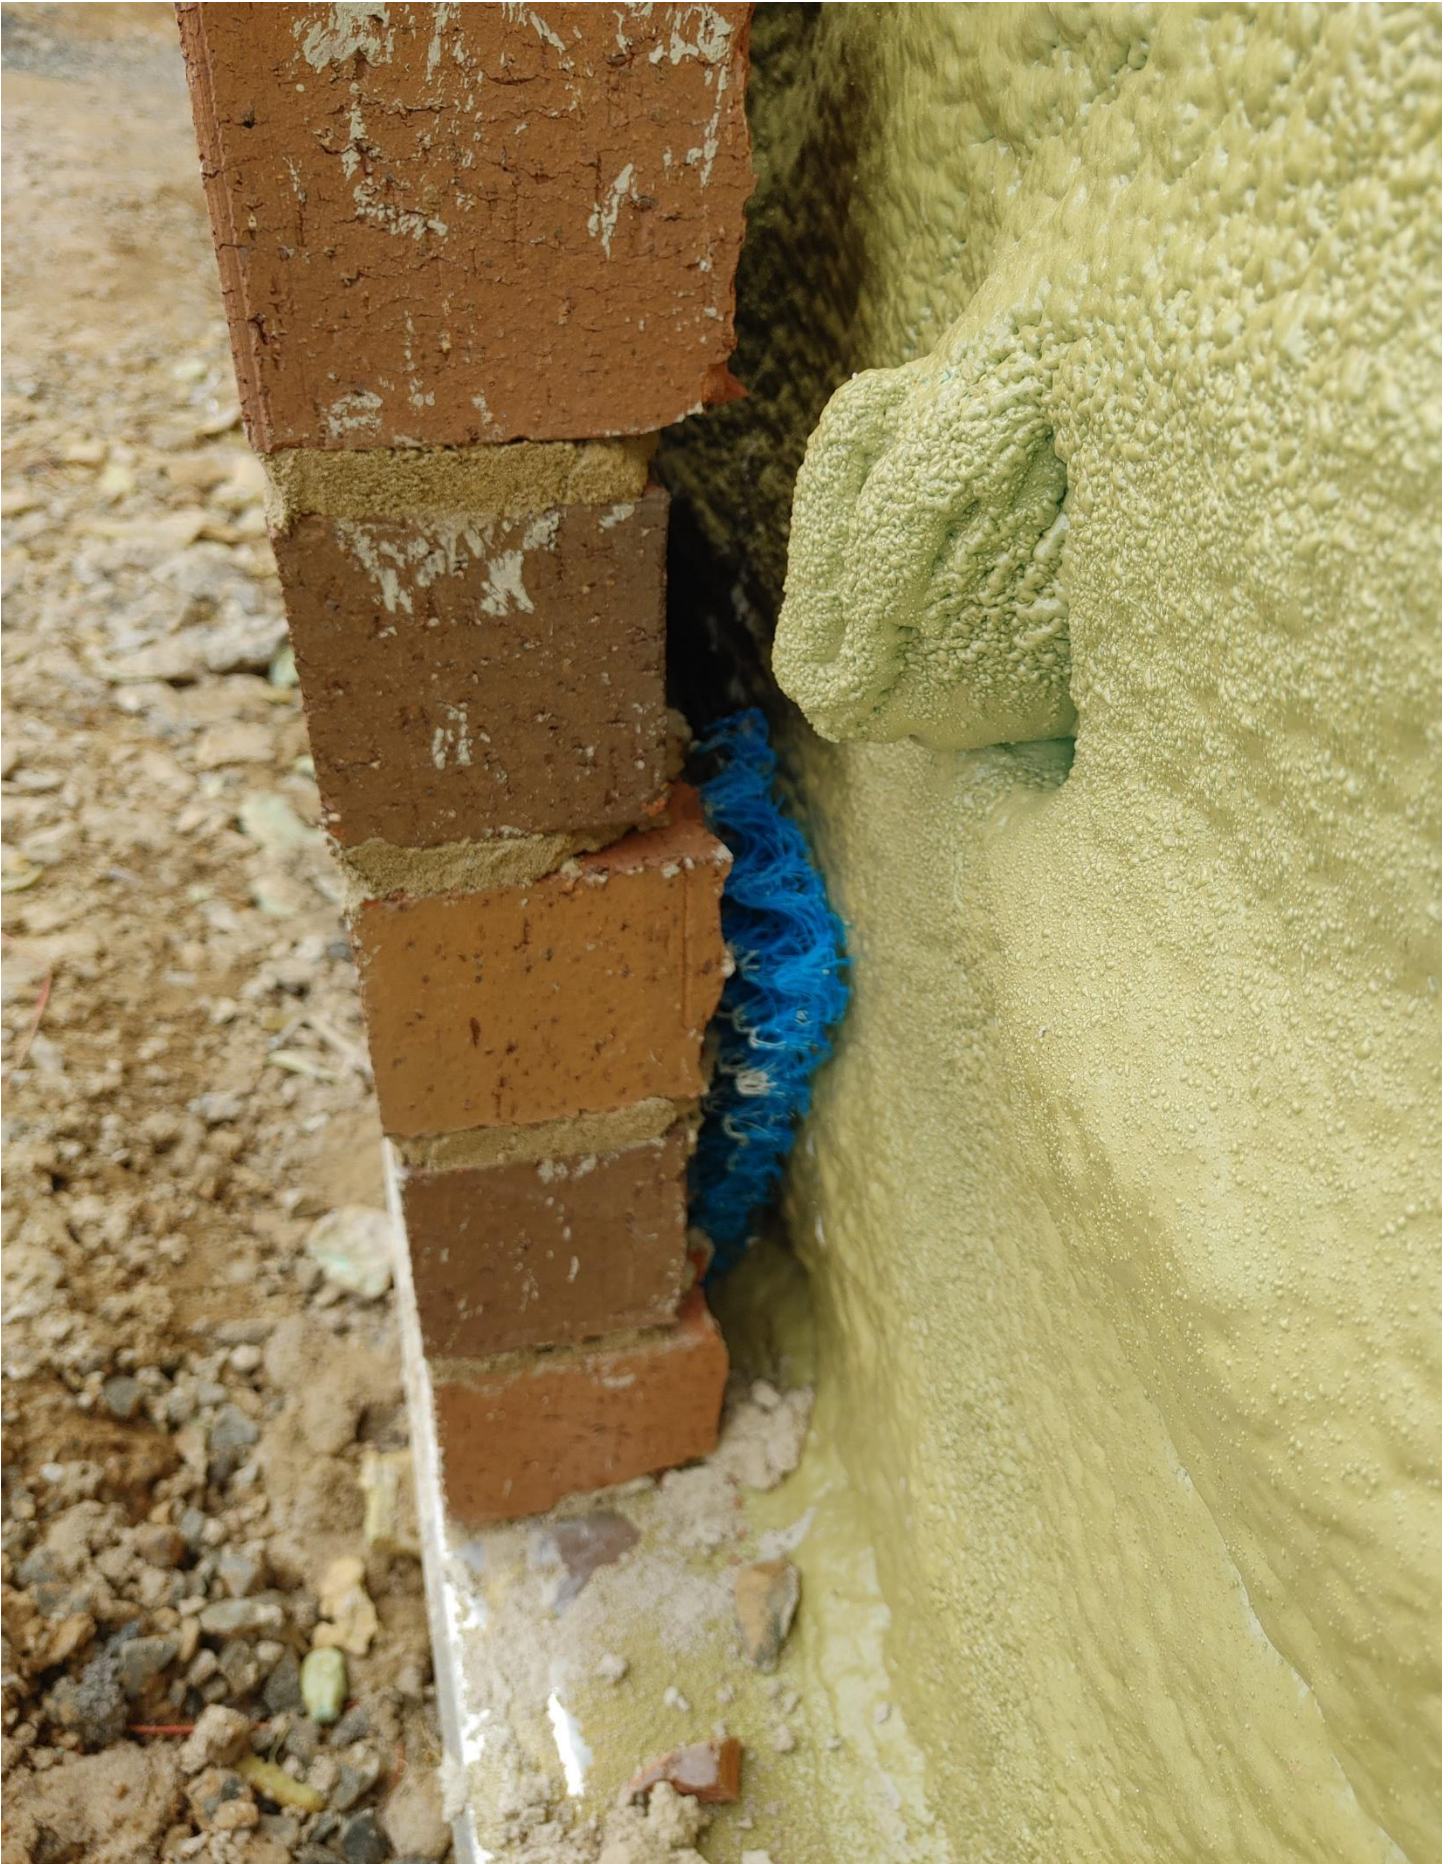
*Photo 1 - Verification that Mortar Screen is being used on the Northside of Area A*

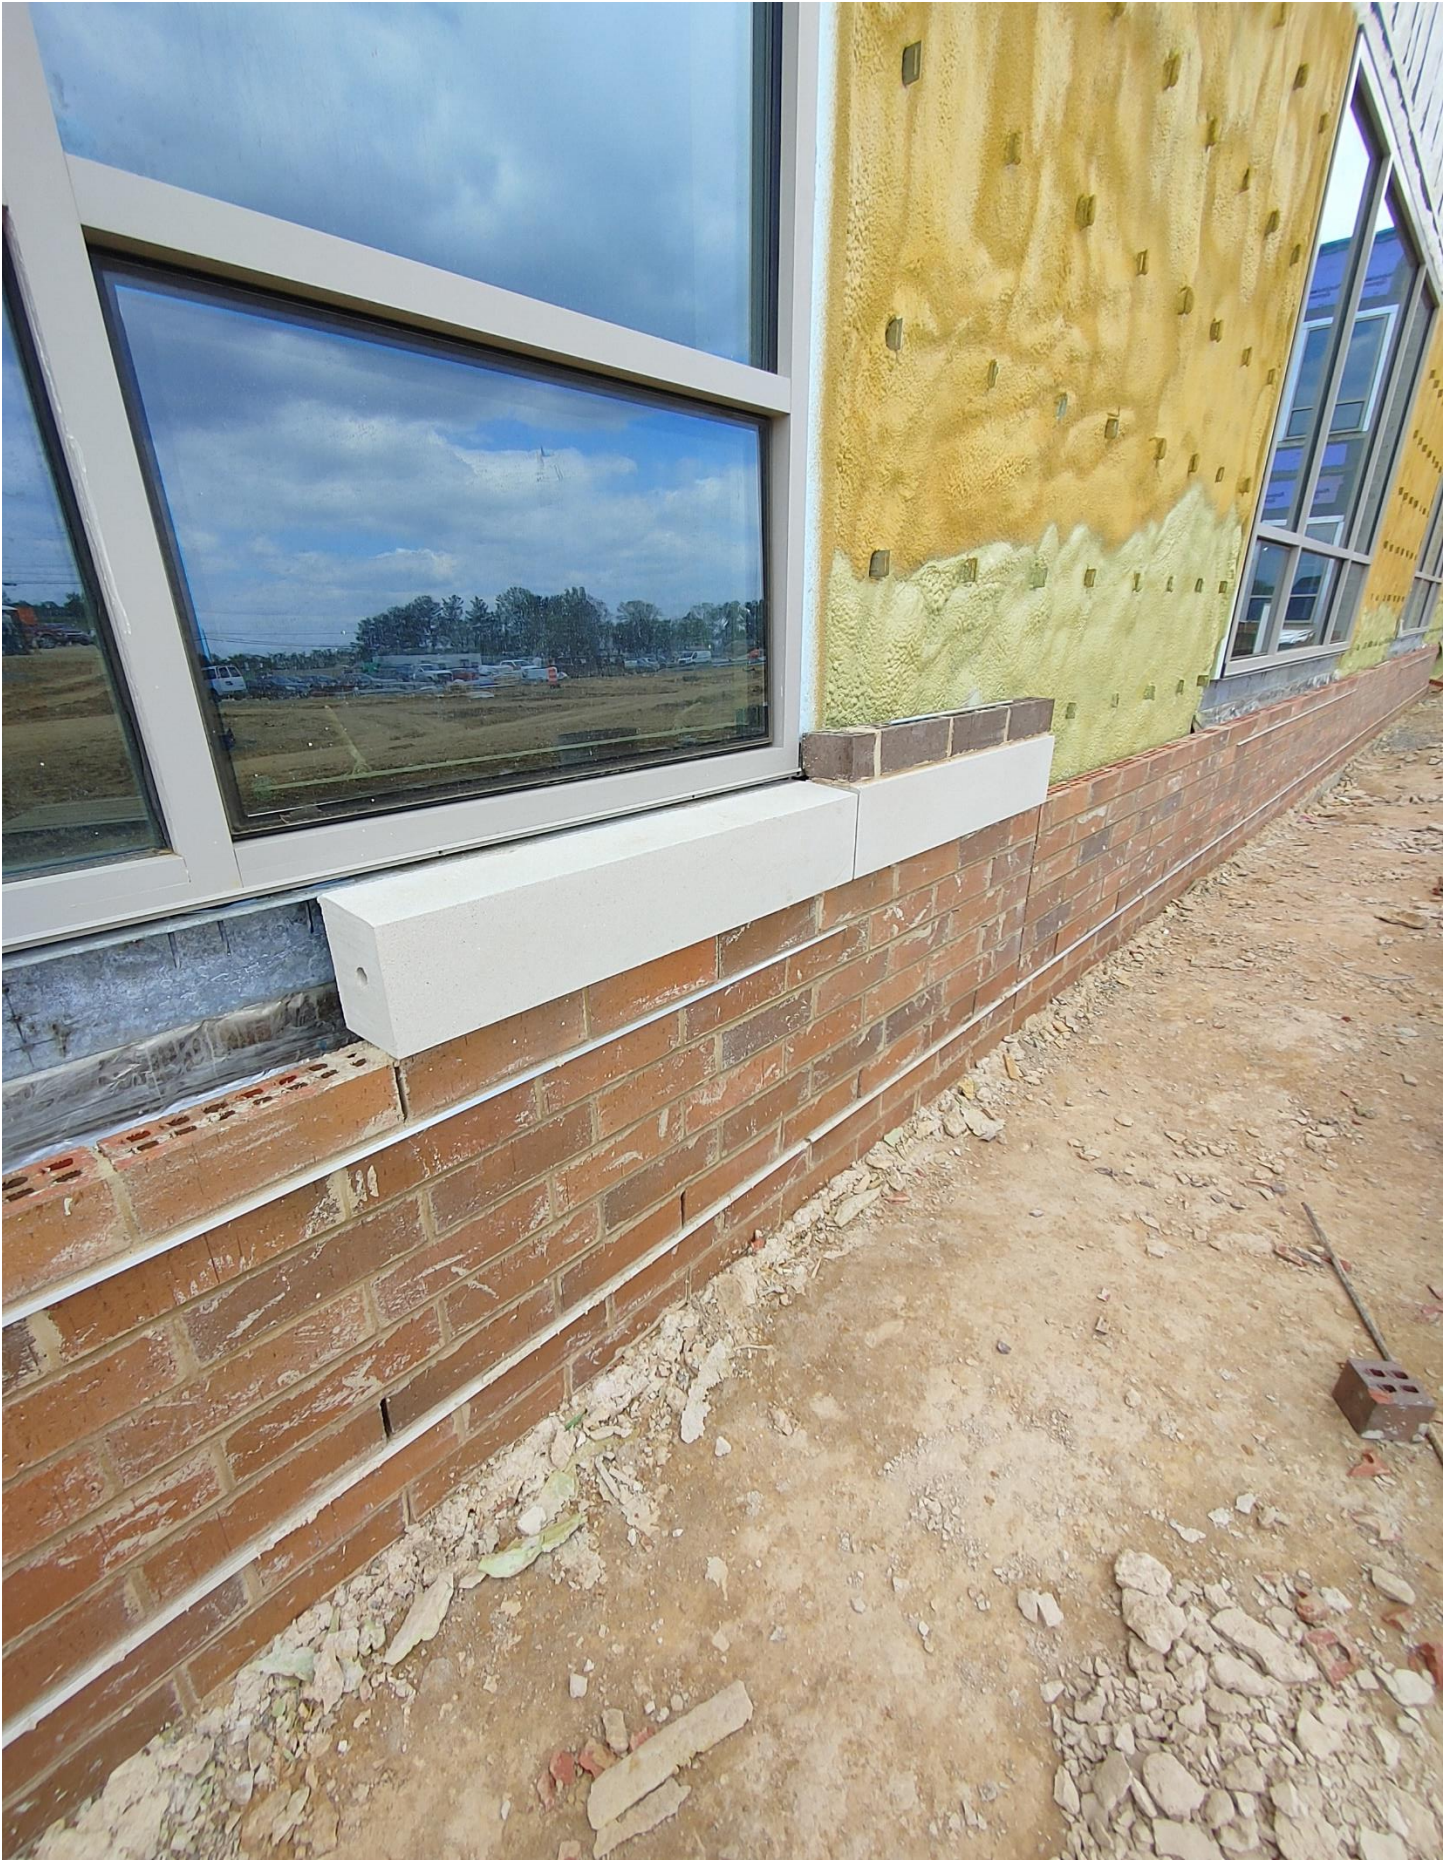
Photo 2 - Brick being laid on the Northside of Area A. Flashing is in place and weep holes are open.

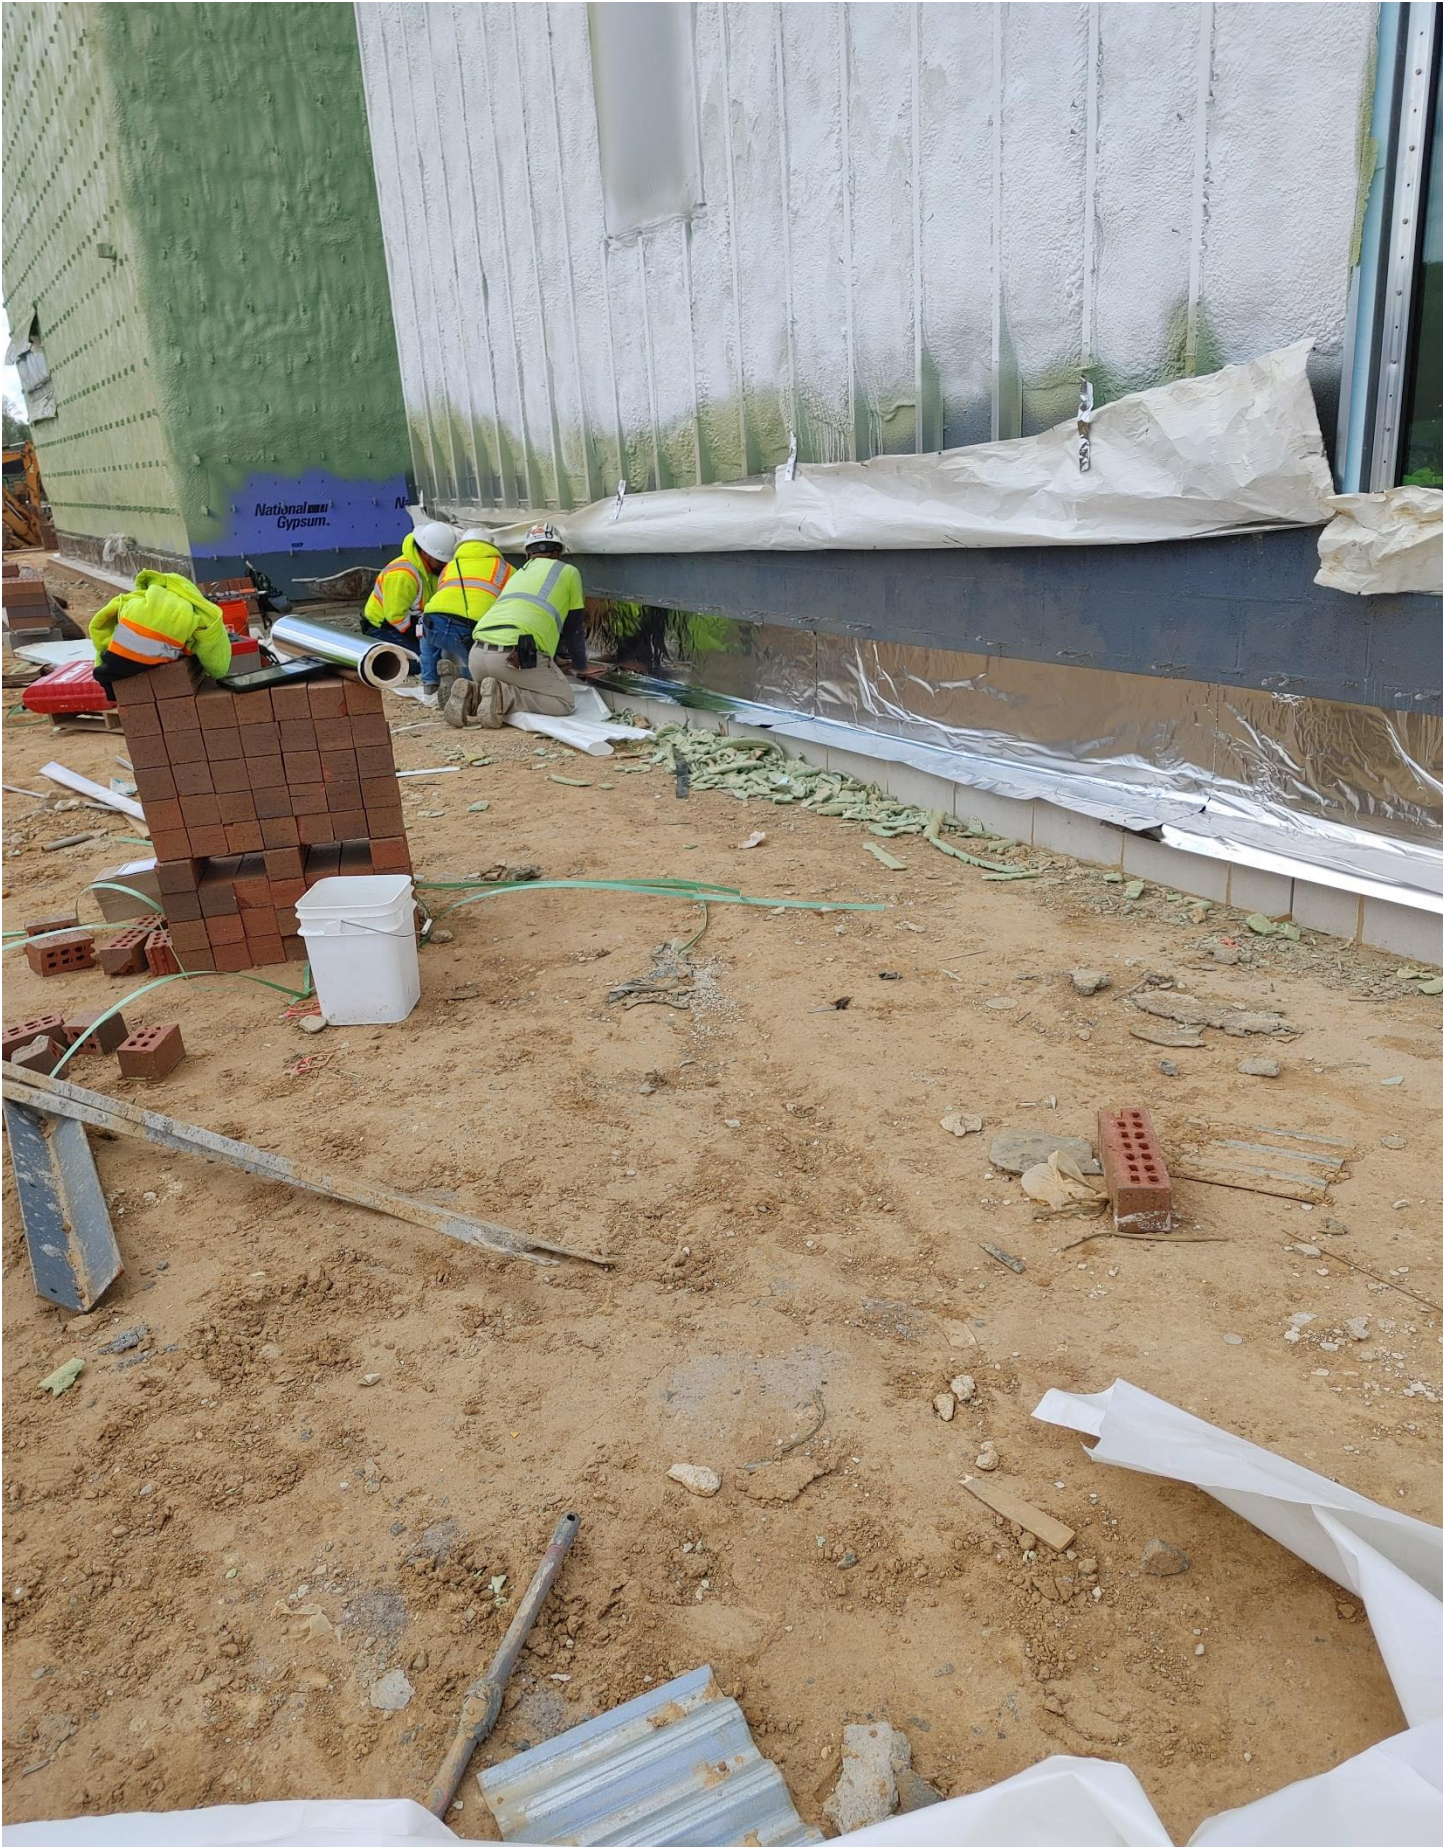
**JP Construction:** Eighteen (18) men are on site today. They continue to erect interior walls and hanging sheet rock in Area A. two men are also installing flashing on the east side of Area A.

Photo 3 - Flashing being installed on the East side of Area A

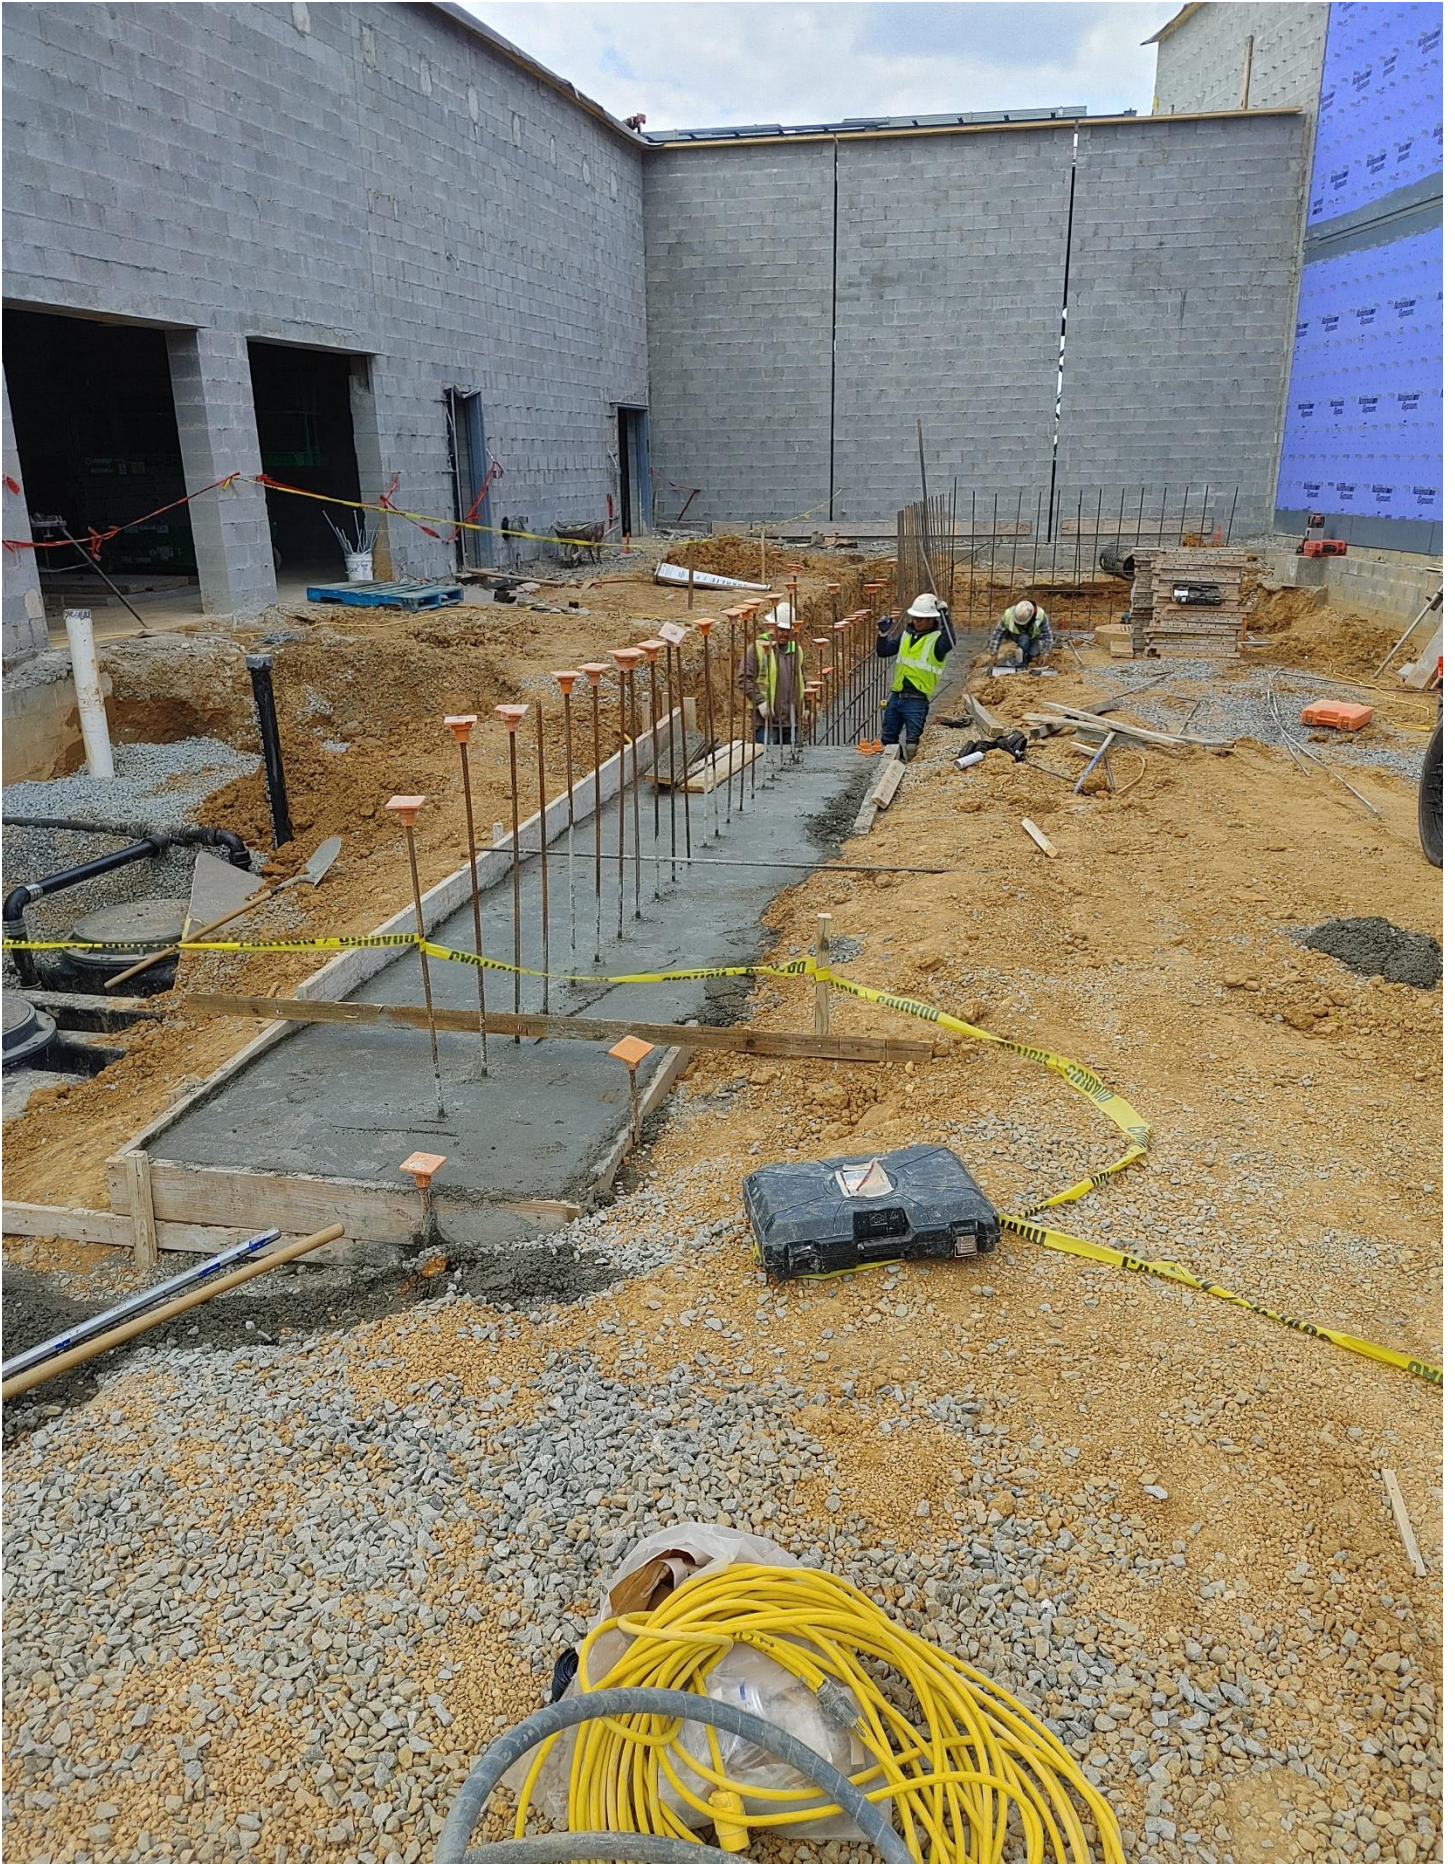
**Industrial Concrete:** Four (4) men are on site today. They poured the concrete footer for the Loading Dock Wall.

Photo 4 - Concrete Footer poured for Loading Dock Wall

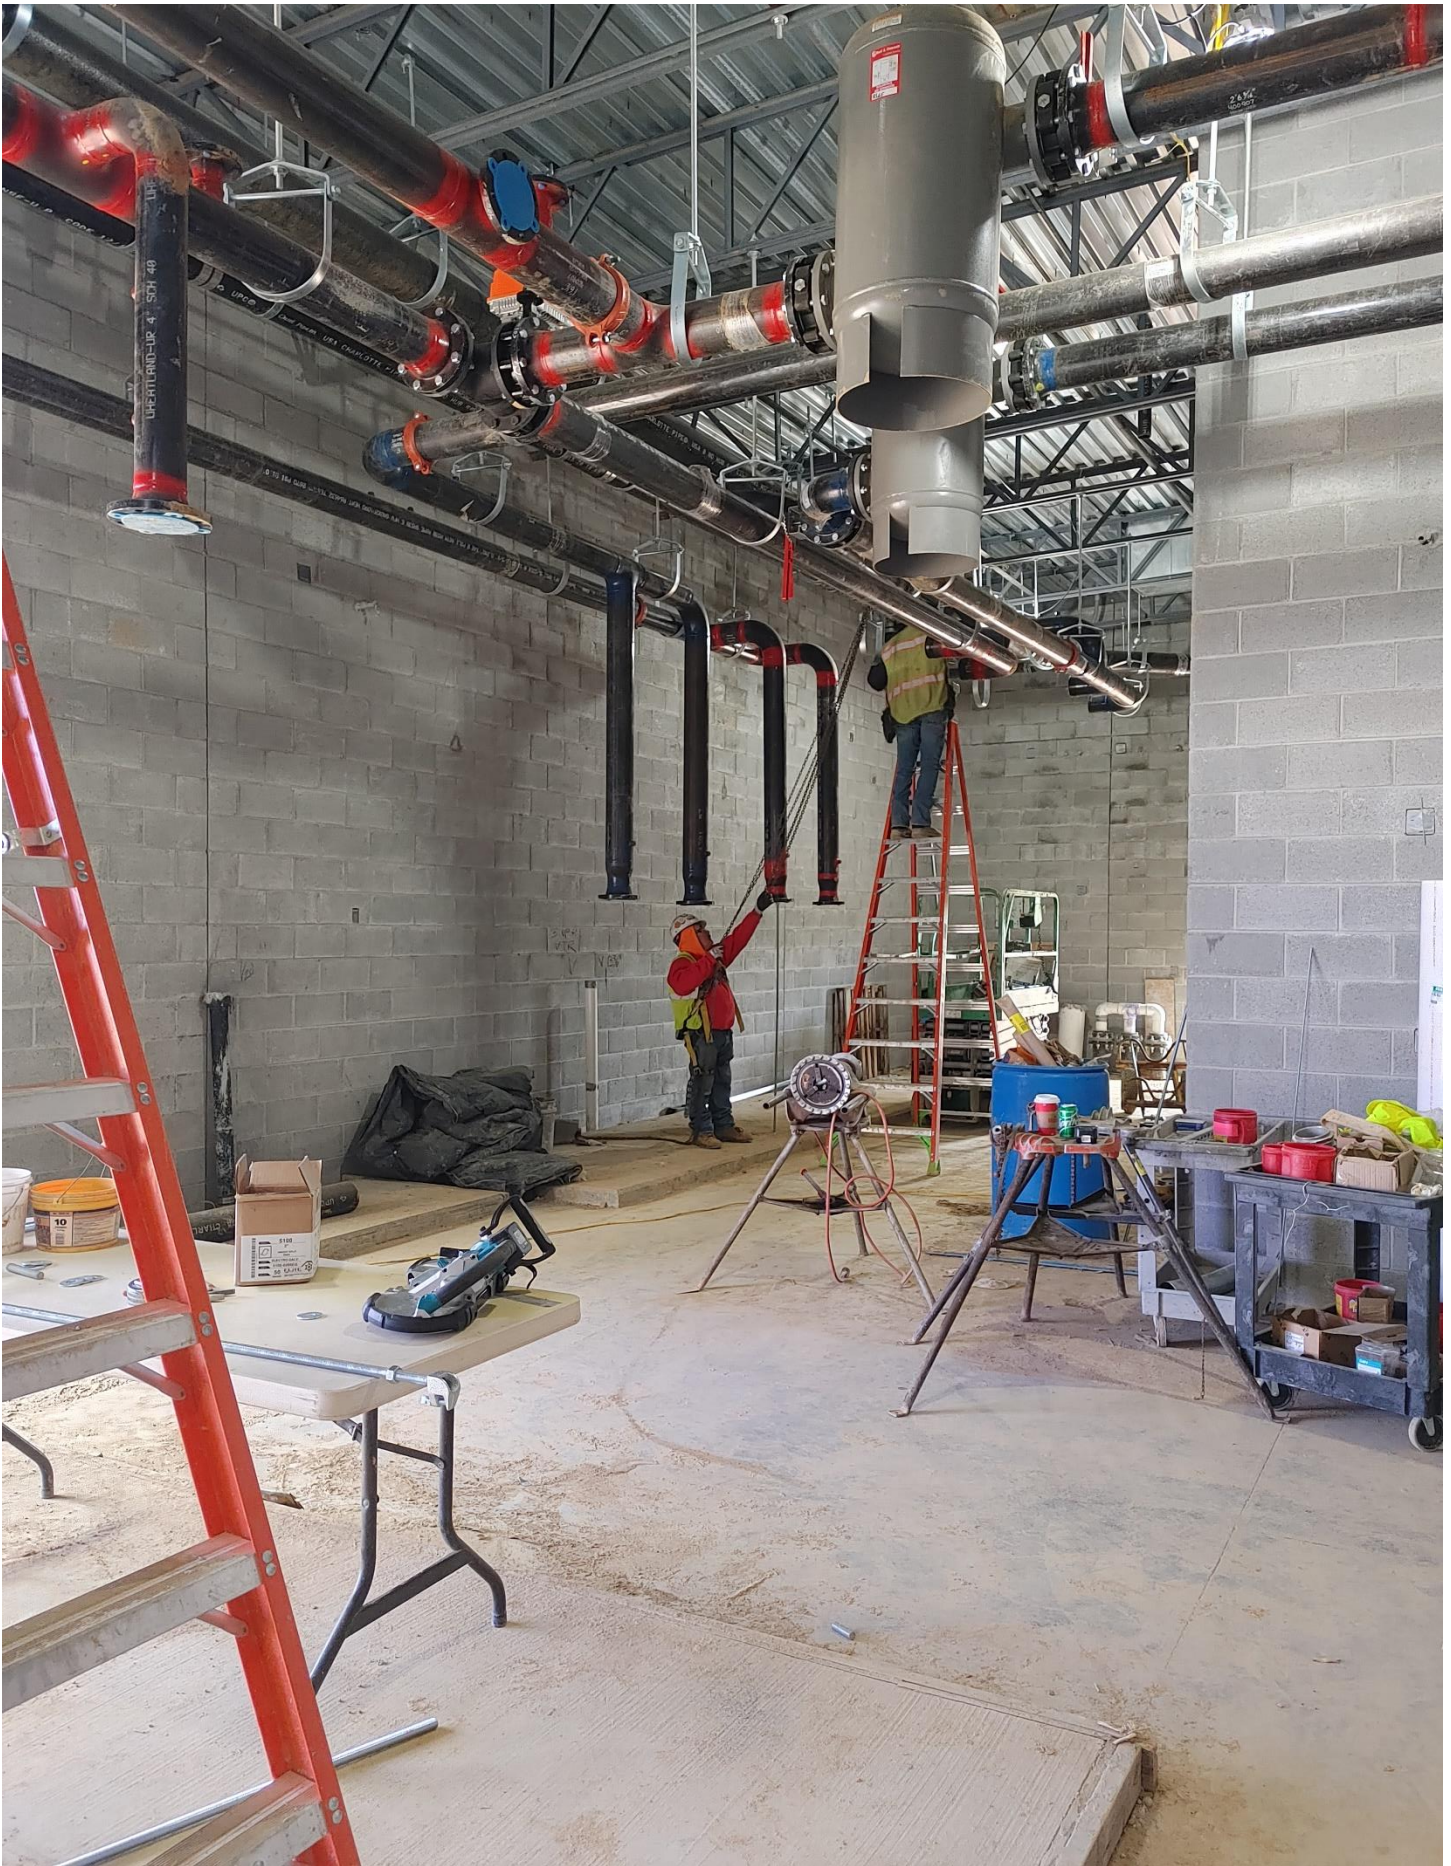
Photo 5 - Colonial Web running pipe in the Mechanical room, Area D.

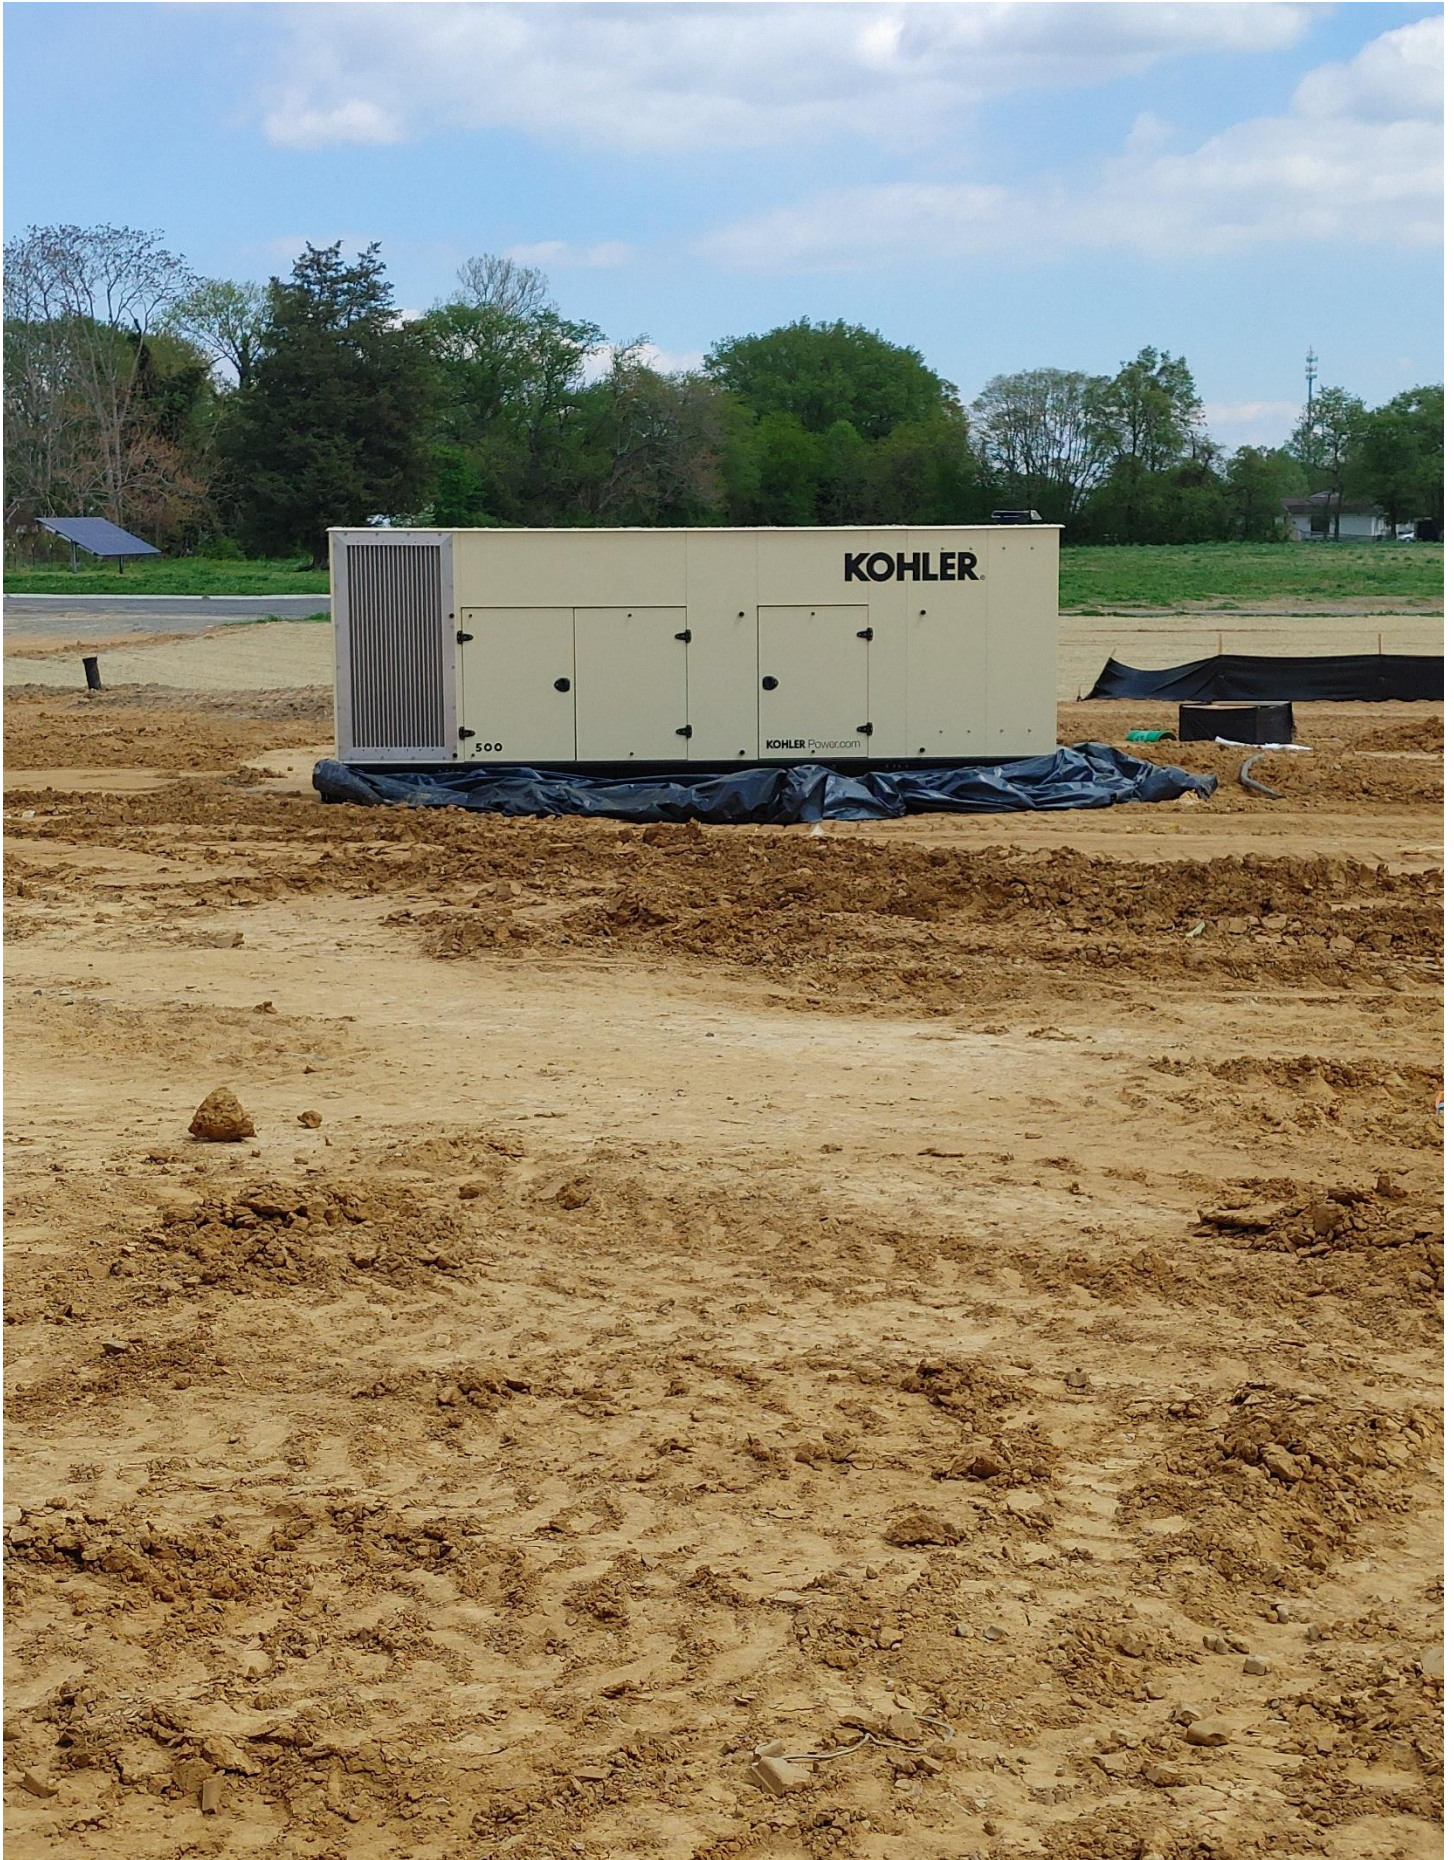
Photo 6 - Generator has been delivered.

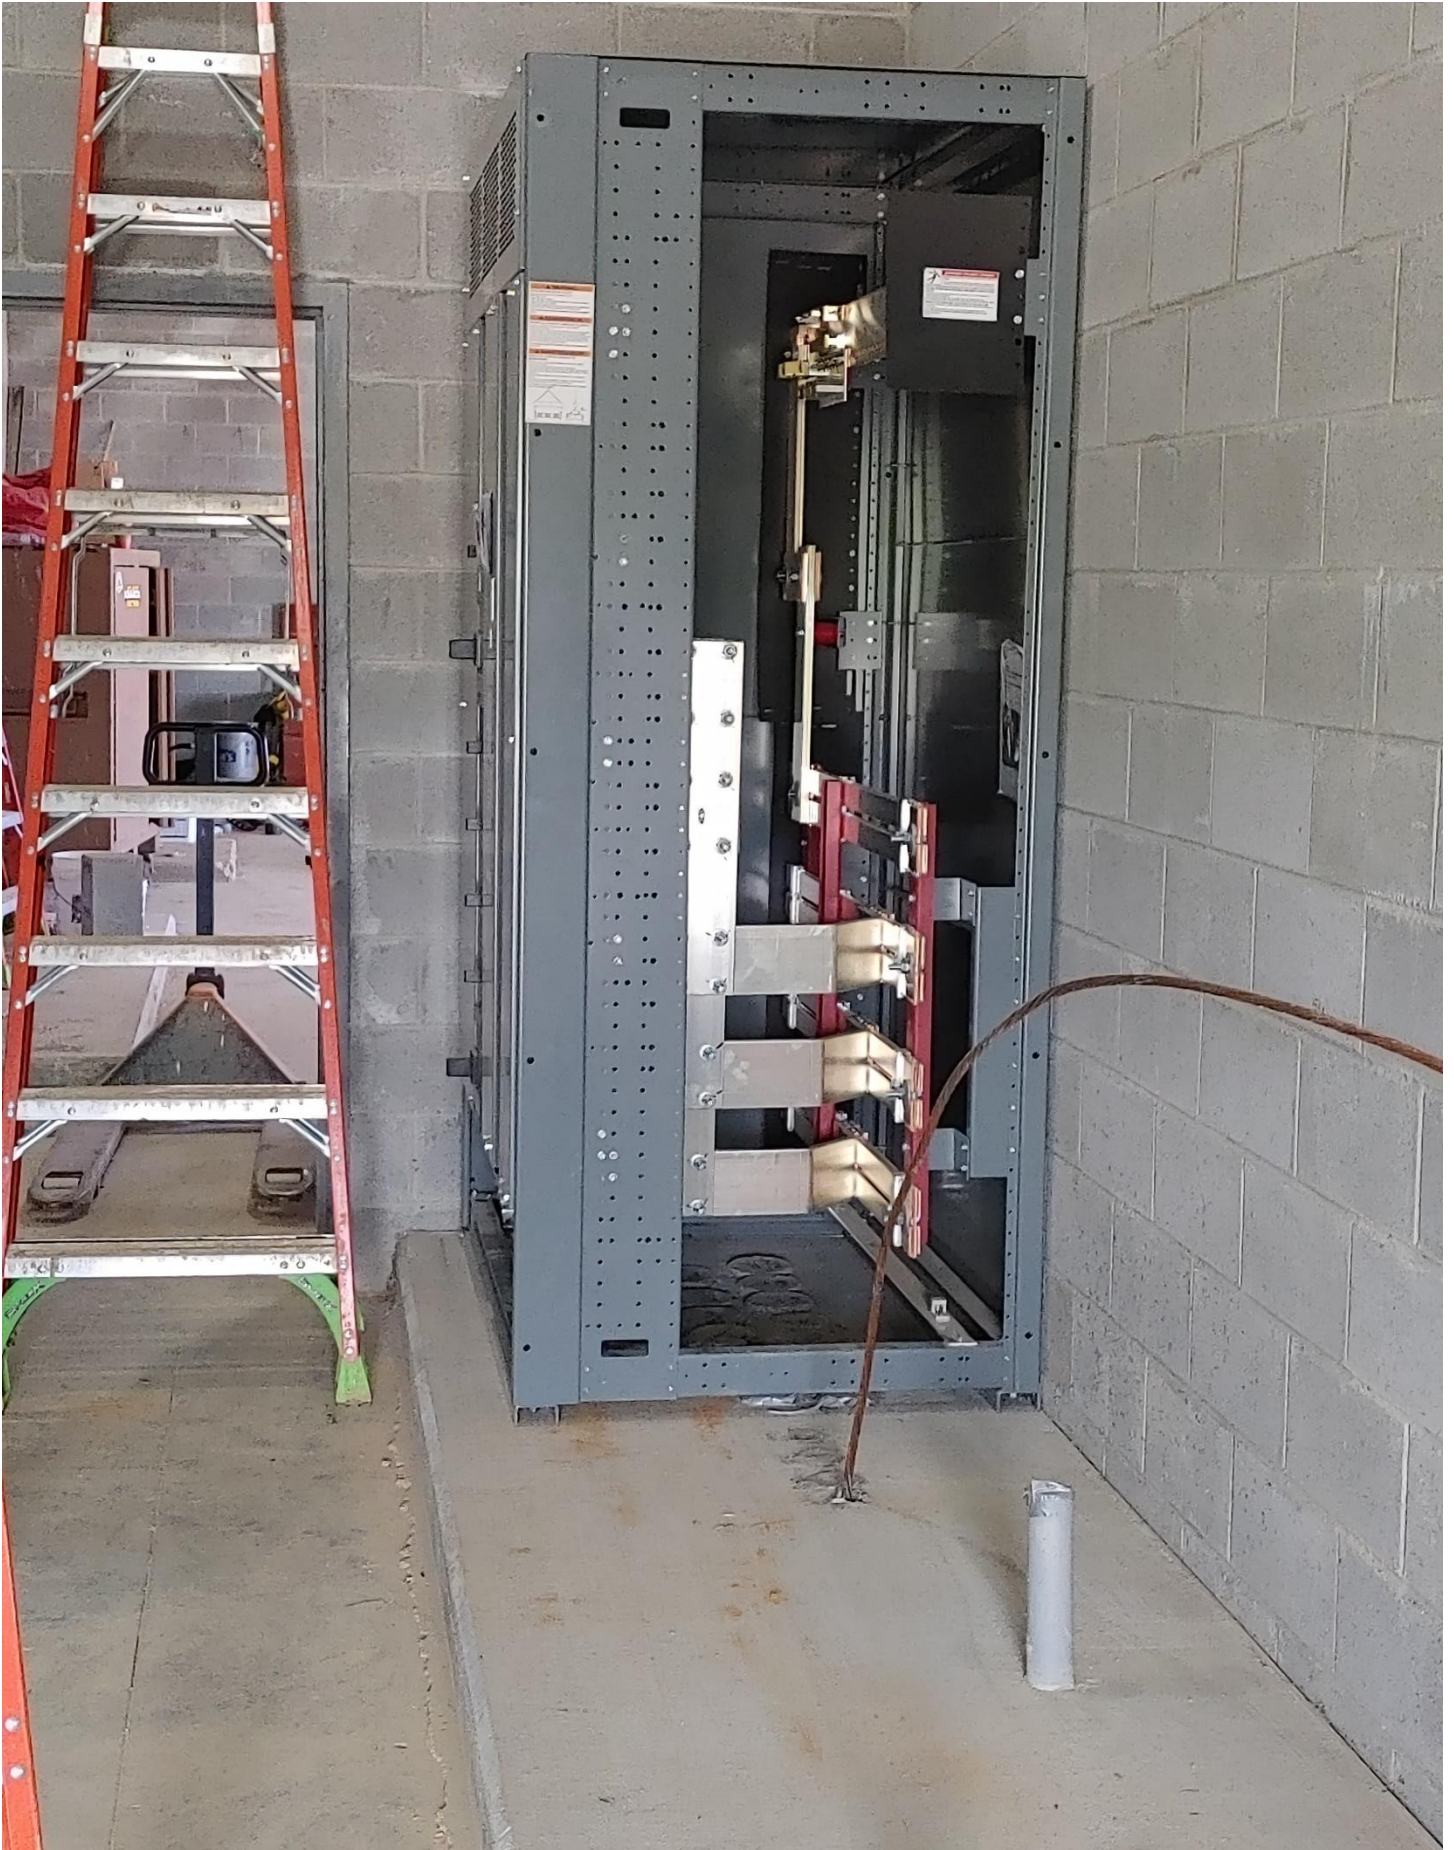
**Hazzard Electric:** Fourteen (14) men are on site and they continue to work in Area A & B & D running conduit and pulling wire. They have set one Switch Gear in the Electrical Room of Area D and are in the process of setting a second Switch Gear.

Photo 7 - Hazzard Electric has set one of the Switch Gears in the Electrical Room, Area D.

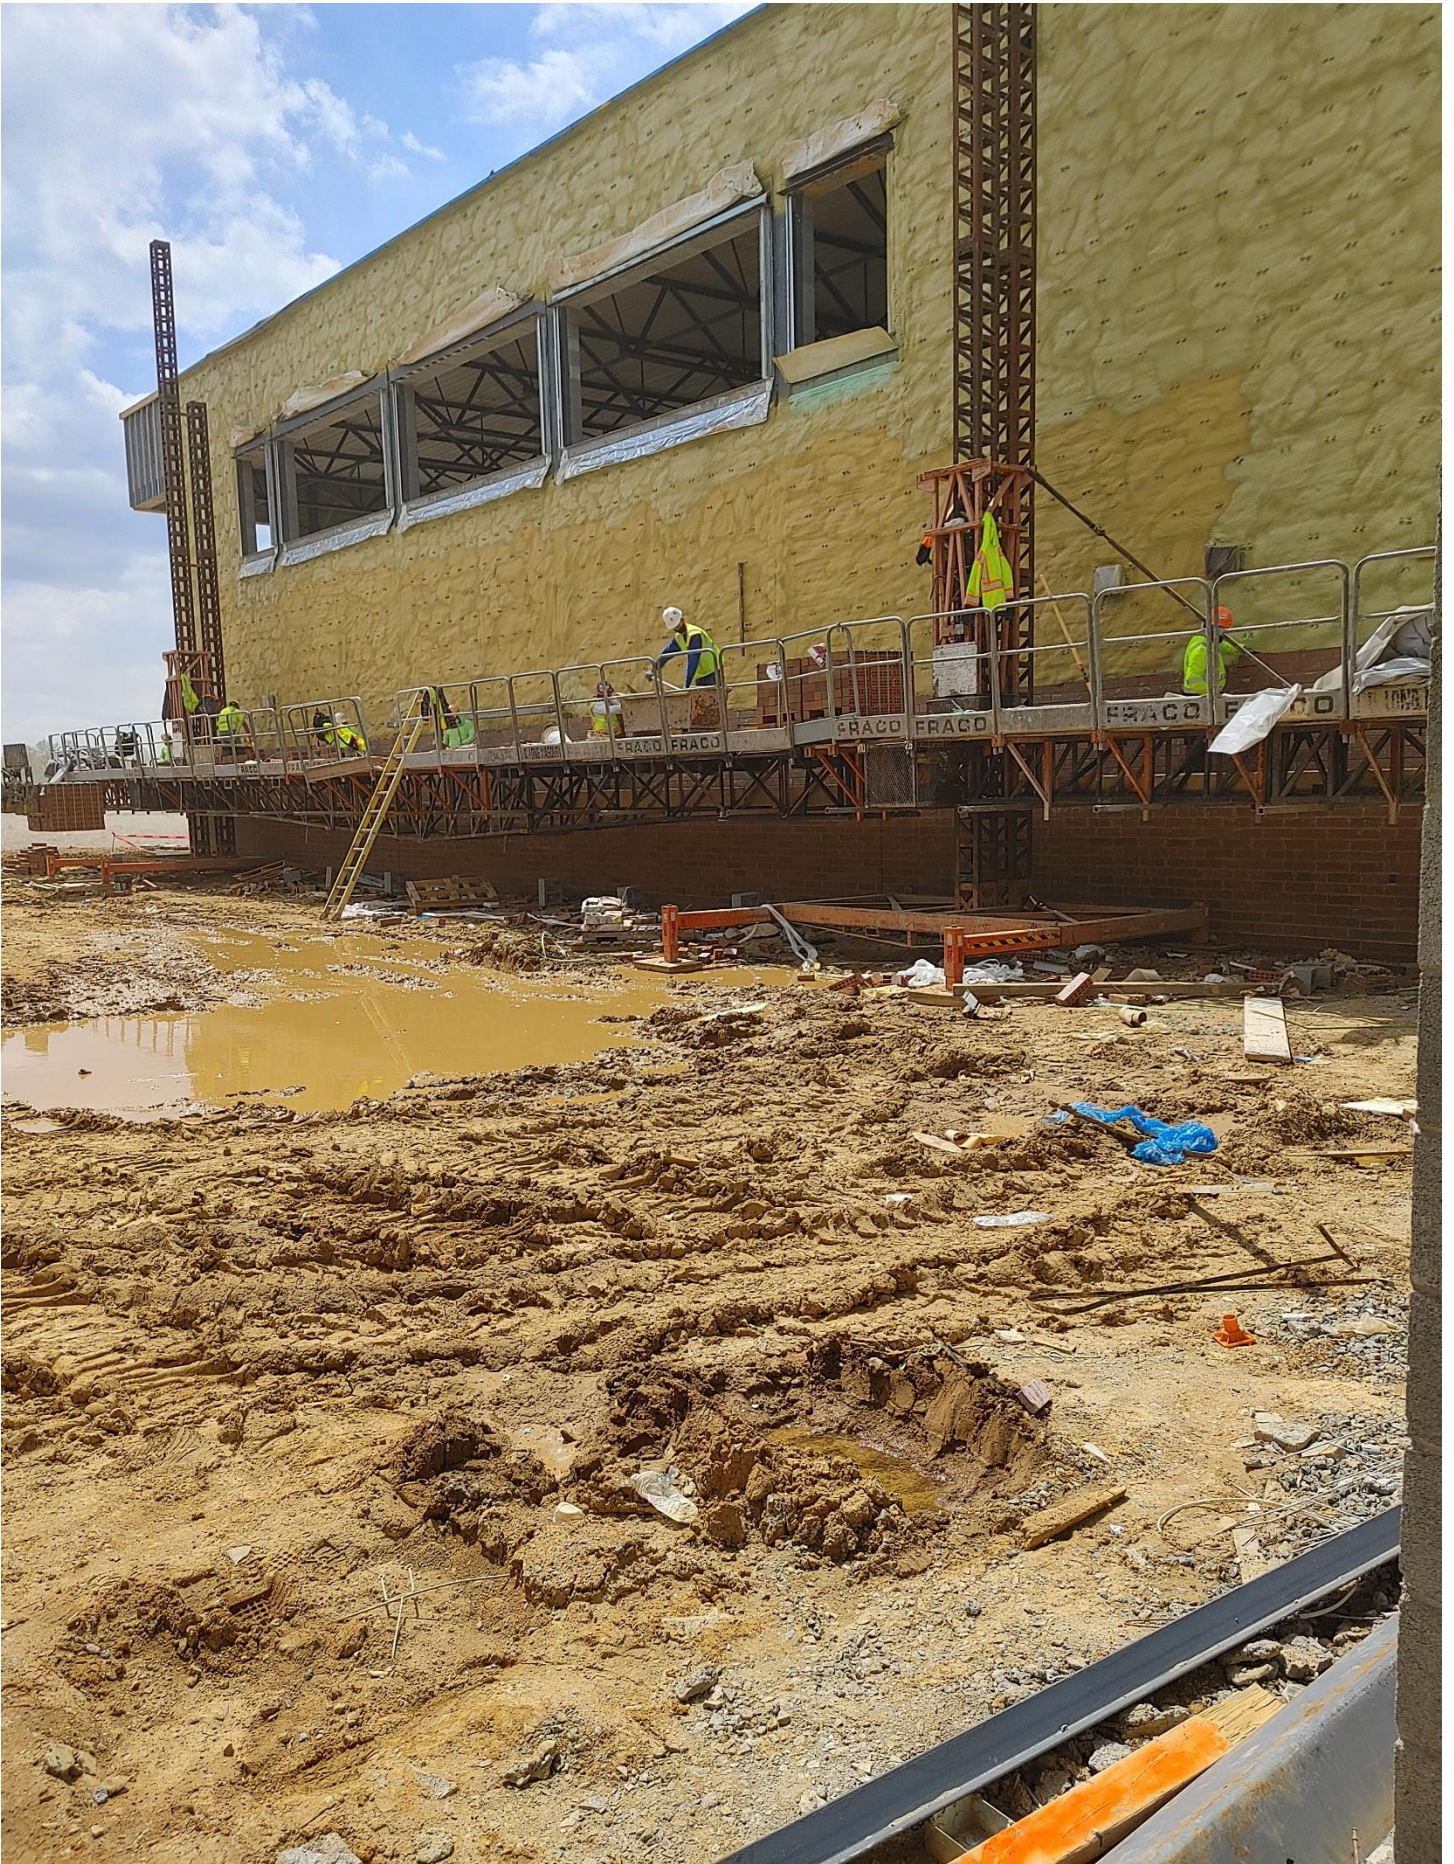
Photo 8 - The Masons are laying Brick on the East side of Area E
