**DAILY REPORT**

**WESTMORELAND COUNTY HIGH SCHOOL**

Date: 04/22/2021  
Weather: 52 degrees at 12:30hrs. High of 55 degrees today.  
Hours Worked: 12:30hrs – 15:00hrs (2.5hrs) Site Visit.

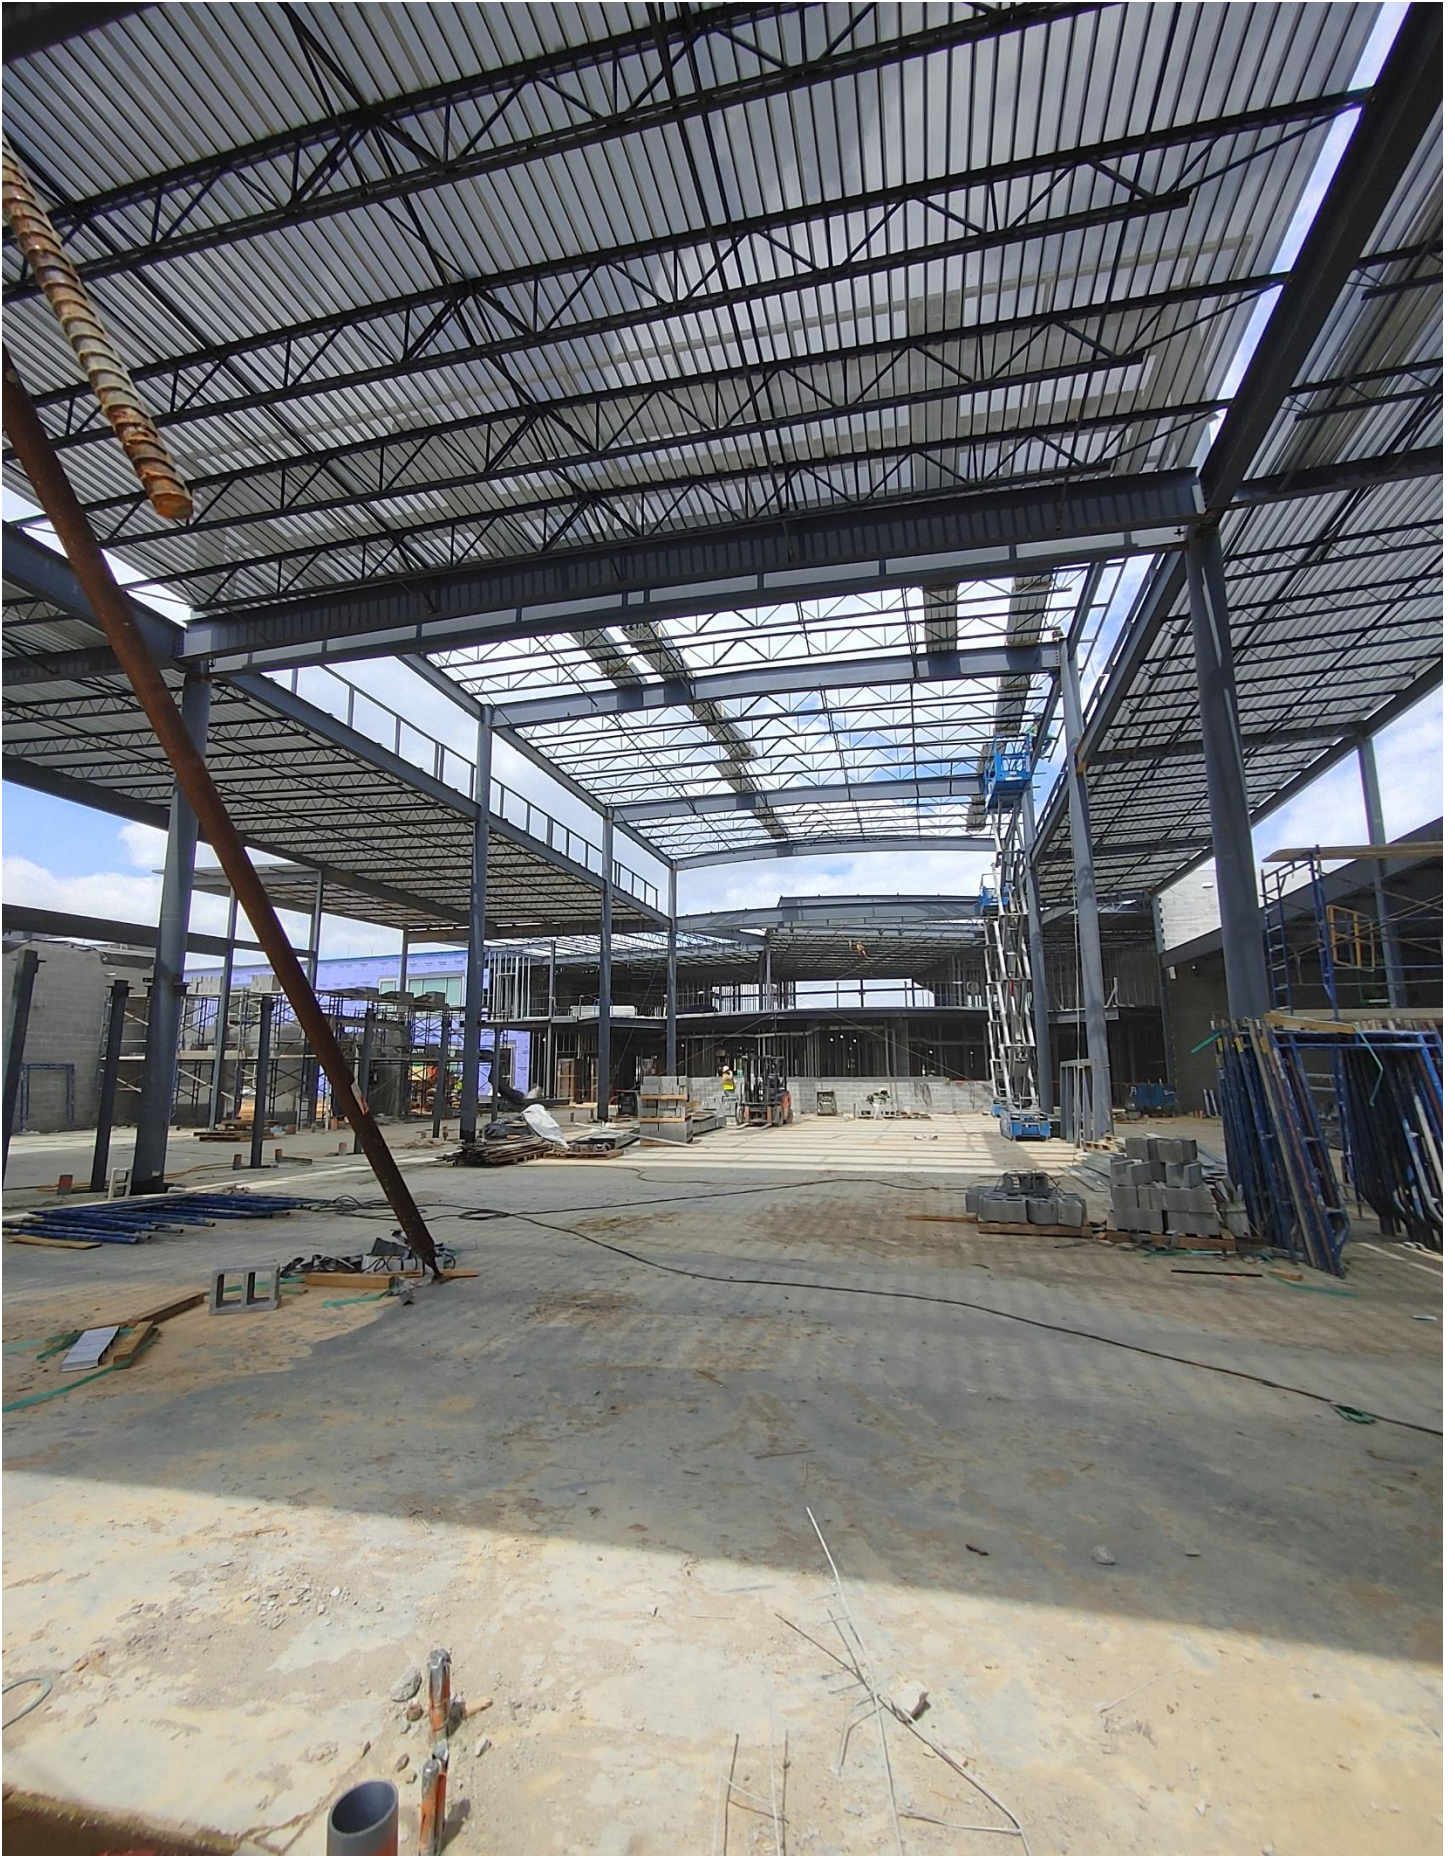
**Weldon Steel:** Six (6) men are on site today. They continue to set and weld steel in Area C. A couple of guys are also laying Roof Decking in Area C.

*Photo 9 - Metal Decking continues to be laid in Area C.*

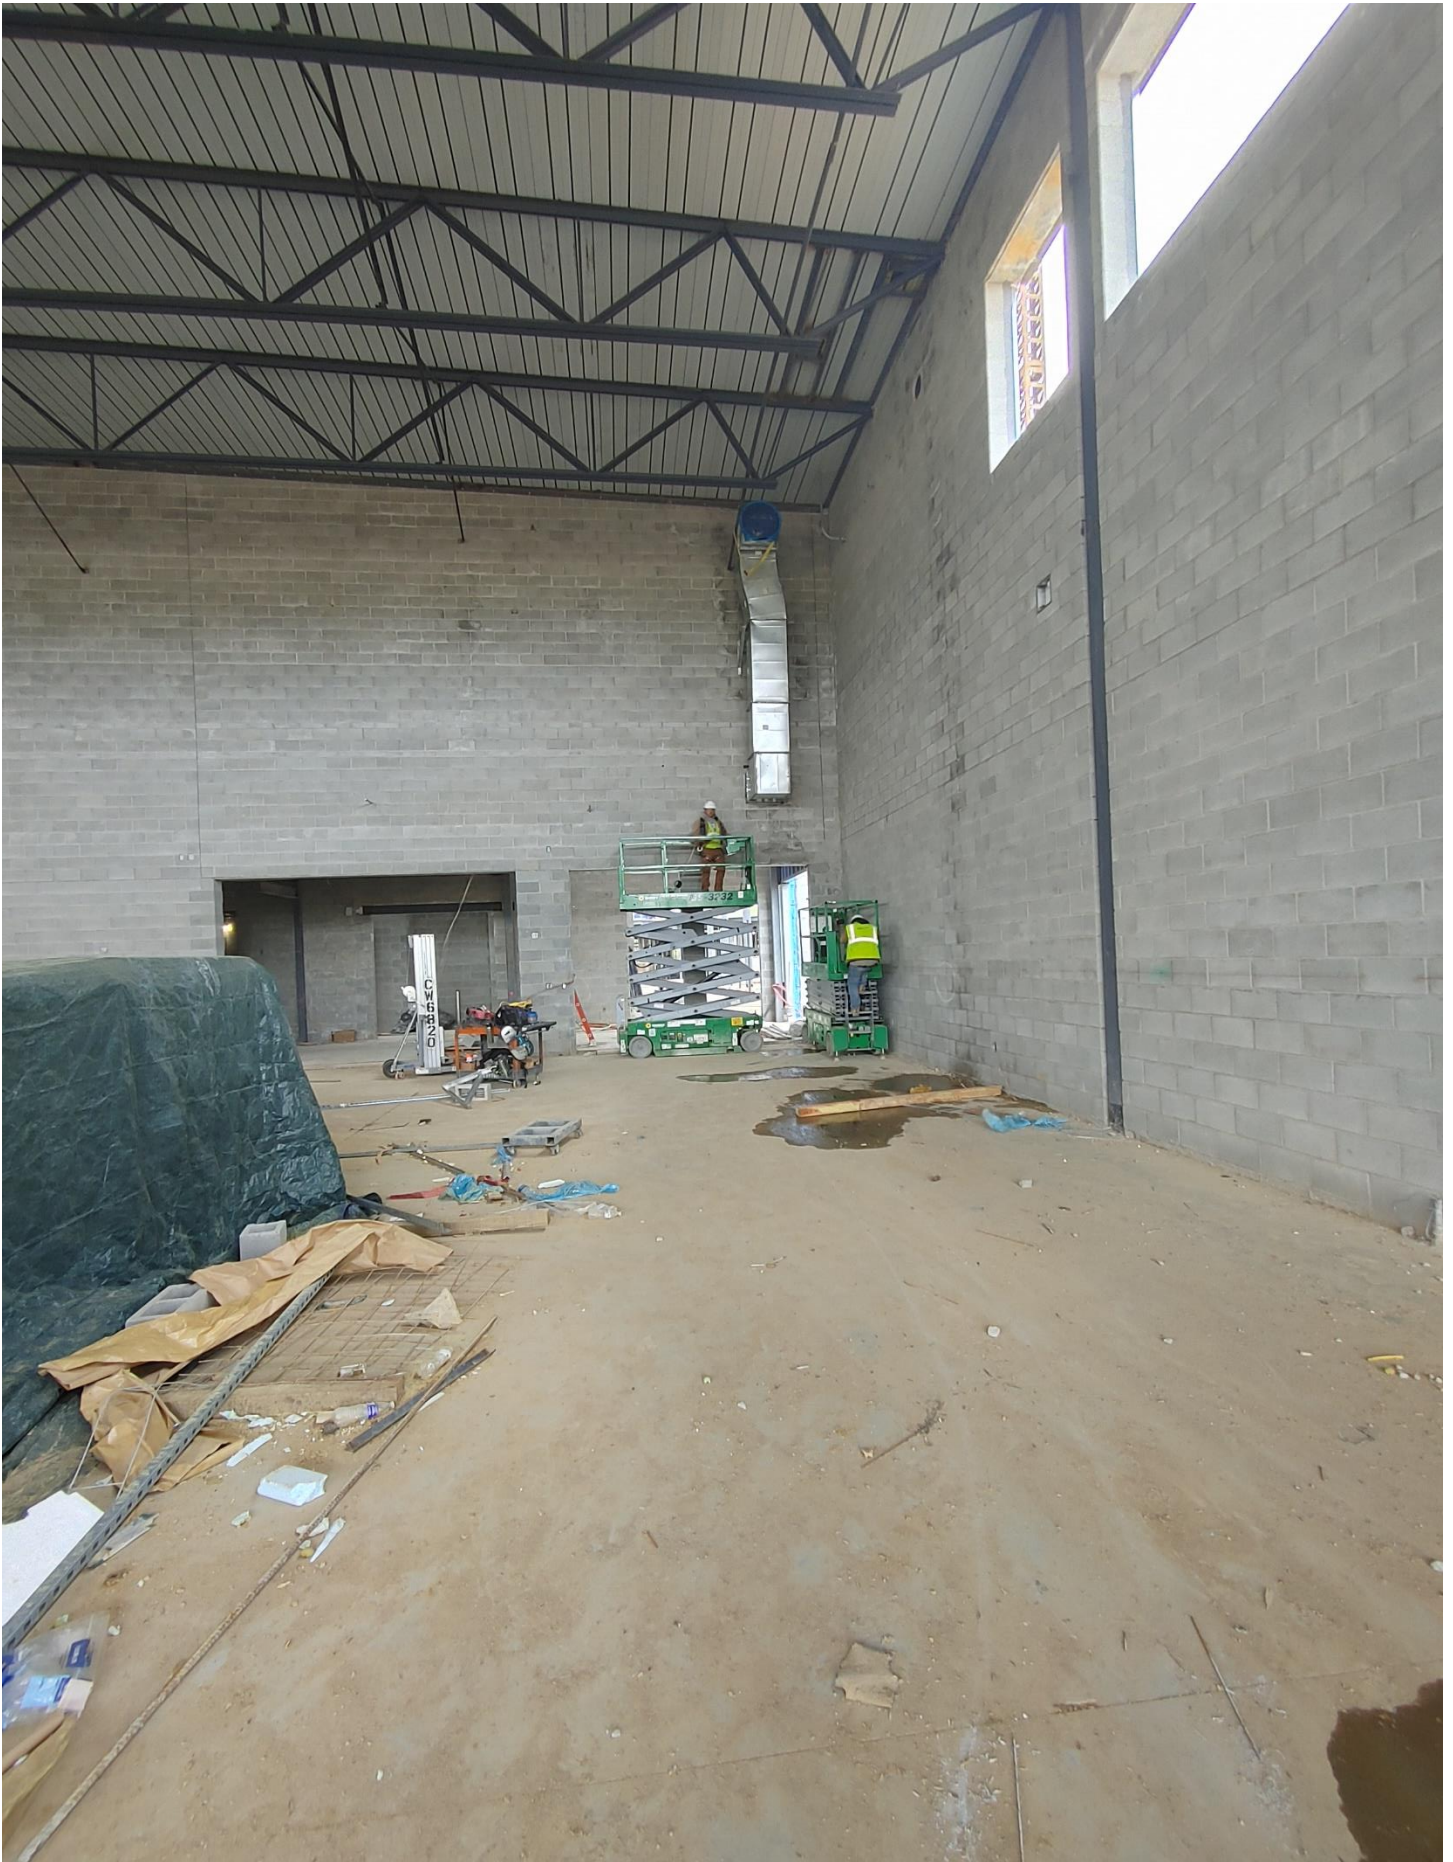
Photo 10 - Colonial Webb has begun to run HVAC Duct in the Gym

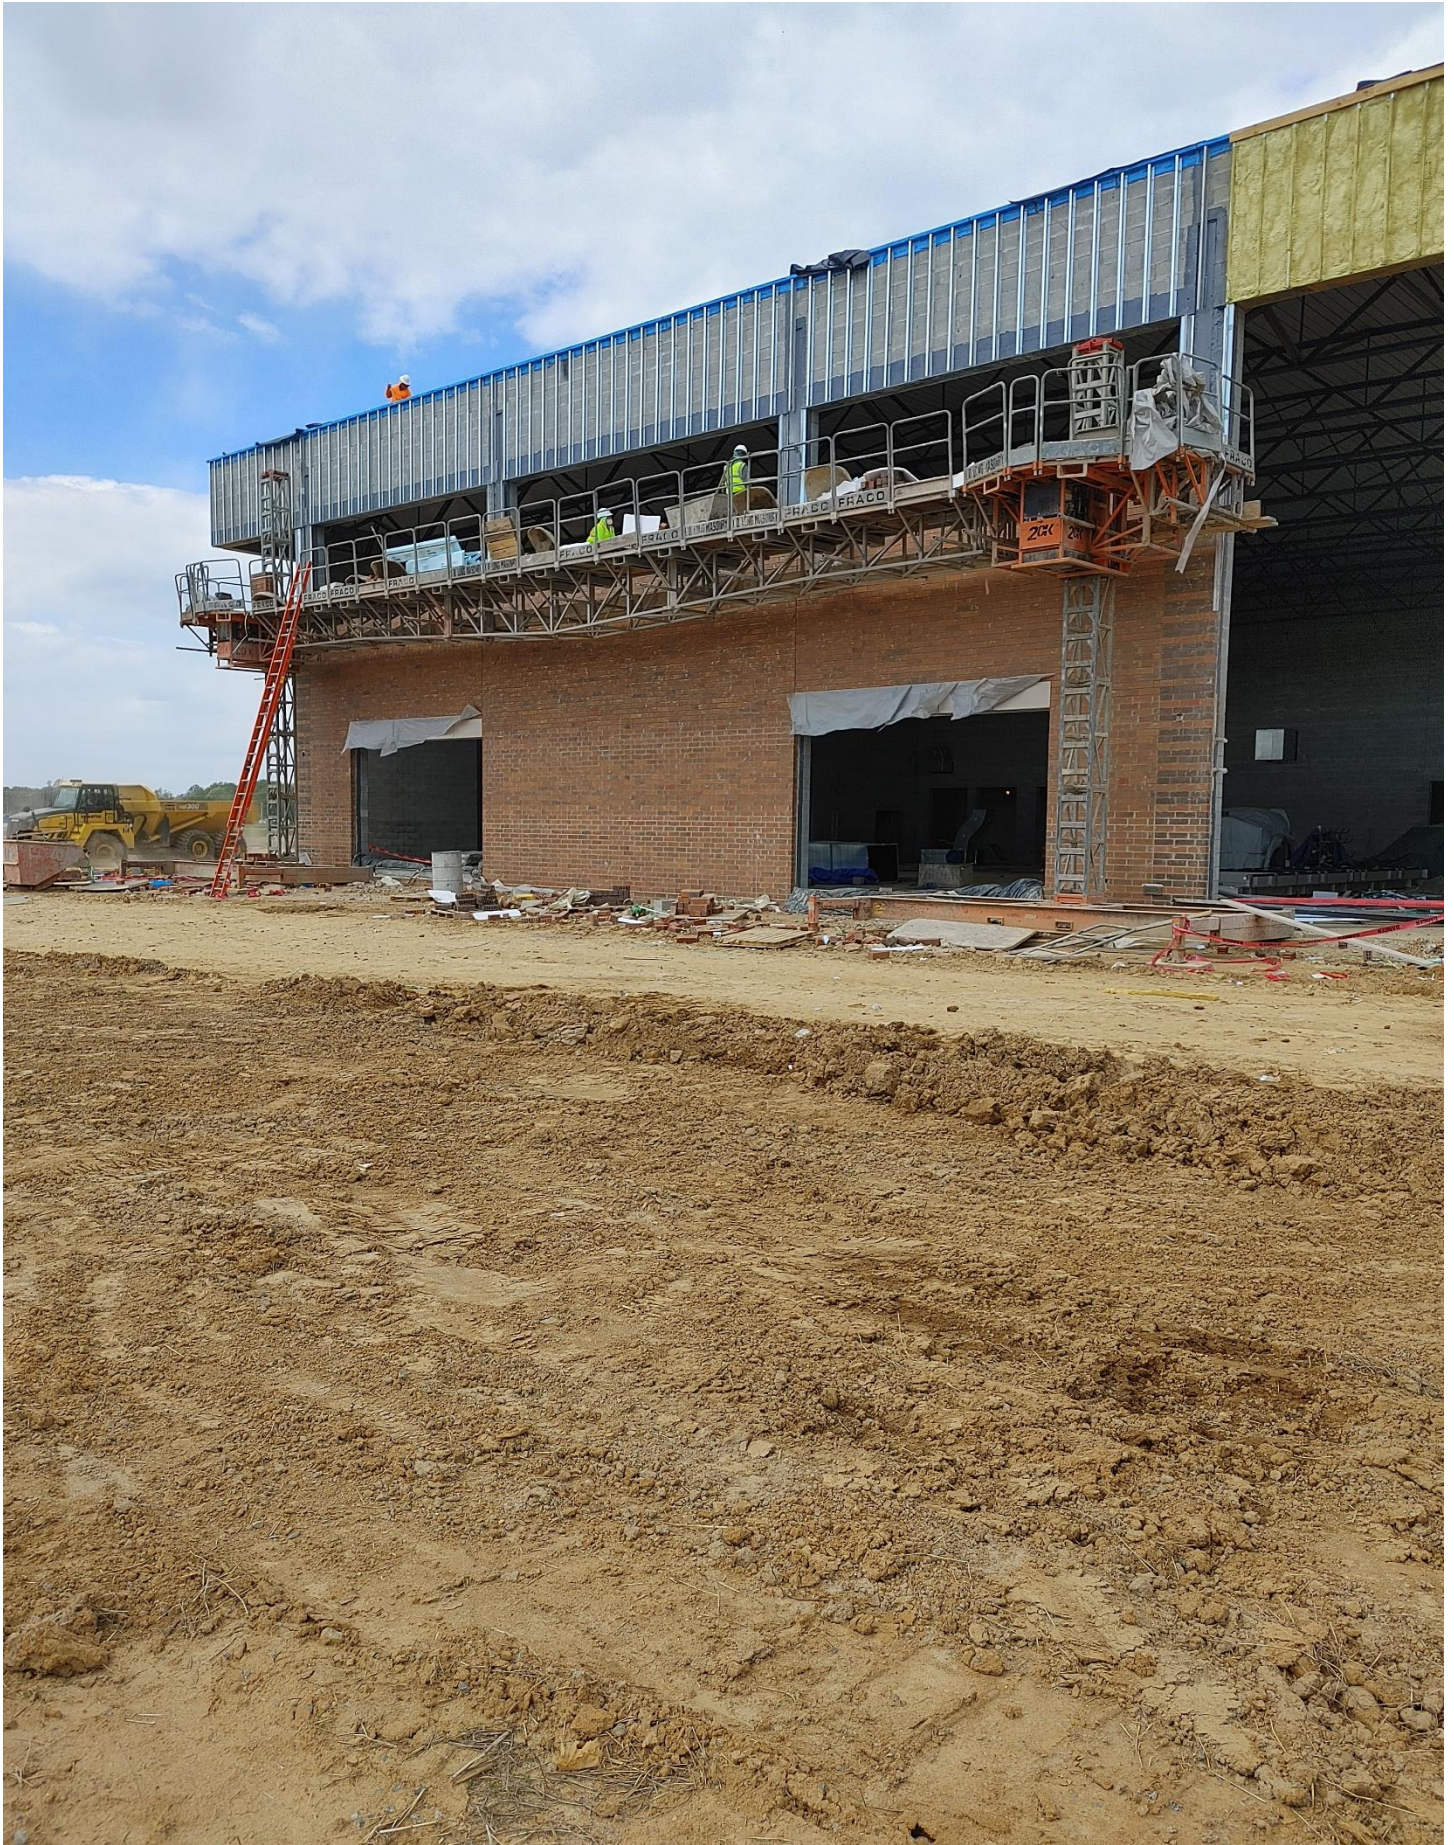
Photo 11 - Brick is being laid on the South side of the Gym

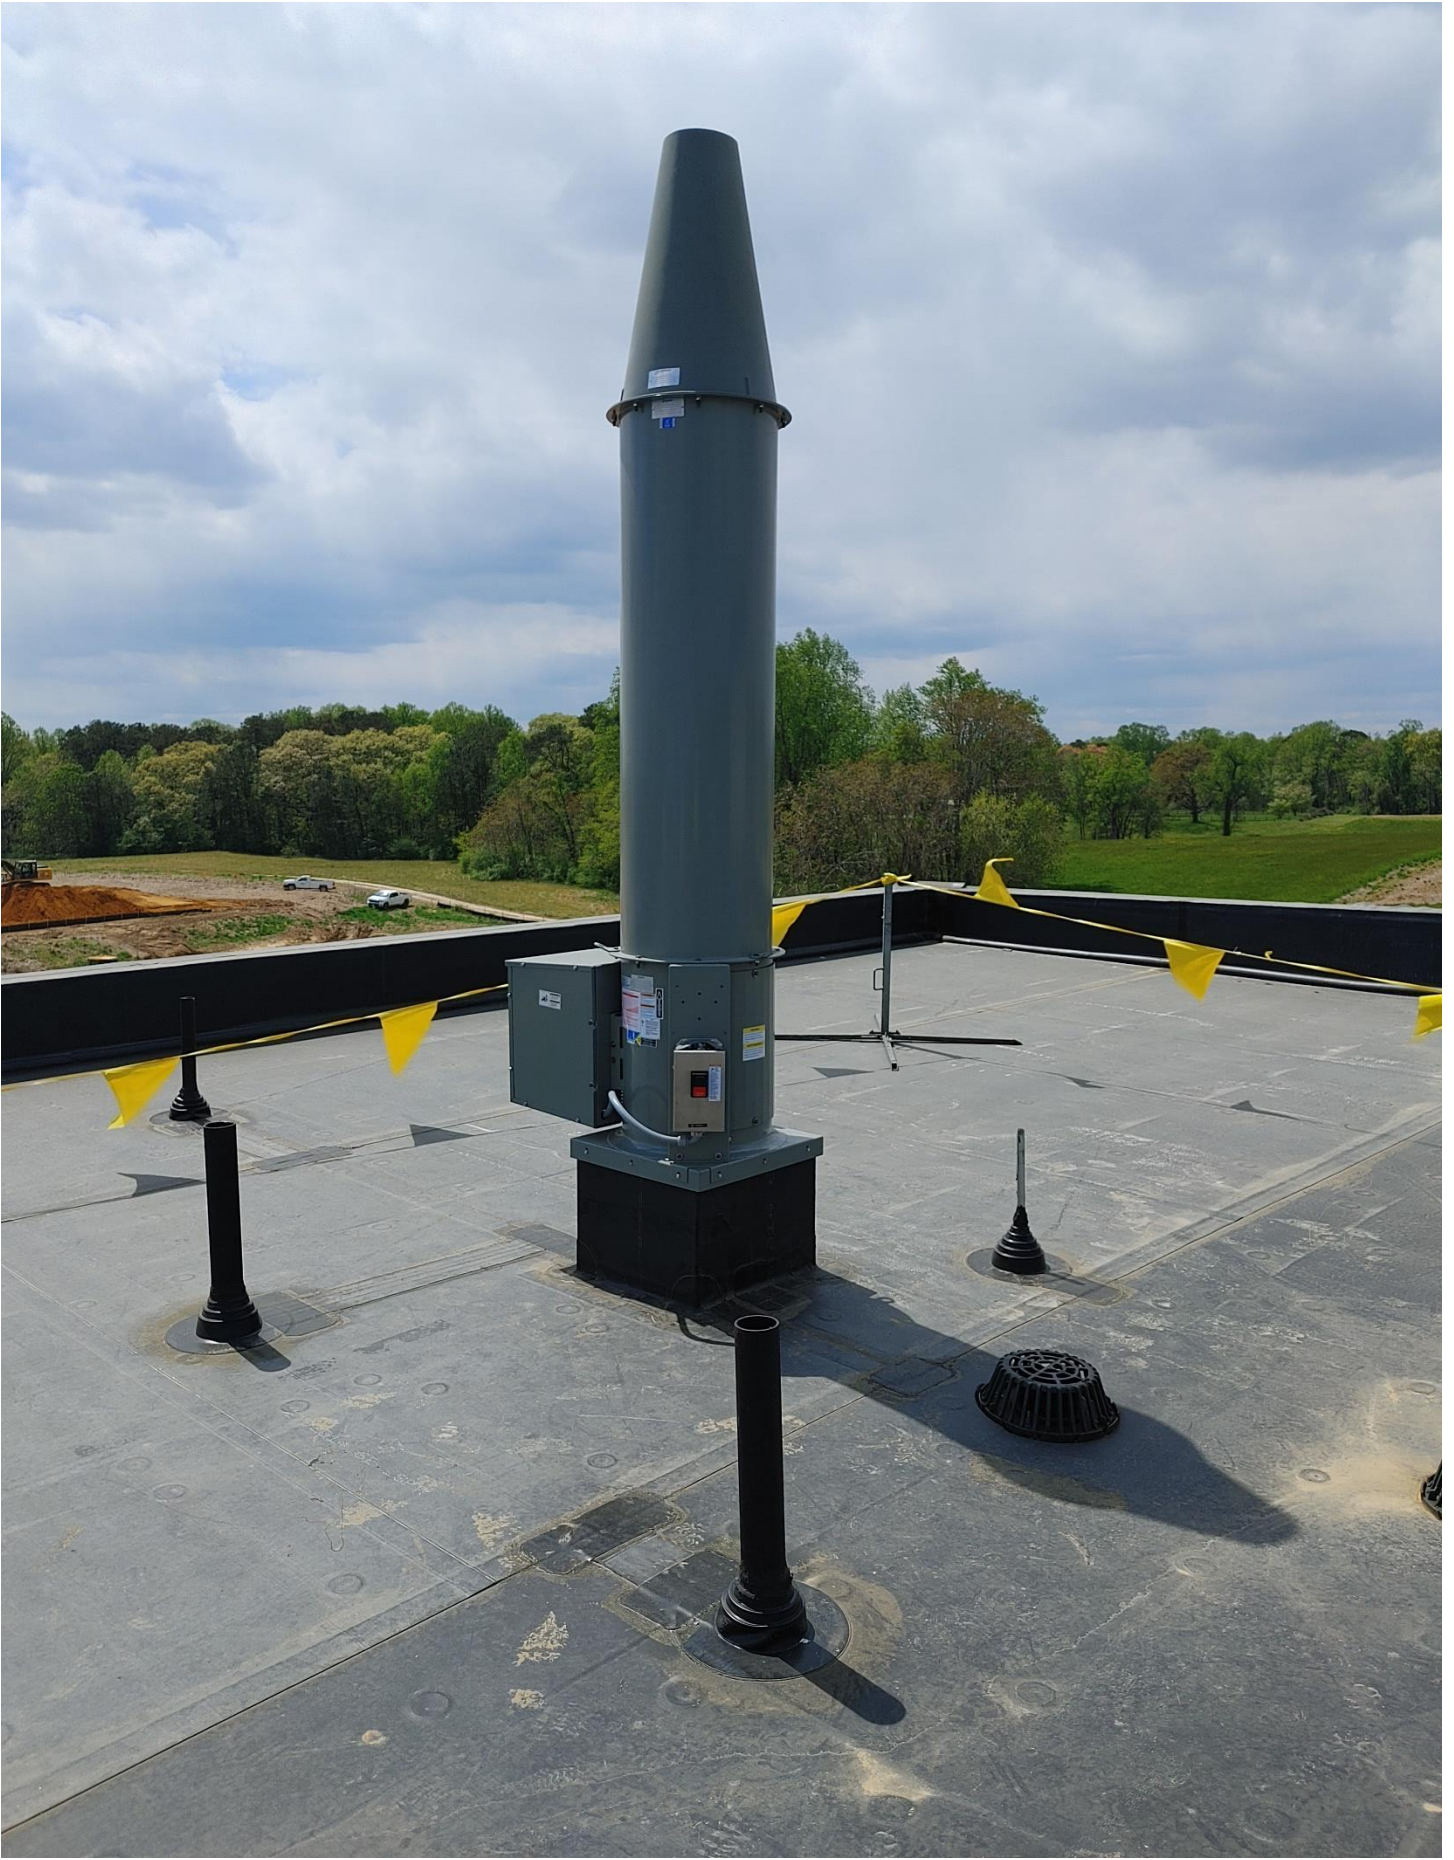
Photo 12 – Fume Hood has been installed Area B

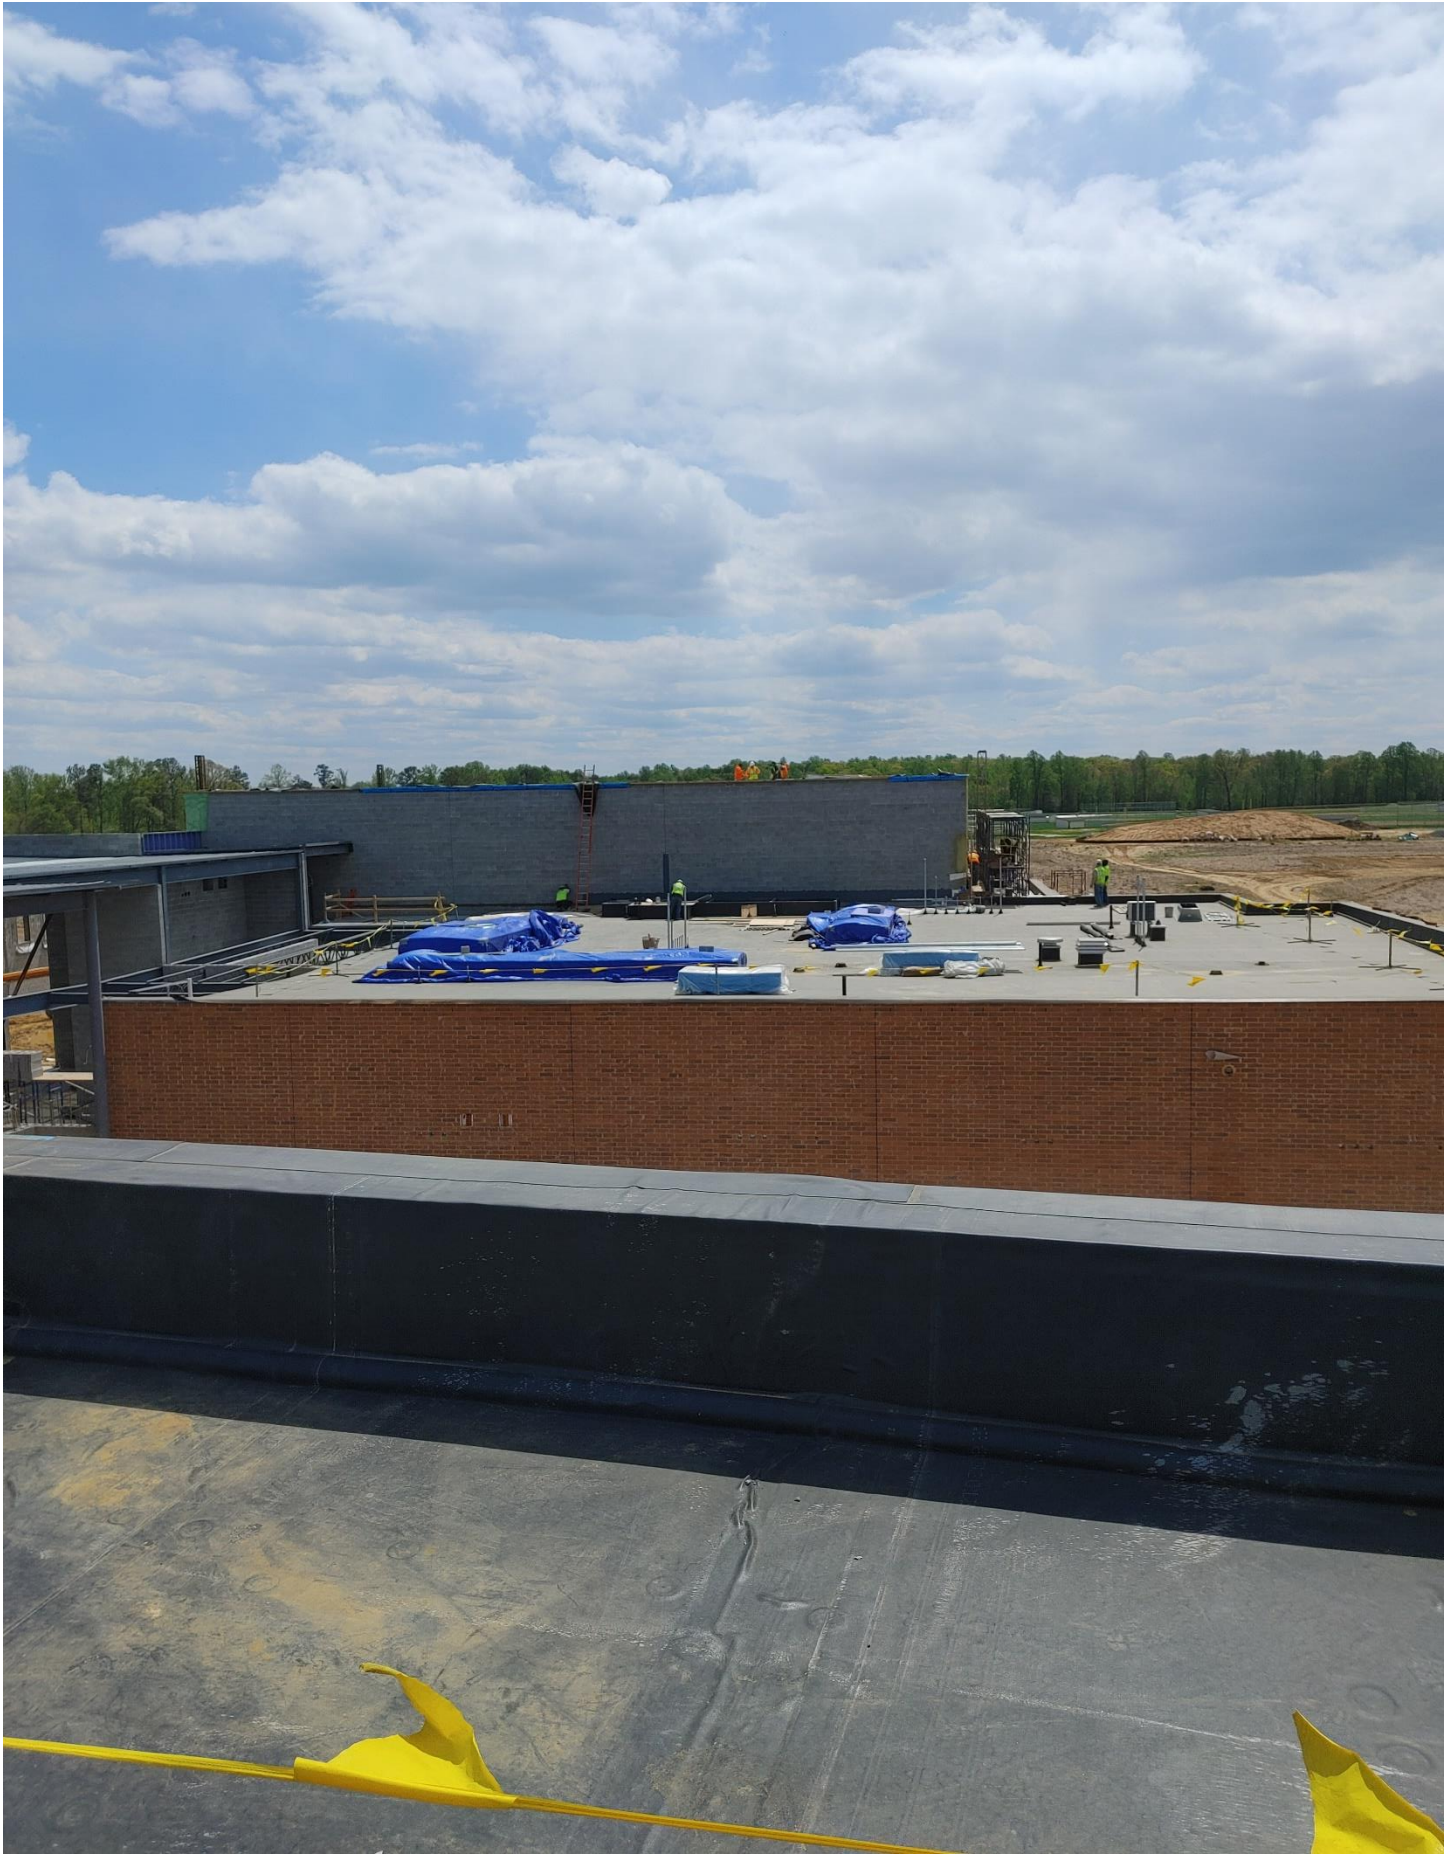
*Photo 13 -Roofers are working on the high roof of Area E and the area between the high and low roof is being flashed.*
