**COMMONWEALTH
BUILDING SOLUTIONS, LLC**

DAILY REPORT

WESTMORELAND COUNTY HIGH SCHOOL

Date: 04/26/2021
Weather: 46 degrees at 09:00hrs. High of 67 degrees today.
Hours Worked: 09:00hrs – 12:30hrs (3.5hrs) Site Visit.

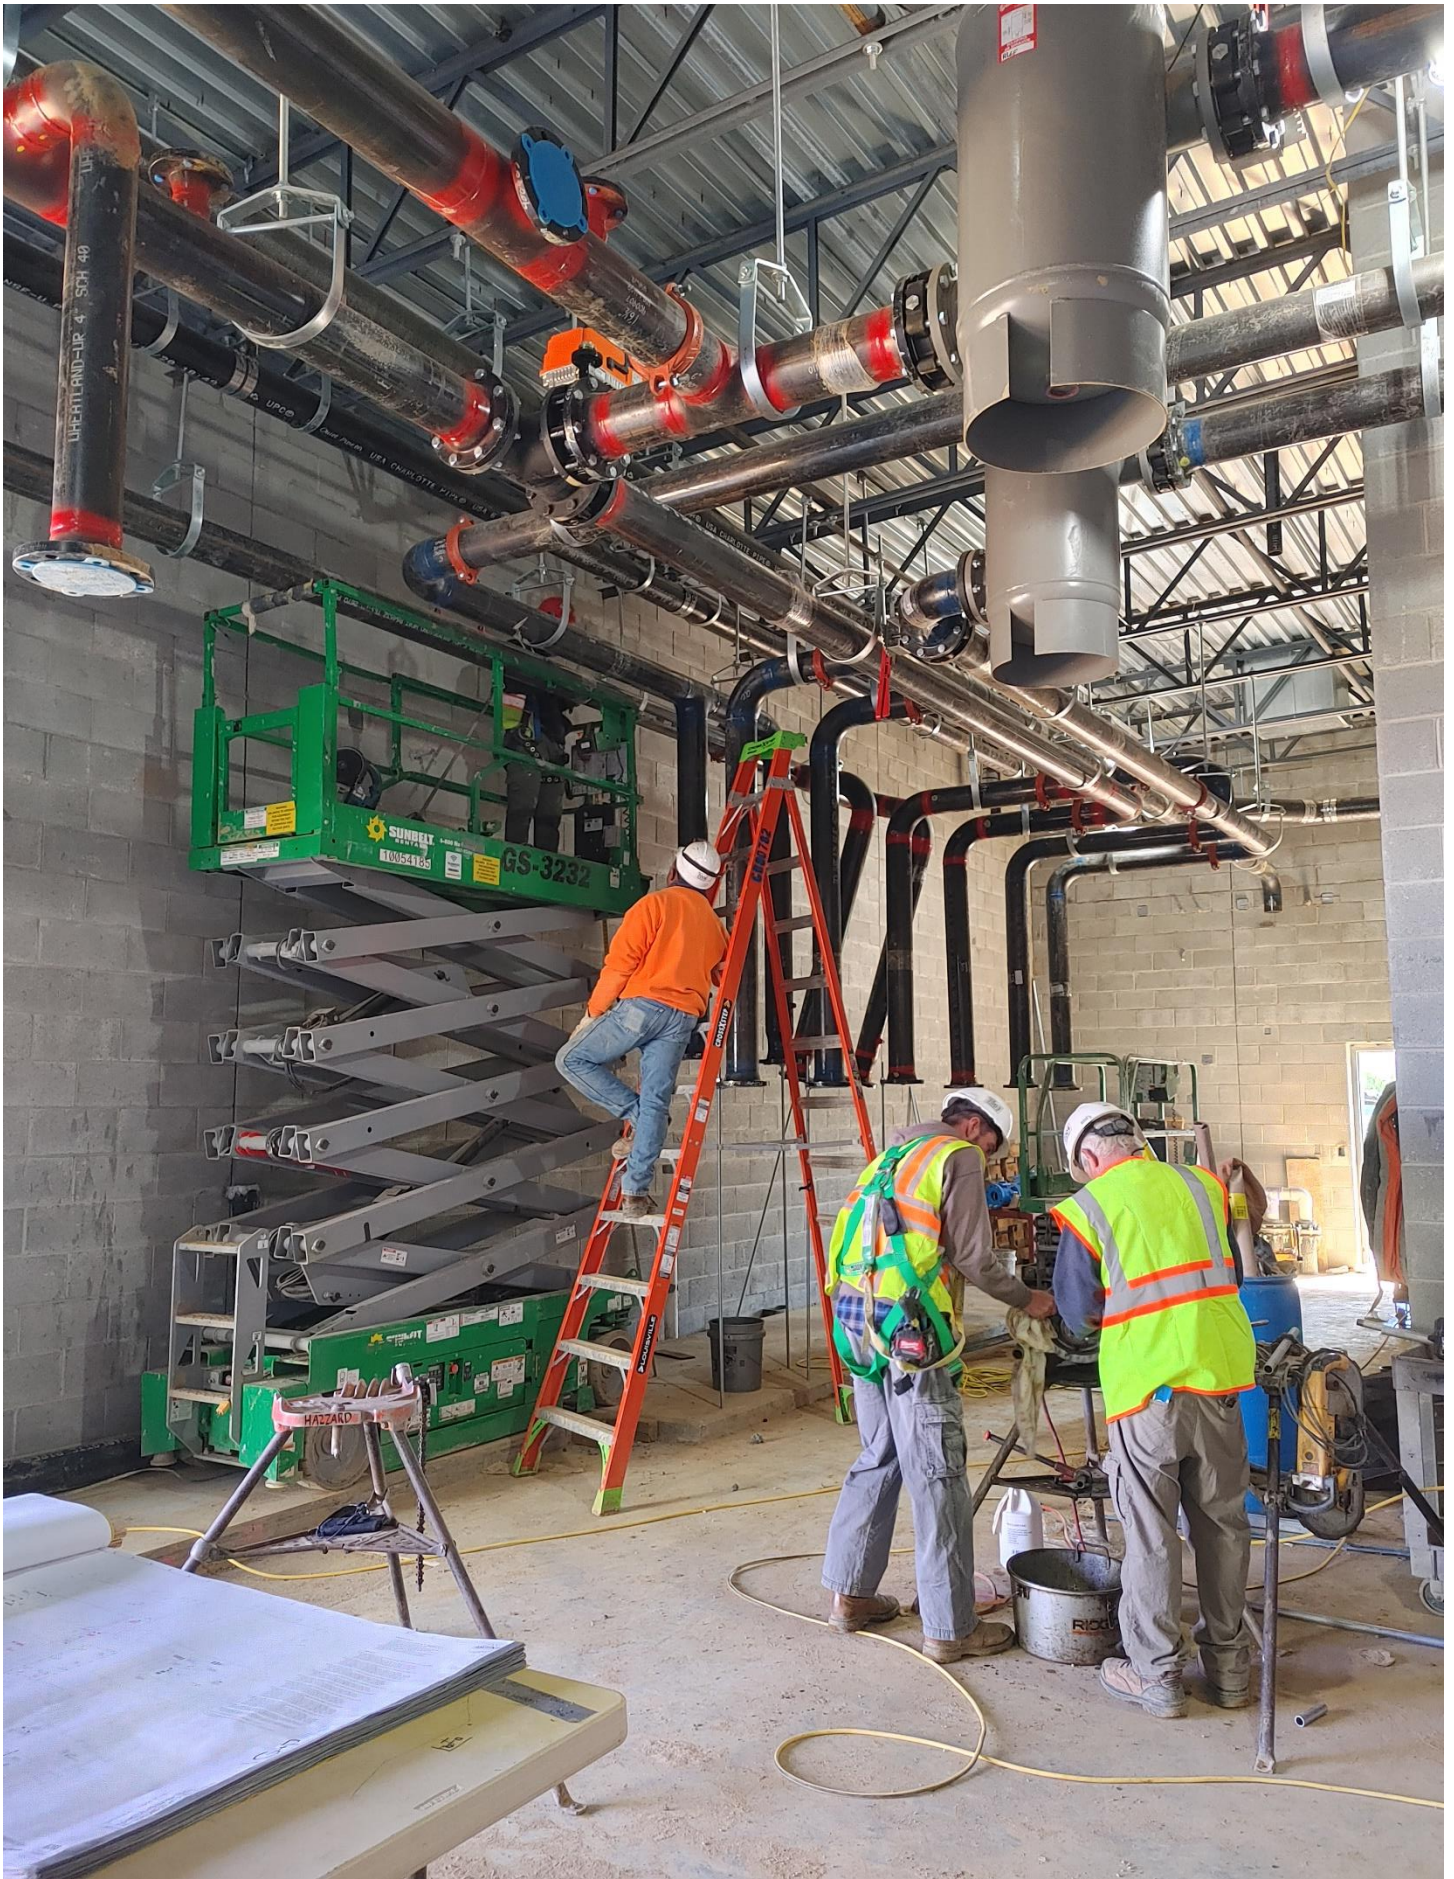
Colonial Webb: Thirty-Seven (37) men is on site today. They are running waterlines and working on roof top Curbs in Area B. A crew is pressurizing water lines and insulating duct in Area E. They continue to work on running pipe in the Mechanical Room in Area D and they are also insulating pipe in Area A.

Photo 1 - Colonial Webb continues to run pipe in the Mechanical Room, Area D.

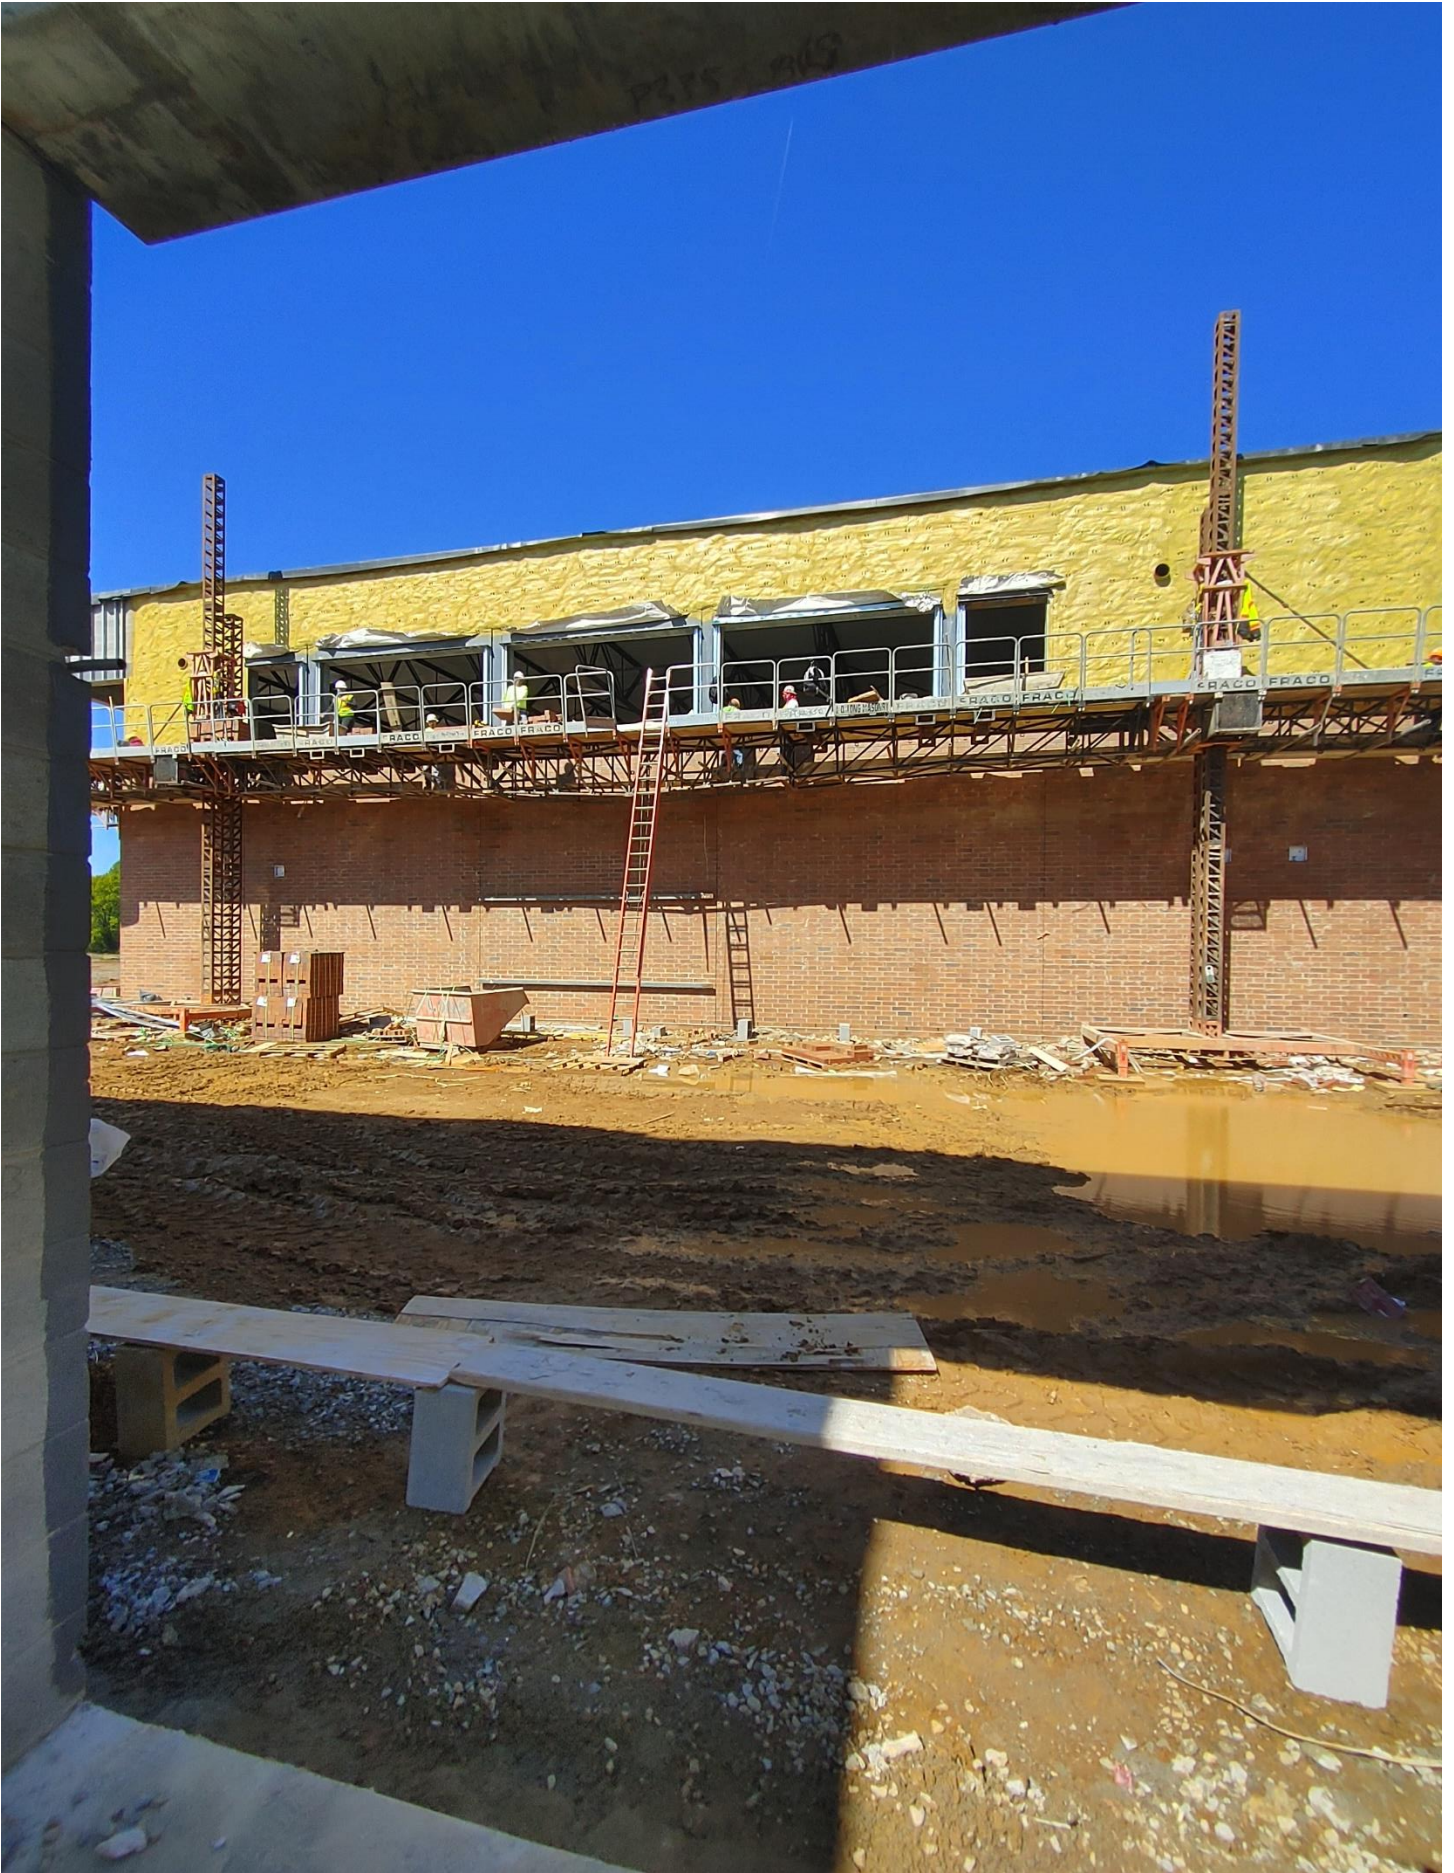
J.D. Long, Masons: Twenty (20) Masons are on site today laying Brick on the East side of Area E and they also continue to lay block in Area C, Vestibule C10. A couple of guys are installing brick flashing on the East side of Area D.

Photo 2 - J. D. Long are laying Brick on the East side of Area E.

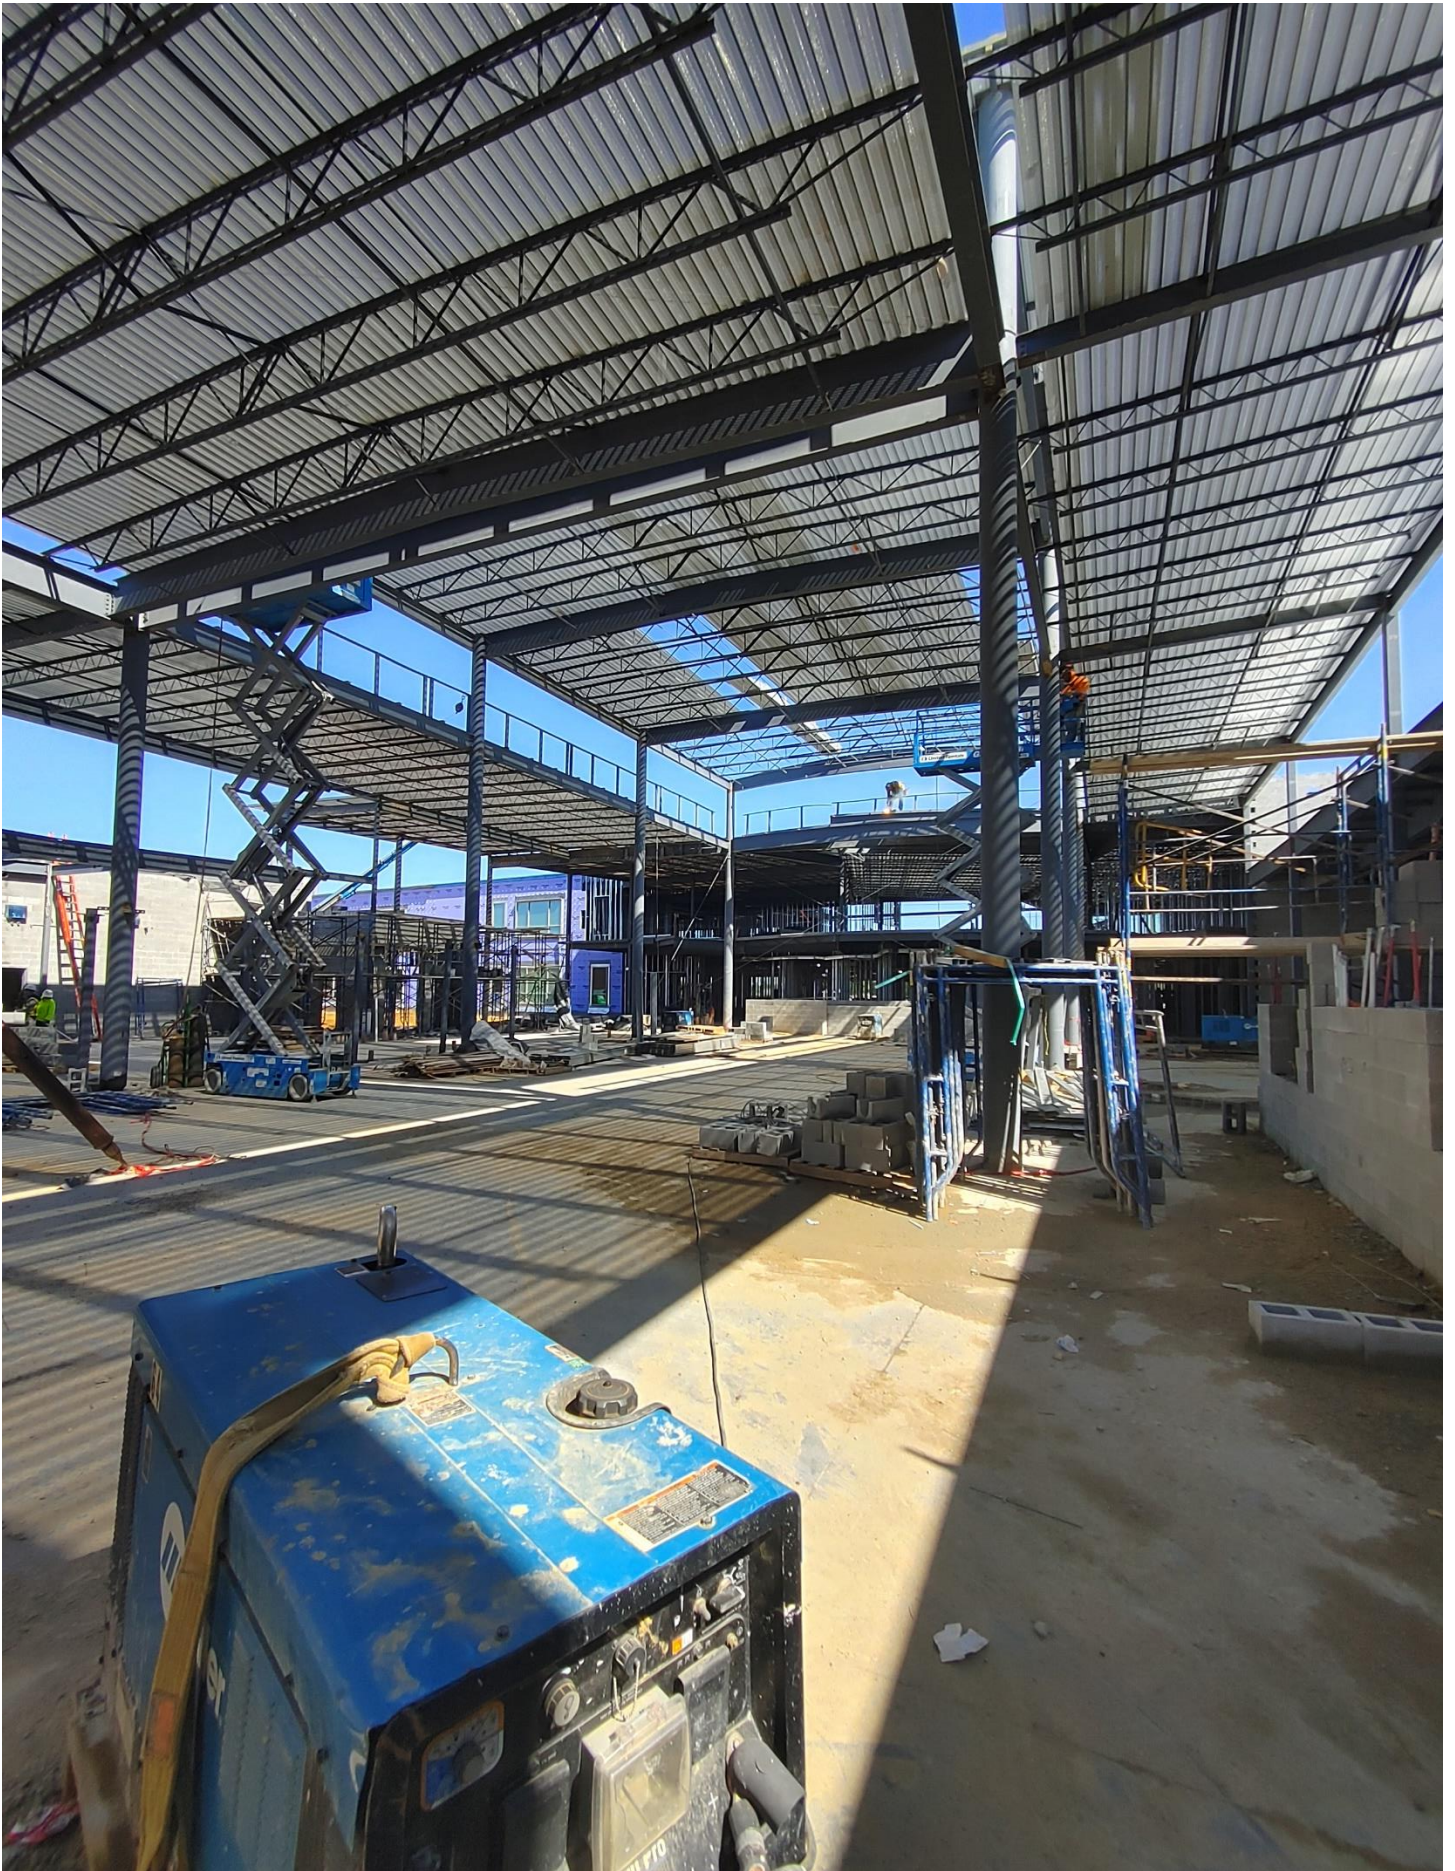
Weldon Steel: Six (6) men are on site today. They continue to set and weld roof decking in Area C. One guy continues to install temporary bracing around the high roof of the Cafeteria.

Photo 3 - Weldon Steel continues to install roof decking and temporary railing around the perimeter of the Cafeteria Roof.

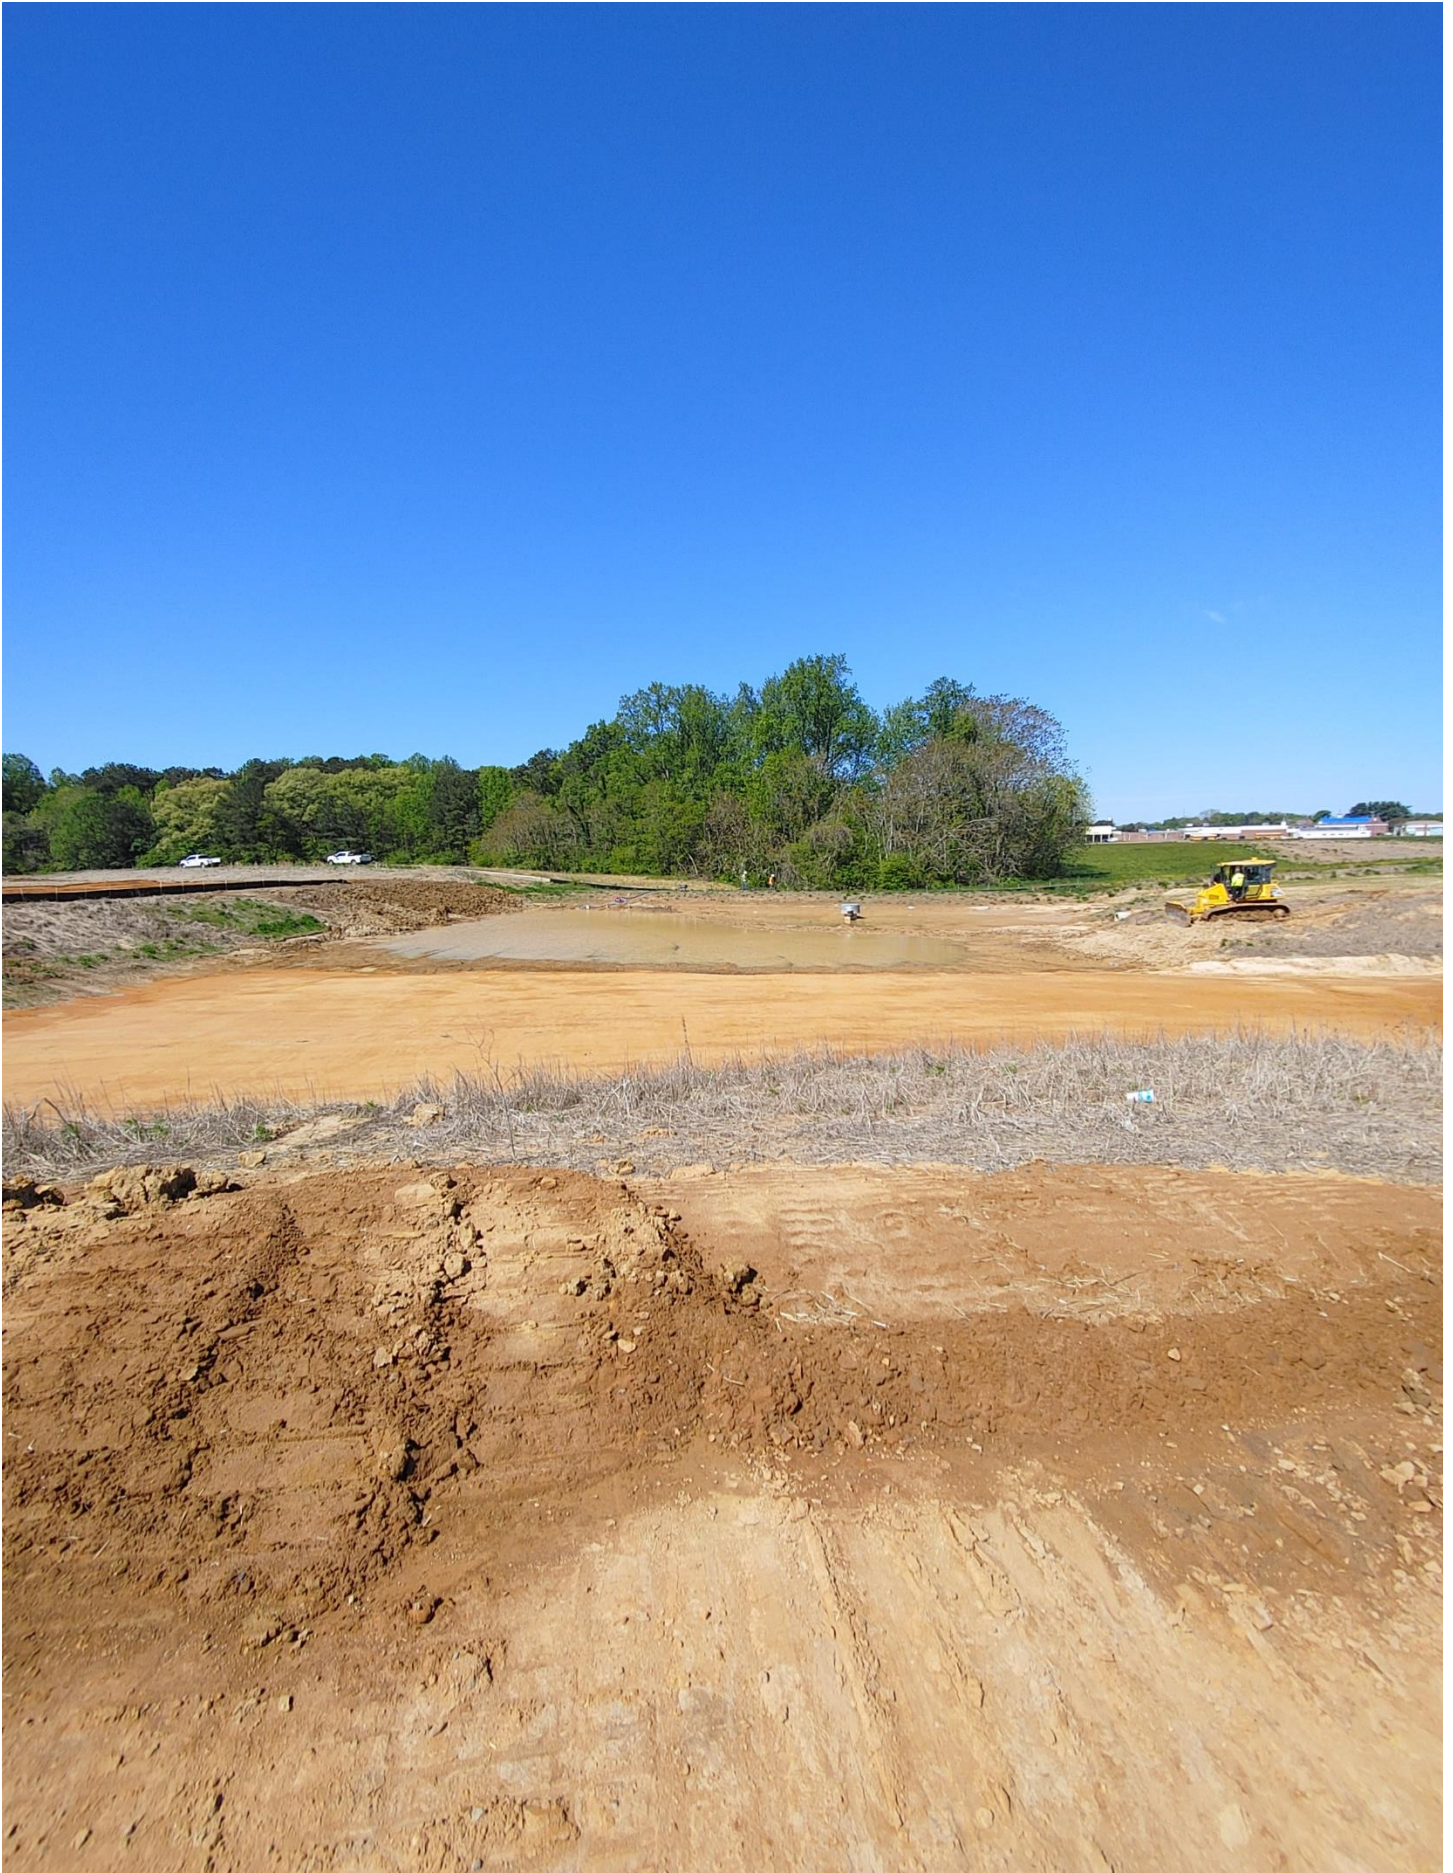
Beuchert Excavation: Five (5) men are on site today and they are currently pumping out Retention Pond #1 and they are also grading and reworking the Retention Pond.

Photo 4 - Beuchert continues to work on the West side of the site, Retention Pond #1.

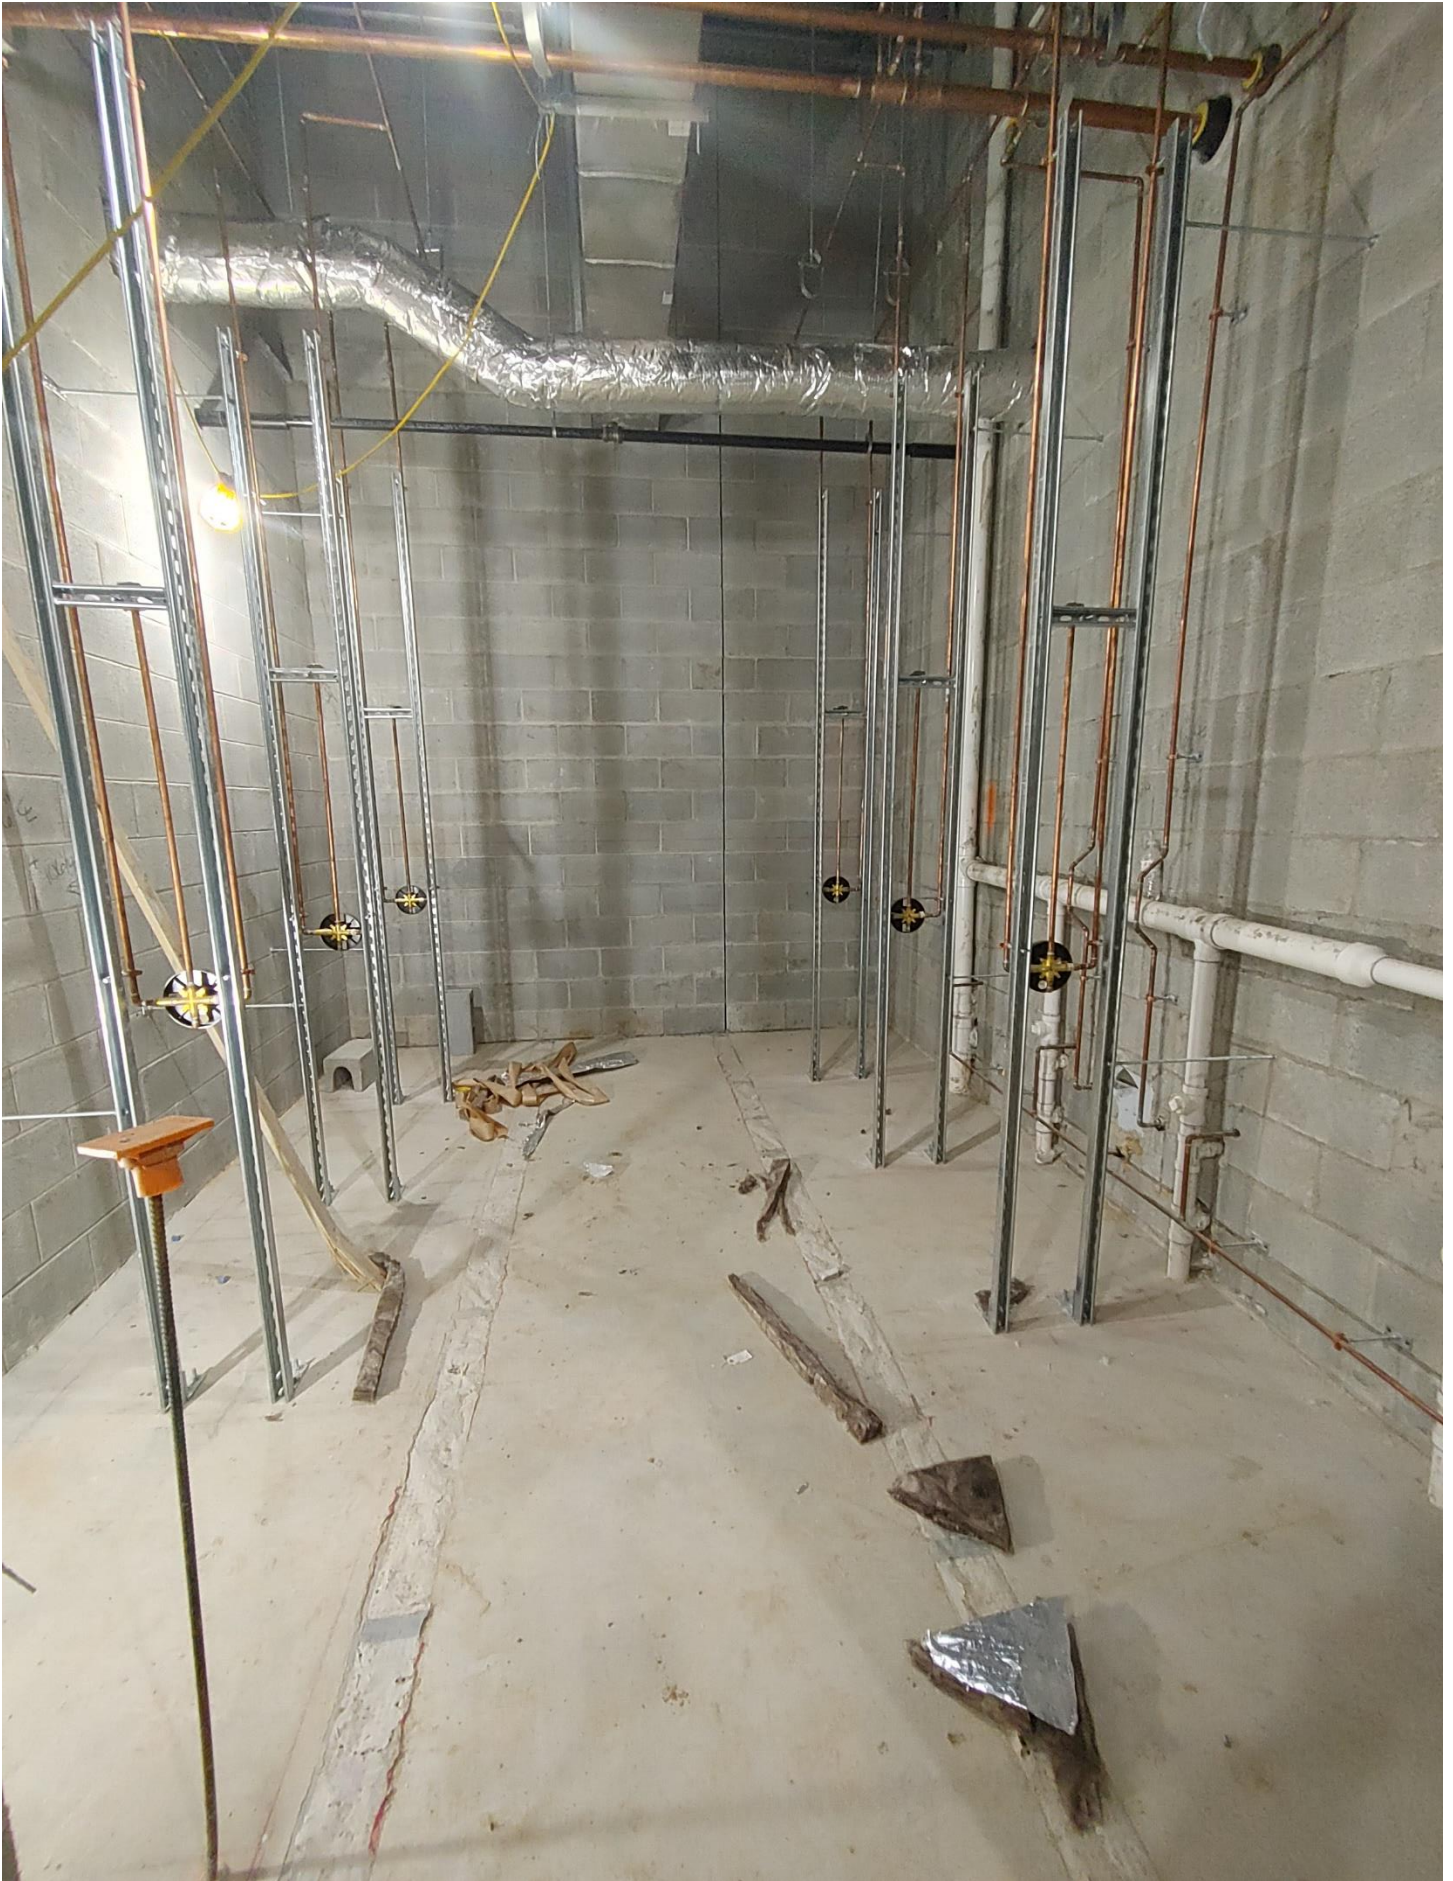
Photo 5 - Plumbing Rough-in in Room E126, Area E.

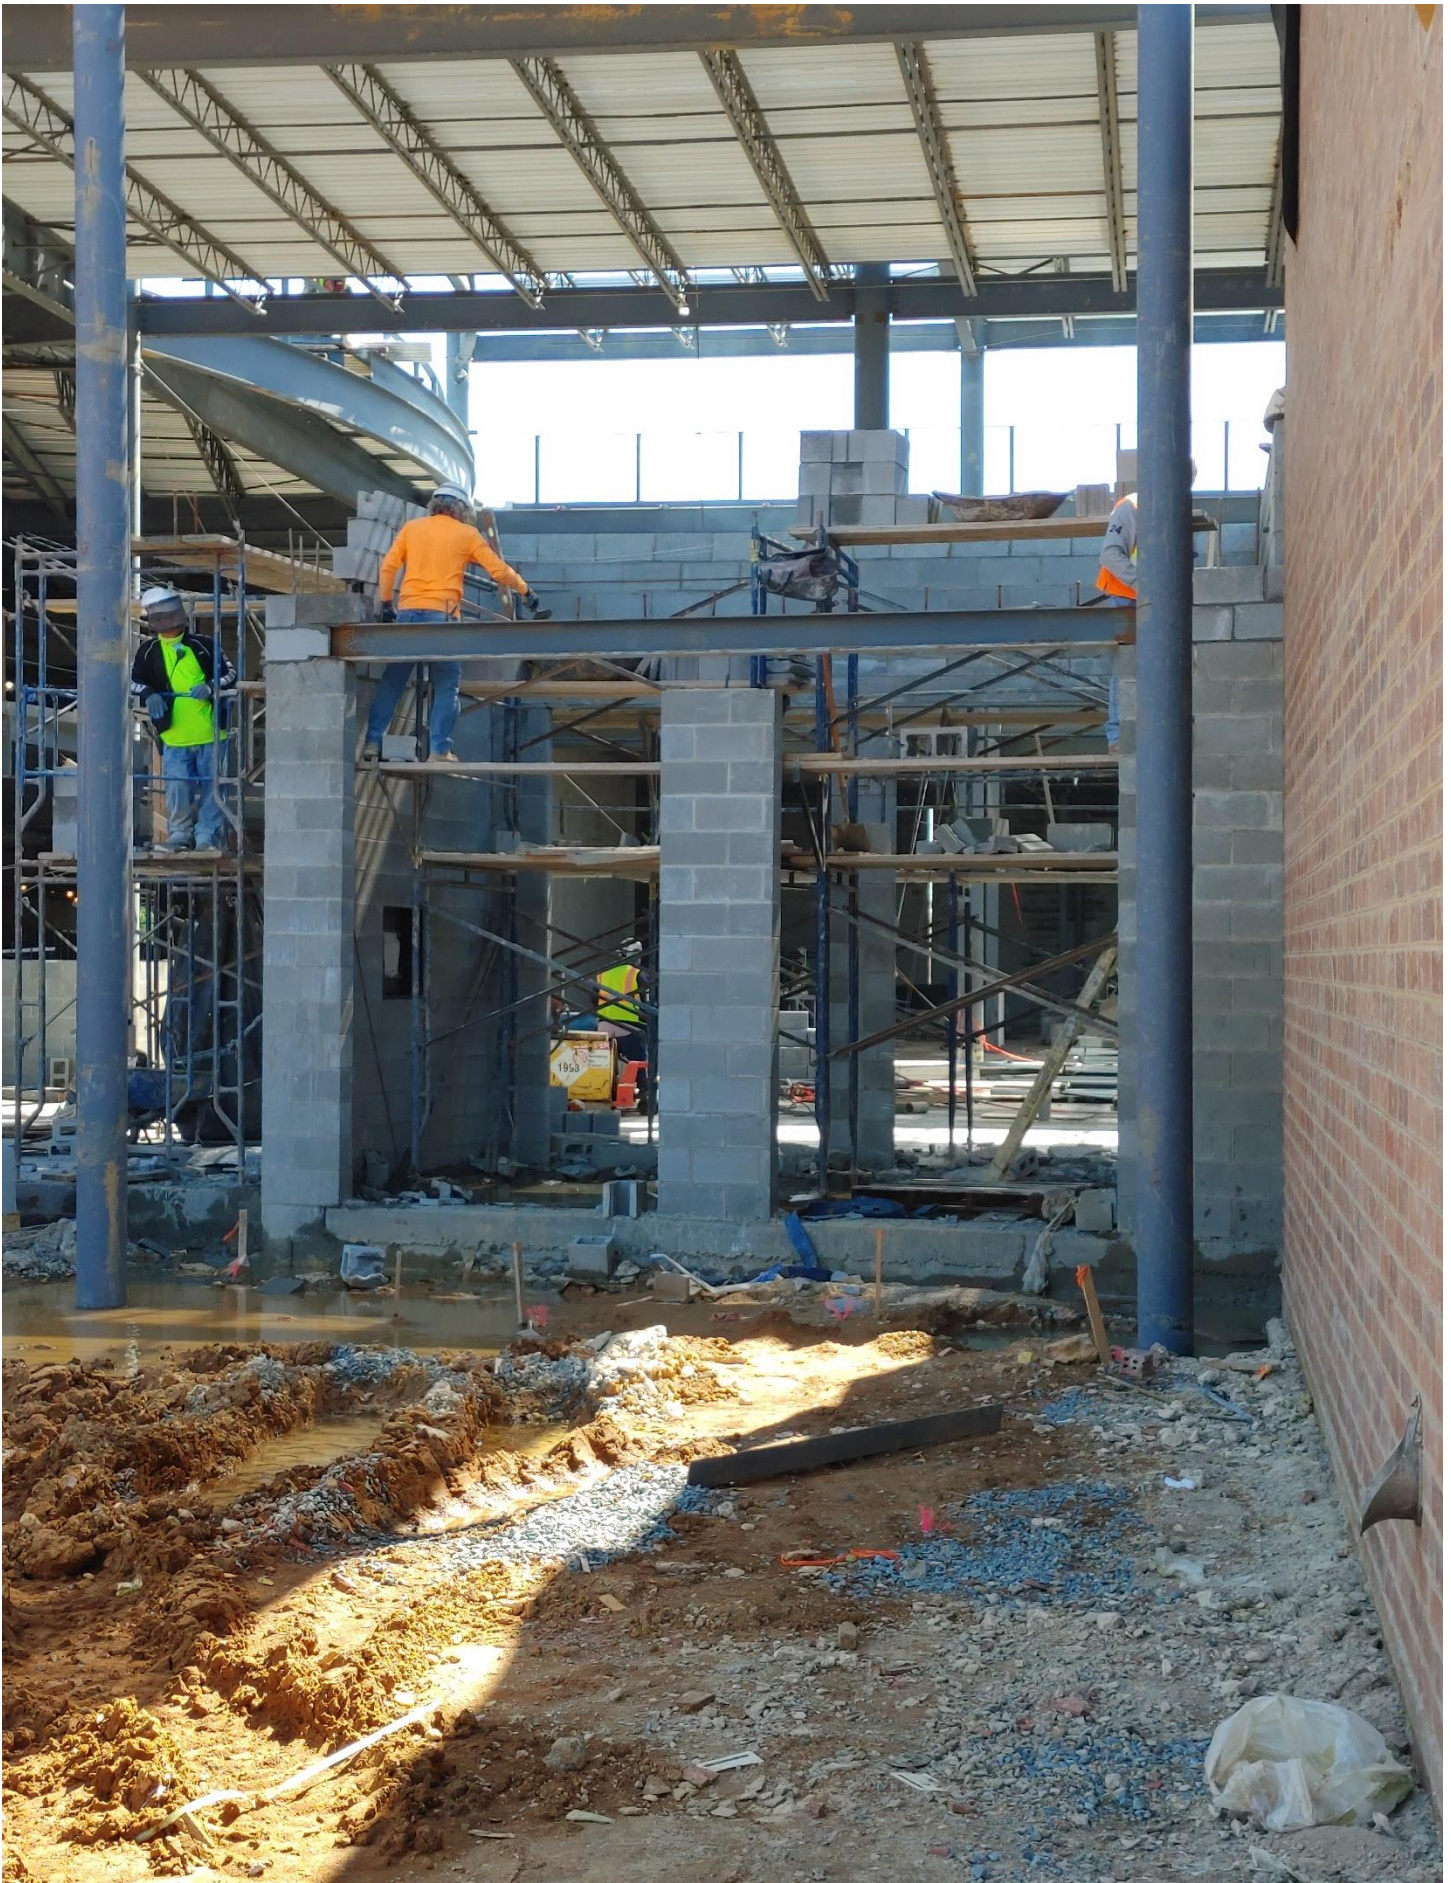
Photo 6 - J. D. Long laying block in Vestibule c10, Area C.

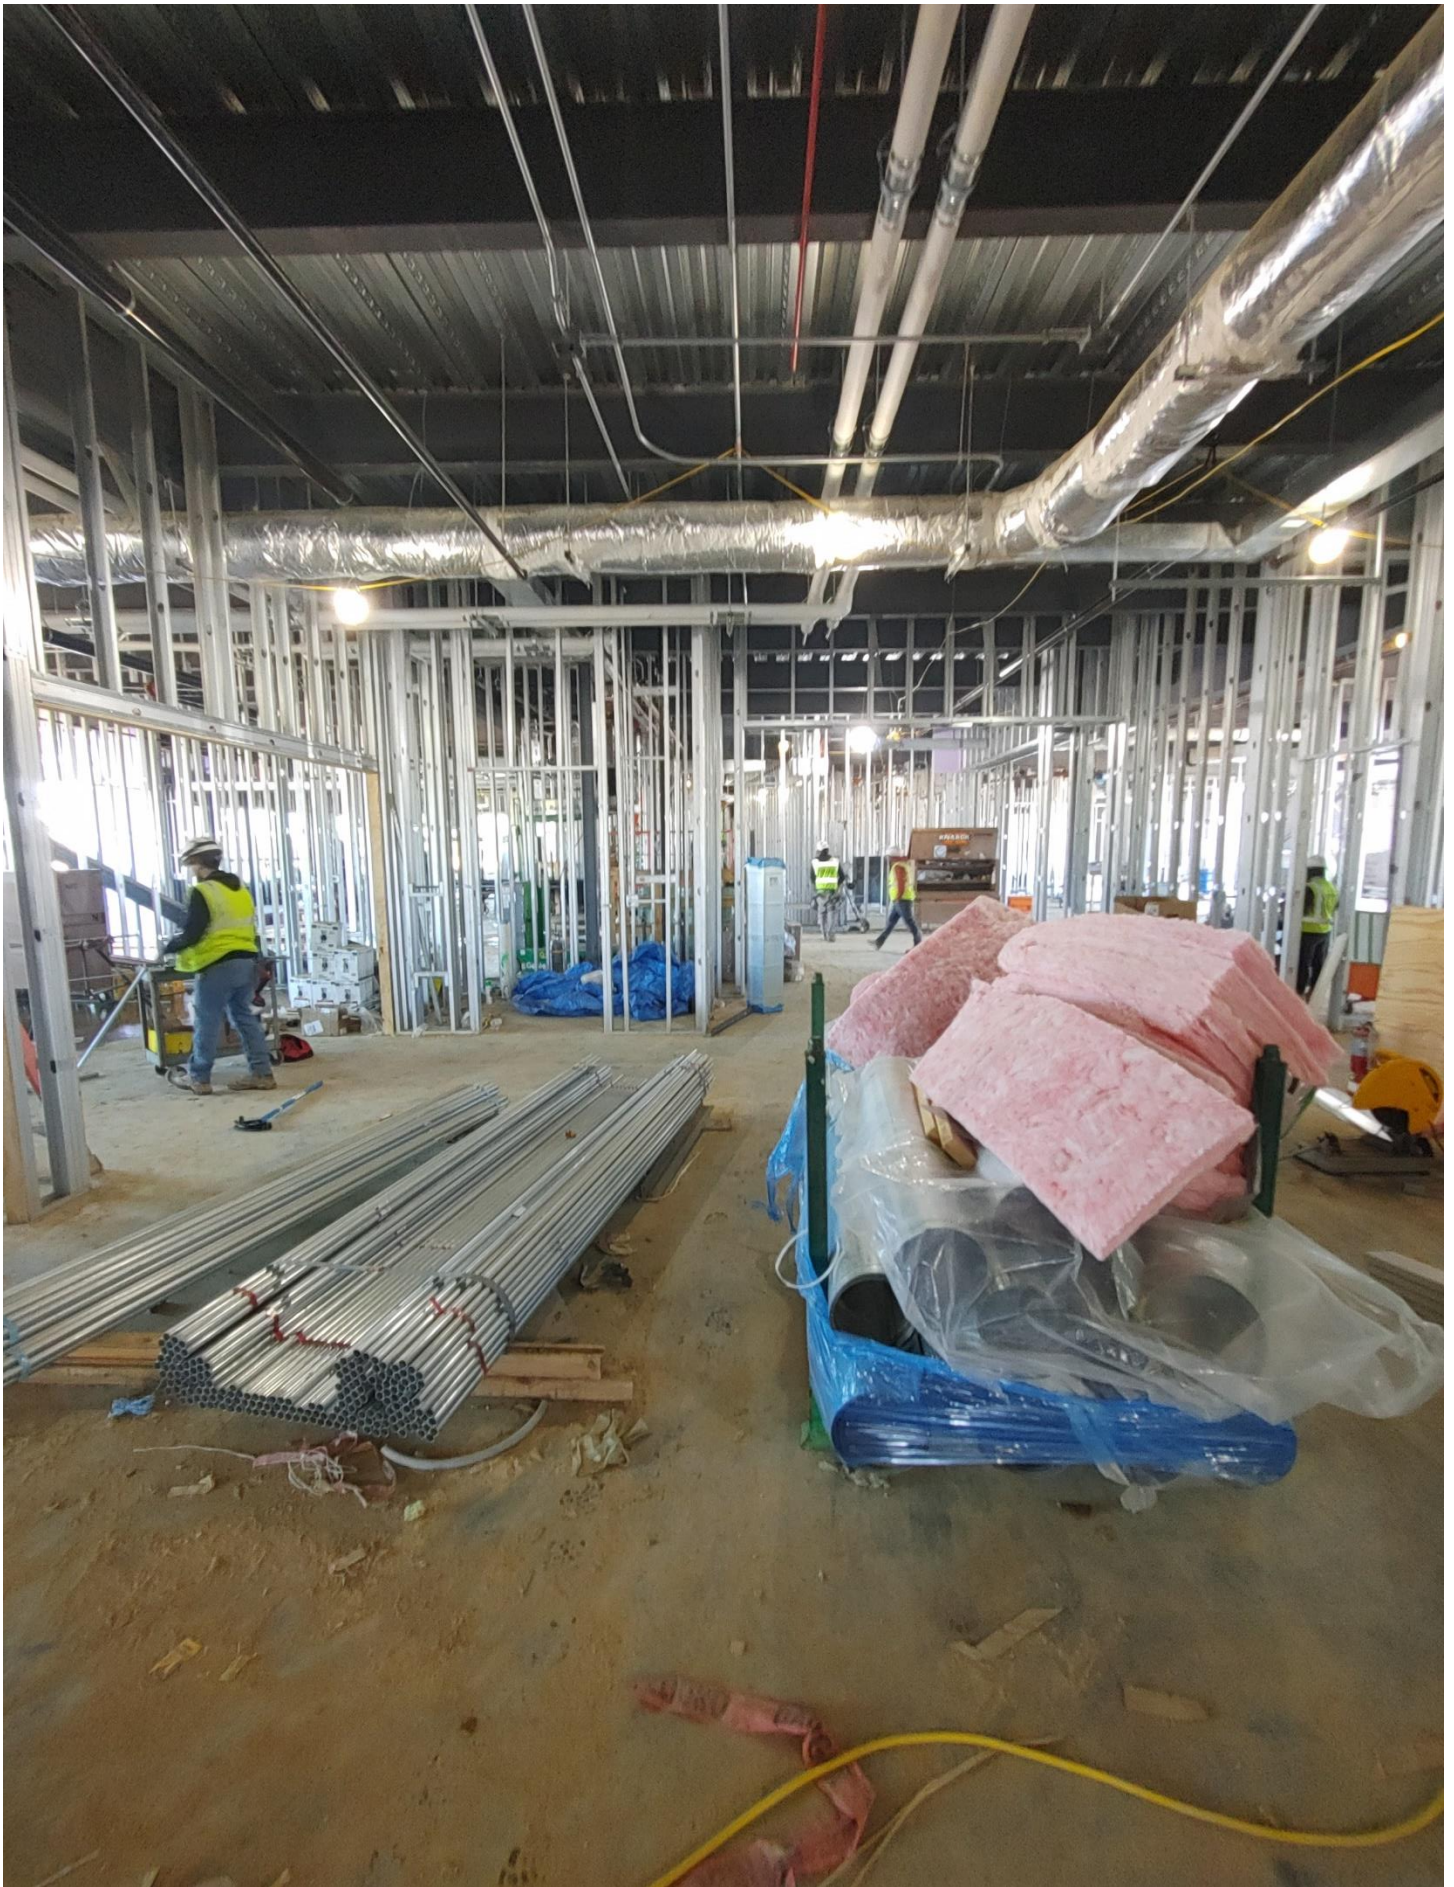
Photo 7 - Framing continues in Area B.

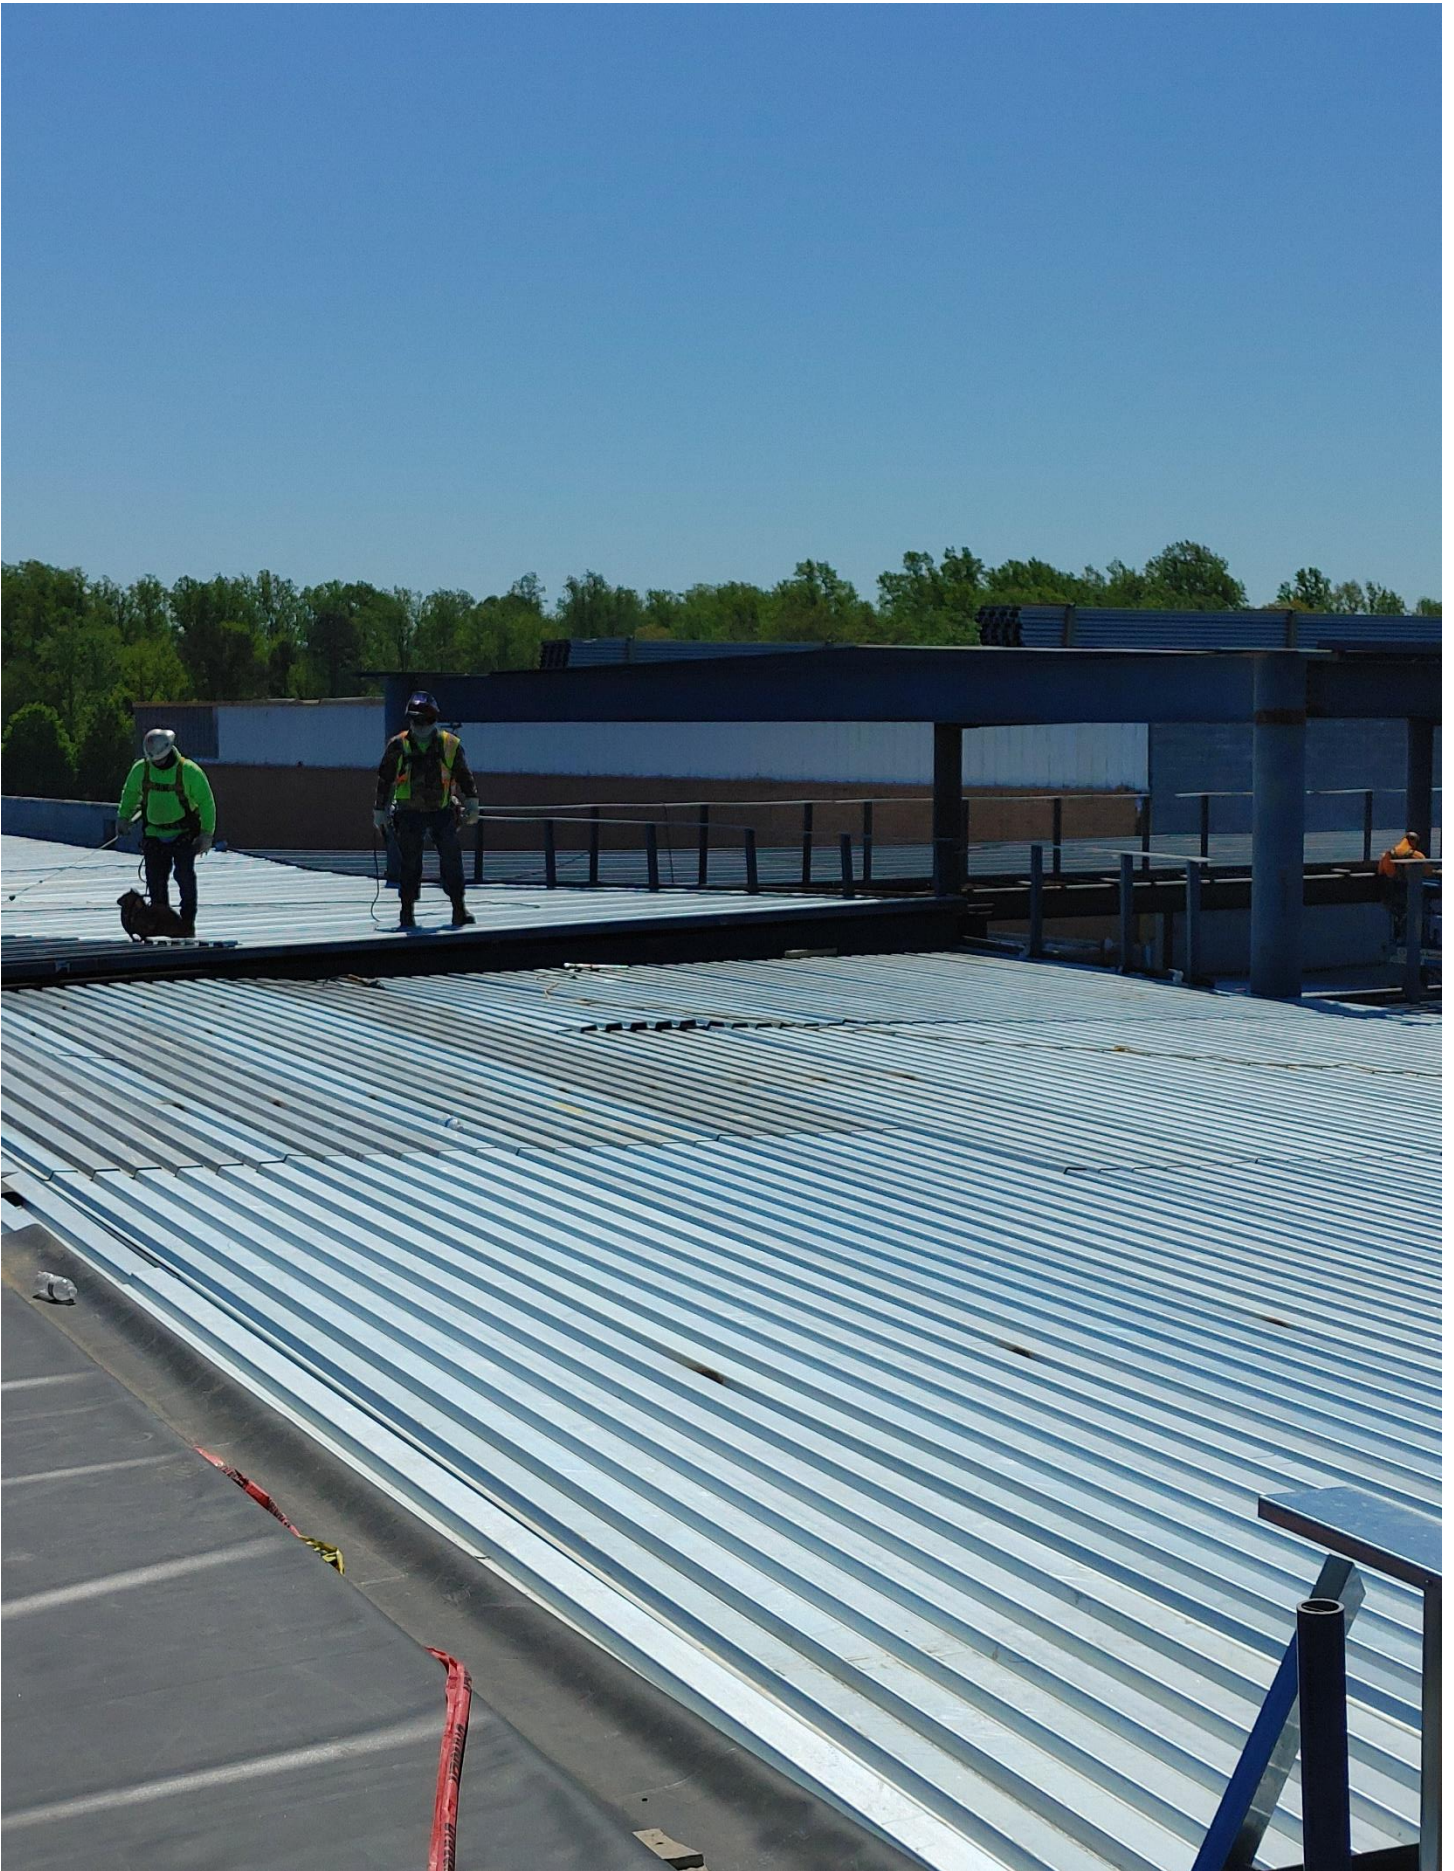
Photo 8 - Weldon Steel installing metal decking , Area A
