**DAILY REPORT**

**WESTMORELAND COUNTY HIGH SCHOOL**

Date: 04/27/2021  
Weather: 78 degrees at 12:00hrs. High of 86 degrees today.  
Hours Worked: 12:00hrs – 15:00hrs (3hrs) Site Visit.

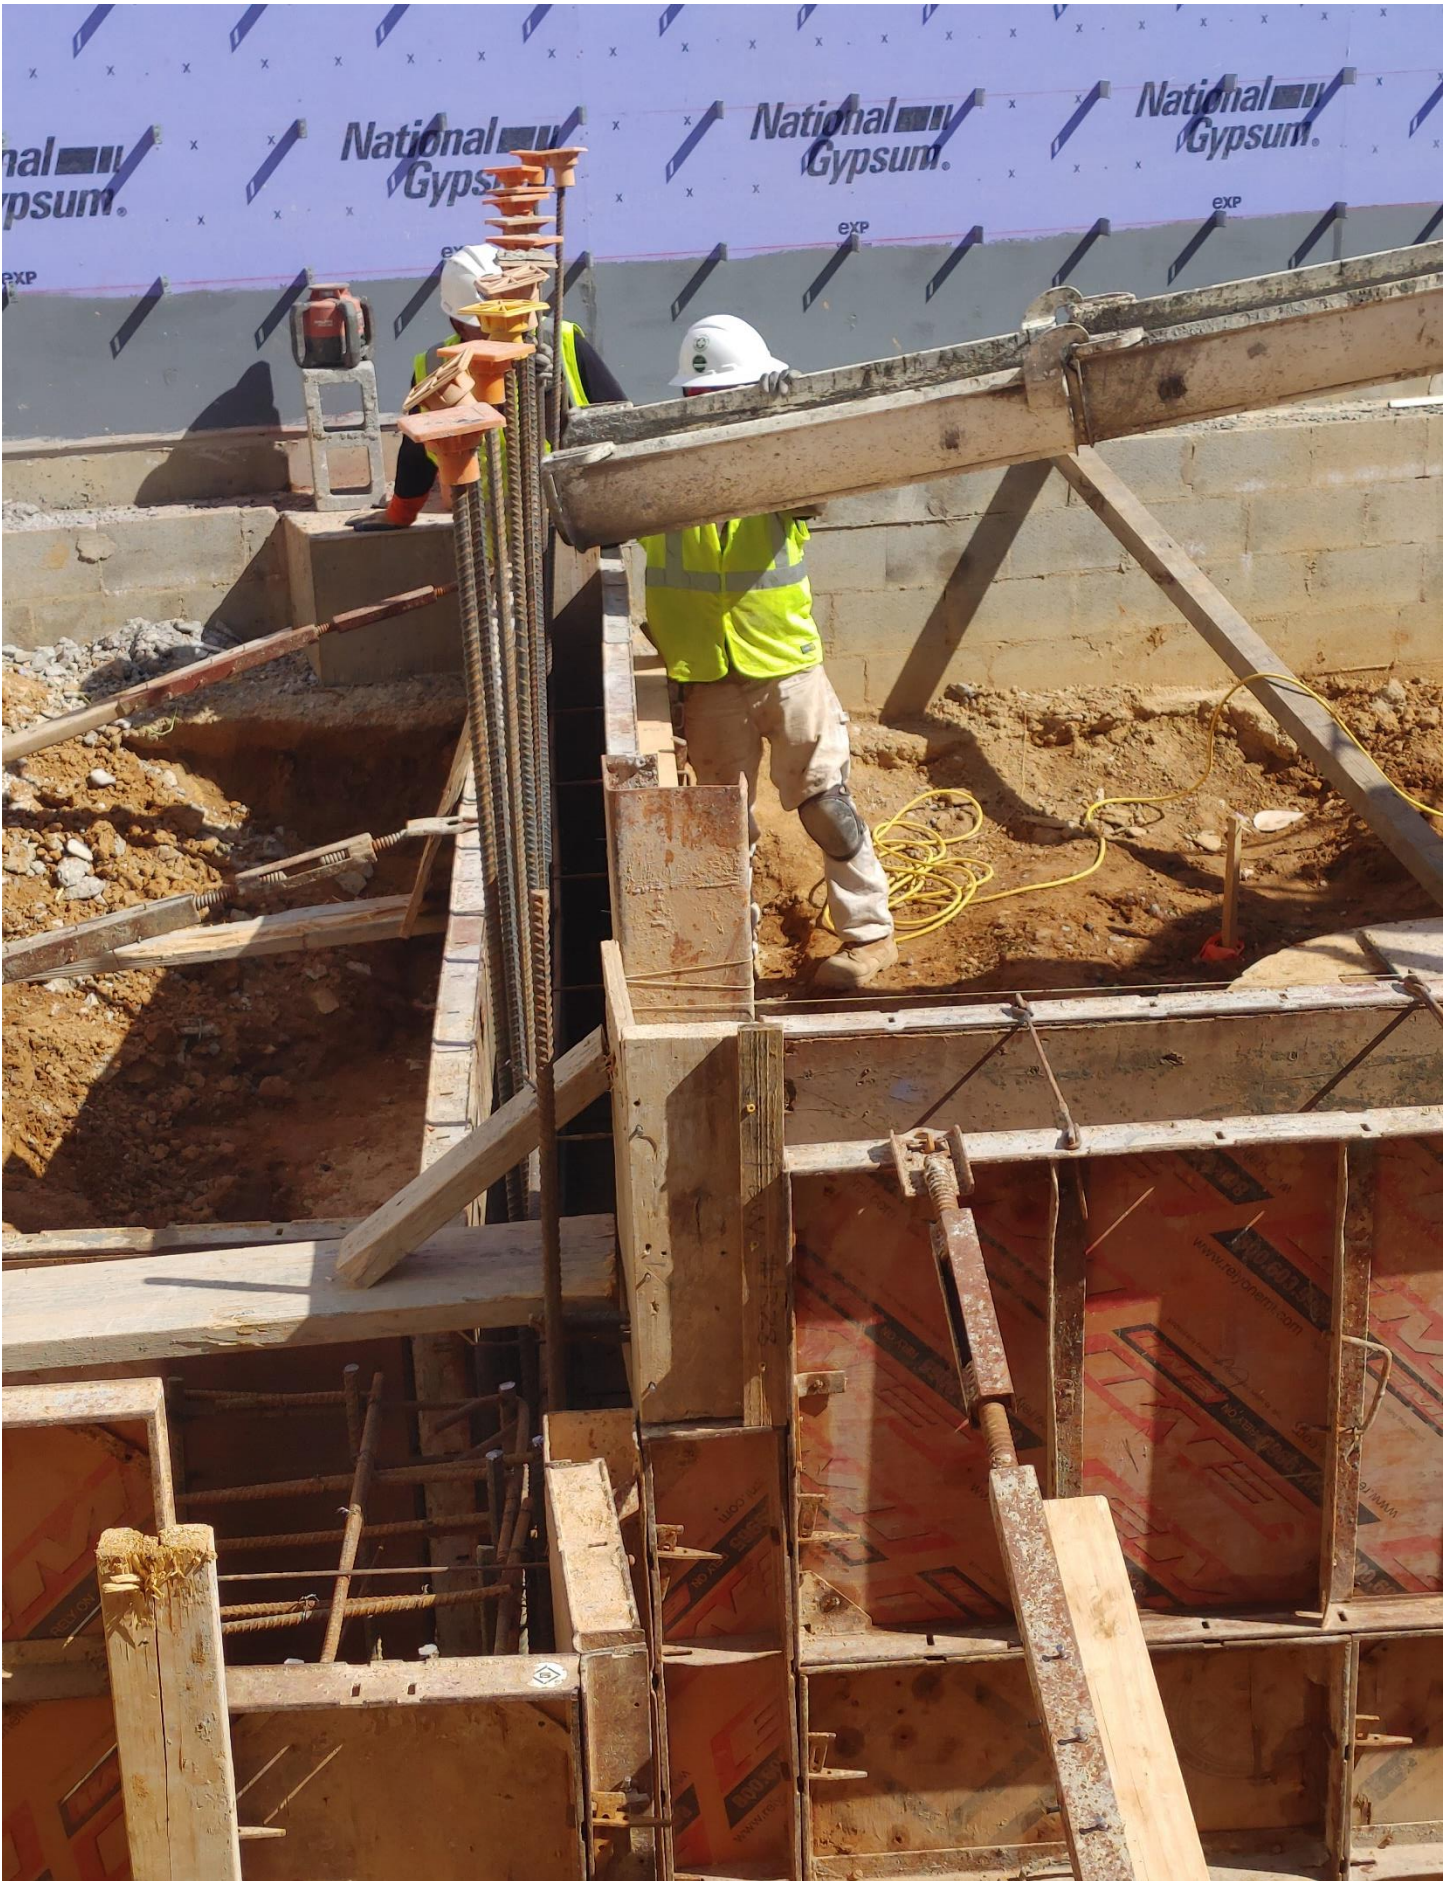
Photo 1 - Preparing to pour the Concrete for the Loading Dock Wall

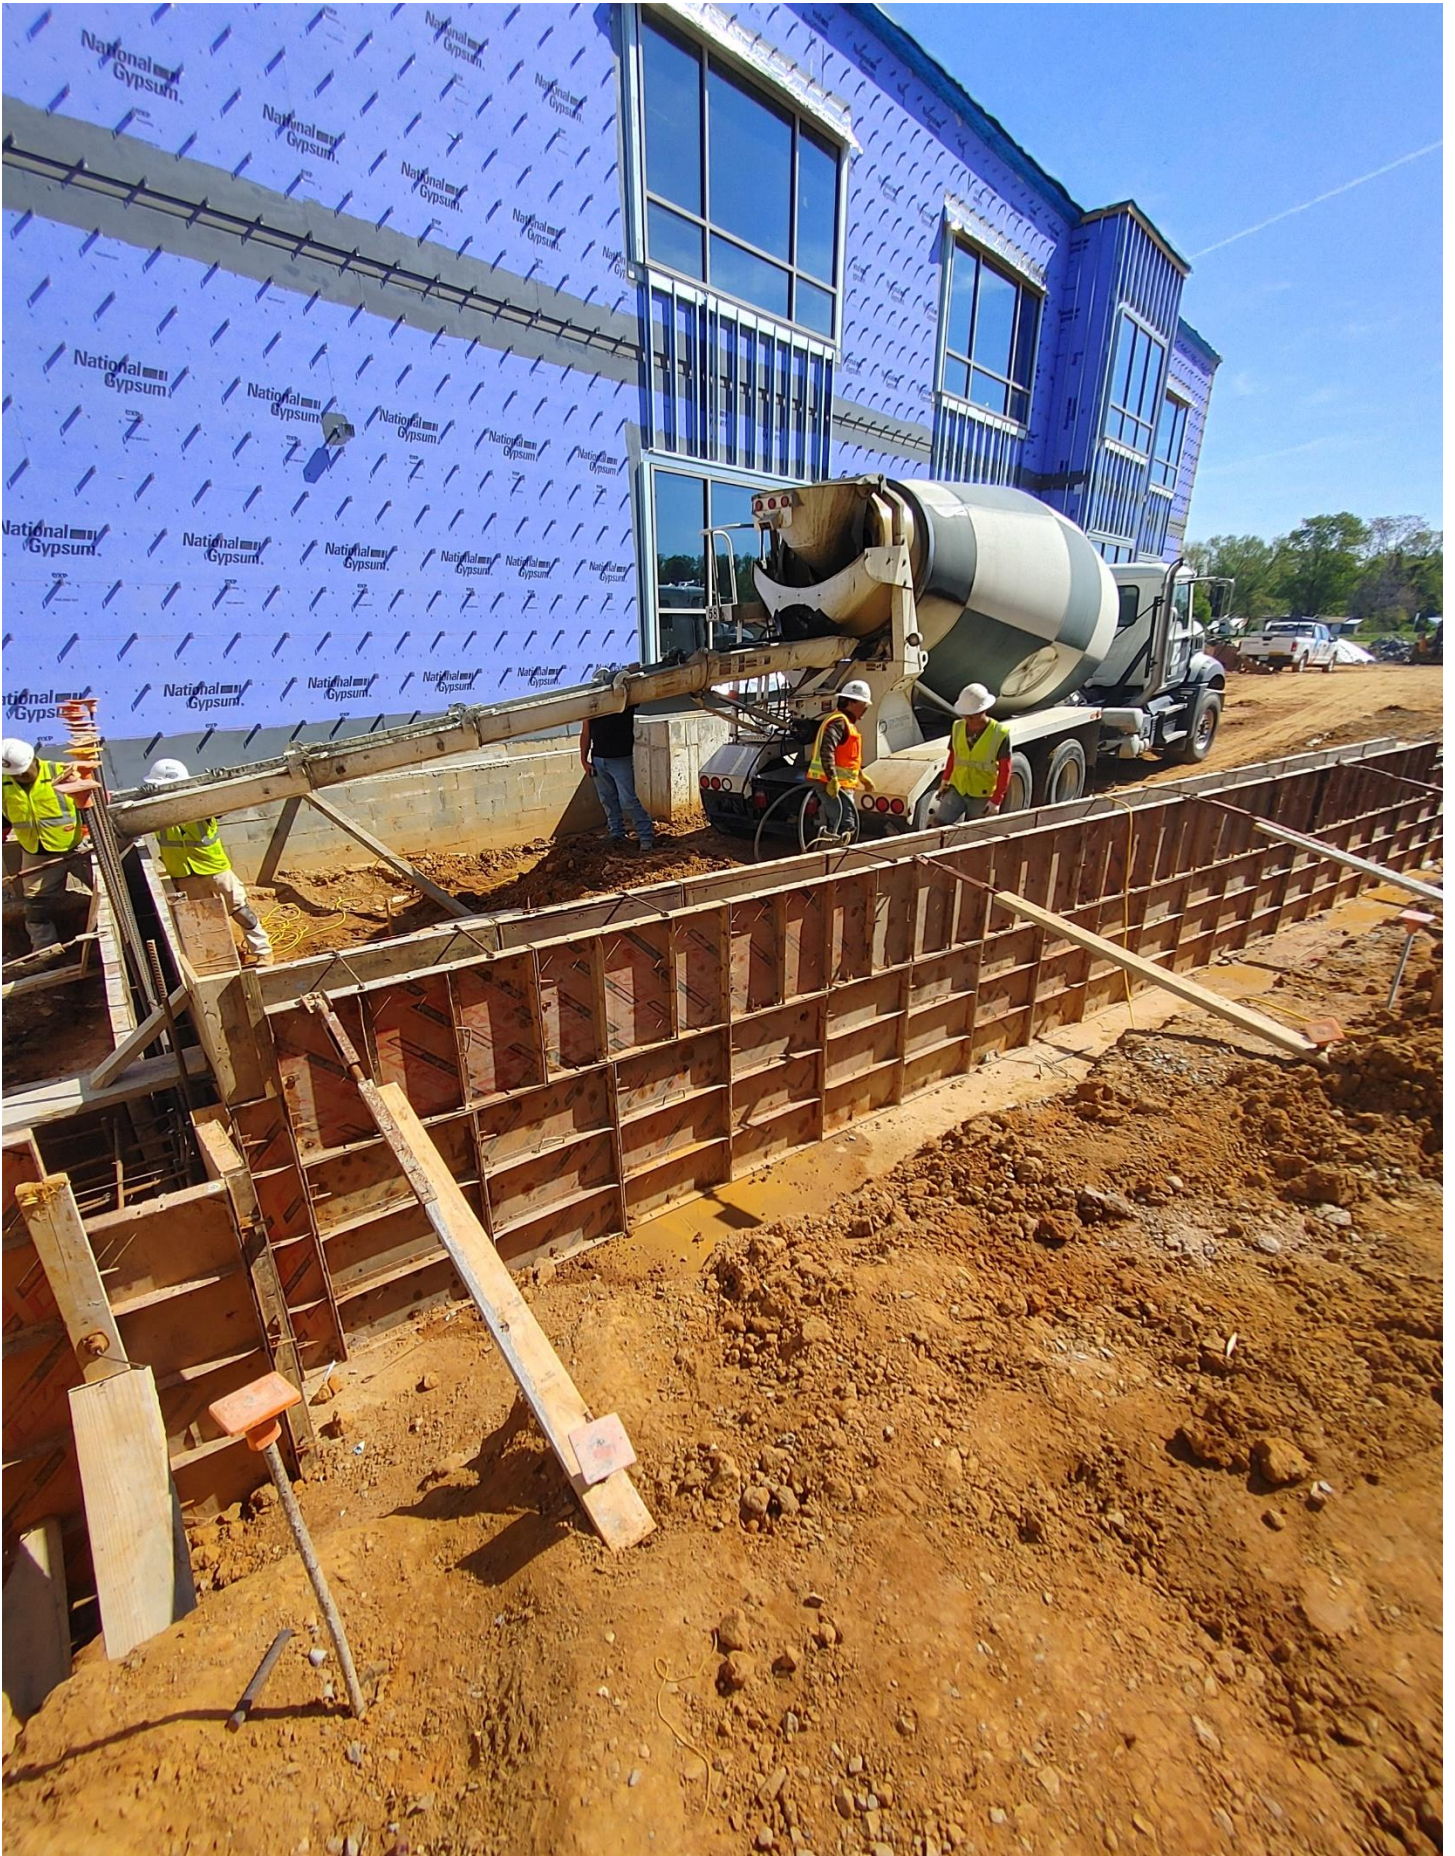
Photo 2 - Loading Dock wall being poured

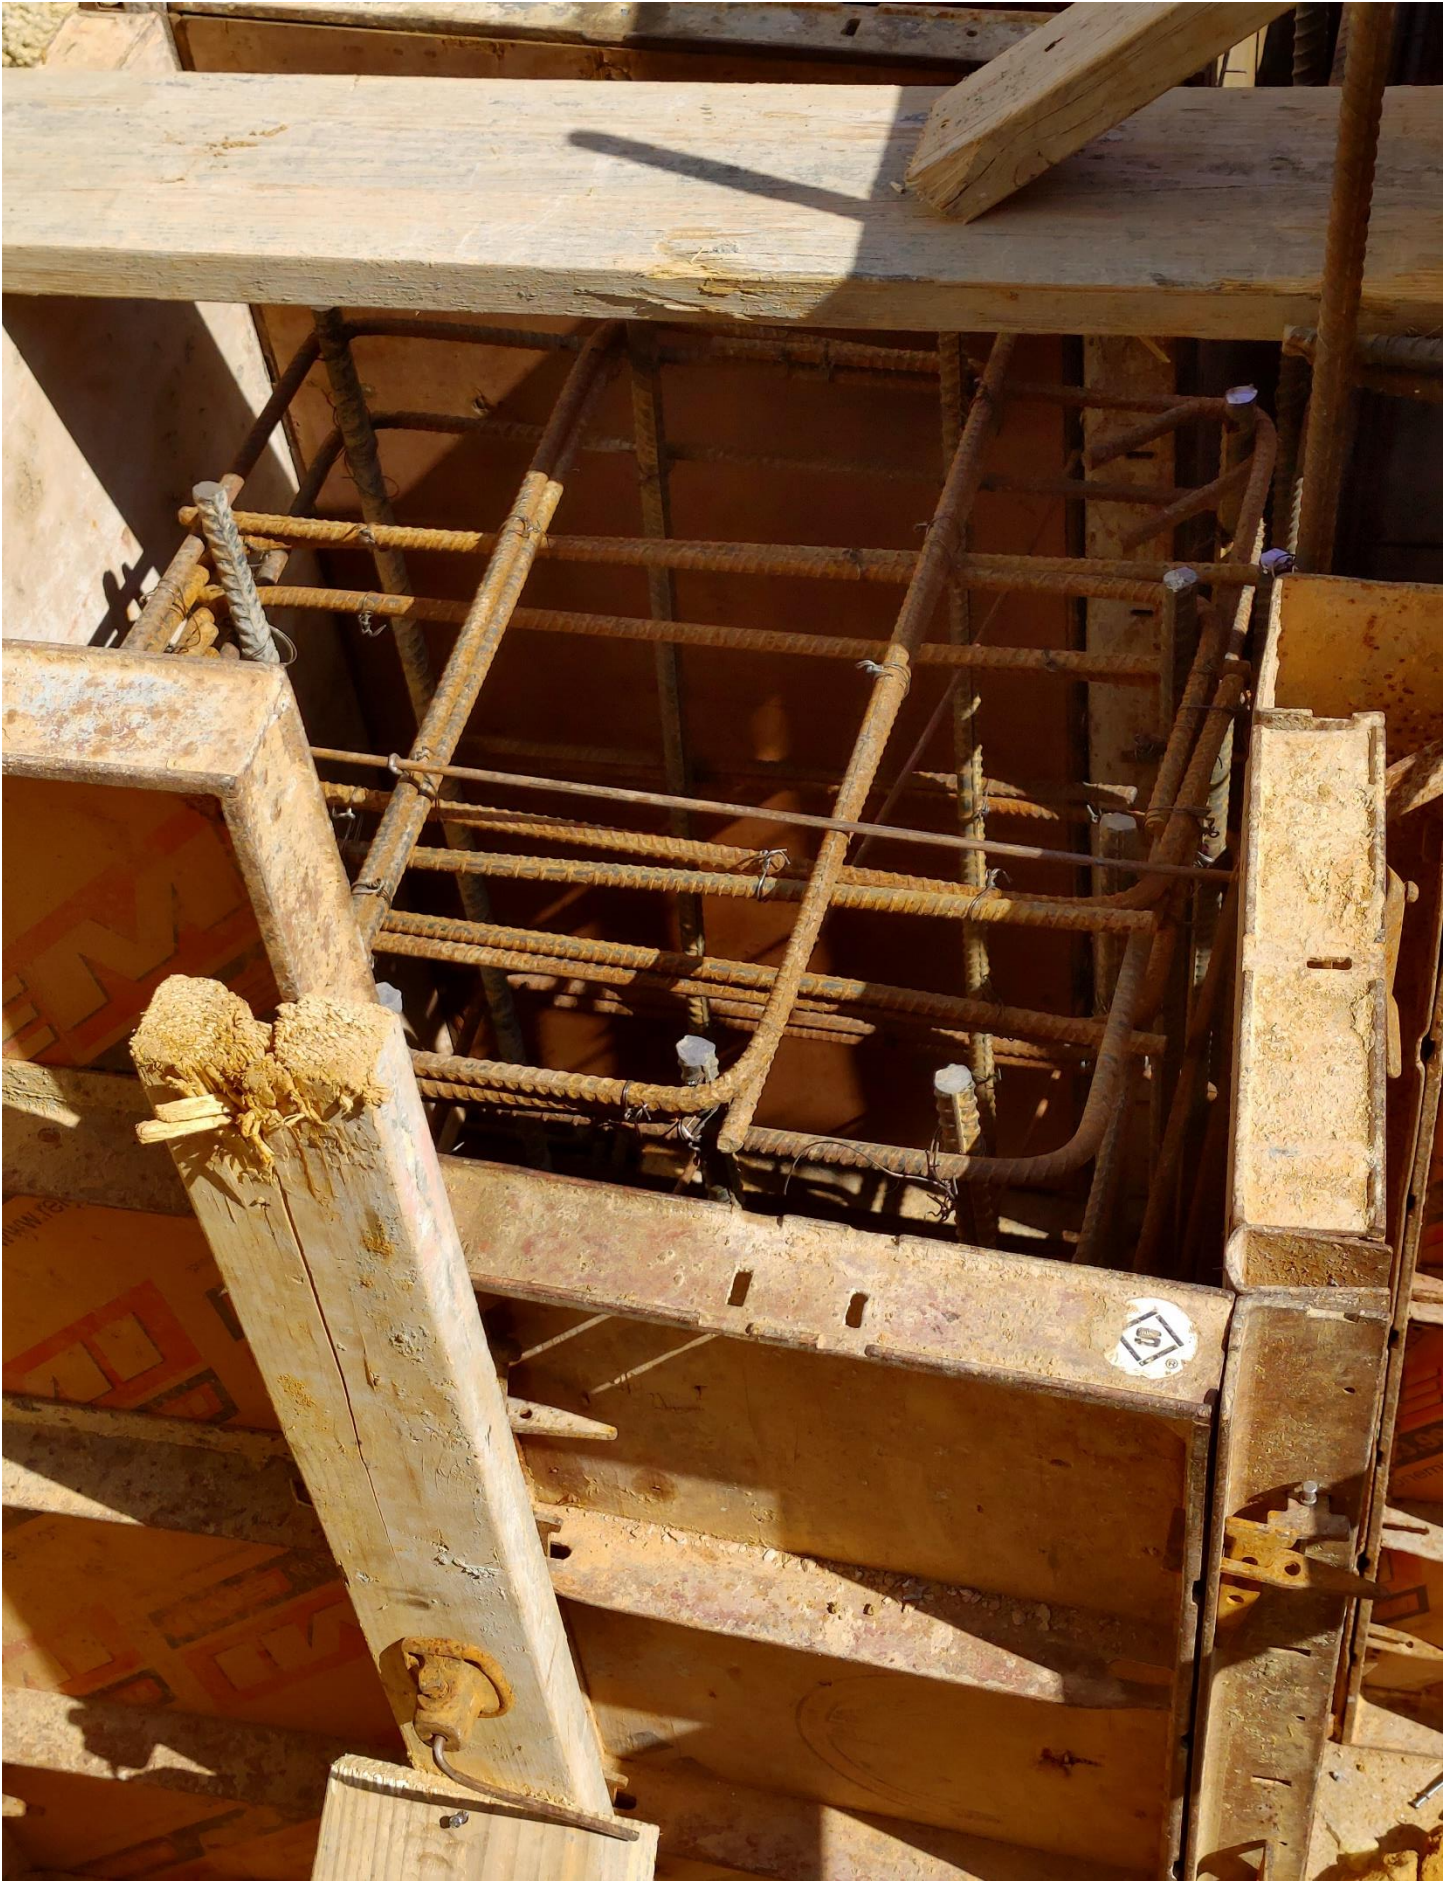
Photo 3 - Rebar cage in corner of Loading Dock Wall

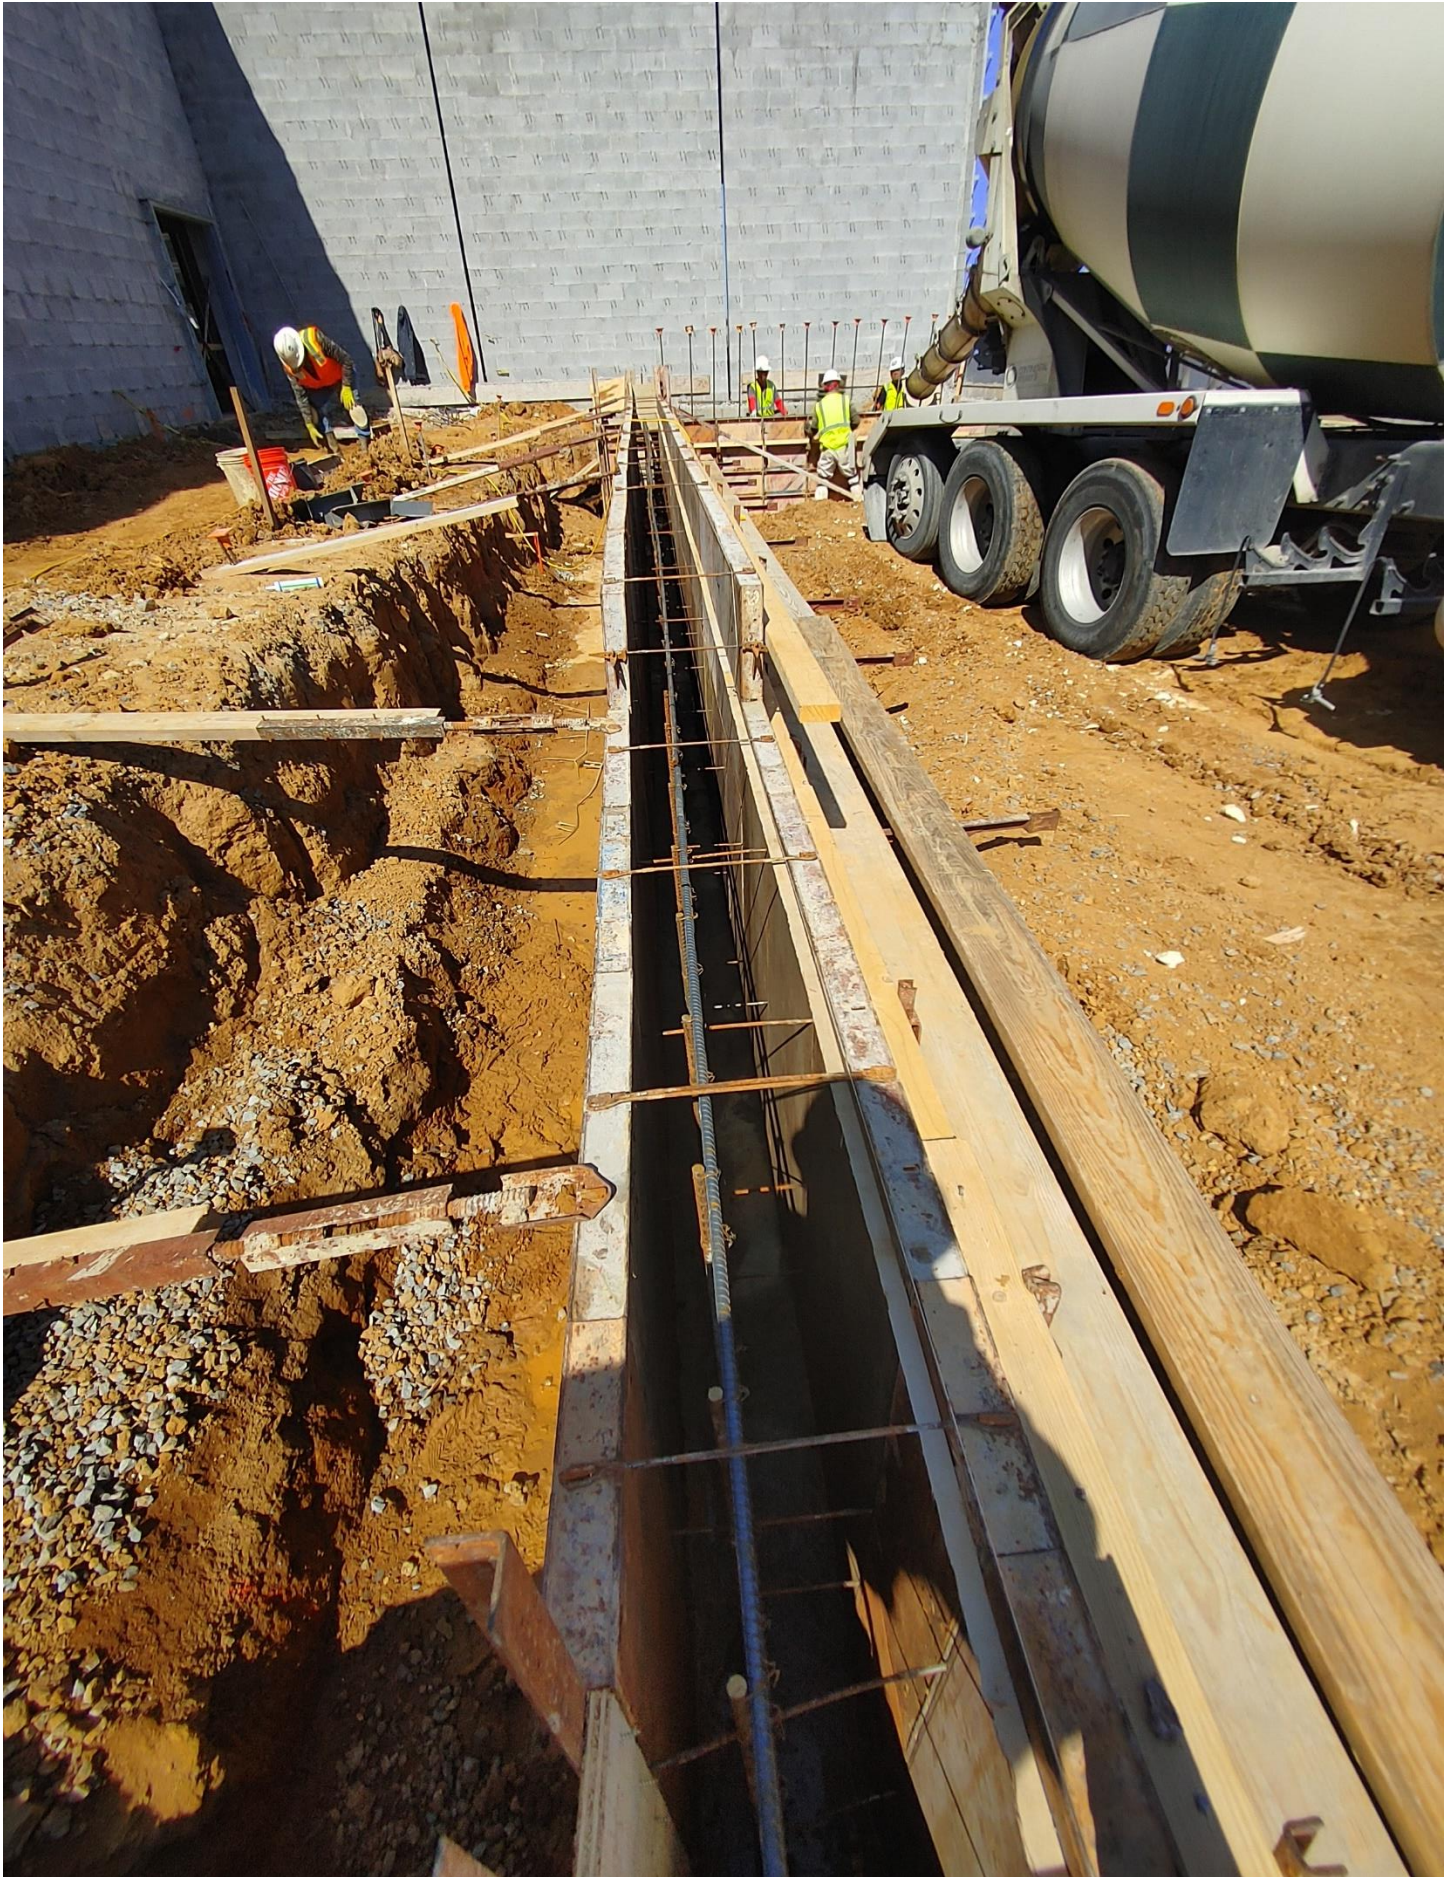
Photo 4 - Verification of Rebar in Loading Dock Wall

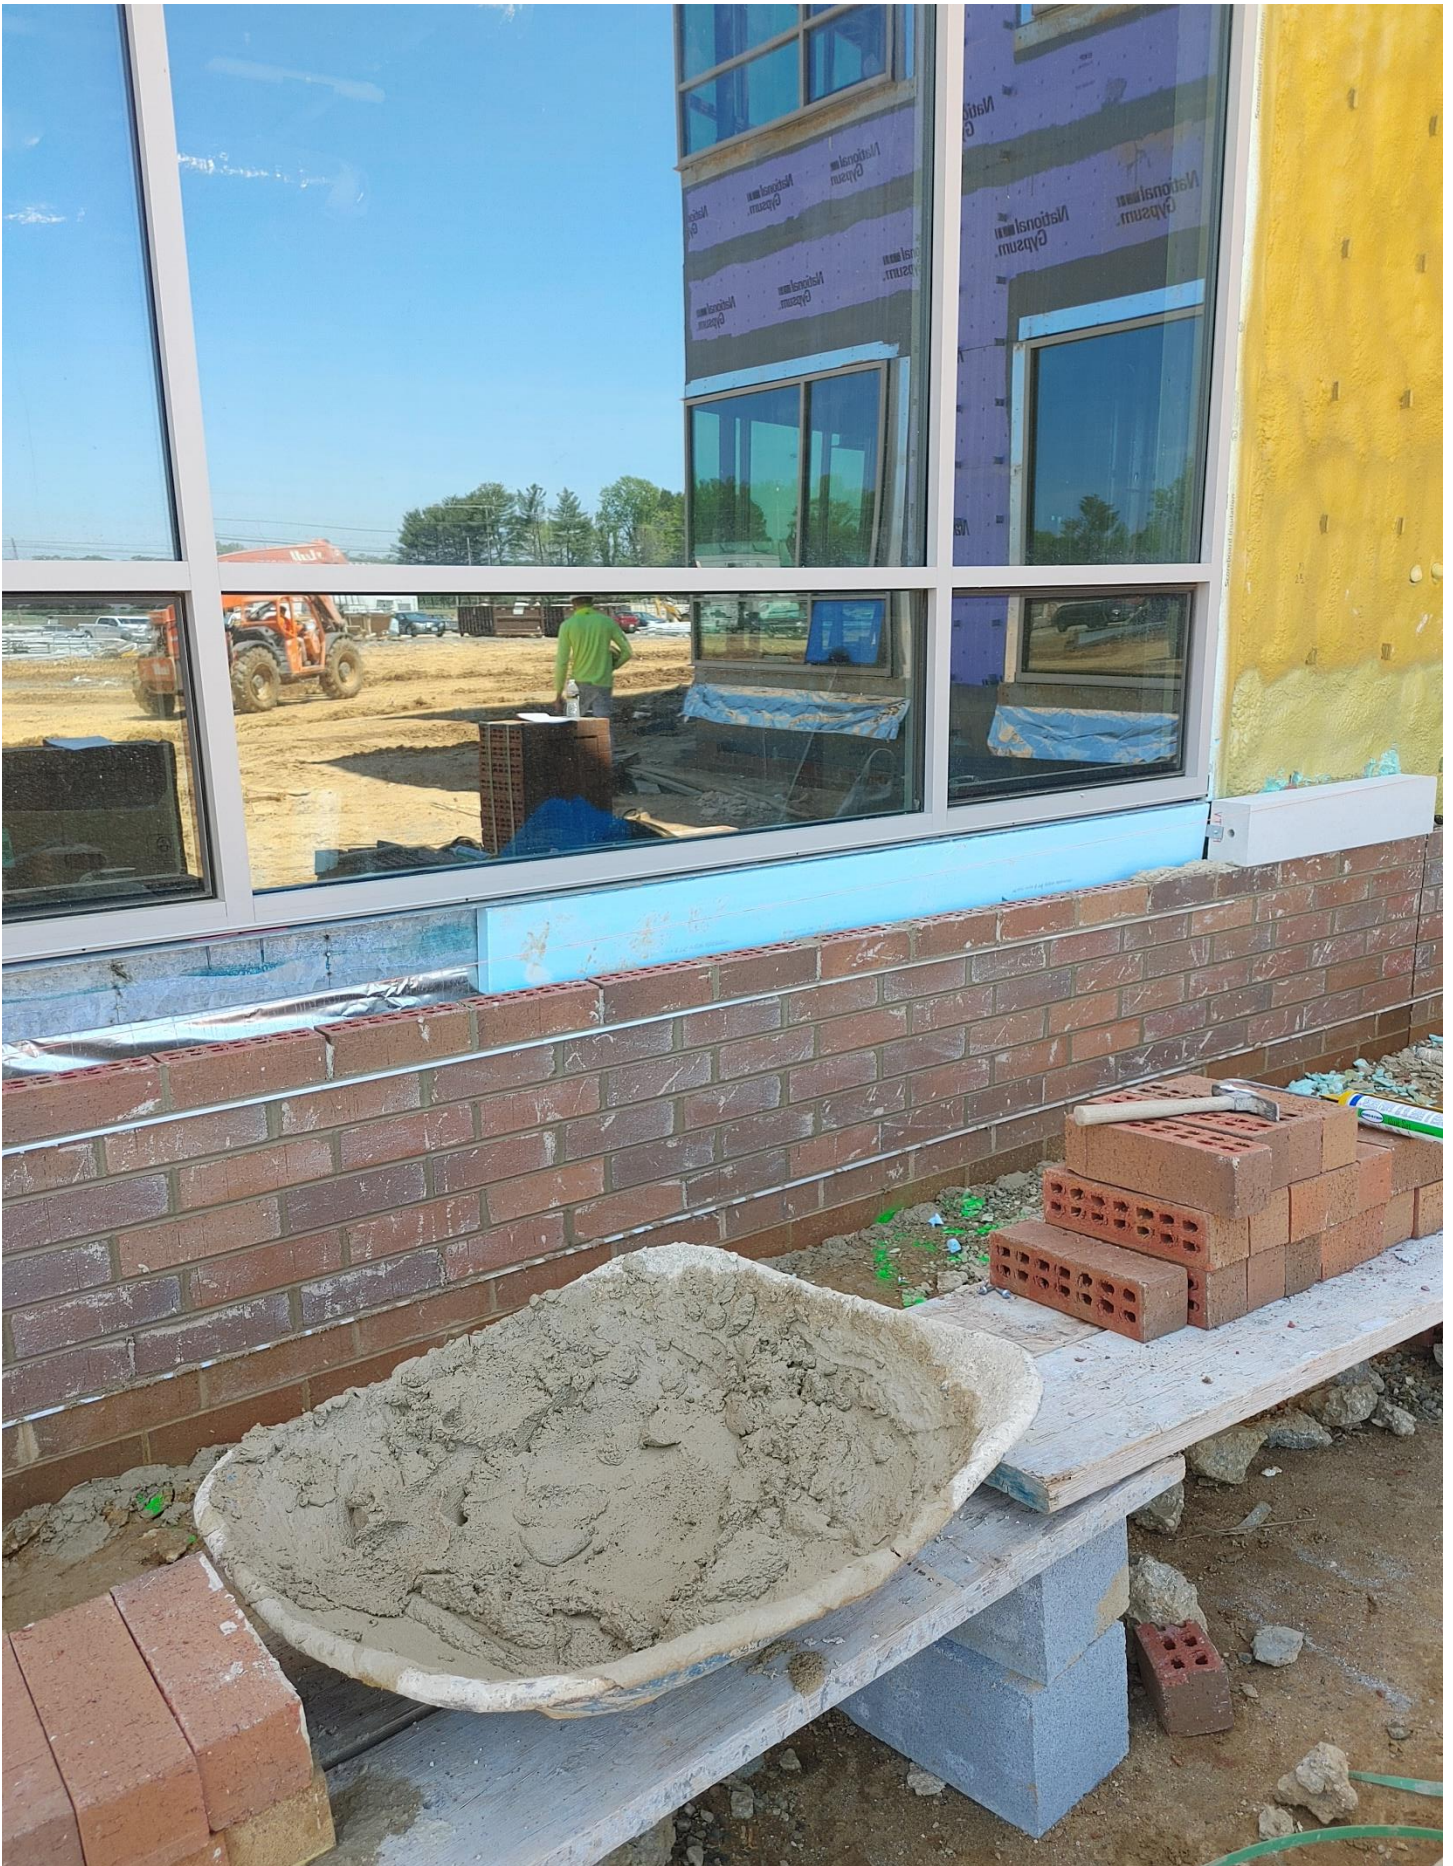
Photo 5 - Brick being laid on the North side of Area A. Flashing is installed and Precast being laid.

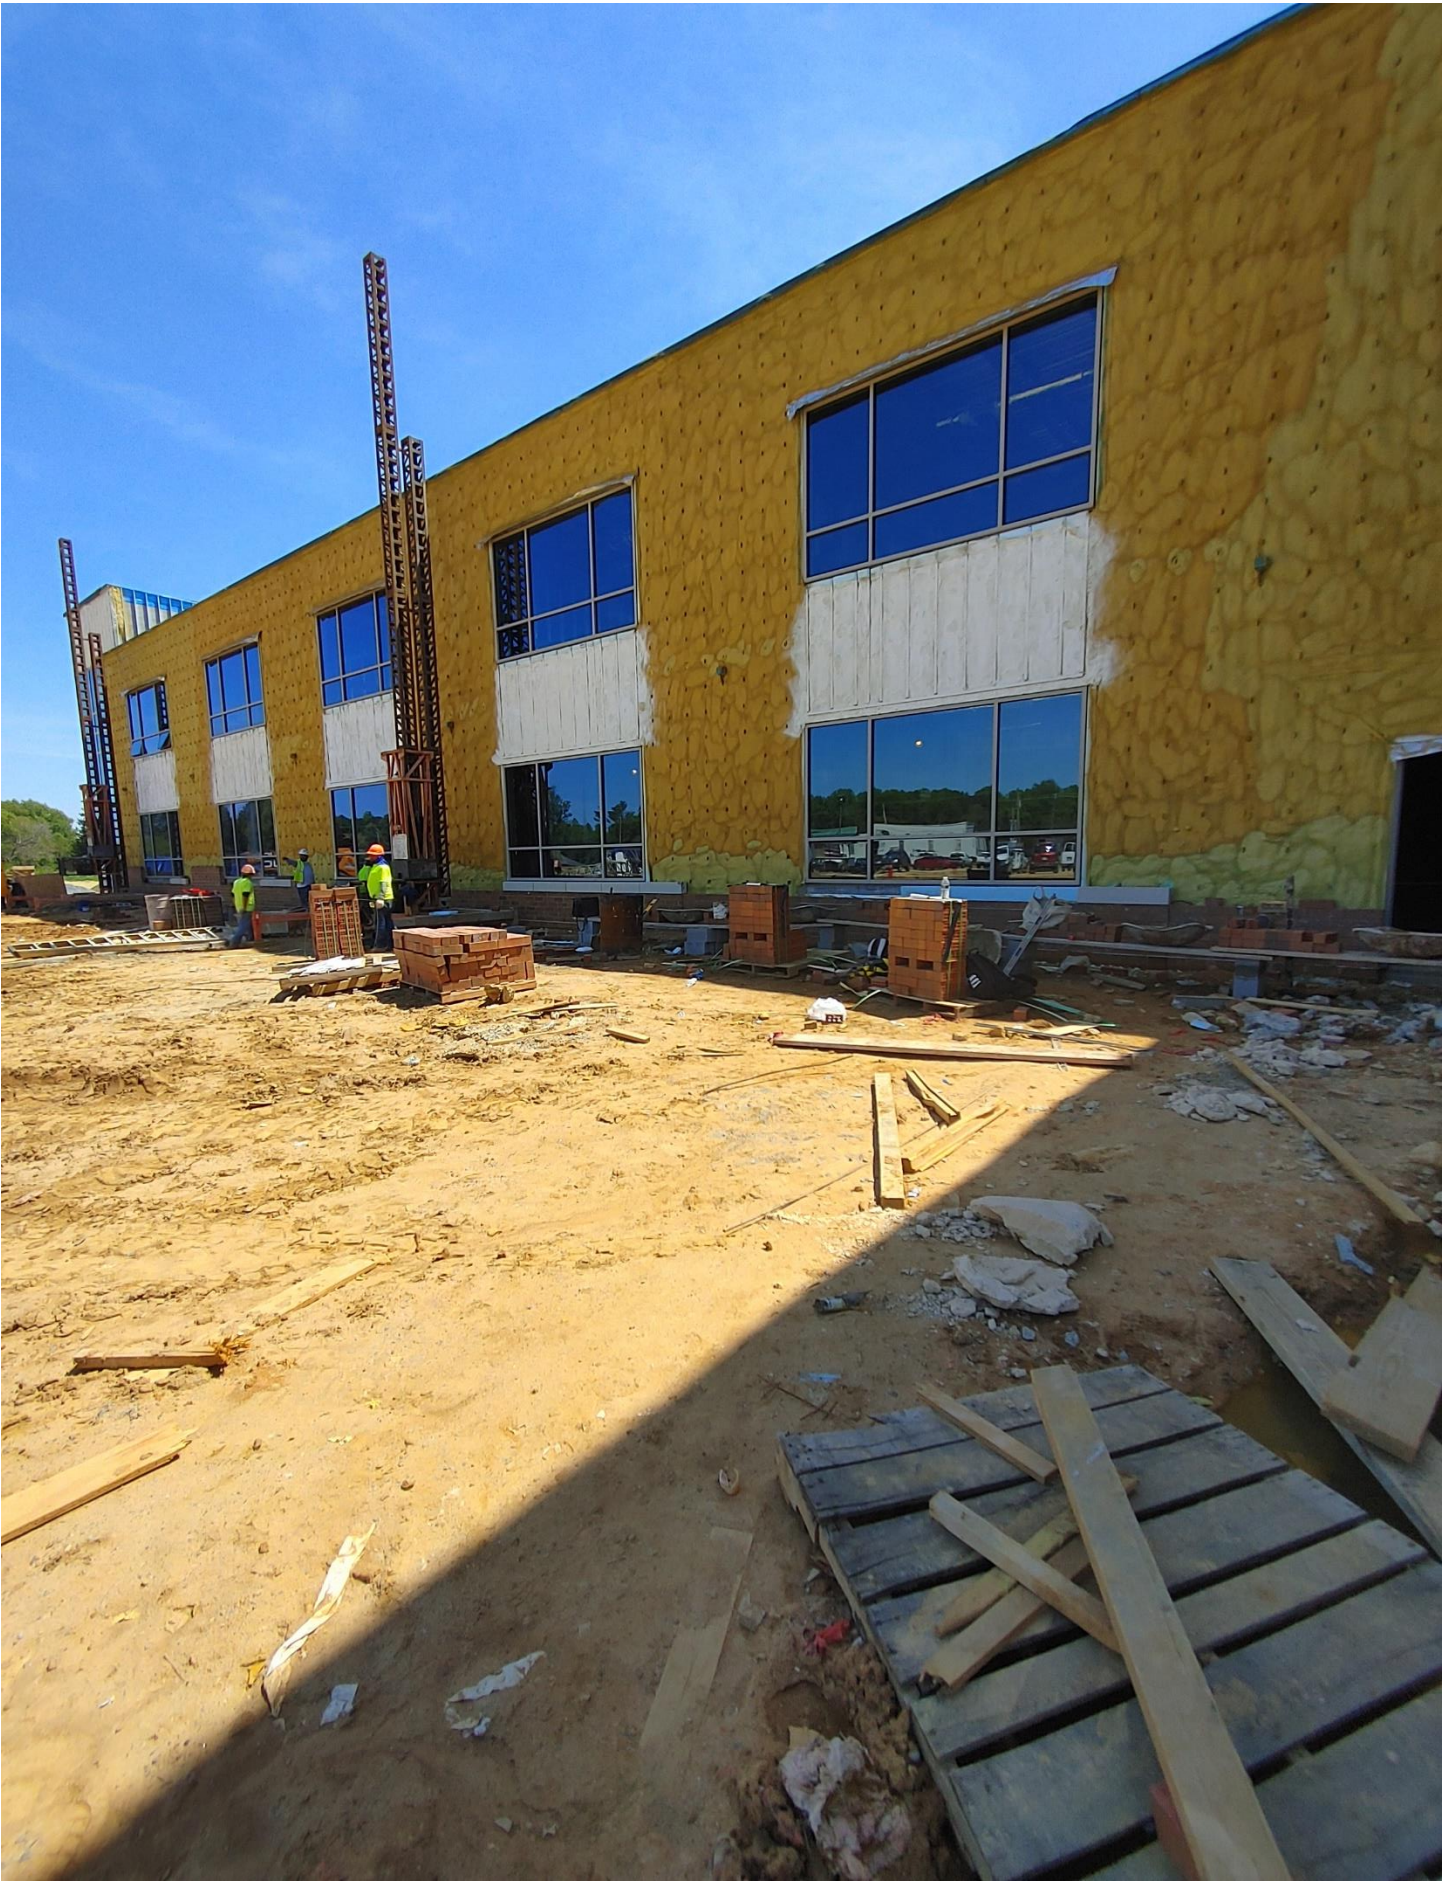
Photo 6 - Brick being laid on the Northside of Area A. Fraco Scaffolding being erected.

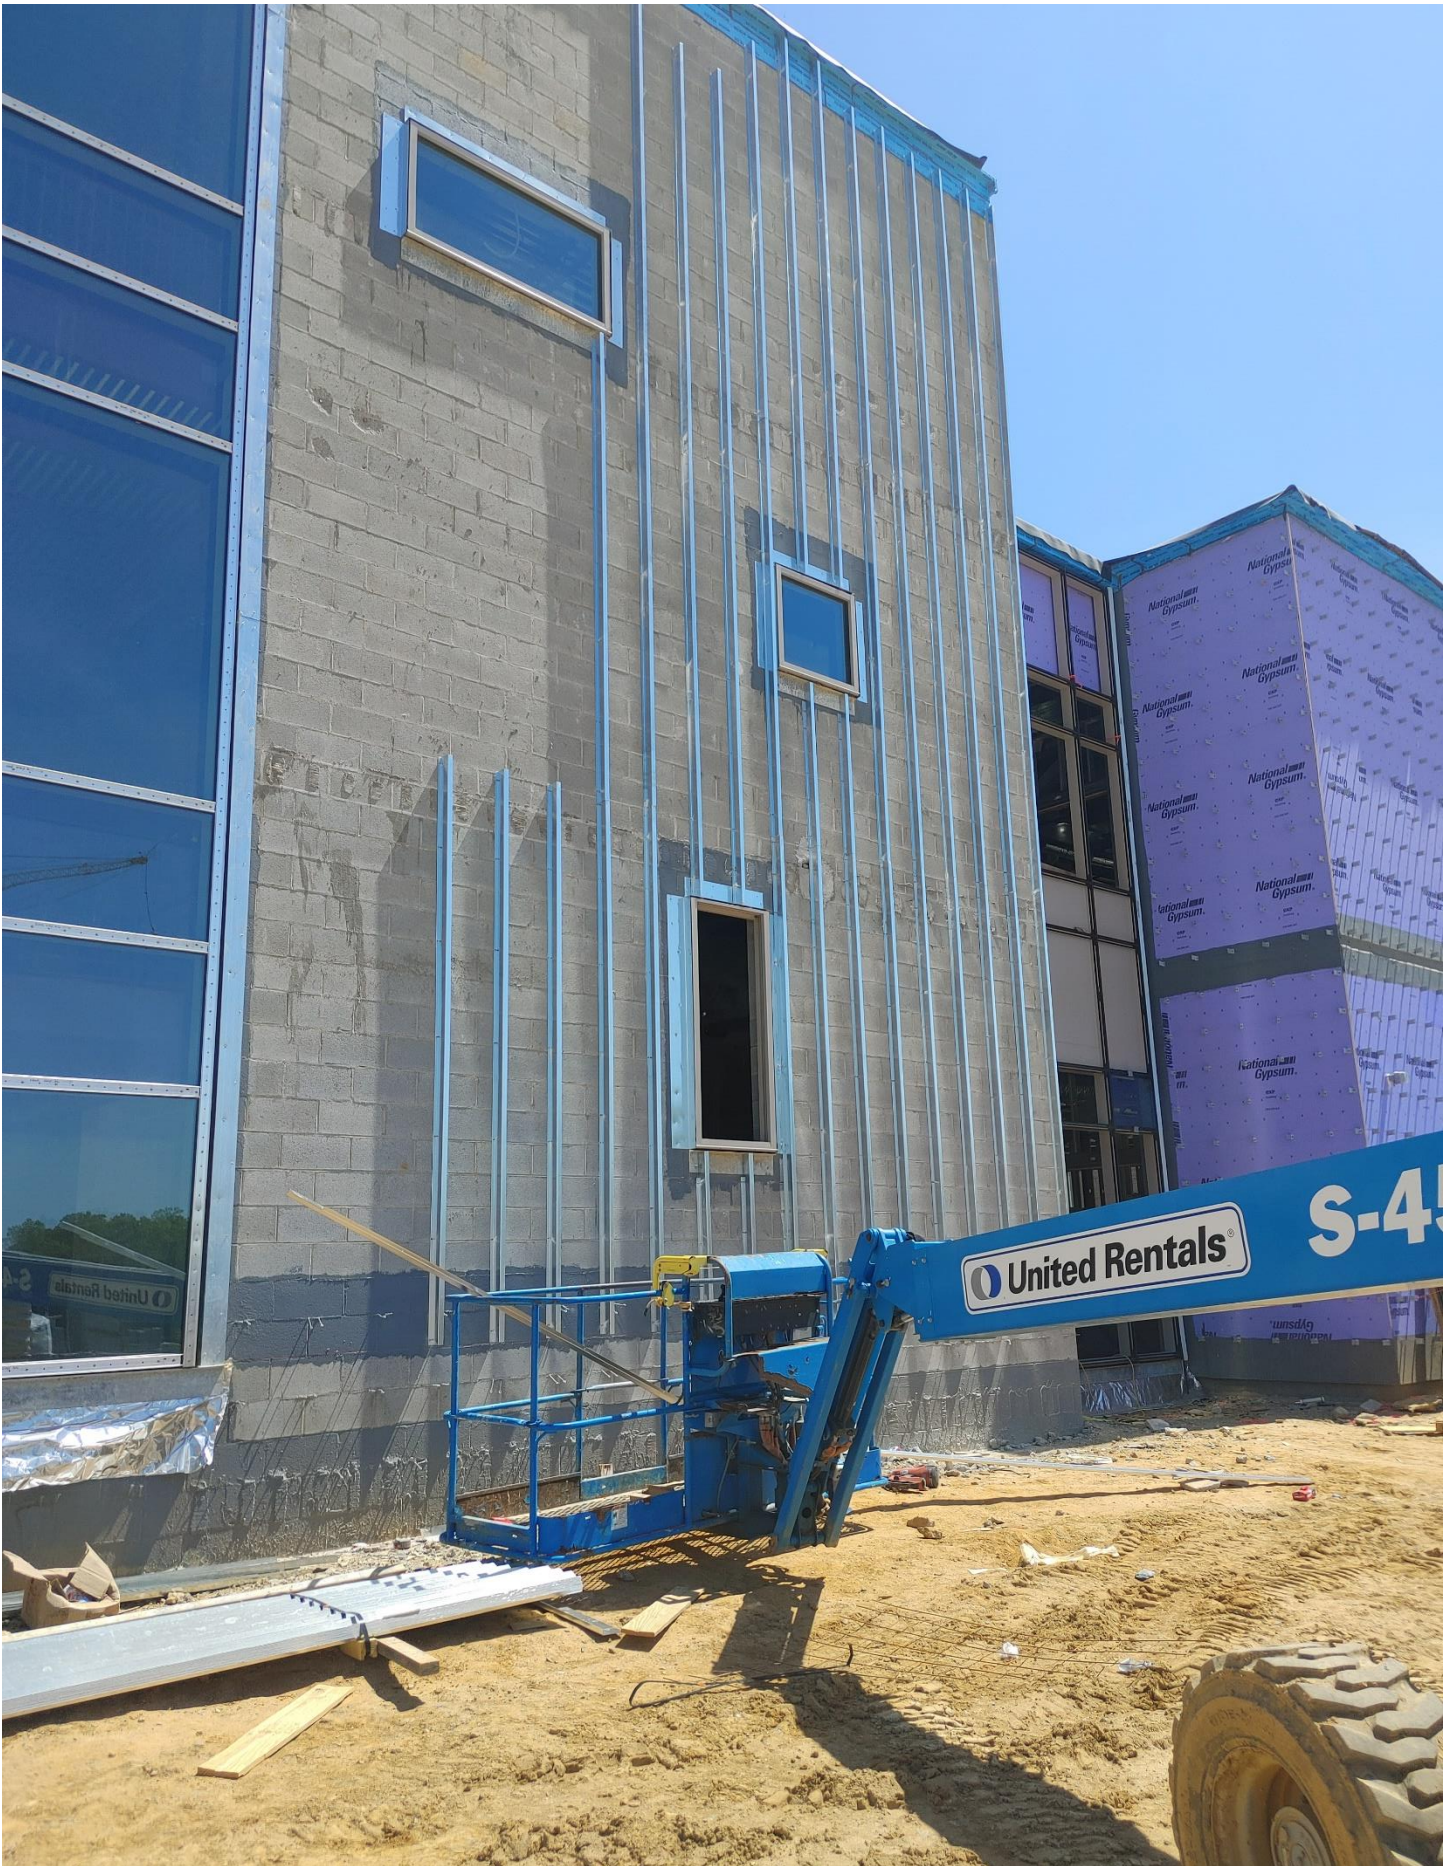
Photo 7 - Stairwell #2 being framed for panels.

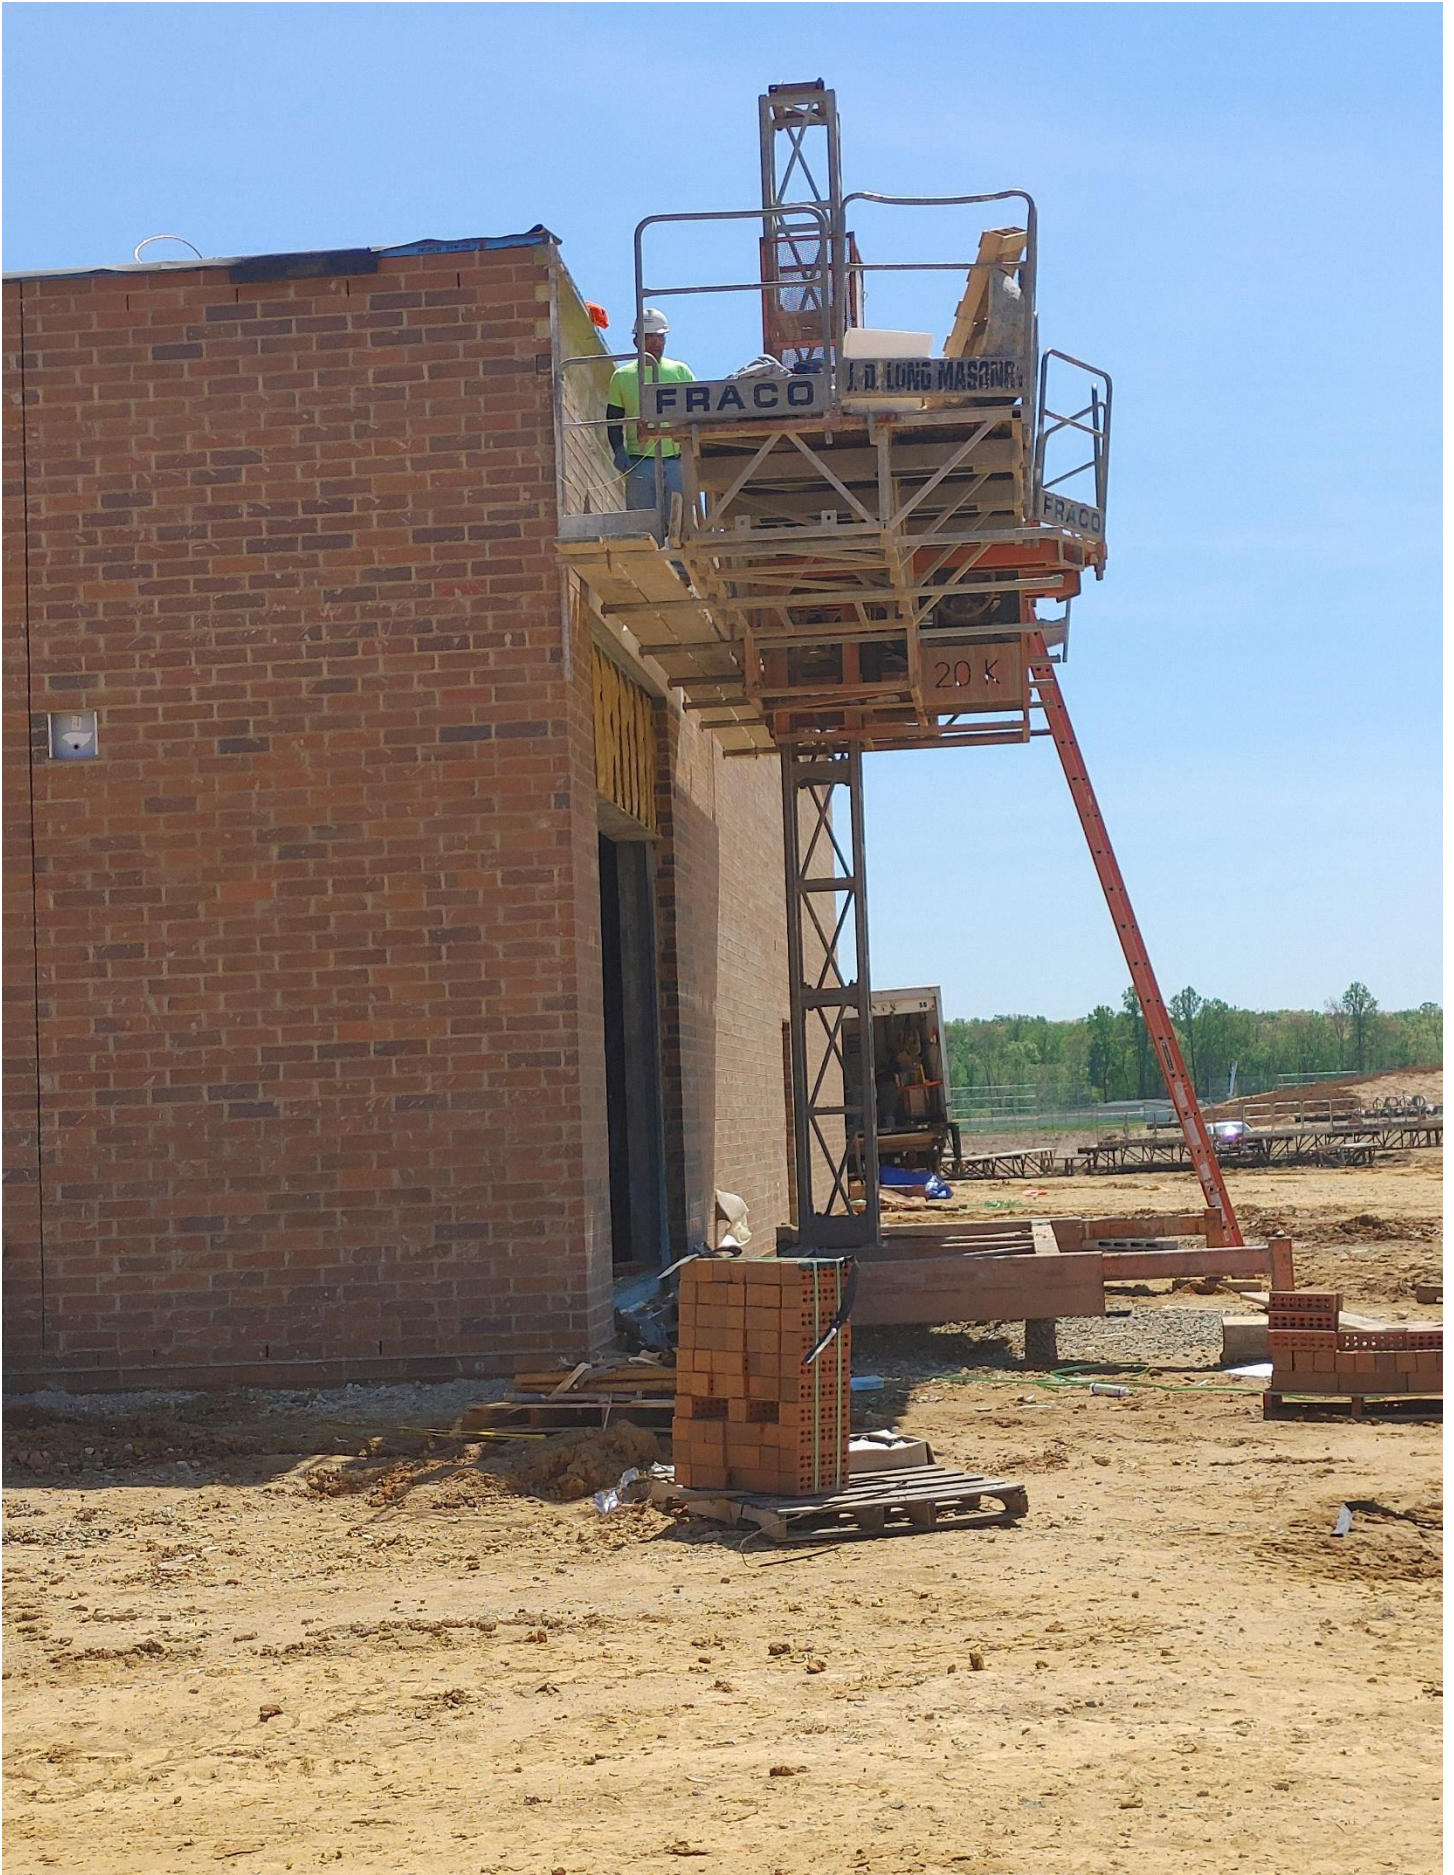
Photo 8 - Lintel and Precast set above Storefront SF6
