**DAILY REPORT**

**WESTMORELAND COUNTY HIGH SCHOOL**

Date: 04/27/2021  
Weather: 78 degrees at 12:00hrs. High of 86 degrees today.  
Hours Worked: 12:00hrs – 15:00hrs (3hrs) Site Visit.

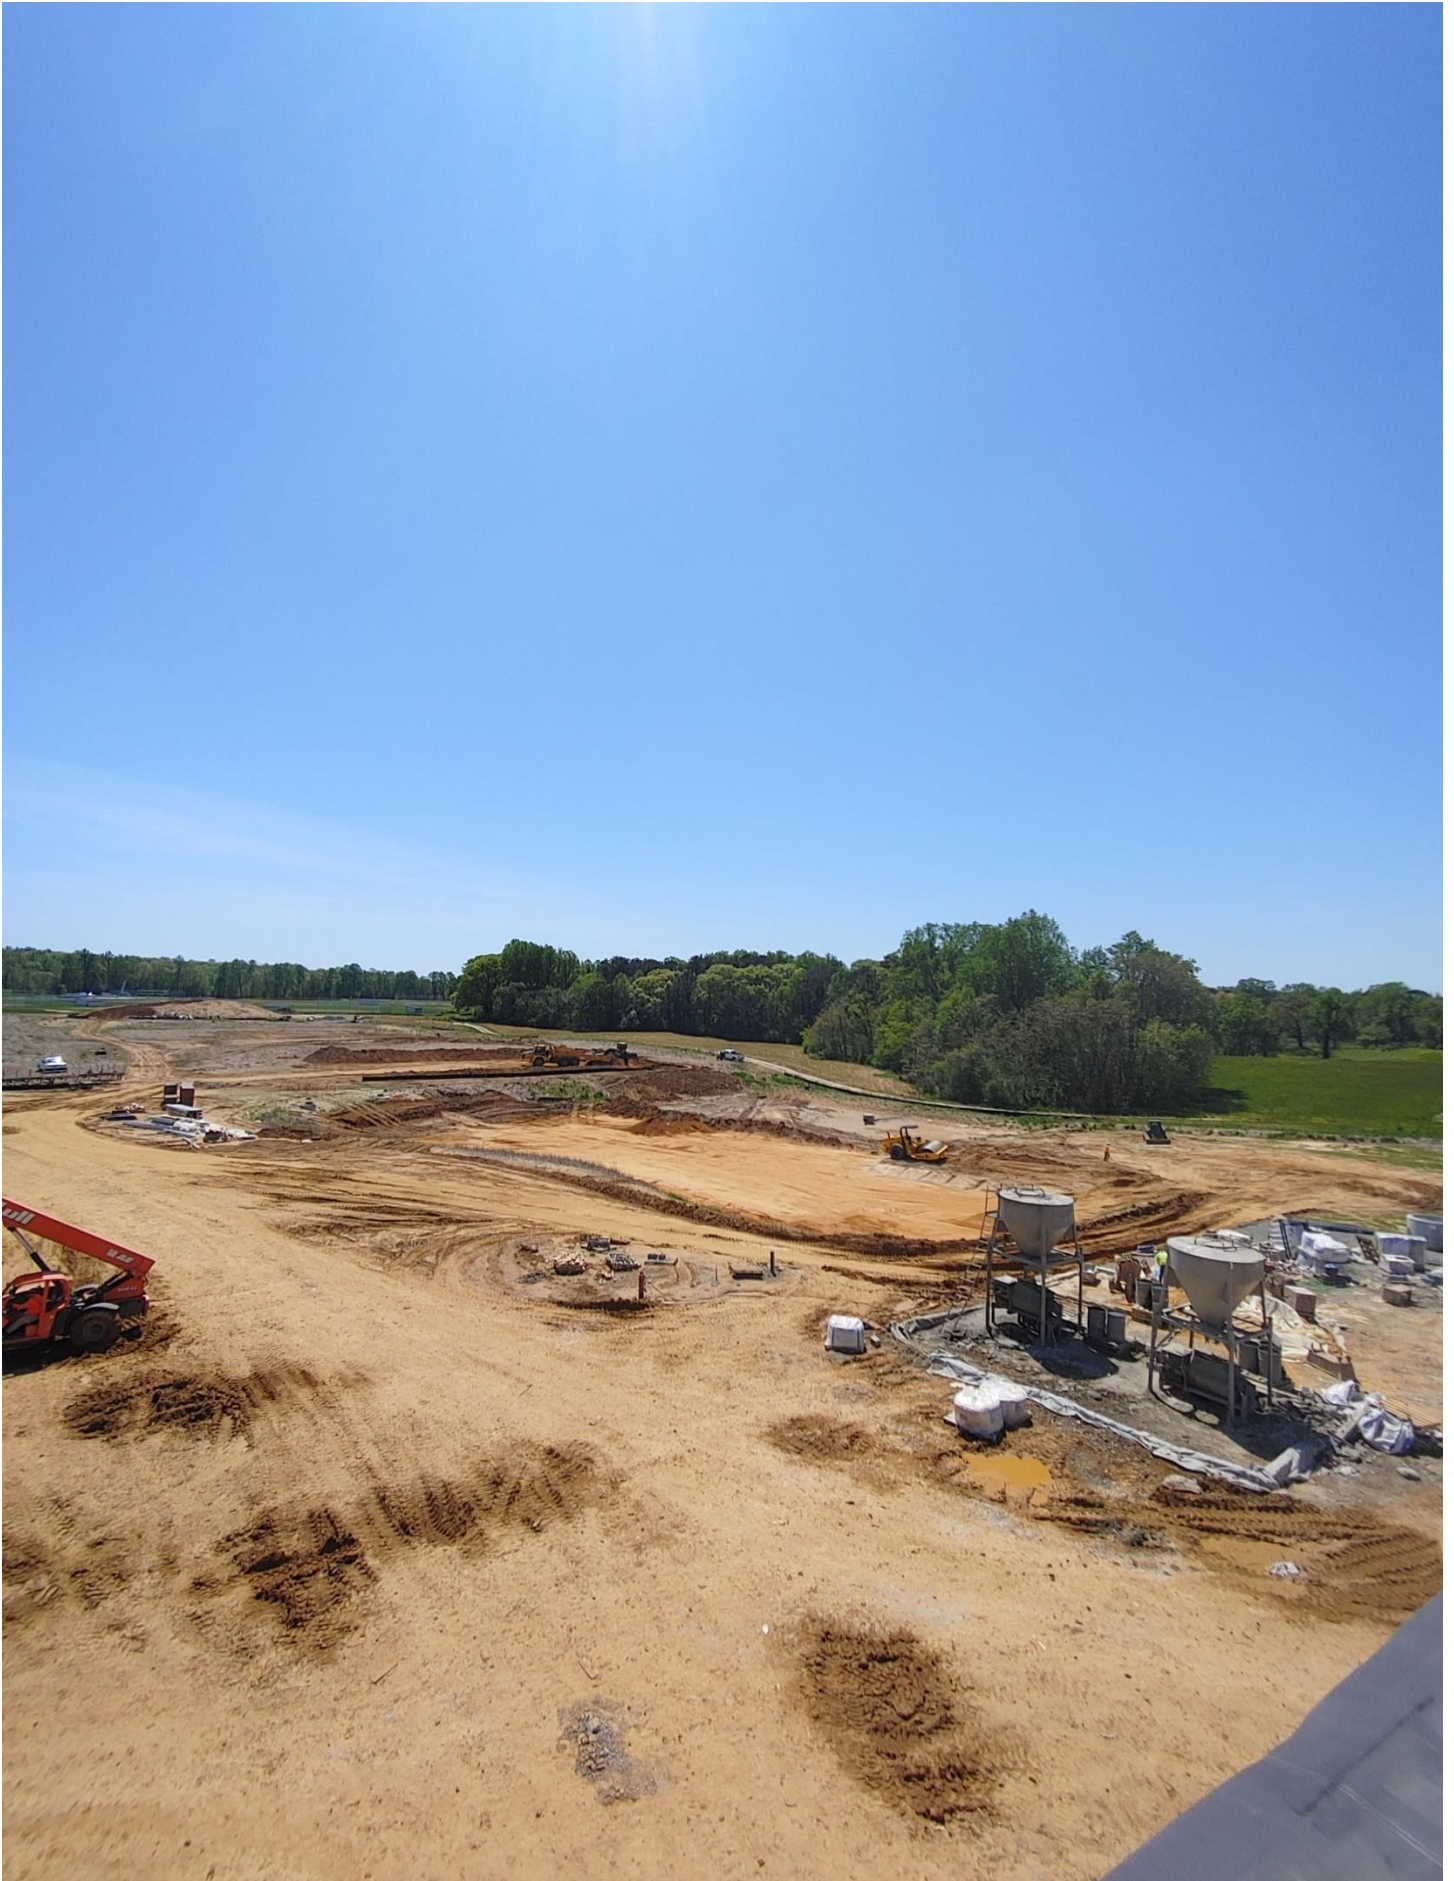
Photo 9 - Beuchert continues to work on the West side of the site.

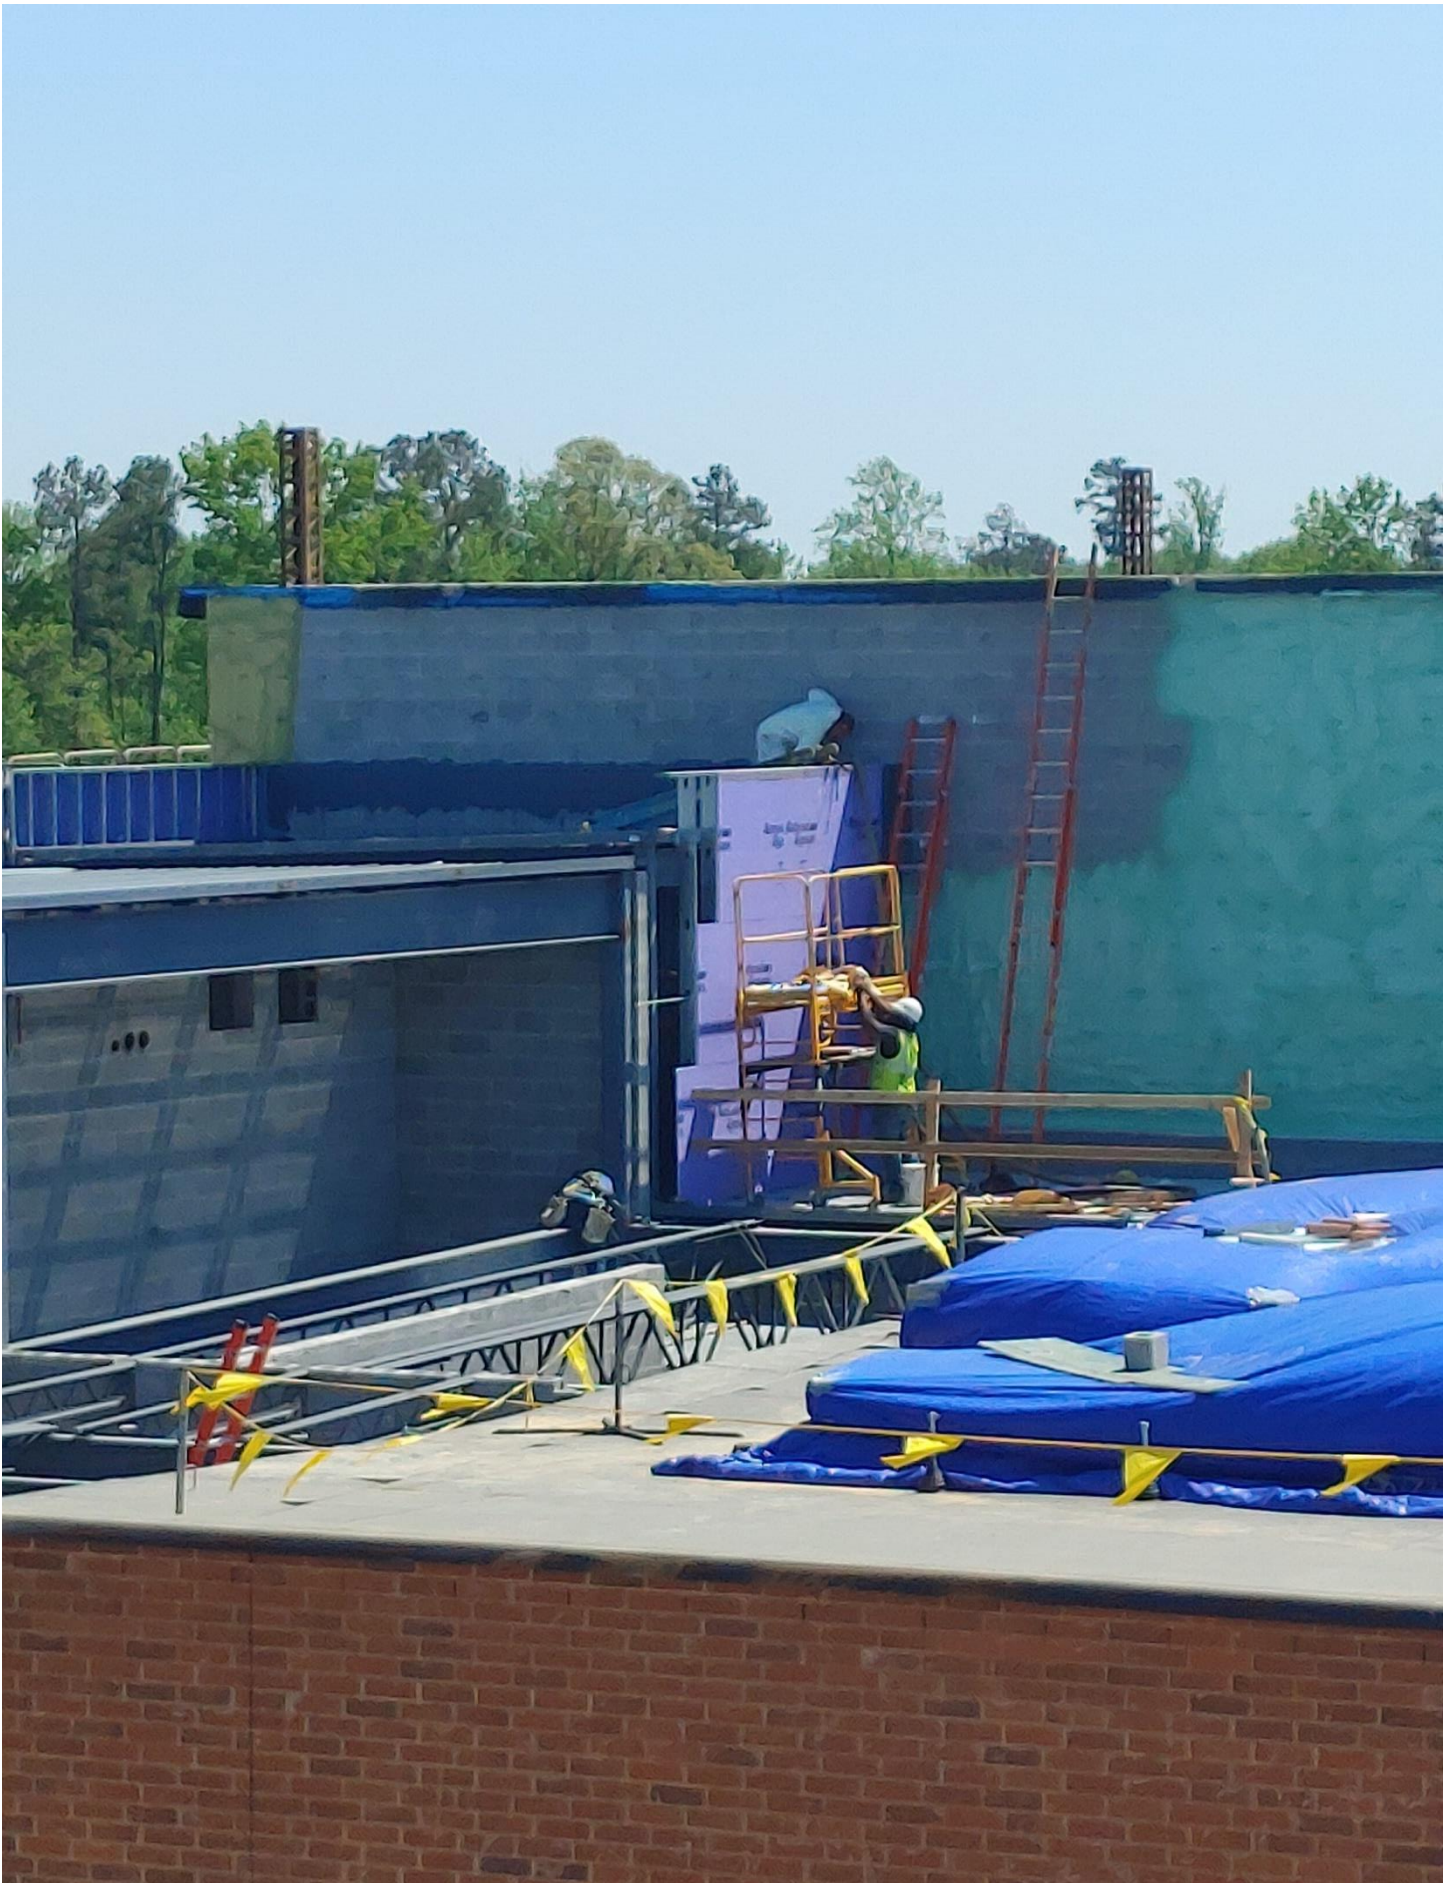
Photo 10 - Area E high wall on the North side being foamed.

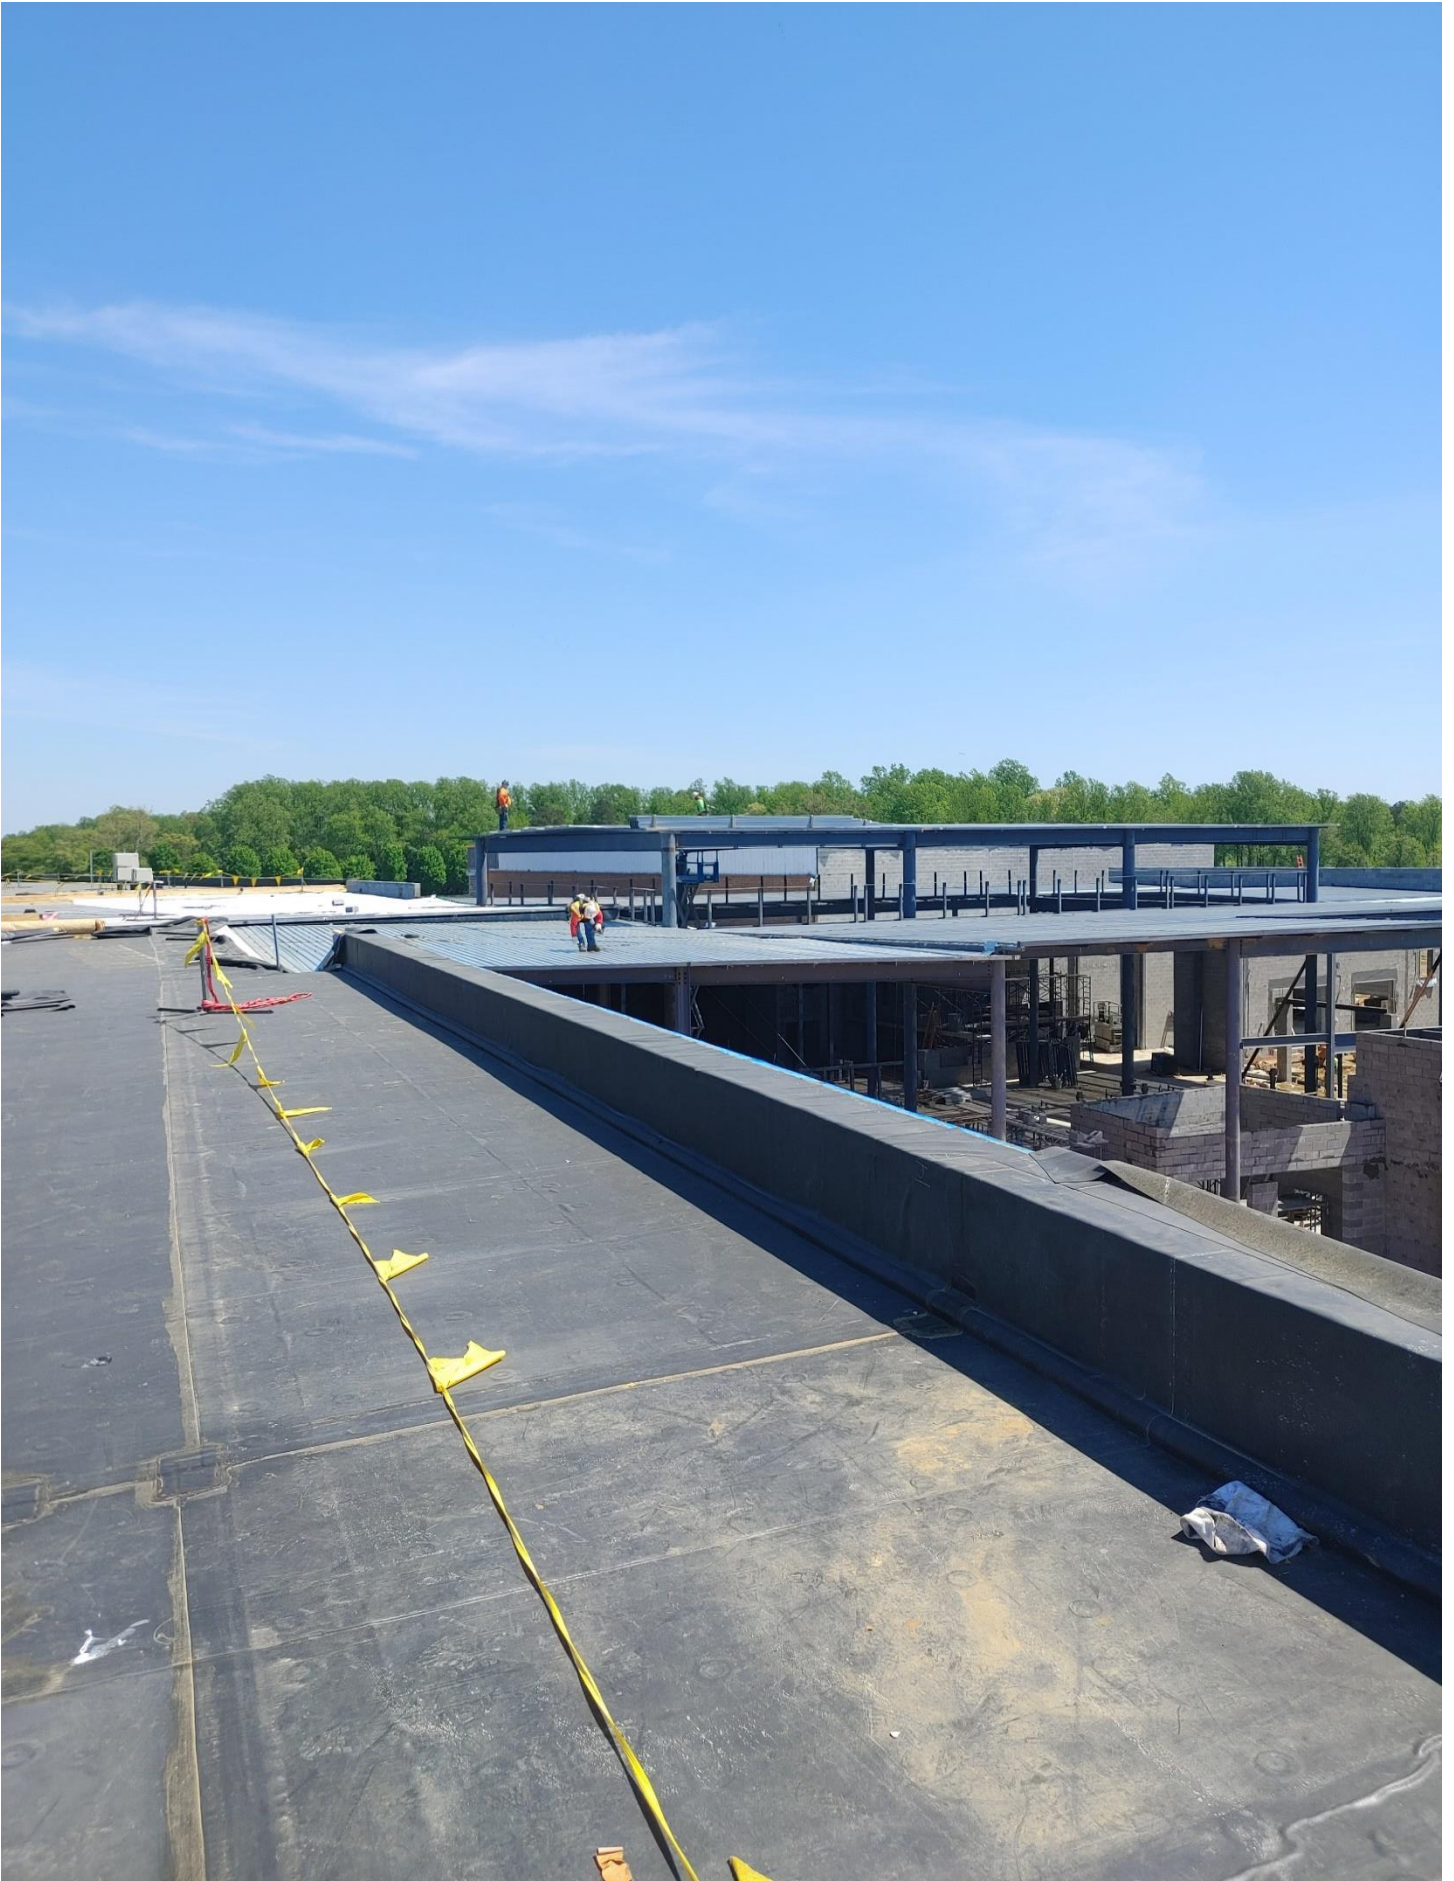
Photo 11 - Metal Decking continues to be laid in Area C

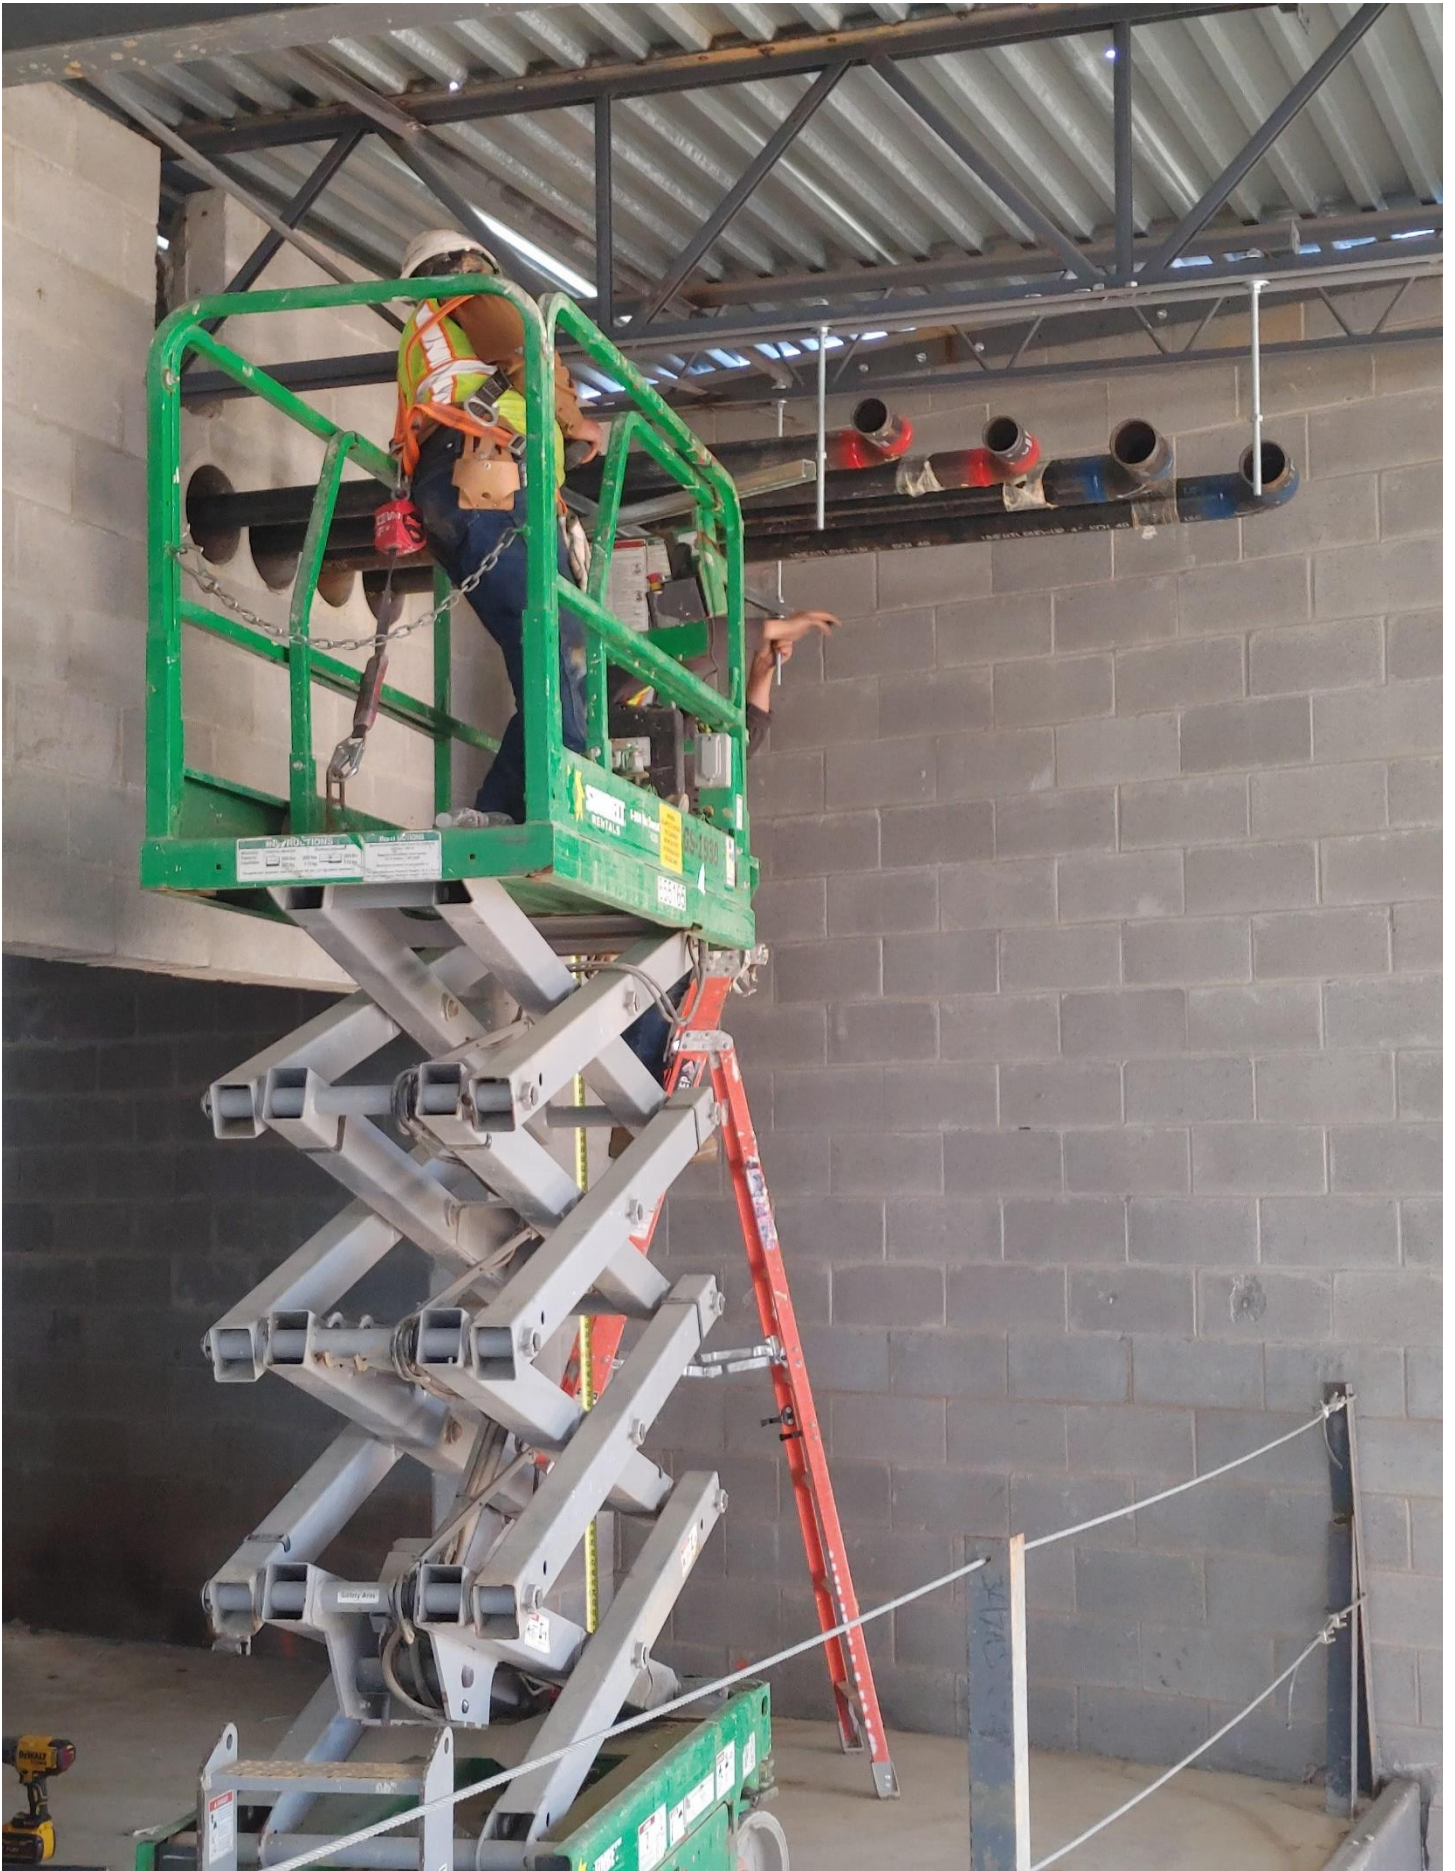
Photo 12 - Colonial running pipe in Area A outside of A229
