**COMMONWEALTH
BUILDING SOLUTIONS, LLC**

DAILY REPORT

WESTMORELAND COUNTY HIGH SCHOOL

Date: 04/28/2021
Weather: 82 degrees. High of 89 degrees today.
Hours Worked: 10:00hrs – 13:30hrs (3.5hrs) Site Visit.

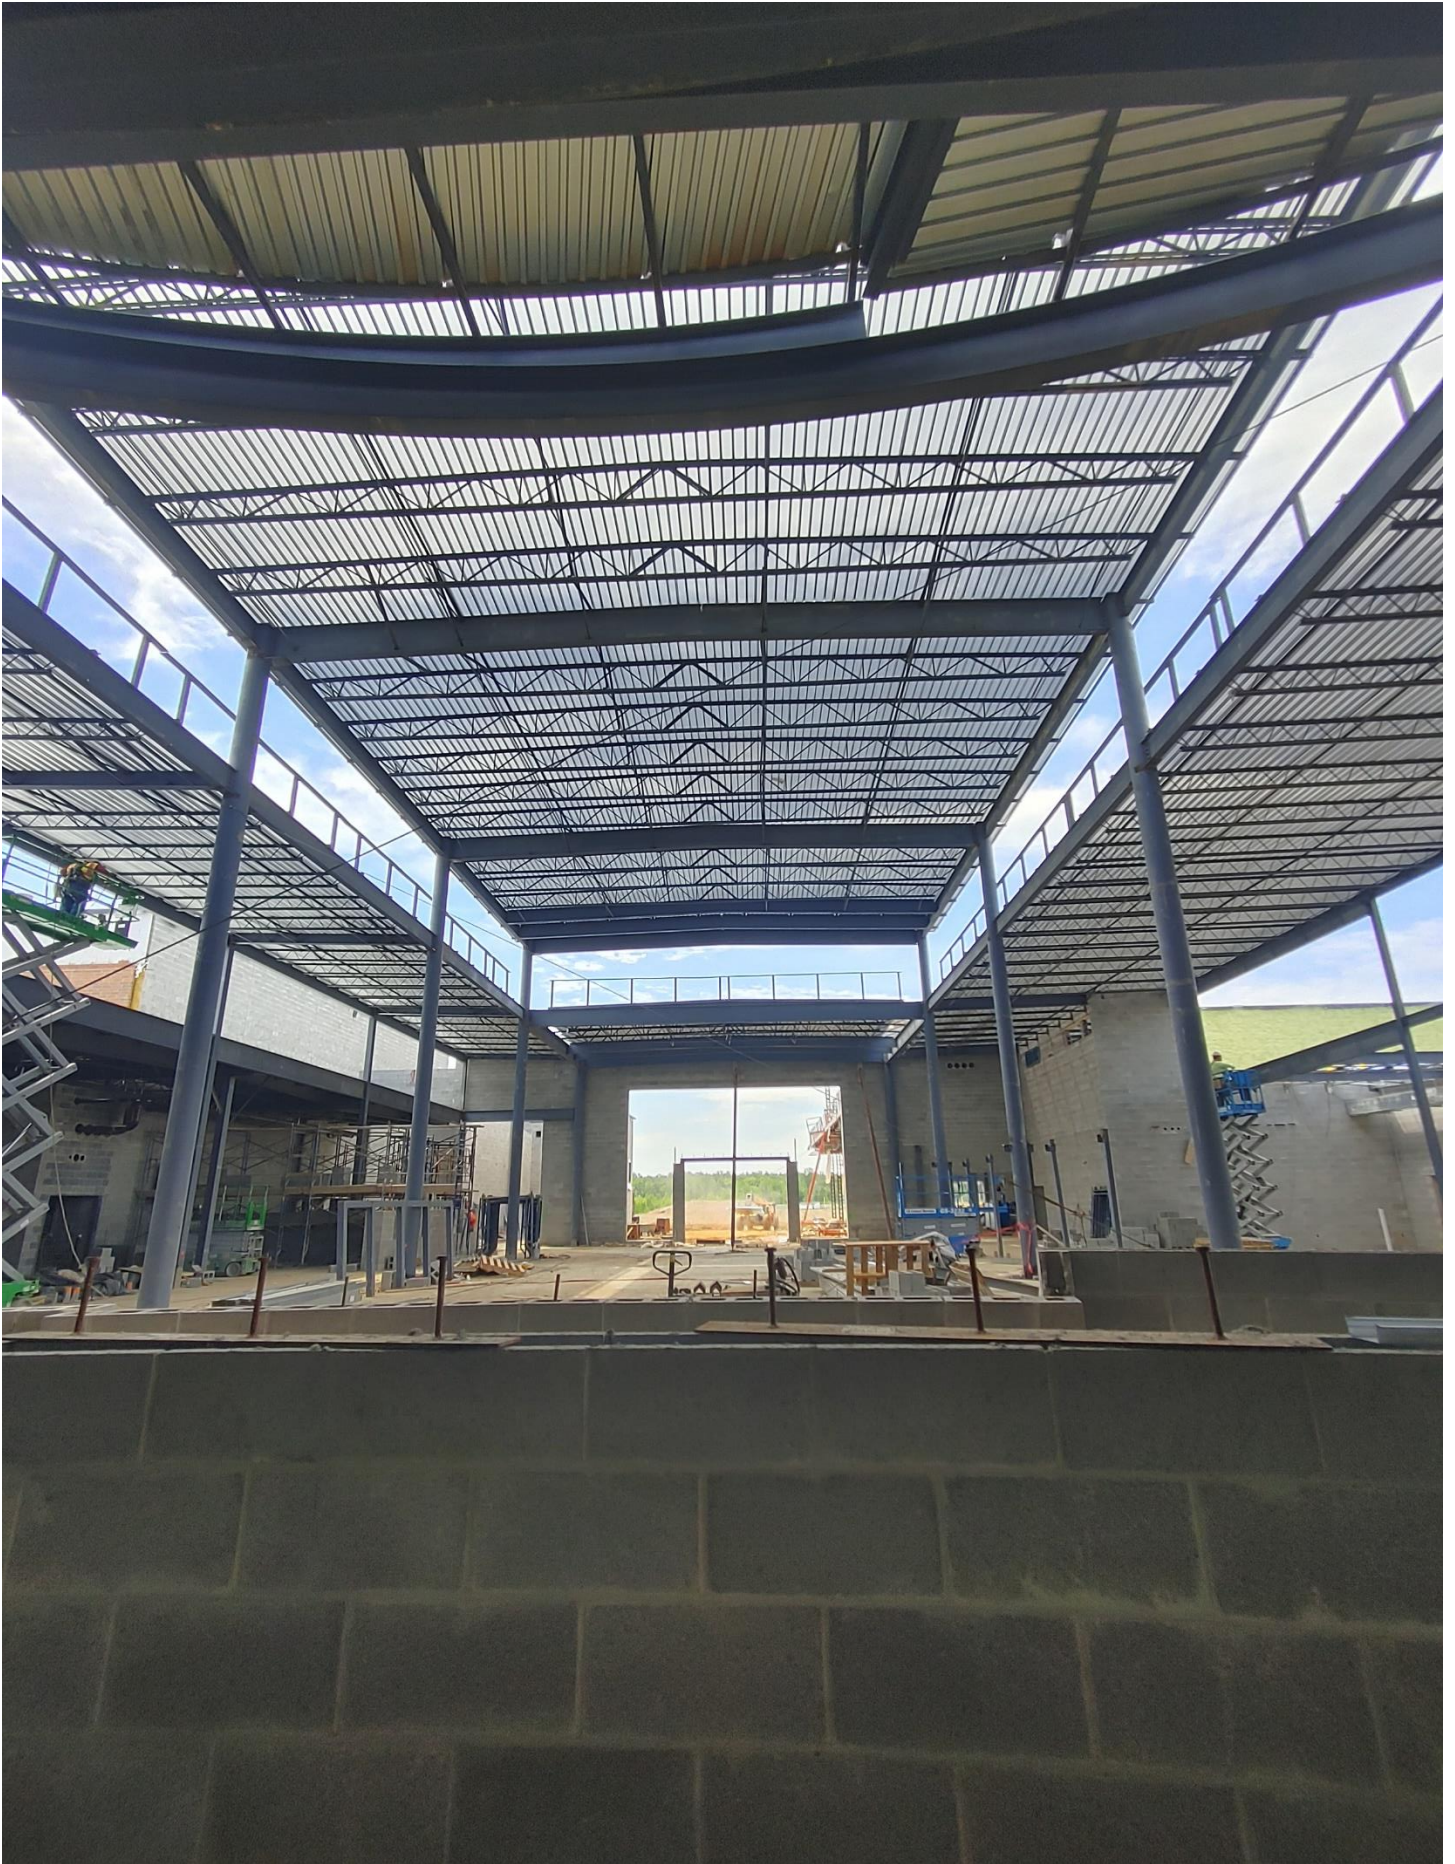
Weldon Steel: Six (6) men are on site today. They continue to set and weld roof decking in Area C. They have only a few pieces on decking that remain to be set.

Photo 1- Roof Decking almost completed in Area C

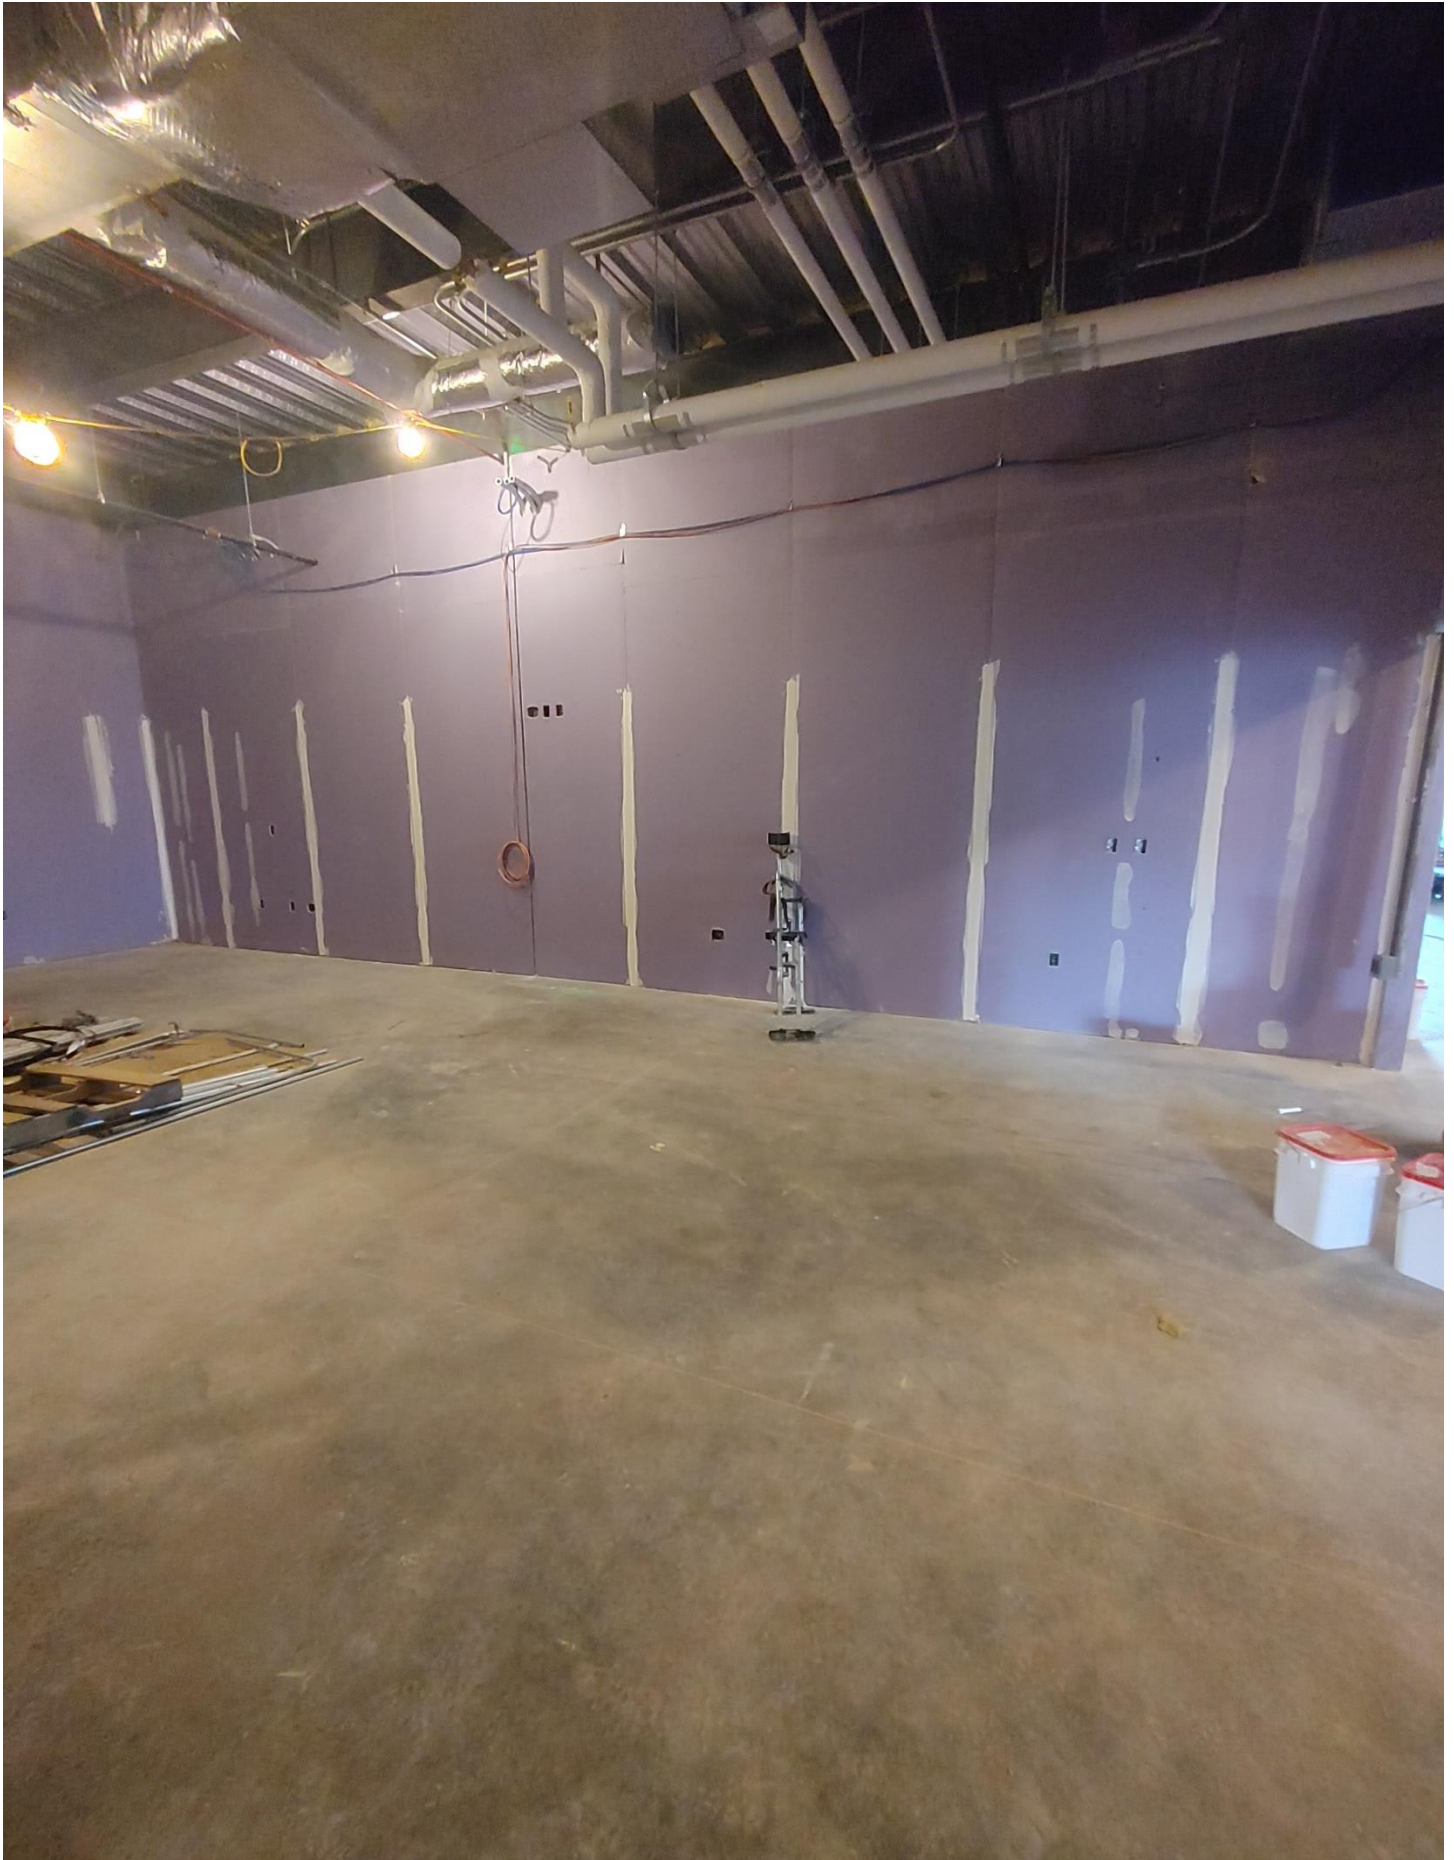
Photo 2 - They have begun to Tape the Sheetrock in Area A

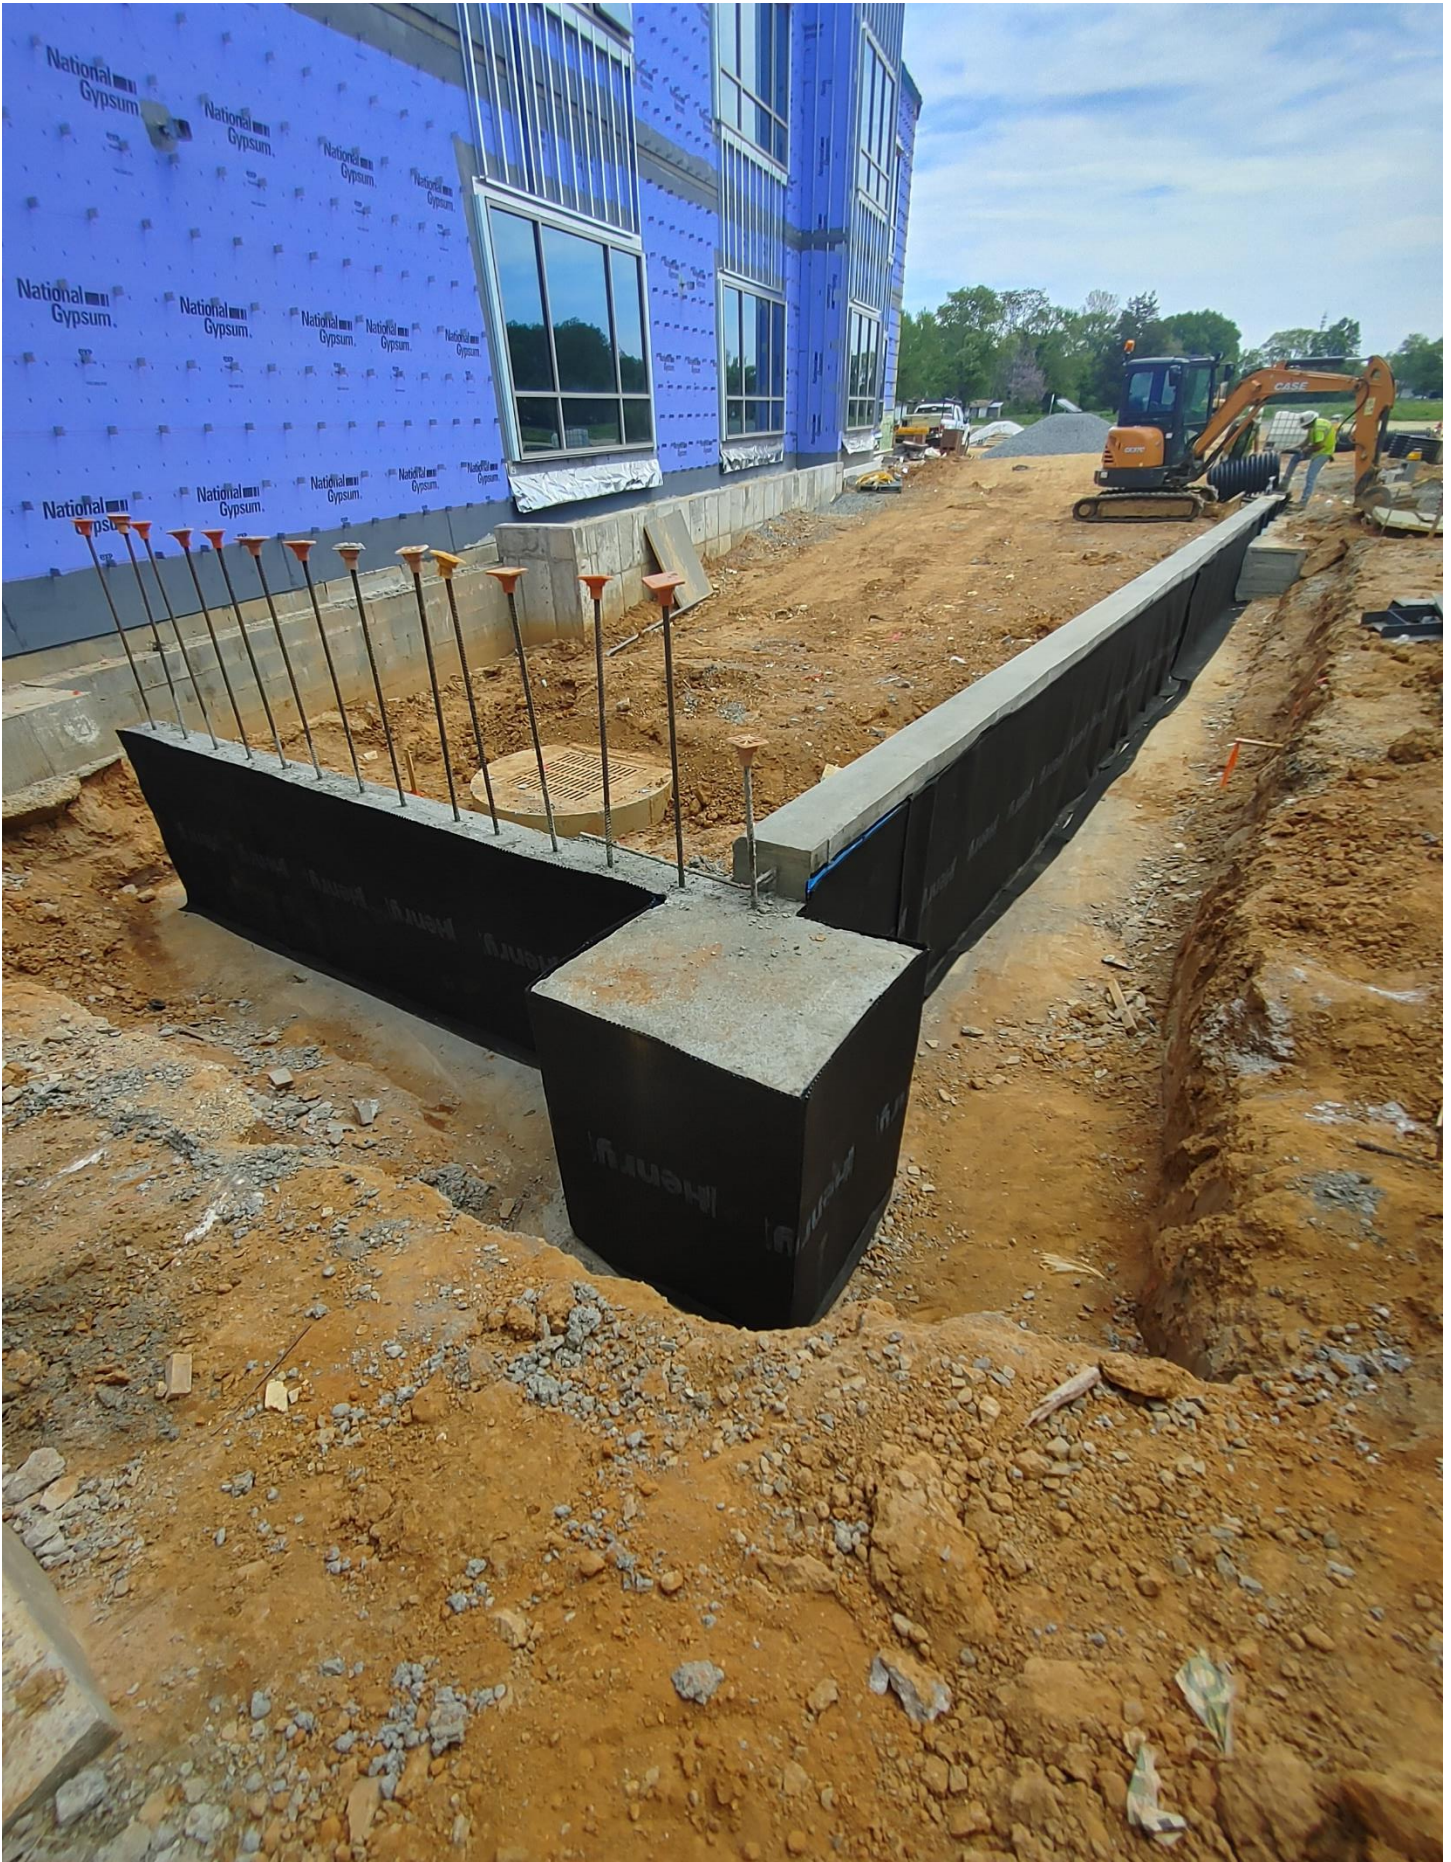
Photo 3 - Loading Dock Wall has waterproof Membrane installed.

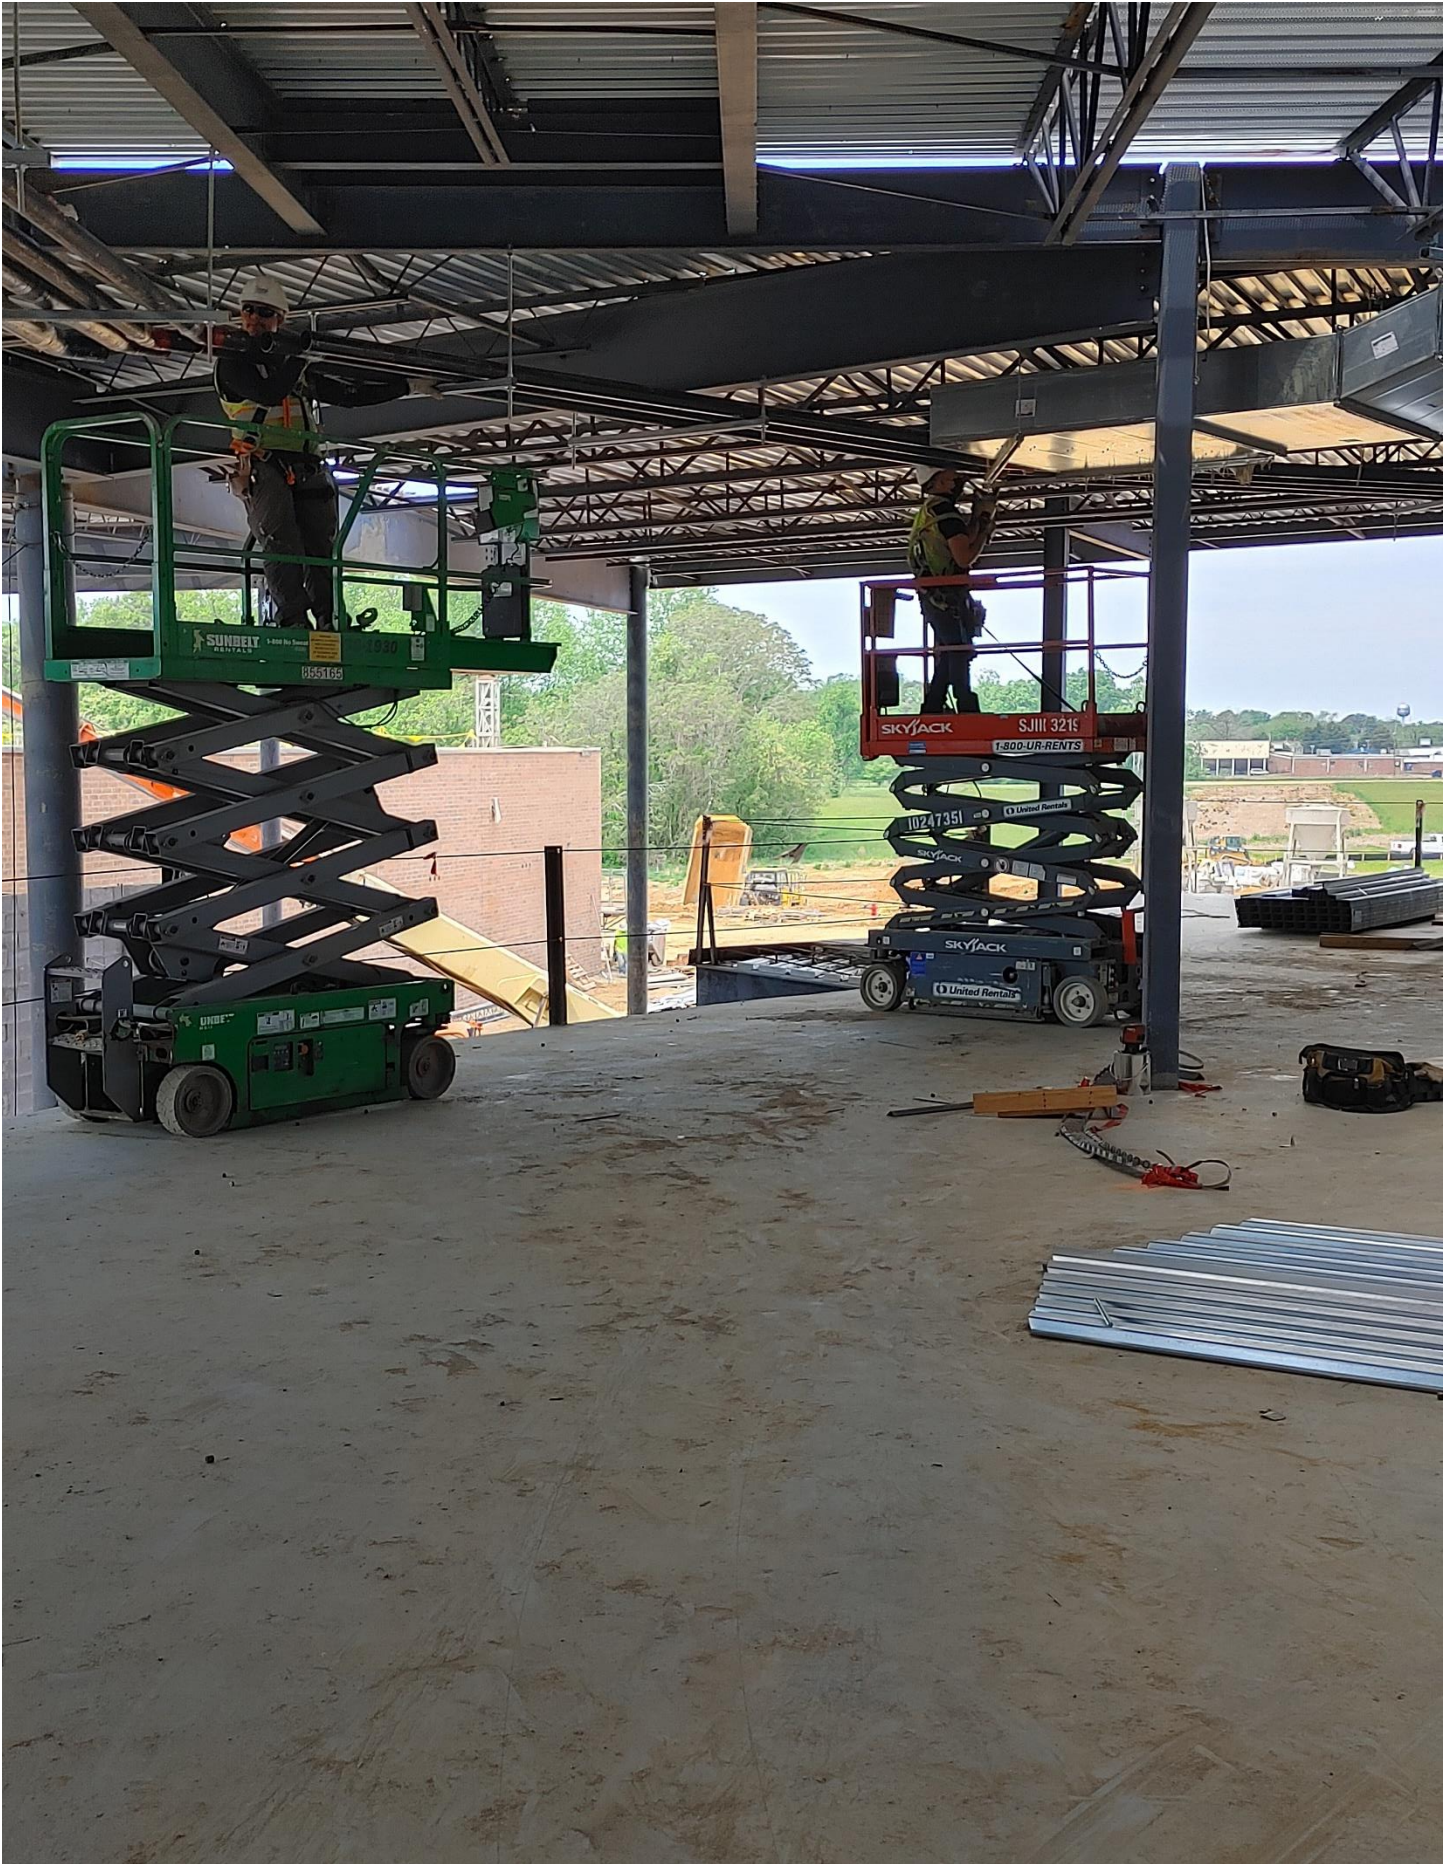
Photo 4 - Colonial Webb continues to run pipe in Area A

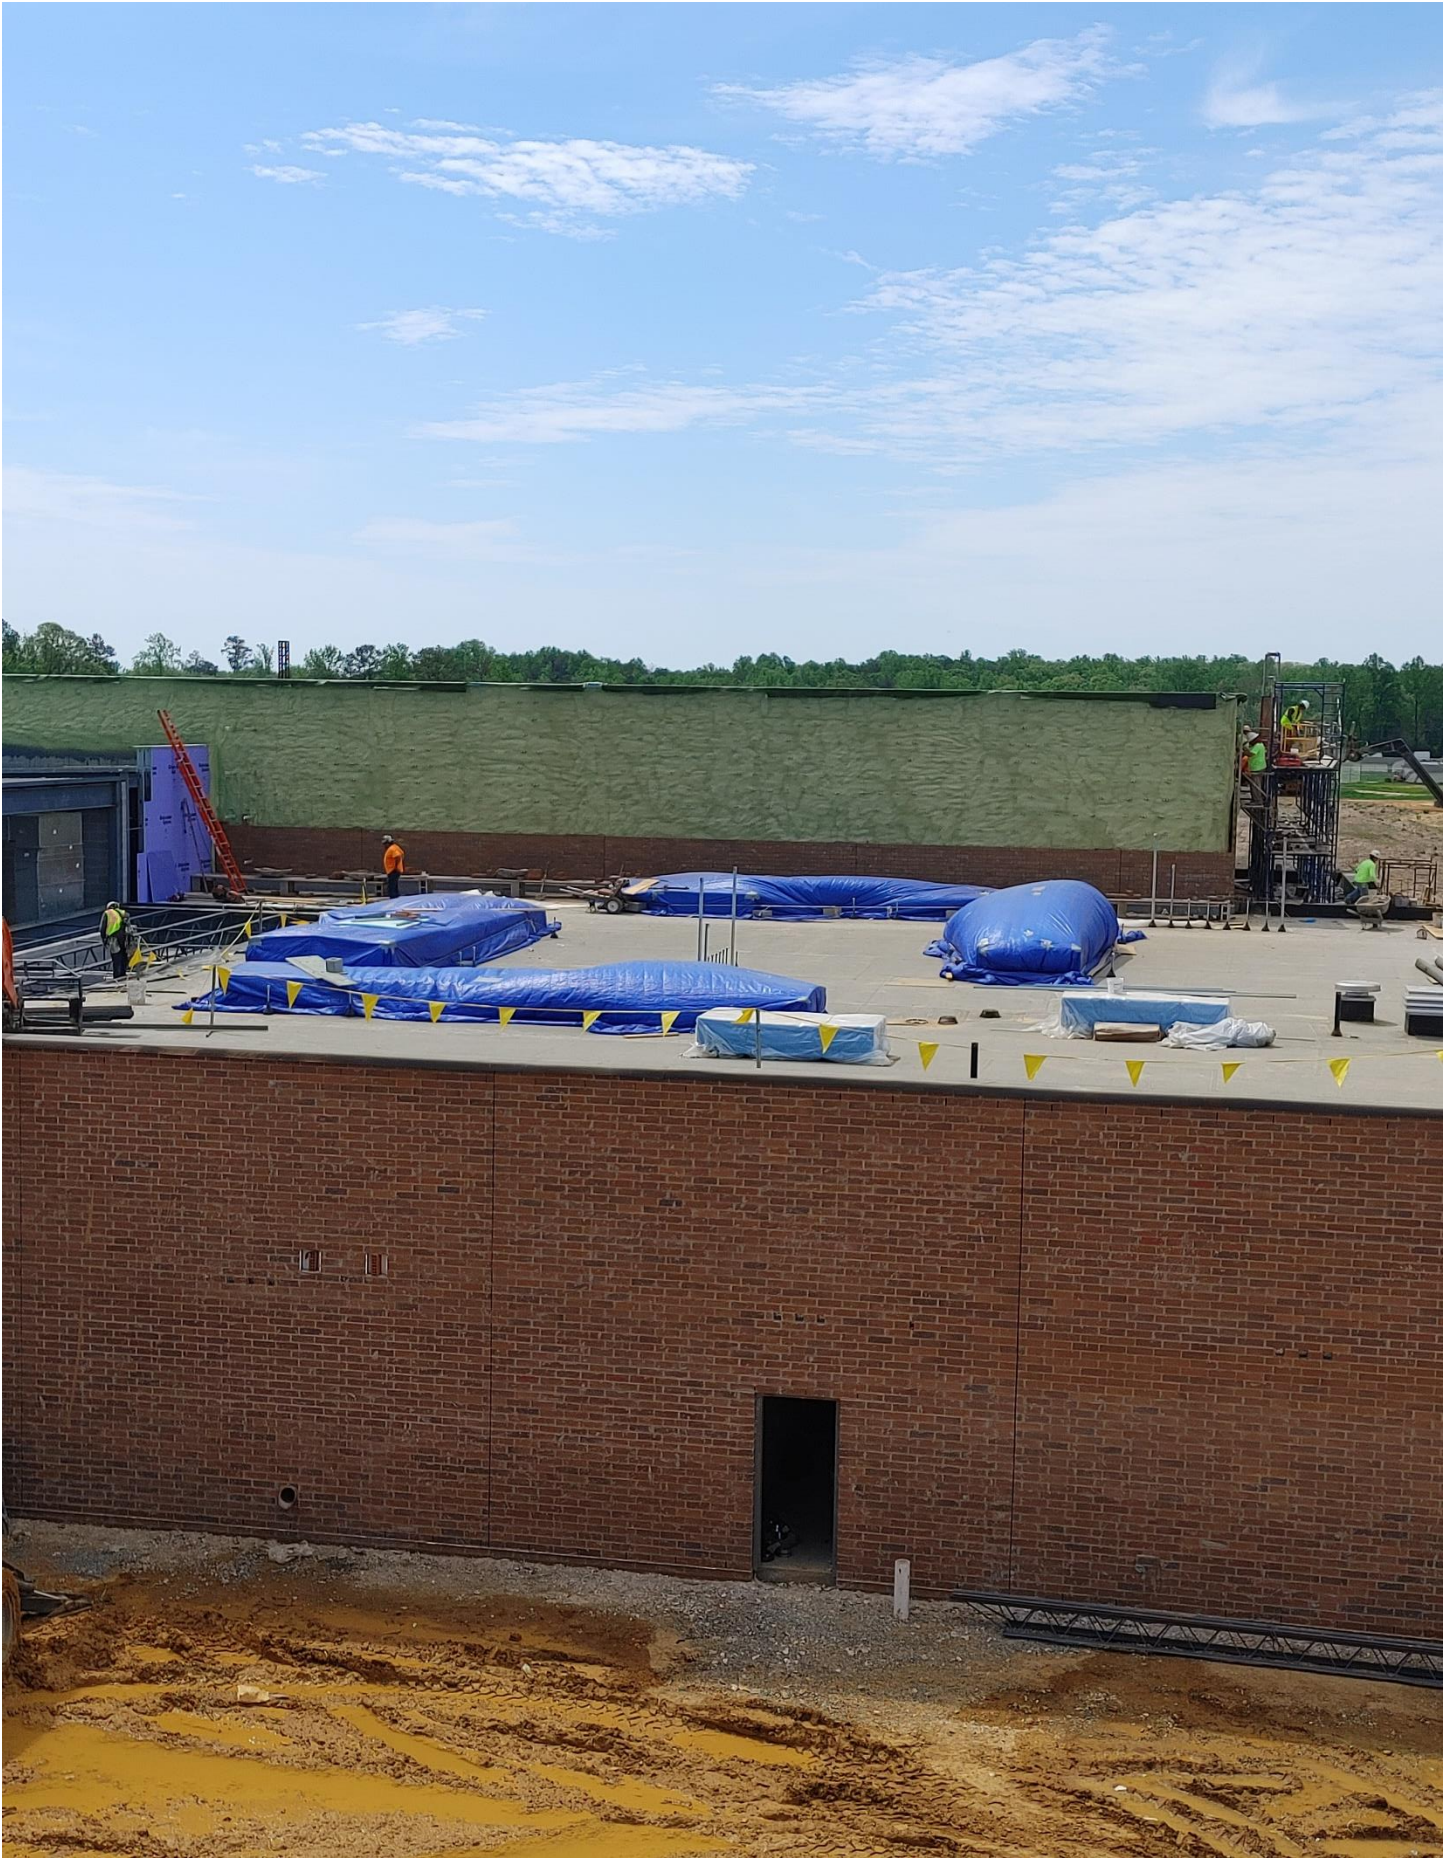
Photo 5 - J.D. Long has begun to lay Brick above the low roof in Area E

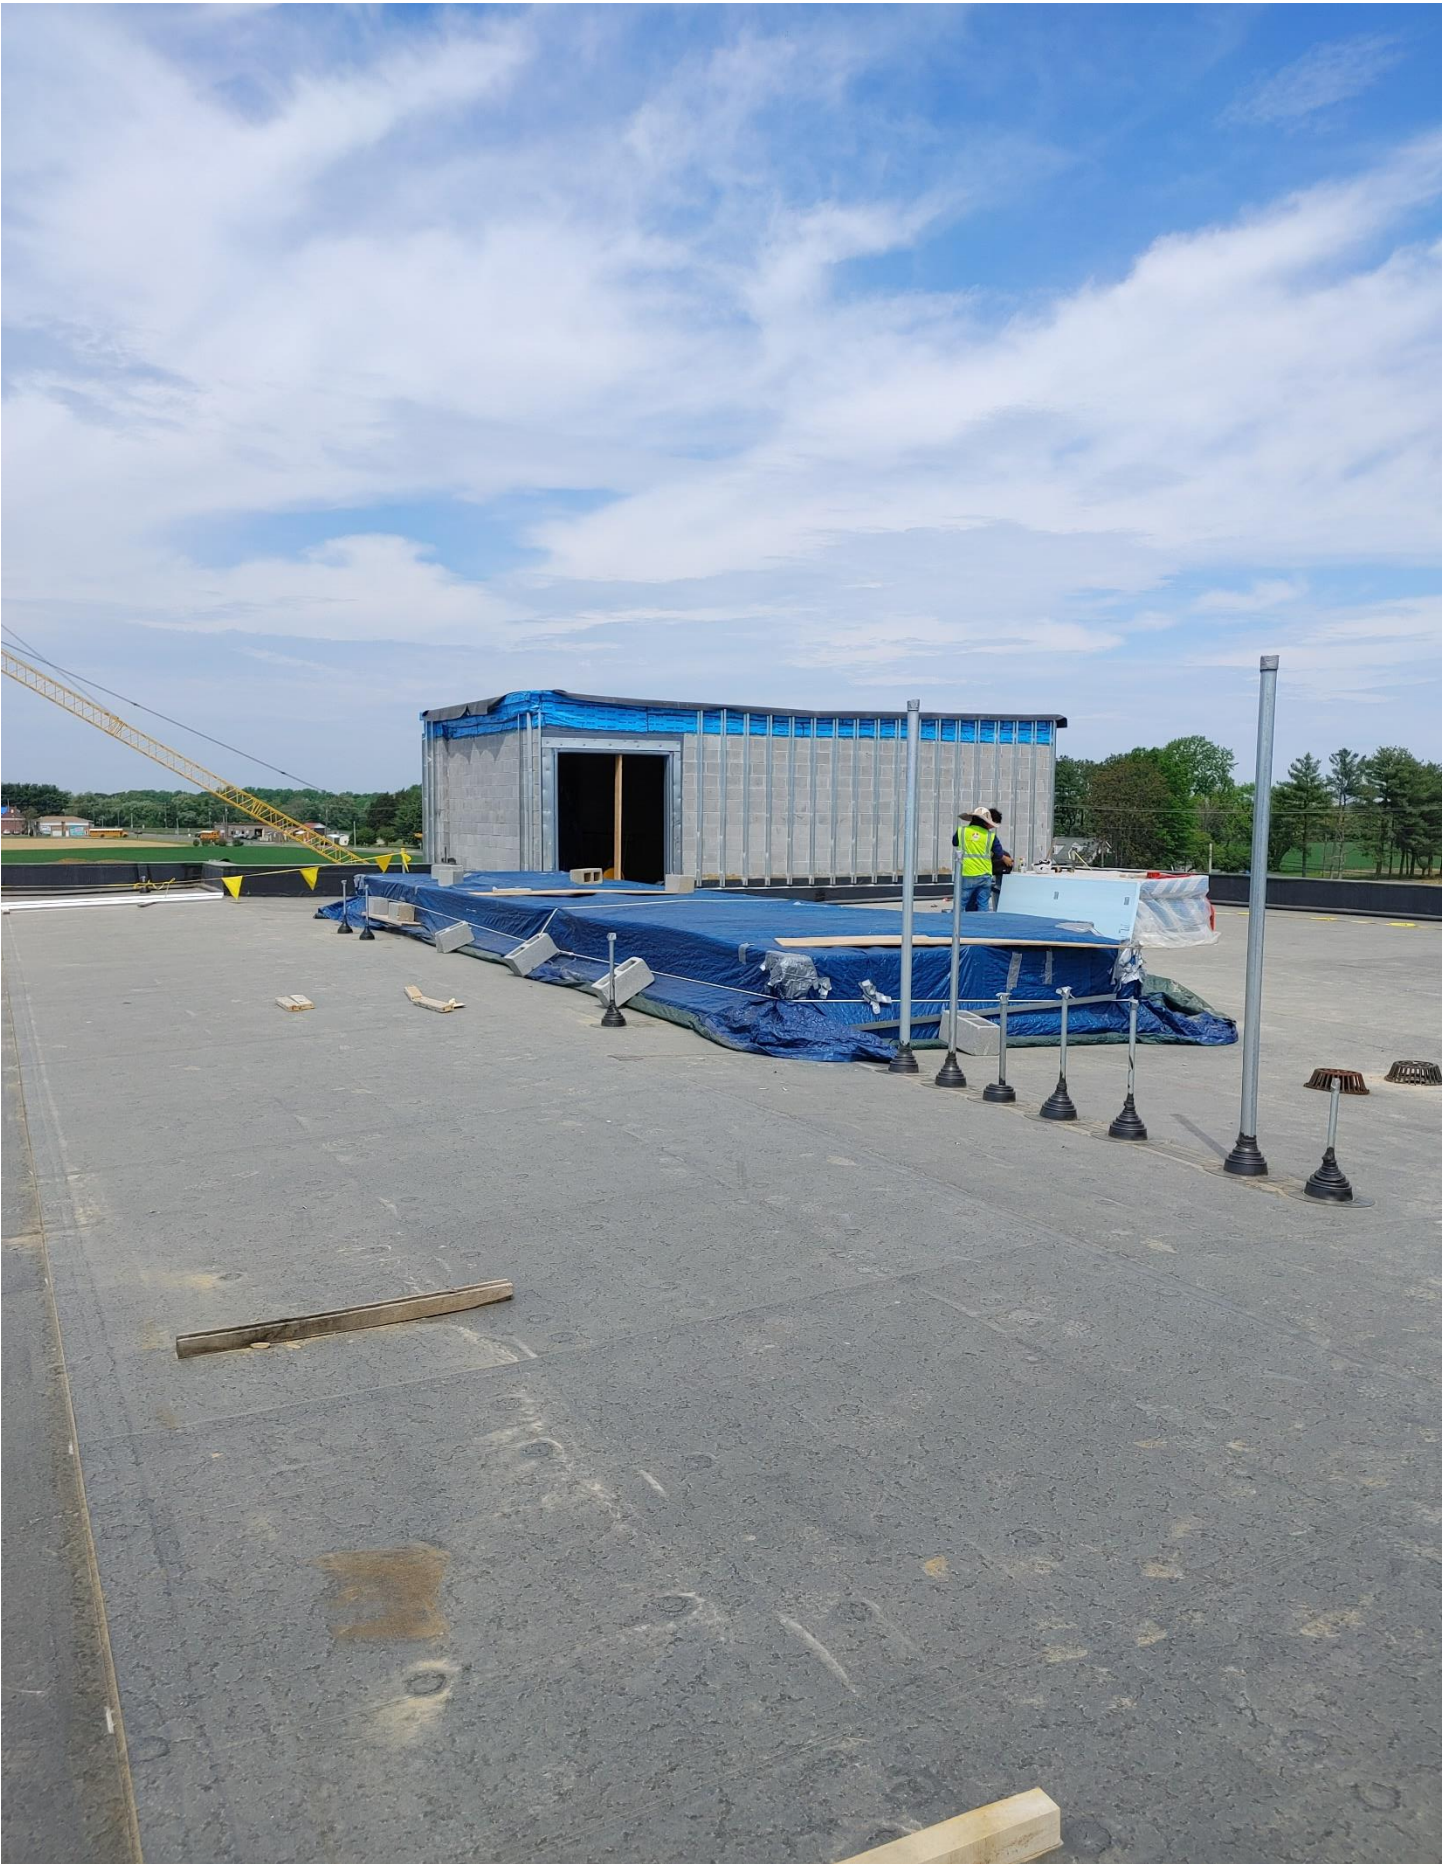
Photo 6 - Z-Channel Framing continues on Stairwell #2

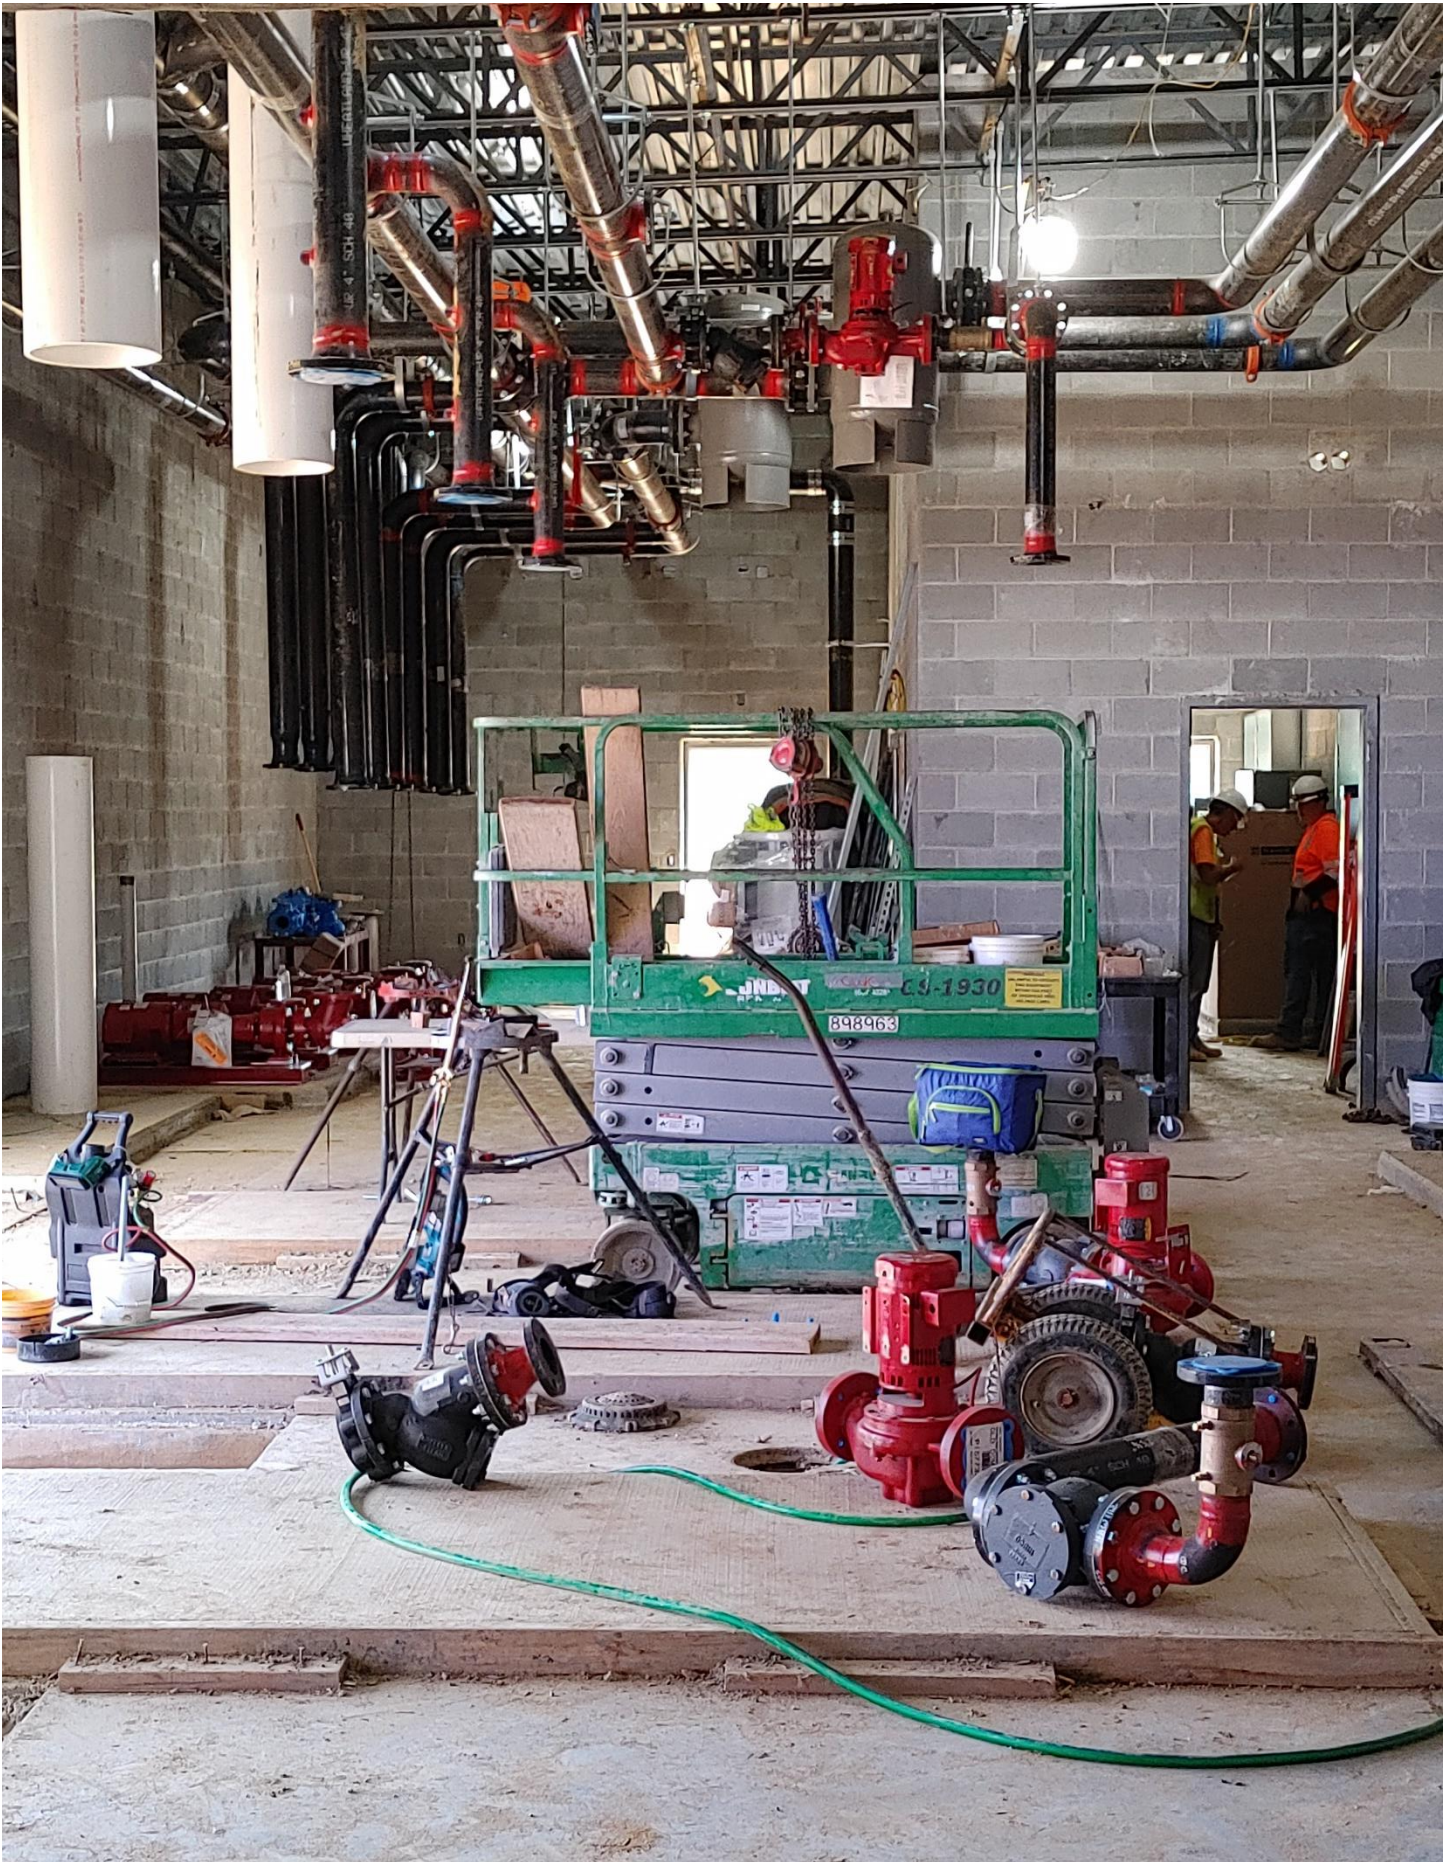
Photo 7 - Colonial Webb continues to run pipe in the Mechanical Room of Area D

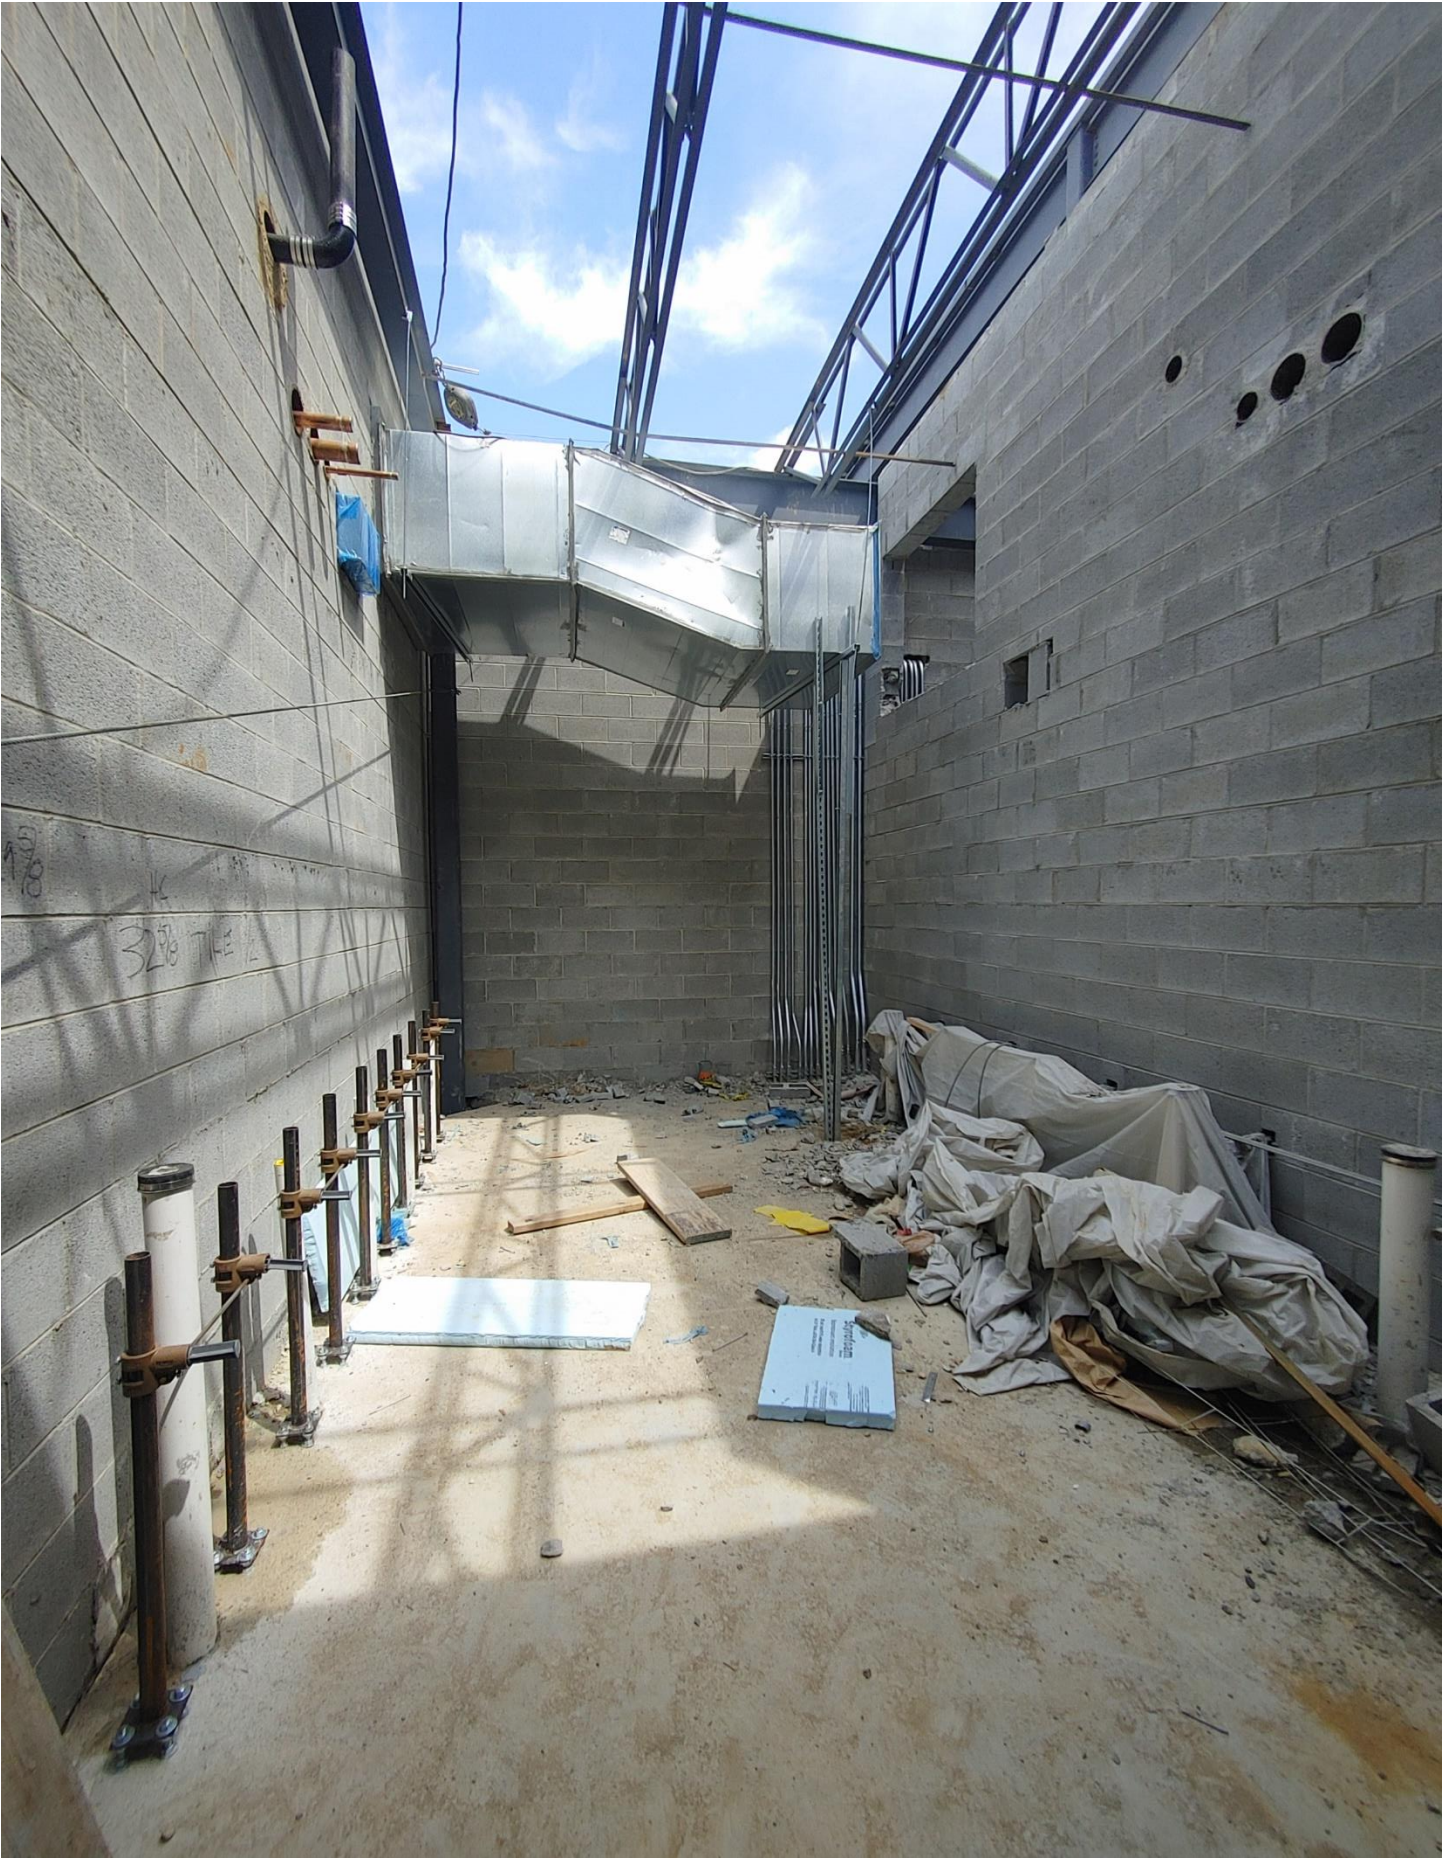
Photo 8 - HVAC Duct is being run in the Girls Toilet E104.
