**COMMONWEALTH
BUILDING SOLUTIONS, LLC**

DAILY REPORT

WESTMORELAND COUNTY HIGH SCHOOL

Date: 04/28/2021
Weather: 82 degrees. High of 89 degrees today.
Hours Worked: 10:00hrs – 13:30hrs (3.5hrs) Site Visit.

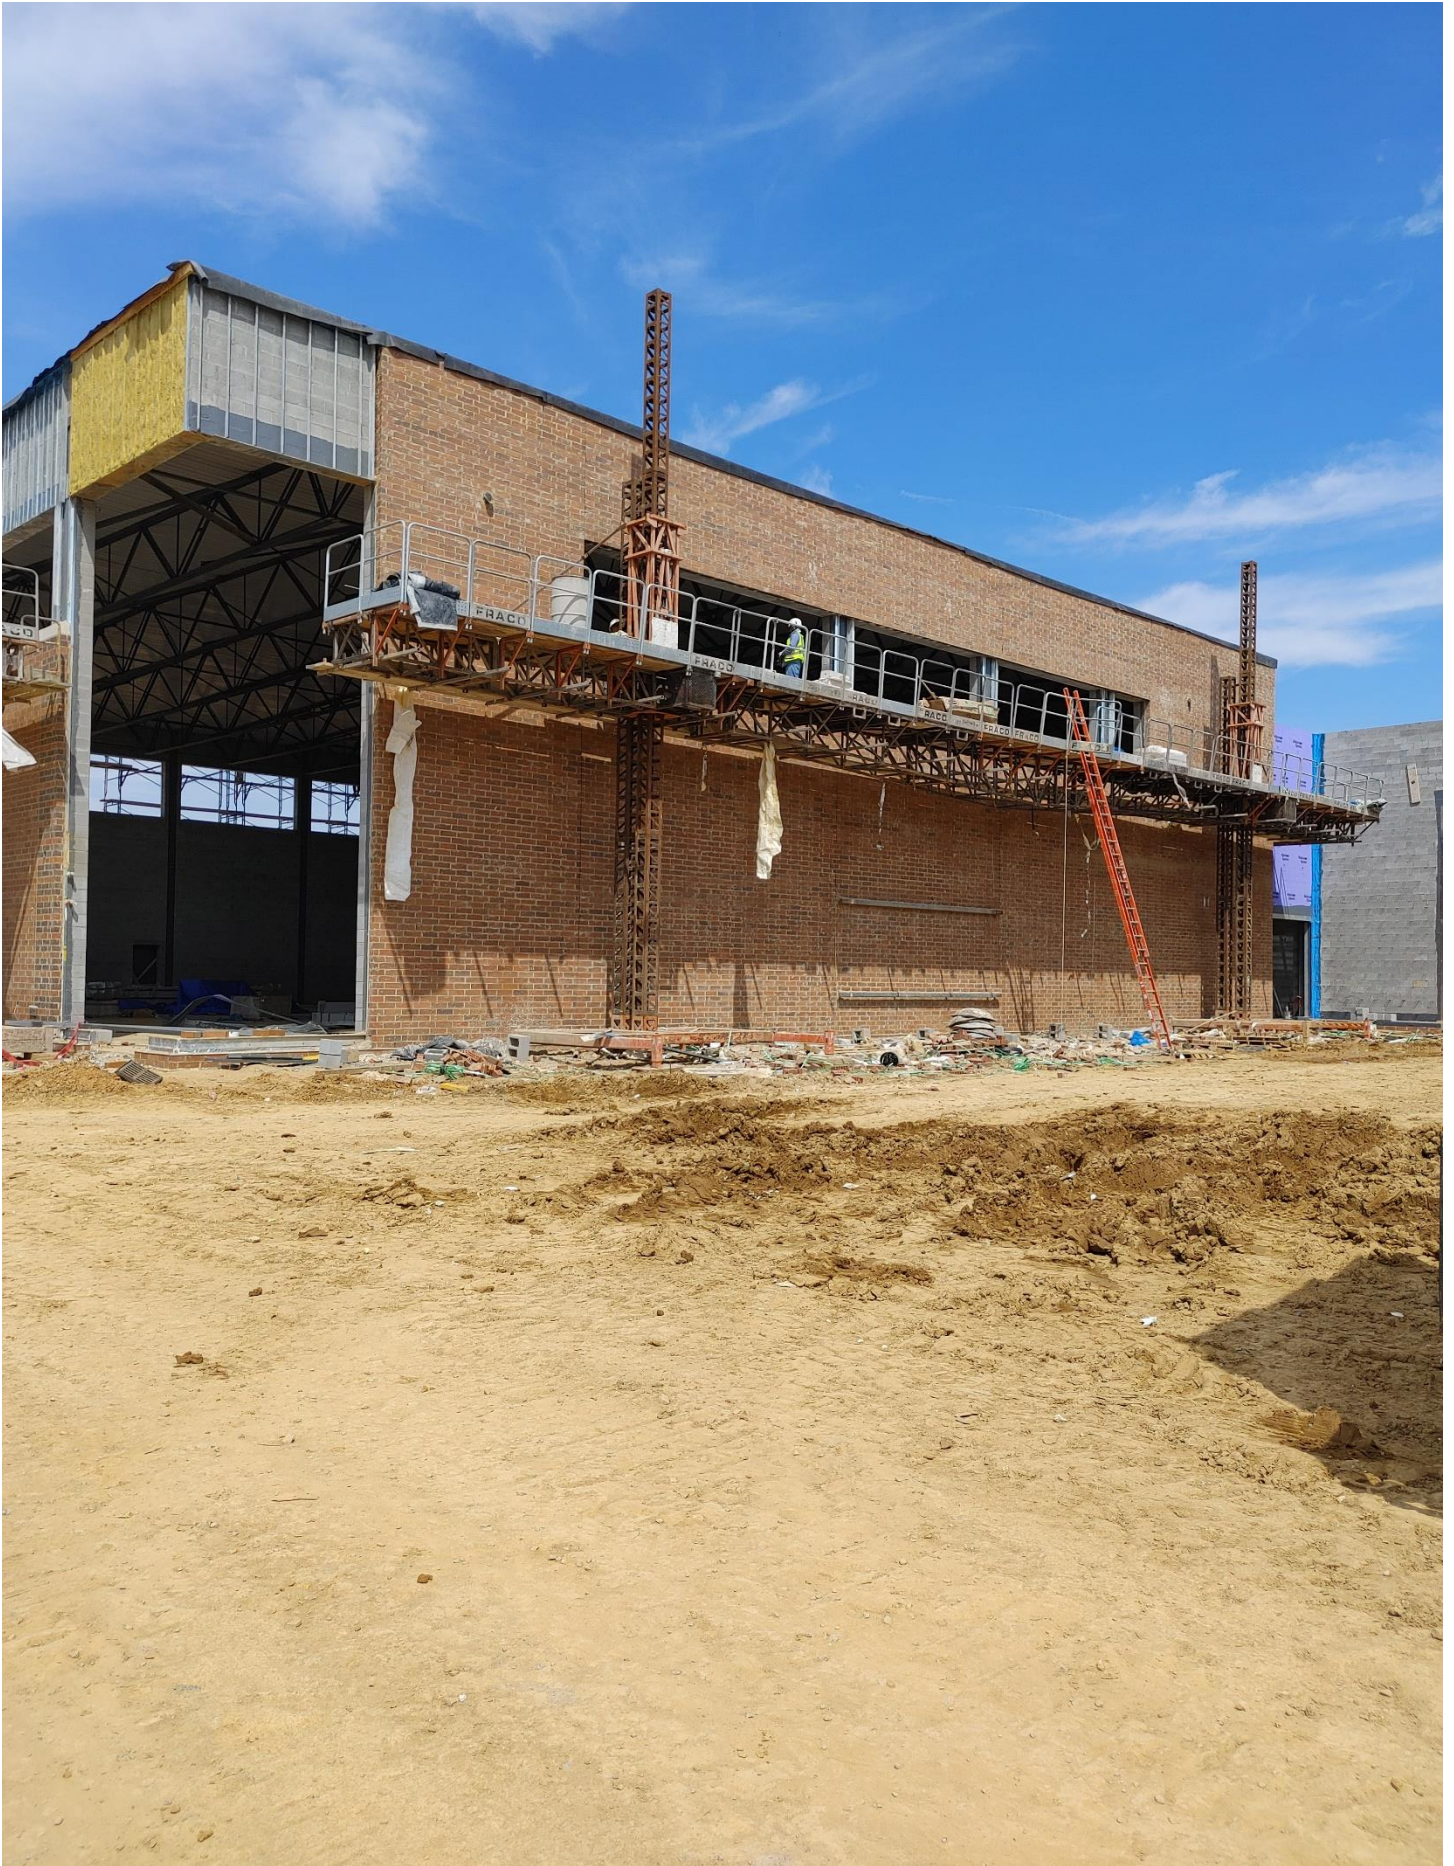
Photo 9 - Masons finishing up Brick work on the East side of Area E.

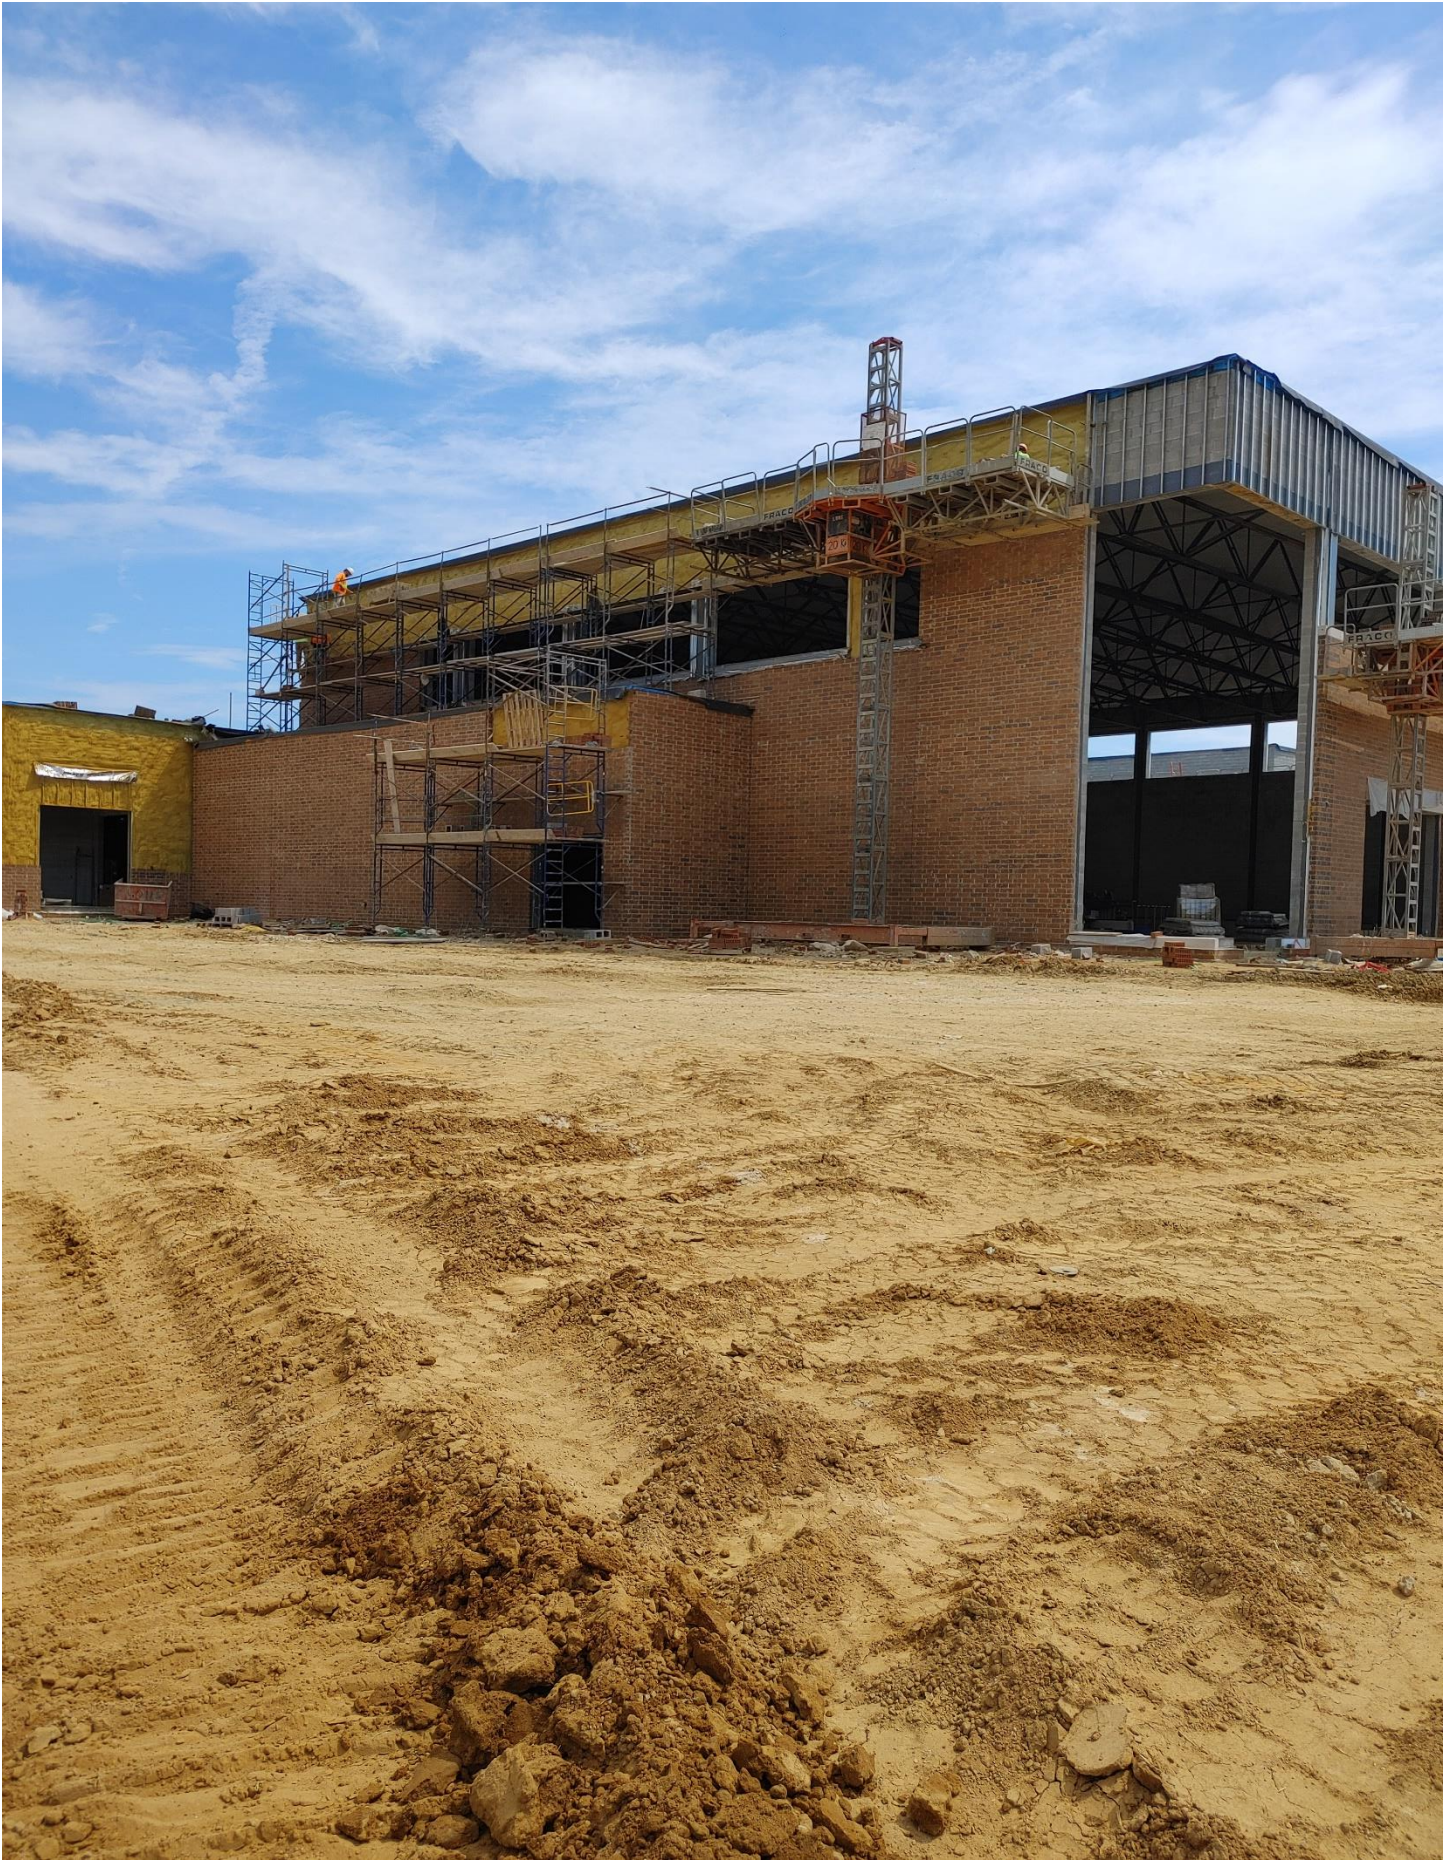
Photo 10 - Masons are preparing to lay Brick on the West side of Area E.

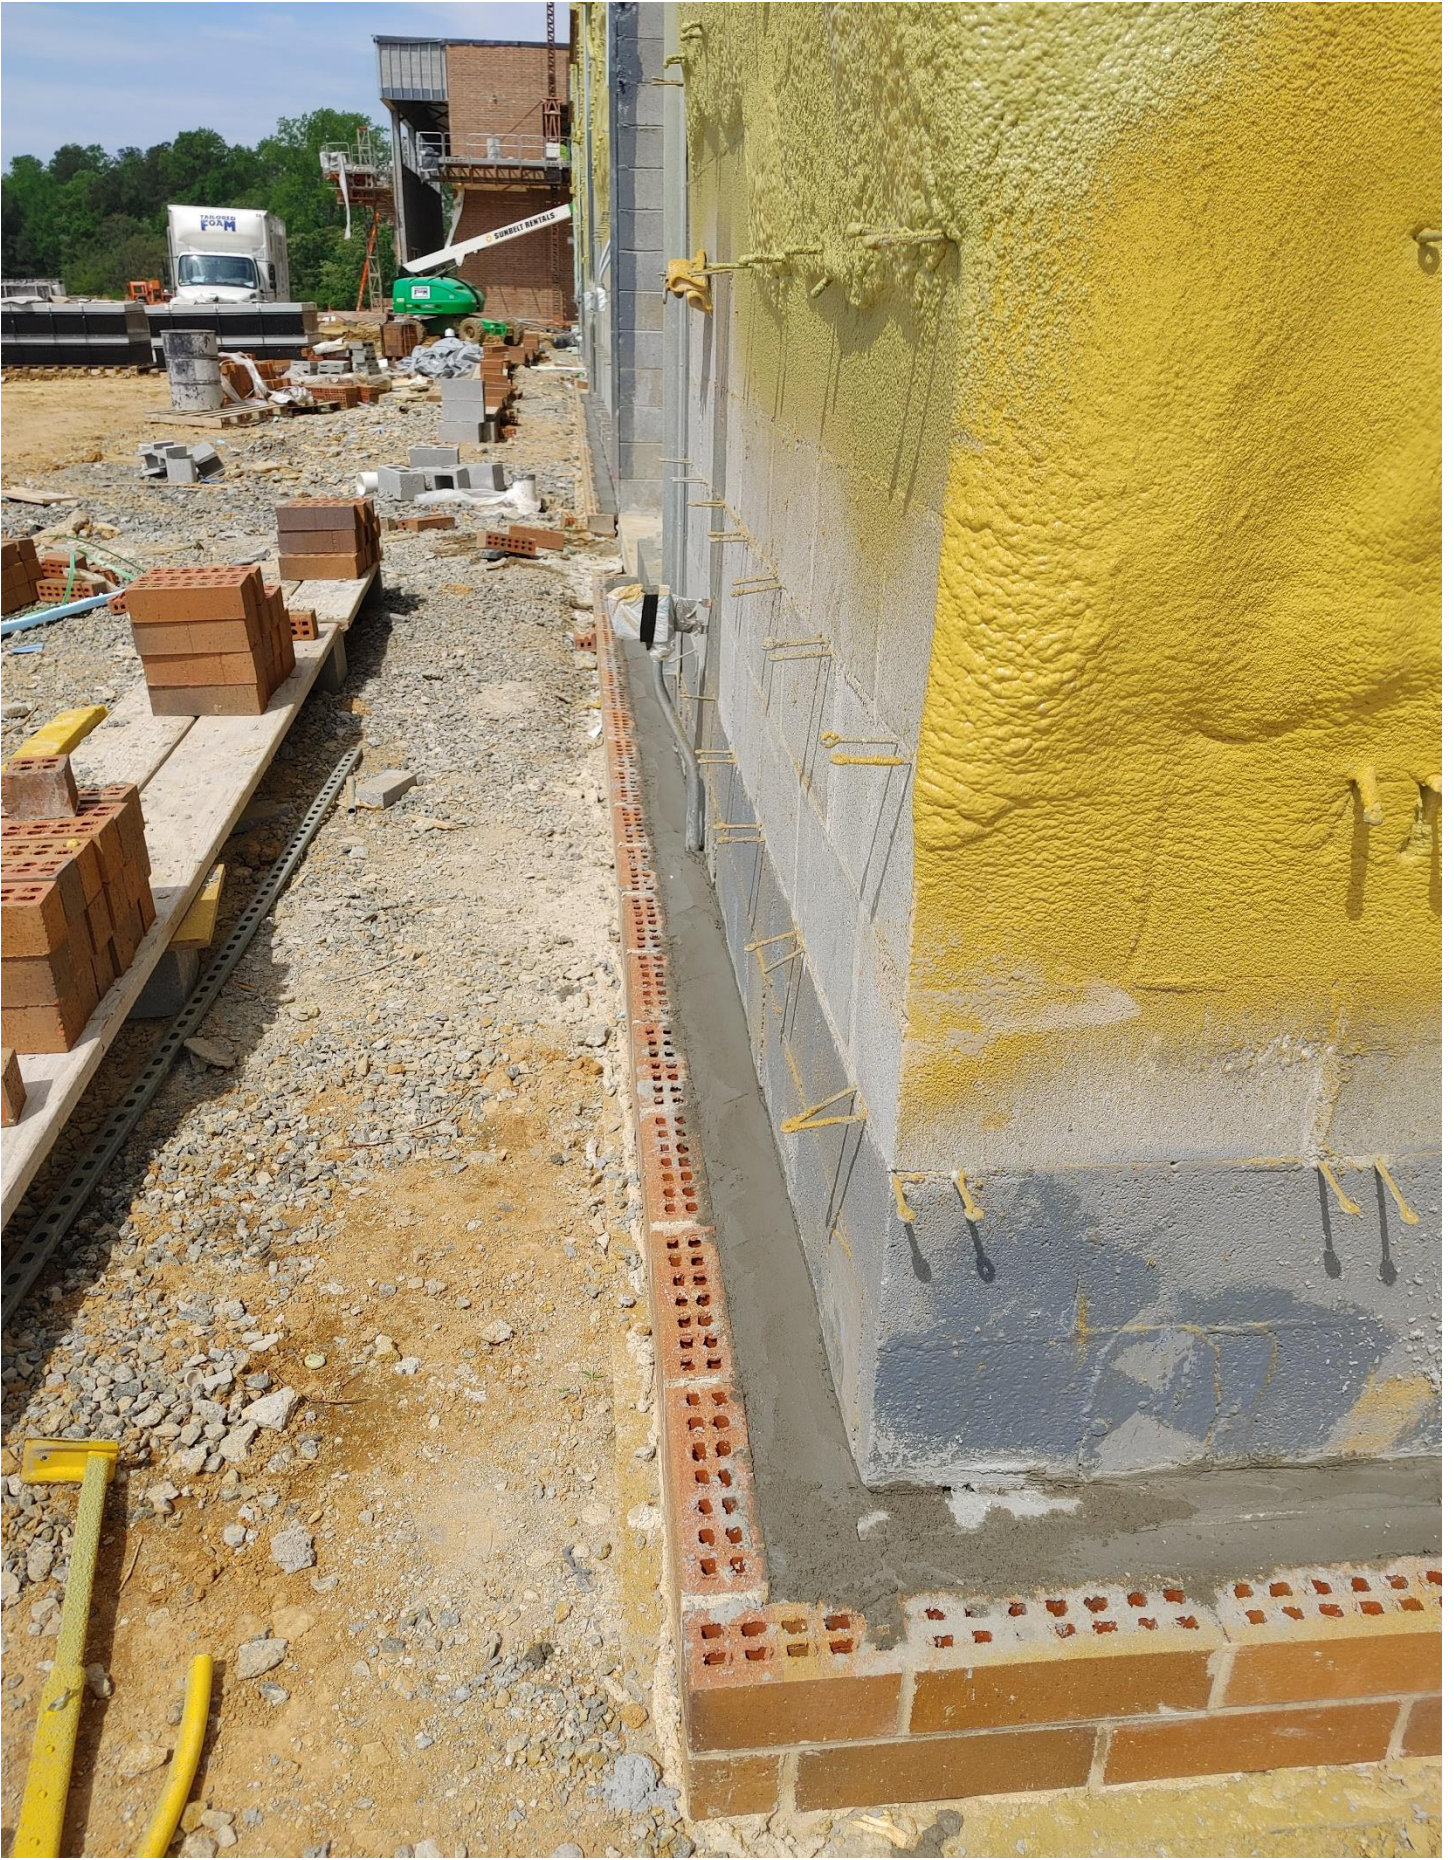
Photo 11 - Brick being prepped for flashing on the South side of Area D.

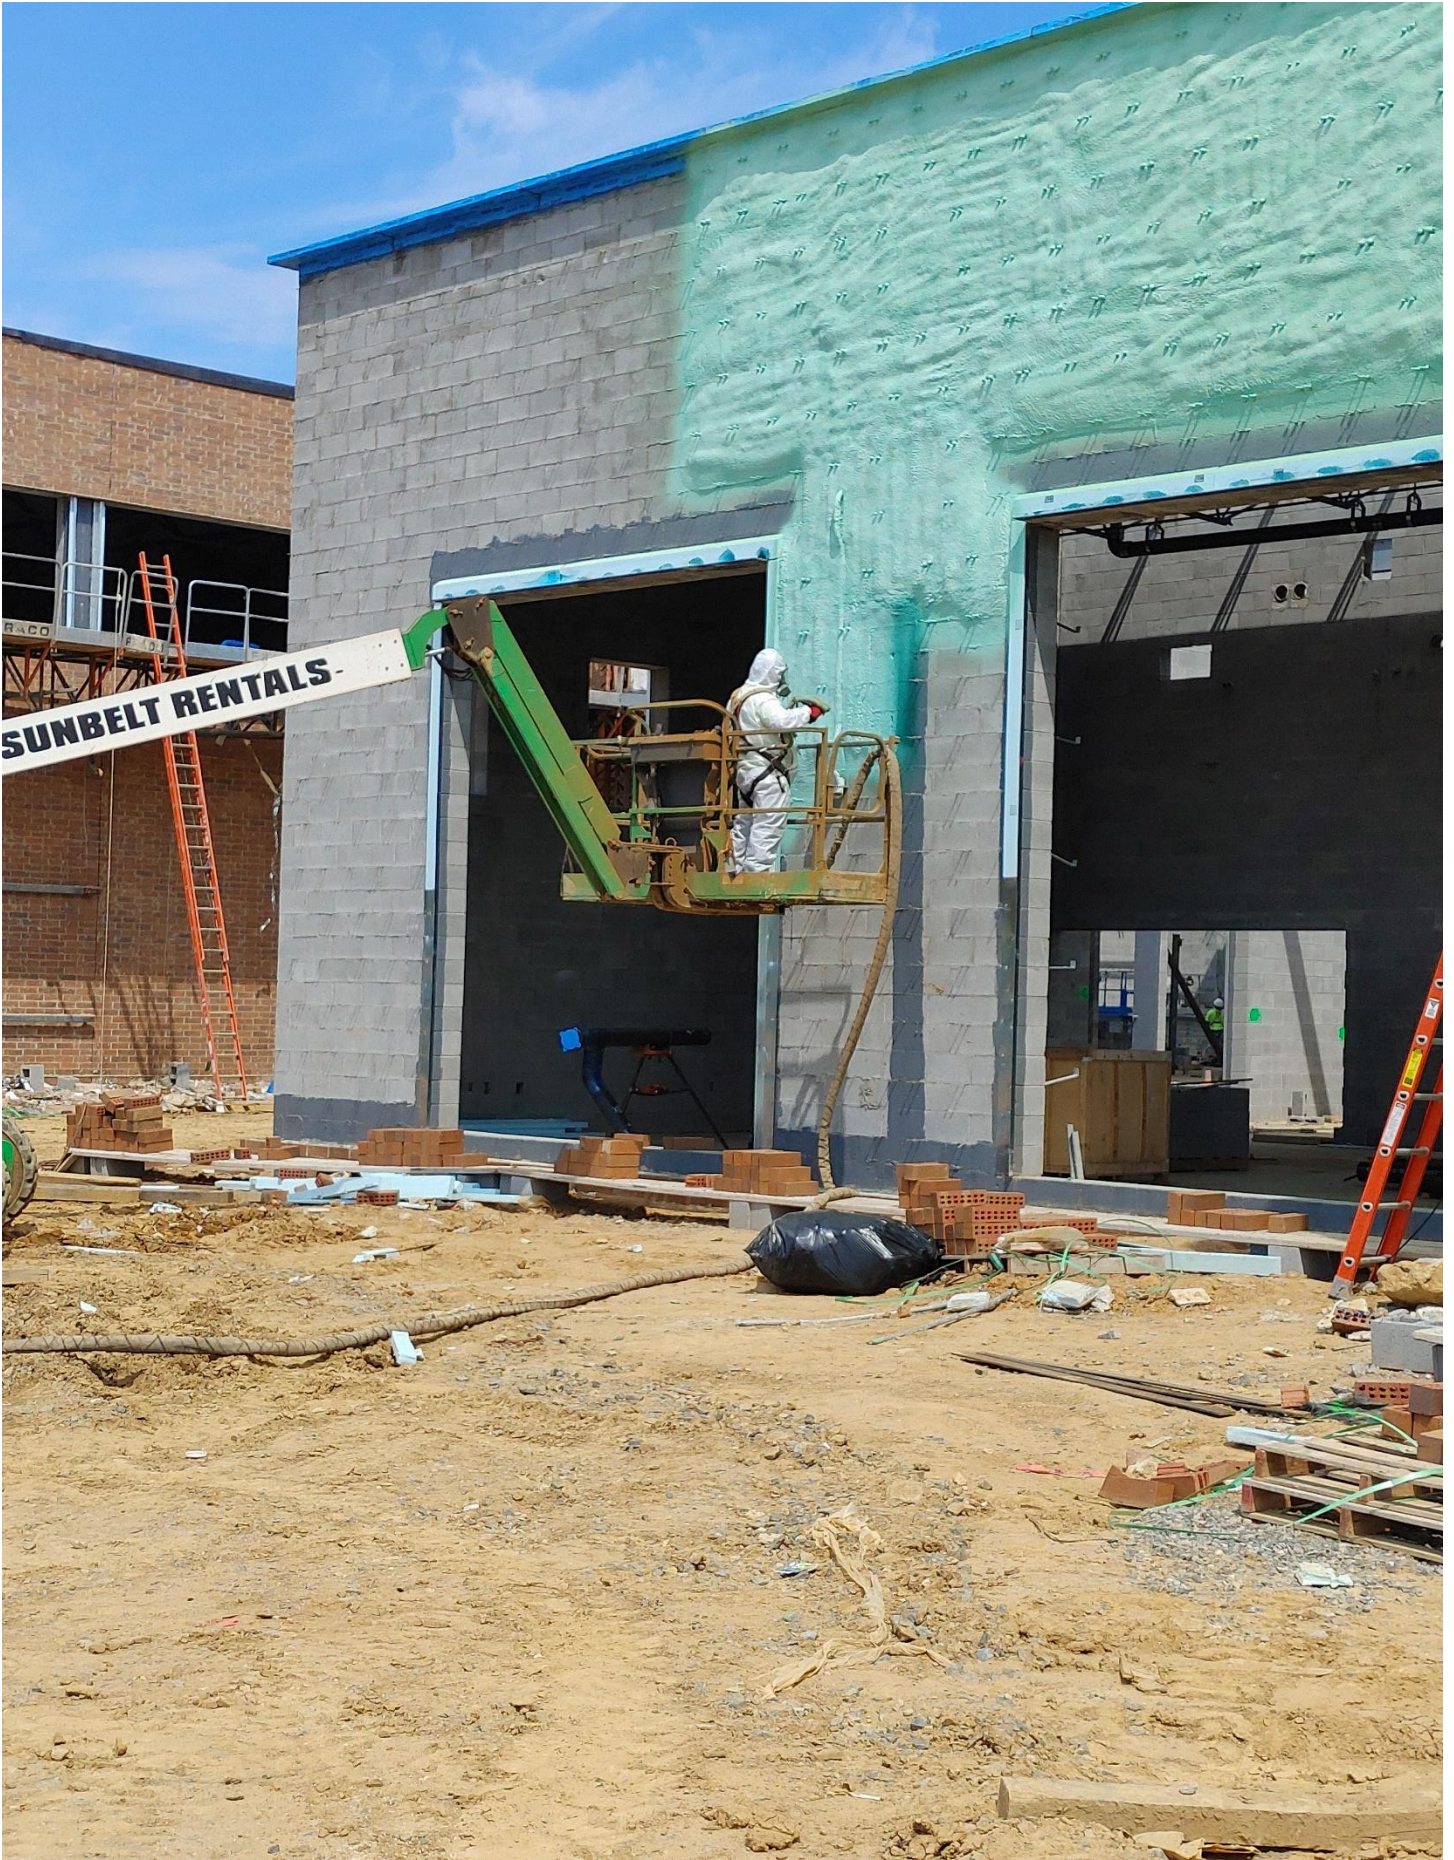
Tailored Foam: Two (2) men are on site today. They are spraying foam on the South side of Area D this morning.

Photo 12 - Spray Foam is being applied to the South side of Area D.
