**COMMONWEALTH
BUILDING SOLUTIONS, LLC**

DAILY REPORT

WESTMORELAND COUNTY HIGH SCHOOL

Date: 04/28/2021

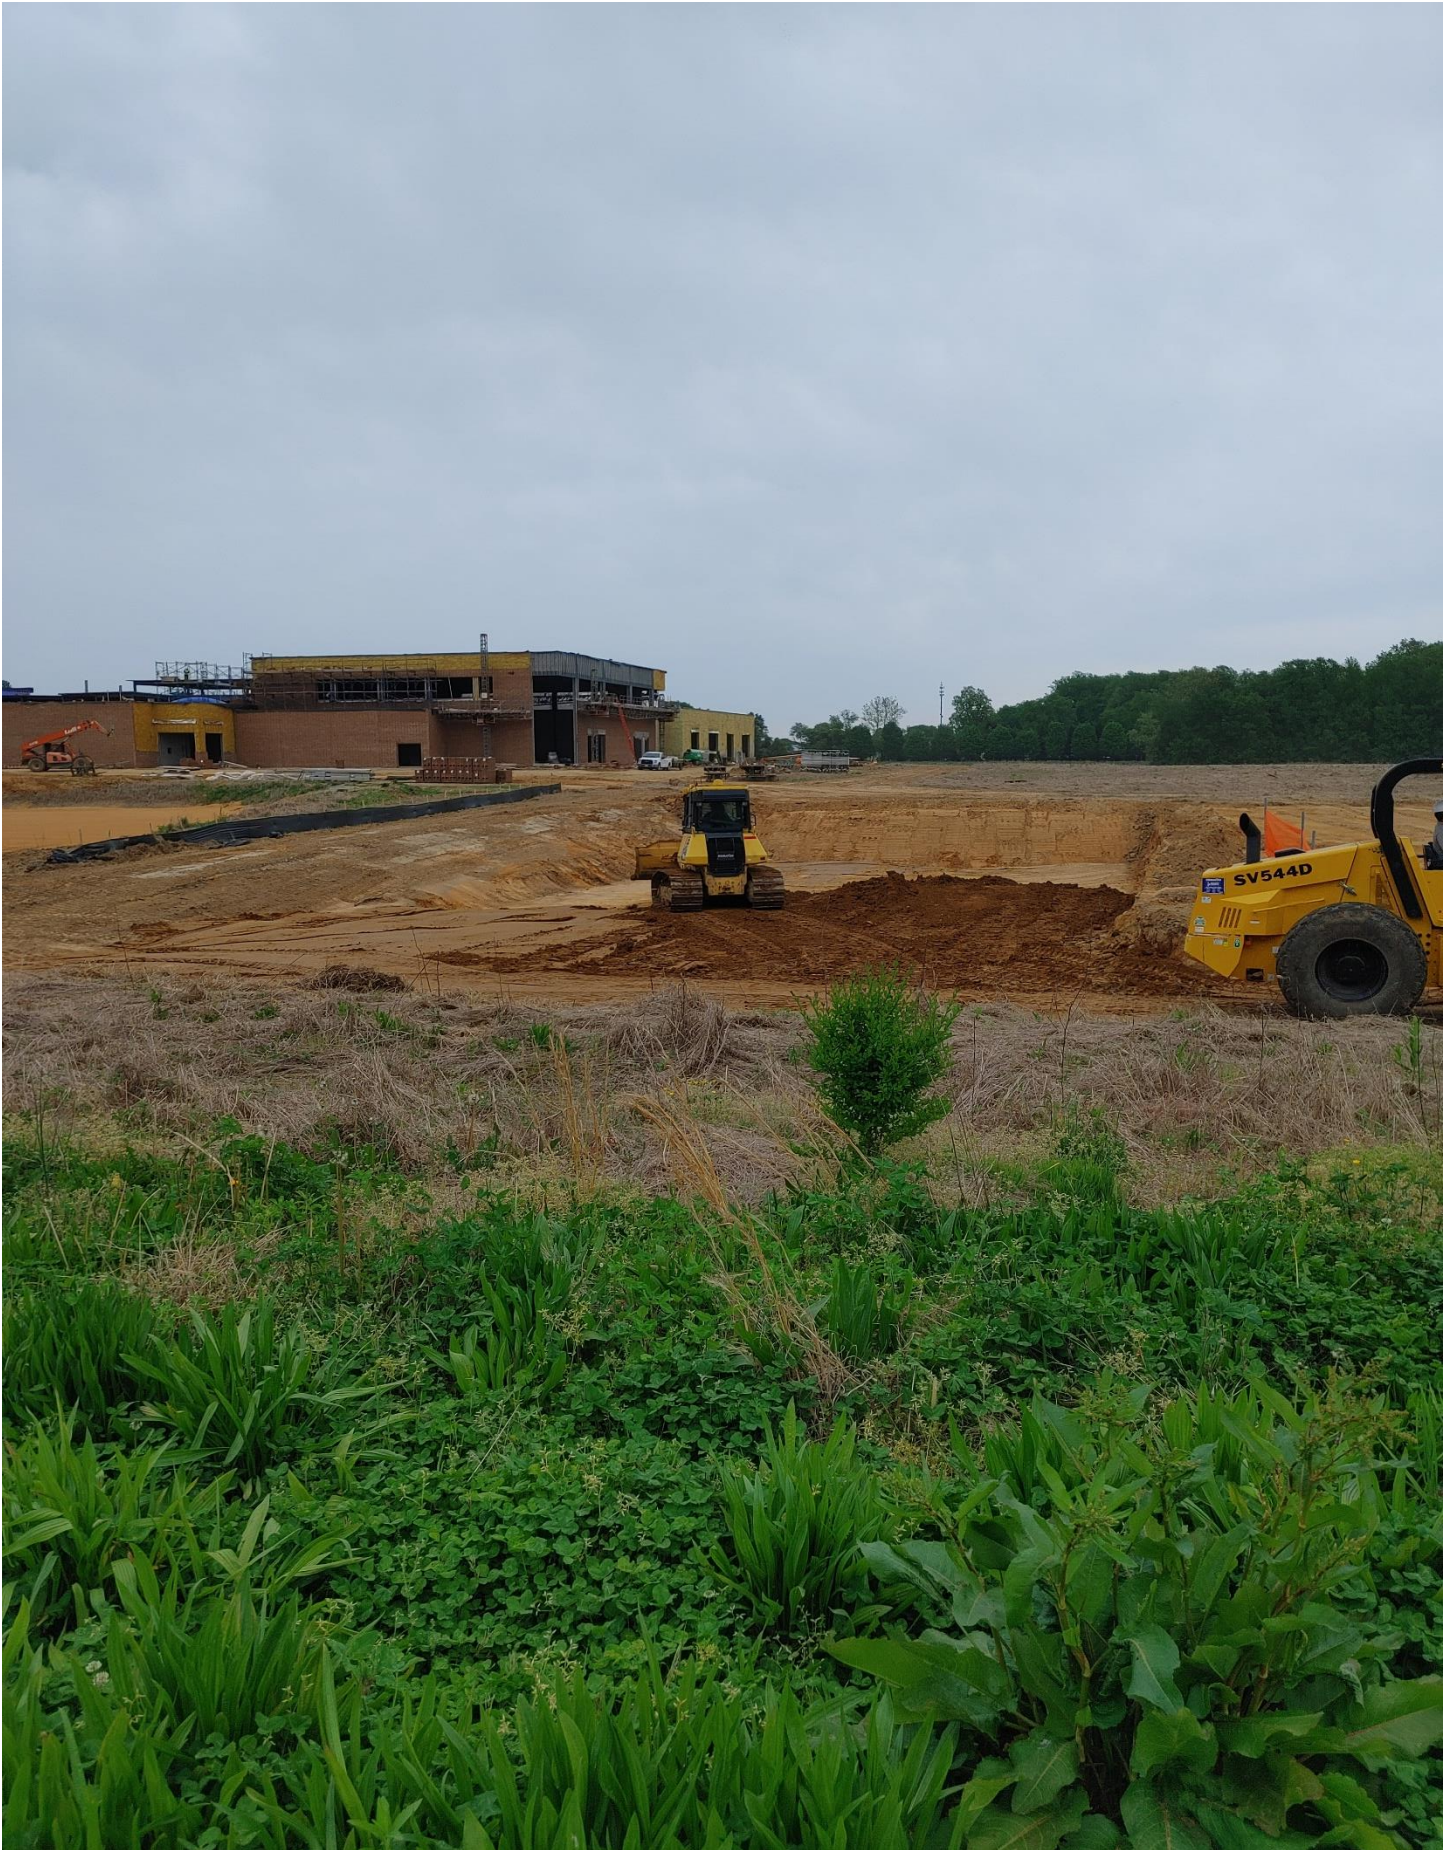
Photo 1 - Beuchert continues to move dirt on the West side of the site.

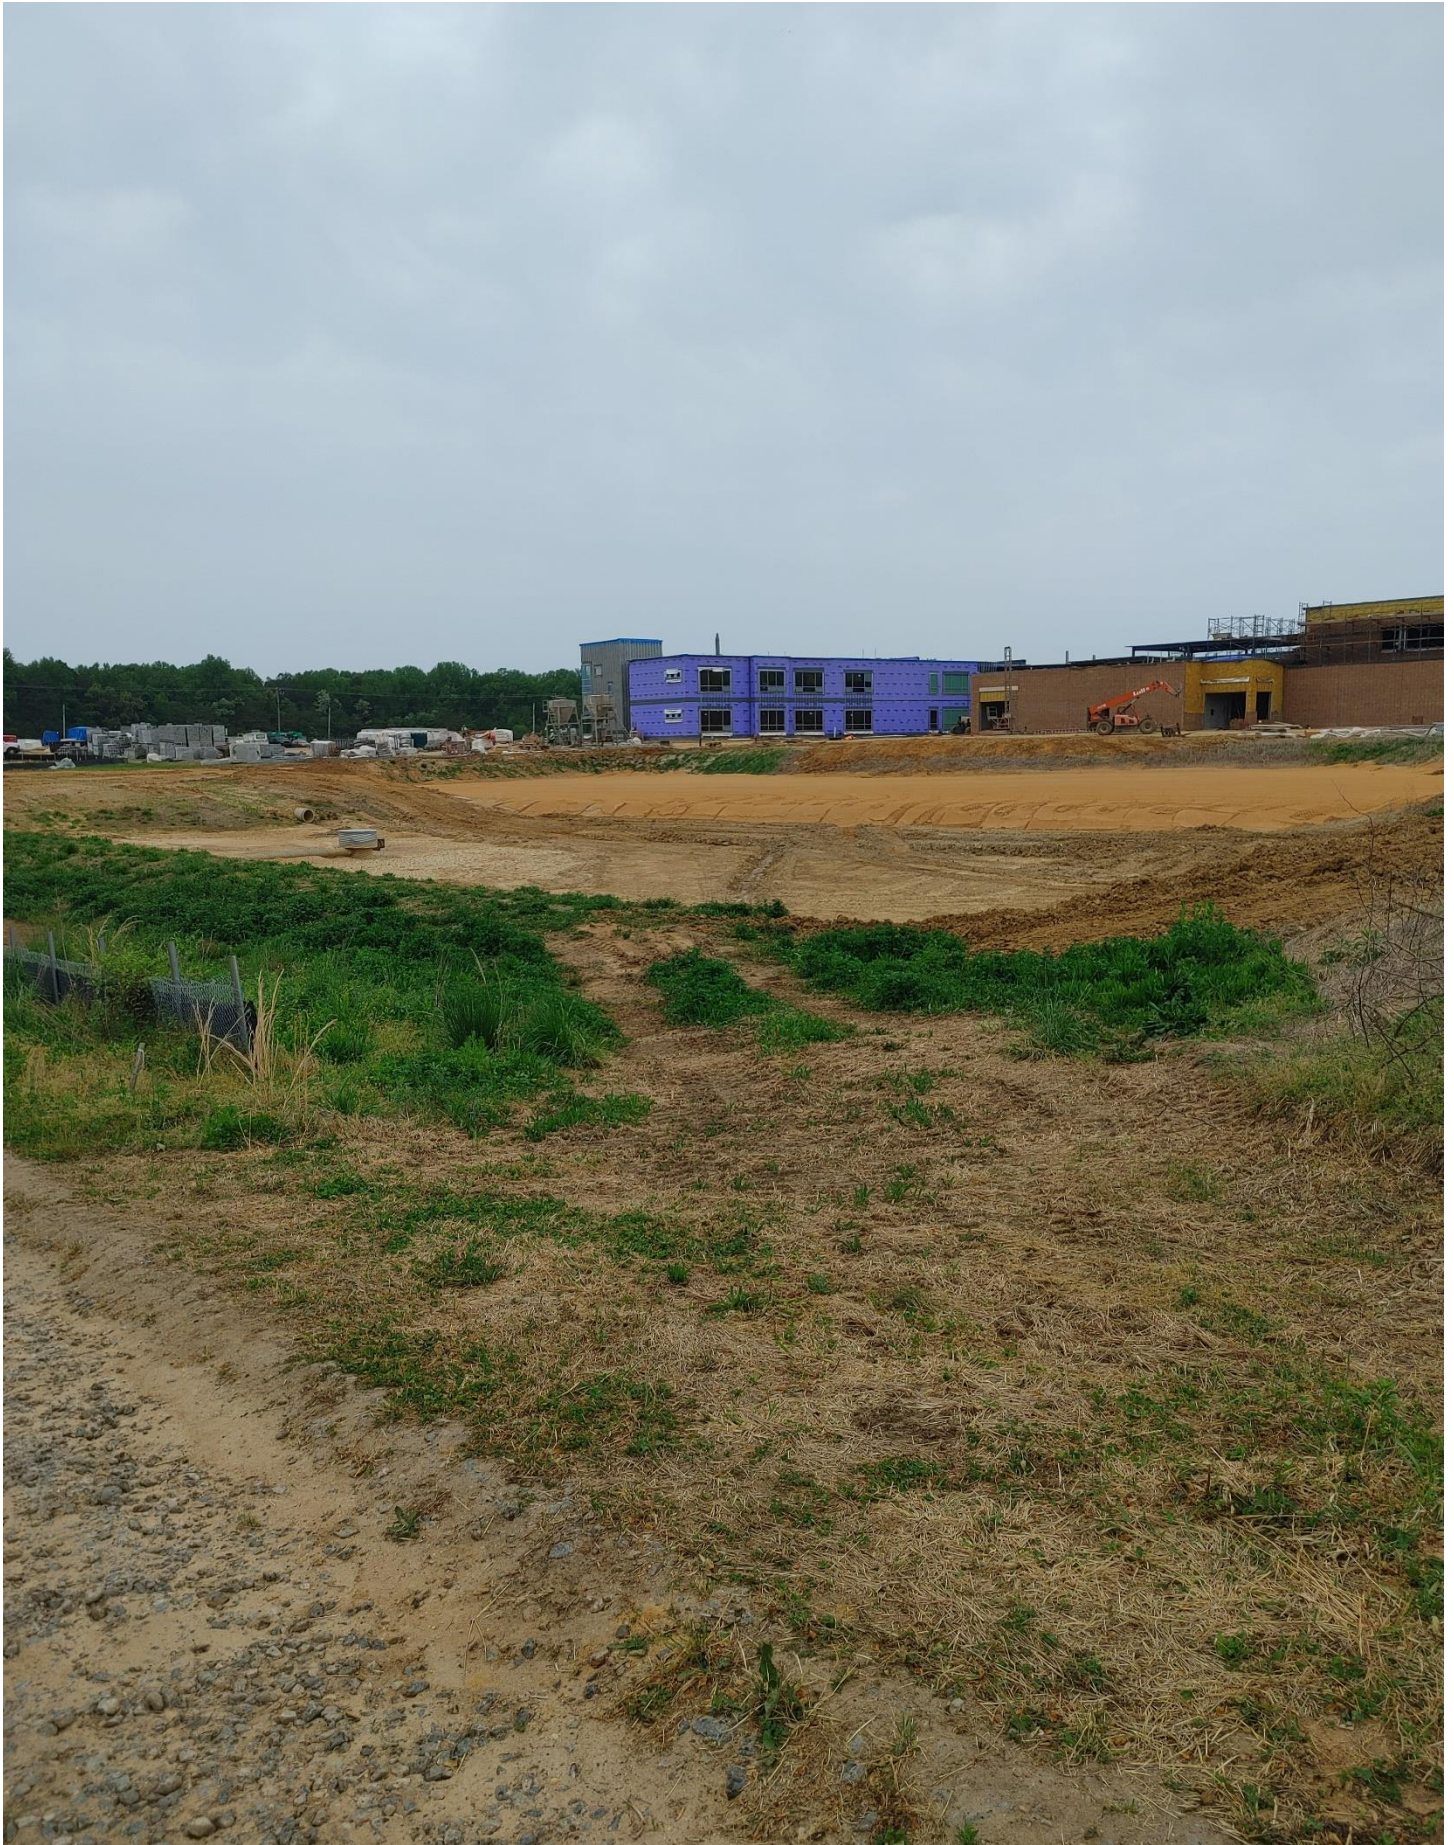
Photo 2 - Retention Pond #1 being reworked.

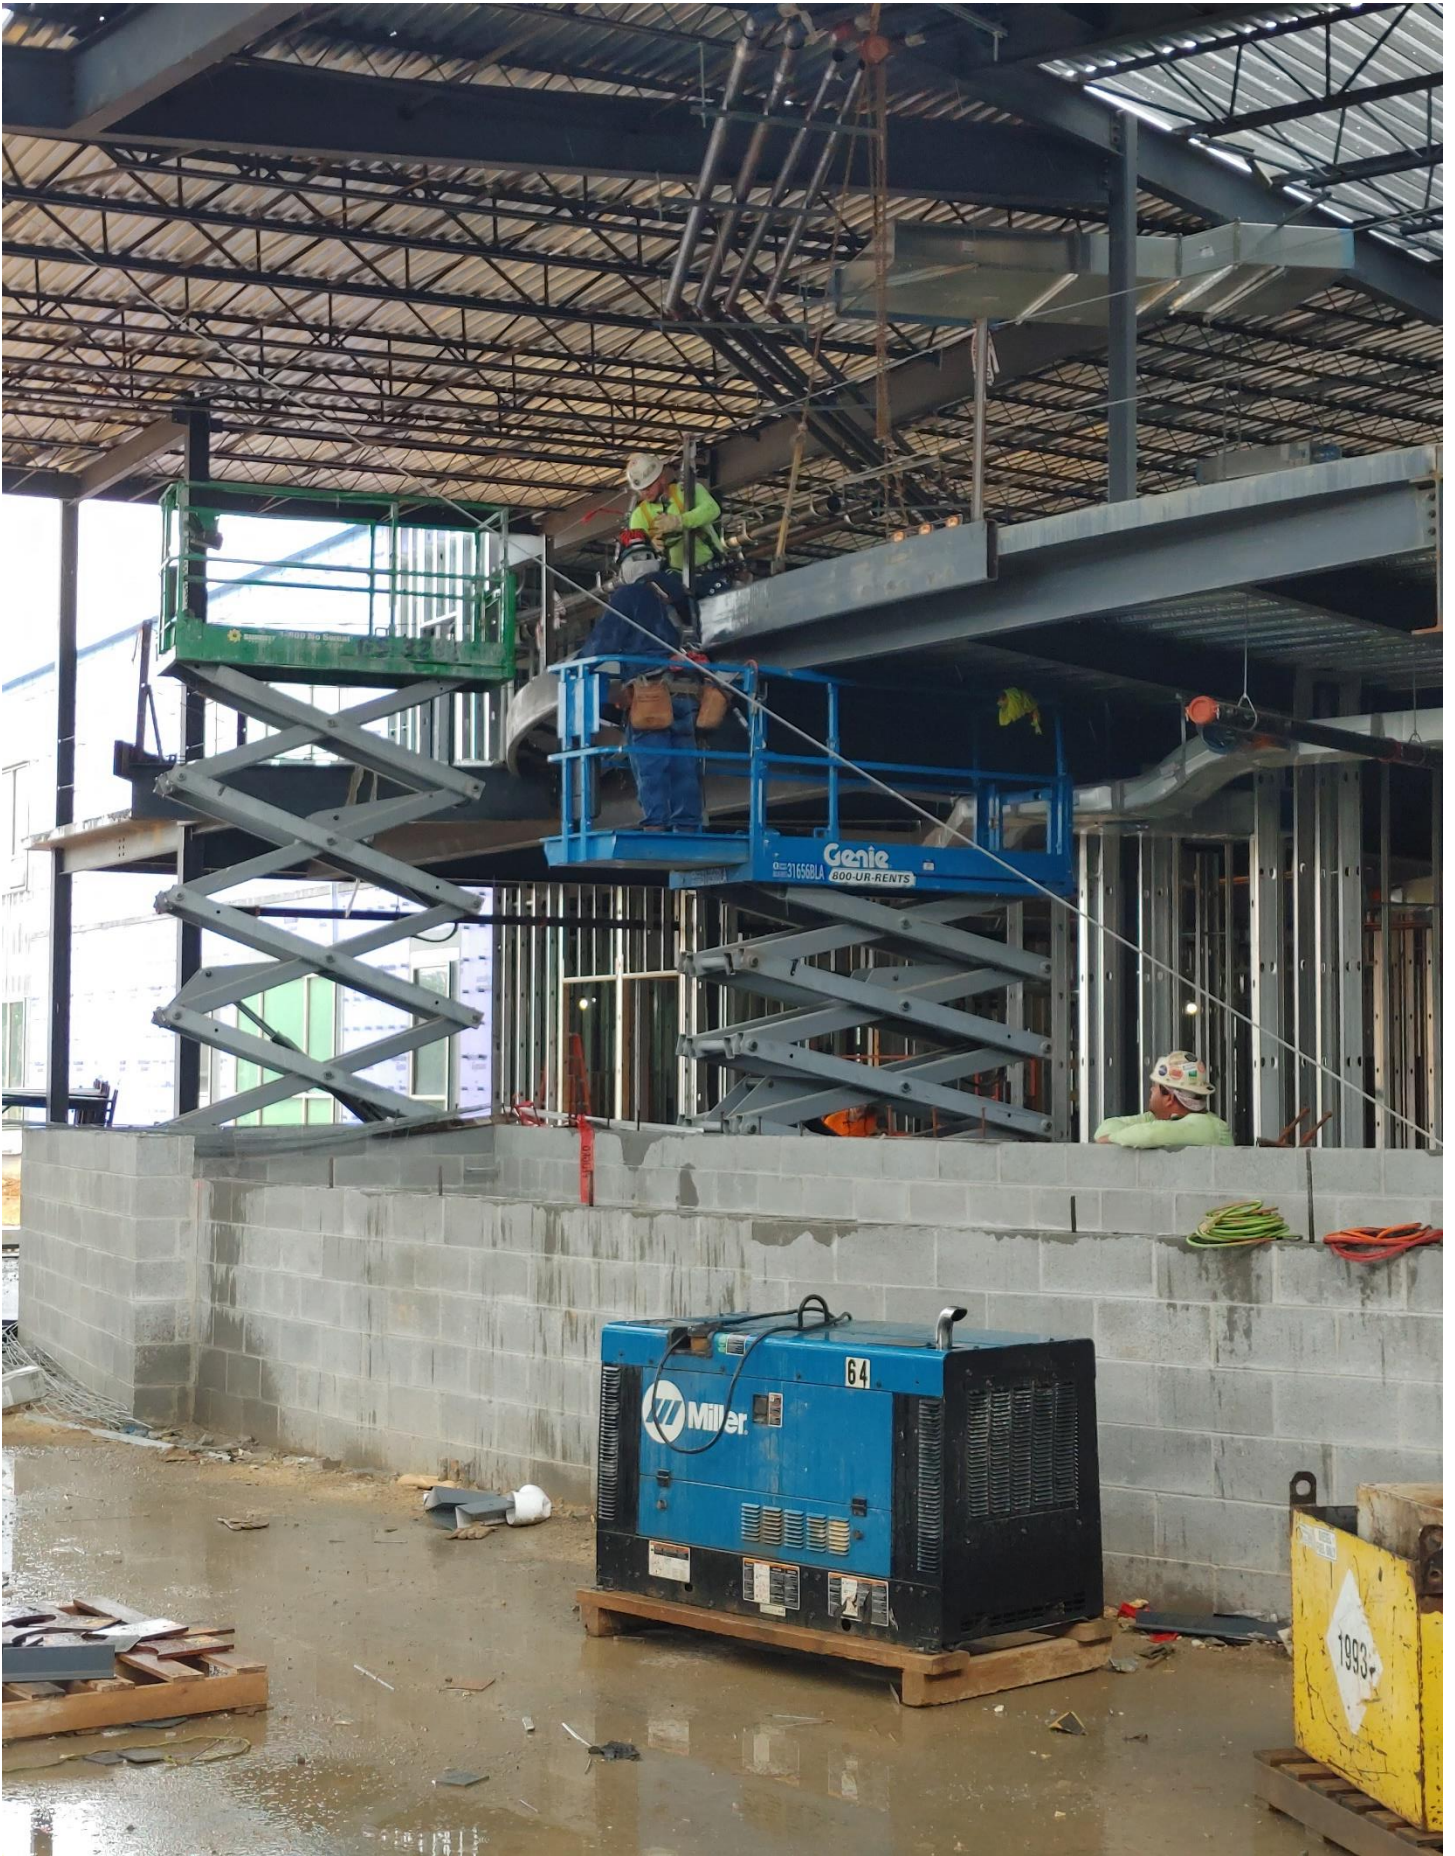
Photo 3 - Weldon Steel working of Stair #3

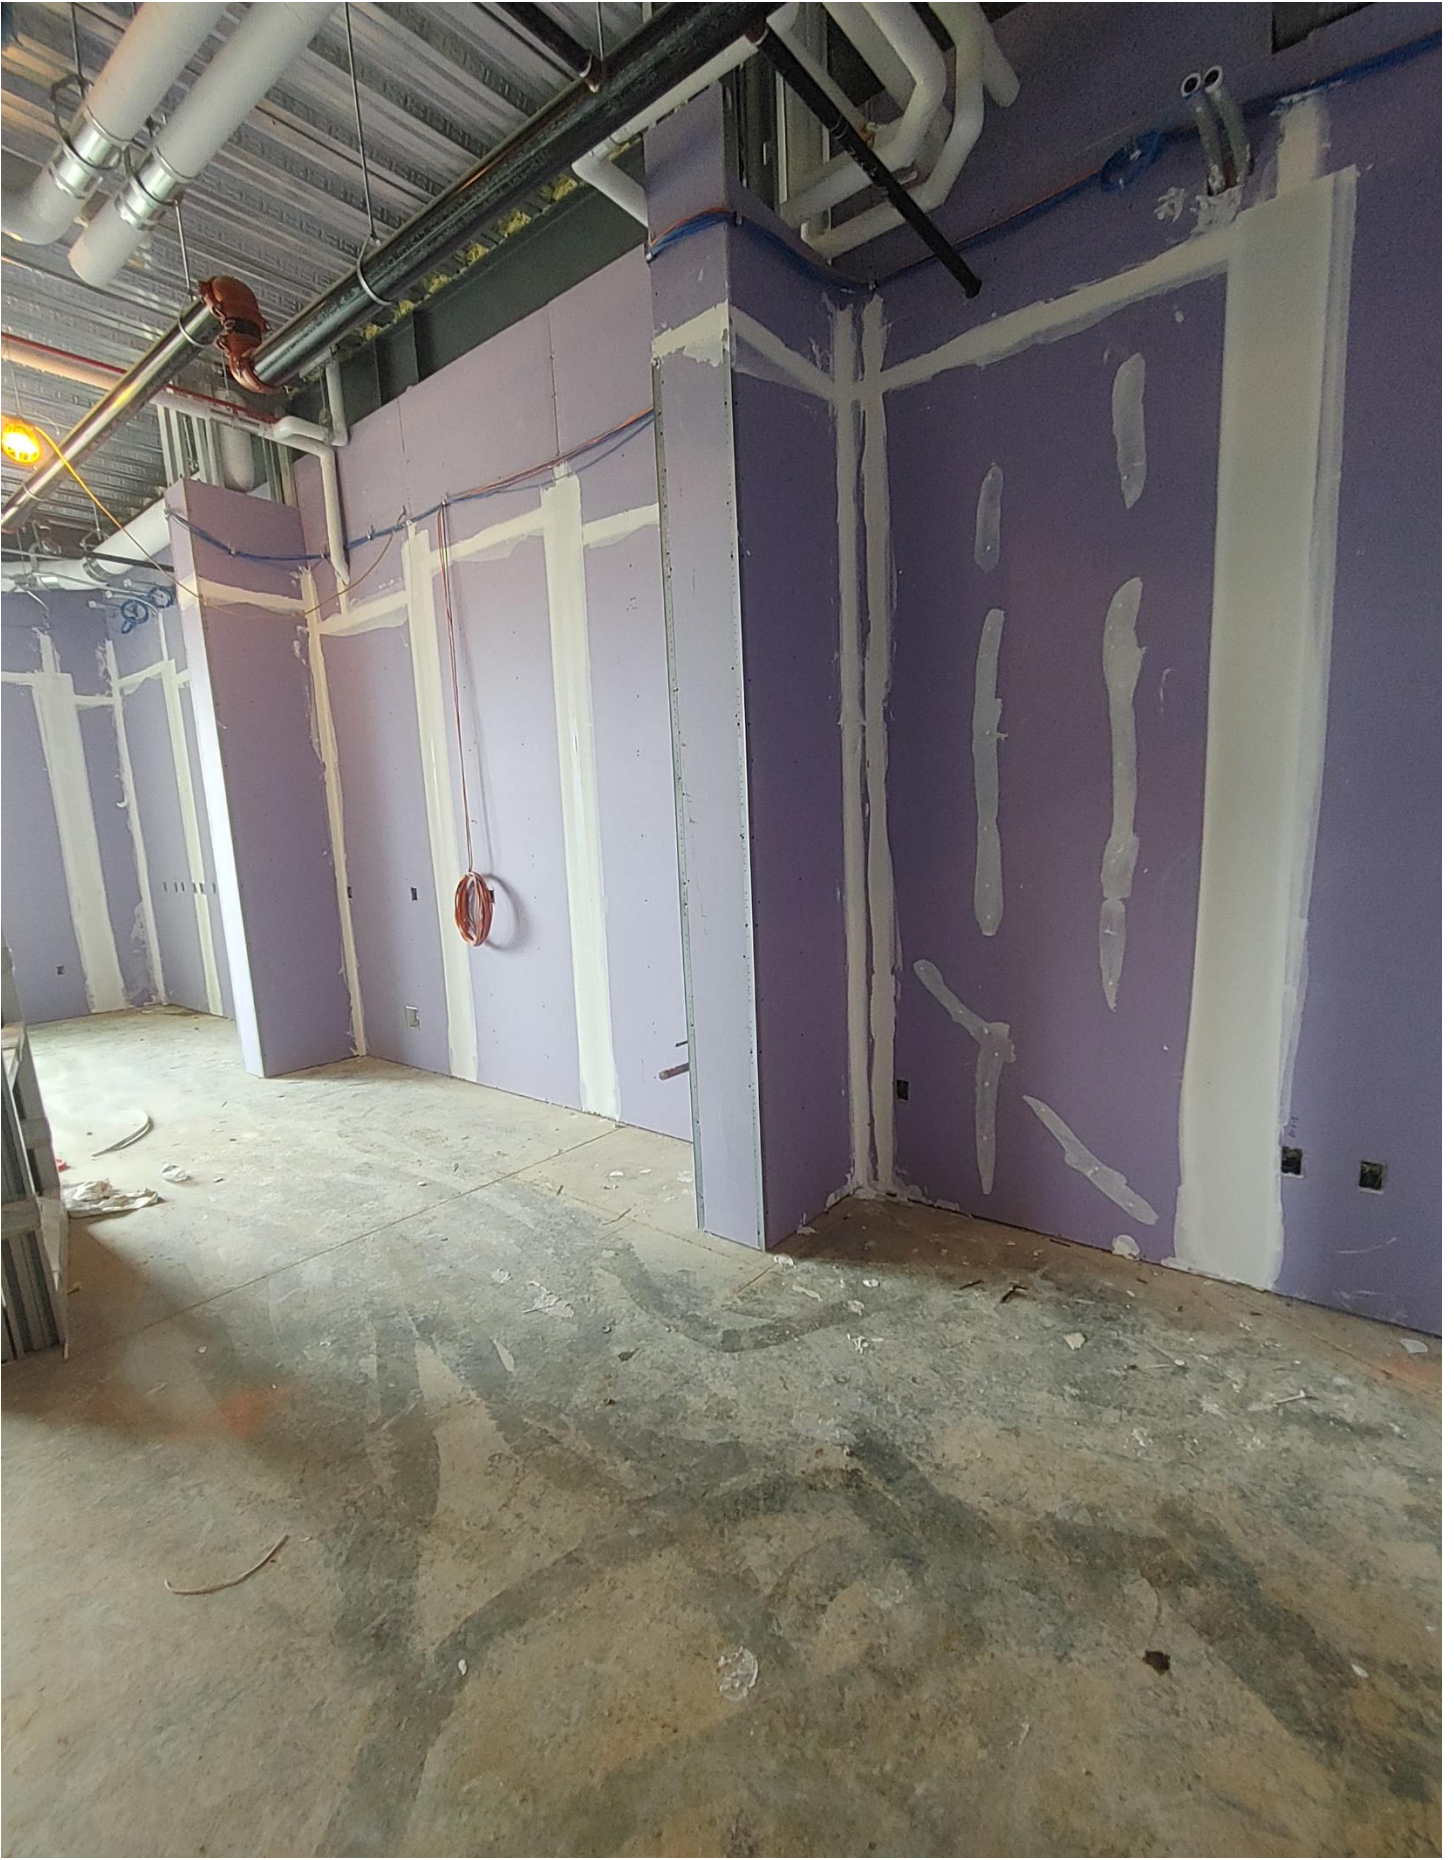
Photo 4 - Block Coat of mud being applied to Vertical Joints in Area A

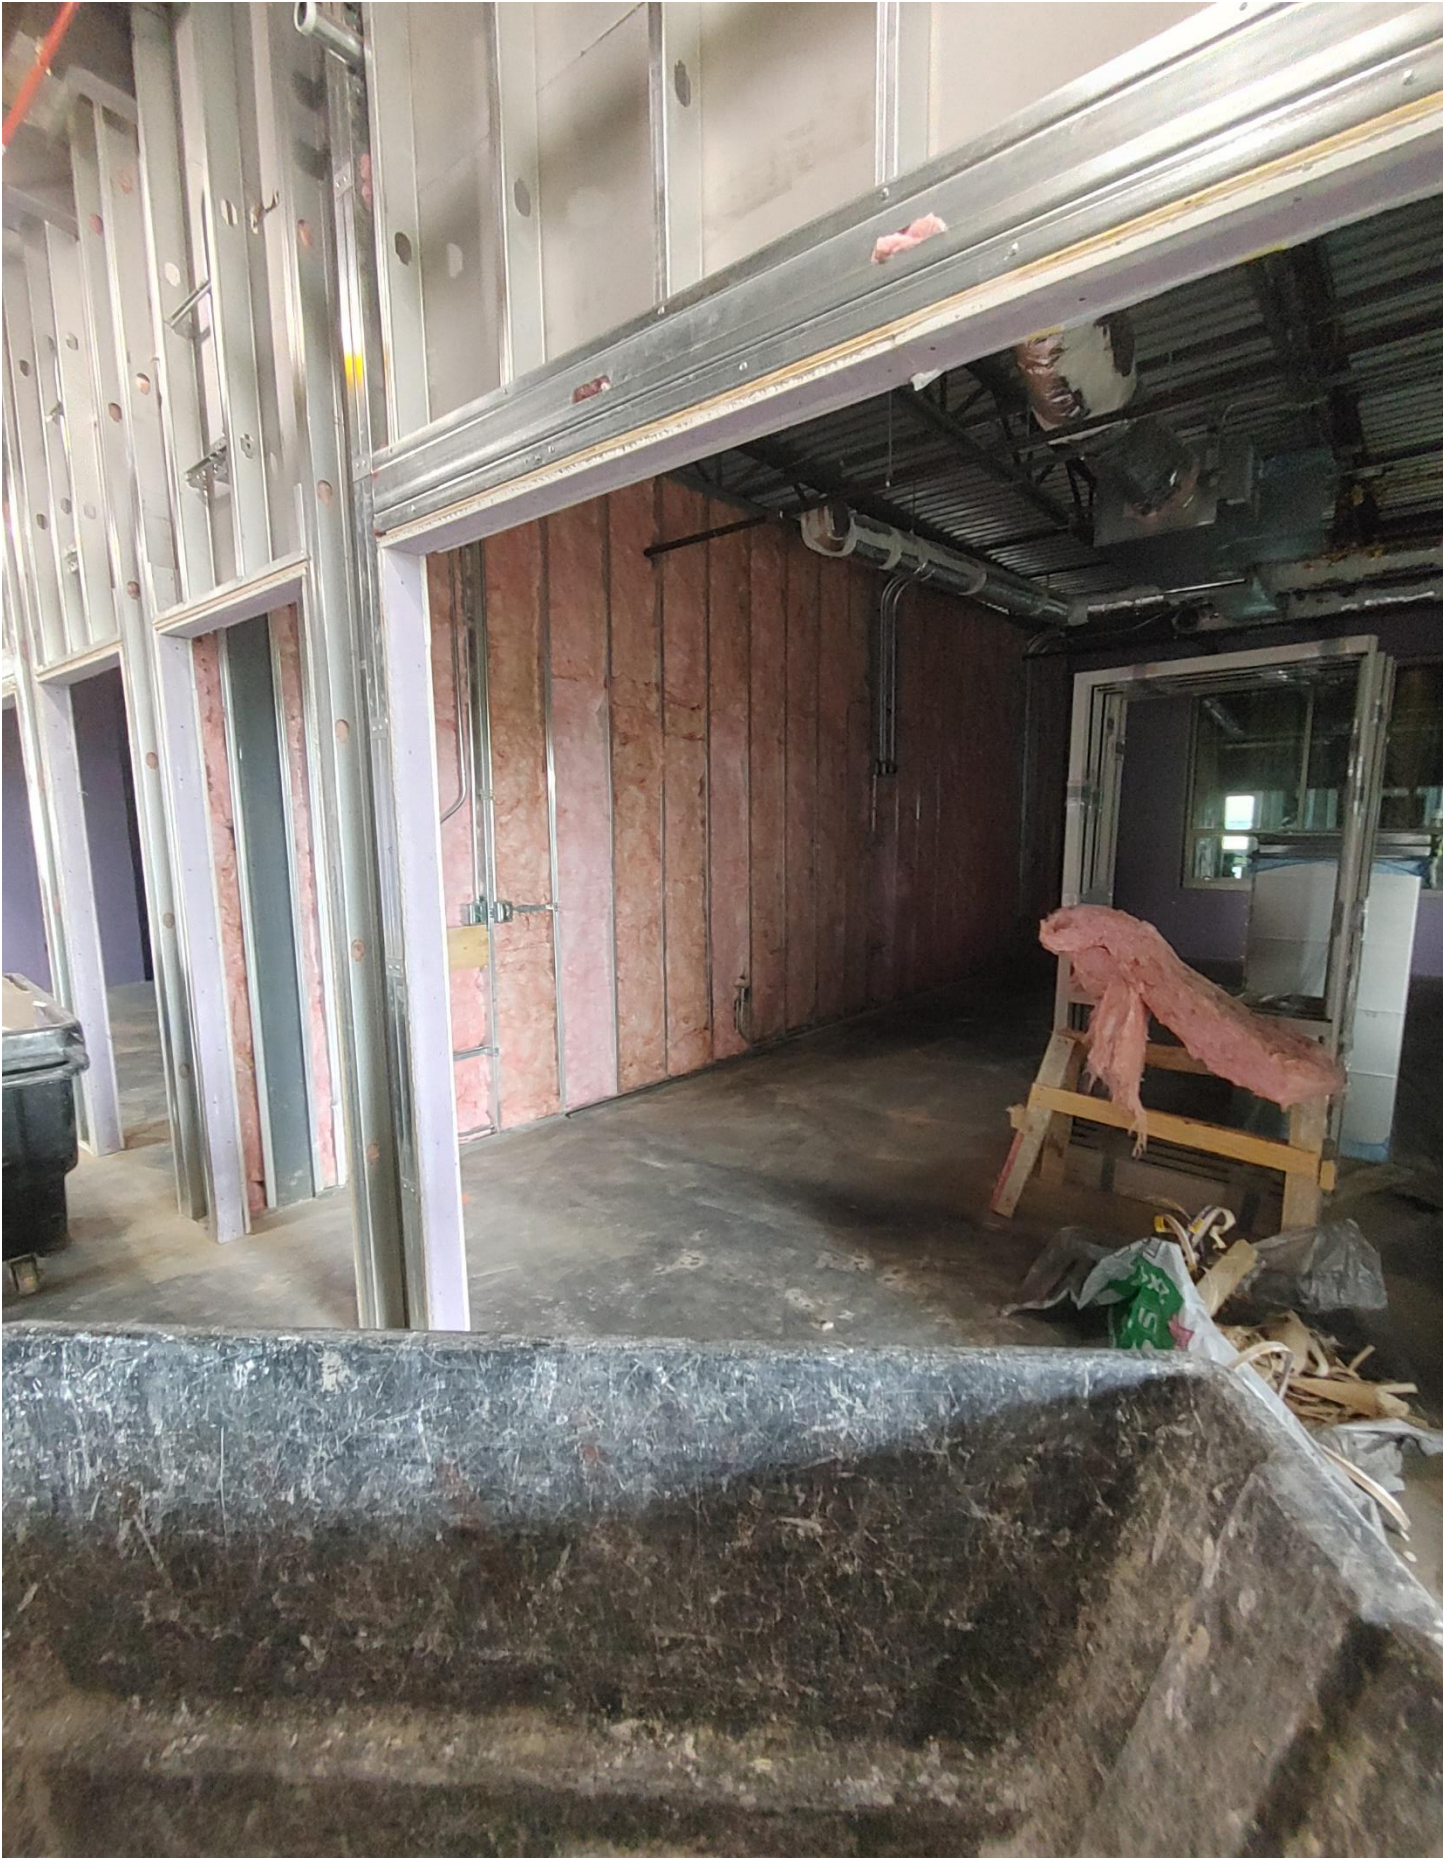
Photo 5 - Walls being insulated in Area A

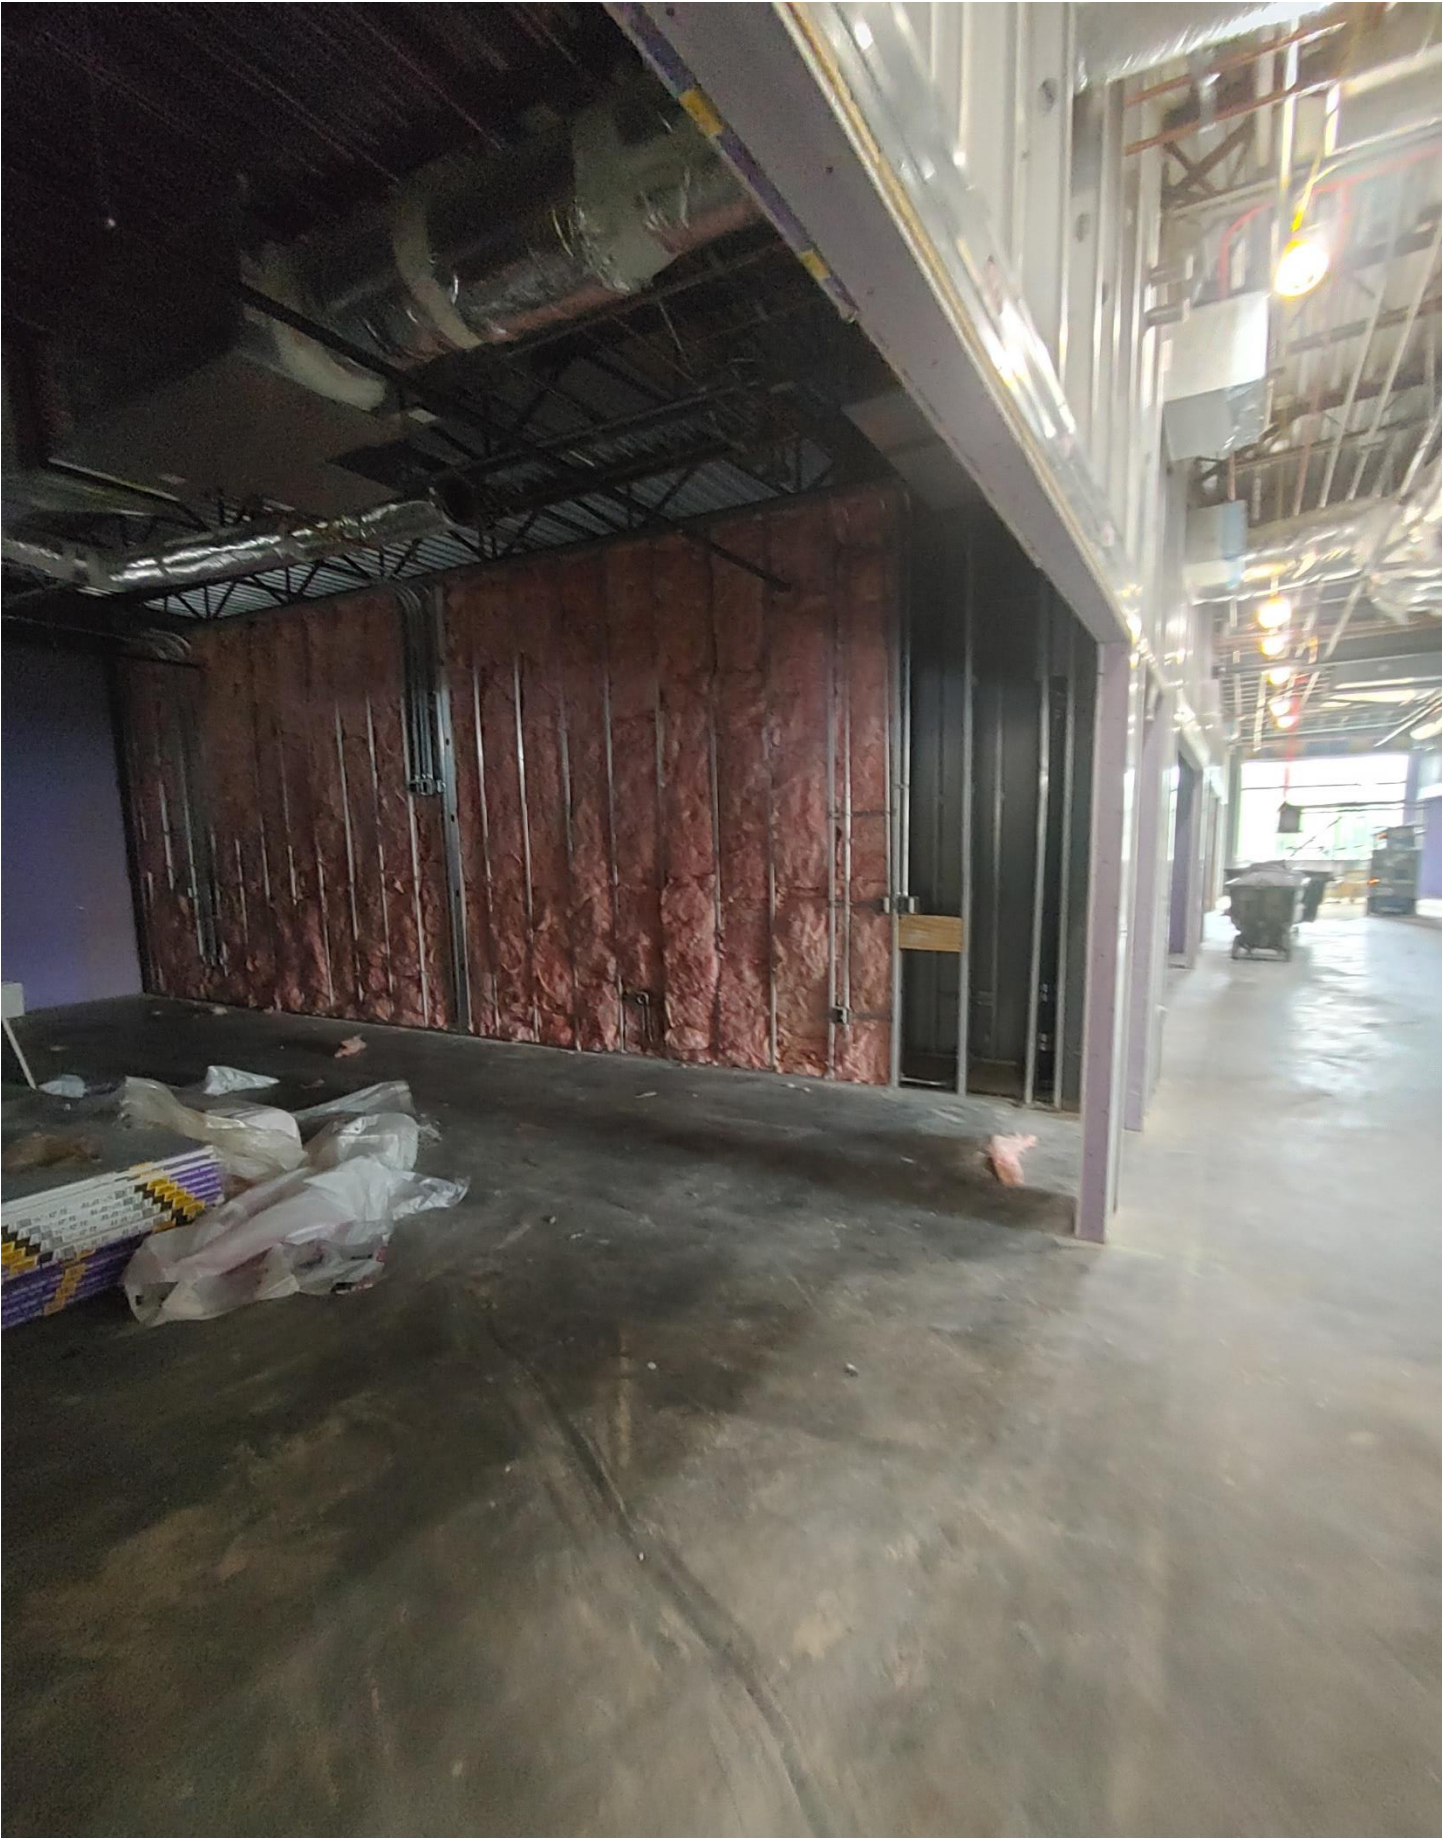
Photo 6 - Area A walls being insulated

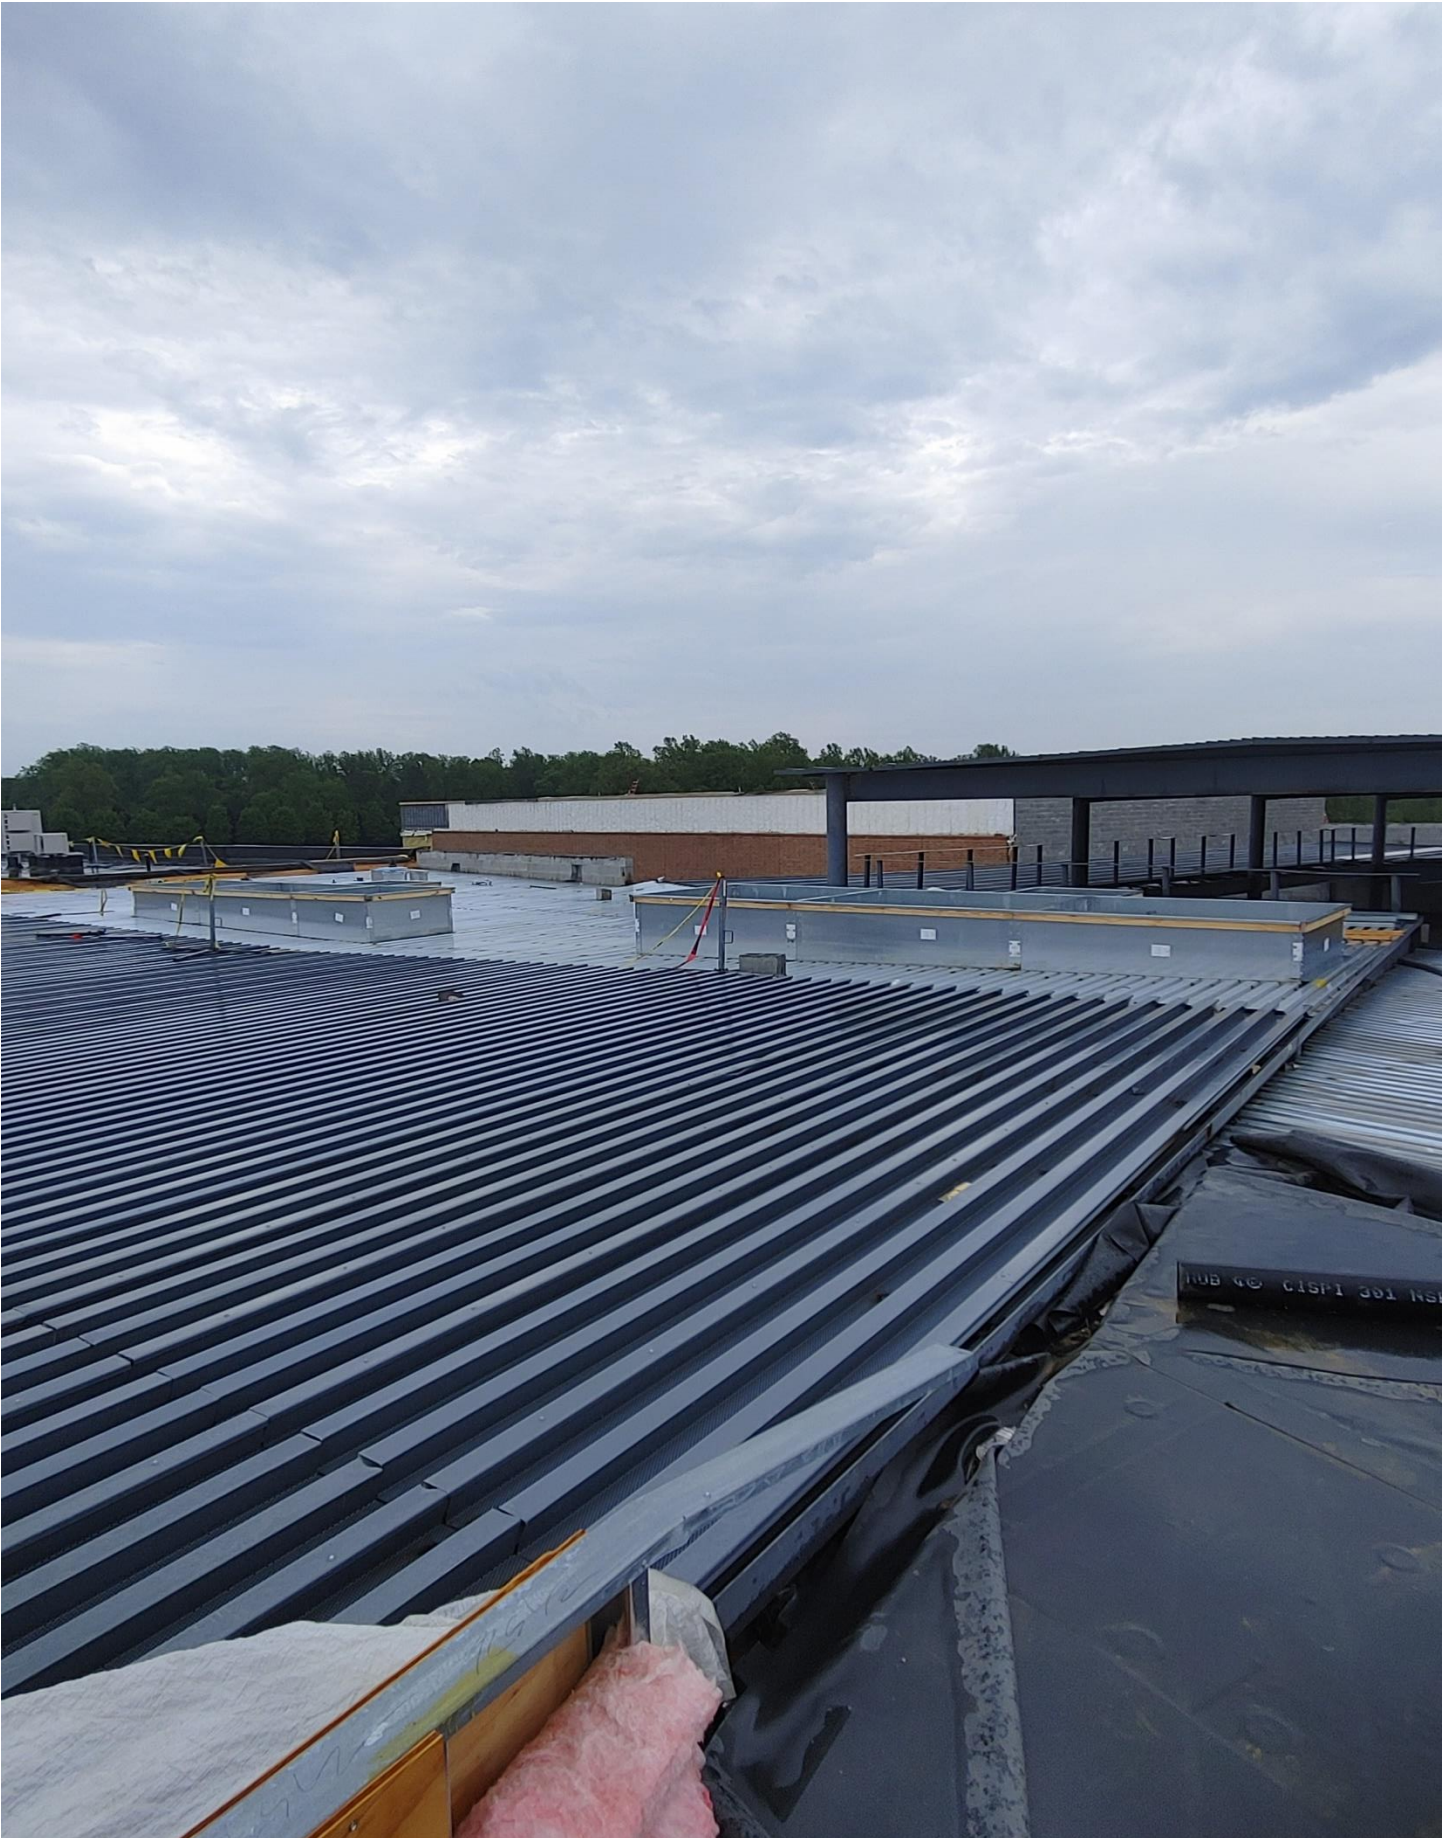
Photo 7 - HVAC equipment curbs being constructed above Area A.
