## **DAILY REPORT**

## WESTMORELAND COUNTY HIGH SCHOOL

Date: 05/06/2021

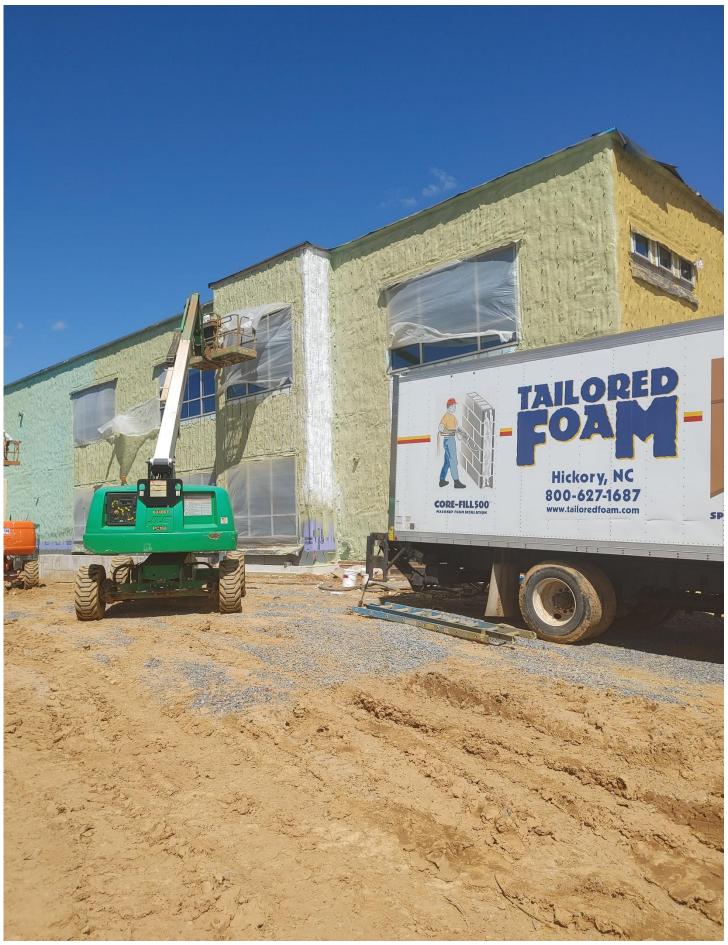
**Tailored Foam:** I observed two men are on site today. They are spraying foam on the South side of Area A.

Photo 1 – Spray foam being applied to the South Side of Area A

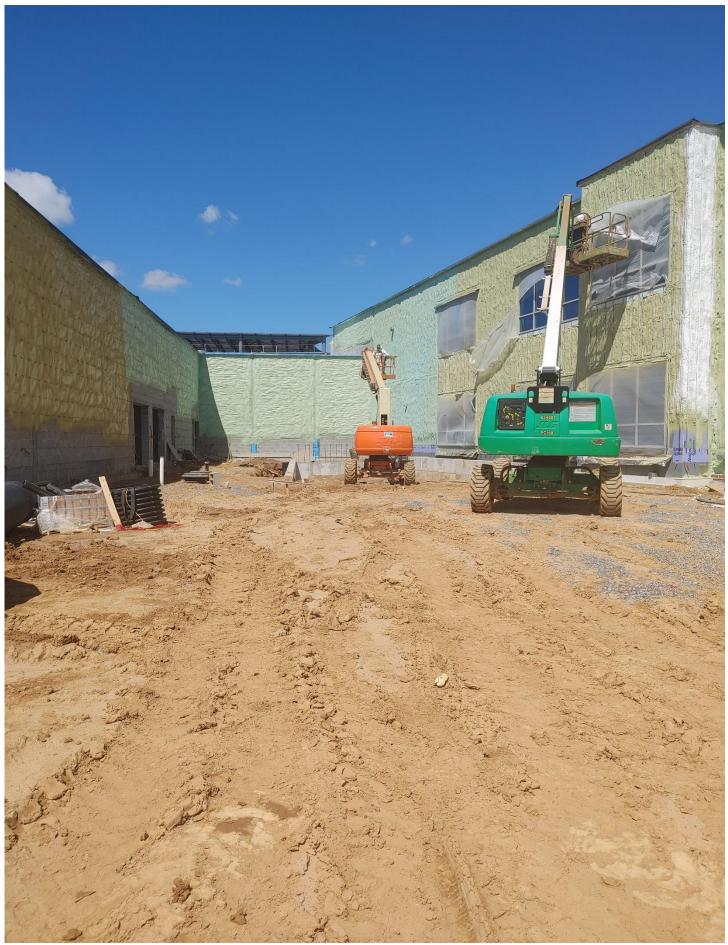
Photo 2 - Spray foam being applied to the East side of Area C

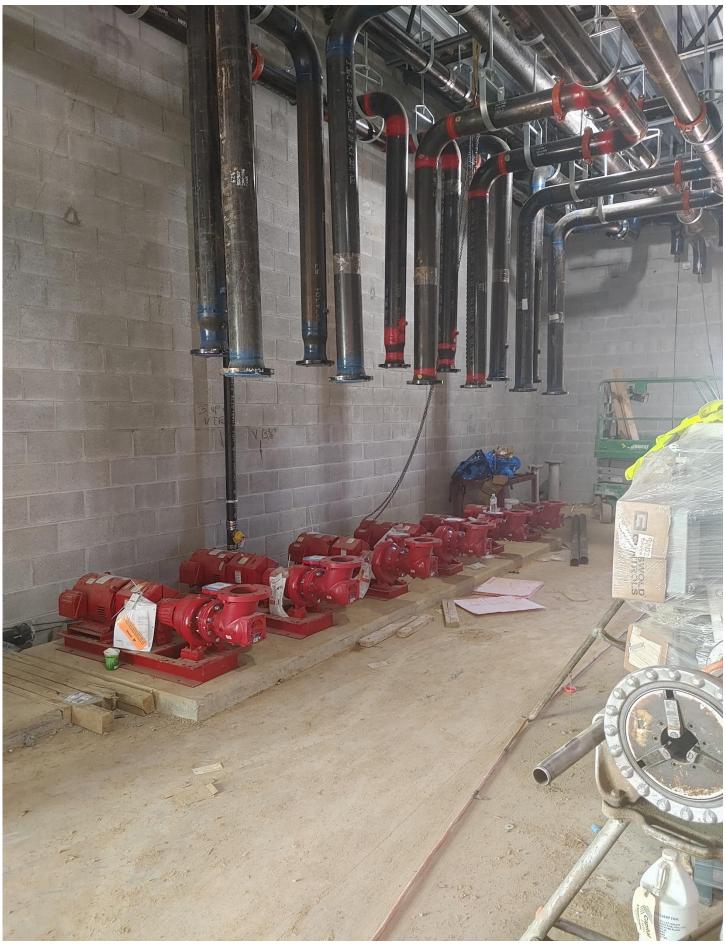
Photo 3 - Circulating Pumps set in Area D

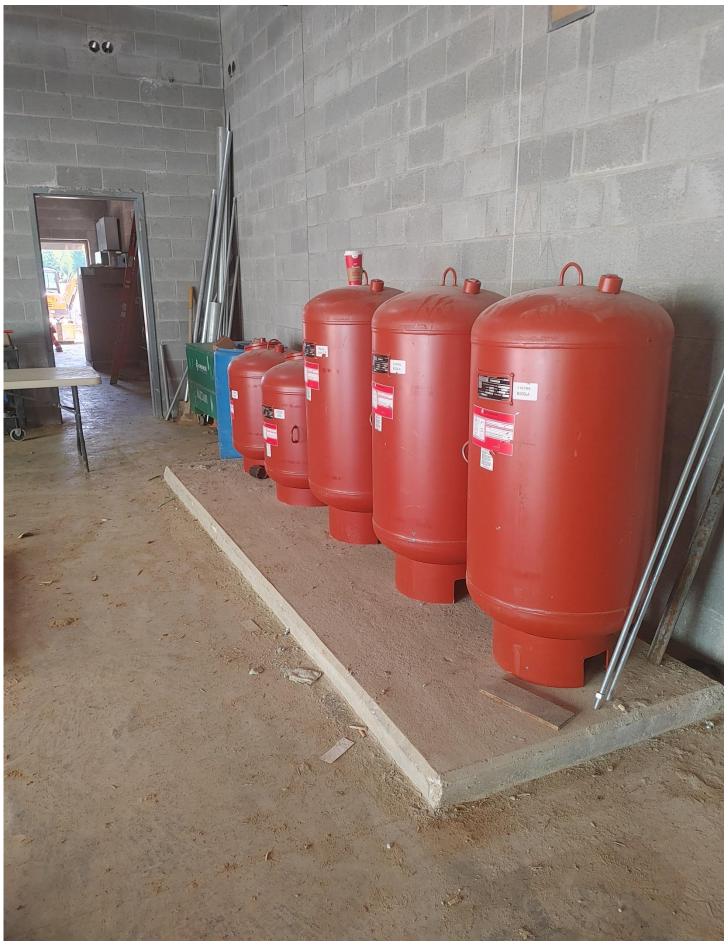
Photo 4 - Expansion Tanks Set in Area D

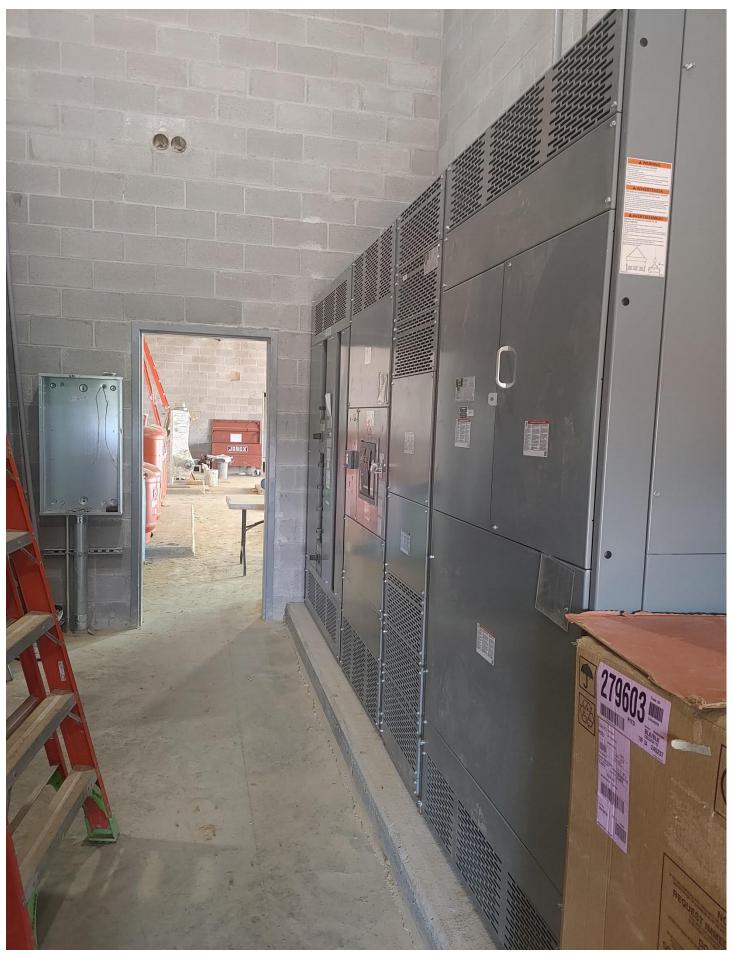
Photo 5 - Switch Gears in the Electrical Room of Area D

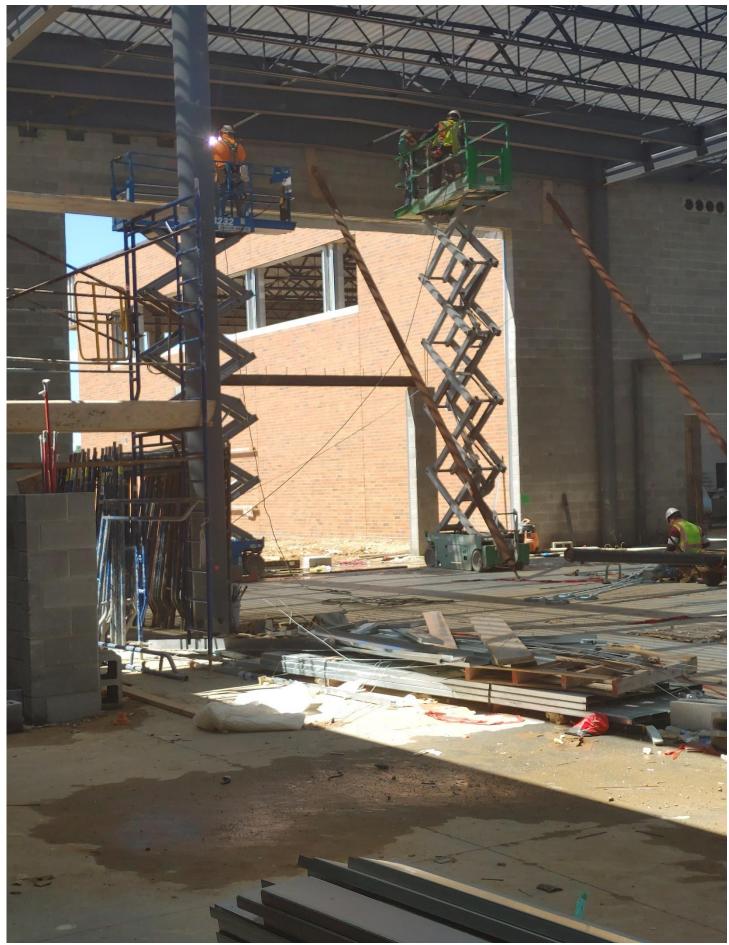
Weldon Steel: Six (6) men are on site today. They continue to set and weld steel in Area C.

Photo 6 - Steel being welded in Area C

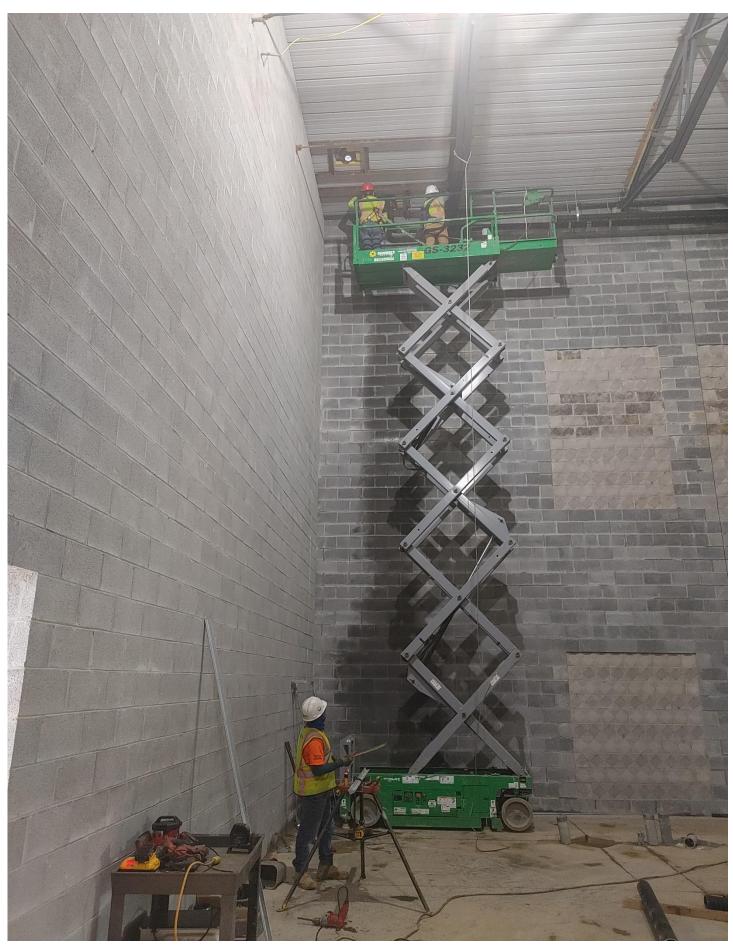
Photo 7 - Pipe is being connected to Roof Drains in Area D Auditorium

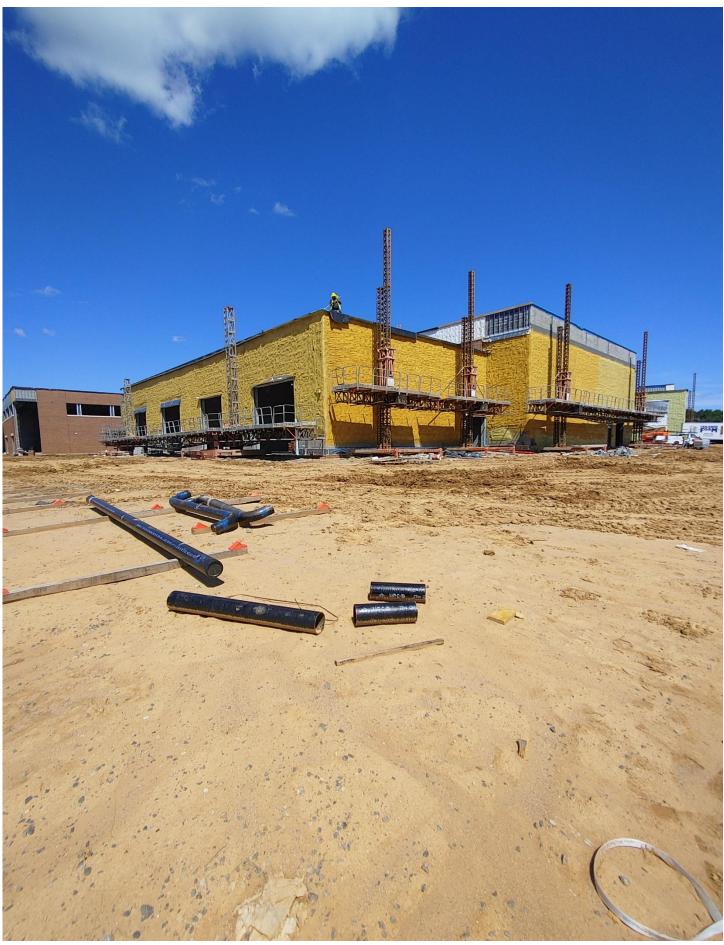
Photo 8 - Fraco Scaffolding has been erected on the East and South side of Areas D and on the East Side of Area A

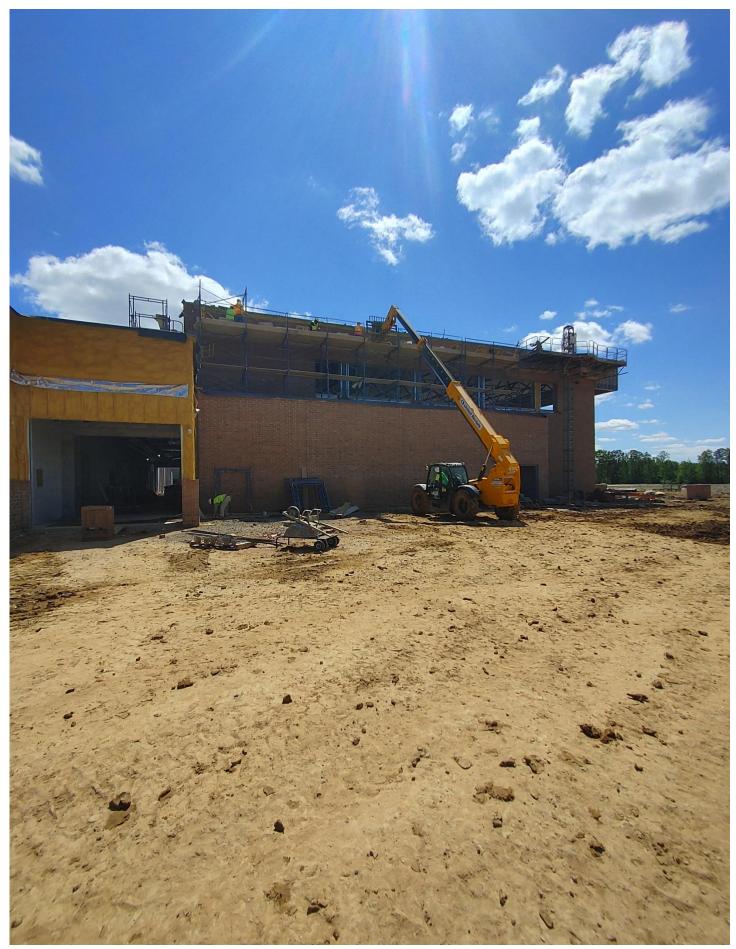
Photo 9 - Masons are laying Brick on the West side of Area  $\it E$

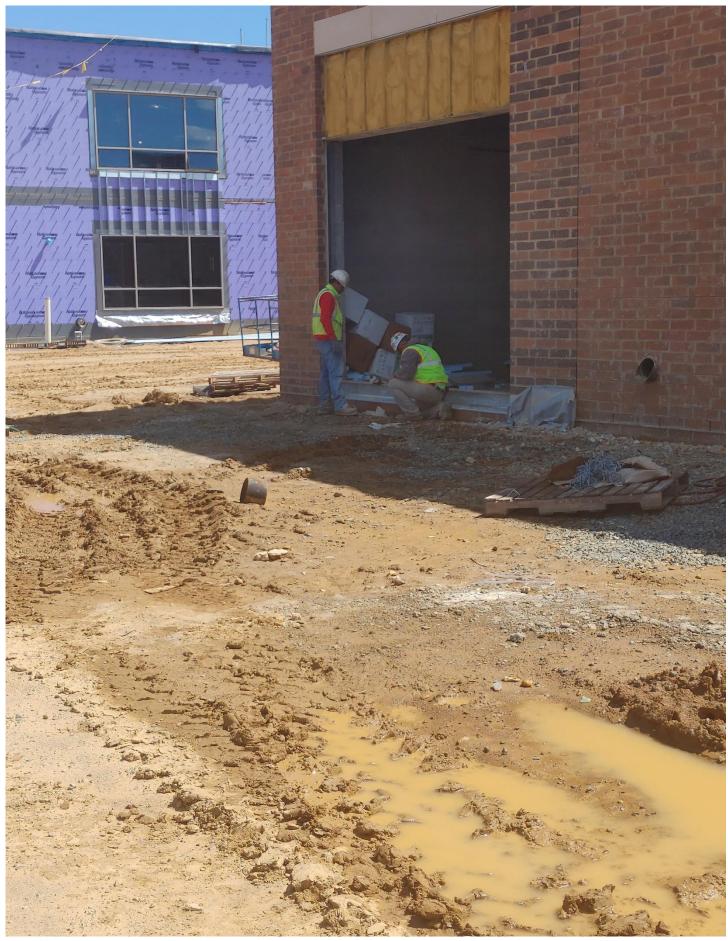
Photo 10 - Display Nook on the West side of Area E is being flashed.

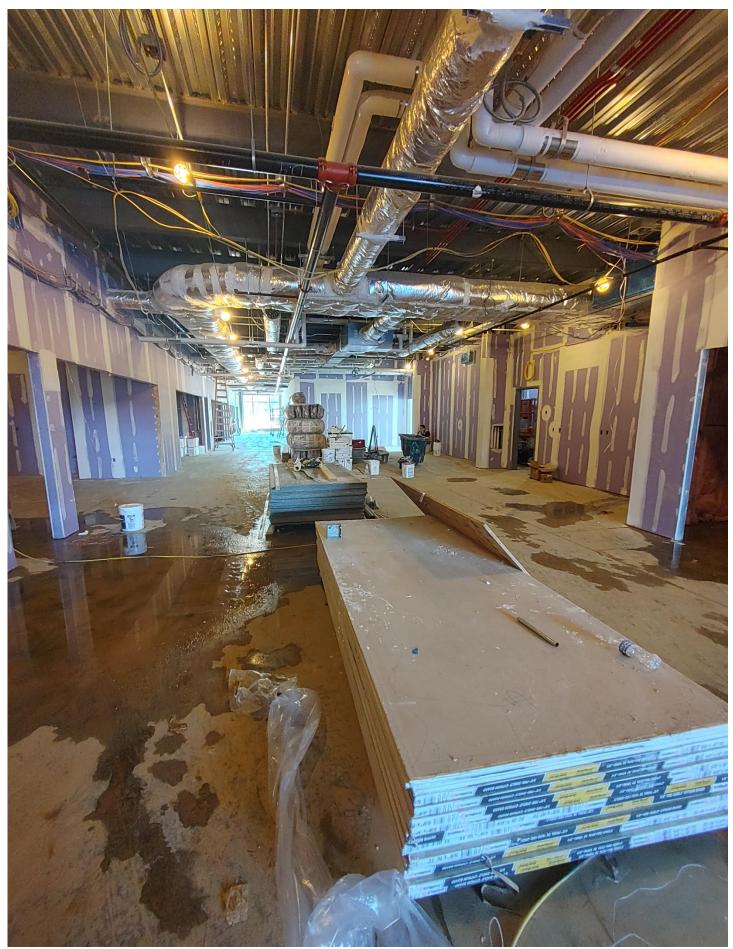
**JP Construction:** They continue to hang sheetrock and are applying the Block Coat of mud to the Vertical Joints of sheetrock in Area A. They are also continue to frame walls in Area A.

Photo 11 - Sheet Rock continues to be finished in Area A

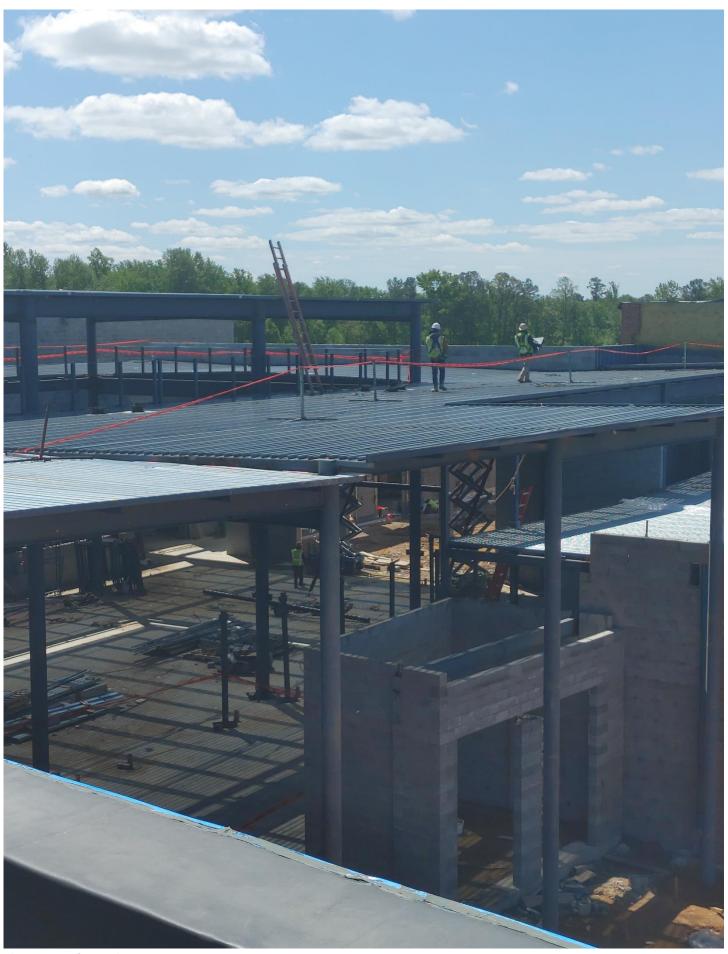
Photo 12 - Roof Drains being set in Area C

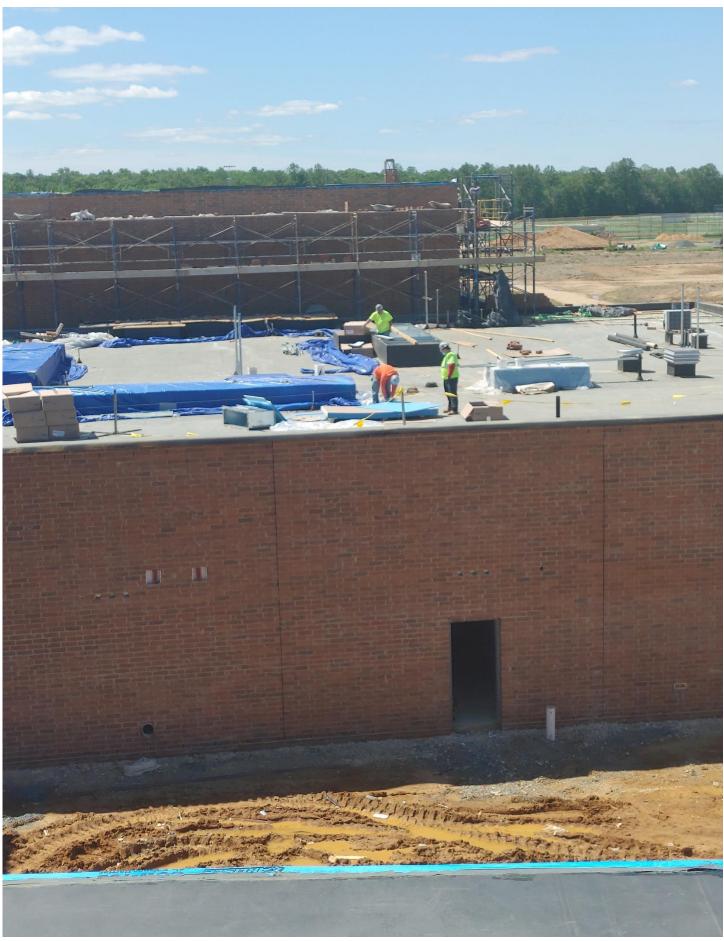
Photo 13 - Colonial Webb working on Curbs on the Roof of Area E

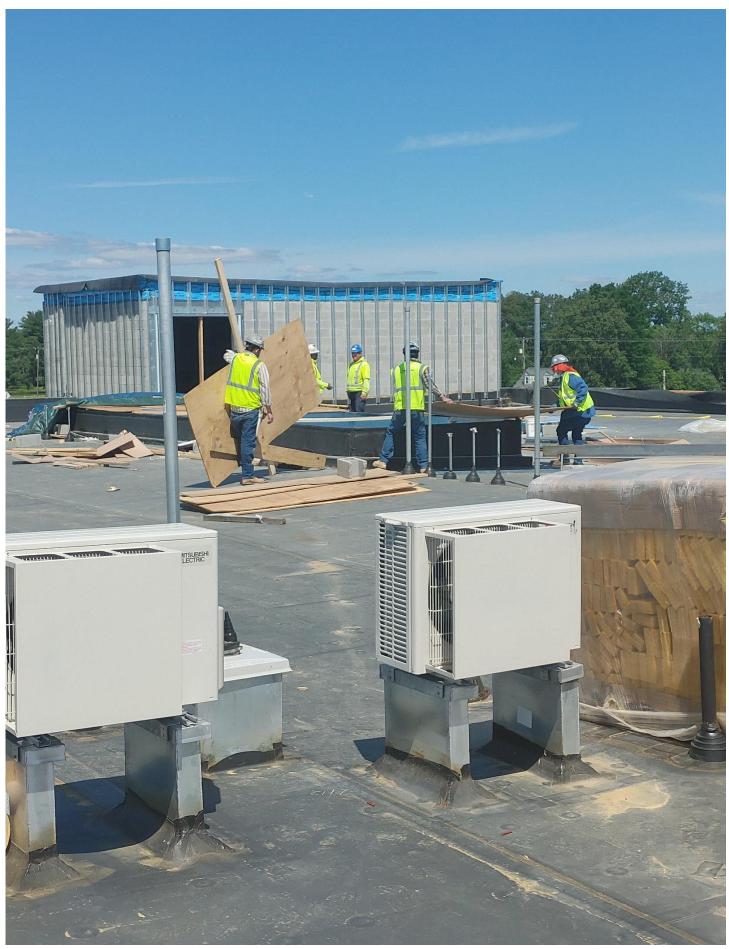
Photo 14 - Colonial Webb working on Curbs on the Roof of Area B
