DAILY REPORT

WESTMORELAND COUNTY HIGH SCHOOL

Date: 05/18/2021
Weather: 74 degrees. High of 76 degrees today.
Hours Worked: 11:00hrs – 14:00hrs (3hrs) Site Visit.

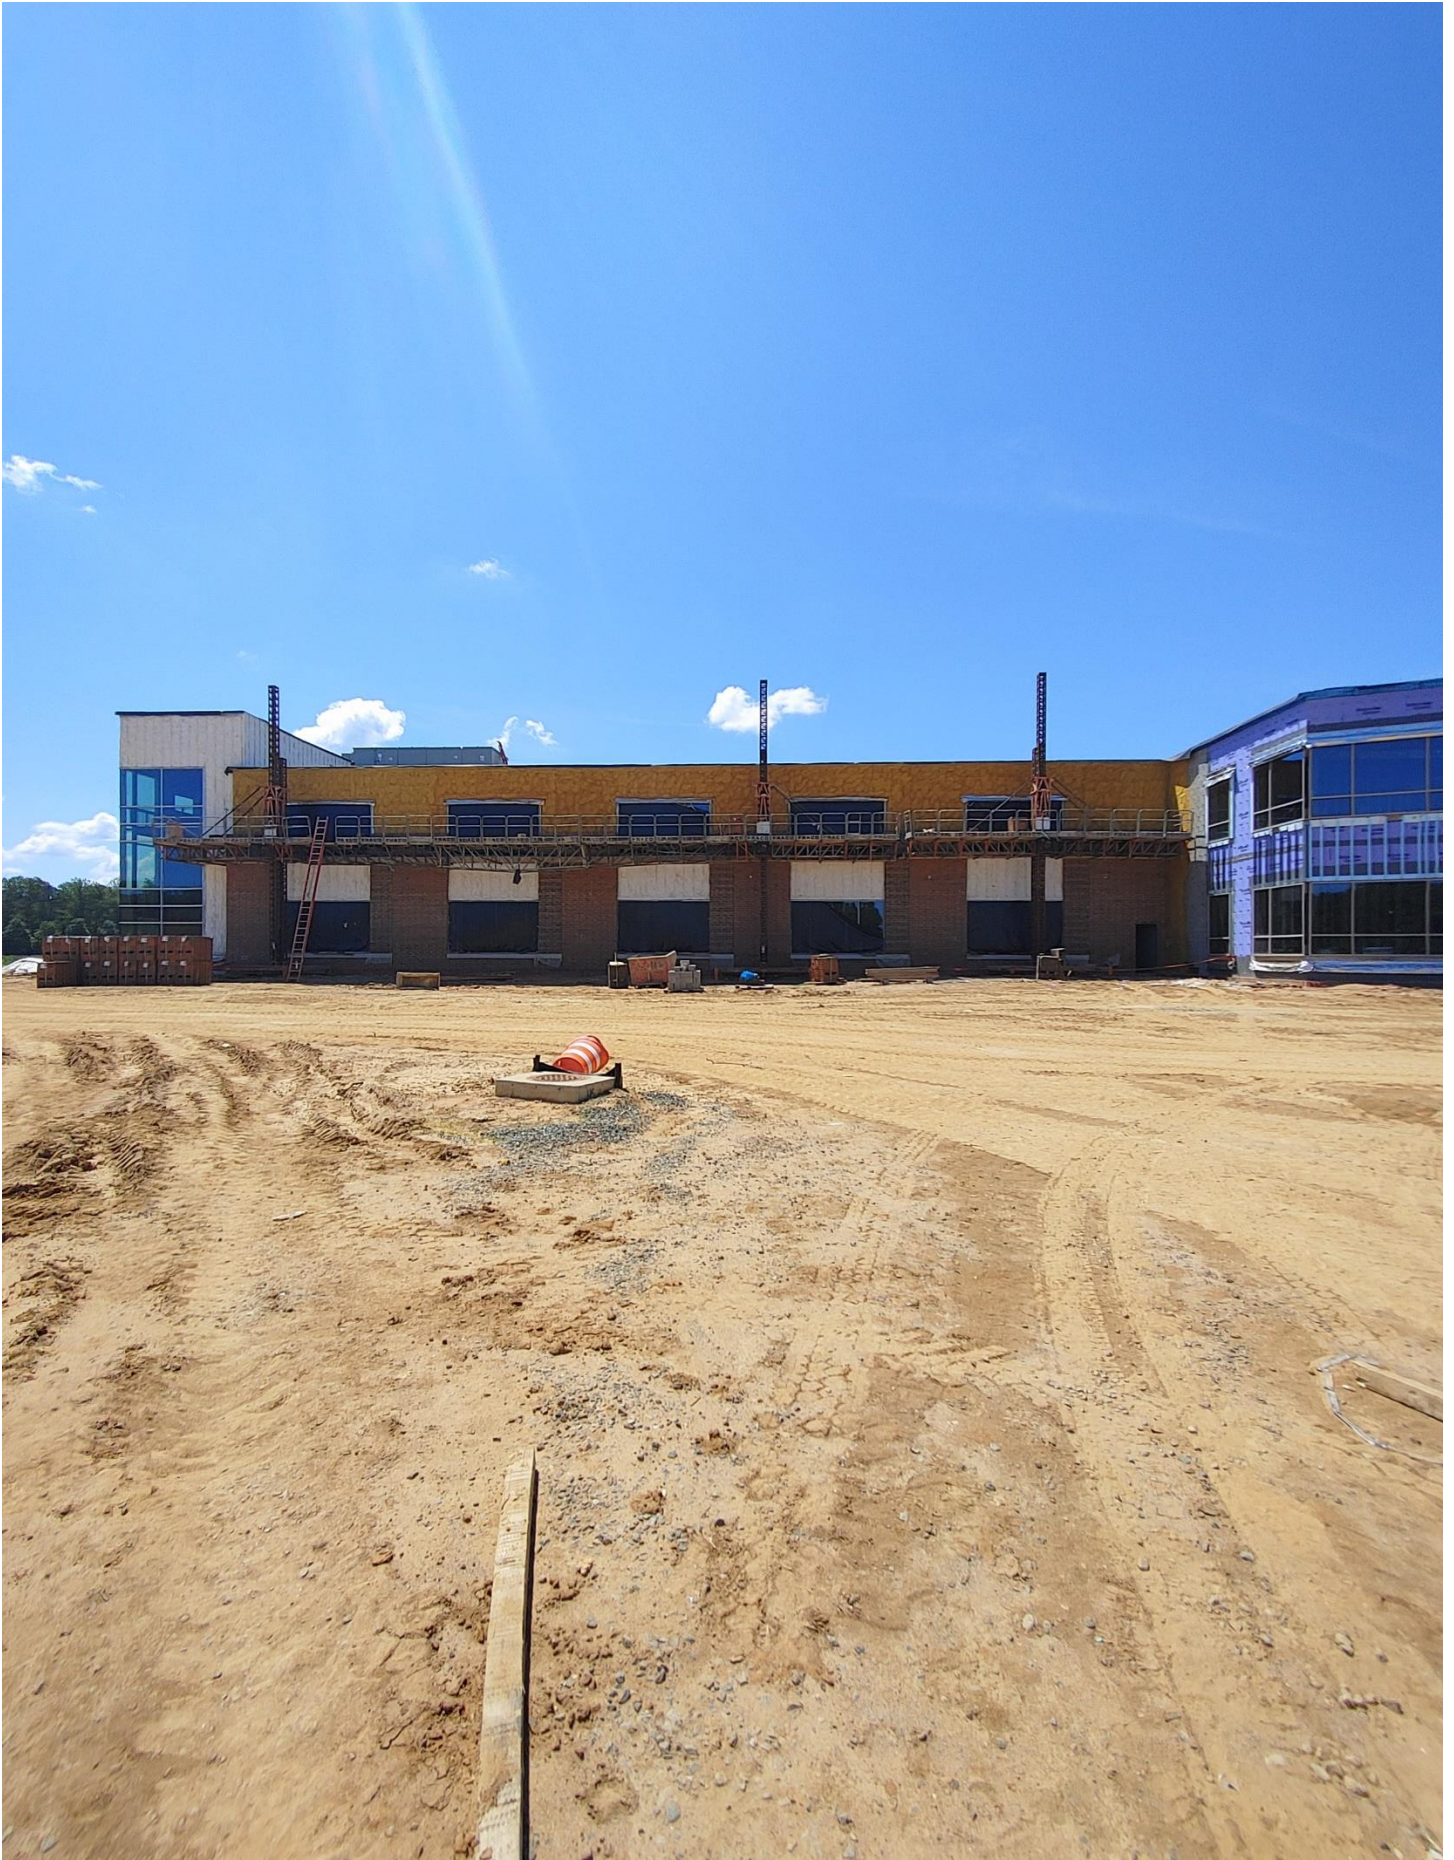
Photo 1 - Brick continues to be laid on the North side of Area A

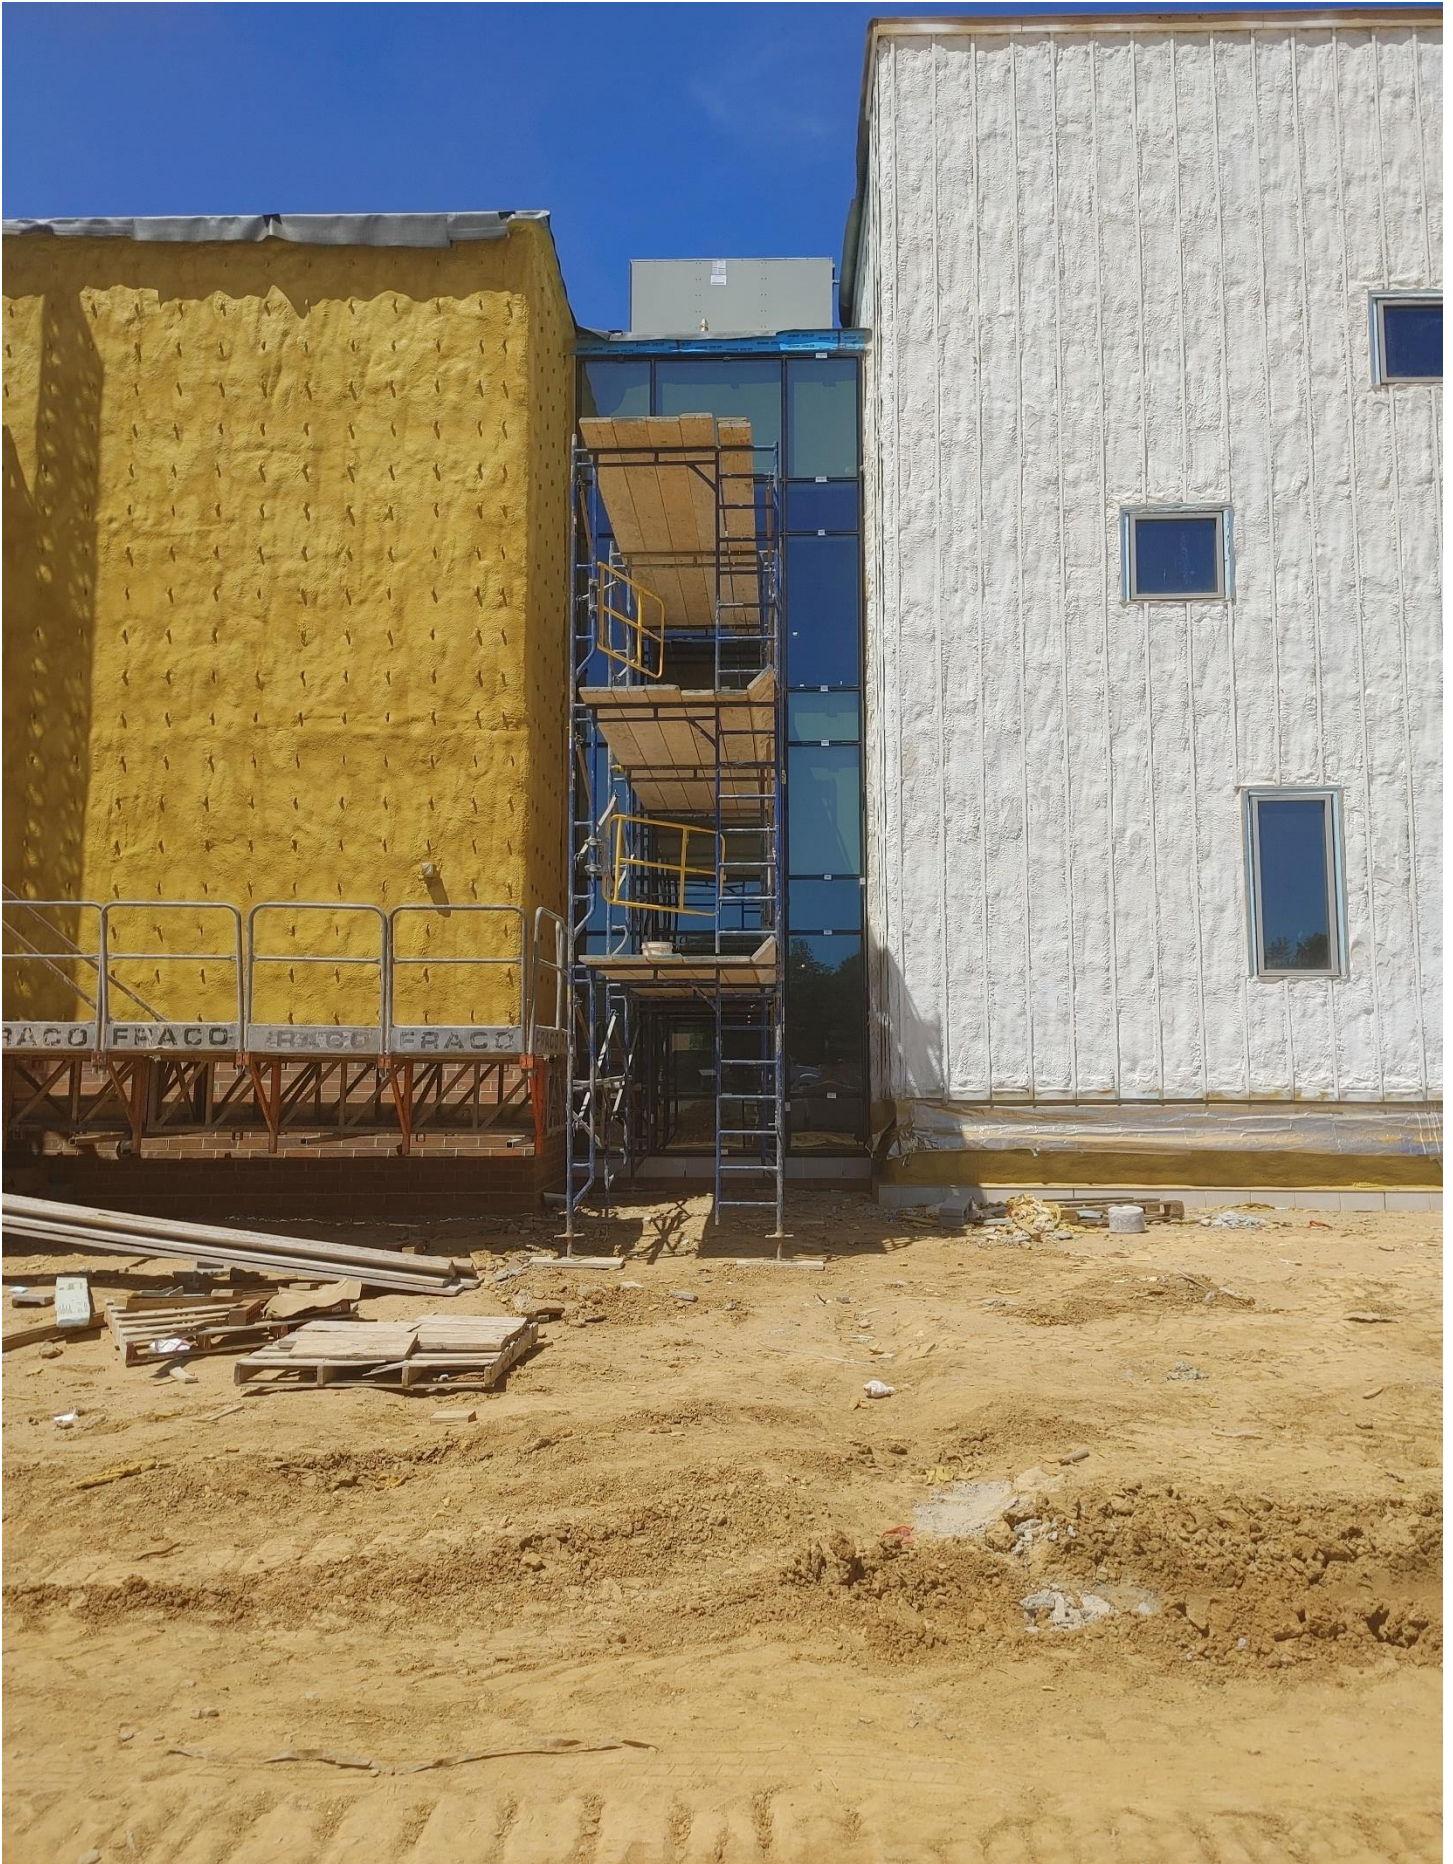
Photo 2 - Glass has been installed in the Curtain Wall on the East side of Area A

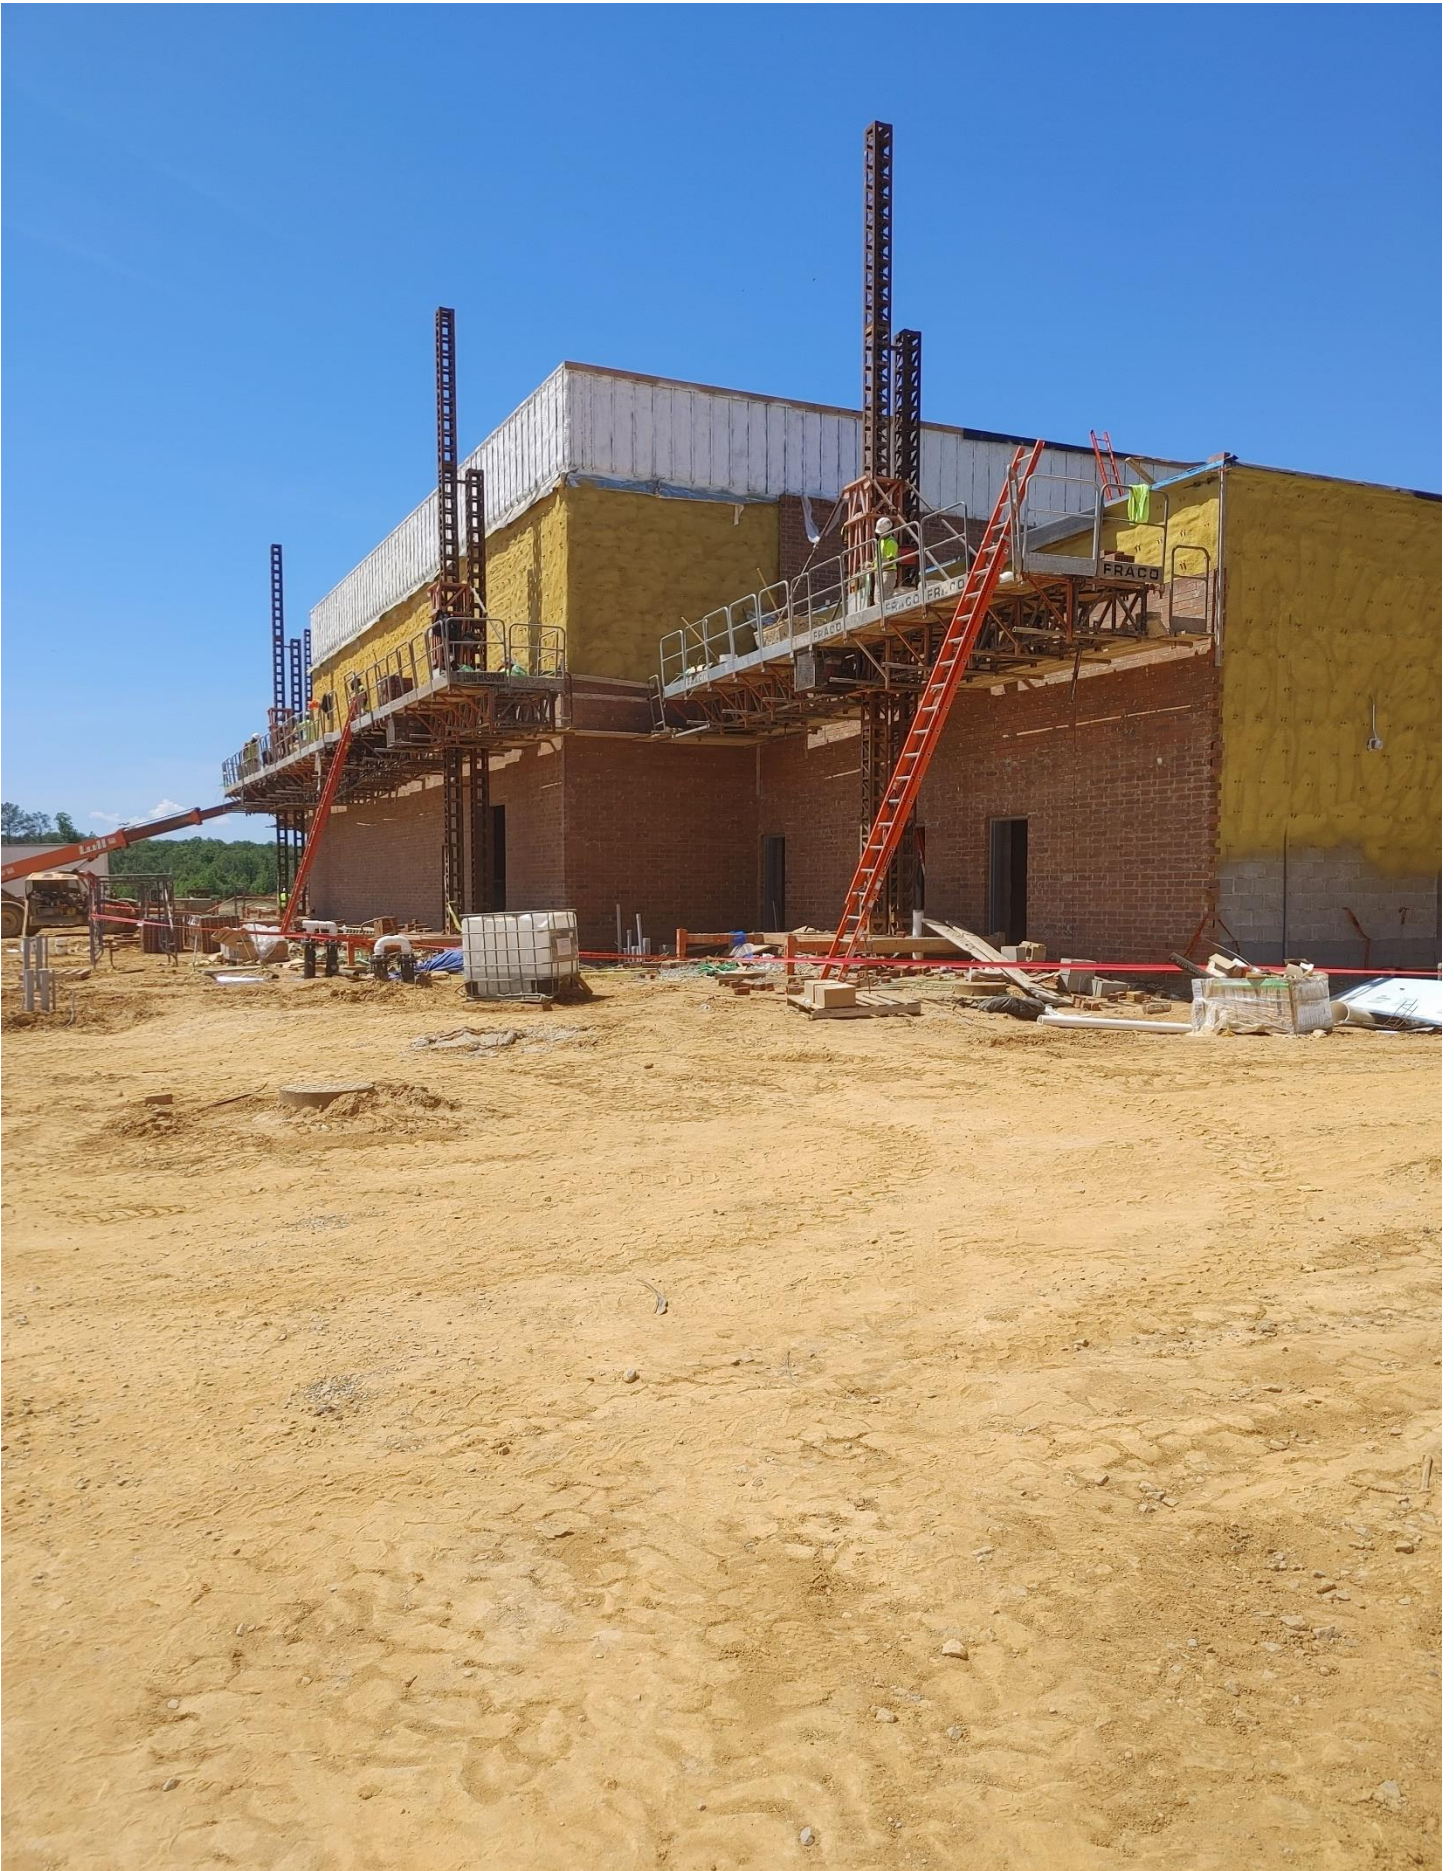
Photo 3 - Masons are laying brick on the East side of Area D

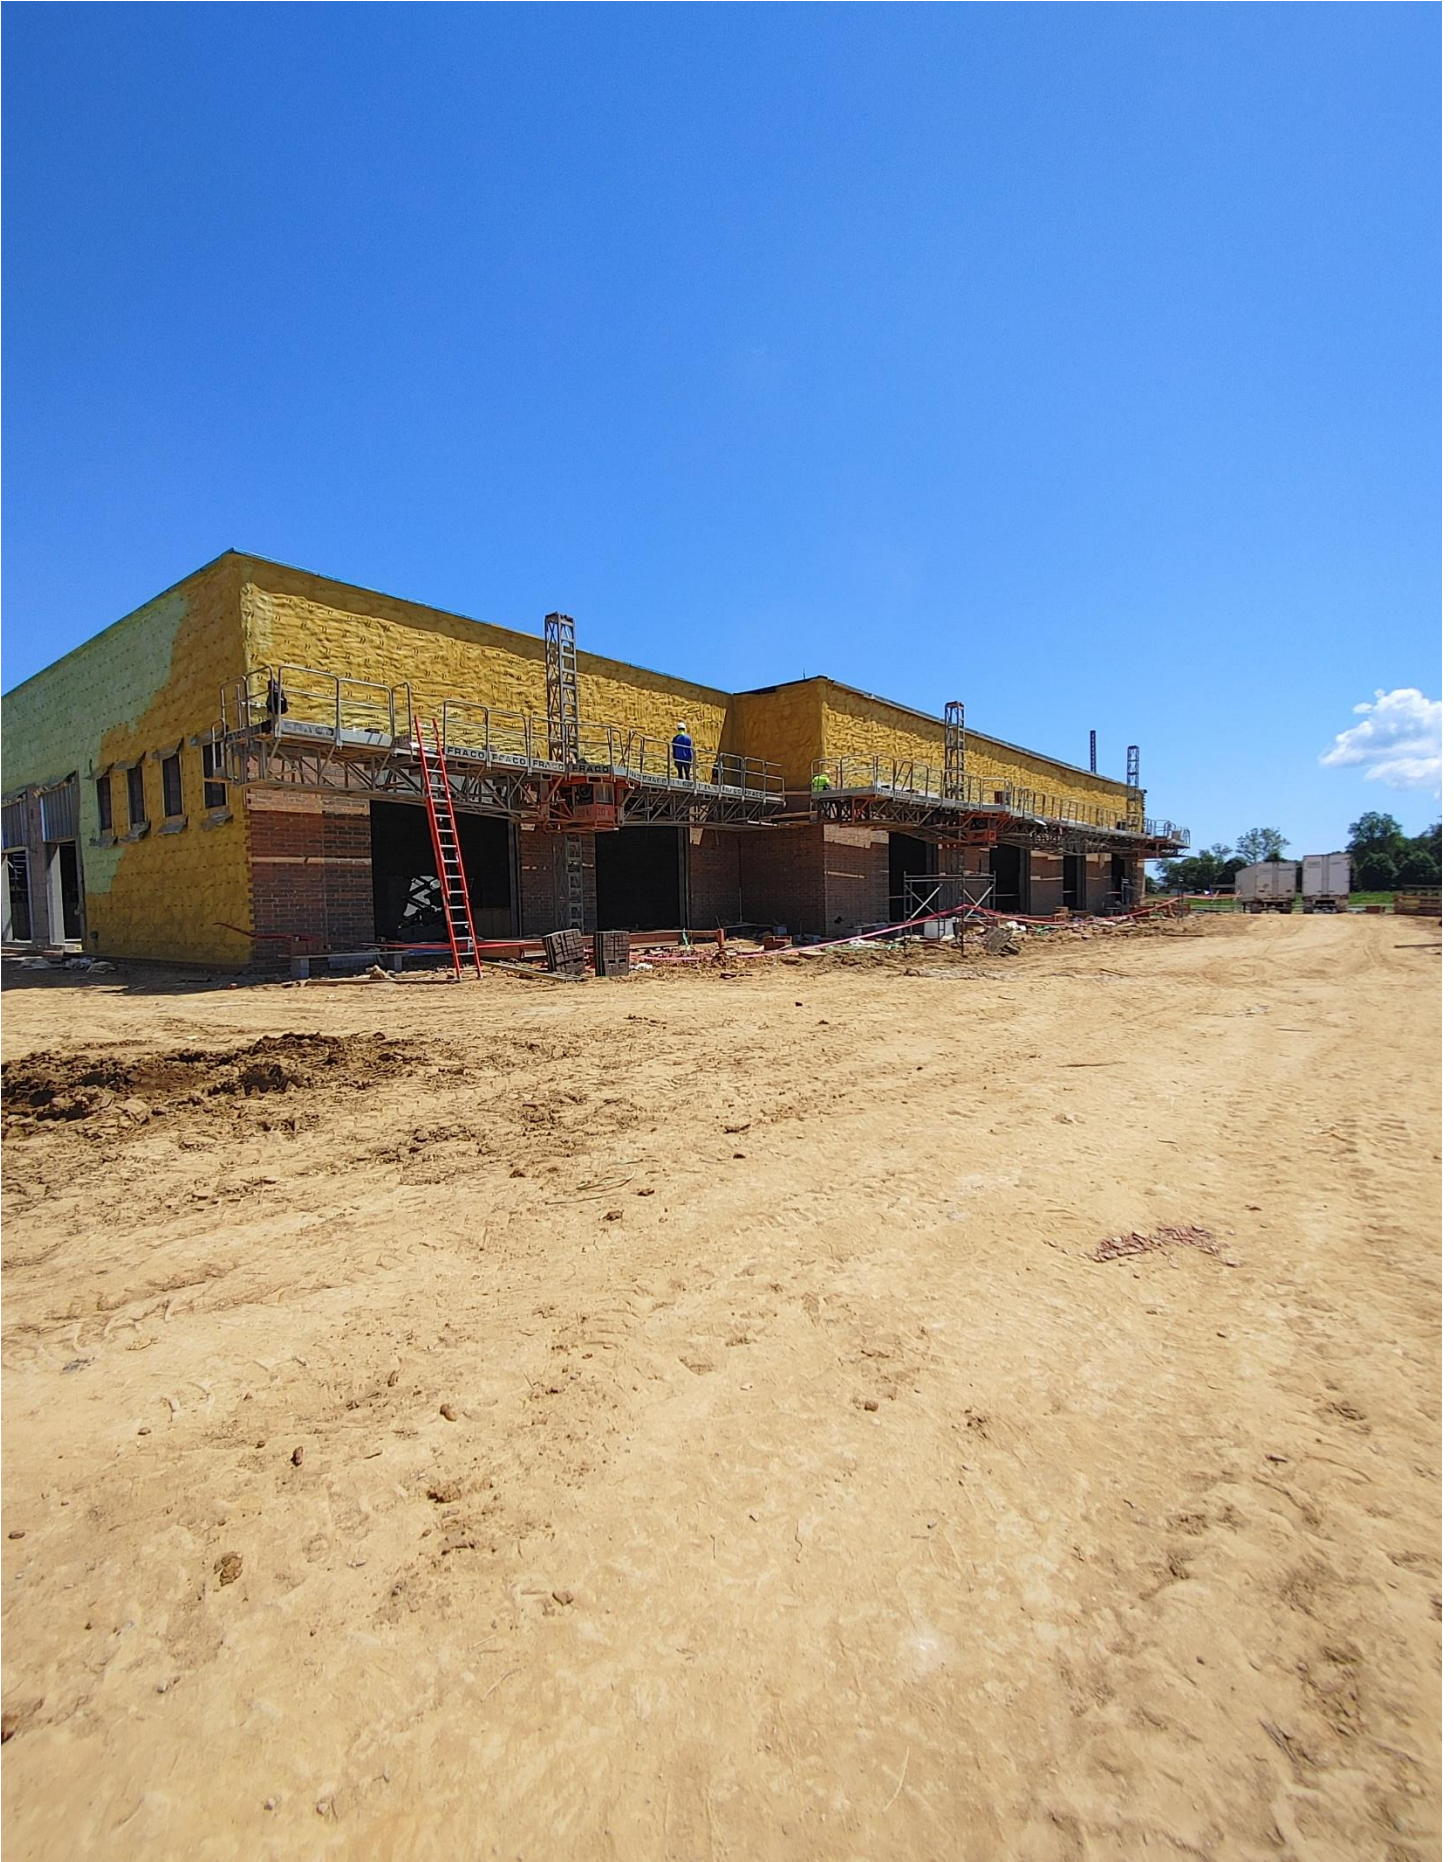
Photo 4 - Brick is being laid on the South side of Area D

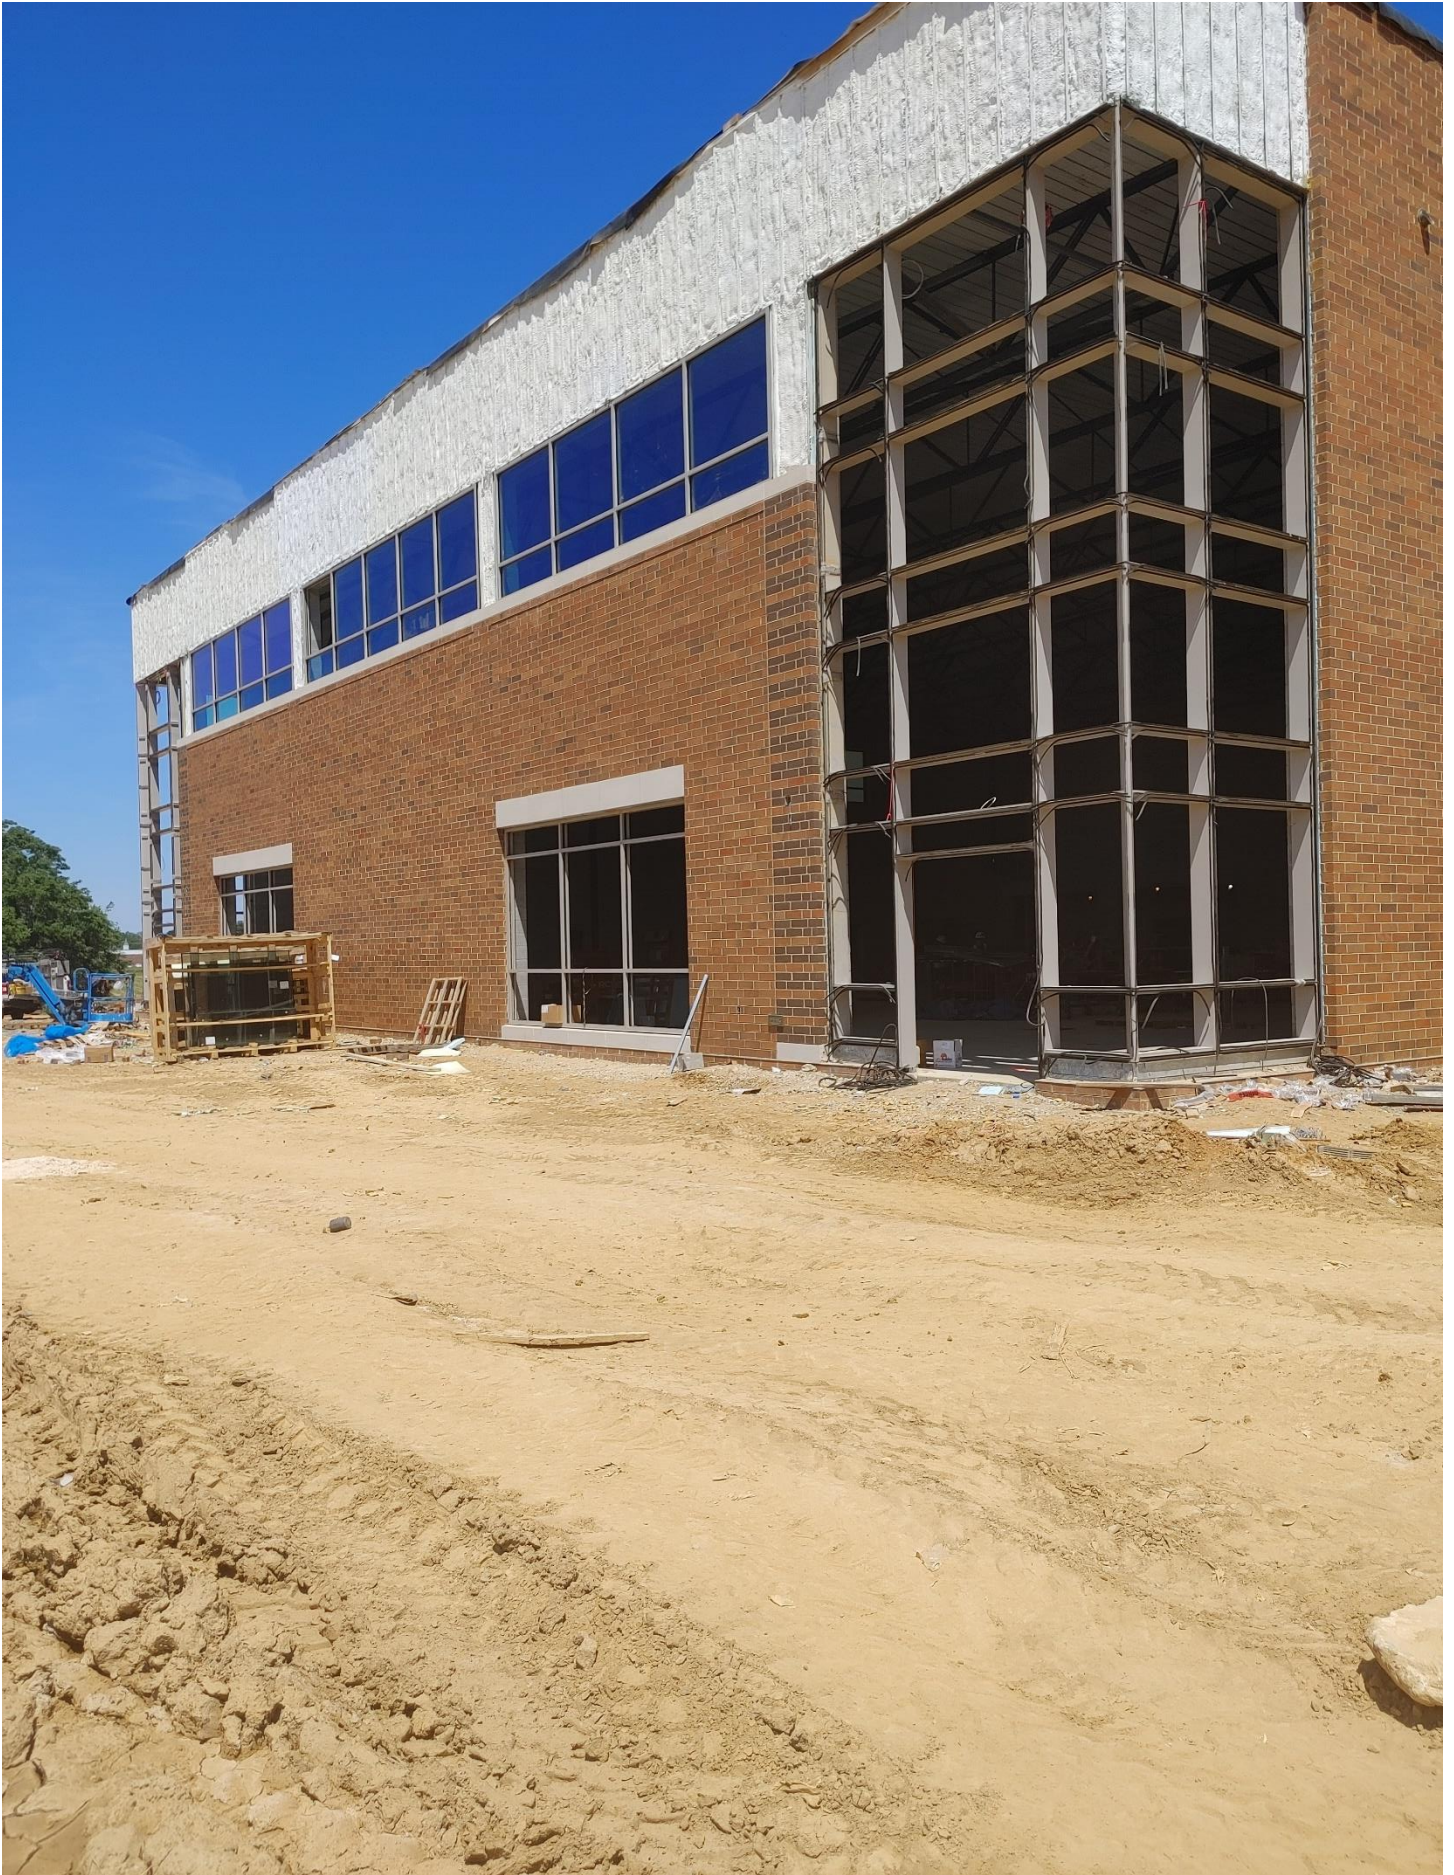
Photo 5 - Progress is being made on the Gymnasium Curtain Walls and Store Fronts

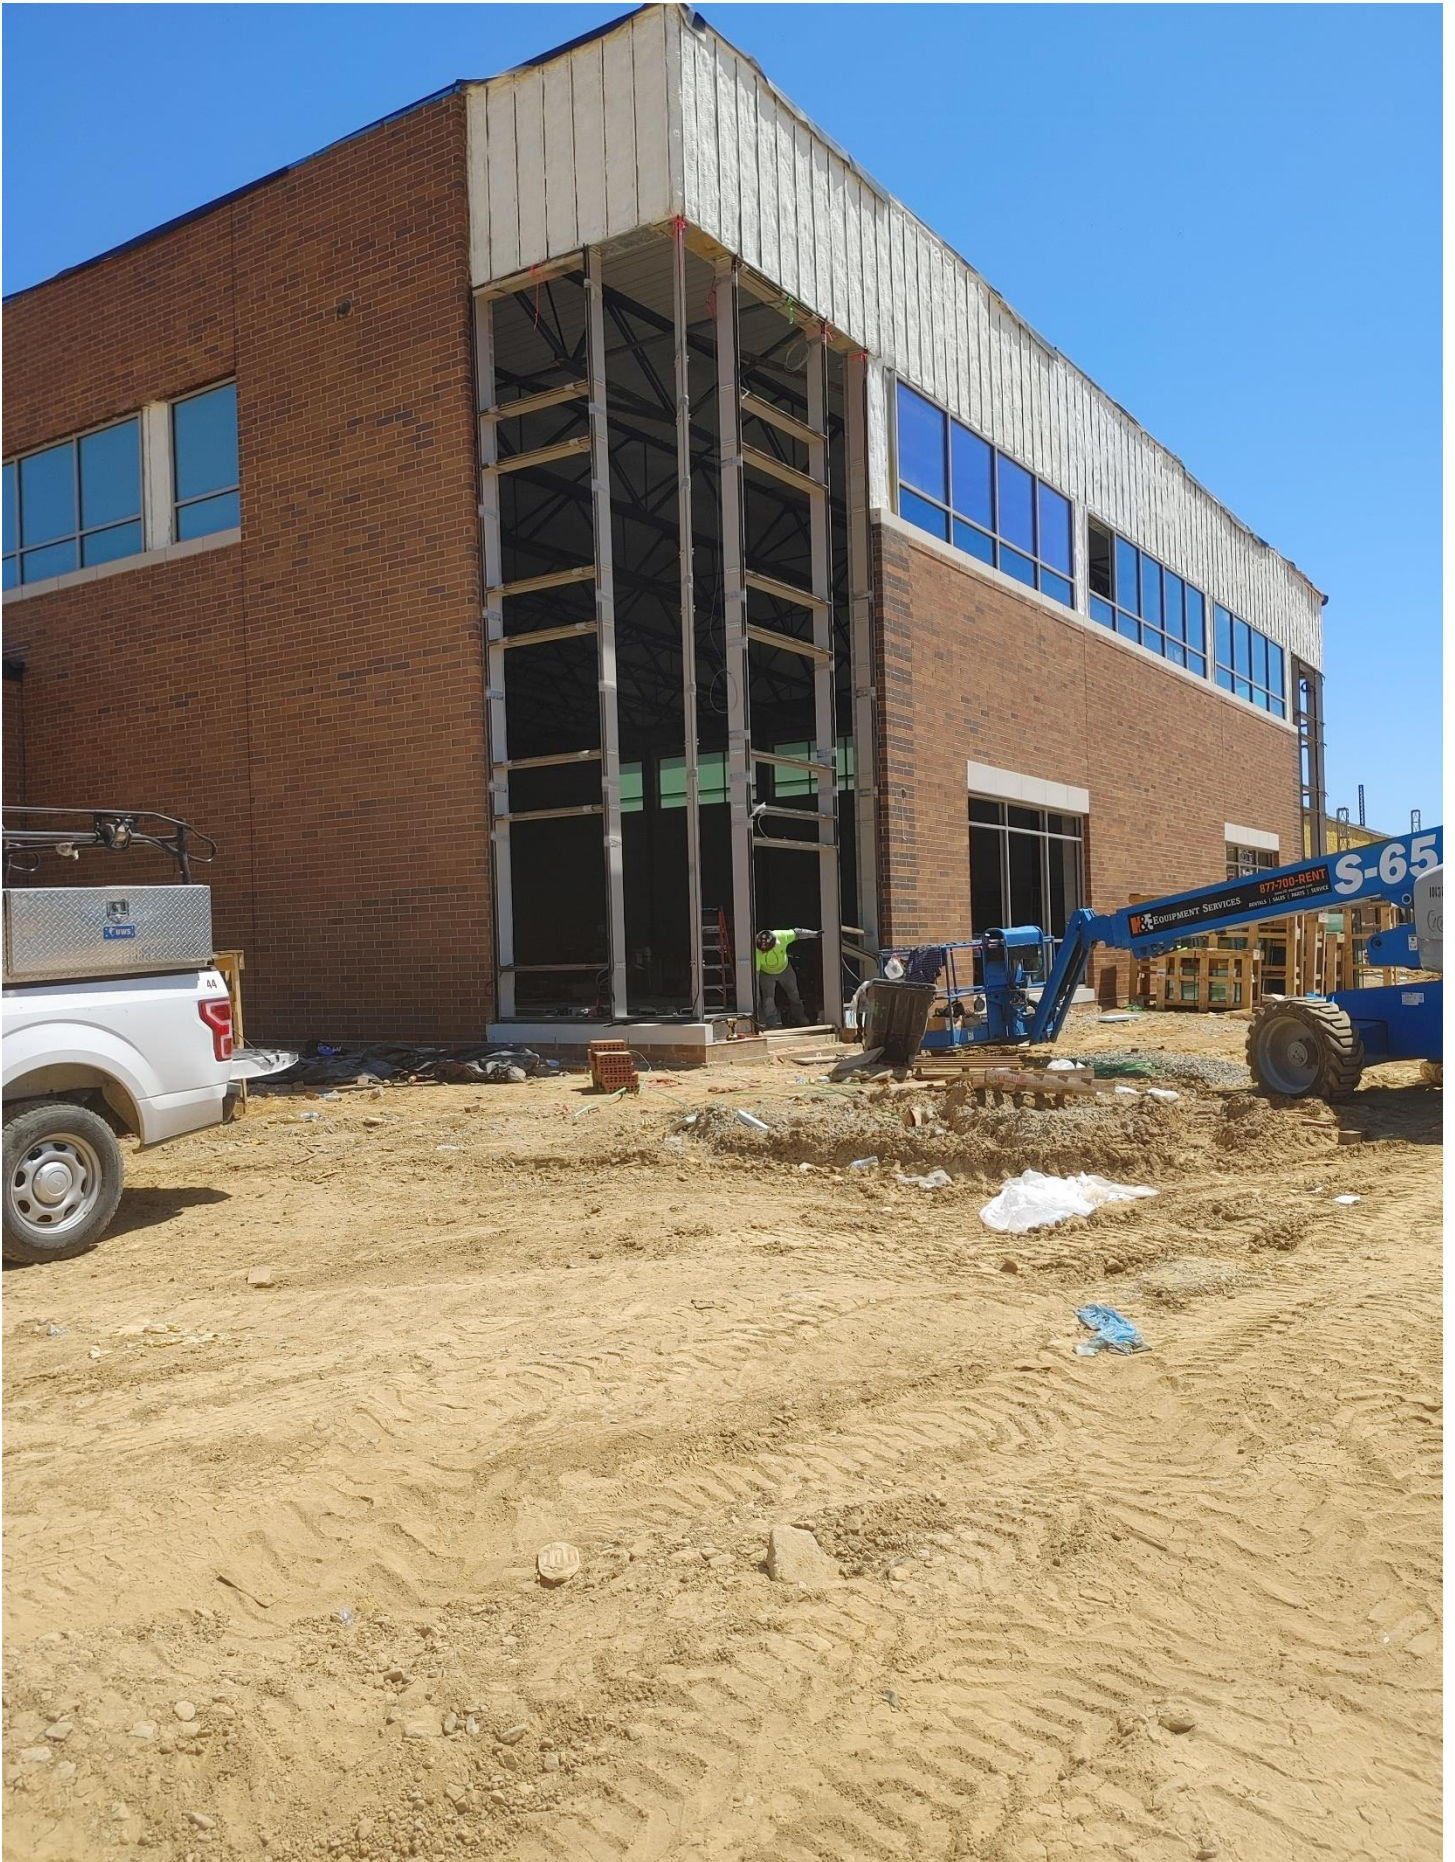
Photo 6 - FG&M working on Curtain Wall on the Southwest corner of Area E

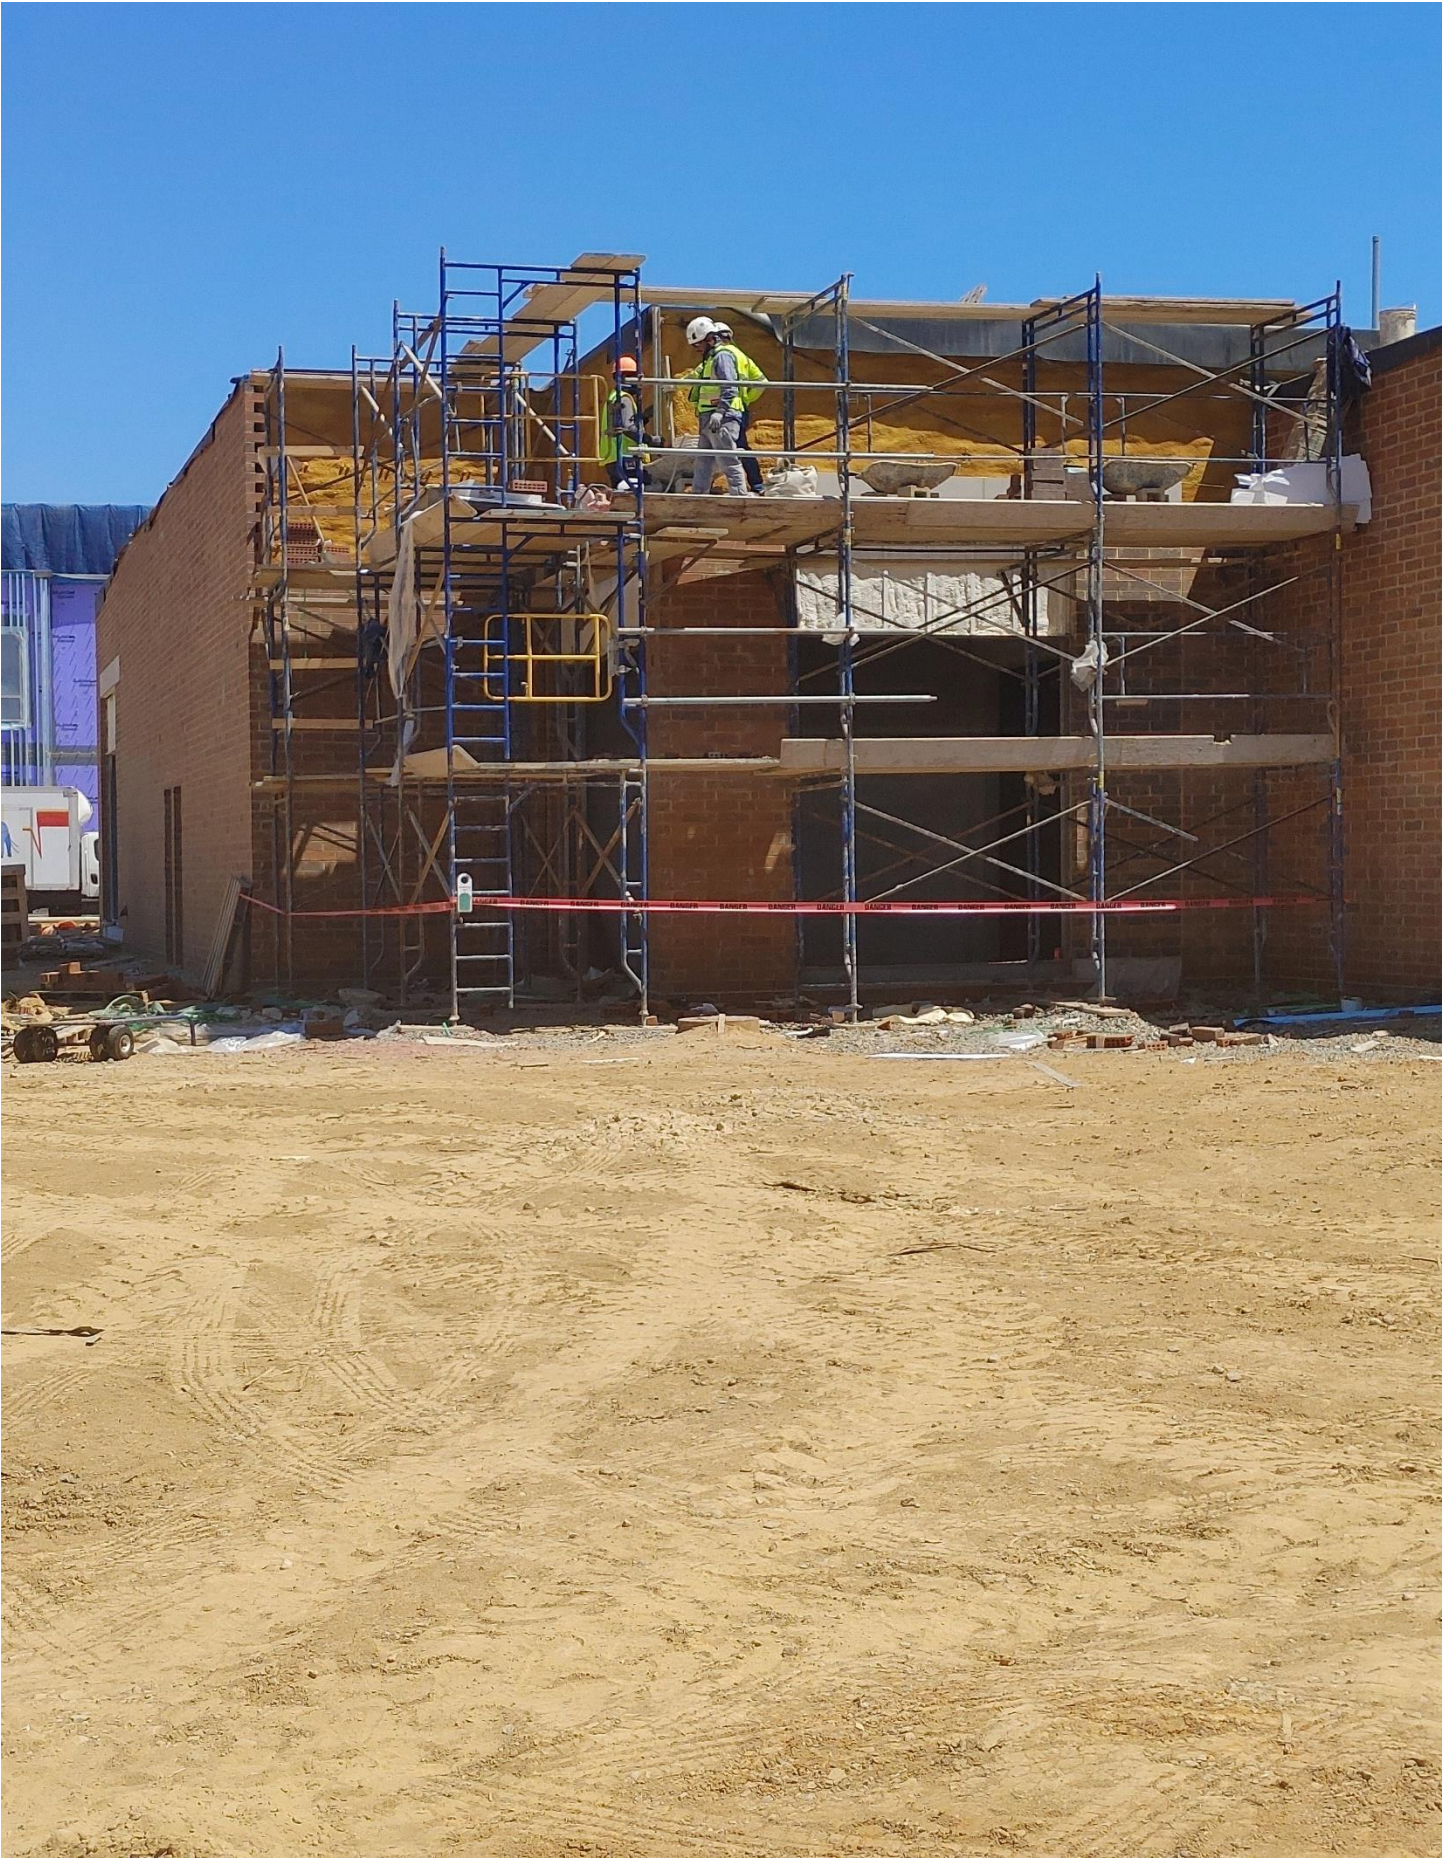
Photo 7 - Brick is being laid on the West side of Area E

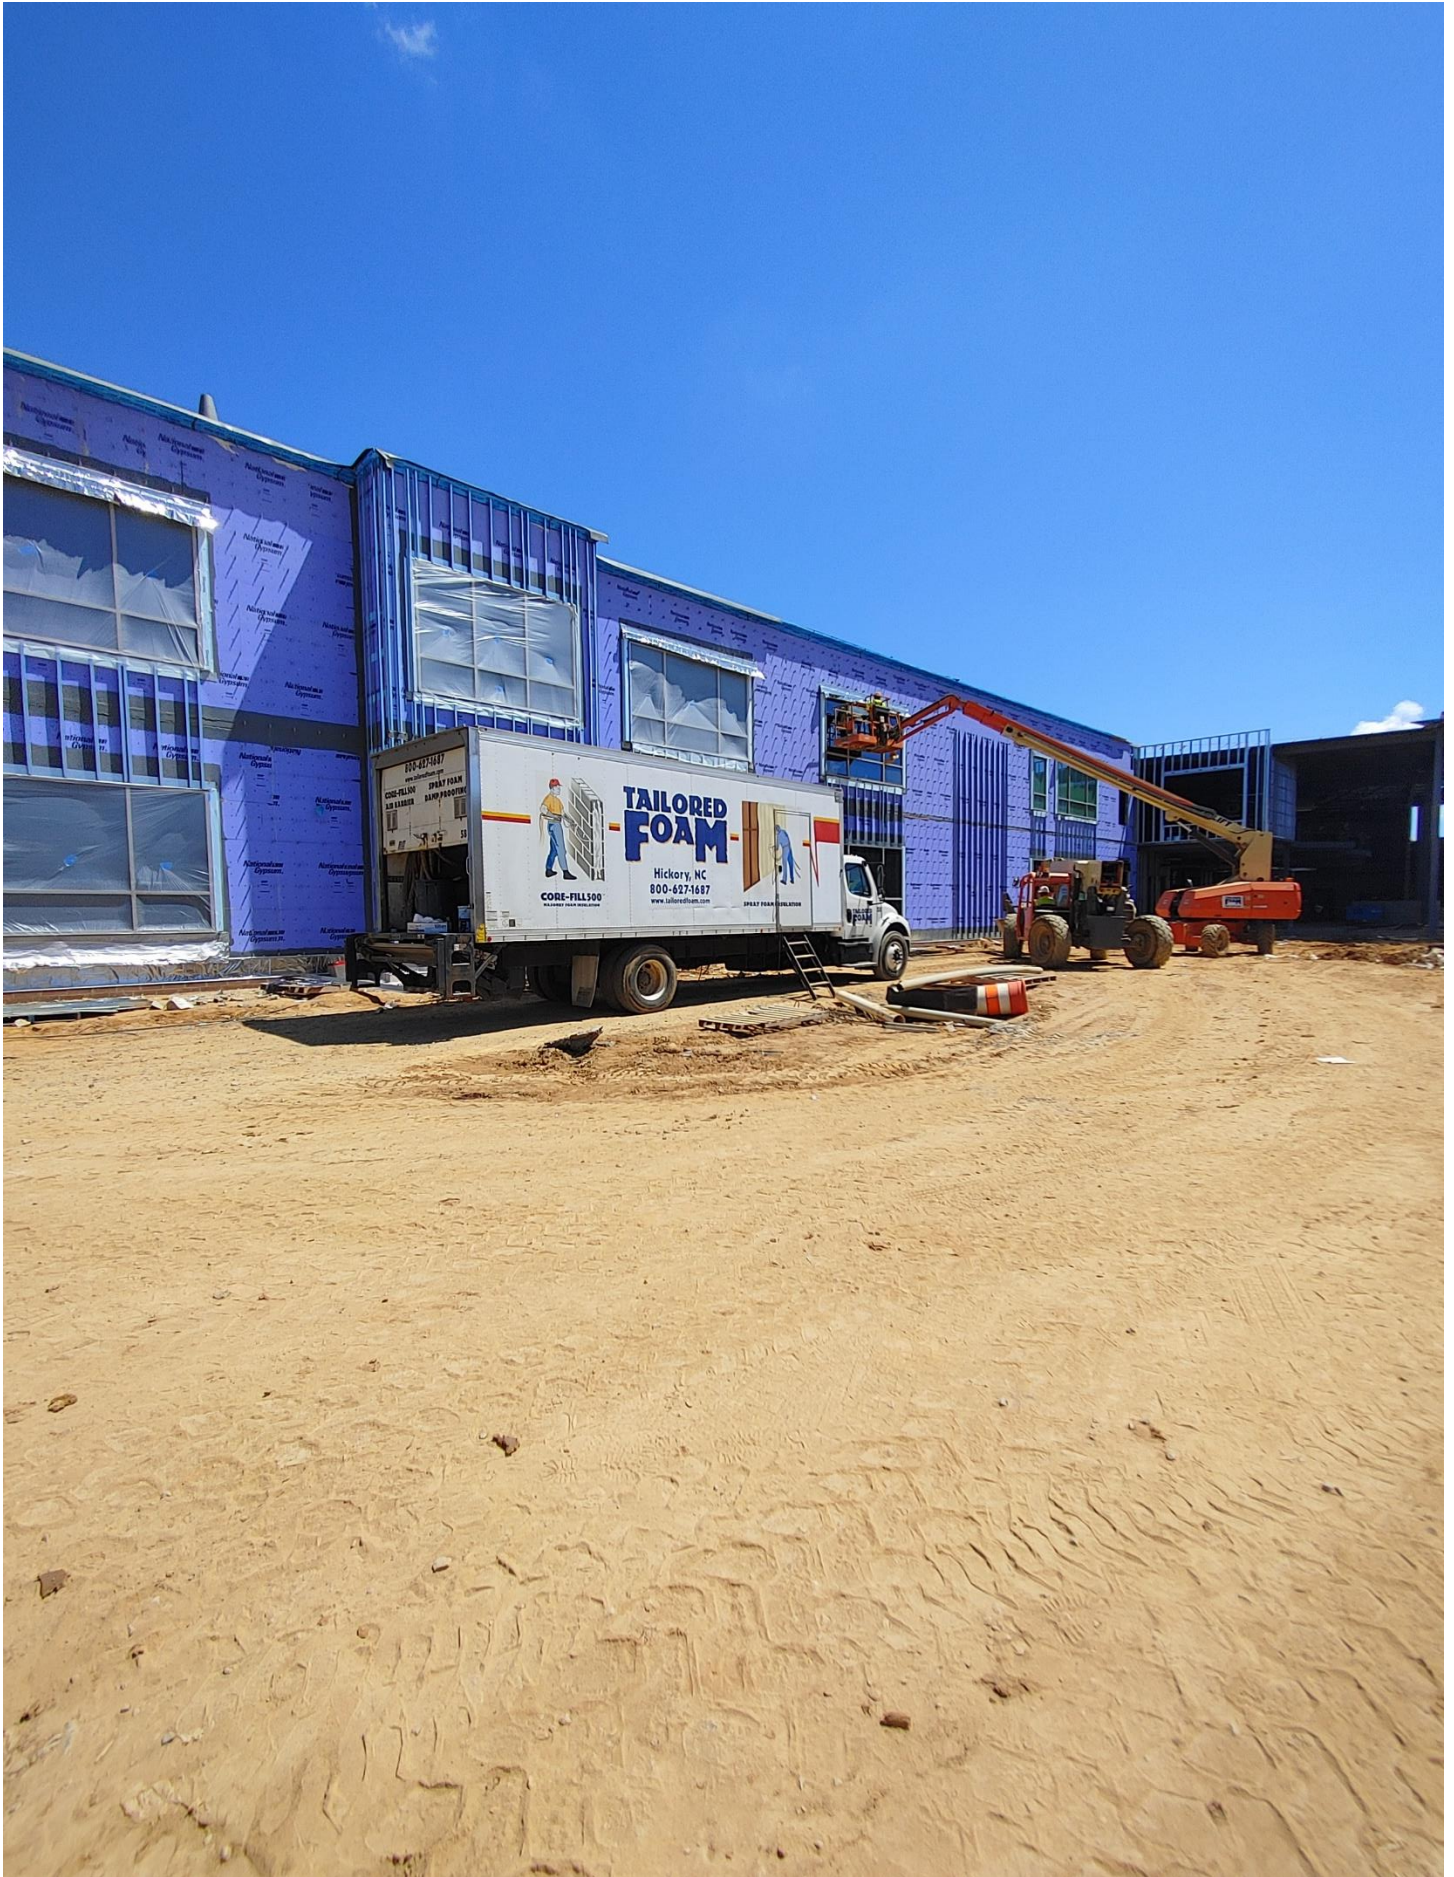
Photo 8 - Tailored Foam setting up on the South side of Area B
