DAILY REPORT

WESTMORELAND COUNTY HIGH SCHOOL

Date: 05/18/2021
Weather: 74 degrees. High of 76 degrees today.
Hours Worked: 11:00hrs – 14:00hrs (3hrs) Site Visit.

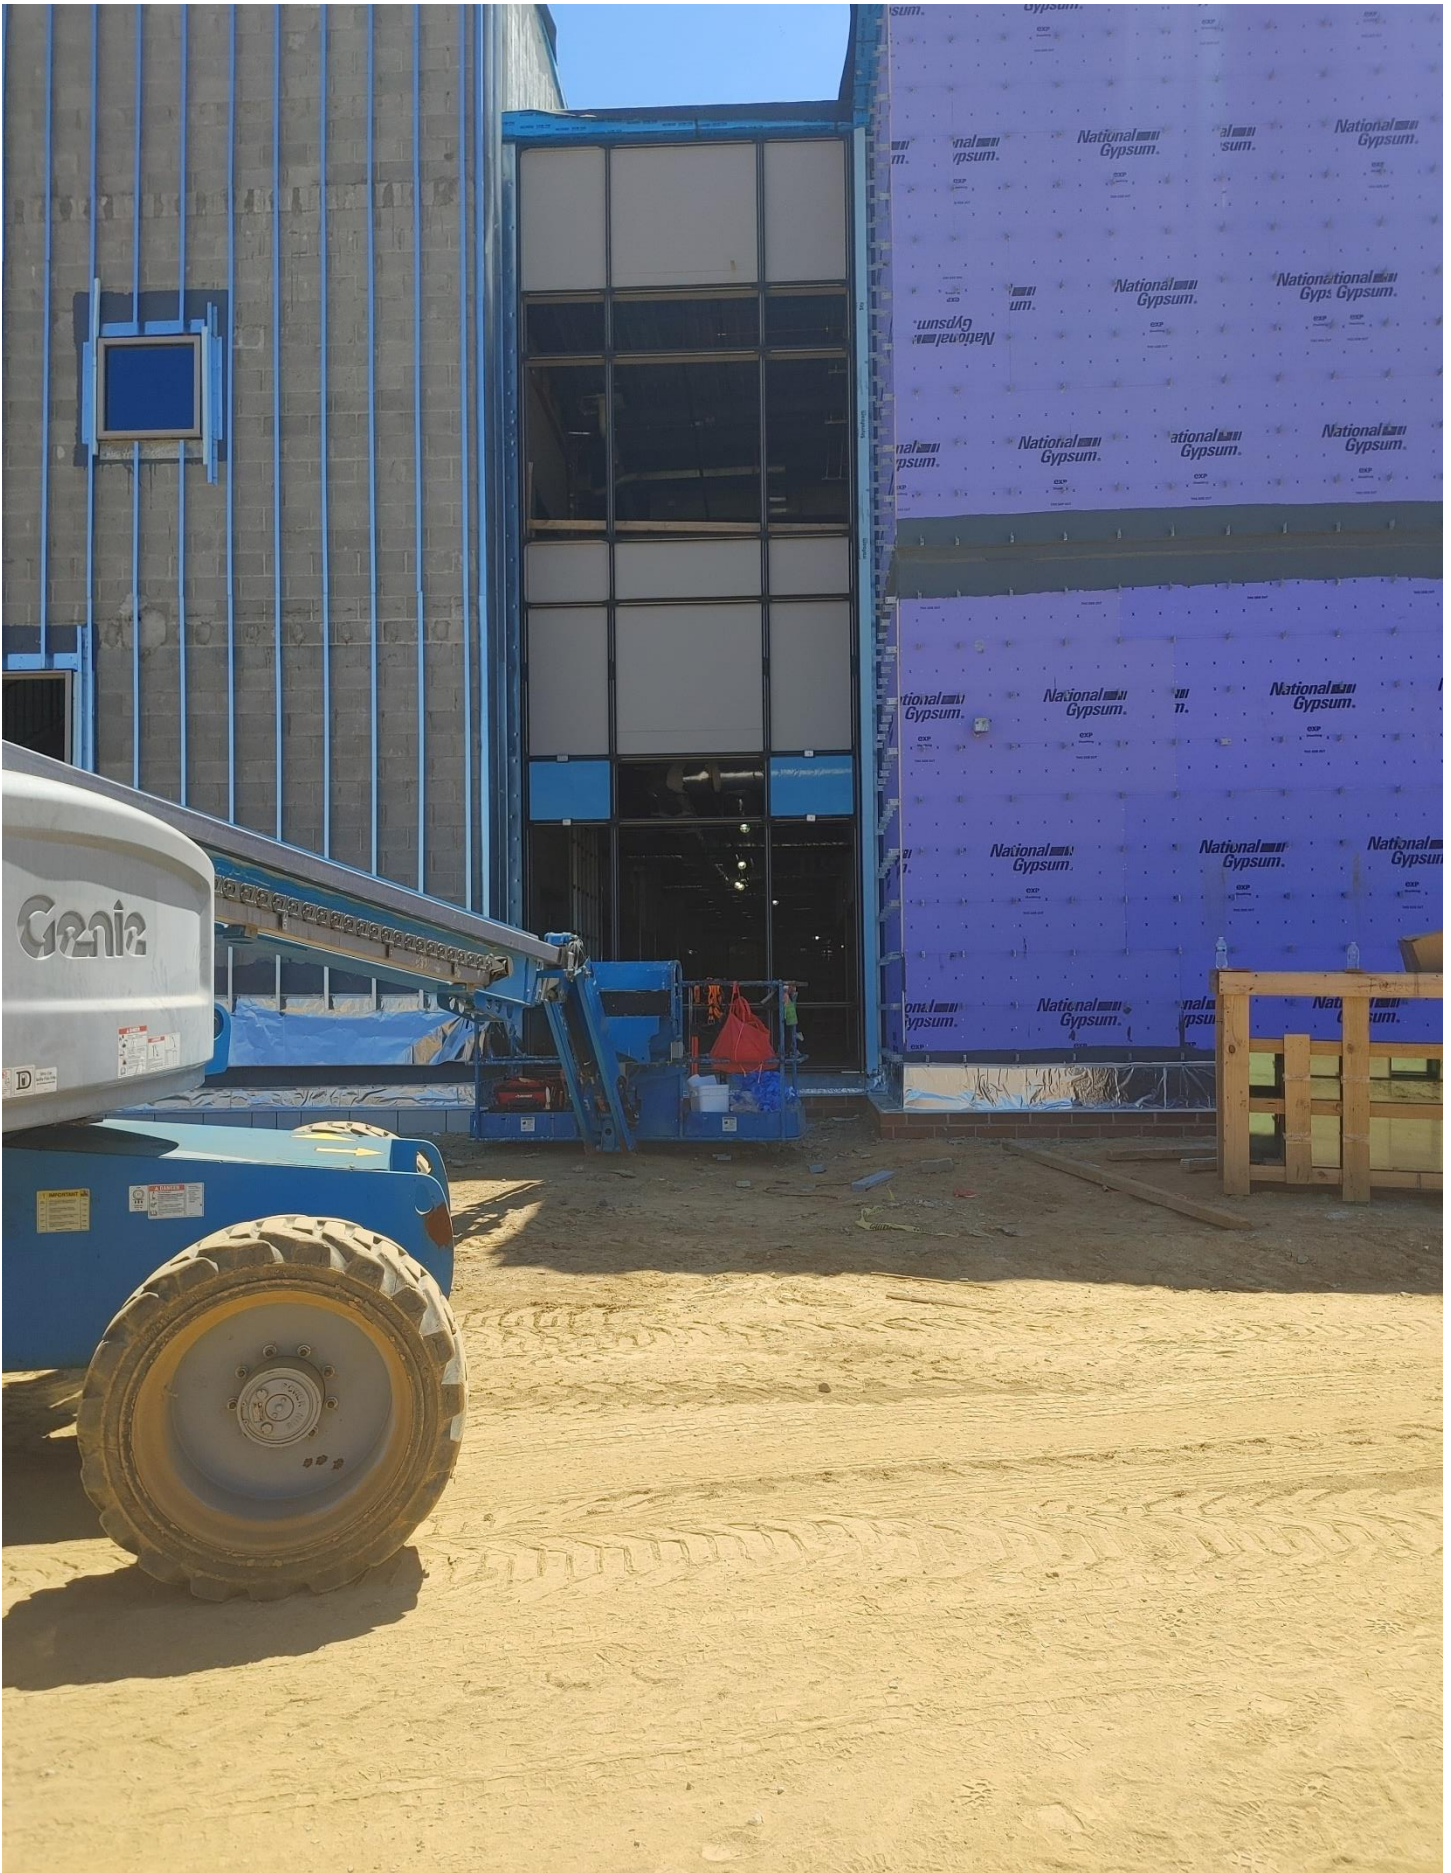
Photo 9 - Glass is being installed in the Curtain Wall on the West side of Area B

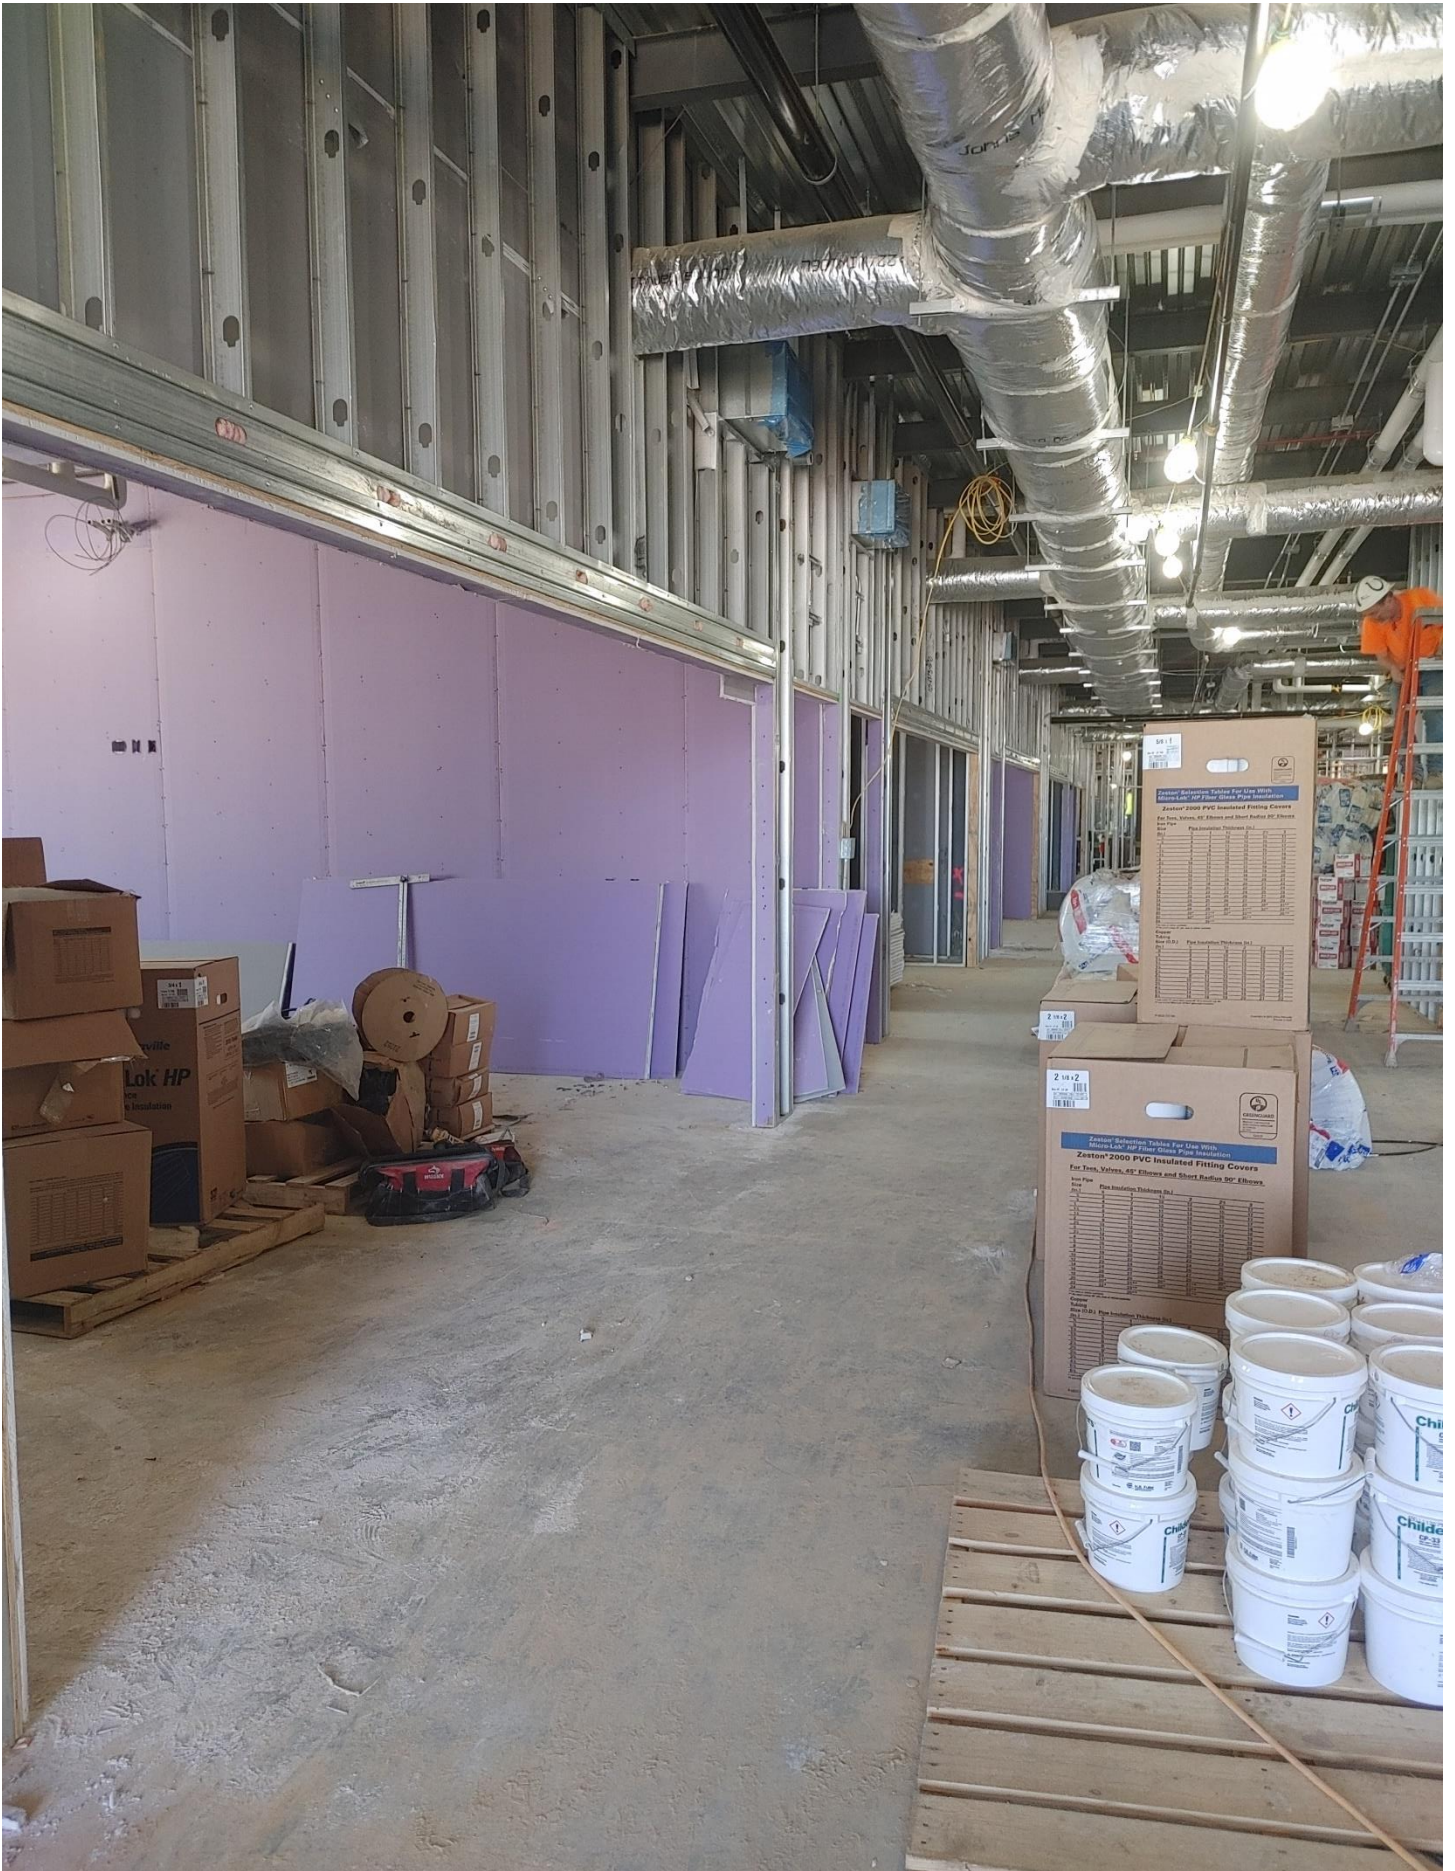
Photo 10 - Sheetrock is now being hung on the 1st floor of Area B

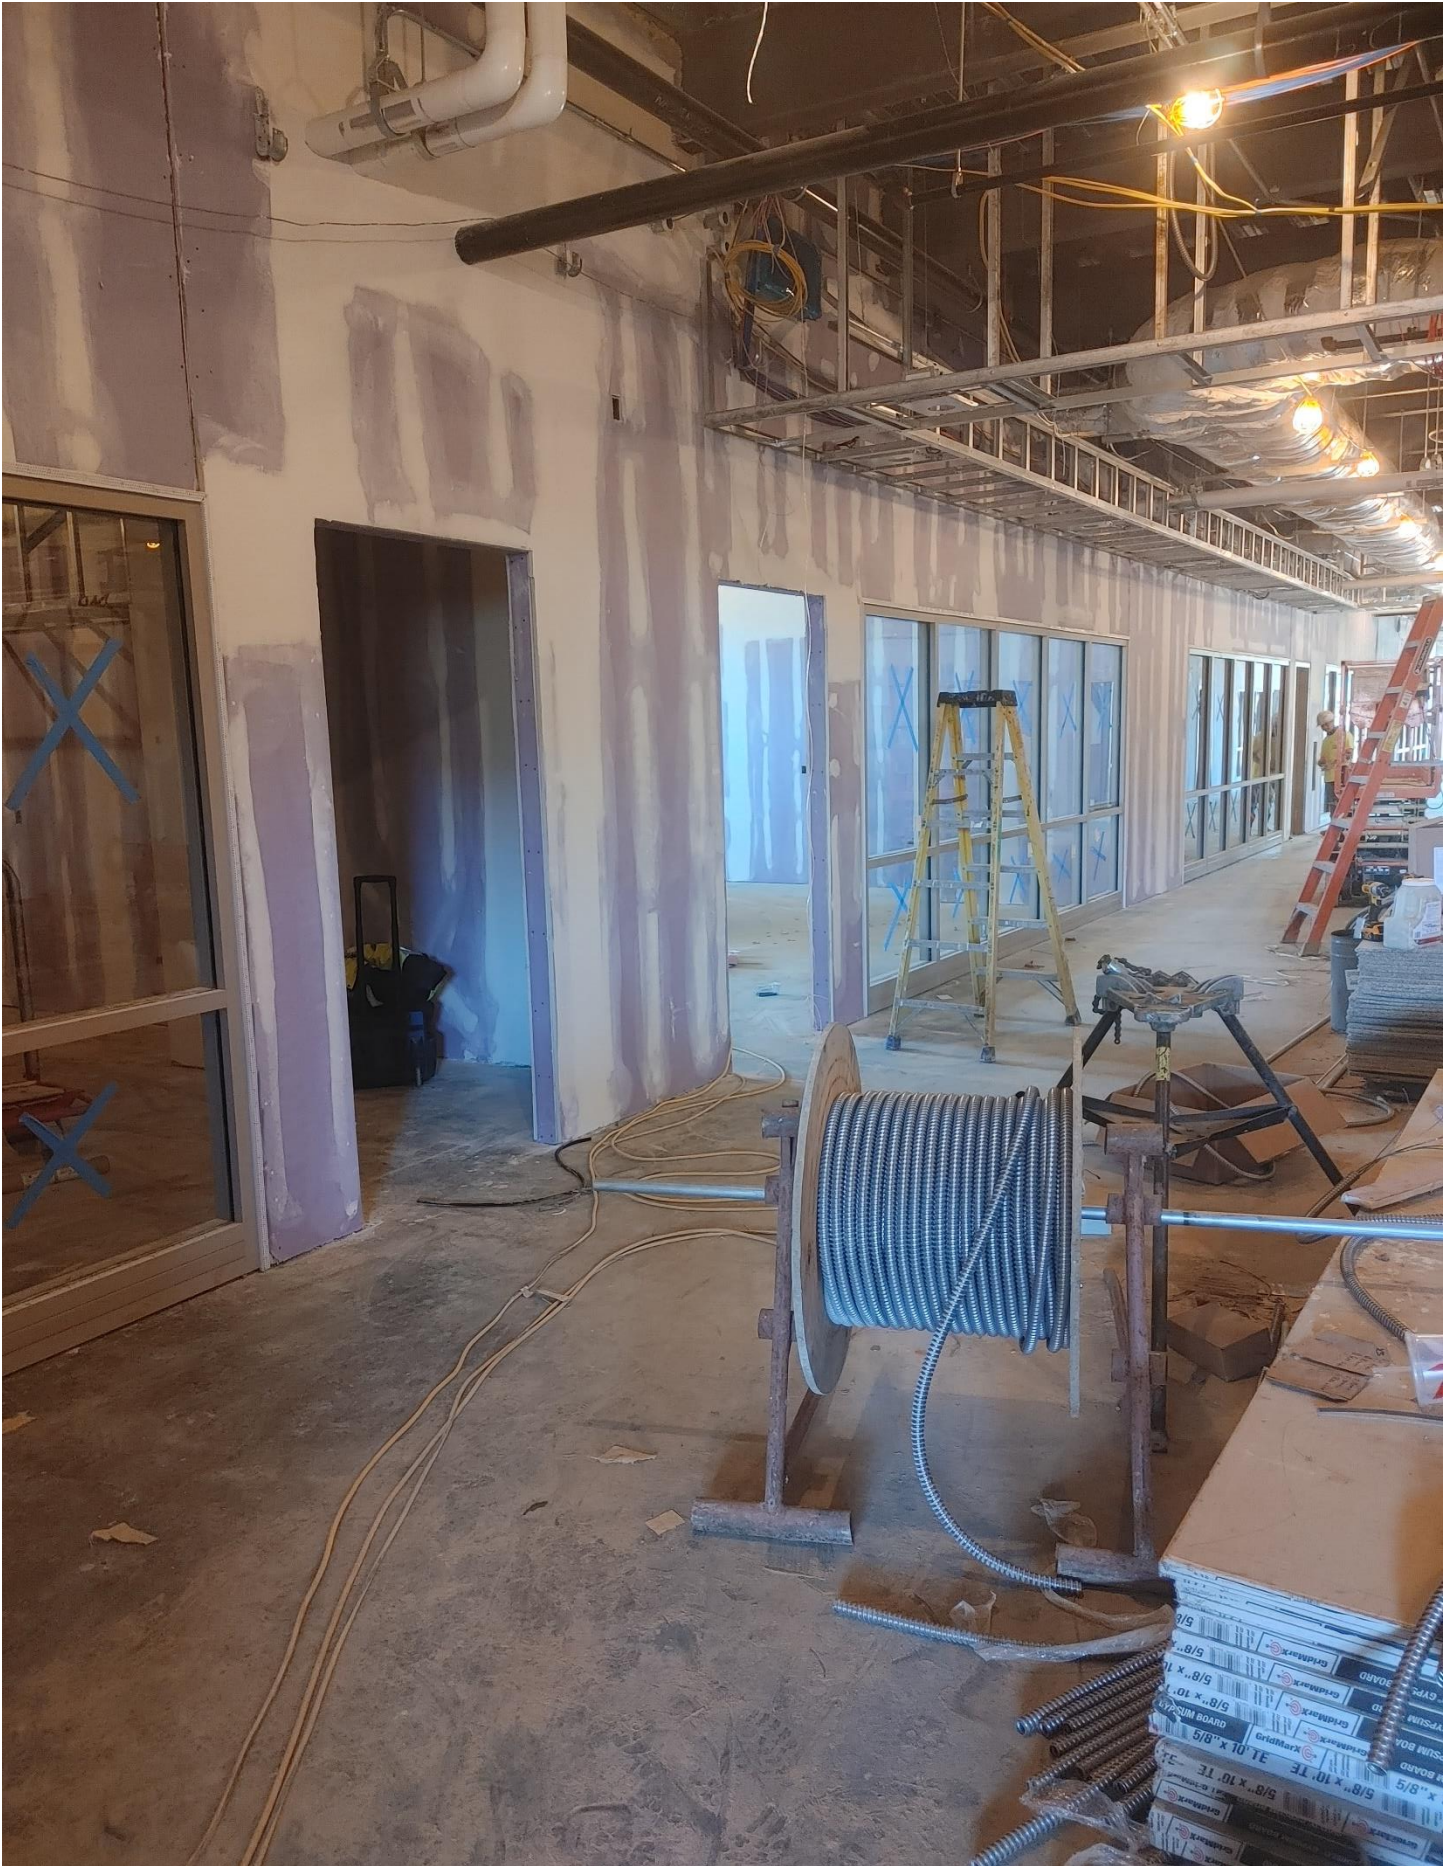
Photo 11 - Glass has been installed in some of the Storefronts on the 1st floor of Area A

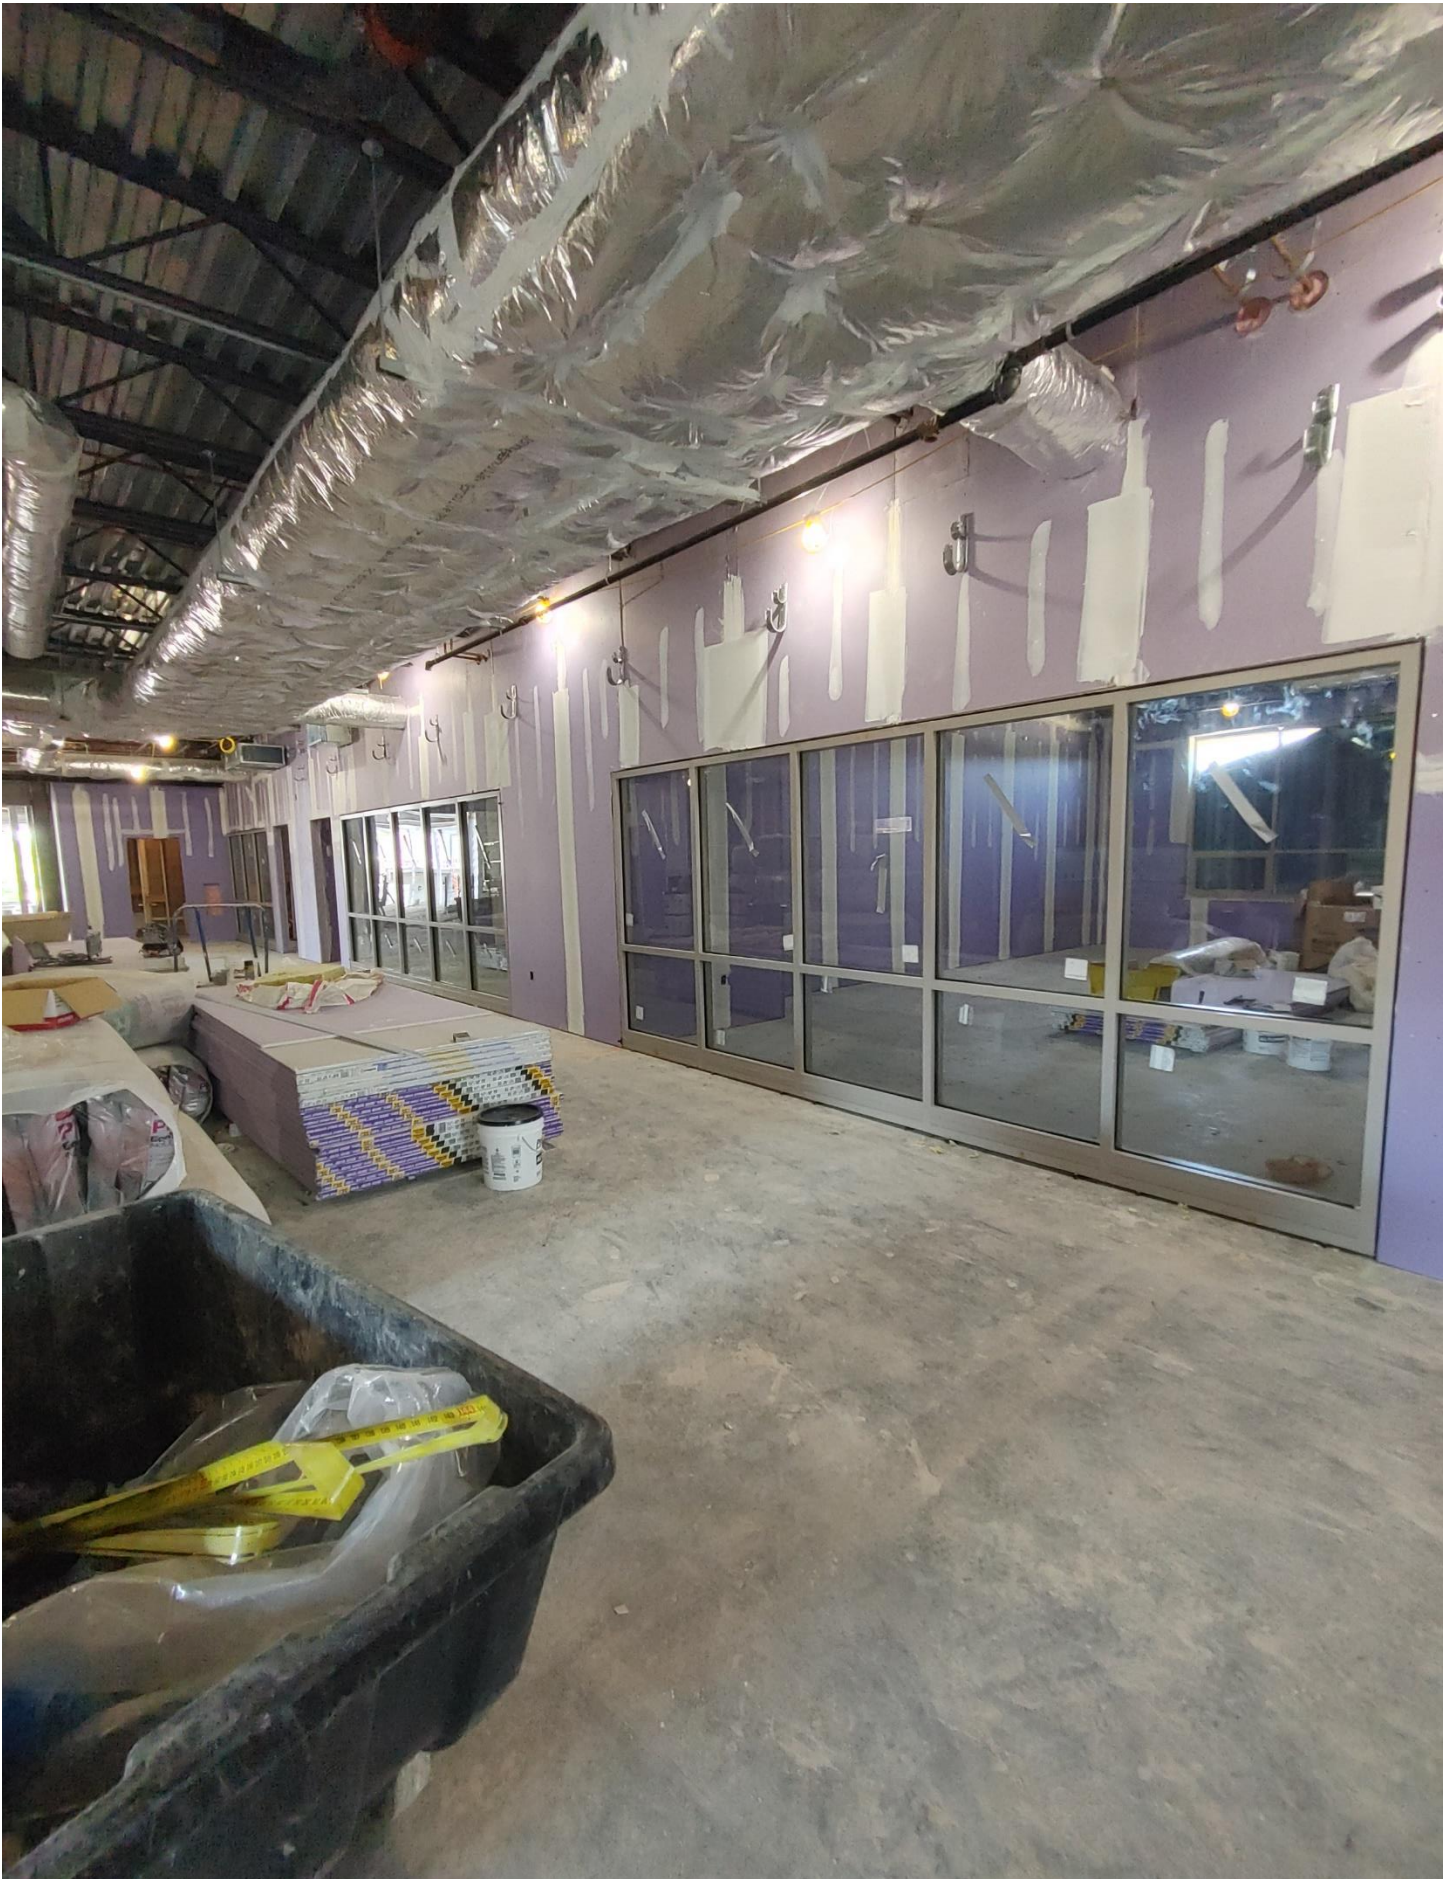
Photo 12 - Glass is being installed in the Storefronts on the 2nd floor of Area A

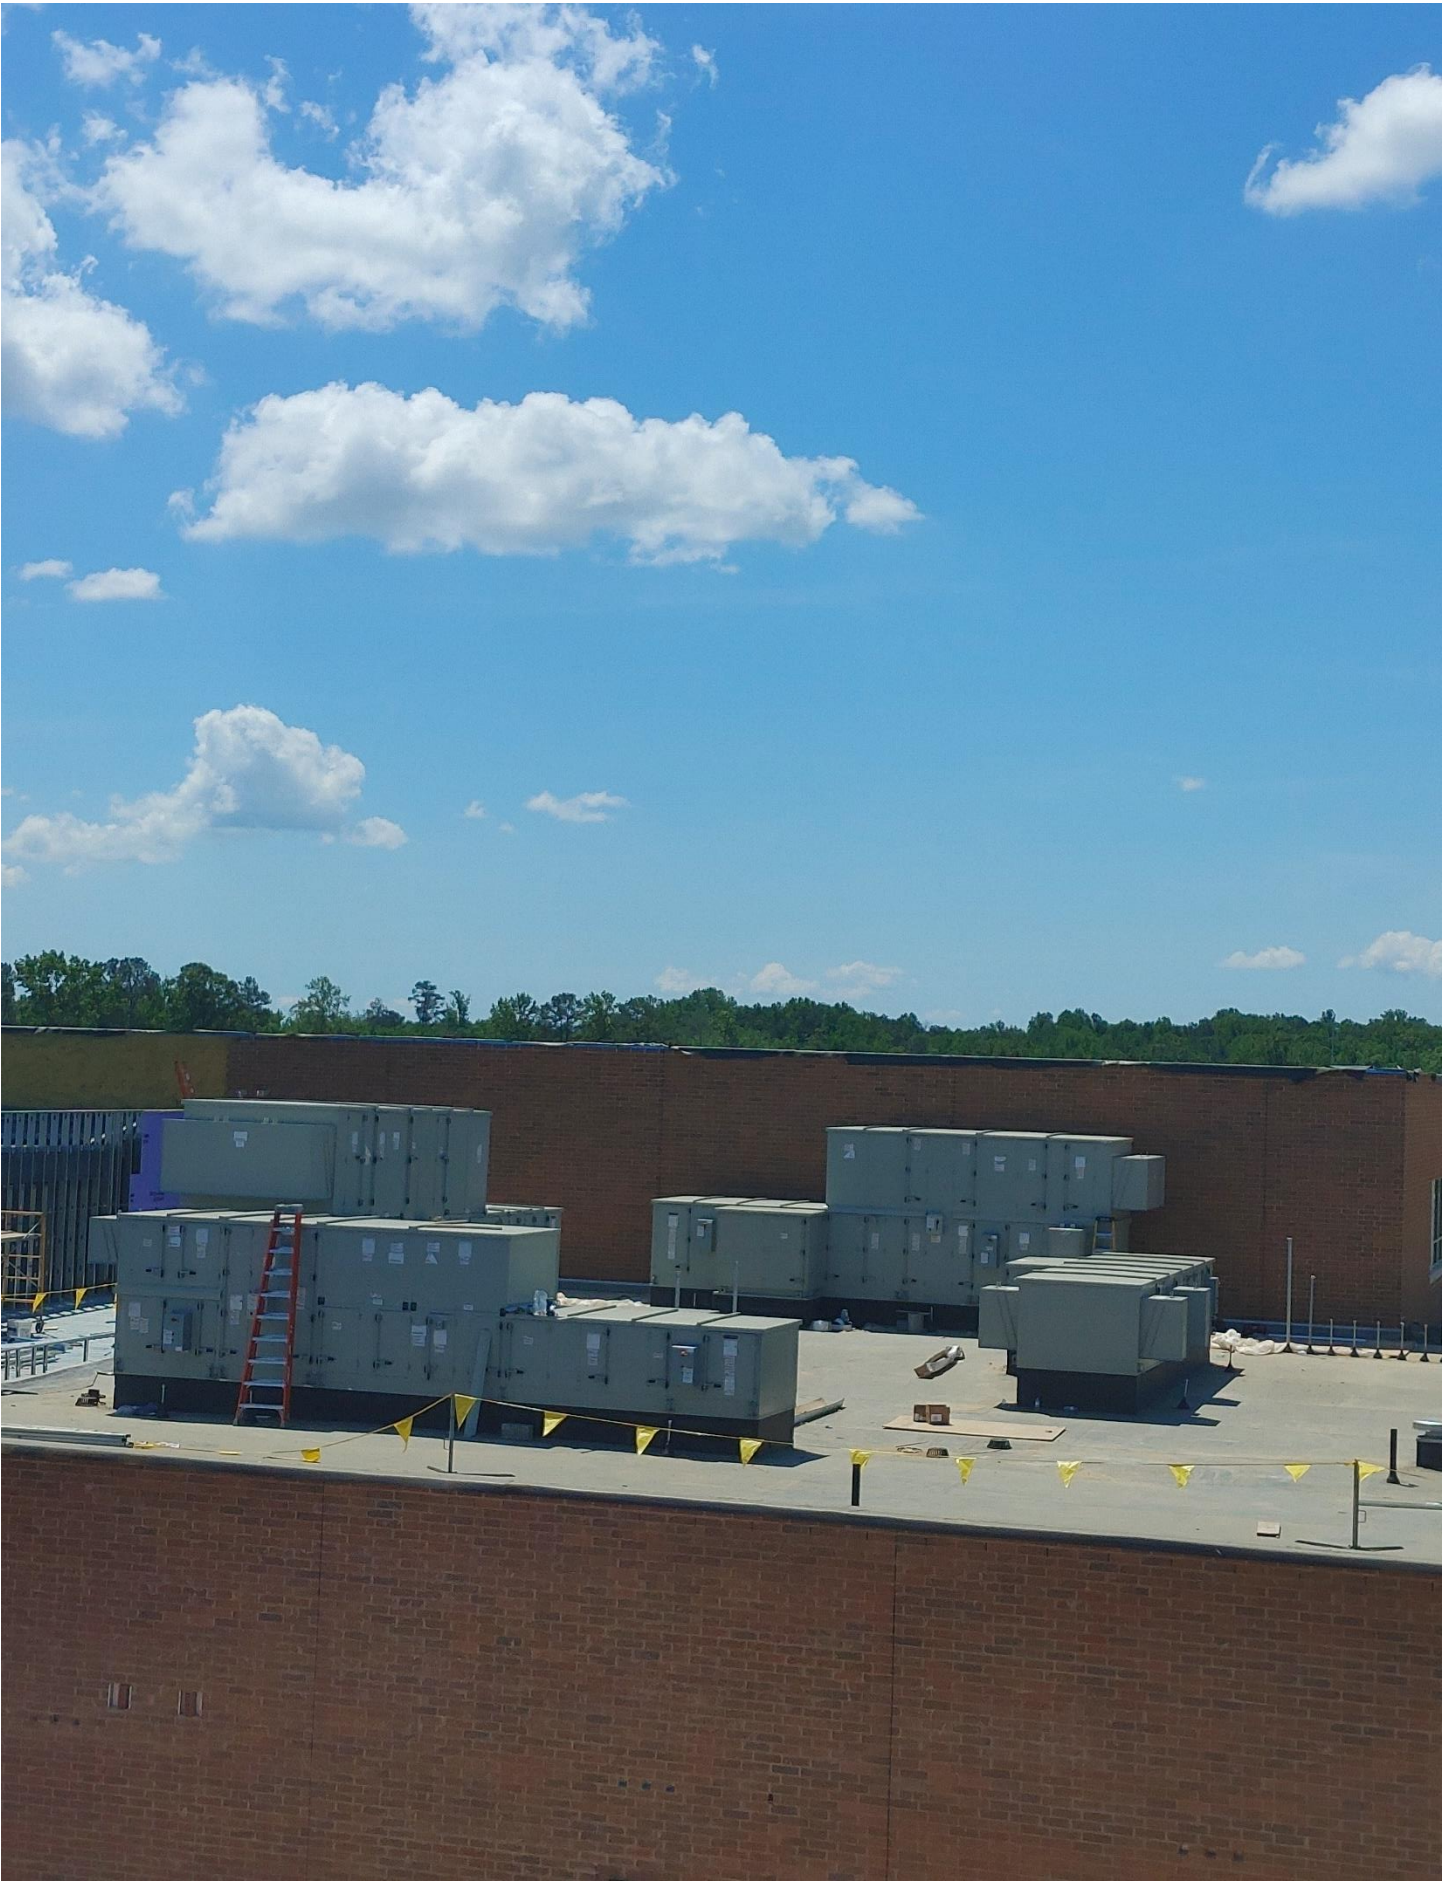
Photo 13 - Roof Top units have been set in Area E

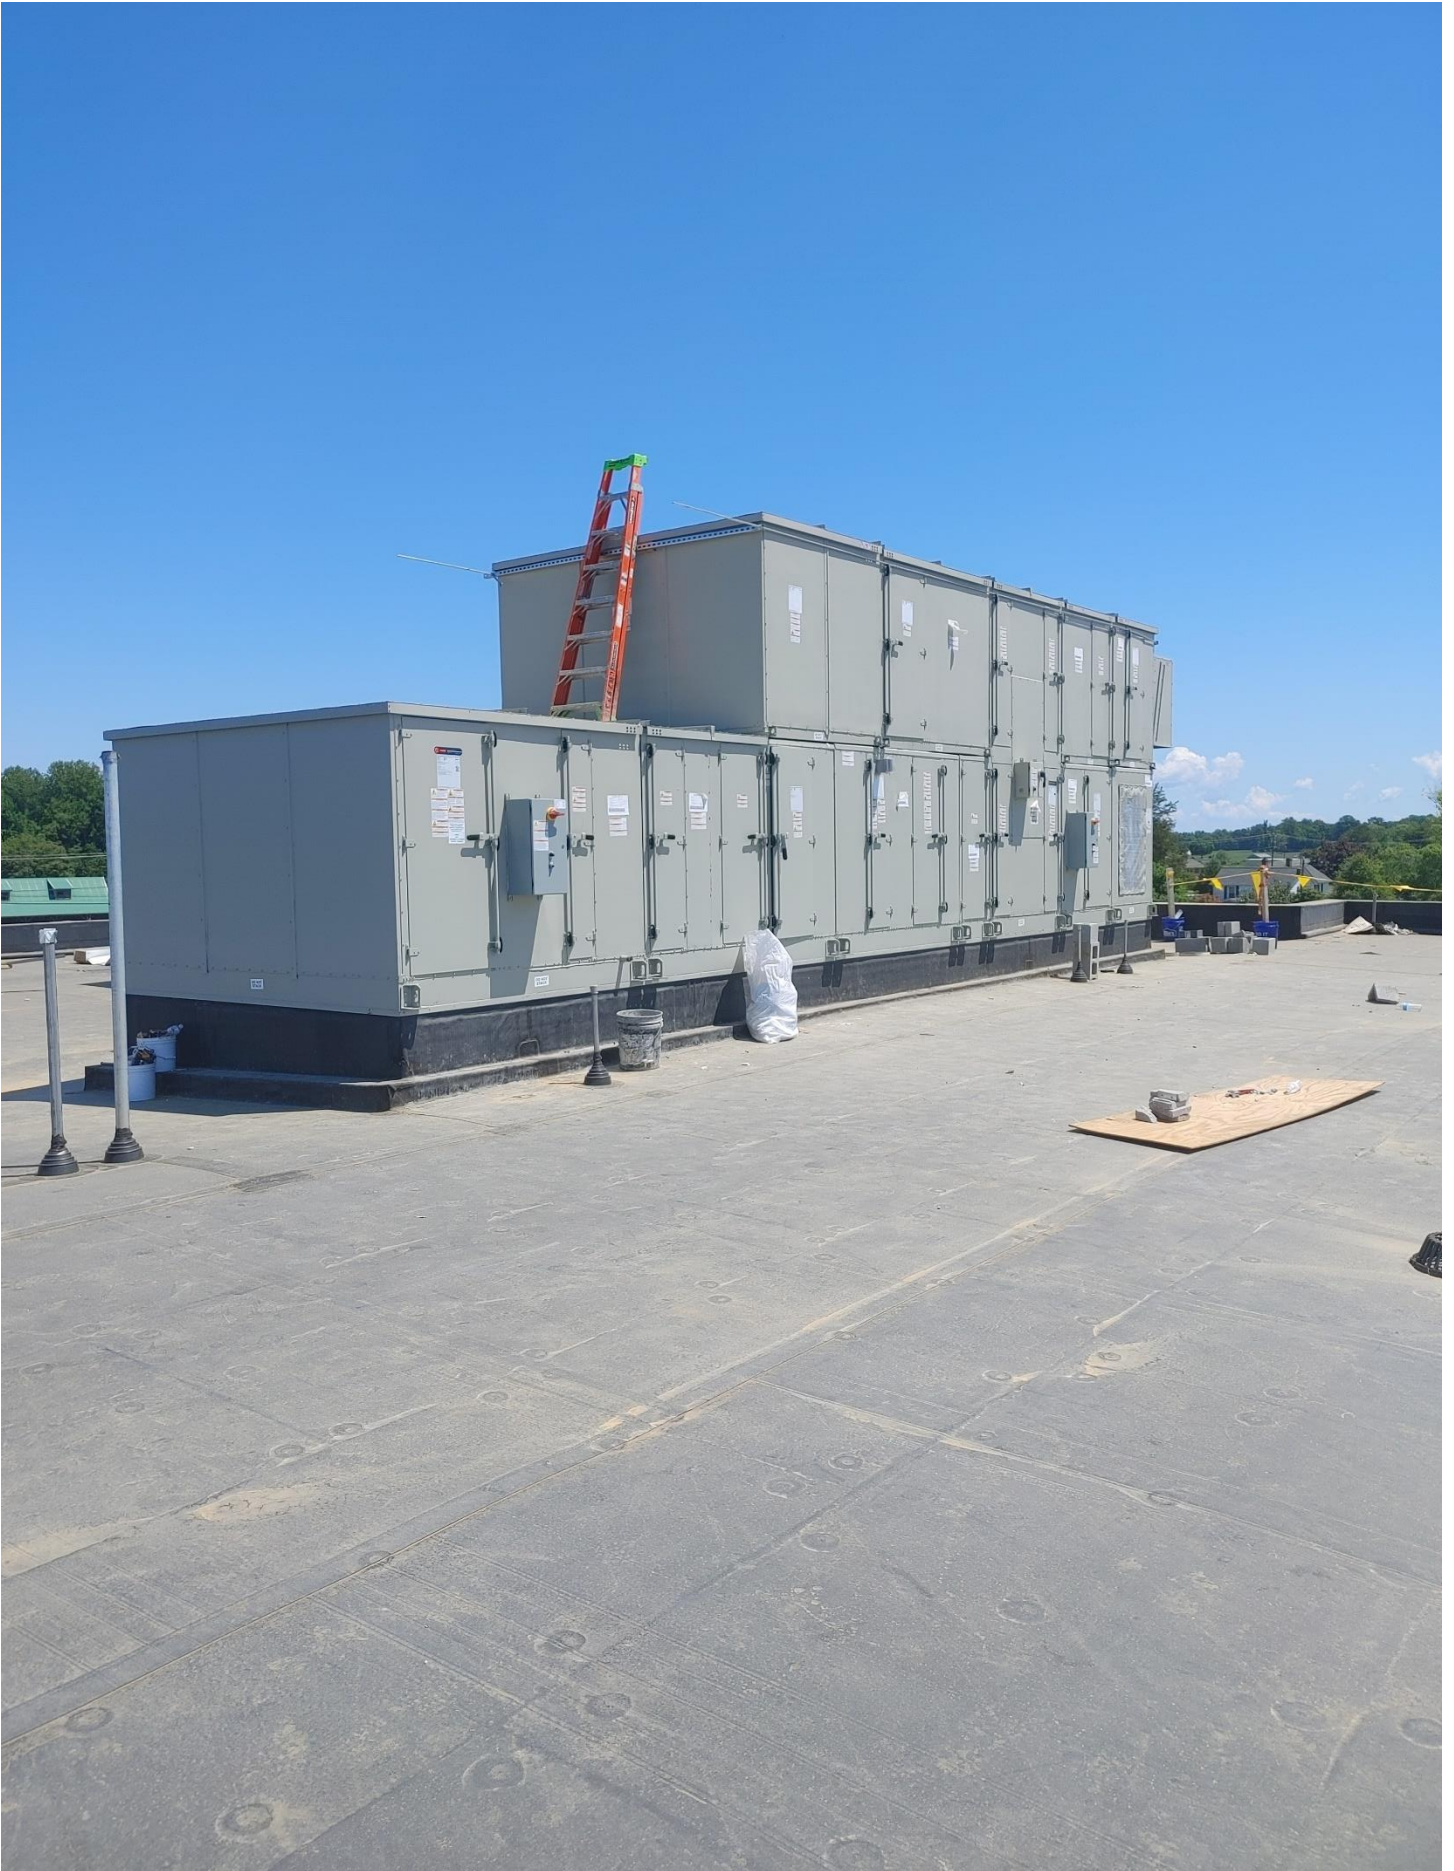
Photo 14 - Roof Top Unit has been set in Area A
