**COMMONWEALTH
BUILDING SOLUTIONS, LLC**

DAILY REPORT

WESTMORELAND COUNTY HIGH SCHOOL

Date: 05/19/2021
Weather: 74 degrees. High of 77 degrees today.
Hours Worked: 11:30hrs – 14:00hrs (2.5hrs) On Site.

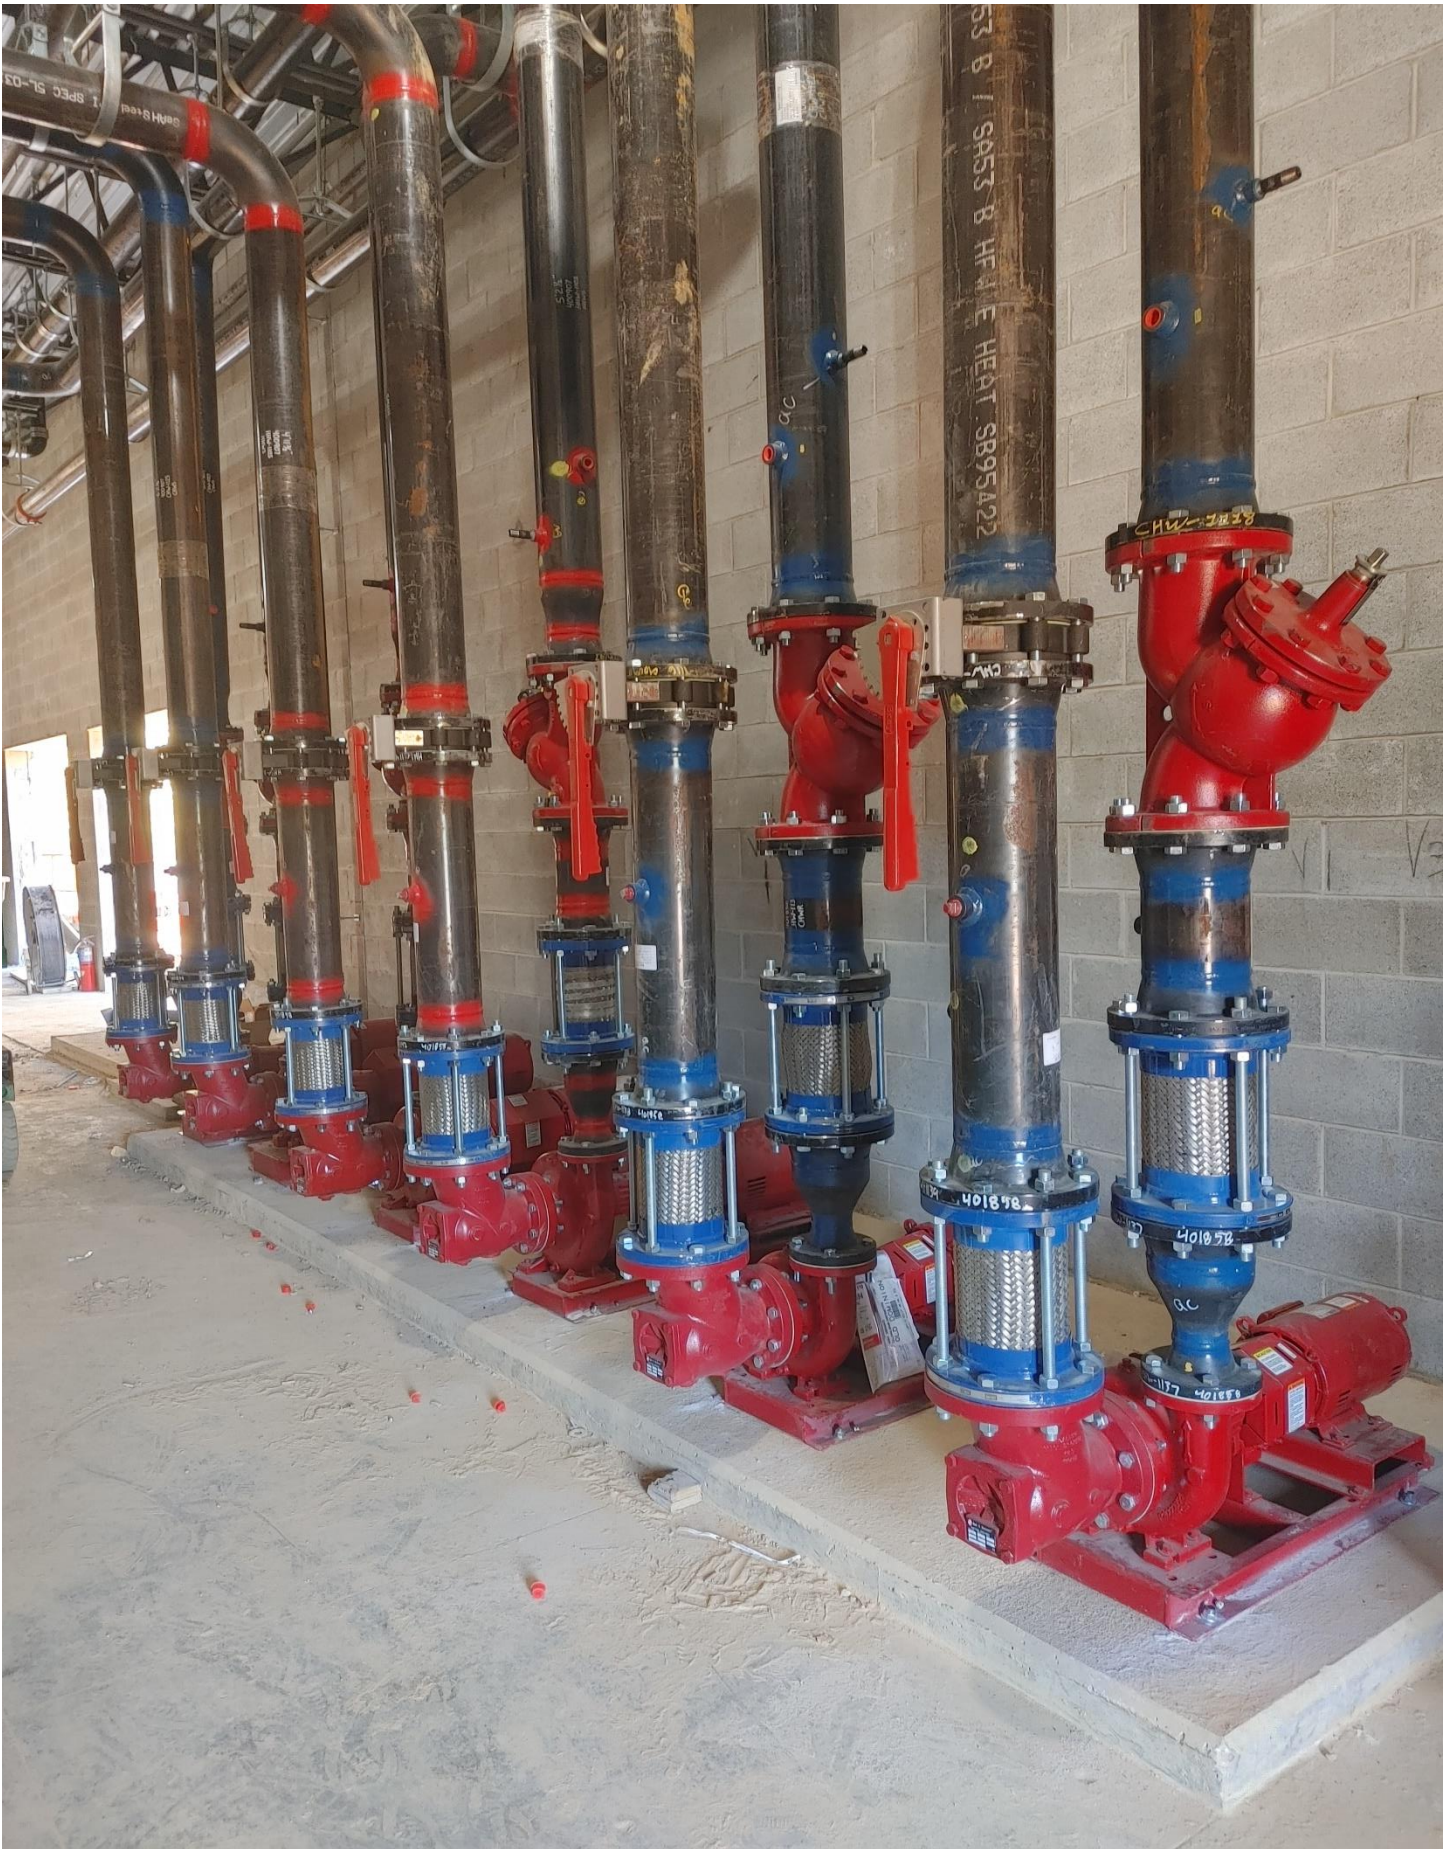
Photo 1 - Work continues in Area D Mechanical Room

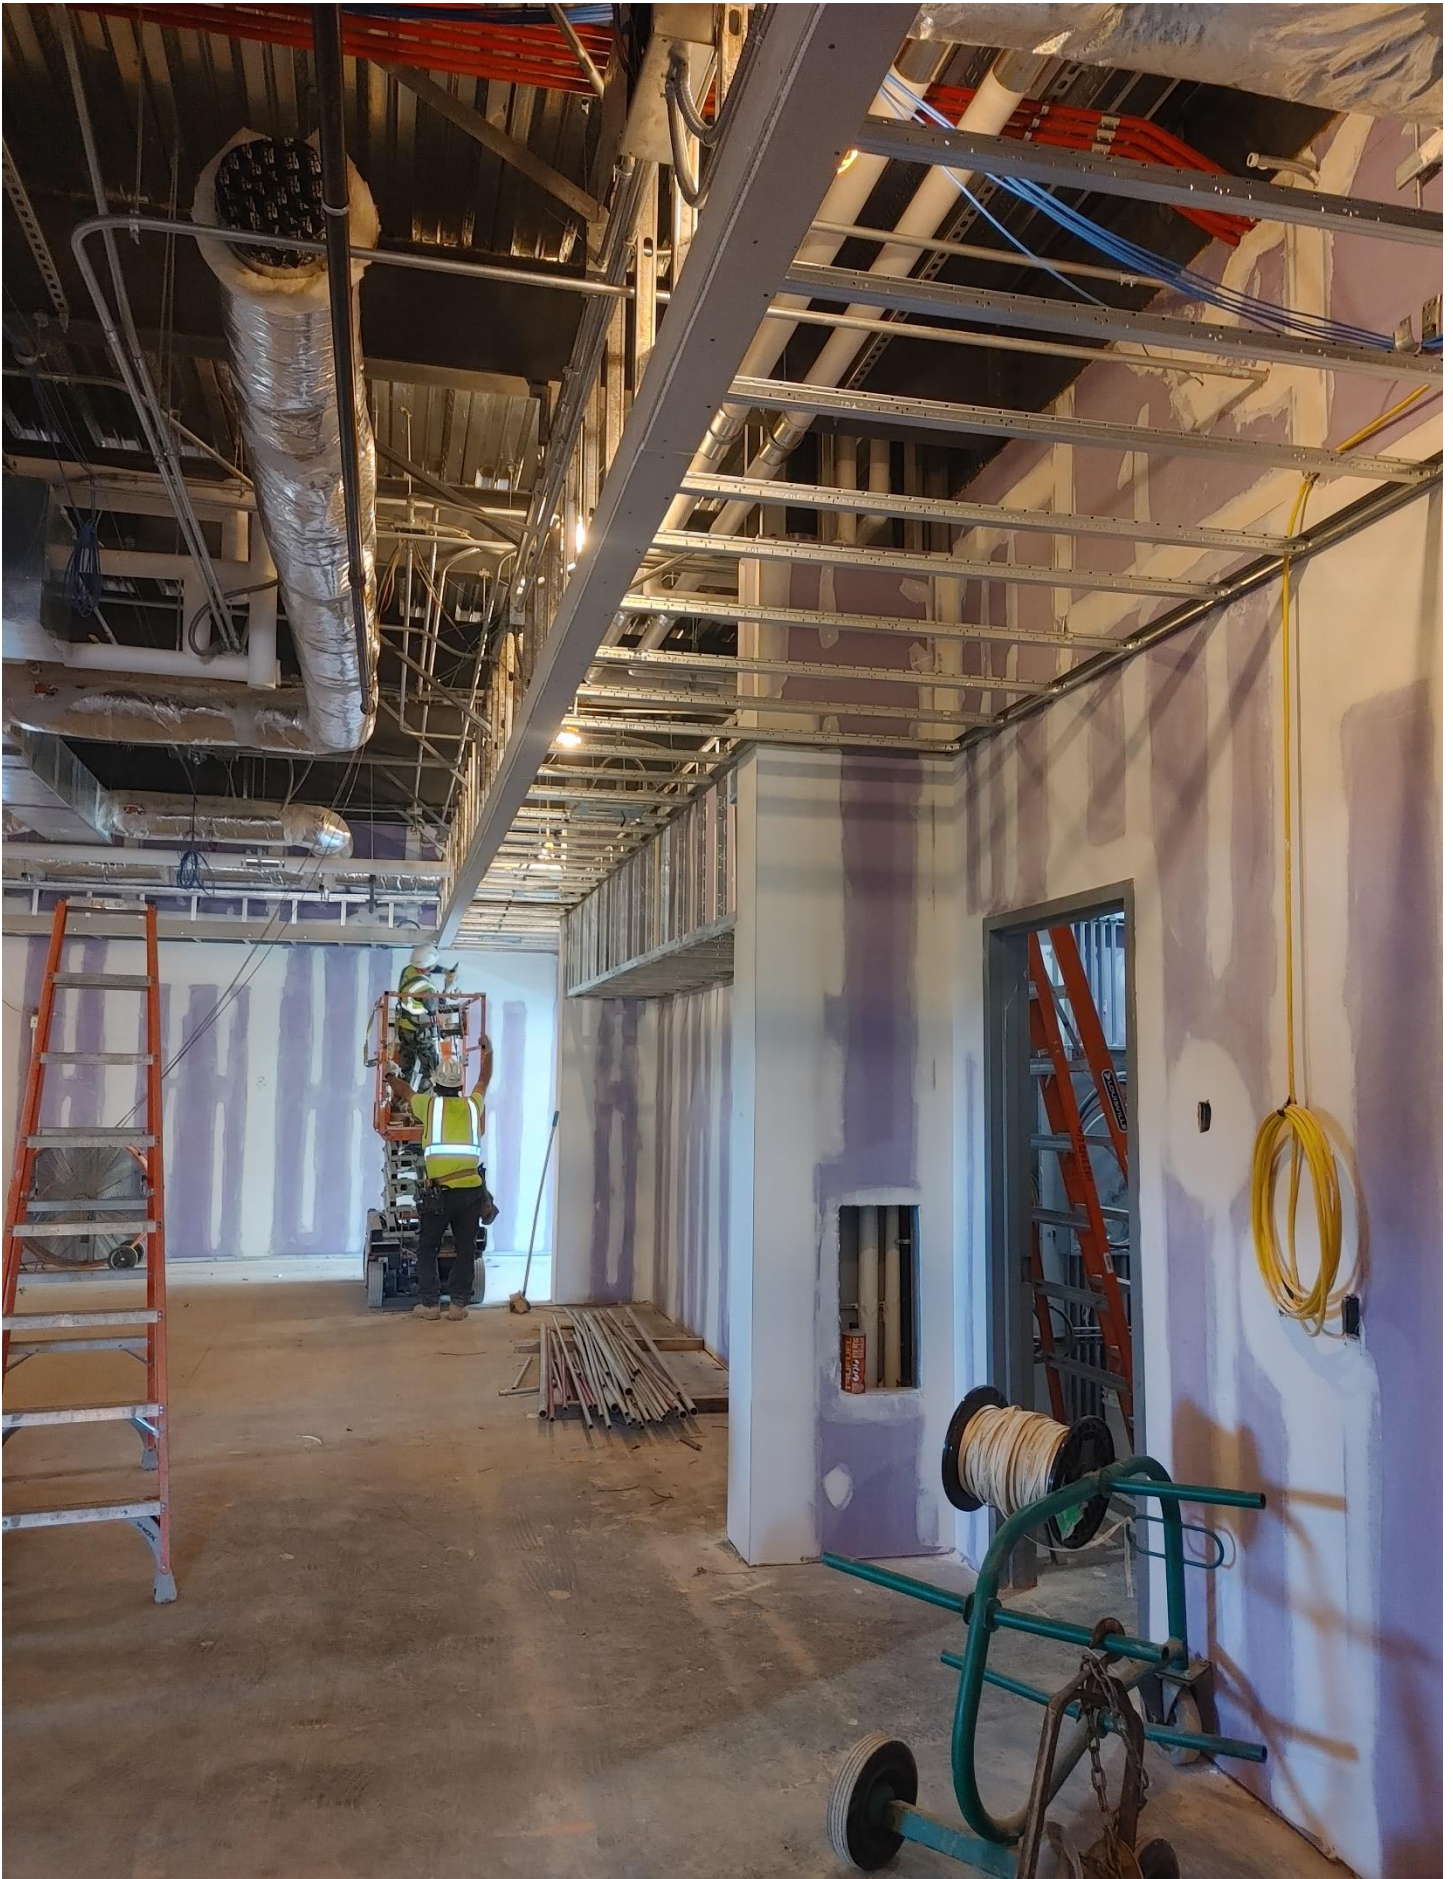
JP Construction: They have Seventeen (17) men here today. They are framing bulk heads in Area A and hanging and finishing sheetrock in Areas A & B.

Photo 2 - Bulk Heads being constructed in Area A

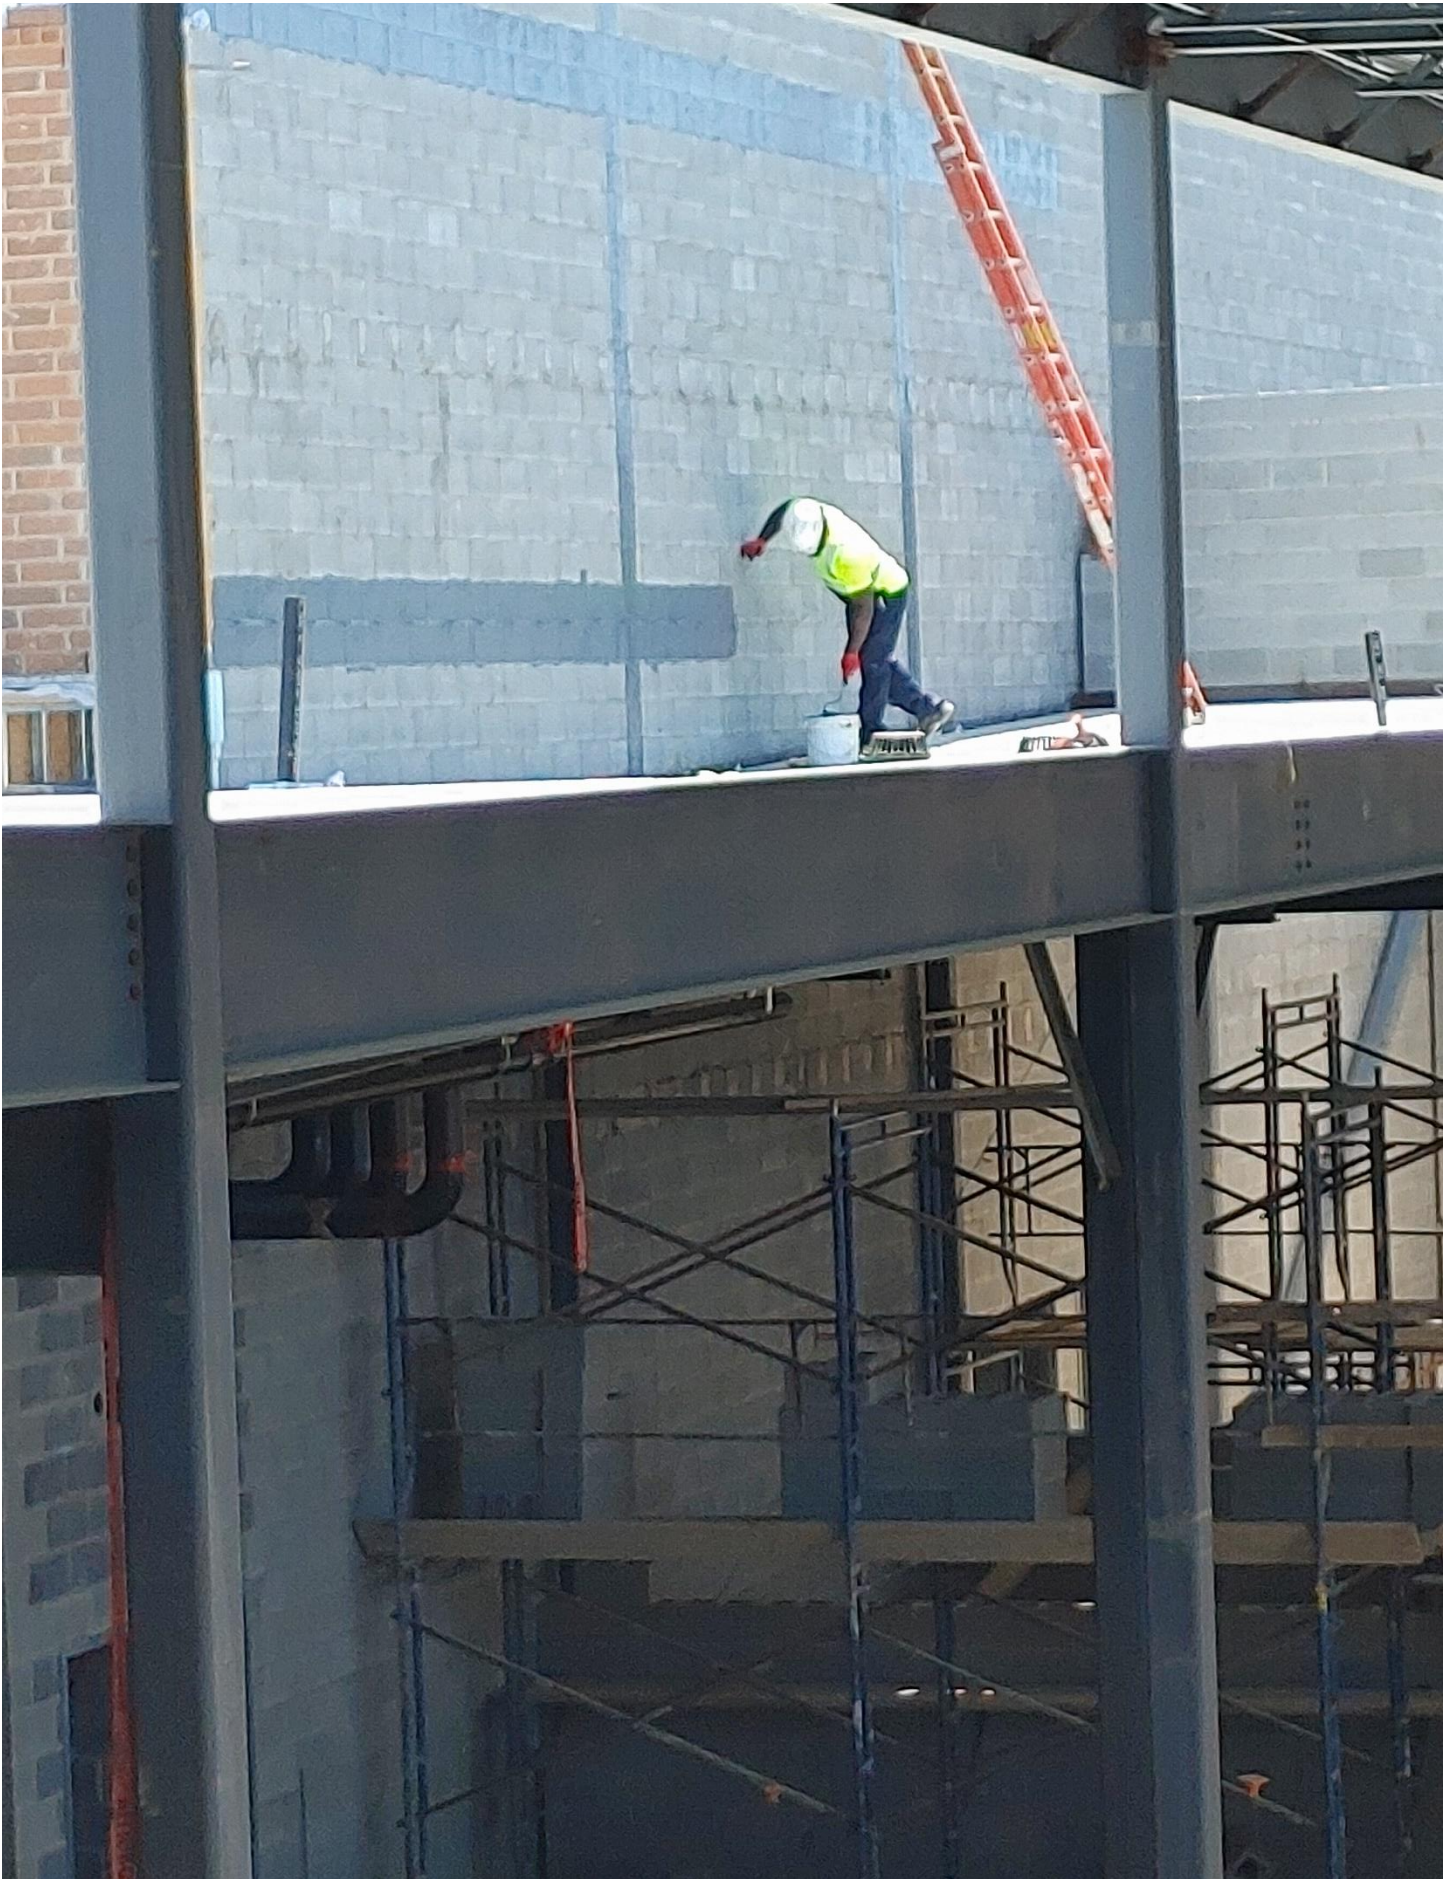
Tailored Foam: Two (2) men are on site today. They are installing Transition Membrane in Area D.

Photo 3 - Transition Membrane being installed on the West side of Area D

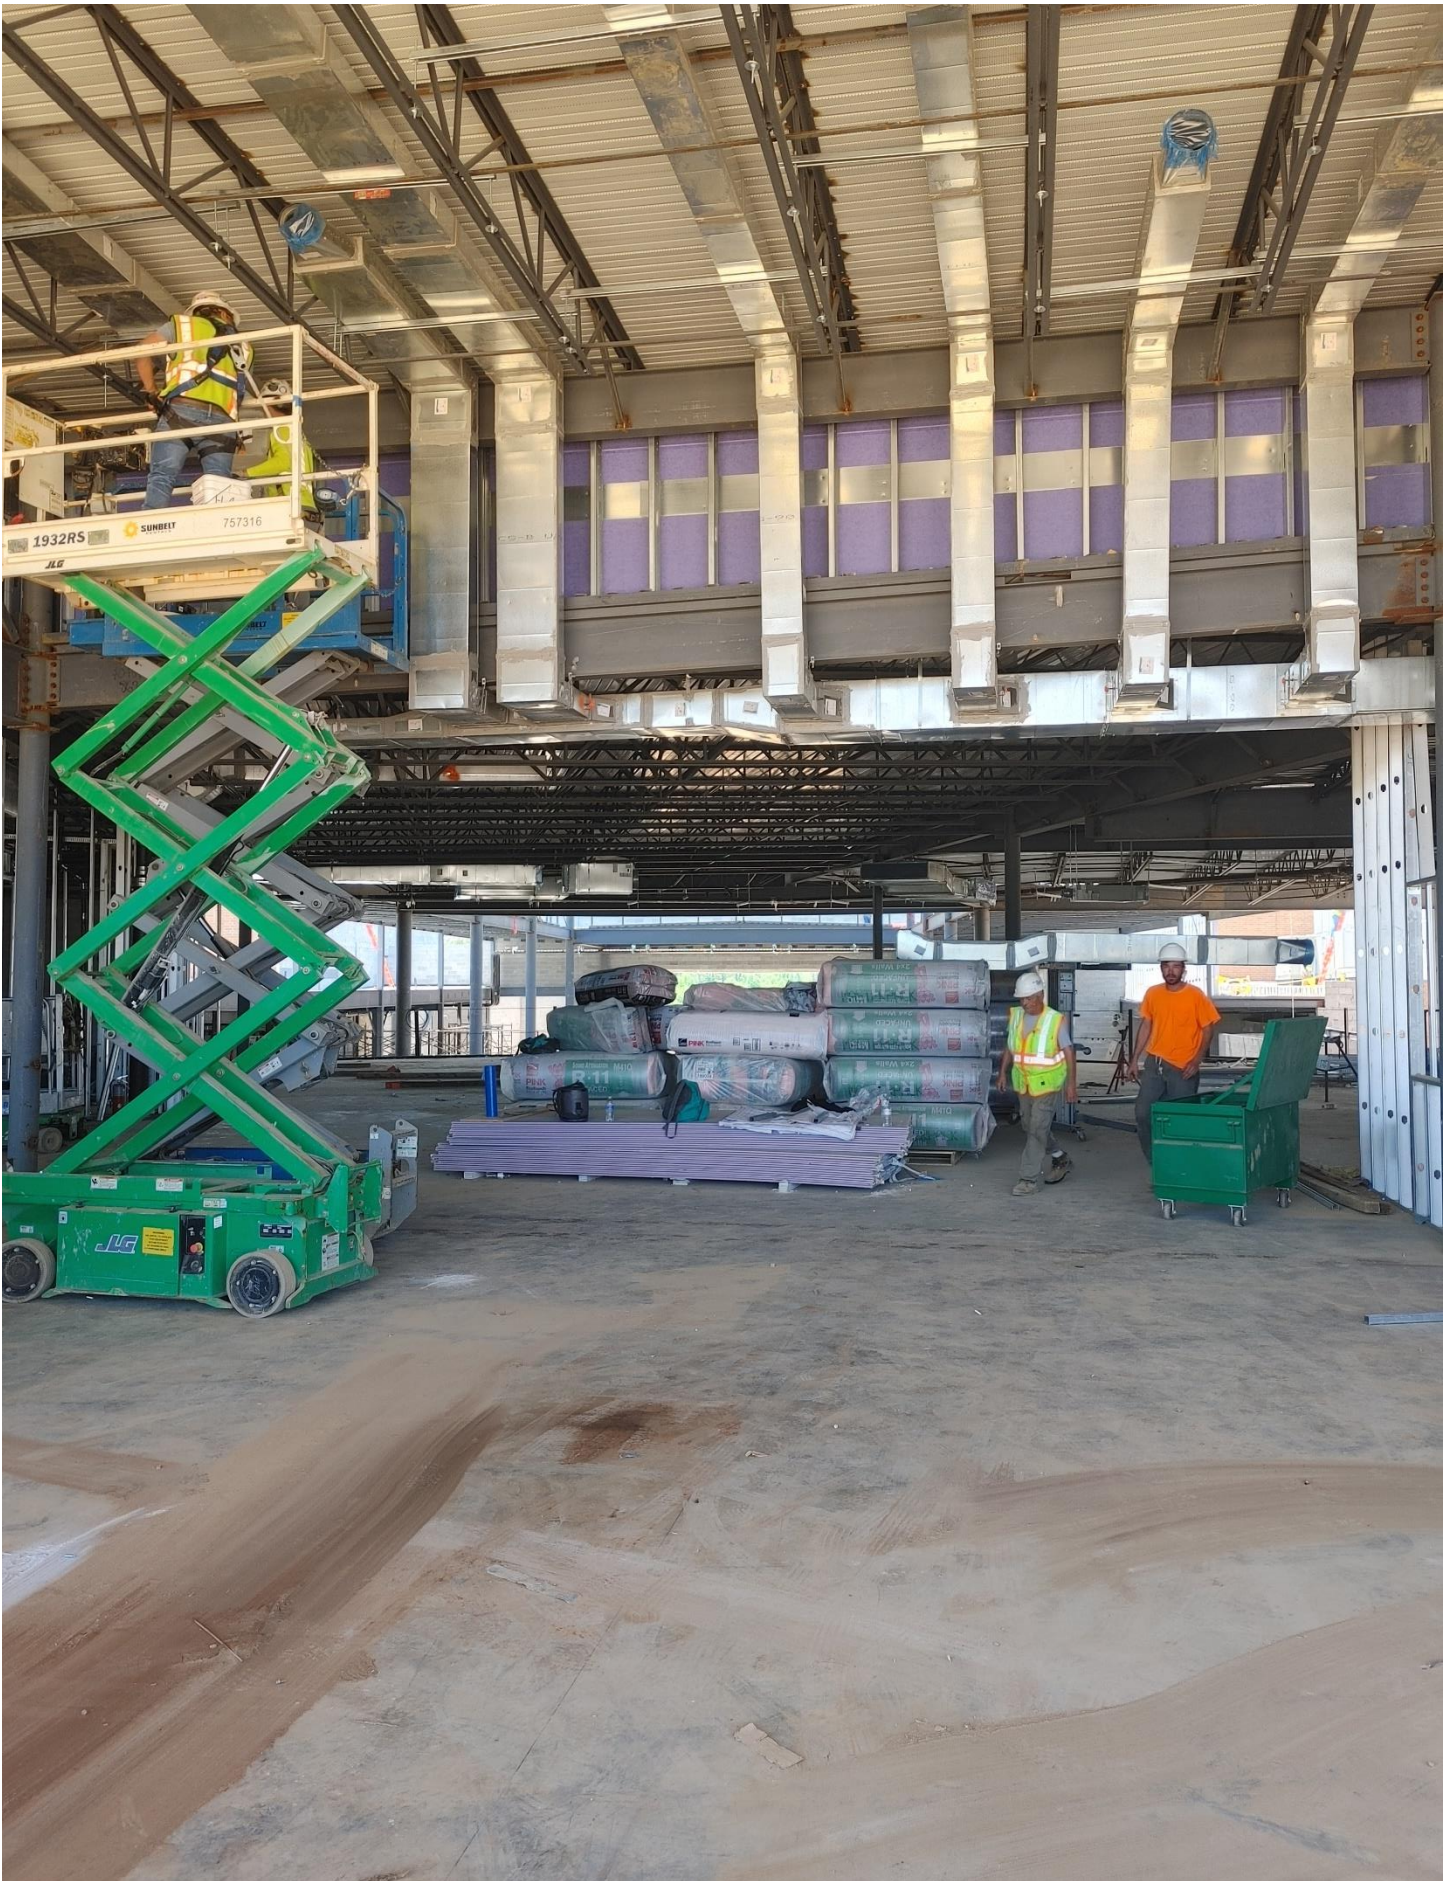
Photo 4 - Duct Banks being run in Area A

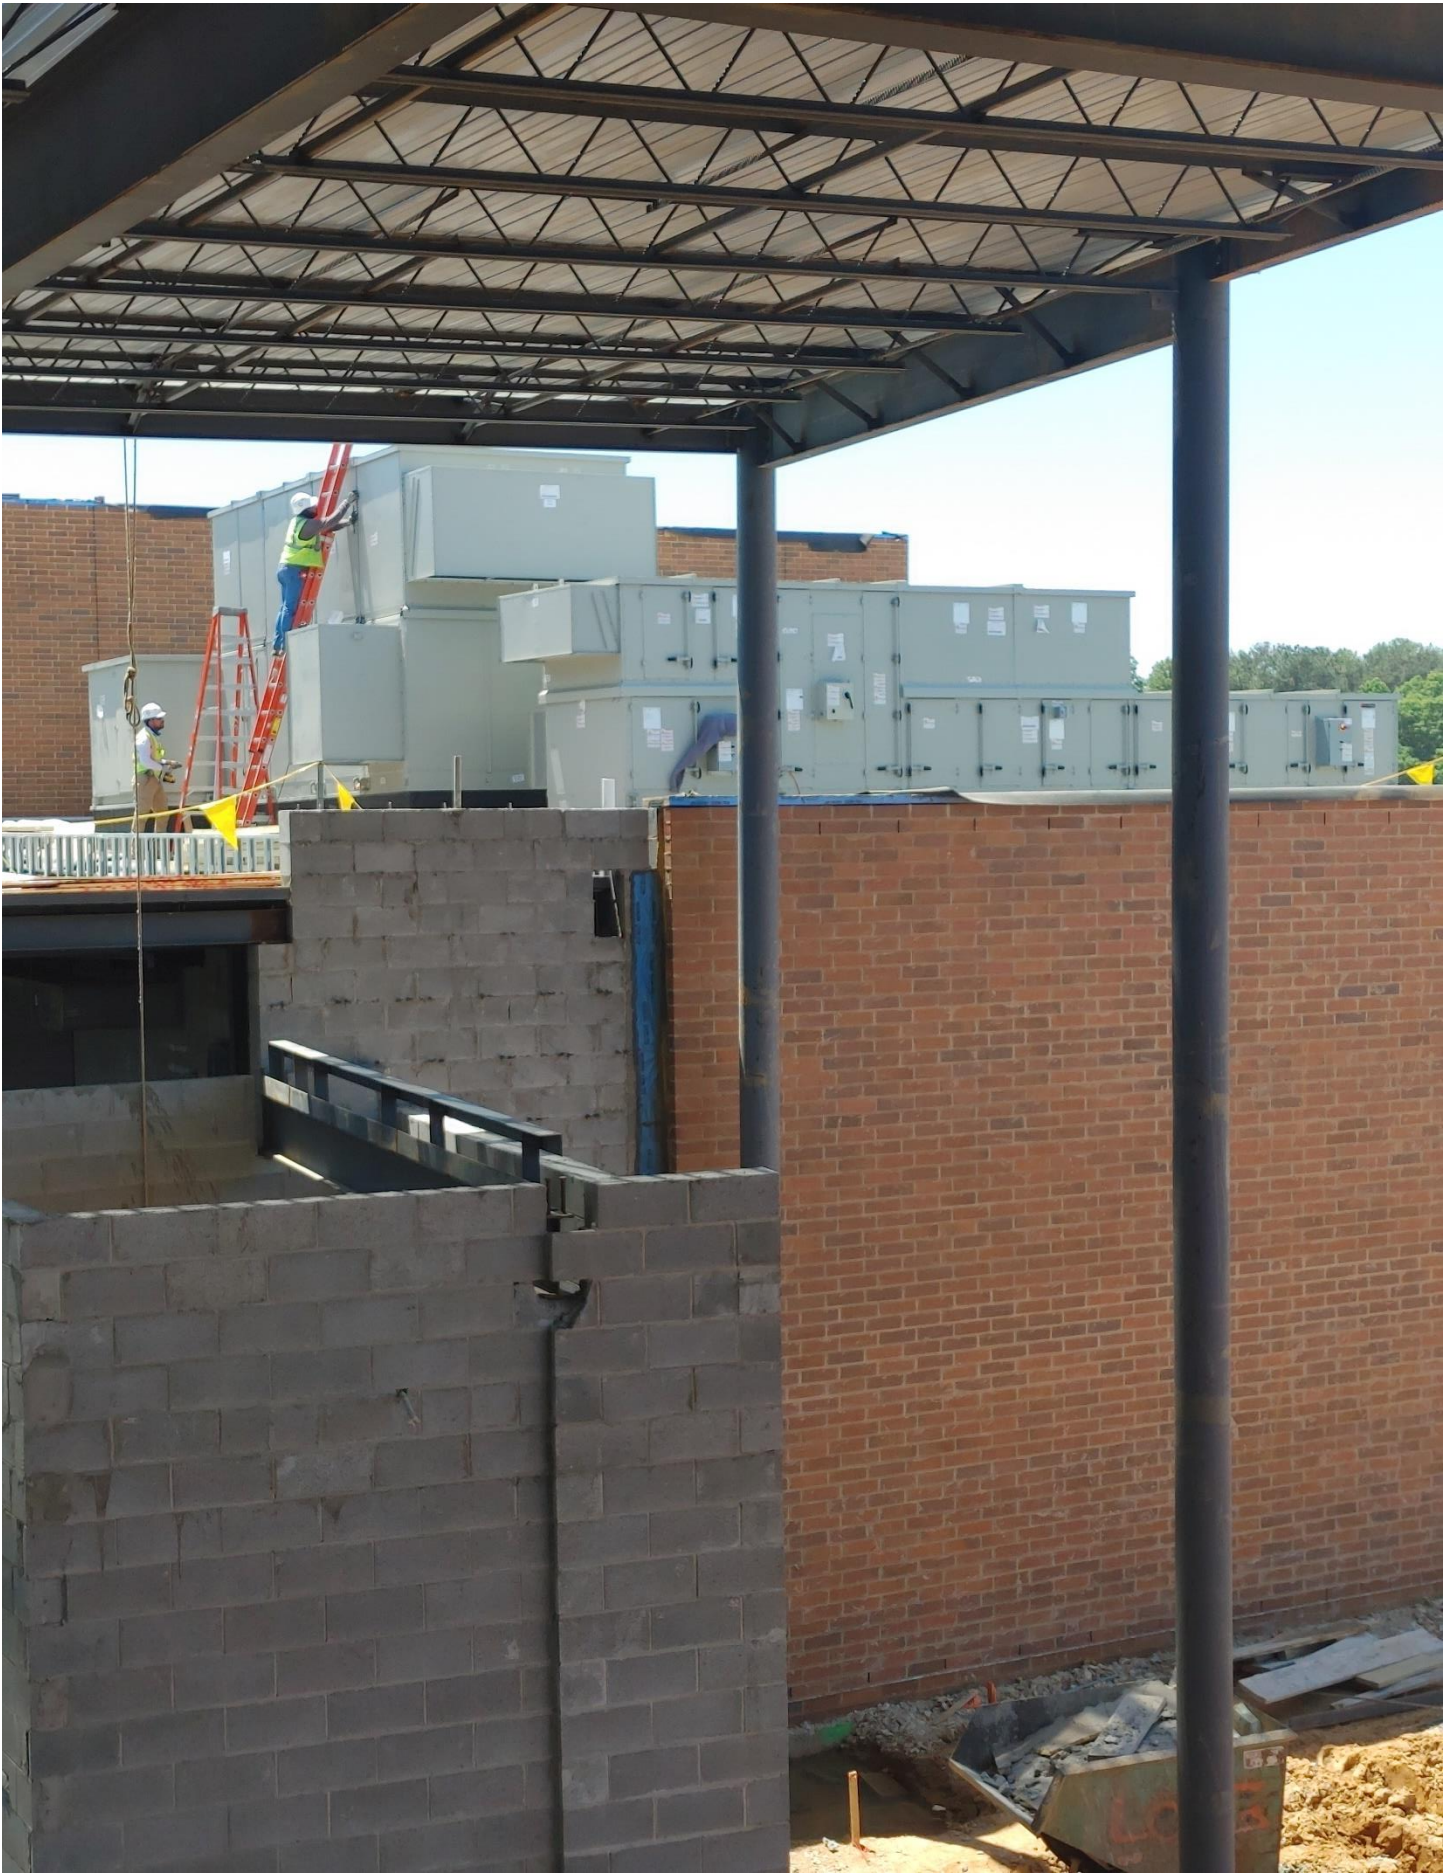
Colonial Webb: There are Thirty-seven (37) men are on site today. Duct is being run and insulated in Area A & B. Crews also continue to work on Roof top units in Areas A & E.

Photo 5 - Work continues on the roof top units in Area E

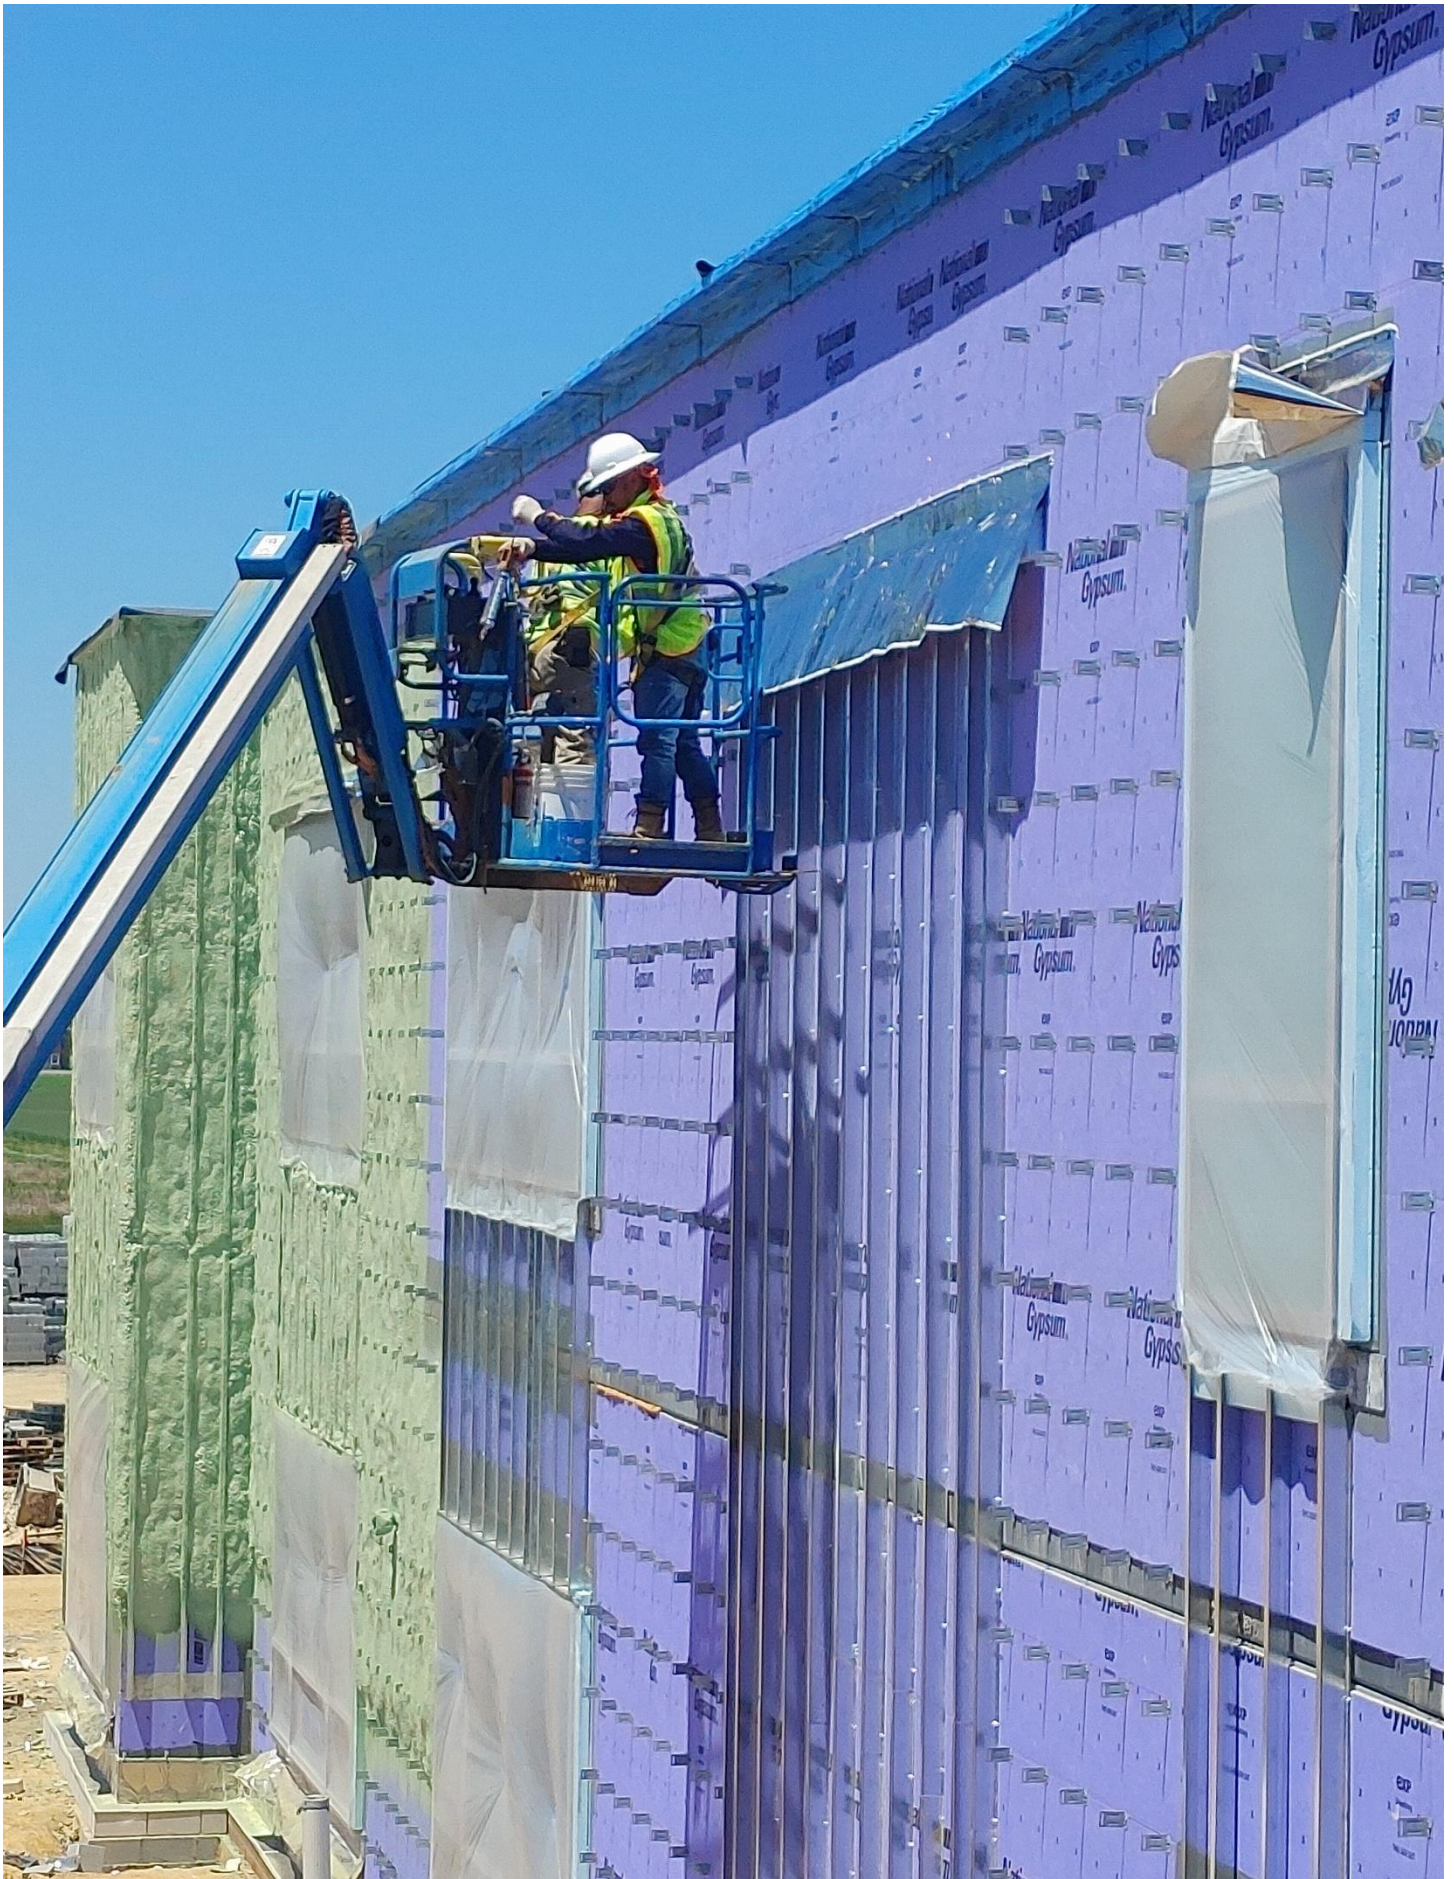
Photo 6 - Flashing being installed on the Southside of Area B

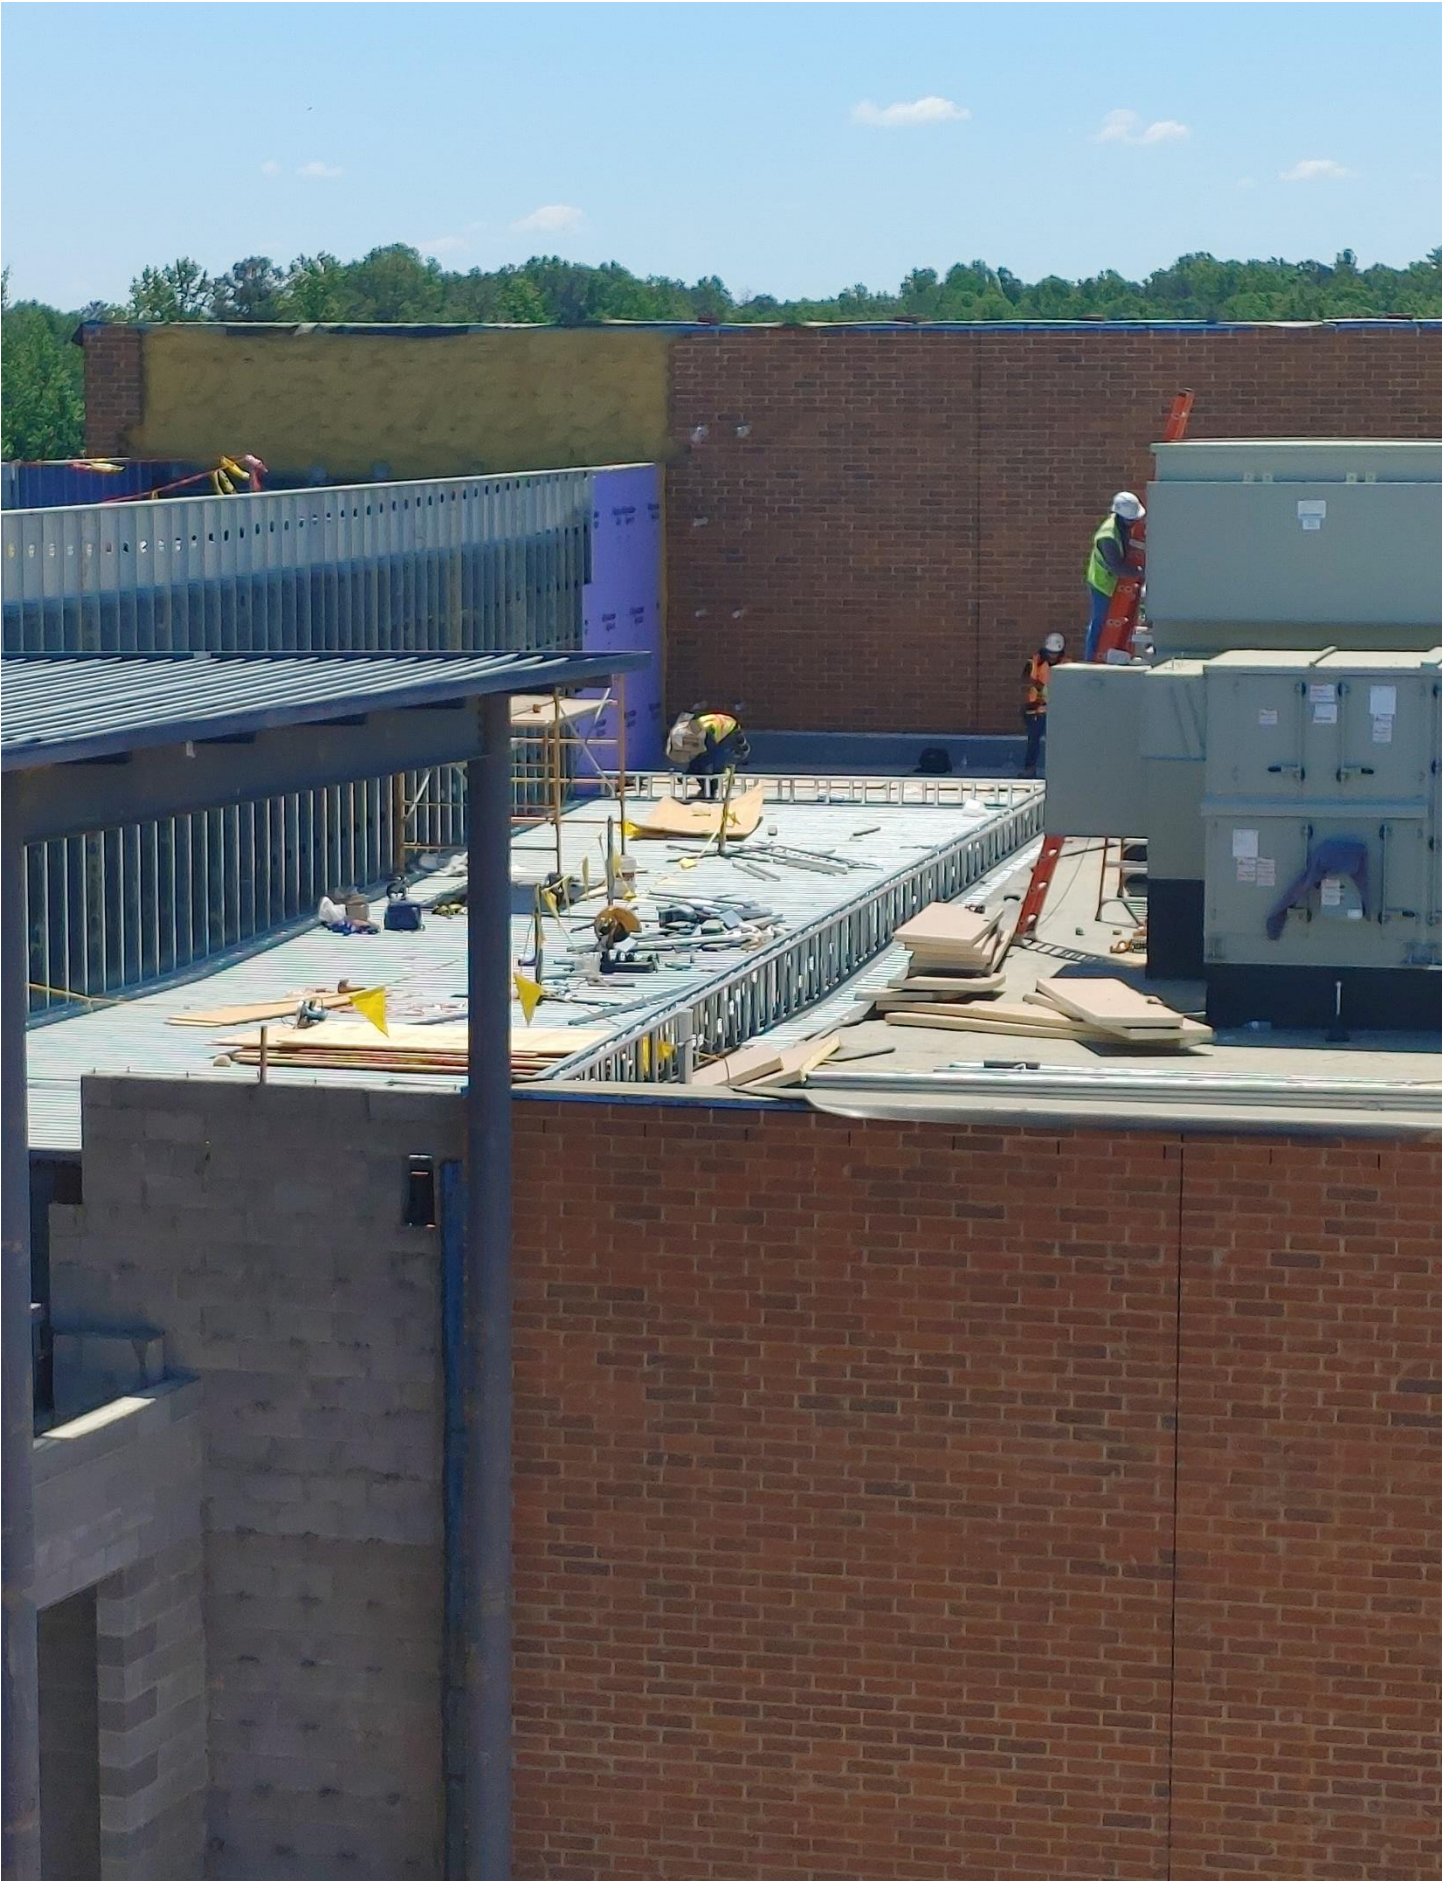
Photo 7 - Parapet walls being constructed on the roof of Area E

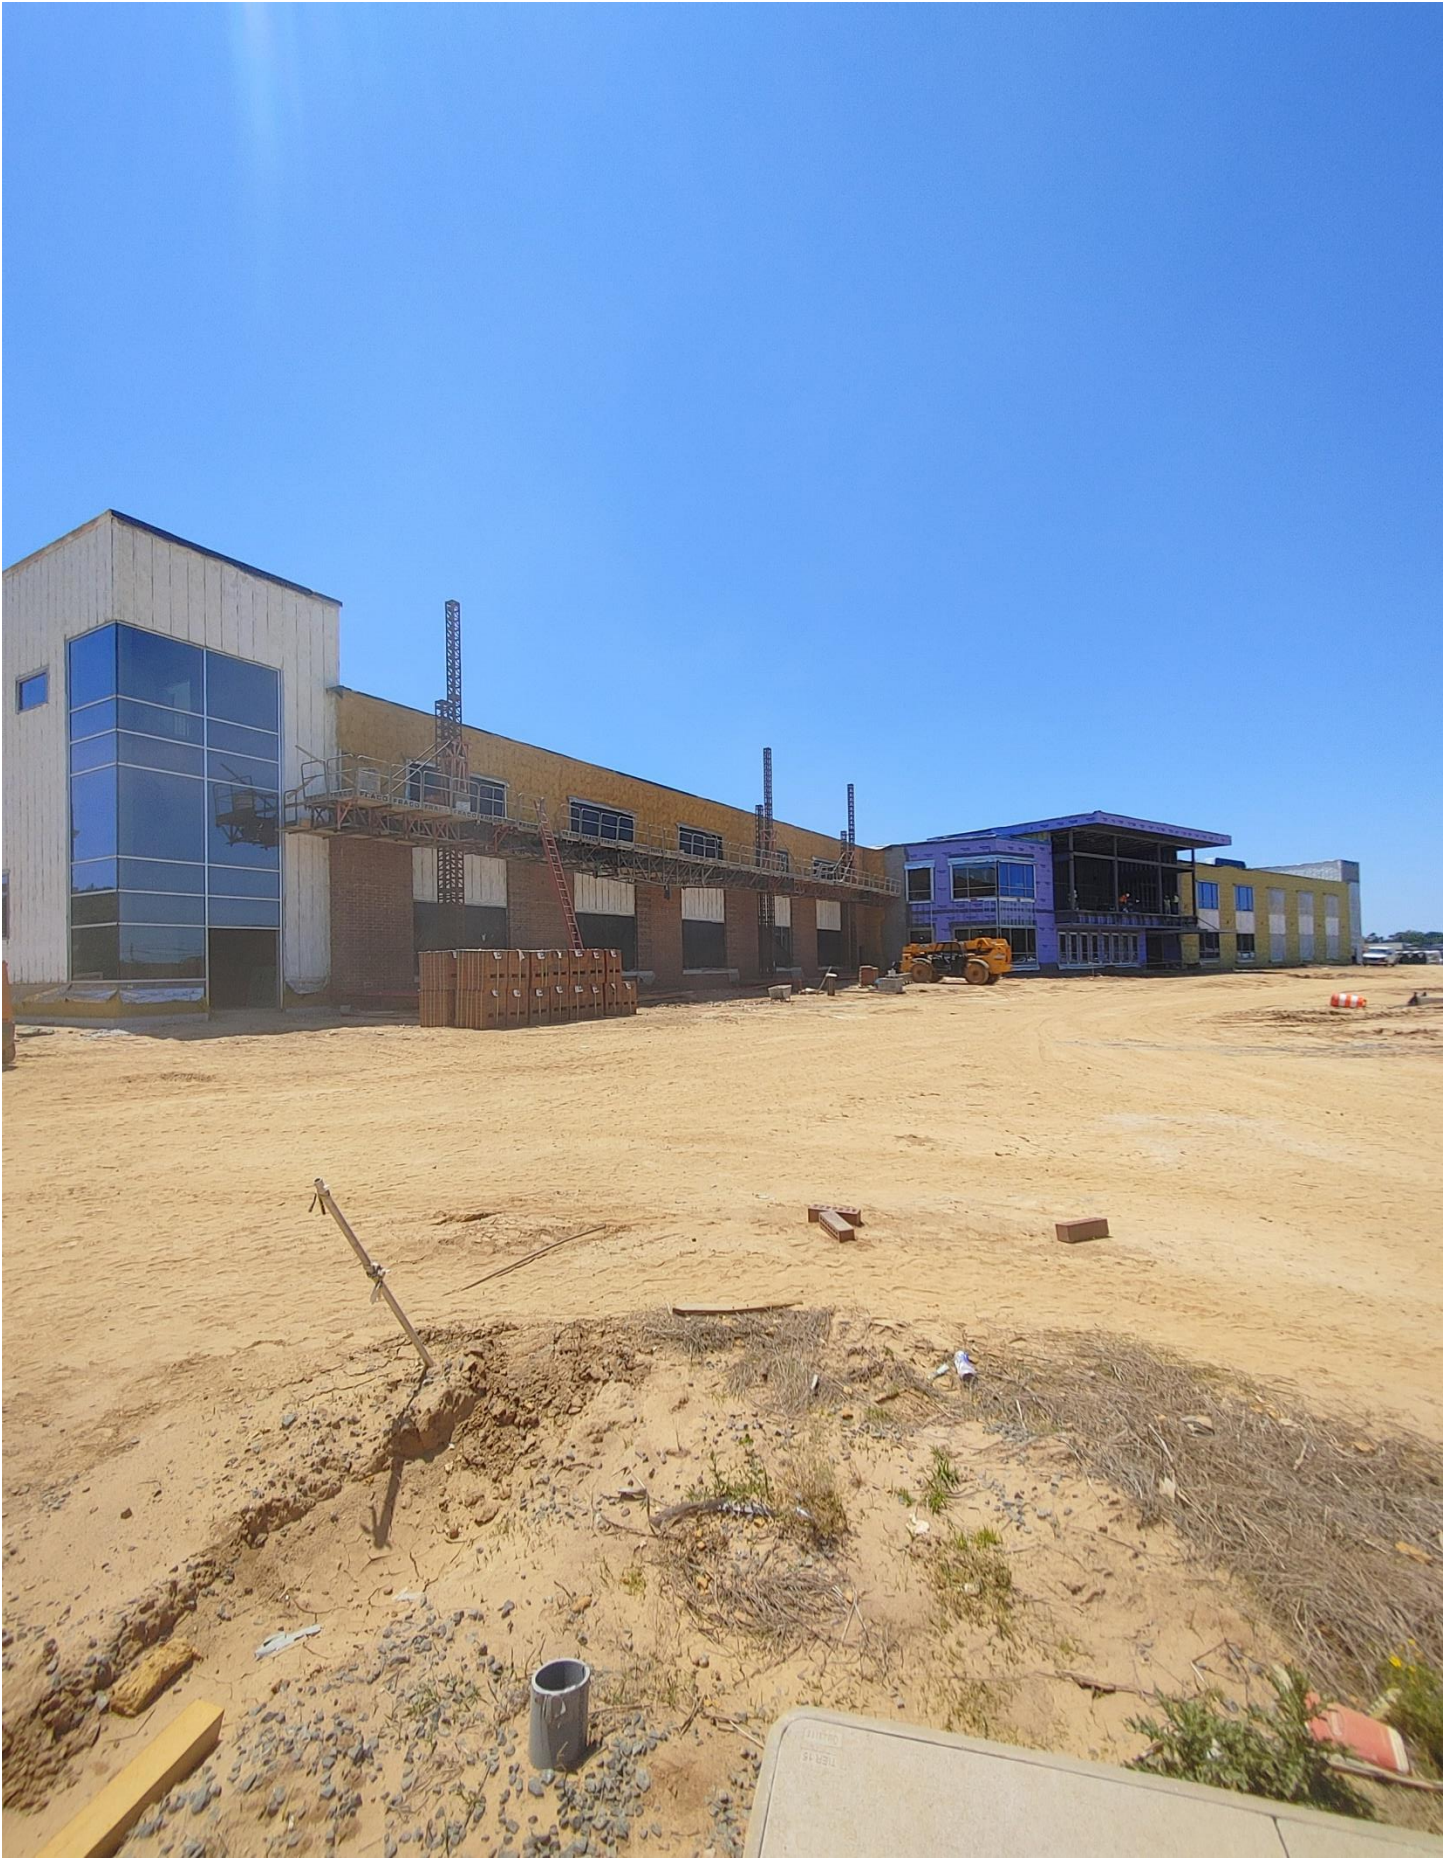
Photo 8 - Front elevation coming along
