**COMMONWEALTH
BUILDING SOLUTIONS, LLC**

DAILY REPORT

WESTMORELAND COUNTY HIGH SCHOOL

Date: 05/20/2021

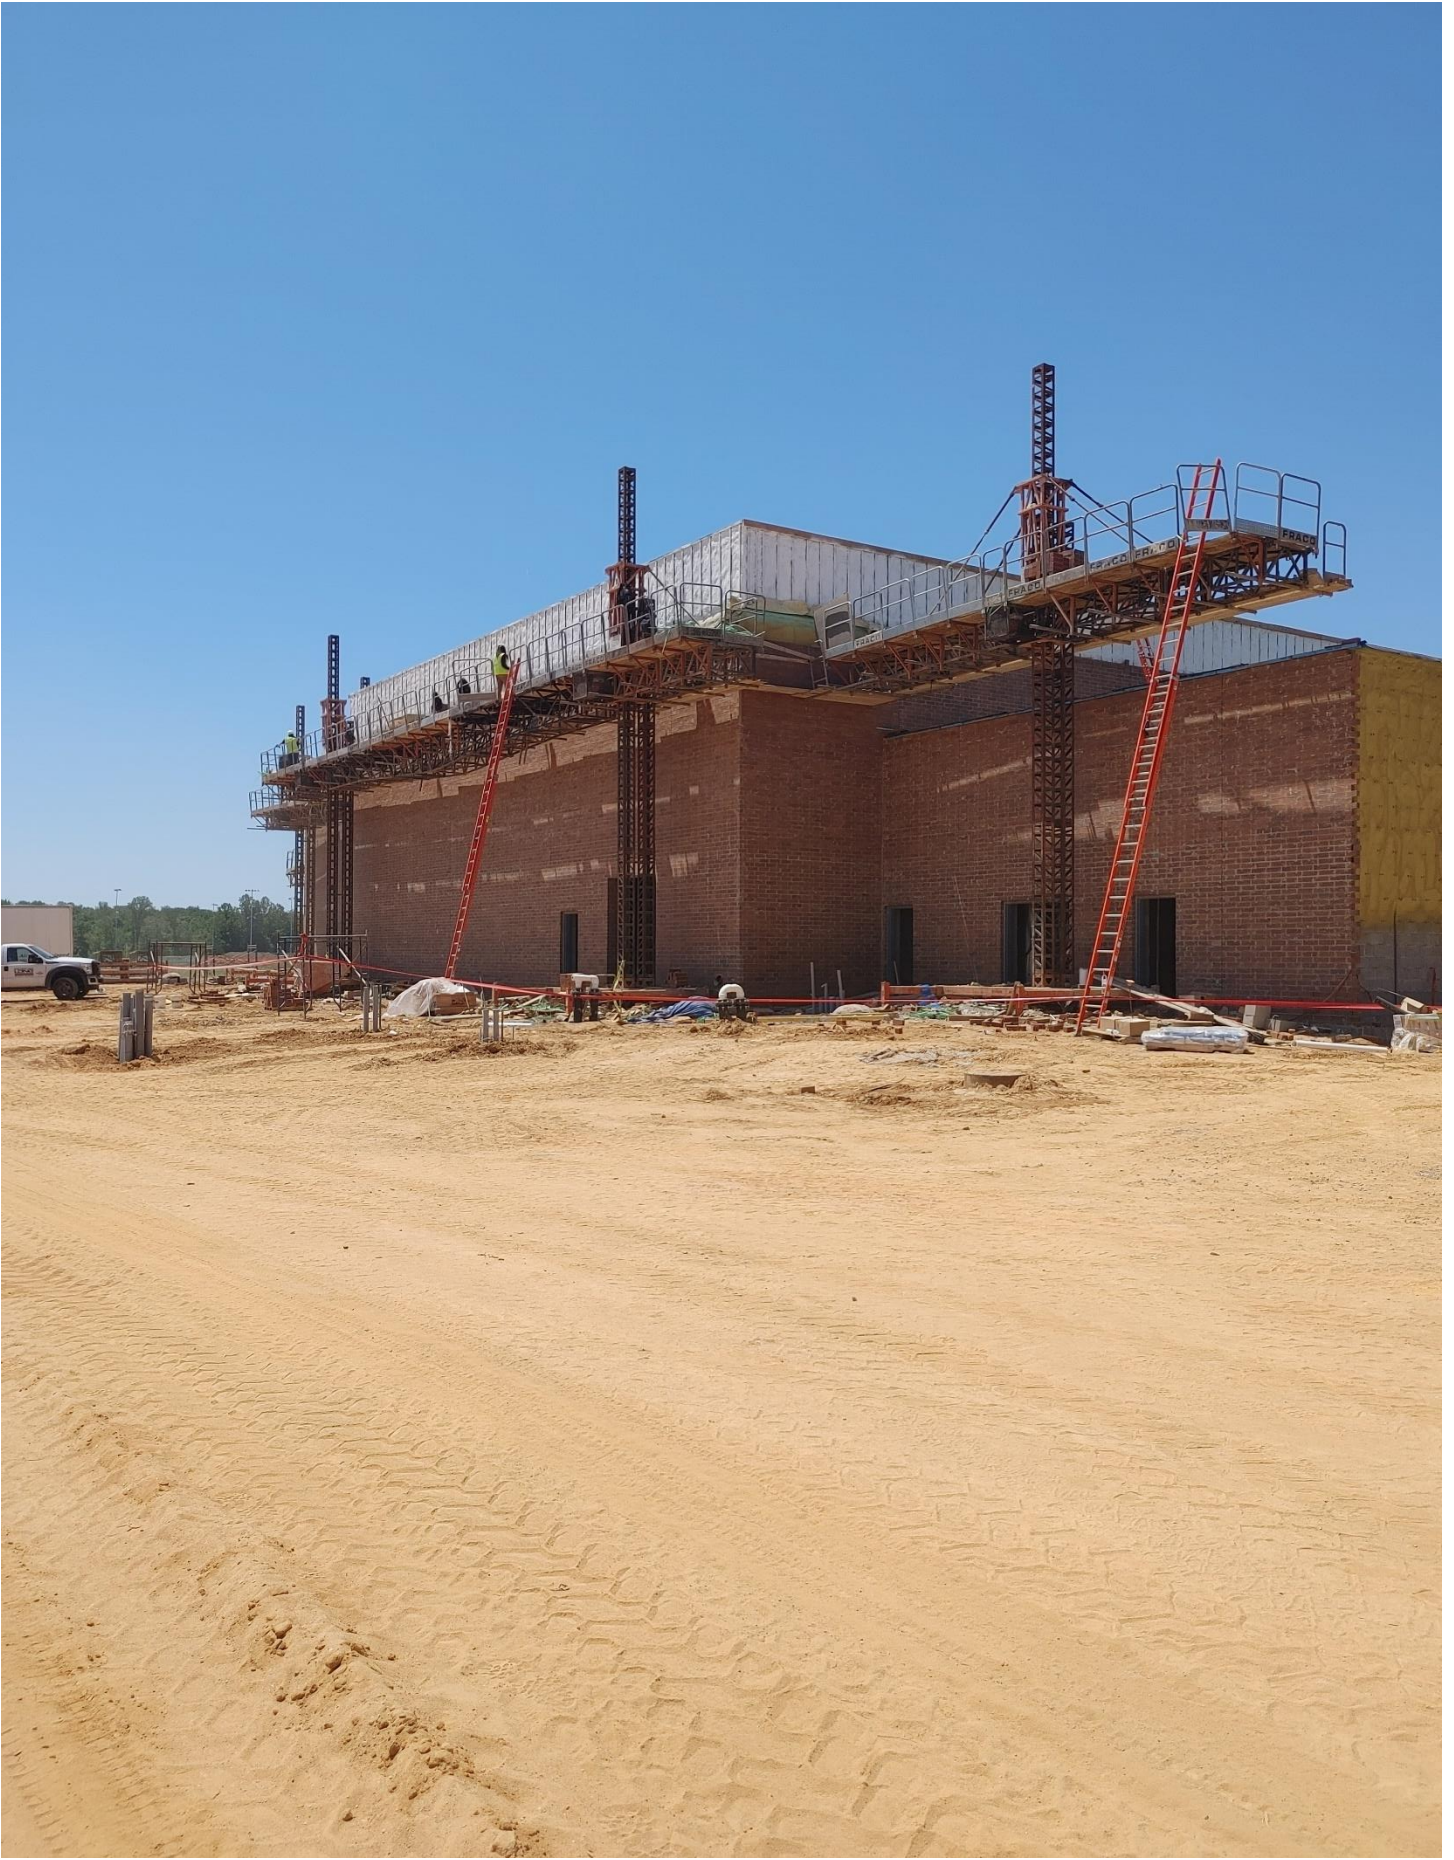
Photo 1 - Brick continues to be laid on the East side of Area D

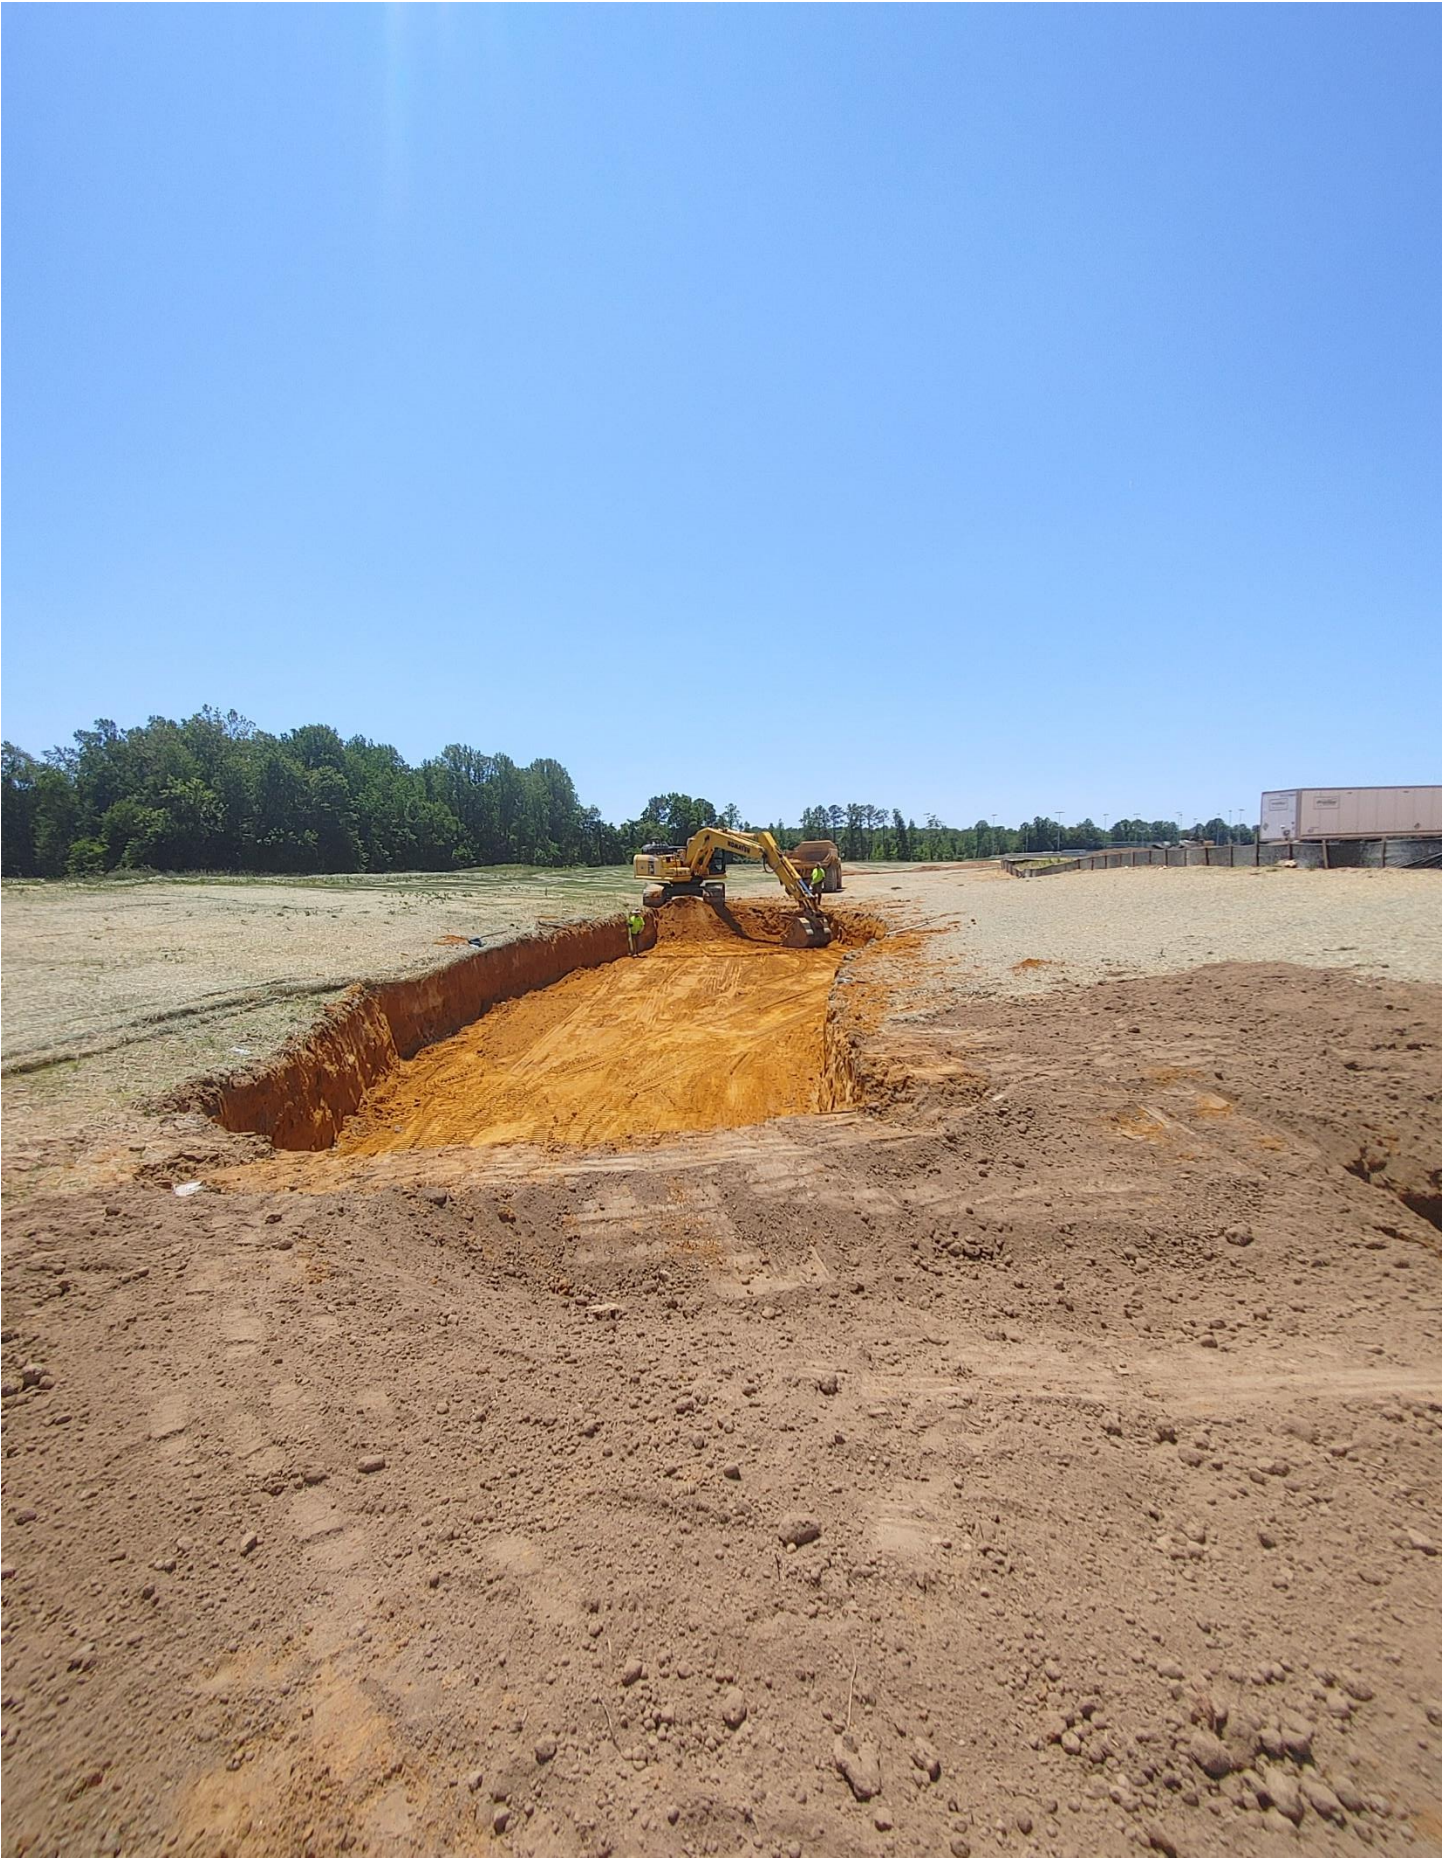
Photo 2 - Beuchert continues to remove soils on the East side of the site to be mixed for use in the BMPs.

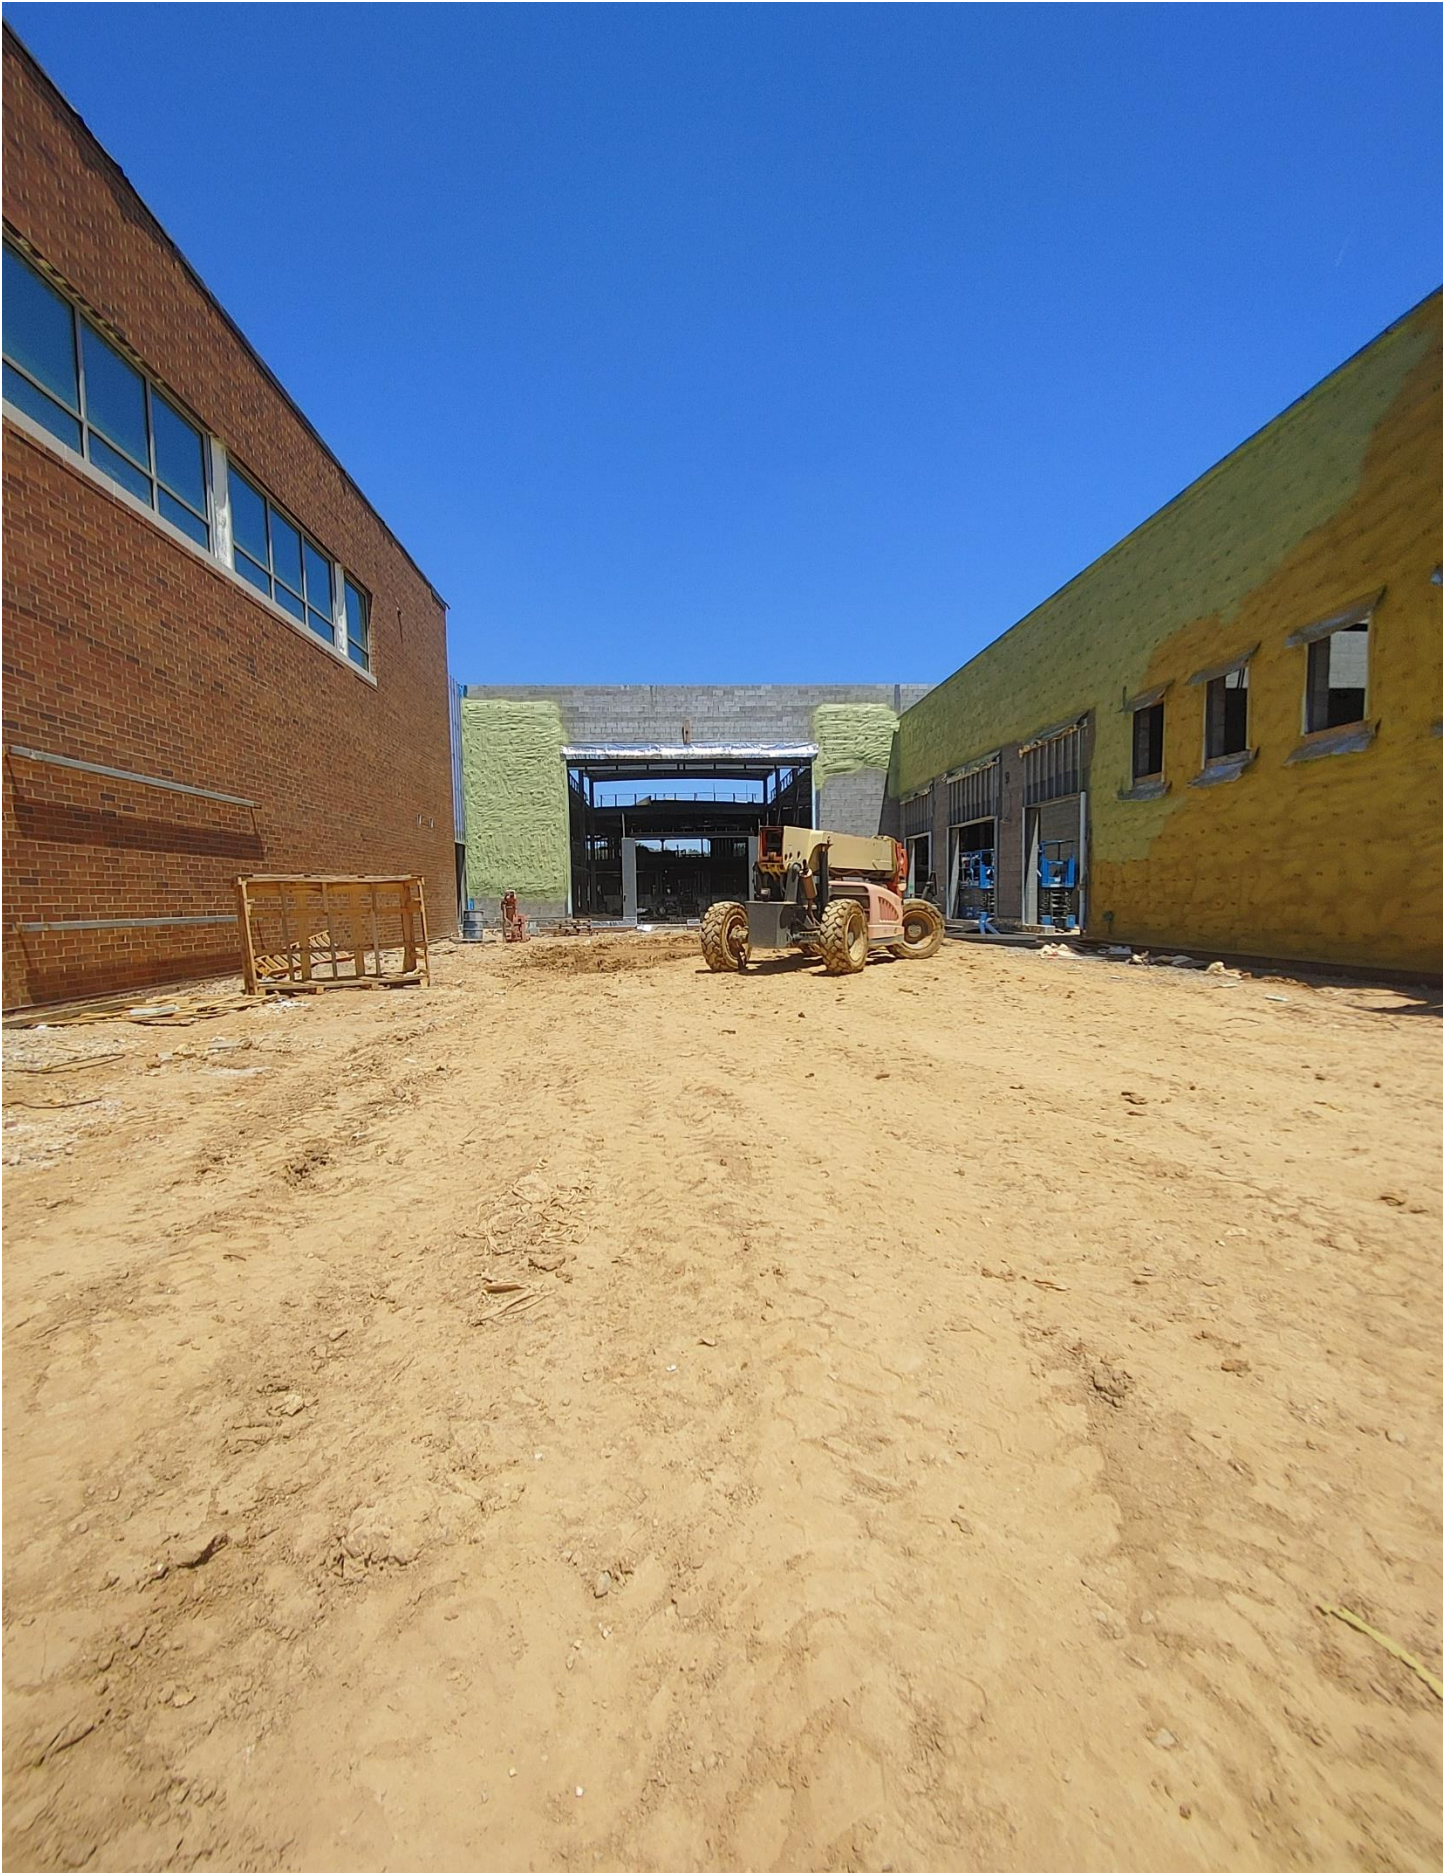
Photo 3 - The South side of Area C has begun to receive foam.

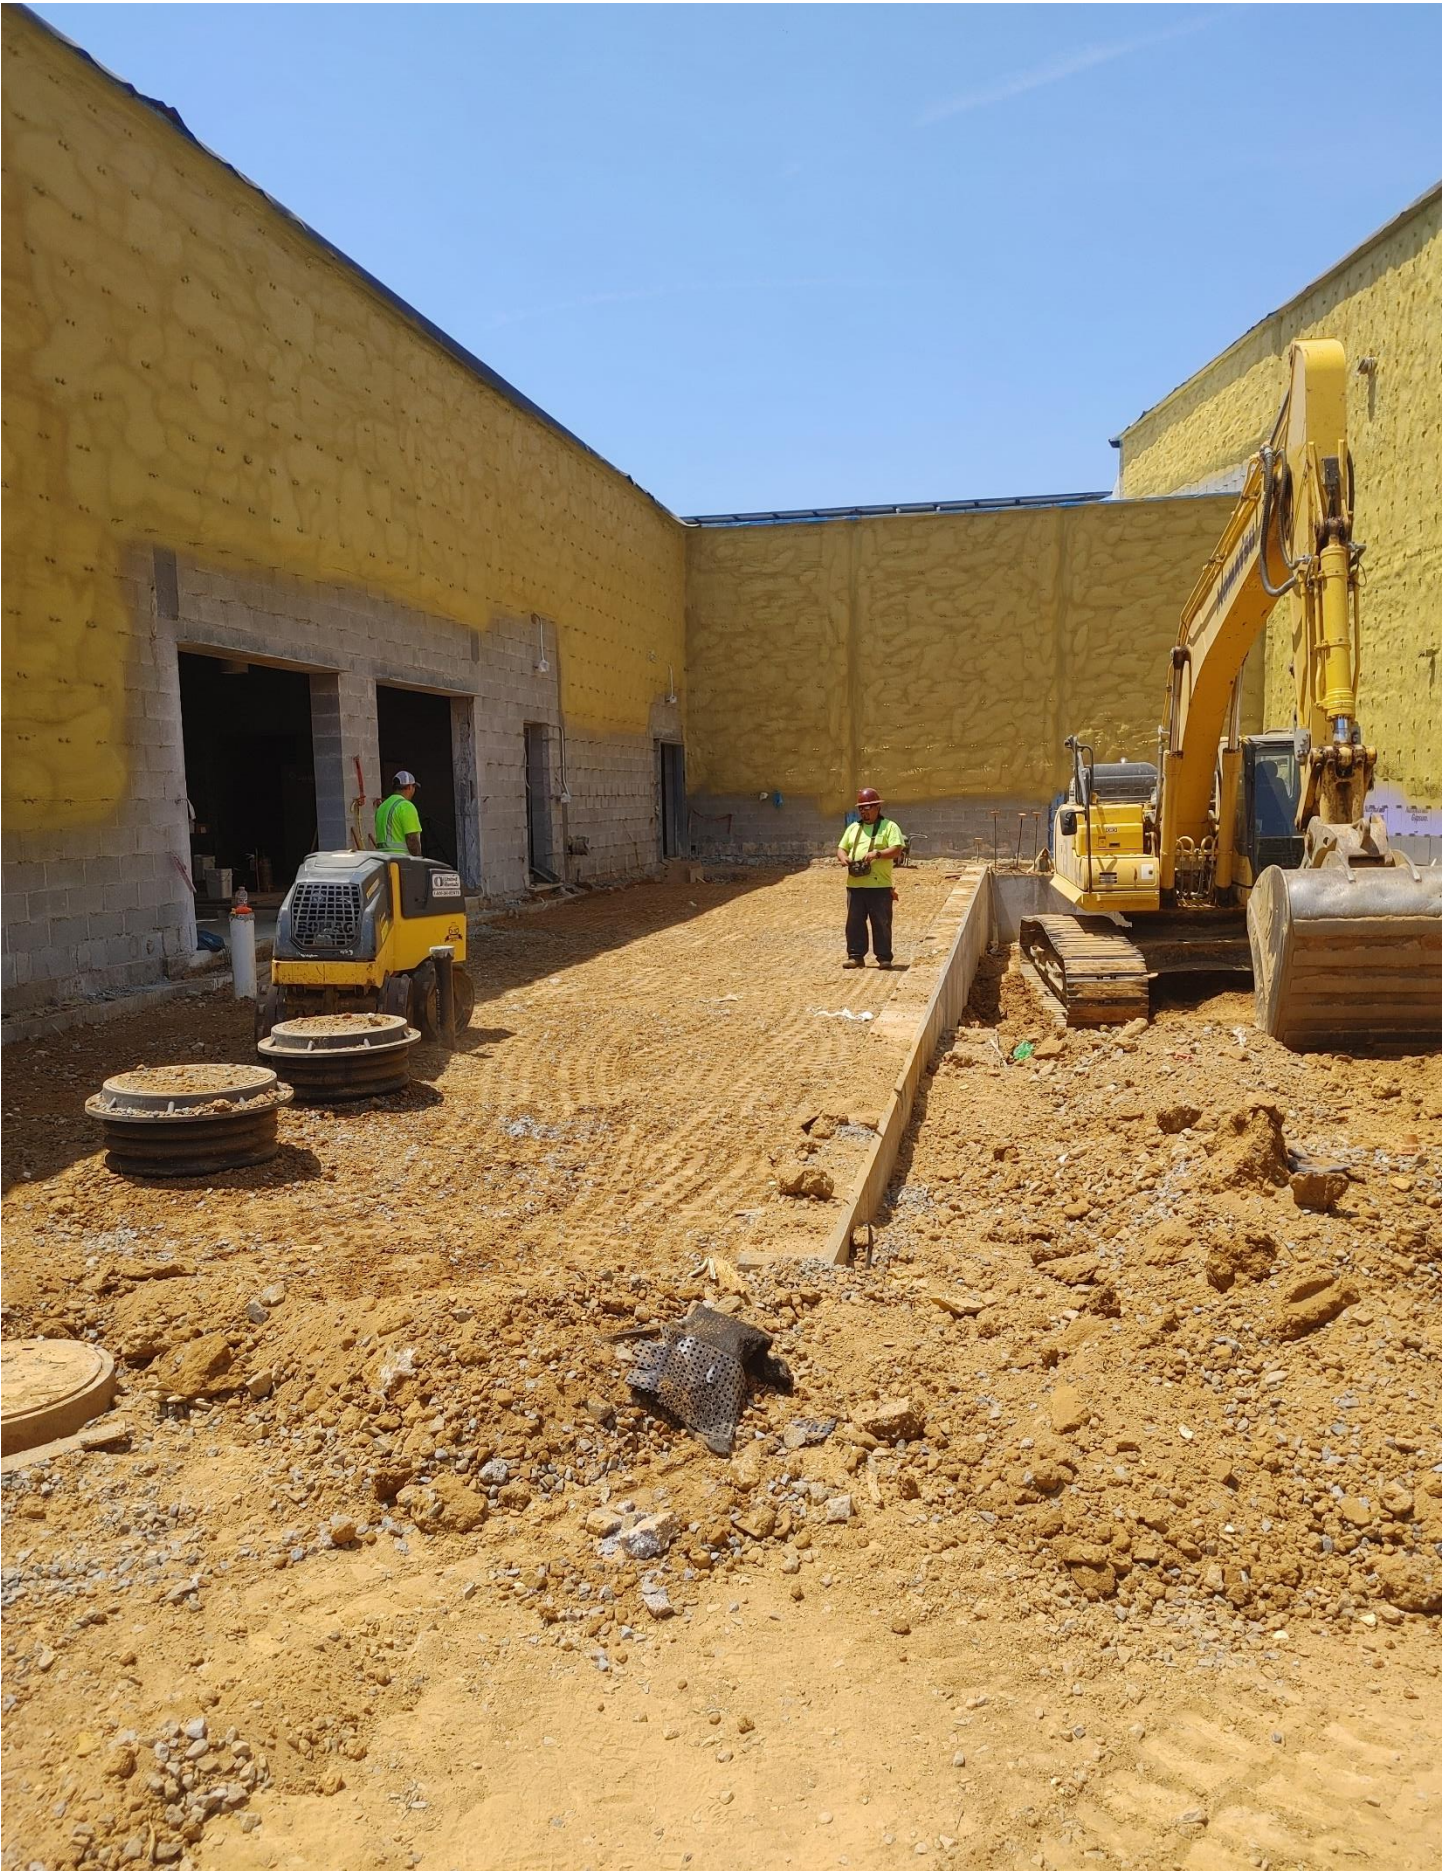
Photo 4 - Beuchert is compacting soils in the Loading Dock Area.

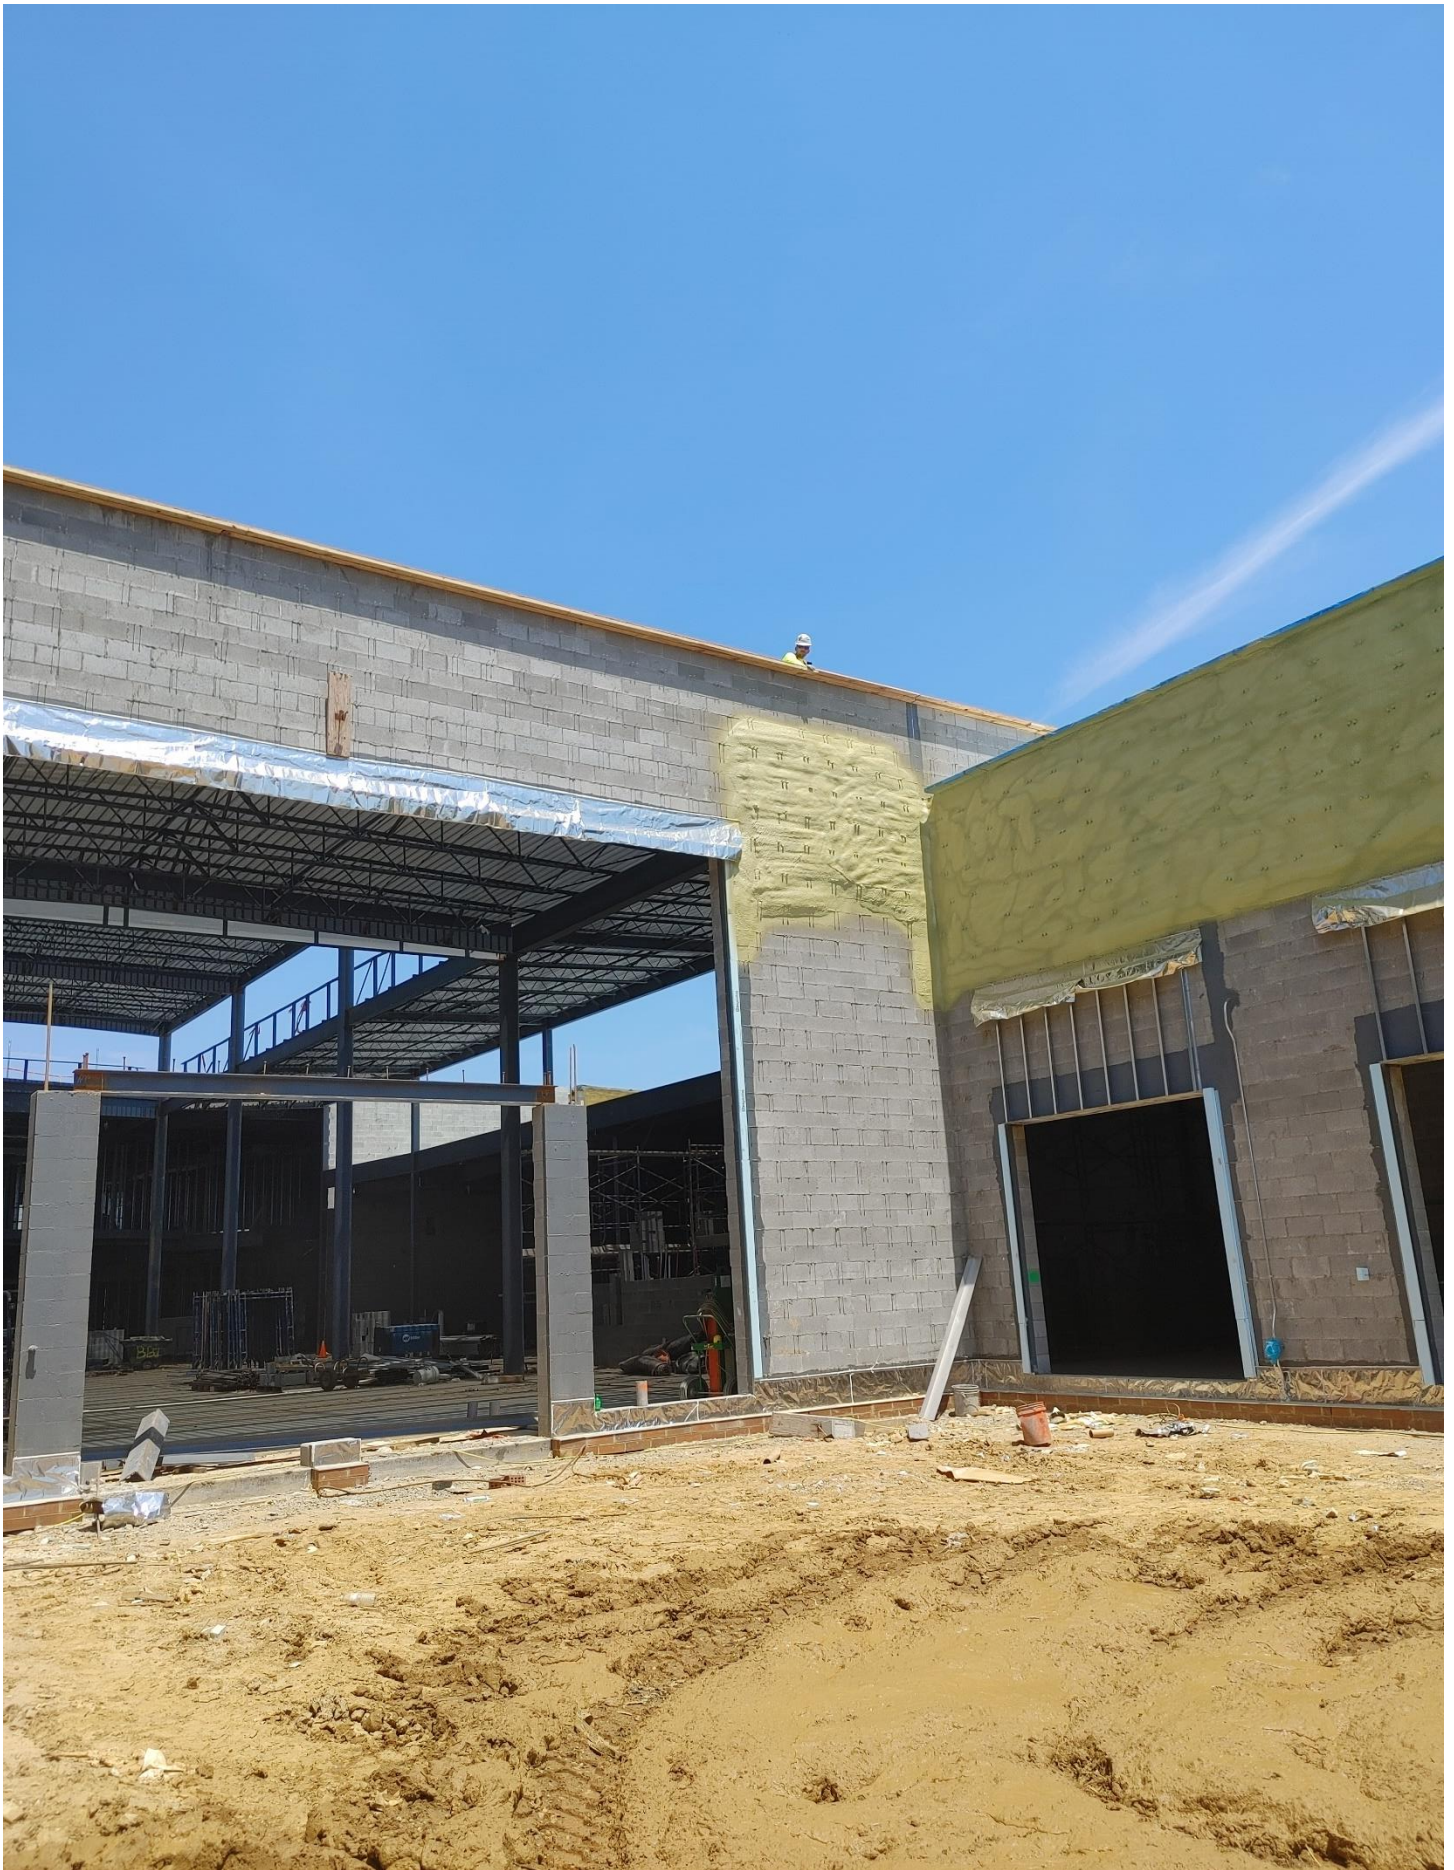
Photo 5 - the Cap of the Parapet wall is being constructed.

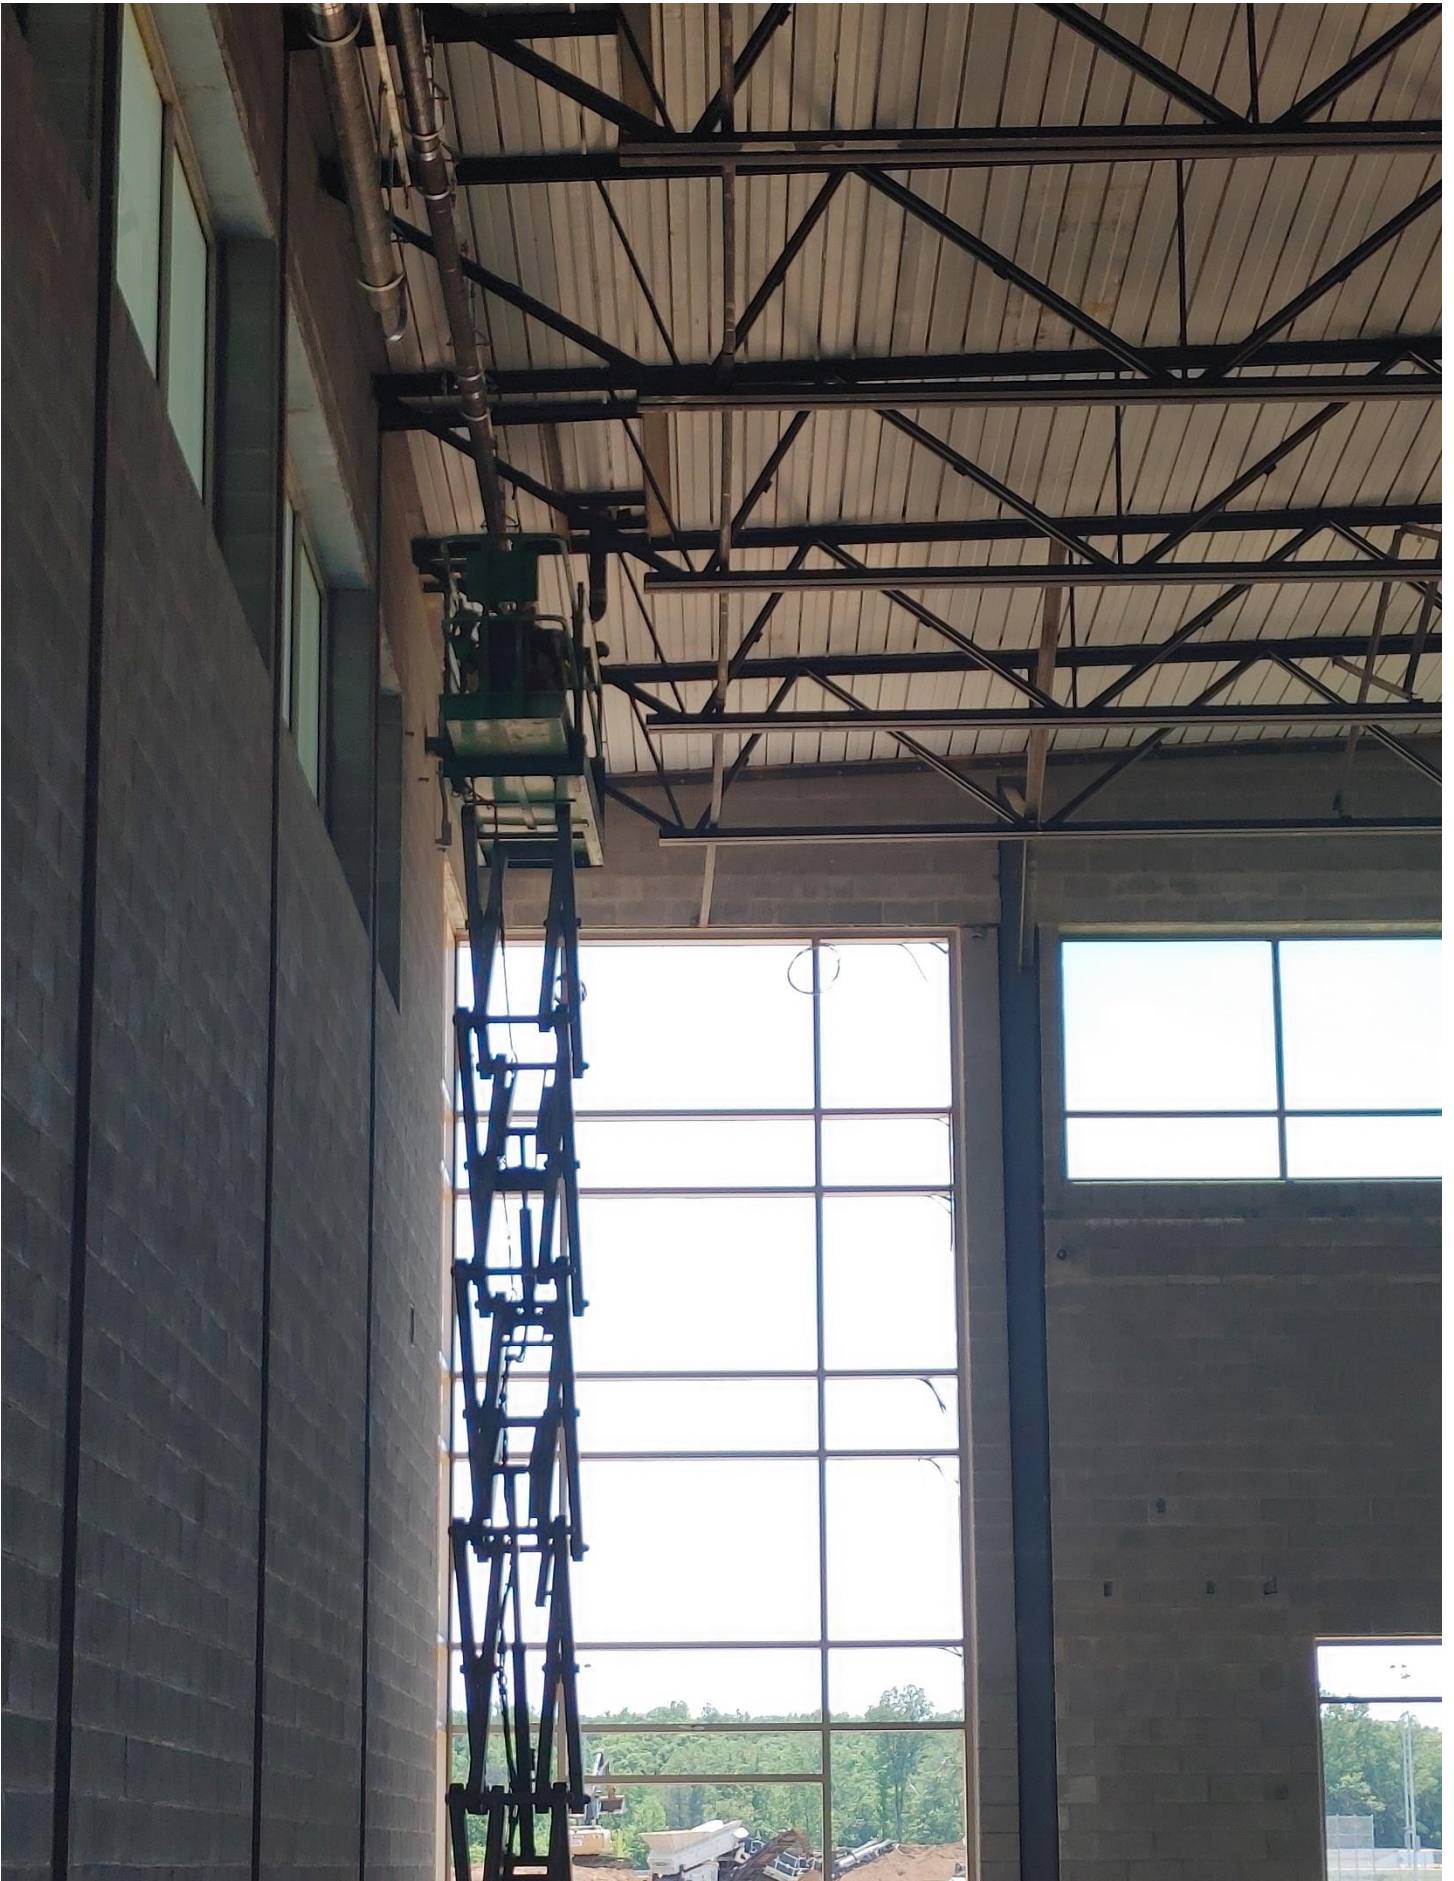
Photo 6 - Roof Drains are being installed in the Gym.

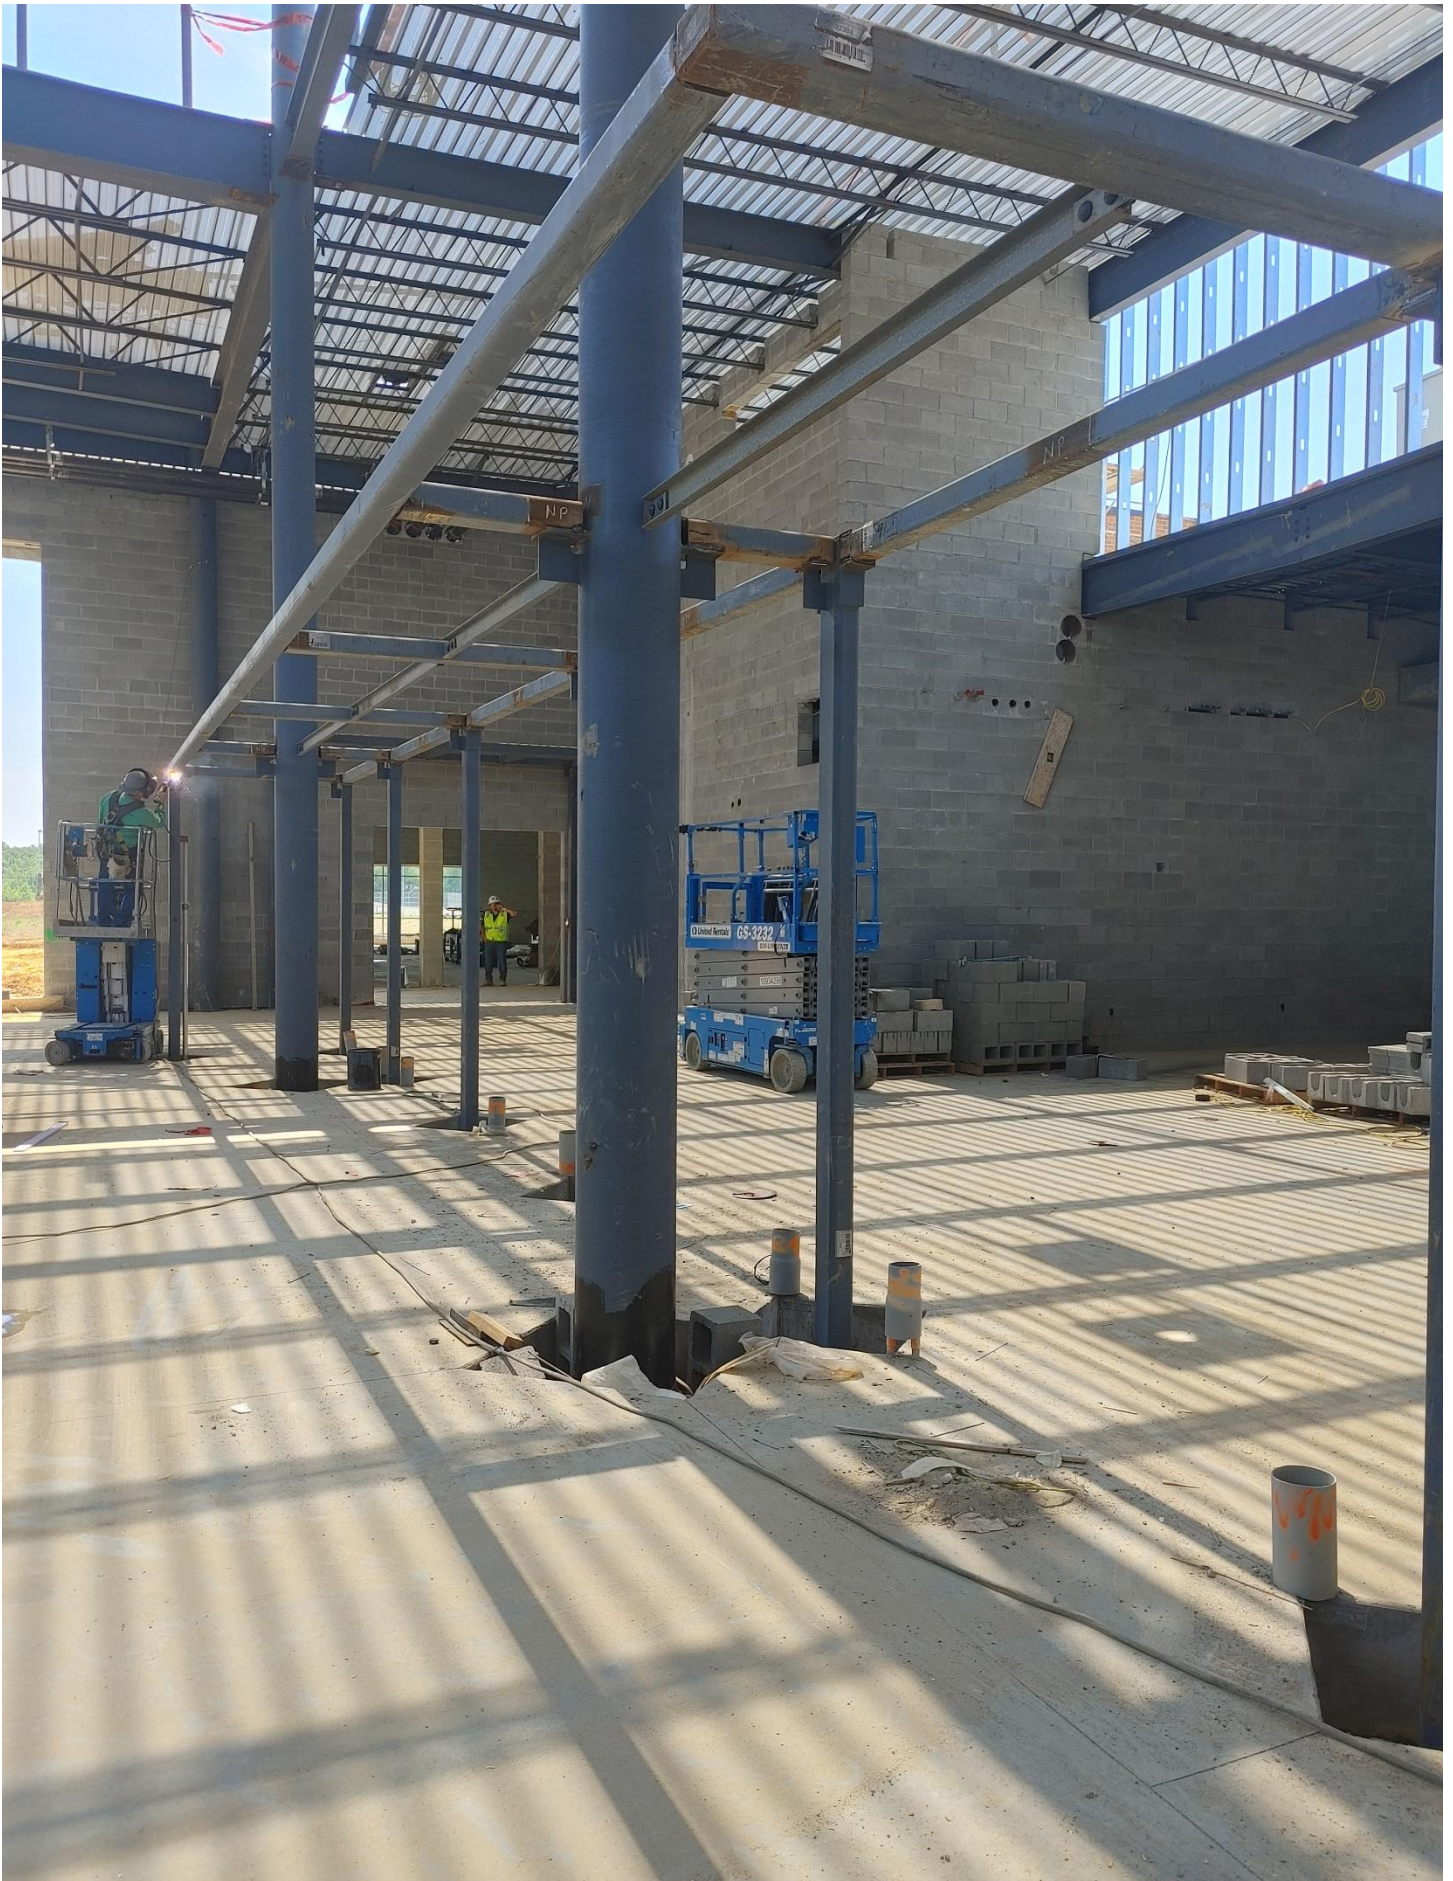
Photo 7 - Steel being welded in Area C.

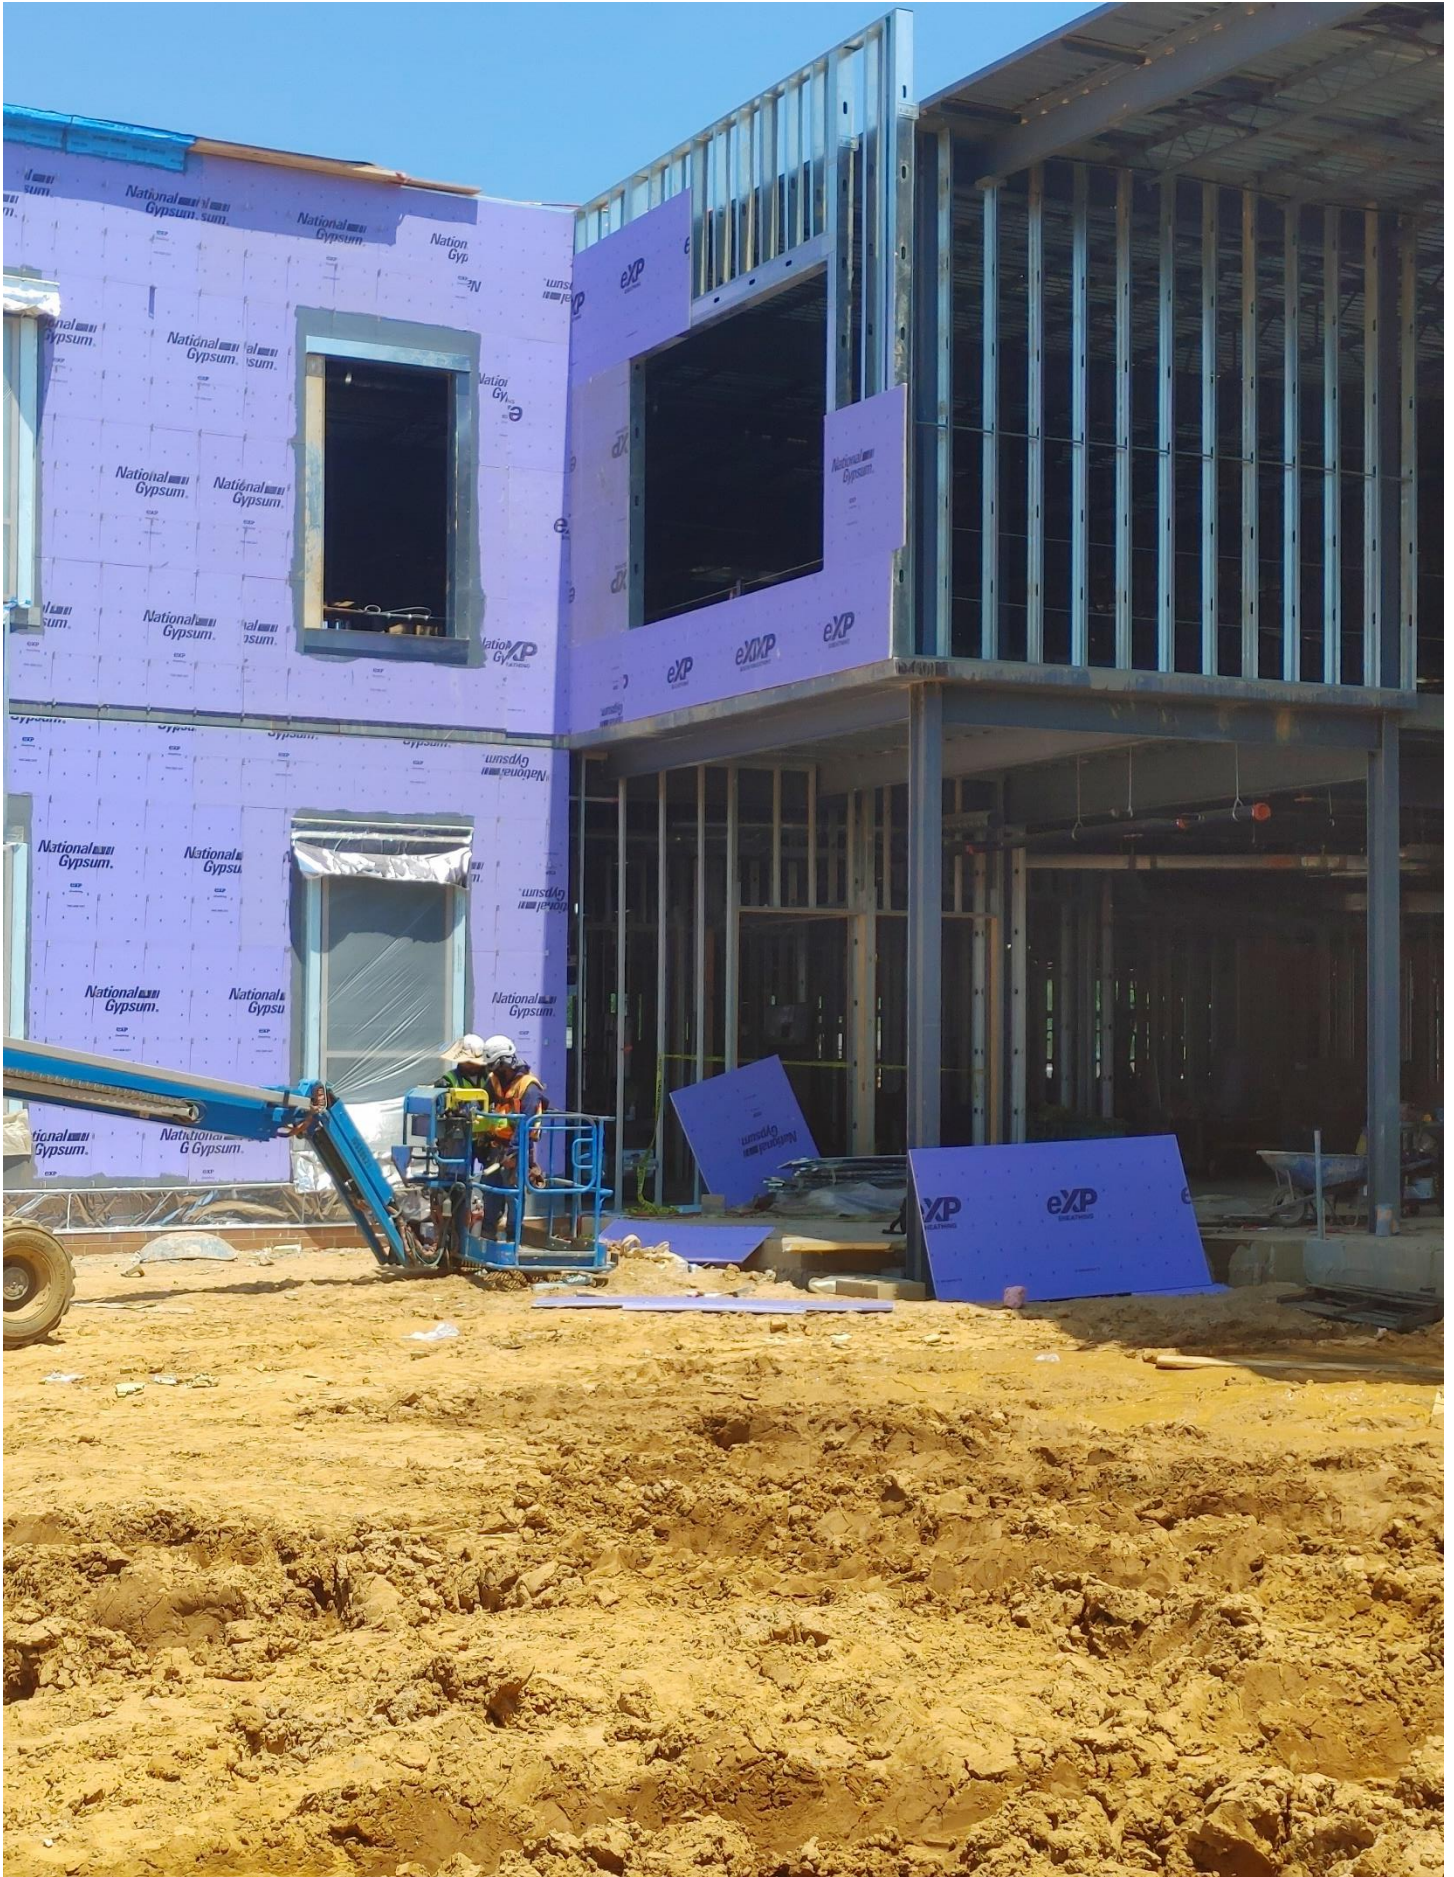
Photo 8 - Gyp Board being hung on the West side of Area C
