**COMMONWEALTH
BUILDING SOLUTIONS, LLC**

DAILY REPORT

WESTMORELAND COUNTY HIGH SCHOOL

Date: 05/20/2021

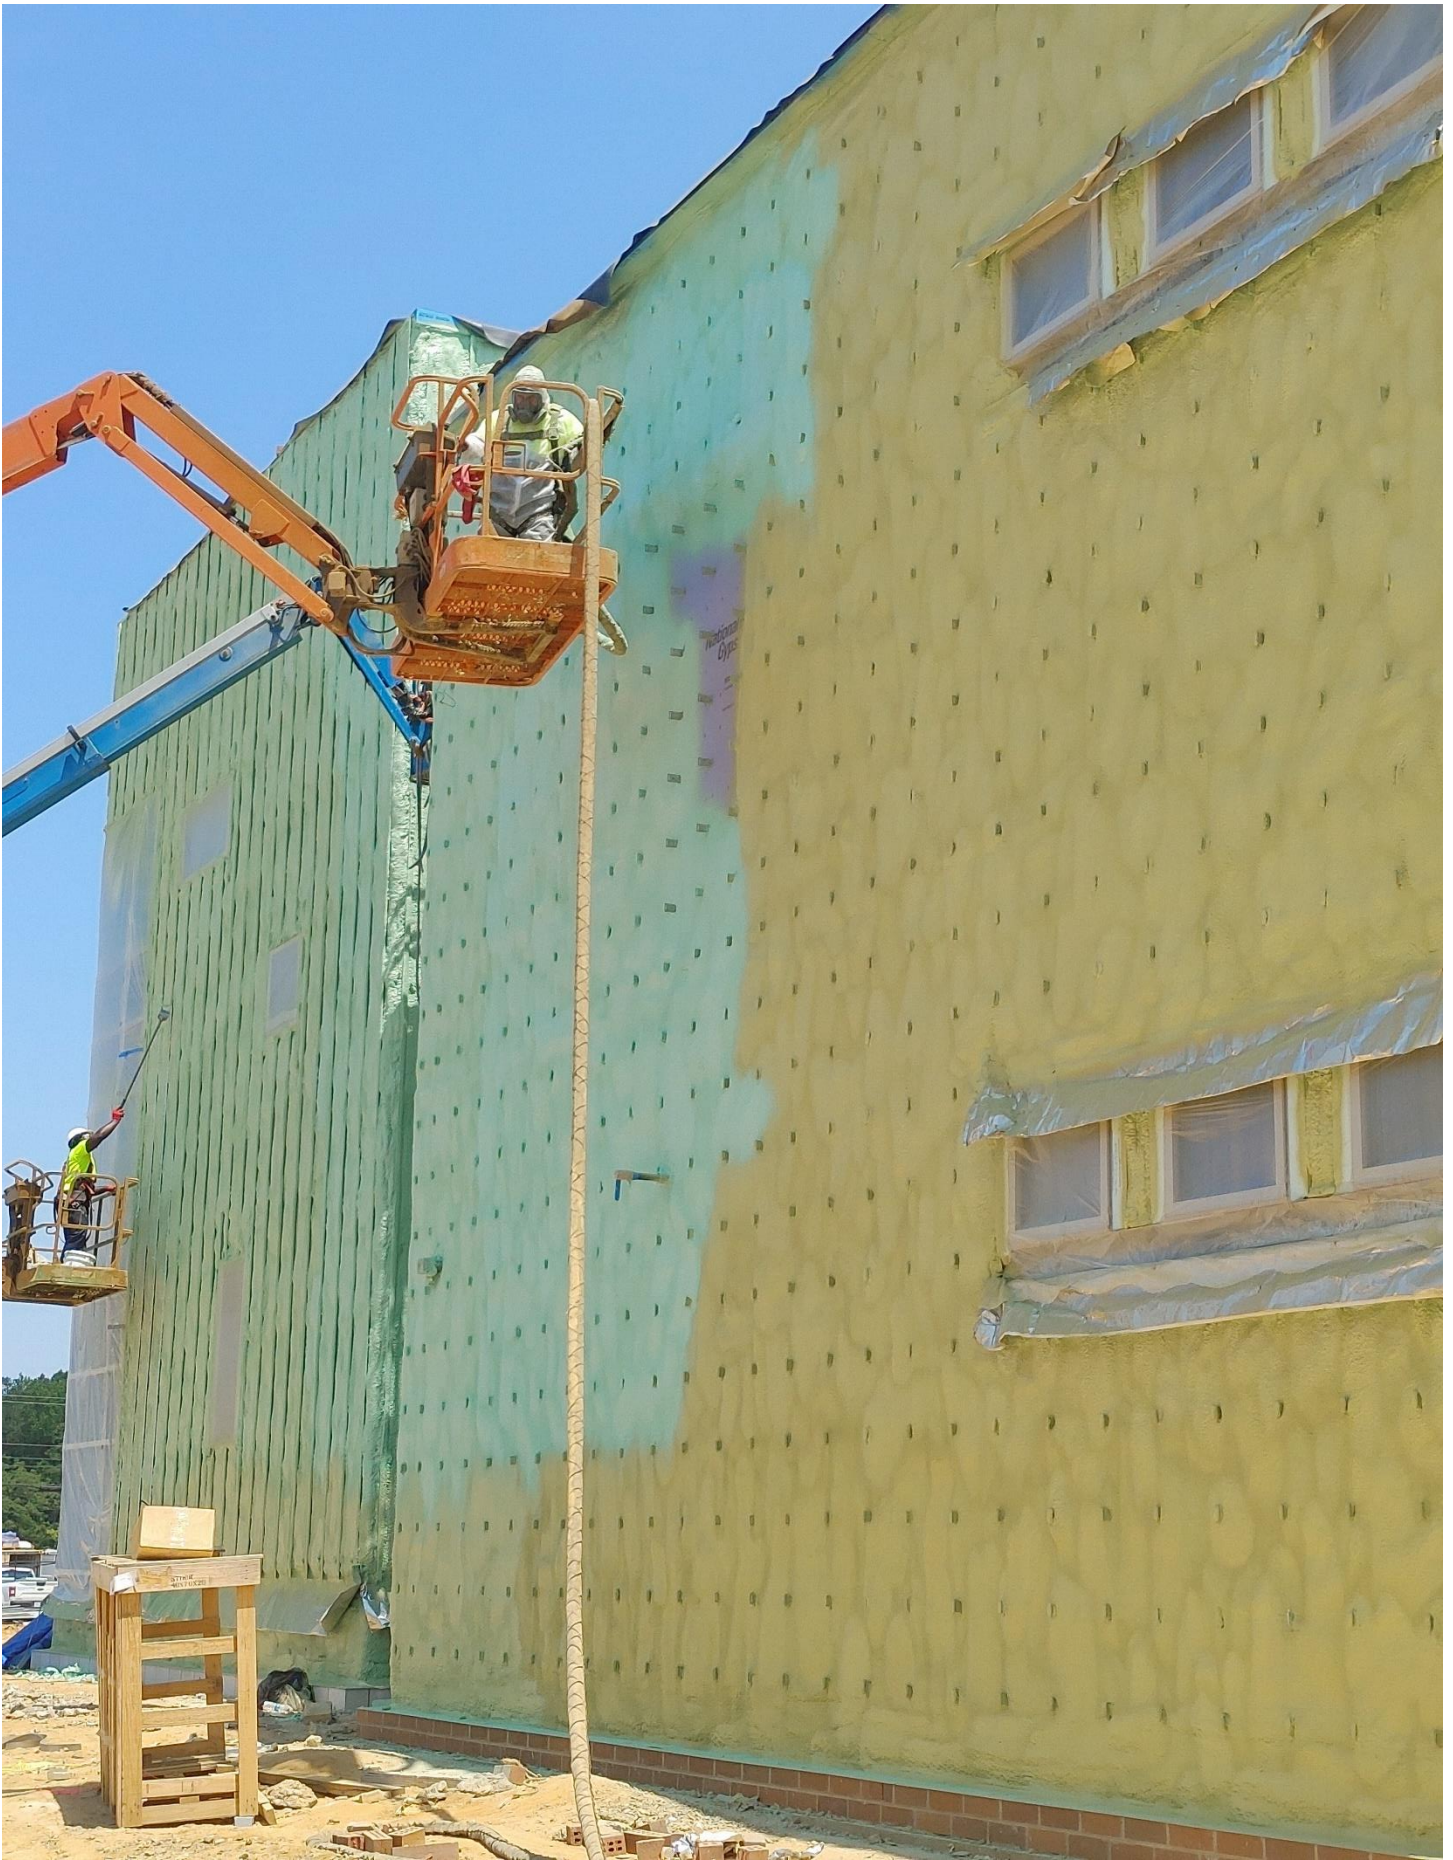
Photo 9 - West side of Area B receiving Spray Foam

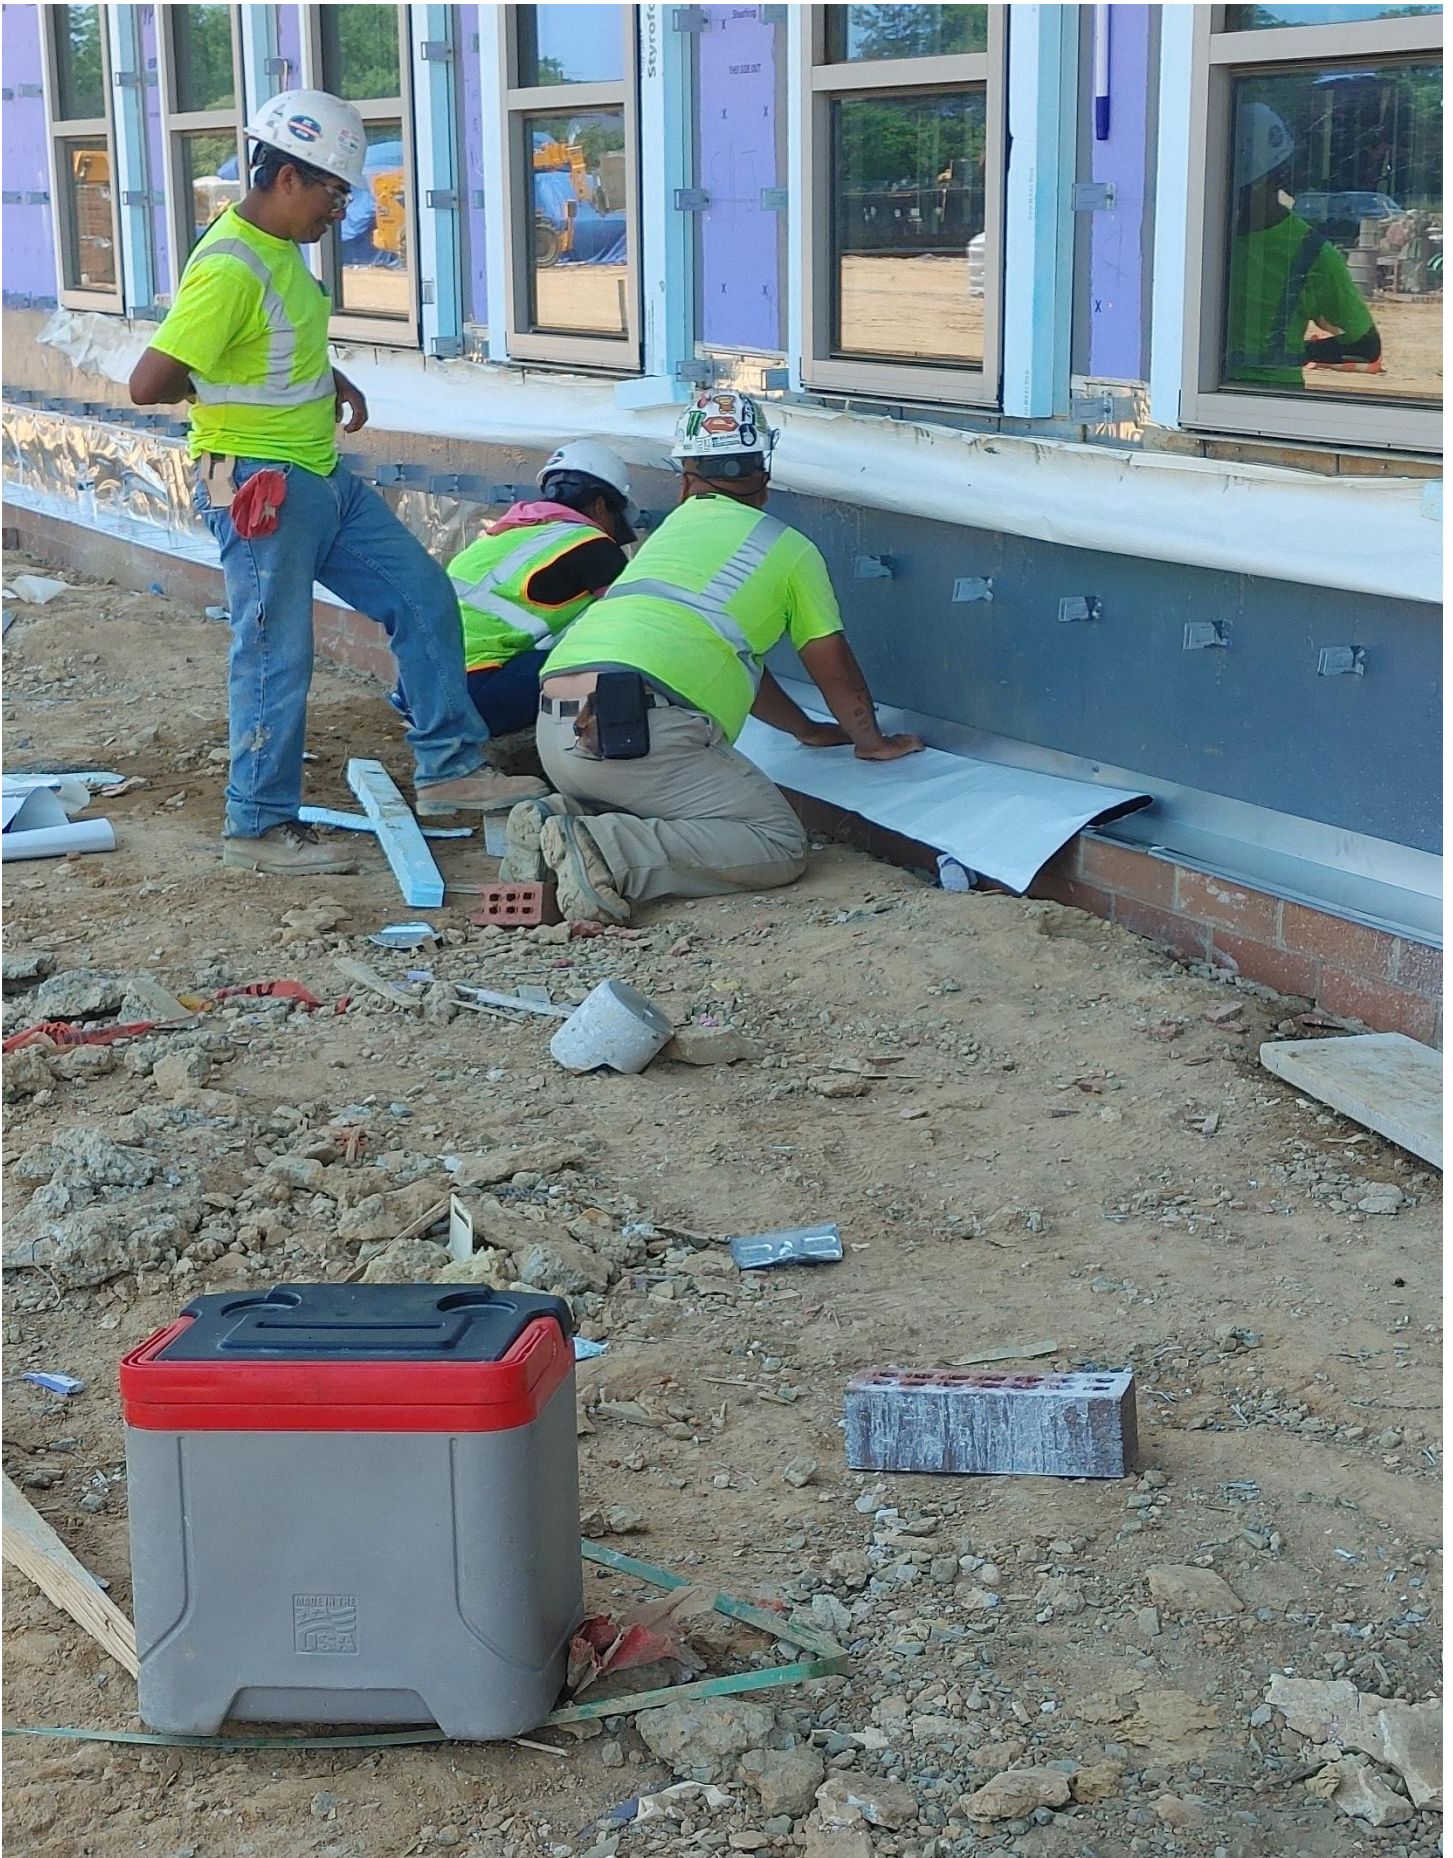
Photo 10 - Brick being flashed on the North side of Area A
