**COMMONWEALTH
BUILDING SOLUTIONS, LLC**

DAILY REPORT

WESTMORELAND COUNTY HIGH SCHOOL

Date: 06/01/2021

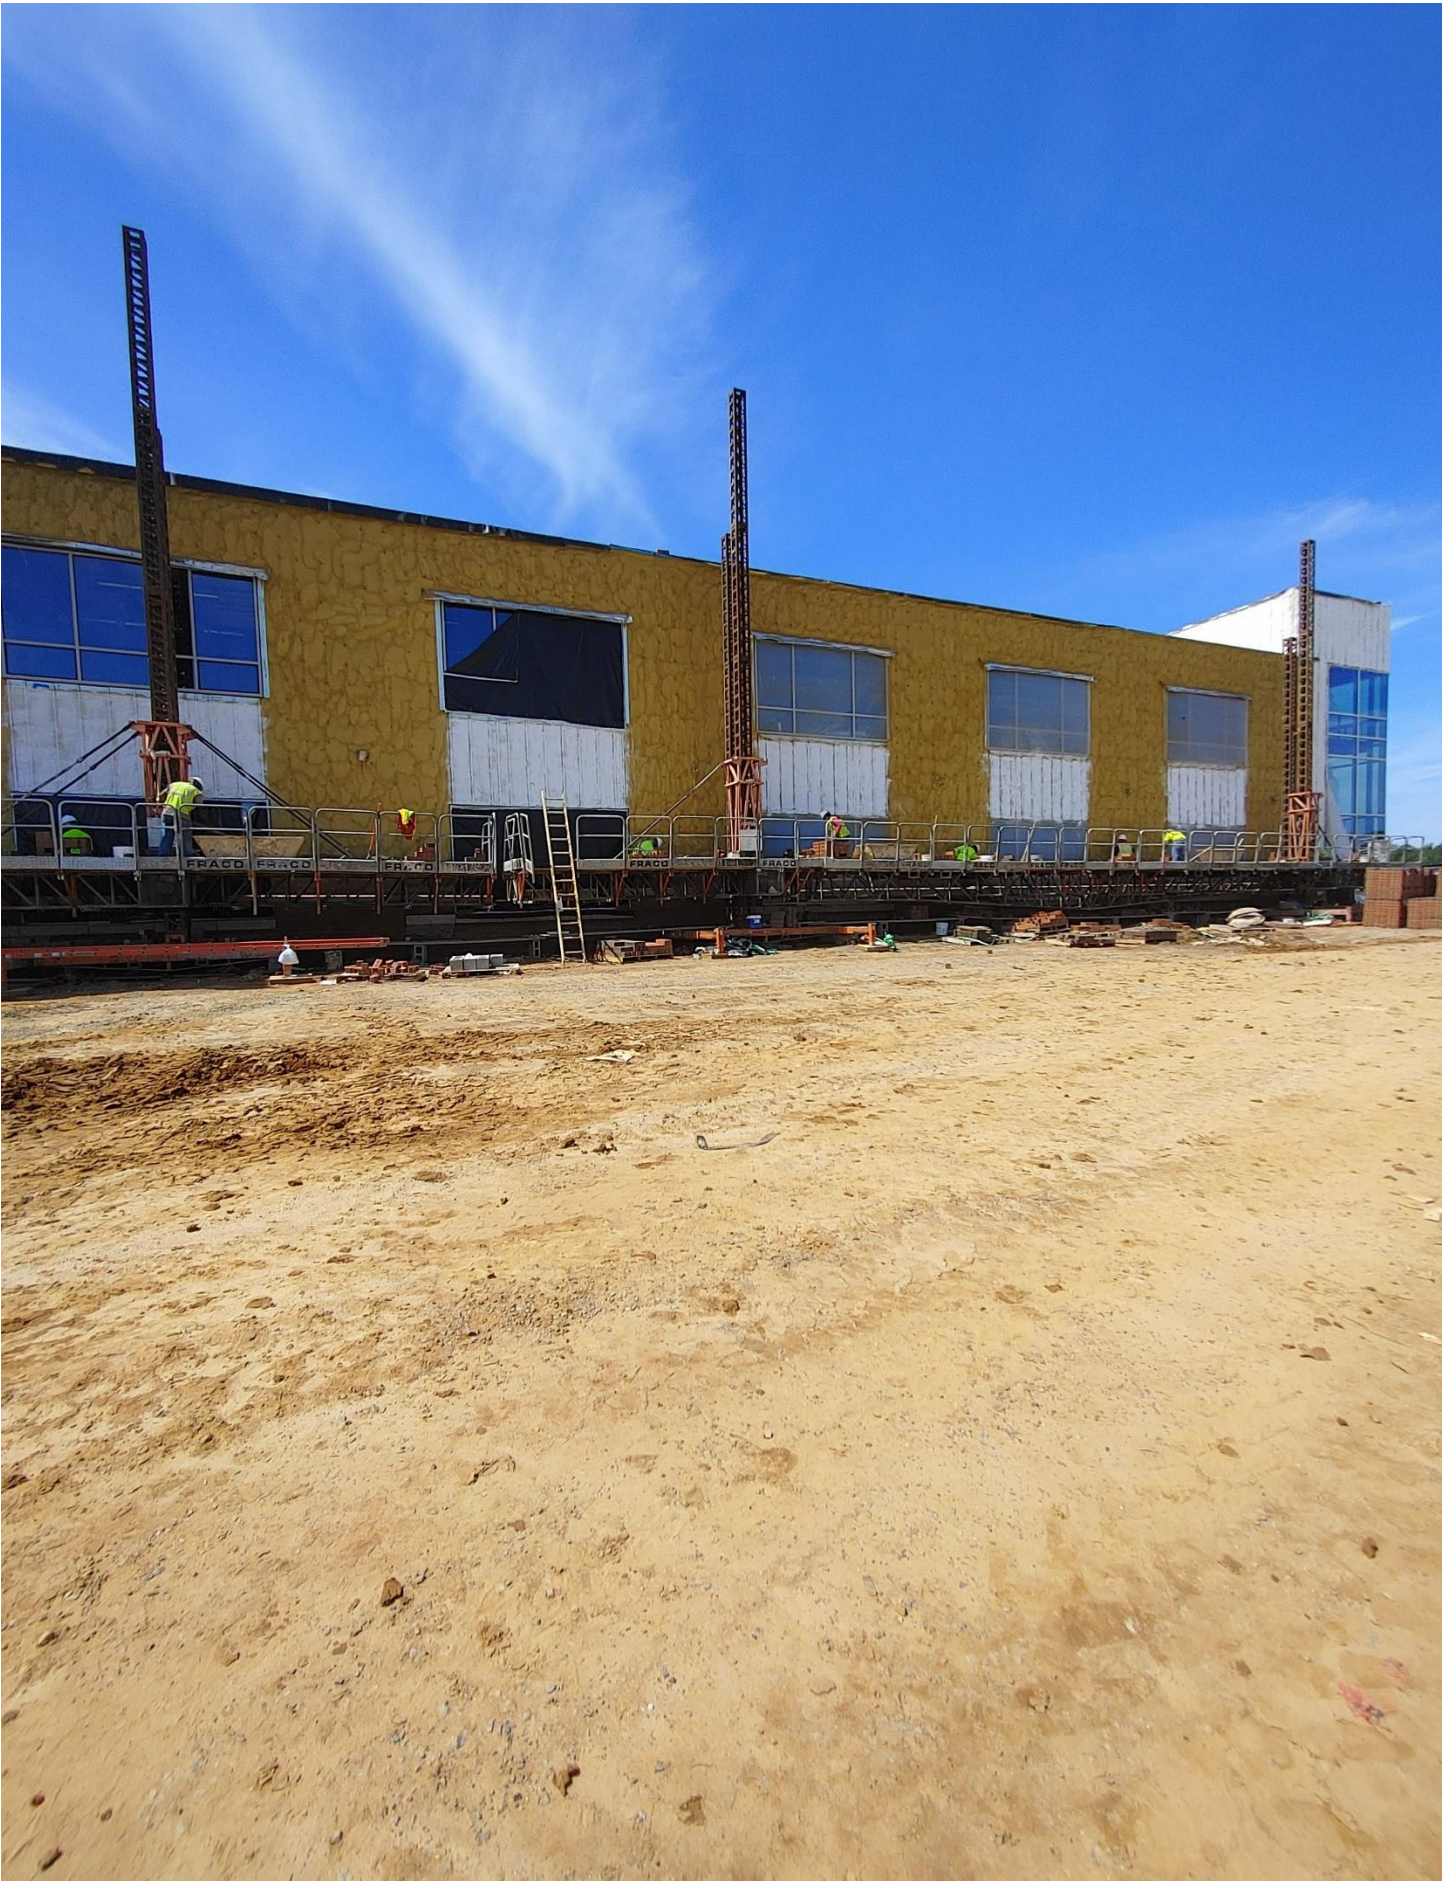
Photo 1 - Brick is being laid on the North side of Area B.

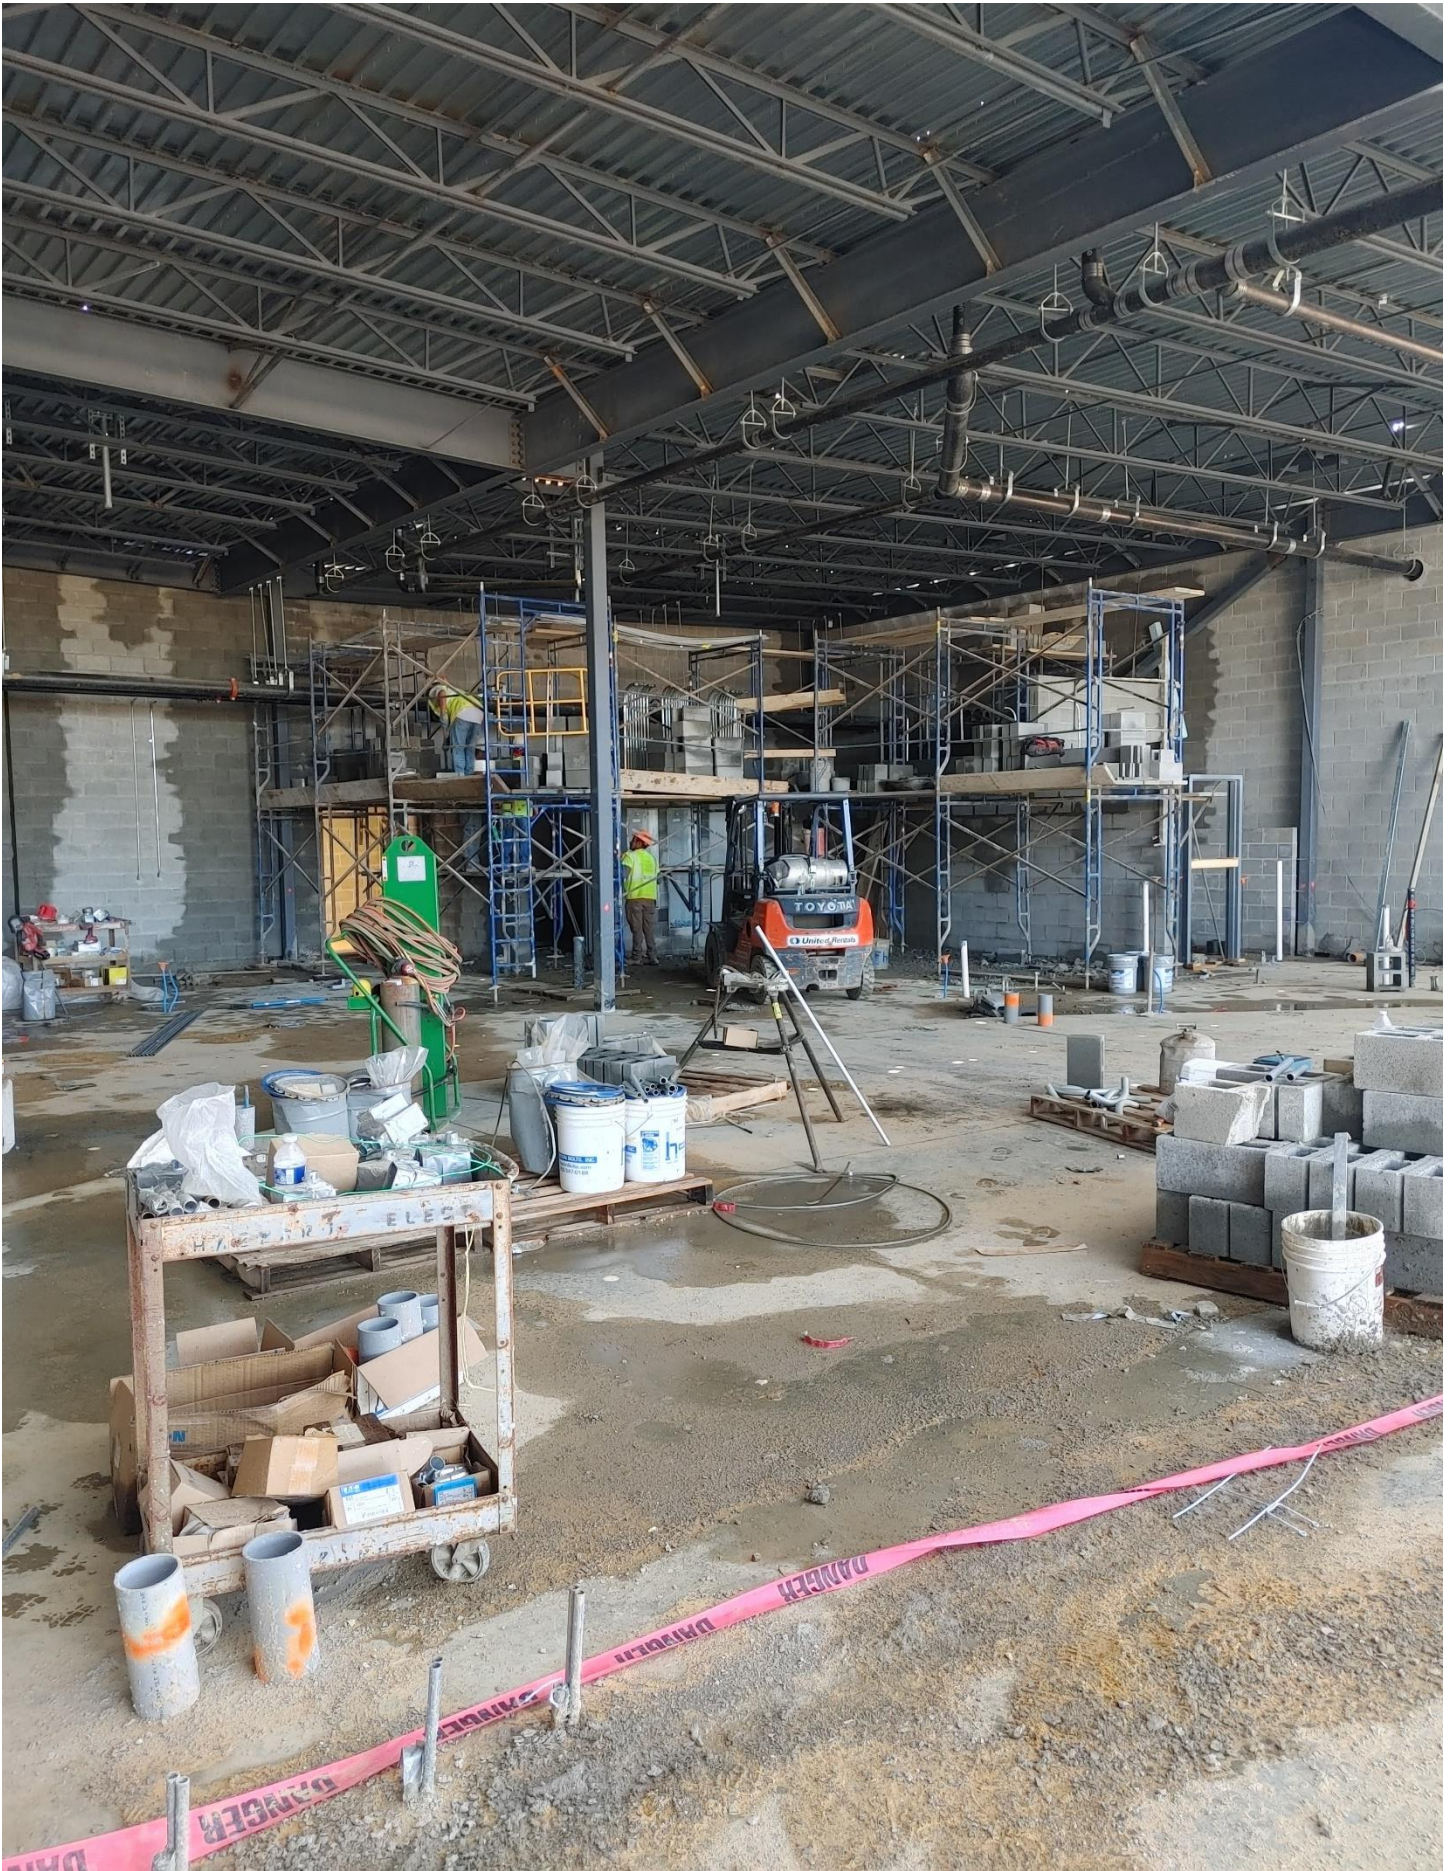
Photo 2 - Block is being laid in the Kitchen Area.

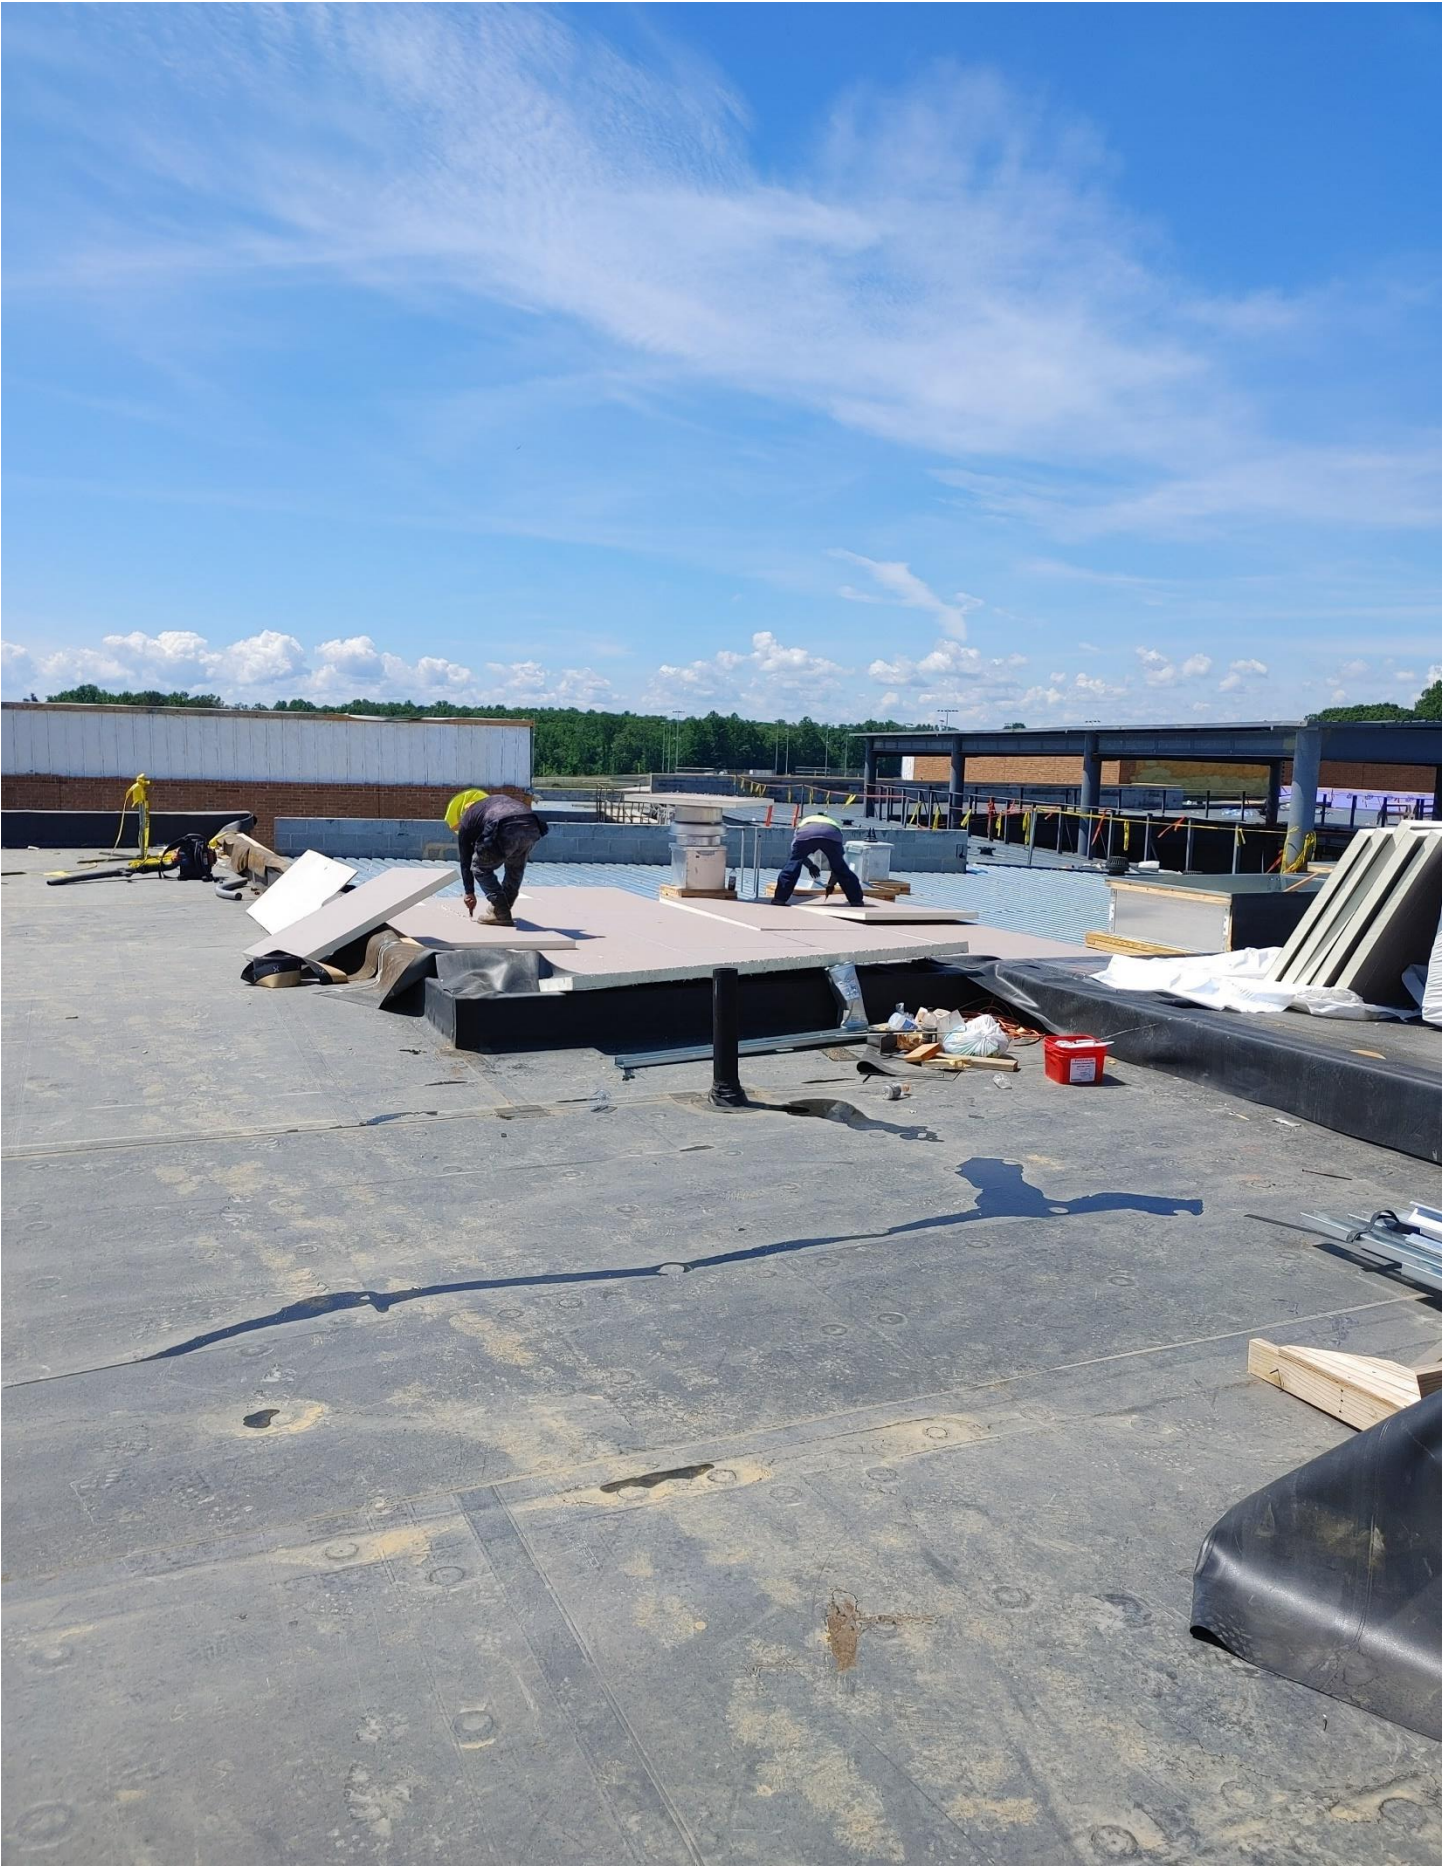
Photo 3 - Roofers are working on a section of Area A.

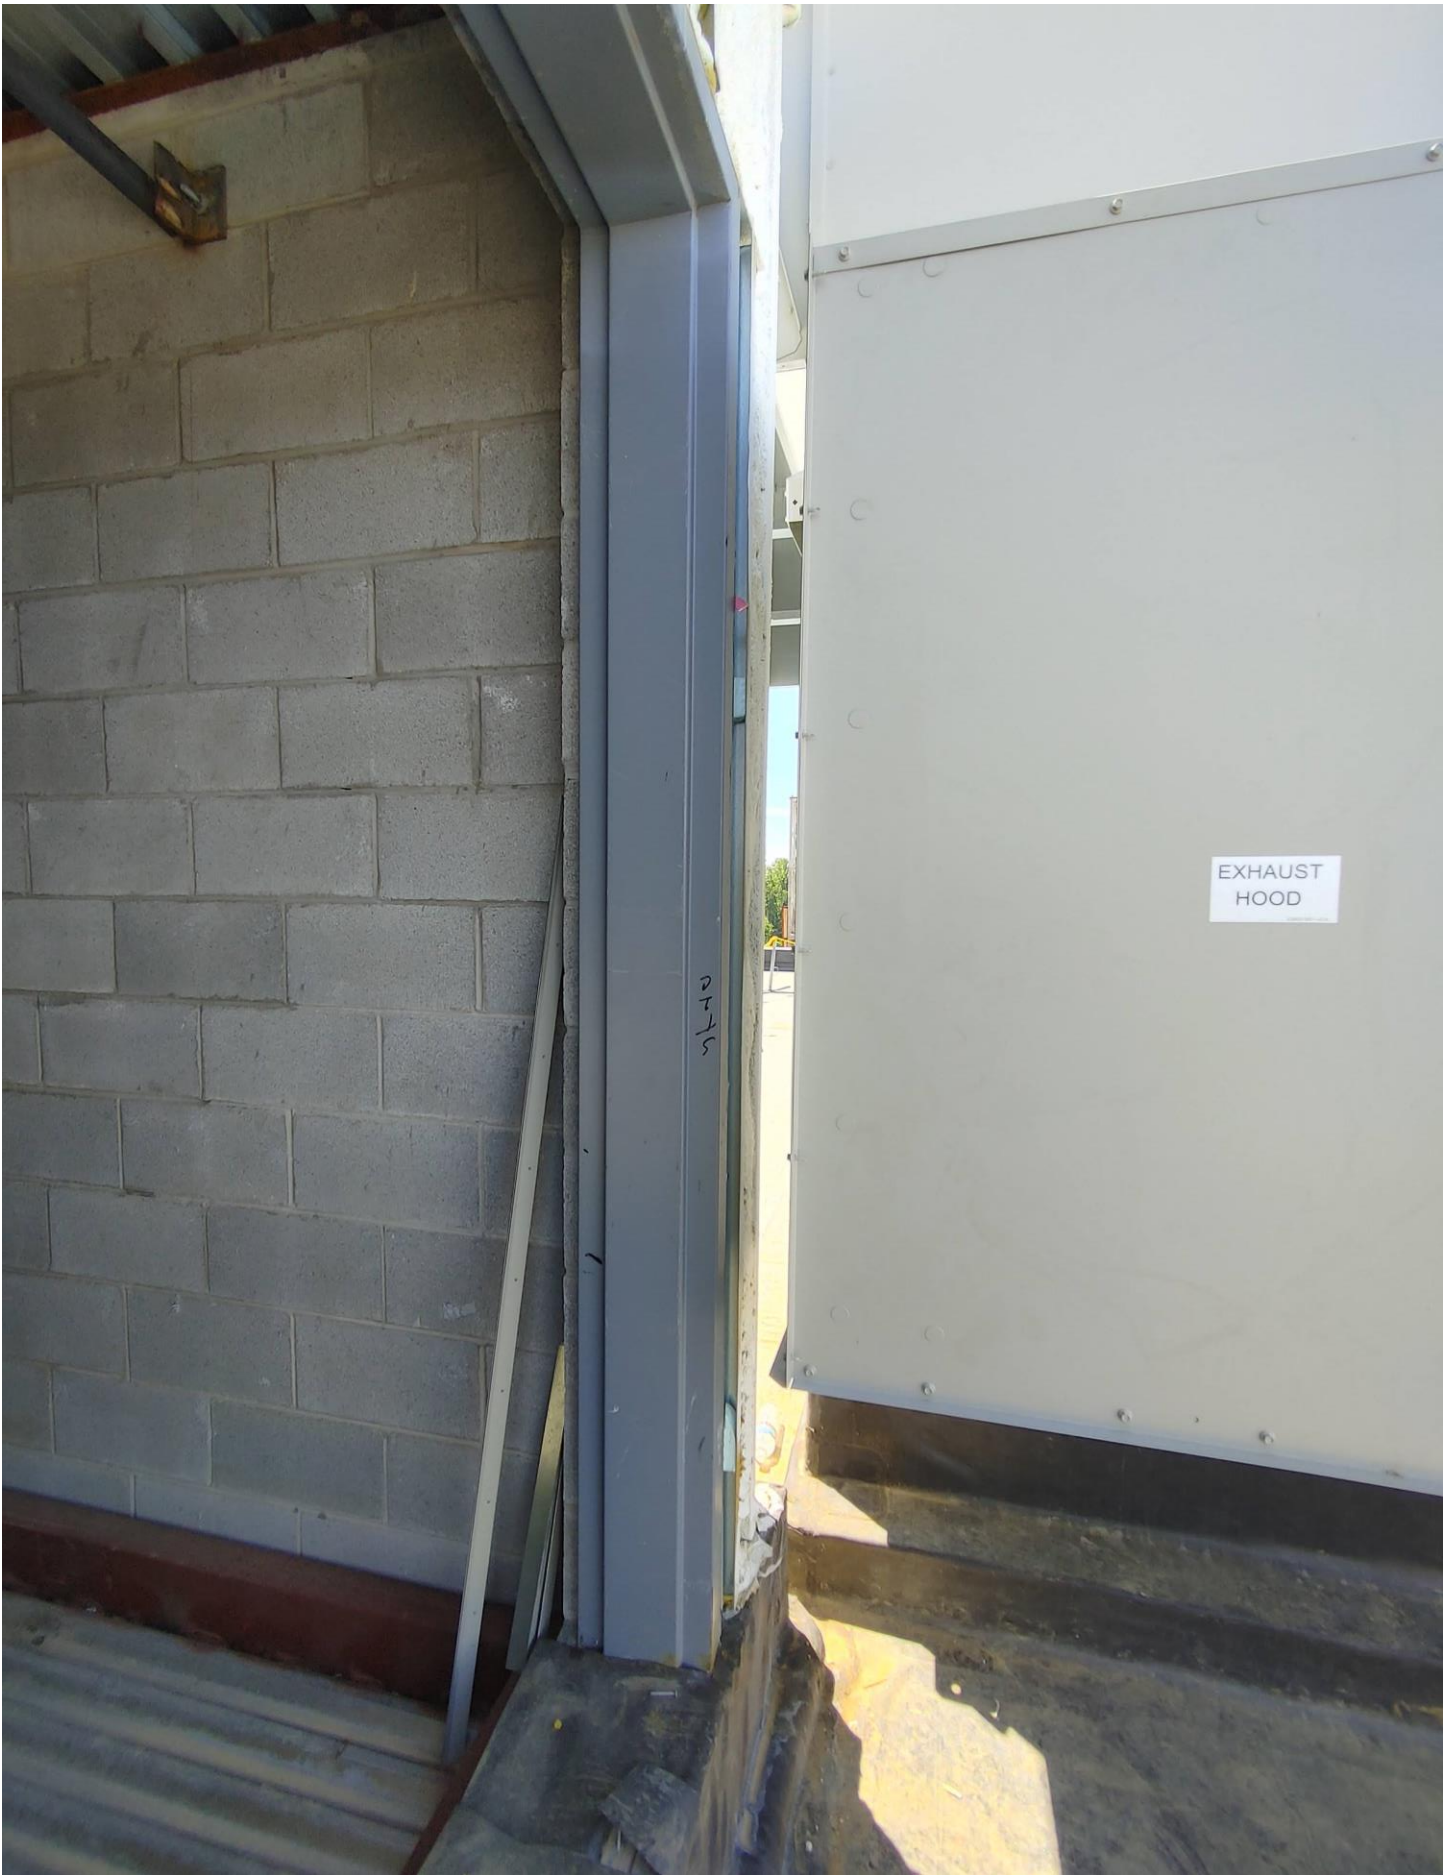
Questions to or from Branch Builds: I met with Brian after I walked the site this morning. We discussed the project and I pointed out that a small section of the roofing material in Area A that had not adhered properly (picture below). Brian immediately called the roofer who was working on the roof in that area and told him to take a look at the section I had pointed out. I also pointed out to Brian that the large HVAC Unit next to the roof access door in Area A was extremely close to the door frame and that I was concerned about getting that frame flashed and sealed properly. Brian acknowledged that he was aware of situation and that they would probably have to disassemble a section of the HVAC Unit to seal up that area (picture below). I will continue to monitor both items.

Photo 4 - HVAC Unit on the roof of Area A sits close to door frame.

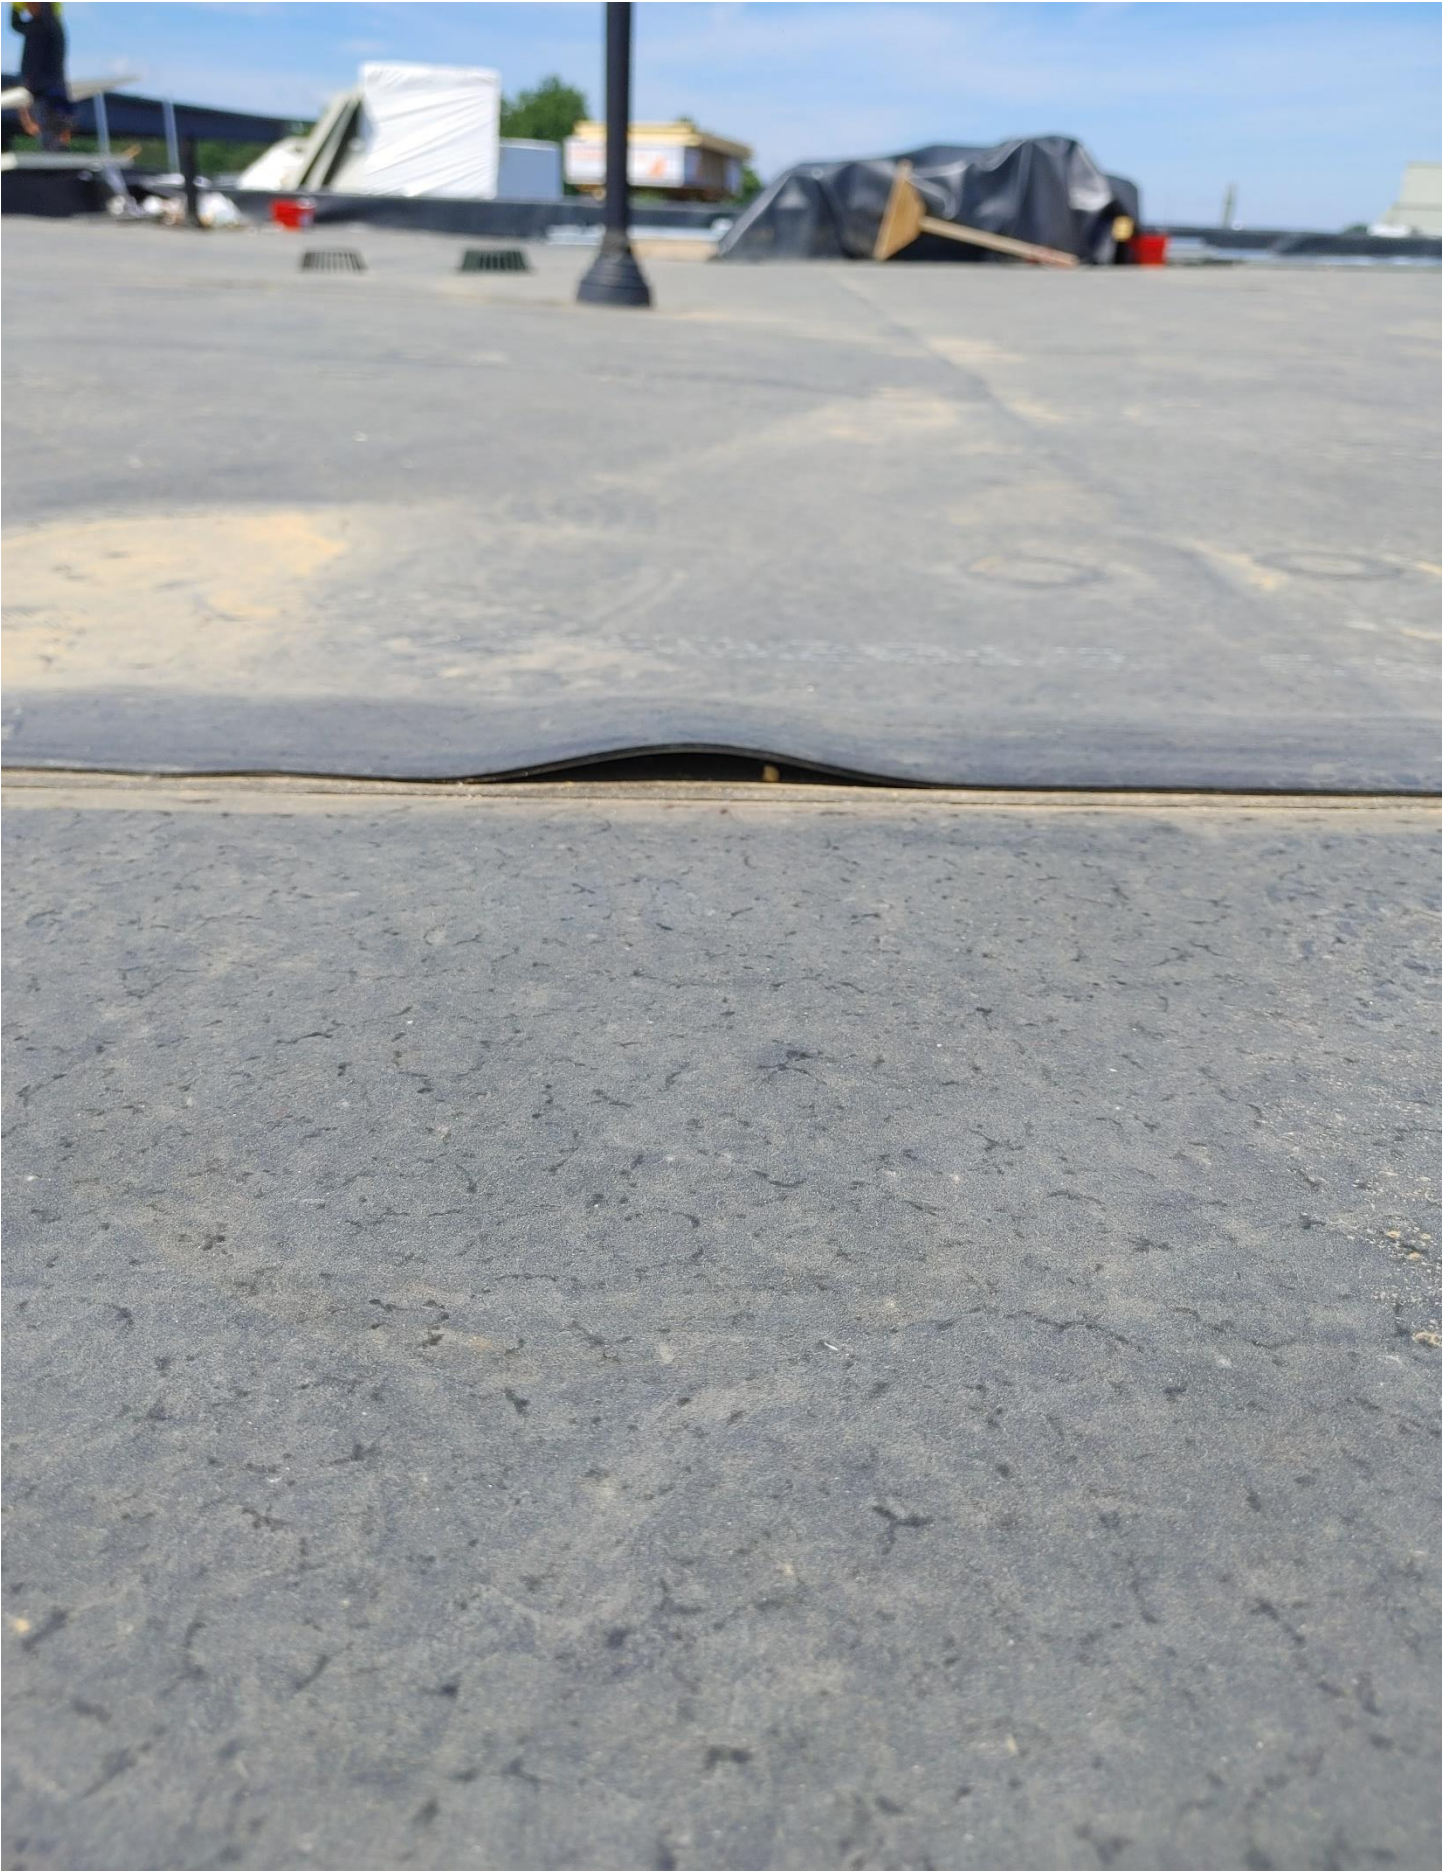
Photo 5 - A small section of the roof membrane overlap joint did not adhere properly on the roof of Area A.

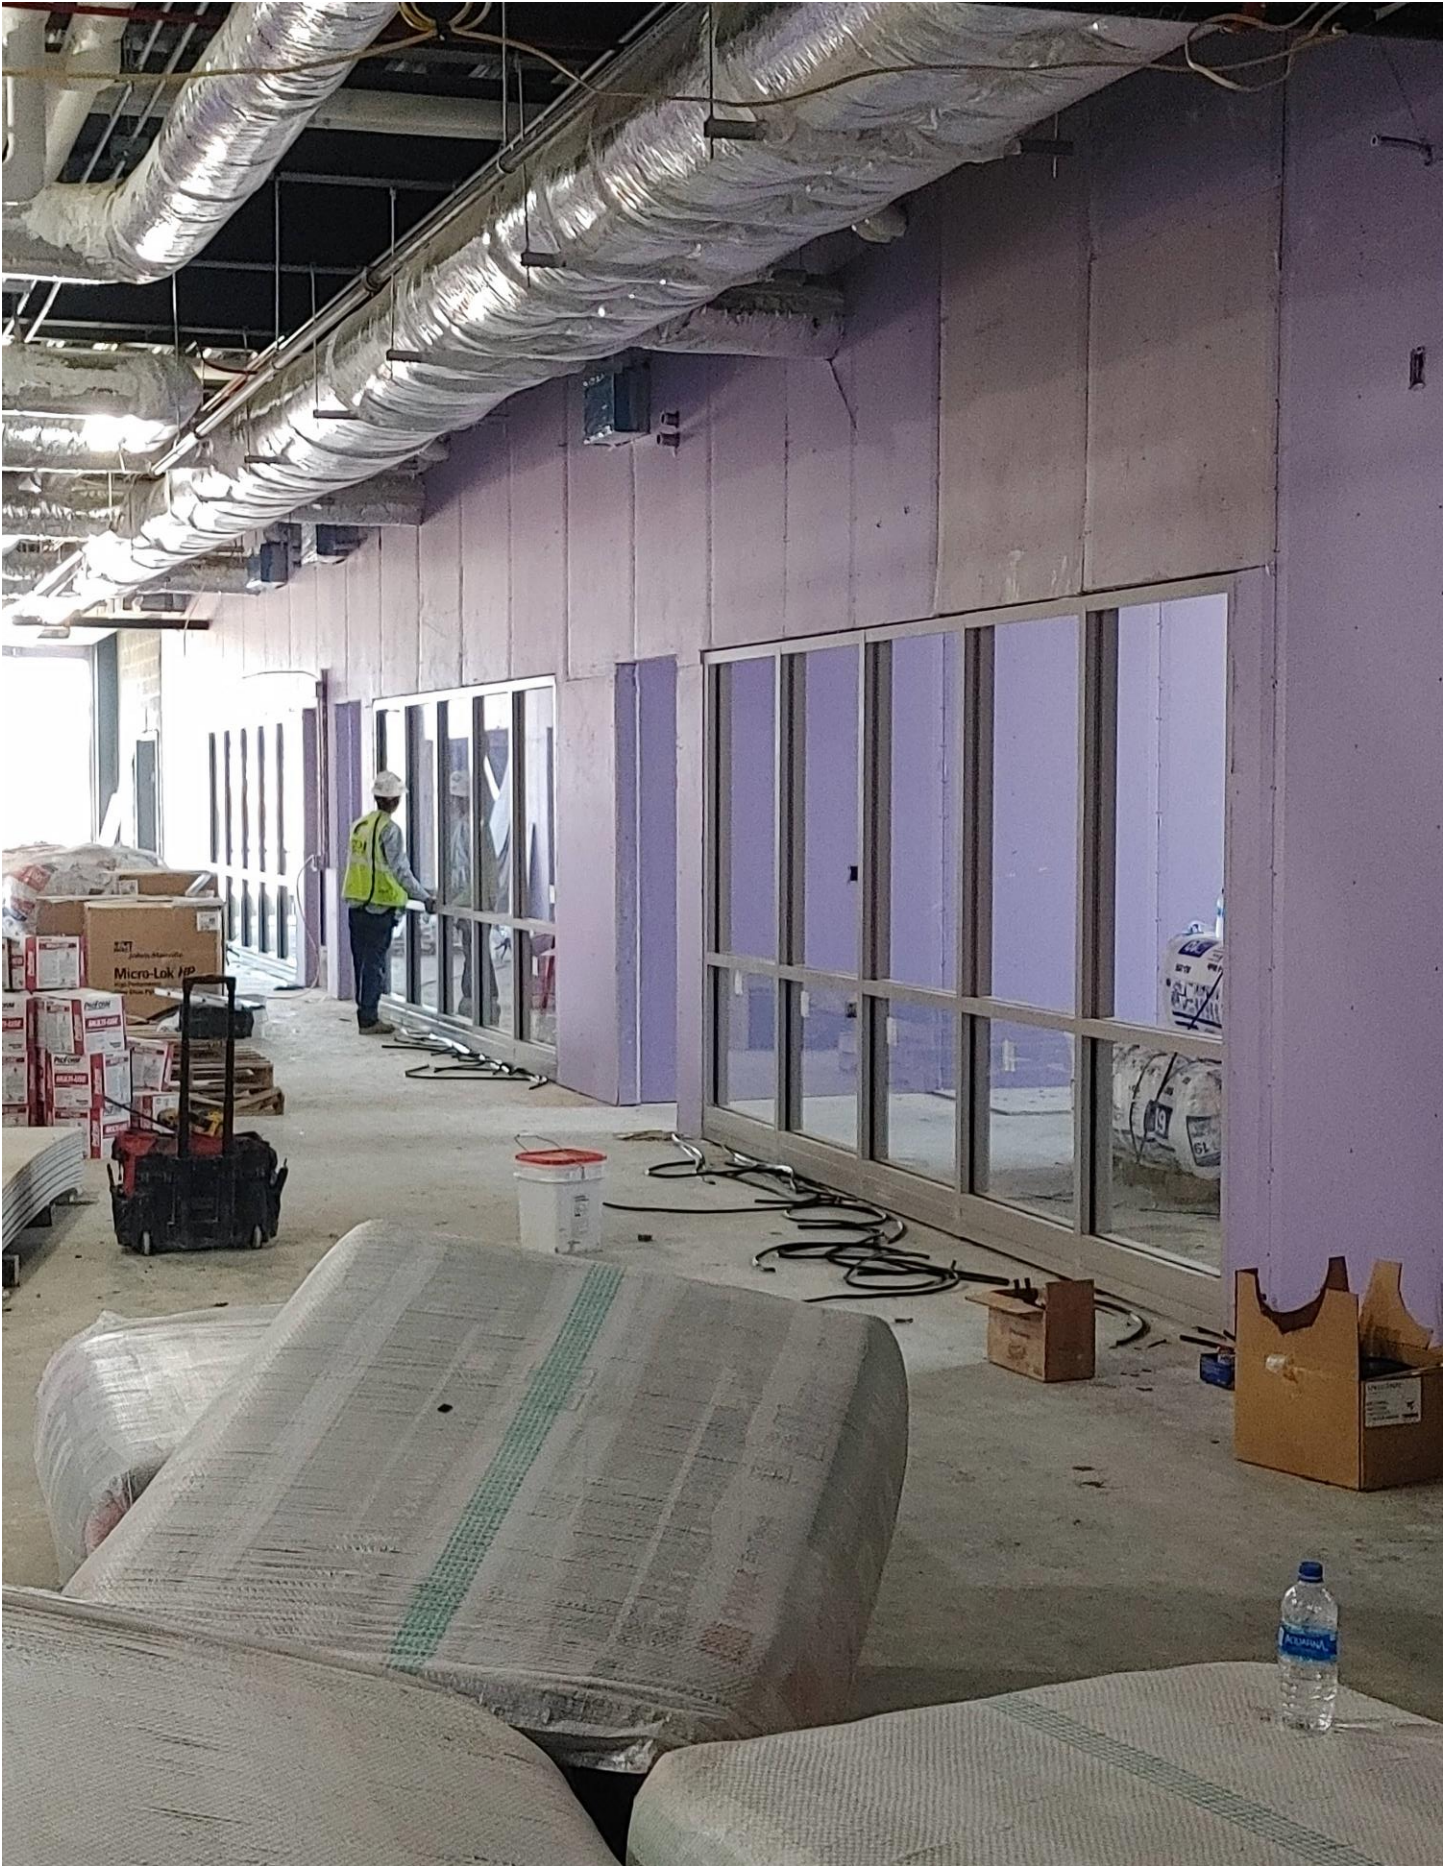
Photo 6 - Glass and backer rod is being installed in Area B.

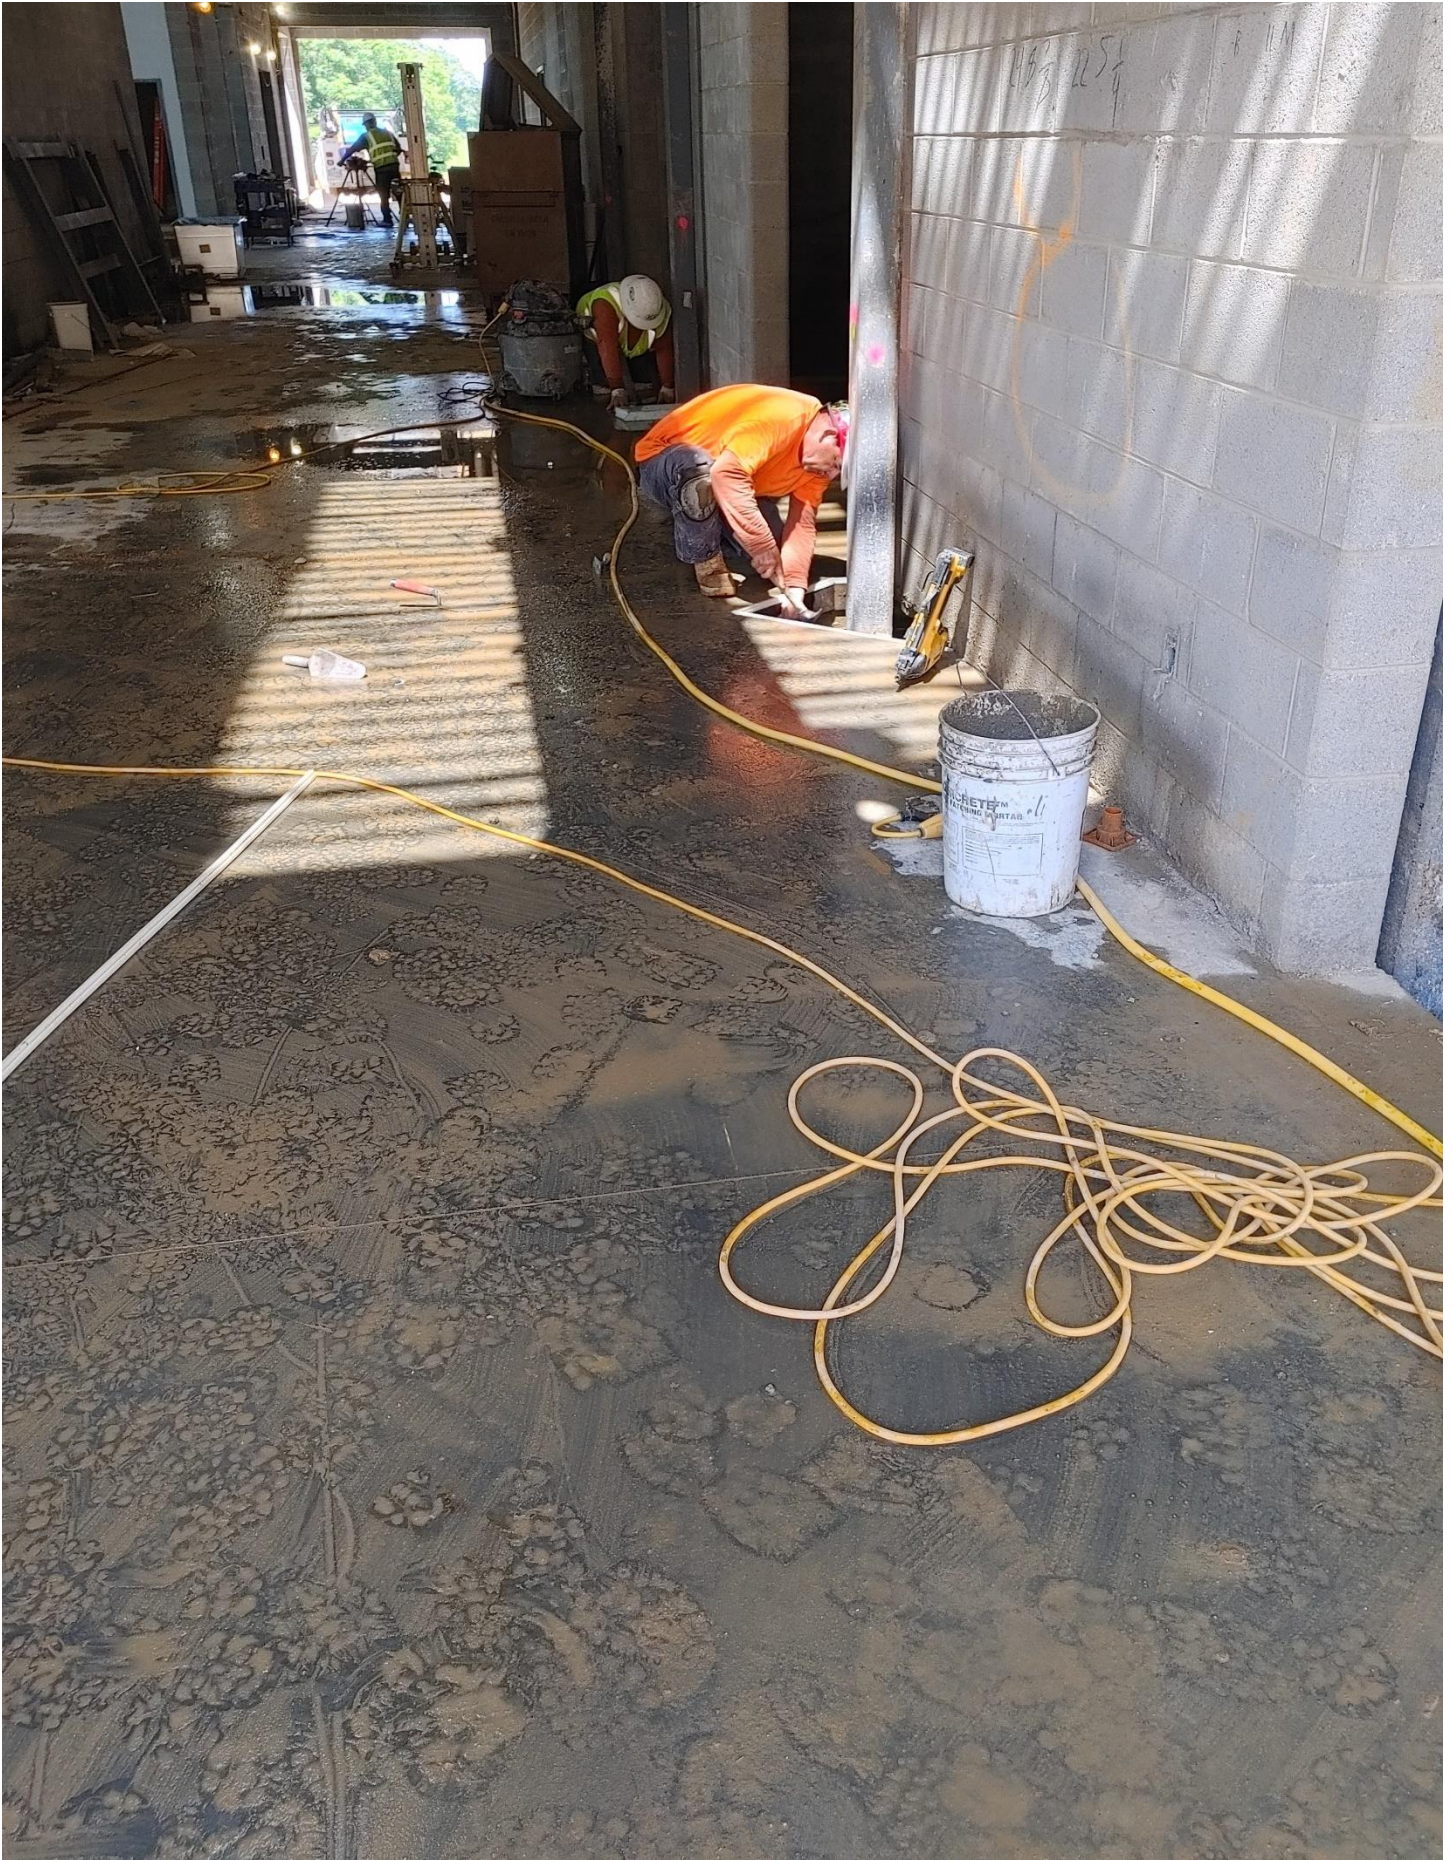
Photo 7 - Diamonds are be prepped for concrete.

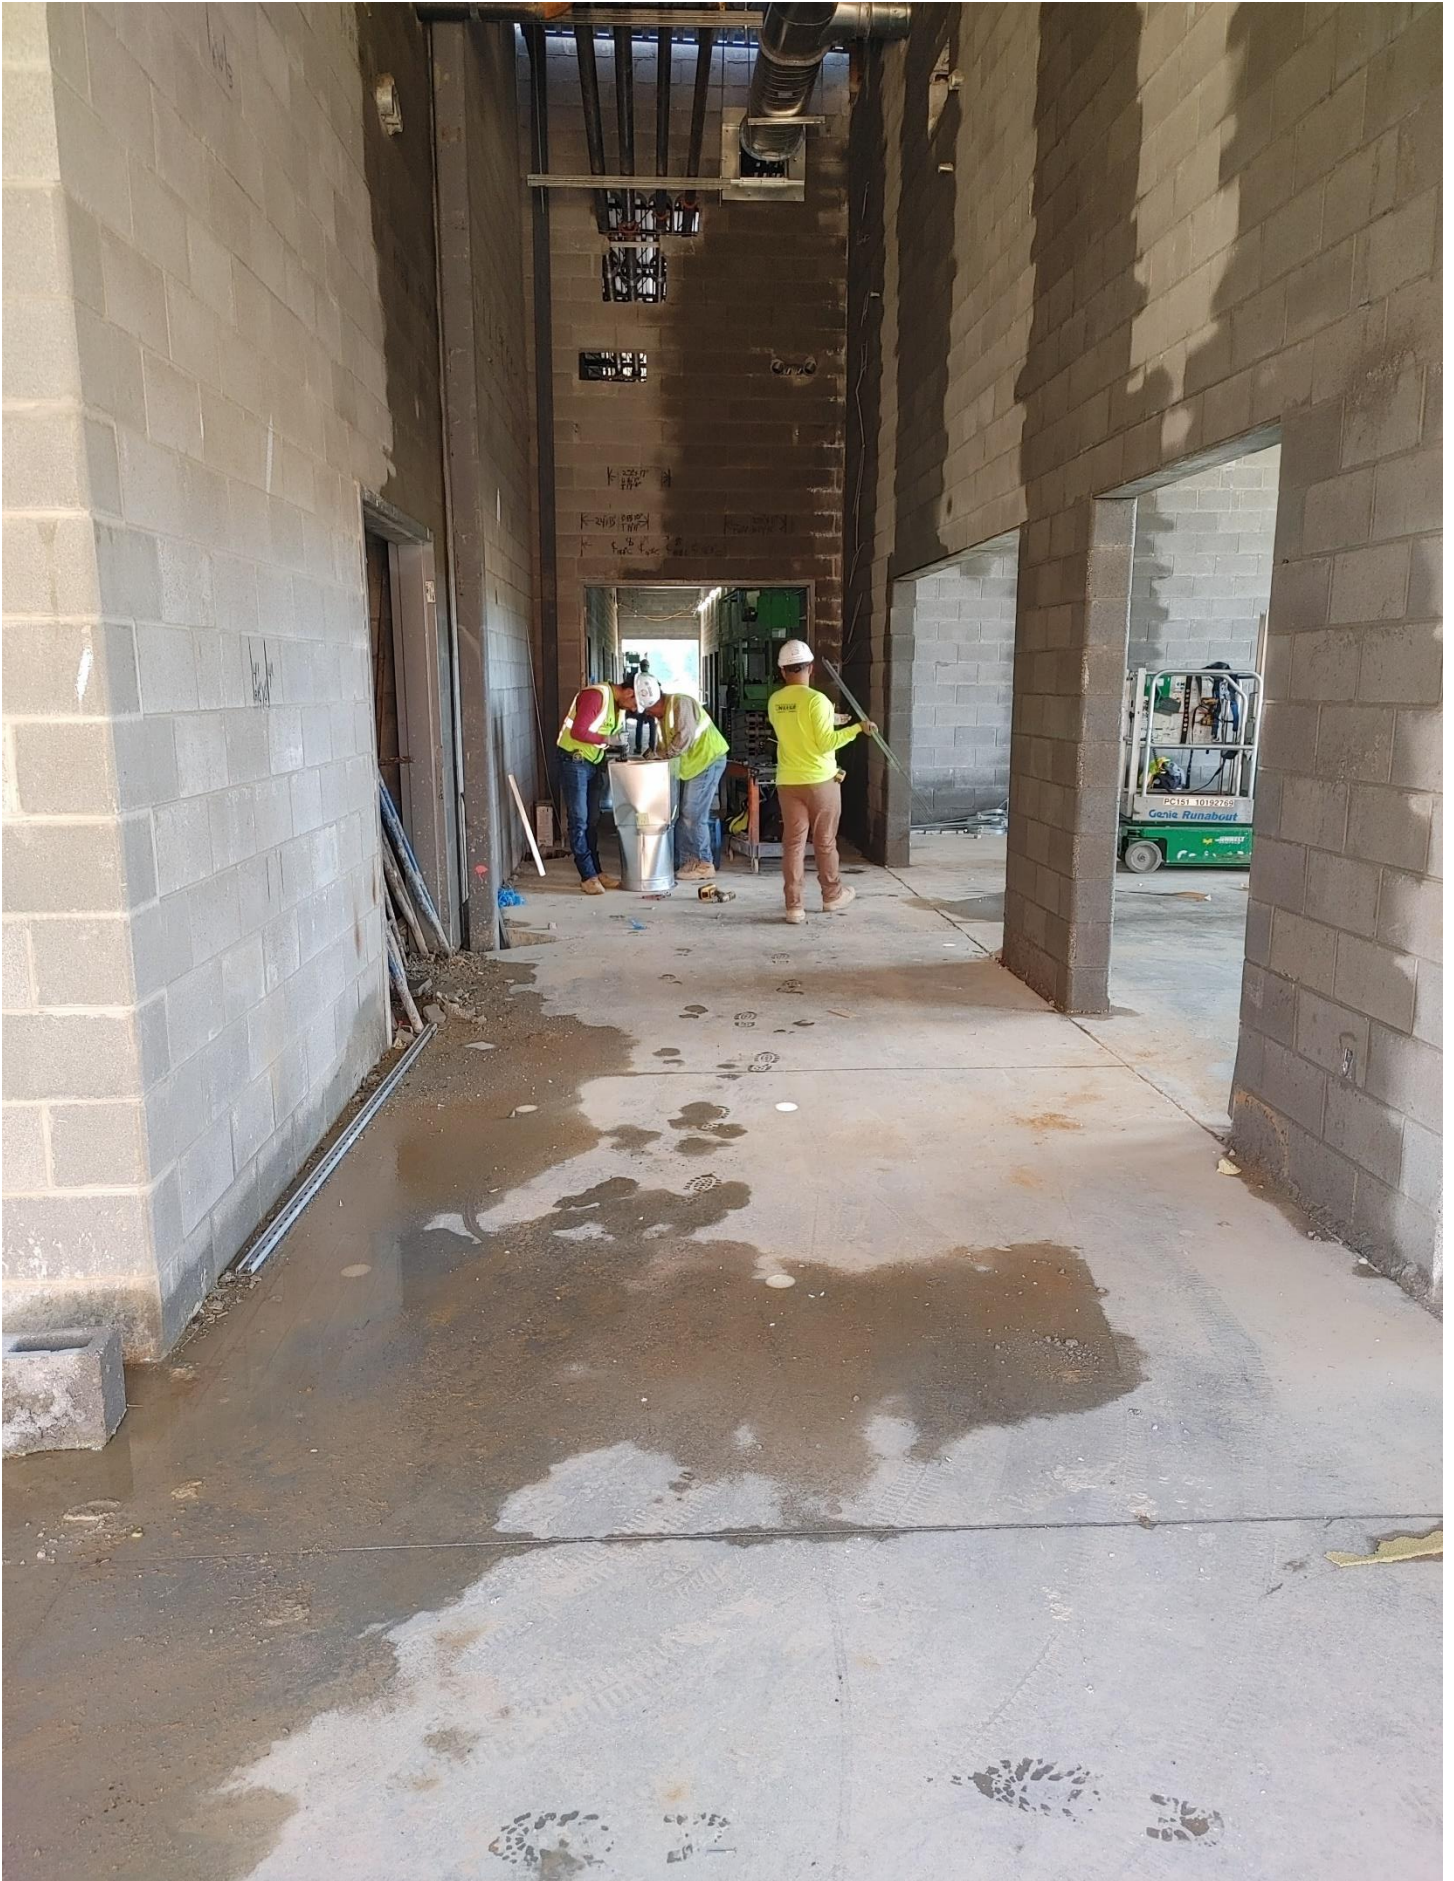
Photo 8 - HVAC duct is being run in Corridor D12
