**COMMONWEALTH
BUILDING SOLUTIONS, LLC**

DAILY REPORT

WESTMORELAND COUNTY HIGH SCHOOL

Date: 06/08/2021
Weather: 82 degrees. Mostly Cloudy. High of 90 degrees today.
Hours Worked: 08:30hrs – 11:00hrs (2.5hrs) On Site.

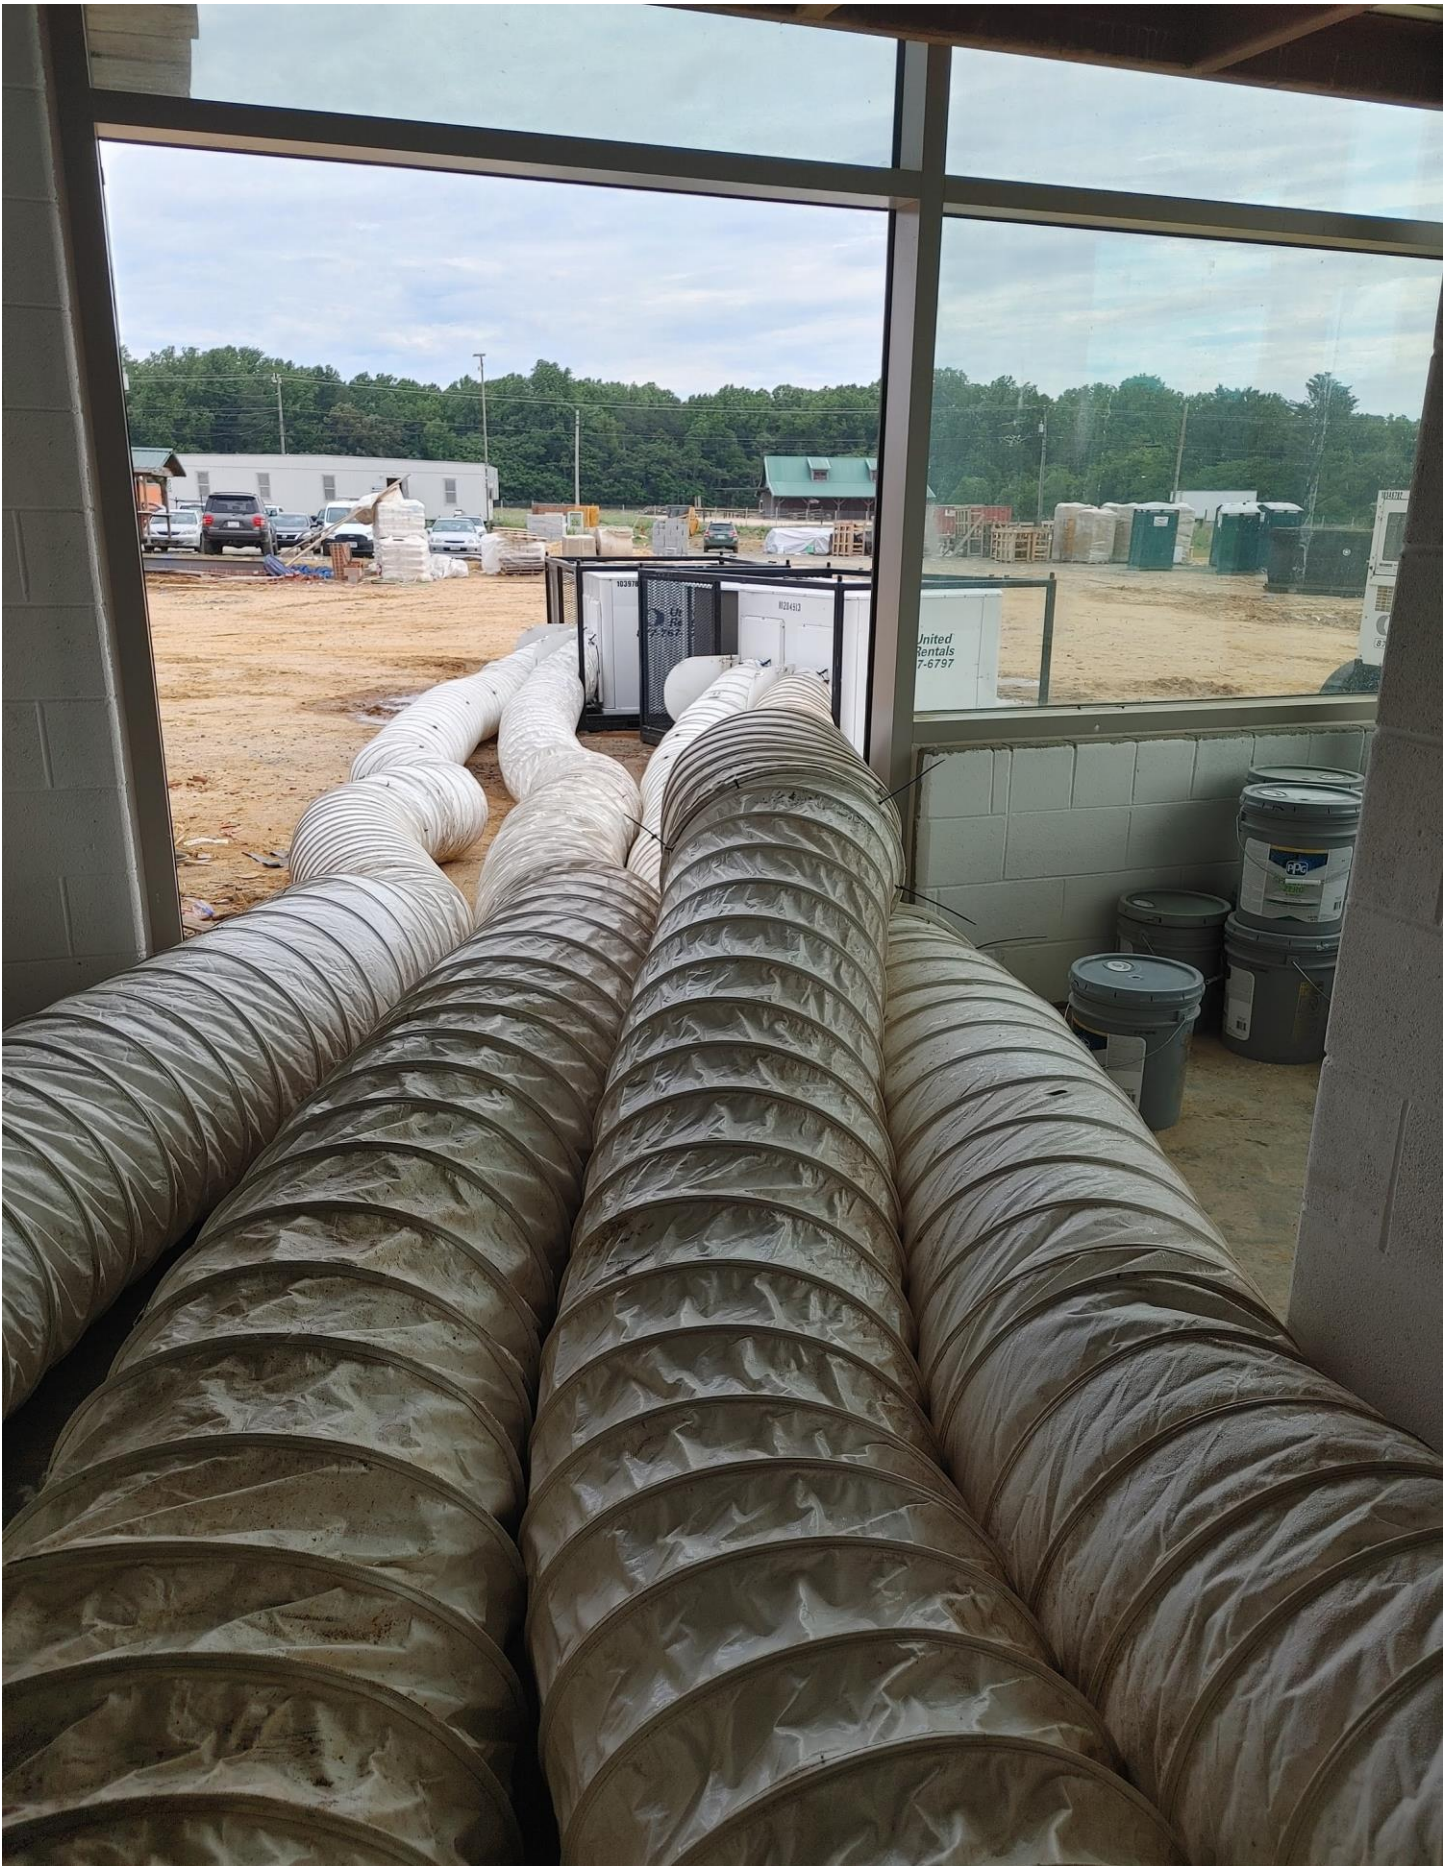
Photo 1 - Temporary Cooling Units have been run into Area A to condition the space.

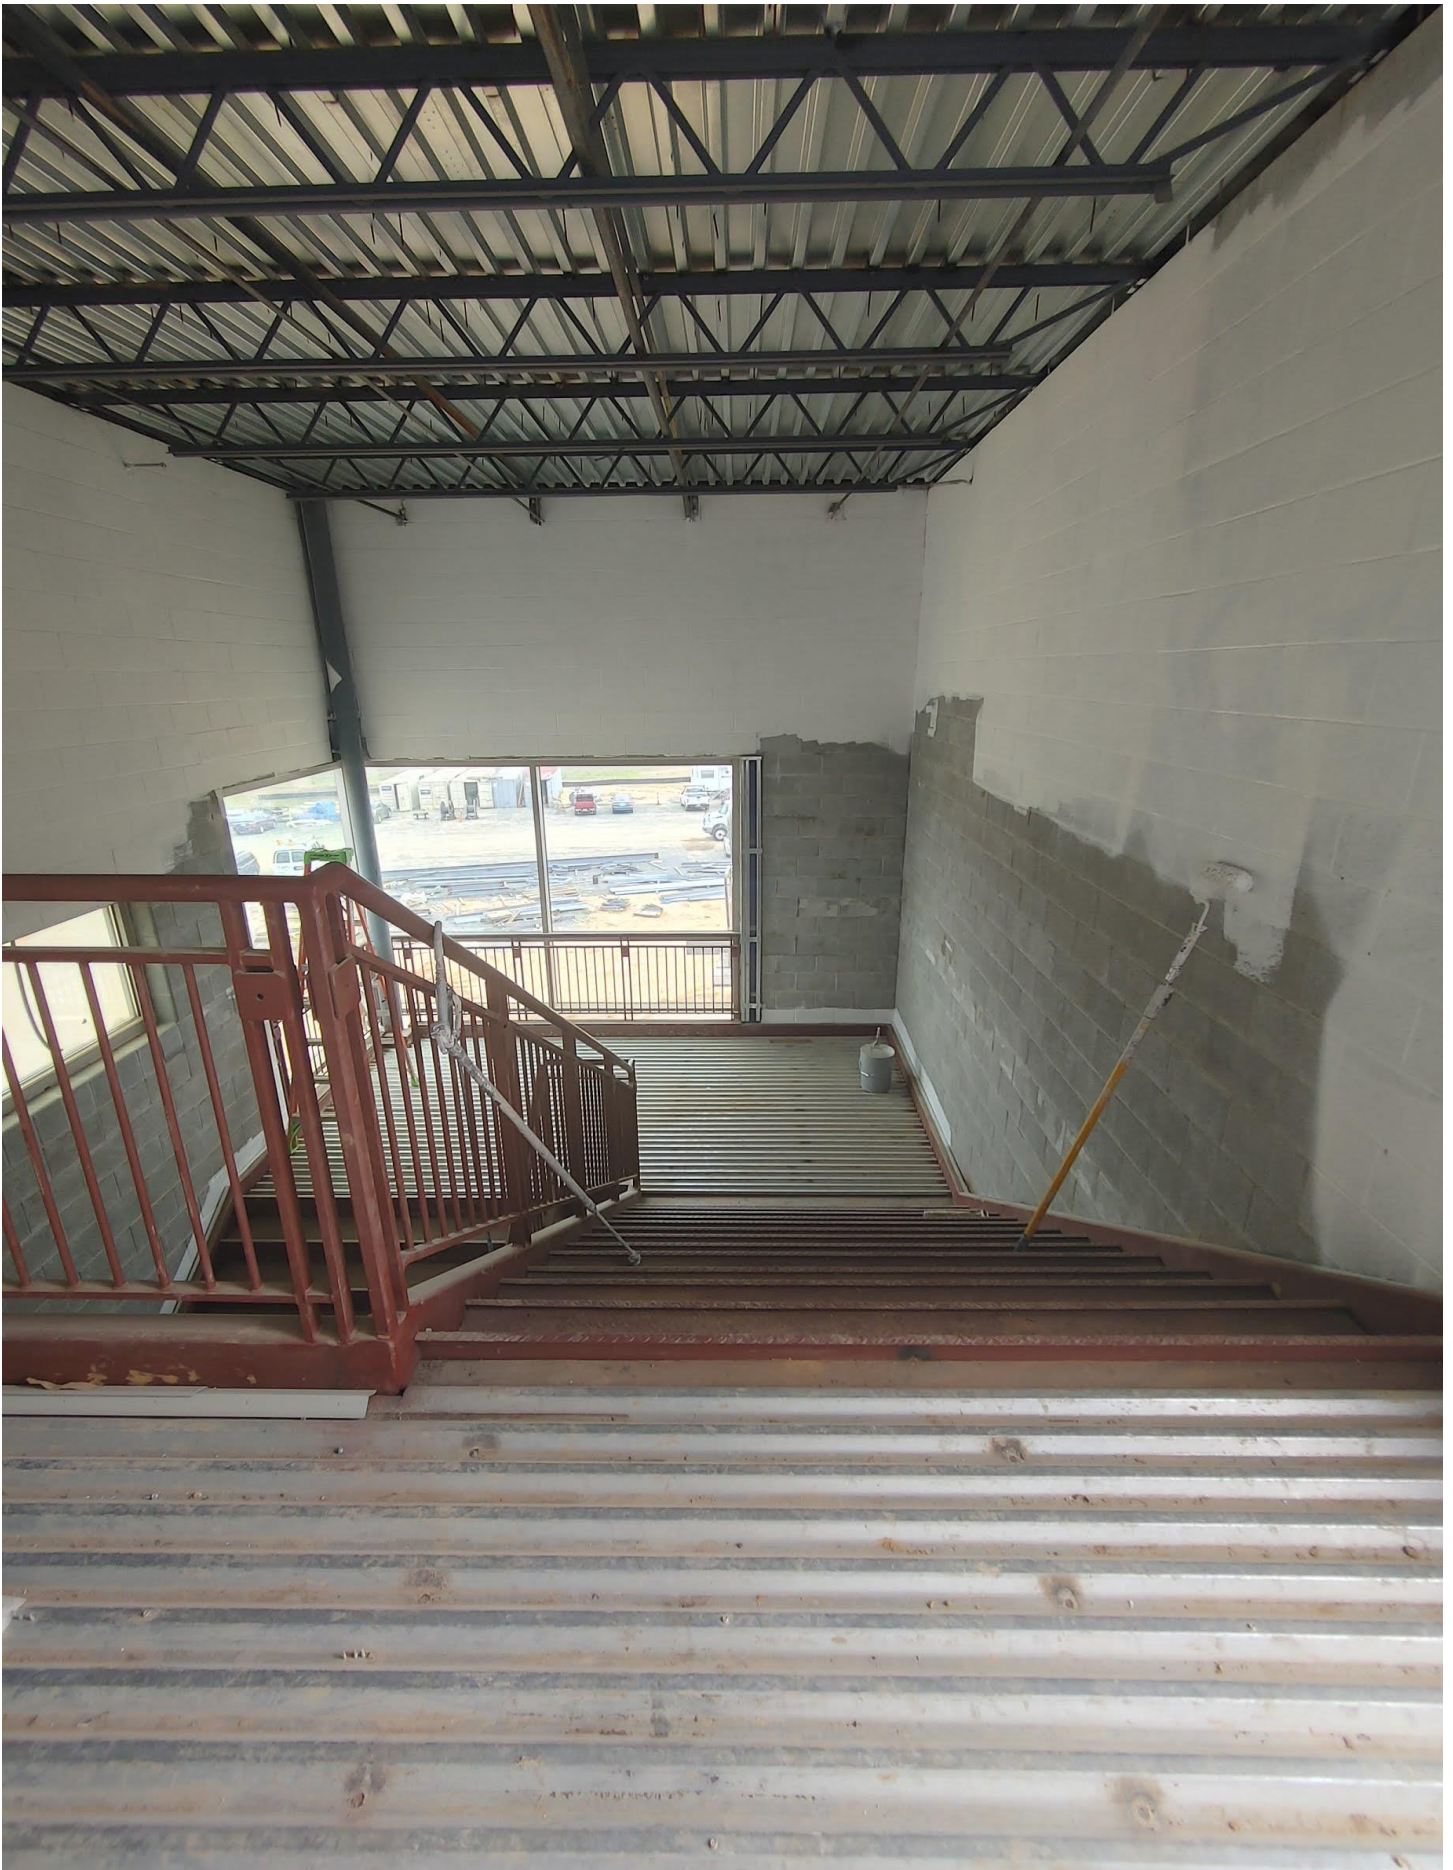
M. L. Straight: Two (2) men are on site today spraying and back rolling Block sealer in Stairwell #2.

Photo 2 - Block sealer being sprayed and rolled on walls in Stairwell #2

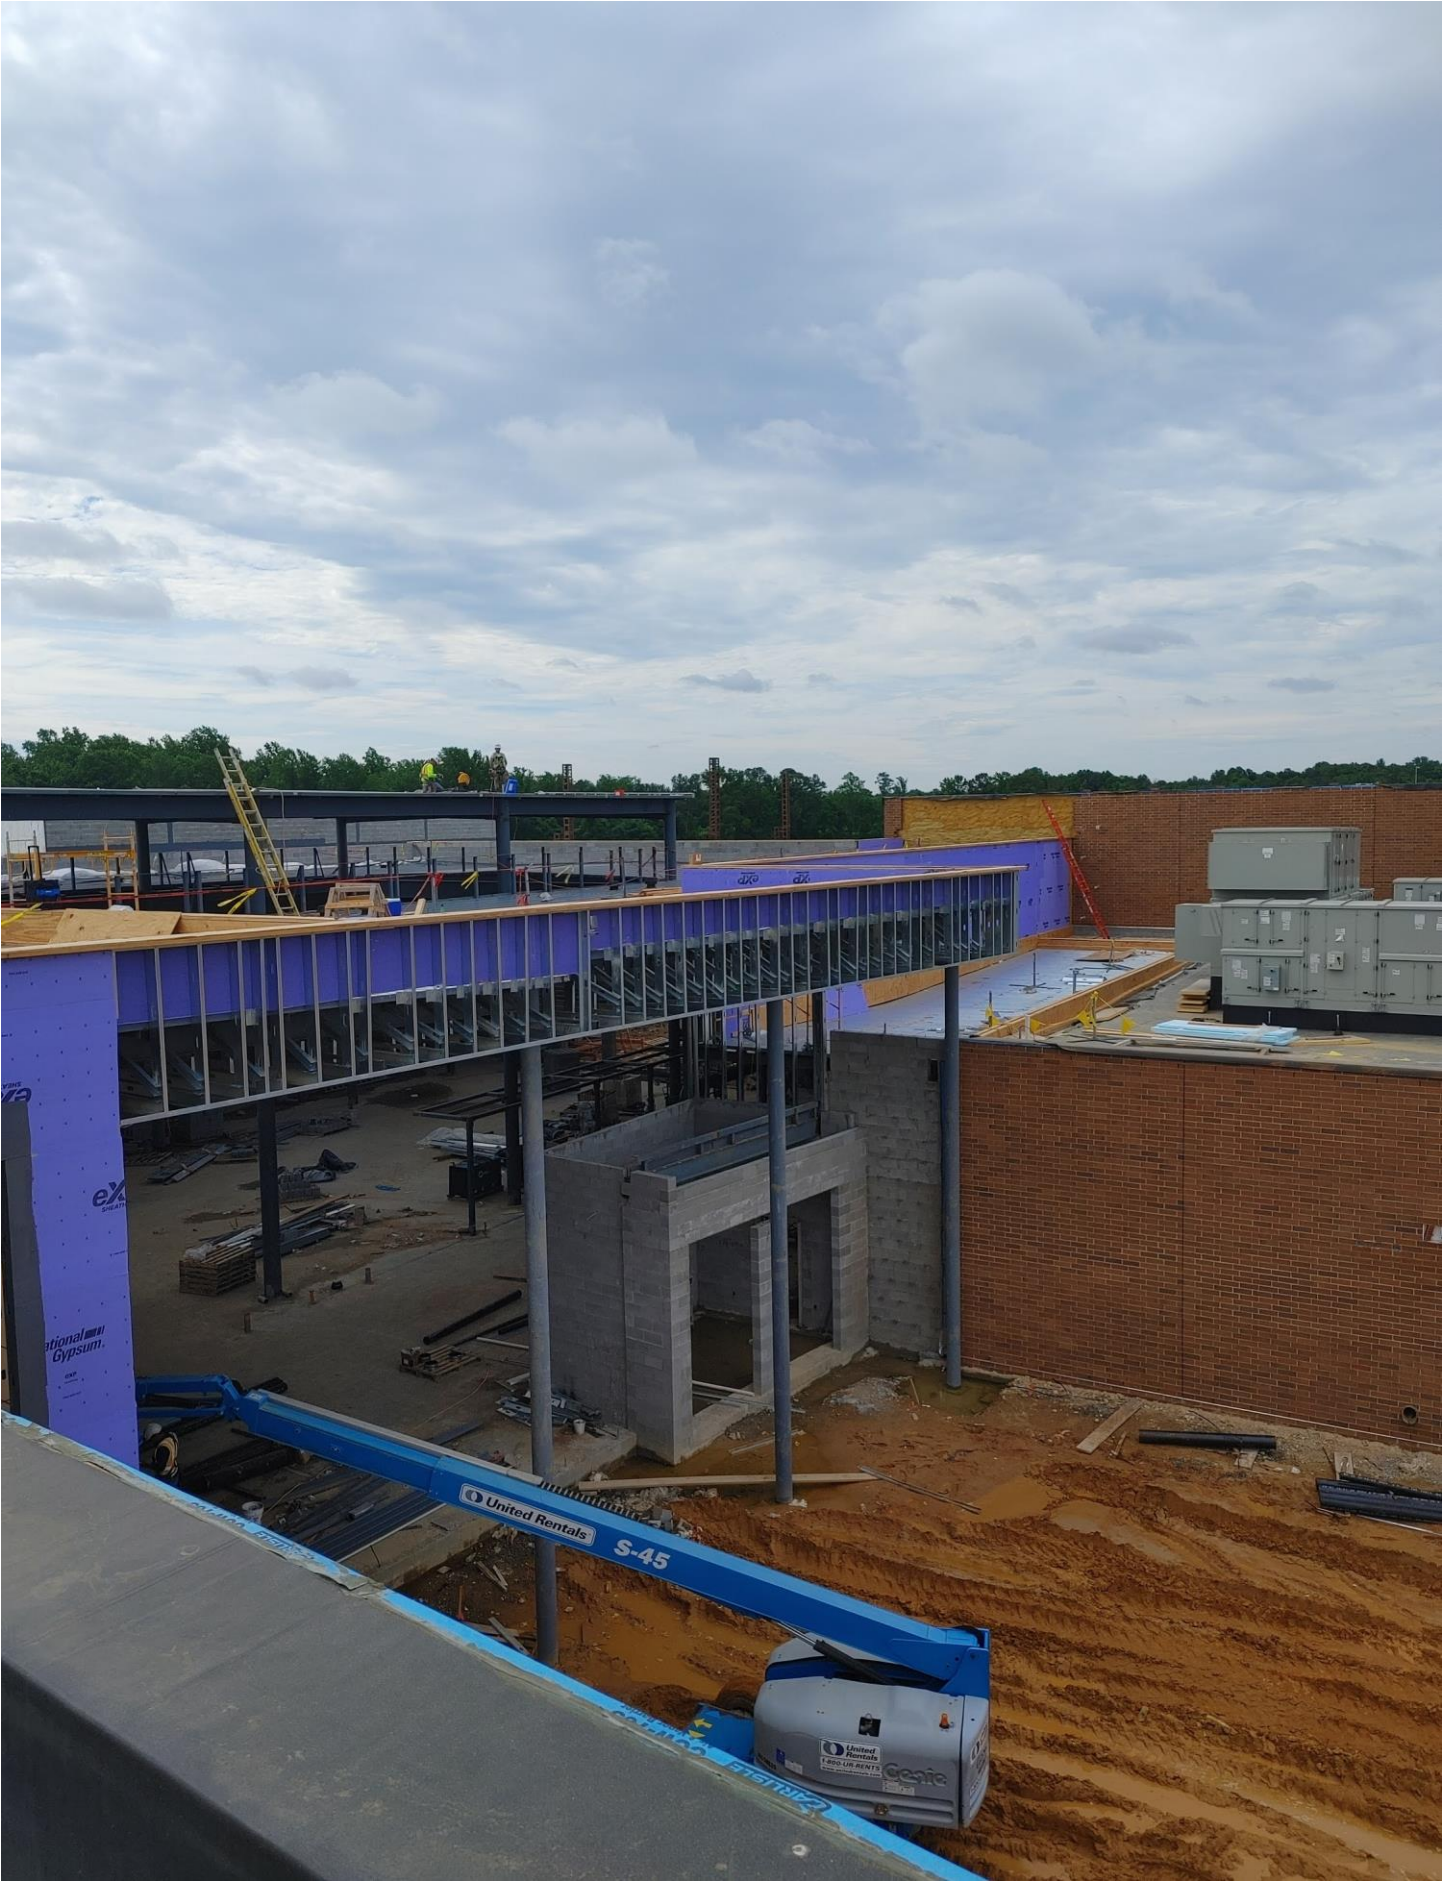
Photo 3 - Parapet Walls are being constructed

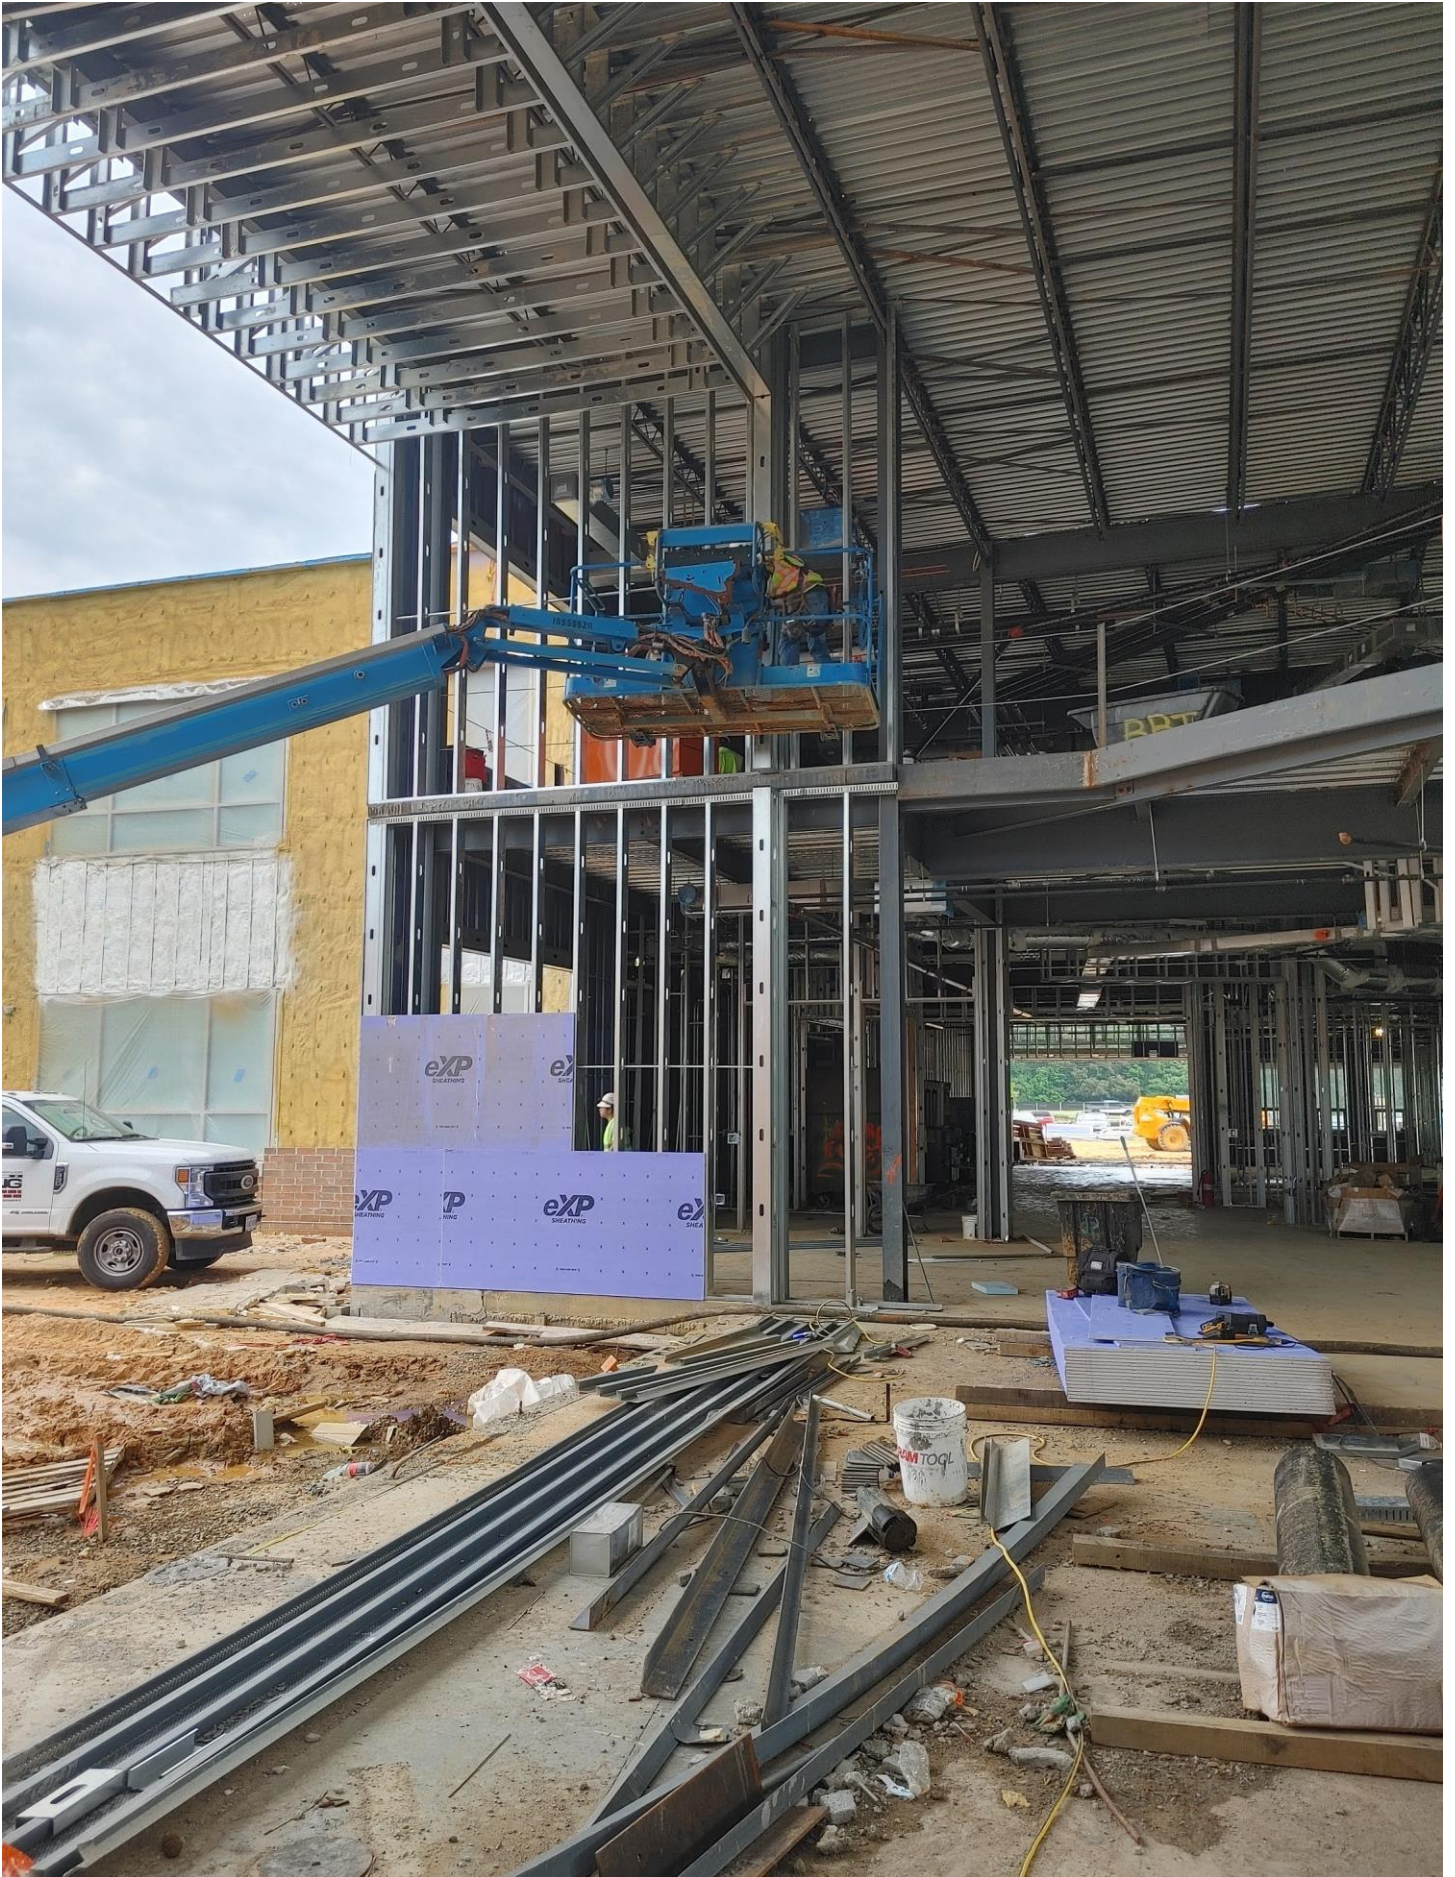
Photo 4 - Walls being framed in Area C.

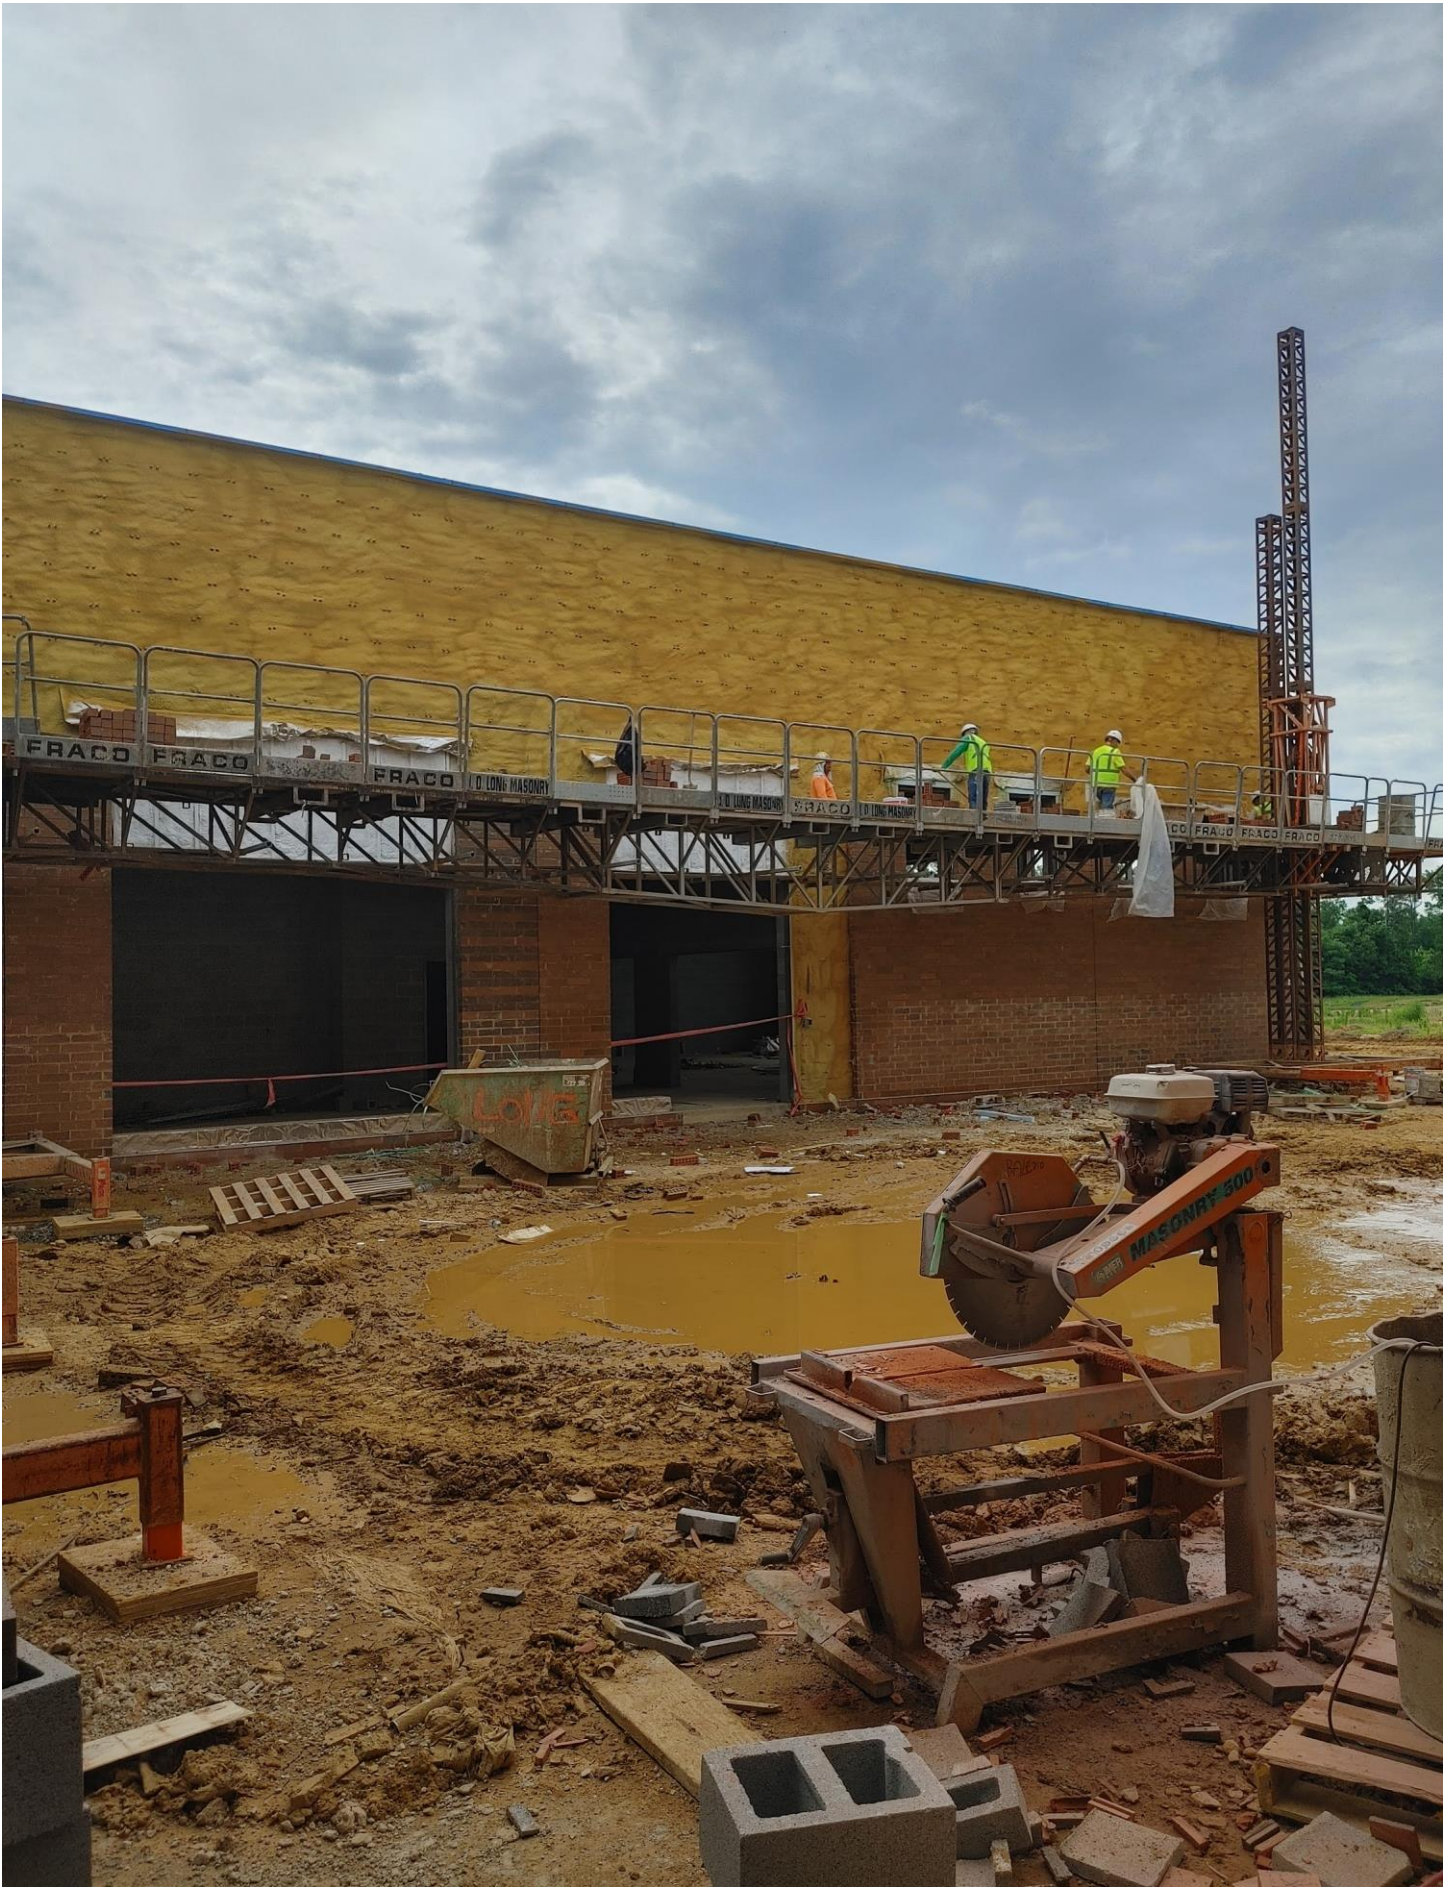
Photo 5 - Brick is being laid on the West side of Area D.

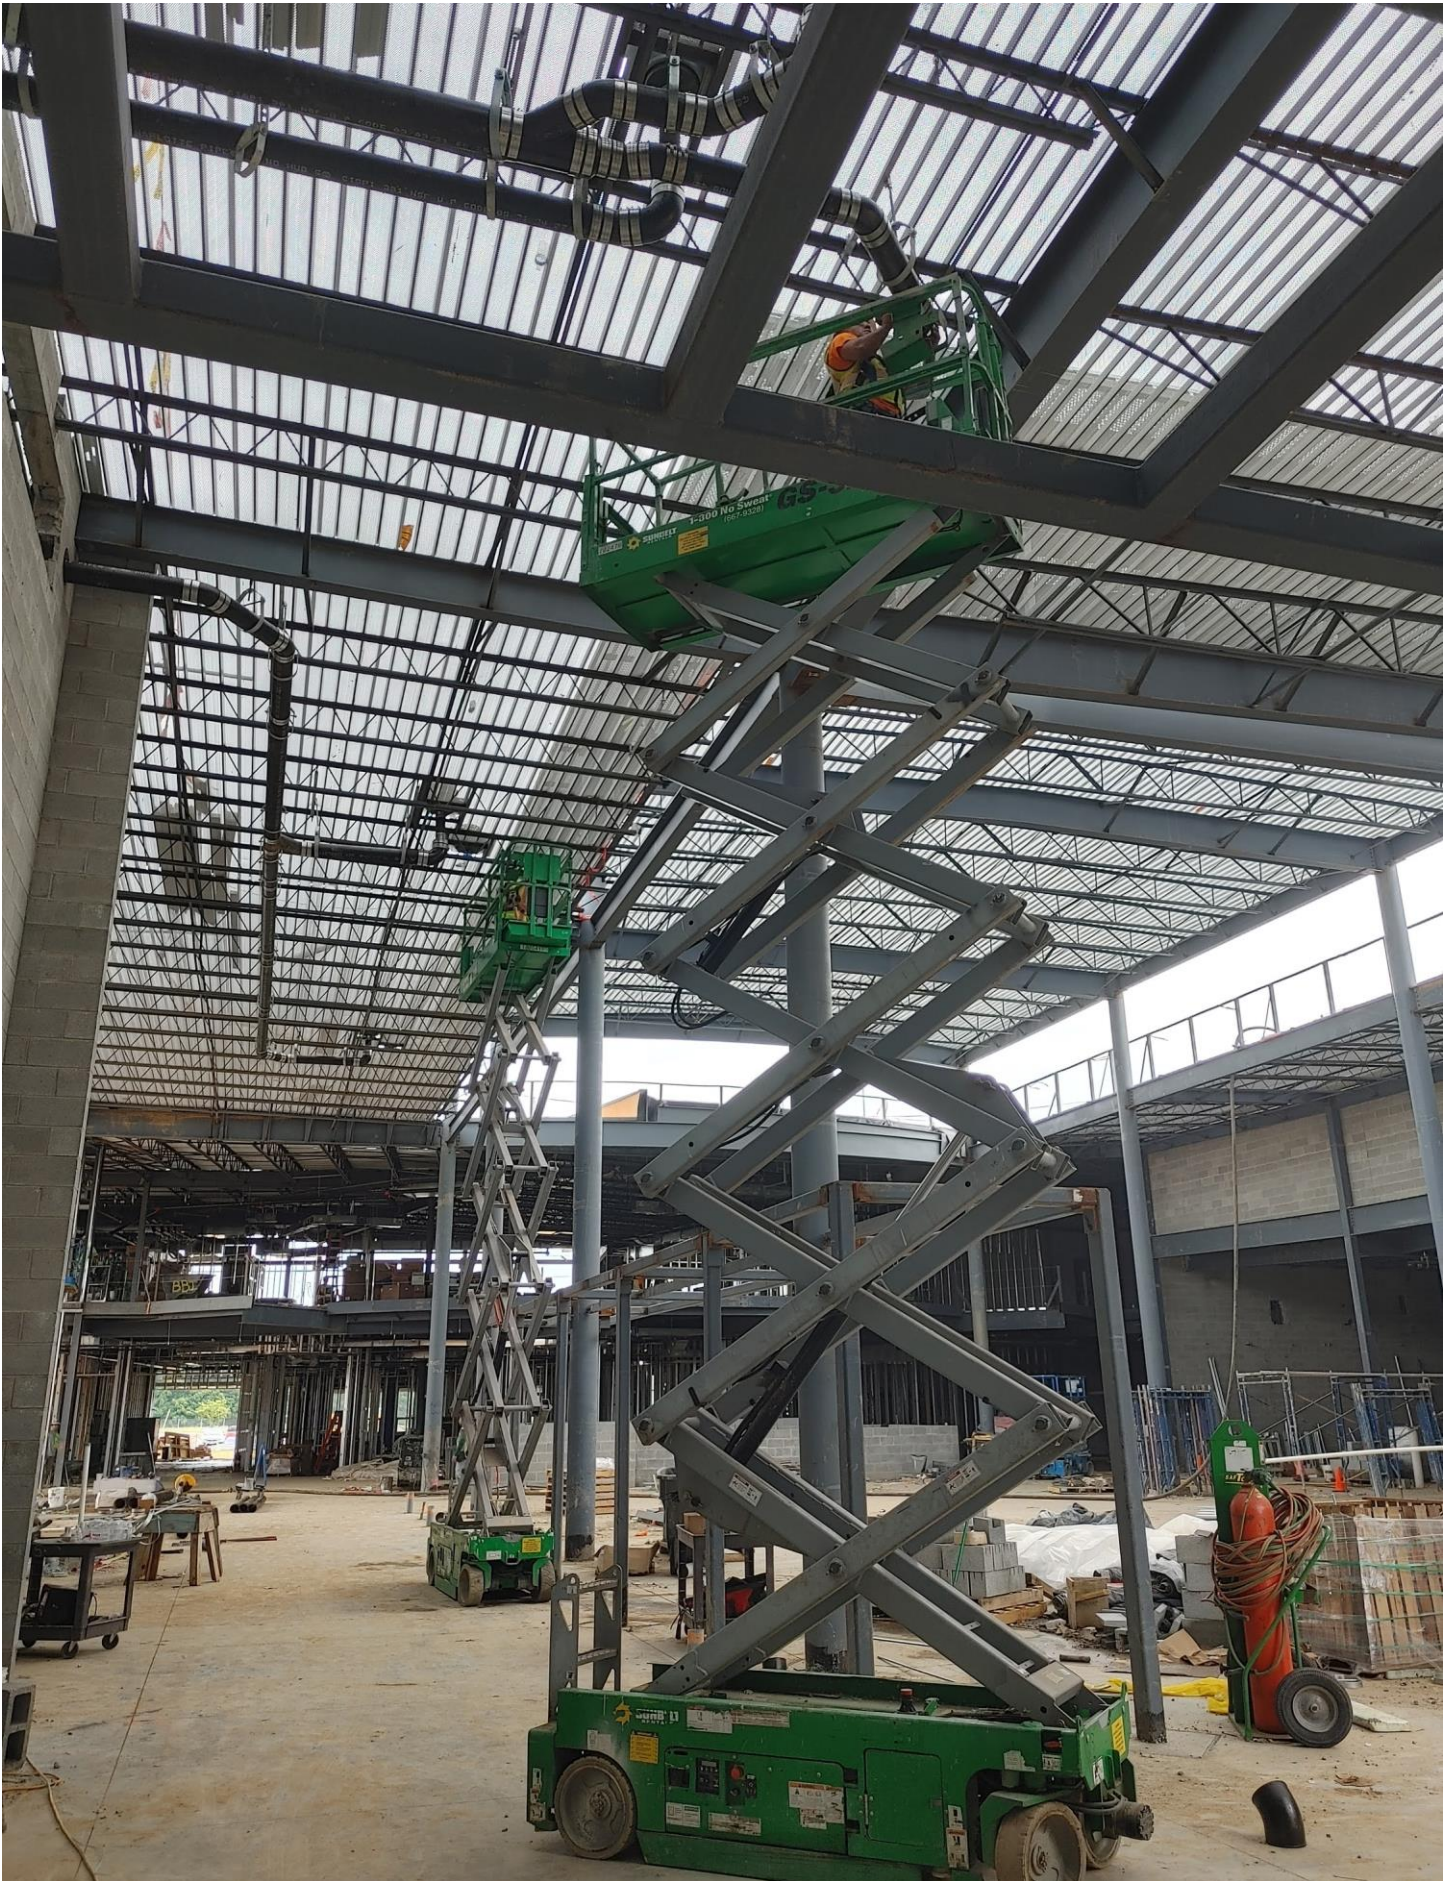
Photo 6 - Roof Drains being installed in Area C.

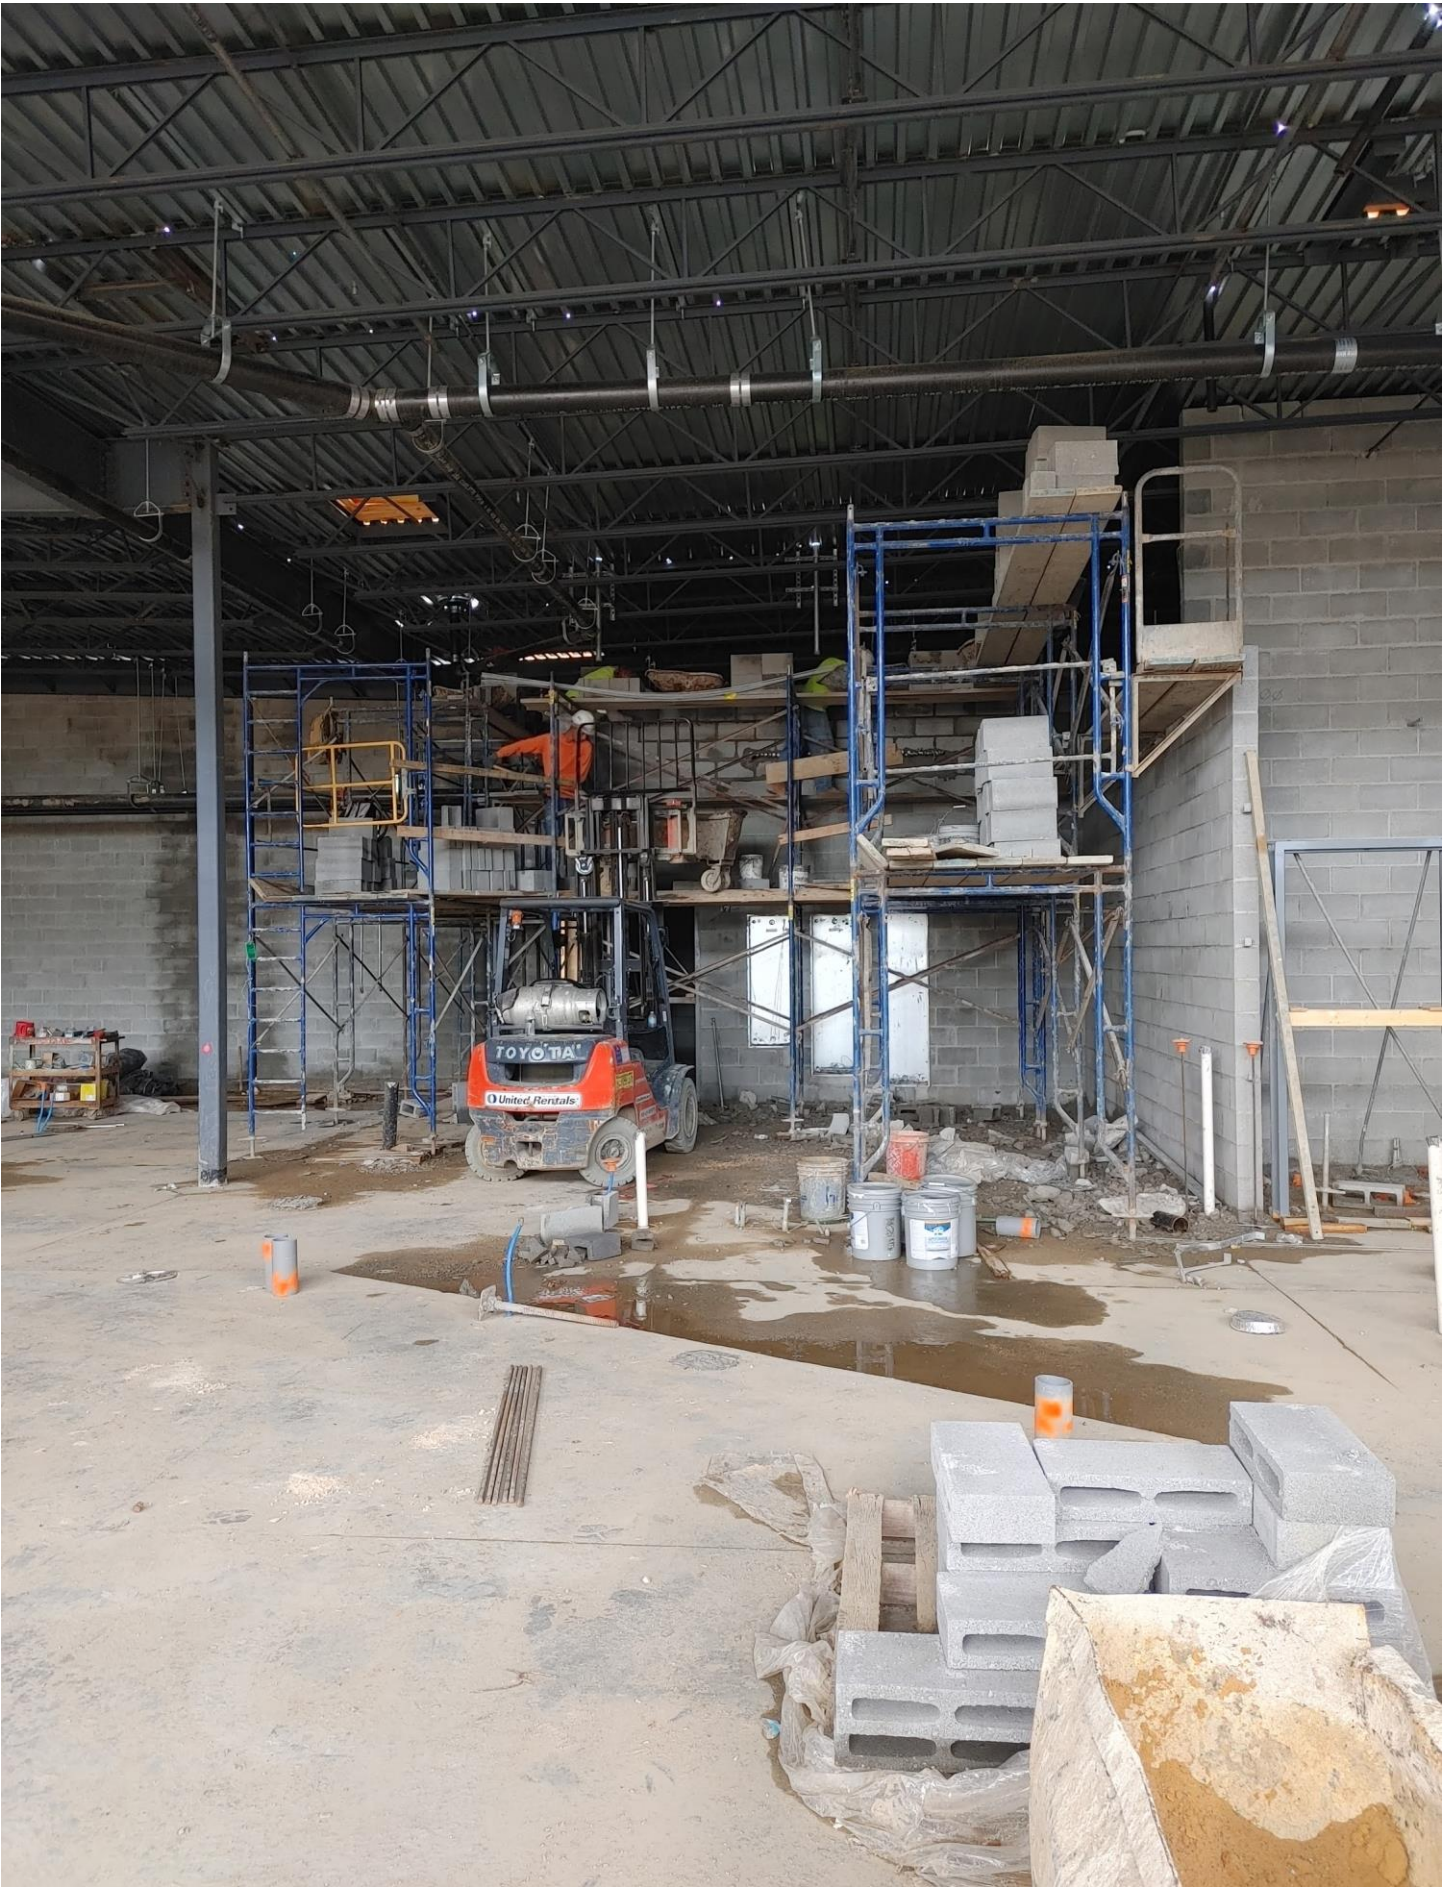
Photo 7 - Block continues to be laid in the Kitchen.

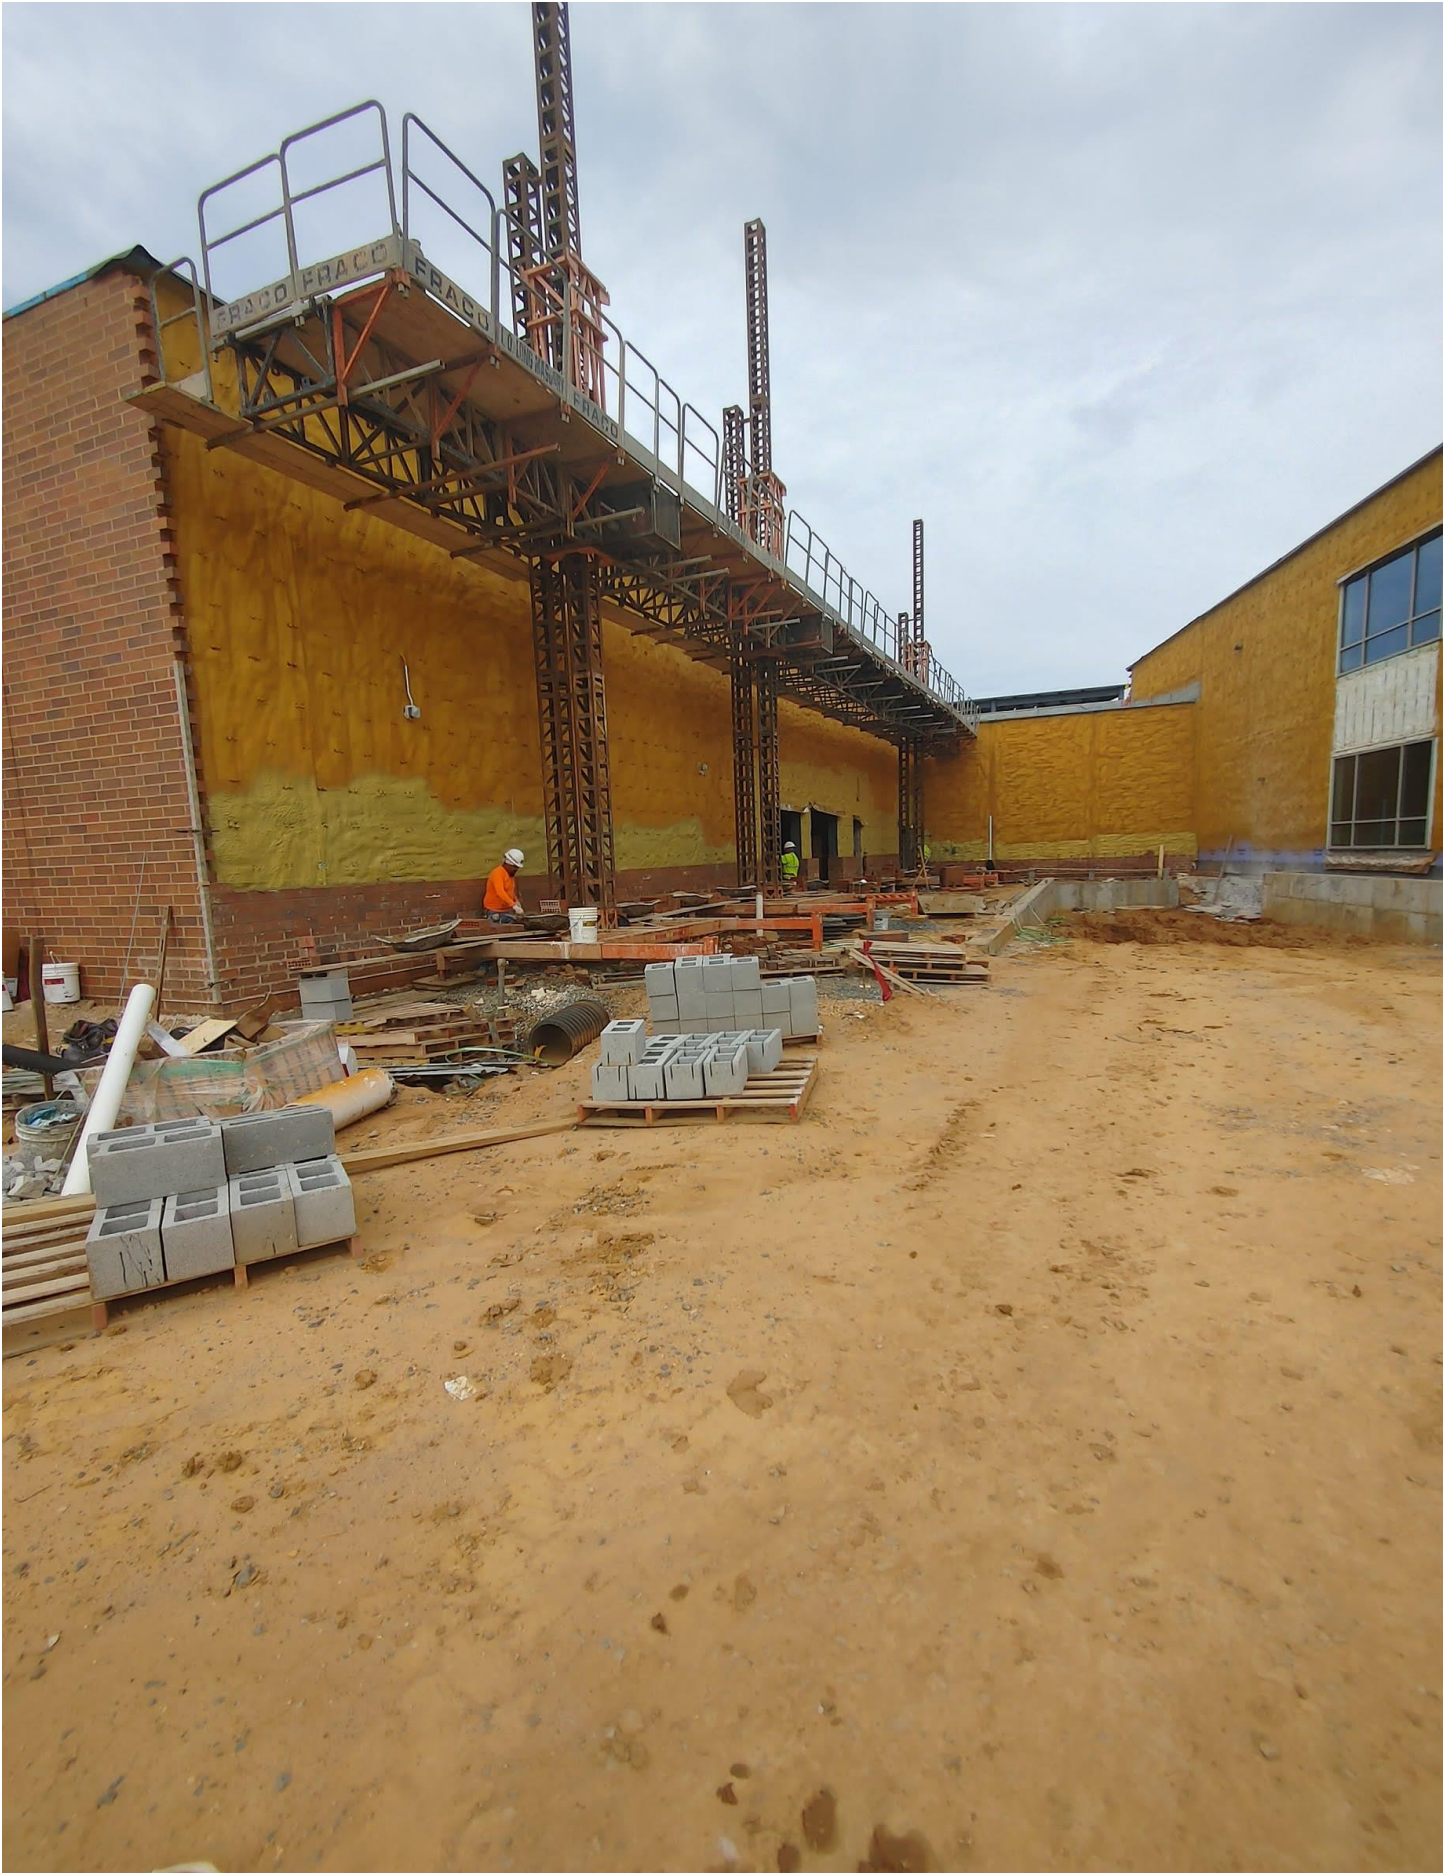
Photo 8 - Brick is being laid on the North side of Area D and the East side of Area C.
