**COMMONWEALTH
BUILDING SOLUTIONS, LLC**

DAILY REPORT

WESTMORELAND COUNTY HIGH SCHOOL

Date: 06/08/2021
Weather: 82 degrees. Mostly Cloudy. High of 90 degrees today.
Hours Worked: 08:30hrs – 11:00hrs (2.5hrs) On Site.

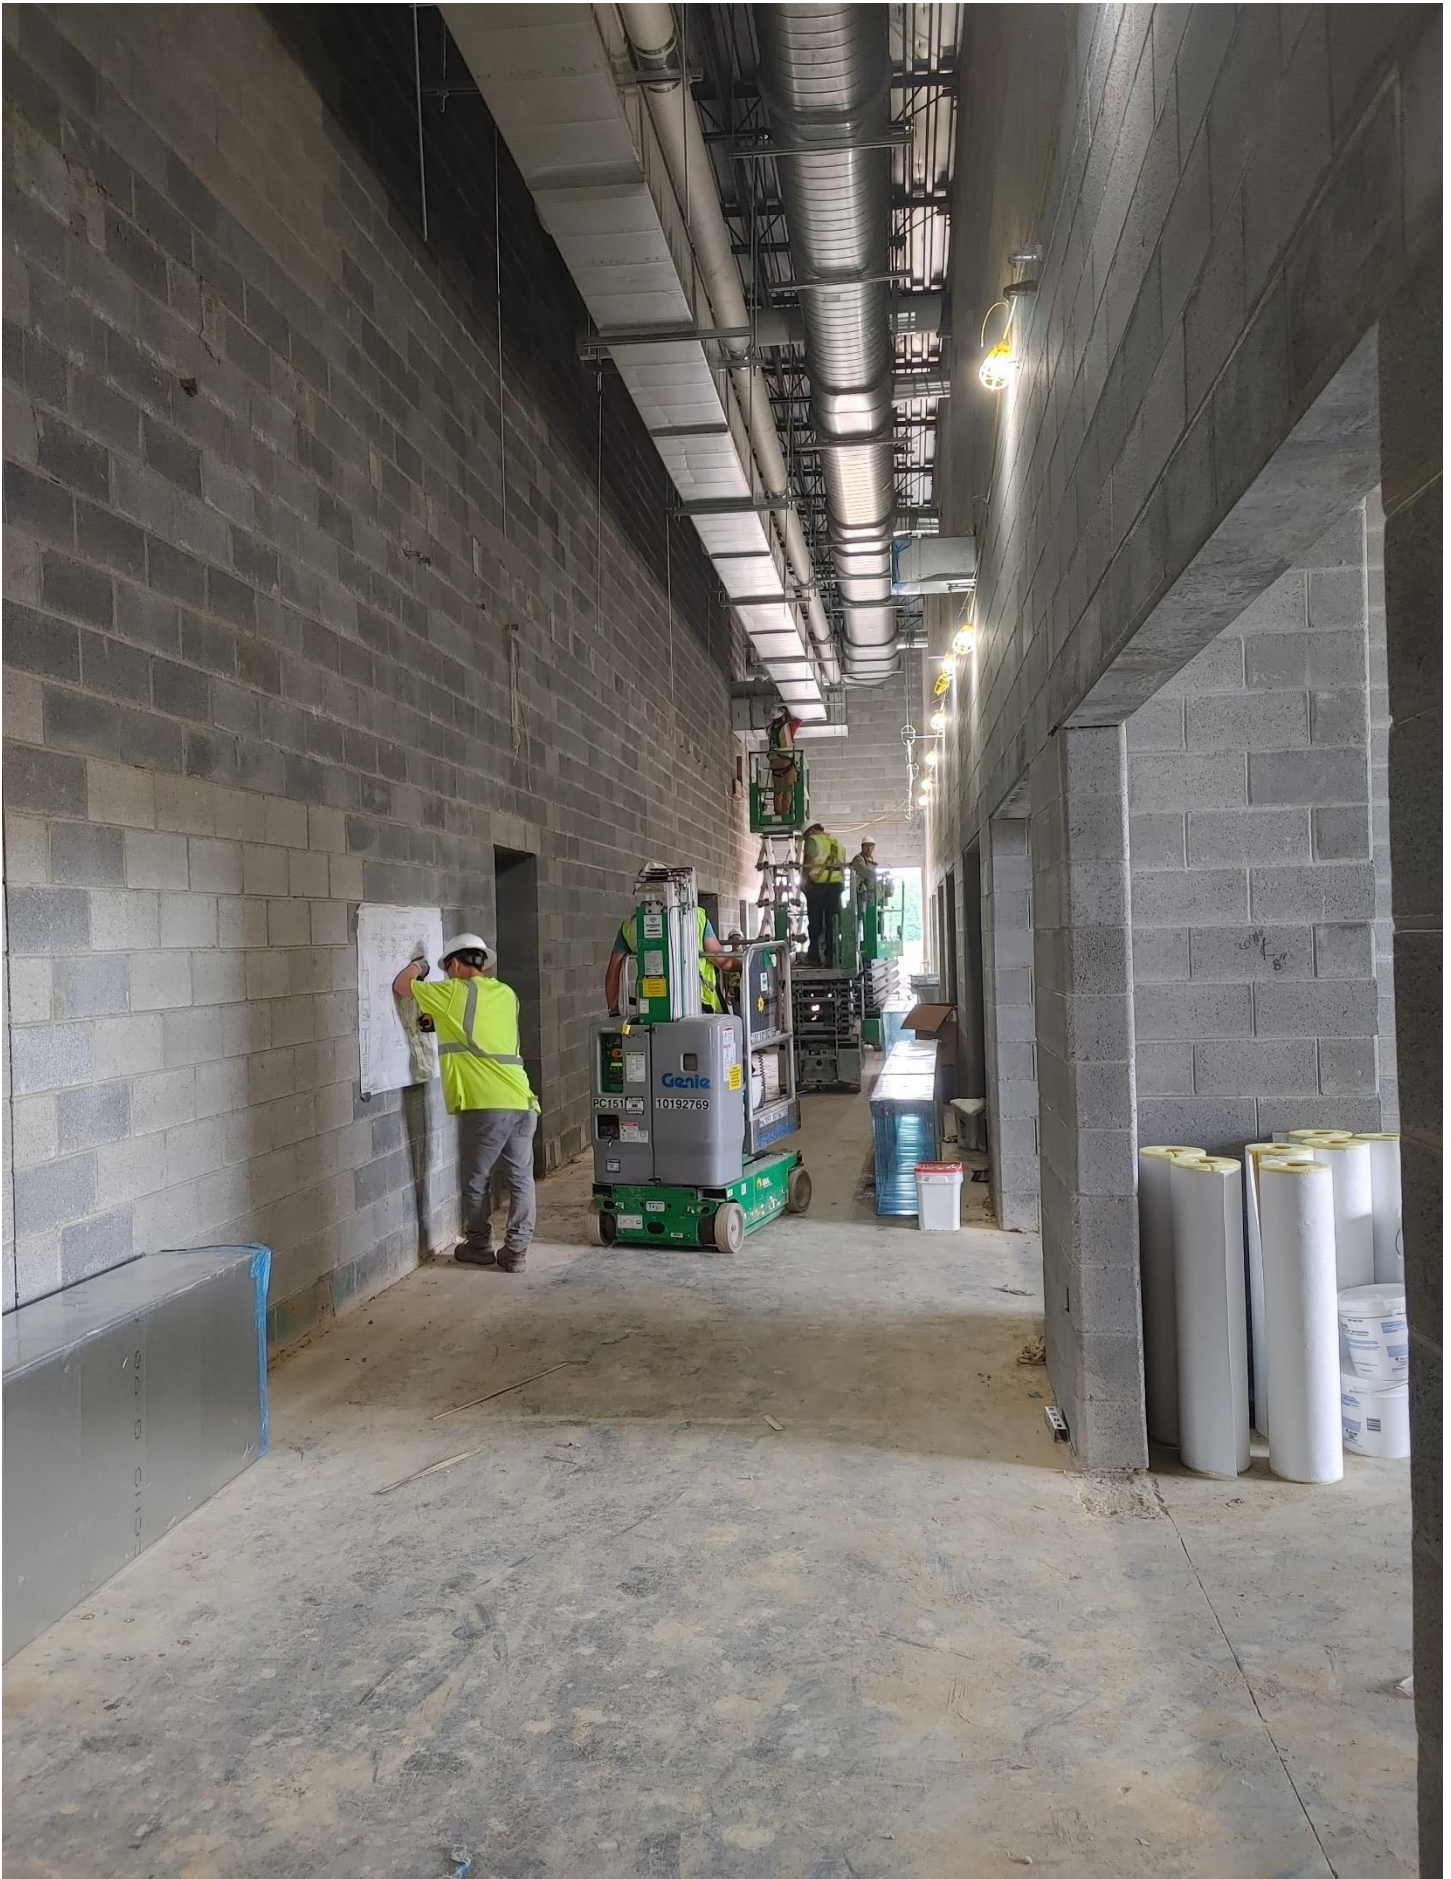
Photo 9 - HVAC Duct is being run in Area D.

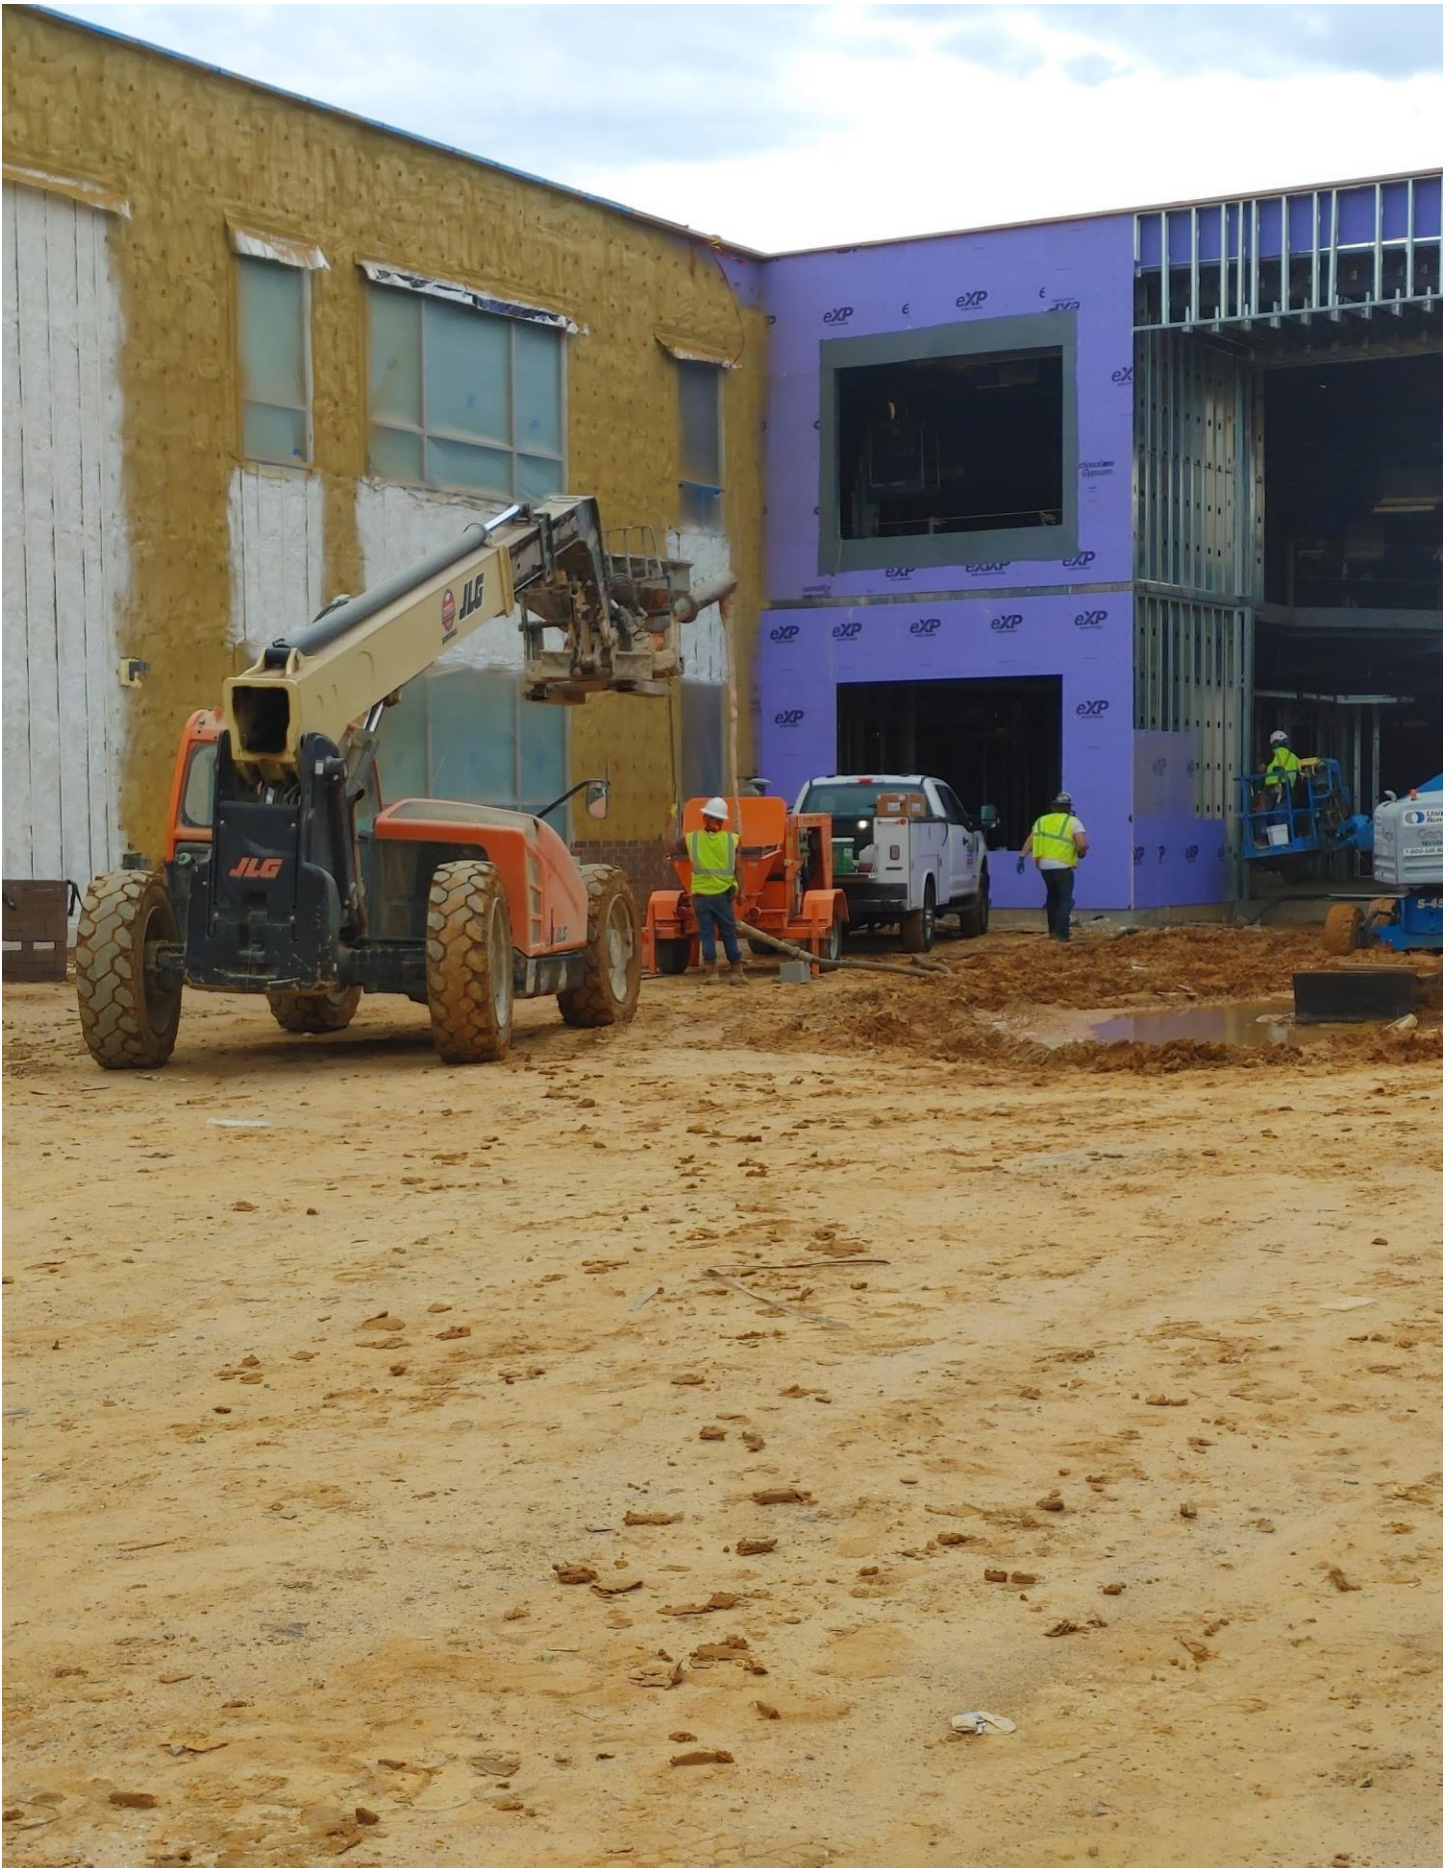
Photo 10 - The Masons are grouting block in Area C.

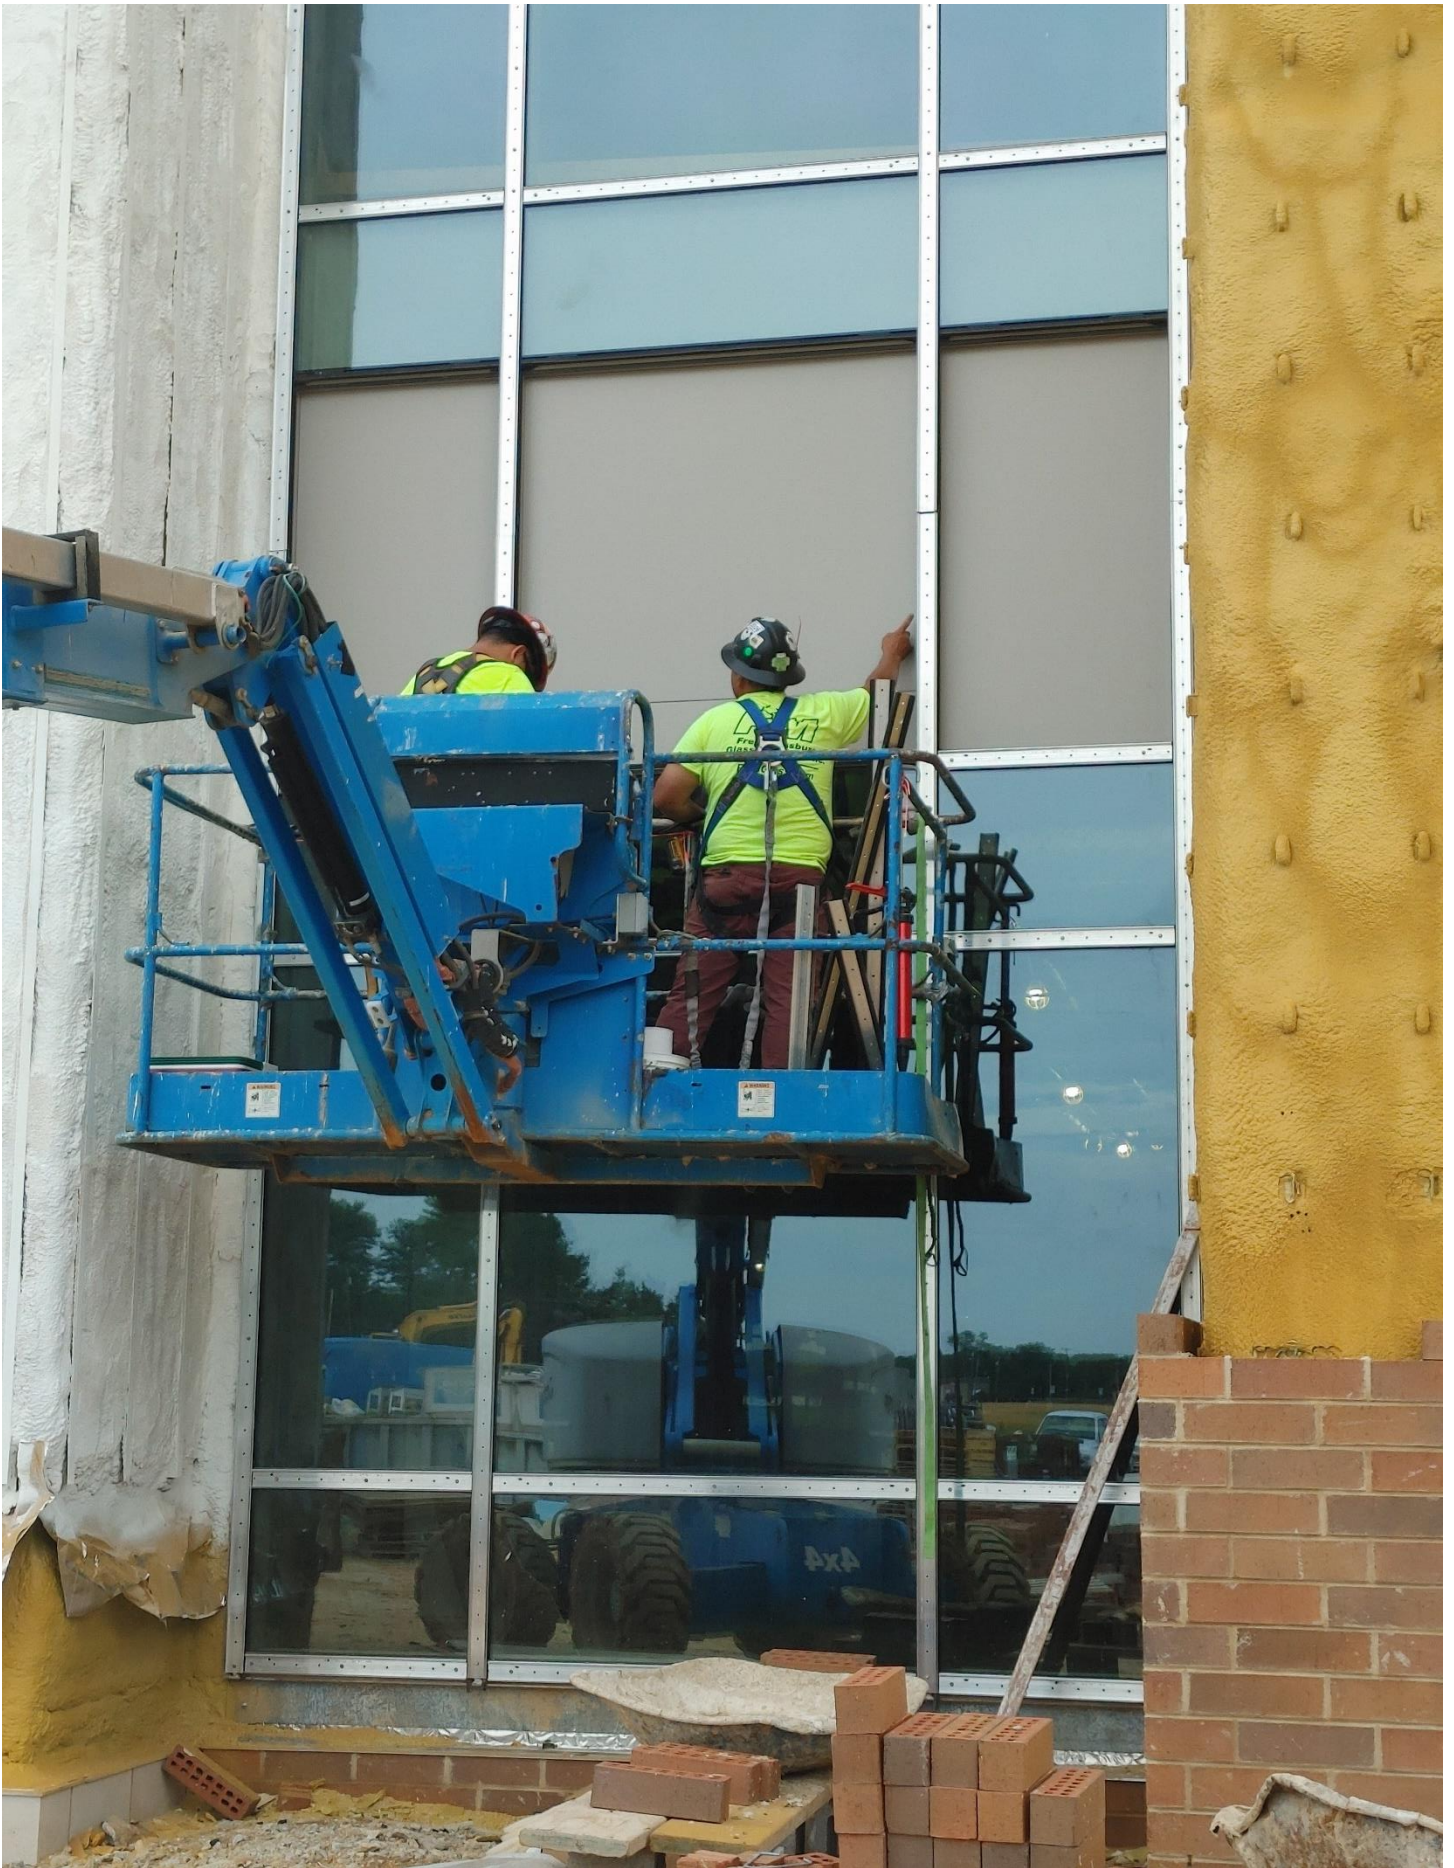
Photo 11 FG&M is working on the Curtainwall on the West side of Area B.

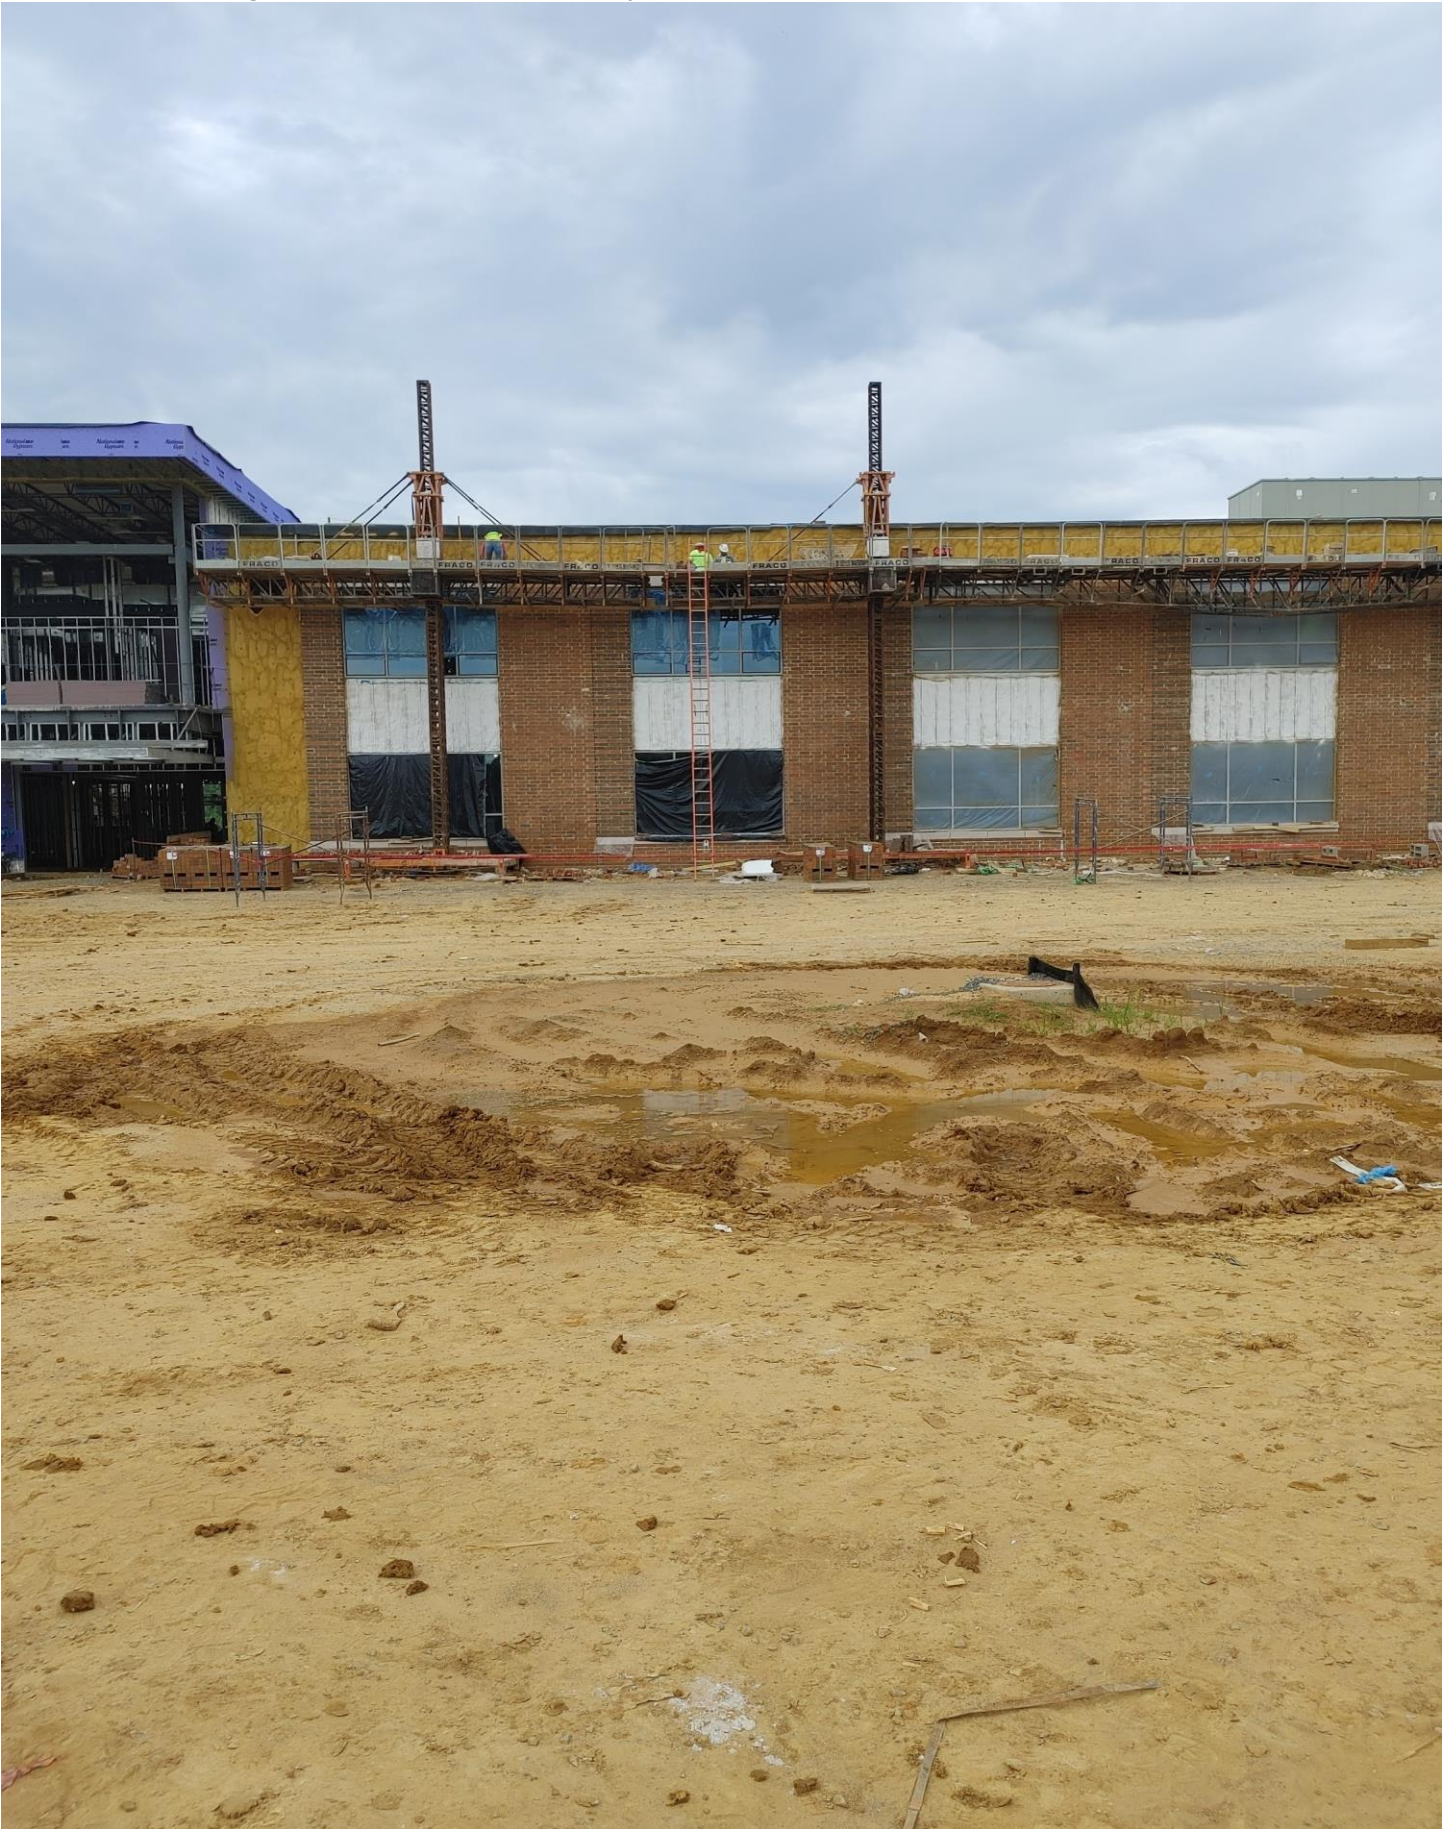
Photo 12 - Brick is being laid on the North side of Area B.
