## DAILY REPORT

## WESTMORELAND COUNTY HIGH SCHOOL

Date:	06/17/2021
Weather:	70 degrees. Sunny. High of 80 degrees today.
Hours Worked:	09:00hrs – 12:00hrs (3hrs) On Site.
	I met with Todd Demetriou yesterday afternoon to discuss the status of the 12" water line and the Third Party Inspections of the BMPs. The Contractor installing the Water Line said that best case he would be ready for the line to be tested in Mid-August. Worst Case would be October. We will discuss this at the next Progress Meeting on June 23, 2021. Hillis-Carnes is also requesting a Schedule for the BMPs and Todd is working on getting it together.
	Beuchert Excavation: No one is on site today.
	Industrial Concrete: I counted eight (8) men on site today. They poured the Generator Pad yesterday and are now forming up the Fuel Tank and Chiller Pads.
	J.D. Long, Masons: Twenty-one (21) men are here today. They are laying Brick on the West and South side of Area B and they are Laying Block in Area D.

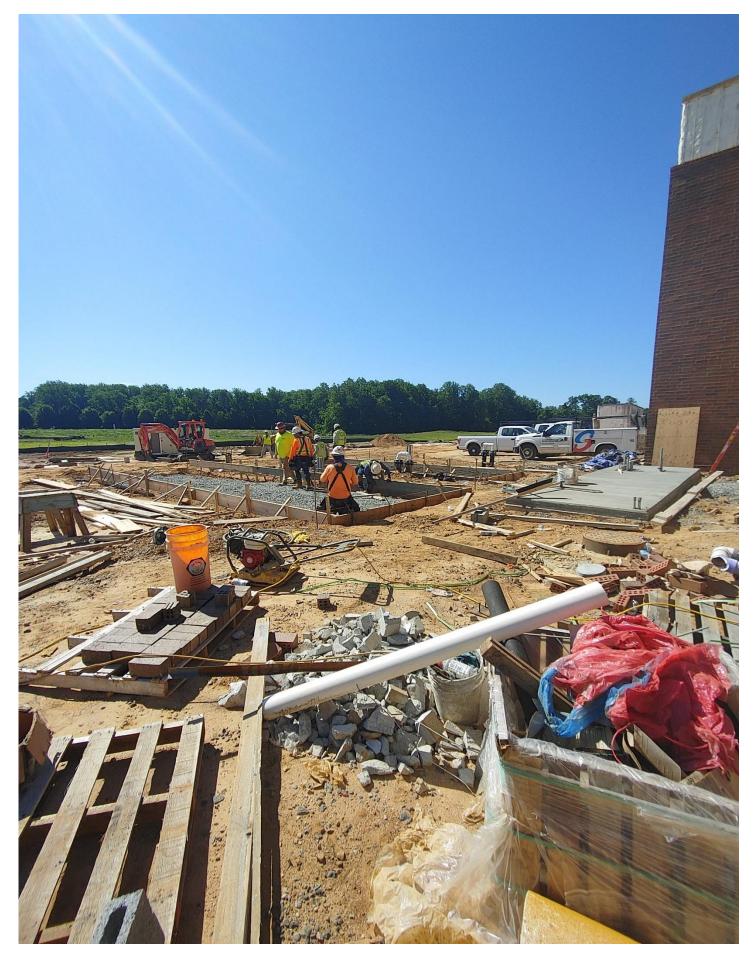
Photo 1 - Generator Pad has been poured. Forming up the Fuel Tank and Chiller slabs.

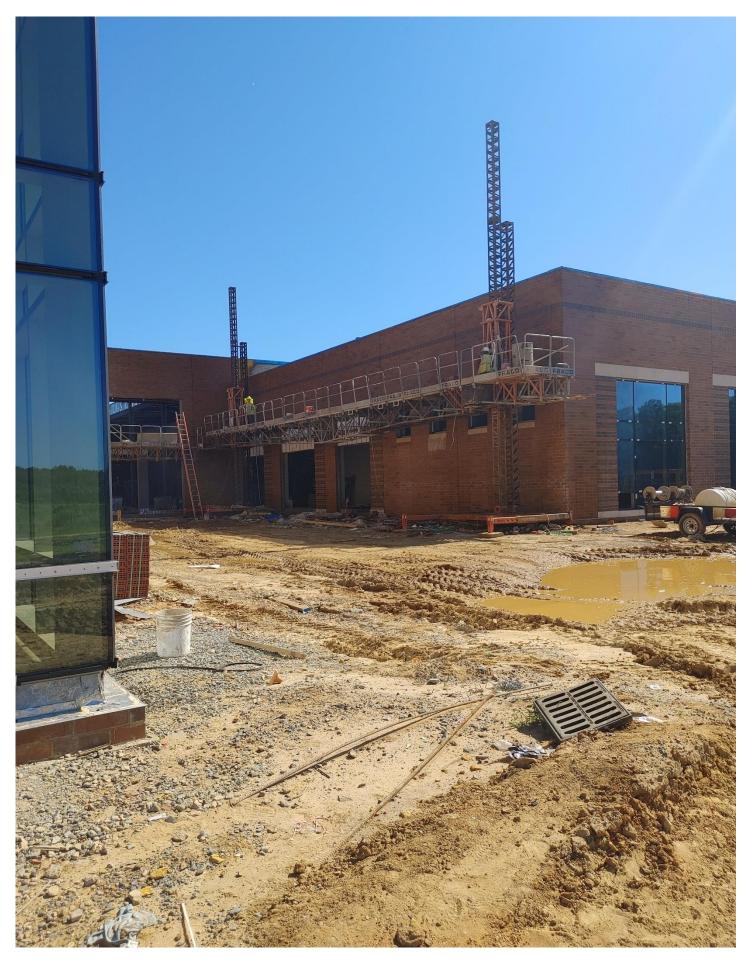
Photo 2 - Brick is being power washed on the West side of Area D.

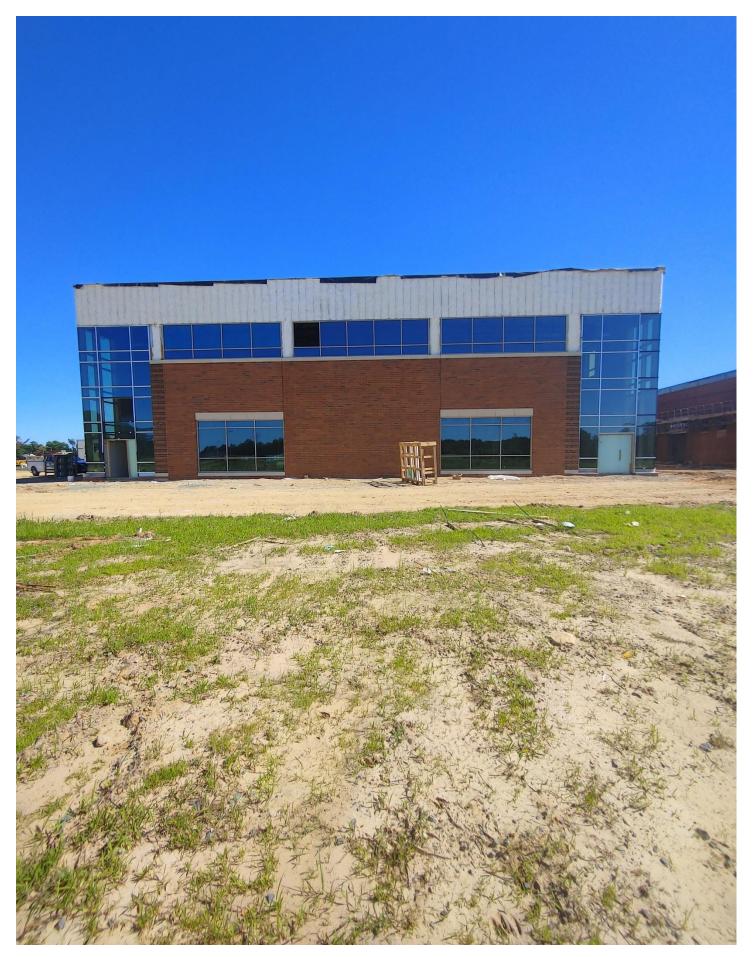
Photo 3 - All but two pieces of glass has been installed in the Gym.

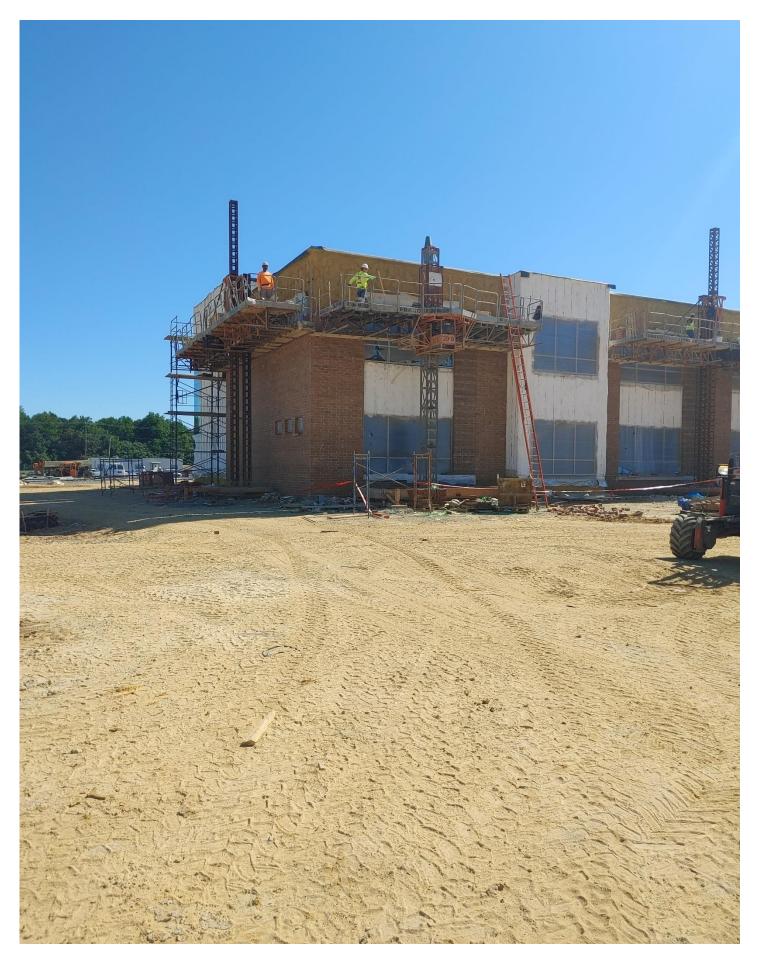
Photo 4 - Masons are laying brick on the West and South side of Area B.

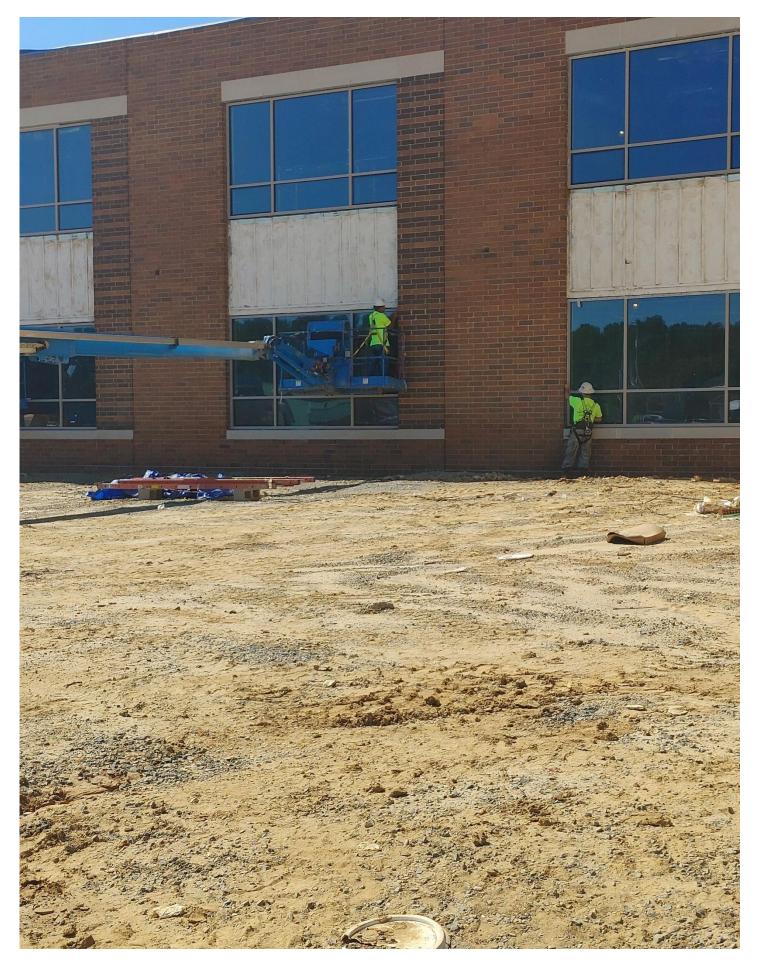
Photo 5 - FM&G installing Backer Rod around windows in Area A.

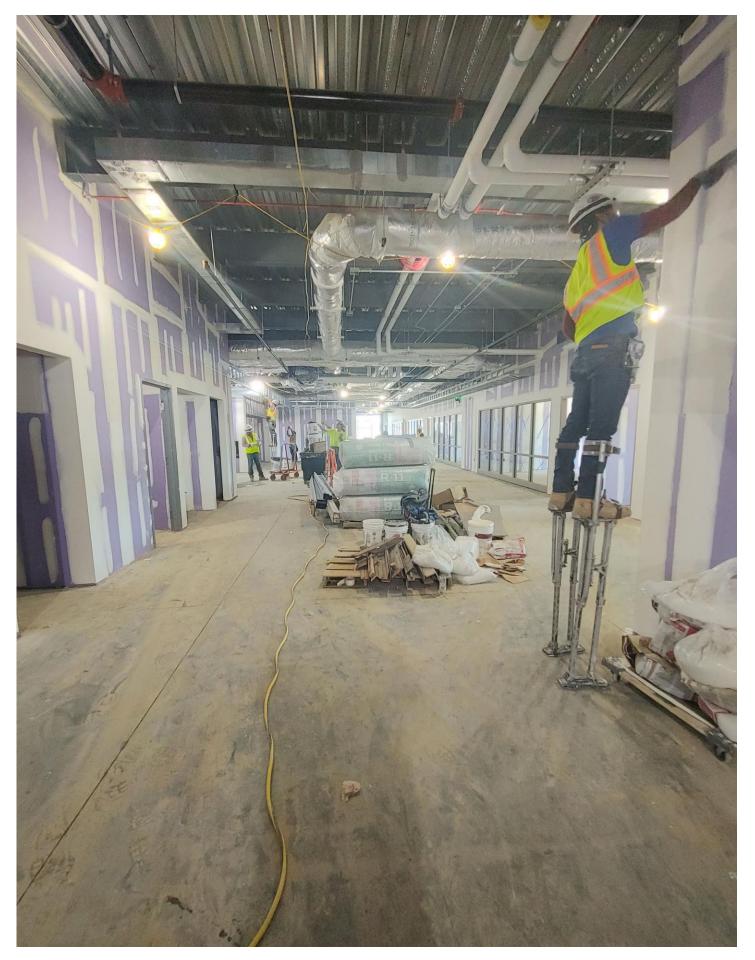
Photo 6 - Sheetrock is being finished and Bulk Heads constructed on the 1st floor of Area B.

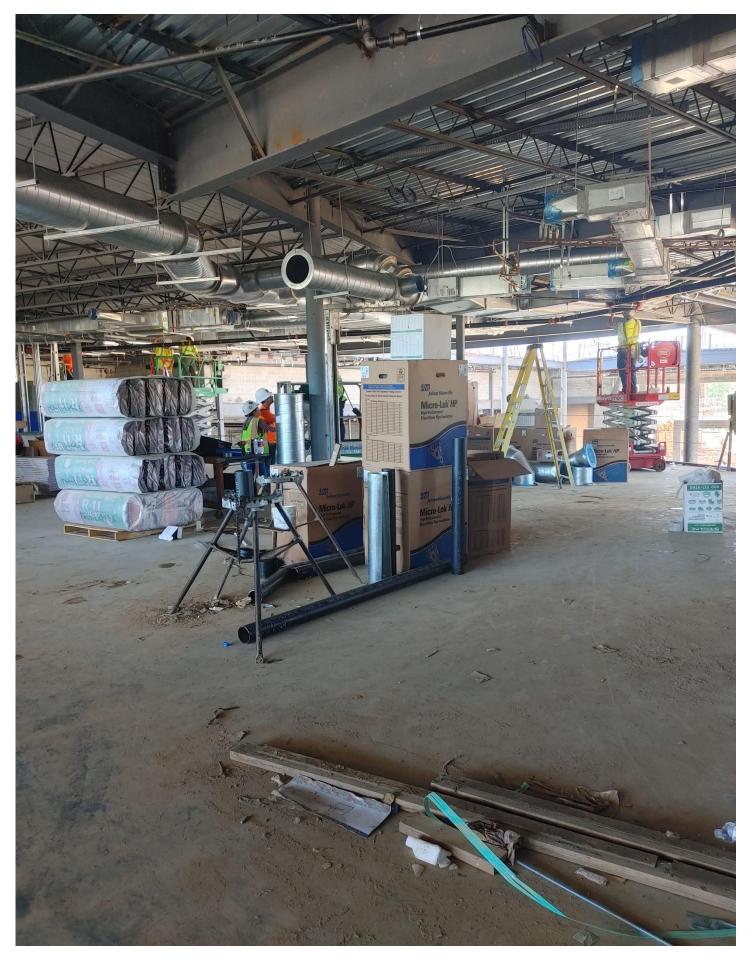
Photo 7 - Duct work is being run and pipe is being insulated in Area A.

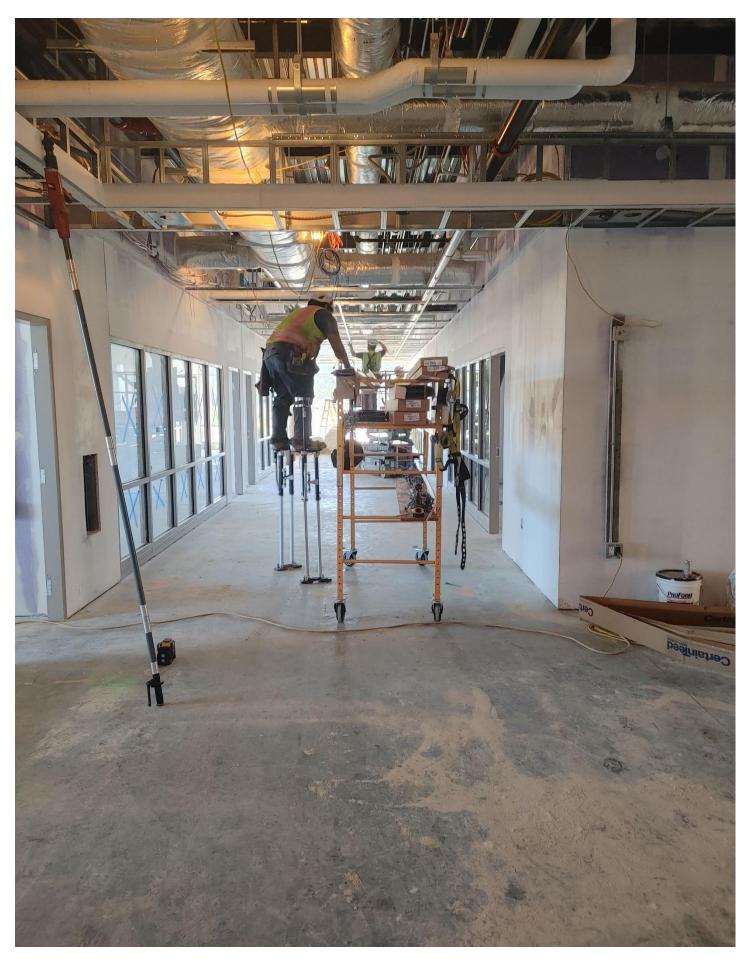
Photo 8 - Ceiling Grid is being run on the 1<sup>st</sup> floor of Area A.

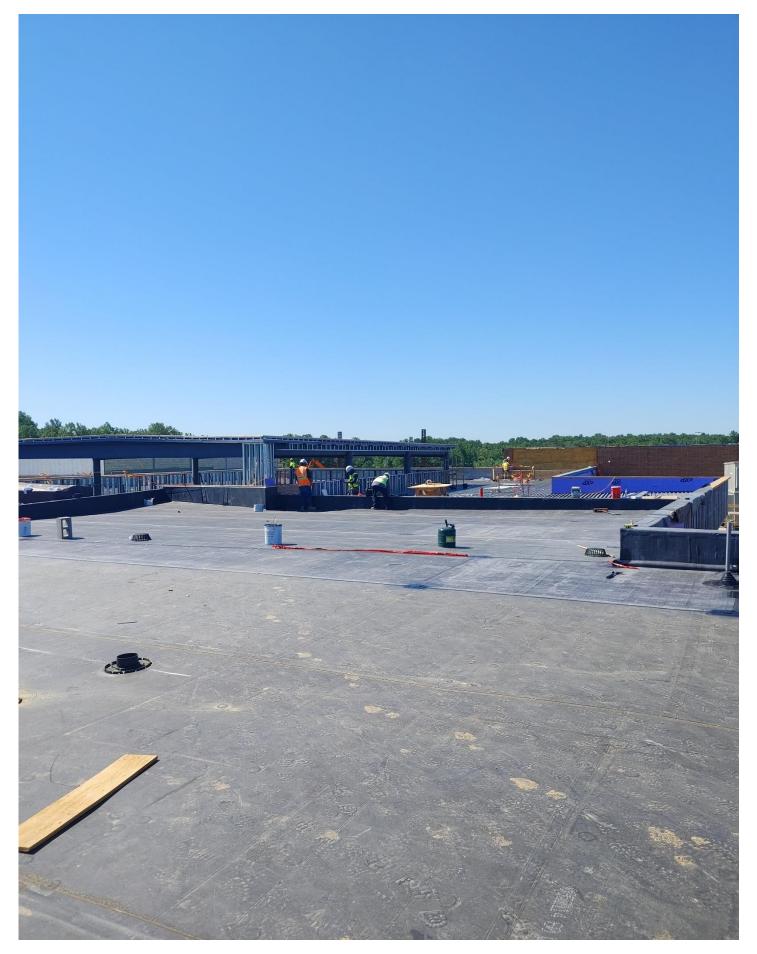
Photo 9 - Roofers are working on the Parapet Wall between Area A & C.

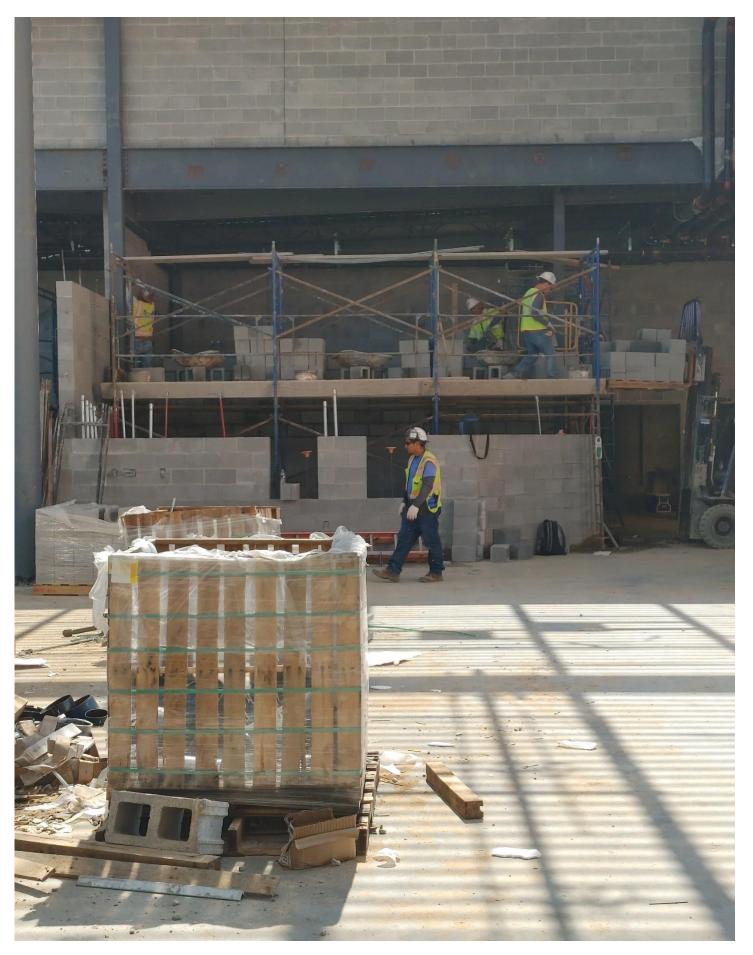
Photo 10 Masons are laying Block in Area D.

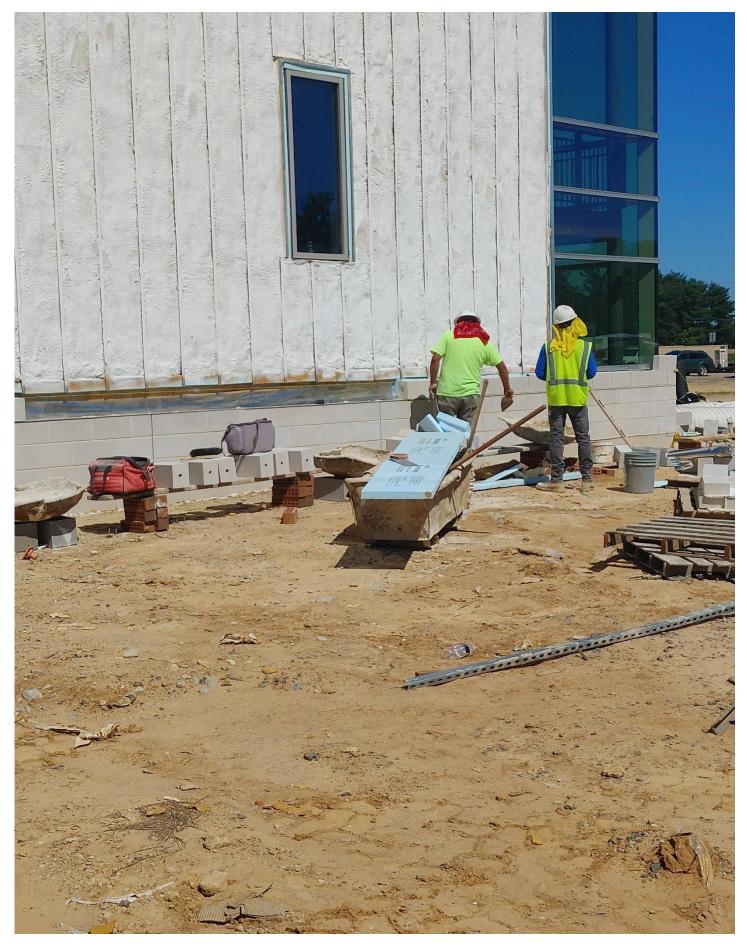
Photo 11 - Pre-cast is being laid on the East side of Stairwell #1.
