**DAILY REPORT**

**WESTMORELAND COUNTY HIGH SCHOOL**

Date: 06/23/2021

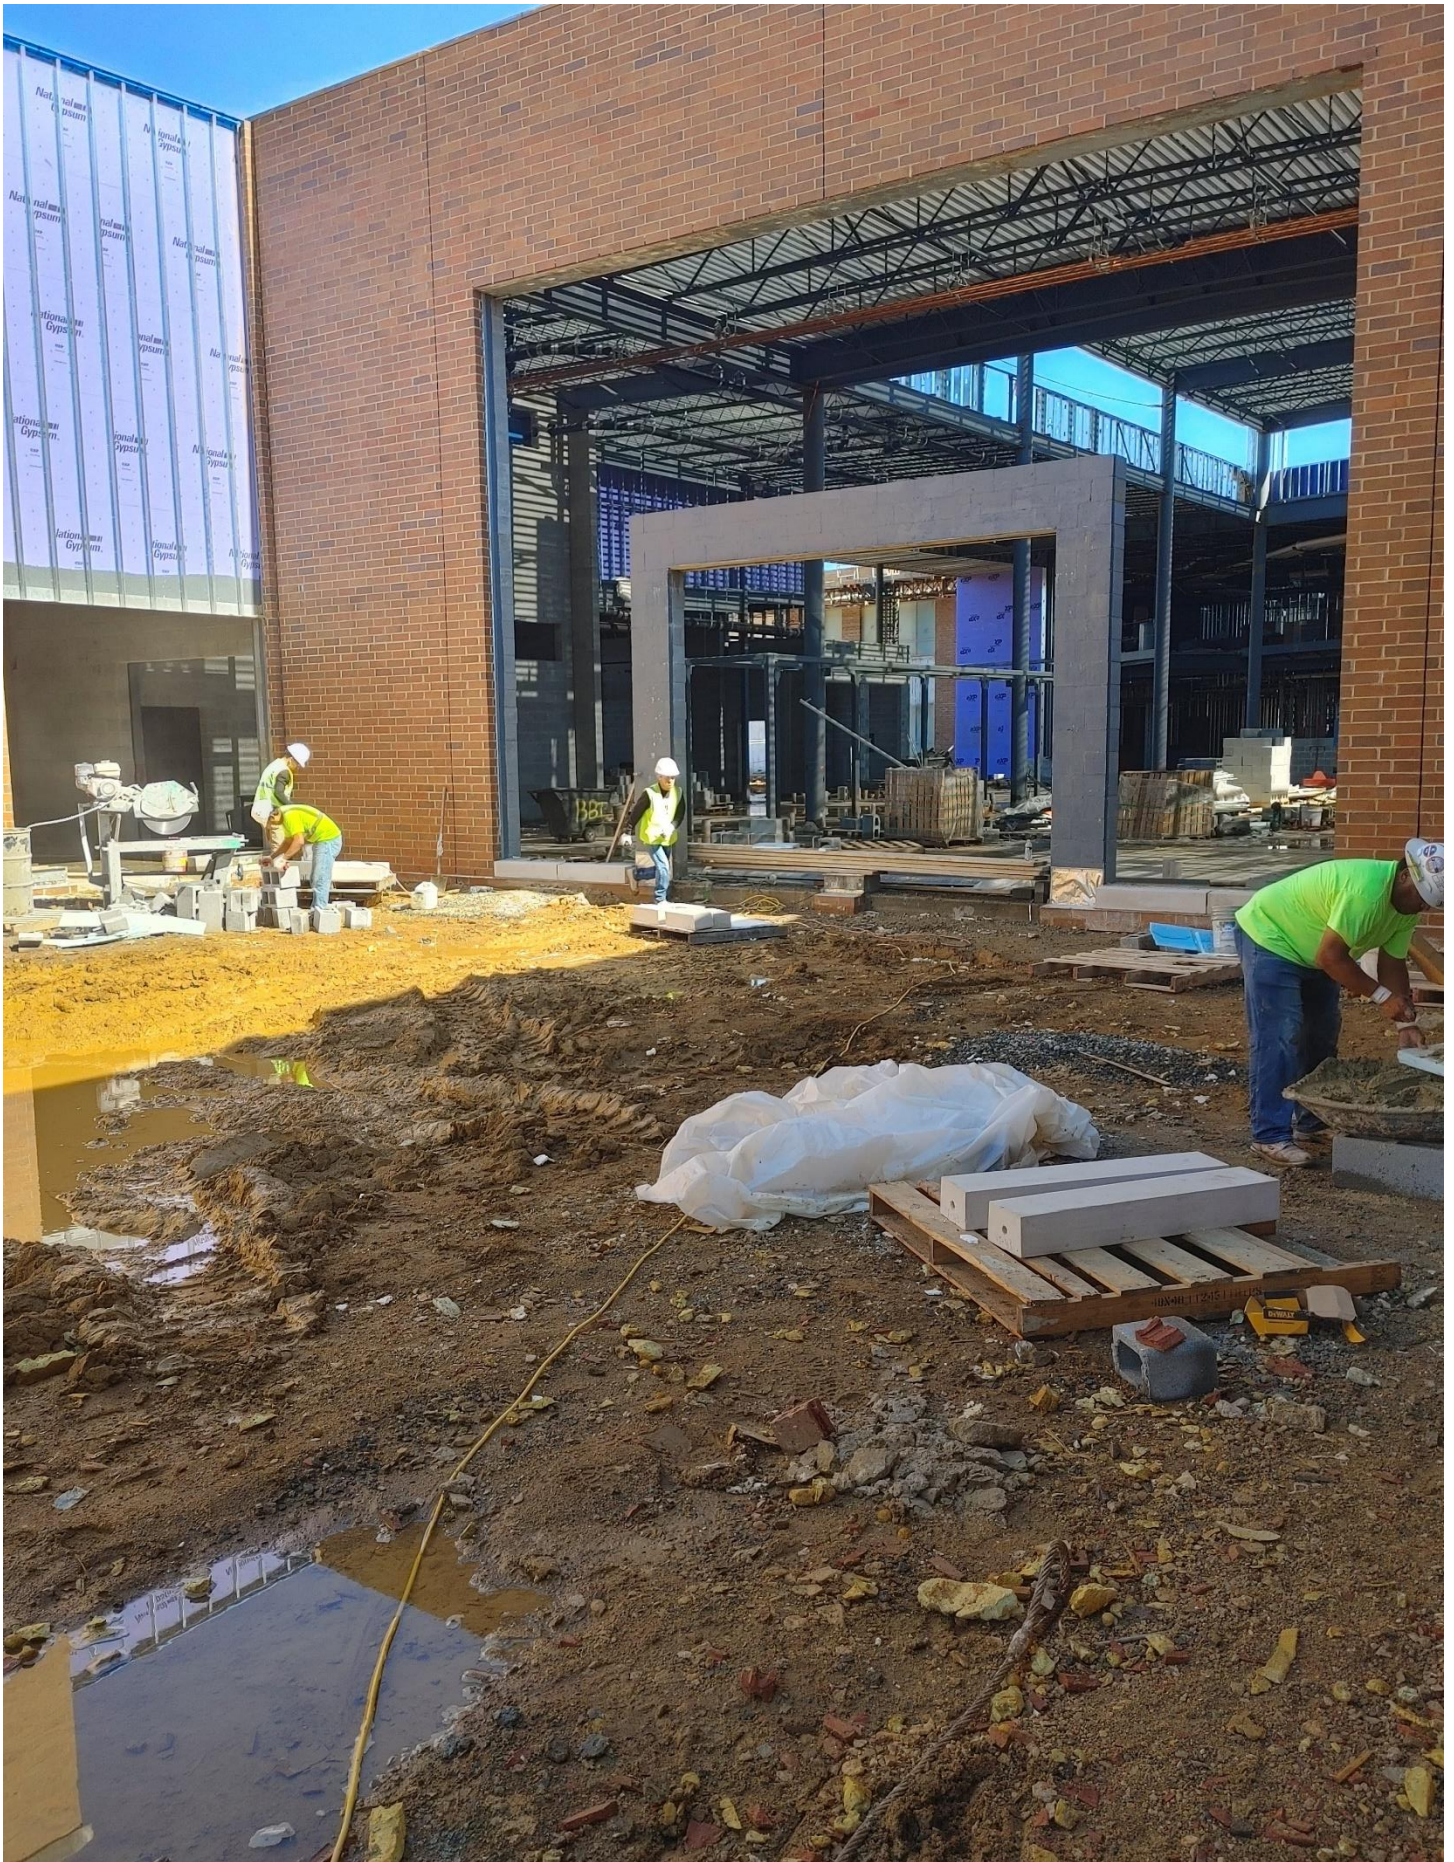
Photo 1 - Masons are laying Pre-cast on the South side of Area C

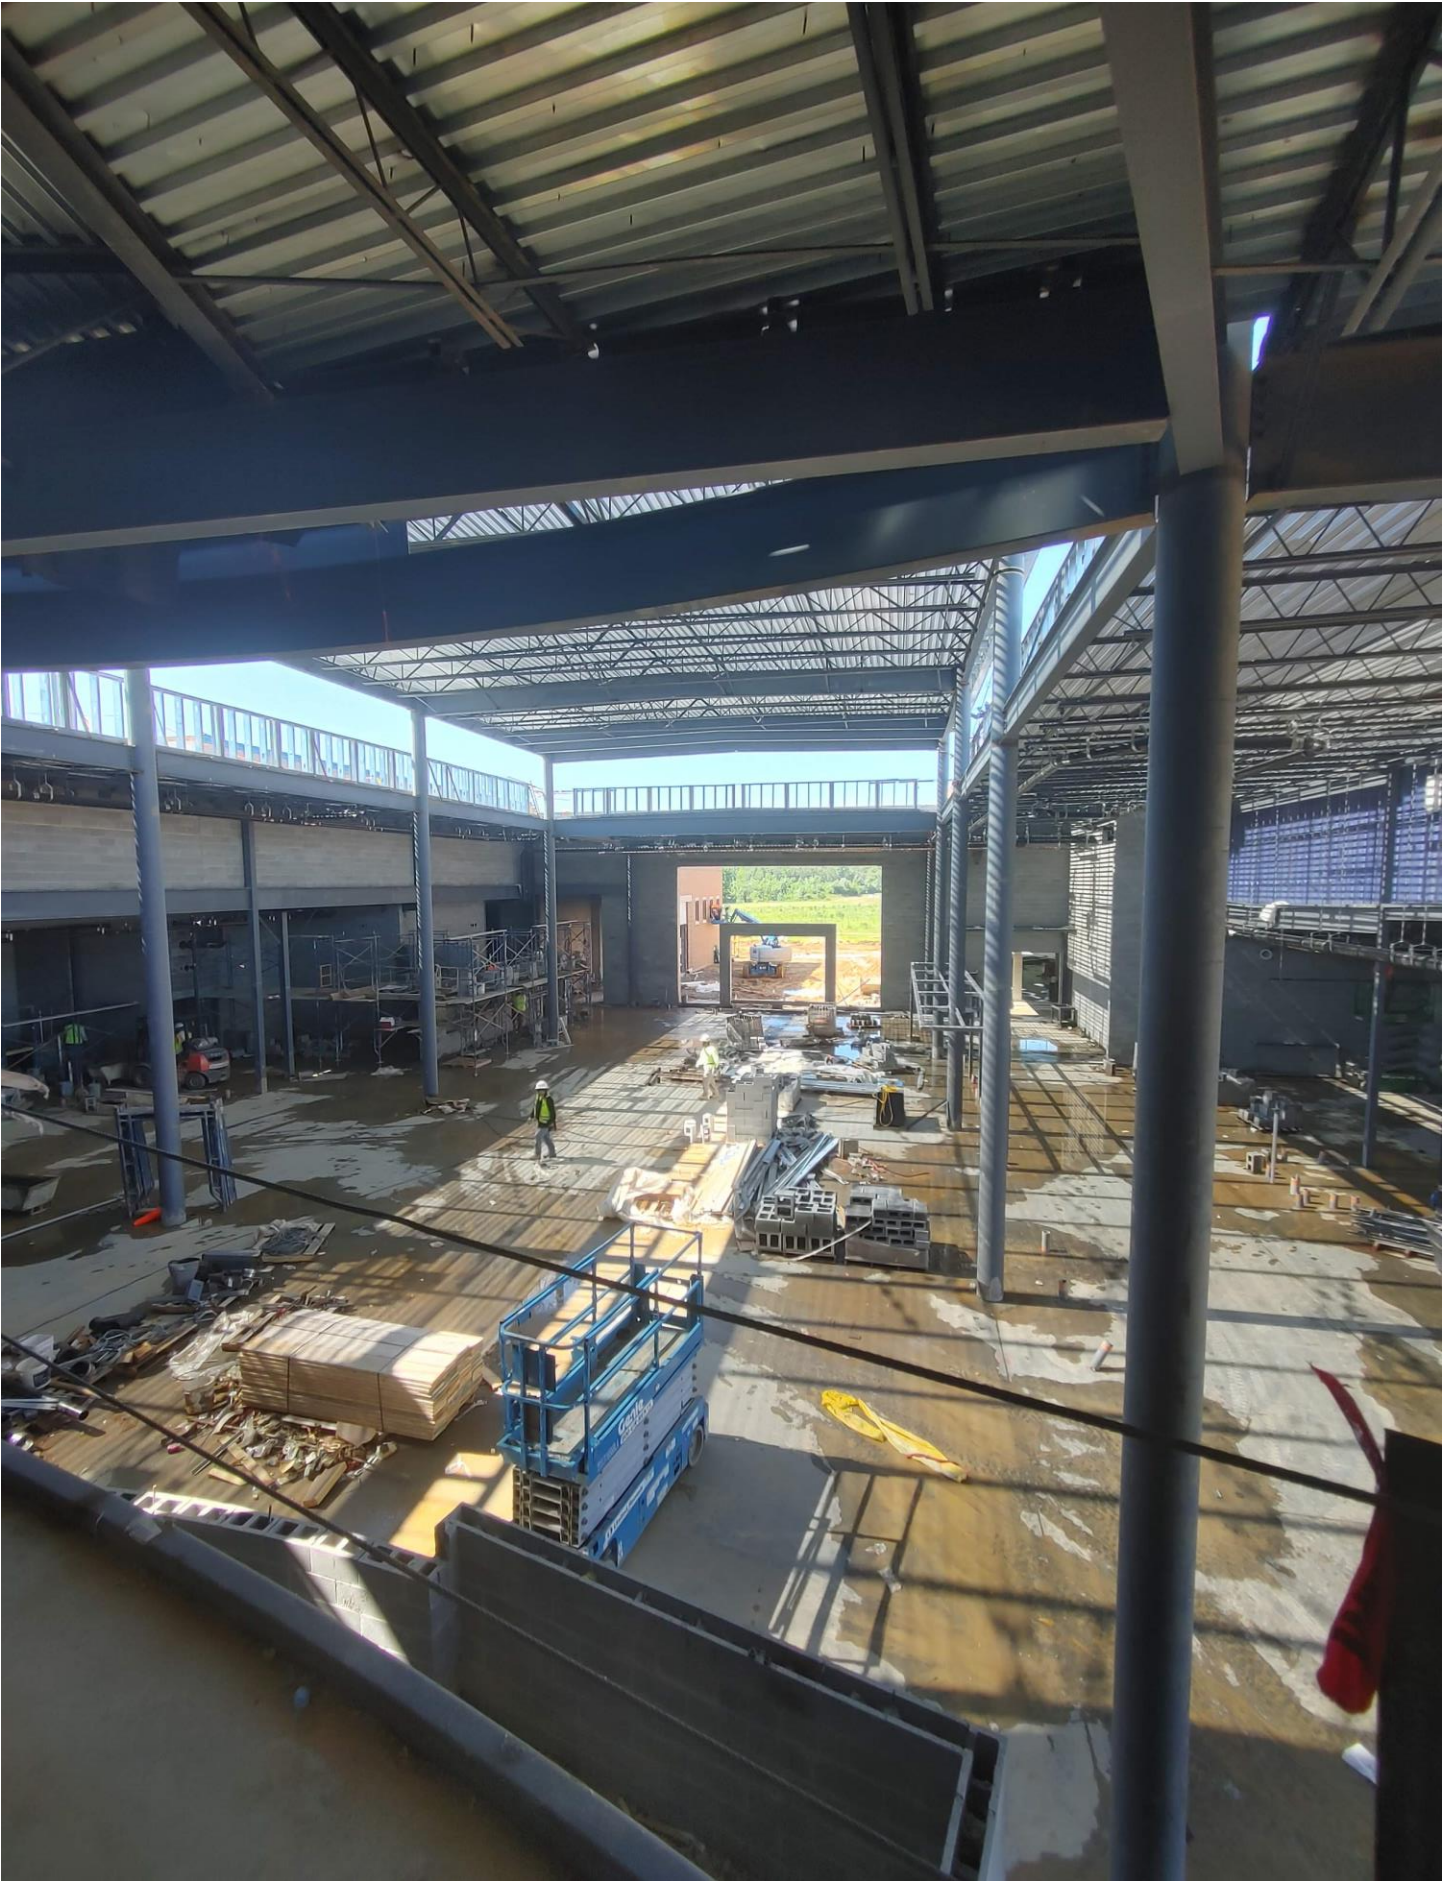
Photo 2 - View from the 2nd floor of Area A into Area C

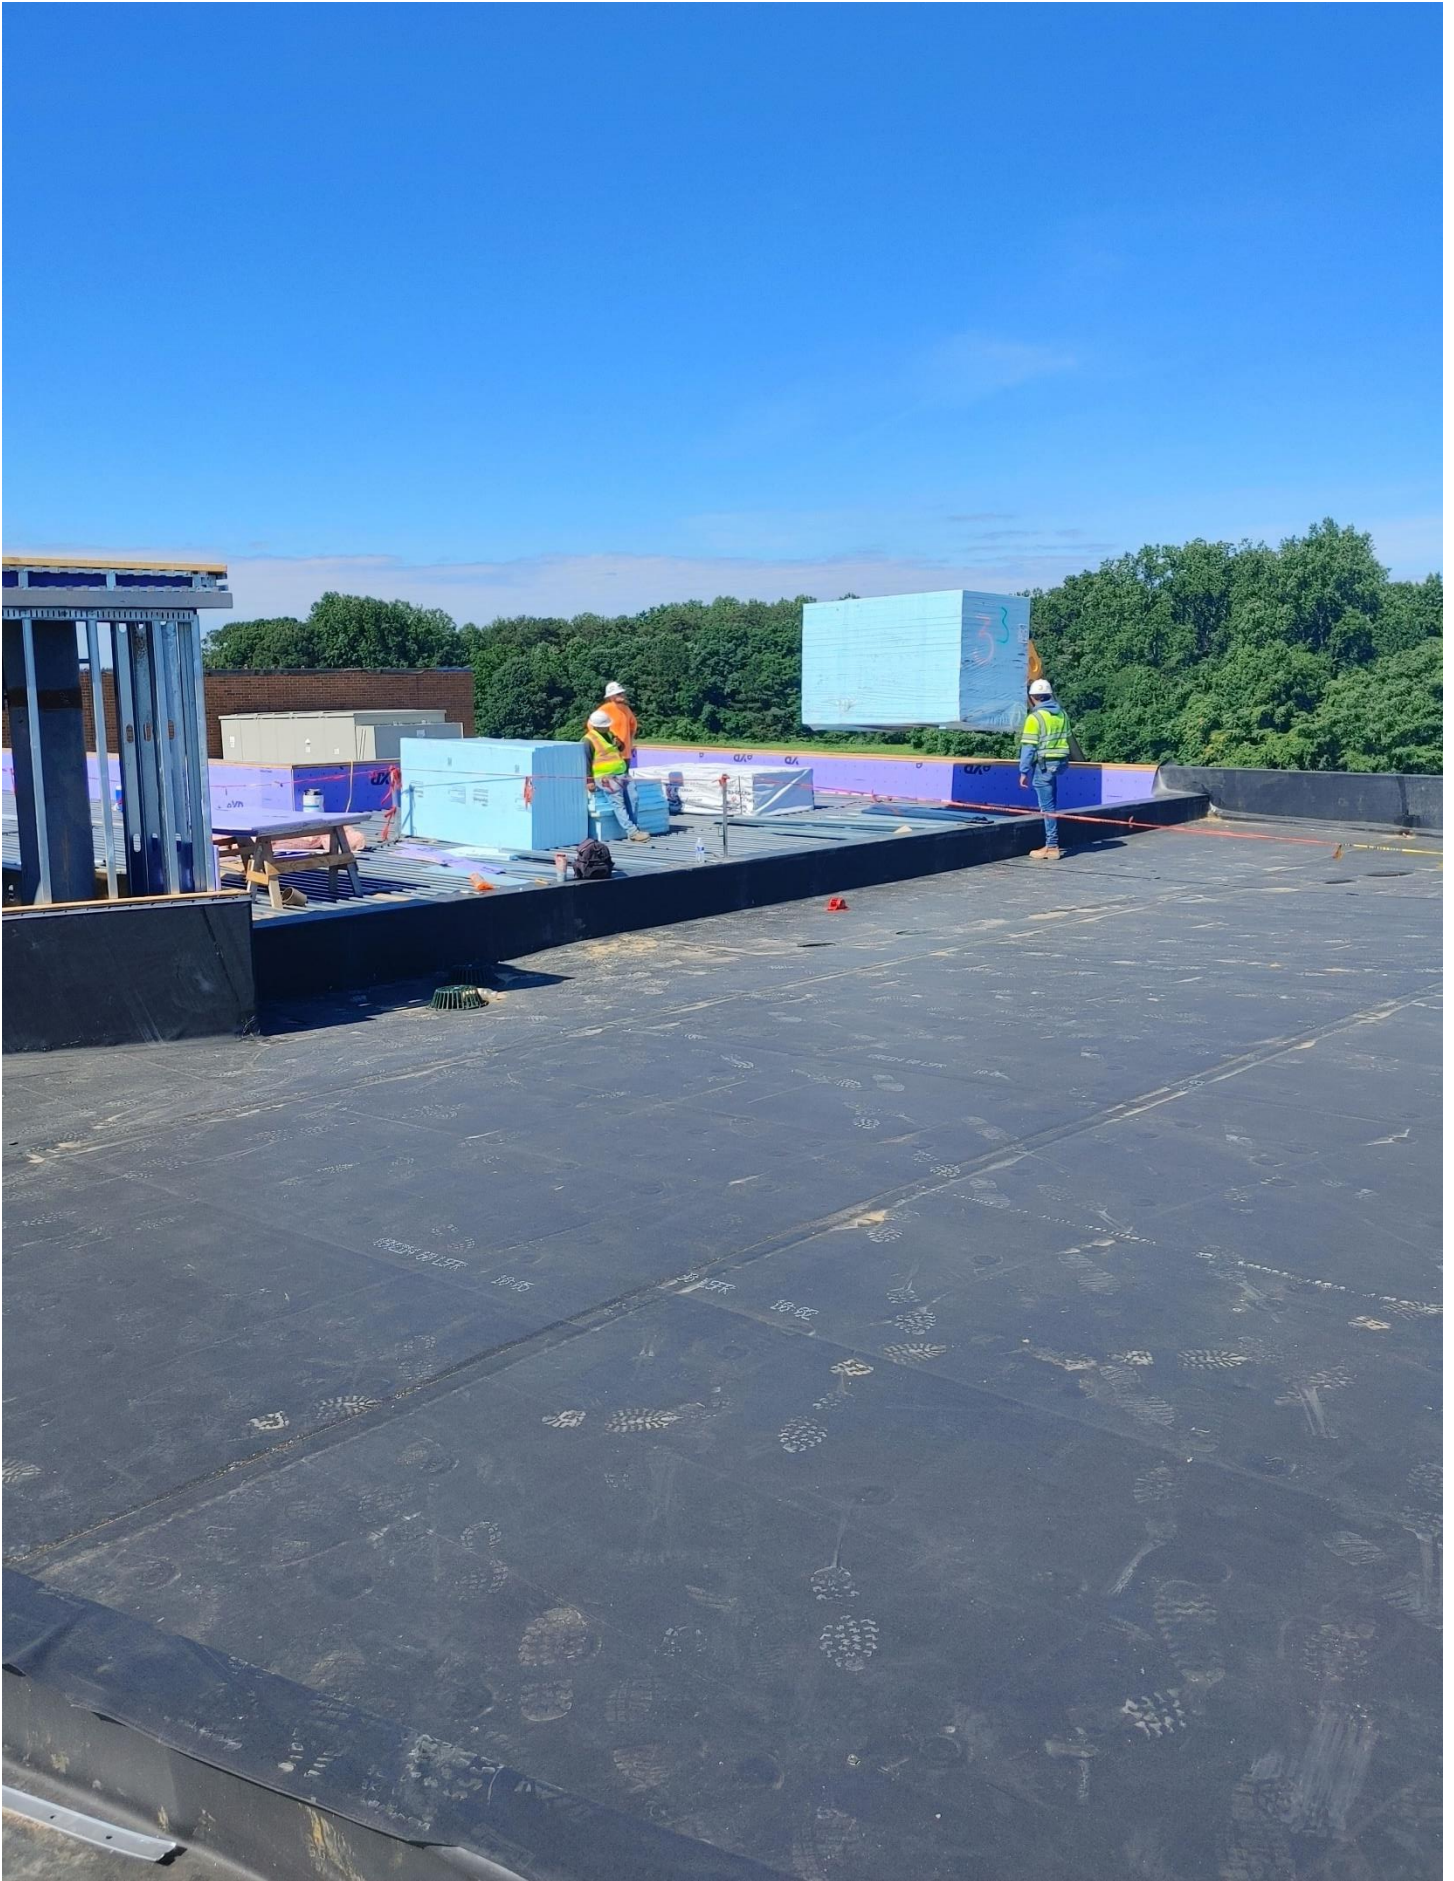
**AAR Roofing:** Four (4) men are on site today working on the Roof of Area C.

Photo 3 - Roofers are working on the Roof of Area C.

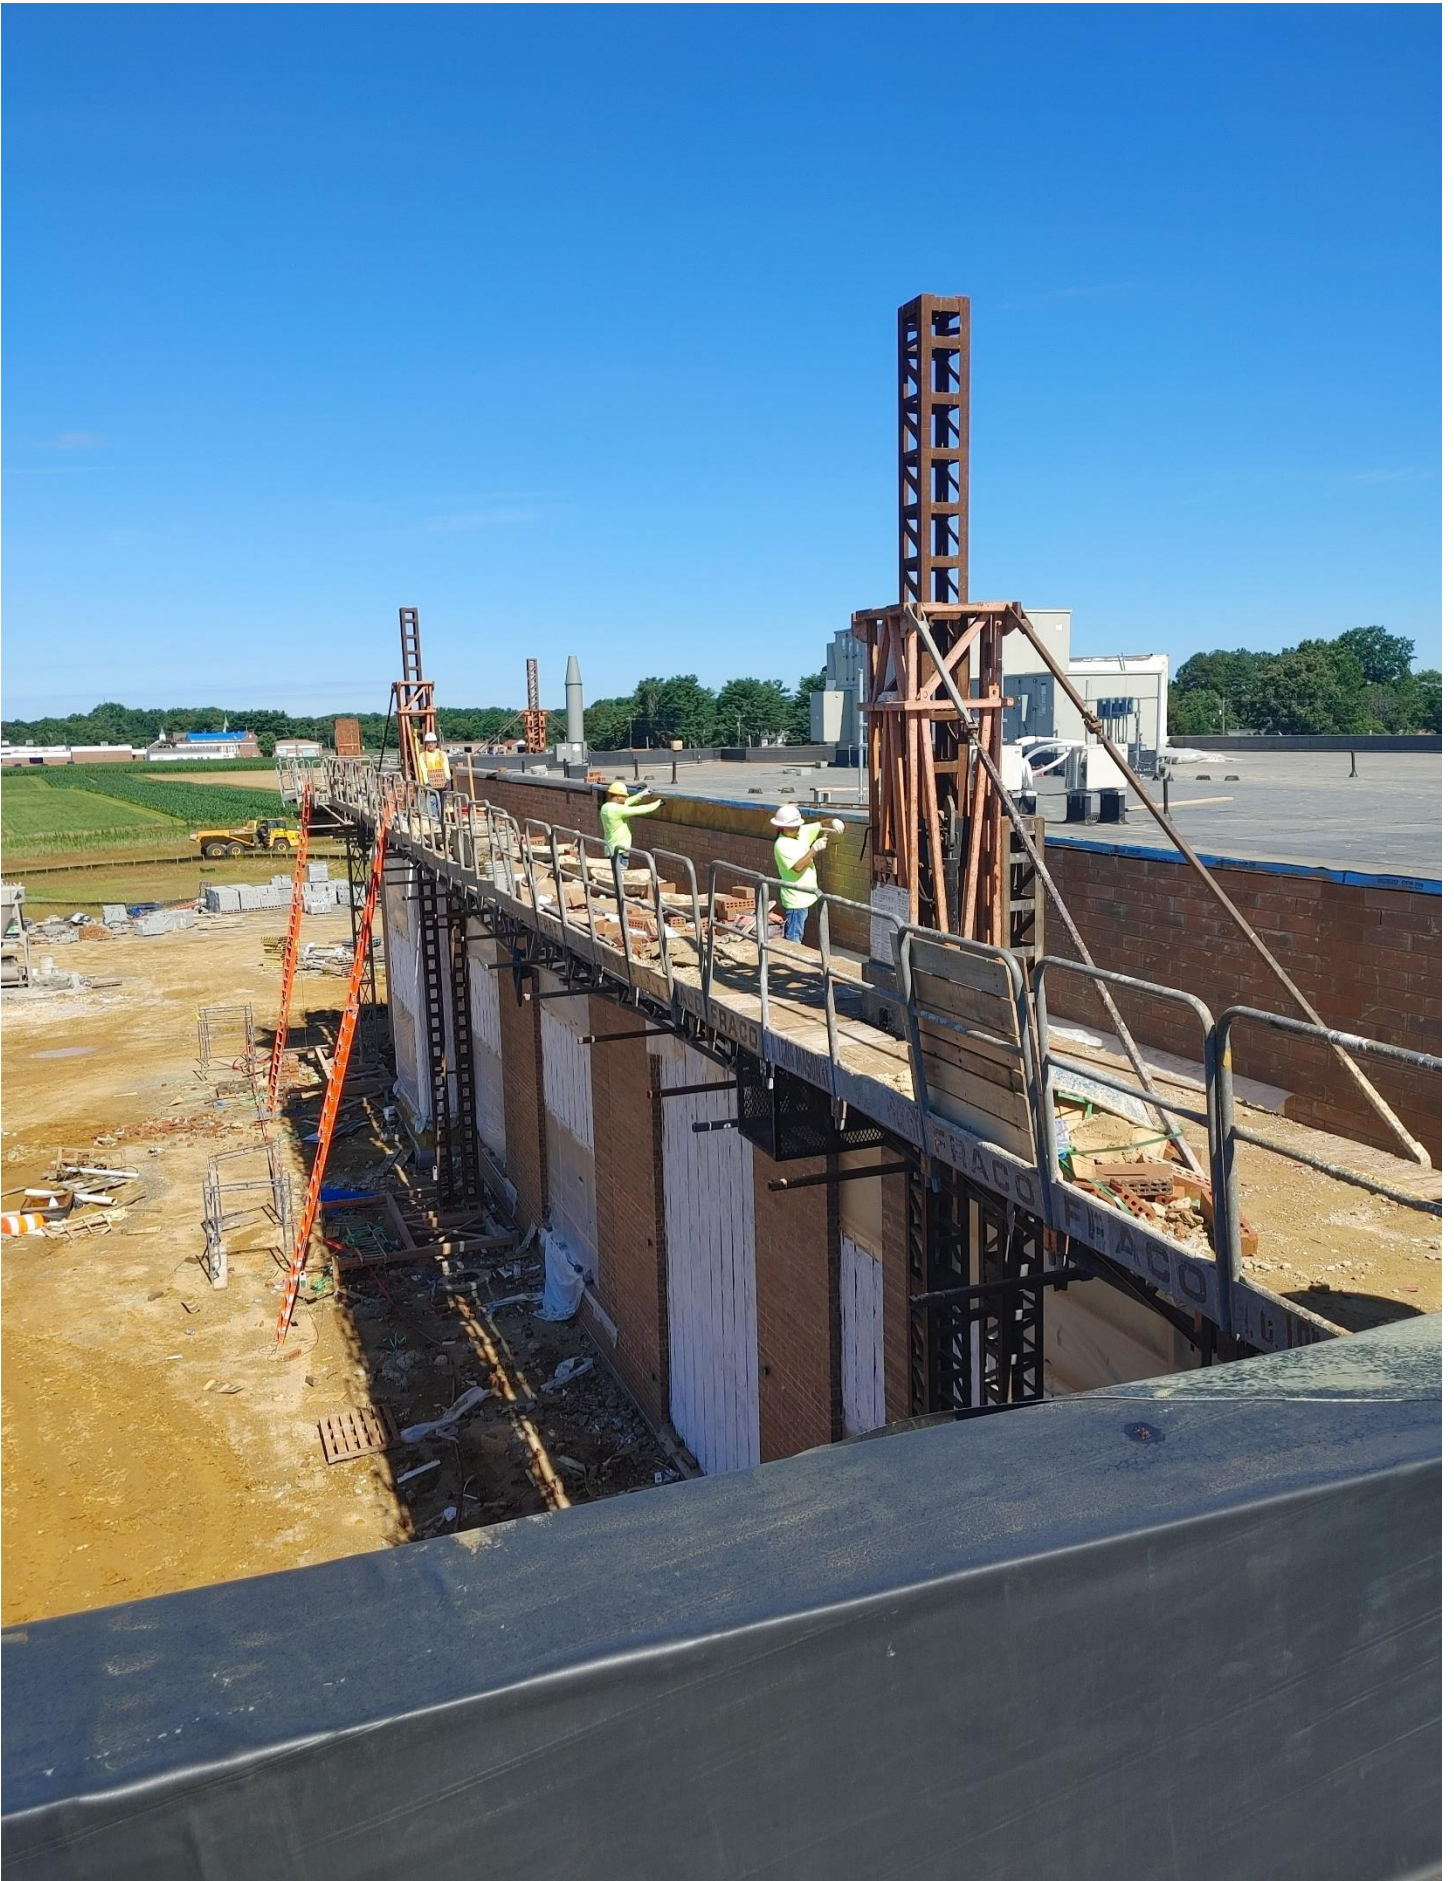
**J.D. Long, Masons:** Twenty-one (21) men are here today. They continue to lay Brick on the South side of Area B and they are also laying Block in room D117.

Photo 4 - Mason are laying Brick on the South side of Area B.

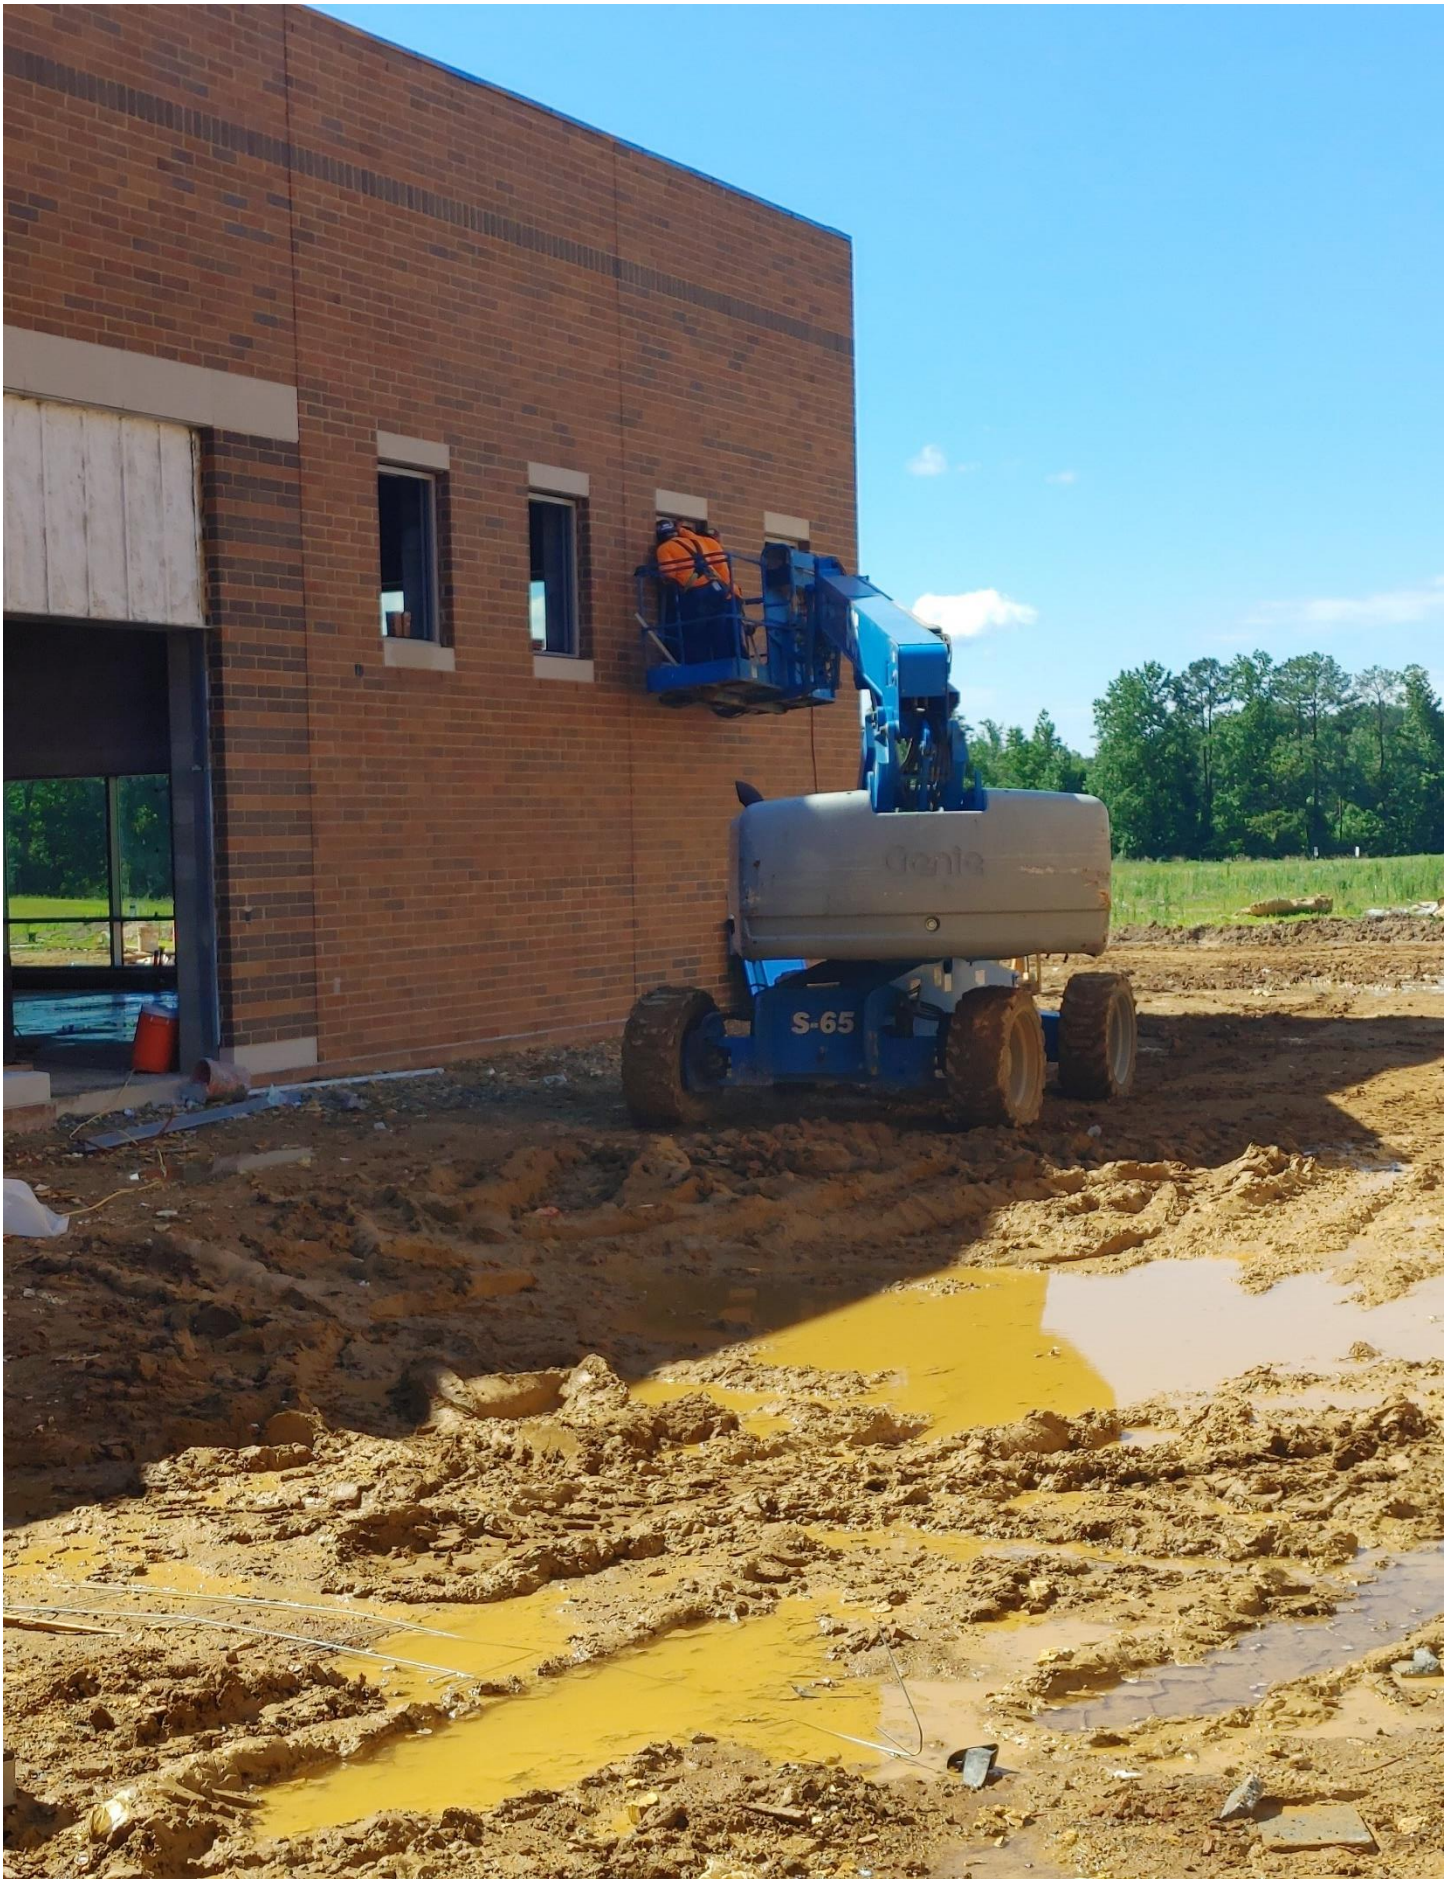
**FG & M:** Seven (7) men are on site today. They are installing the window frames on the West side of Area D and also installing the Storefront SF21 on the East side of Area D.

Photo 5 - Frames being installed by FG&M on the West side of Area D

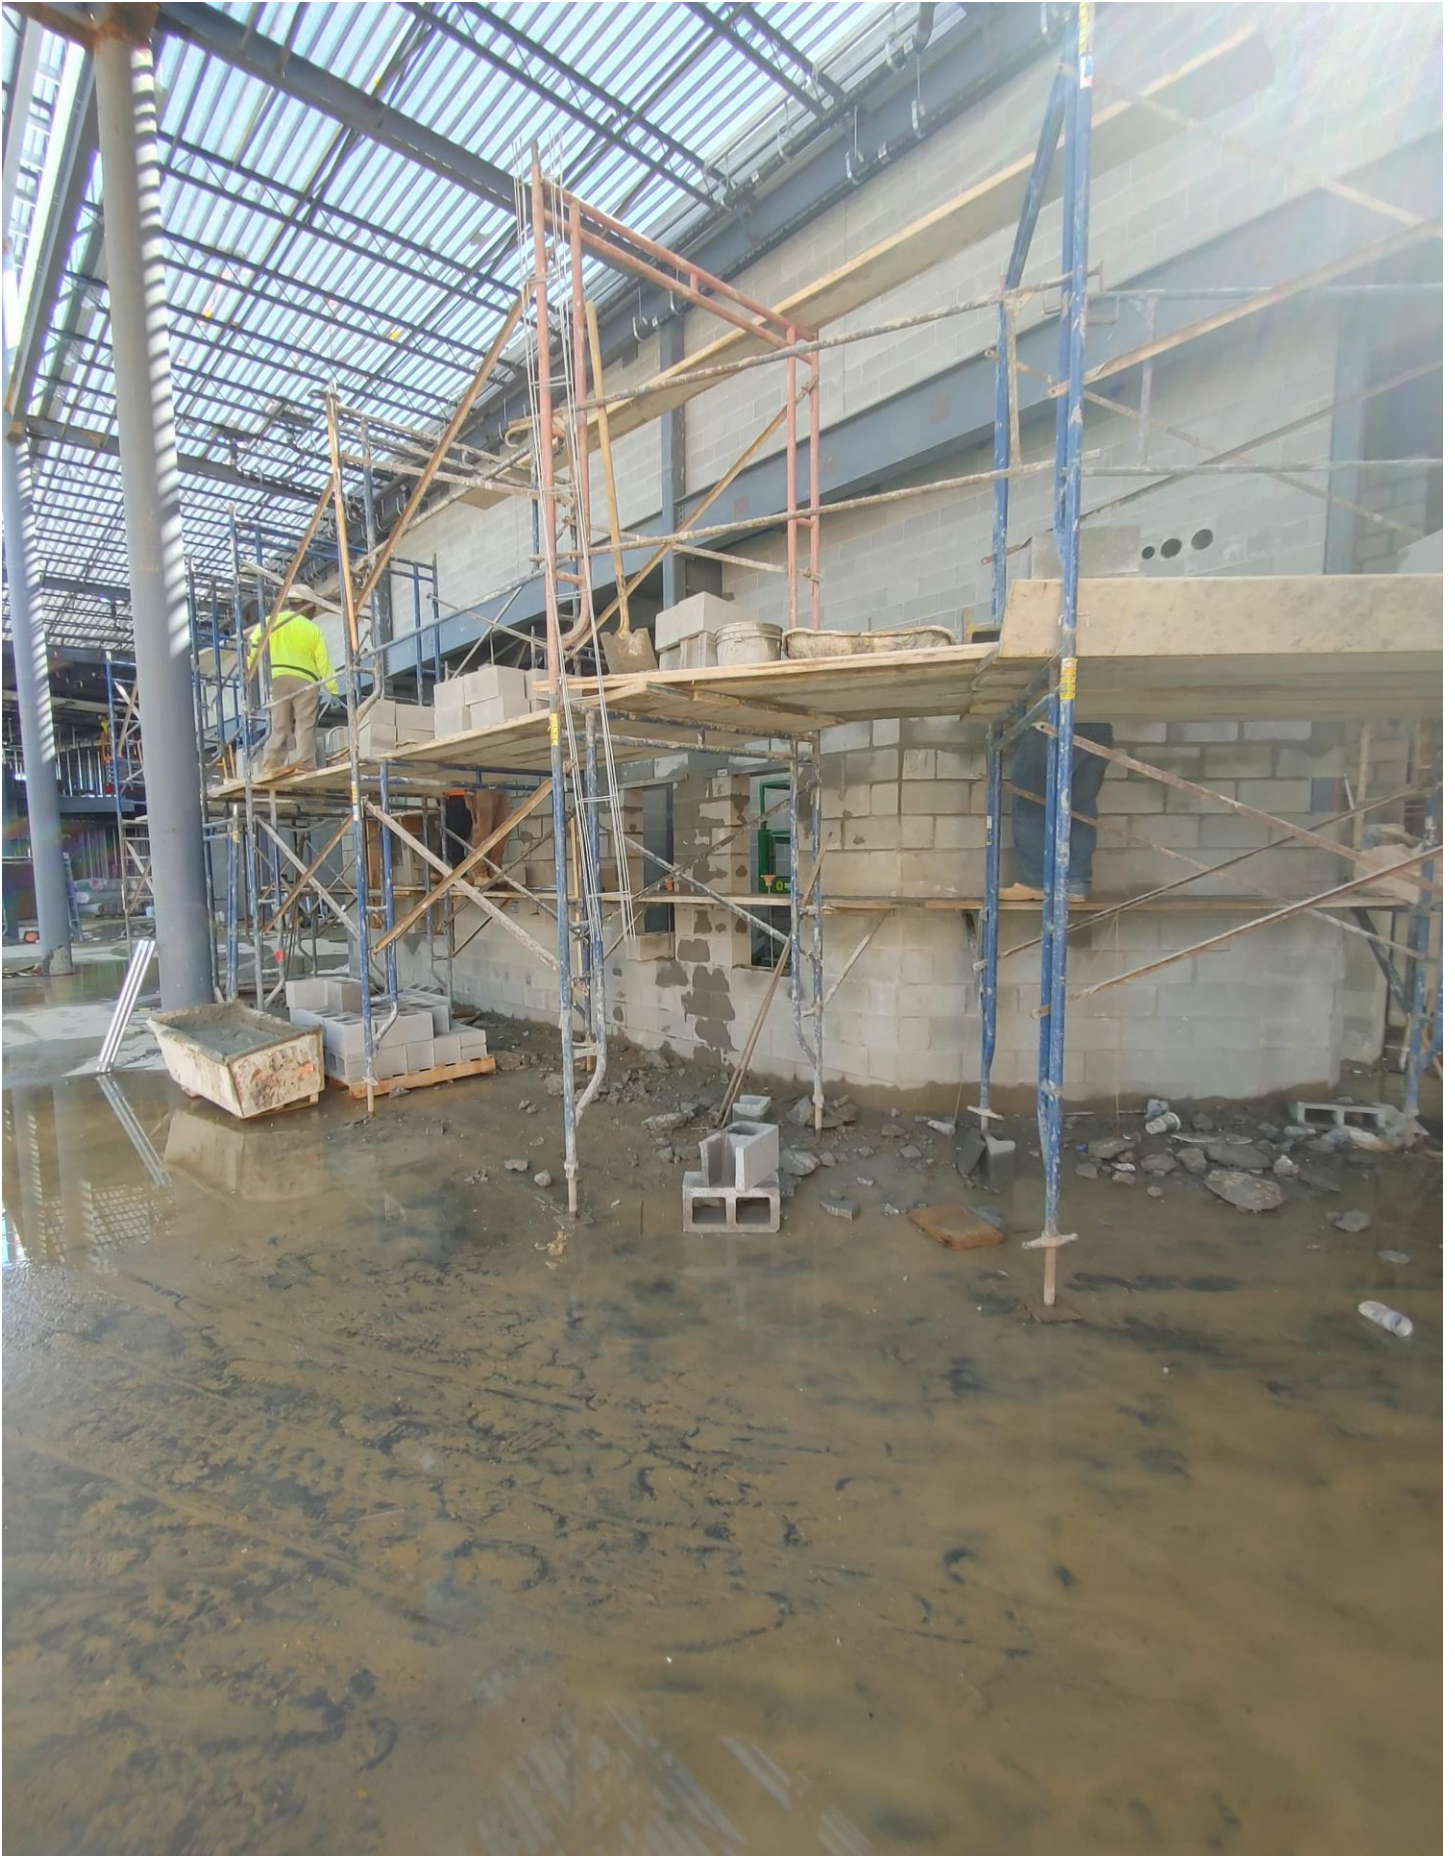
Photo 6 - Block is being laid in Area D, D117.

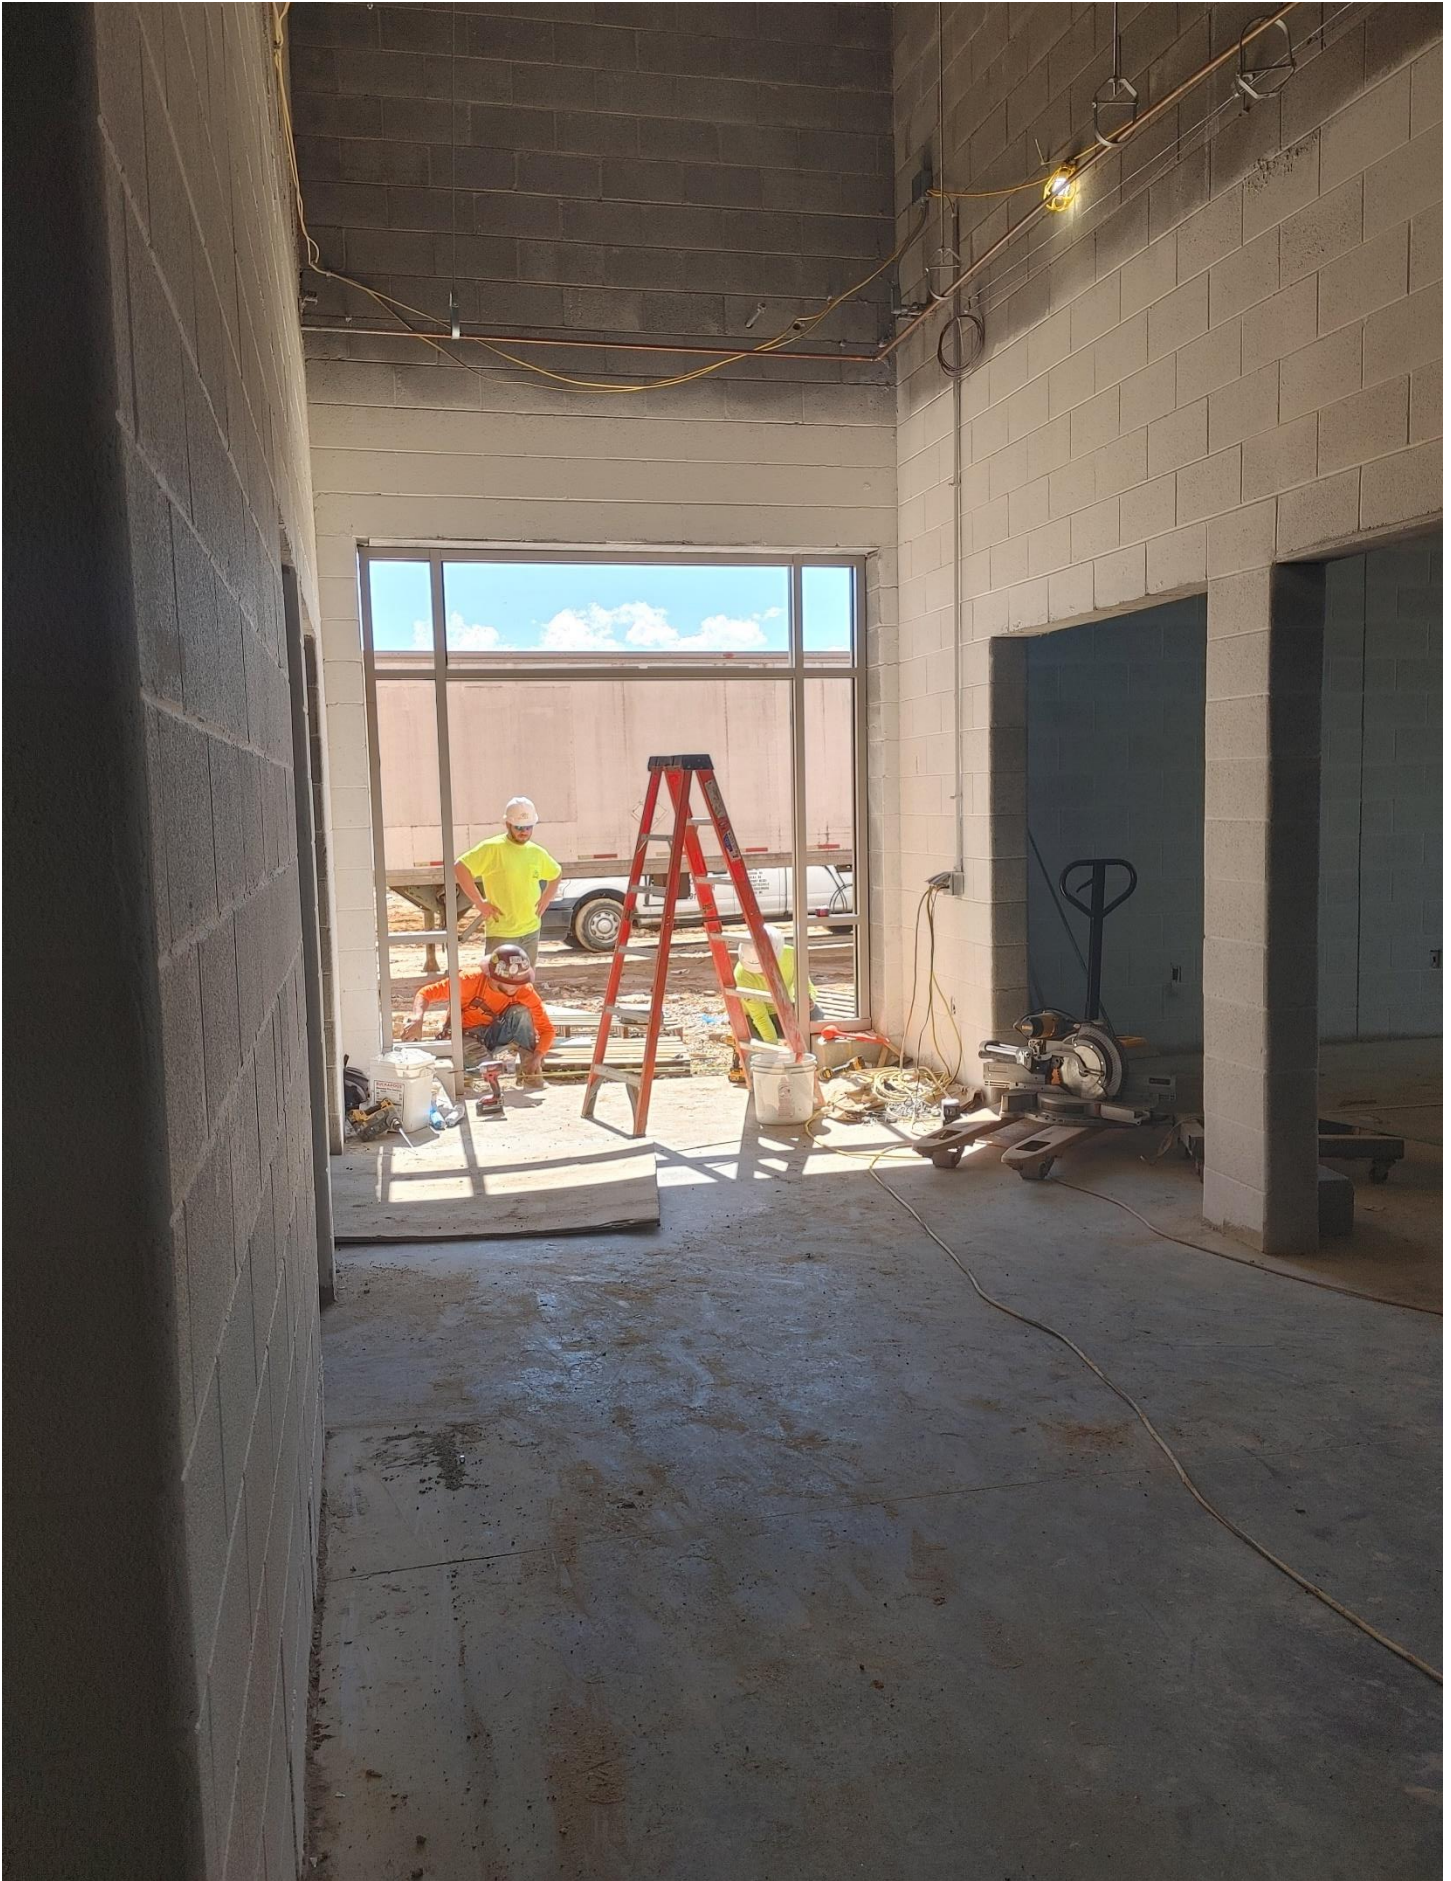
Photo 7 - Storefront SF21 is being set on the East side of Area D.

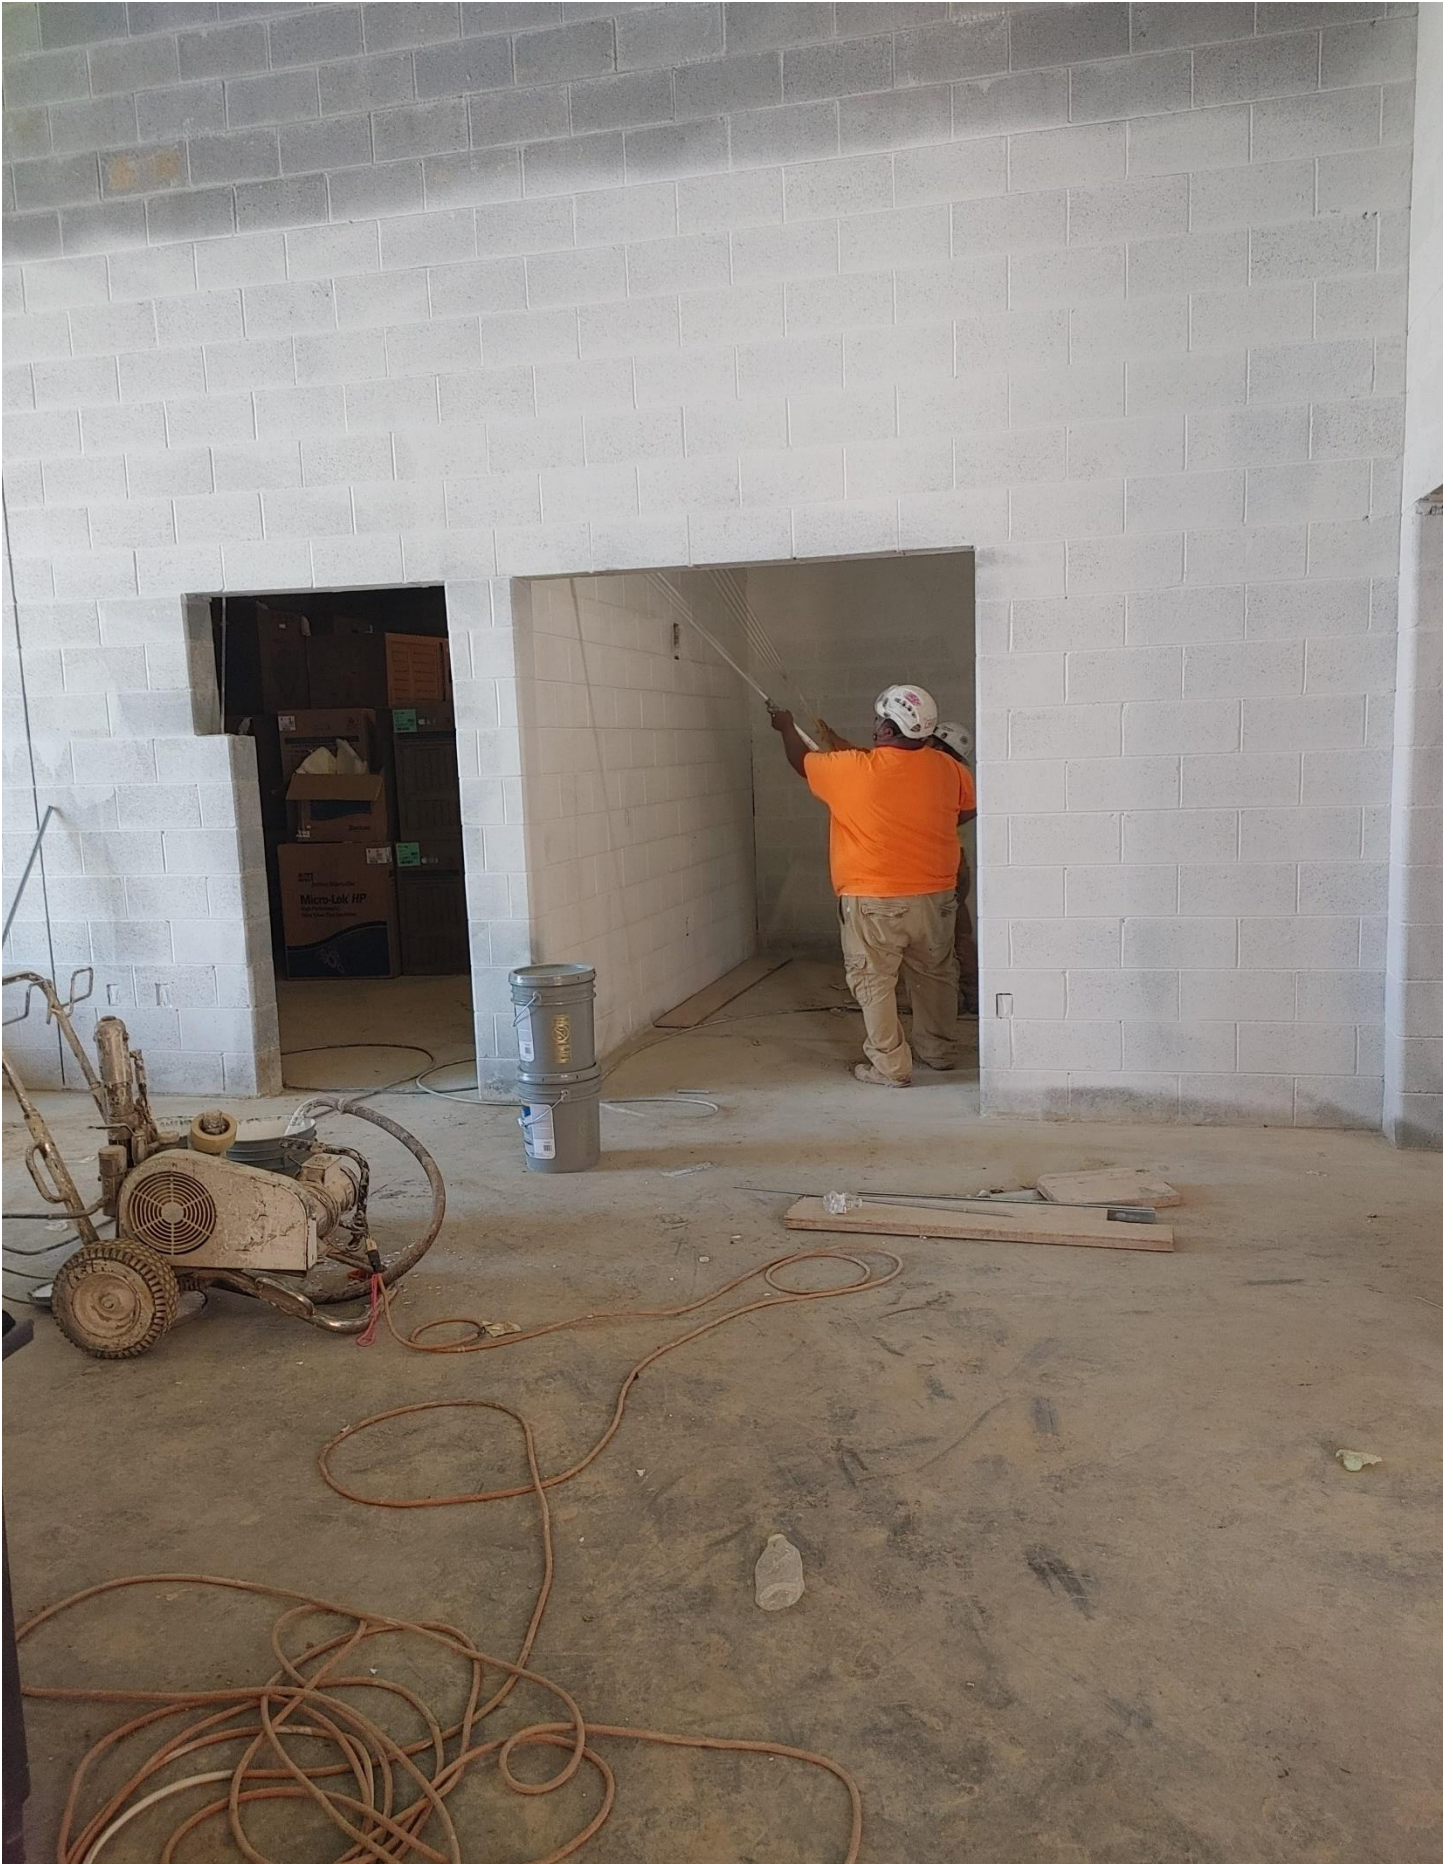
**M. L. Straight:** Two (2) men are on site today spraying and rolling Block Filer in Area D.

Photo 8 - Block filler is being sprayed and rolled in Area D, in room D125B
