**COMMONWEALTH  
BUILDING SOLUTIONS, LLC**

**FIELD REPORT**

**WESTMORELAND COUNTY HIGH SCHOOL**

Date: 06/9/2022

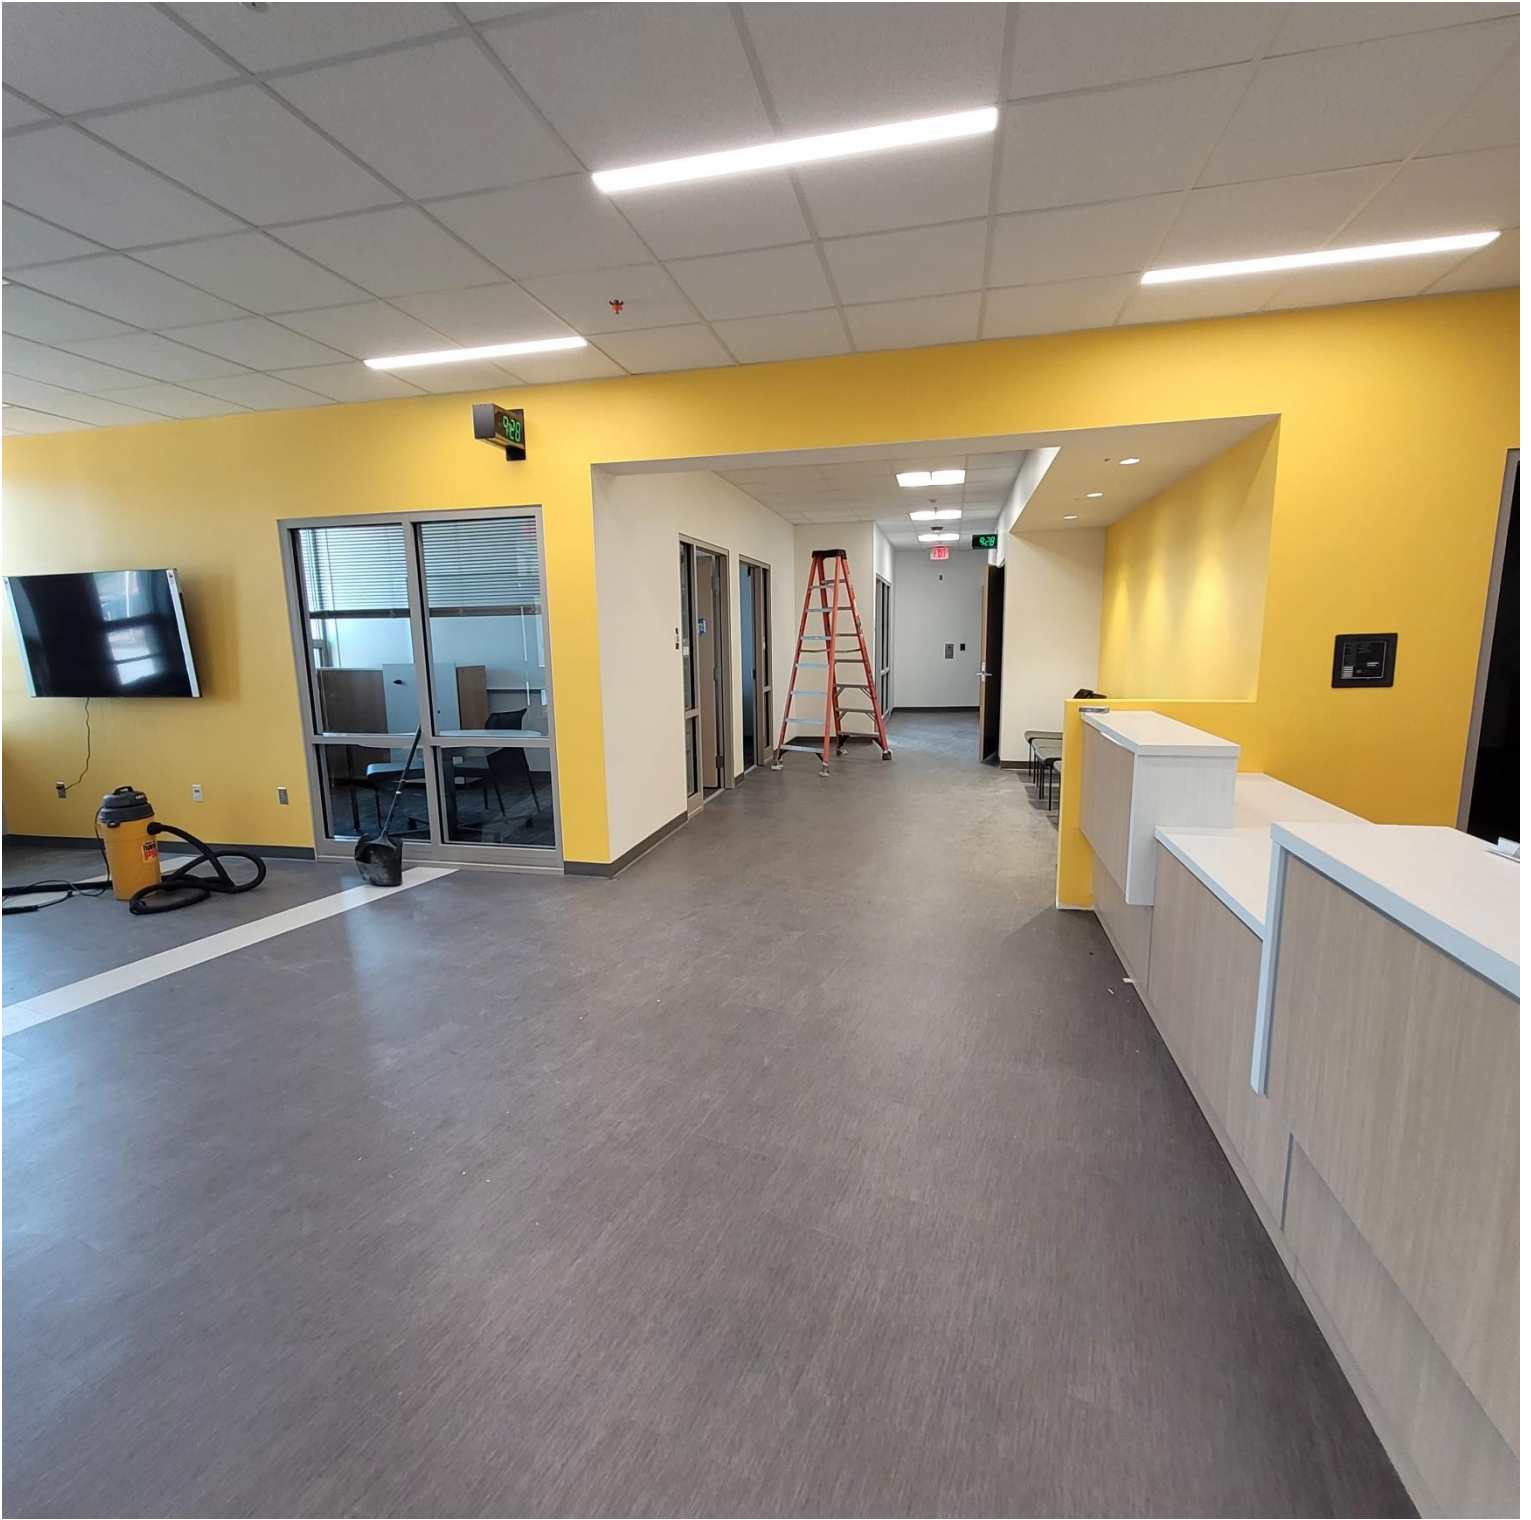
Photo 1 - Administrative Office Area

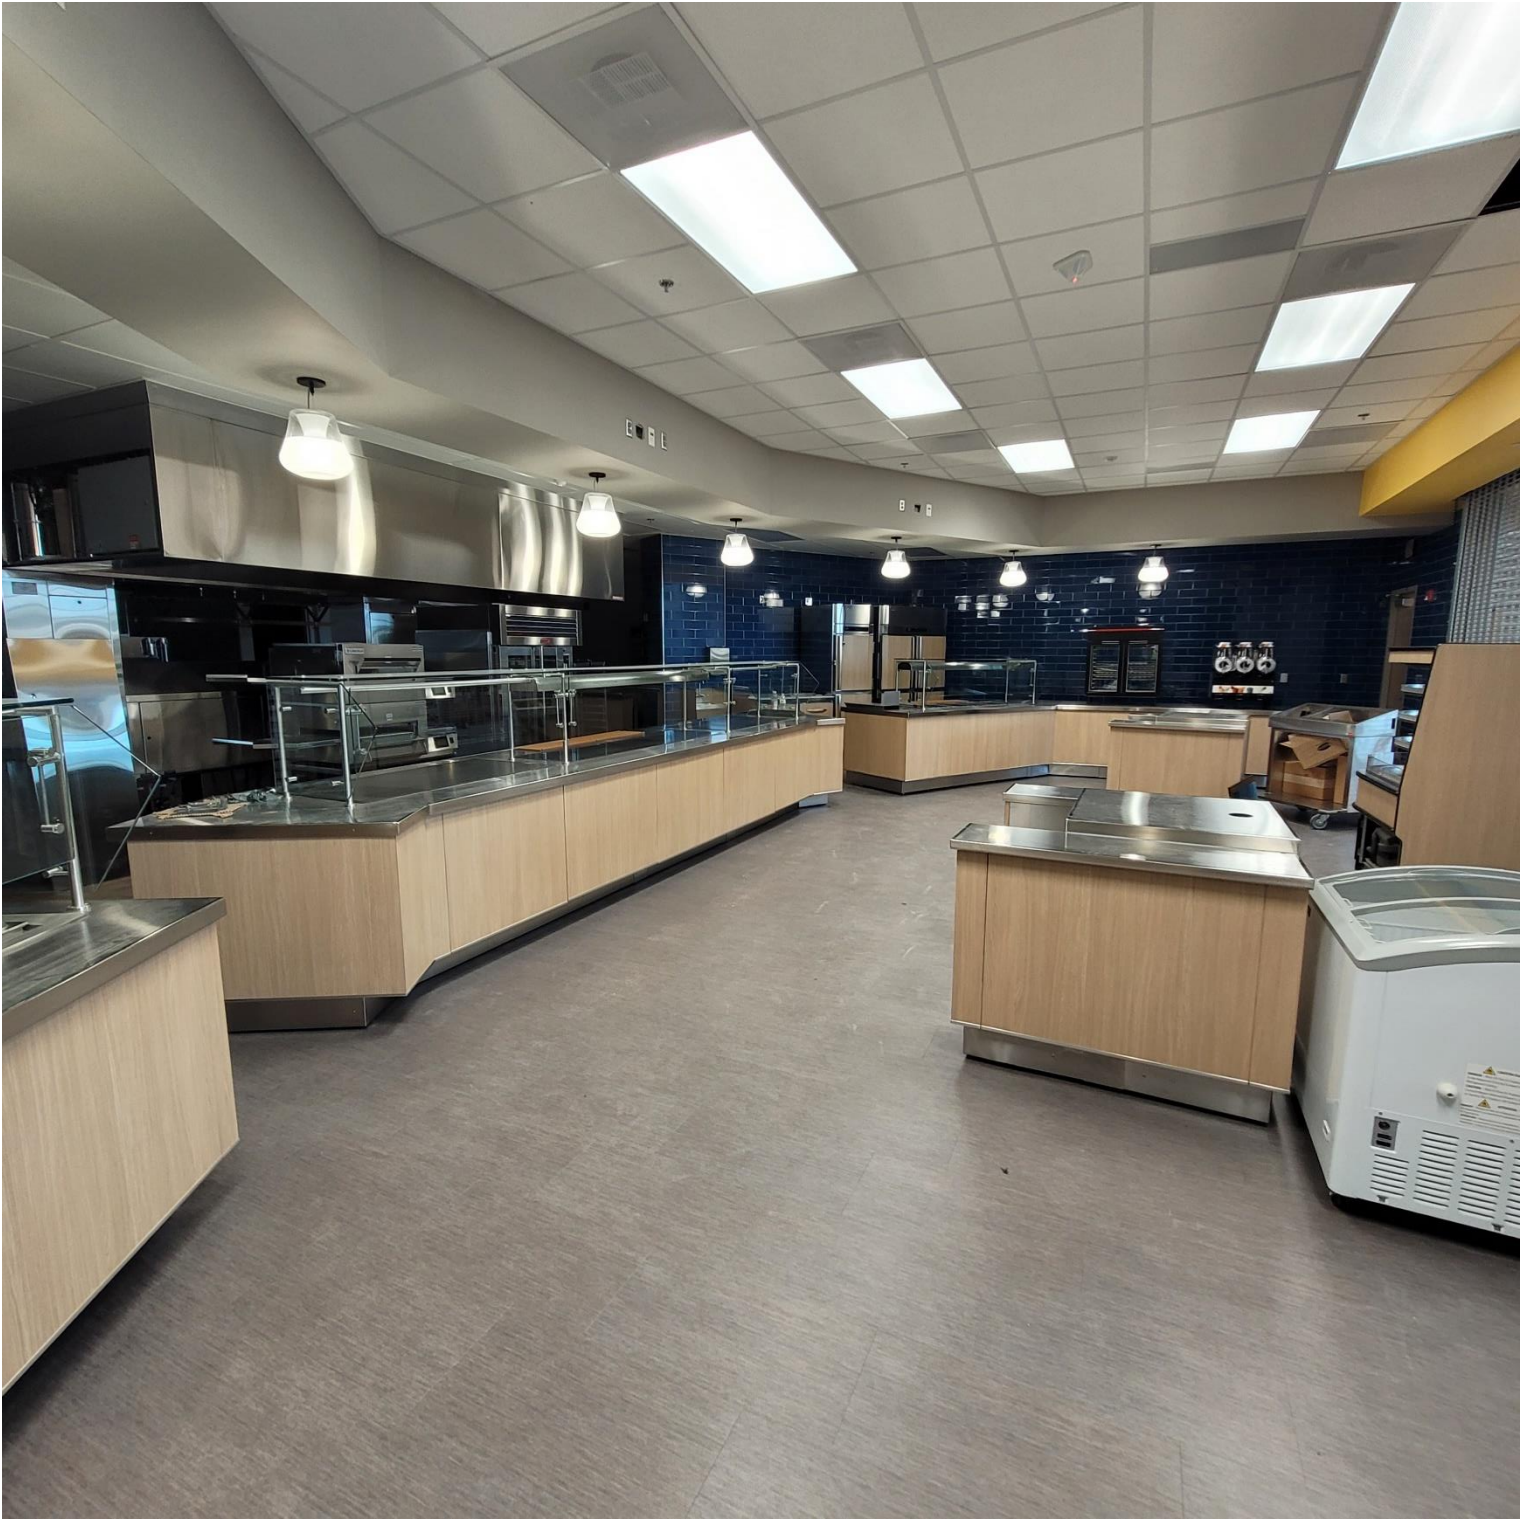
Photo 2 - Kitchen Serving Line

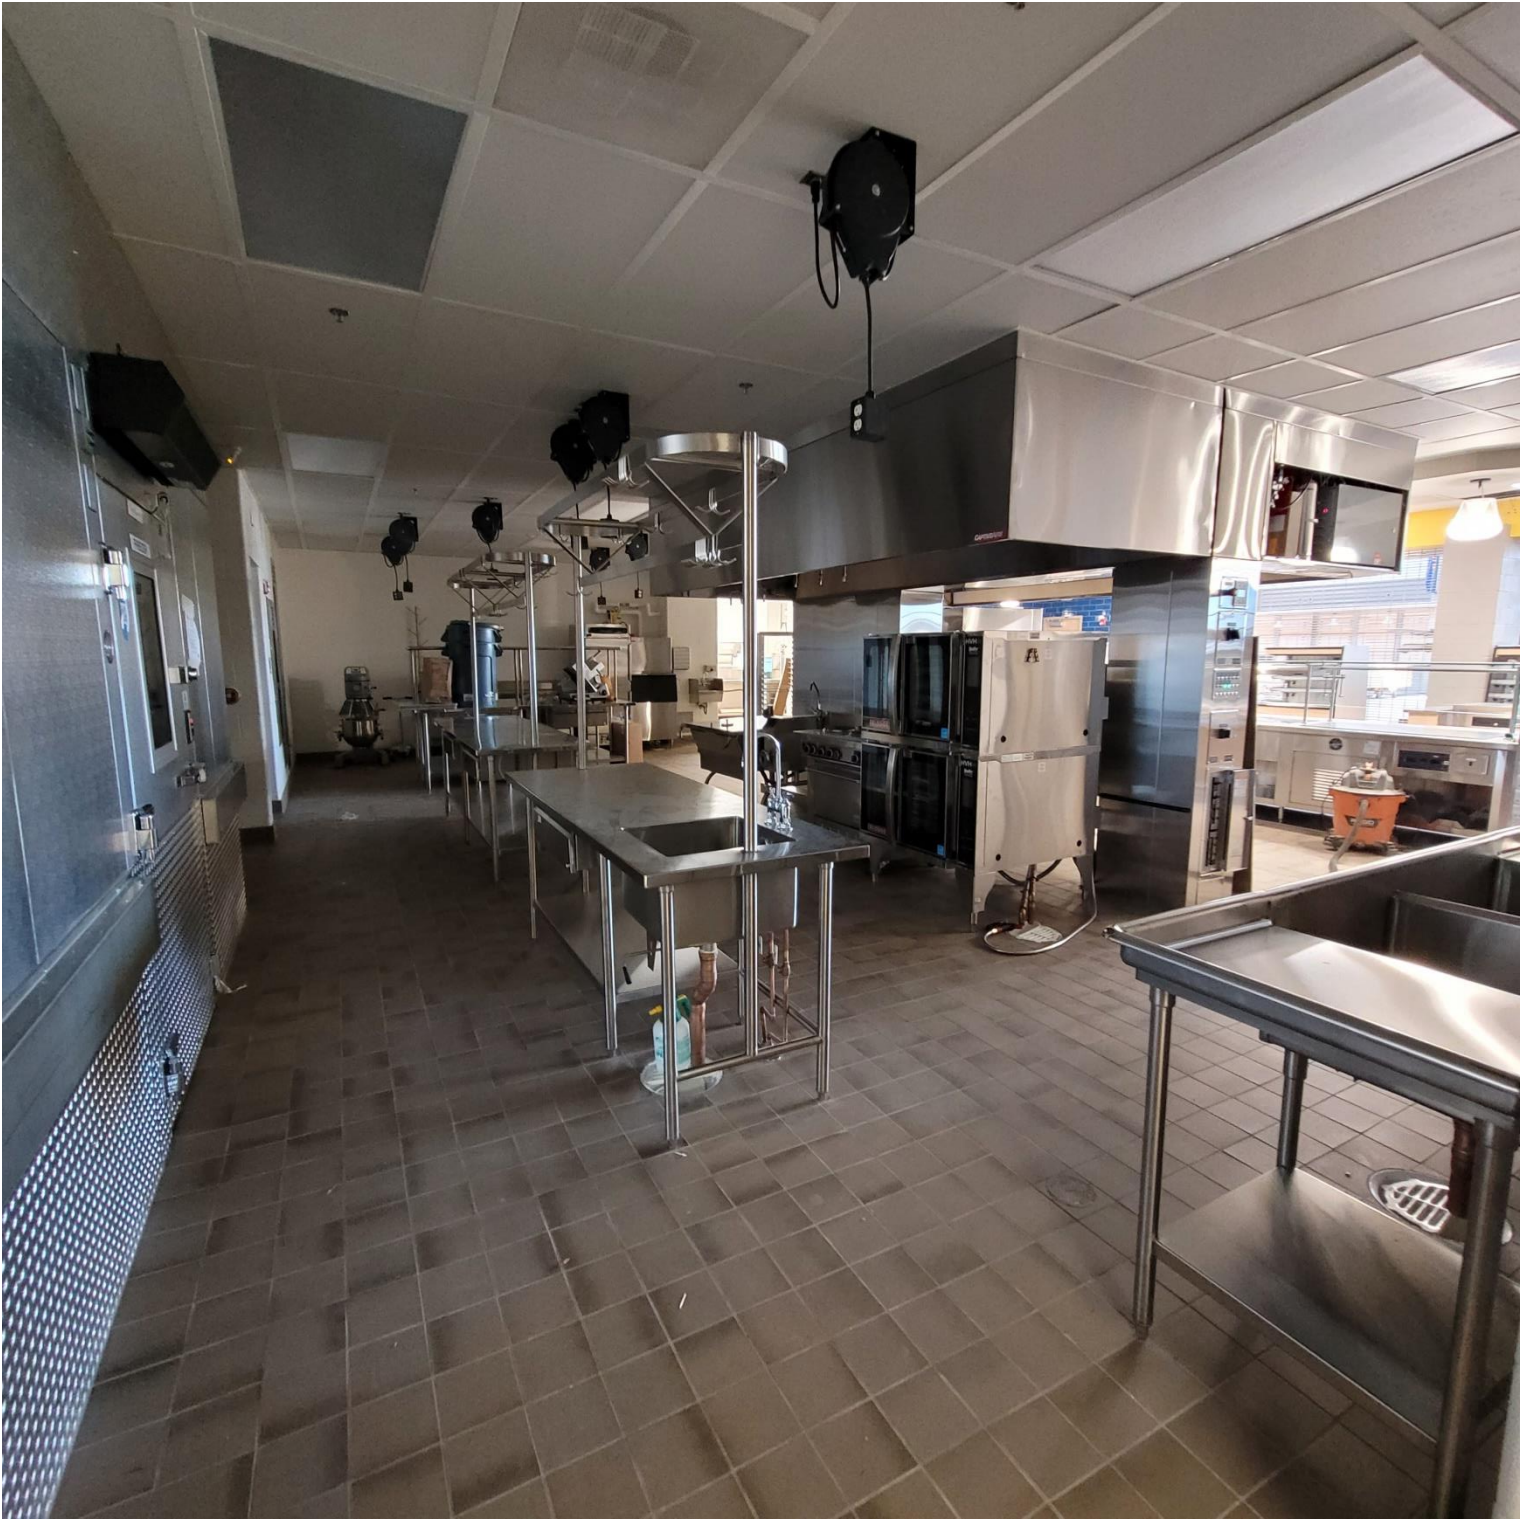
Photo 3 - Kitchen Prep Area

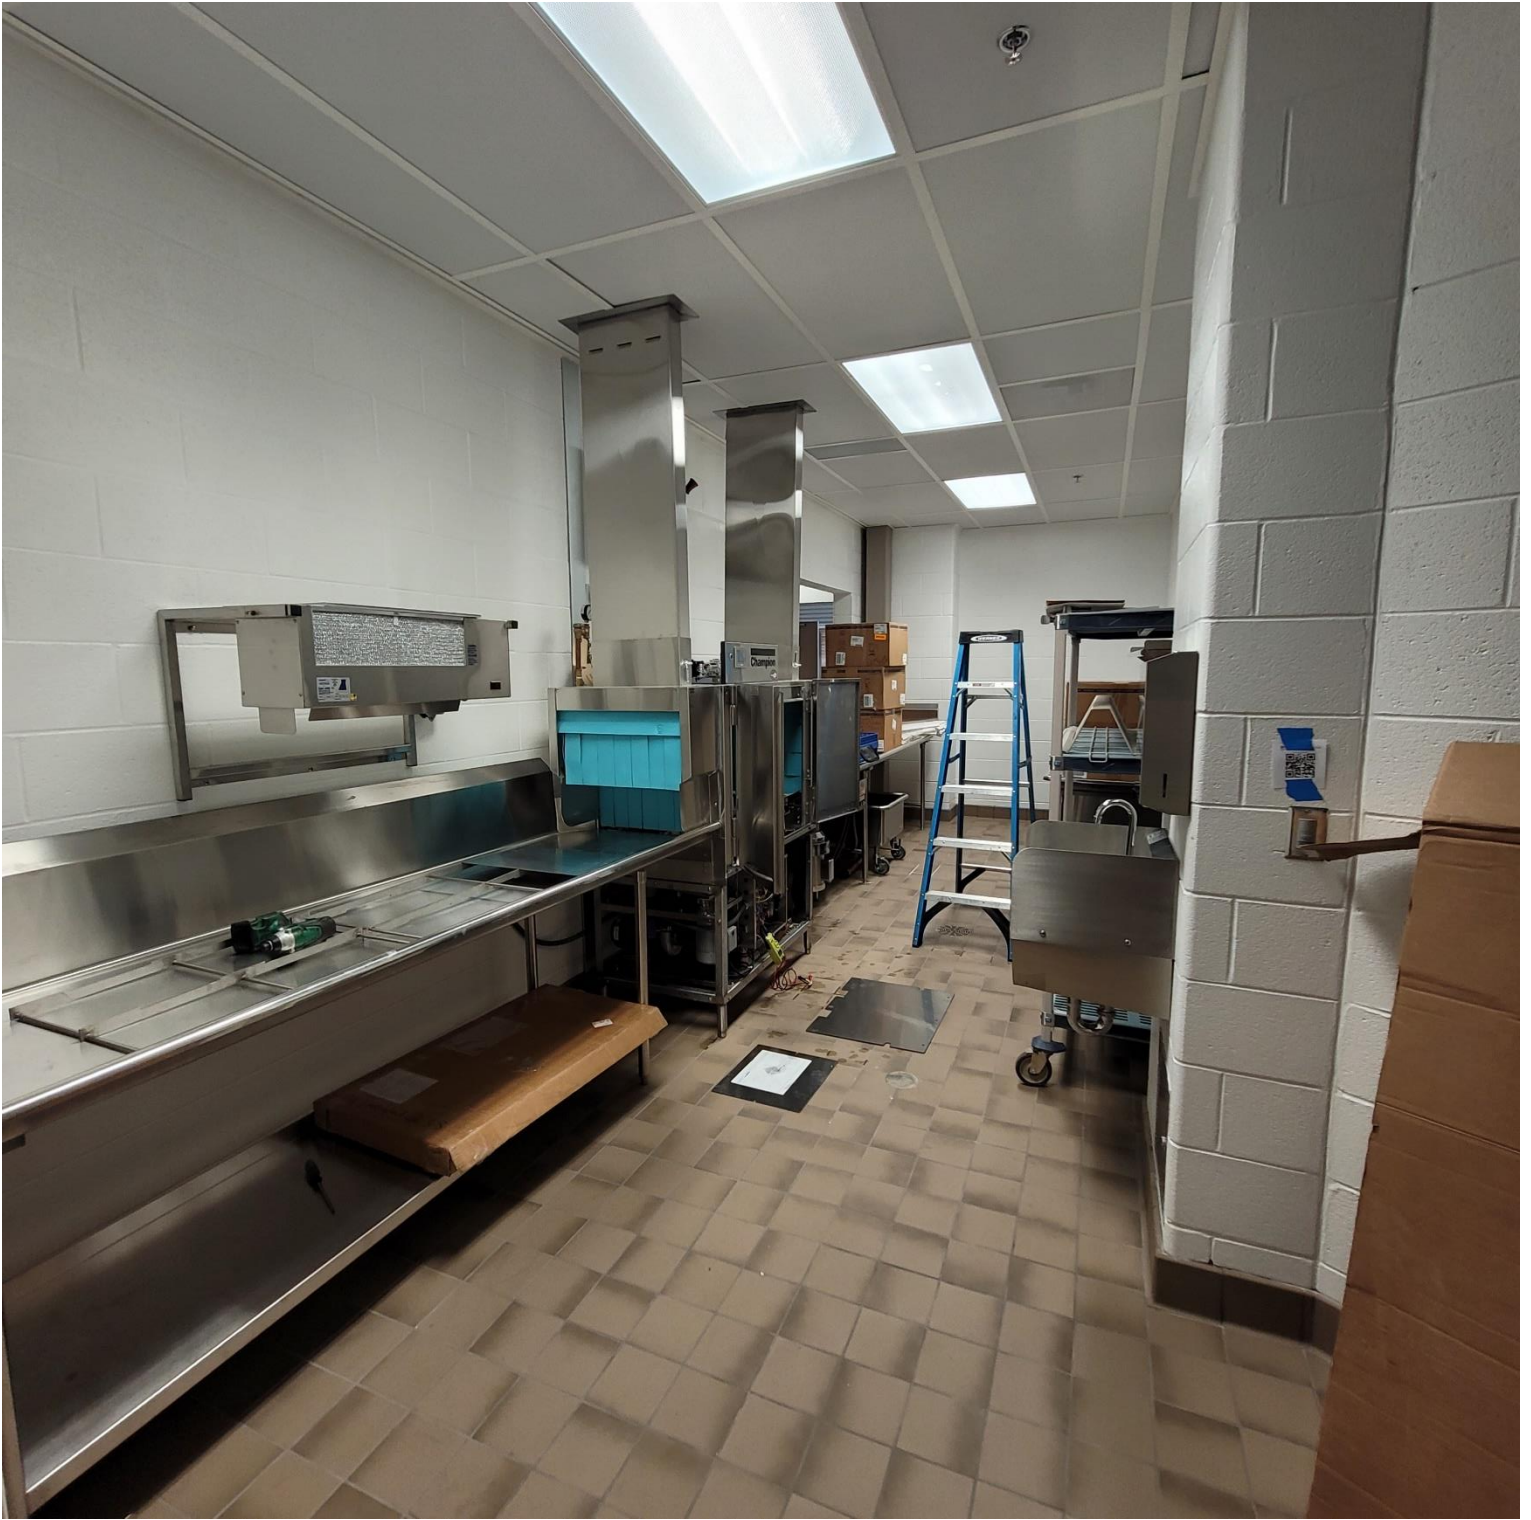
Photo 4 - Dishwasher Area

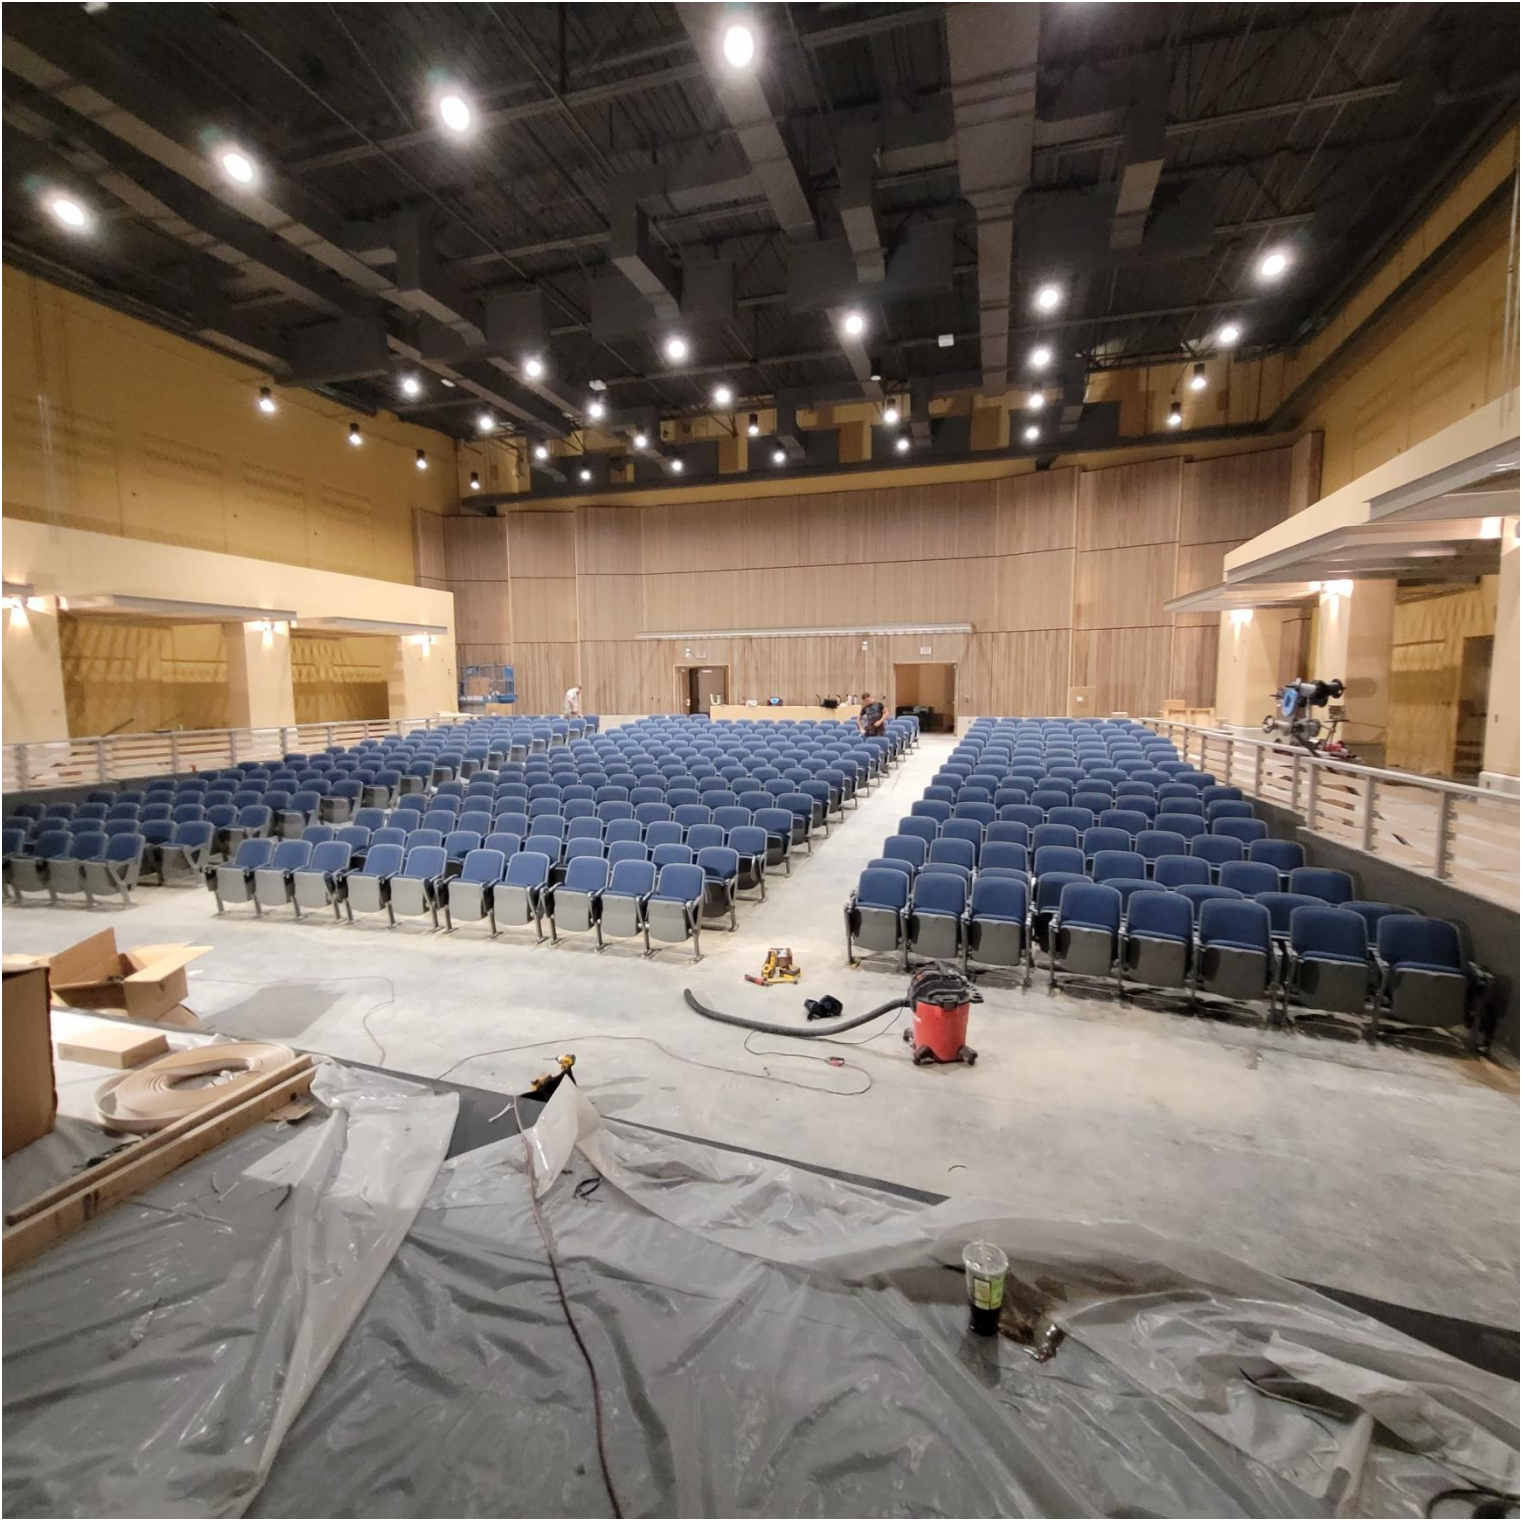
*Photo 5 - Auditorium Seats are being installed*

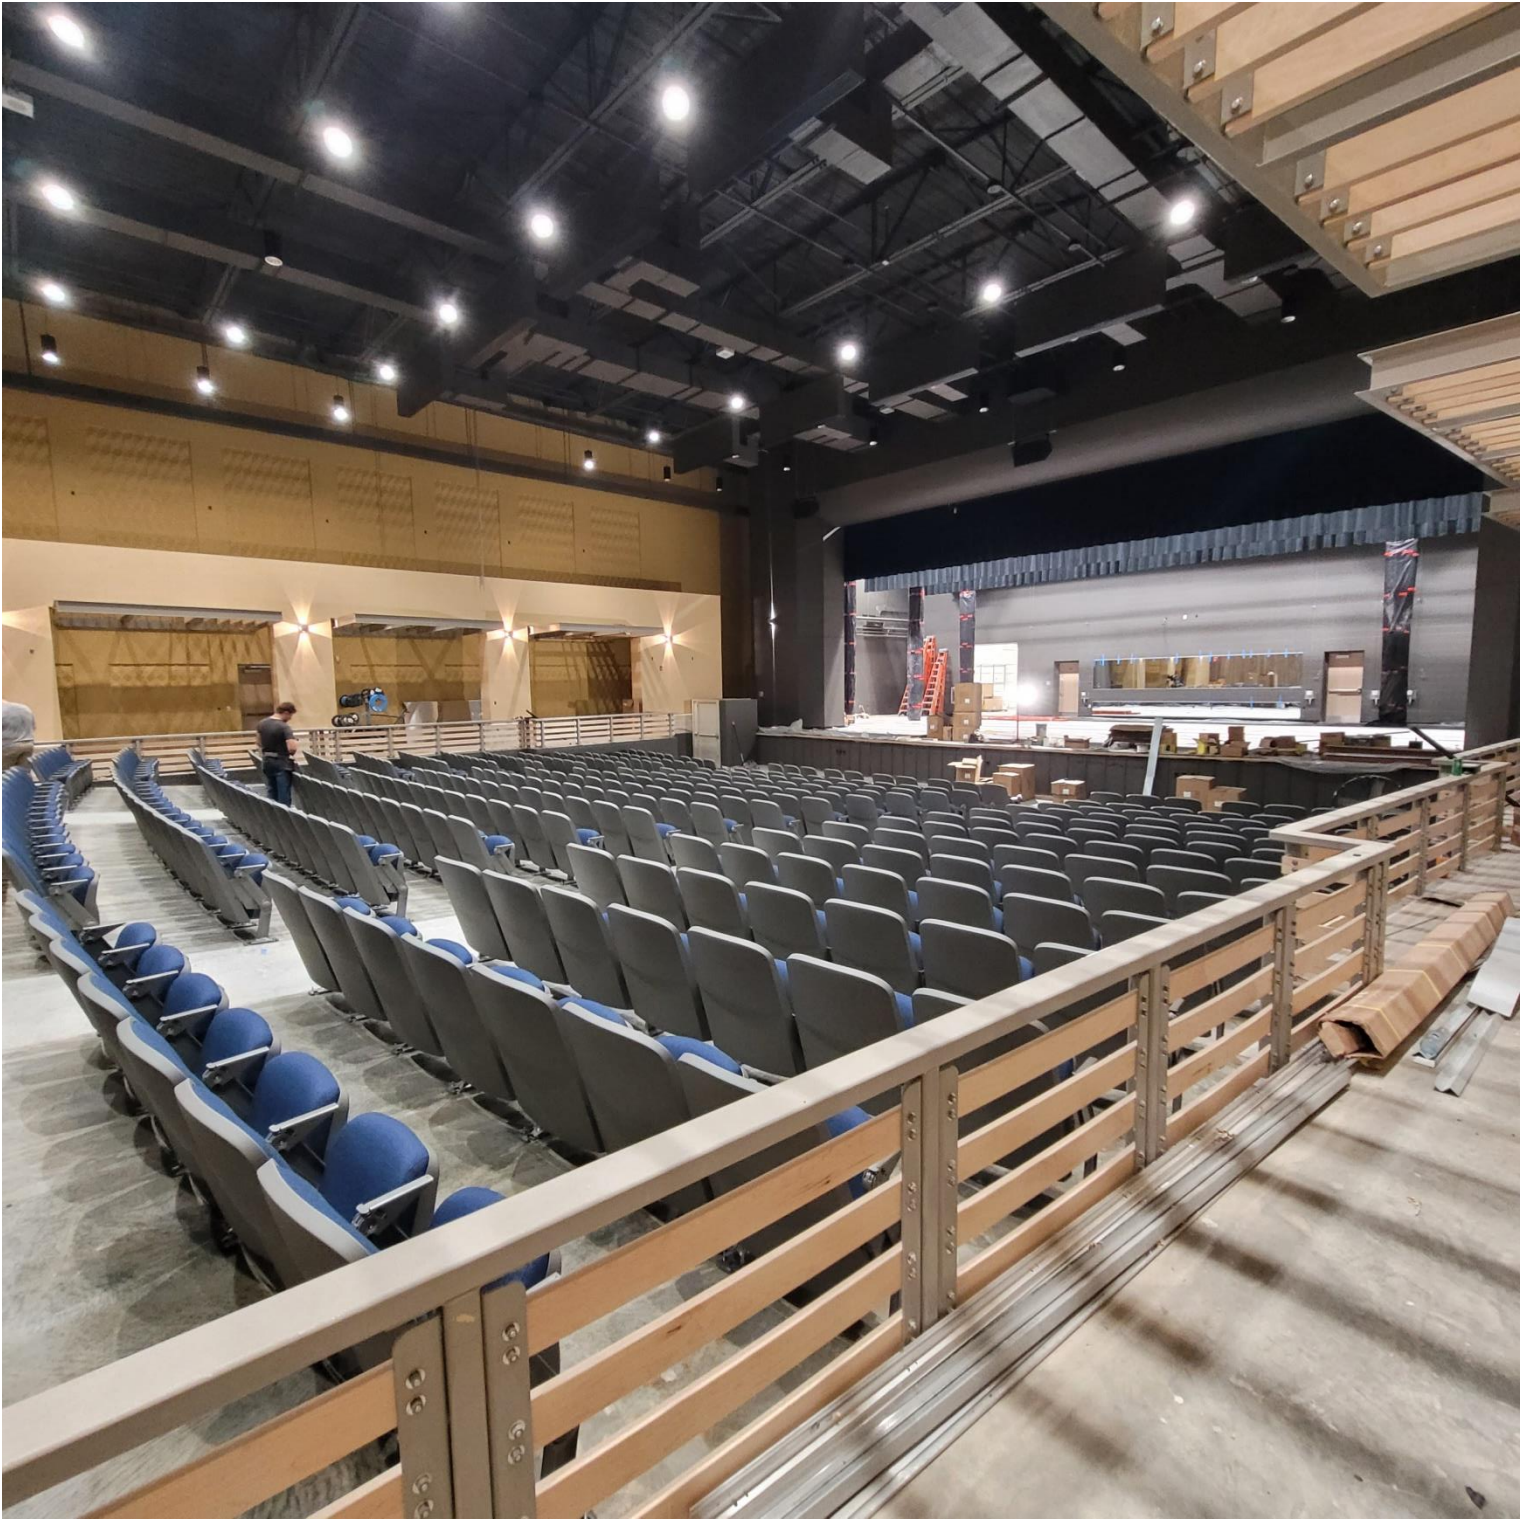
Photo 6 - Auditorium and Stage

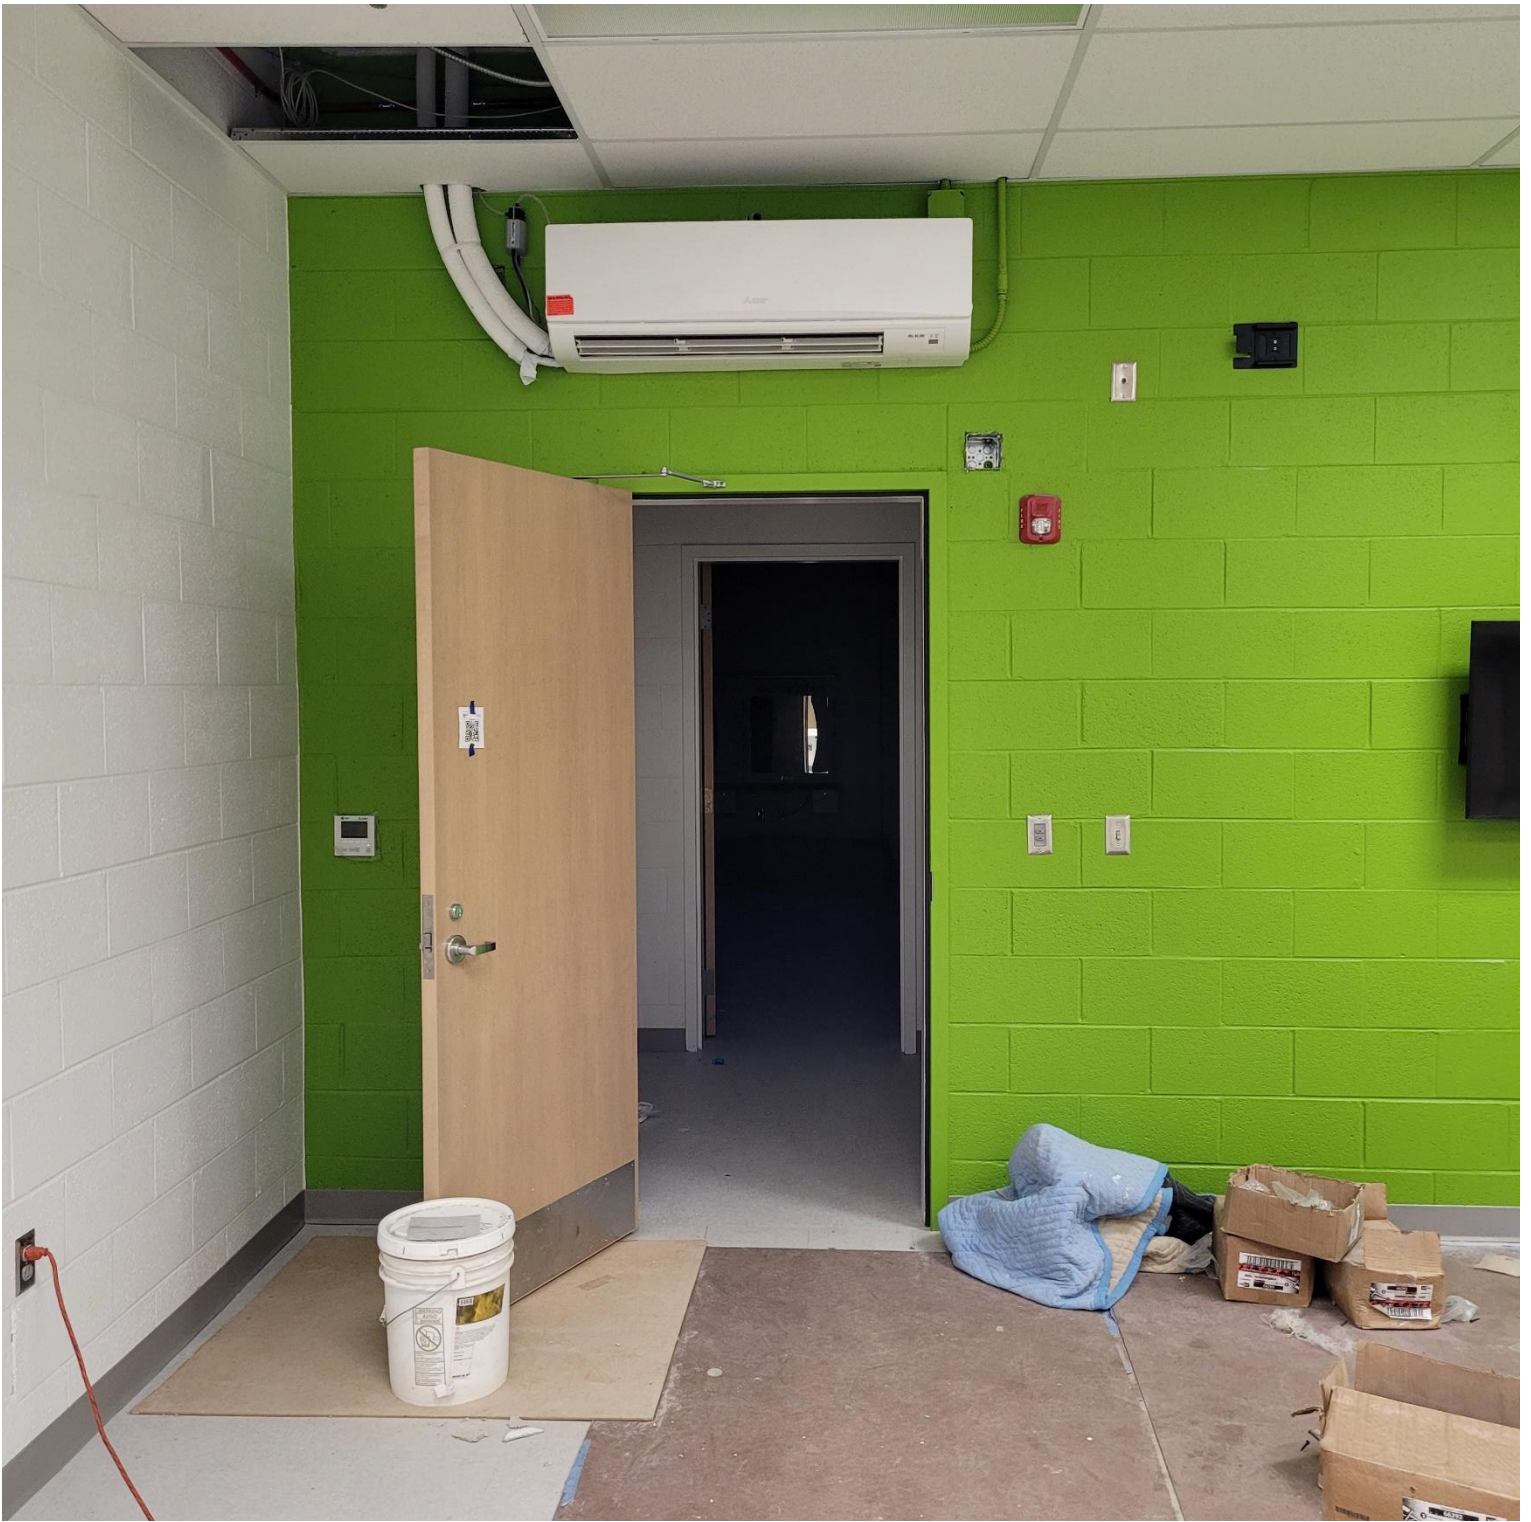
*Photo 7 - Dressing Room #132 HVAC Unit is mounted approximately 14" above Door Frame as compared to the next picture in Room #132 where it is mounted literally on top of the Door Frame.*

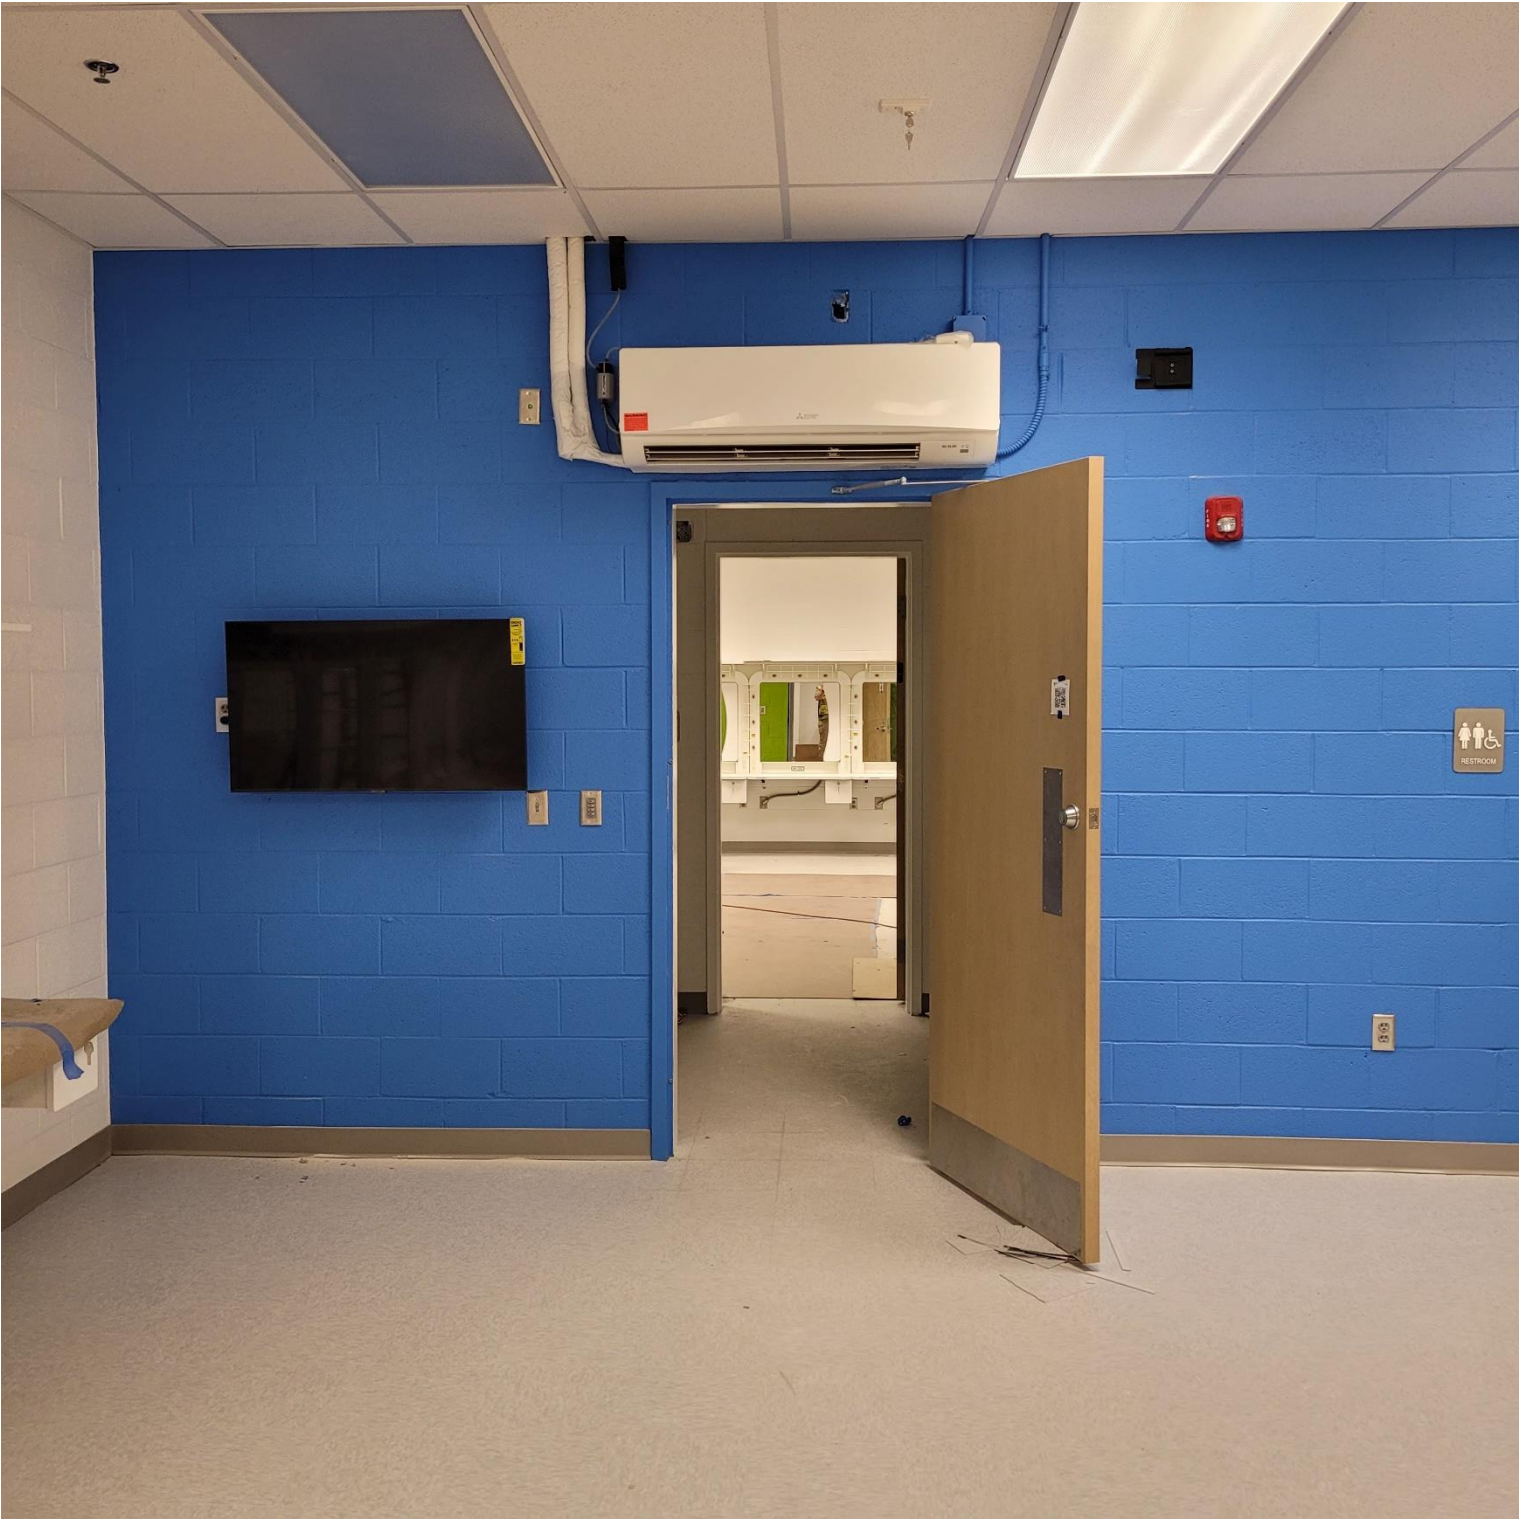
Photo 8 - HVAC Unit in Room #132 mounted on Door Frame.

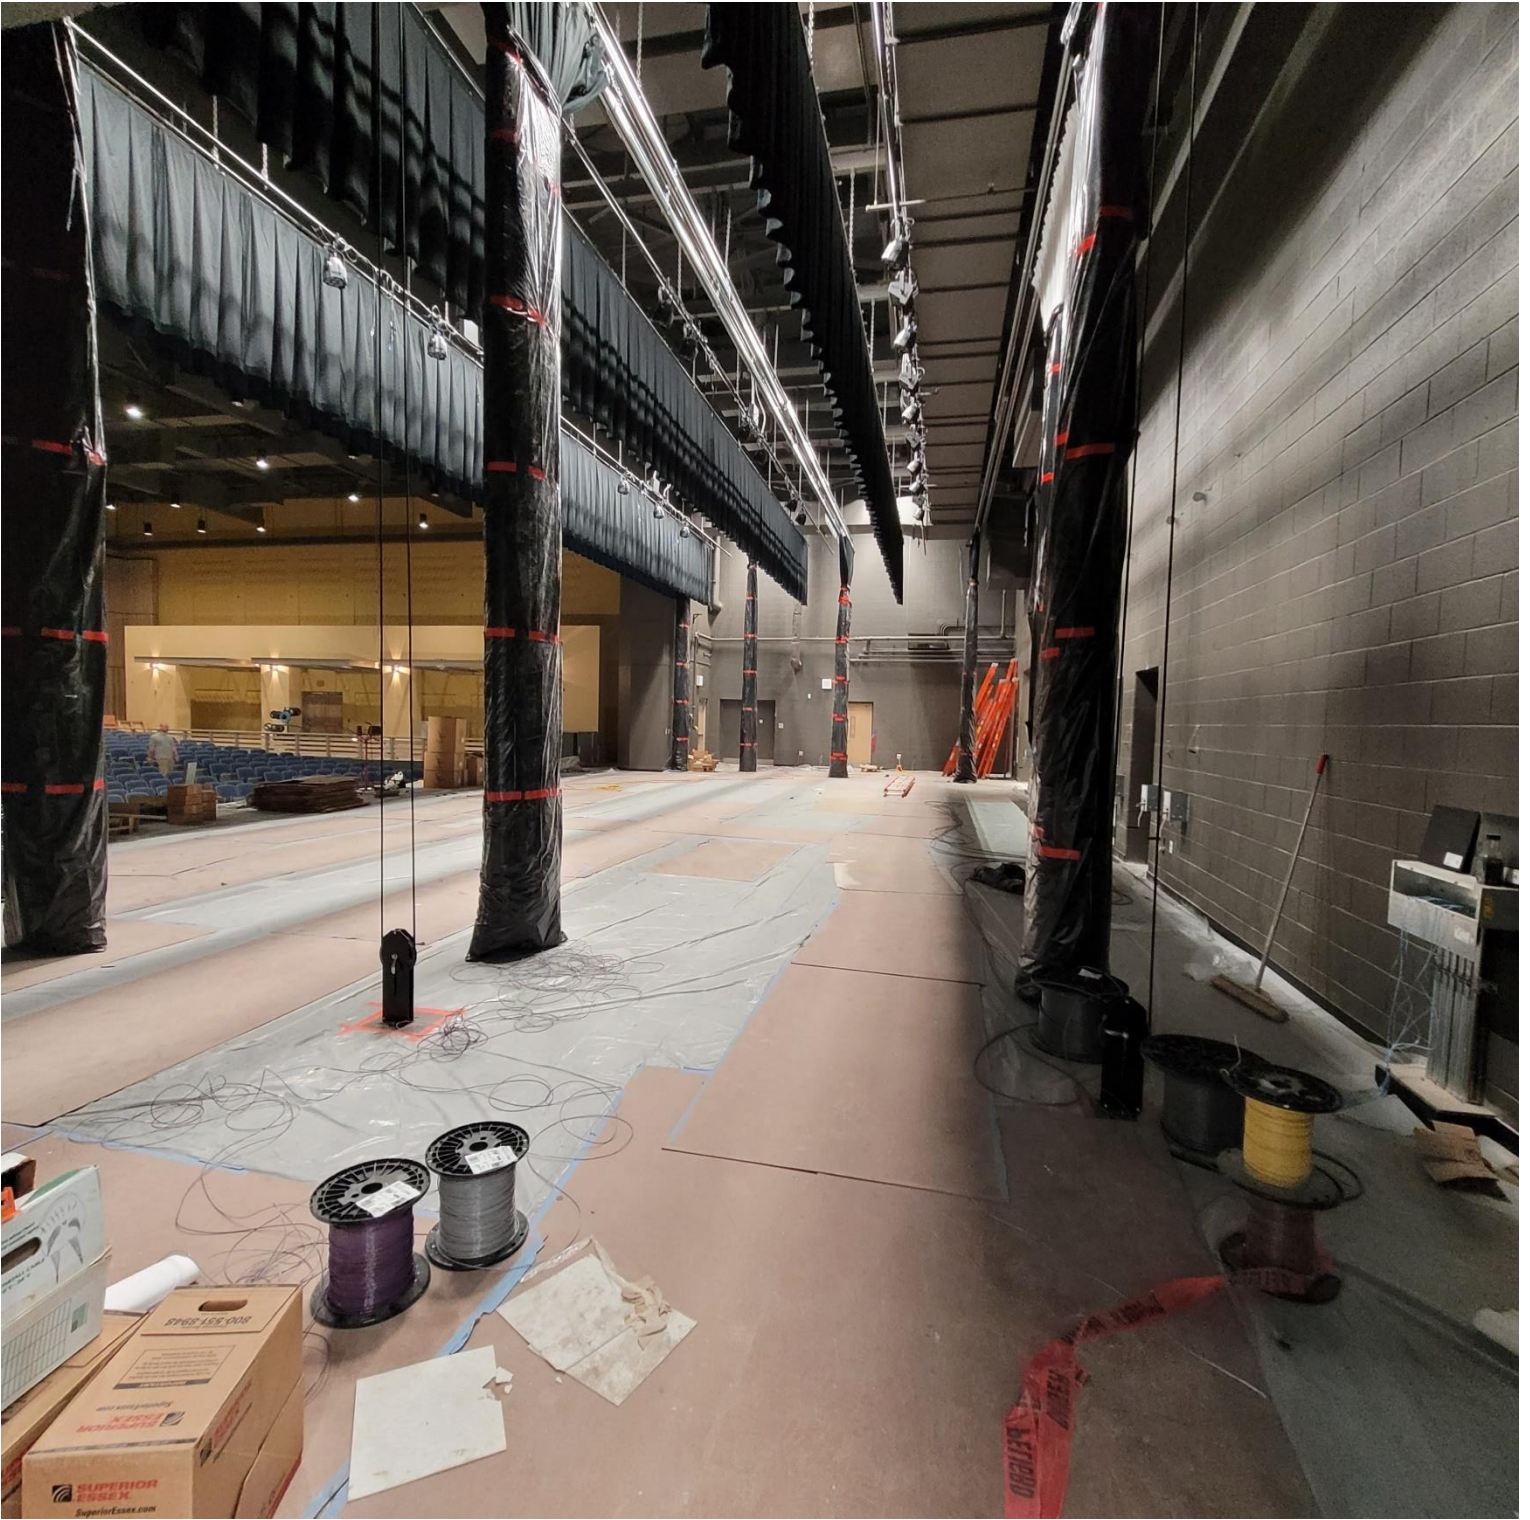
Photo 9 - Auditorium Stage

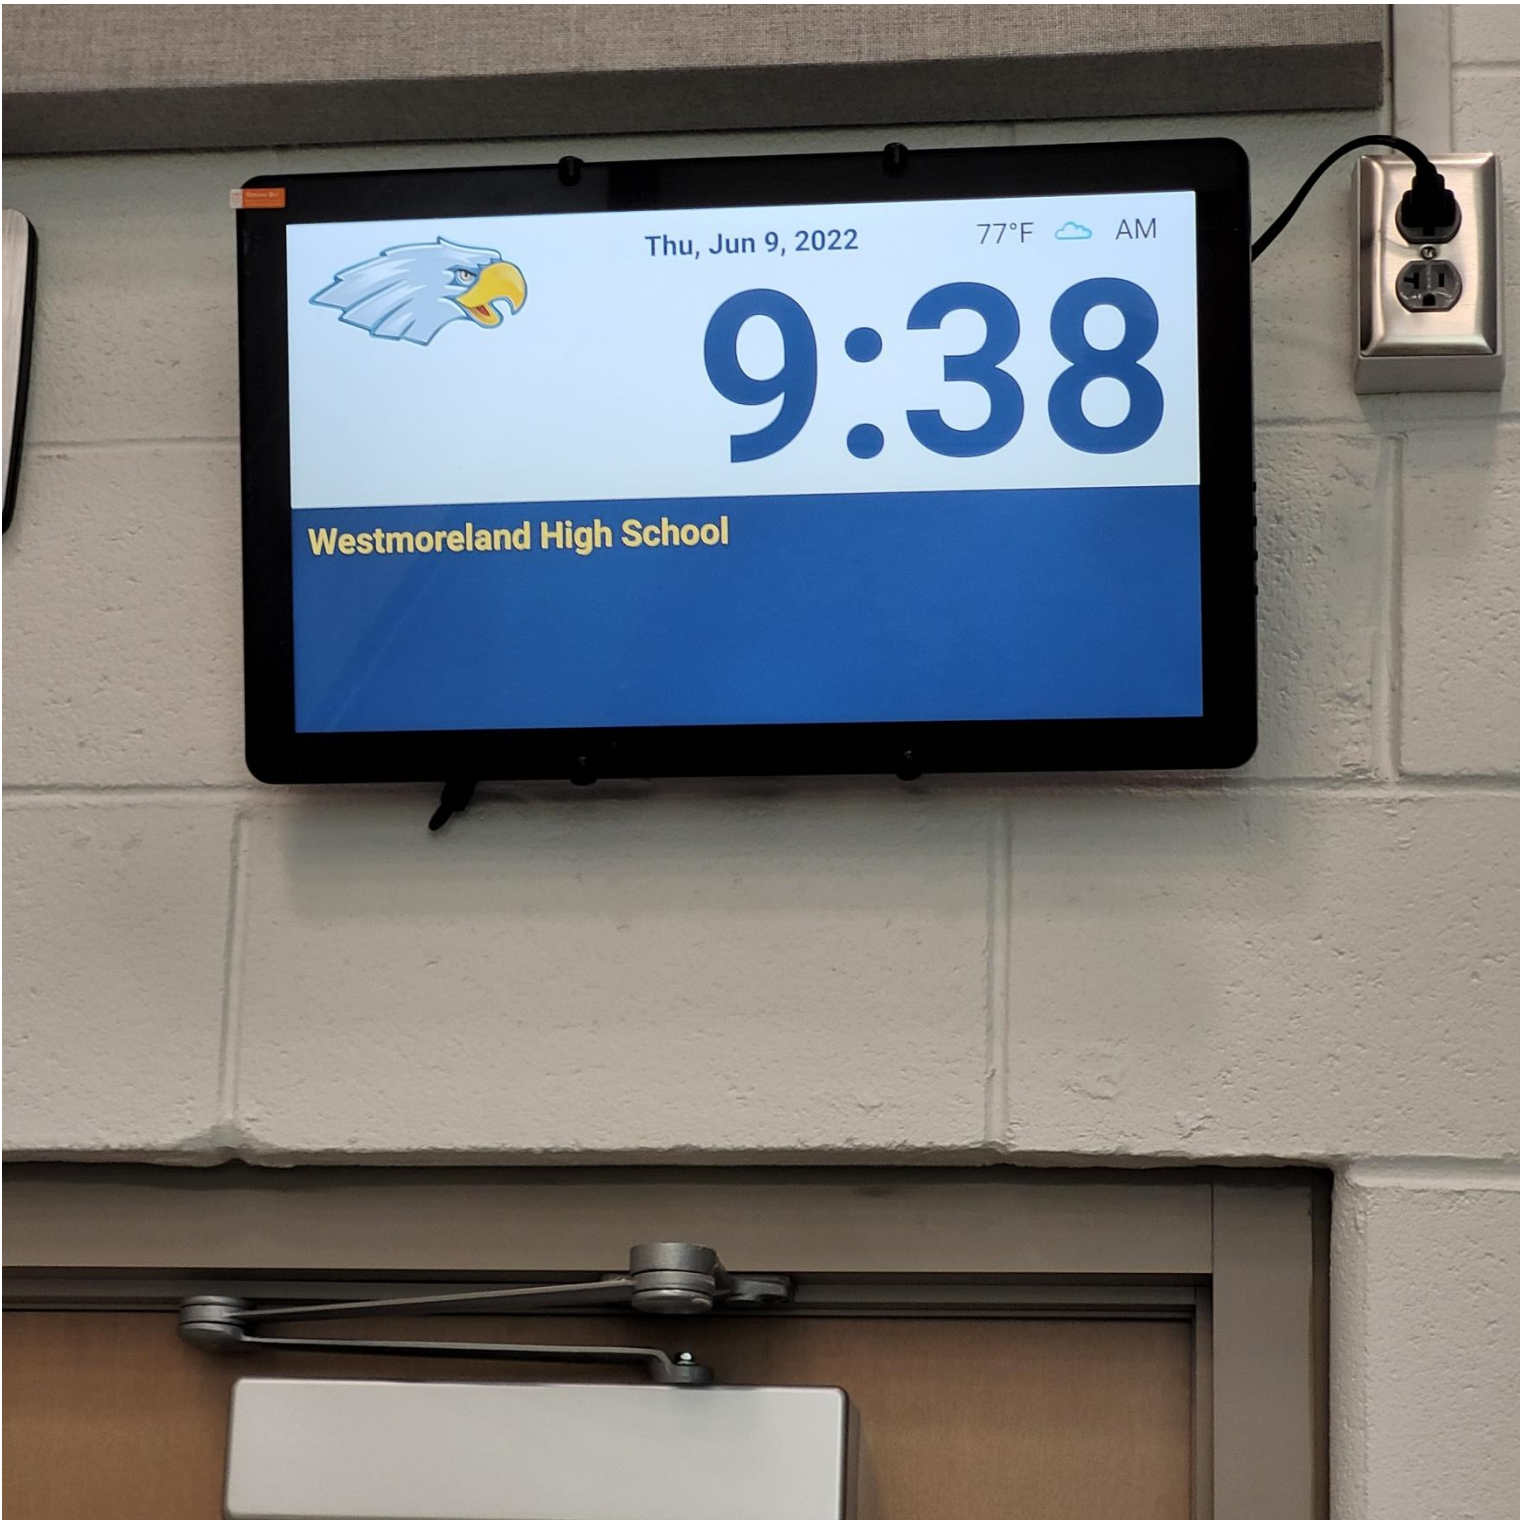
Photo 10 - Clocks installed in Learning Labs
