**COMMONWEALTH  
BUILDING SOLUTIONS, LLC**

**FIELD REPORT**

**WESTMORELAND COUNTY HIGH SCHOOL**

Date: 06/9/2022

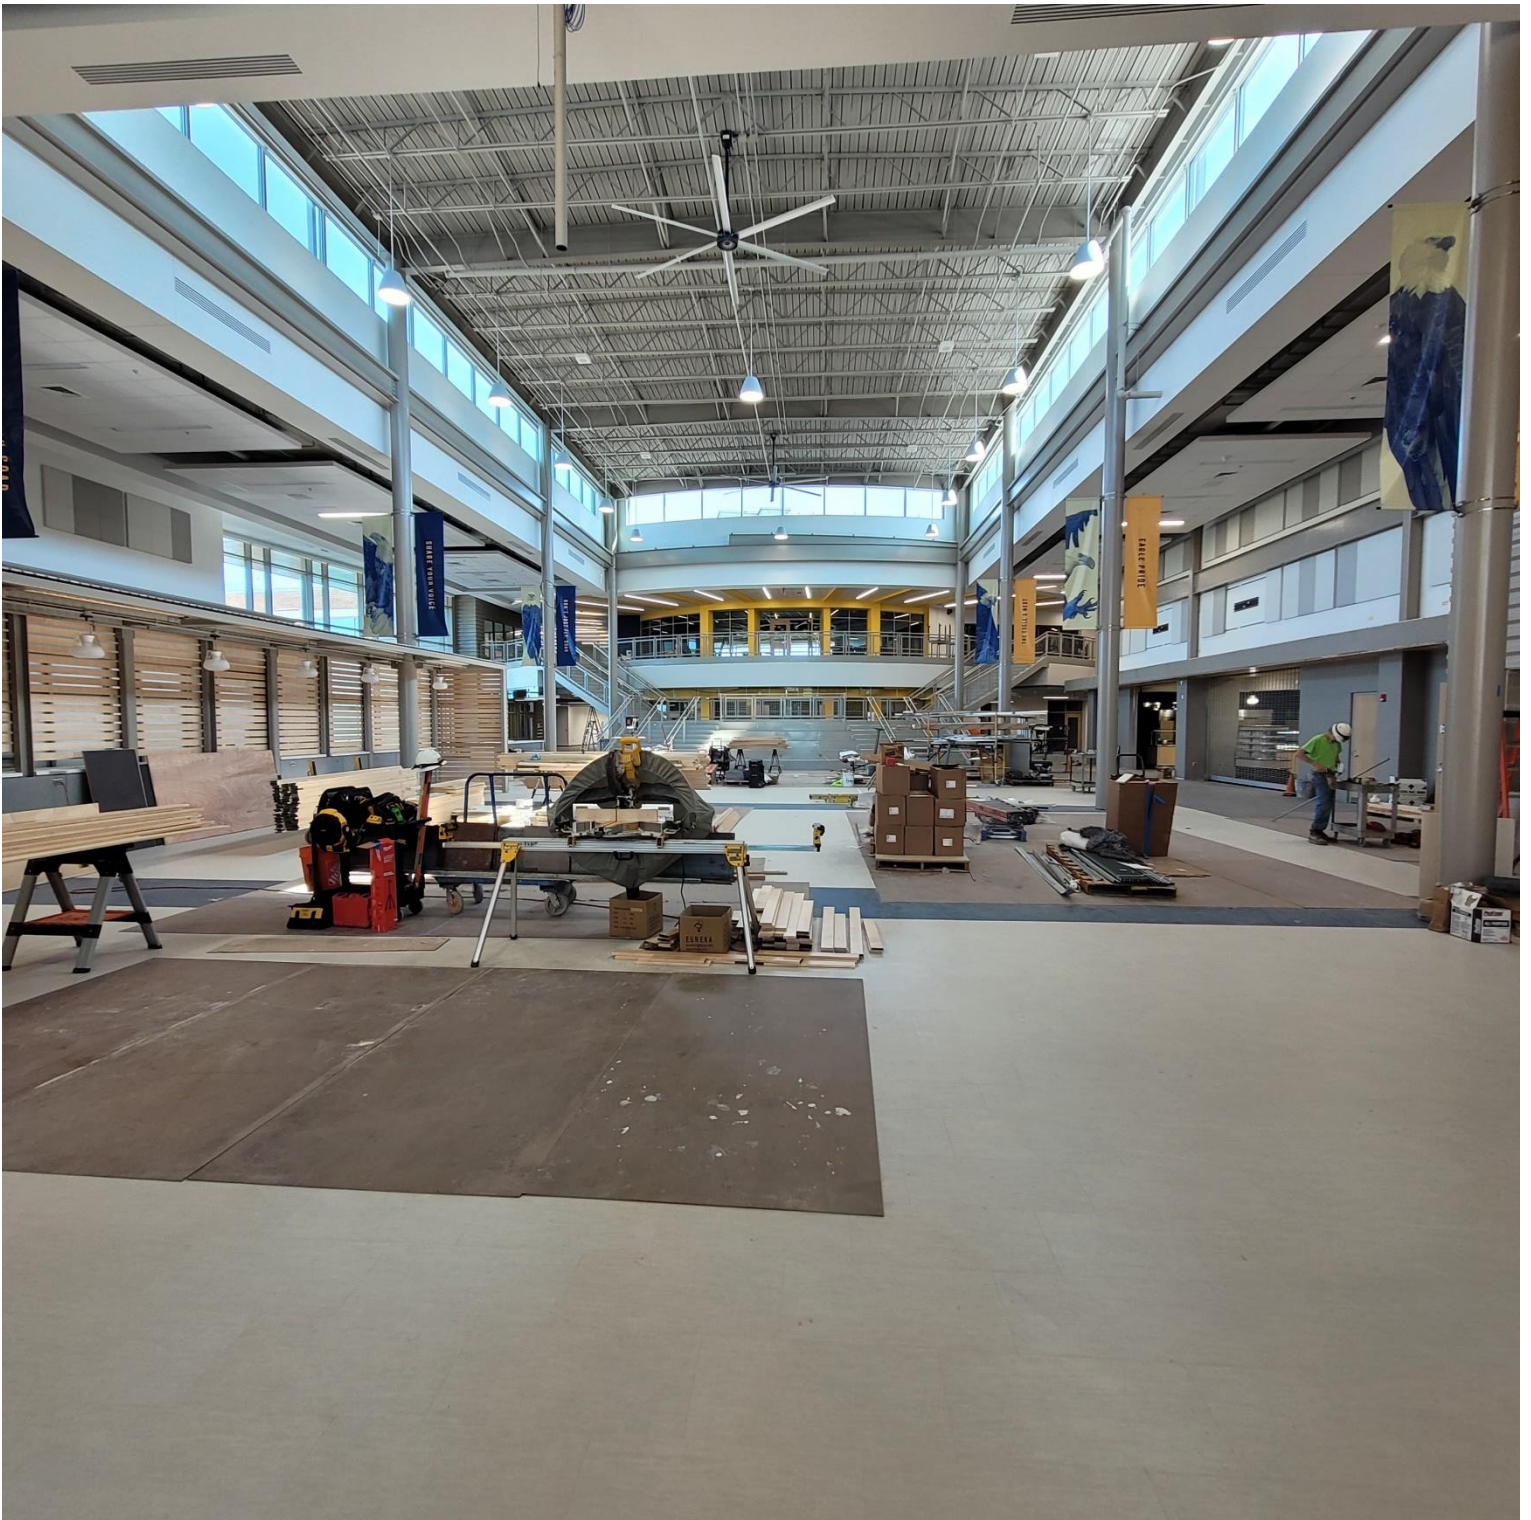
Photo 11 - Area C looking towards the Grand Staircase.

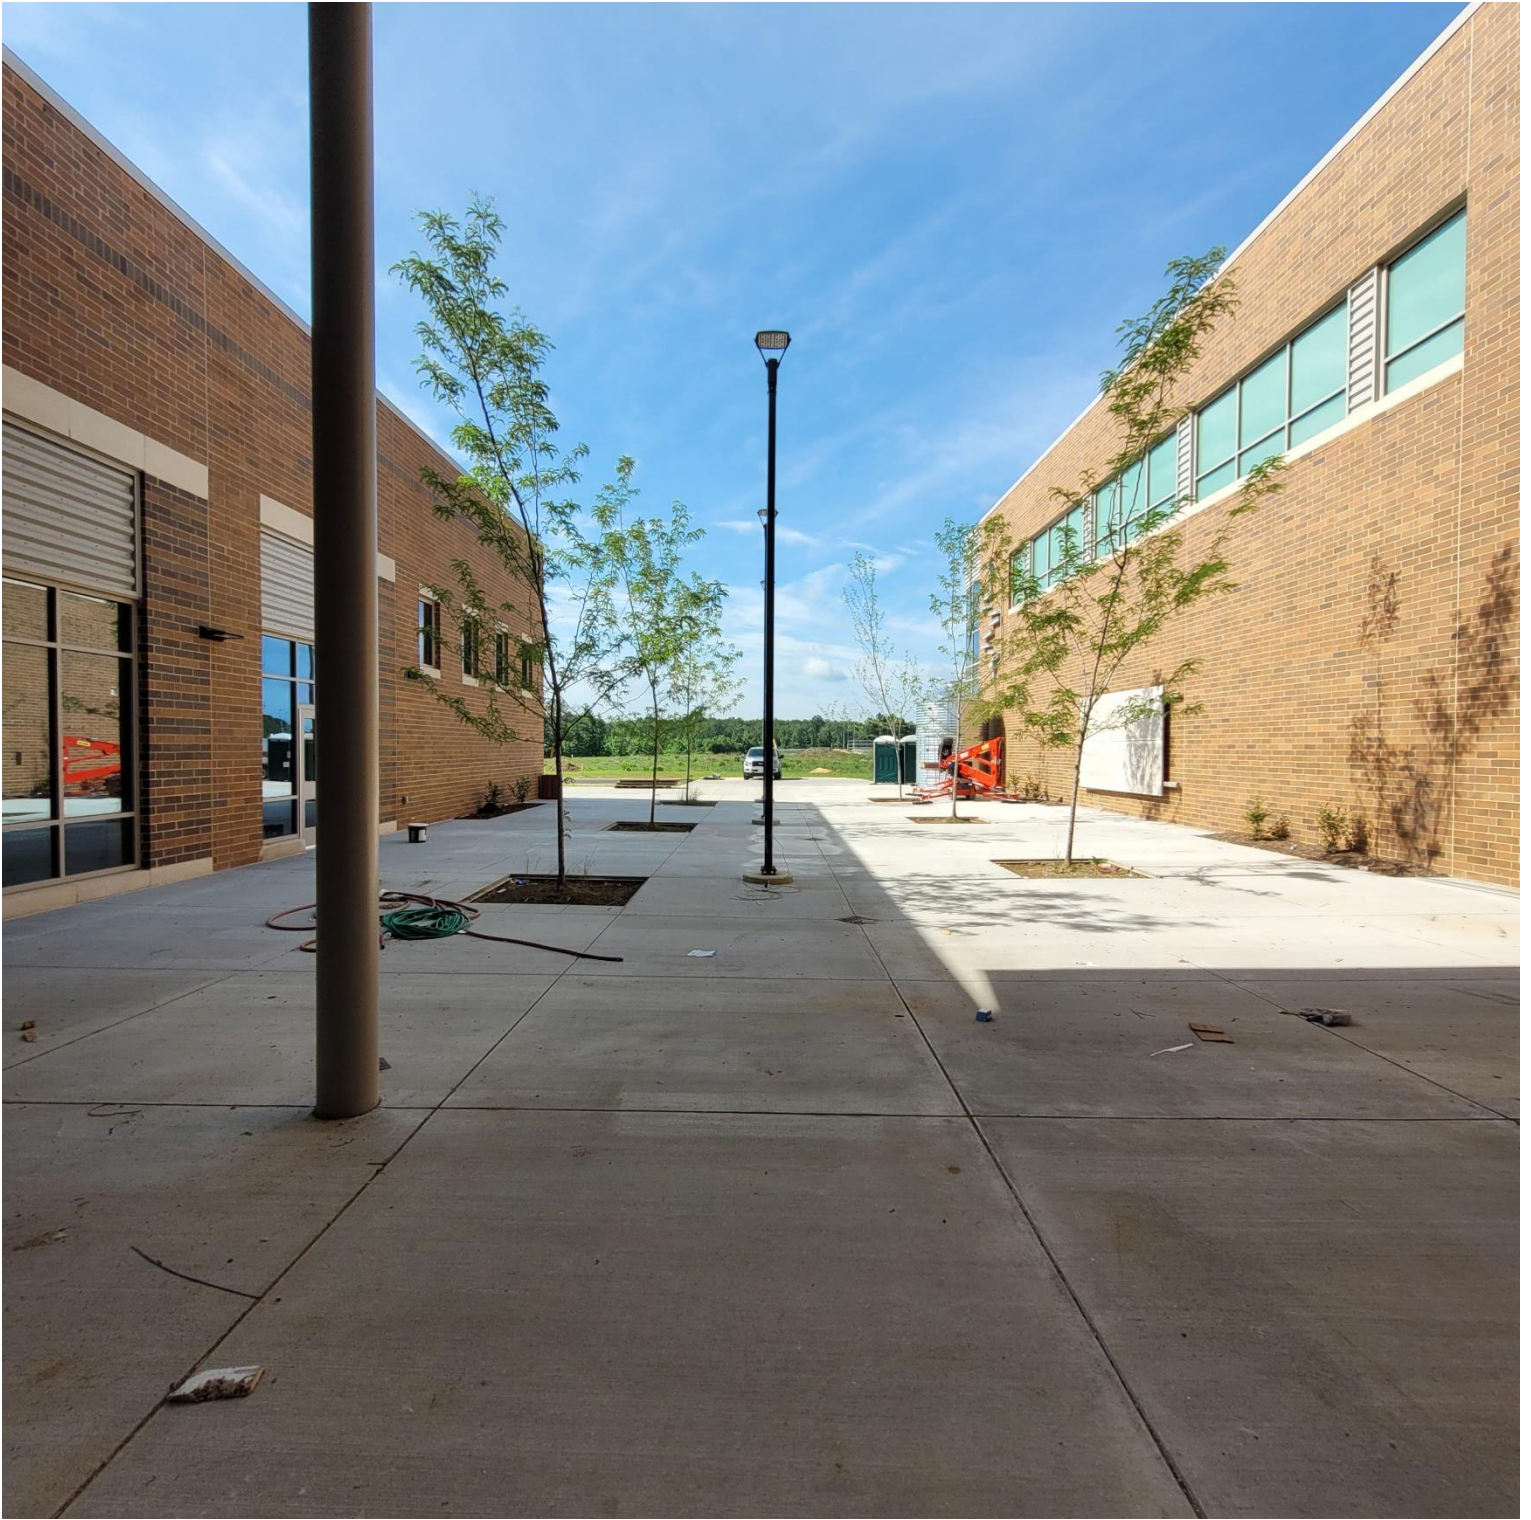
*Photo 12 - Courtyard between Areas D & E*

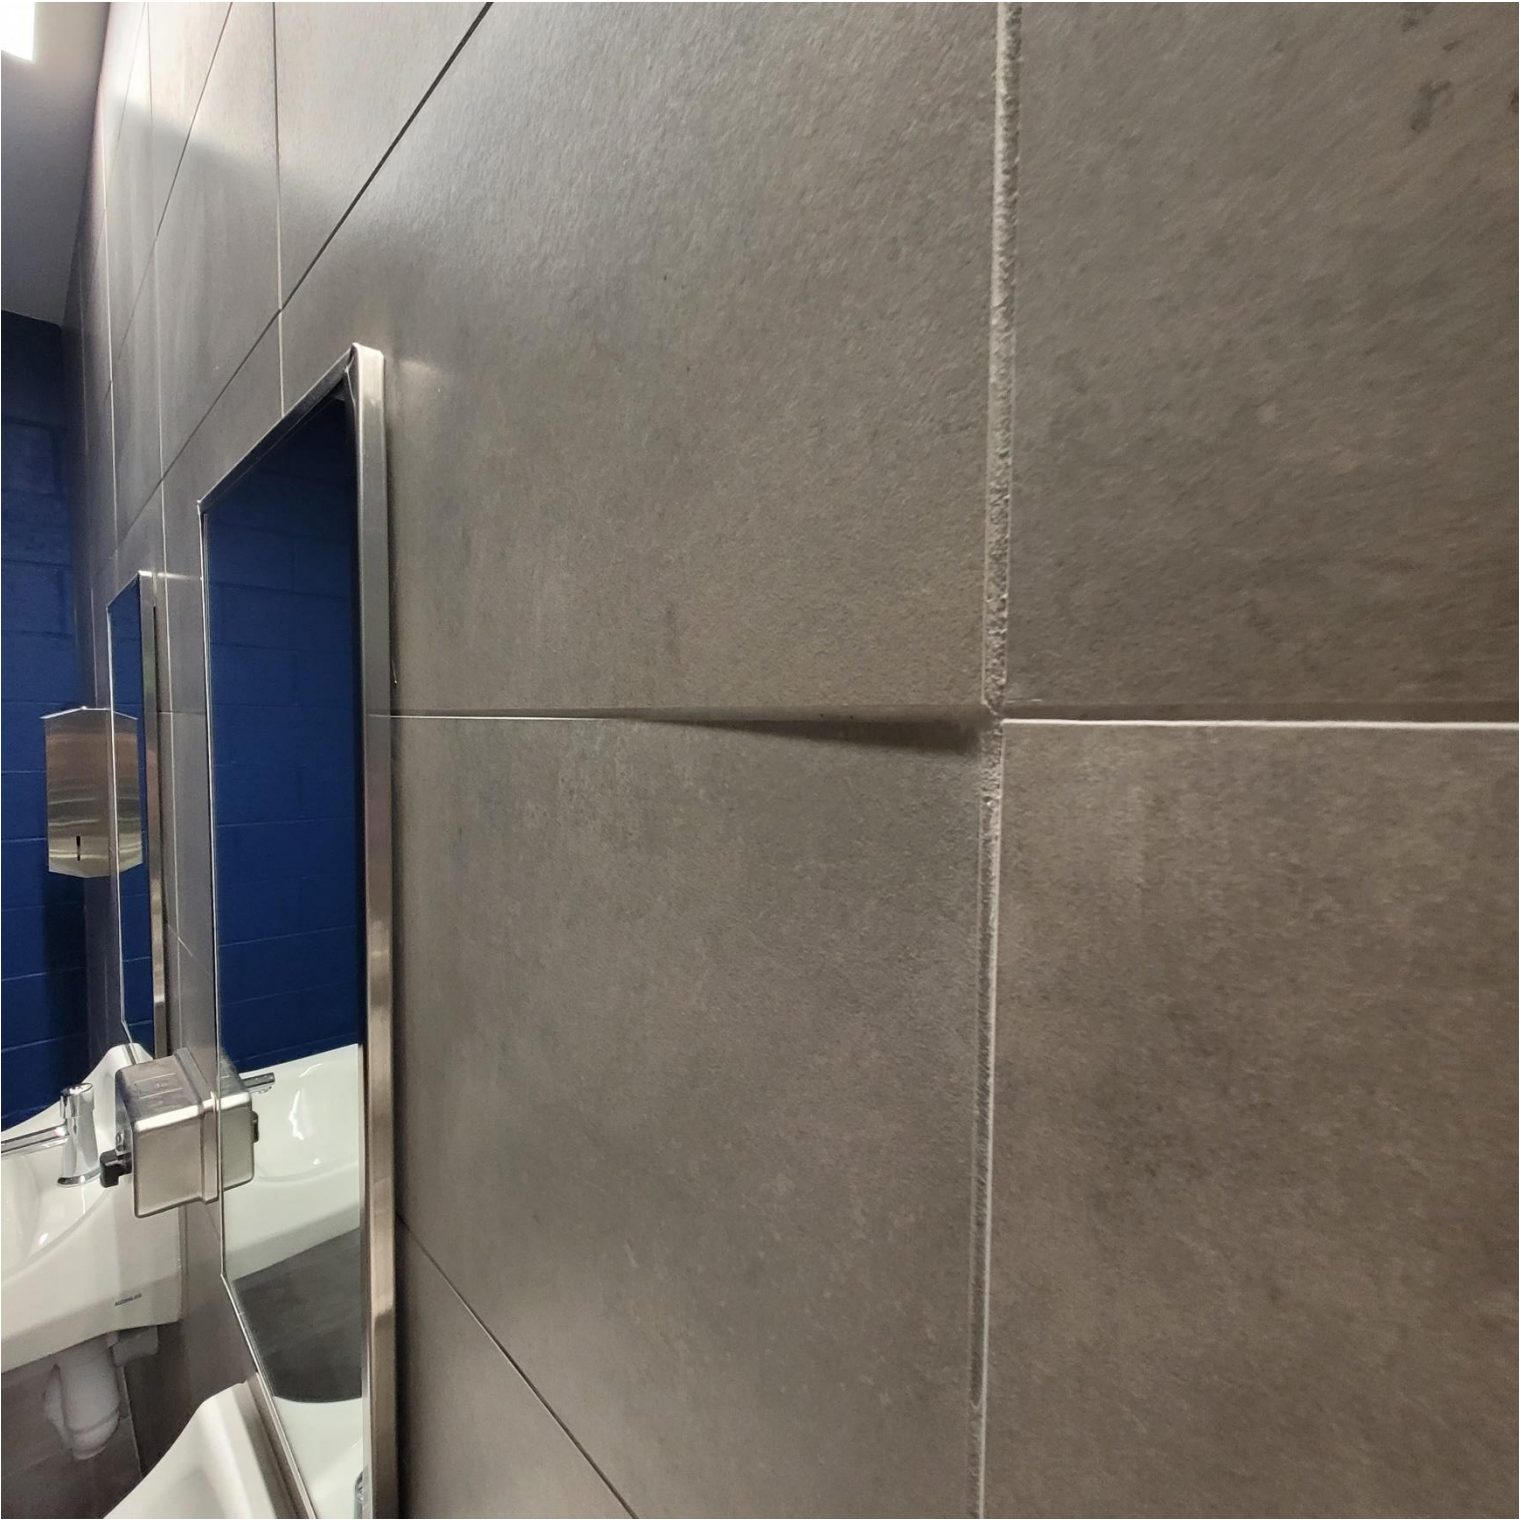
Photo 13 - Wall Tile in Boys Restroom E103

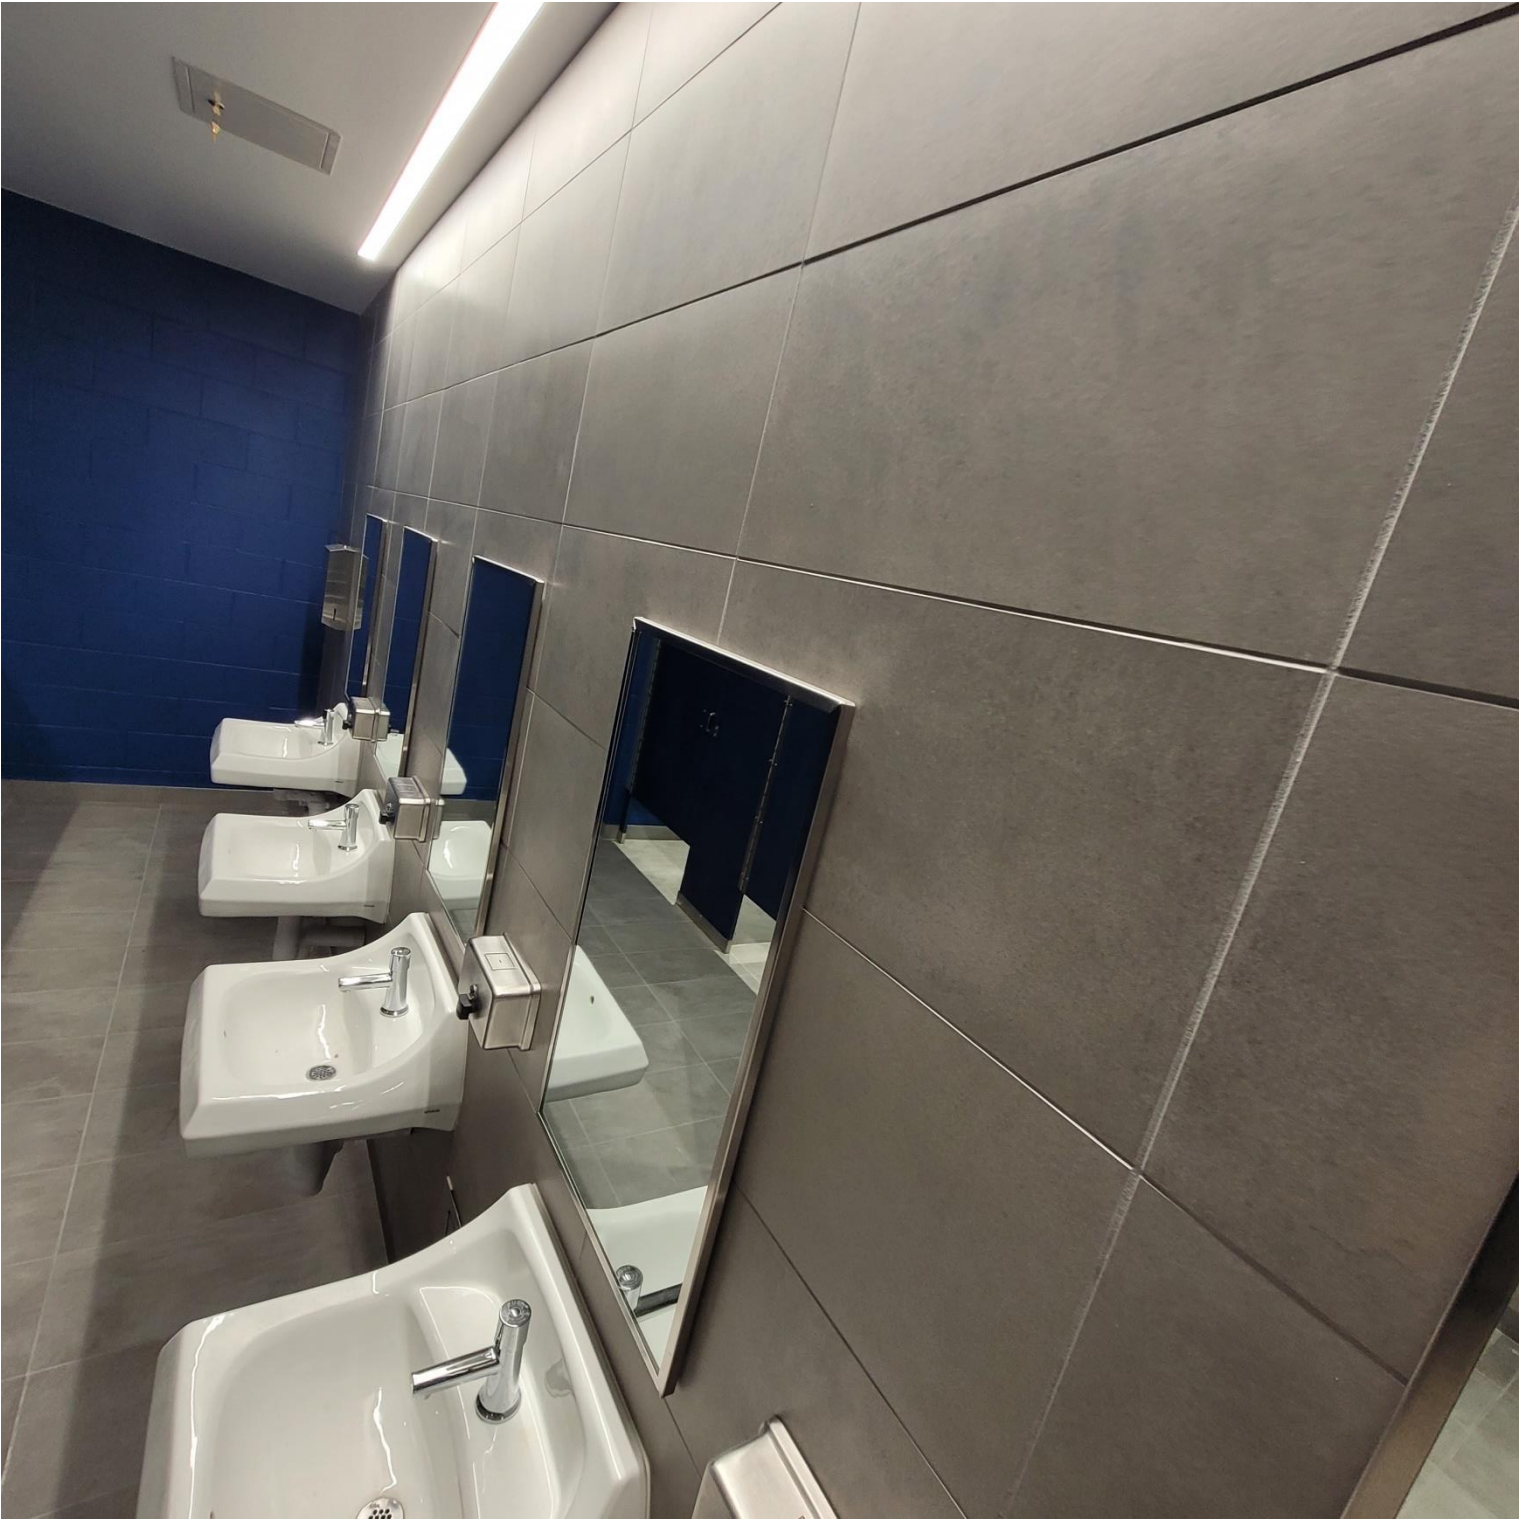
Photo 14 - Wall Tile in E103

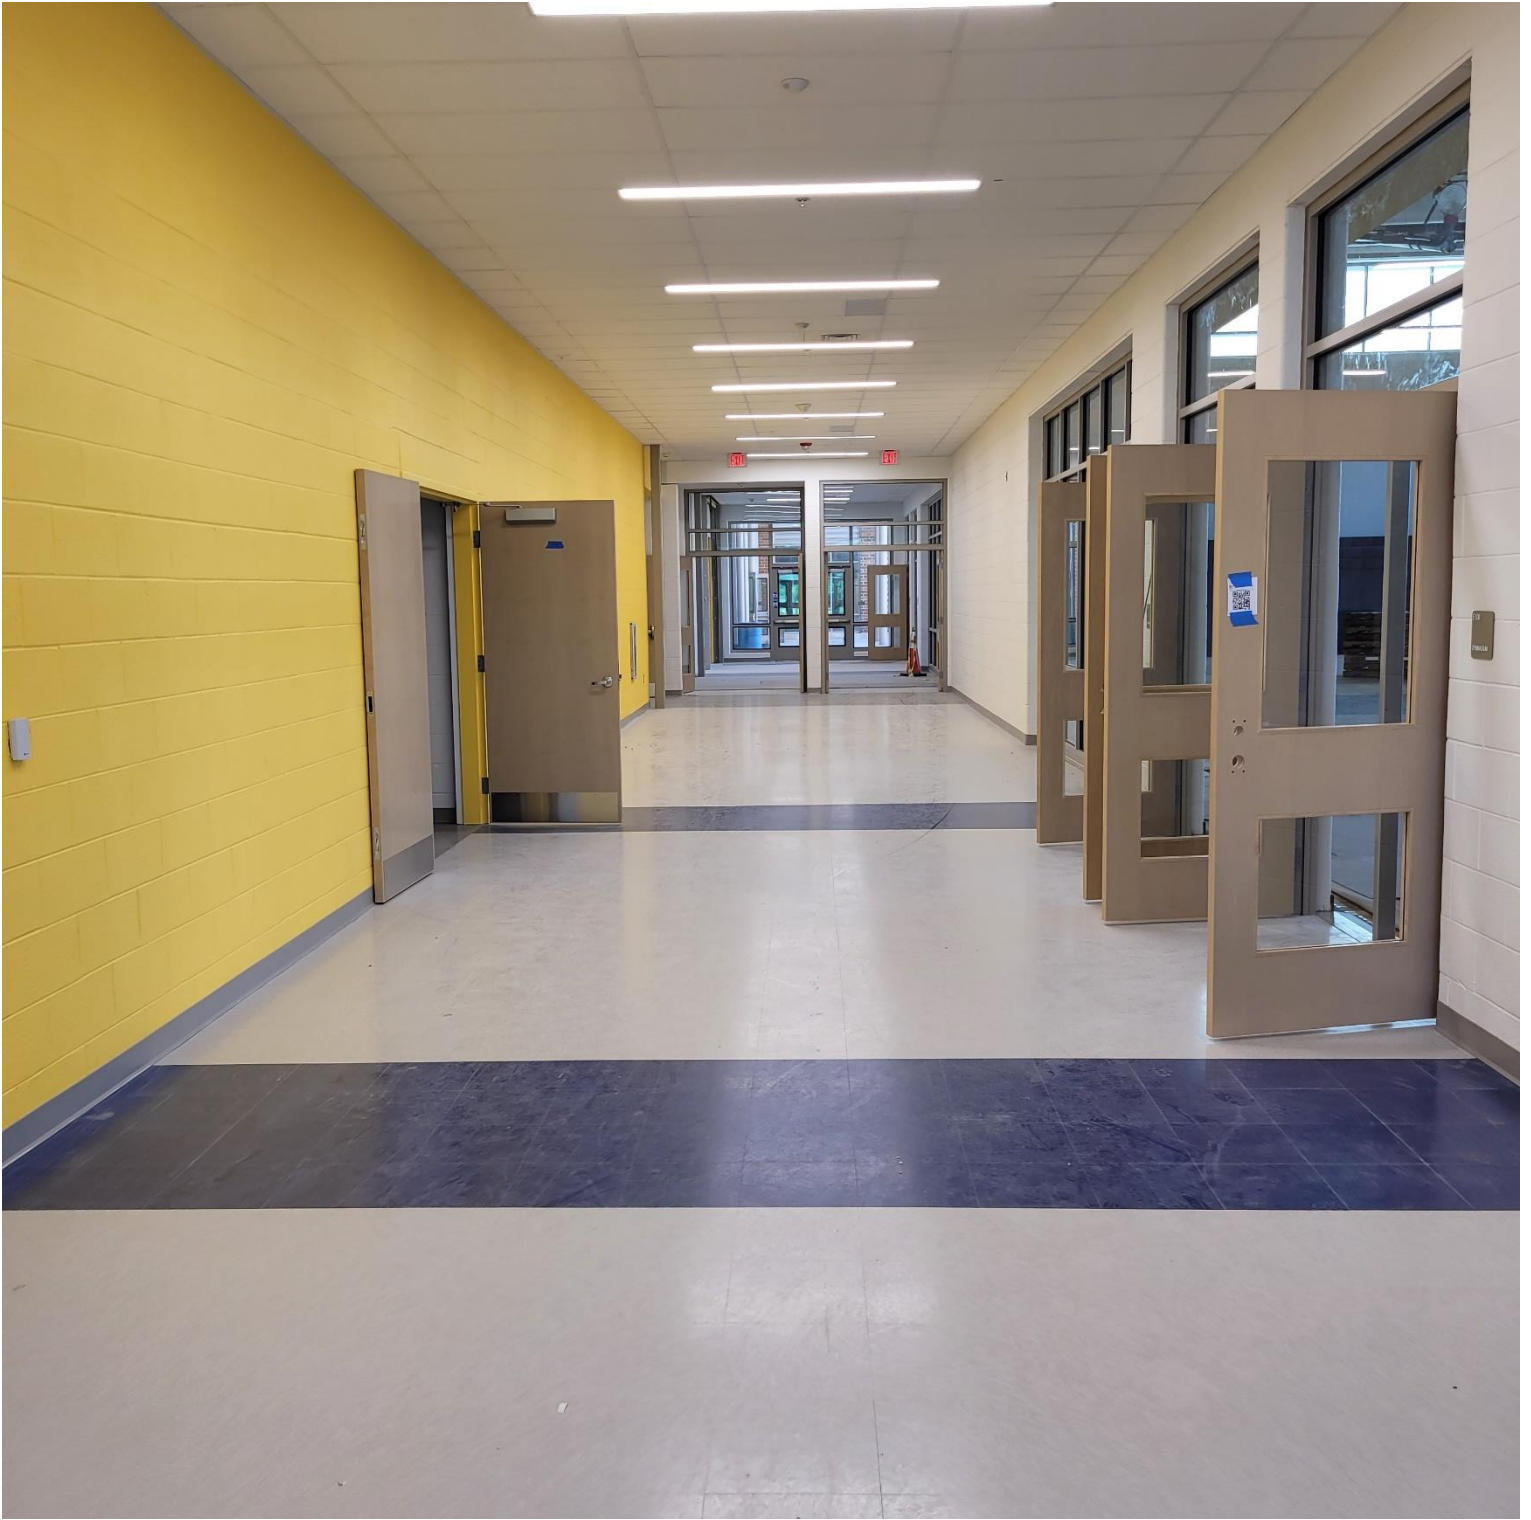
Photo 15 - Gymnasium Hallway looking East

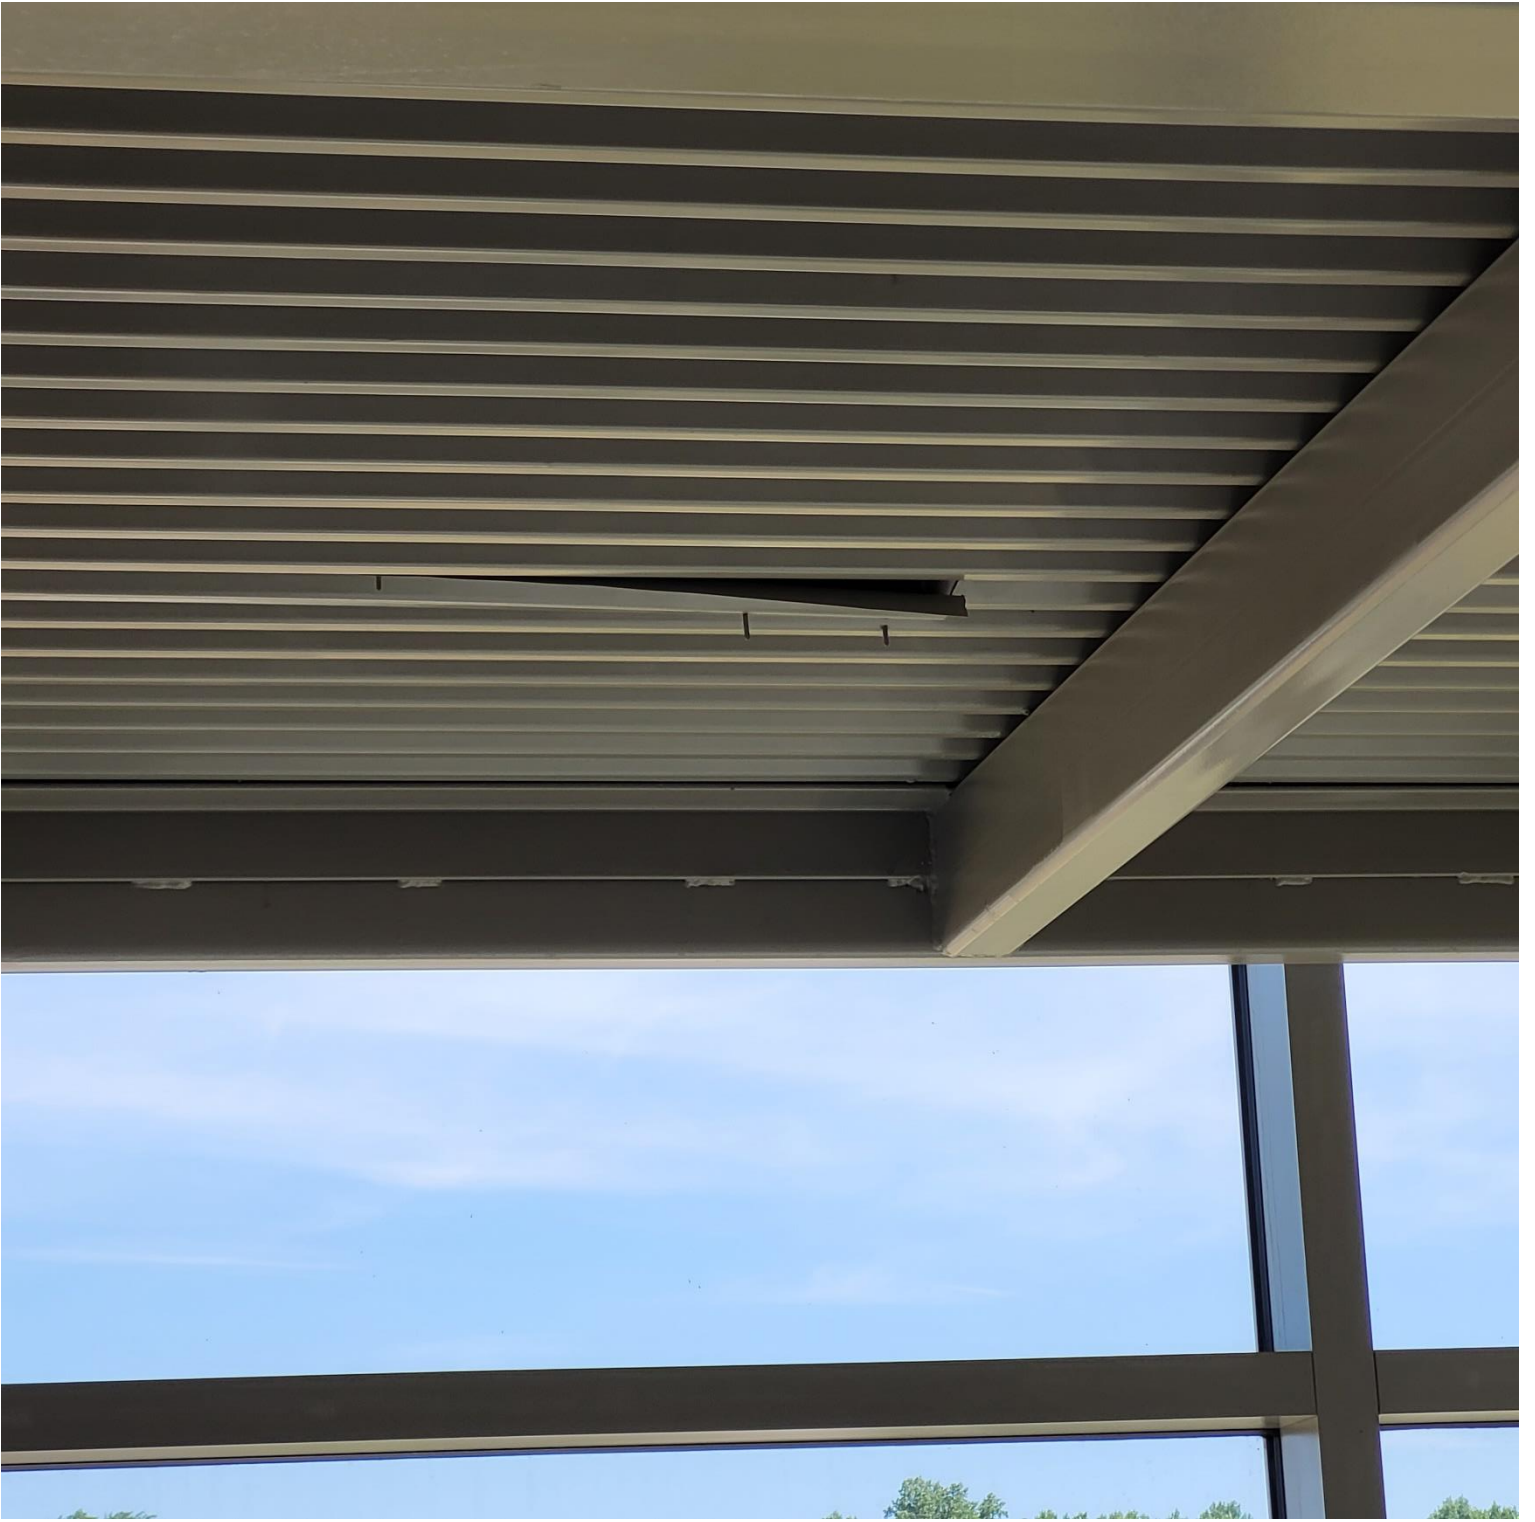
*Photo 16 - Metal Decking in Stairwell #1*

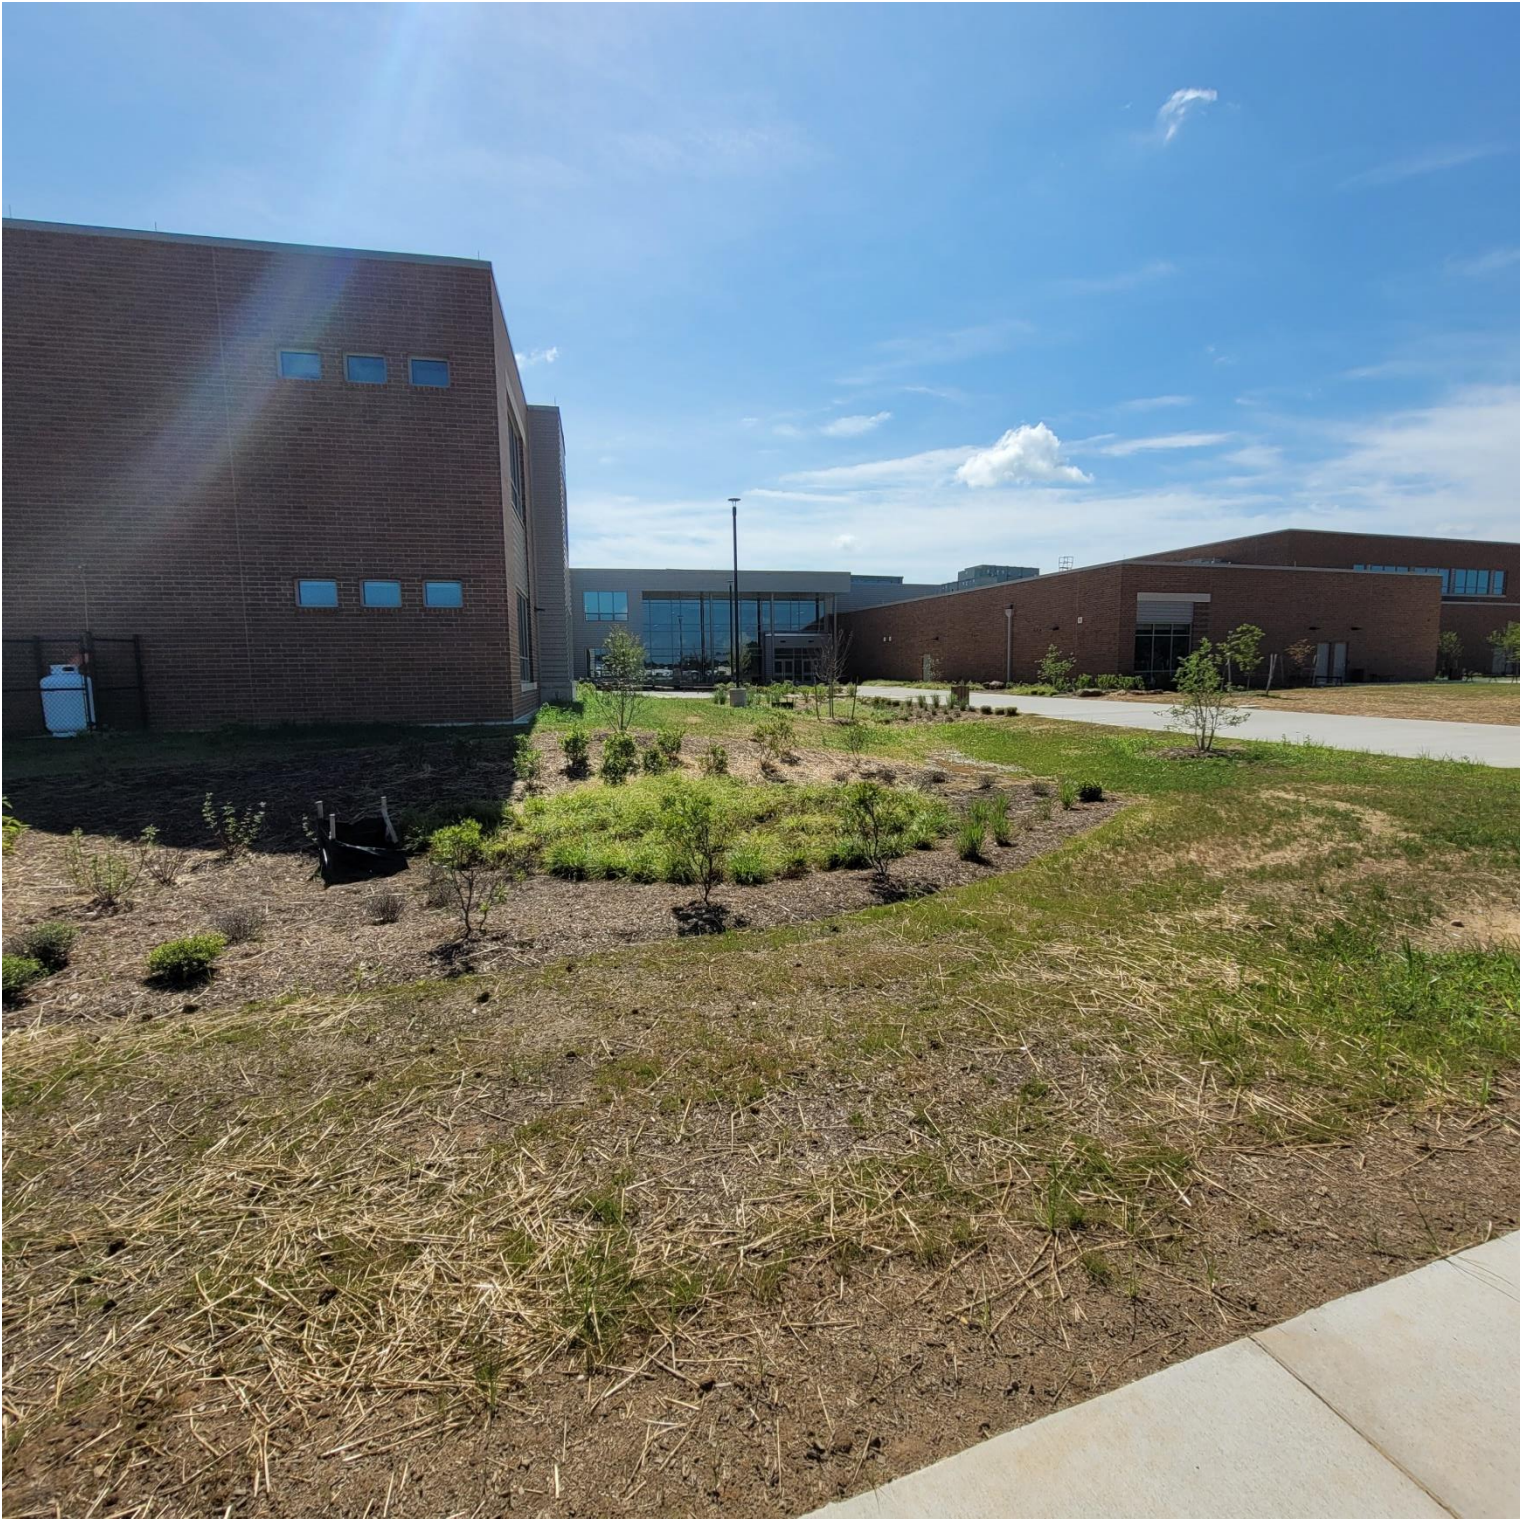
*Photo 17 - Area between Areas B & E*

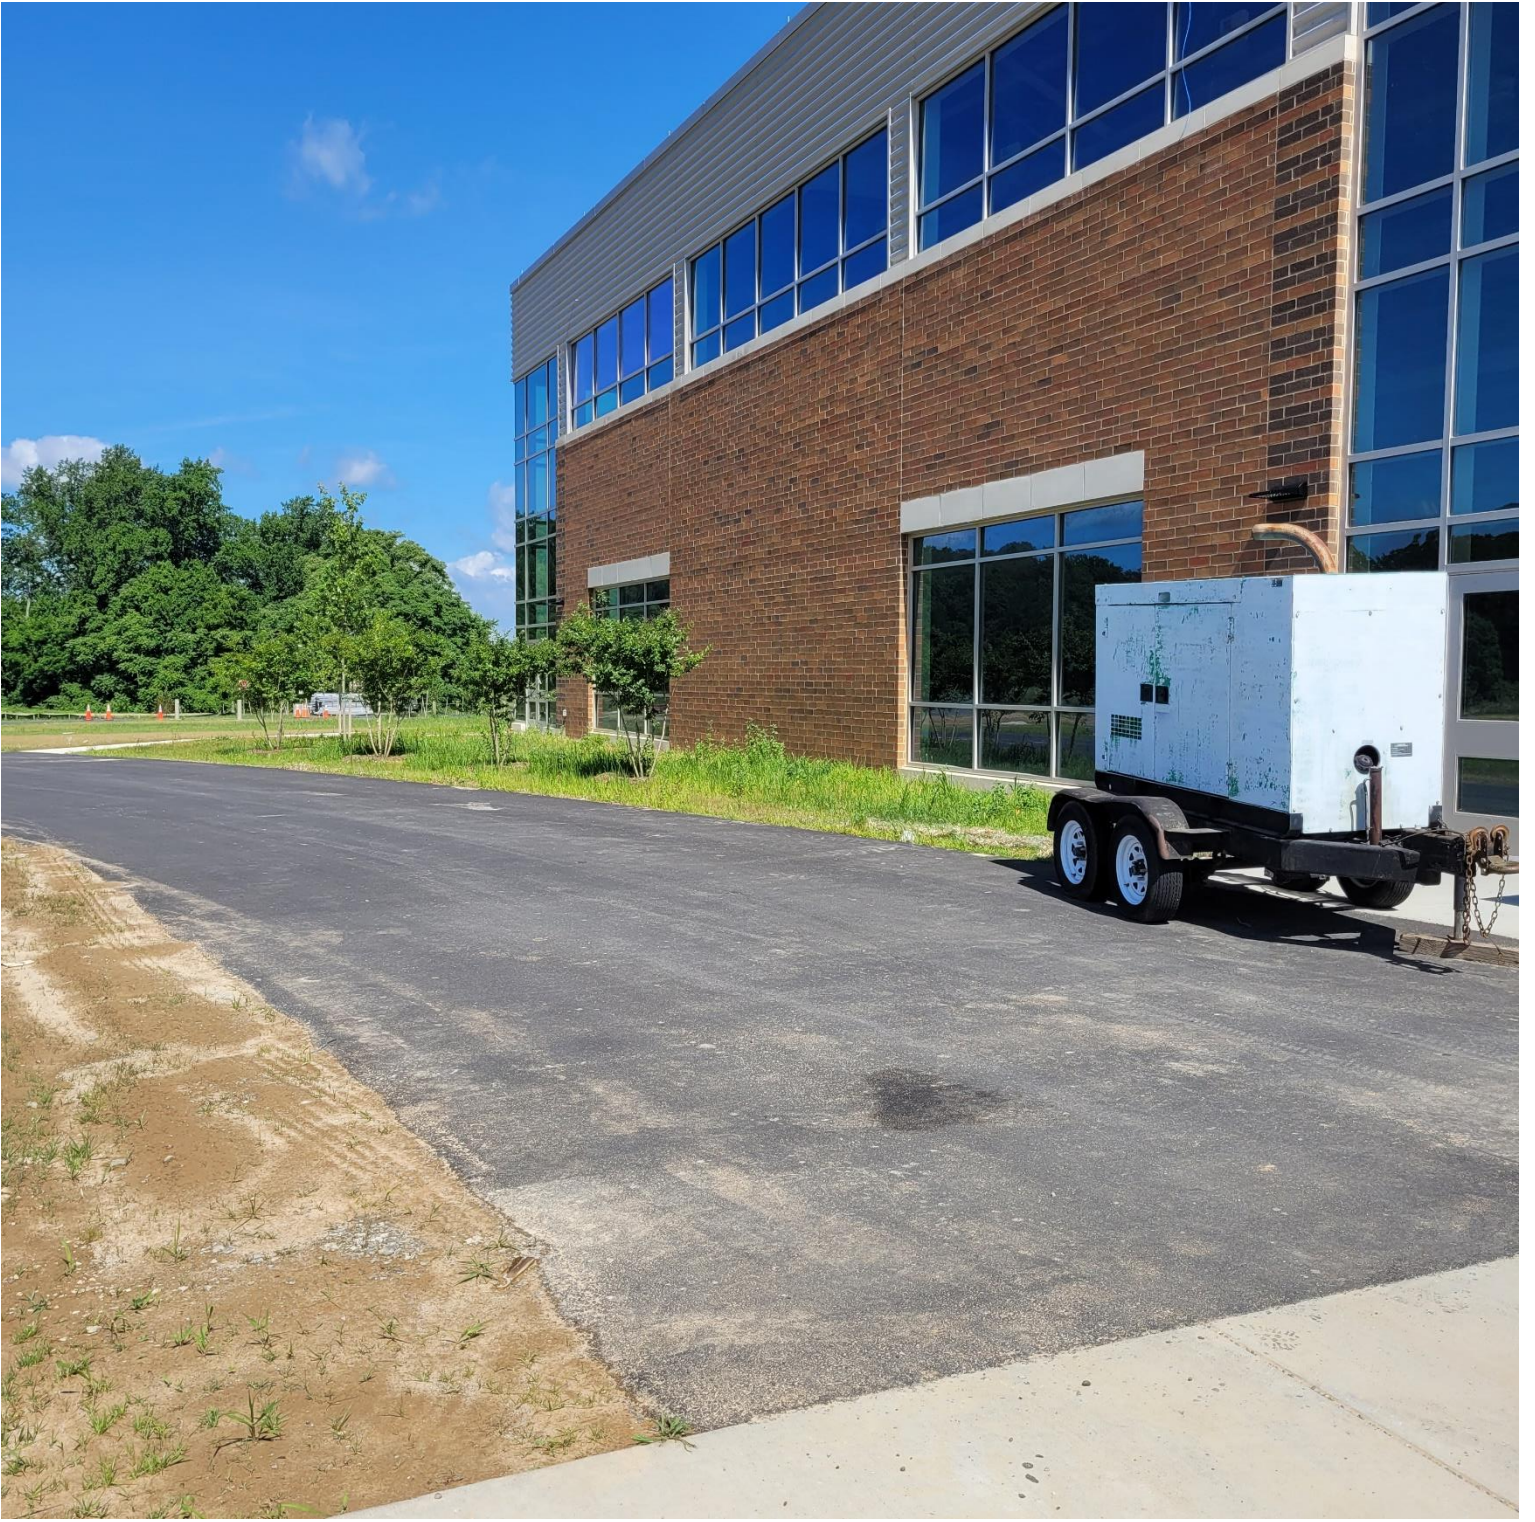
Photo 18 - Southside of Area E

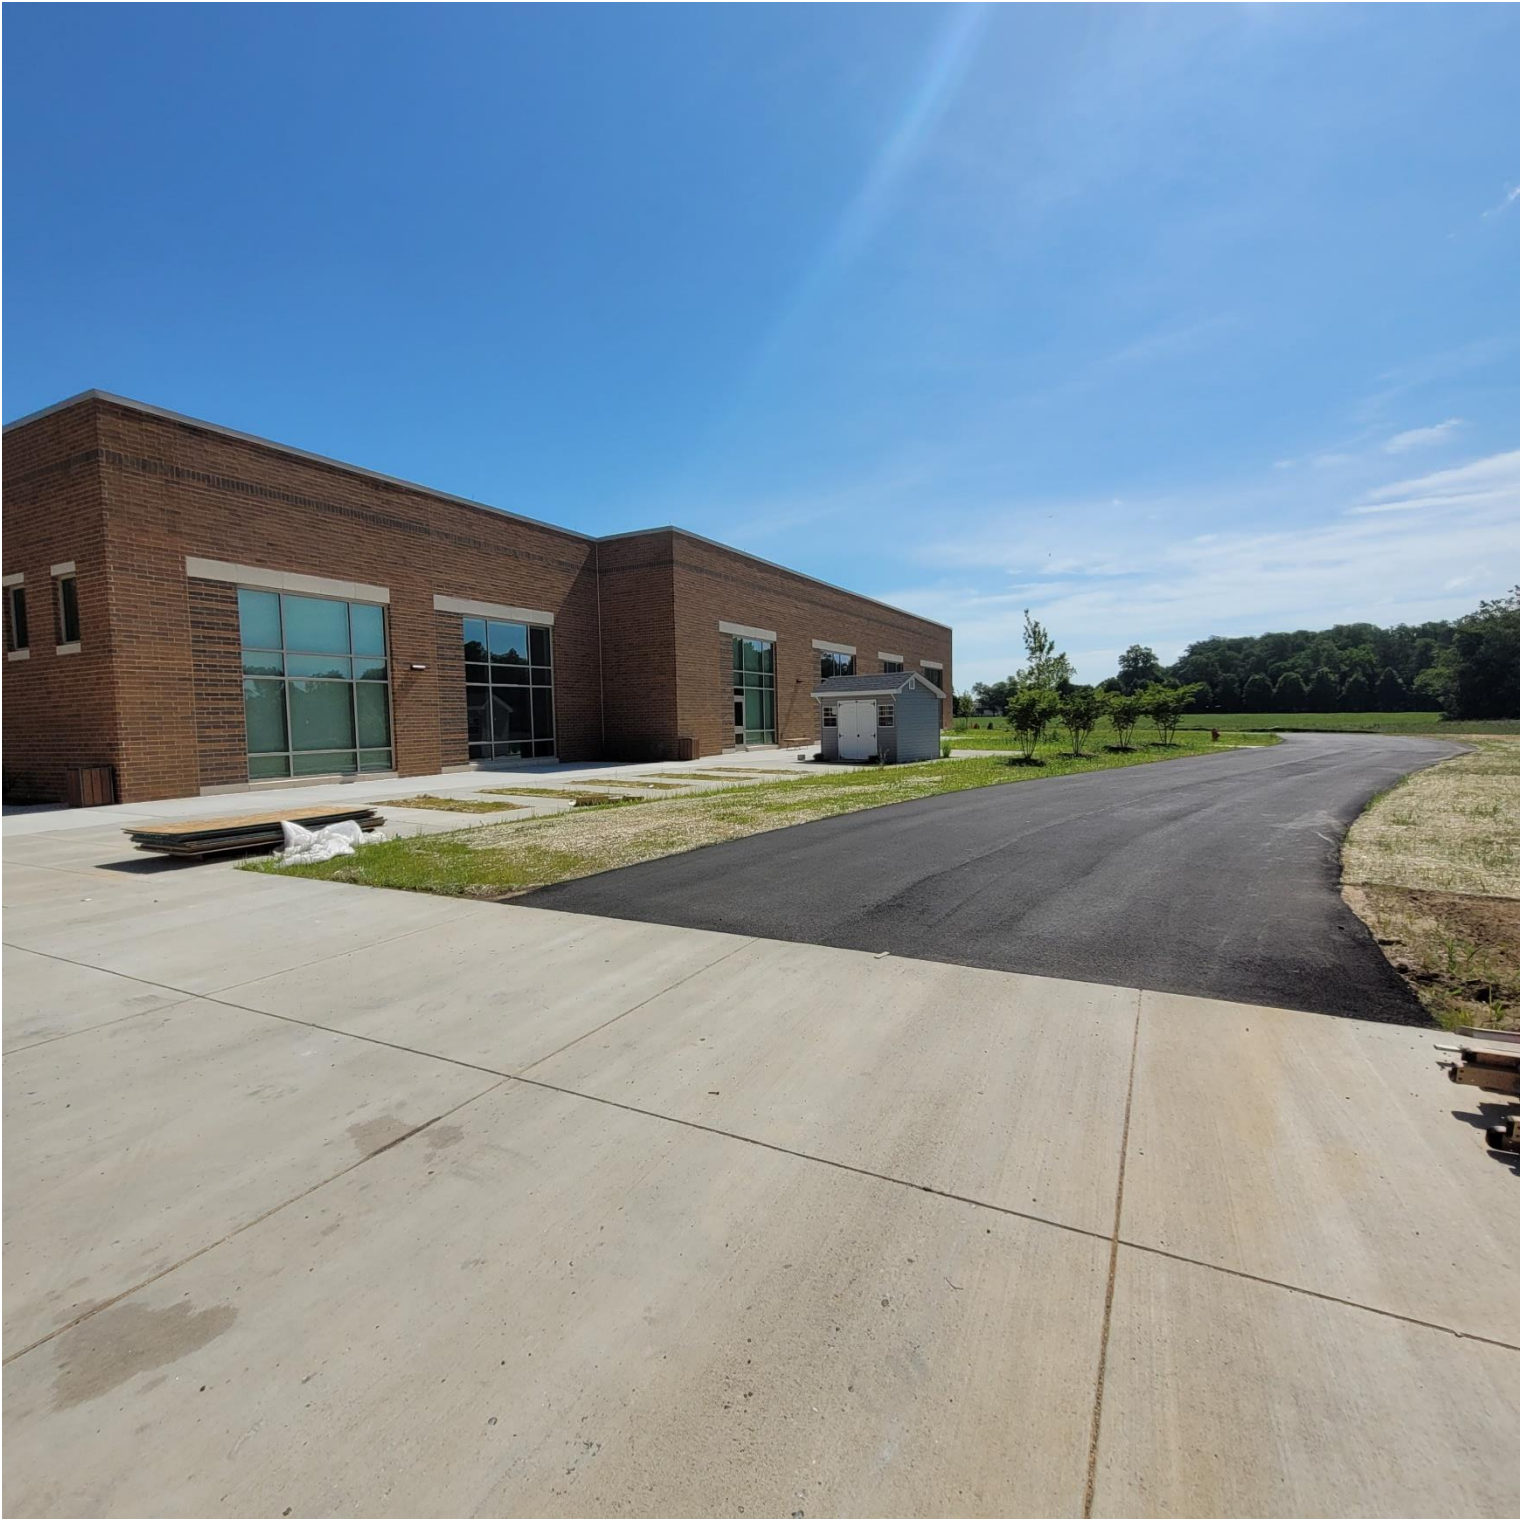
Photo 19 Southside of Area D

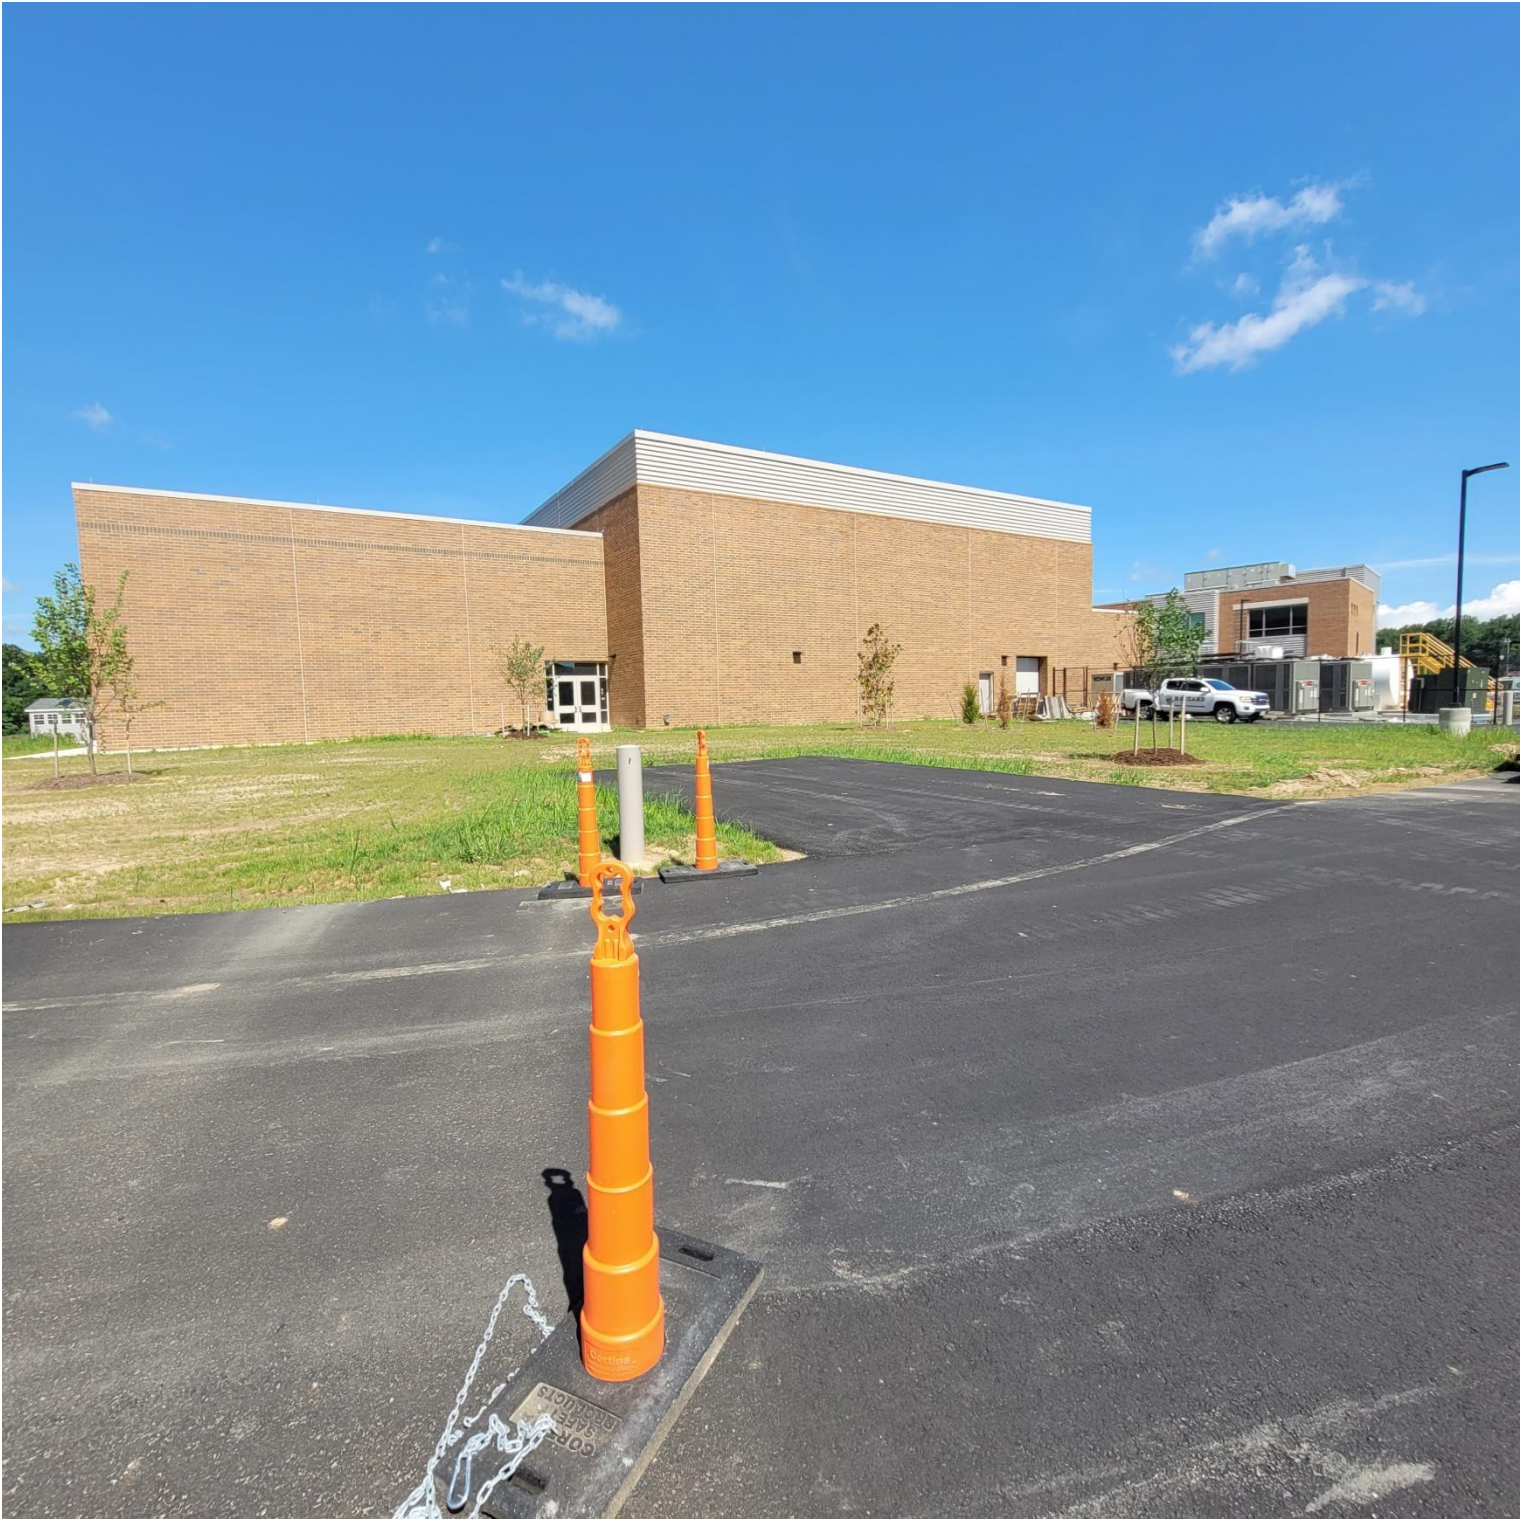
Photo 20 - Eastside of Area E
