**COMMONWEALTH  
BUILDING SOLUTIONS, LLC**

**FIELD REPORT**

**WESTMORELAND COUNTY HIGH SCHOOL**

Date: 06/9/2022

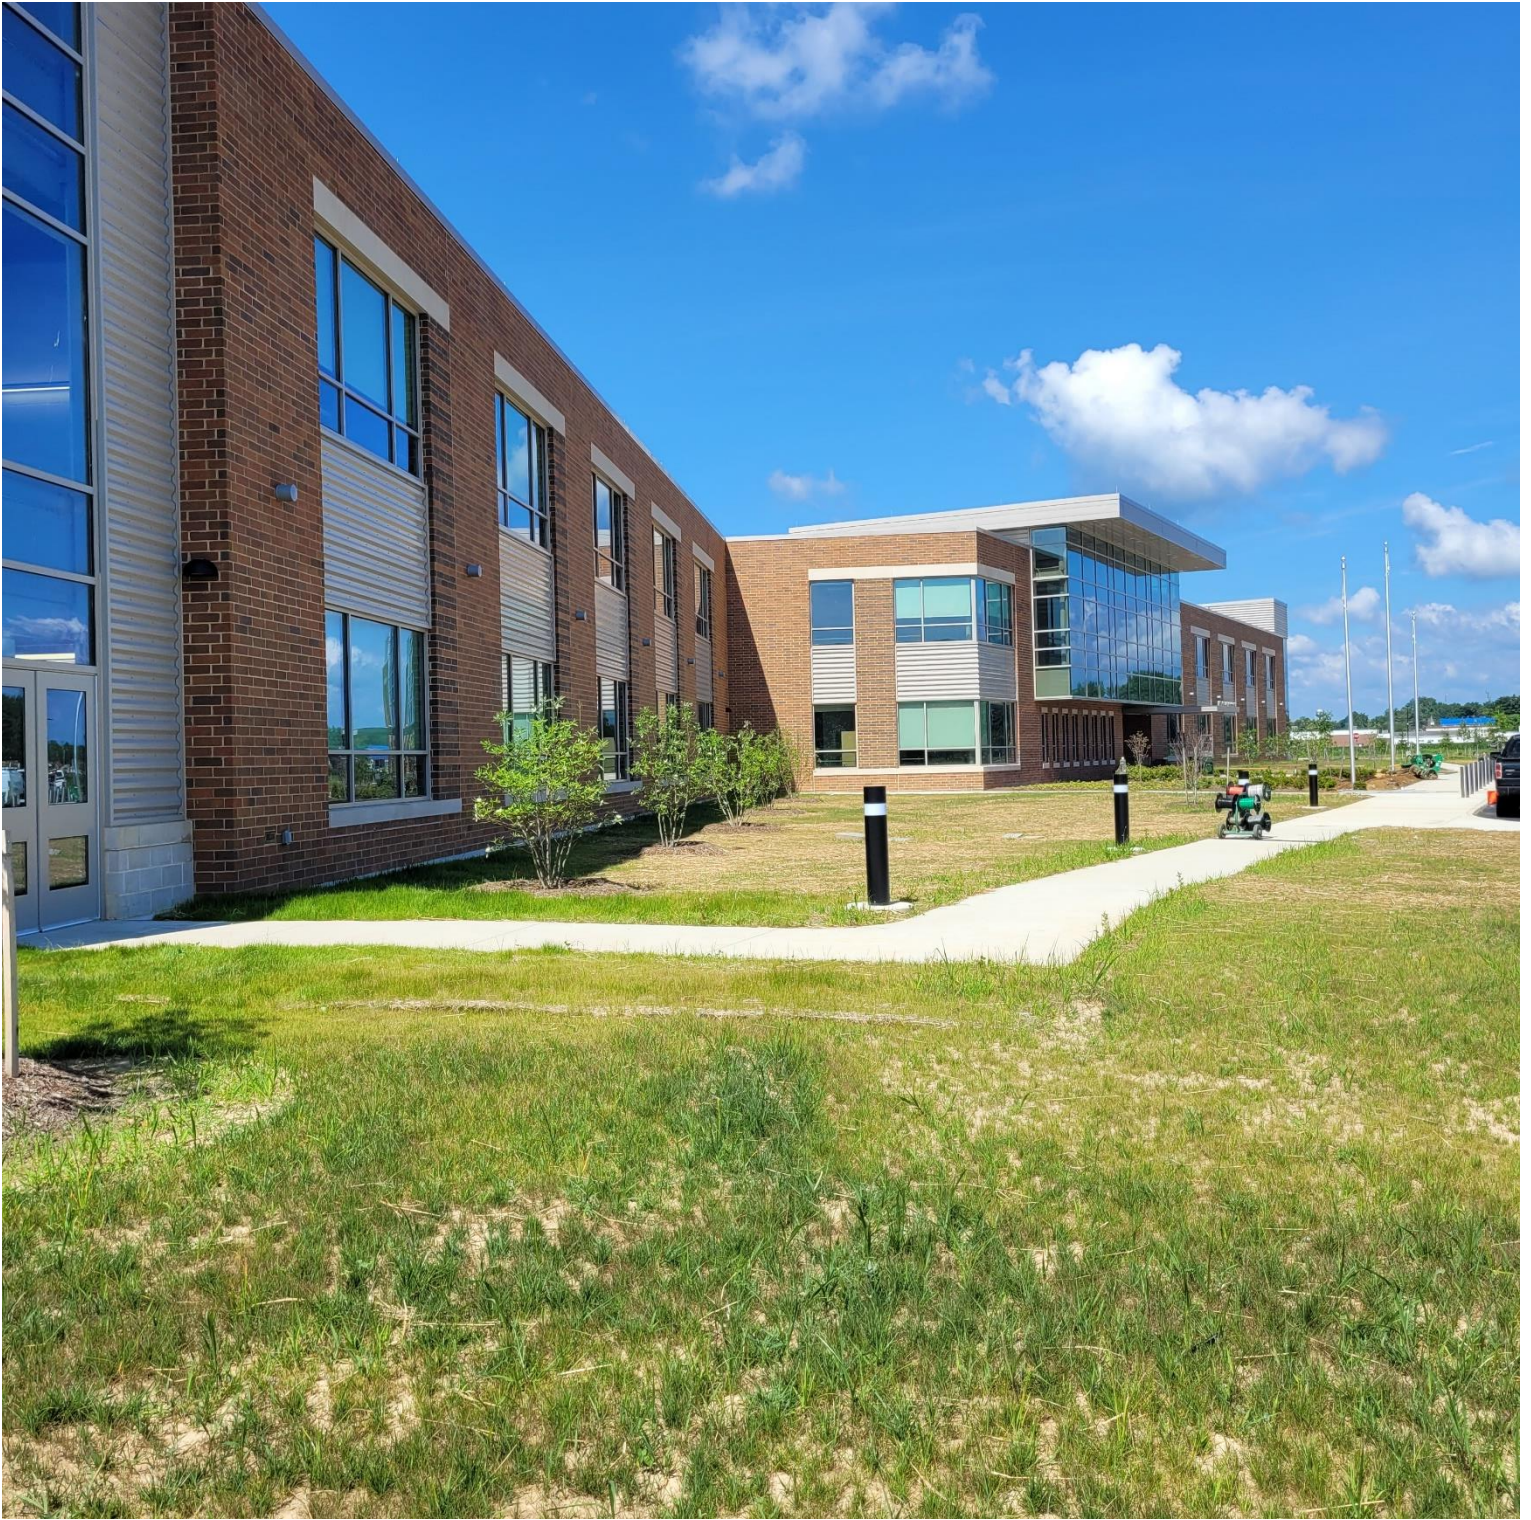
*Photo 21 - Front of High School*
