**COMMONWEALTH
BUILDING SOLUTIONS, LLC**

FIELD REPORT

WESTMORELAND COUNTY HIGH SCHOOL

Date: 08/24/2021

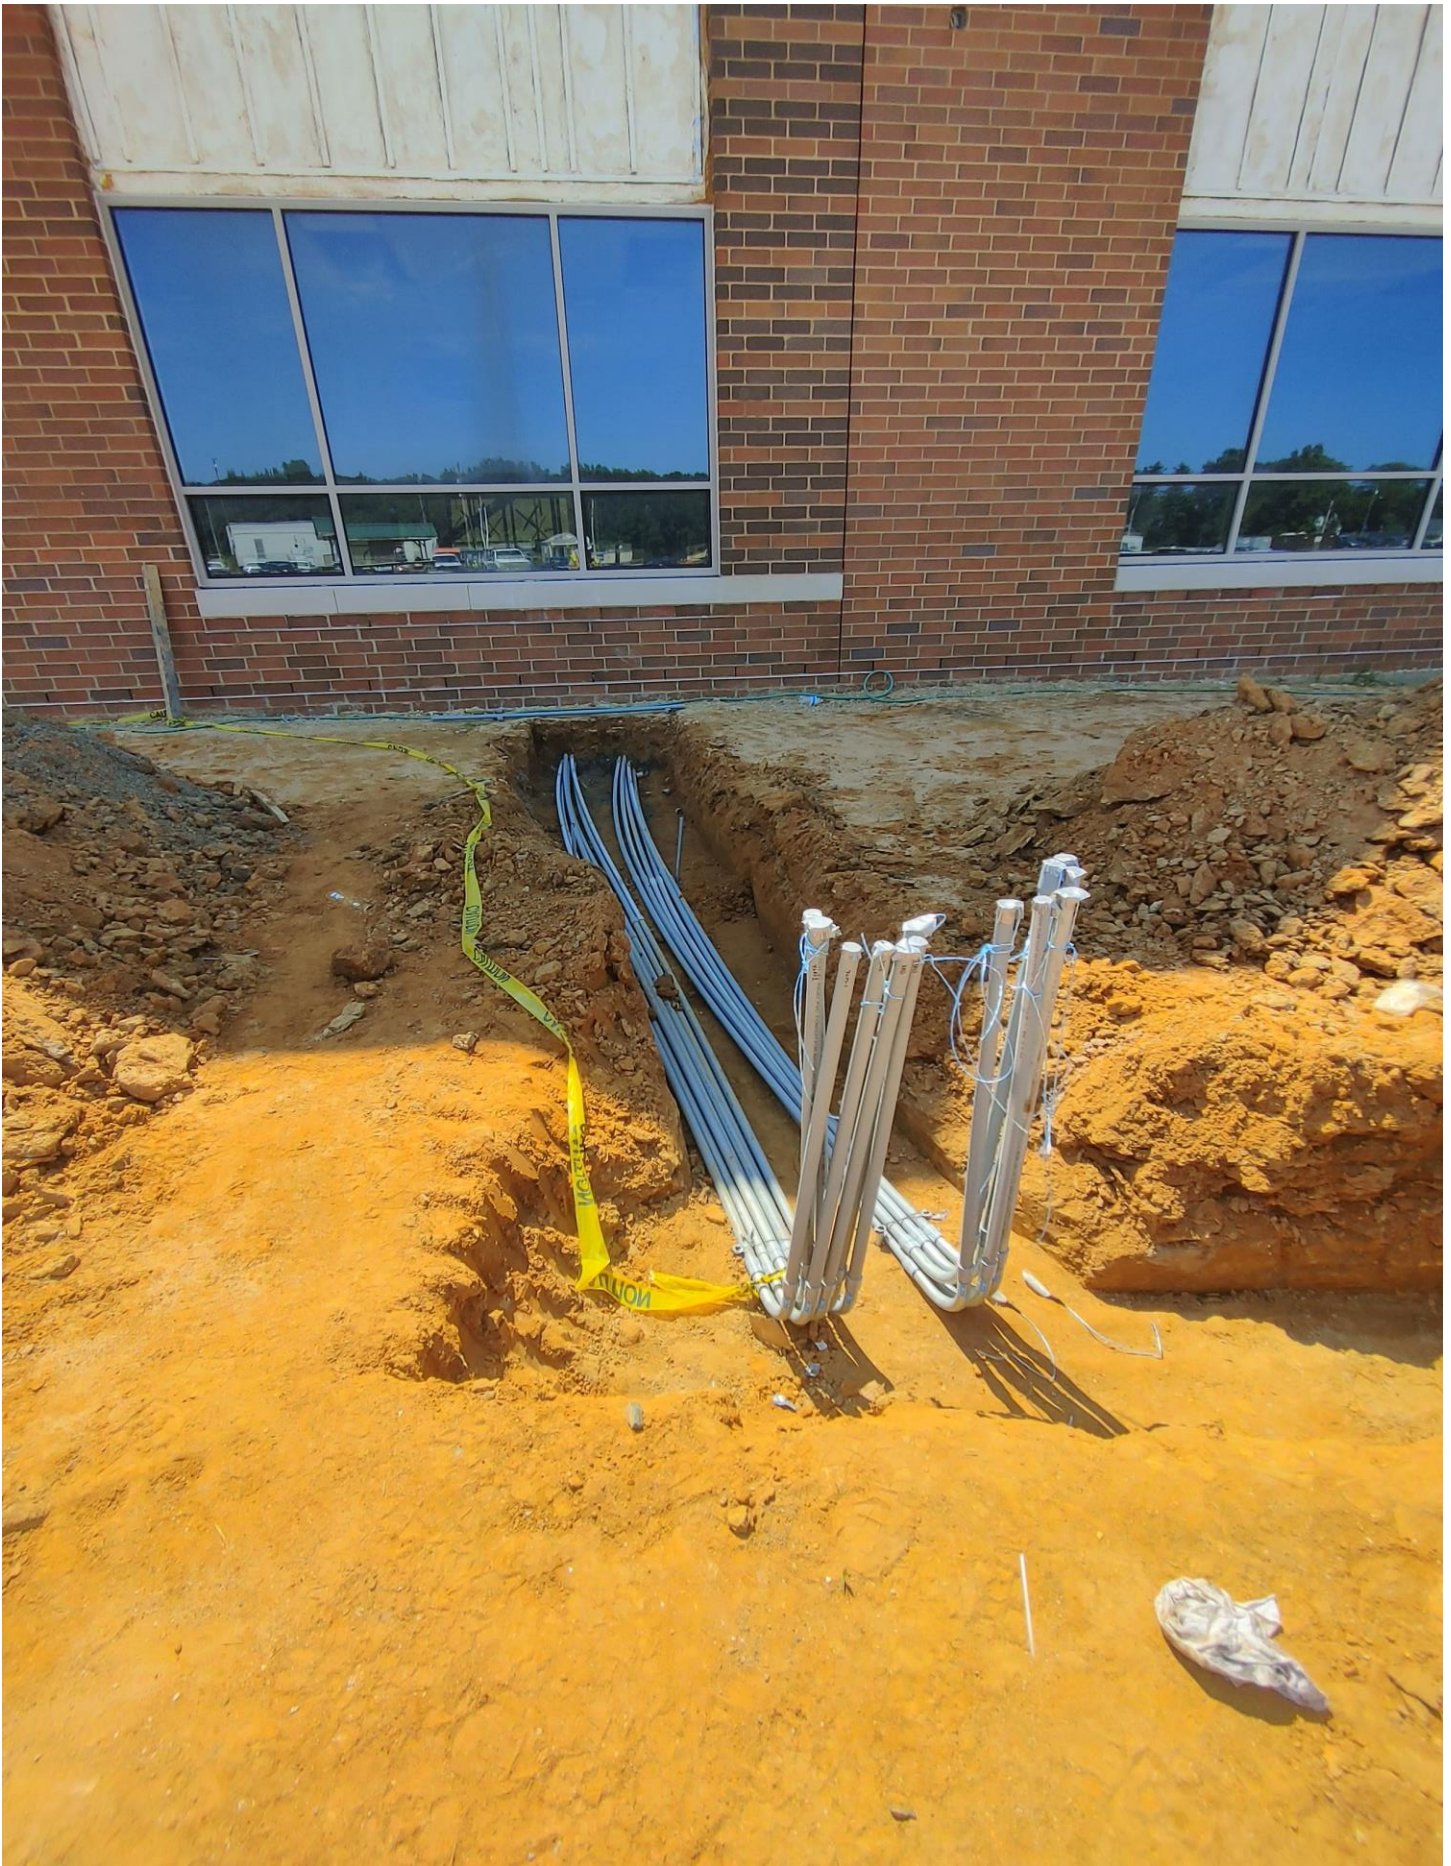
Photo 1 - Conduit for lighting stubbed up in front of Area A

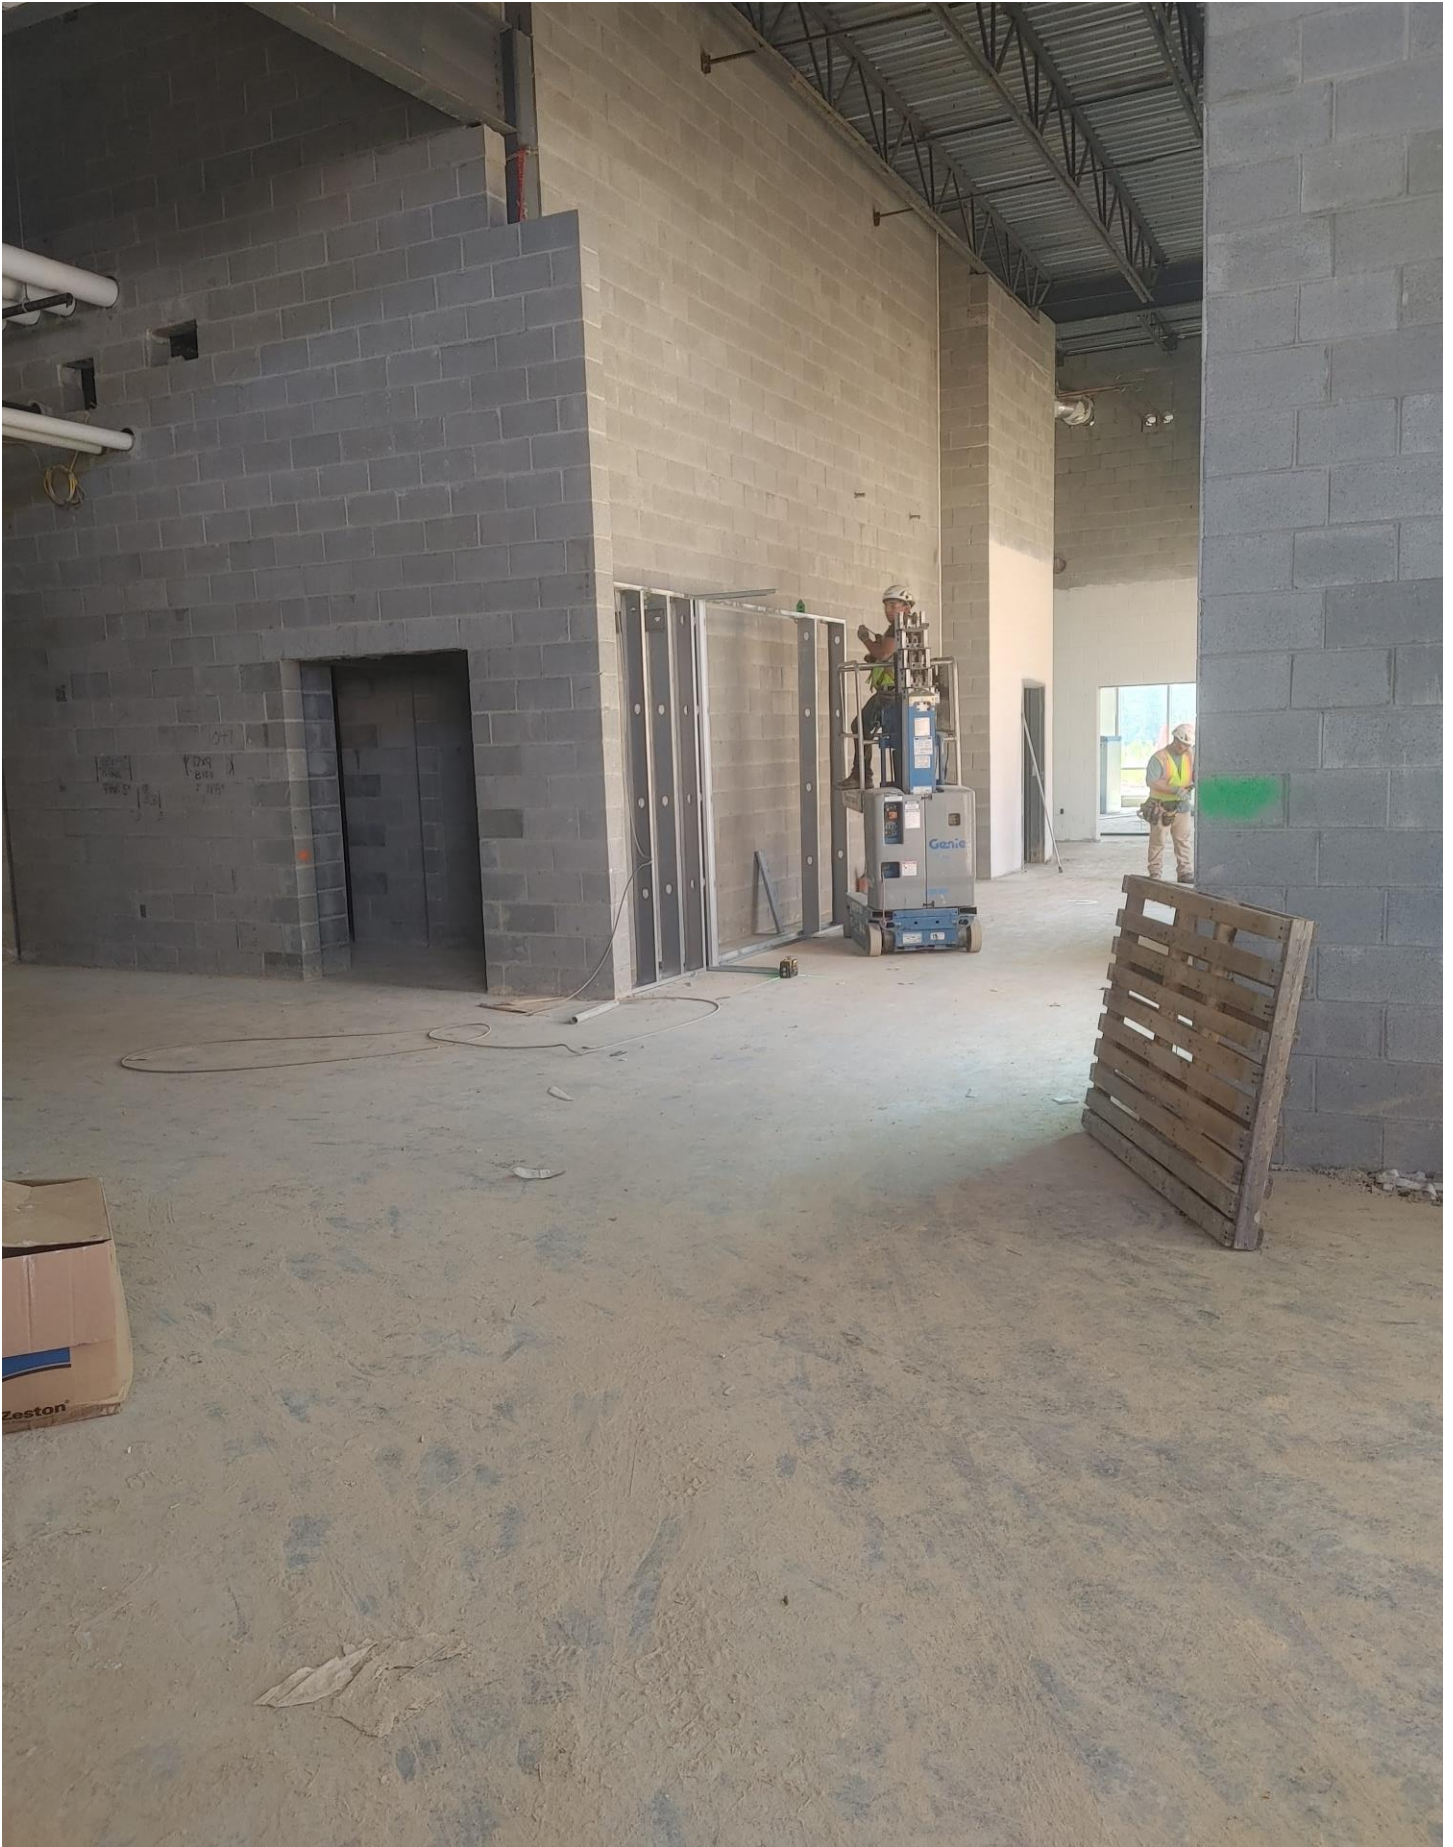
Photo 2 - Walls are being framed in Area D.

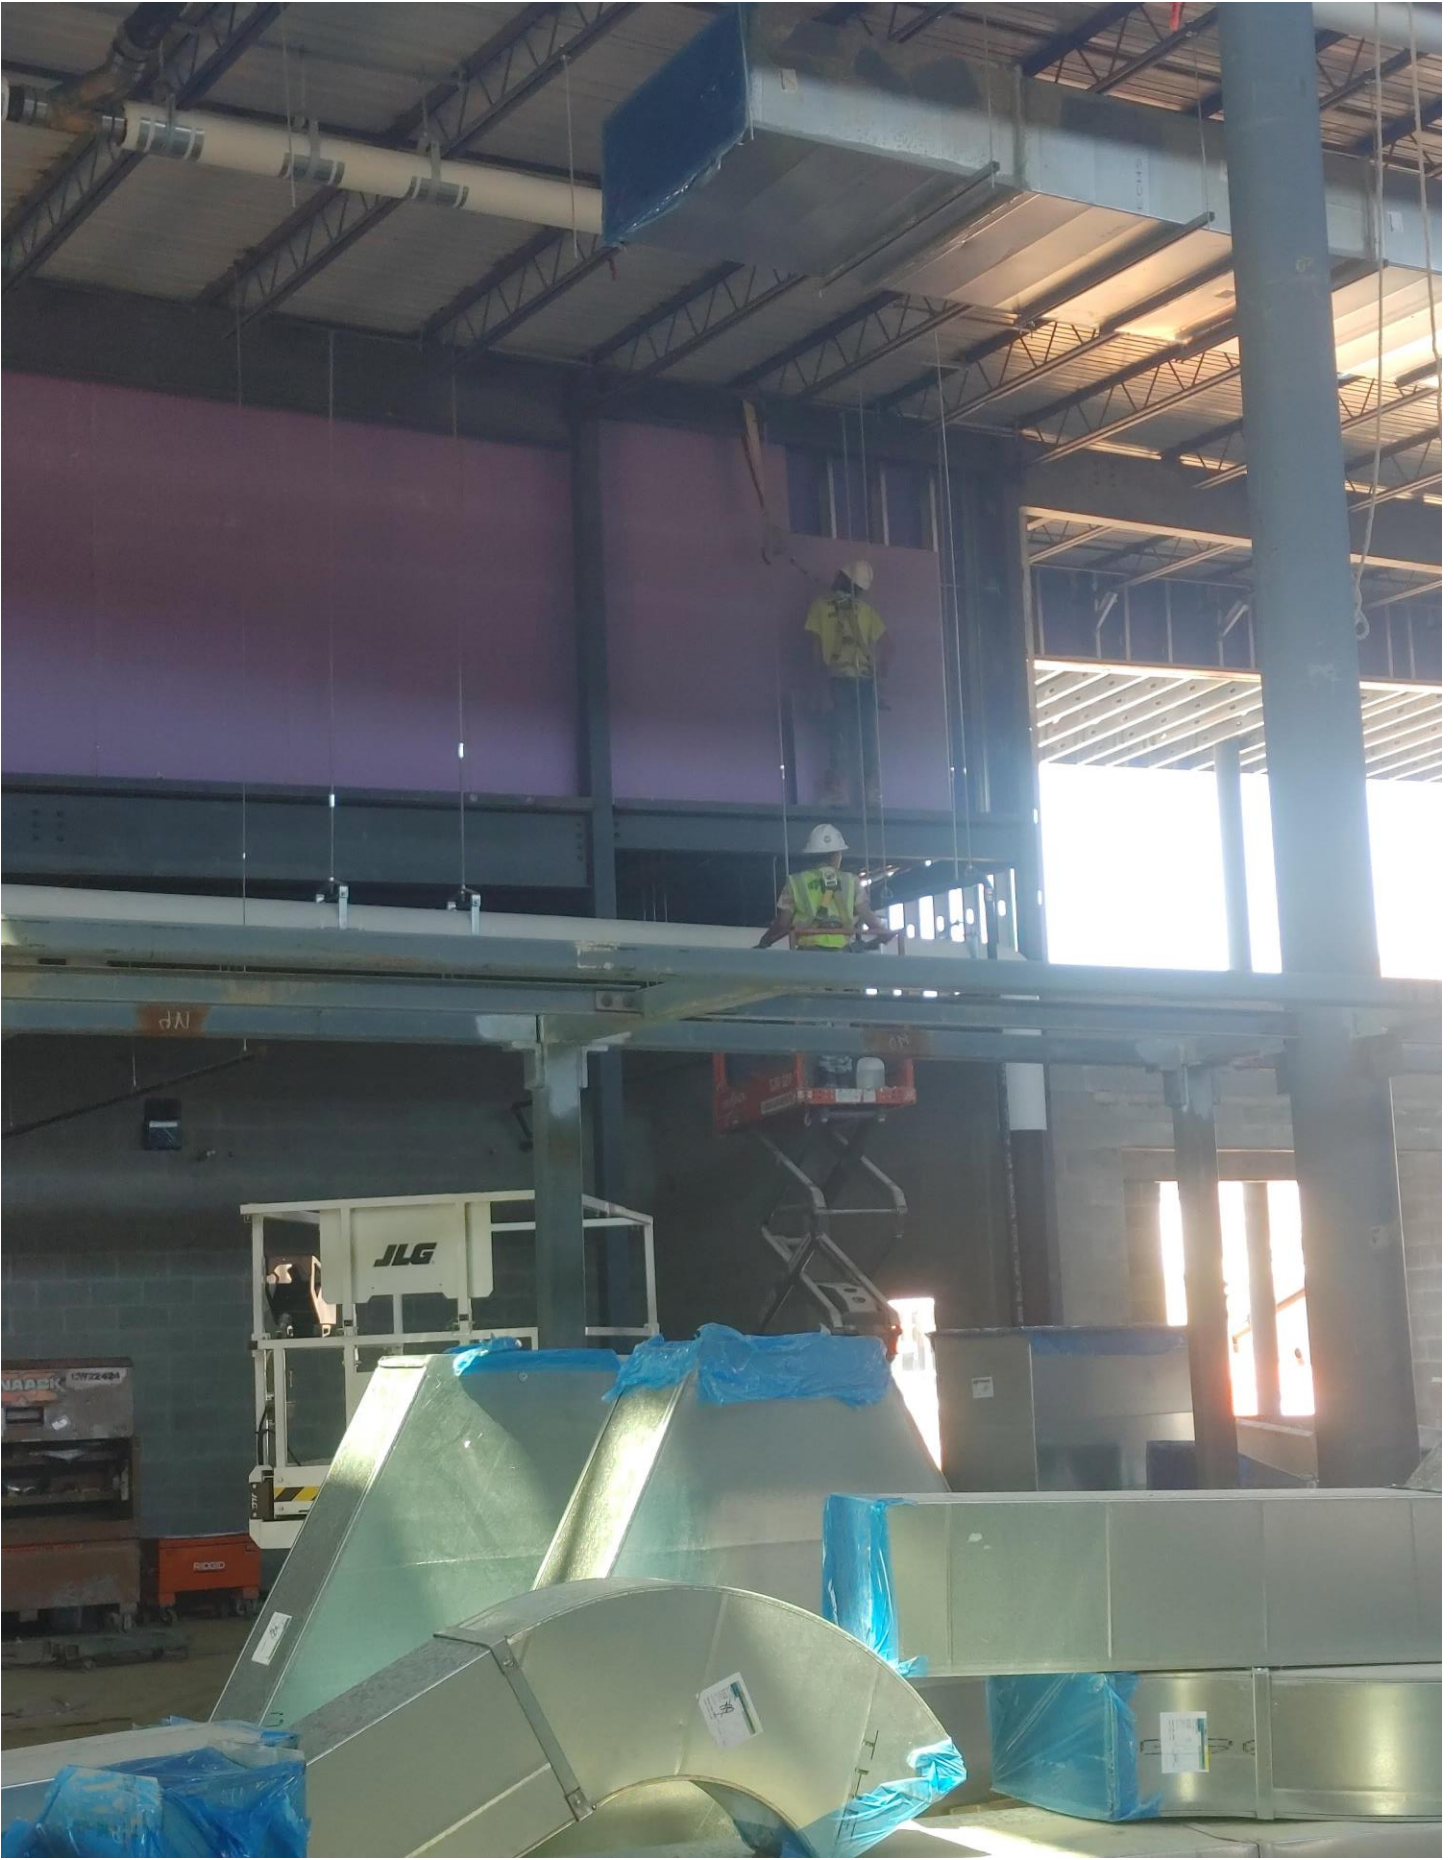
Photo 3 - Sheetrock is being hung in Area C.

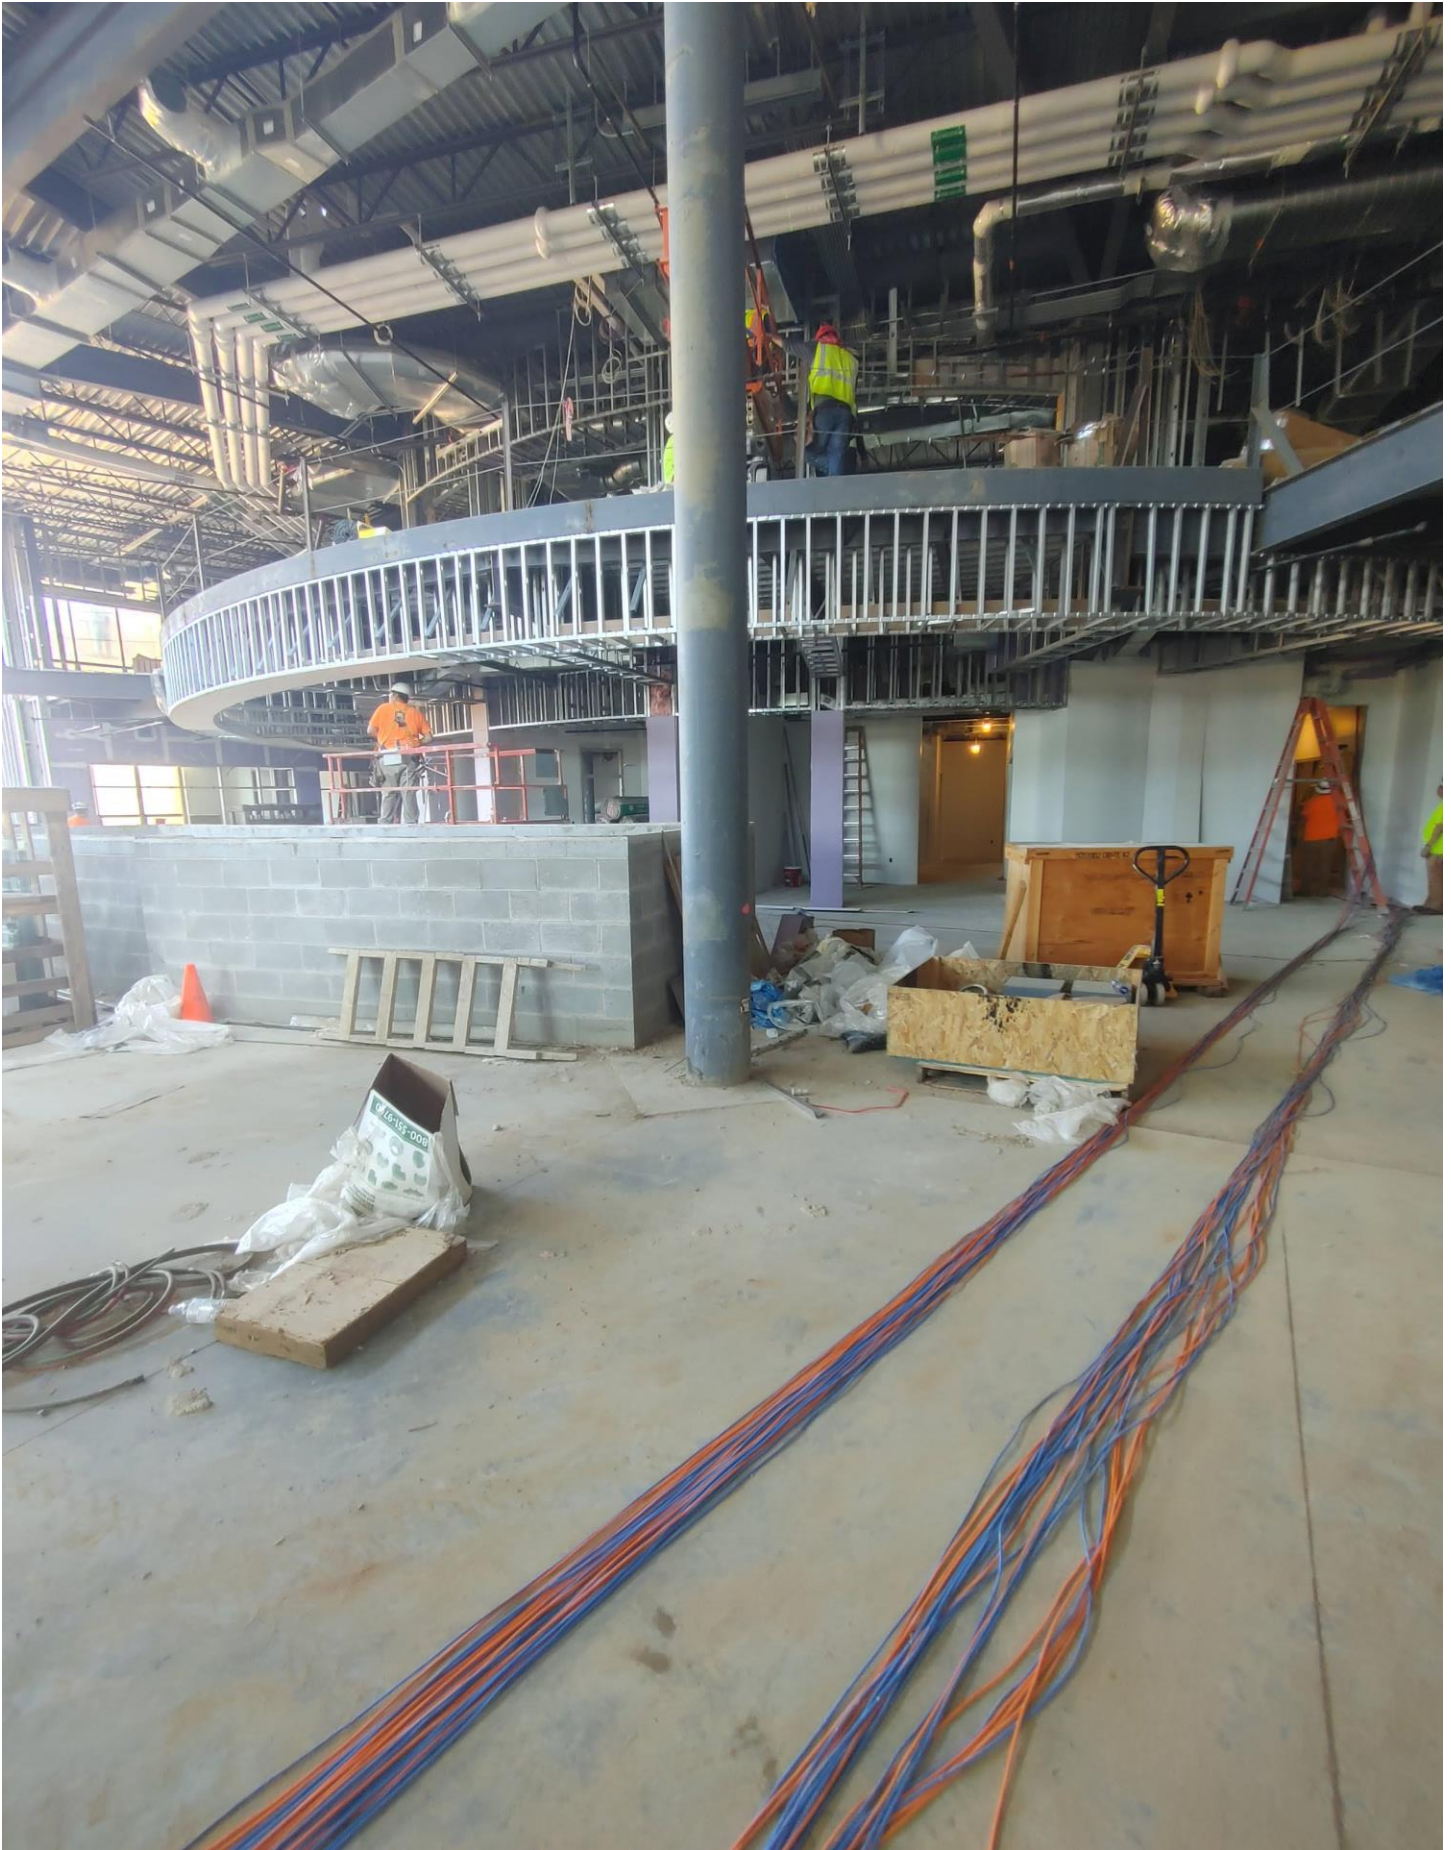
Photo 4 - Sheetrock is being hung on the radius bulkhead.

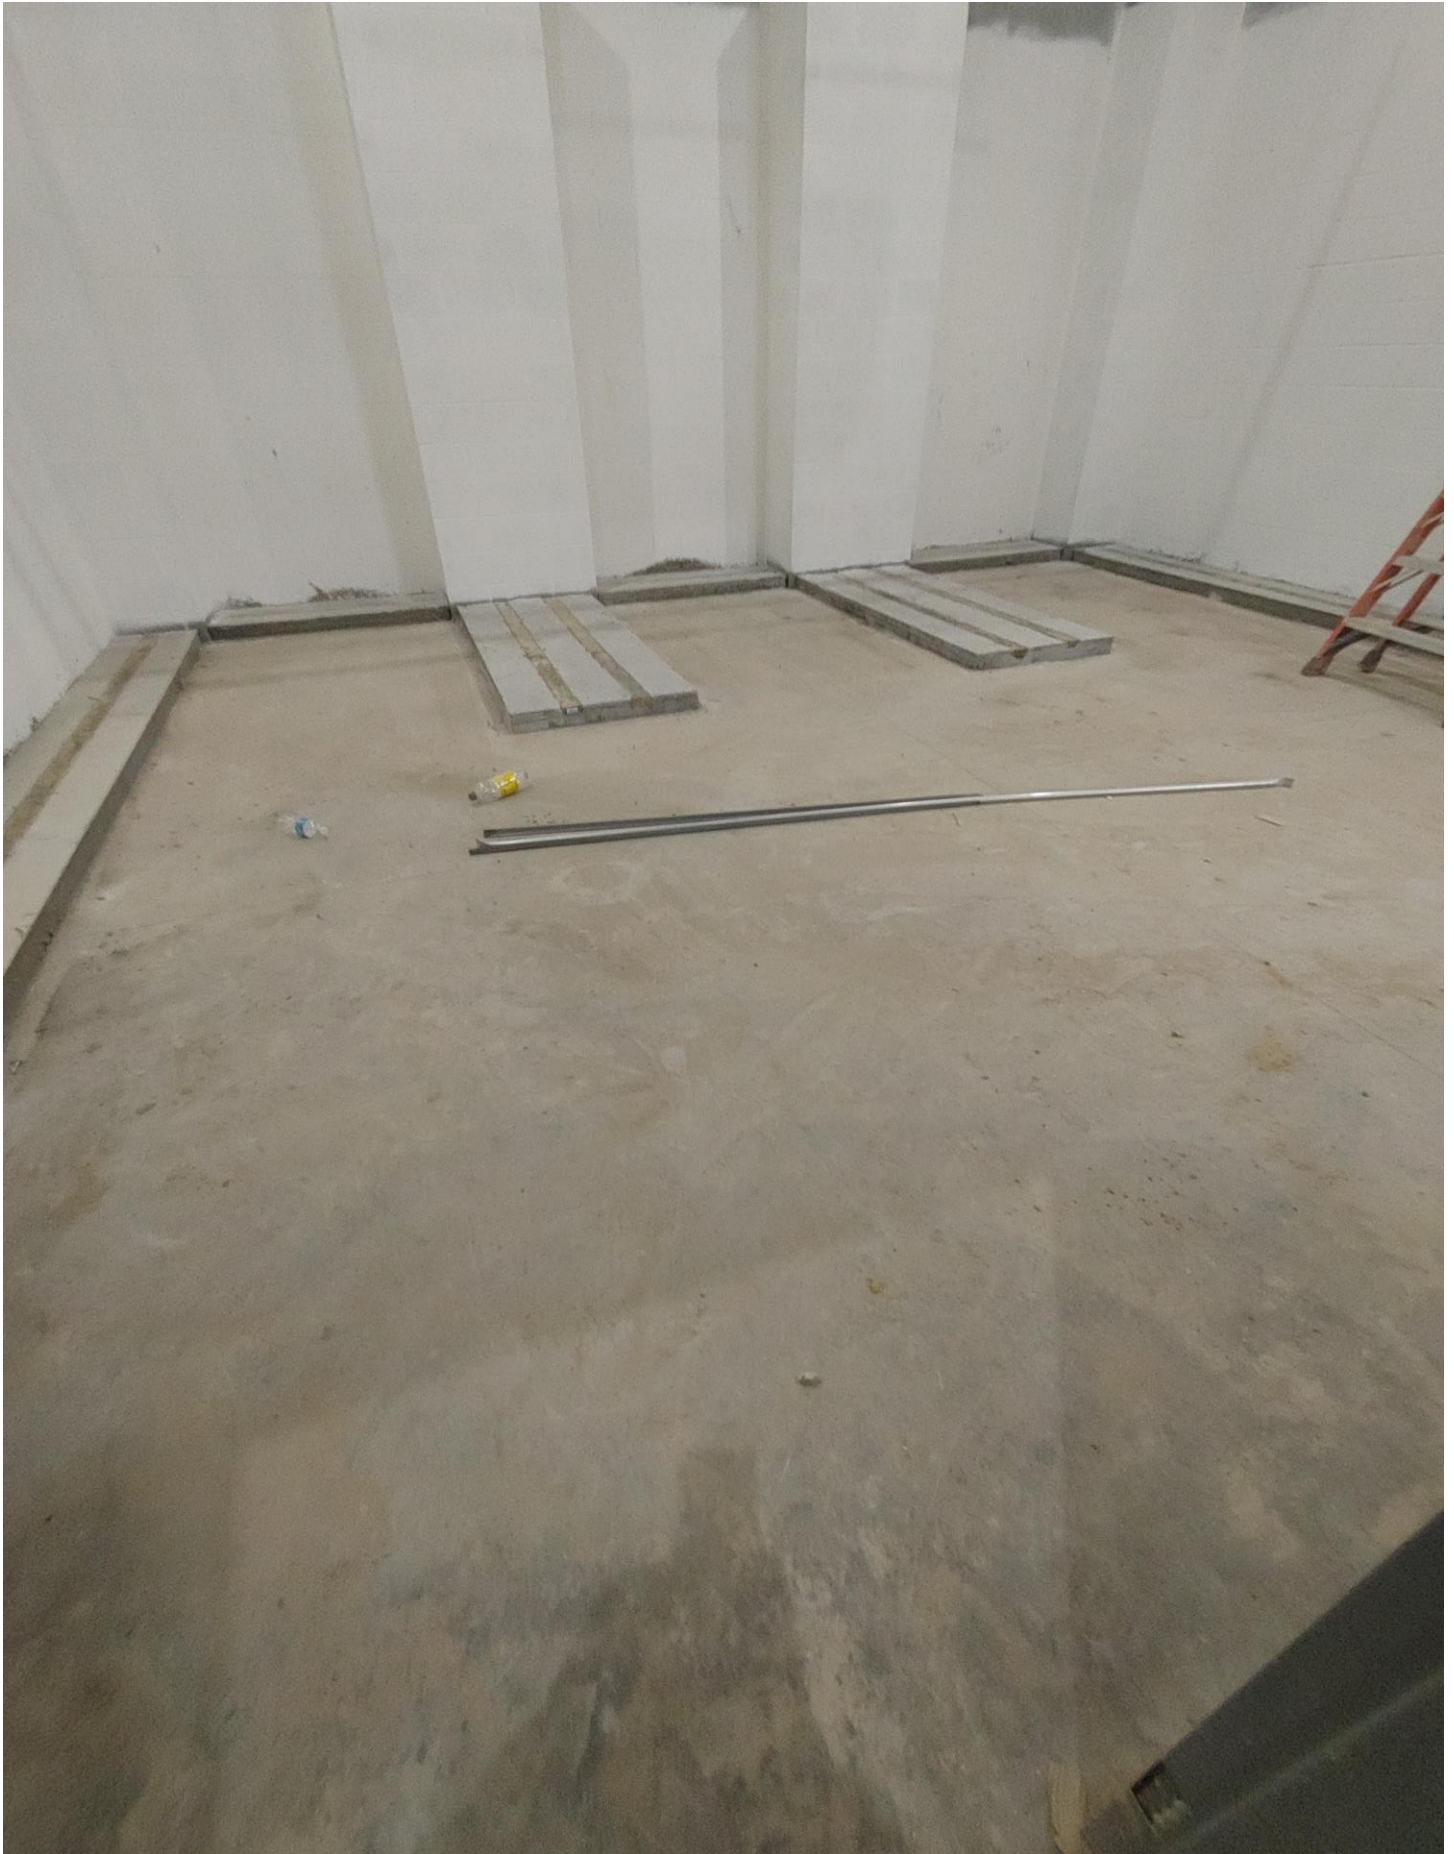
Photo 5 - Raised slabs for locker have been poured in Rooms E135B & E136B

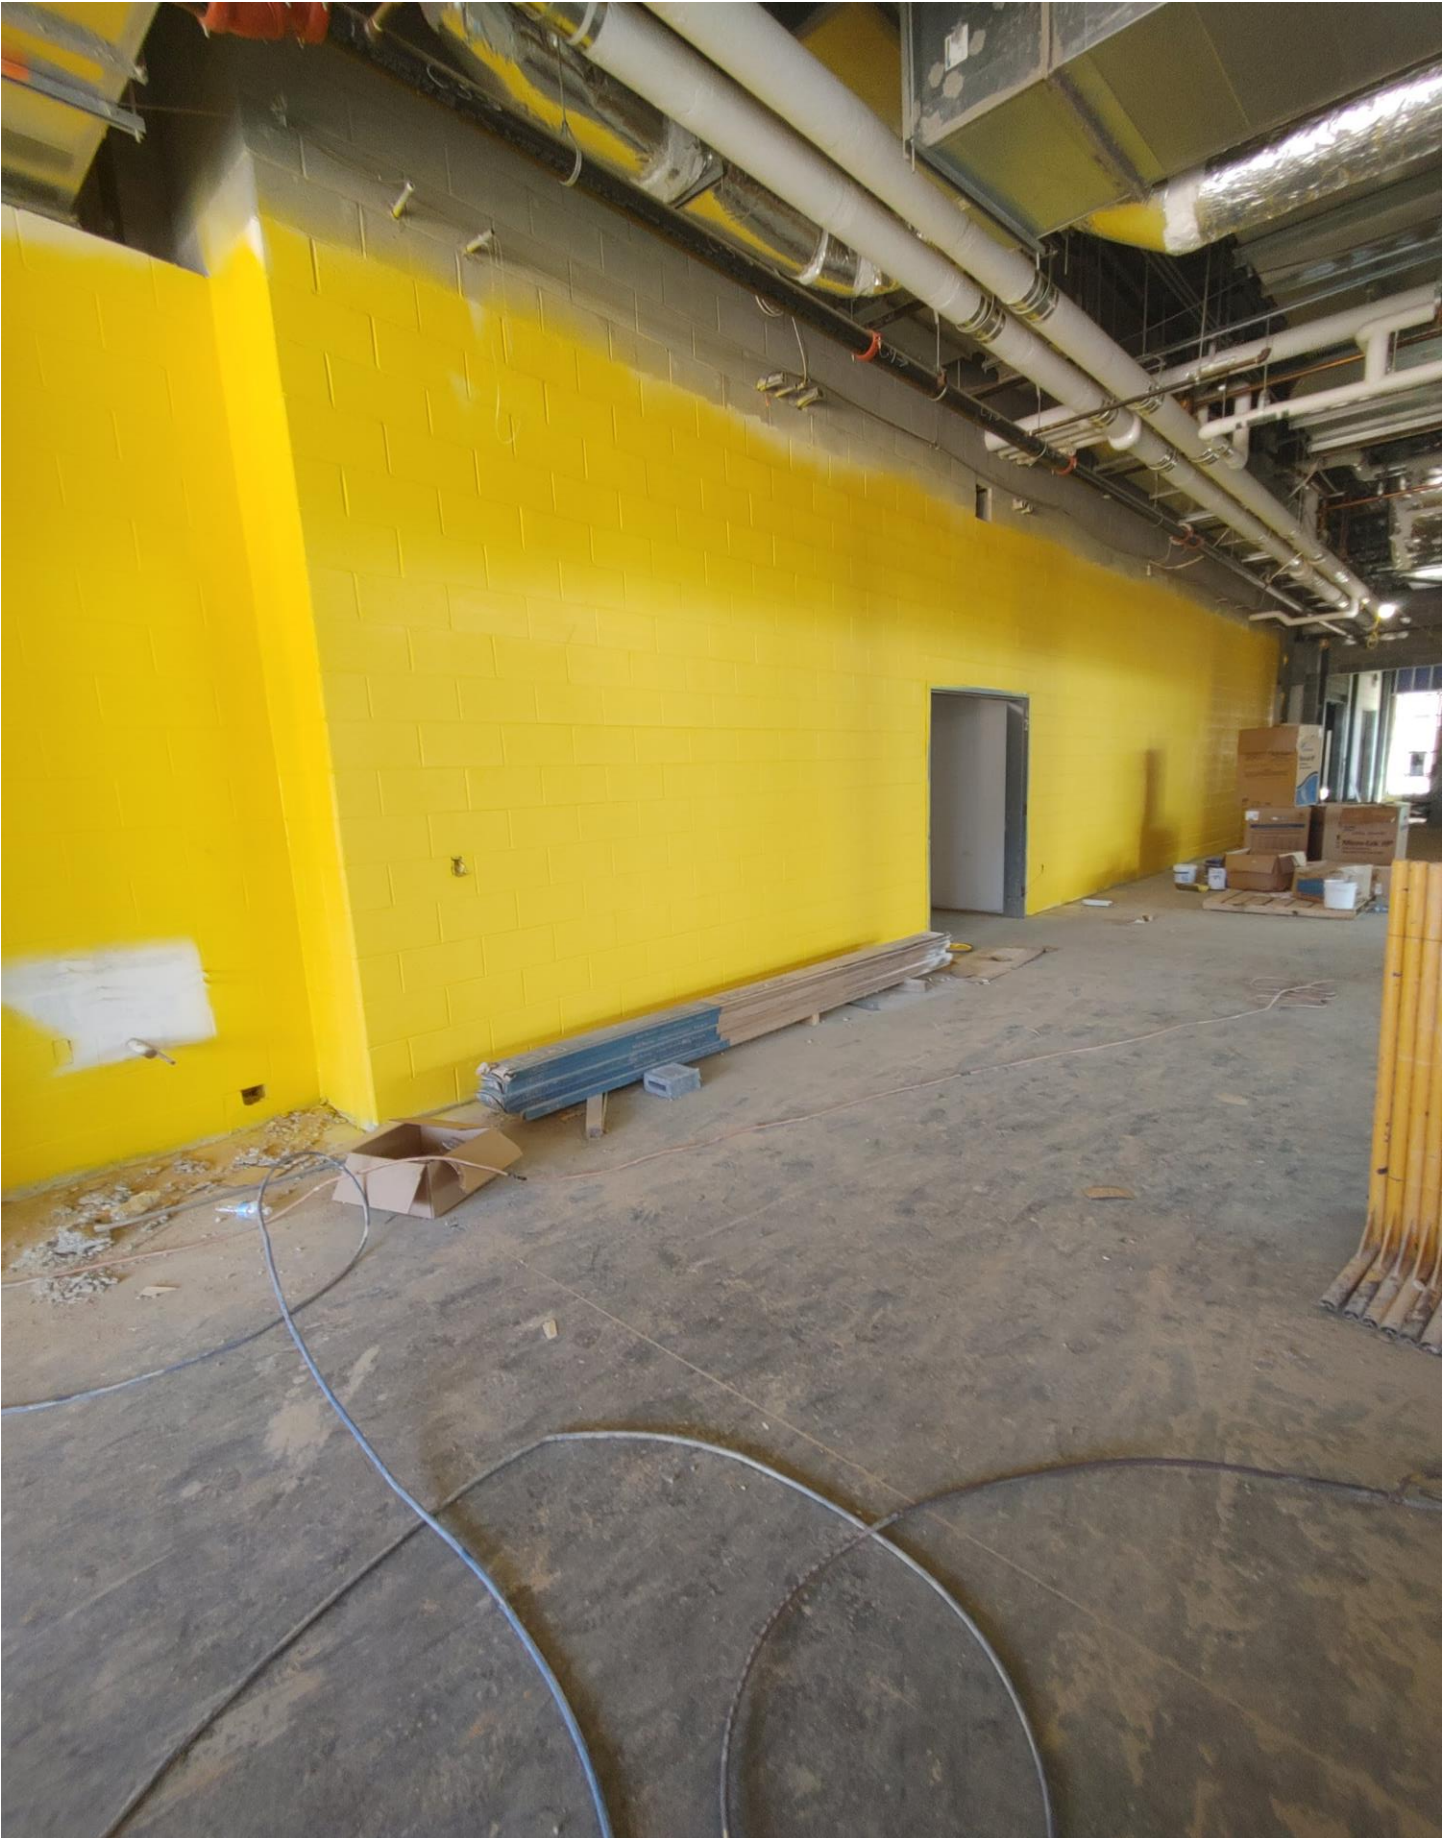
Photo 6 - Painters are working in Area E.

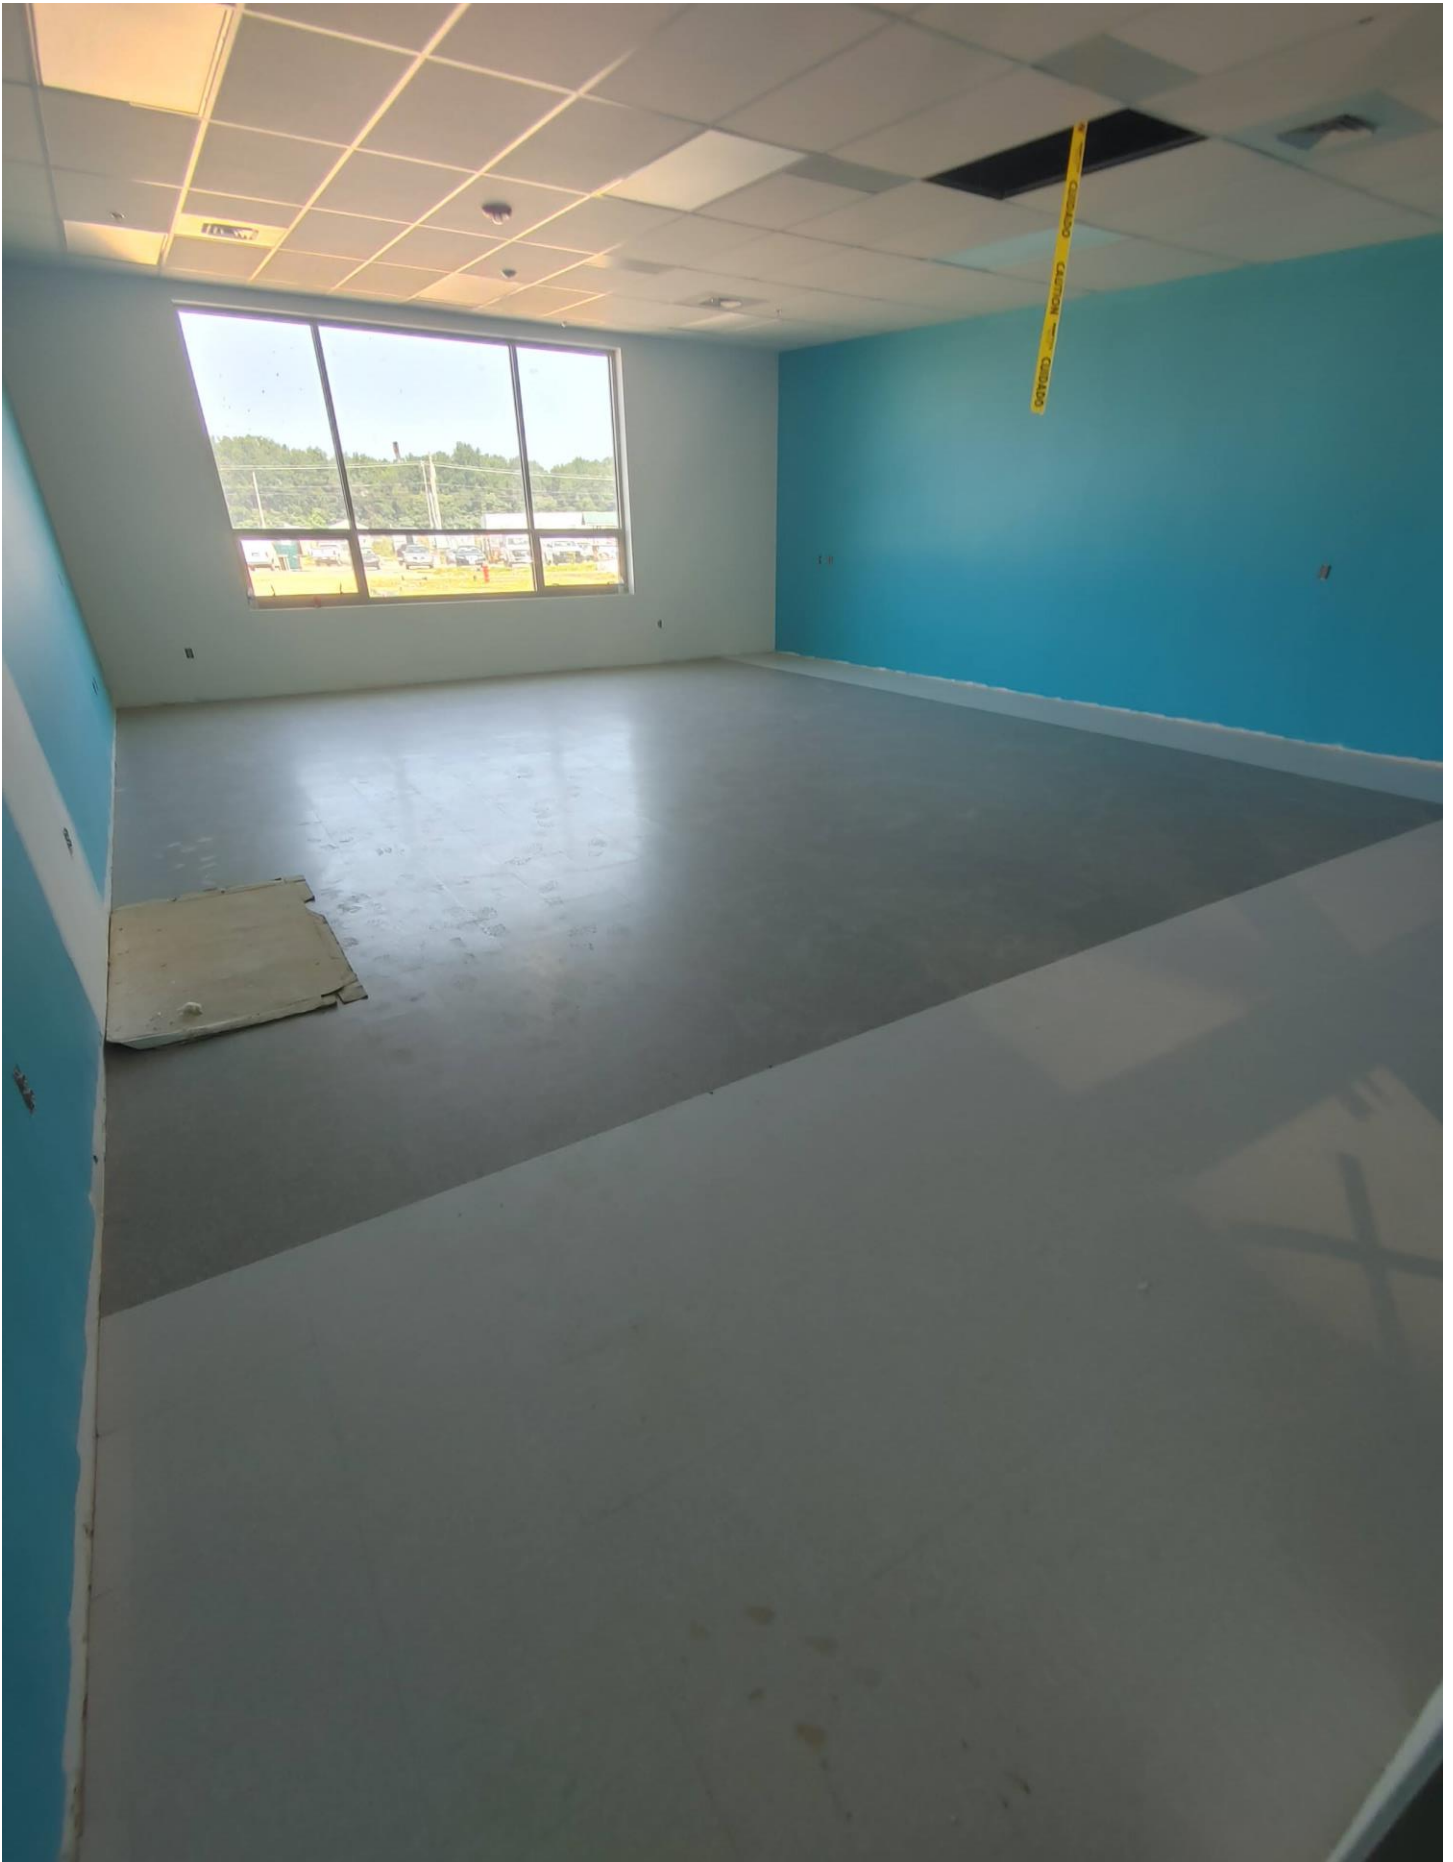
Photo 7 - Tile has been laid in all of the Learning Studios on the 1st floor of Area A.

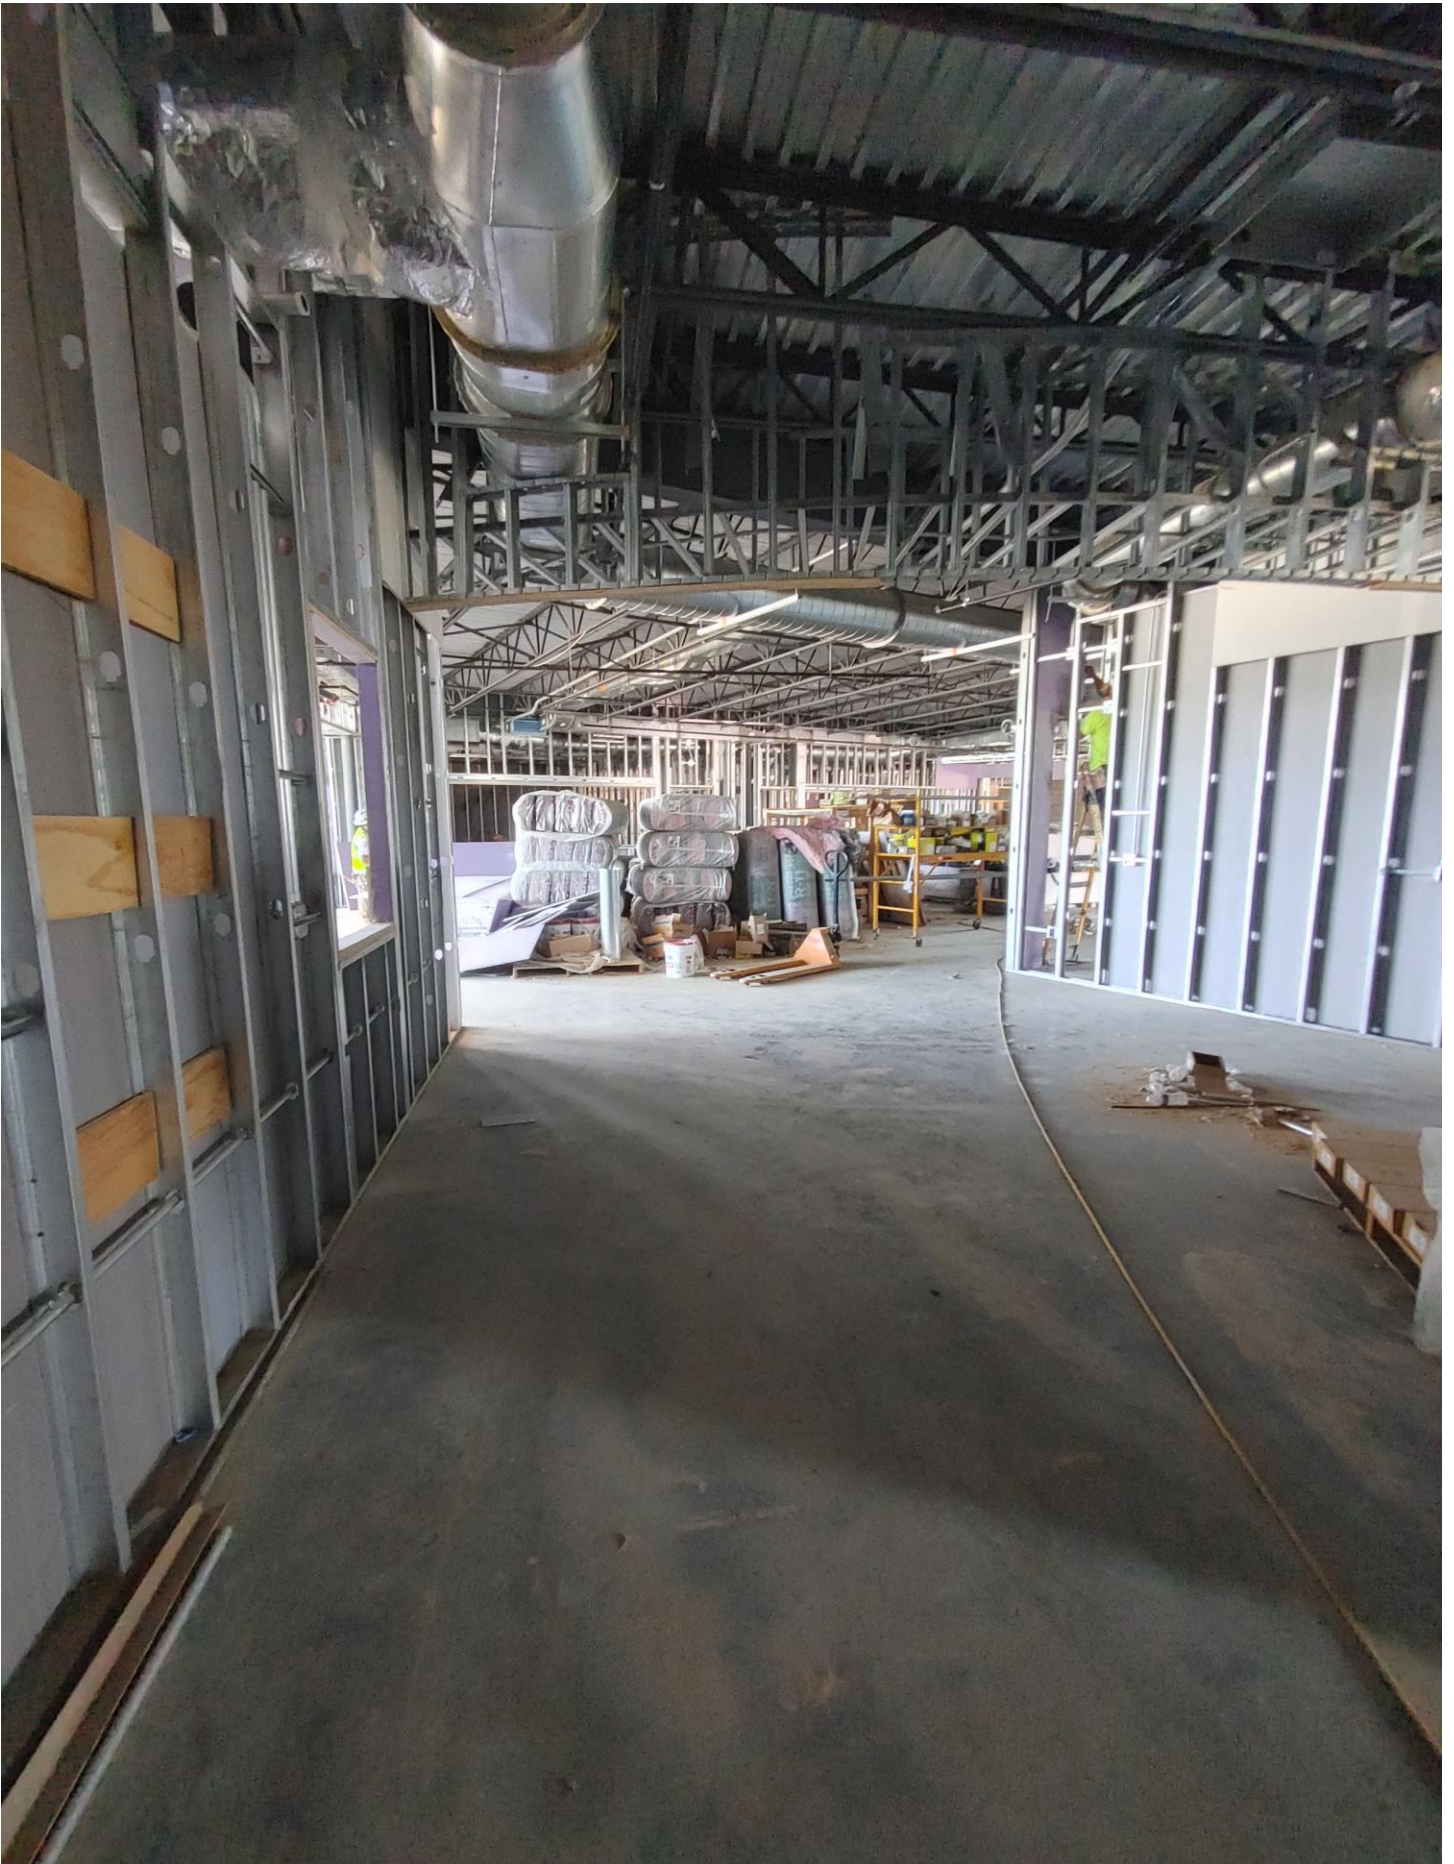
Photo 8 - Sheetrock is being hung on the 2nd floor of Area A.
