**COMMONWEALTH
BUILDING SOLUTIONS, LLC**

FIELD REPORT

WESTMORELAND COUNTY HIGH SCHOOL

Date: 08/24/2021

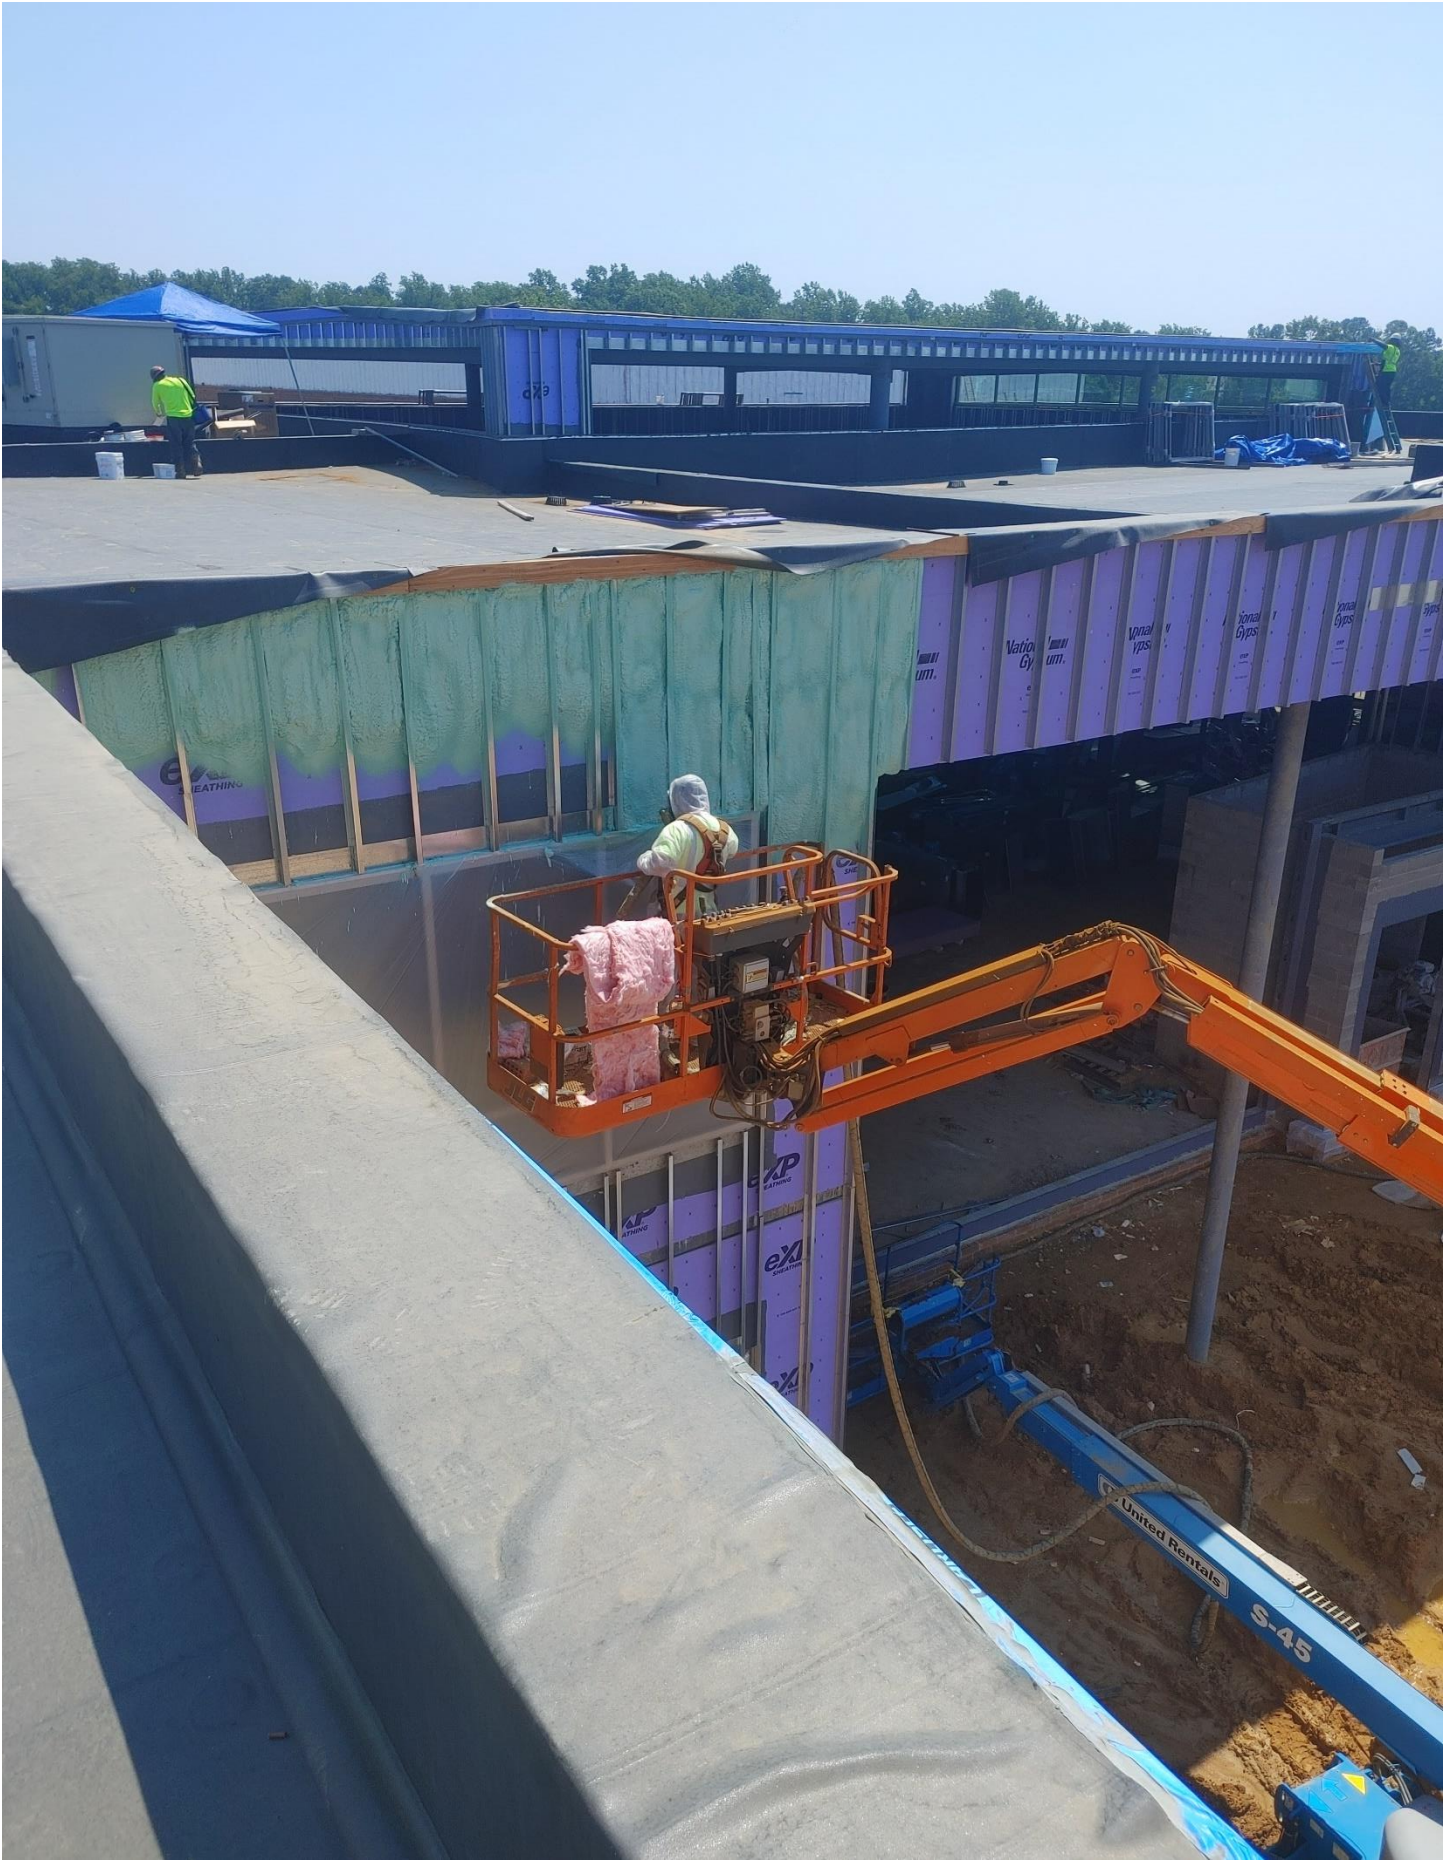
Photo 9 - Spray Foam being applied to the West side of Area C.

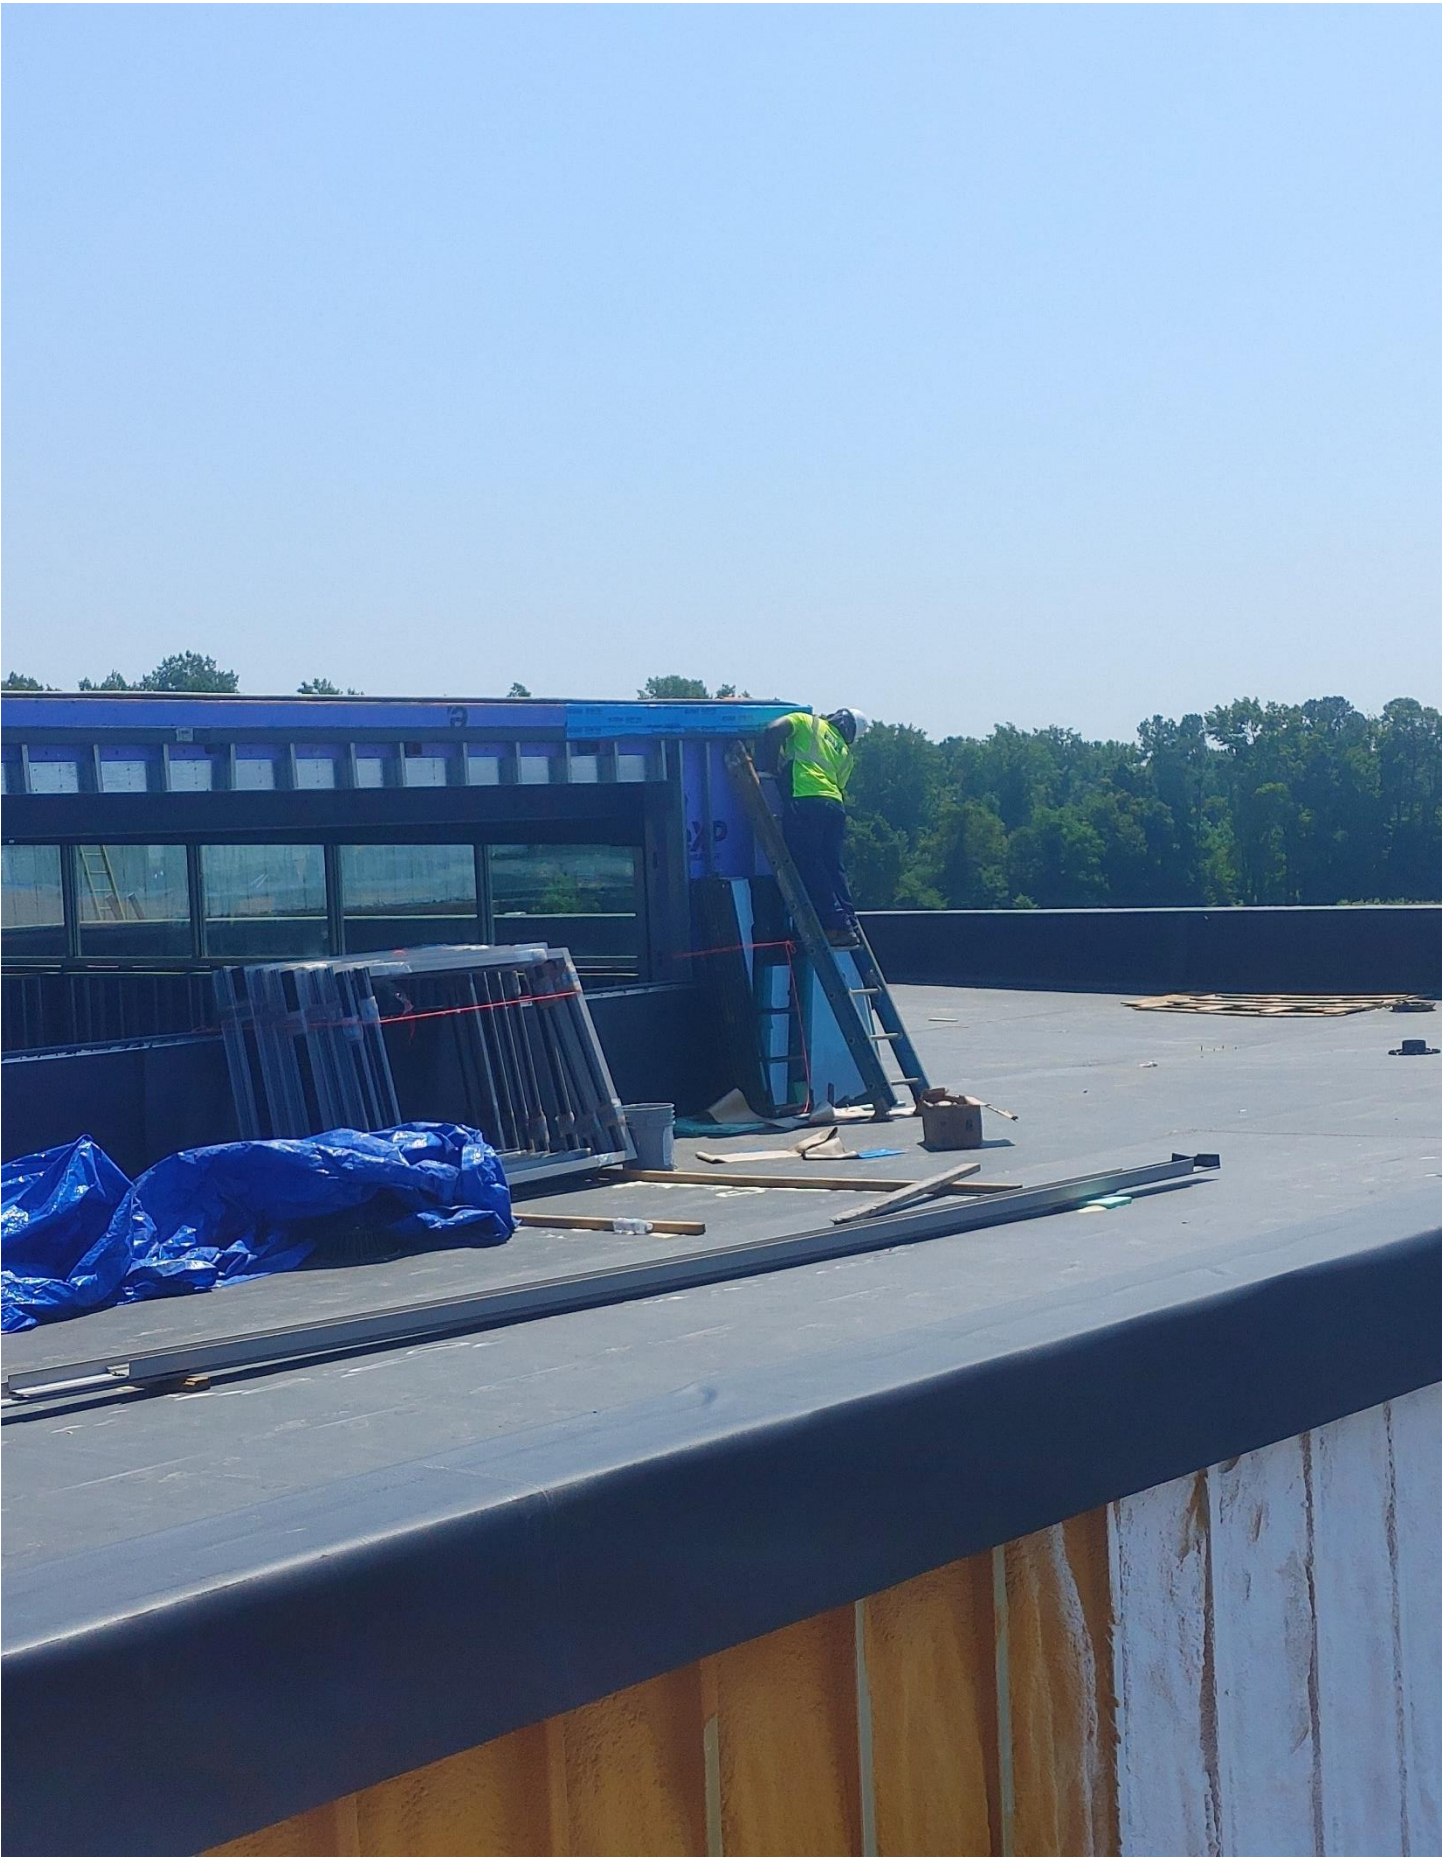
Photo 10 - Flashing being applied to the high roof of Area C.

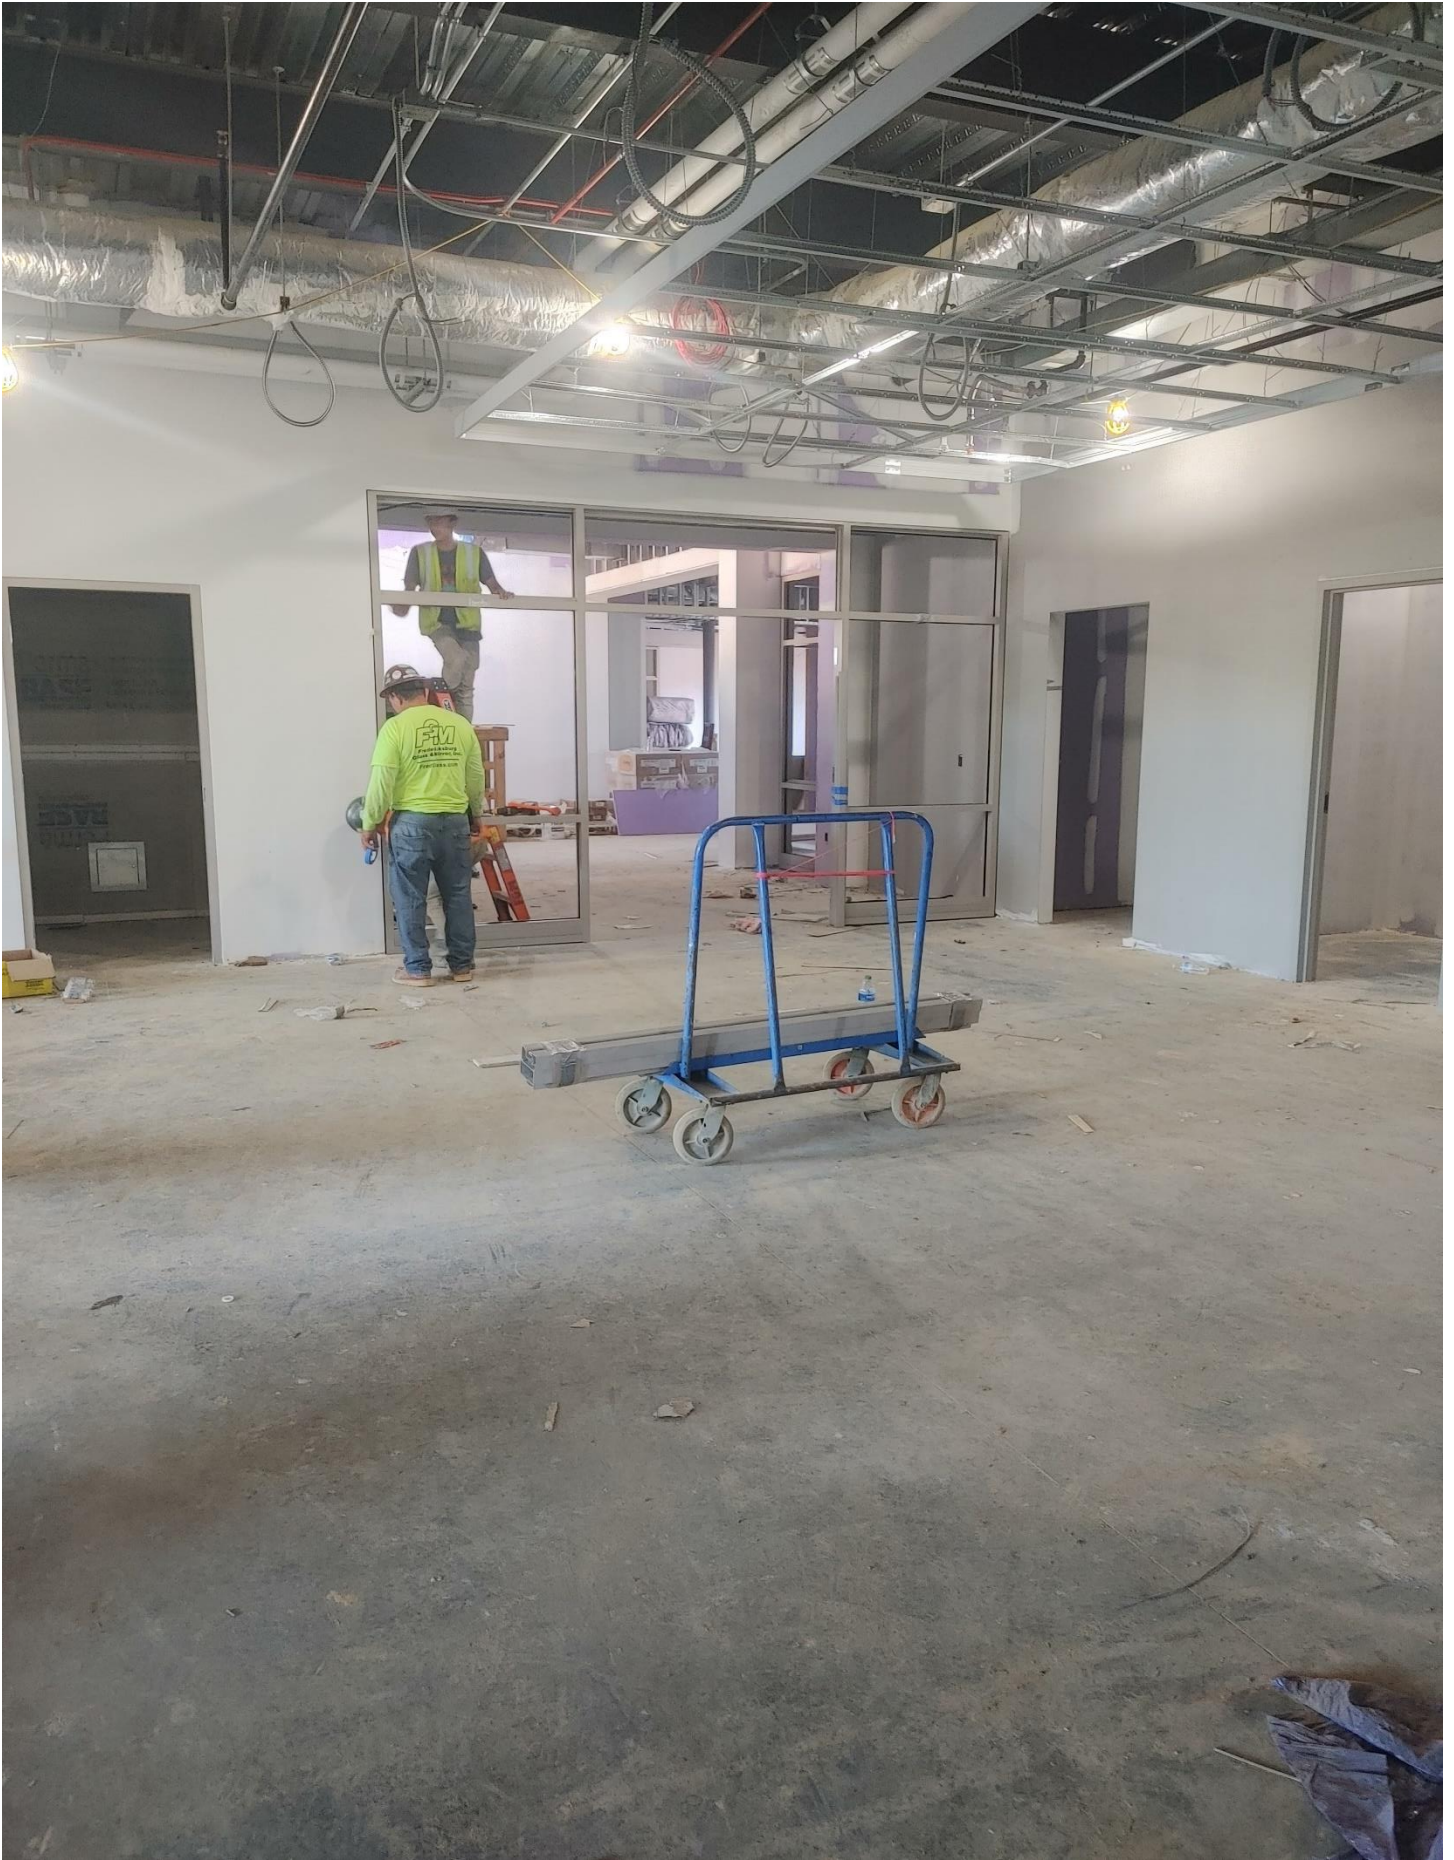
Photo 11 - Storefront 53B is being installed.

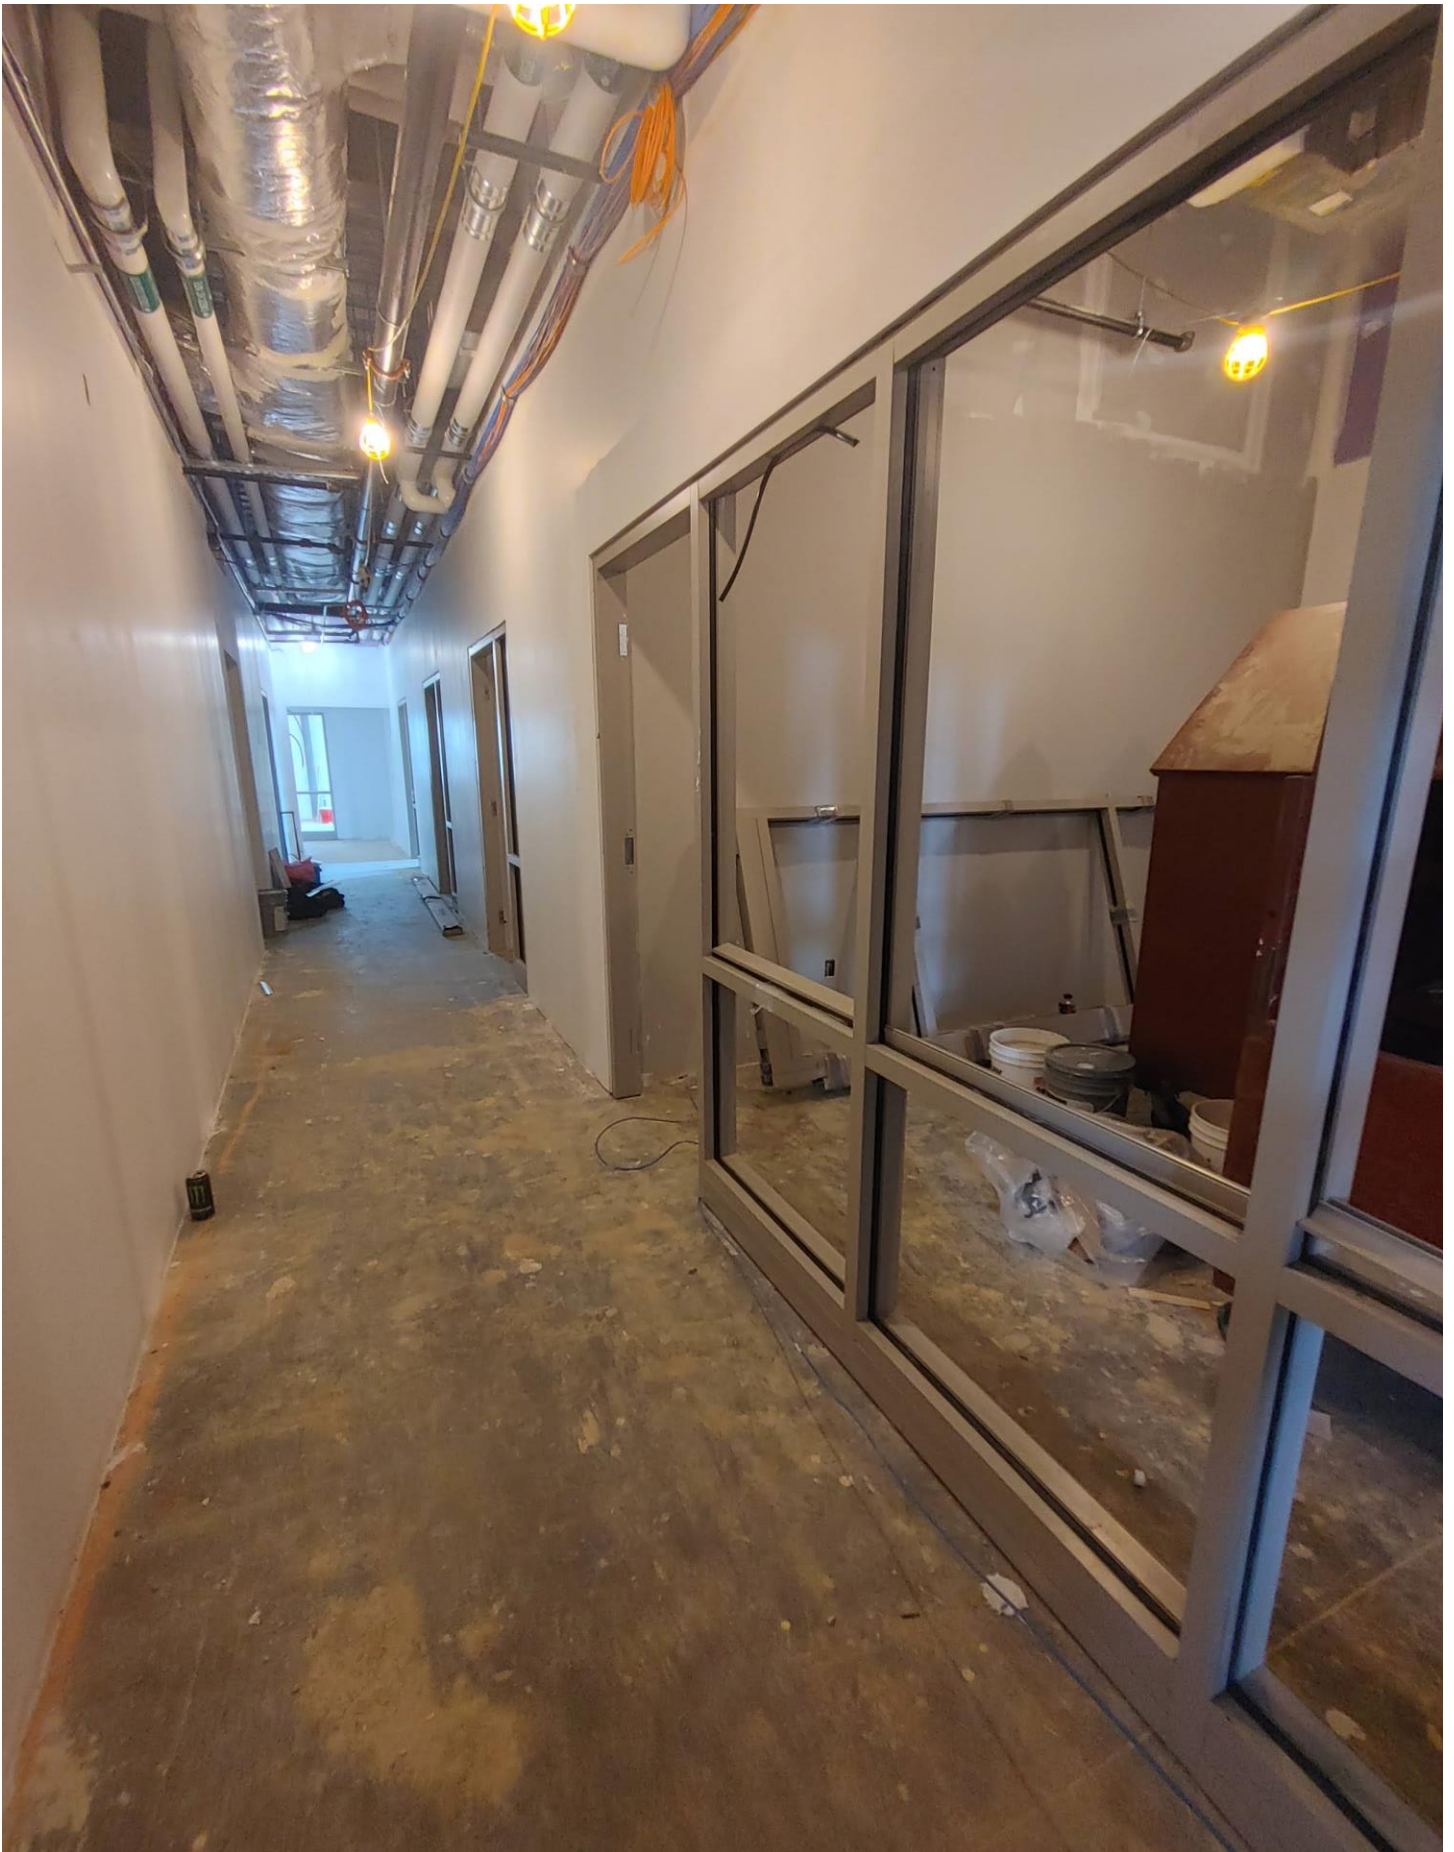
Photo 12 - Storefronts and door frames are being installed in the Administrative area.
