**COMMONWEALTH
BUILDING SOLUTIONS, LLC**

FIELD REPORT

WESTMORELAND COUNTY HIGH SCHOOL

Date: 09/8/2021

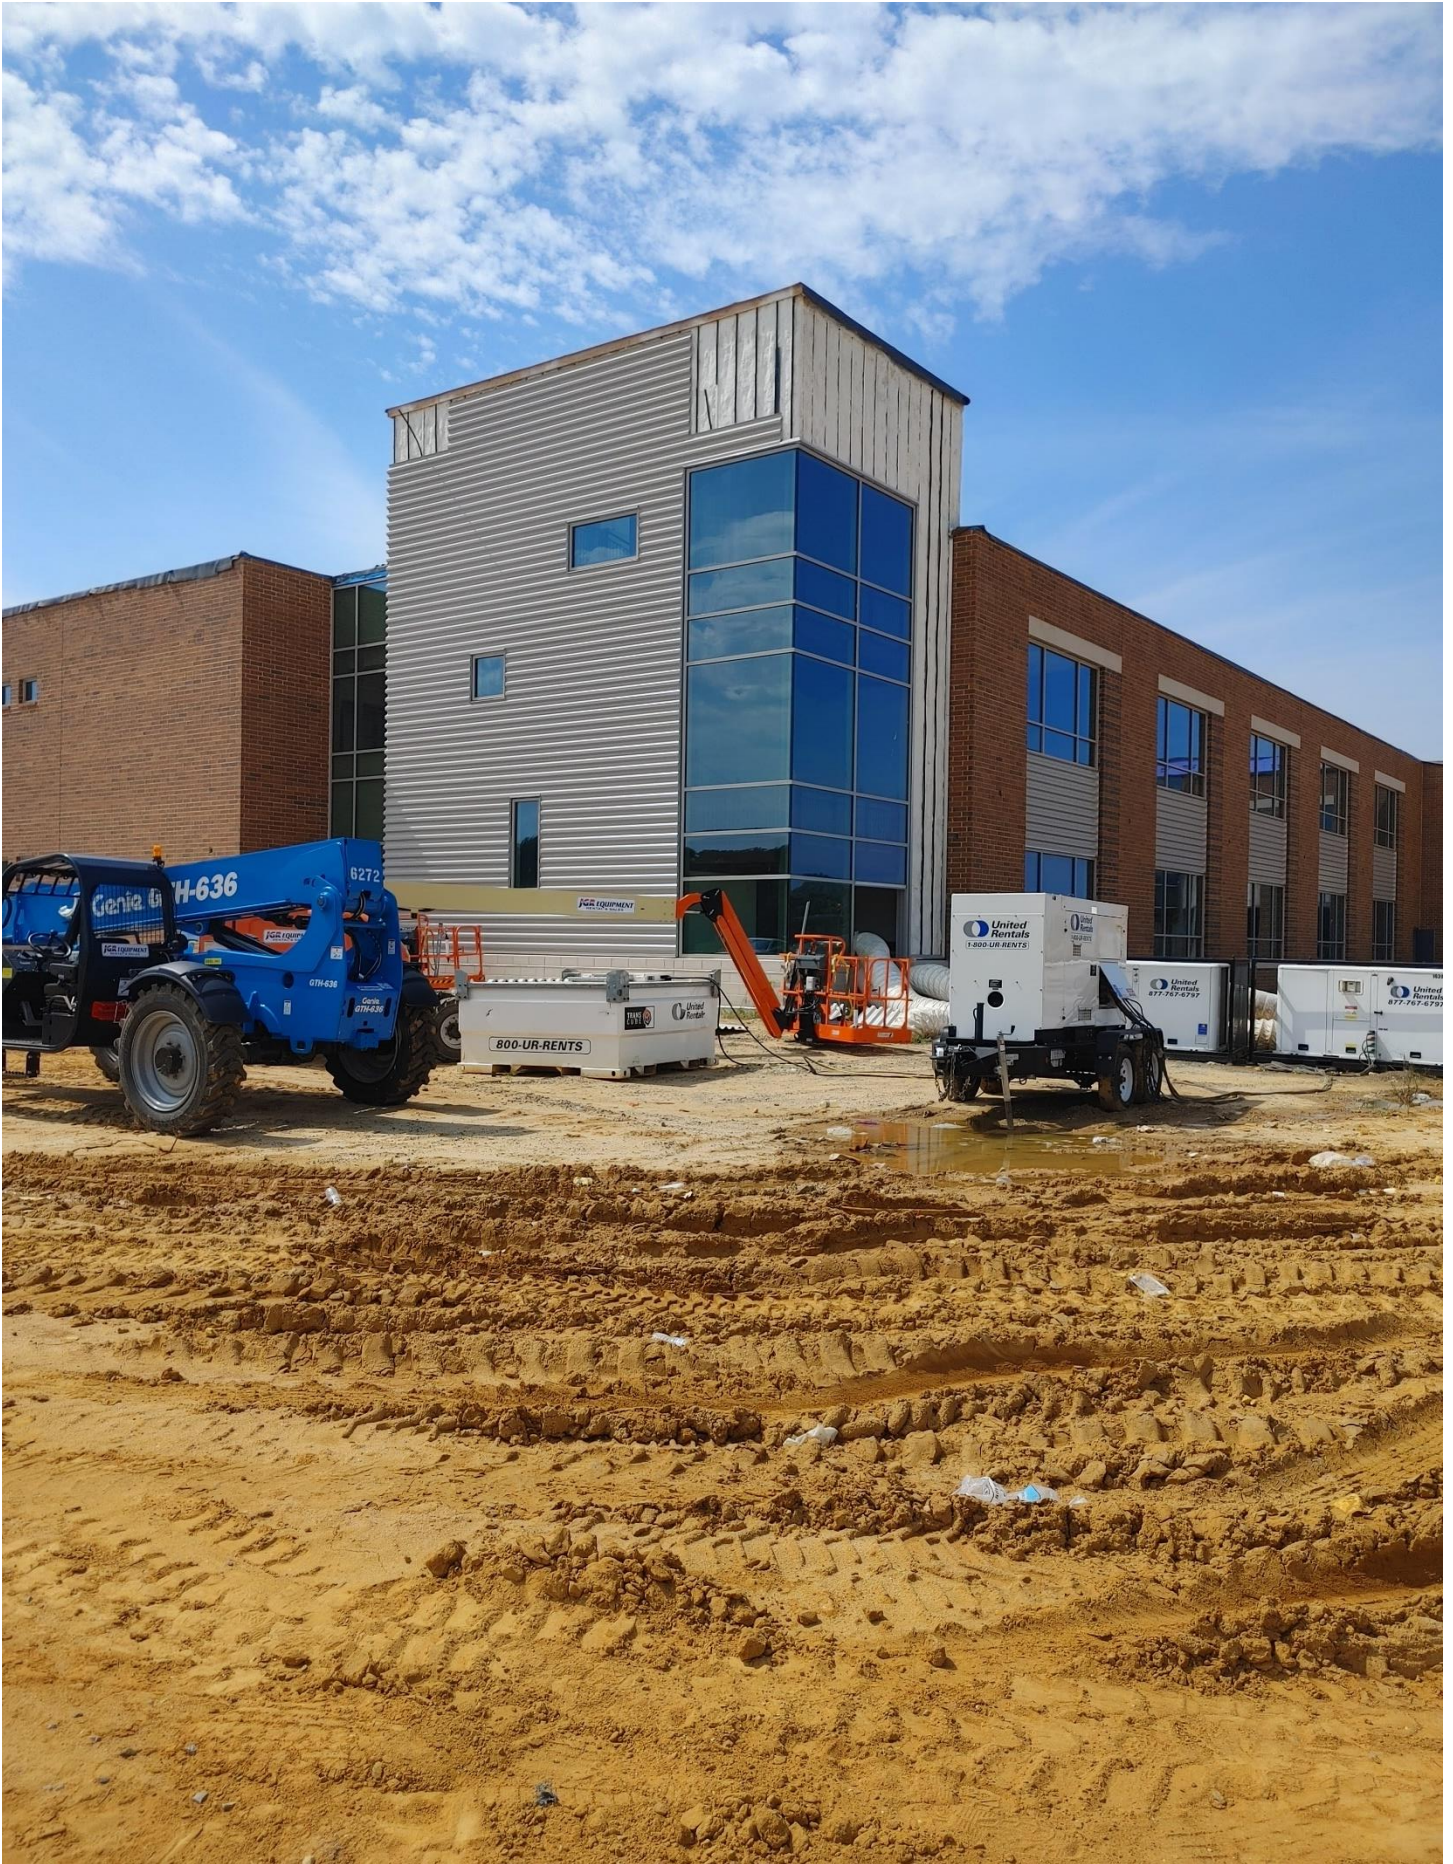
Photo 1 - Metal is being installed on Stairwell #1

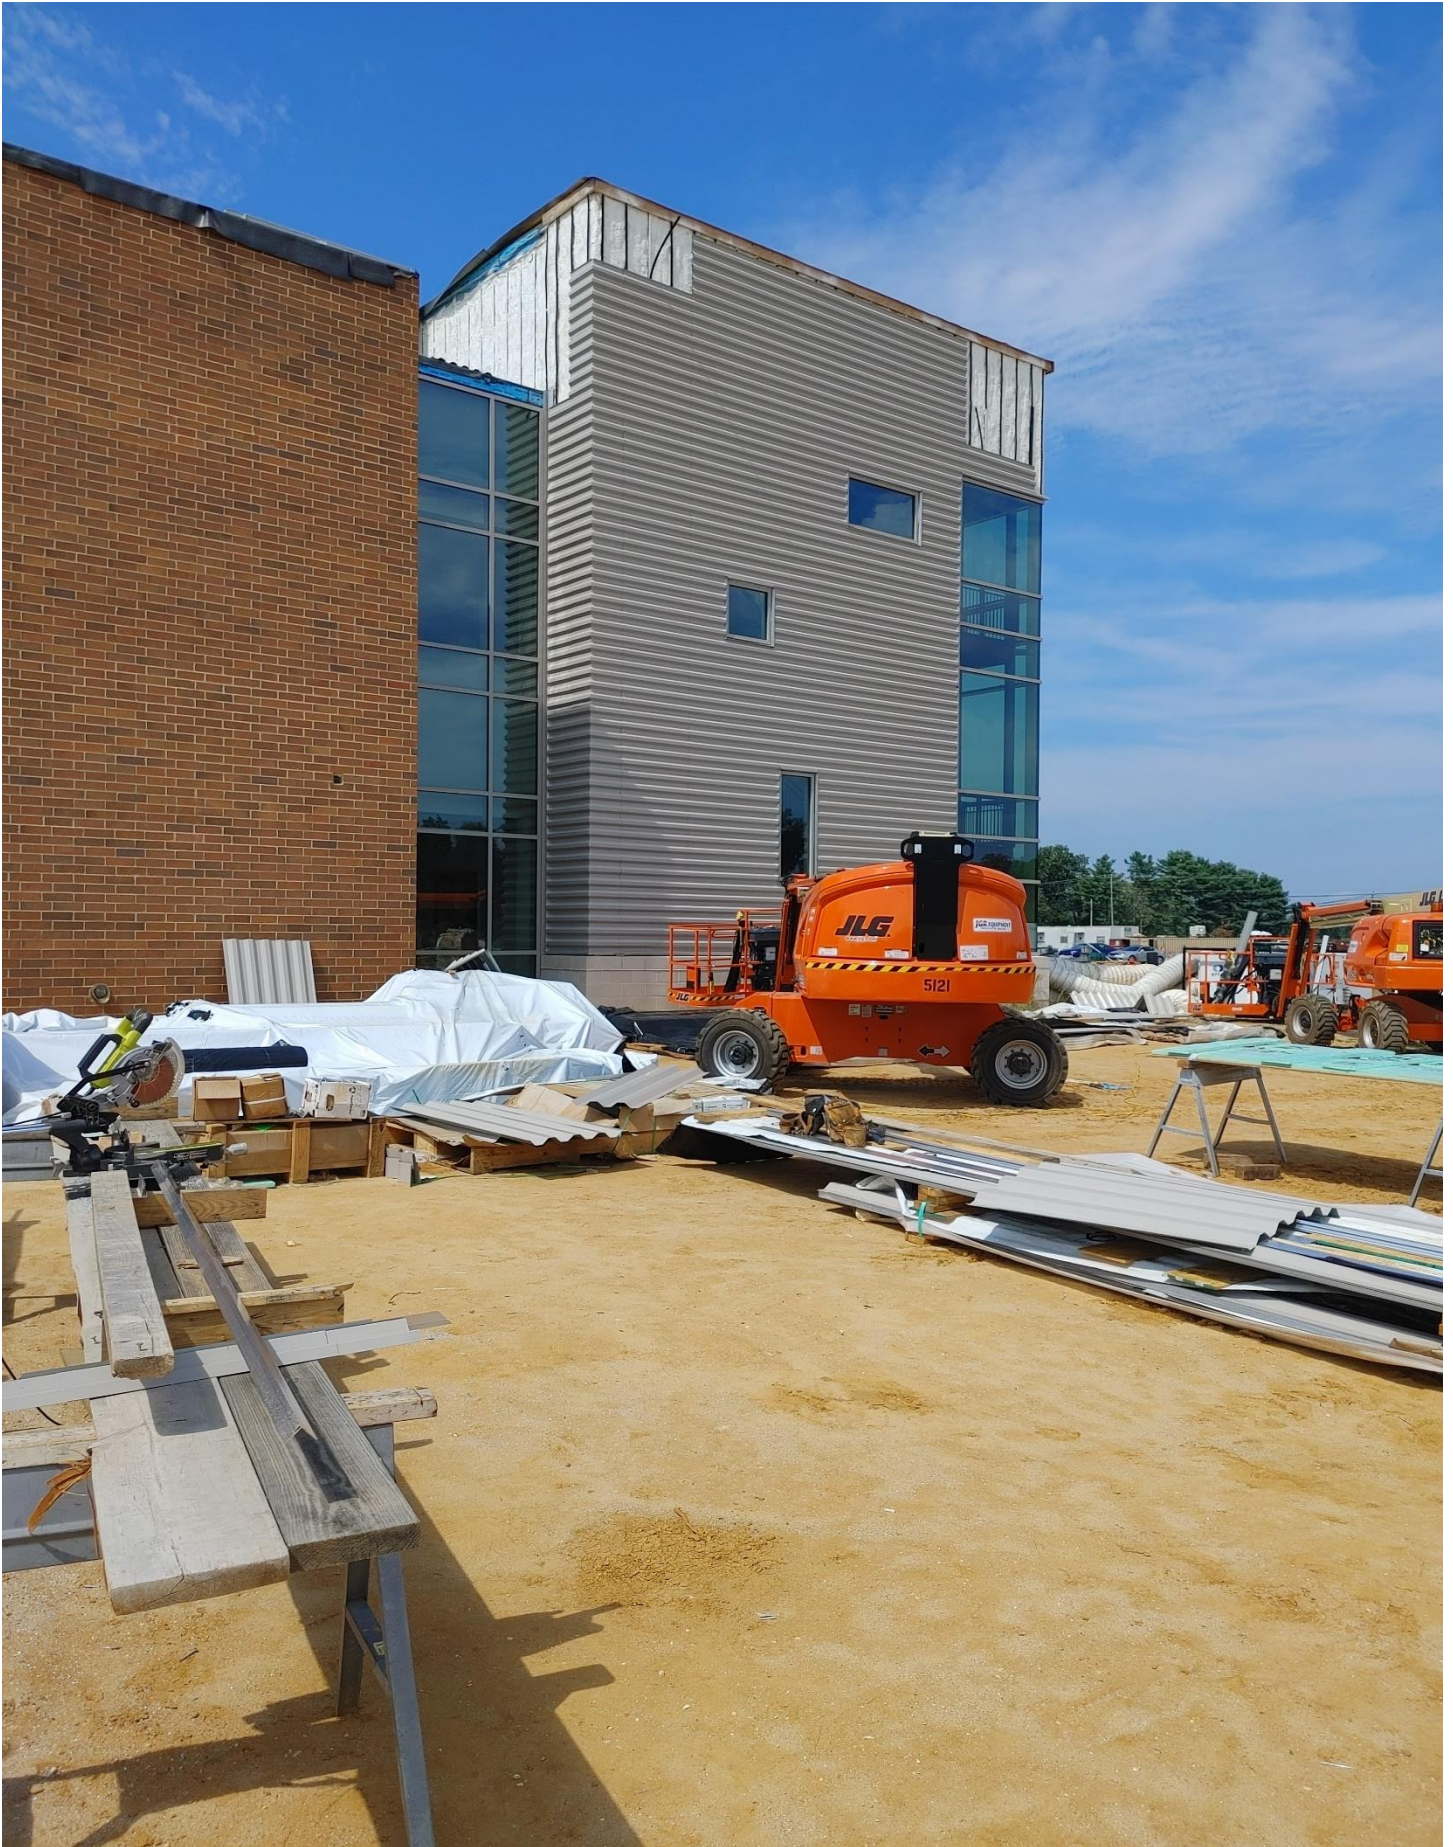
Photo 2 - Stairwell #1 is having metal panels installed.

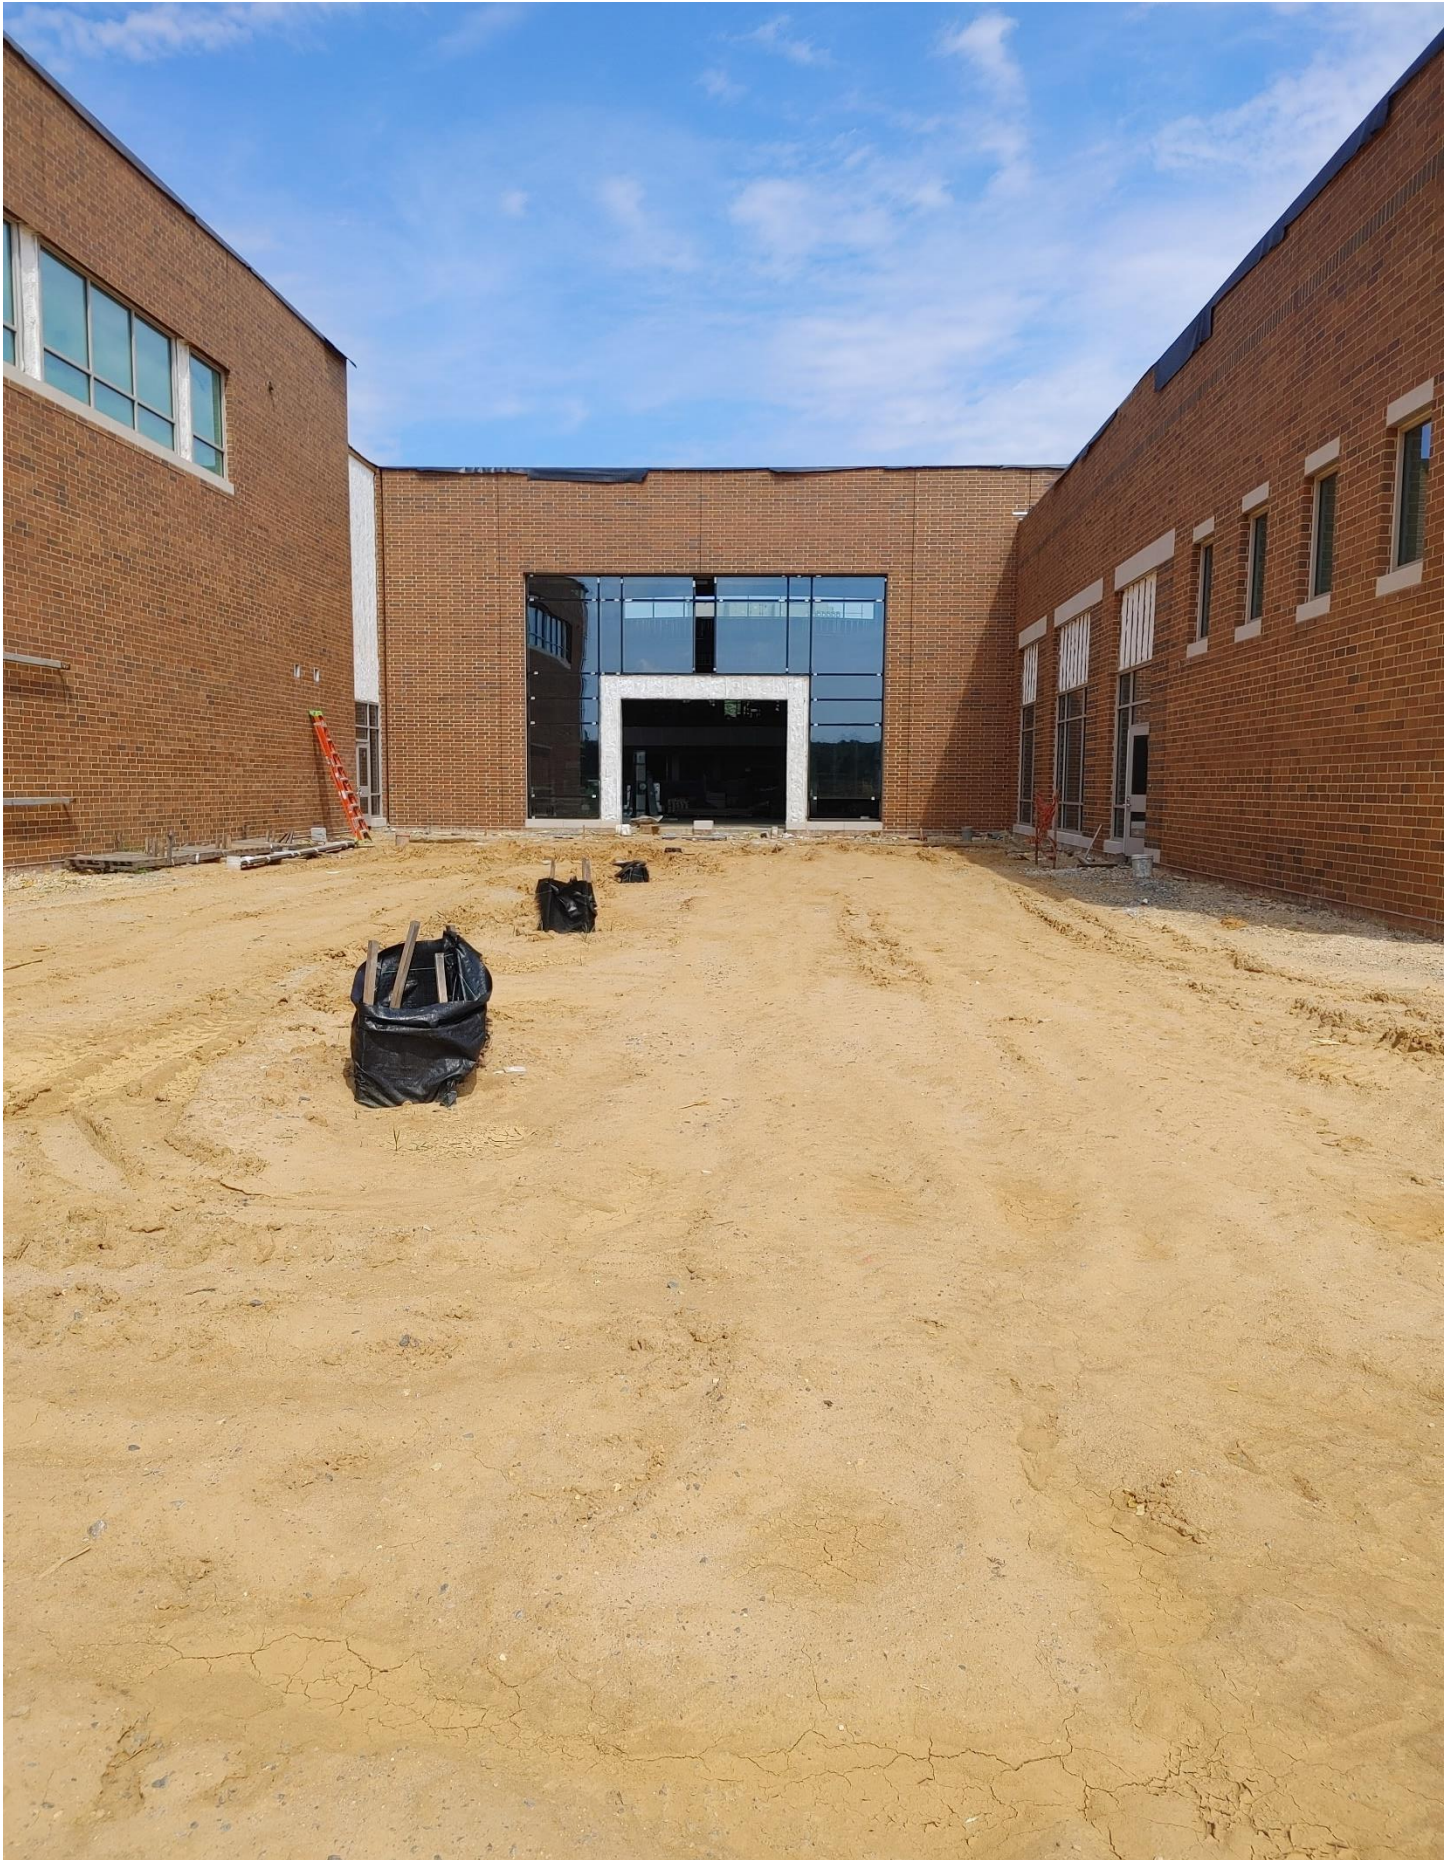
Photo 3 -A few glass panels still need to be installed on CW1

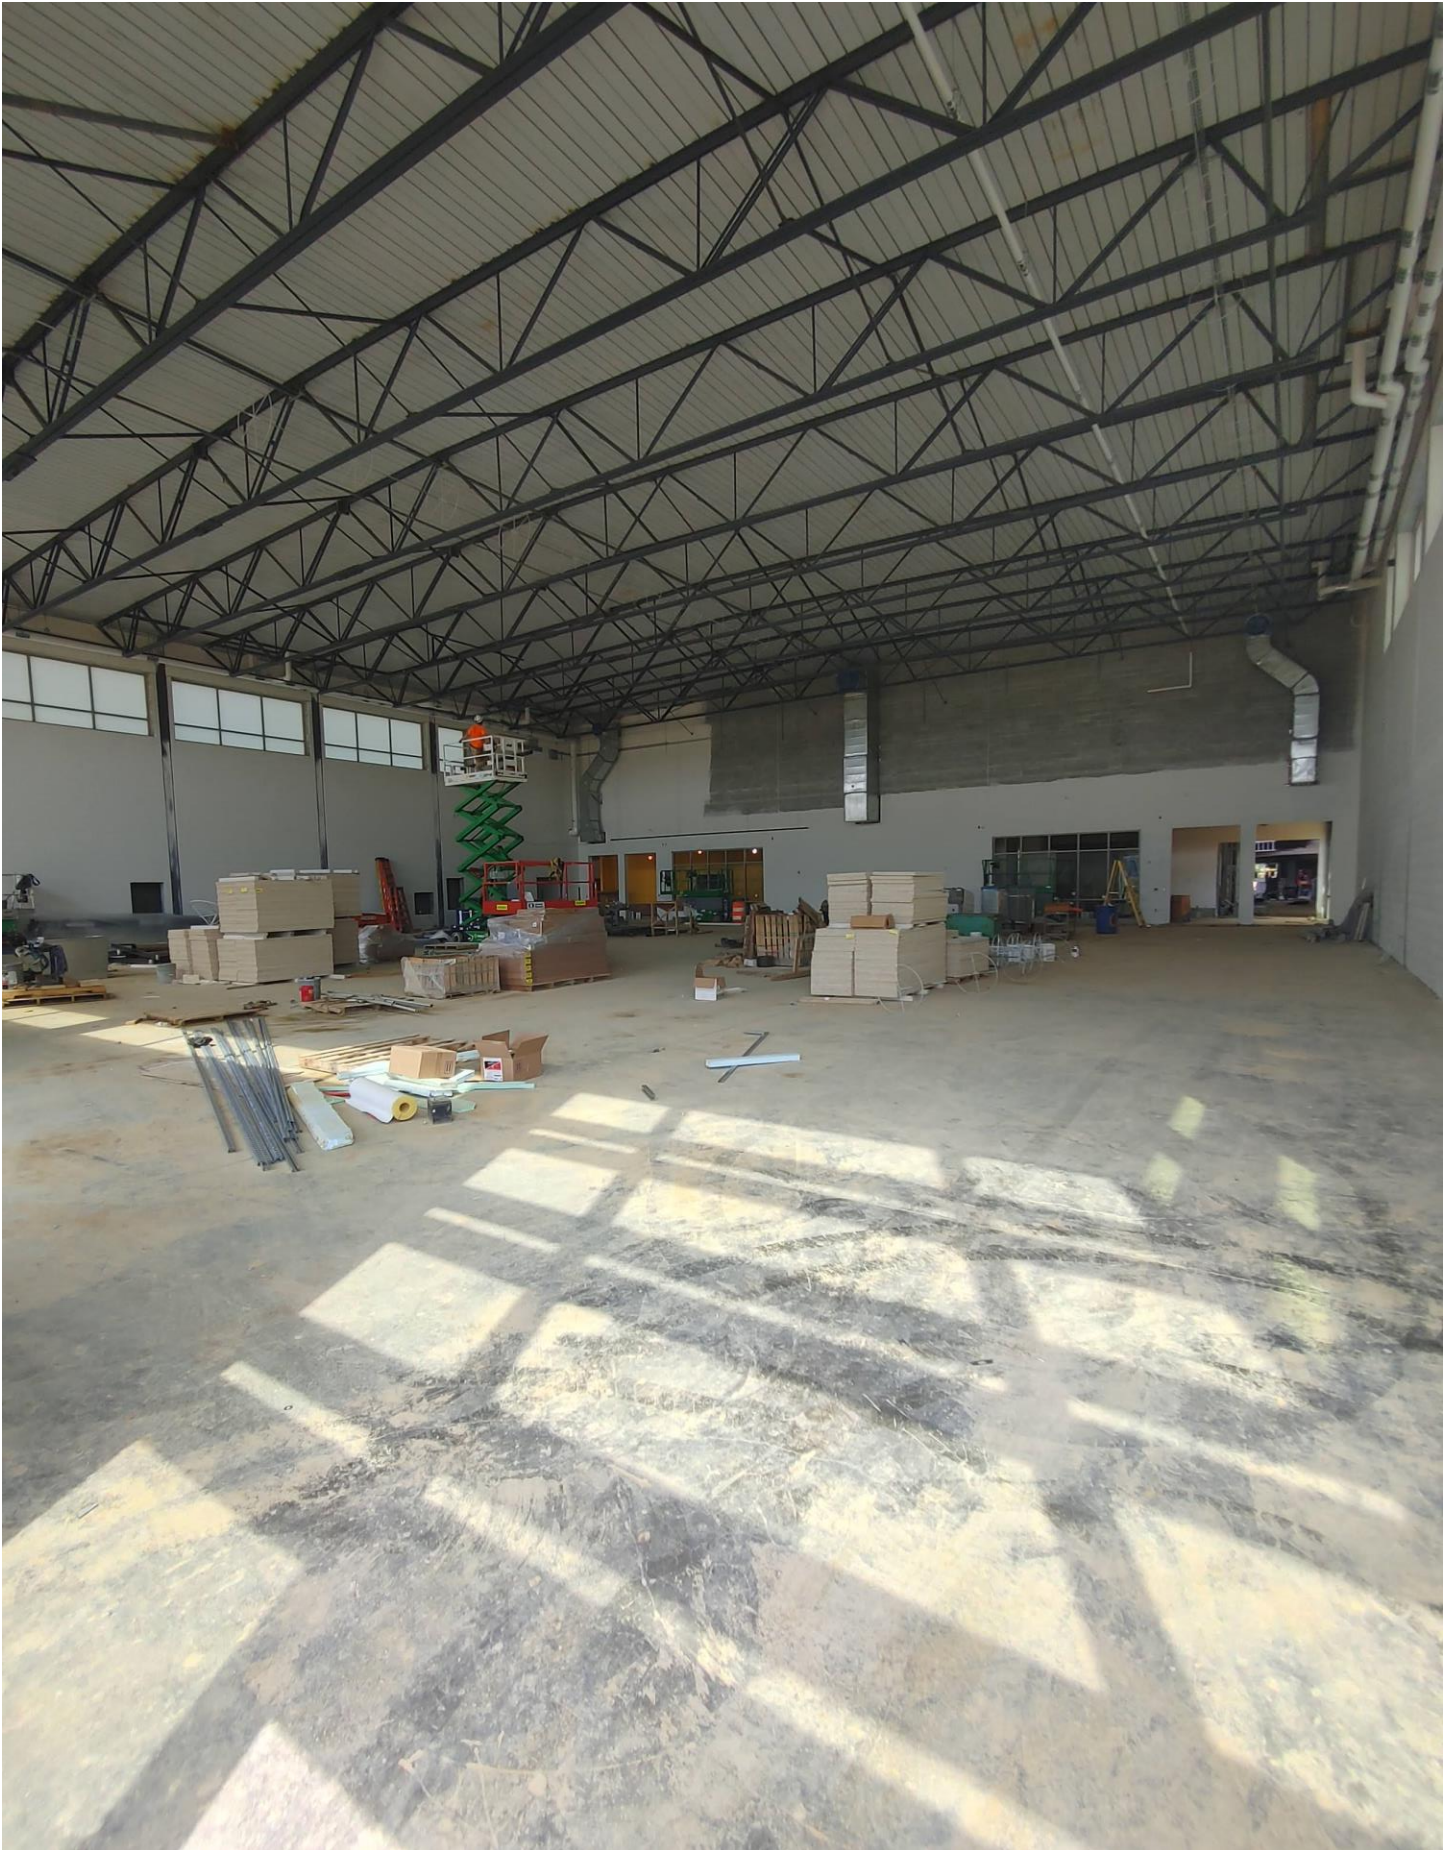
Photo 4 - Sprinkler Pipe is being installed in the Gym.

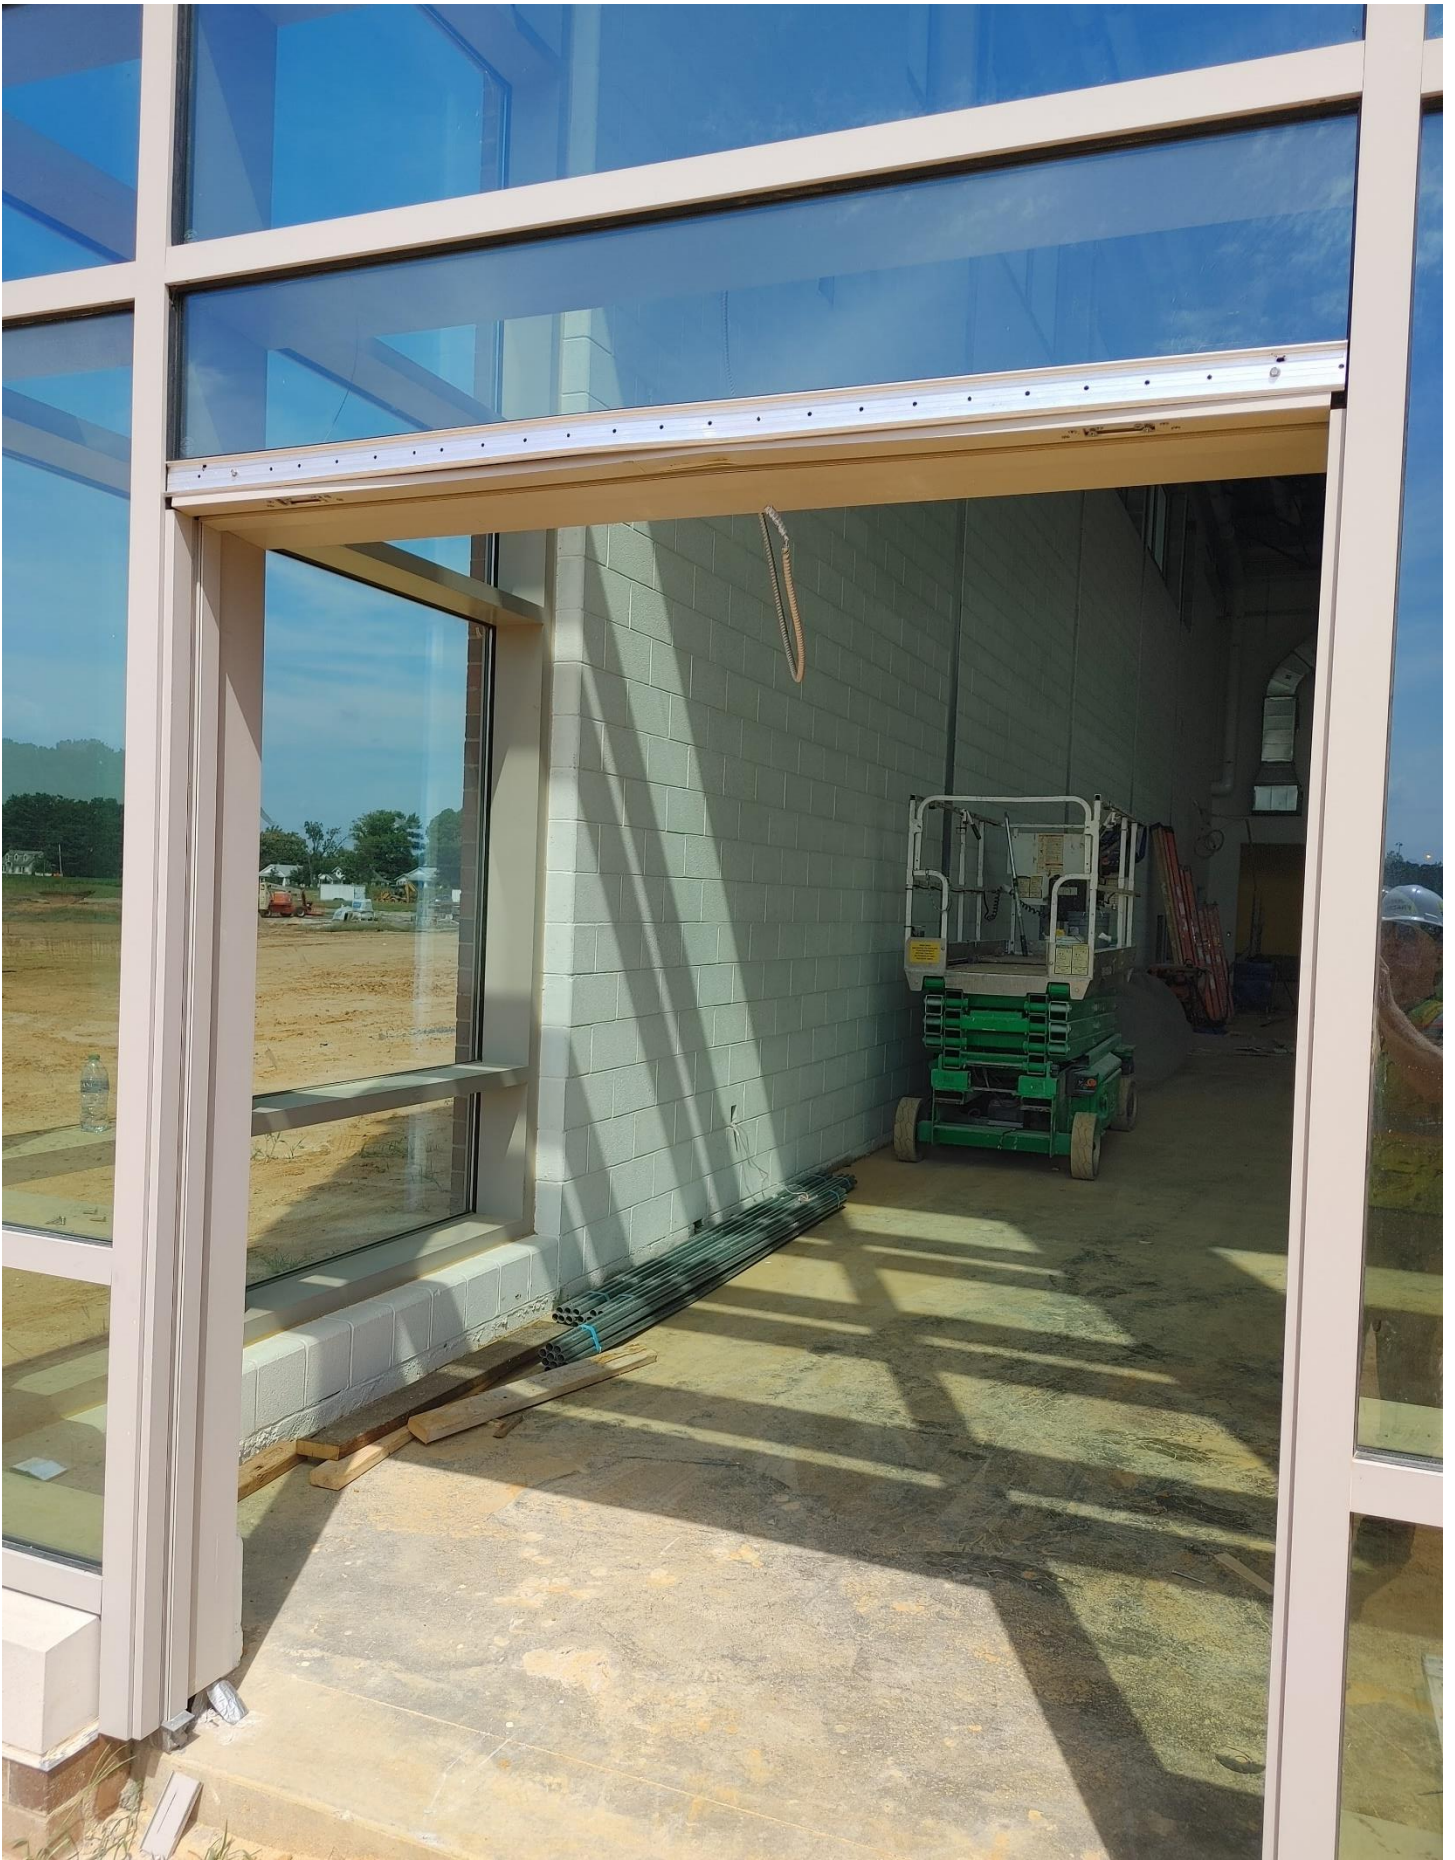
Questions to or from Branch Builds: I met with Cooper, Joh, Jake and Todd during my visit. I pointed out to them that someone had damaged the trim around door XE03, CW4A. They said they were aware of the damage and said that the glass was also cracked. Brian called me when I was walking the site and said that they had lost water to the site and wanted to know if the guys working on the 12" water line had shut down the water. I told him I didn't think so and that I had saw earlier a backhoe digging around the water line up the street and that they probably had a water line break. Brian went and investigated and found that the Town of Montross had shut the Water off the repair a Water Line Break. Brian asked that I inform them that in the future they should notify Branch and ultimately the High School once the building is turned over of any such future shut downs so that Pumps can be shut down to prevent damage. I relayed Brian's comment to Ronnie Saunders with the County so that he can get with the Town Maintenance Department.

Photo 5 - Damage to XE03, CW4A

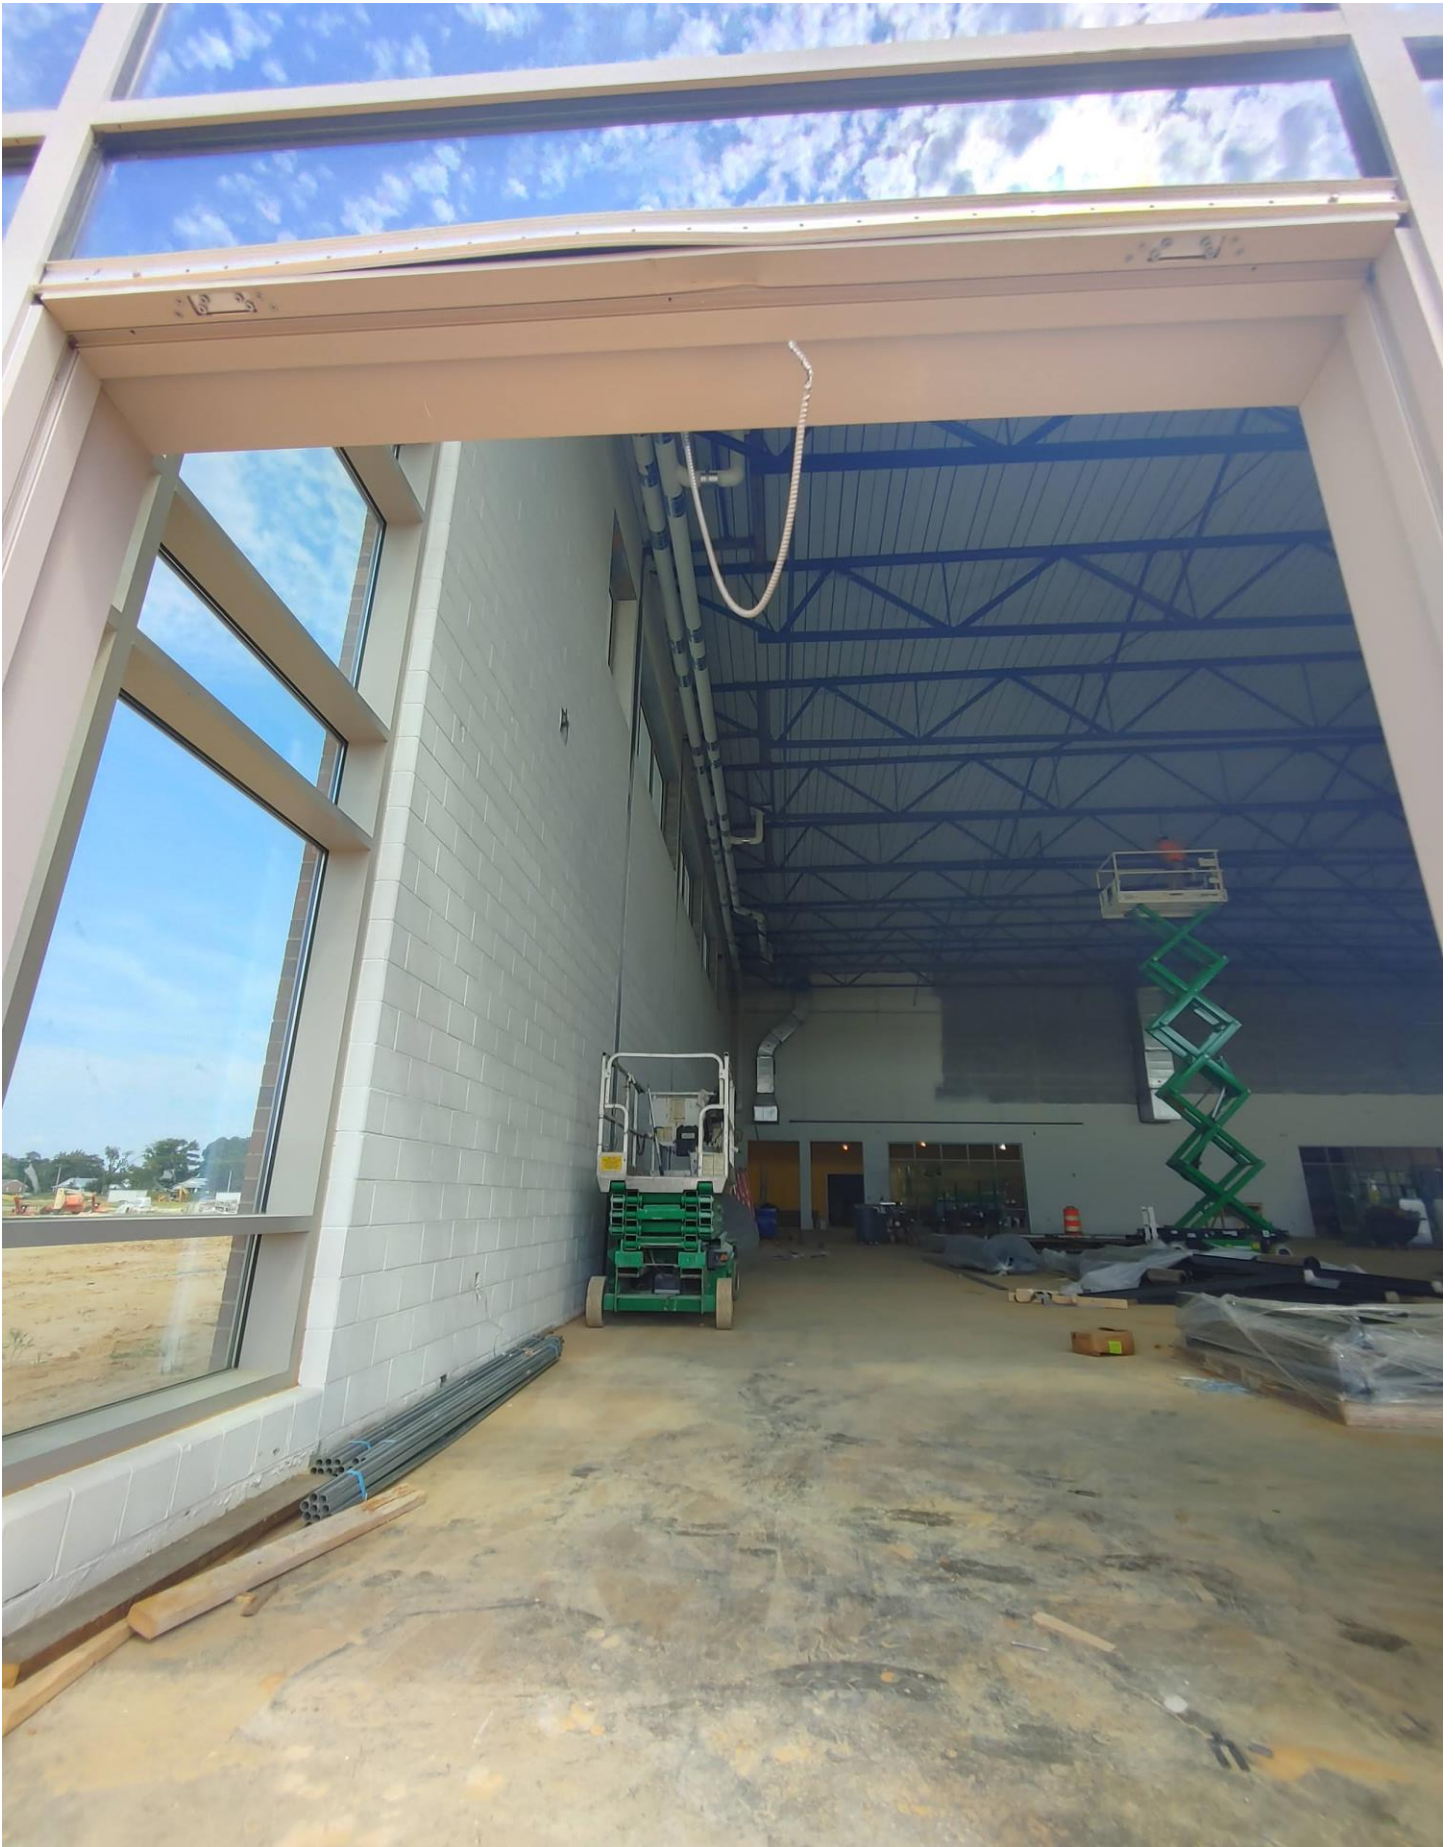
Photo 6 - Damage to XE03, CW4A

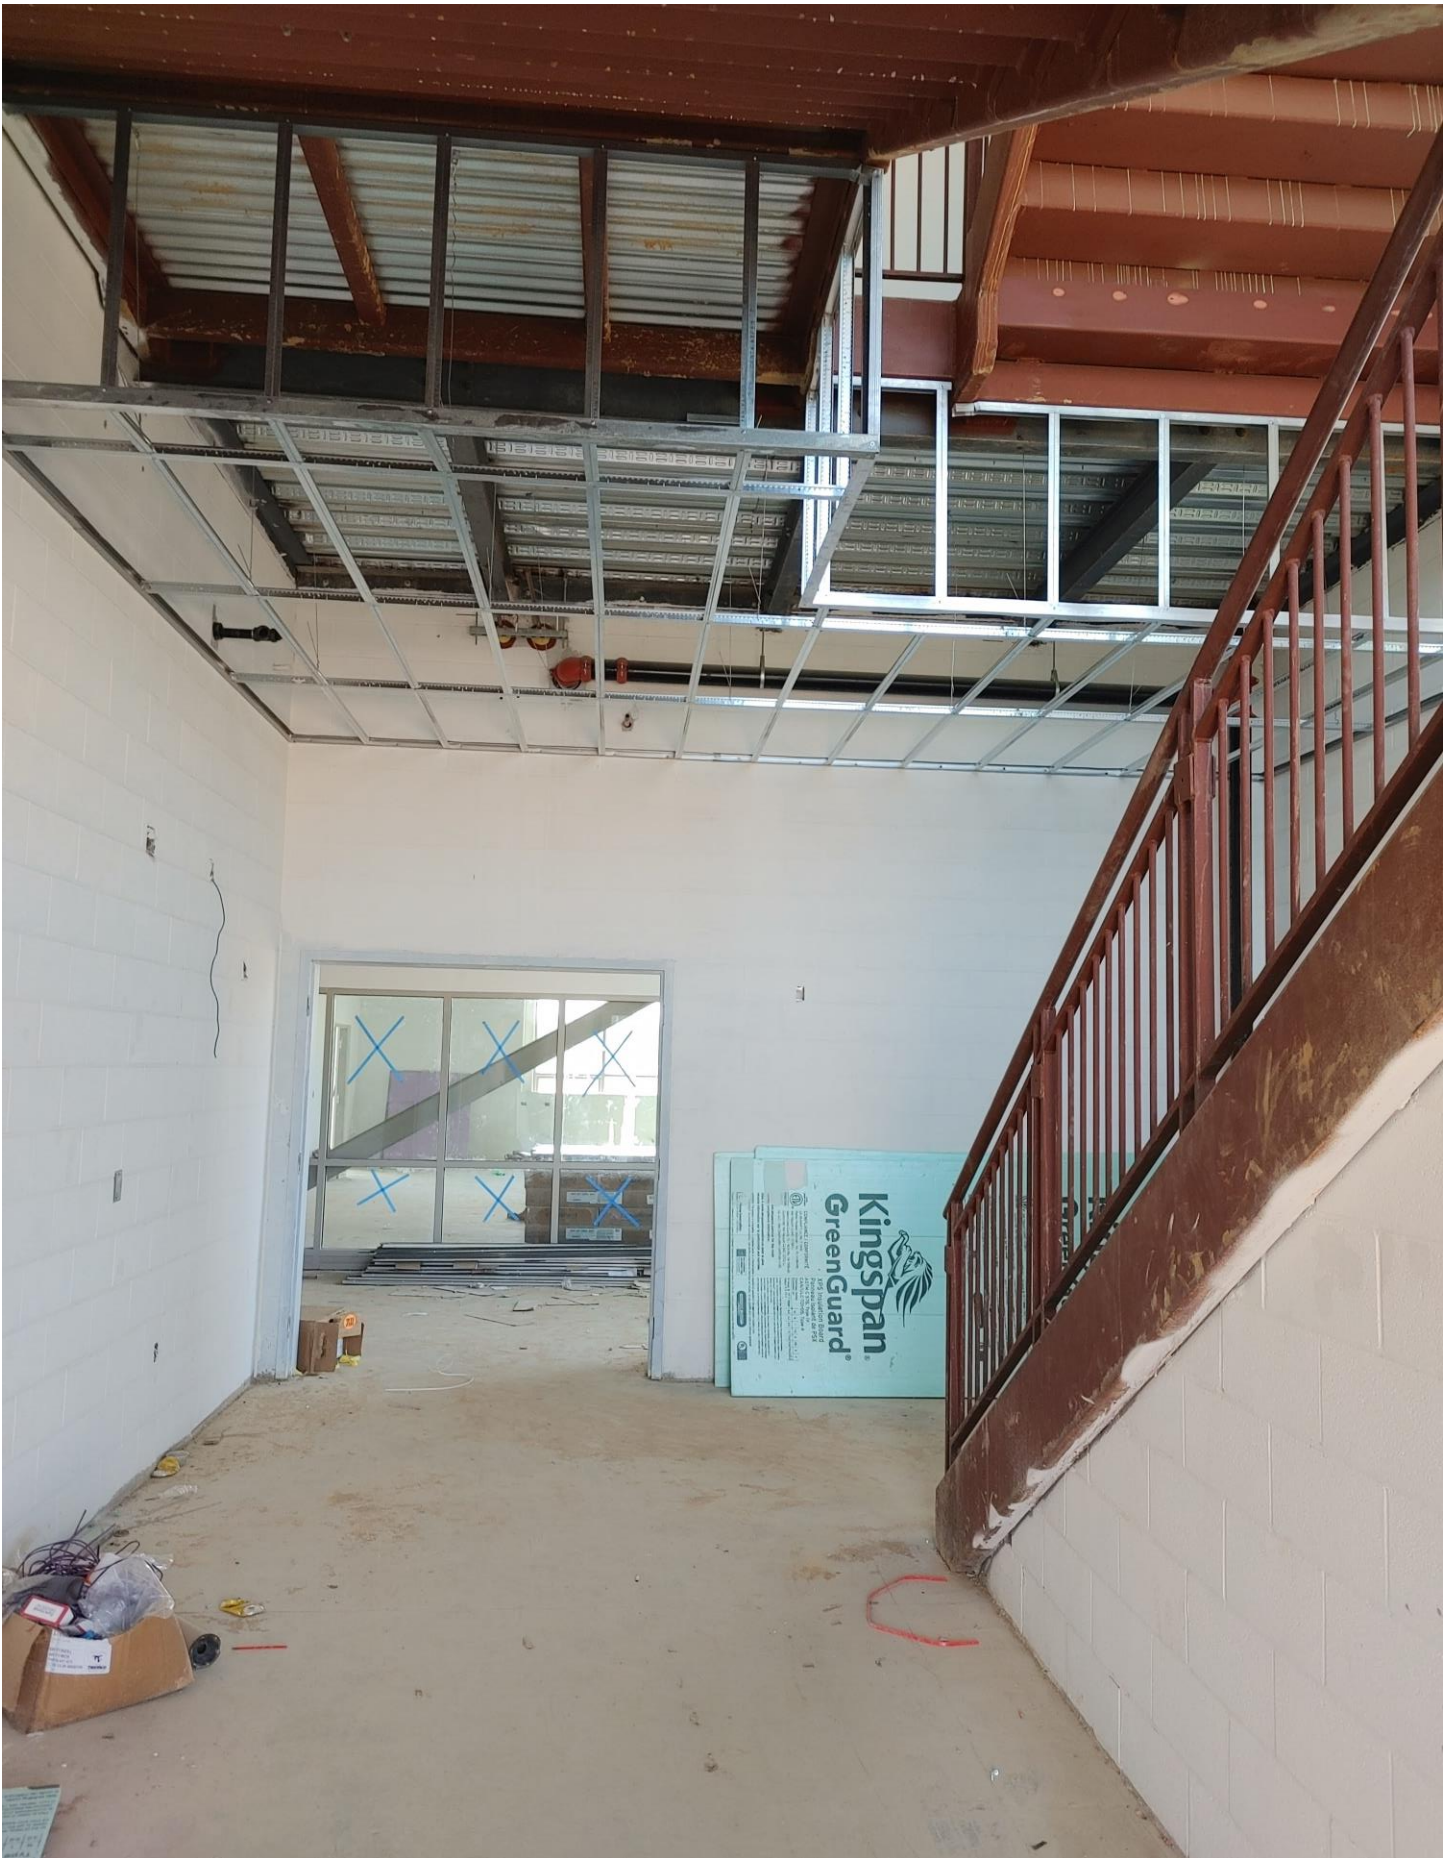
Photo 7 - Ceiling and Bulkhead has been constructed in Stair #2

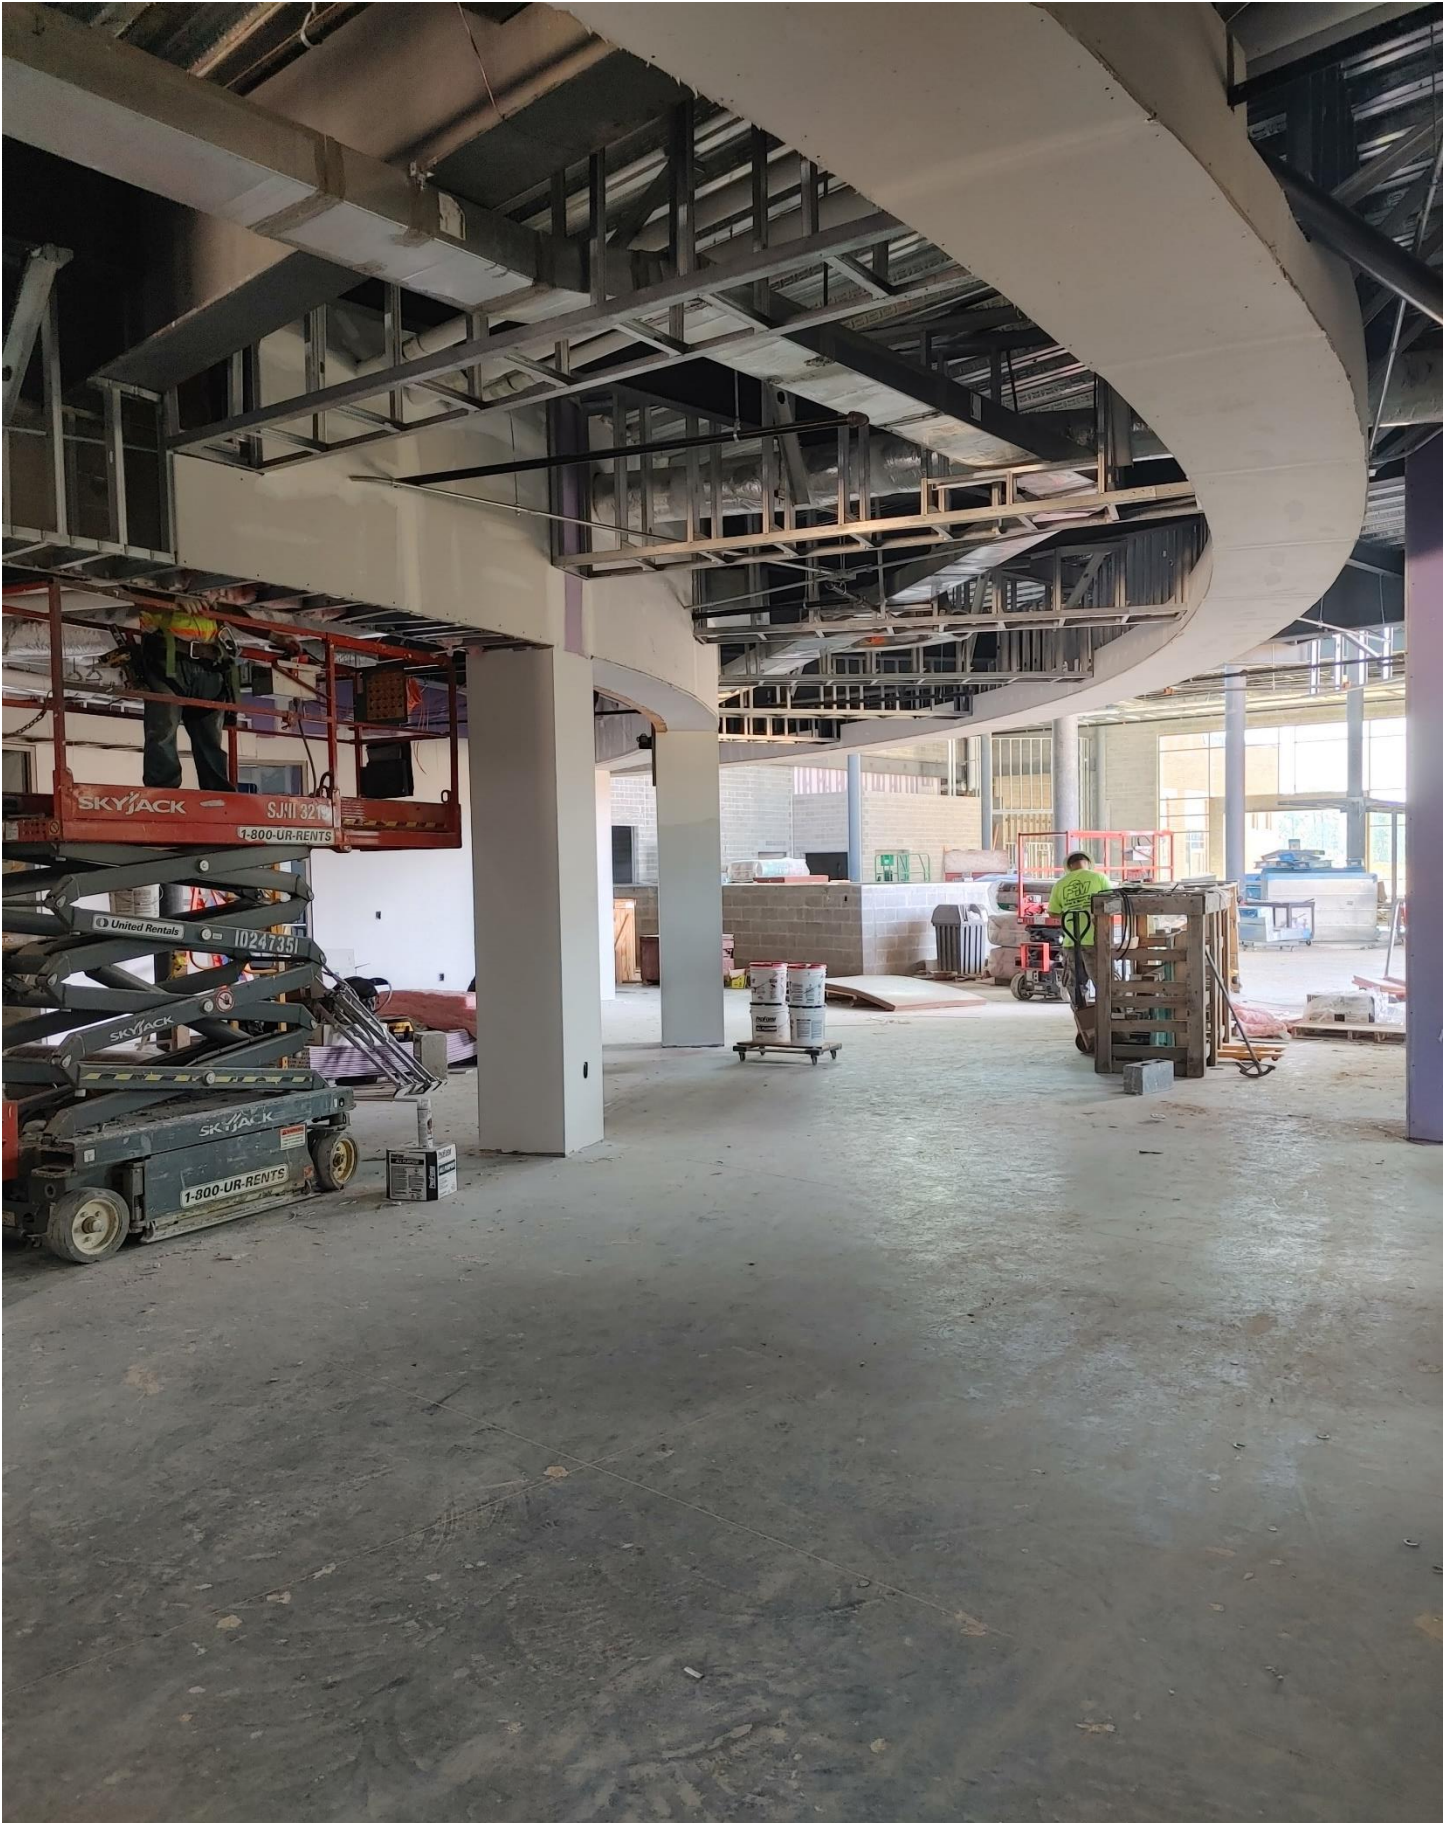
Photo 8 - Sheetrock is being finished in Area A.
