**COMMONWEALTH
BUILDING SOLUTIONS, LLC**

FIELD REPORT

WESTMORELAND COUNTY HIGH SCHOOL

Date: 09/8/2021

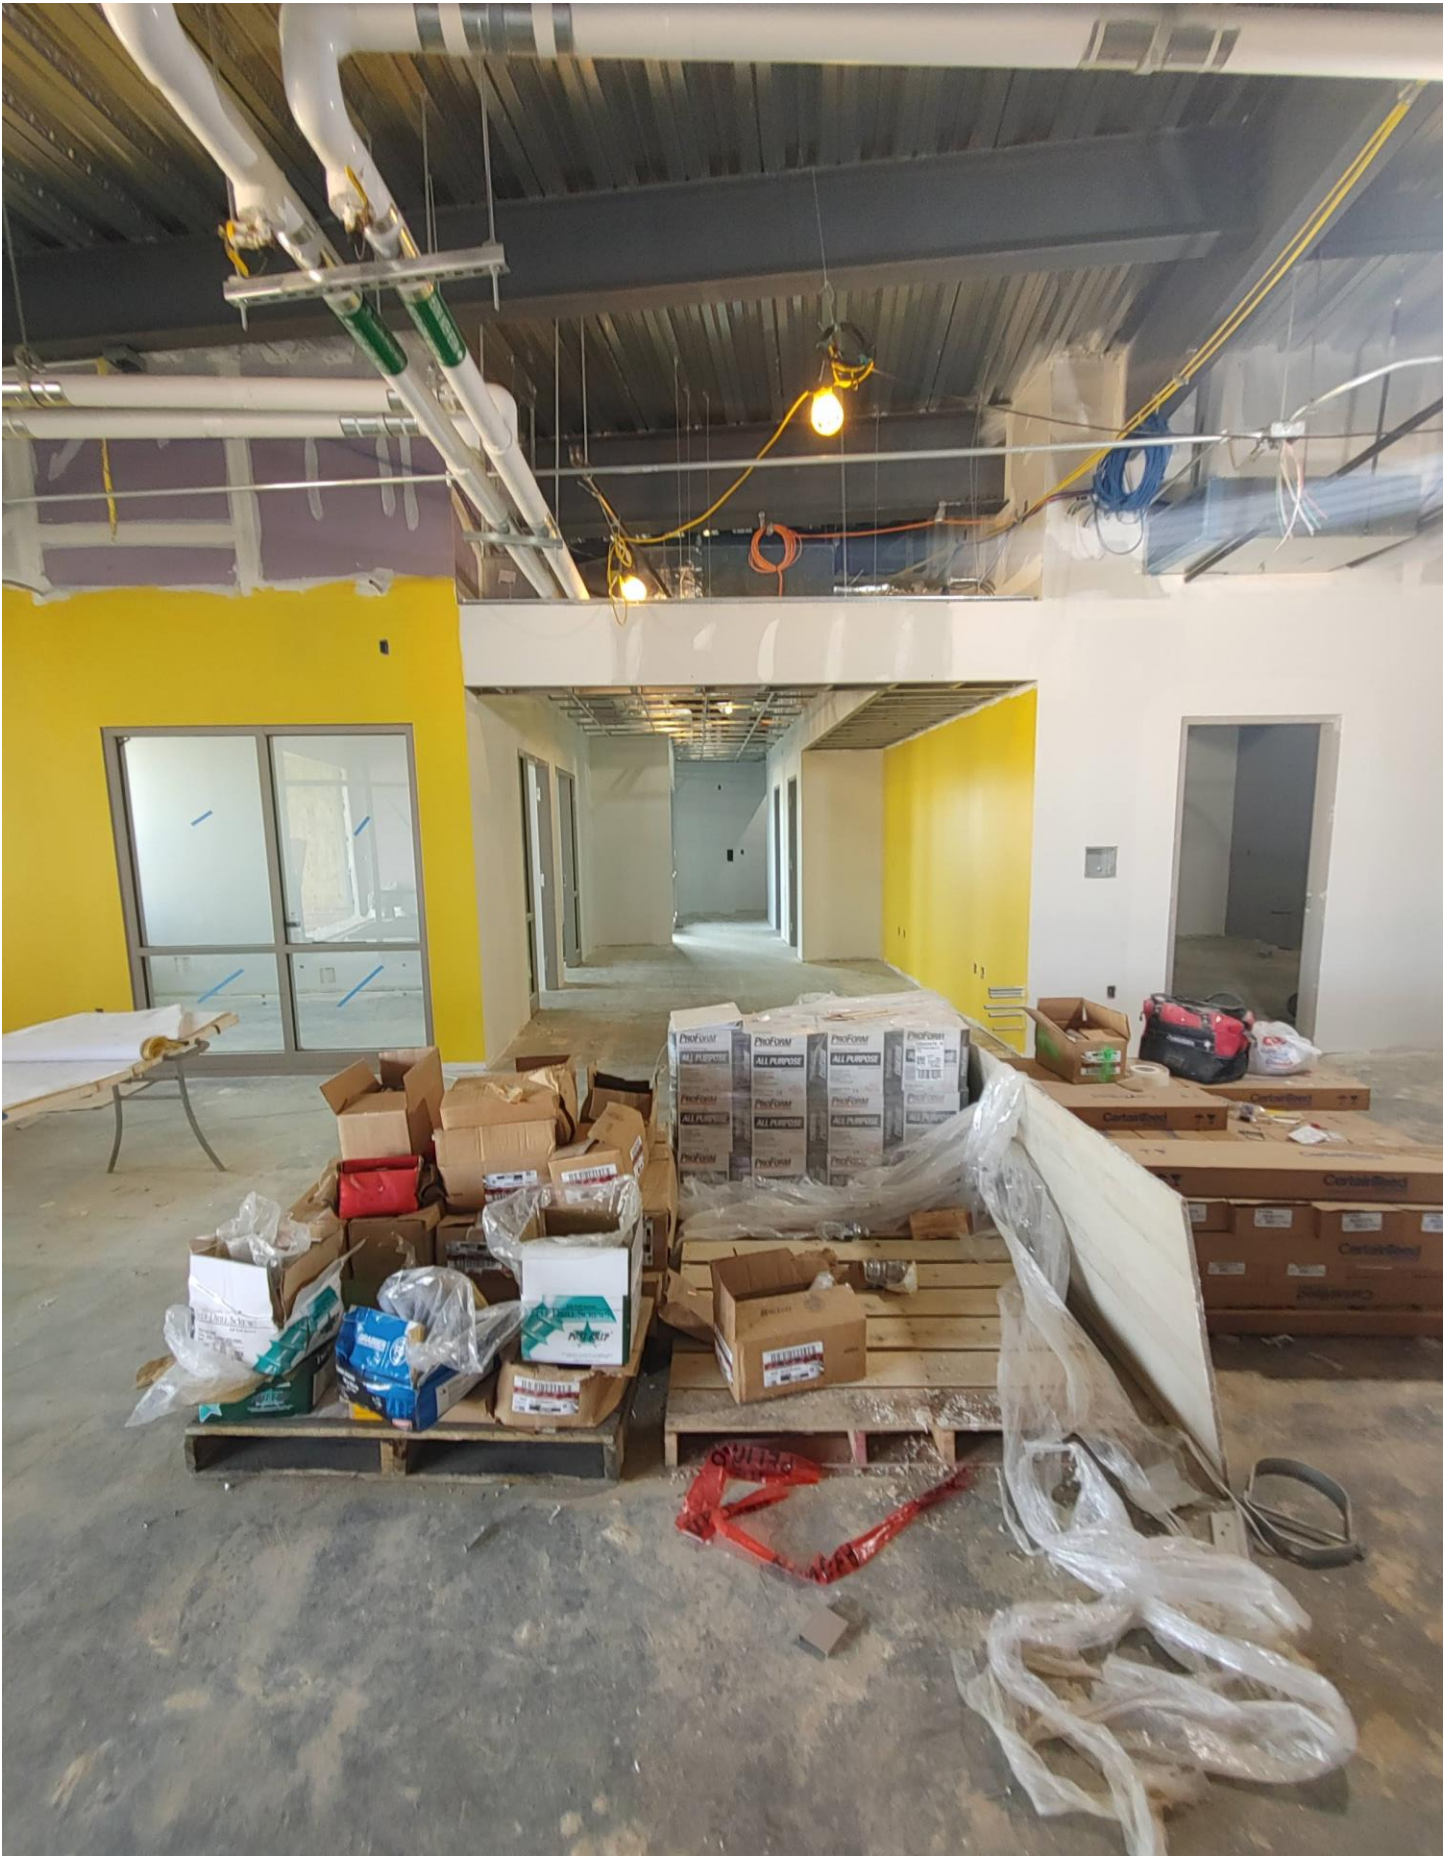
Photo 9 - Walls are being painted in the Administrative area of Area A.

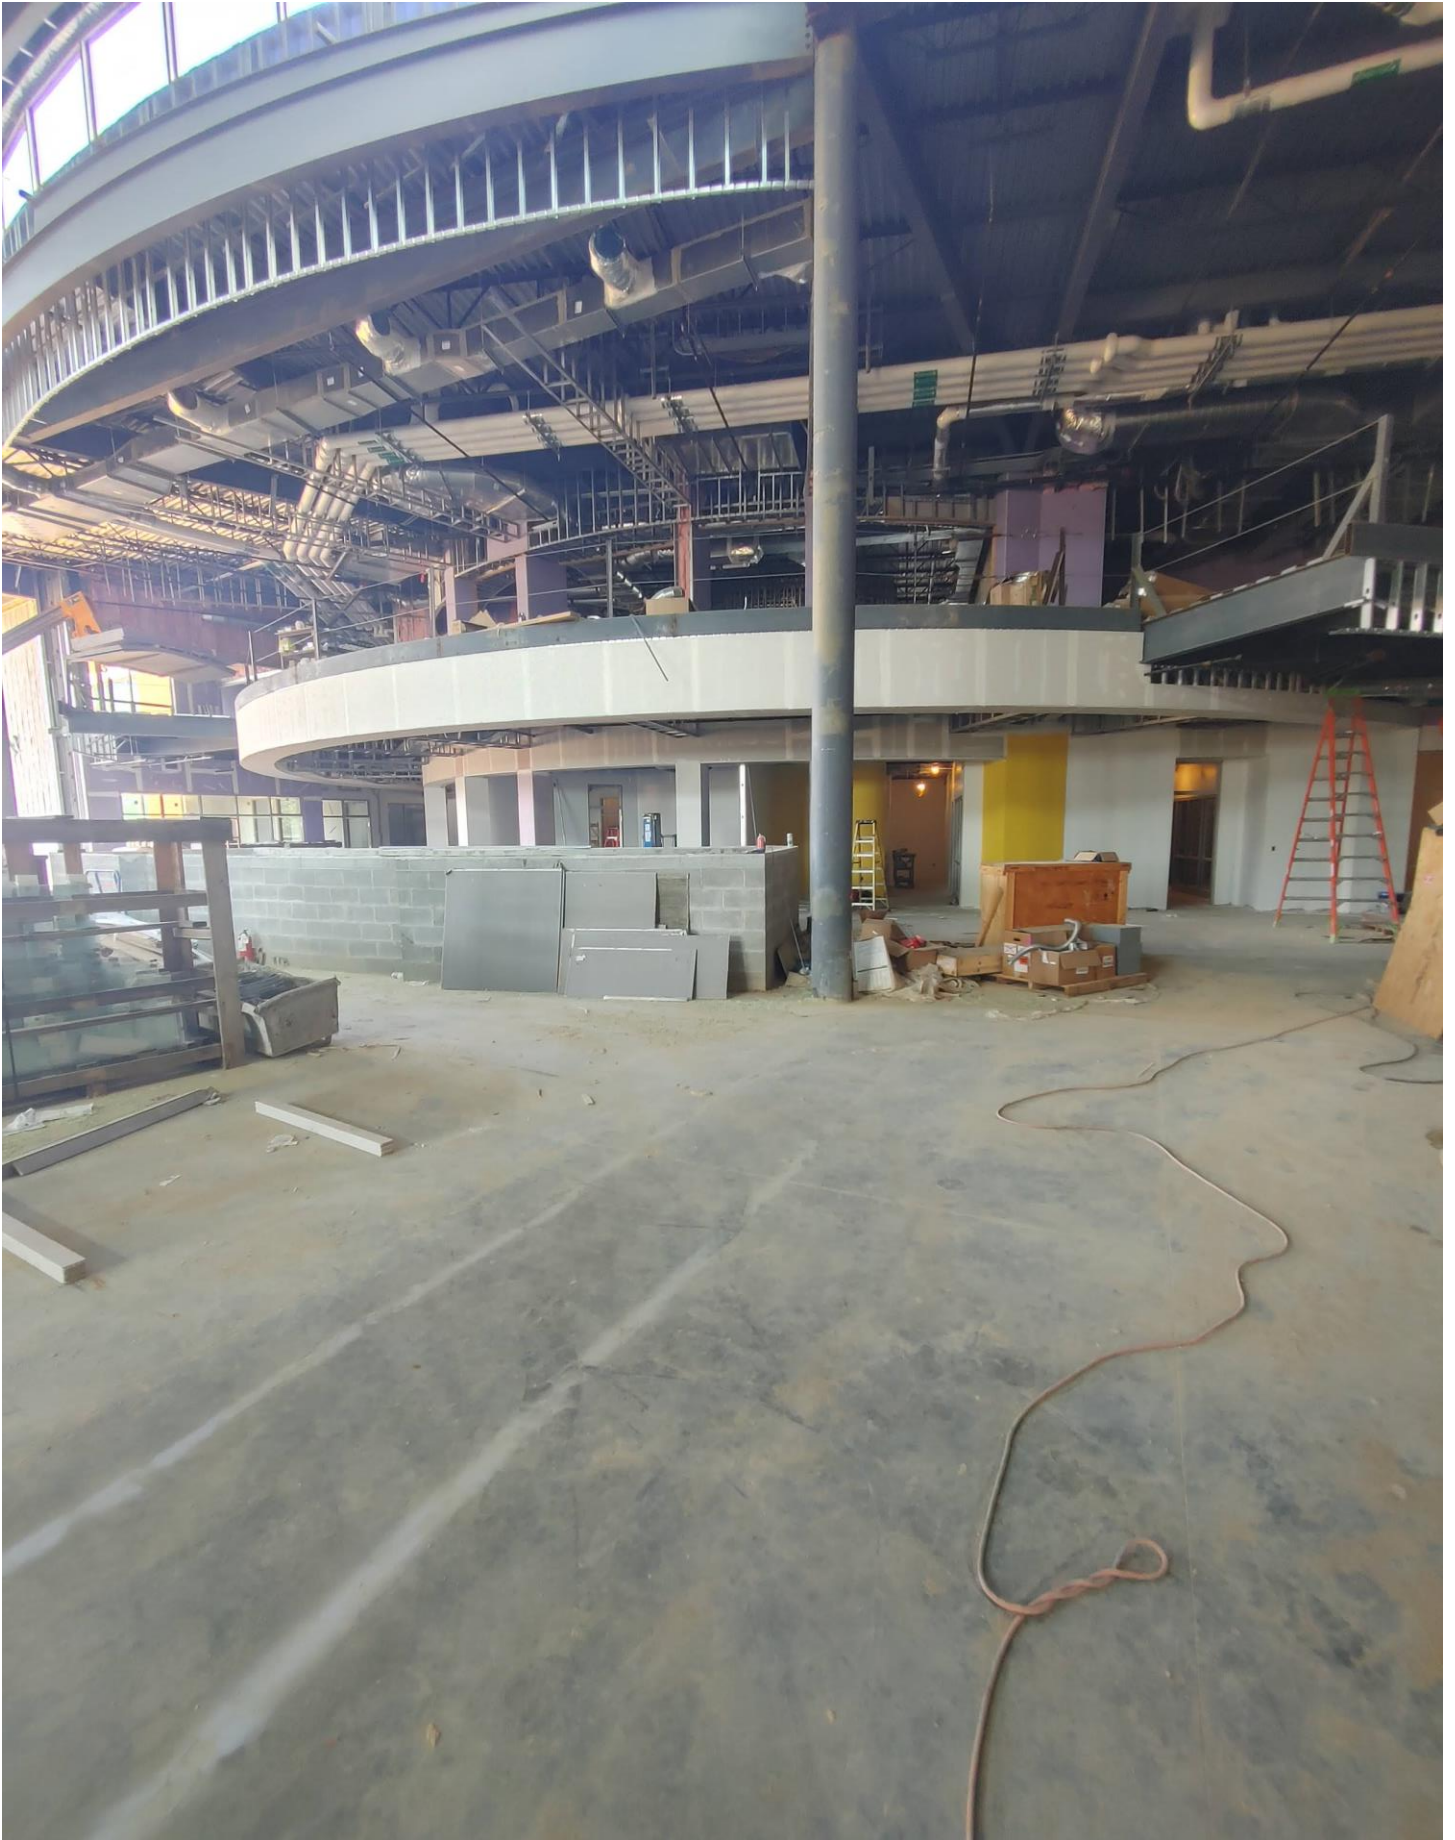
Photo 10 - Sheetrock being finished in Area A.

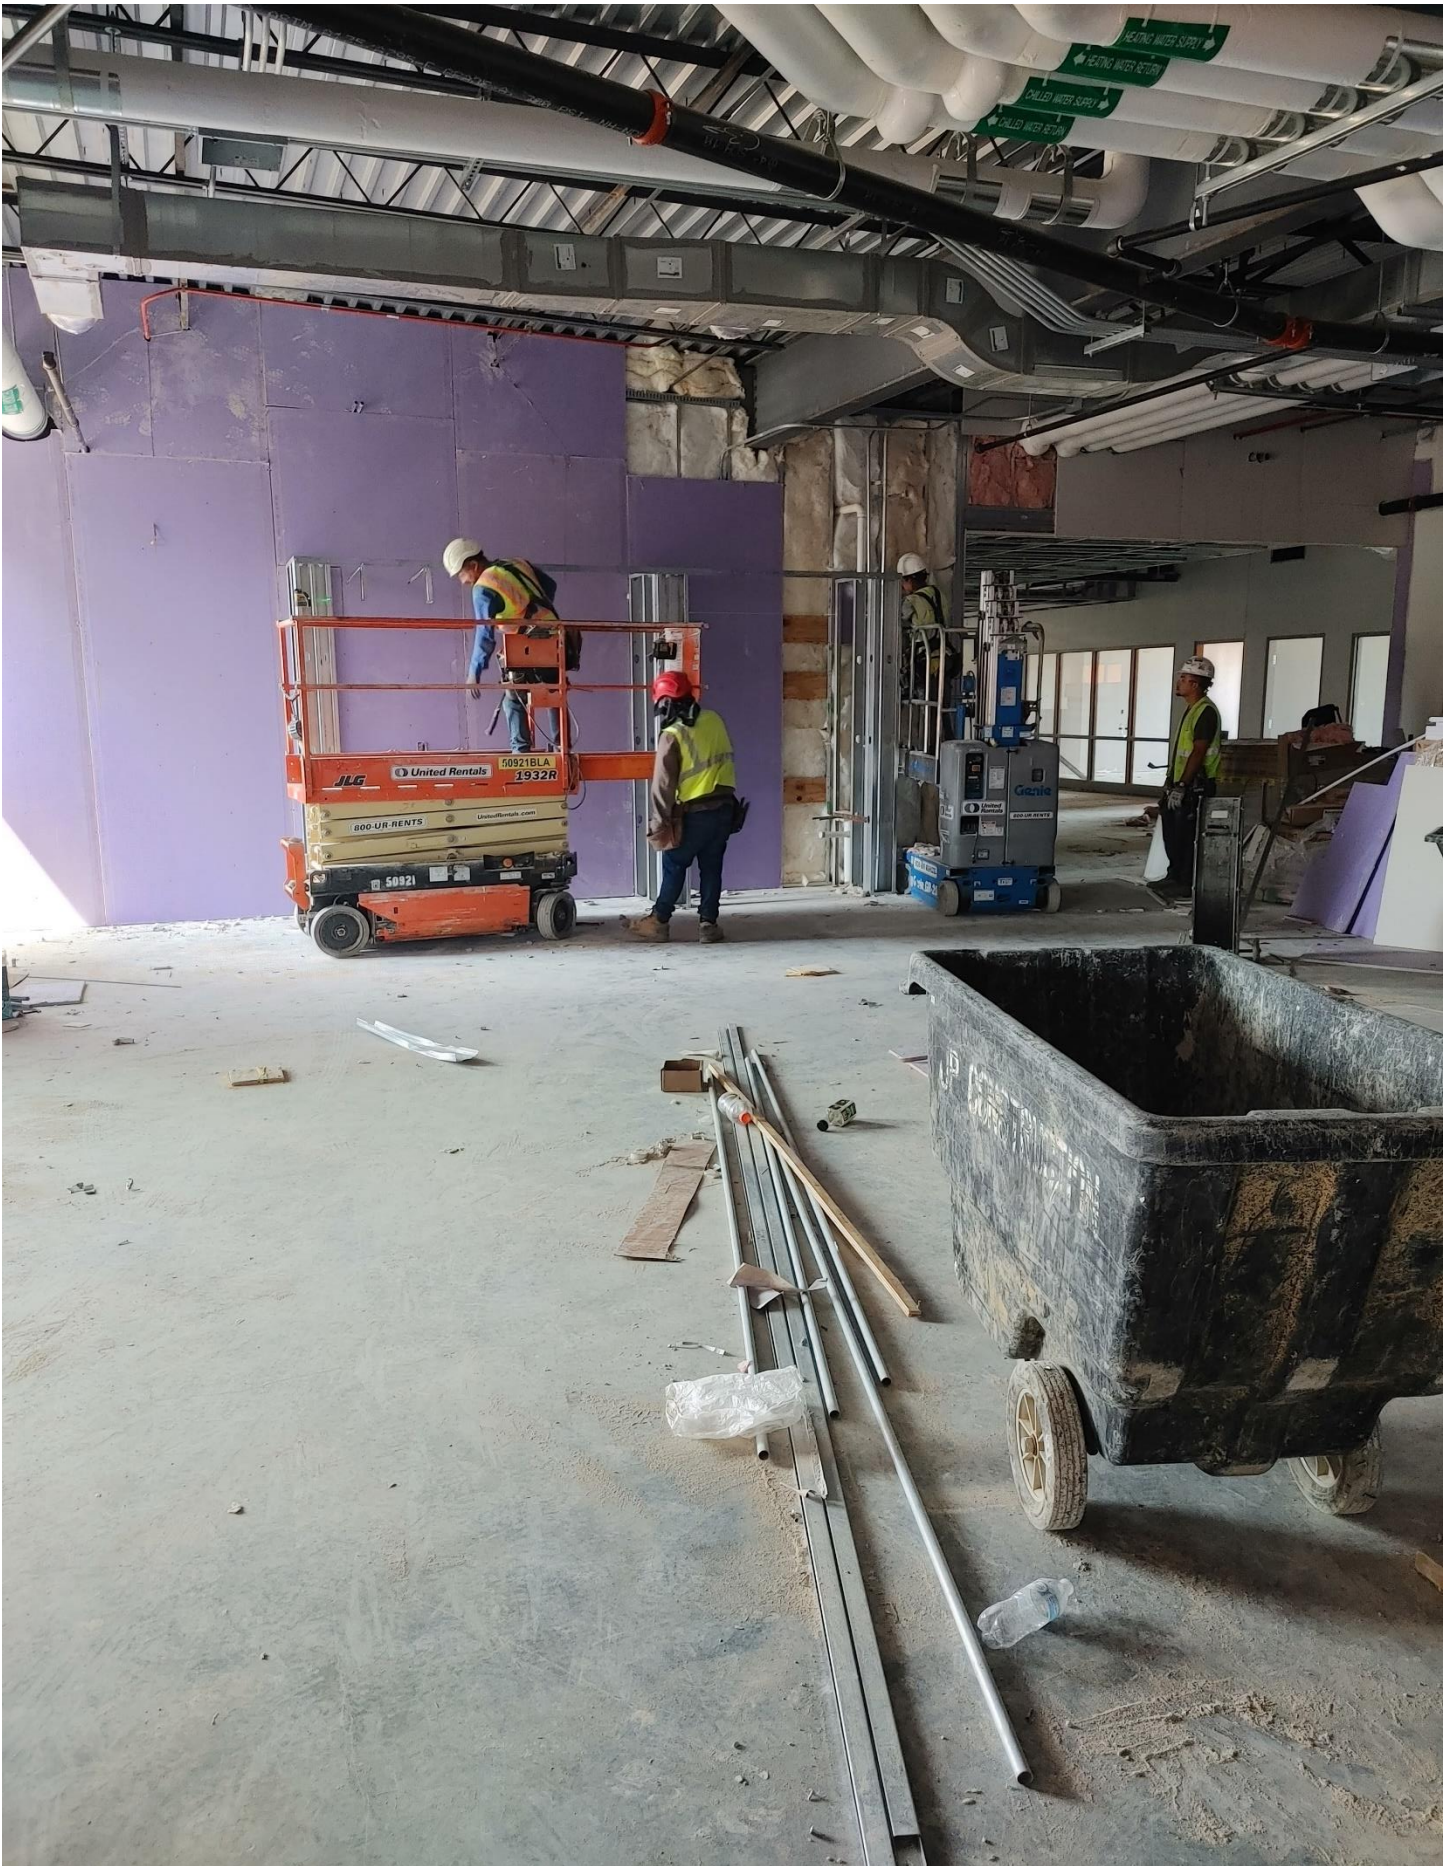
Photo 11 - Built-in Seating Nook and Sink Area on the 2nd floor of Area A is being framed.

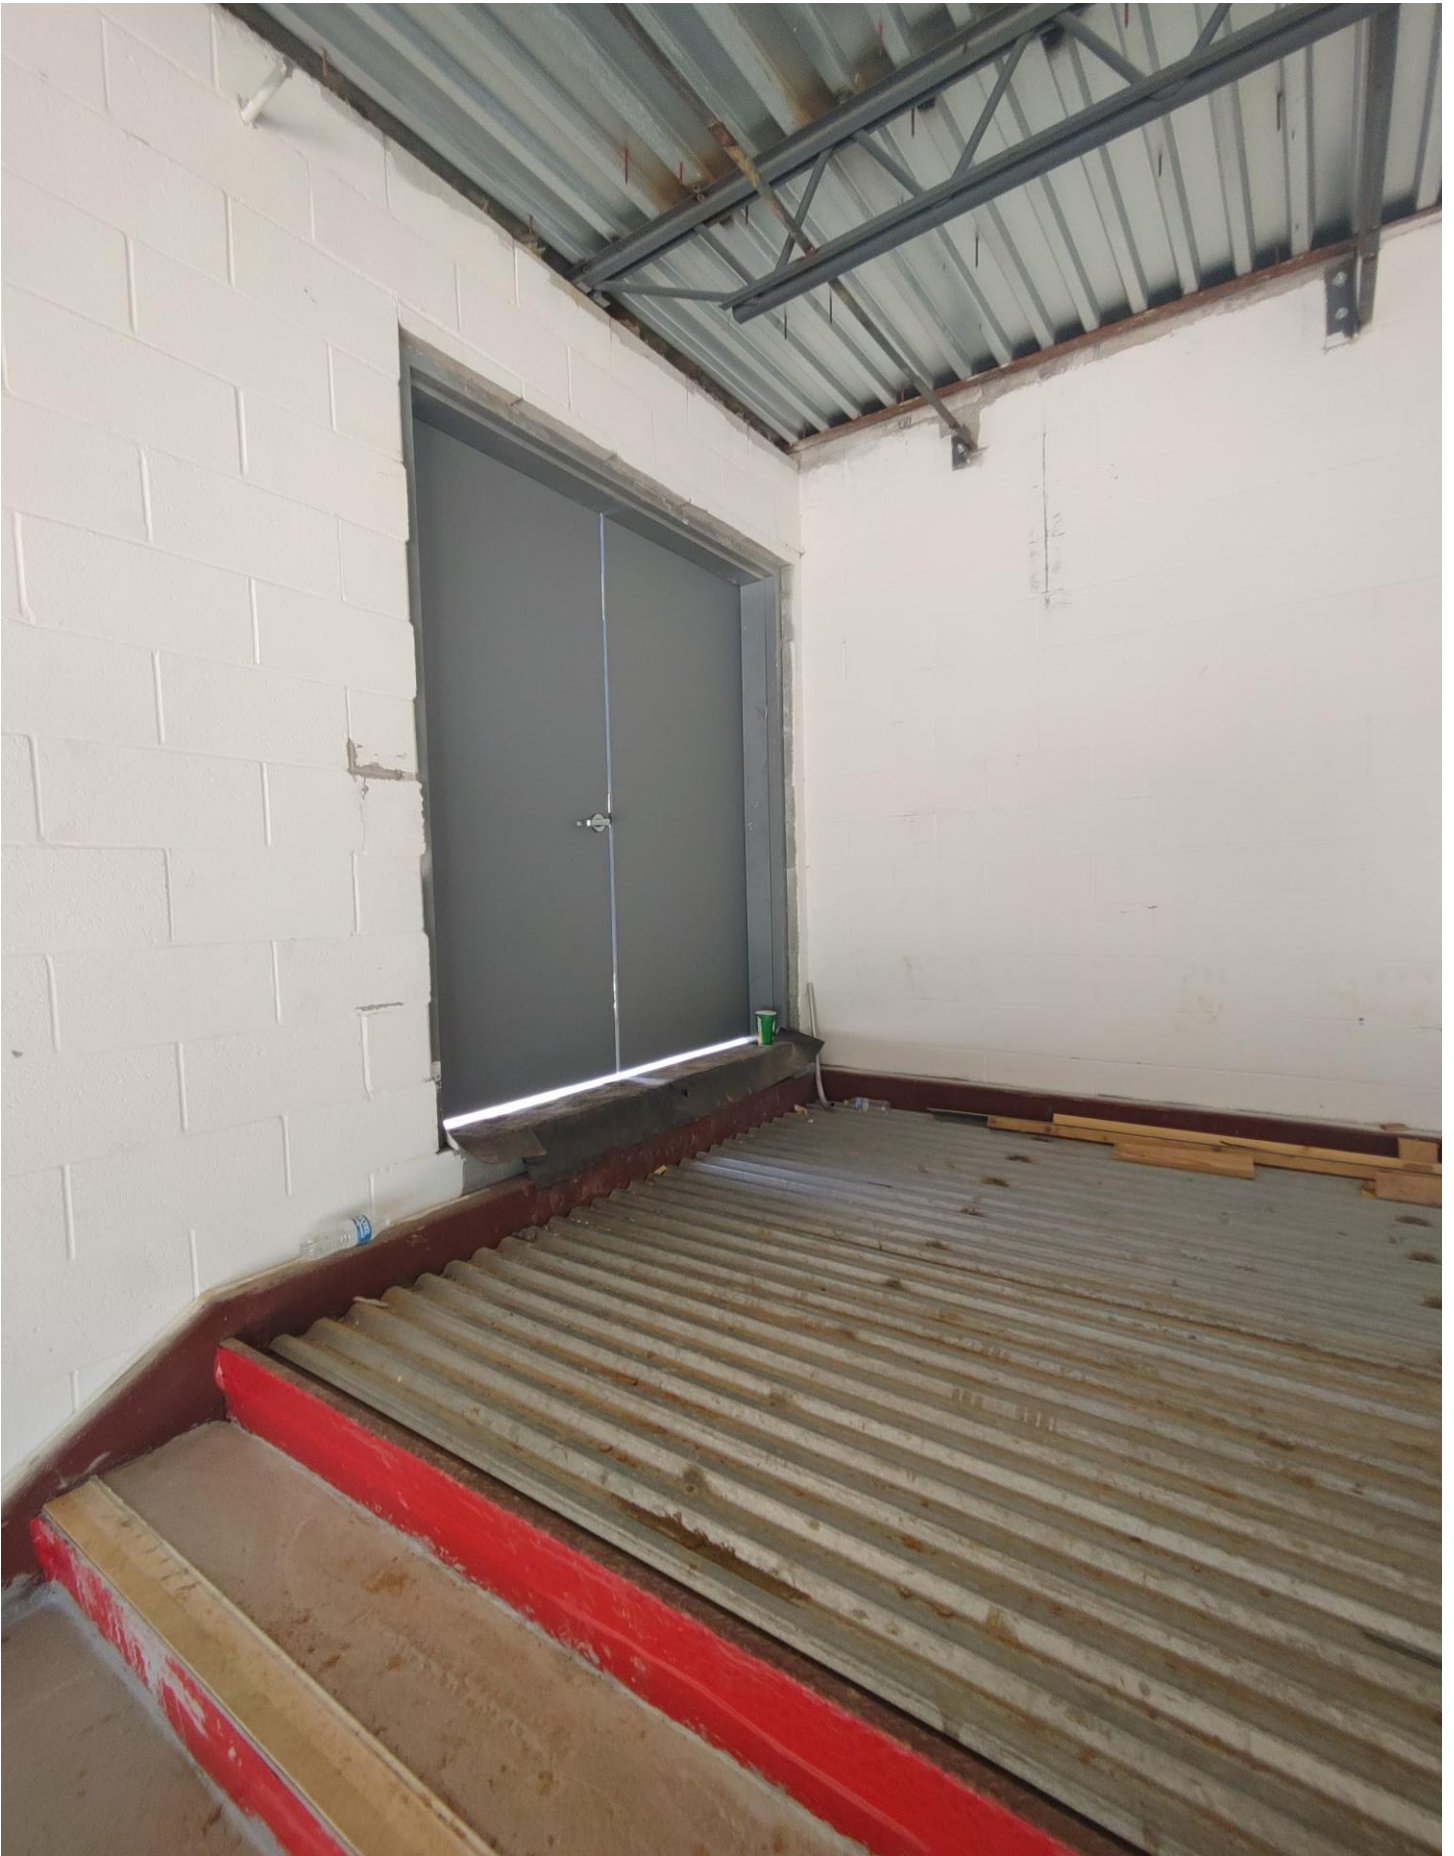
Photo 12 - Doors ST2C at the top of the Stairwell have been installed.

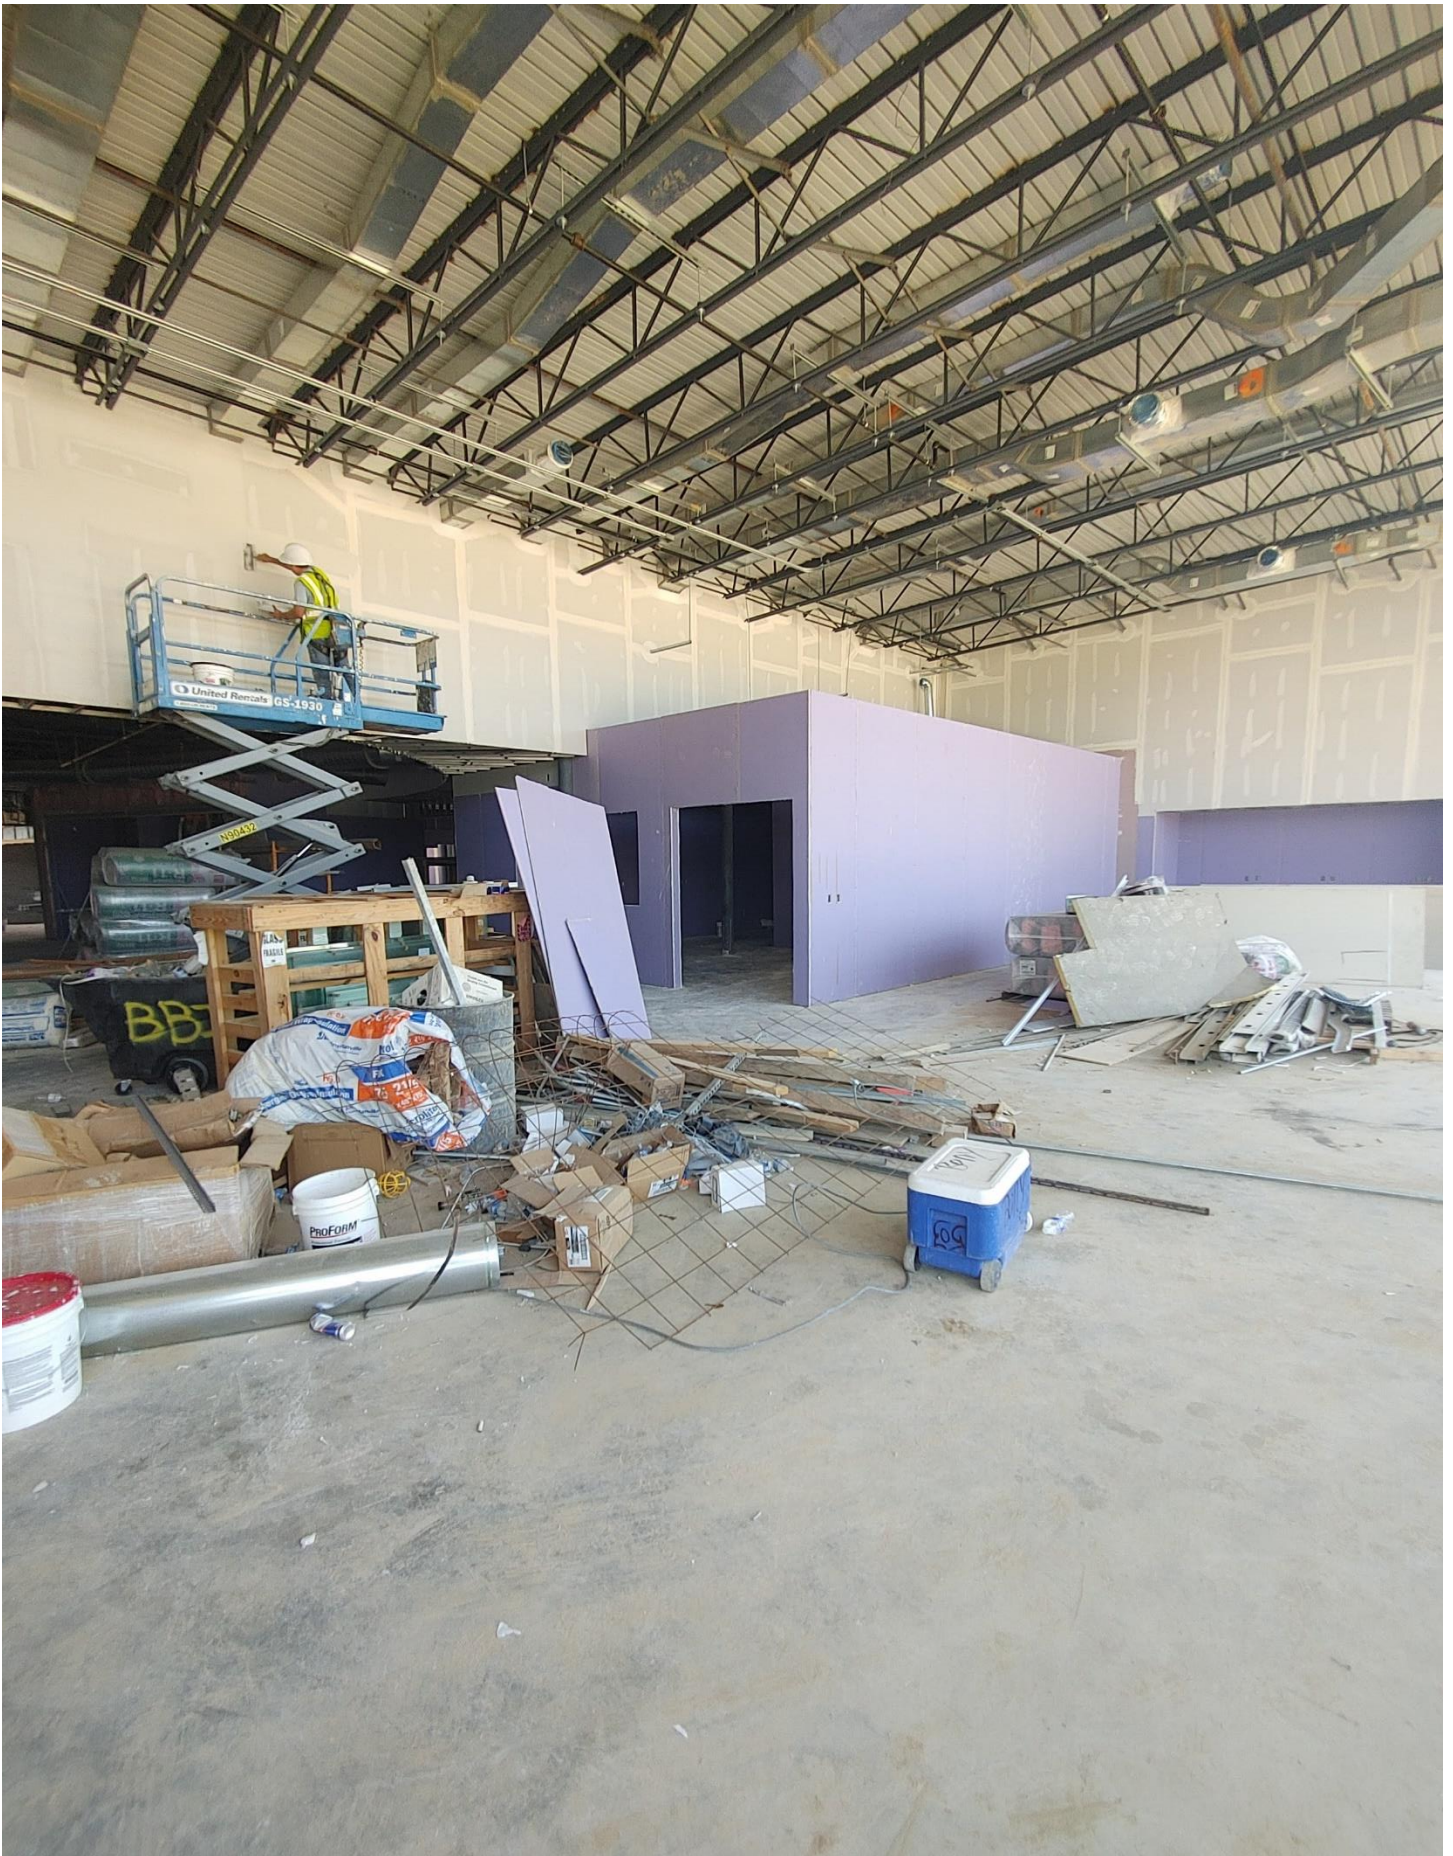
Photo 13 Sheetrock is being finished in Area A

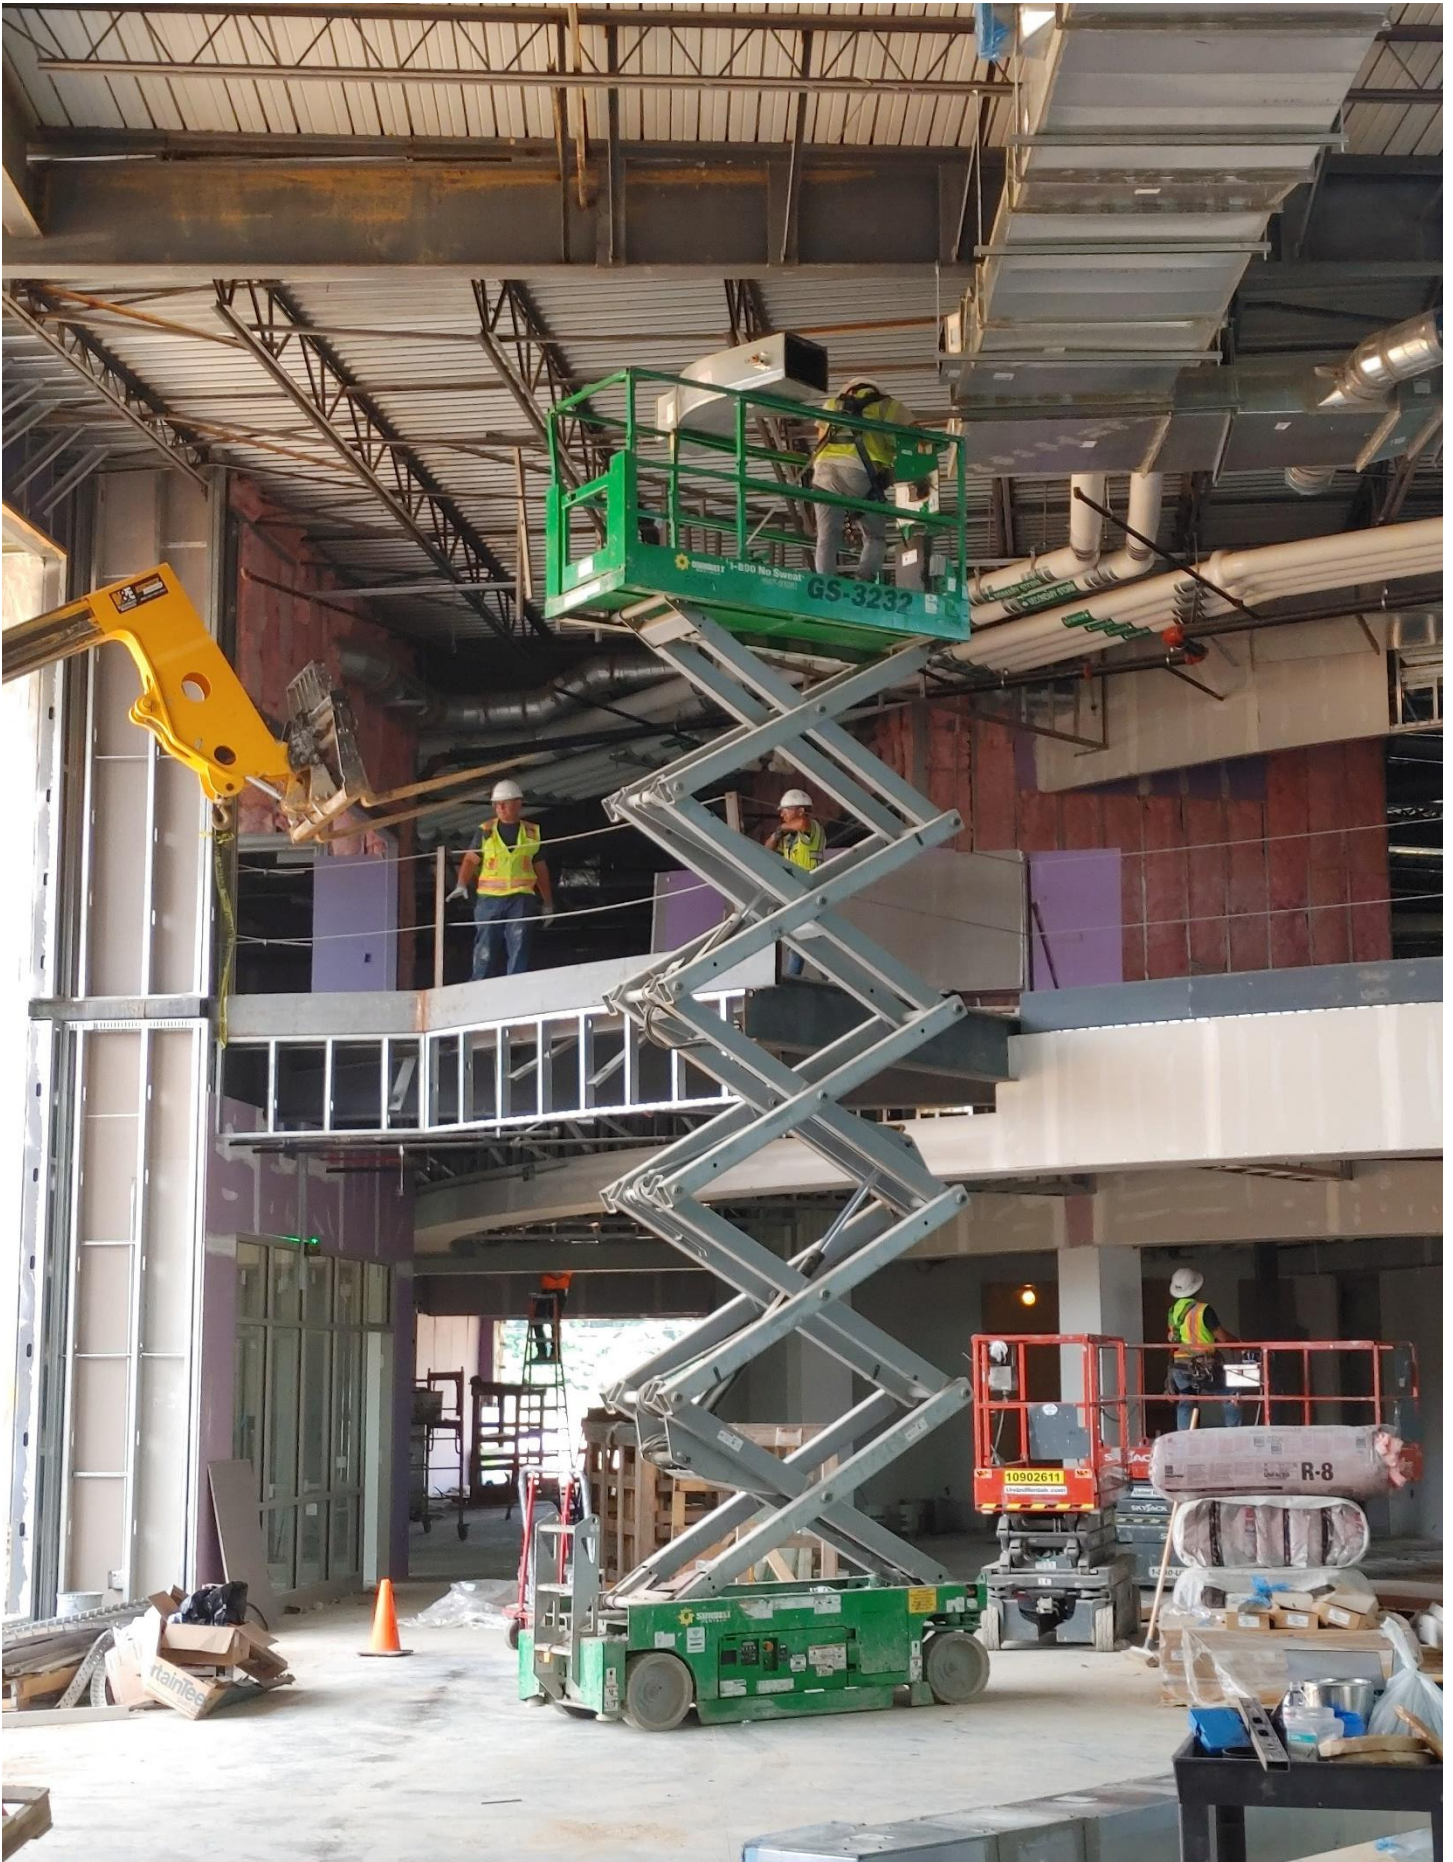
Photo 14 - Ductwork is being installed in Area C

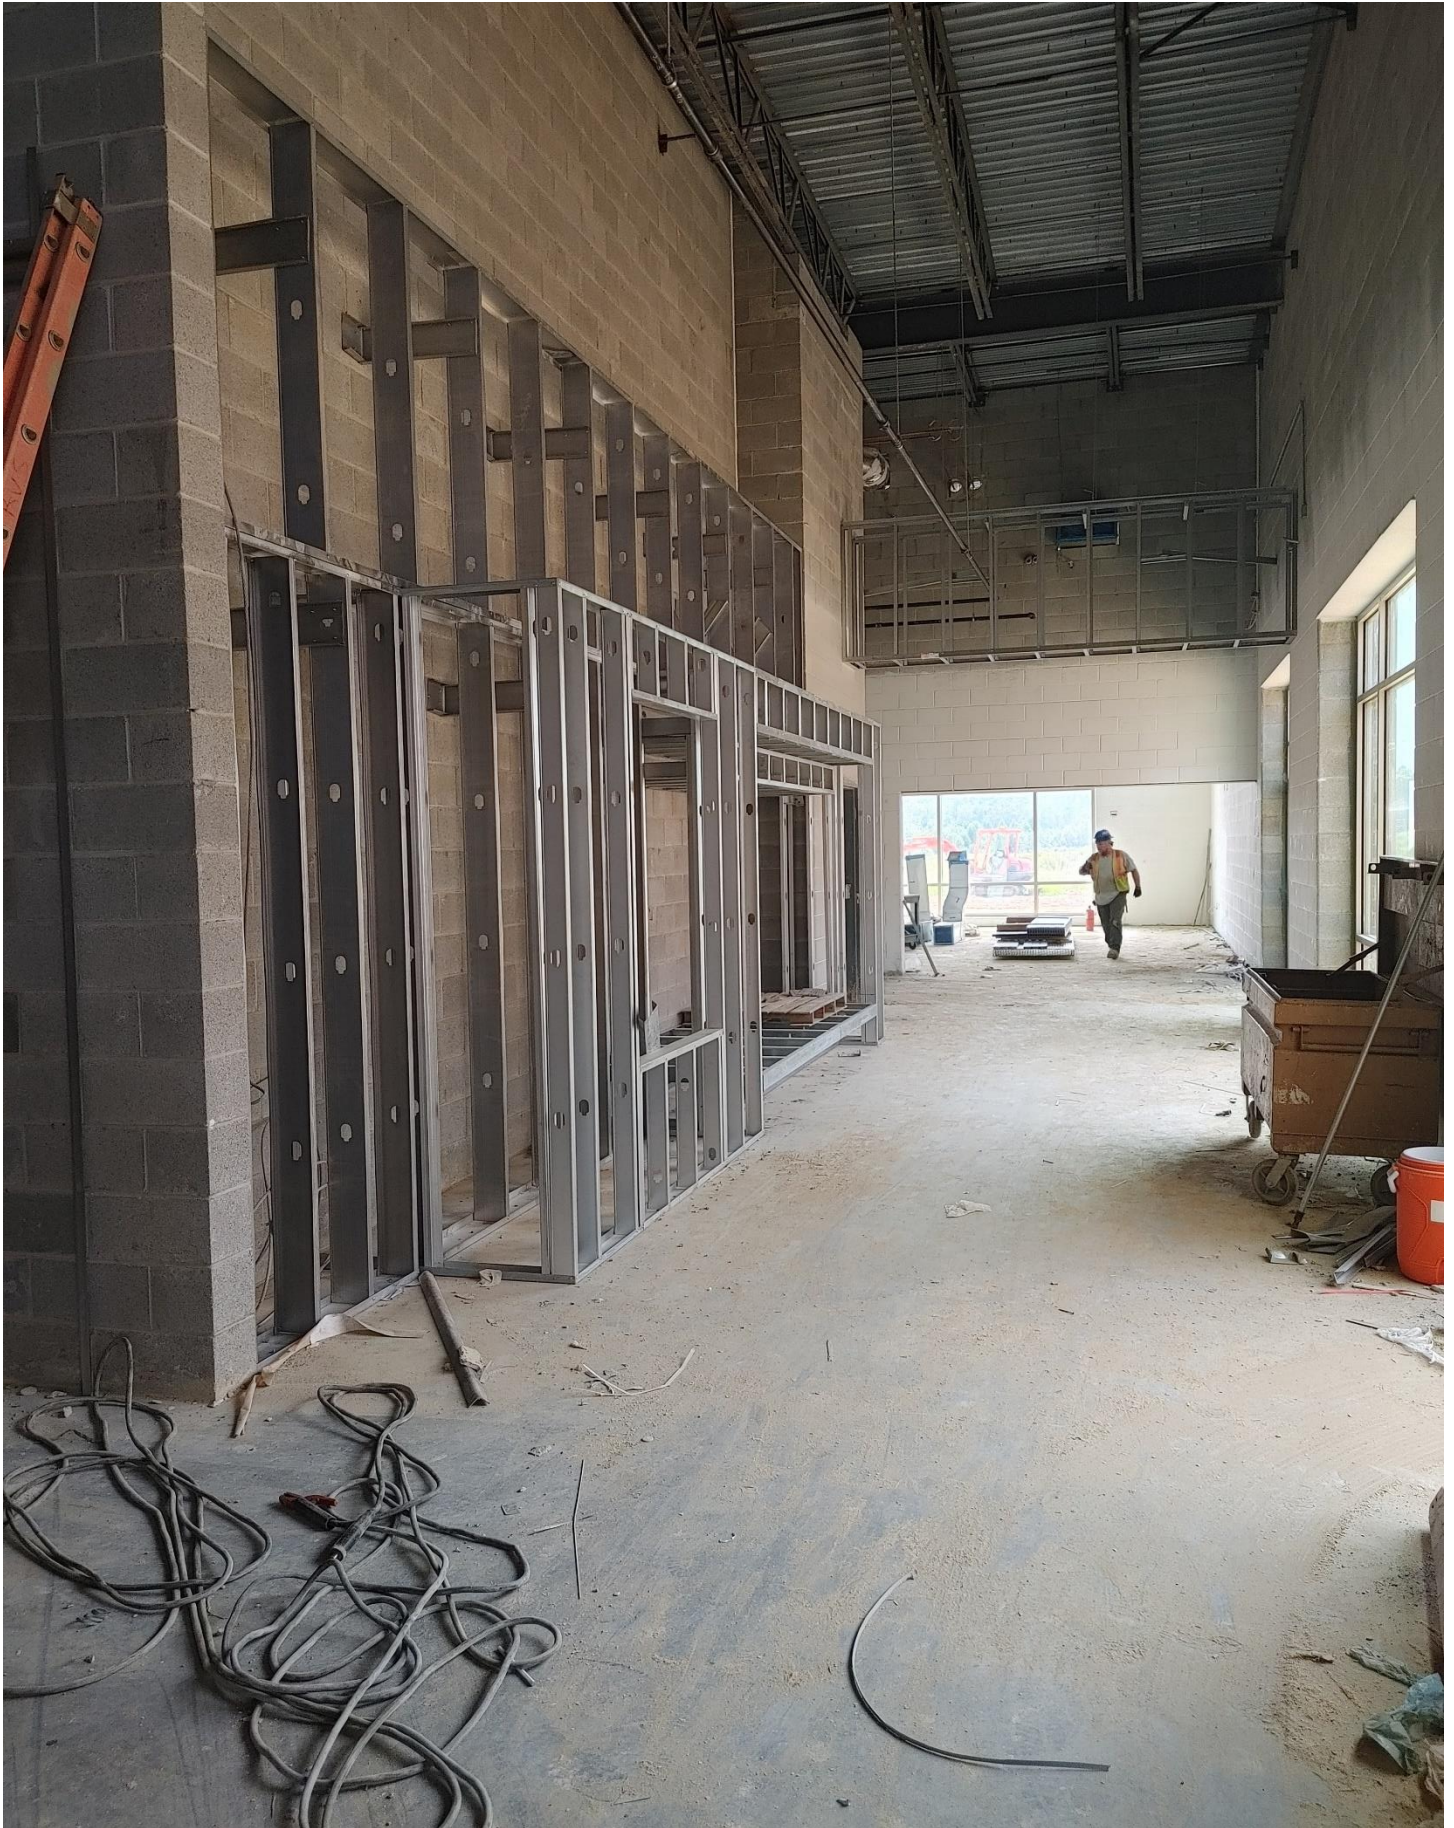
Photo 15 - Walls and Bulkhead have been framed in Area D

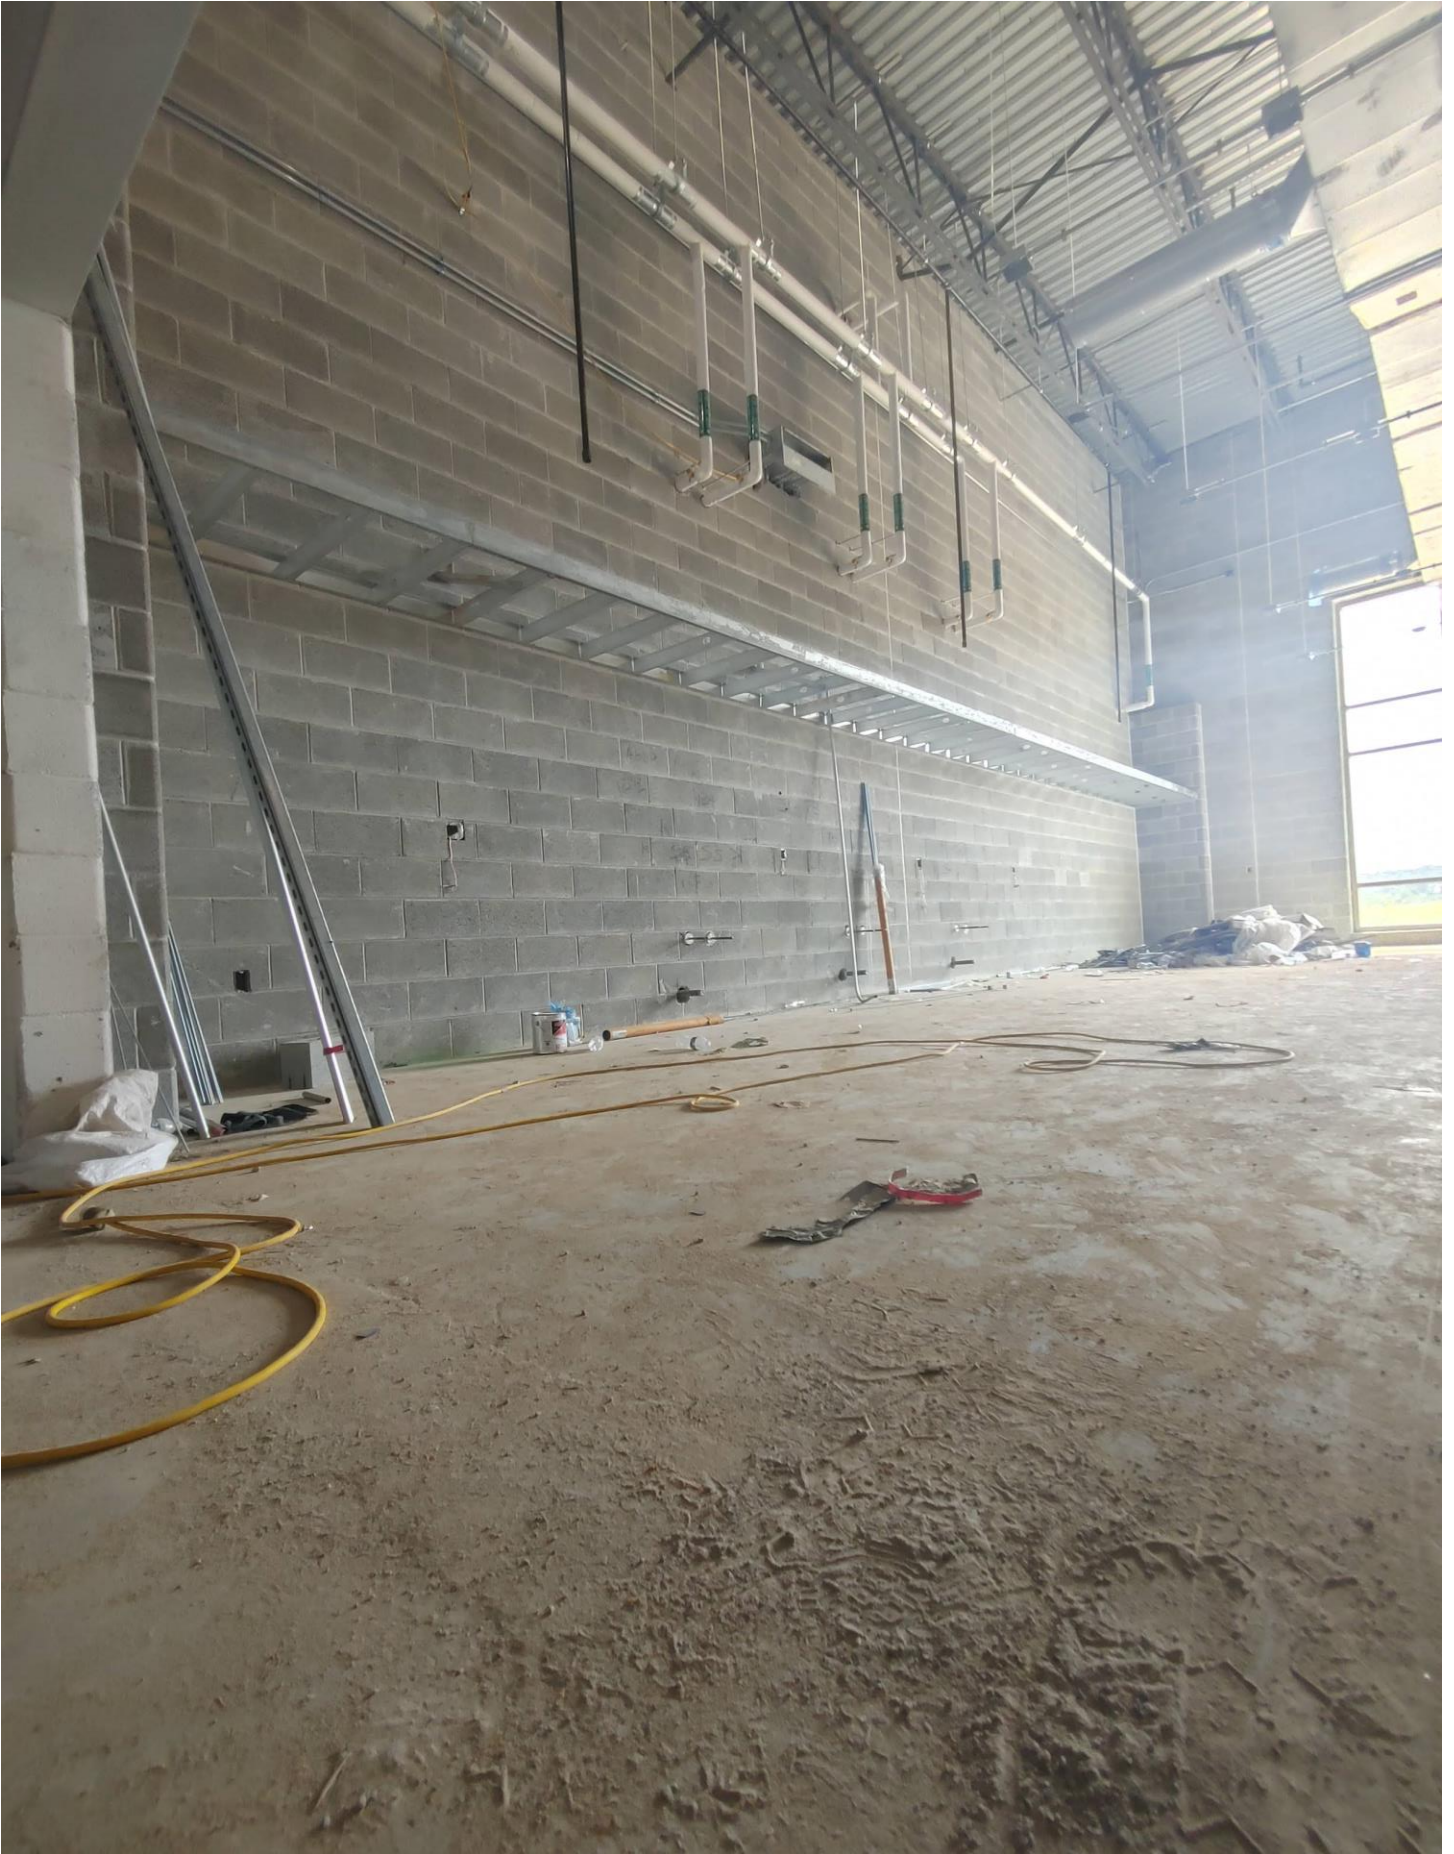
Photo 16 - Ceiling Framing in D121
