## **FIELD REPORT**

## **WESTMORELAND COUNTY HIGH SCHOOL**

Date: 09/15/2021

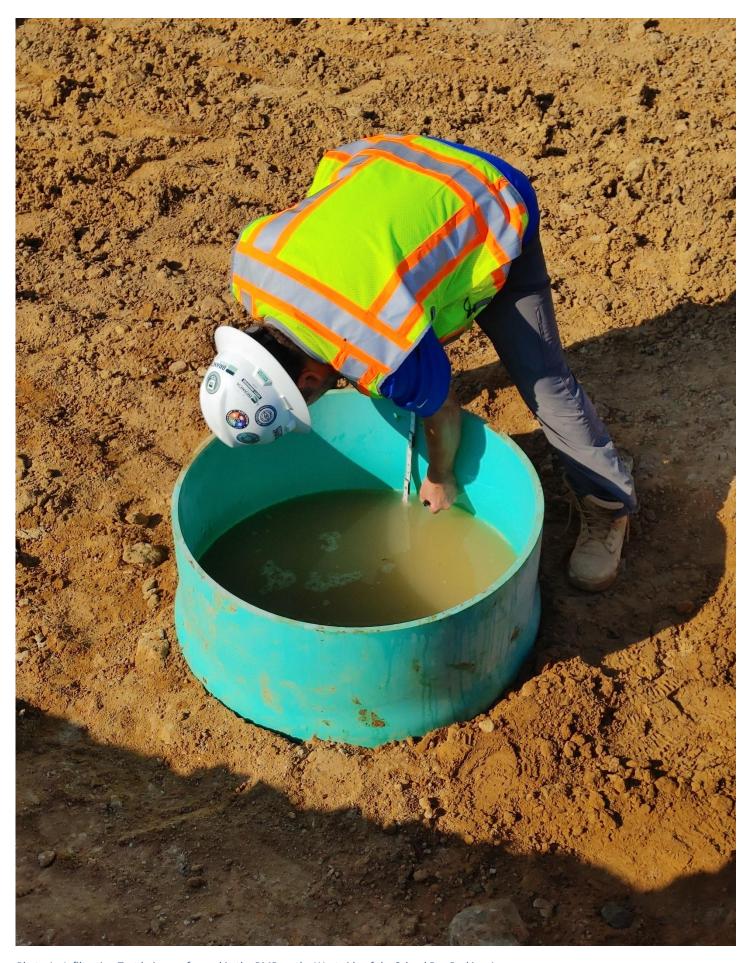
Questions to or from Branch Builds: I arrived this morning and met with Brian Topper and Dean Bunn of Hillis-Carnes at the BMP on the West side of the School Bus Parking Area. Two sections of pipe were set in the BMP to conduct a Infiltration Test. Water was poured into the pipe and measured after one hour. Both tests pasted the requirement of water drainage of a minimum of 1" per hour. After the Progress meeting I returned to the site and noted that Beuchert had almost completed the installation of 12" of 57 stone.

Photo 1 - Infiltration Test being performed in the BMP on the West side of the School Bus Parking Area

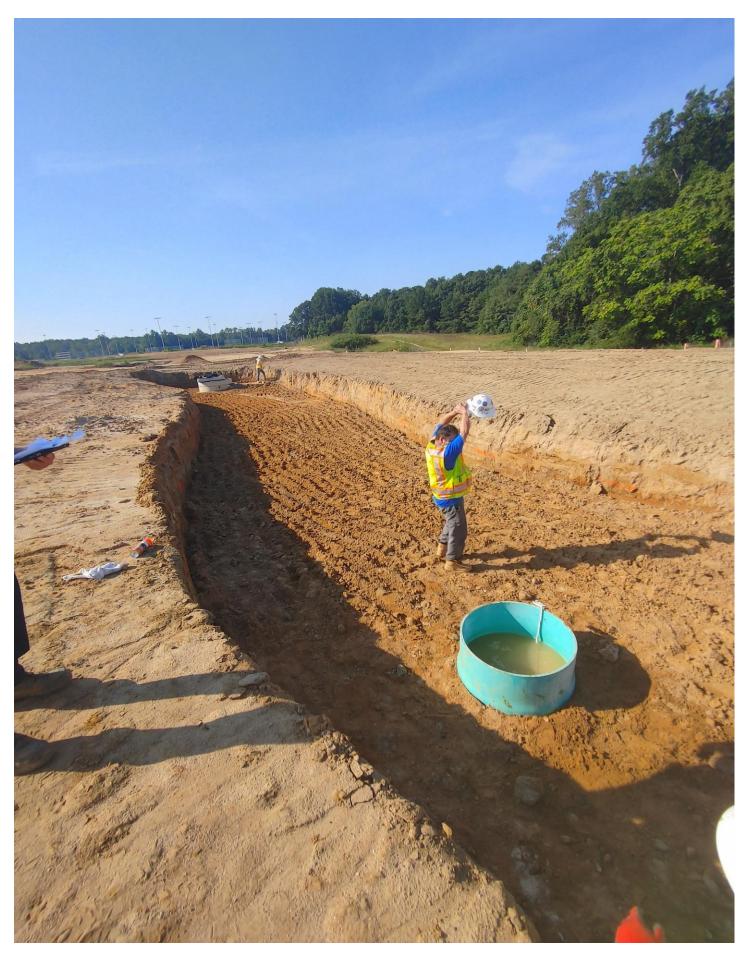
Photo 2 - The BMP on the West side of the Site is being constructed

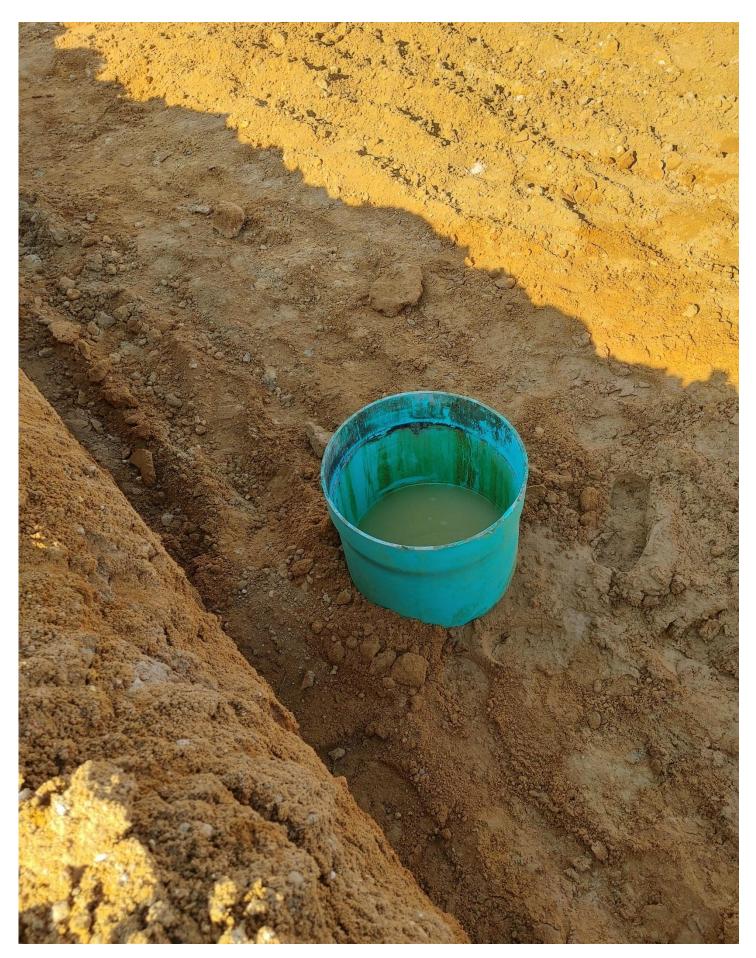
Photo 3 - 2nd Infiltration Test being conducted in the BMP on the West side of the site.

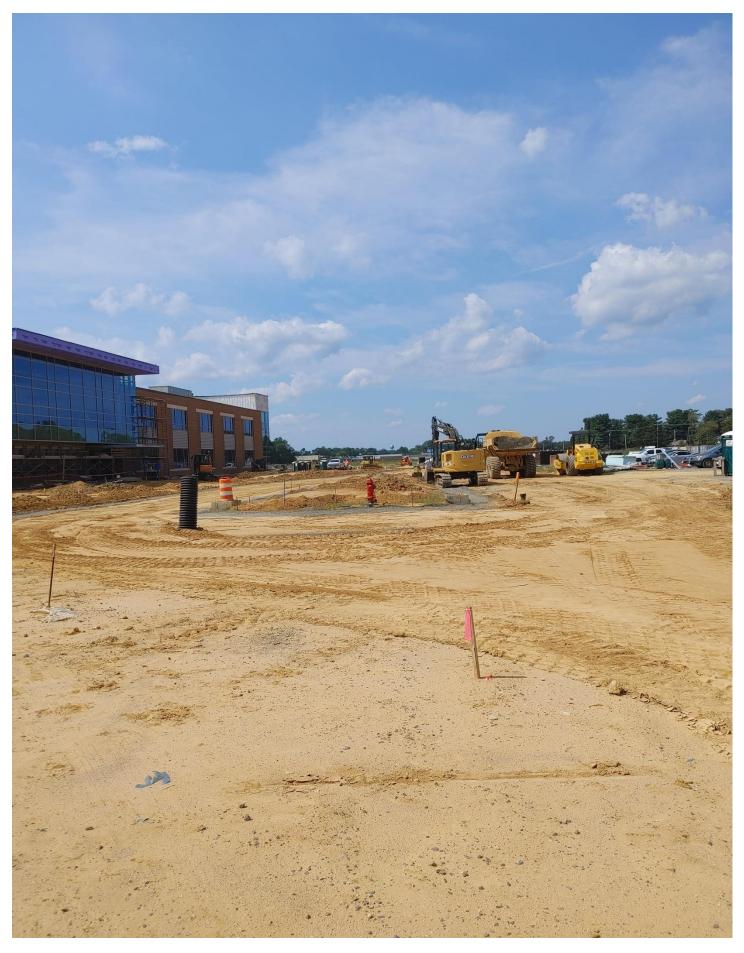
Photo 4 - Drive Lanes in front of the school have been laid out and are being graded

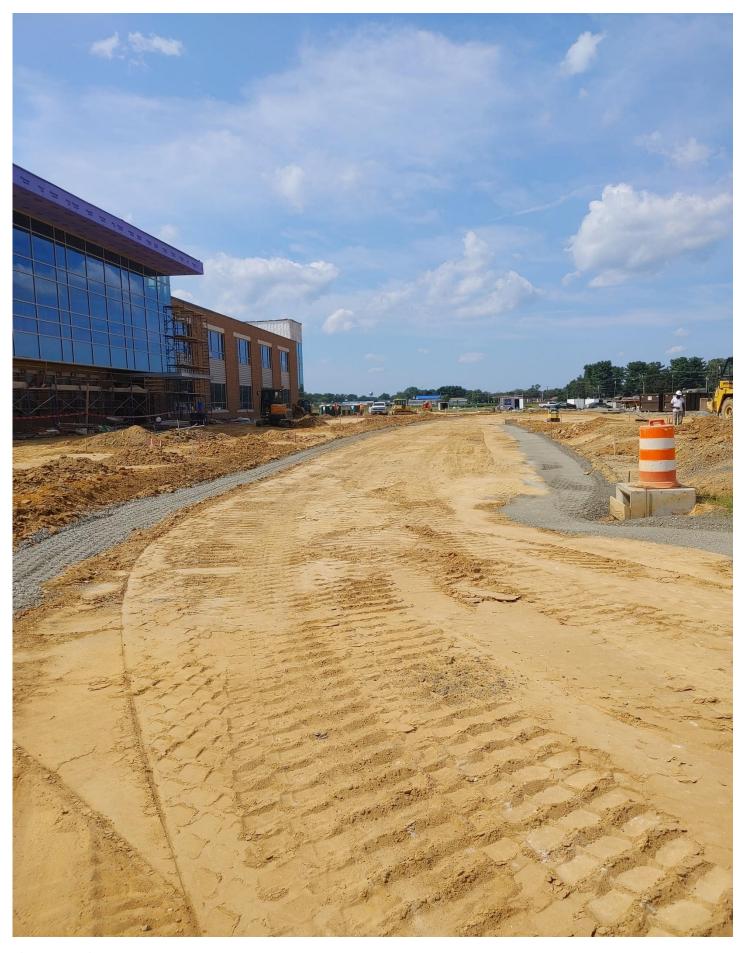
Photo 5 - Drive lane

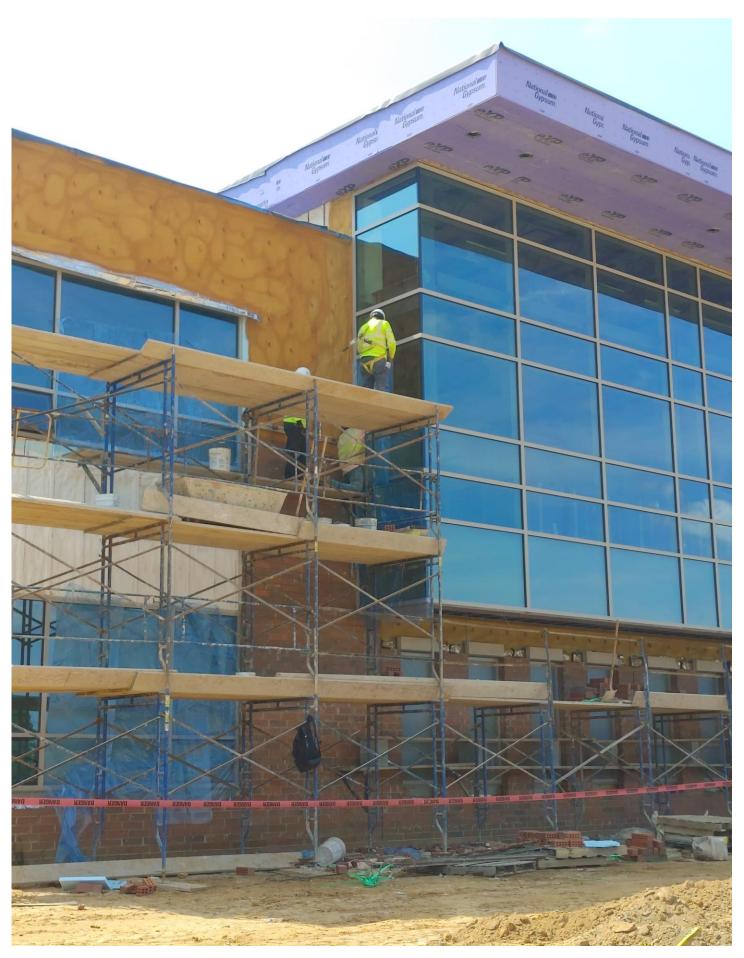
Photo 6 - Steps are being taken to protect the Curtain wall as the mason lays brick.

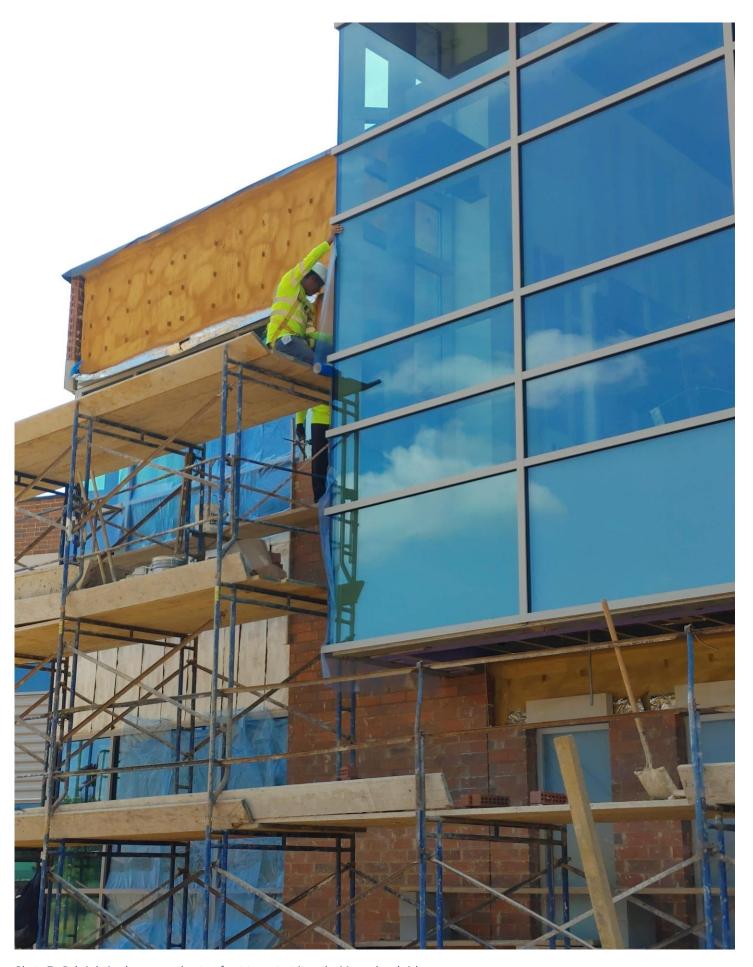
Photo 7 - Poly is being hung over the storefront to protect it as the Mason lays brick.

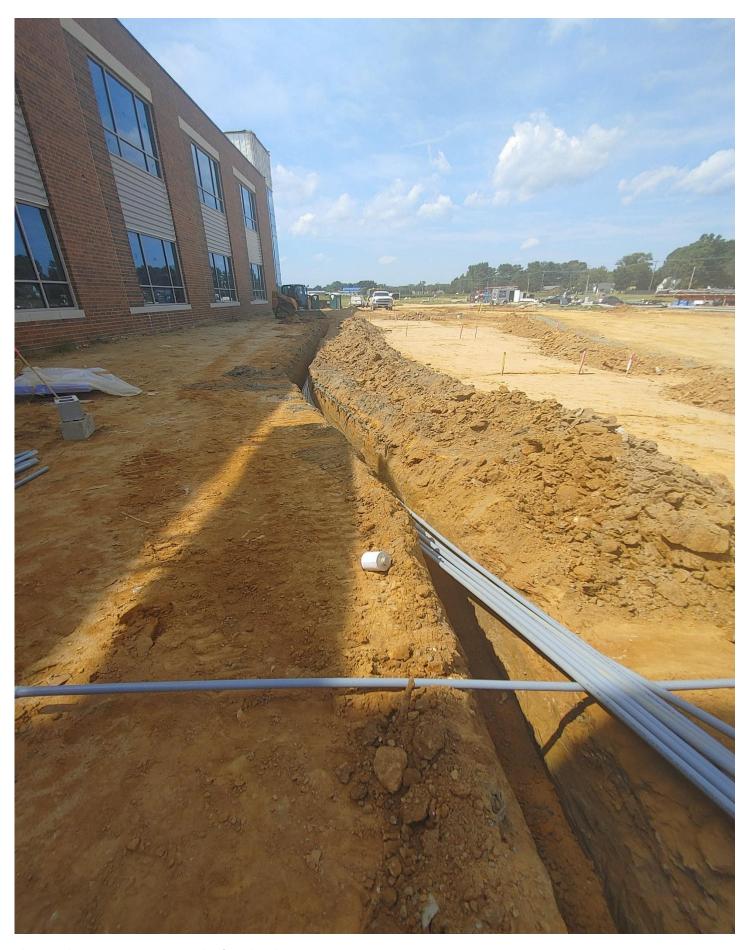
Photo 8 - The masons are running conduit for Pole Lights

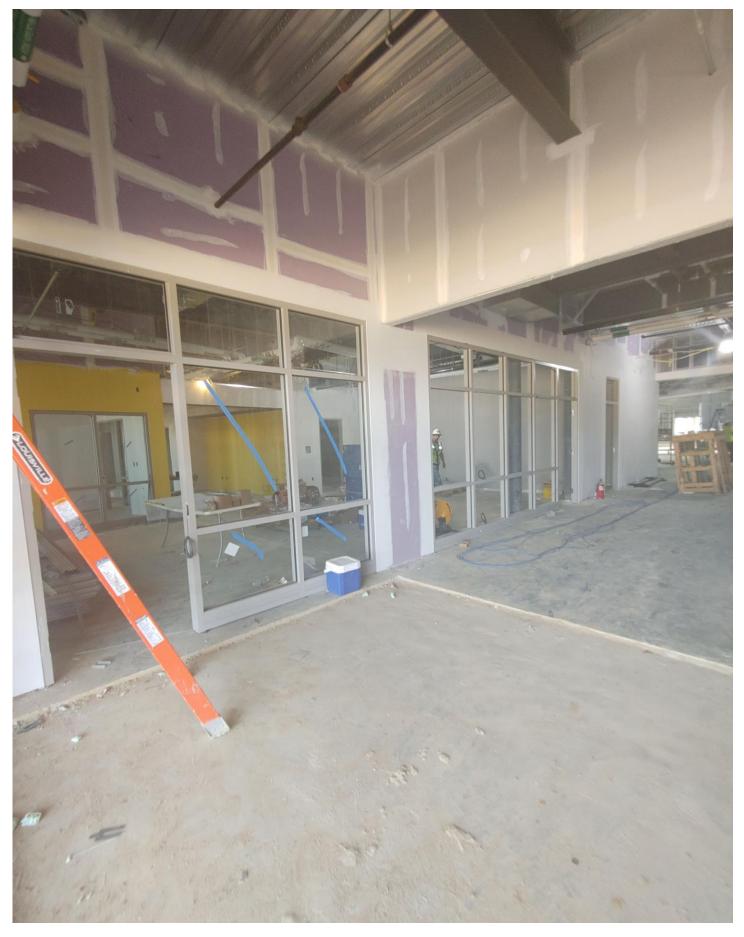
Photo 9 - SF #32A & #33 have been installed

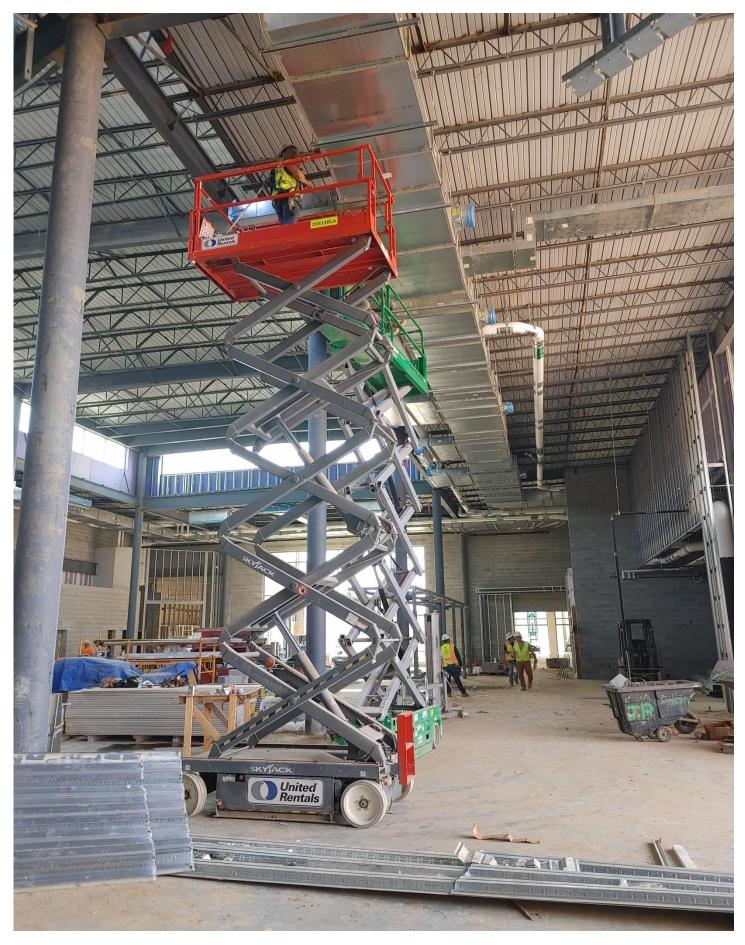
Photo 10 - Duct work is being installed in Area C.

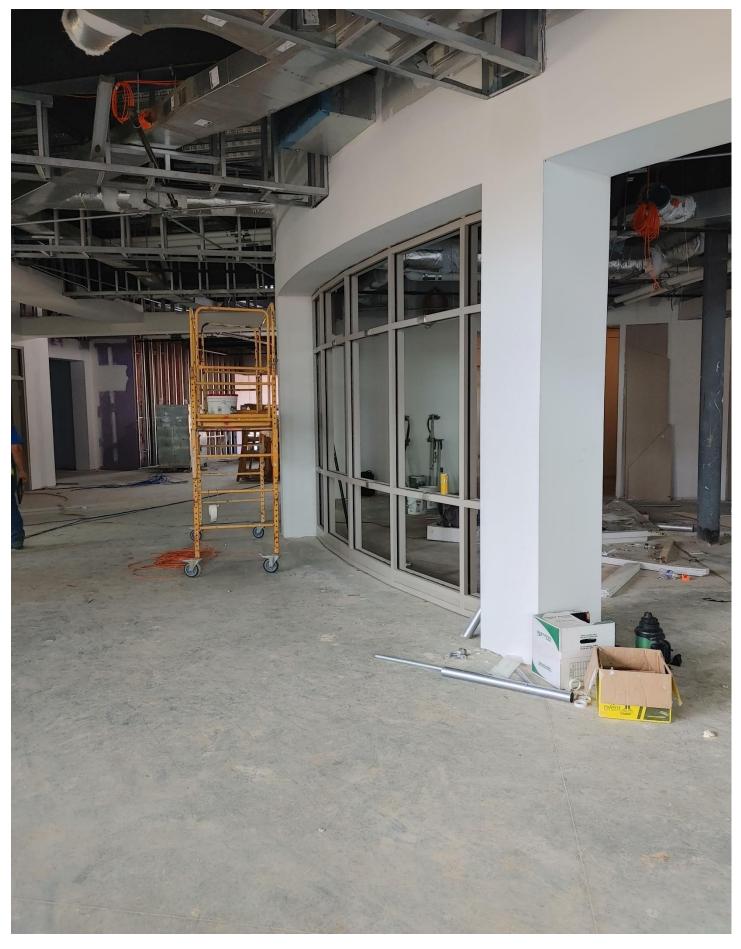
Photo 11 - SF #35 has been installed

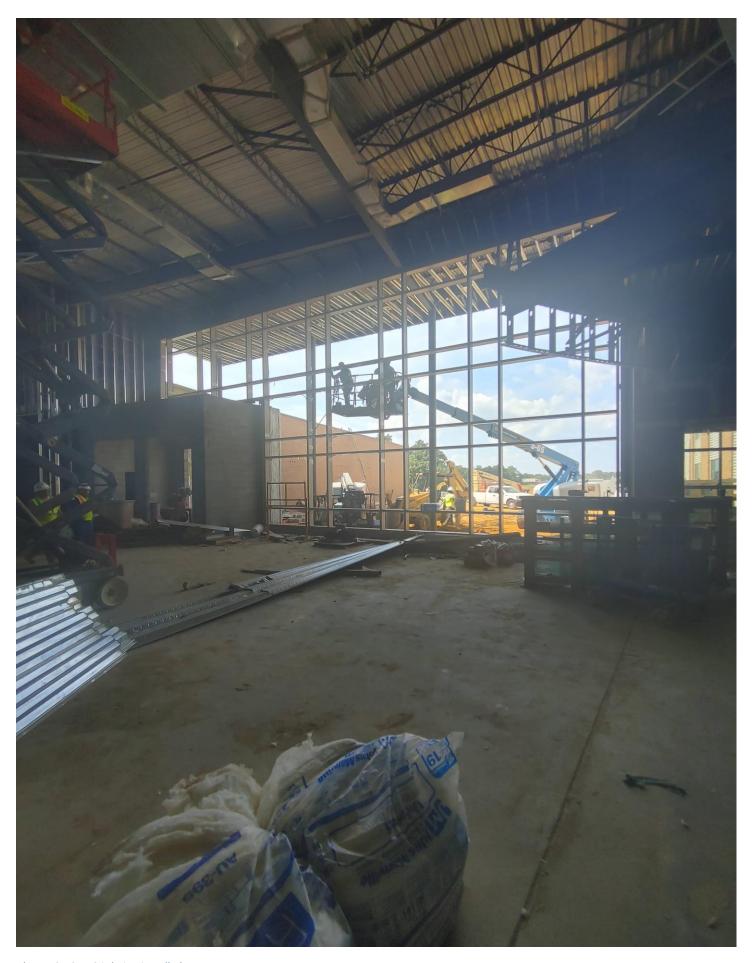
Photo 12 - CW#2 is being installed

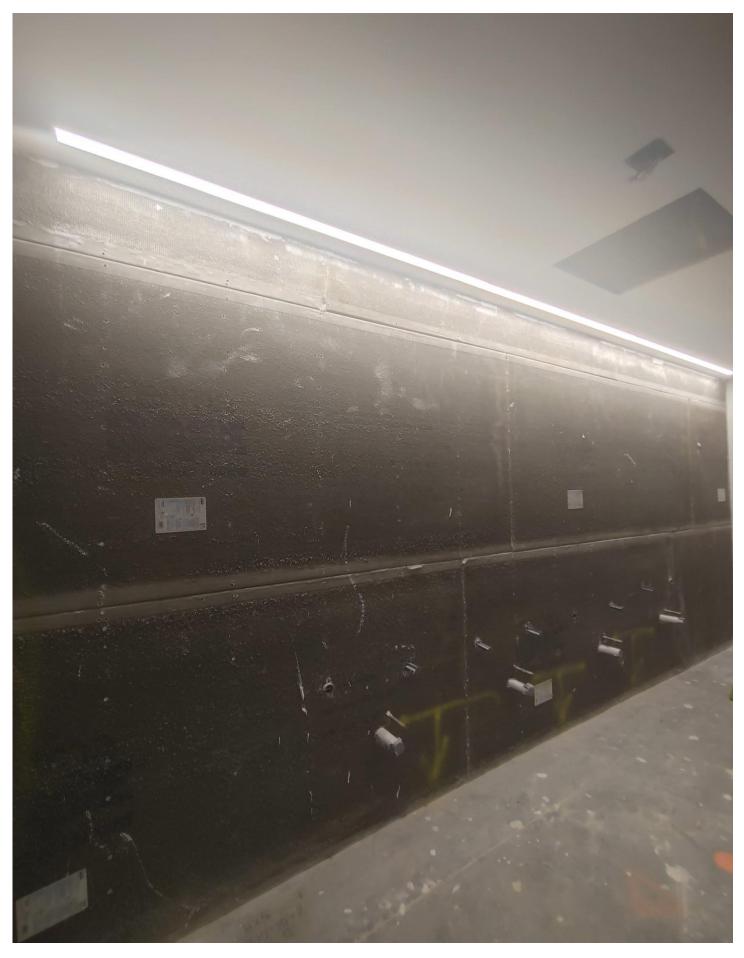
Photo 13 - Lighting has been installed in A118

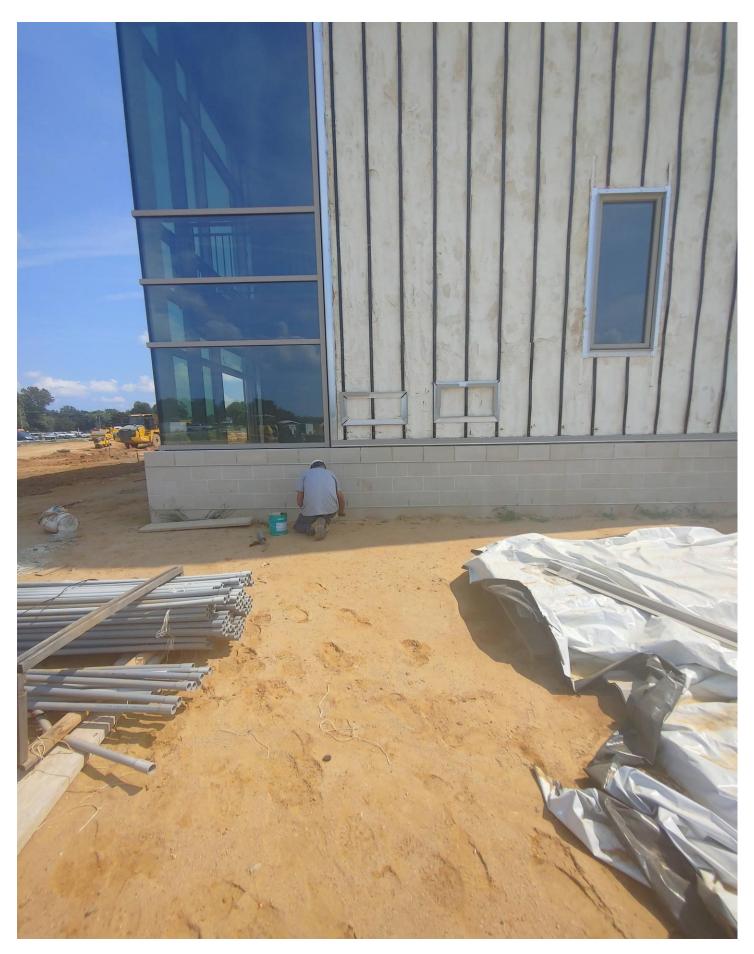
Photo 14 – Exterior Control Joints are being Caulked in Area B

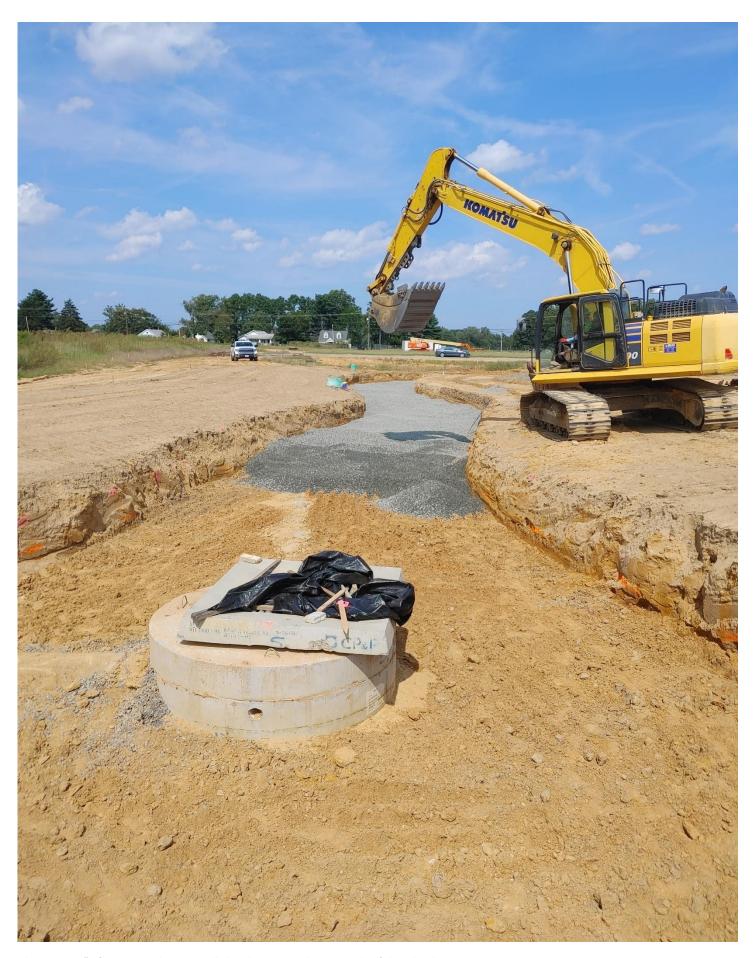
Photo 15 - 12" of 57 Stone is being installed in the BMP on the West side of the School.

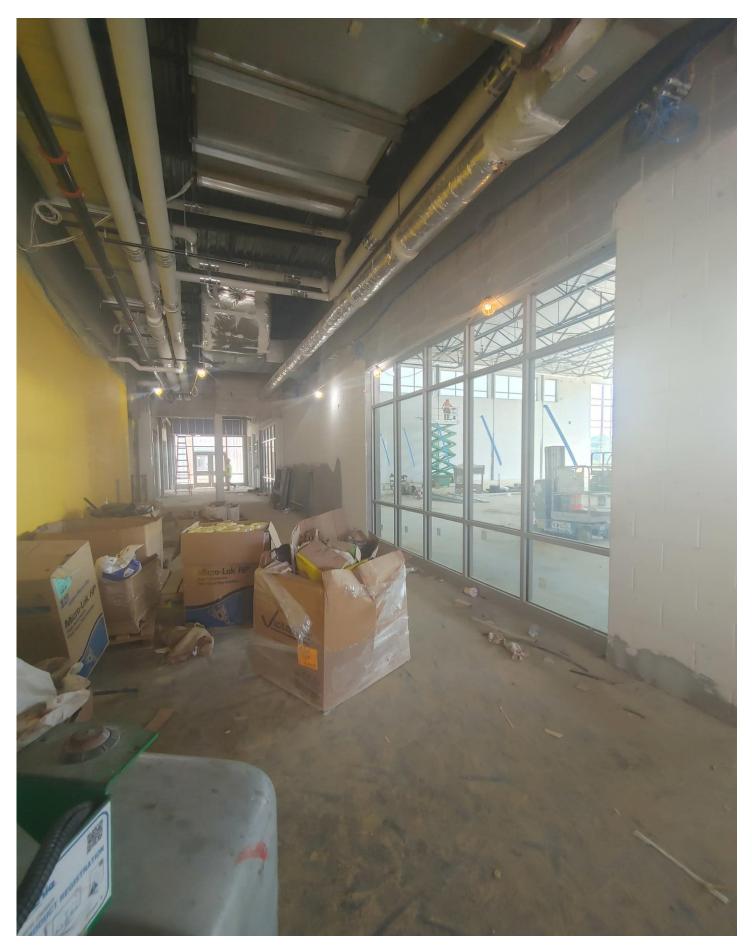
Photo 16 - SF #47 has been installed

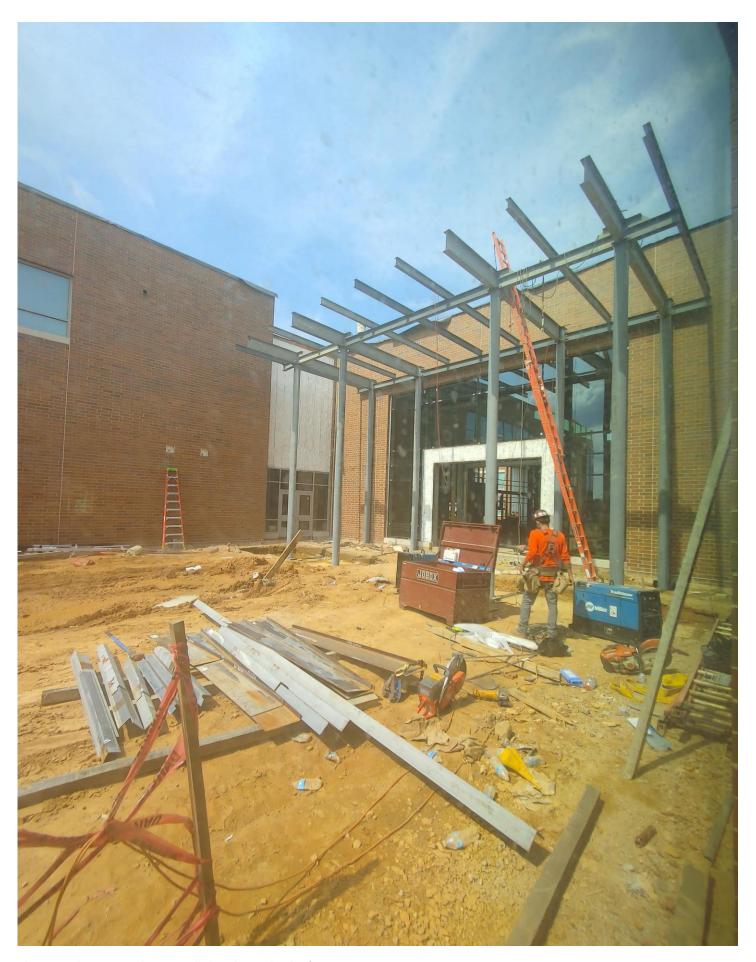
Photo 17 - The Canopy is being Installed on the South side of Area C

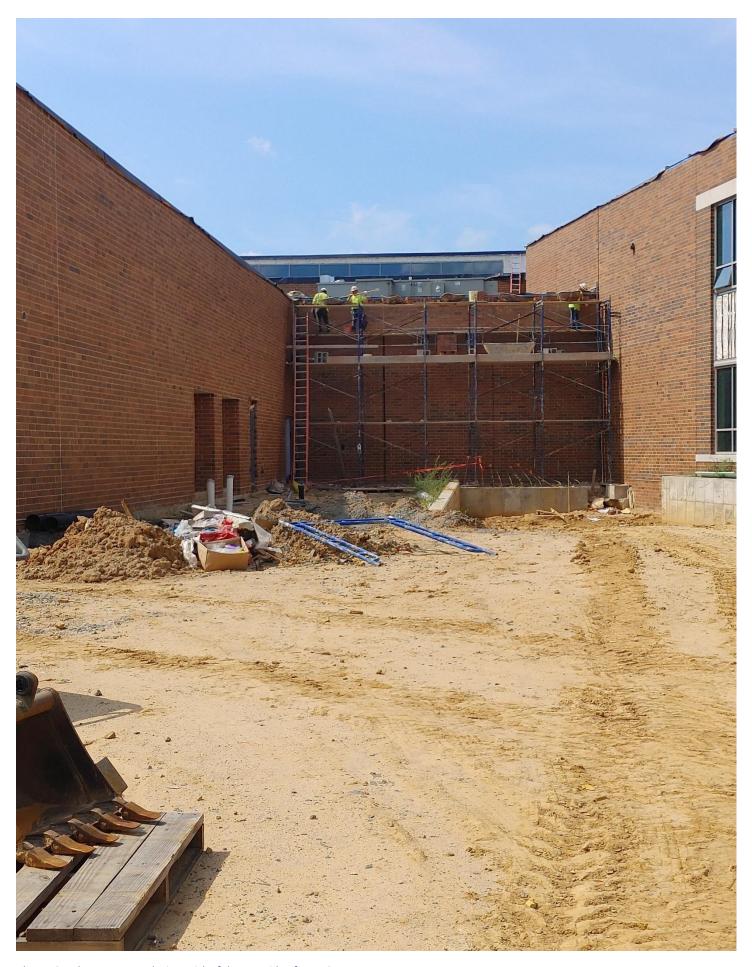
Photo 18 – The Masons are laying Brick of the East side of Area C.
