**COMMONWEALTH
BUILDING SOLUTIONS, LLC**

FIELD REPORT

WESTMORELAND COUNTY HIGH SCHOOL

Date: 09/22/2021

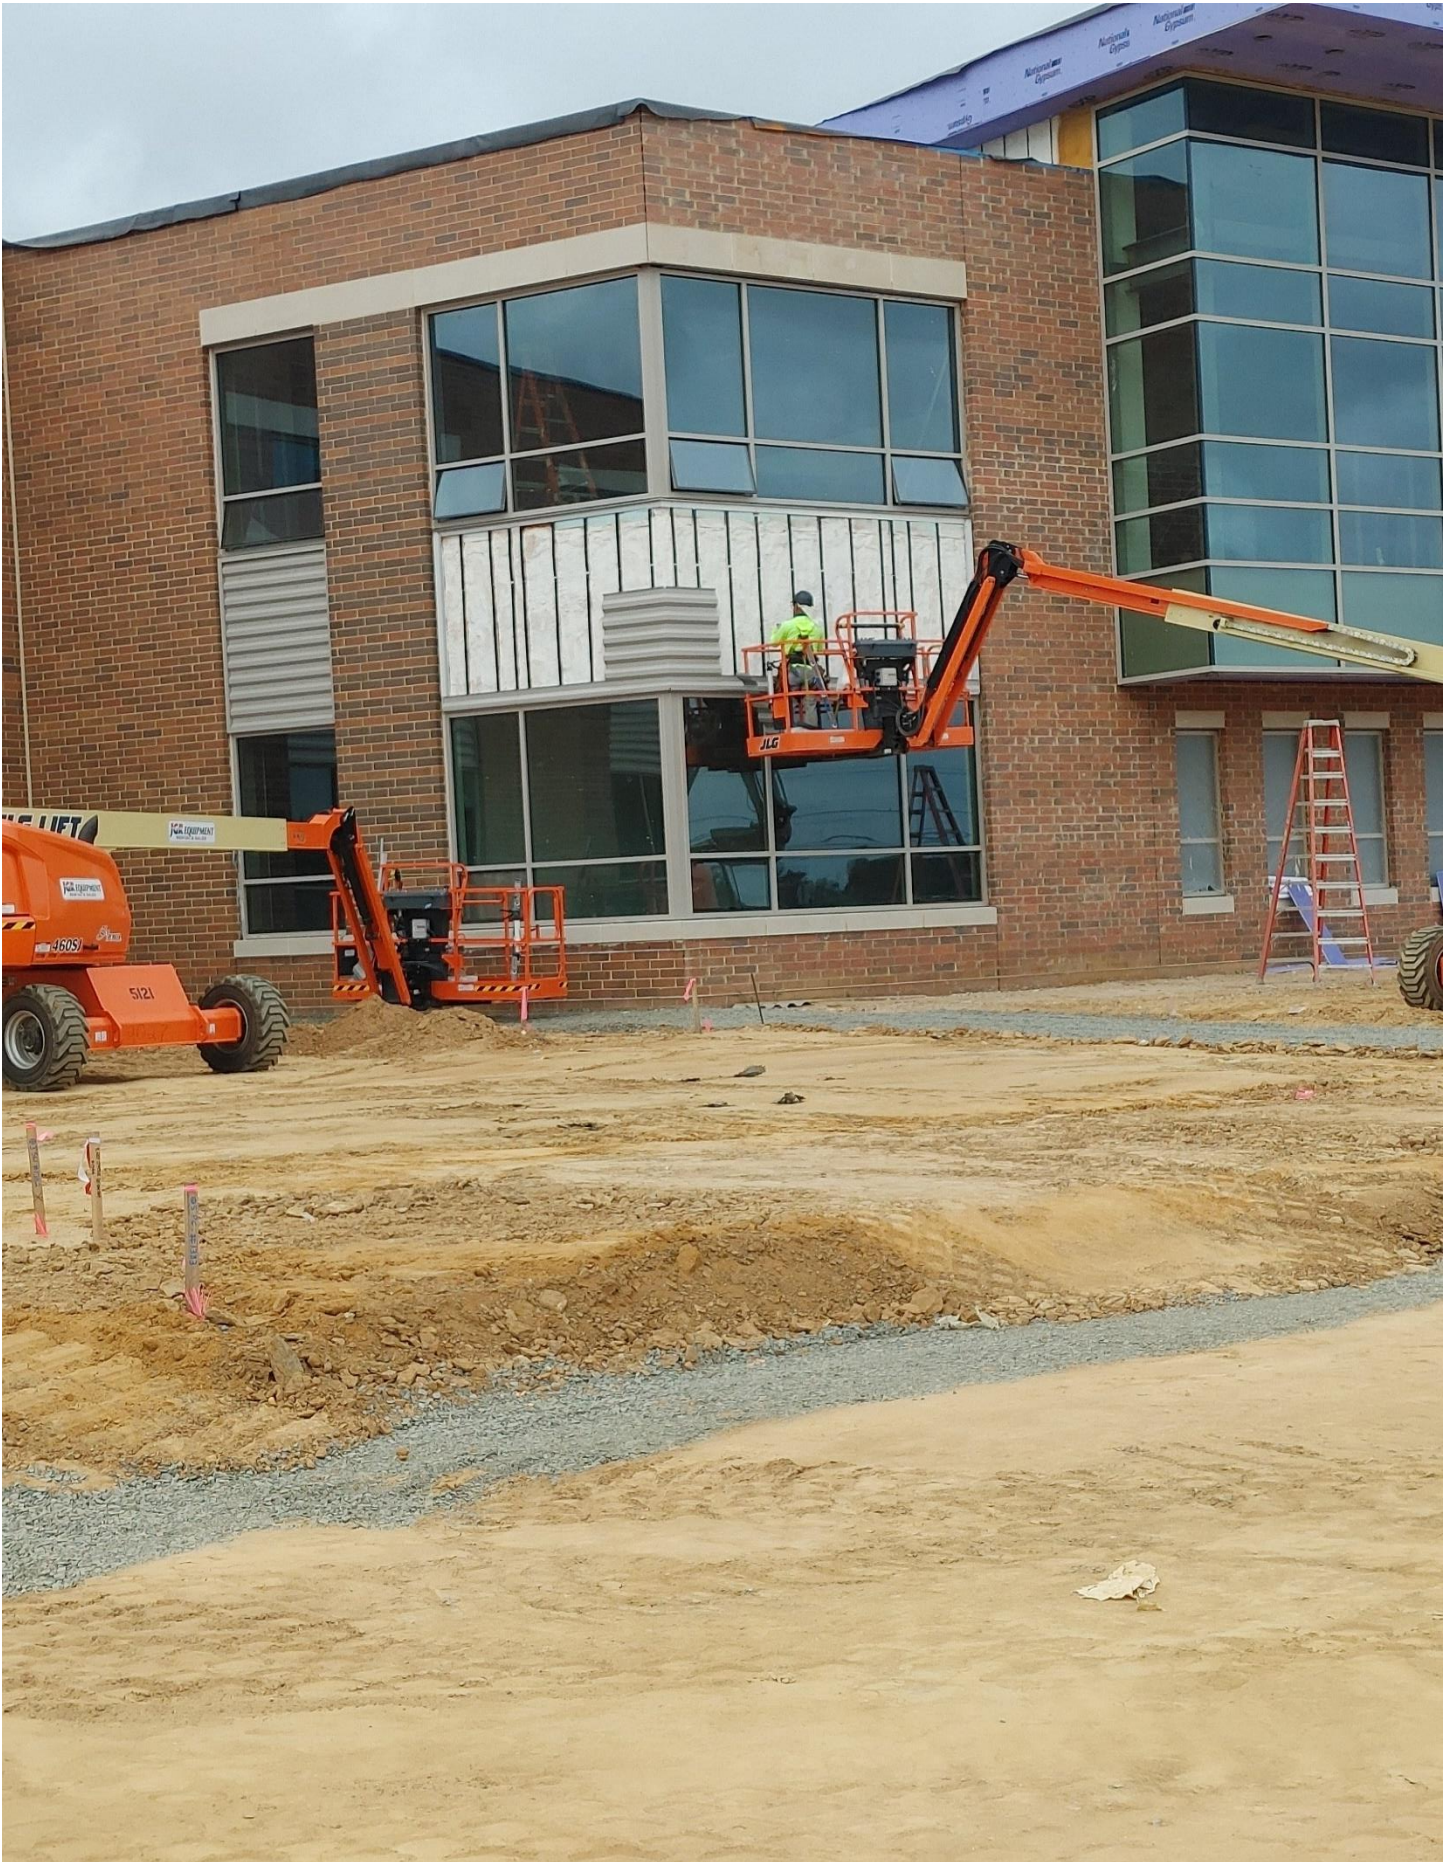
Photo 1 - Metal Panels are being installed on the North side of Area A

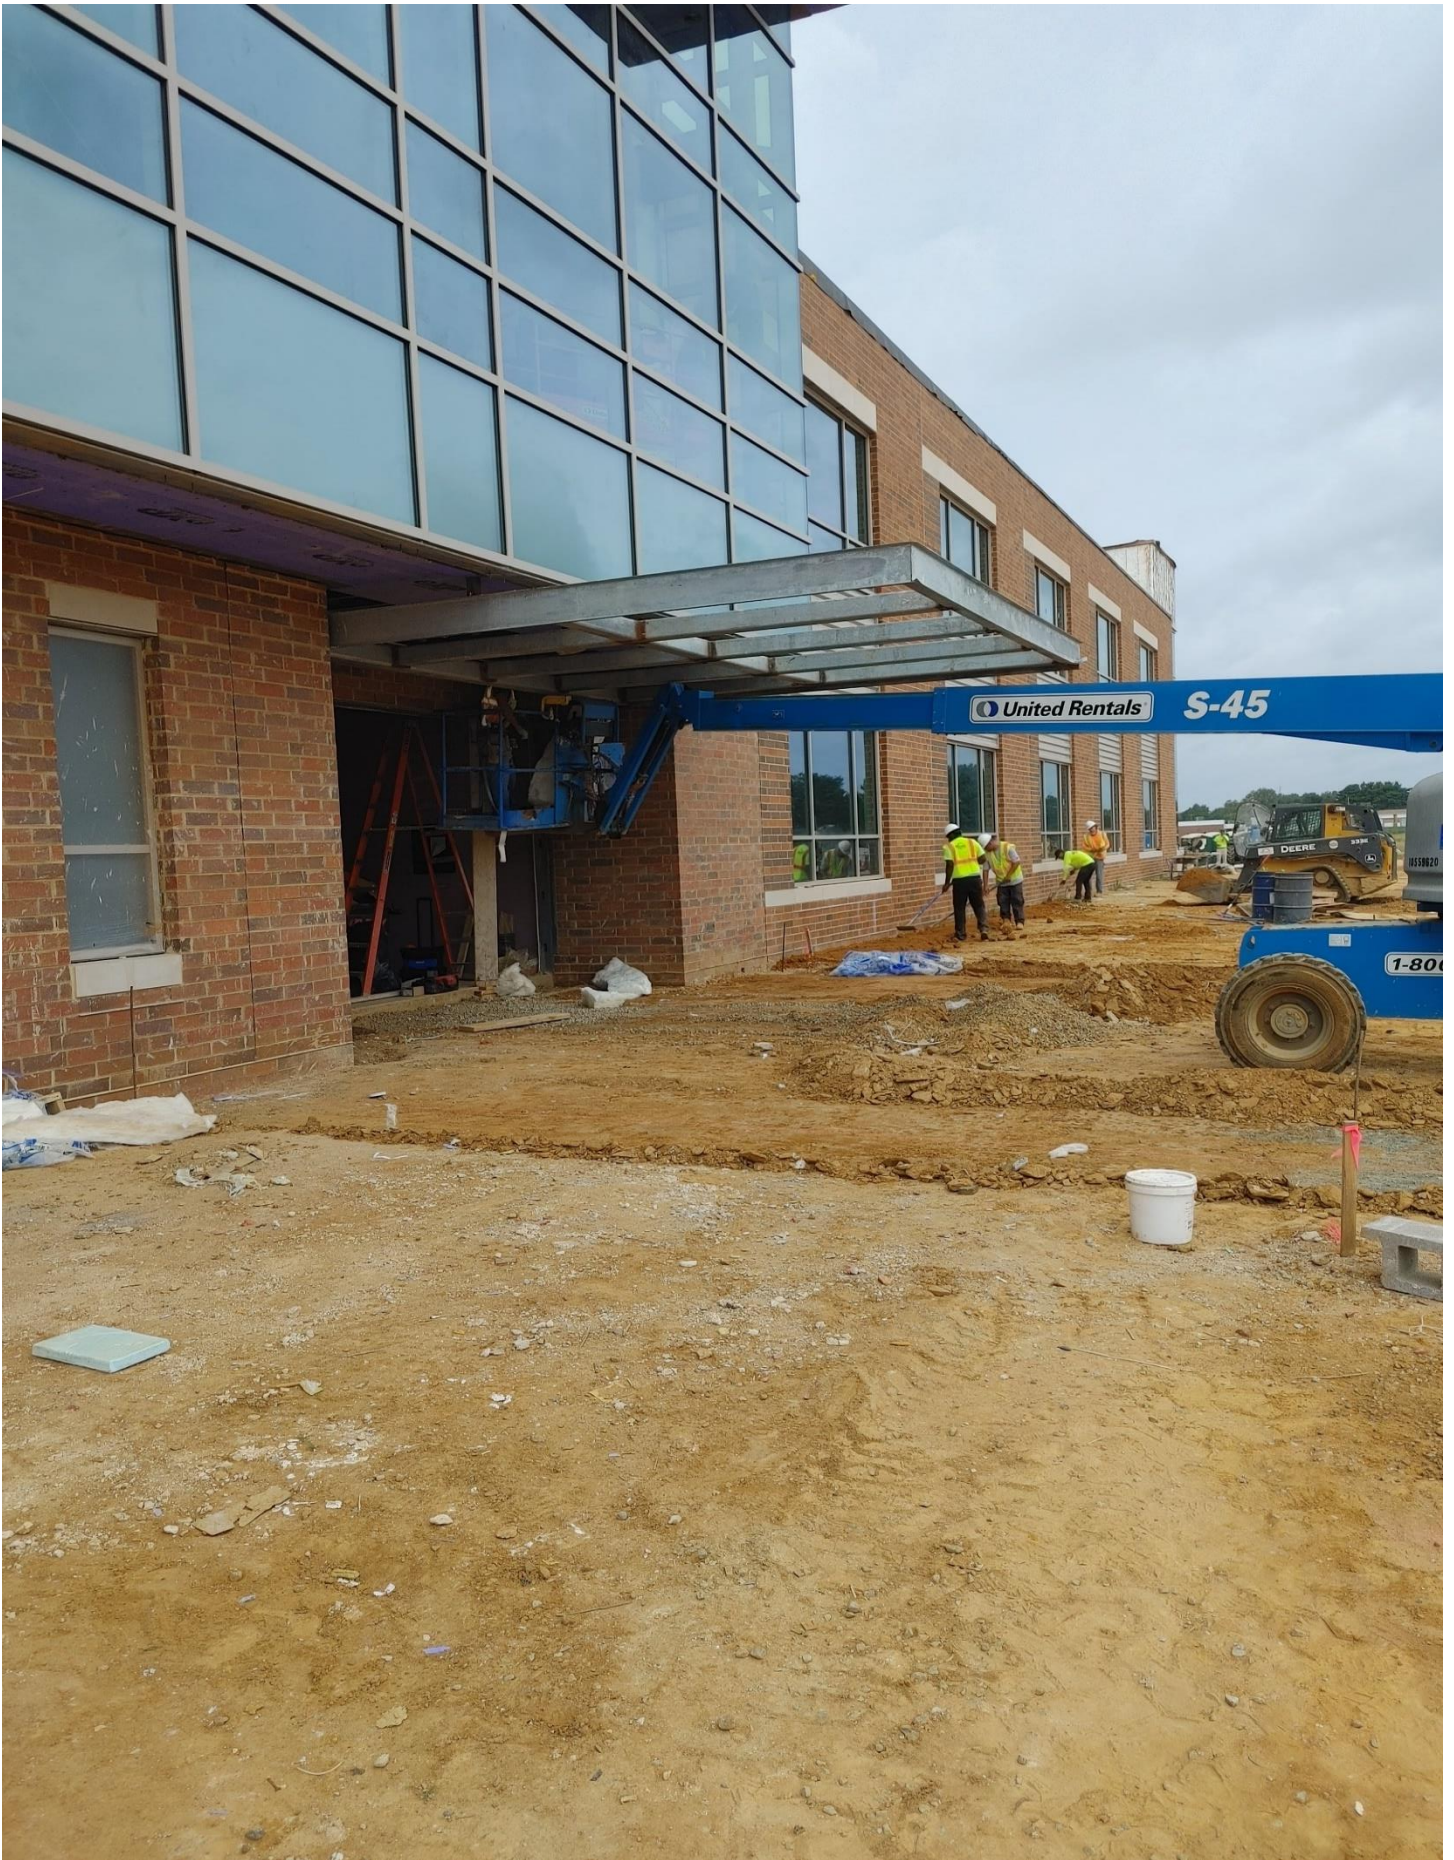
Photo 2 - Insulation is being installed in the Entrance area on the Northside of Area A.

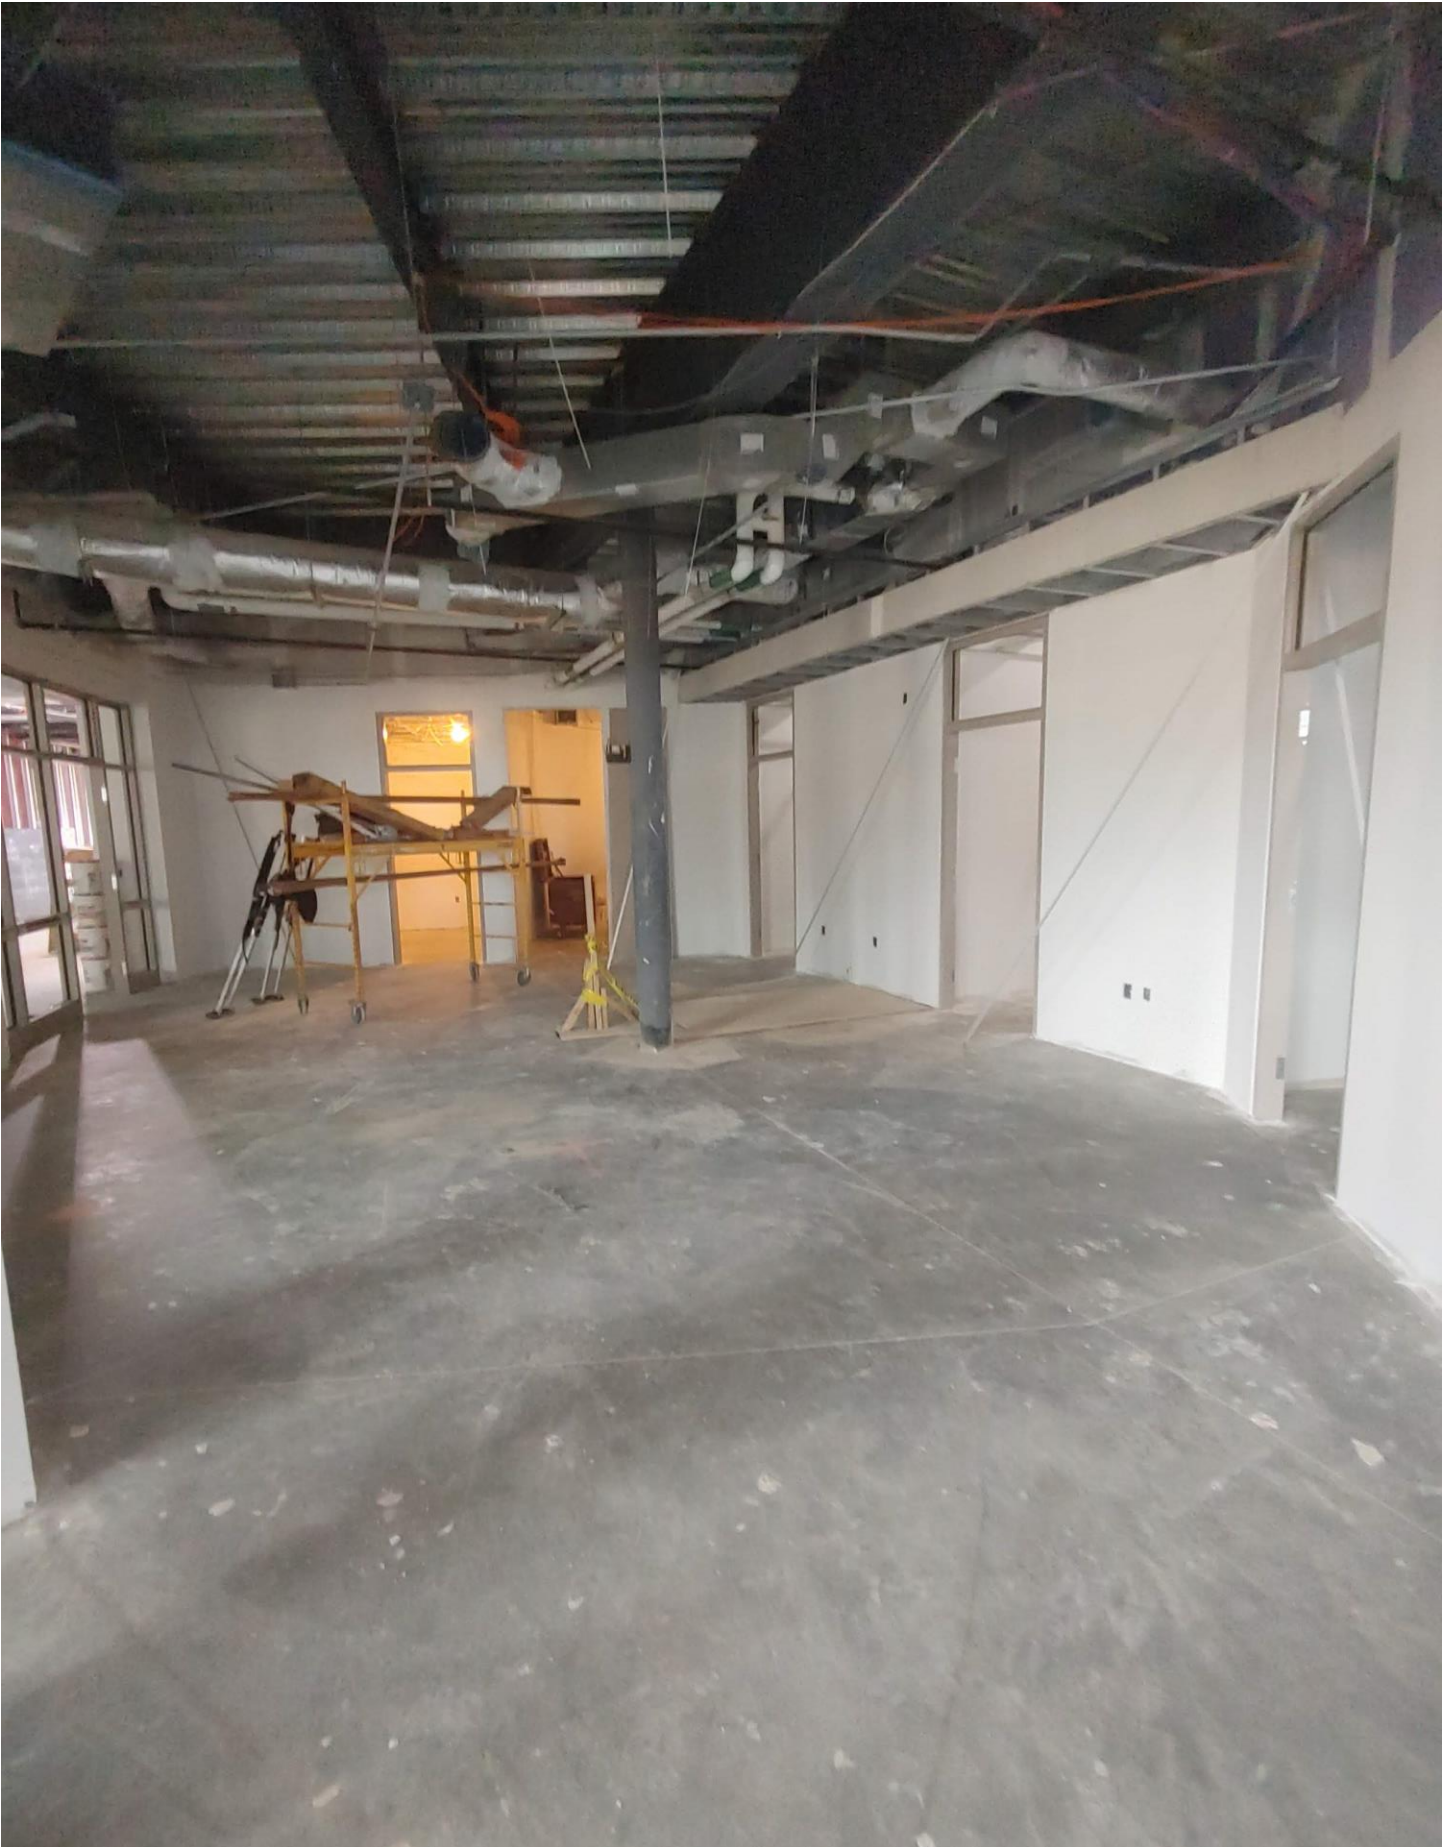
Photo 3 - Frames have been installed A134

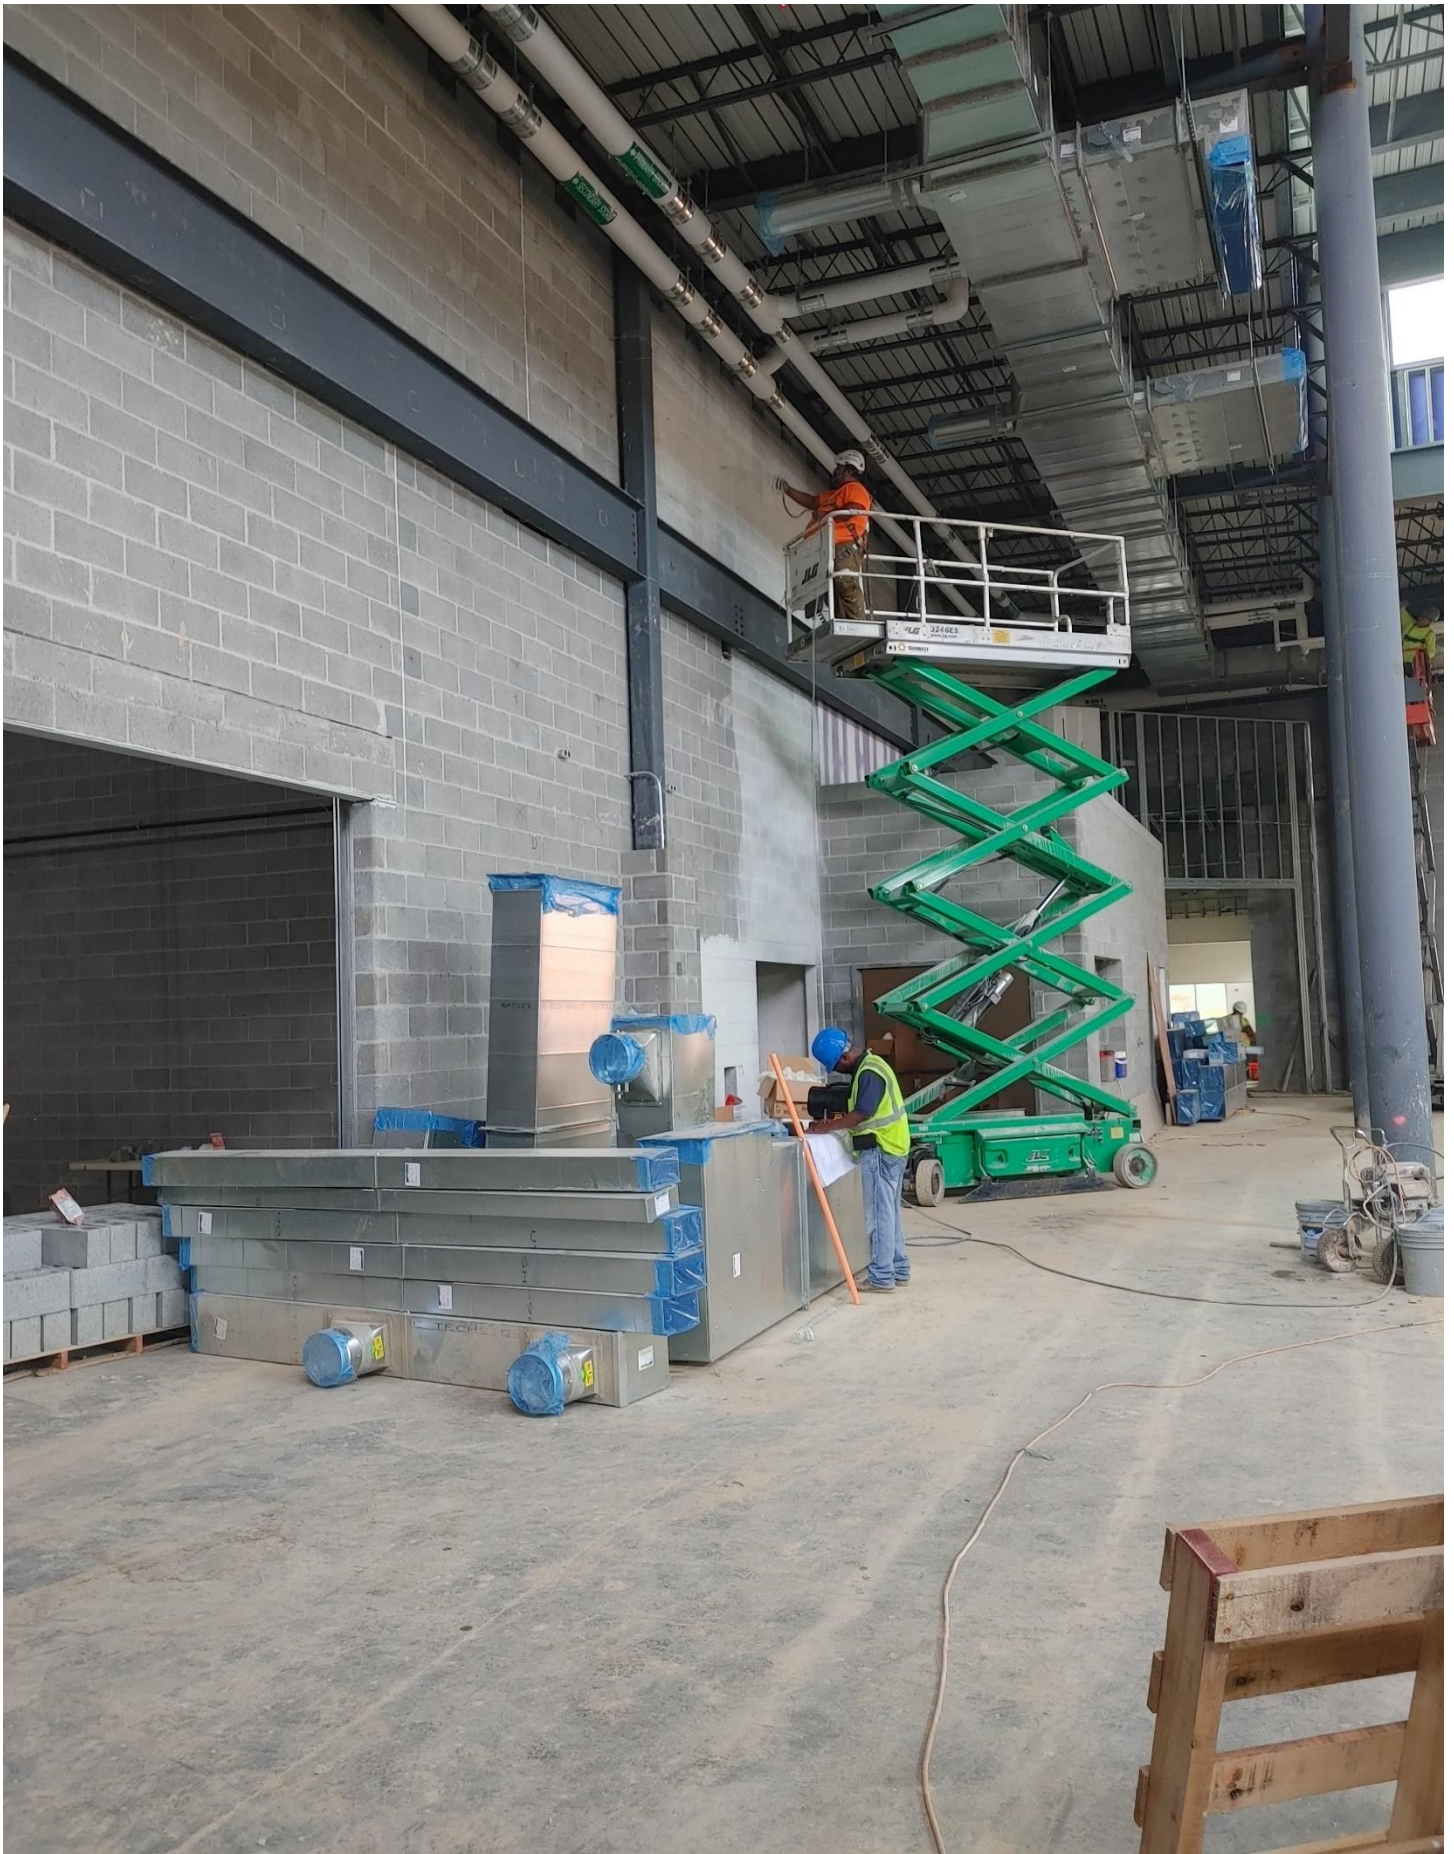
Photo 4 - Block Filler/Sealer is being applied in Area C.

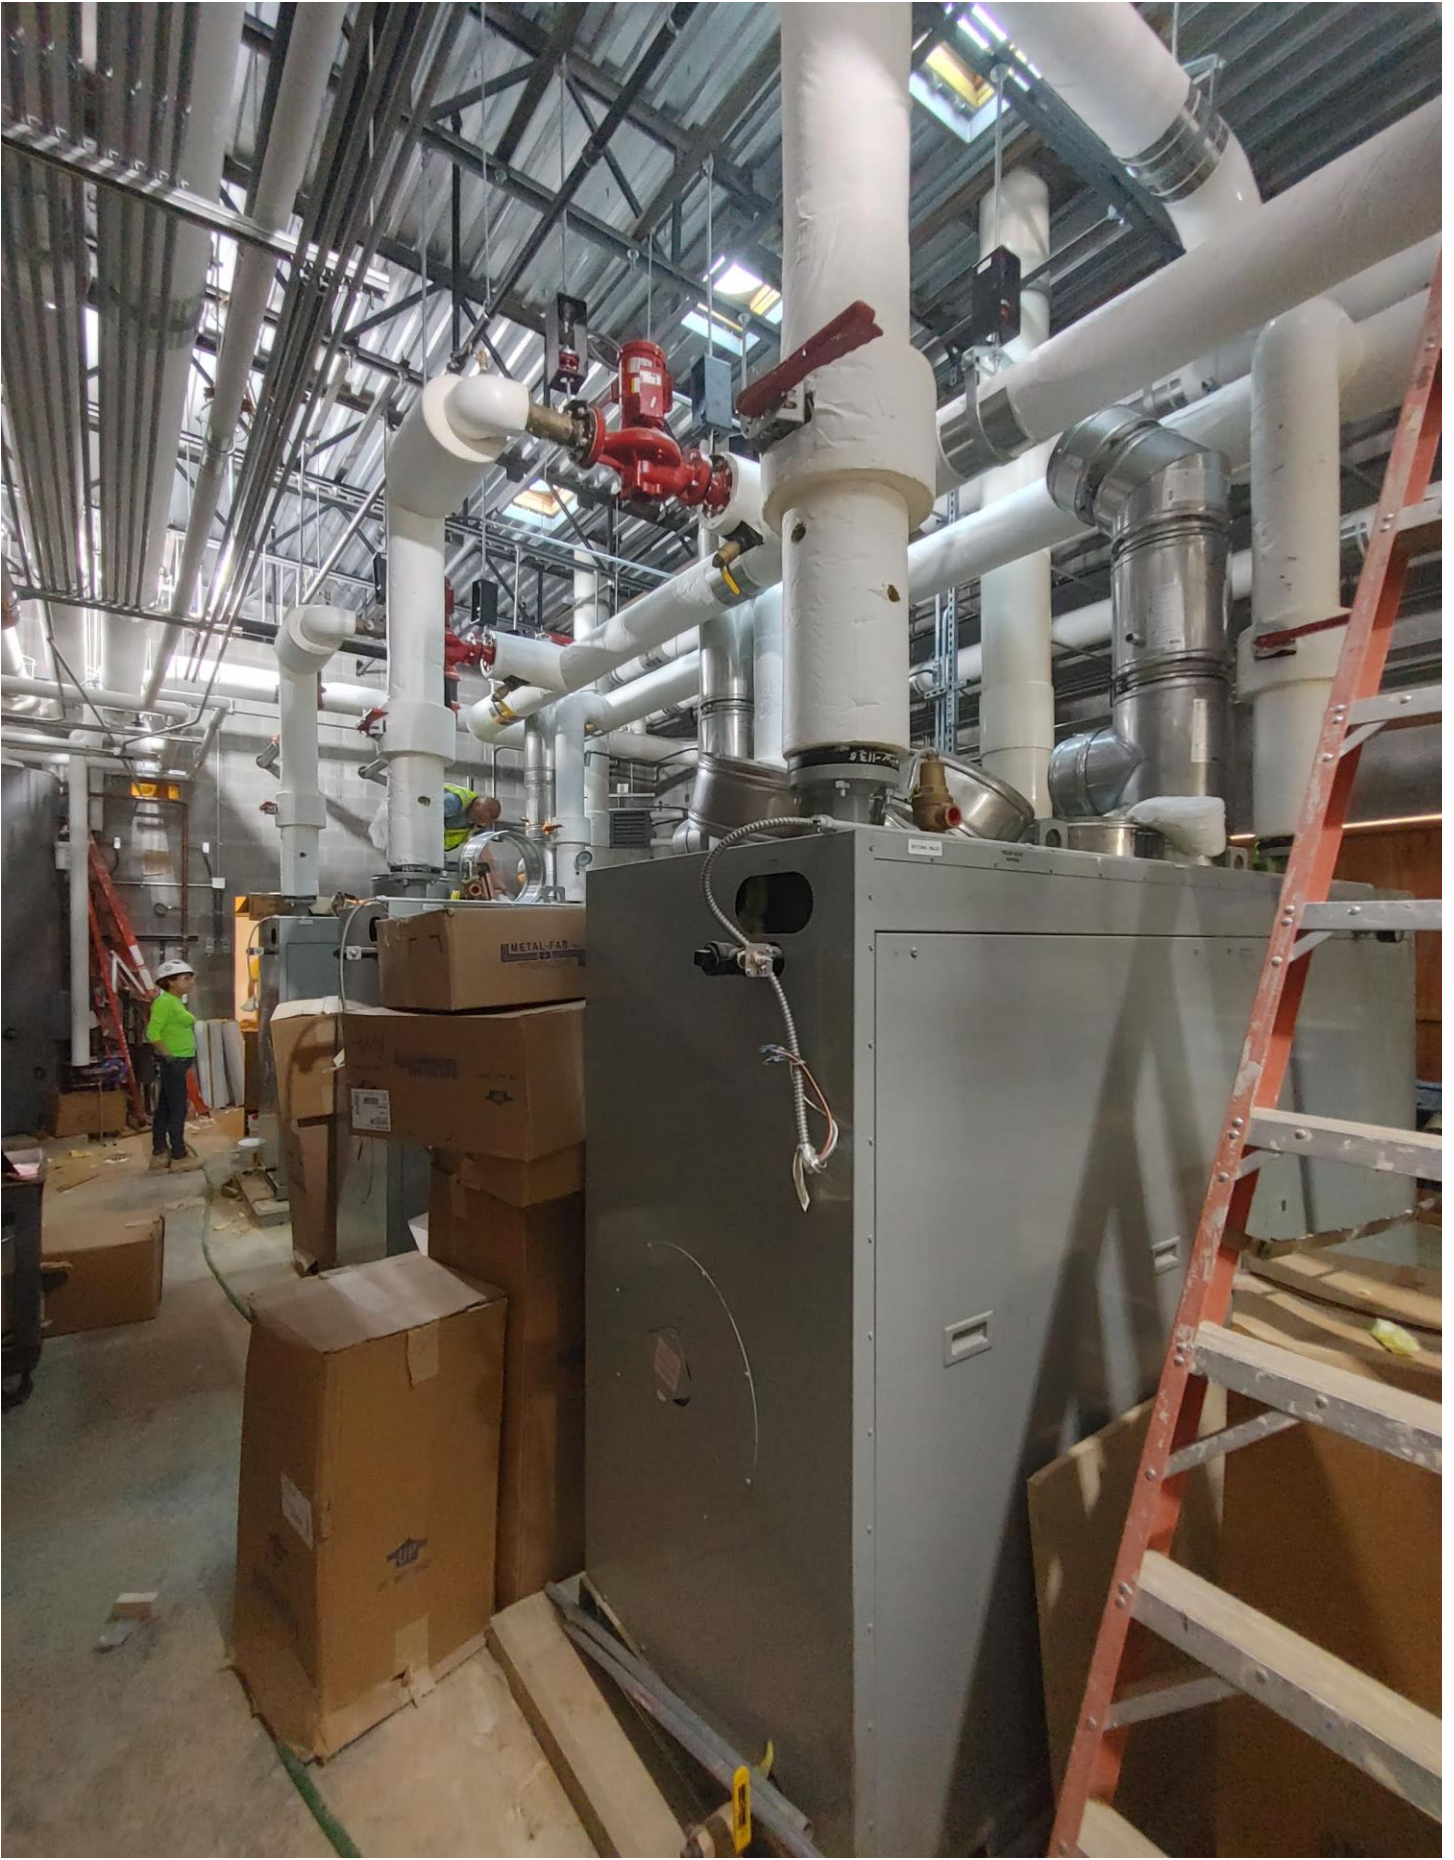
Photo 5 - Work continues on the Boilers in the Mechanical room.

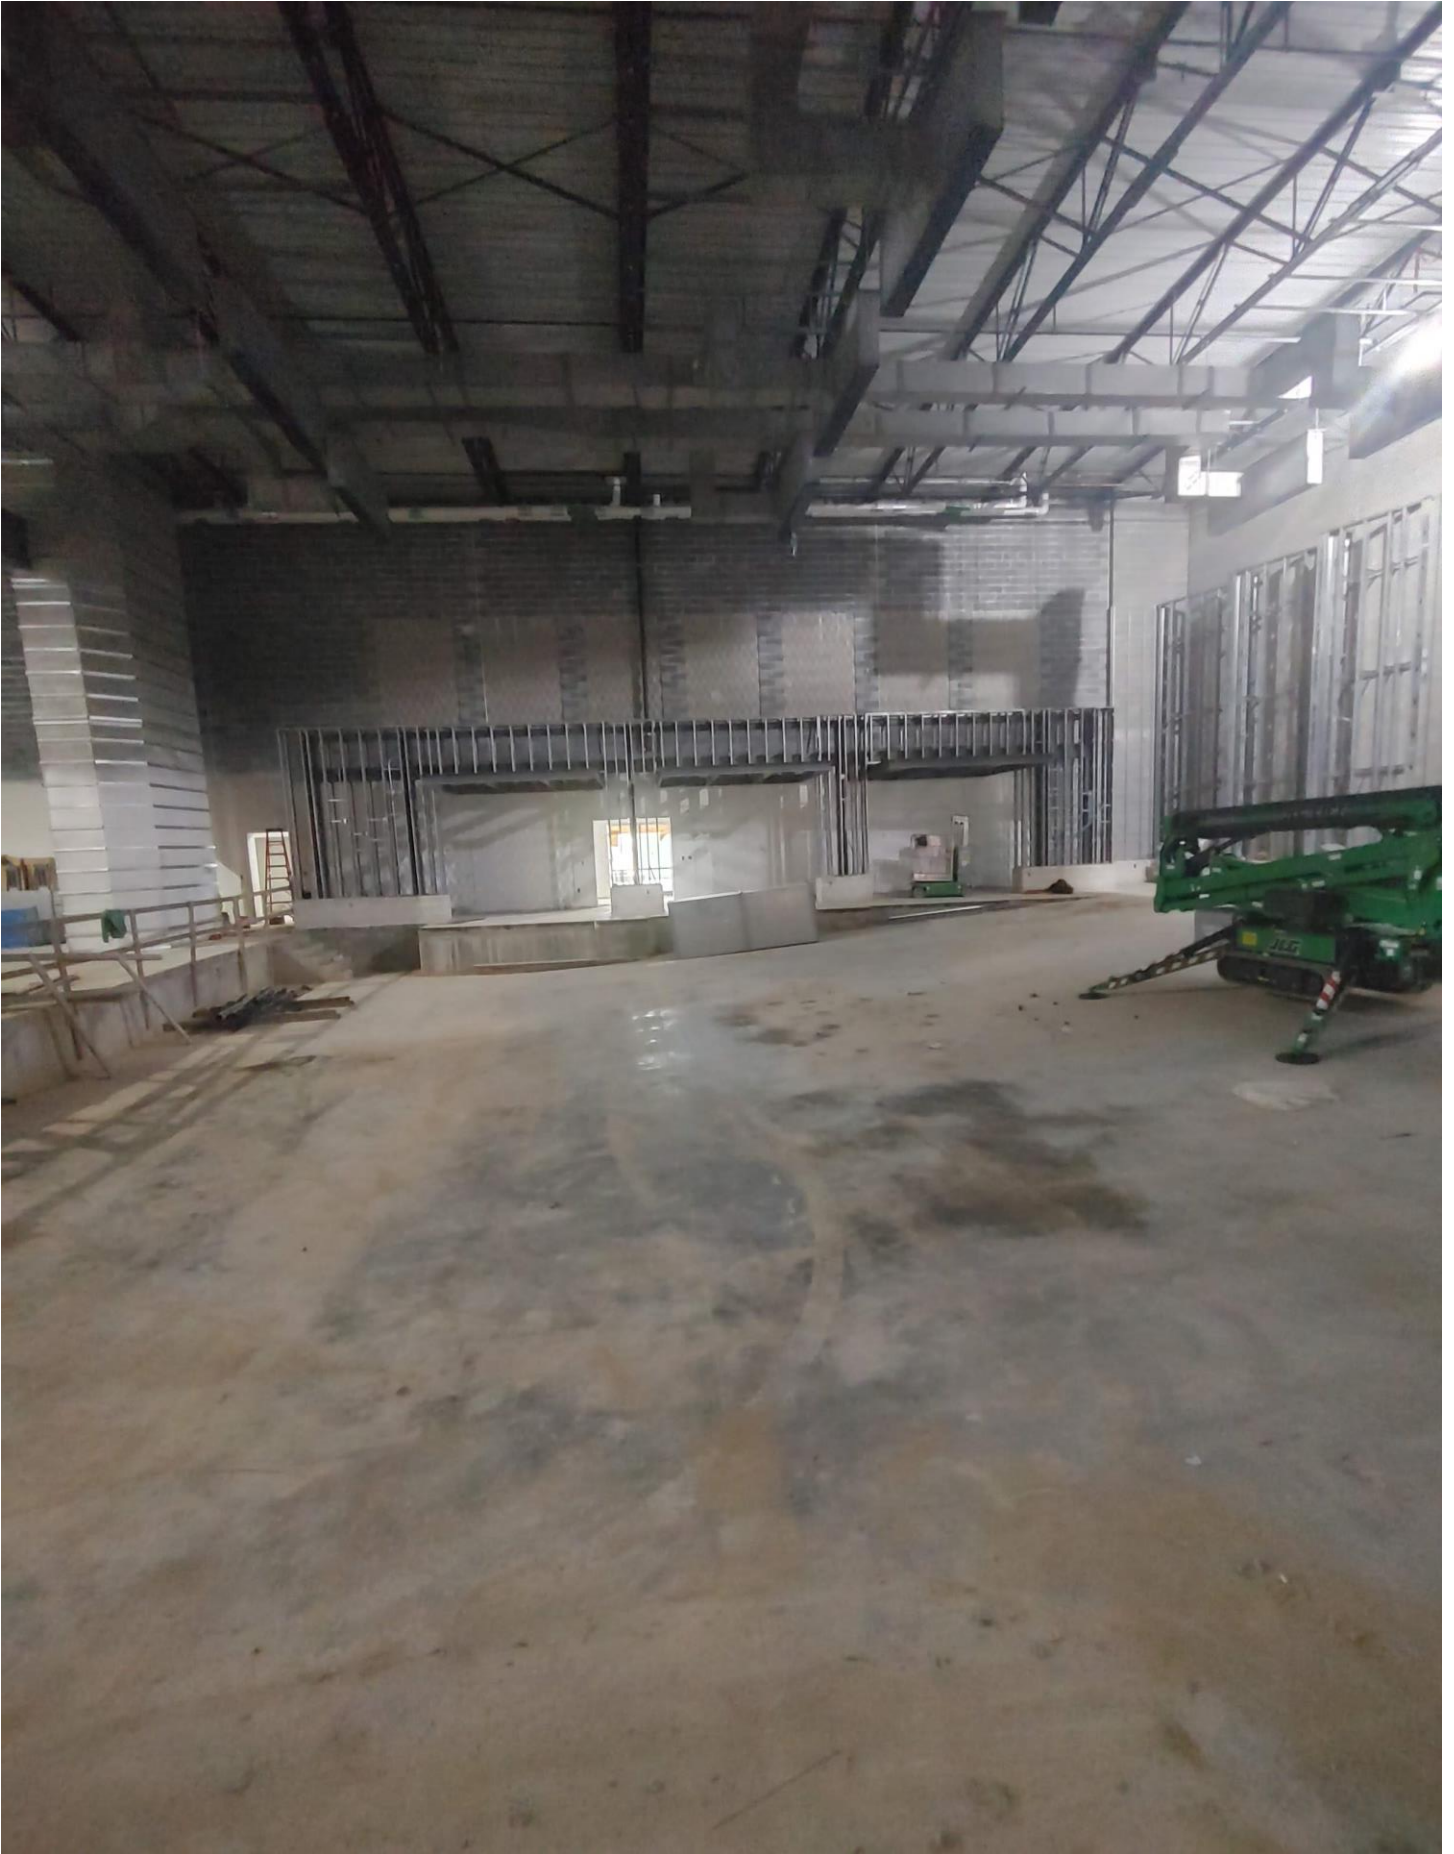
Photo 6 - Metal Stud framing has been completed on the North and South side of the Auditorium.

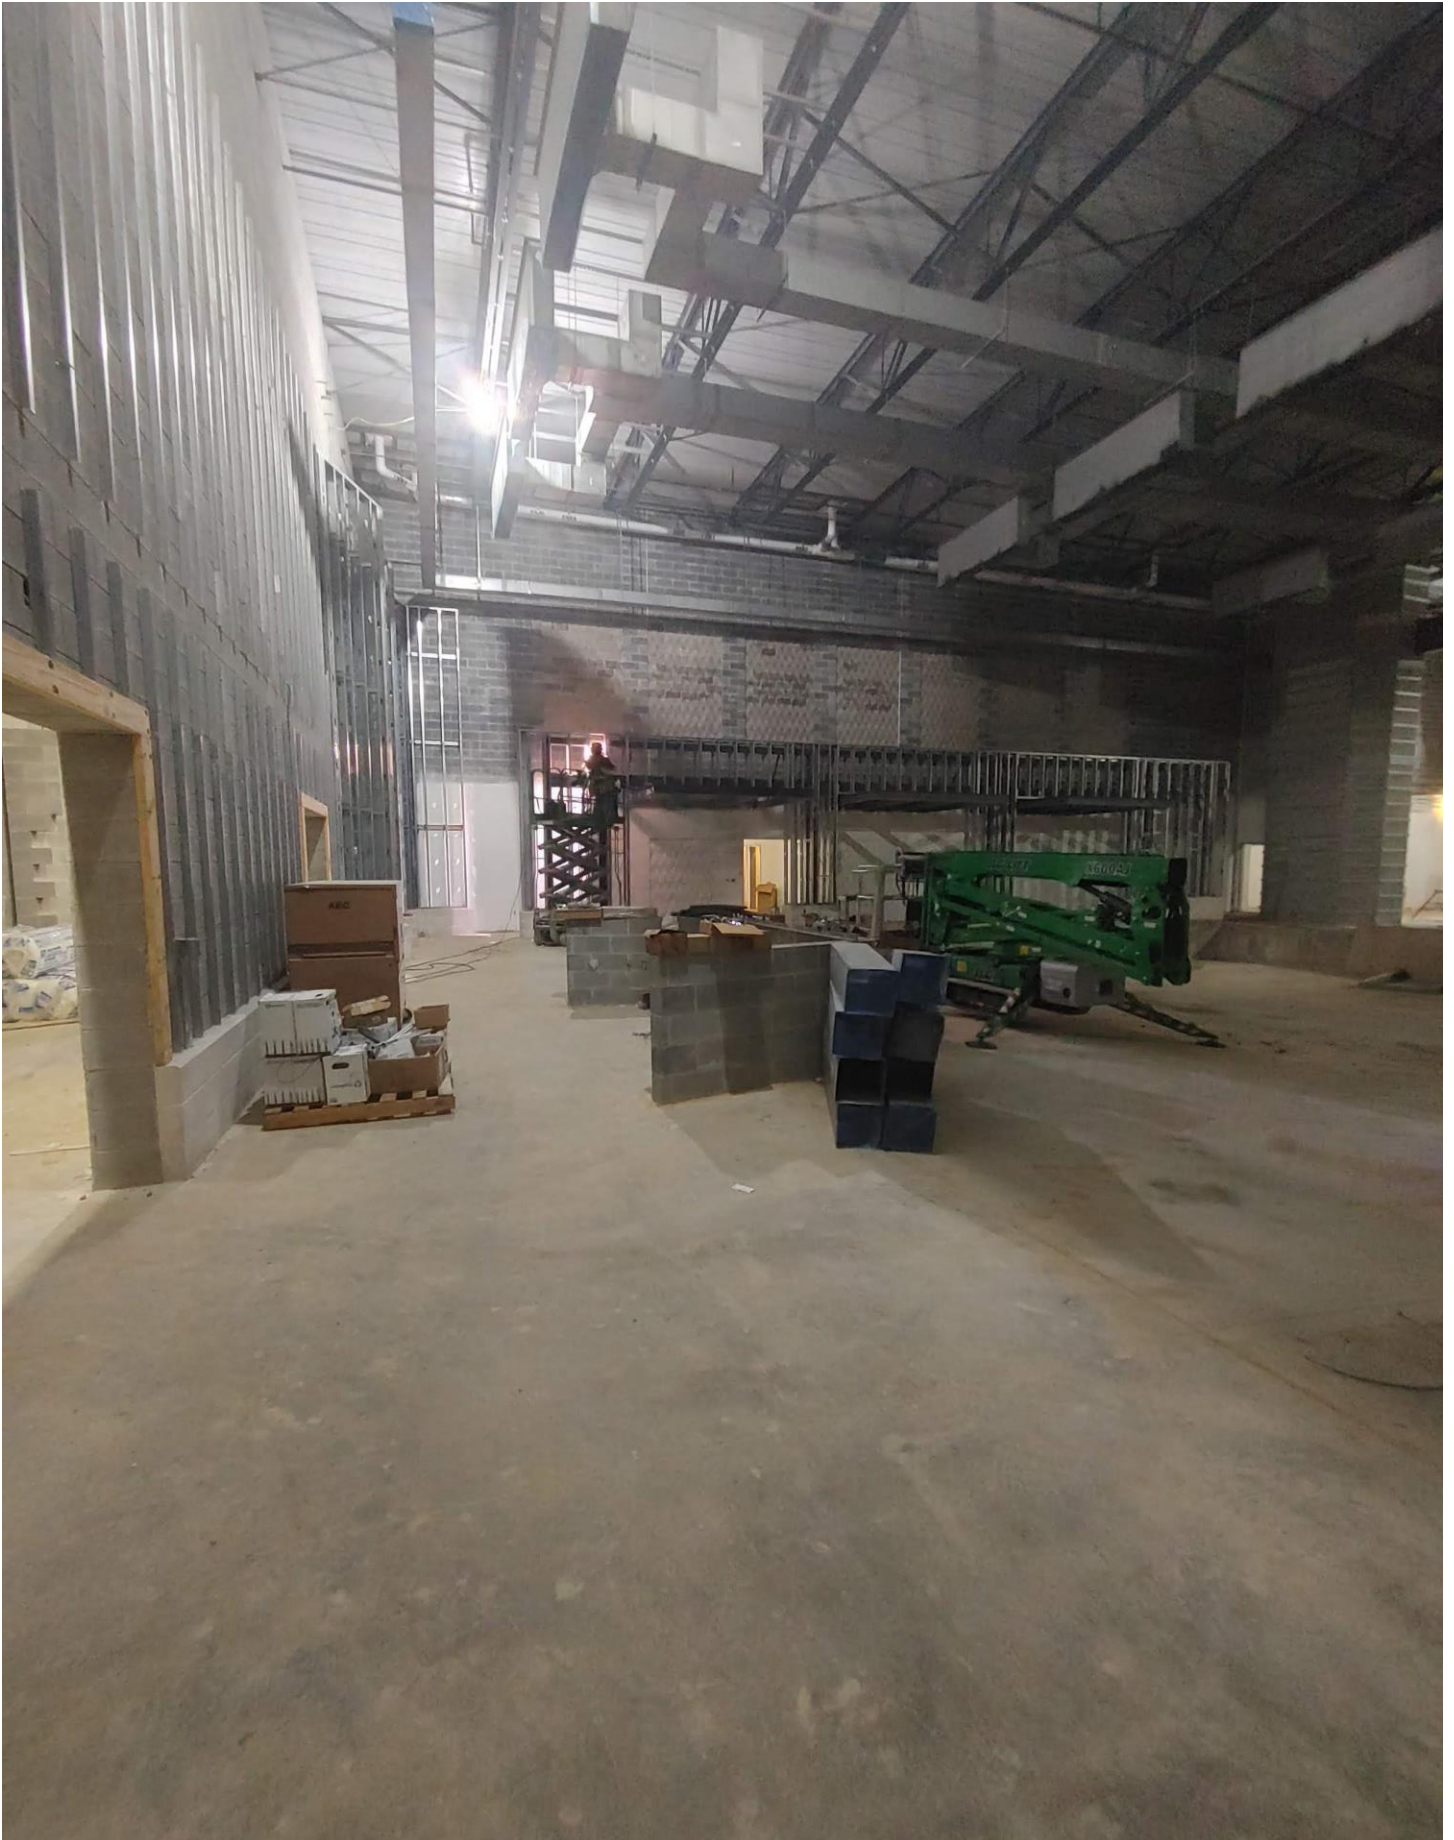
Photo 7 - Metal Beams are being welded in the Auditorium.

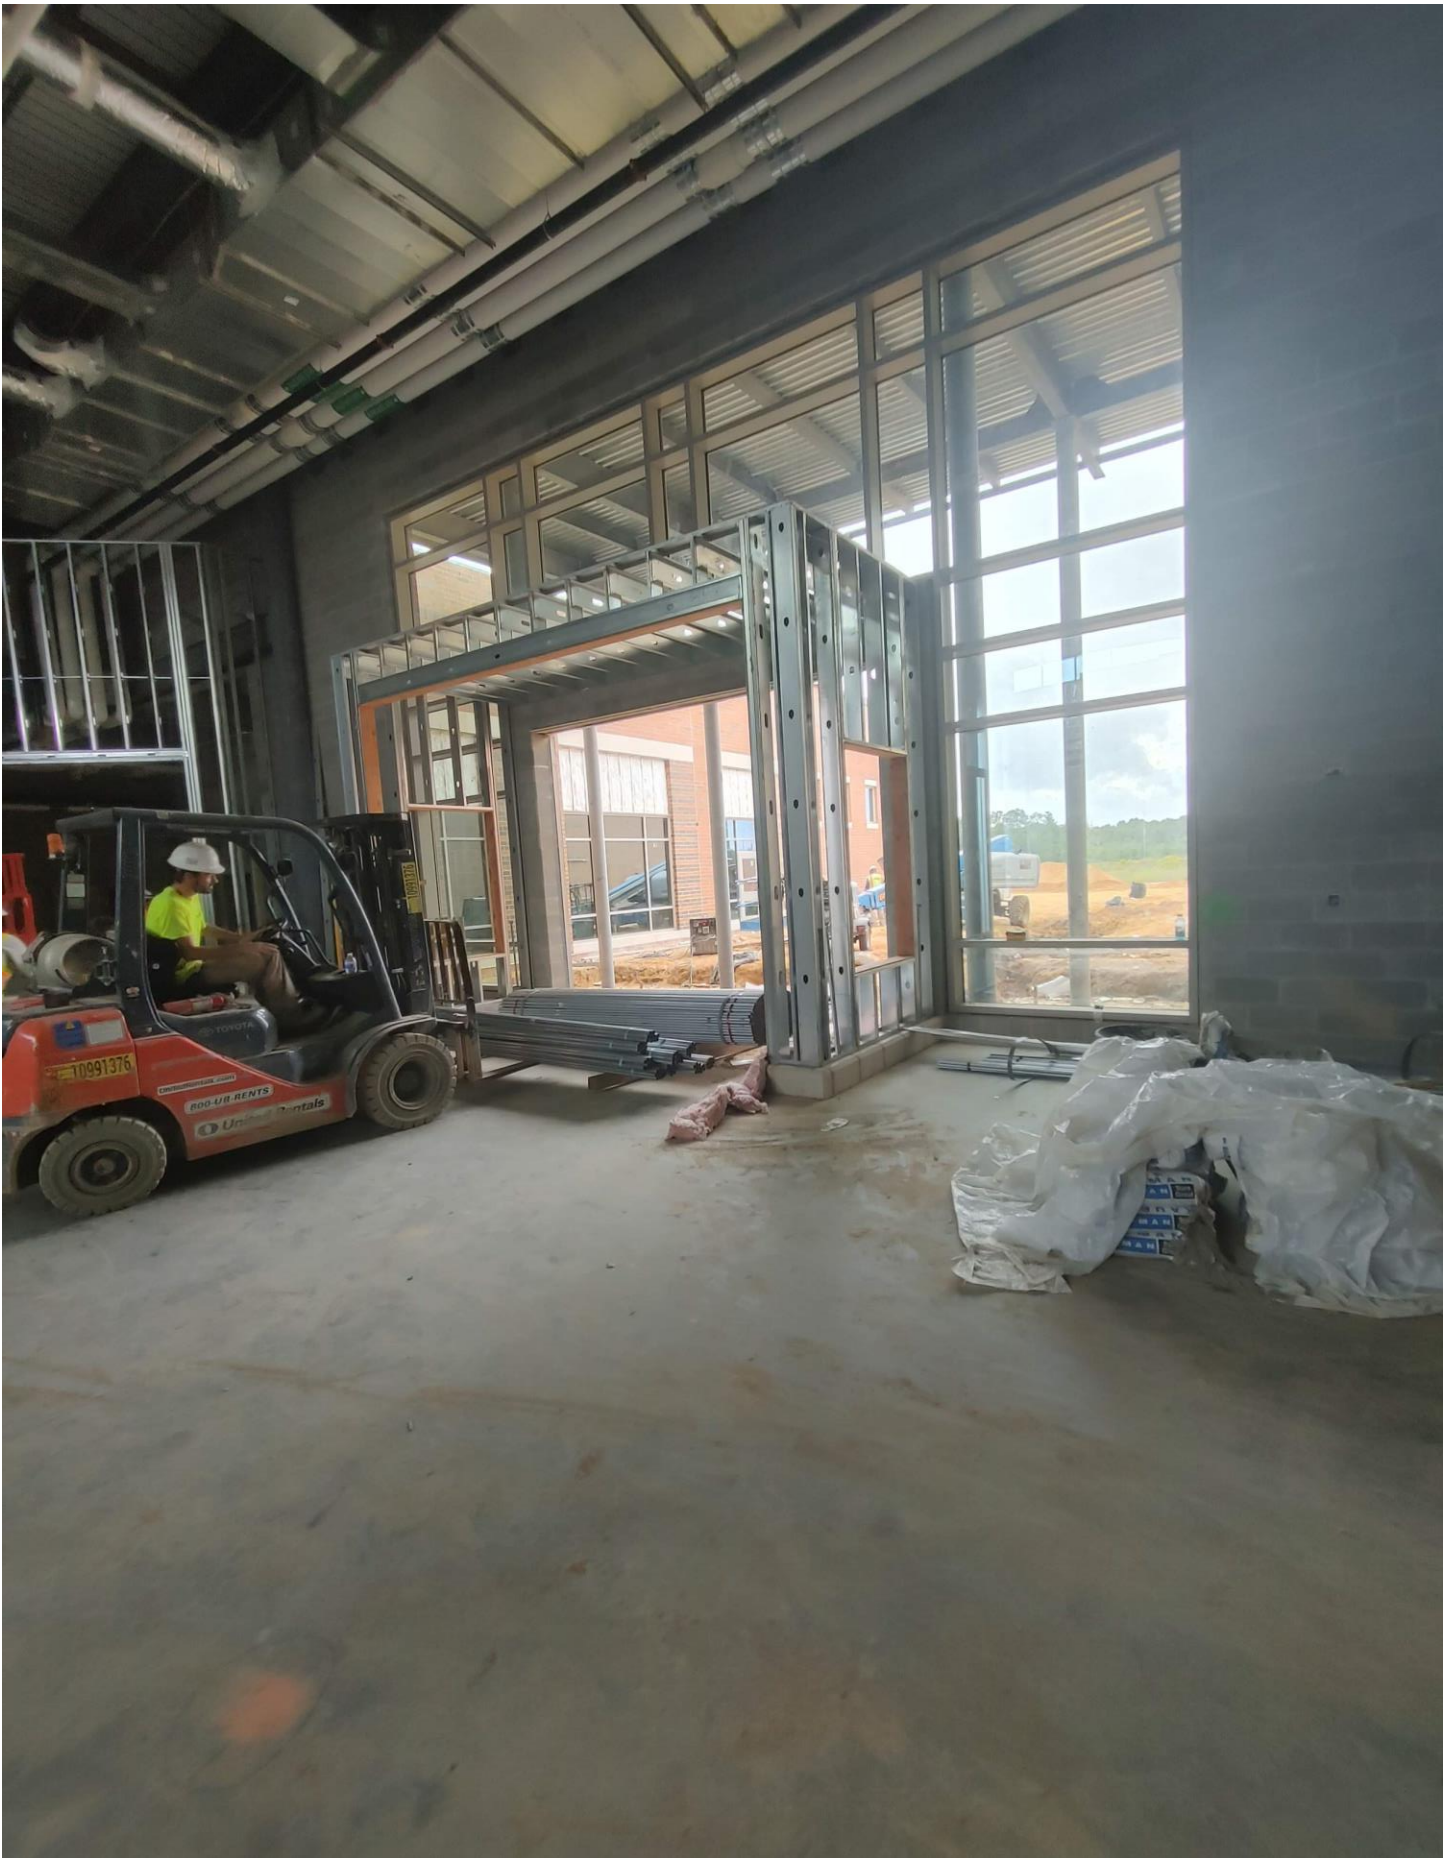
Photo 8 - Vestibule has been constructed on the South Side of Area C
