**COMMONWEALTH
BUILDING SOLUTIONS, LLC**

FIELD REPORT

WESTMORELAND COUNTY HIGH SCHOOL

Date: 09/22/2021

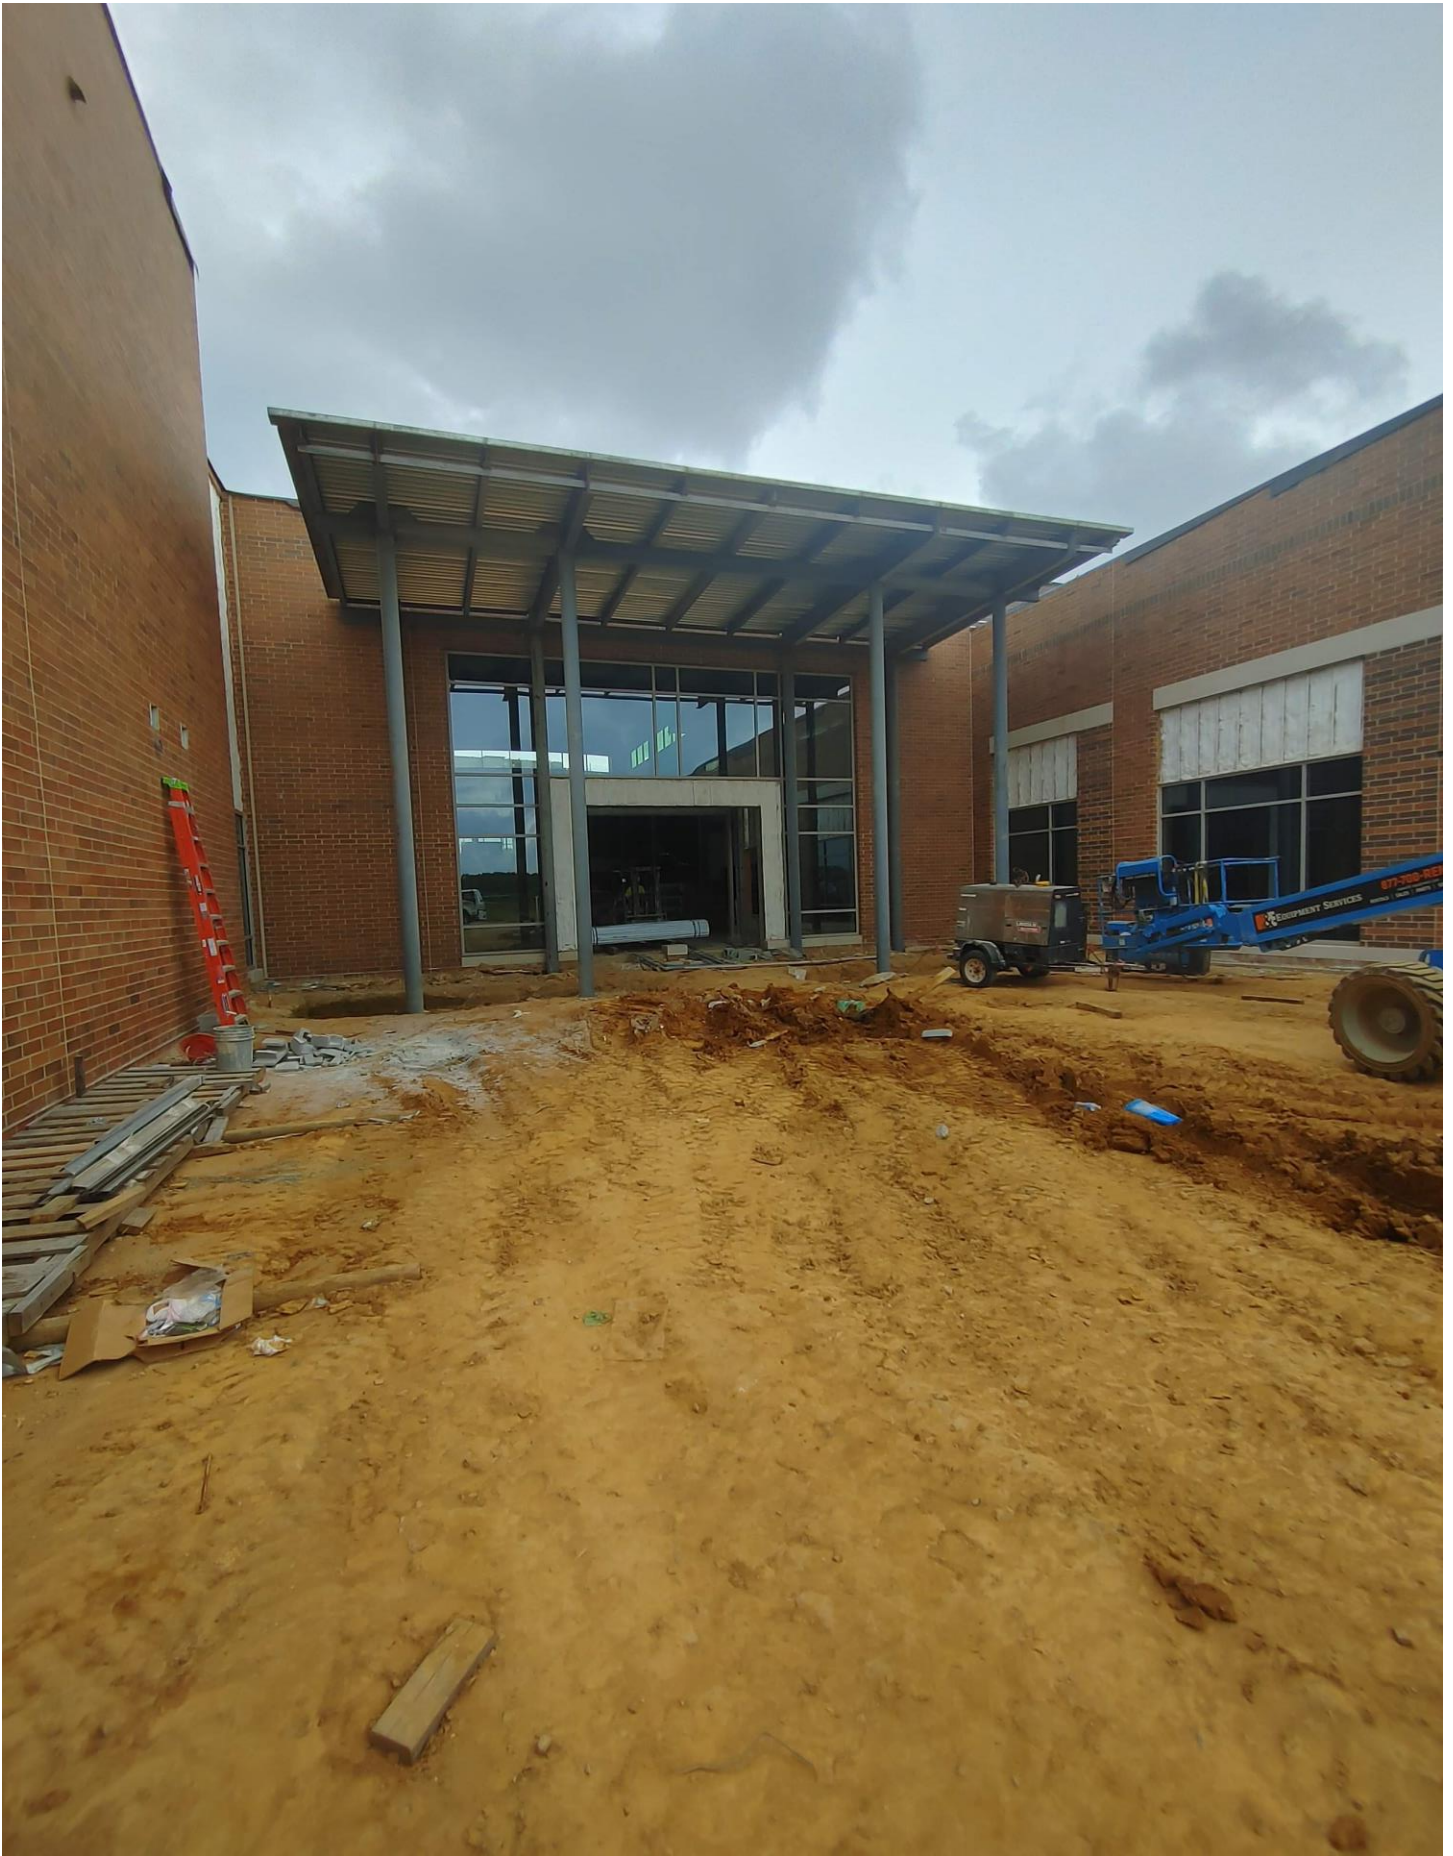
Photo 9 - Metal Pan has been installed on the Canopy on the South side of Area C.

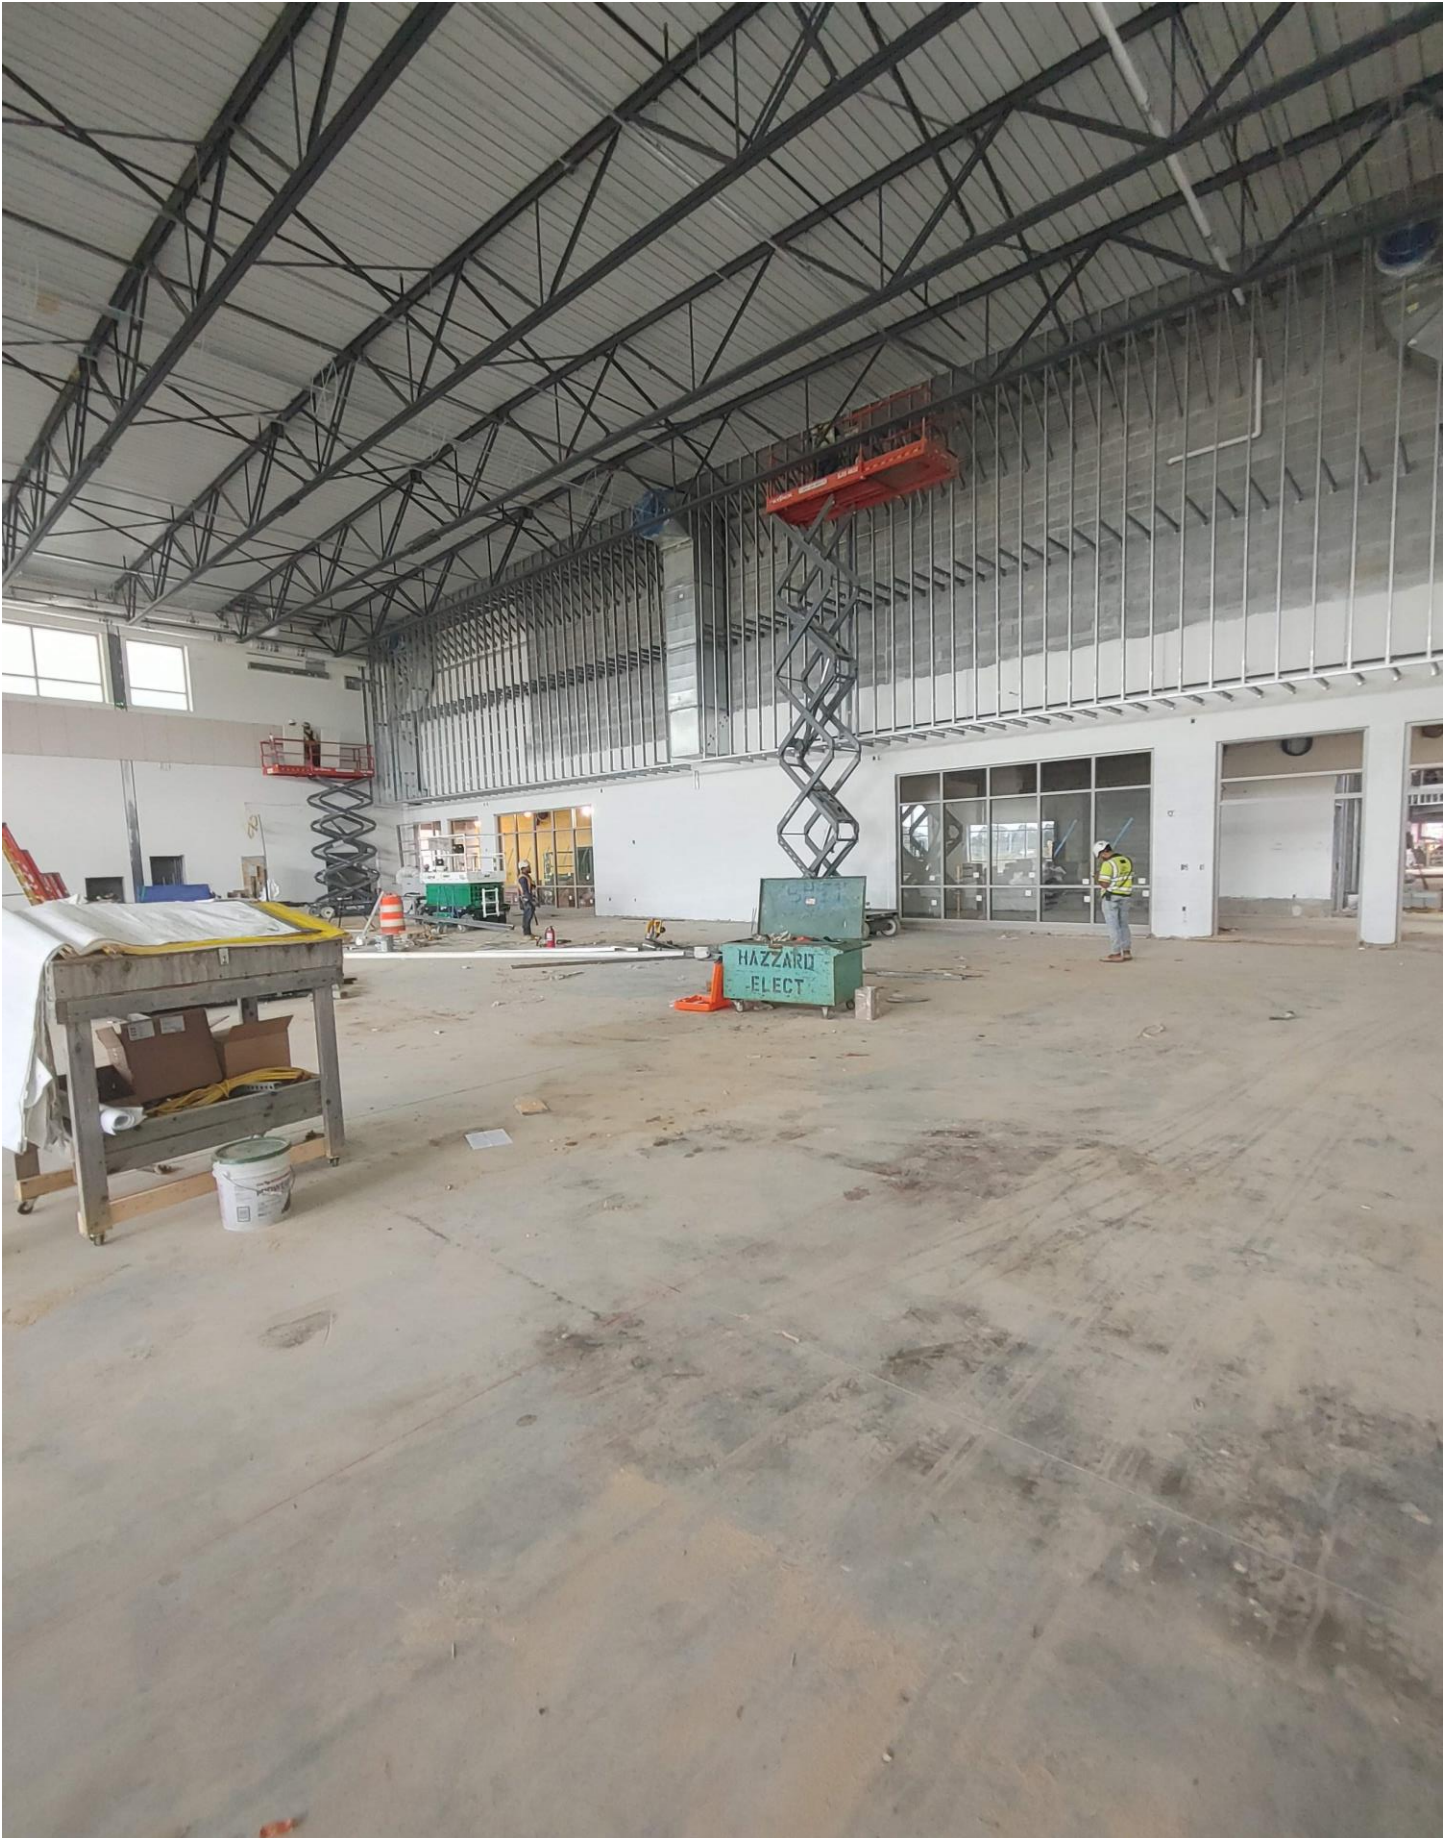
Photo 10 - Metal Stud Framing on the North wall of the Gym.

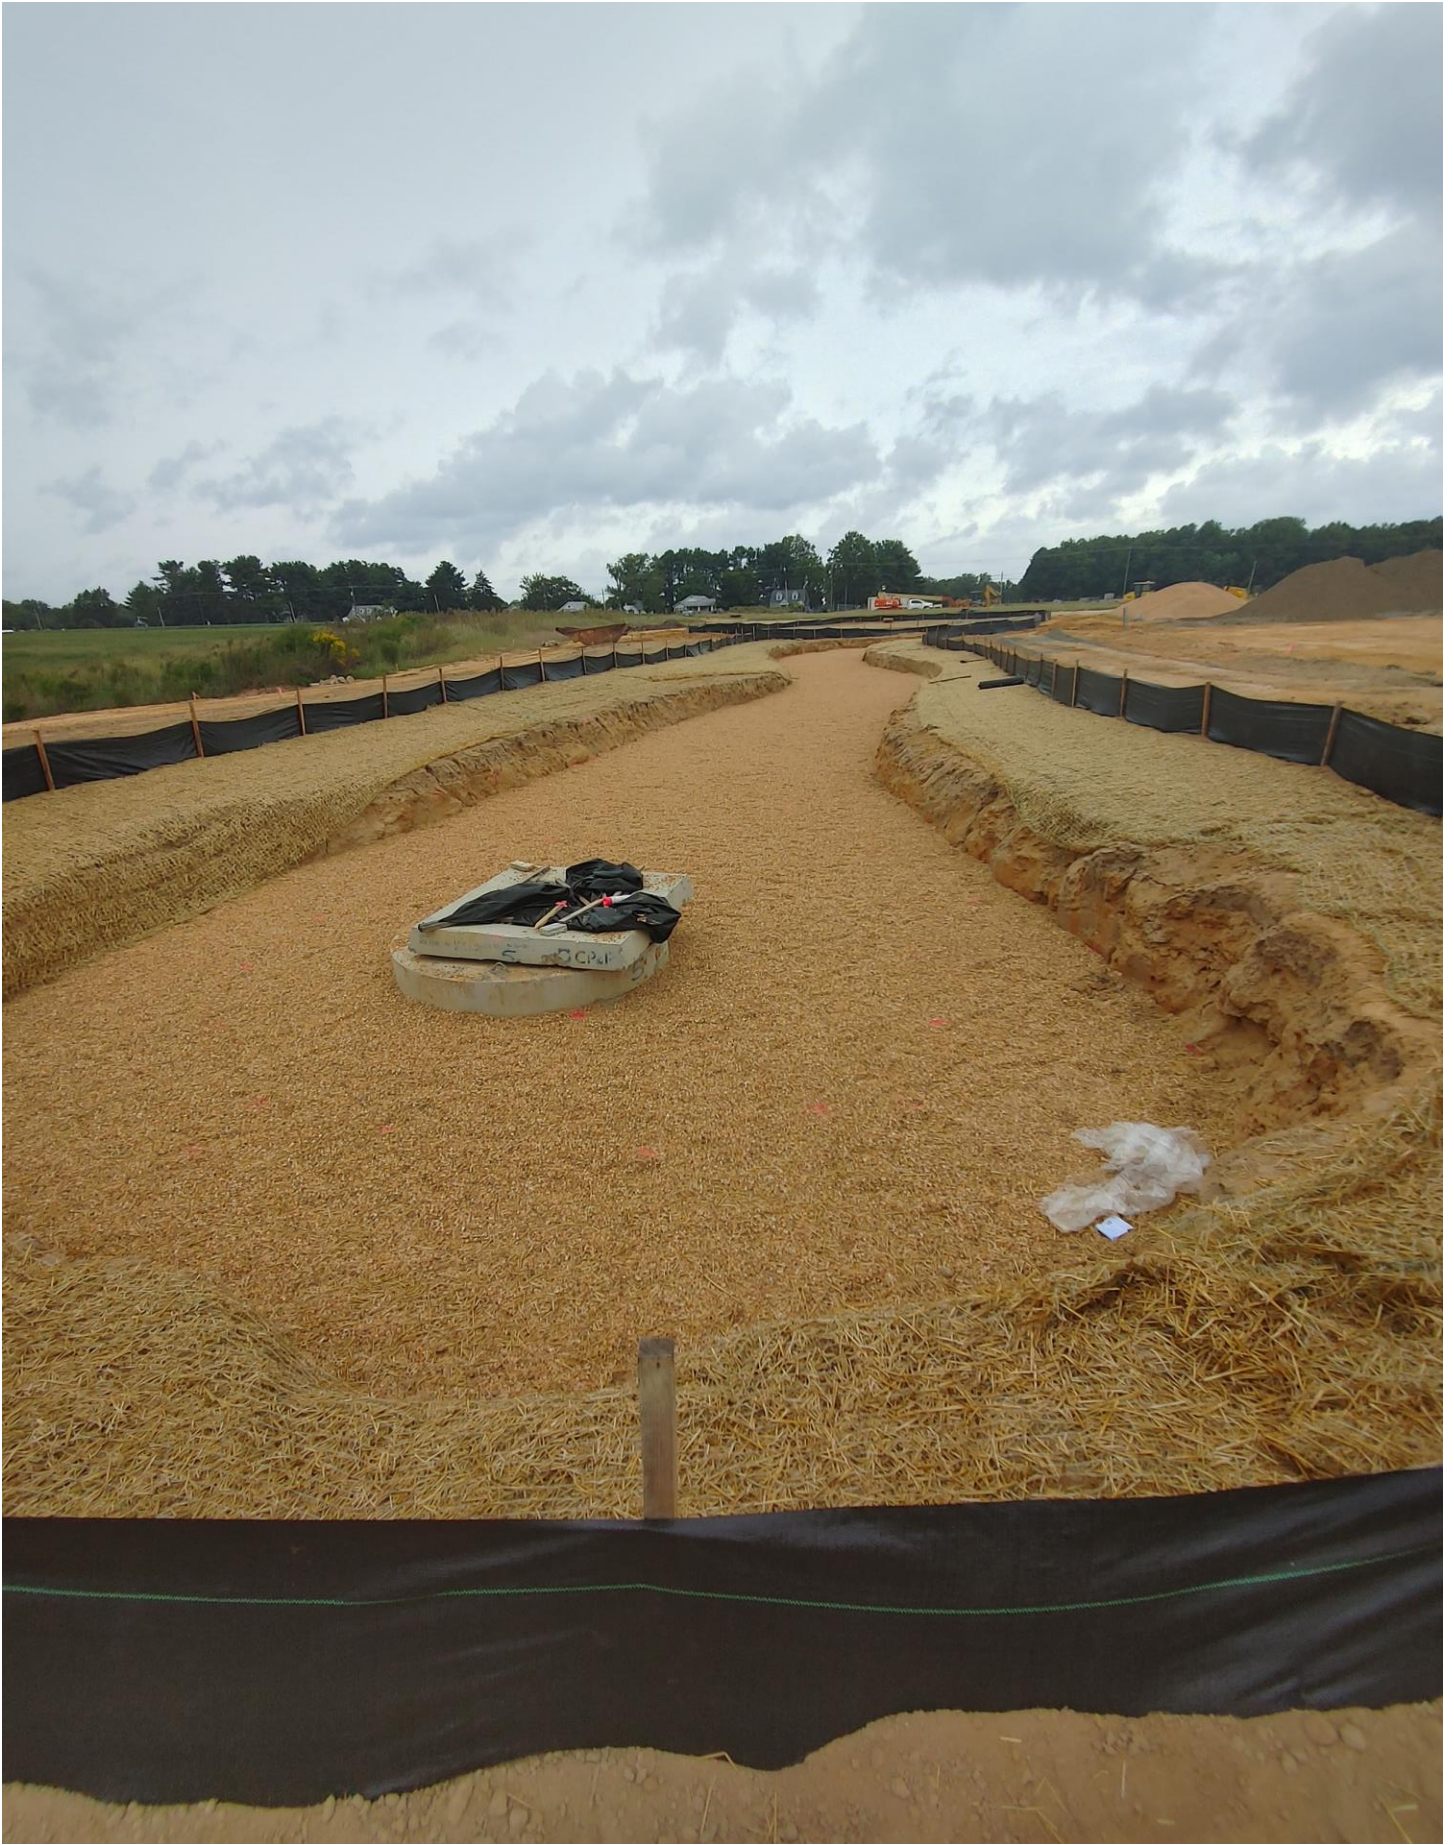
Photo 11 - Pea Gravel has been installed in BMP

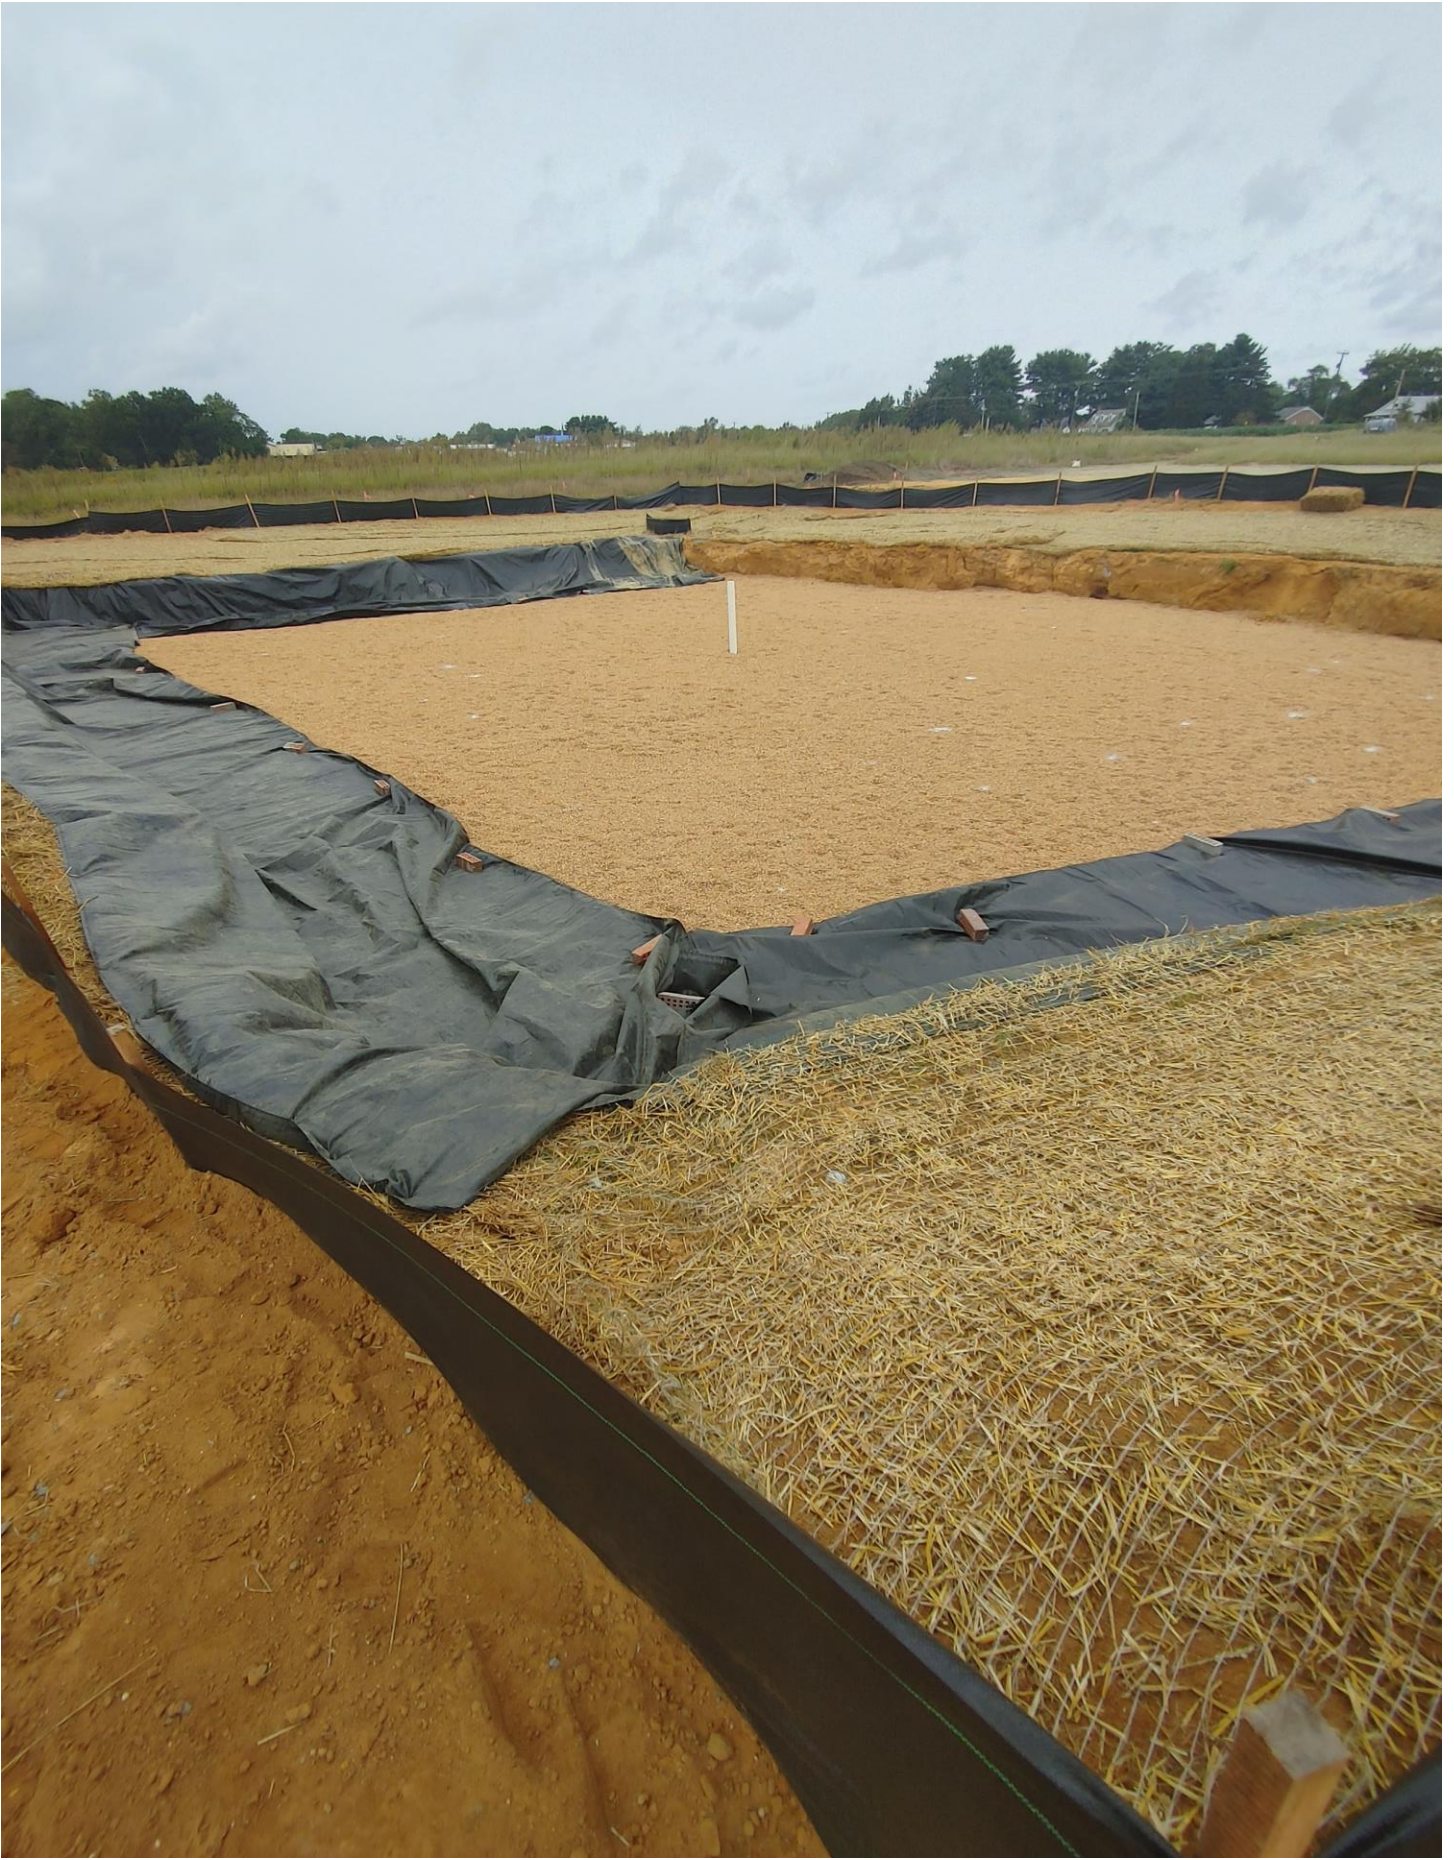
Photo 12 - Pea Gravel installed in smaller BMP

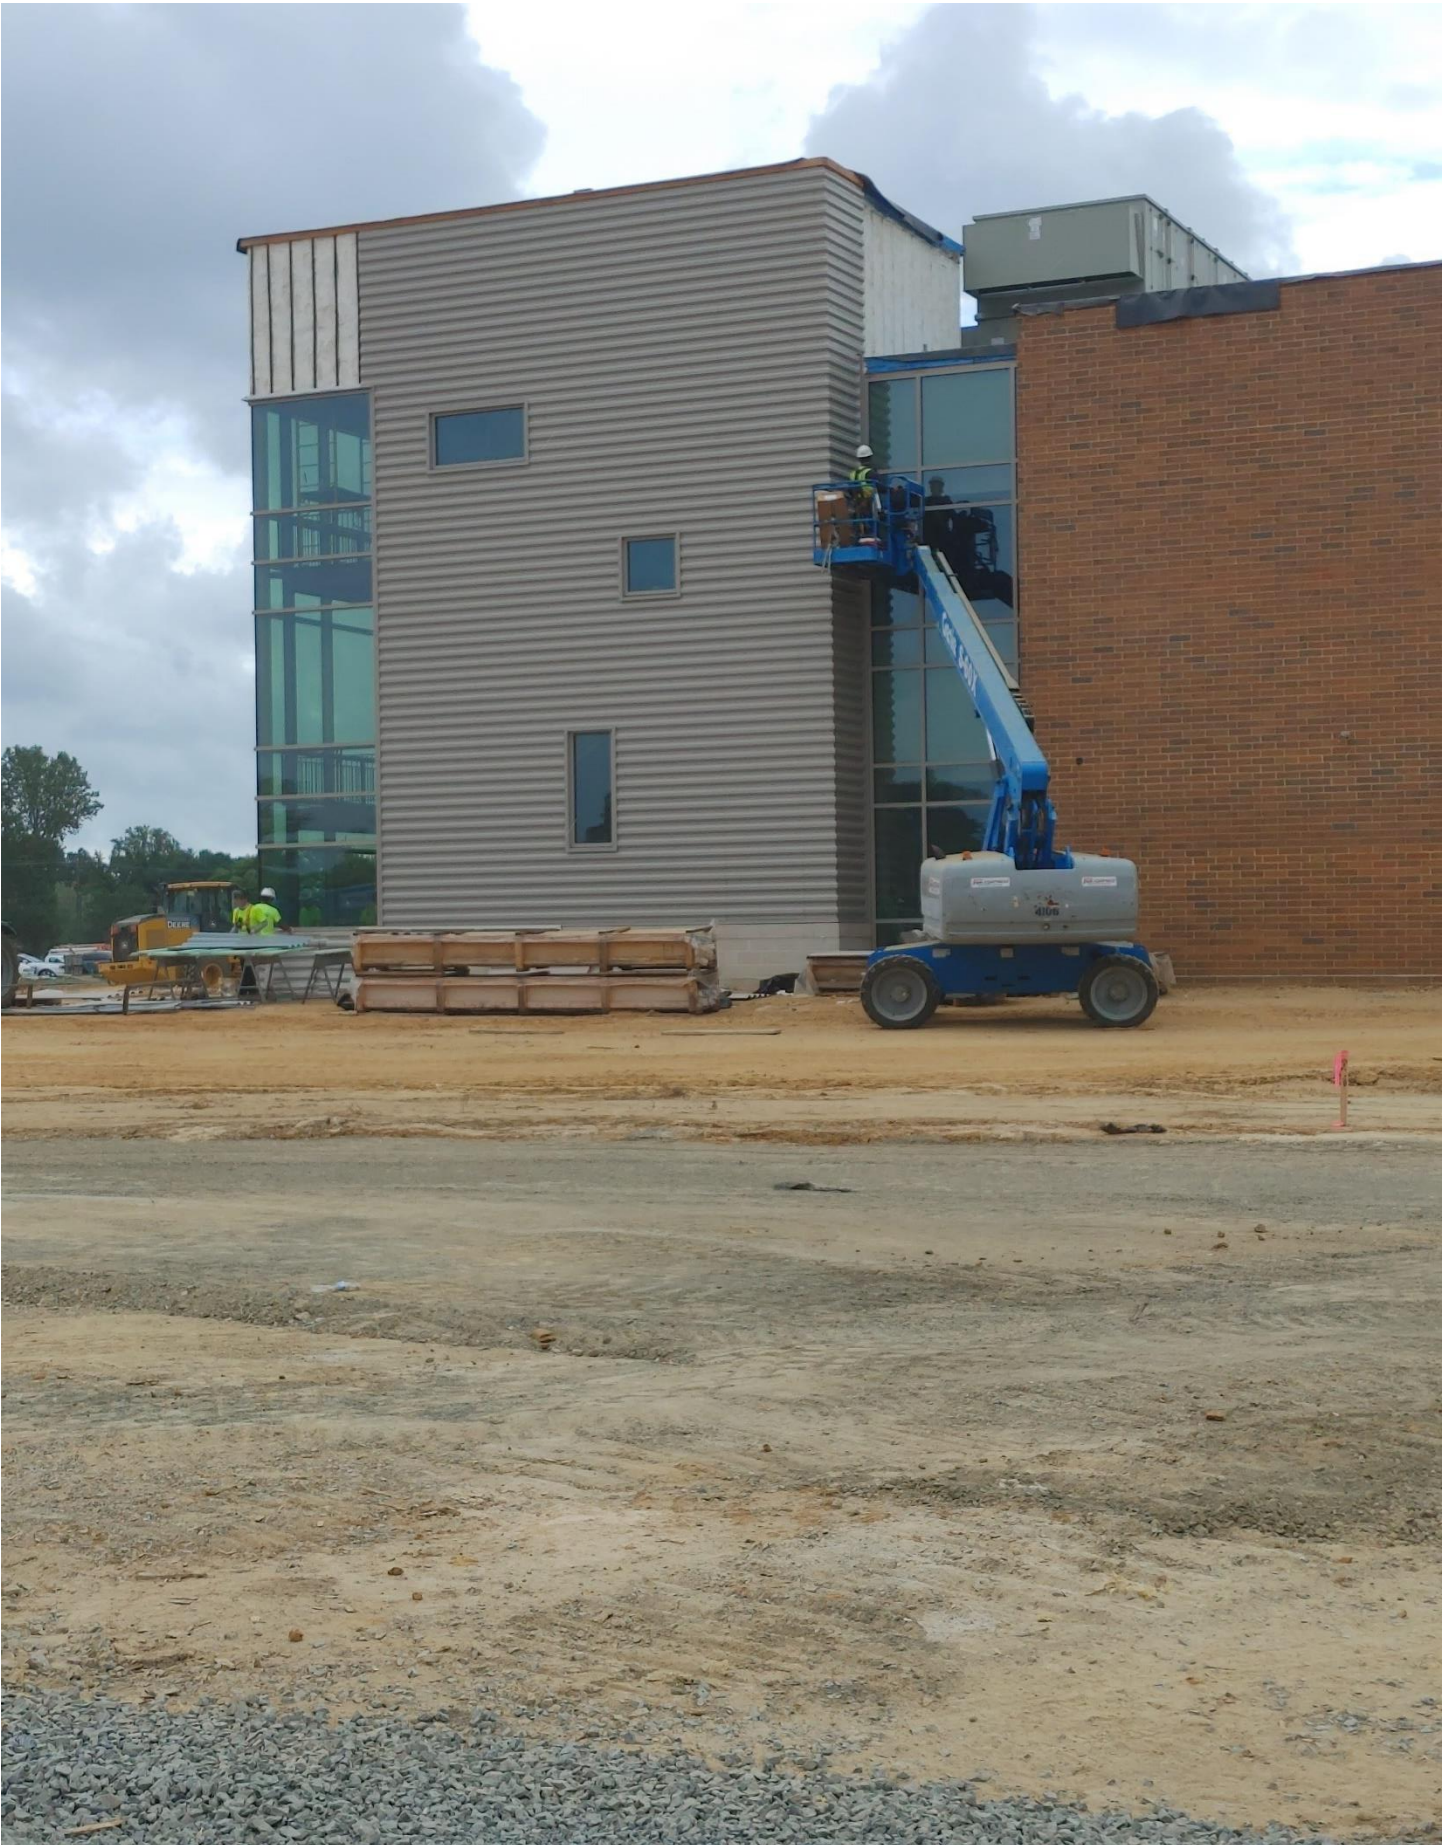
Photo 13 - Metal Panels are being installed on the West side of Area B.

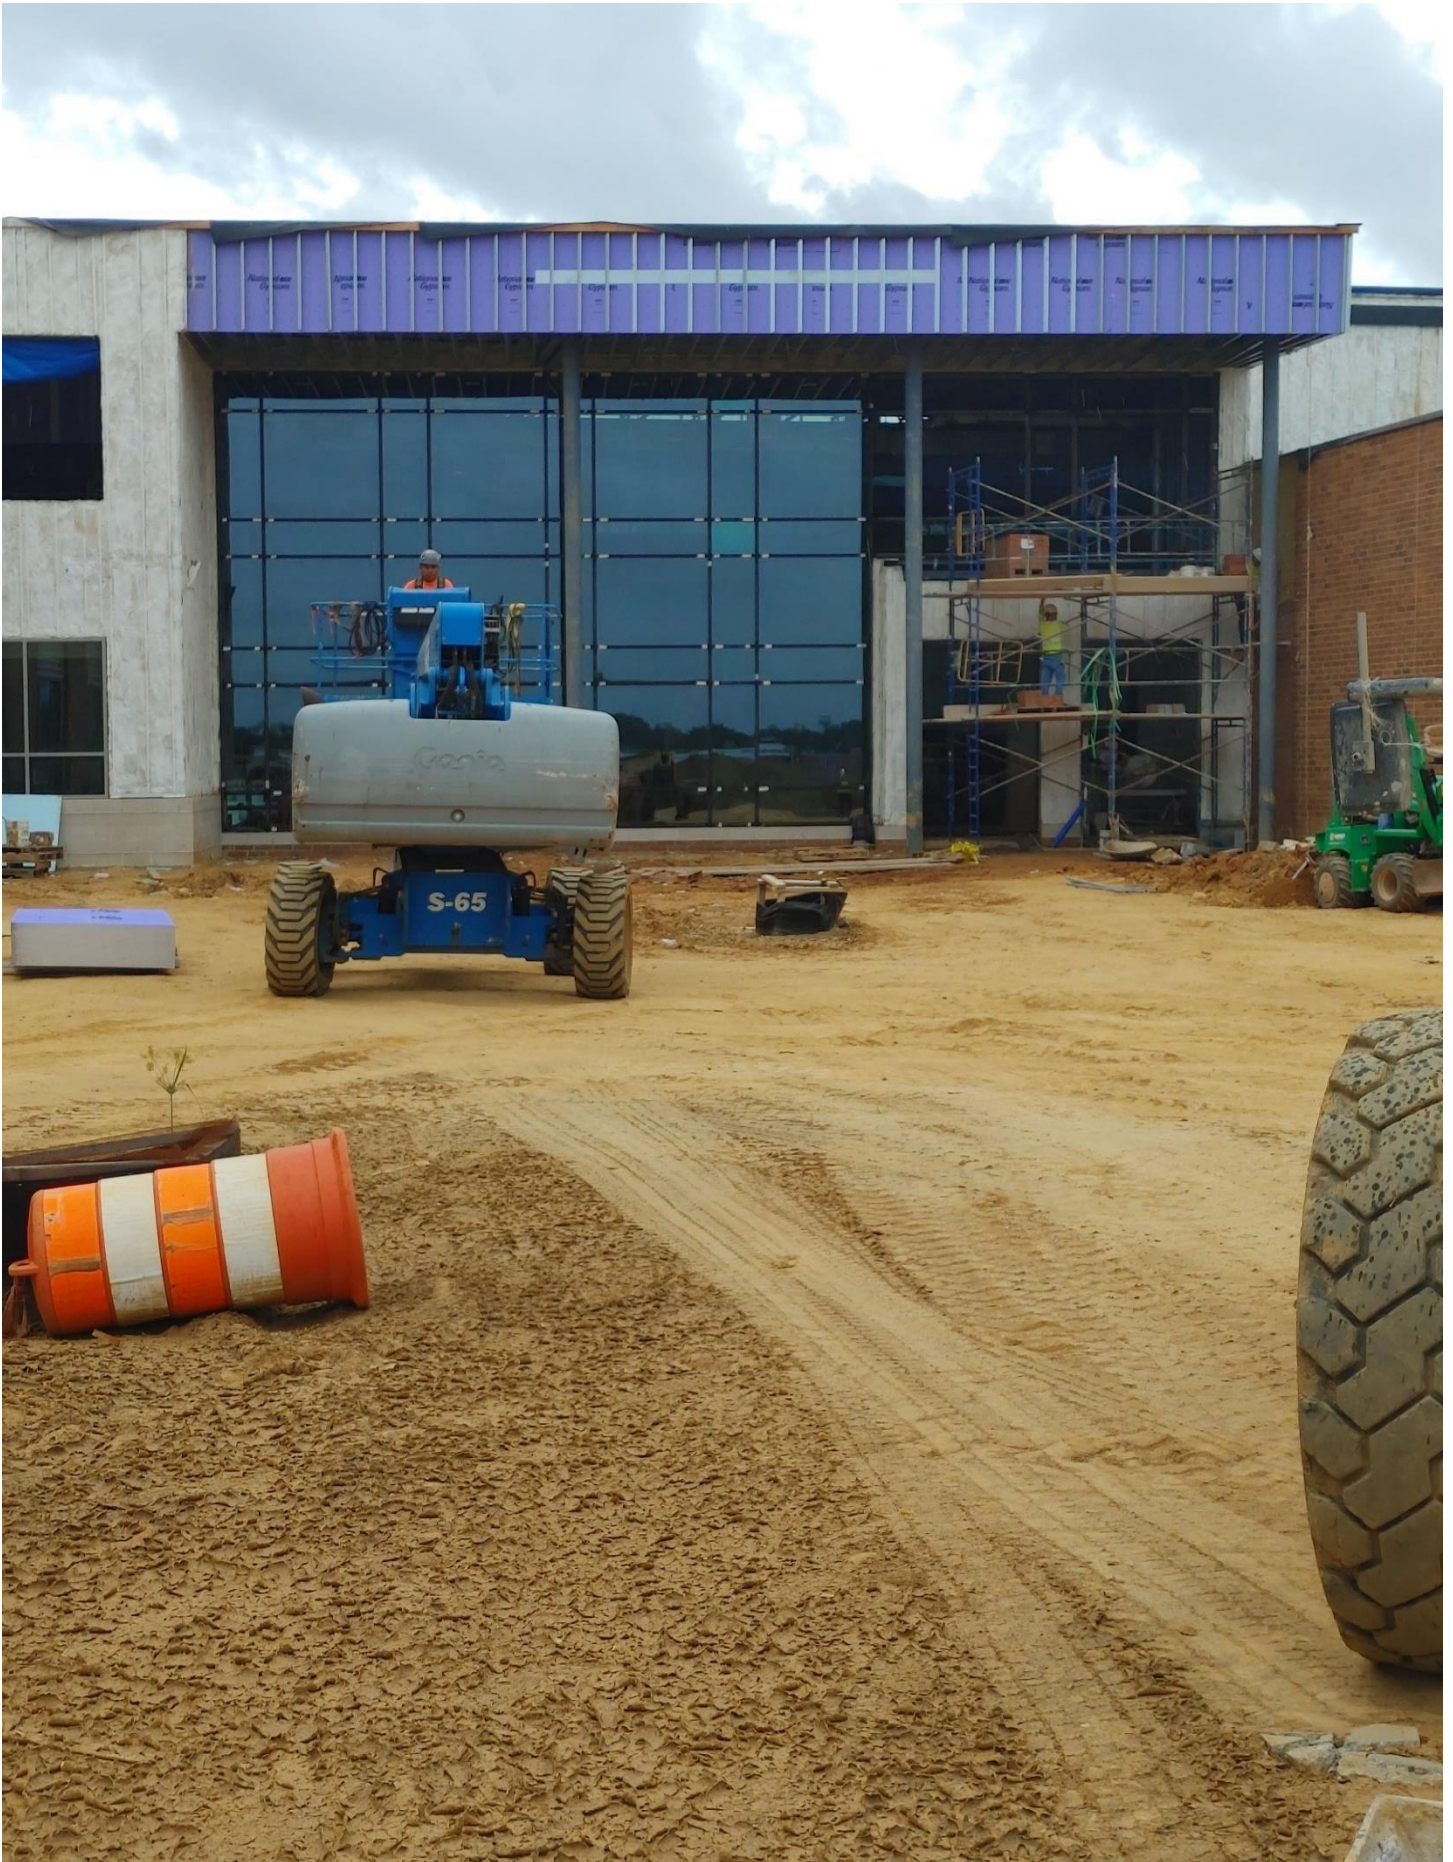
Photo 14 - Glass has been installed in the Curtain Wall on the West side of Area C.

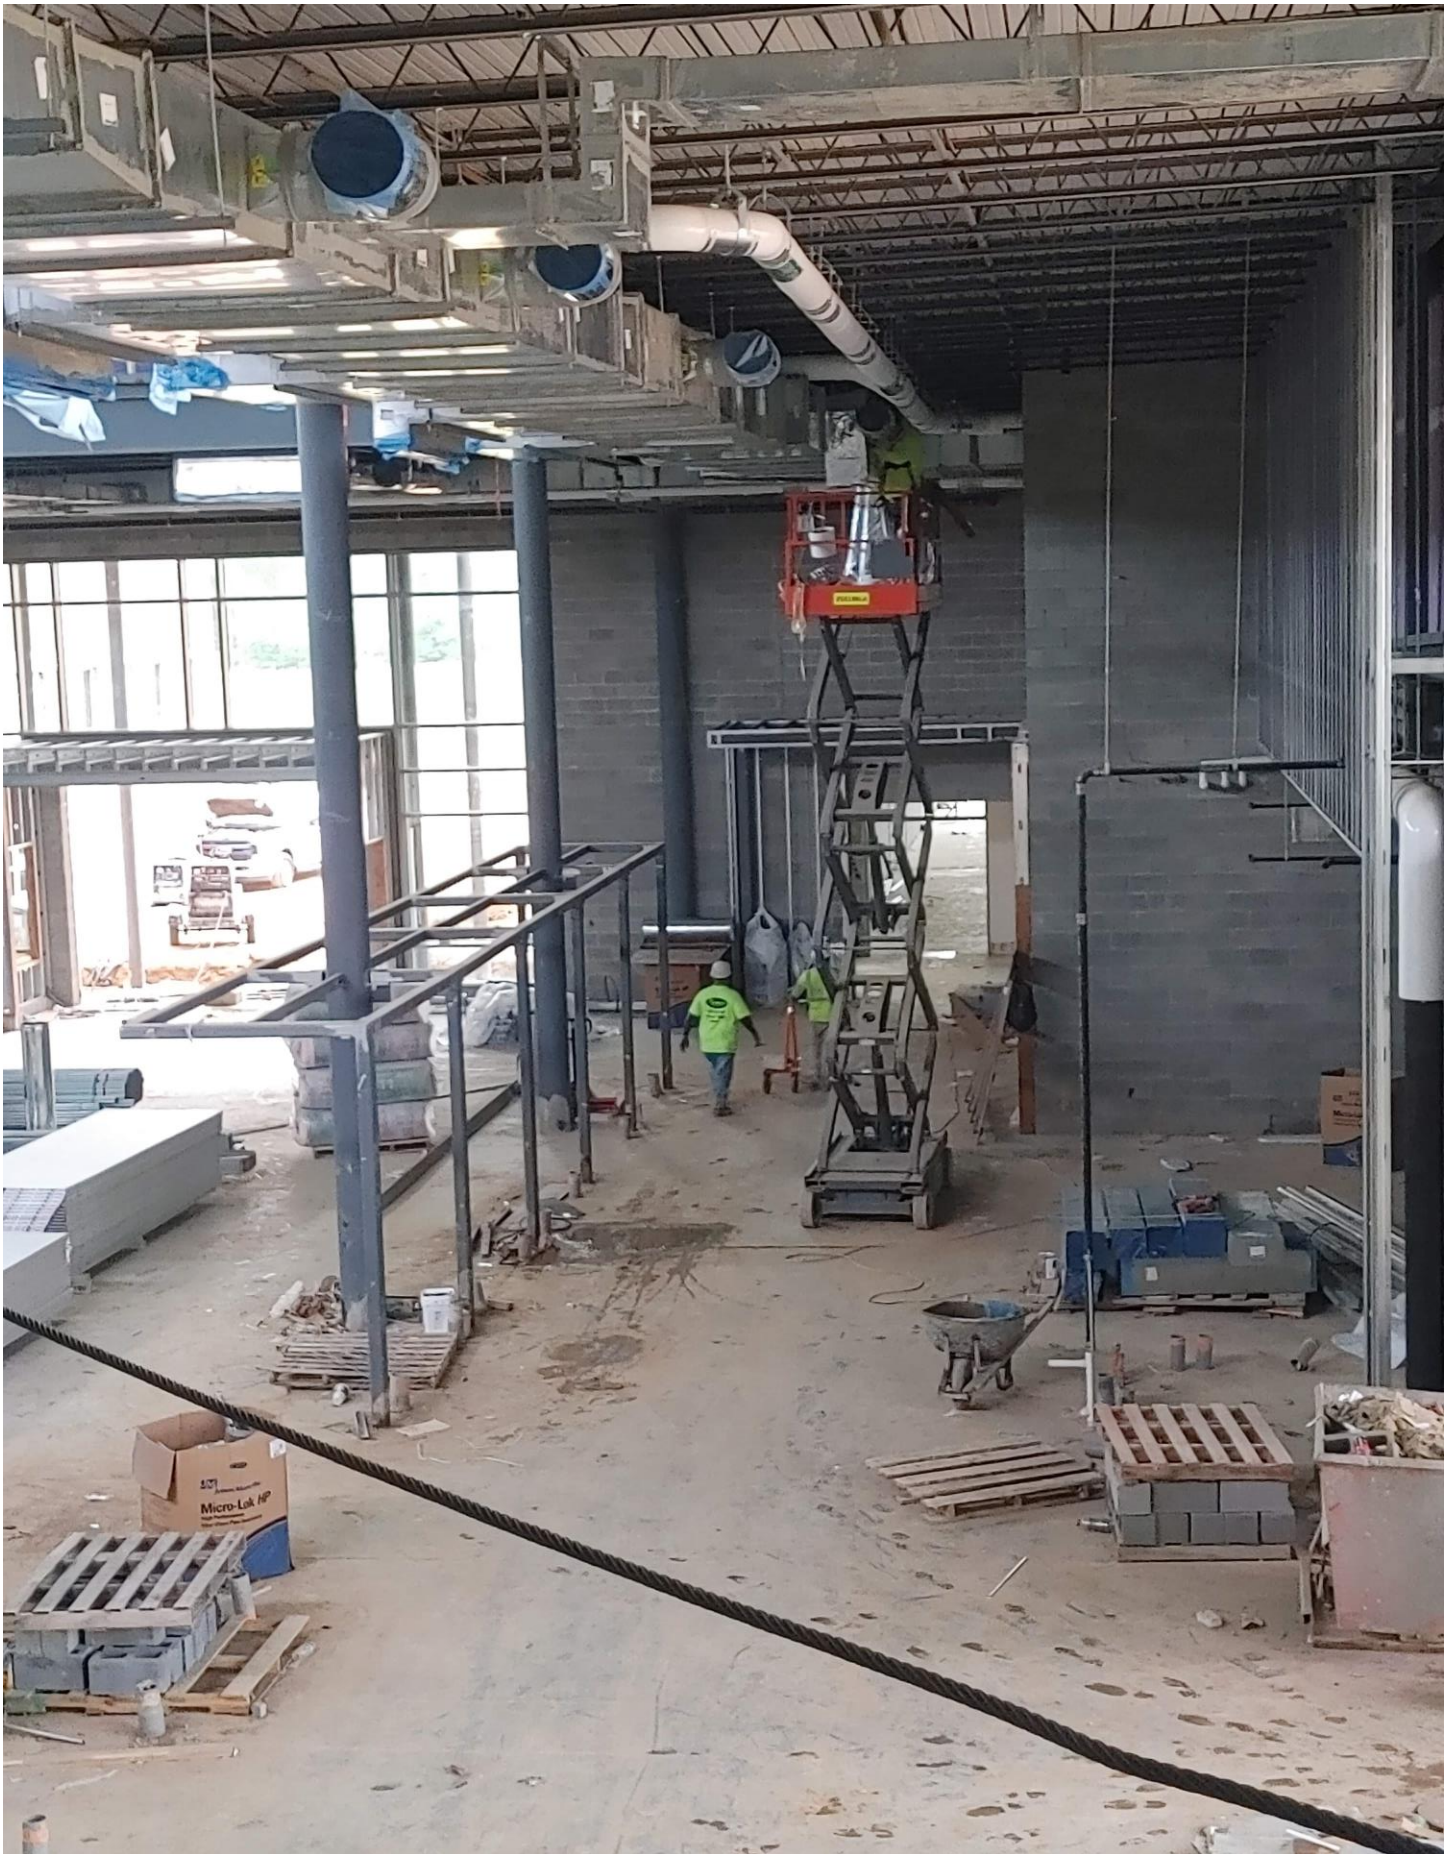
Photo 15 - HVAC Duct is being insulated in Area C.

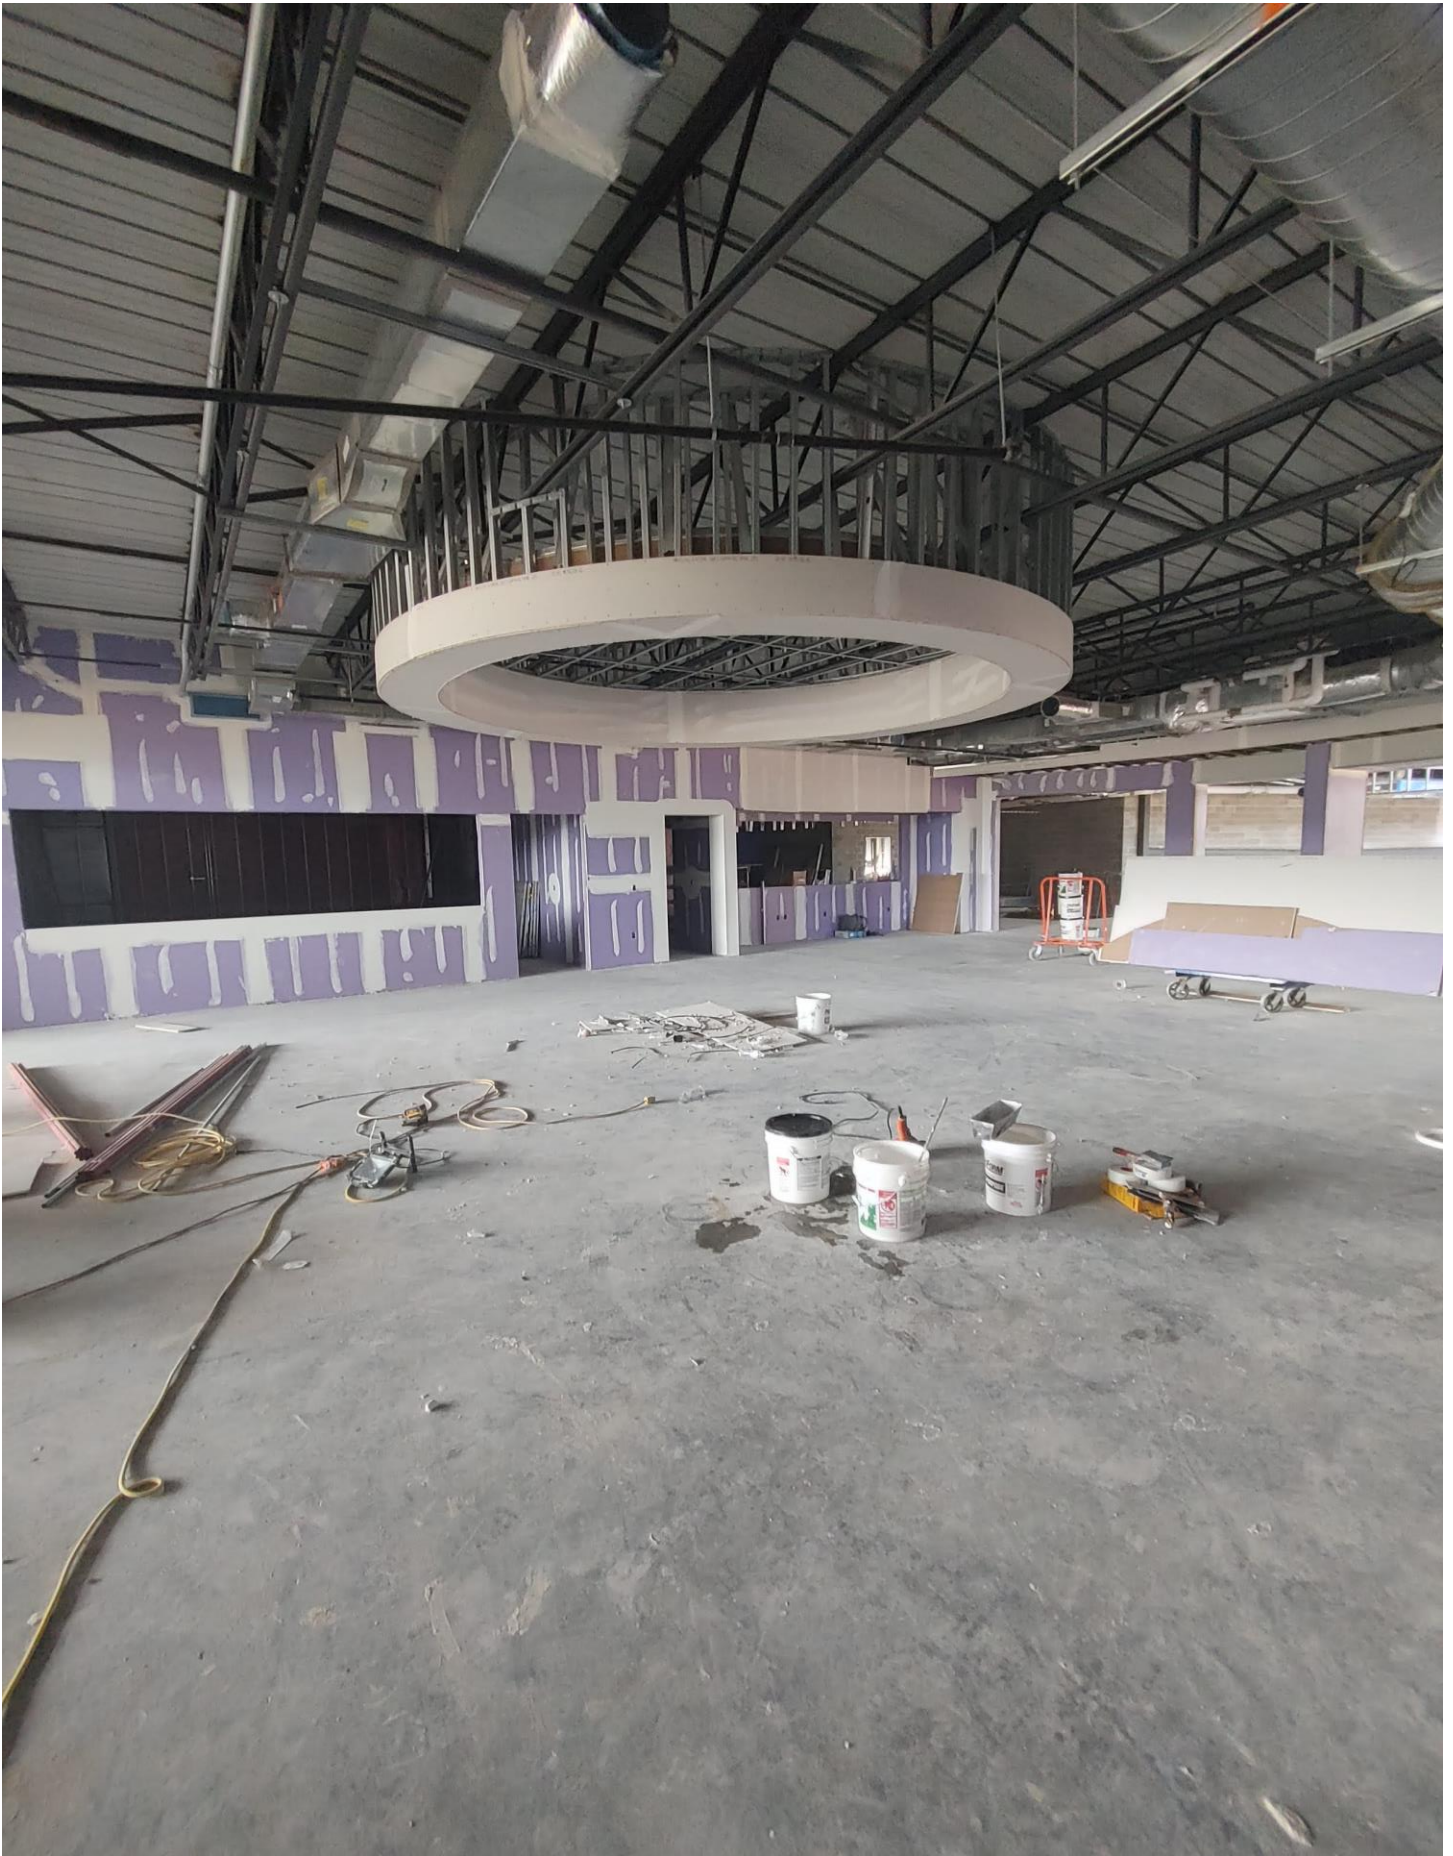
Photo 16 - Sheetrock continues to be hung and finished on the 2nd floor of Area A.
