**COMMONWEALTH
BUILDING SOLUTIONS, LLC**

FIELD REPORT

WESTMORELAND COUNTY HIGH SCHOOL

Date: 09/22/2021

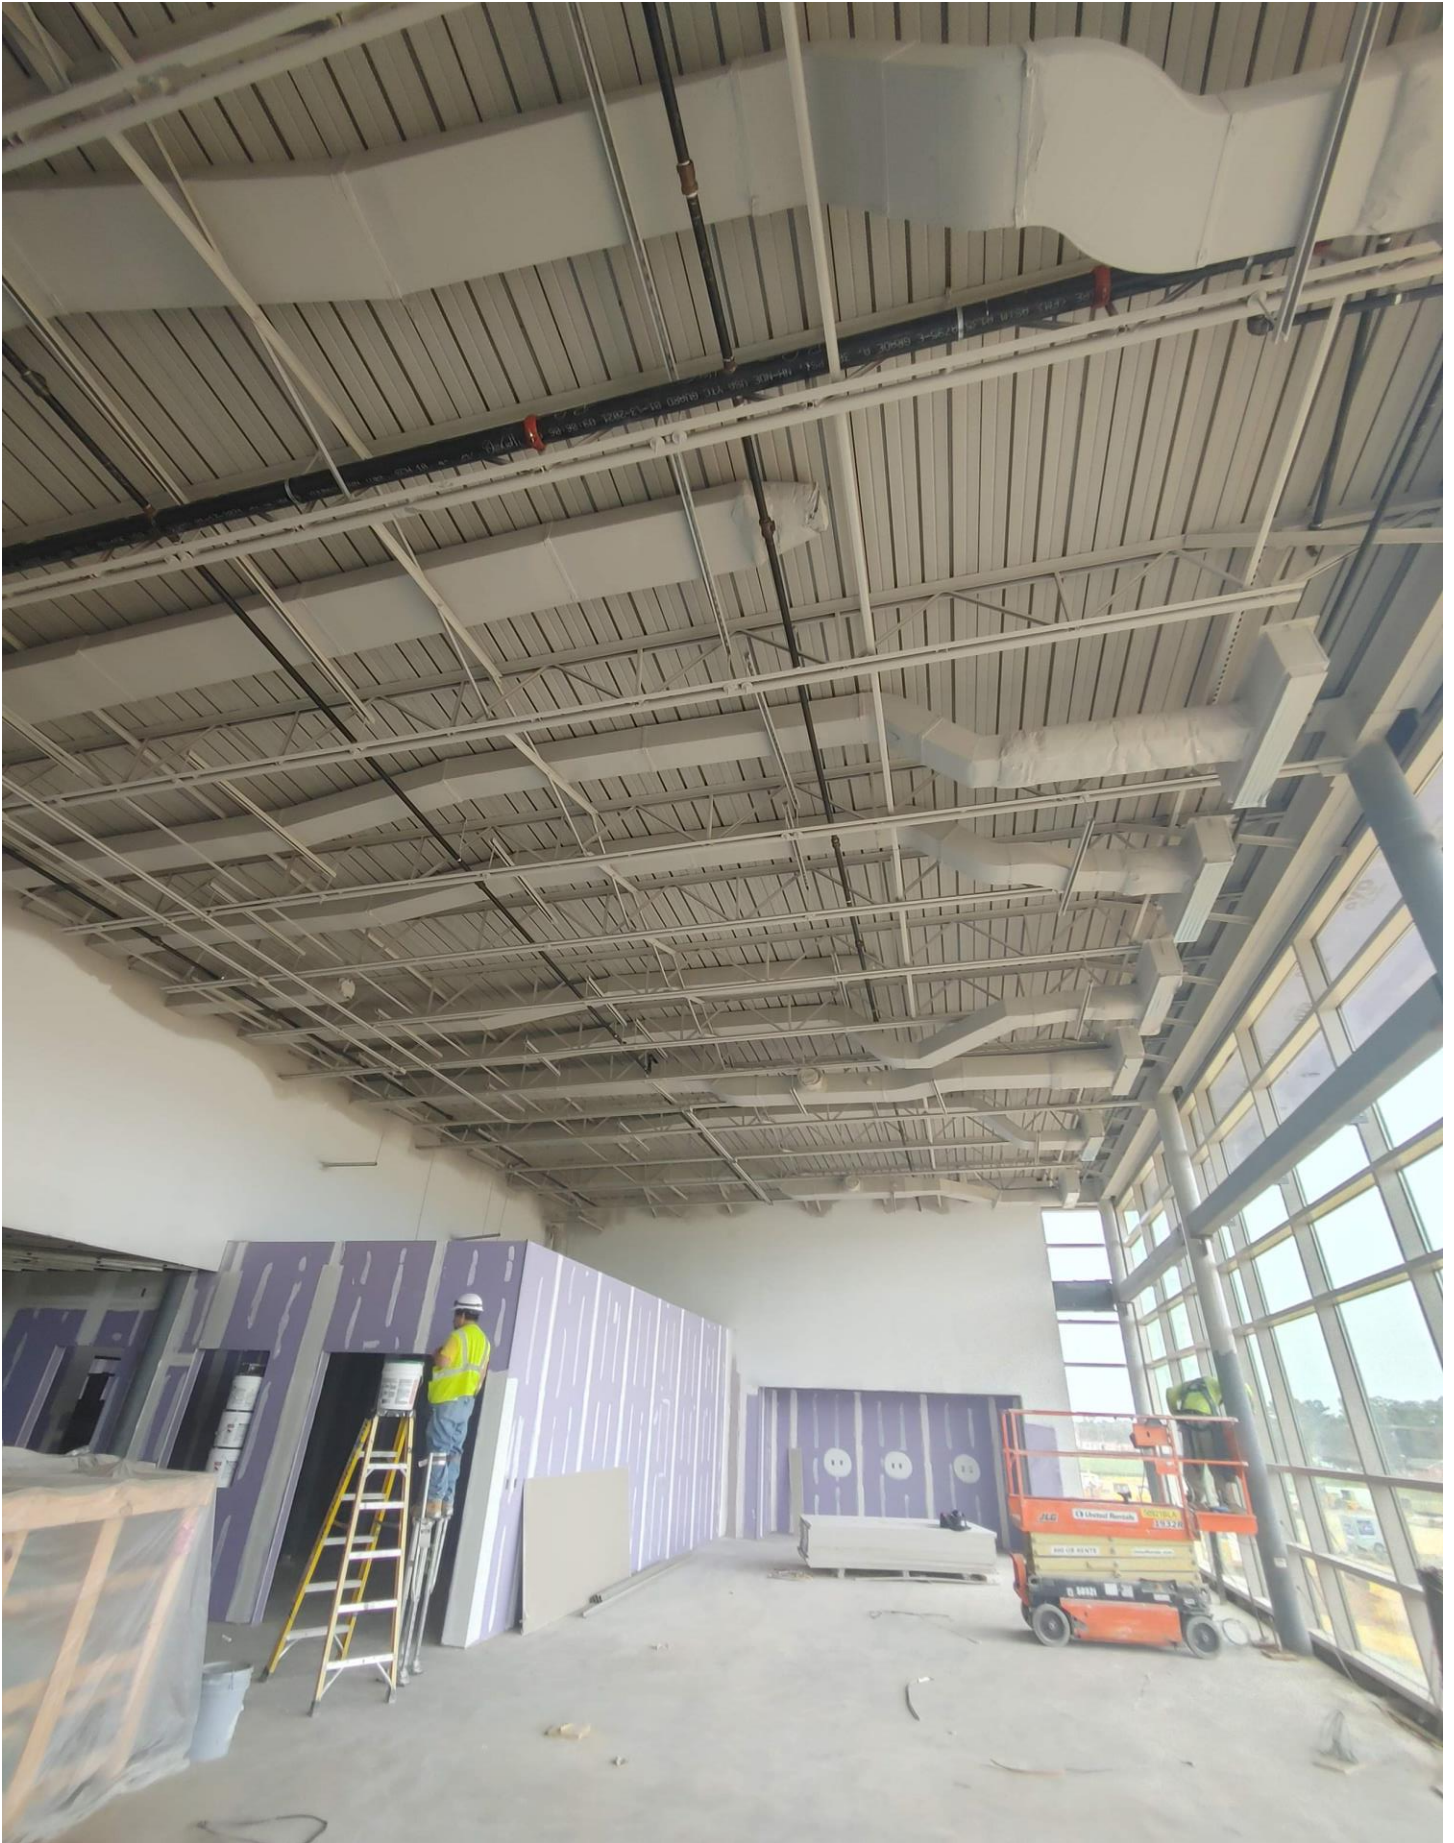
Photo 17 - Metal Deck and Duct has been sprayed in Area A.

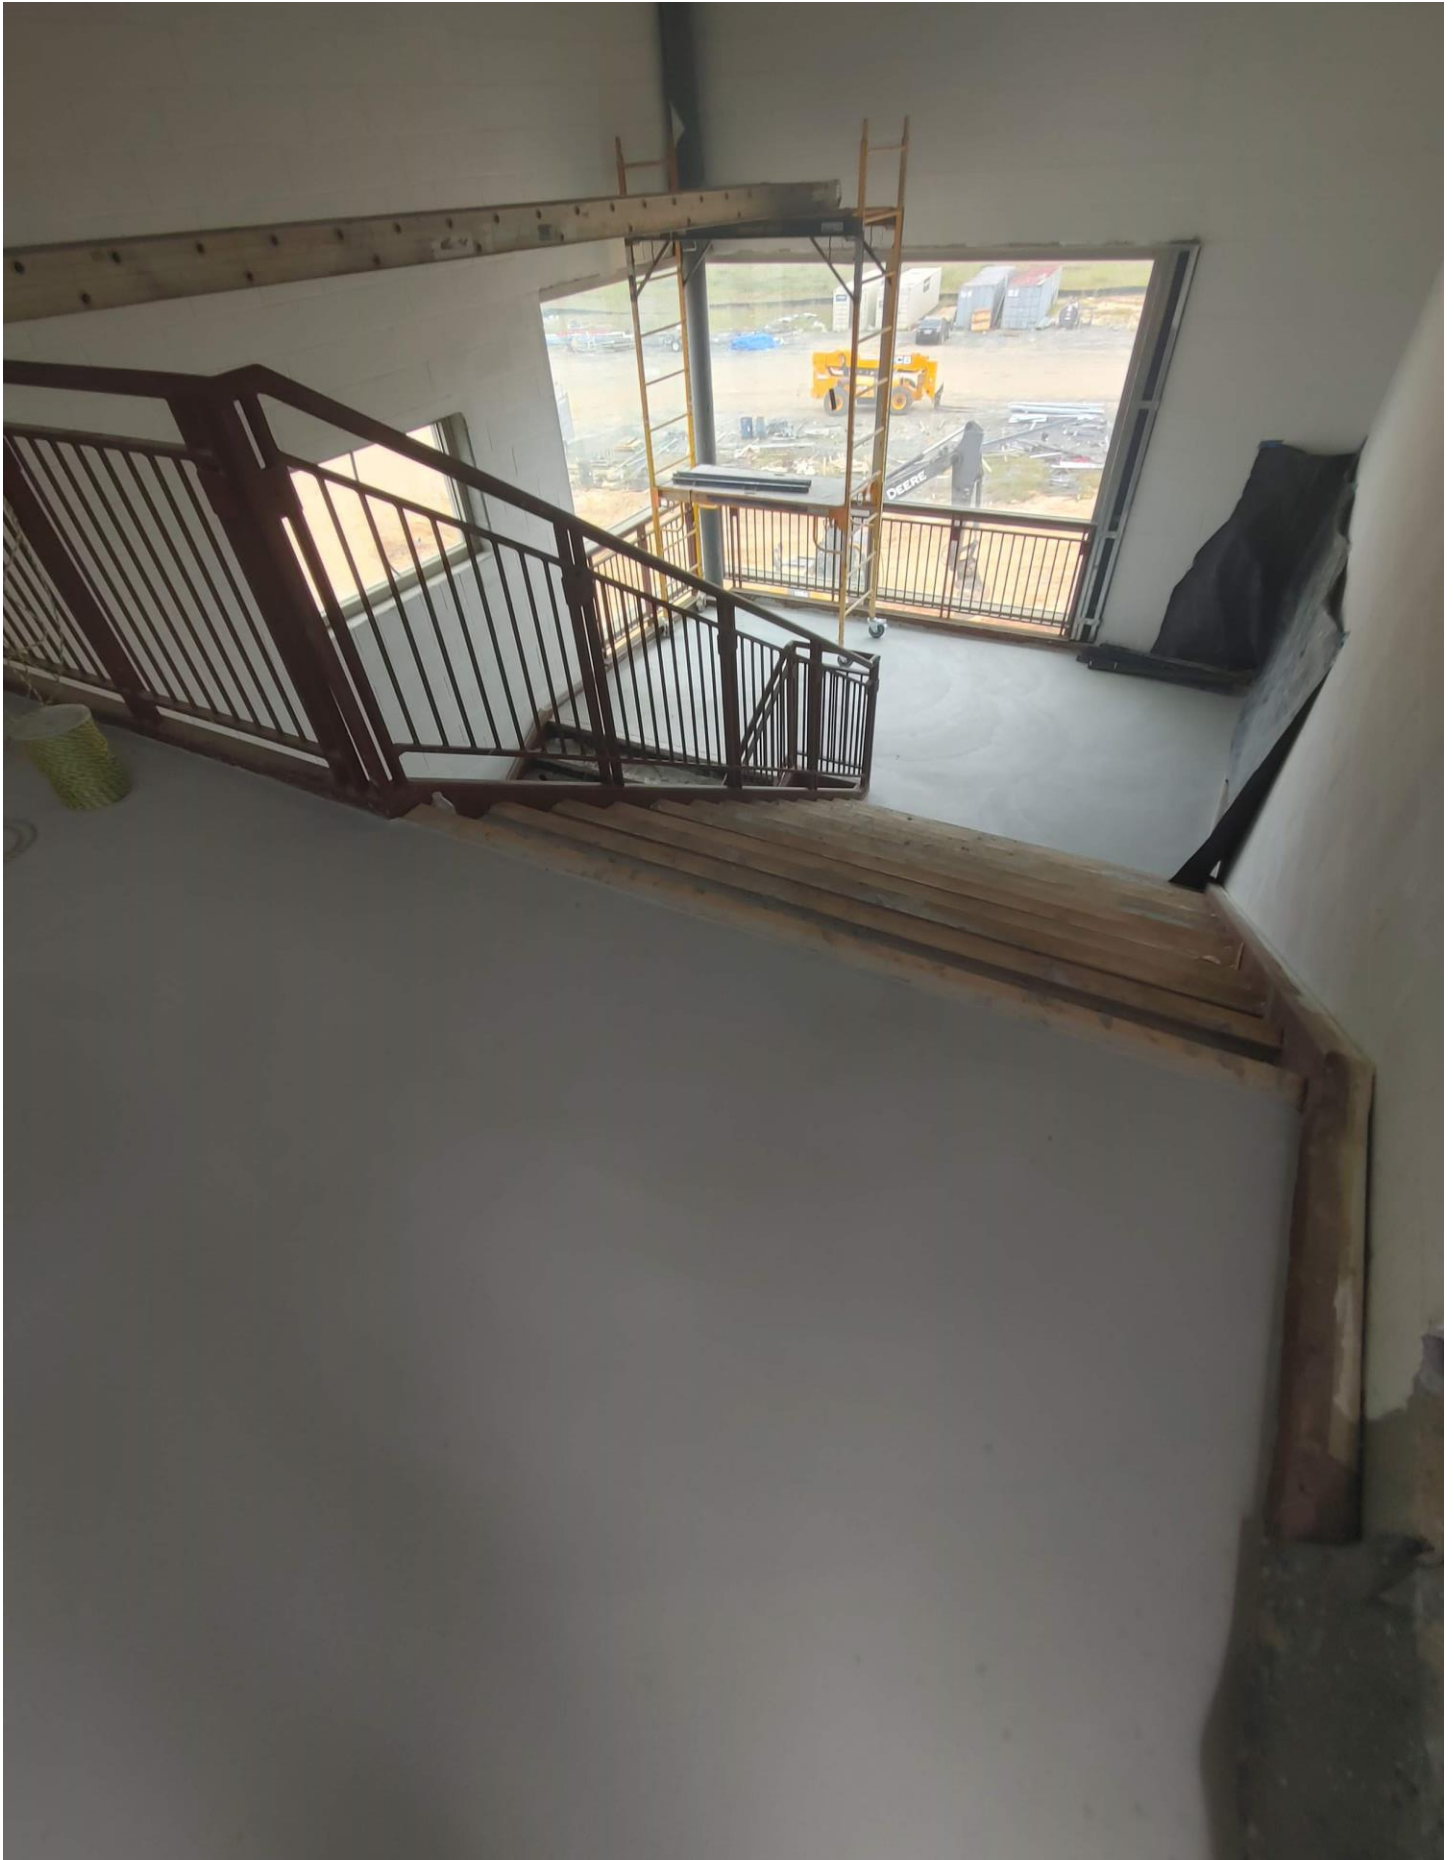
Photo 18 - All of the landings in Stairwell #2 have been poured. Two of the three landings have been poured in Stairwell #1.

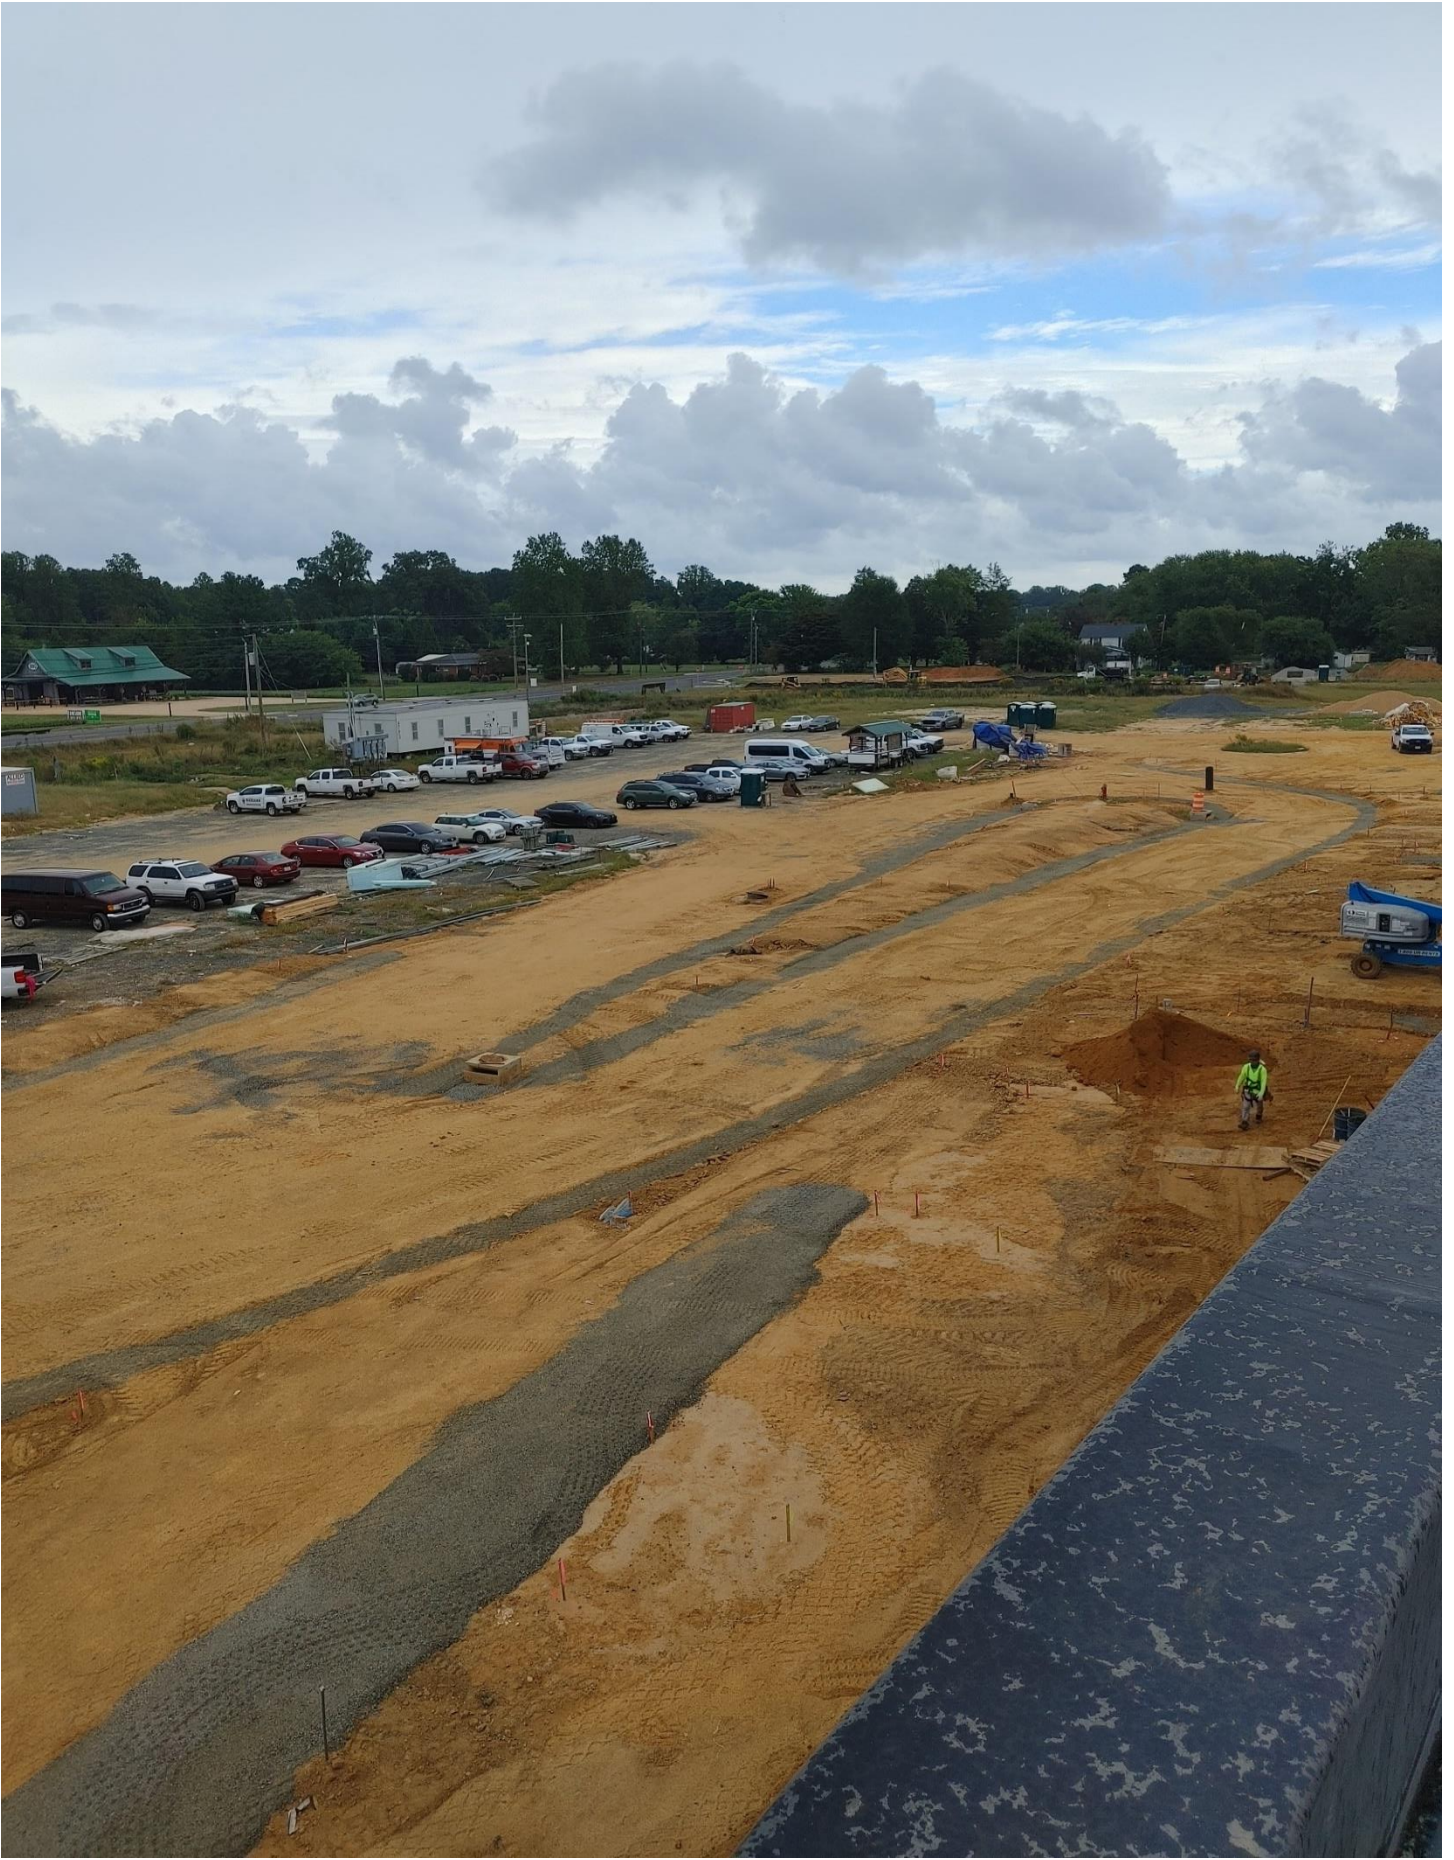
Photo 19 - Drive lane and drop off loop has been rough graded. Stone has been placed for curb and gutter.

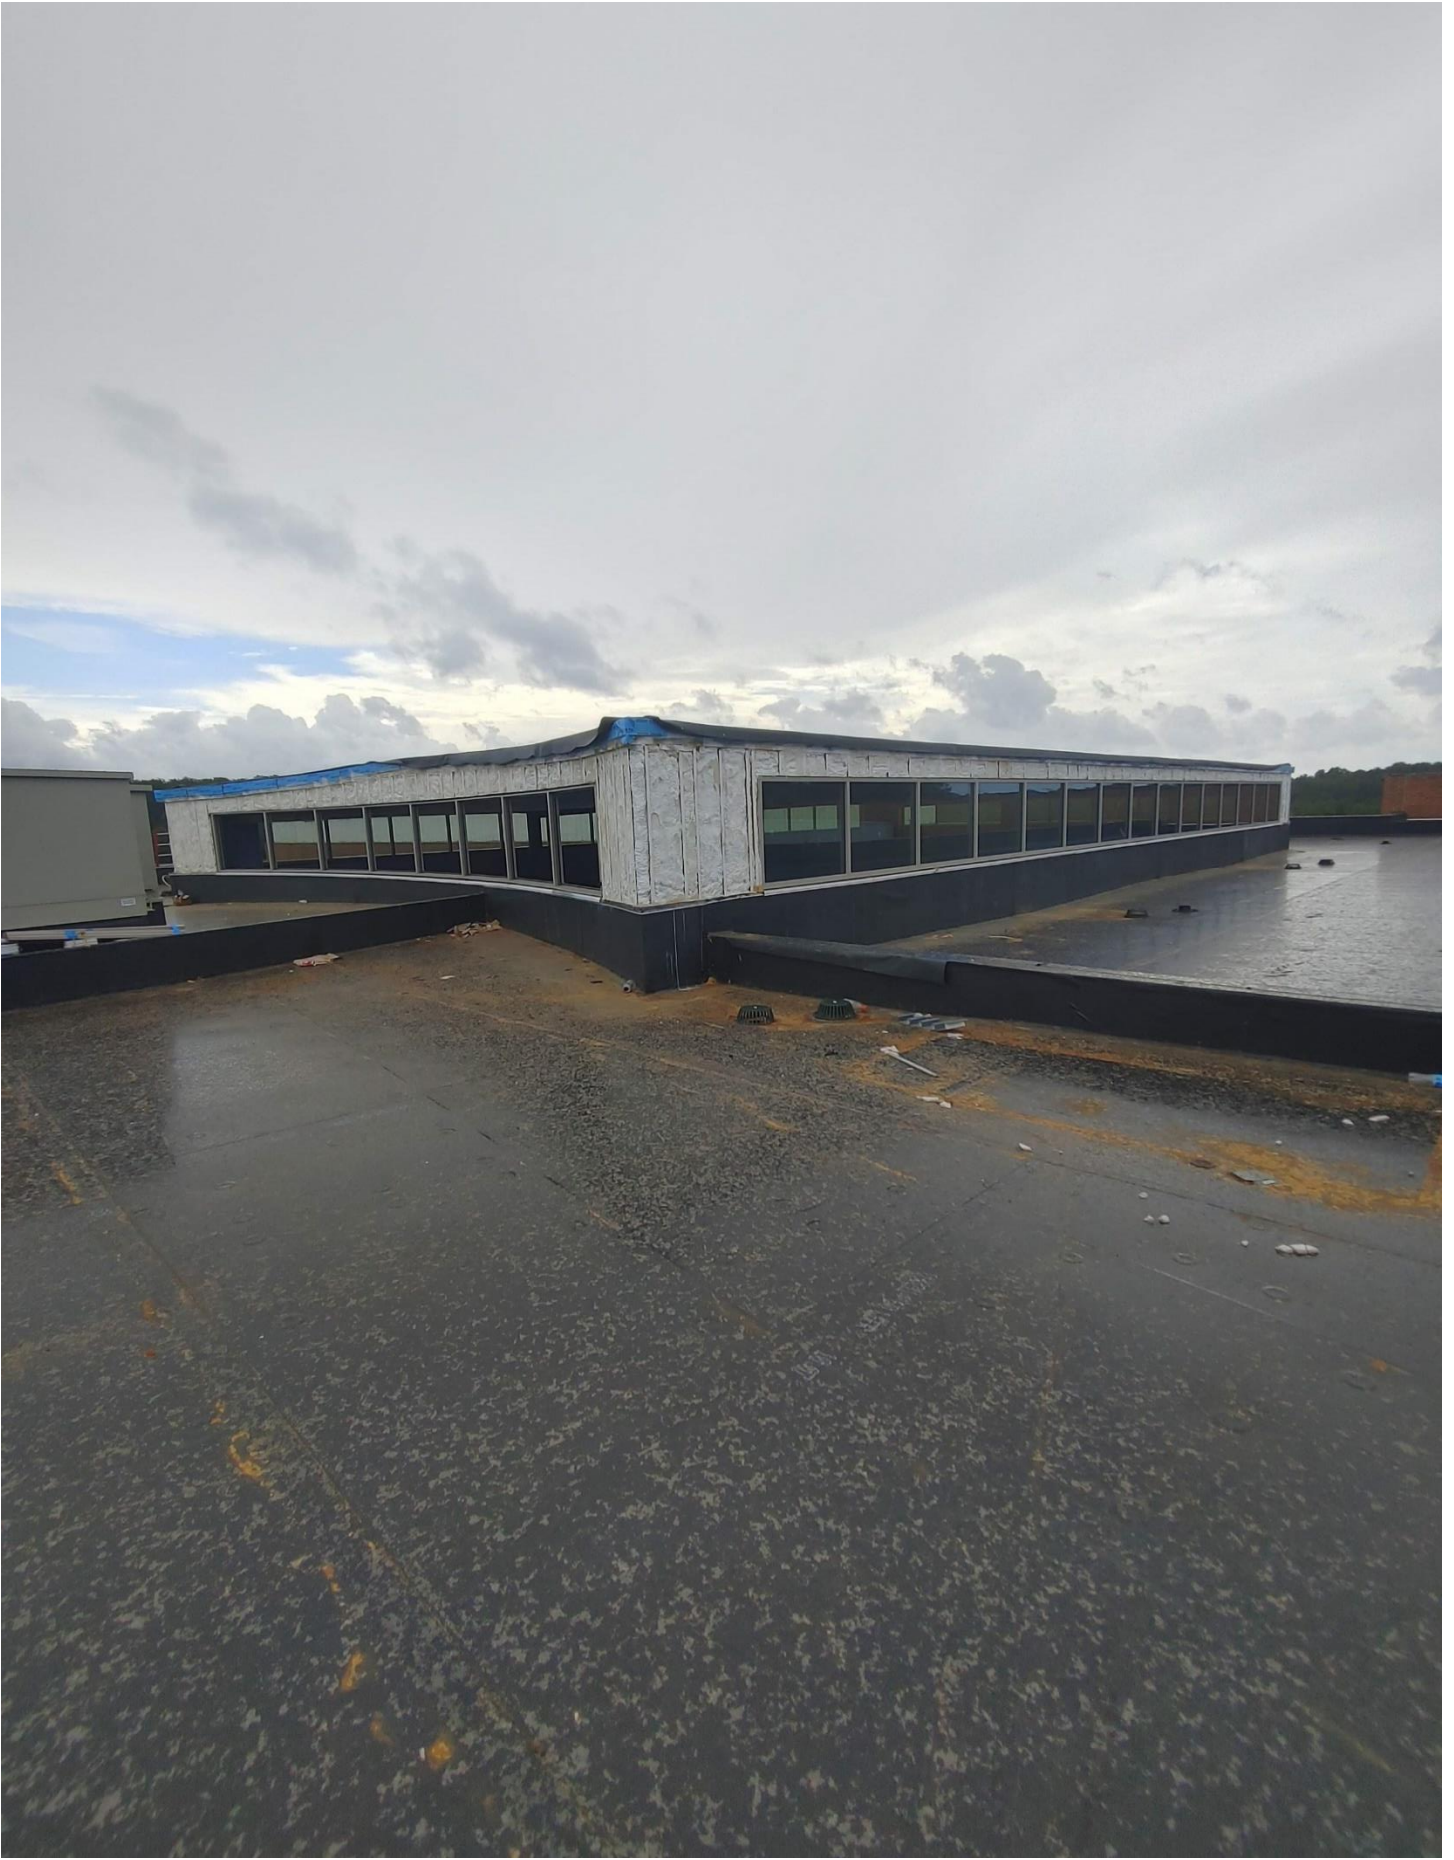
Photo 21 - Glass has been installed in three of the four sides of Area C.
