**COMMONWEALTH  
BUILDING SOLUTIONS, LLC**

**FIELD REPORT**

**WESTMORELAND COUNTY HIGH SCHOOL**

Date: 09/28/2021

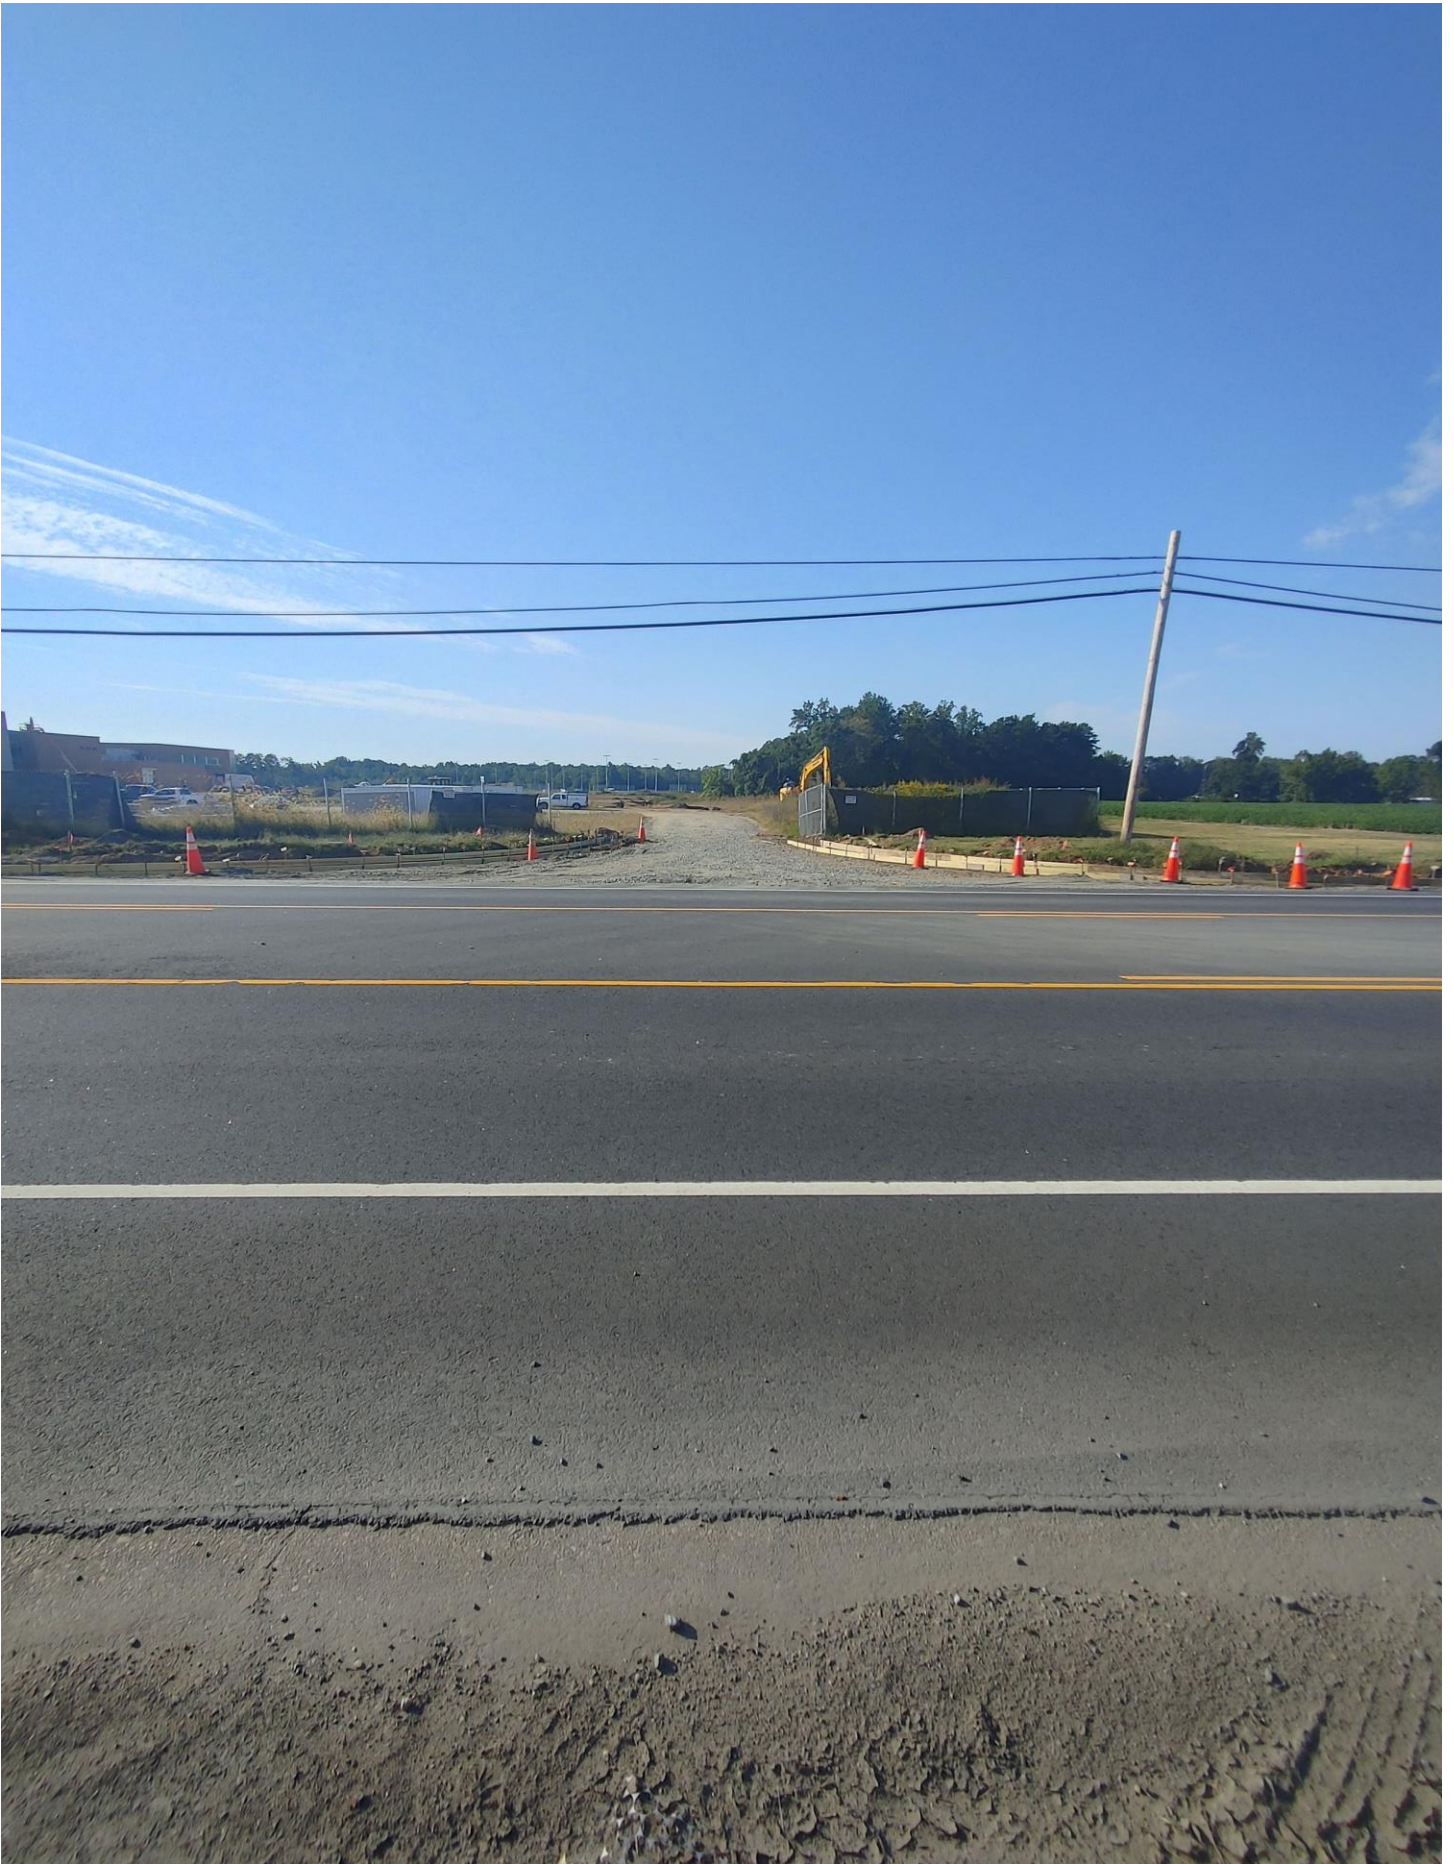
Photo 1 - Bus Loop Entrance Curb & Gutter is being formed

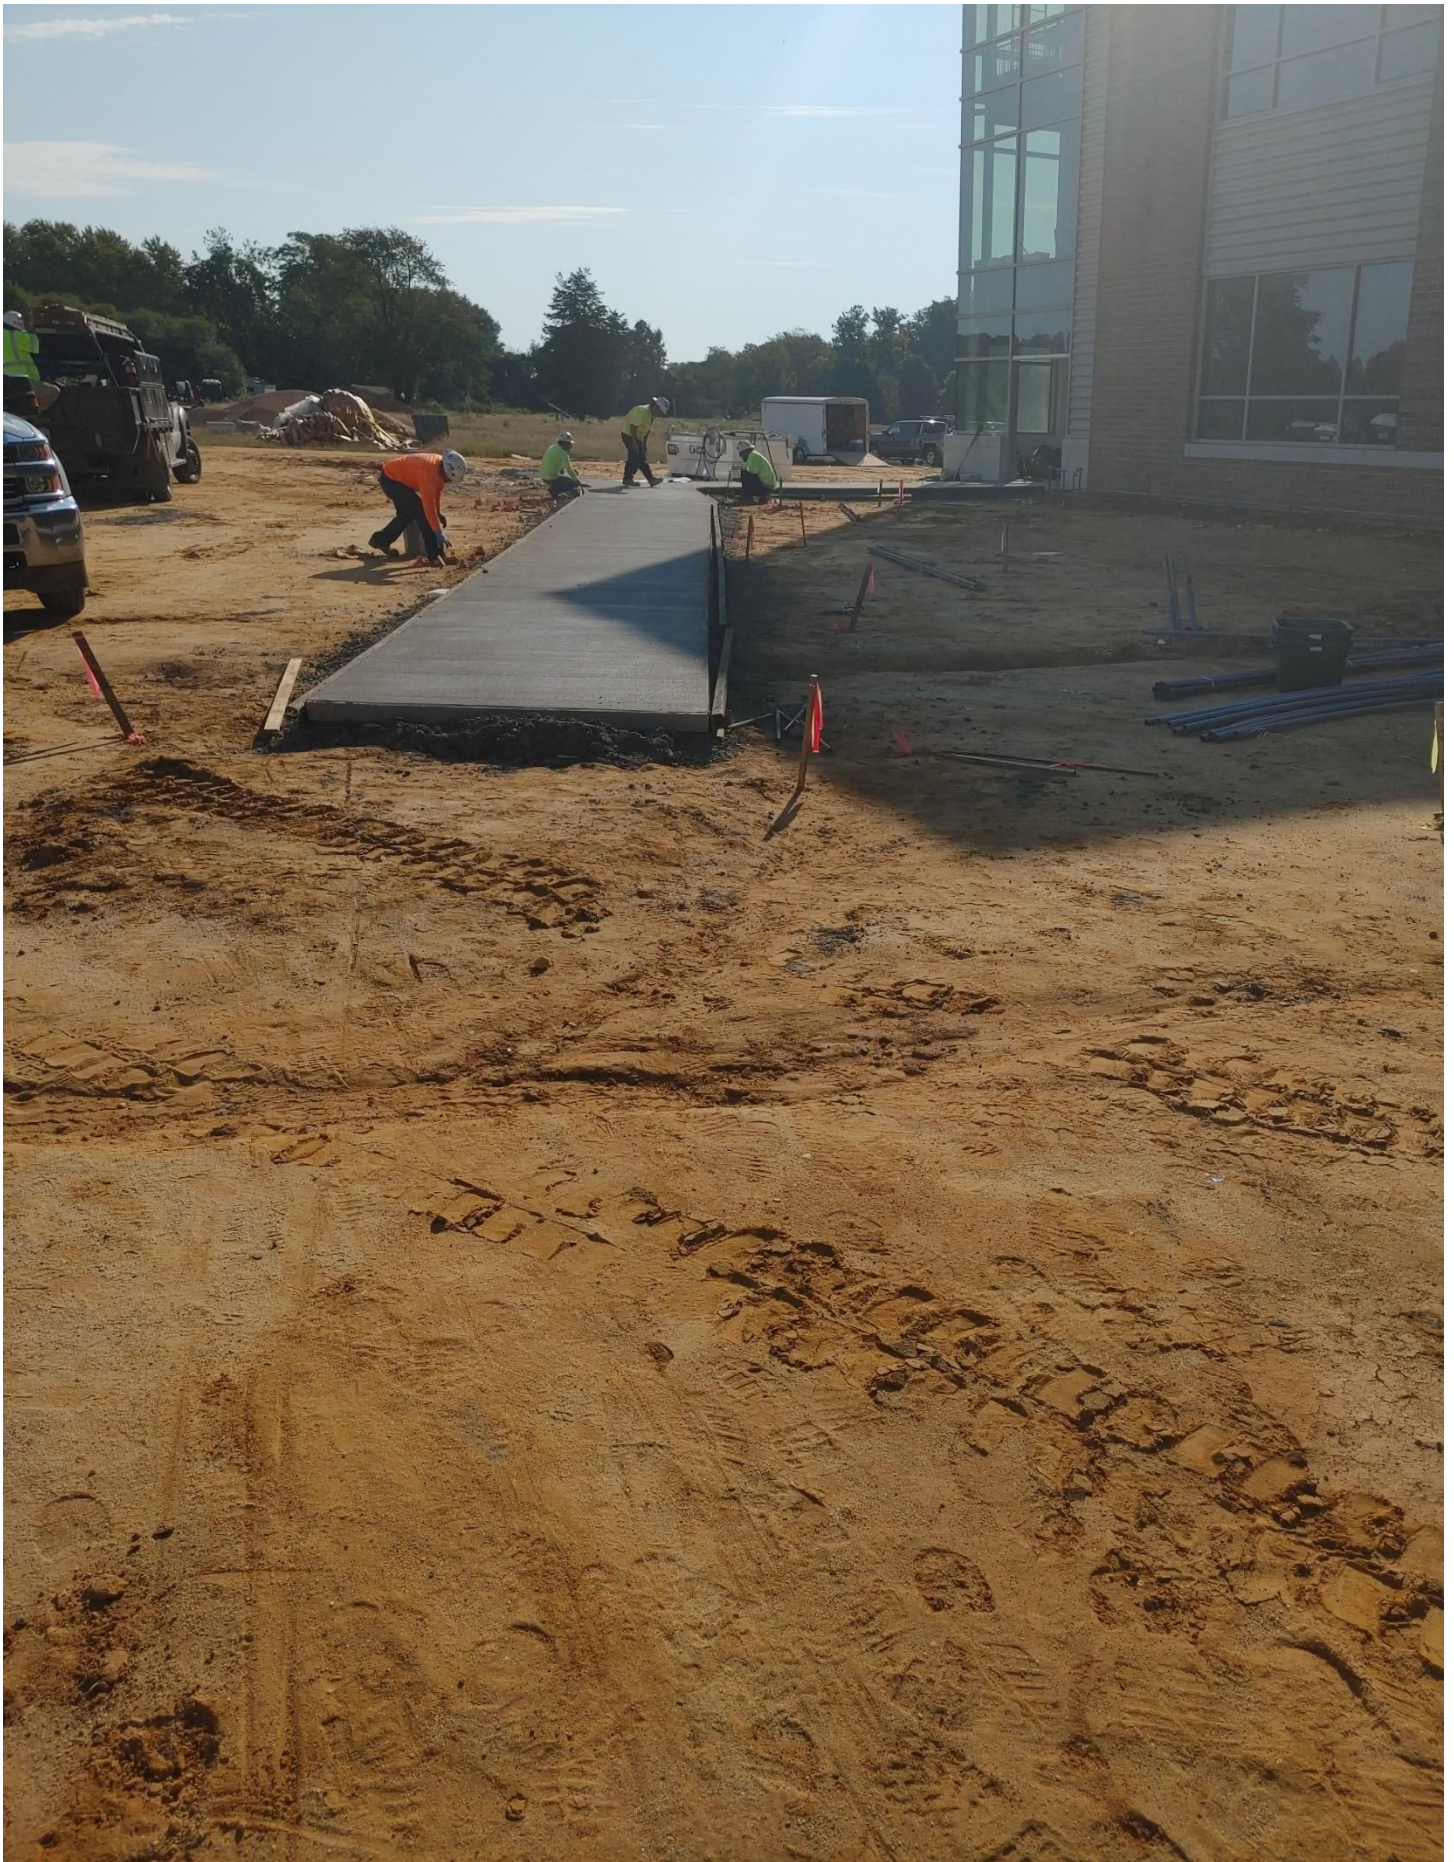
Photo 2 - Sidewalk is being poured in front of Area A.

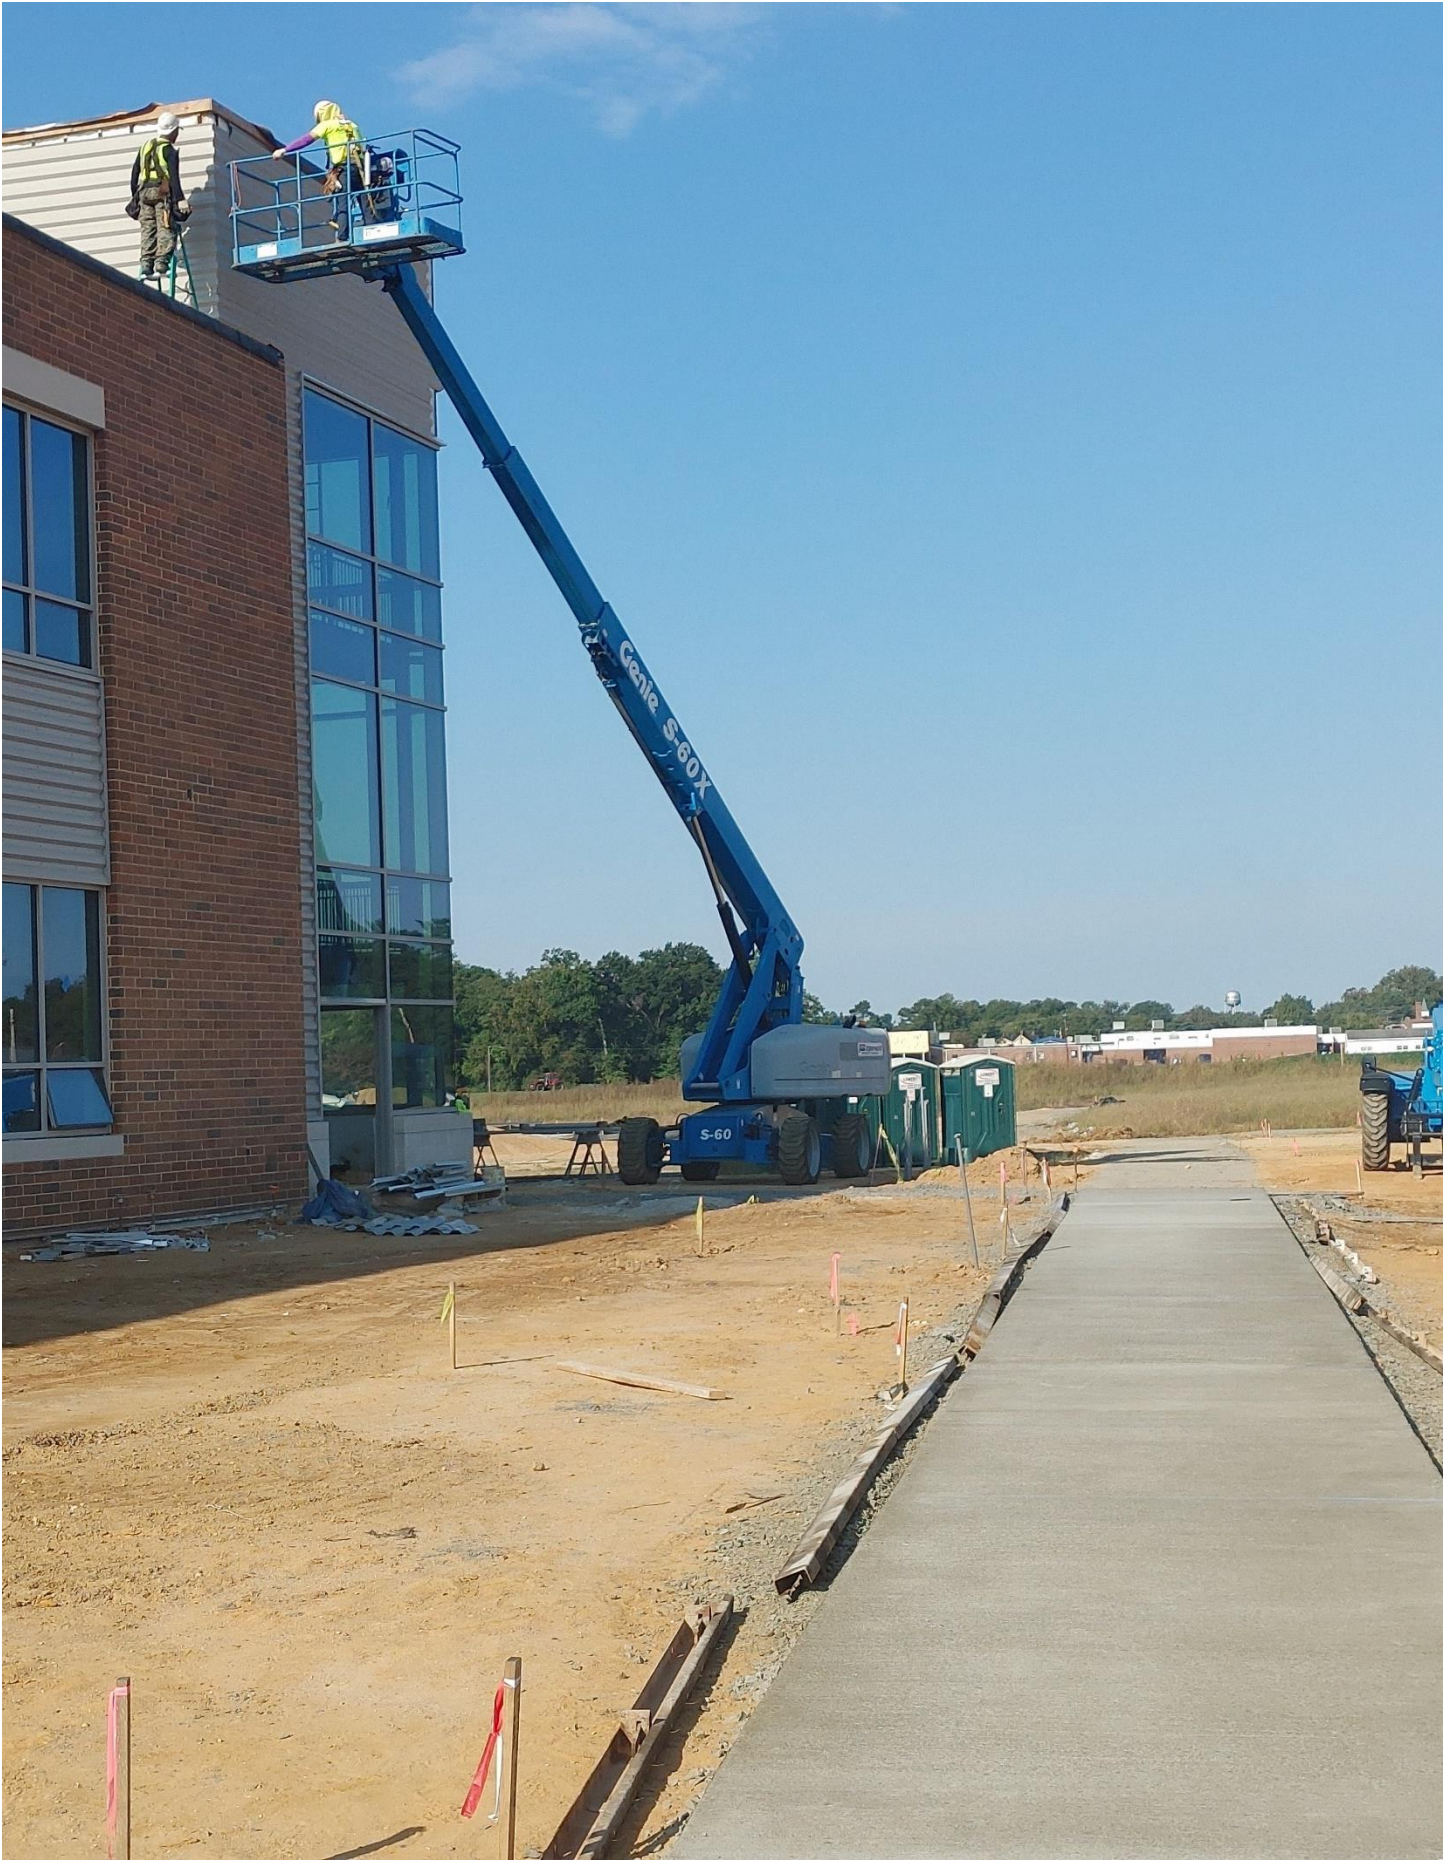
Photo 3 - Sidewalk poured in front of Area B and Metal Panels are being installed.

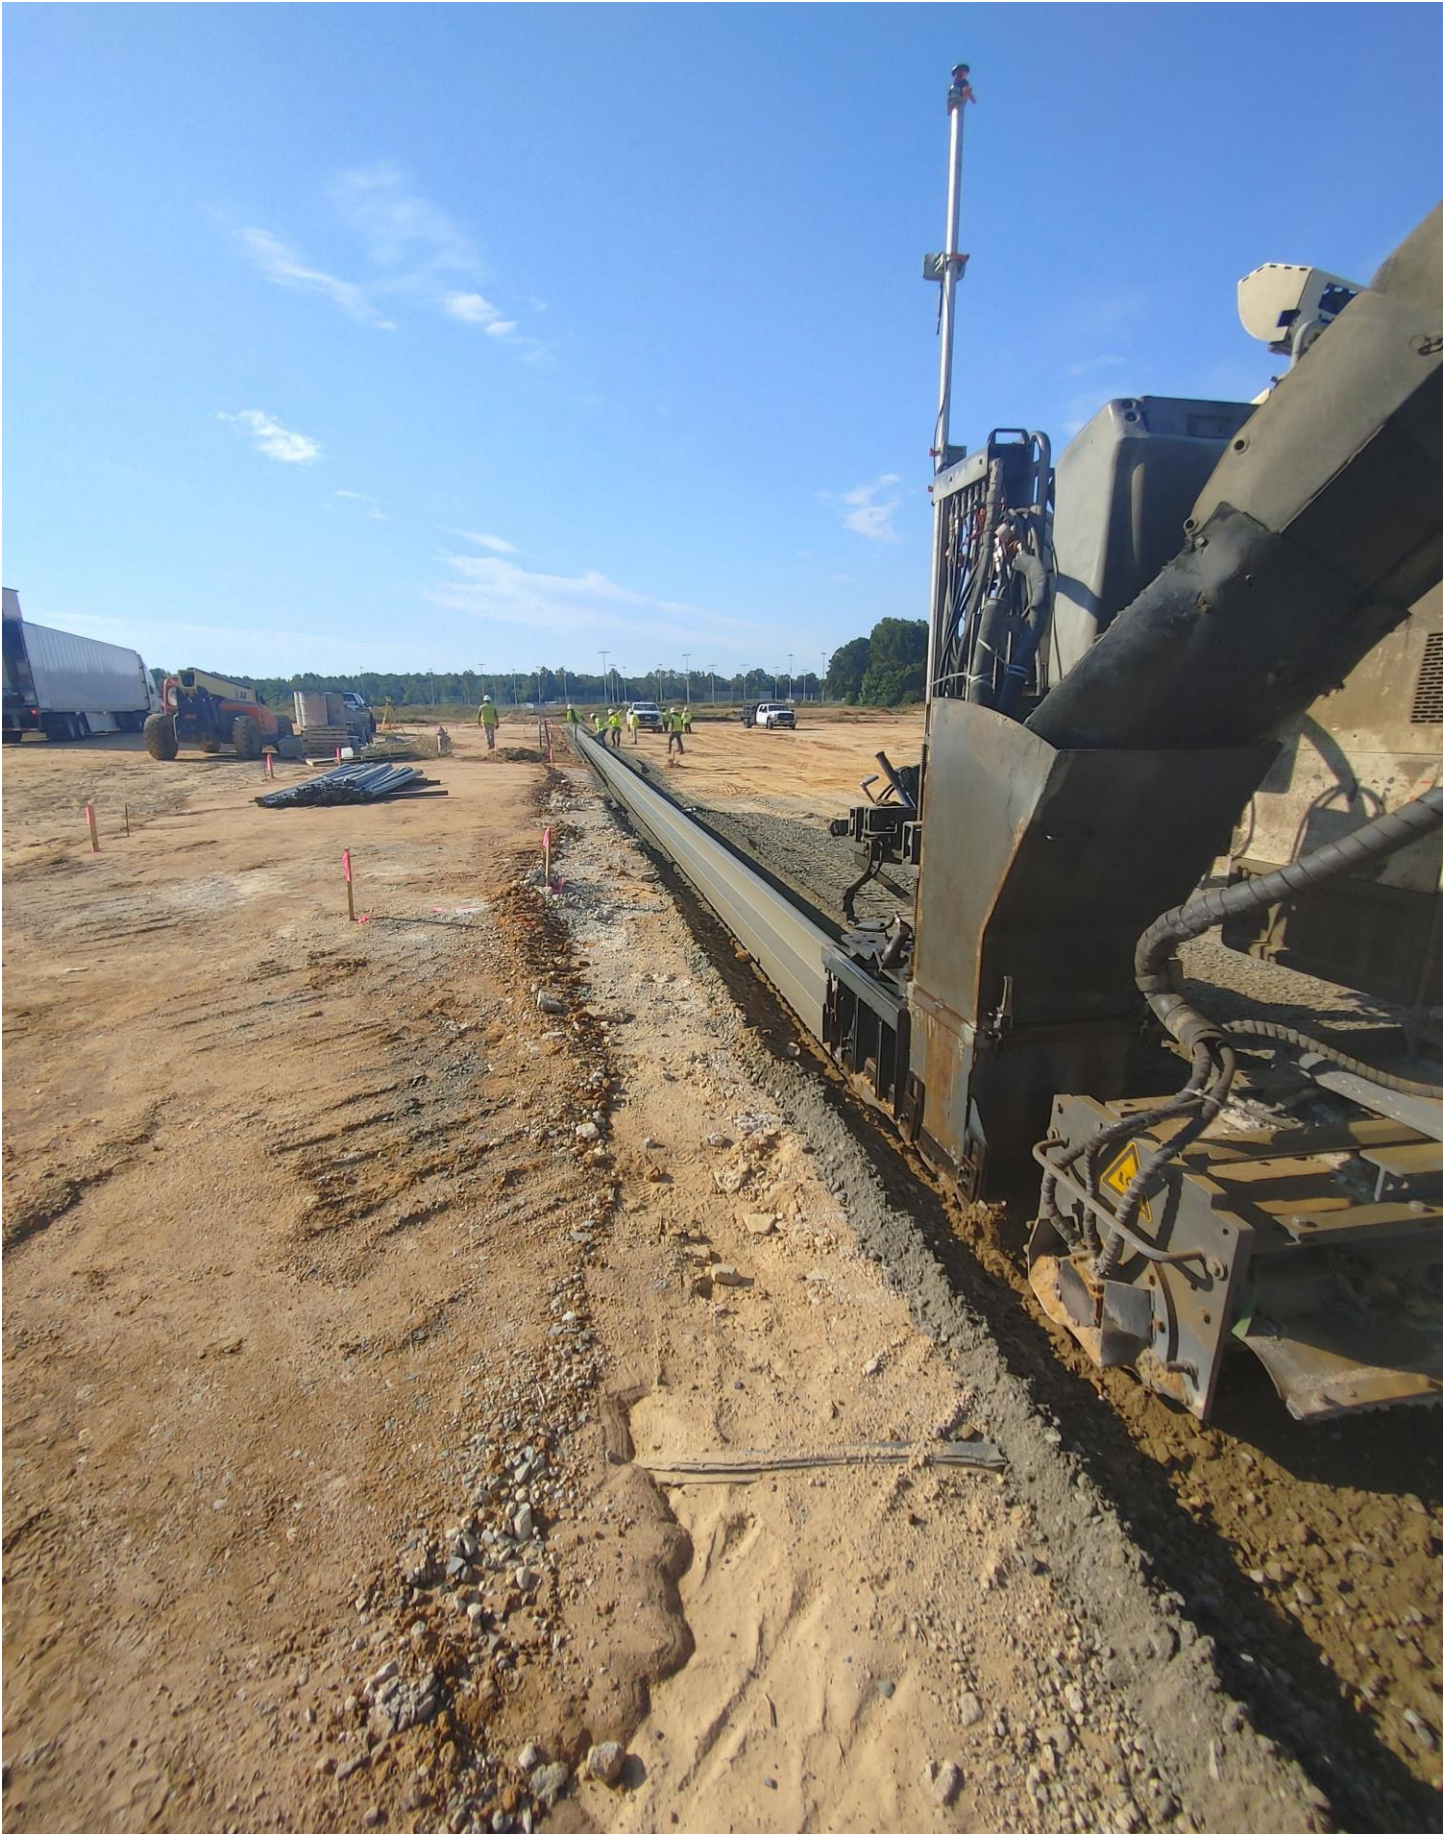
Photo 4 - Curb is being poured in the Bus Loop area.

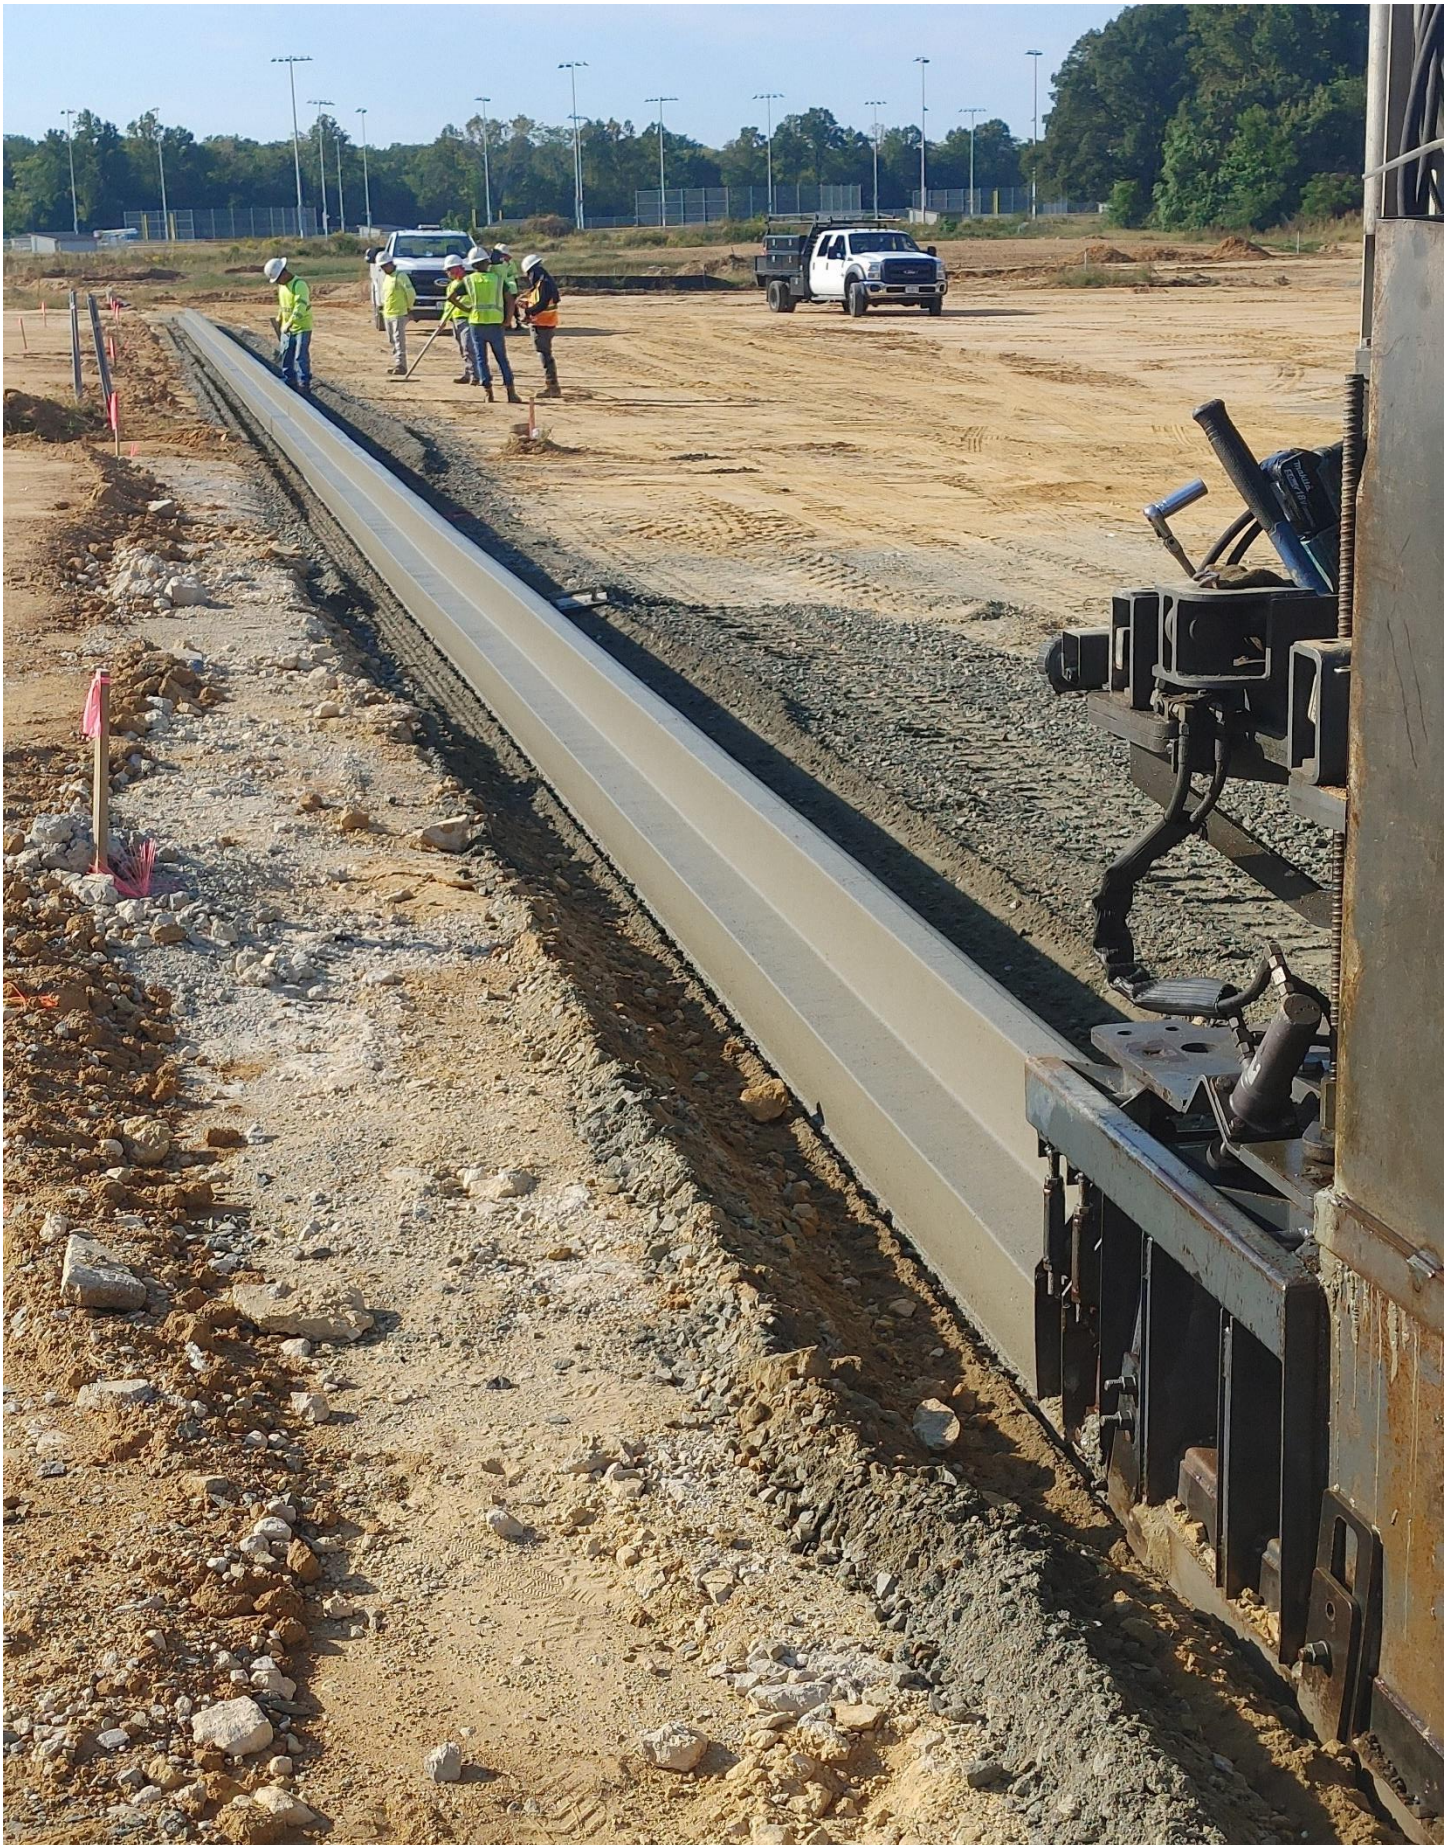
Photo 5 - Curb is being poured in the Bus Loop Area.

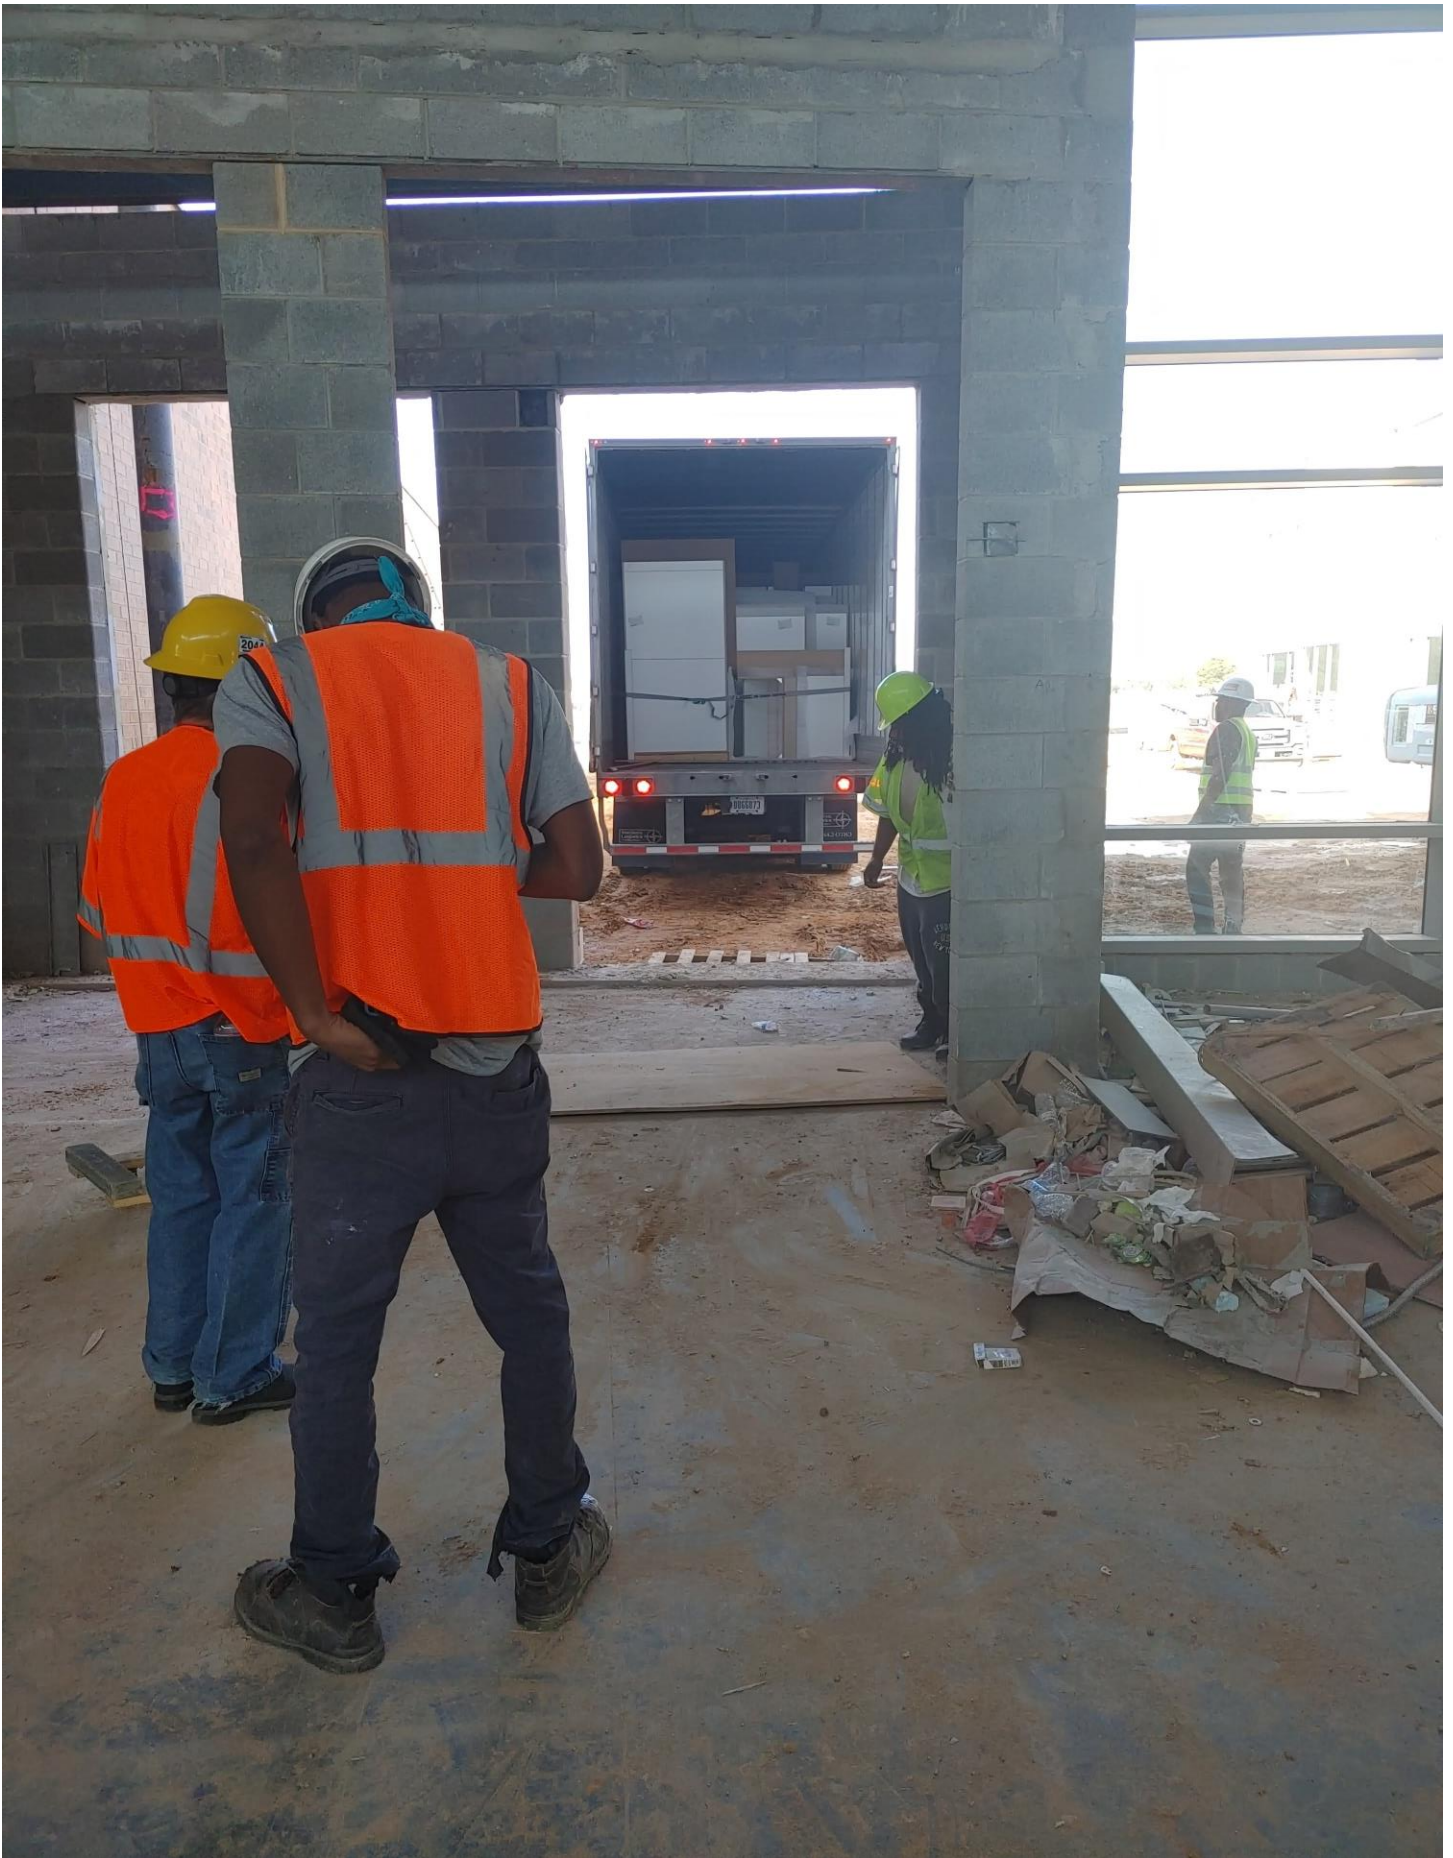
Photo 6 - Millwork delivery is being unloaded.

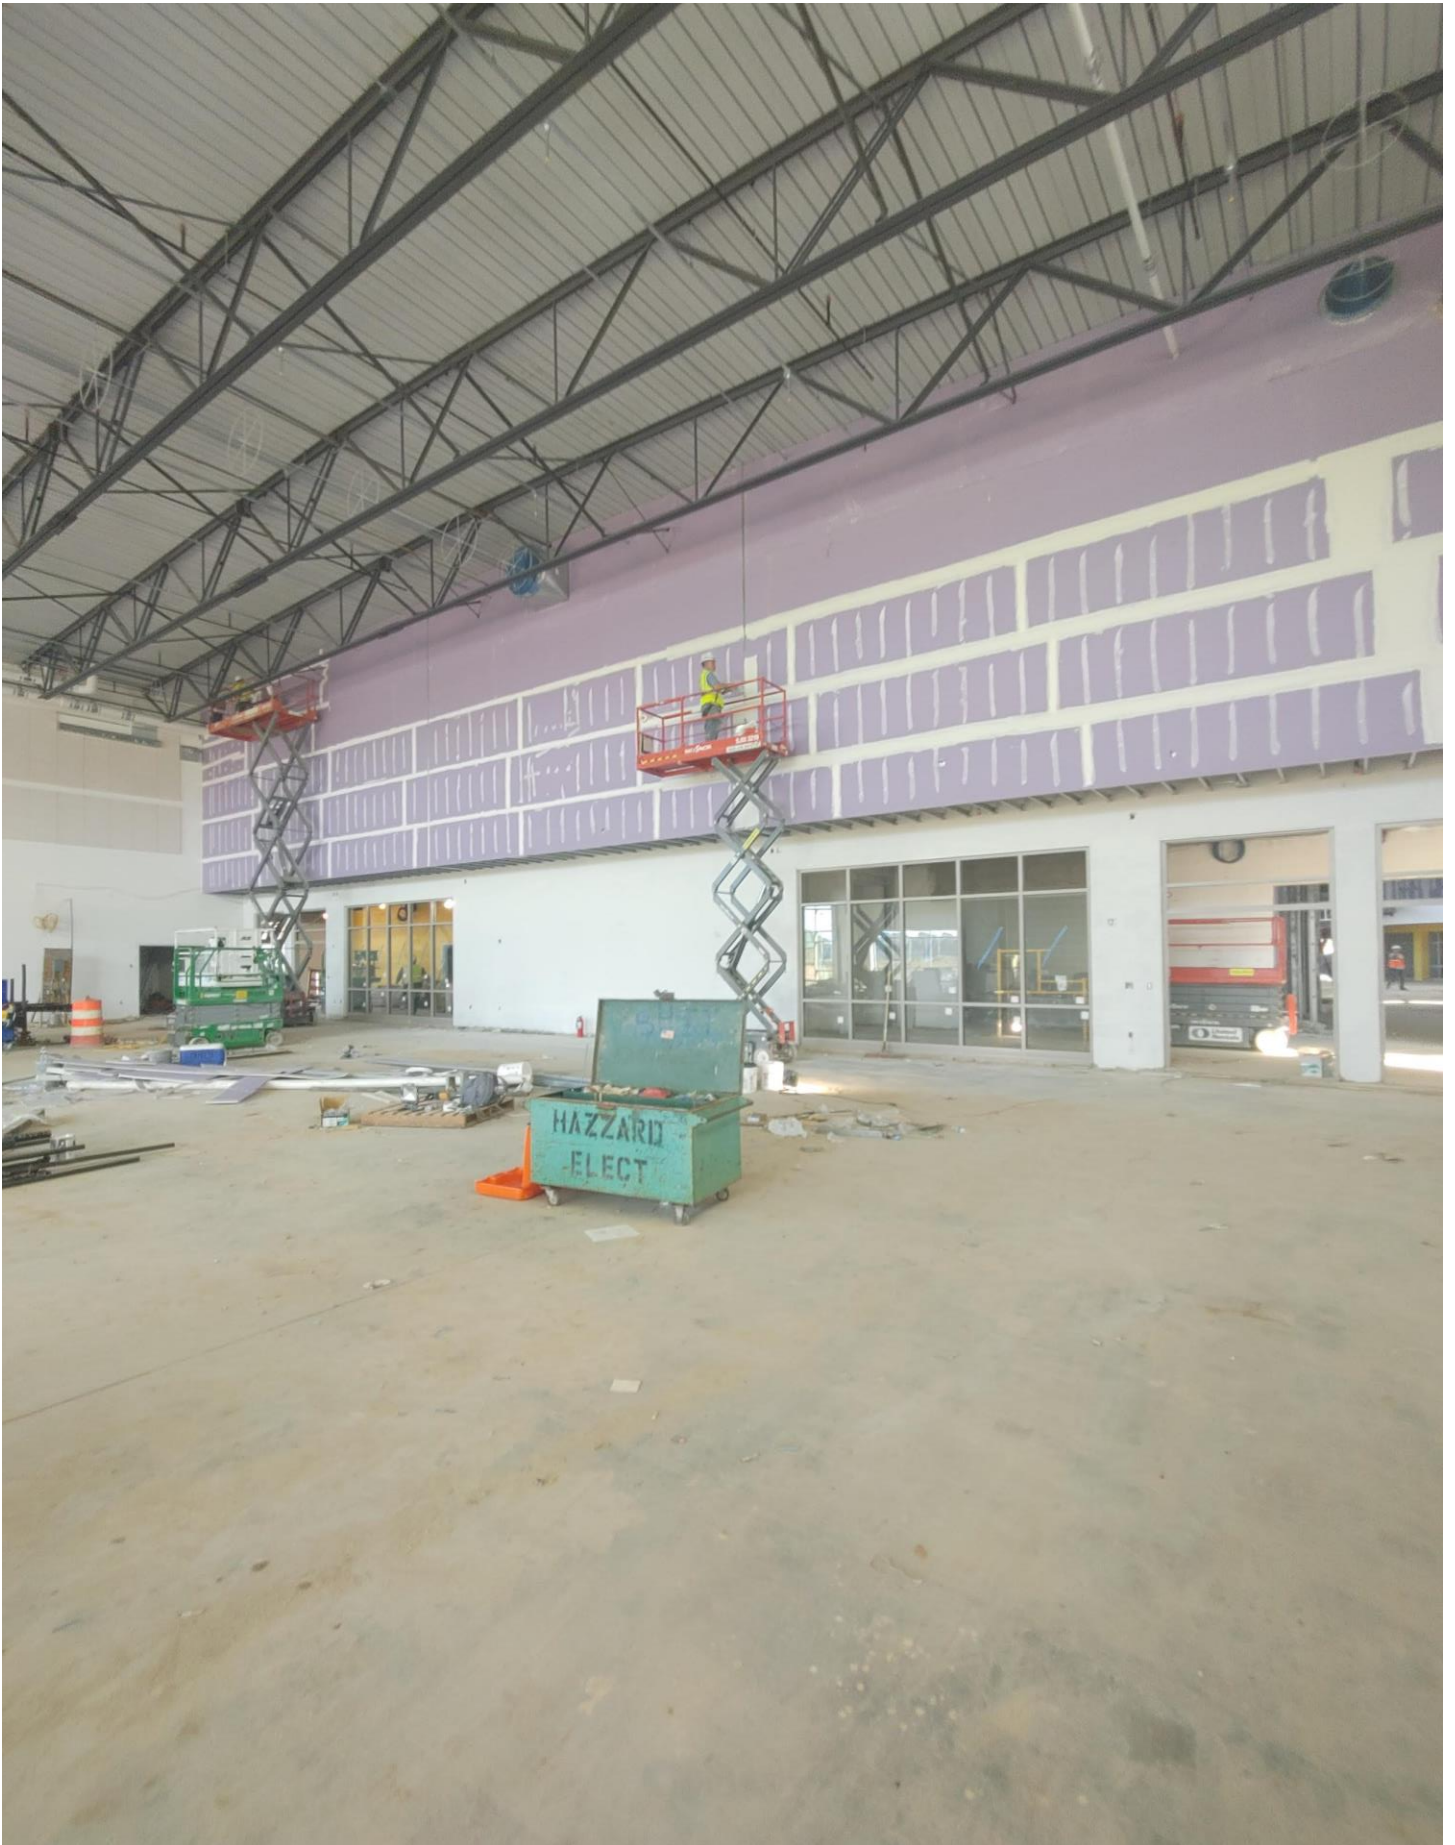
Photo 7 - Sheetrock is being finished in the Gym.

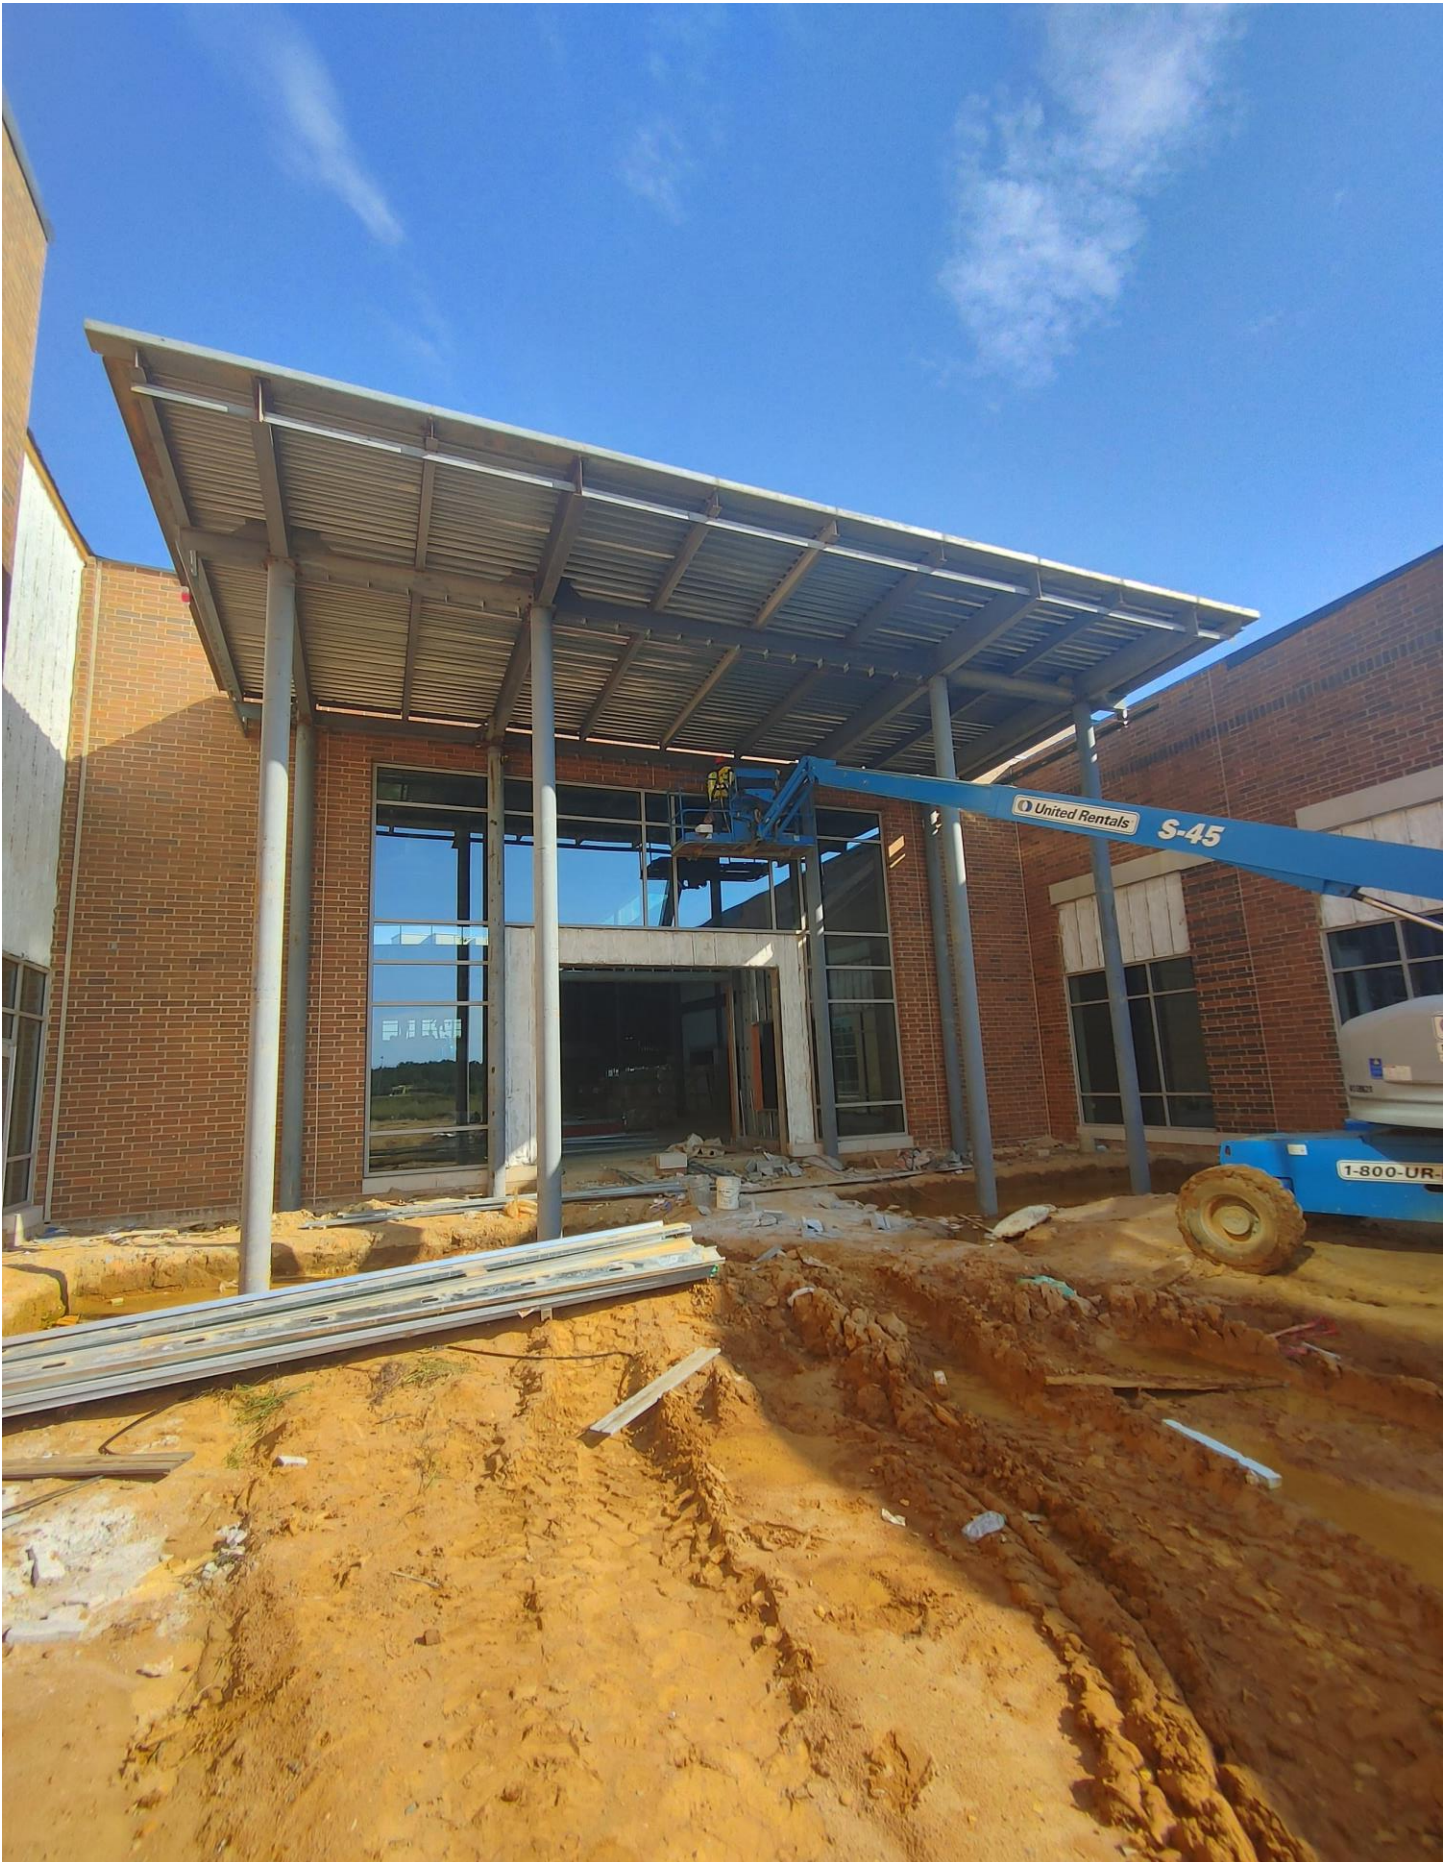
Photo 8 - Metal Stud Framing of the Canopy on the South side of Area C.
