**COMMONWEALTH  
BUILDING SOLUTIONS, LLC**

**FIELD REPORT**

**WESTMORELAND COUNTY HIGH SCHOOL**

Date: 09/28/2021

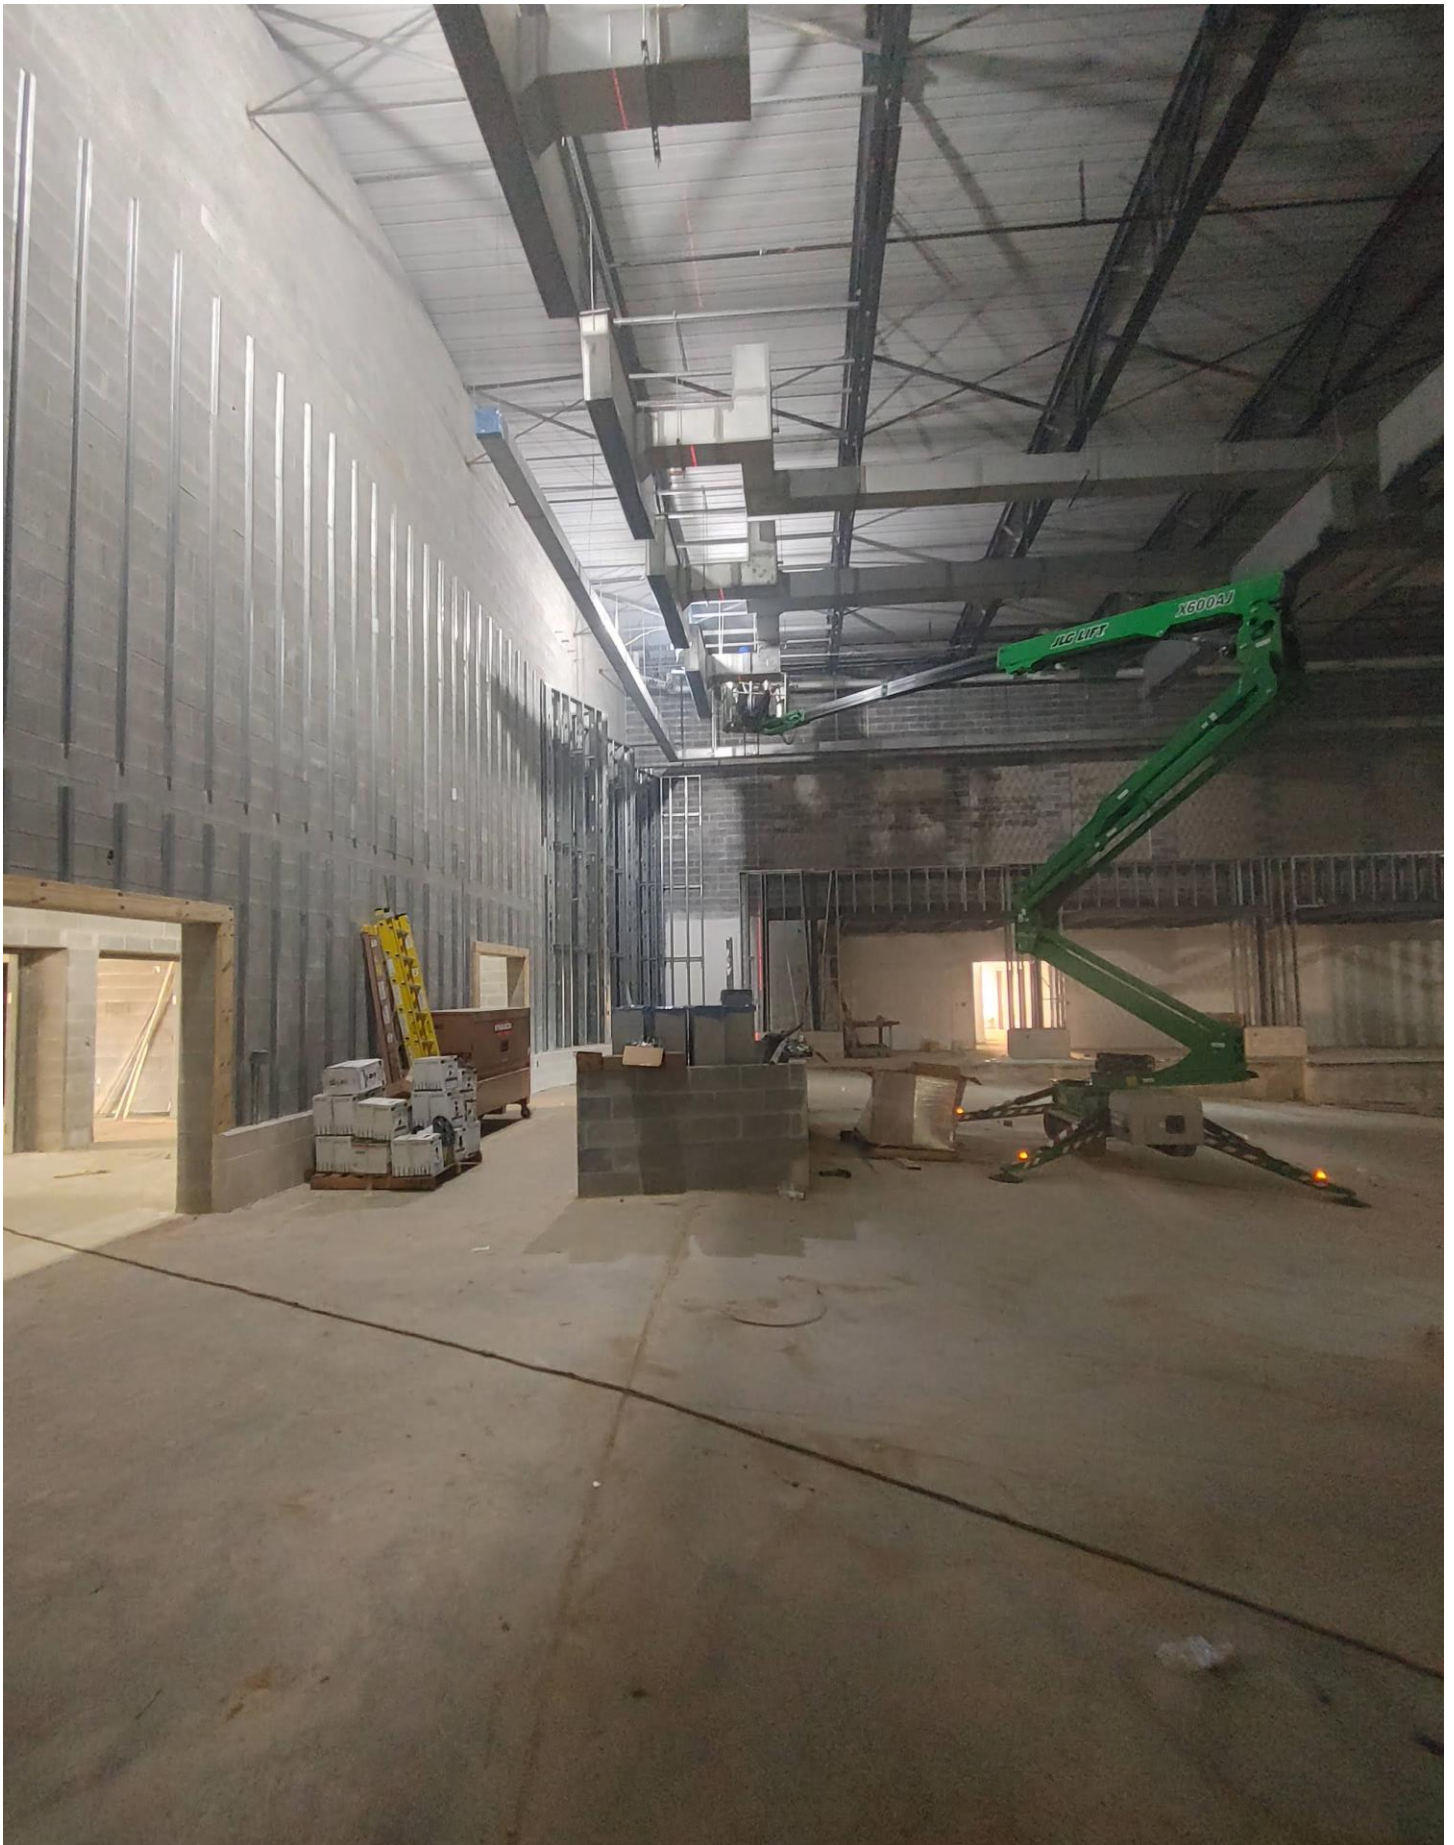
Photo 9 - HVAC Duct is being installed in the Auditorium.

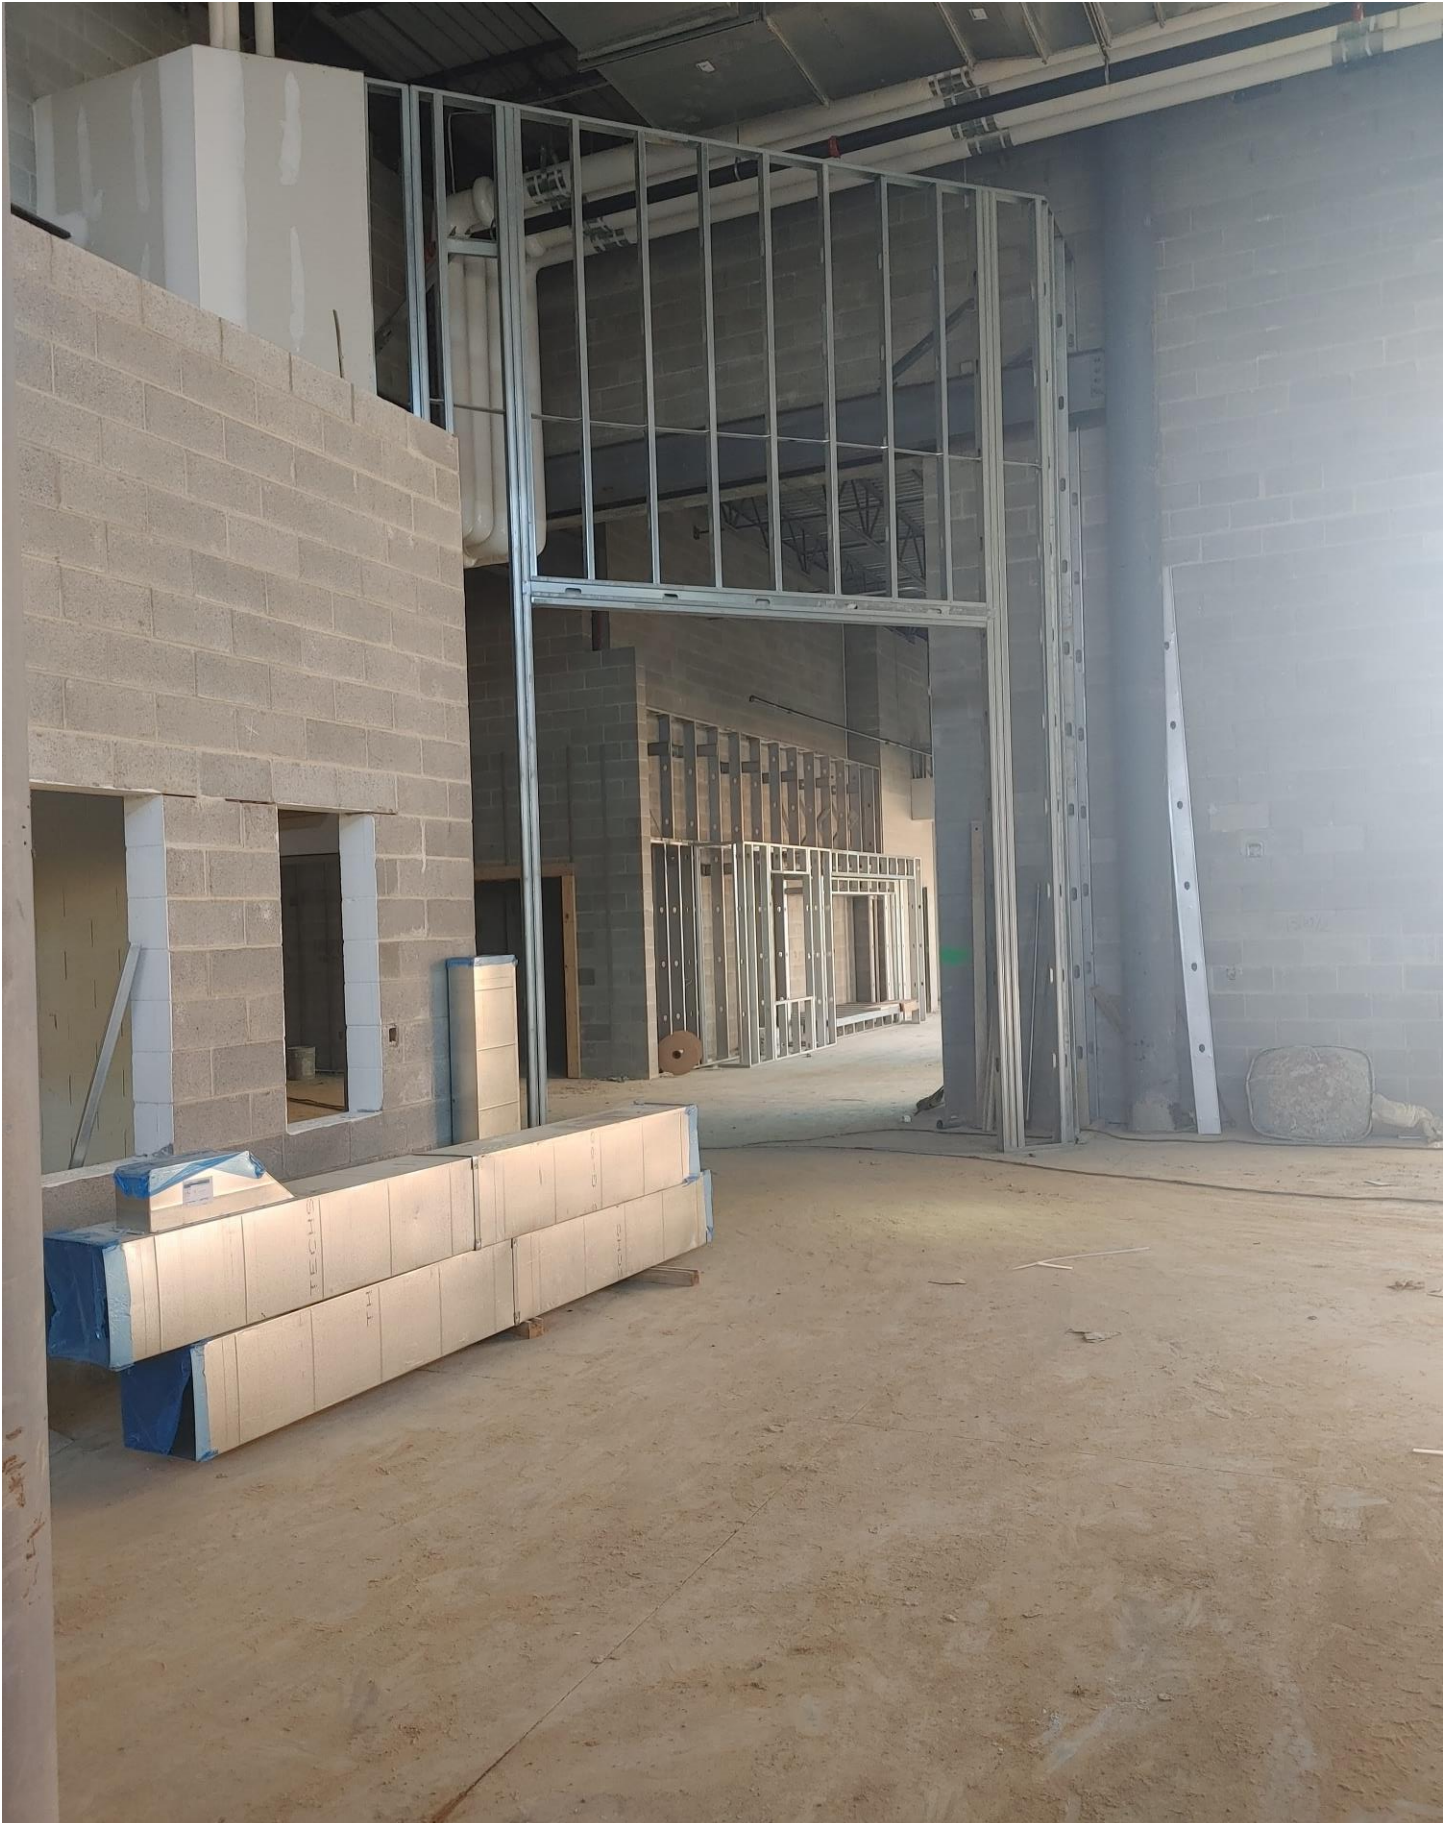
*Photo 10 - Metal Studs have been erected between Areas C & D.*

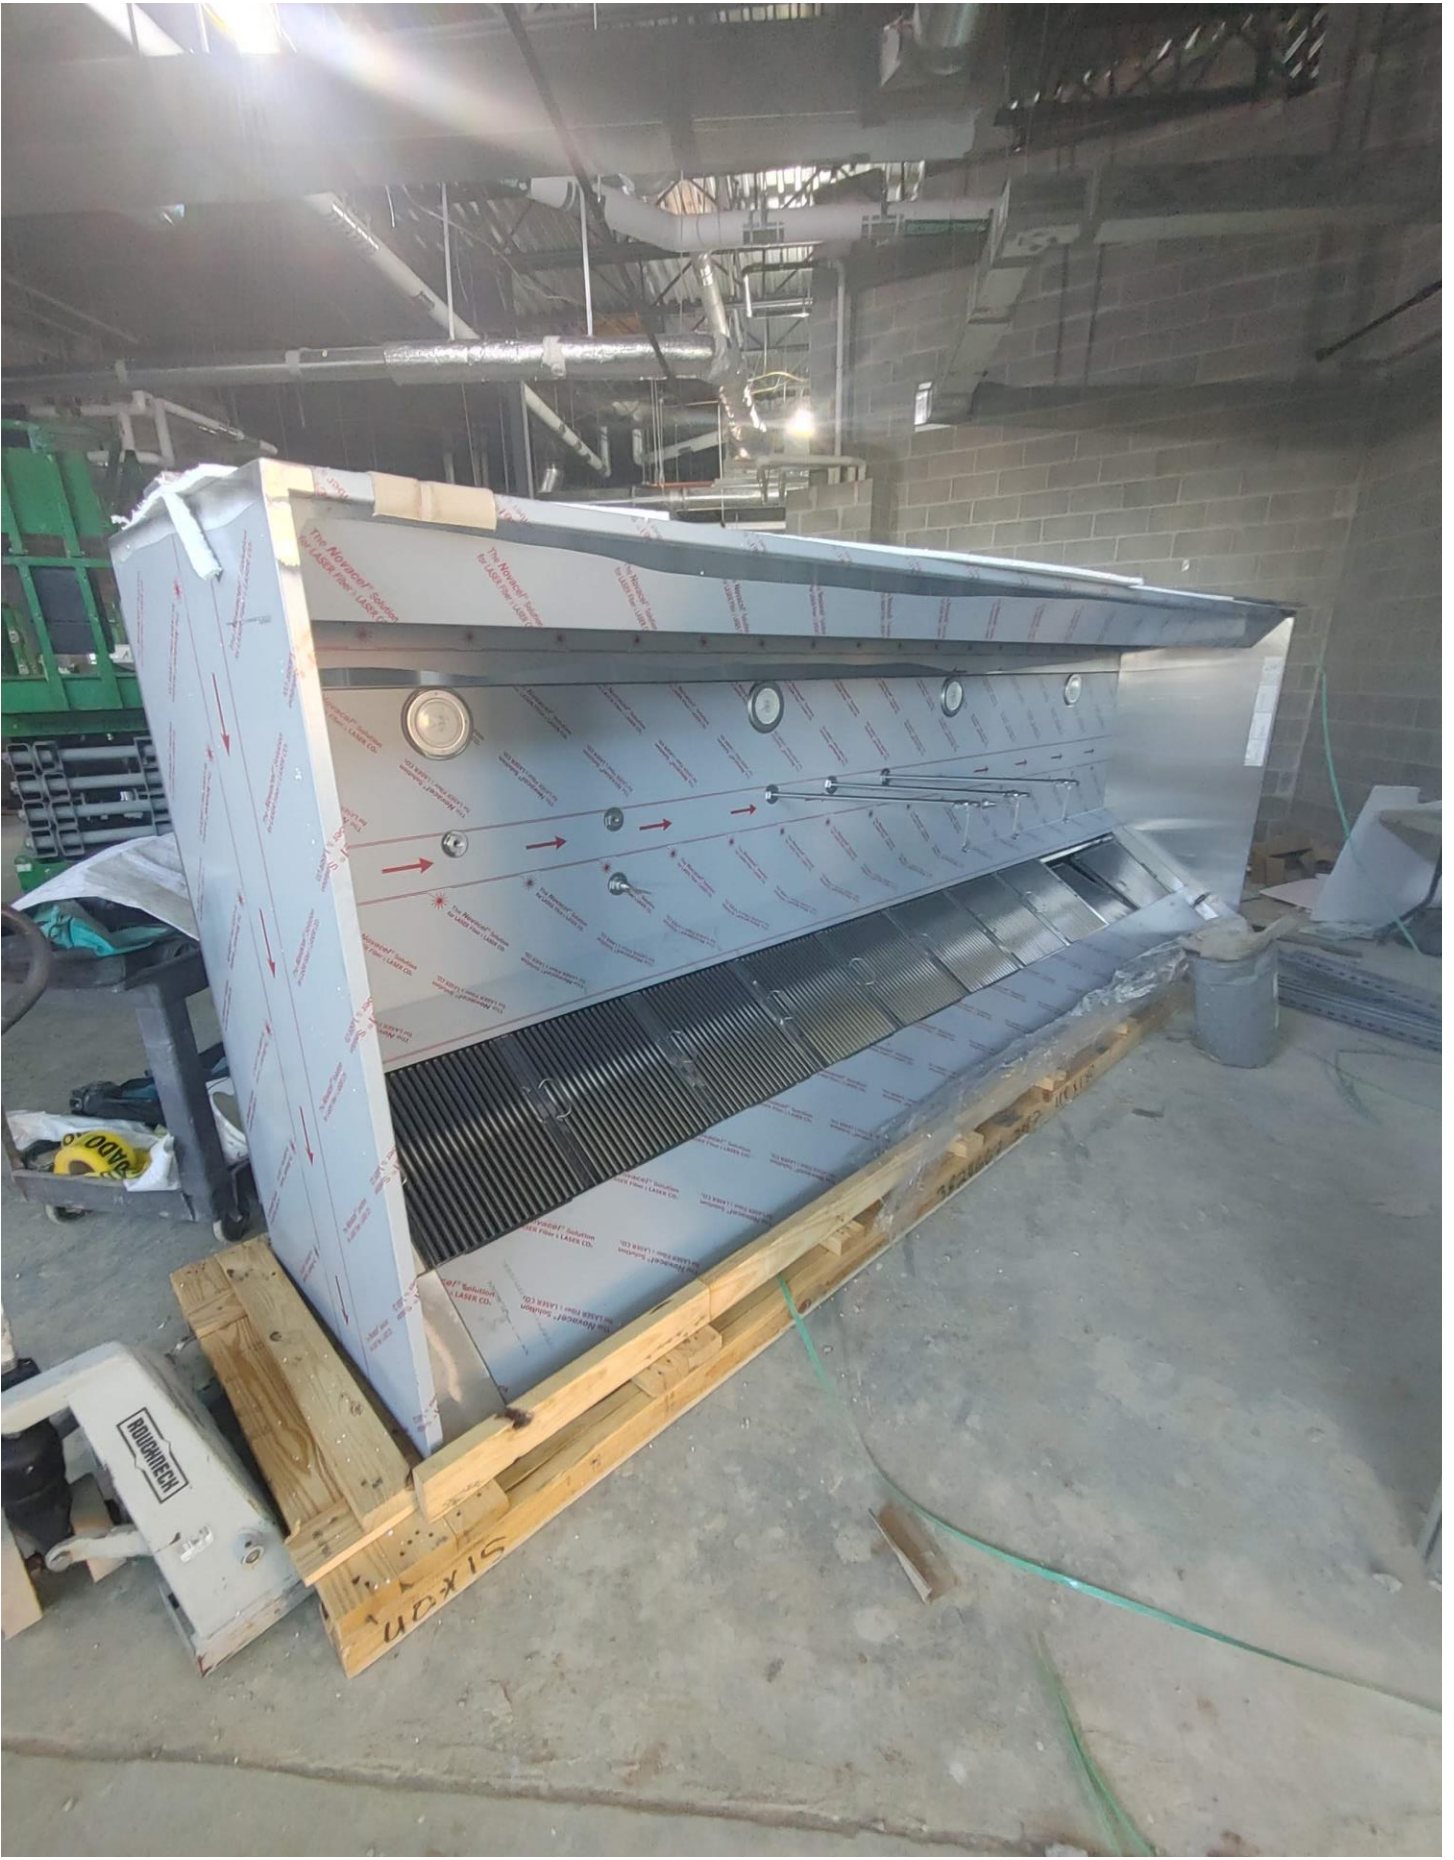
Photo 11 - One of two Range hoods has been delivered.

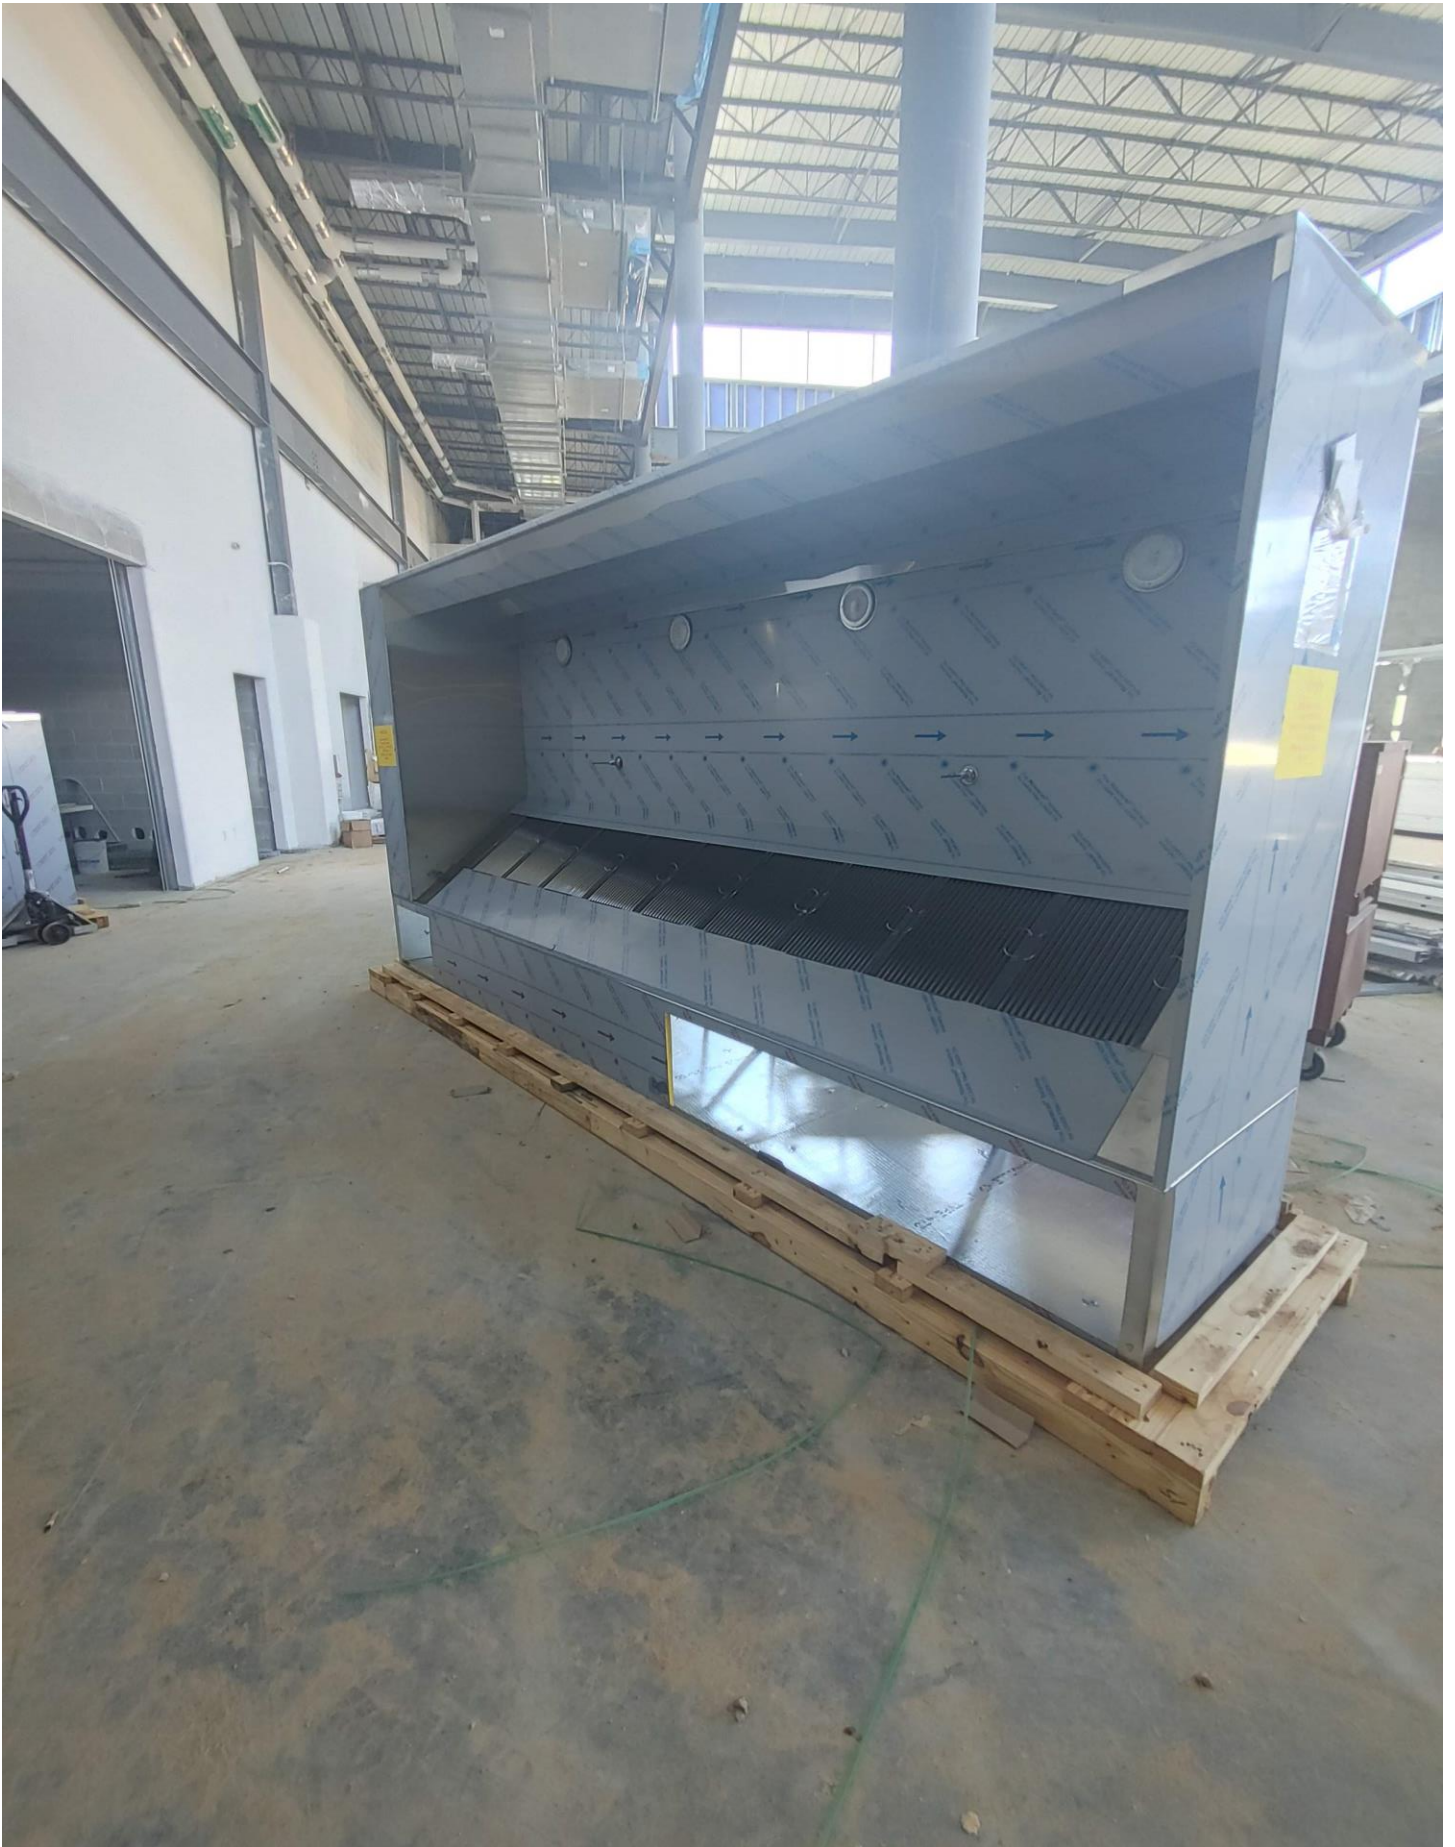
Photo 12 - 2nd Range Hood.

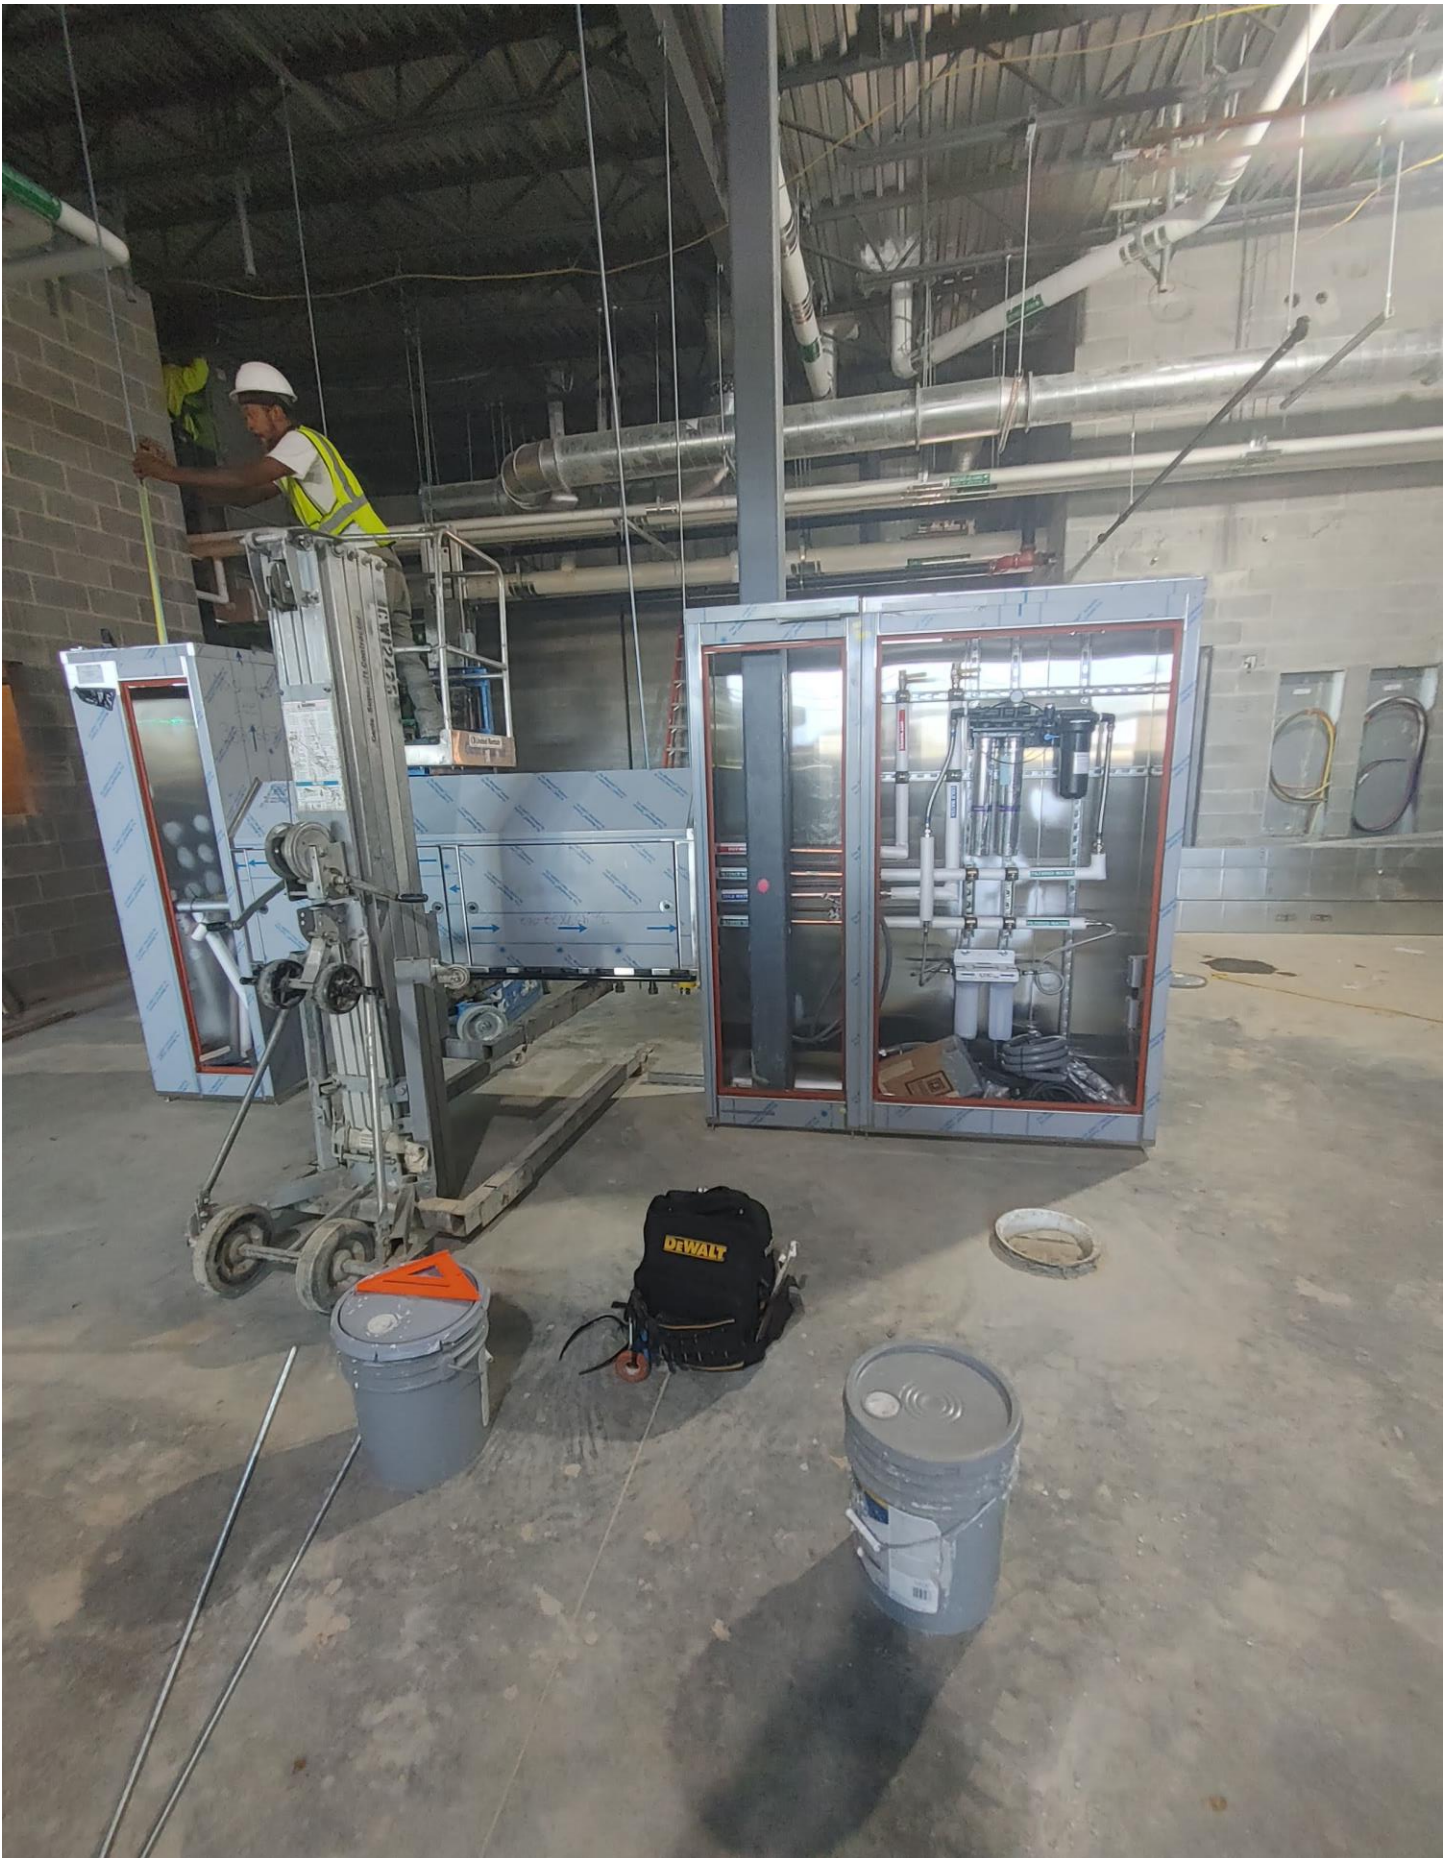
Photo 13 - Utility Distribution System and Water Filtration system is being installed.

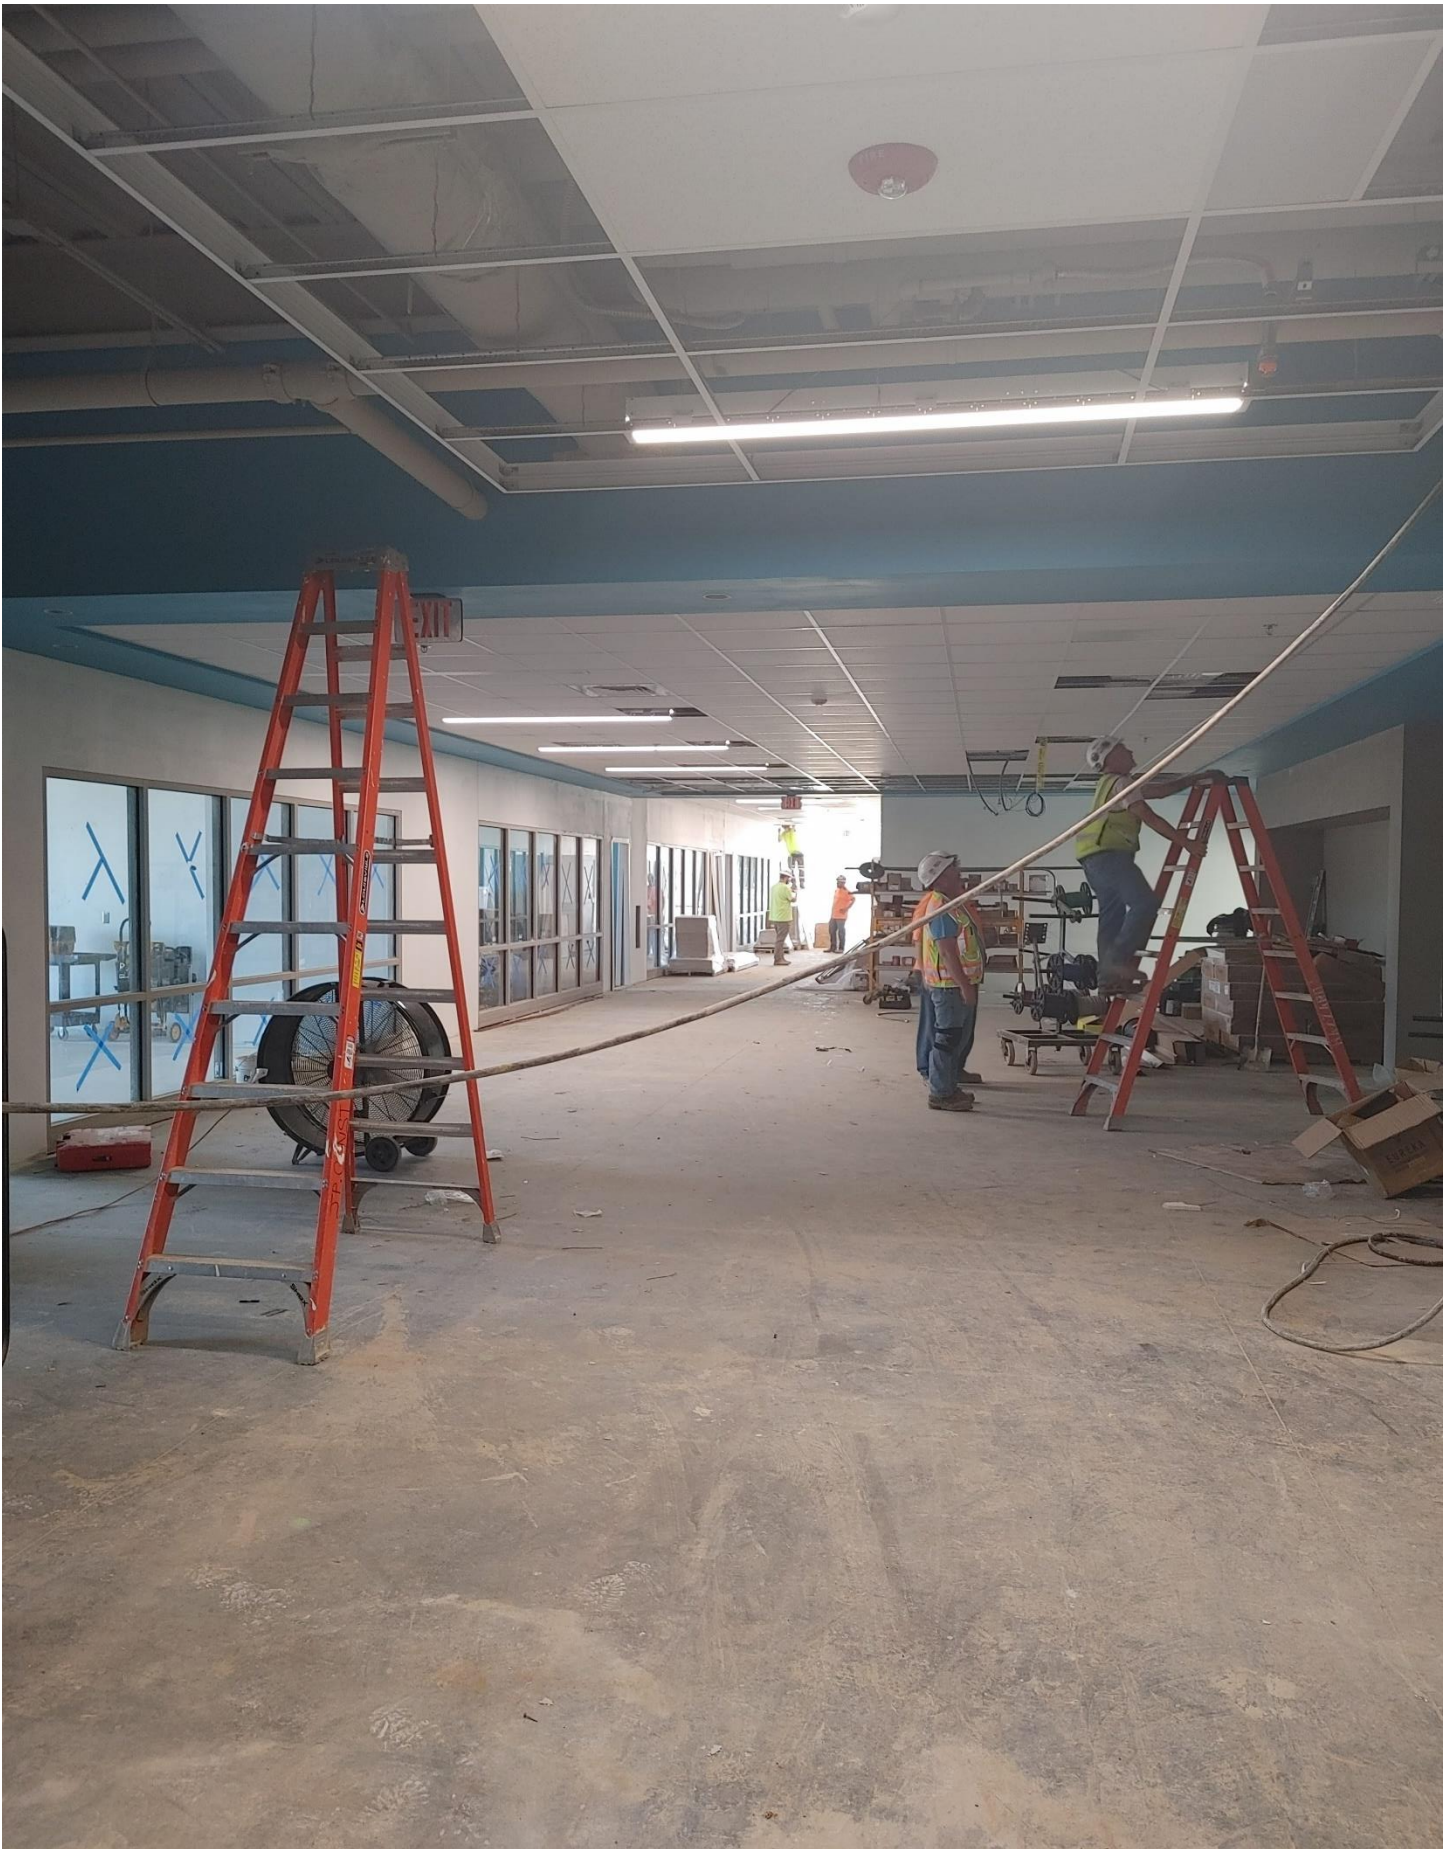
Photo 14 - Lighting installed and energized in Area A, 1st floor.

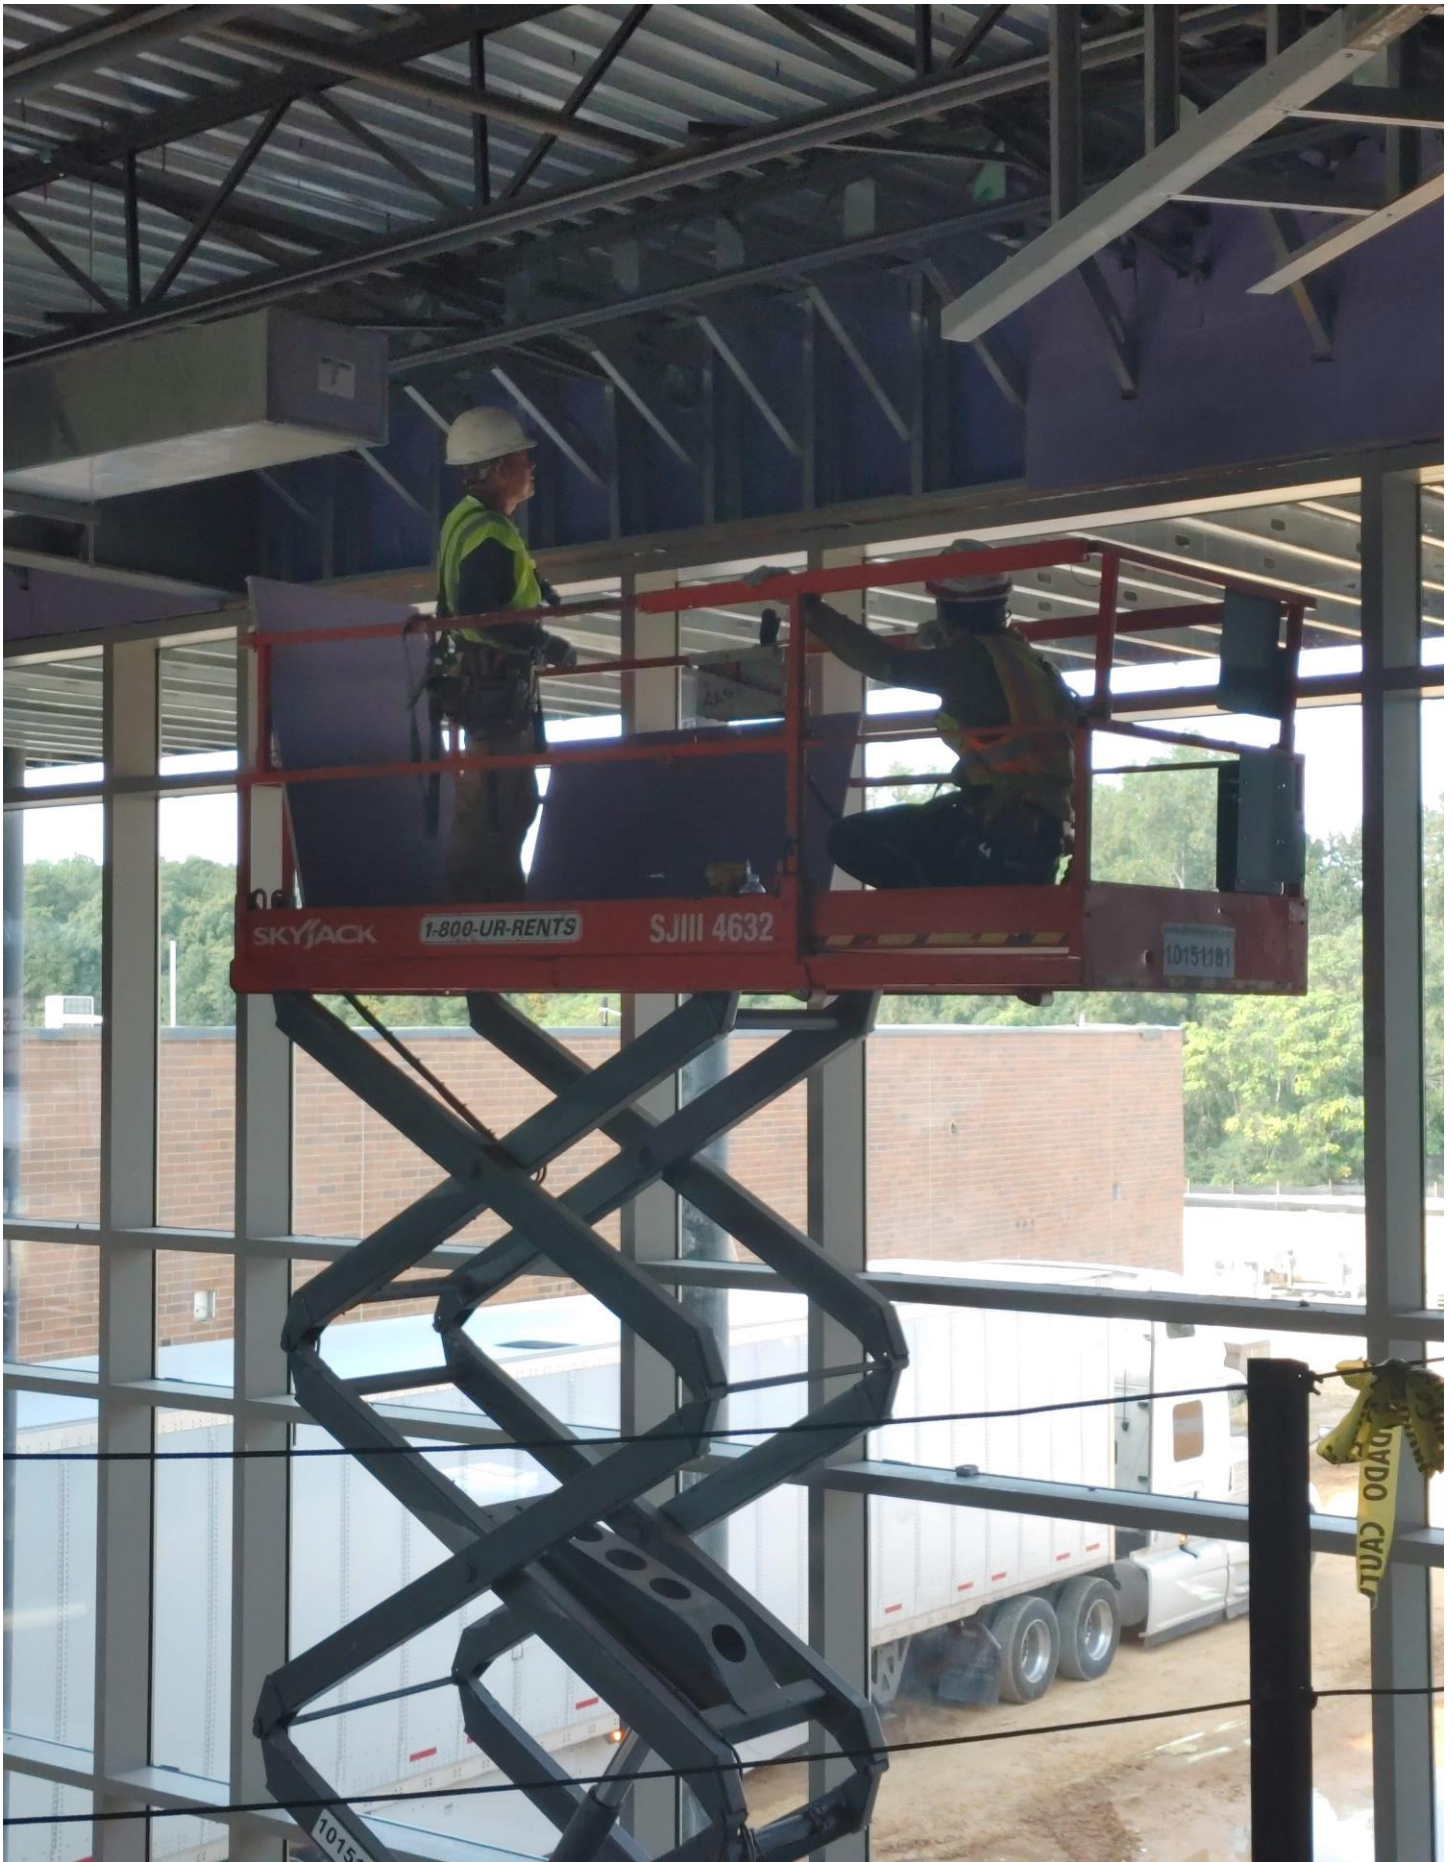
Photo 15 - Sheetrock is being hung in Area C.

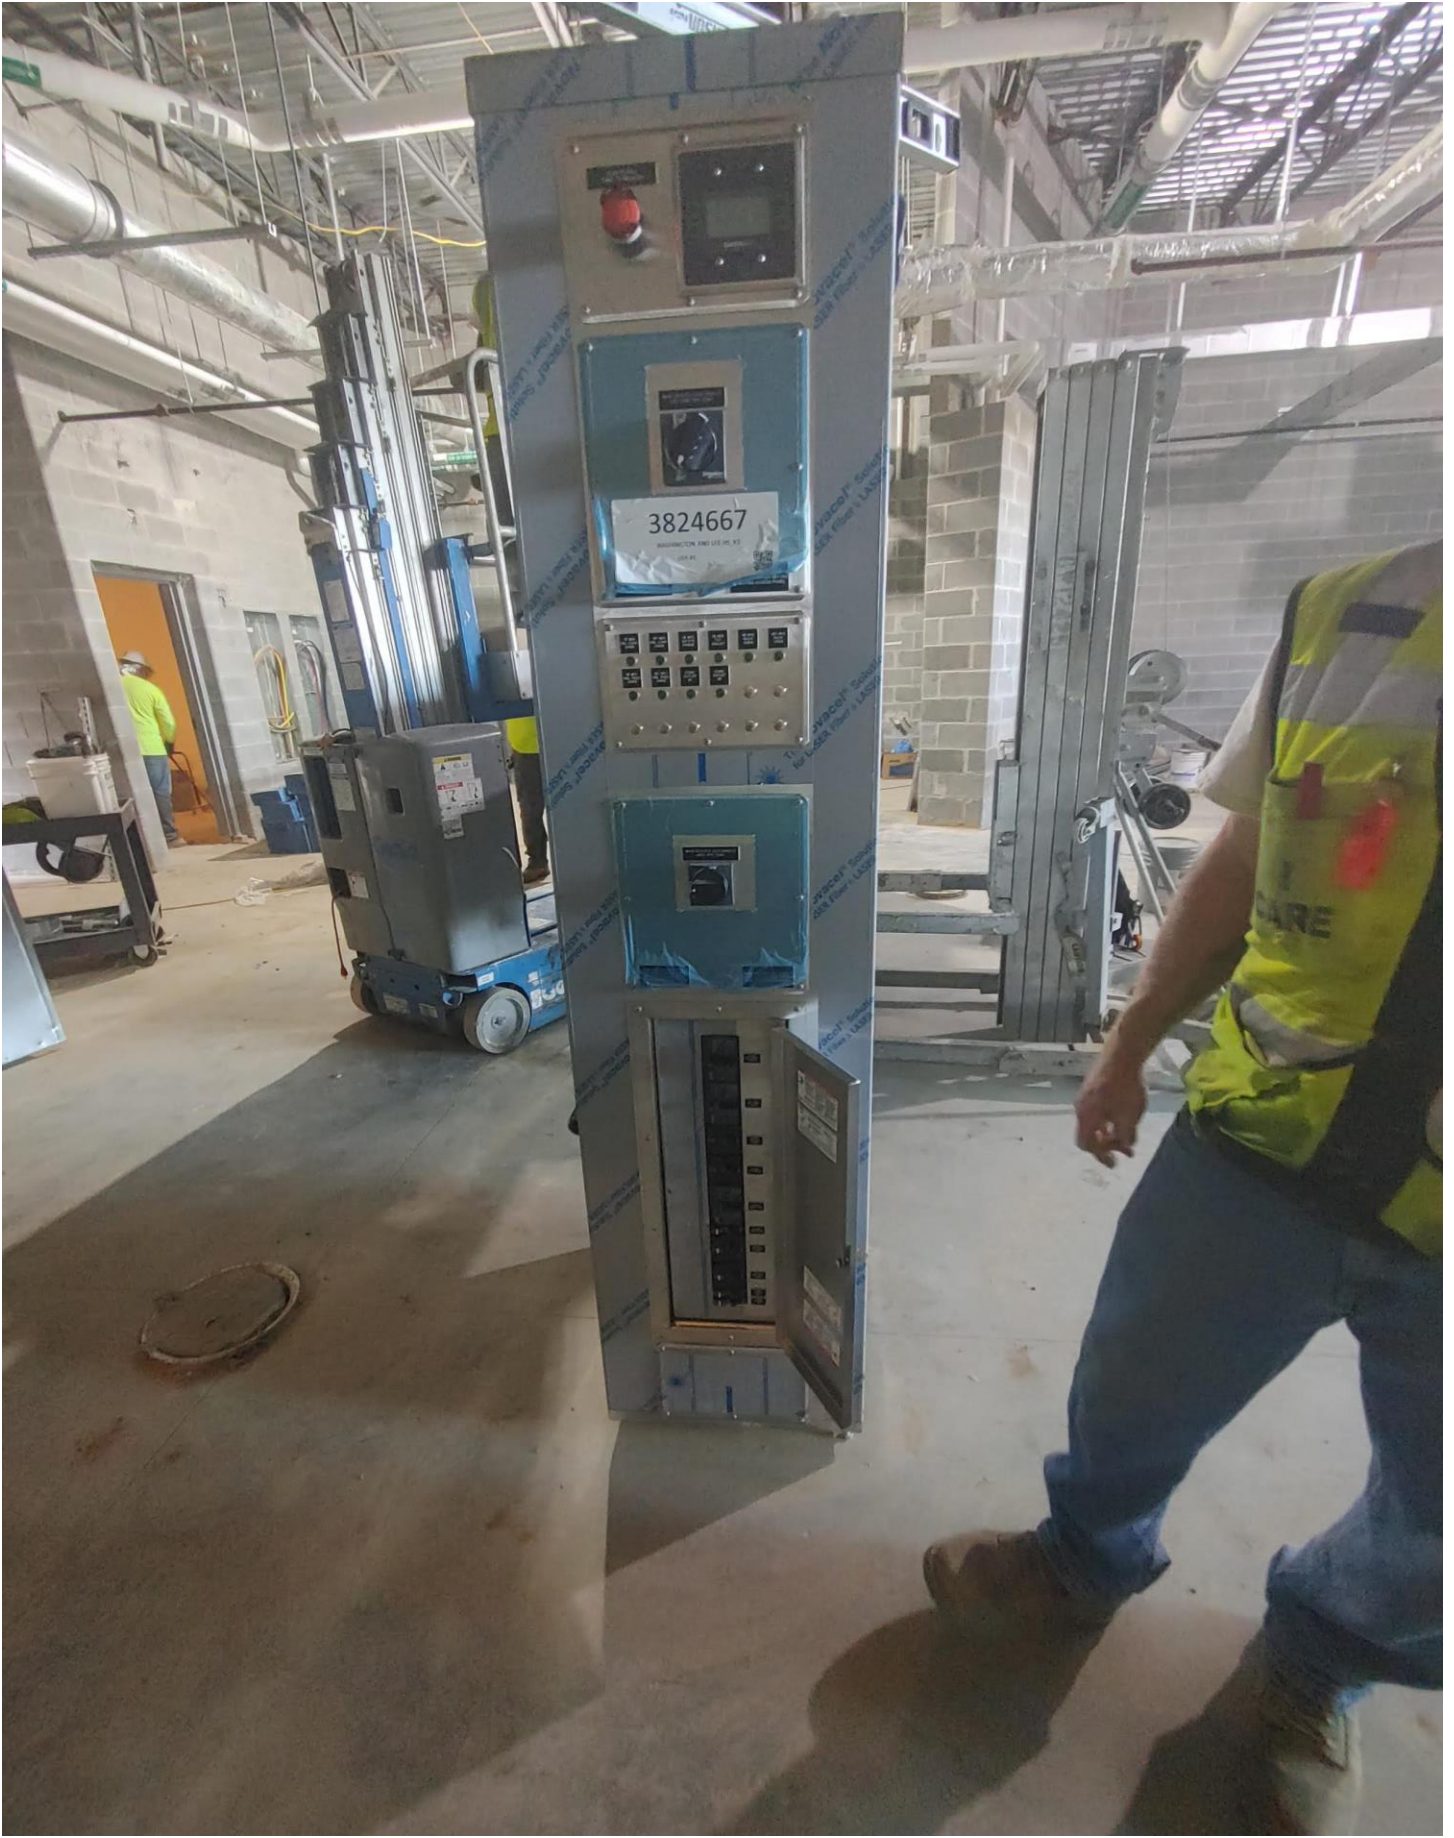
Photo 16 - Utility Distribution System
