**COMMONWEALTH  
BUILDING SOLUTIONS, LLC**

**FIELD REPORT**

**WESTMORELAND COUNTY HIGH SCHOOL**

Date: 09/28/2021

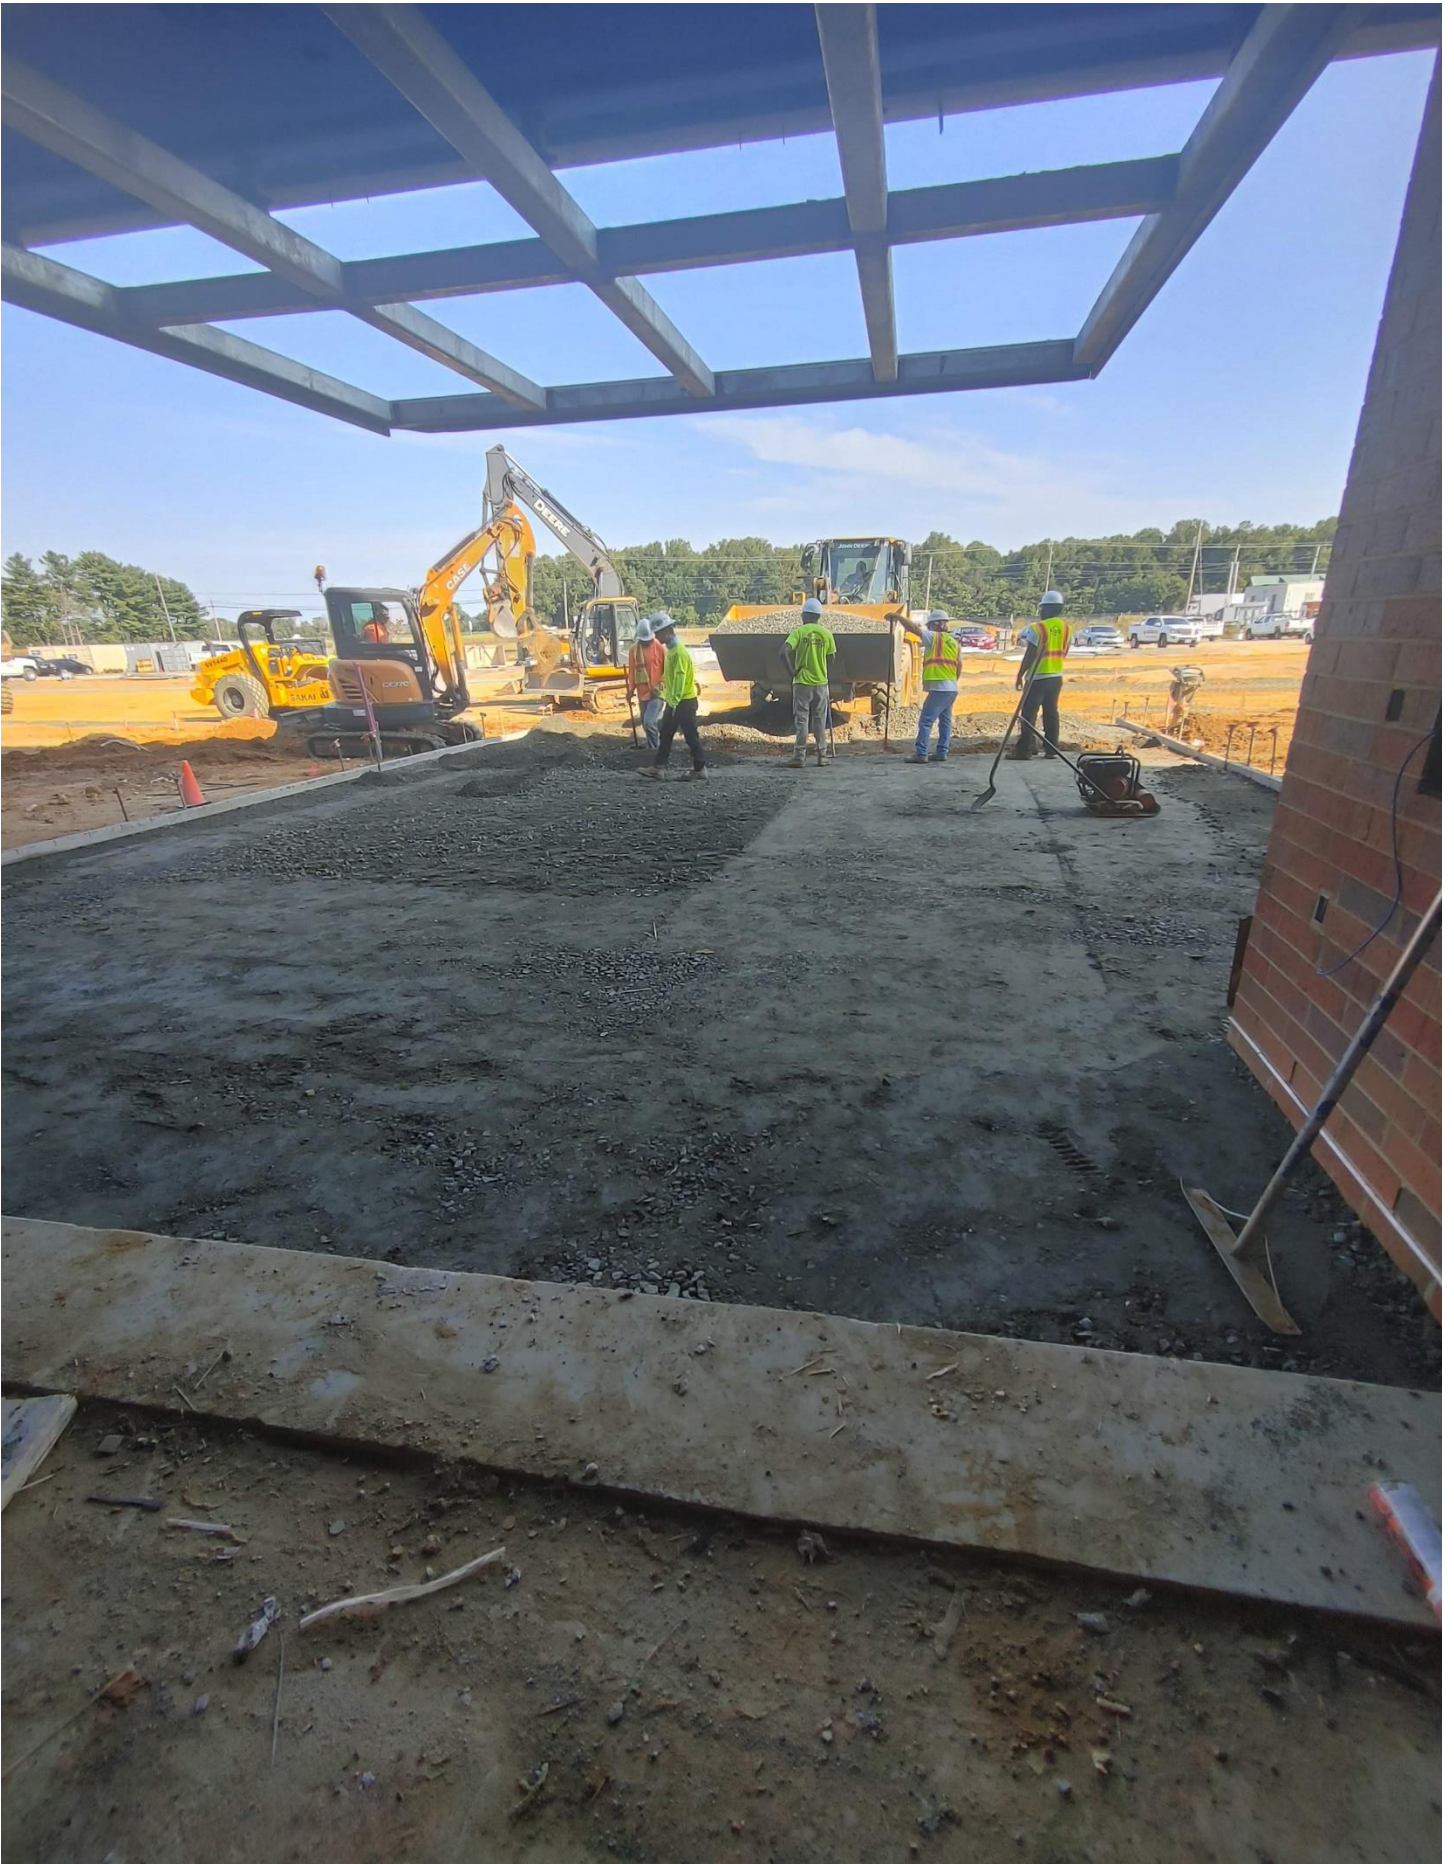
Photo 17 - Trenching for Conduit at the Main Entrance
