**COMMONWEALTH  
BUILDING SOLUTIONS, LLC**

**FIELD REPORT**

**WESTMORELAND COUNTY HIGH SCHOOL**

Date: 10/15/2021

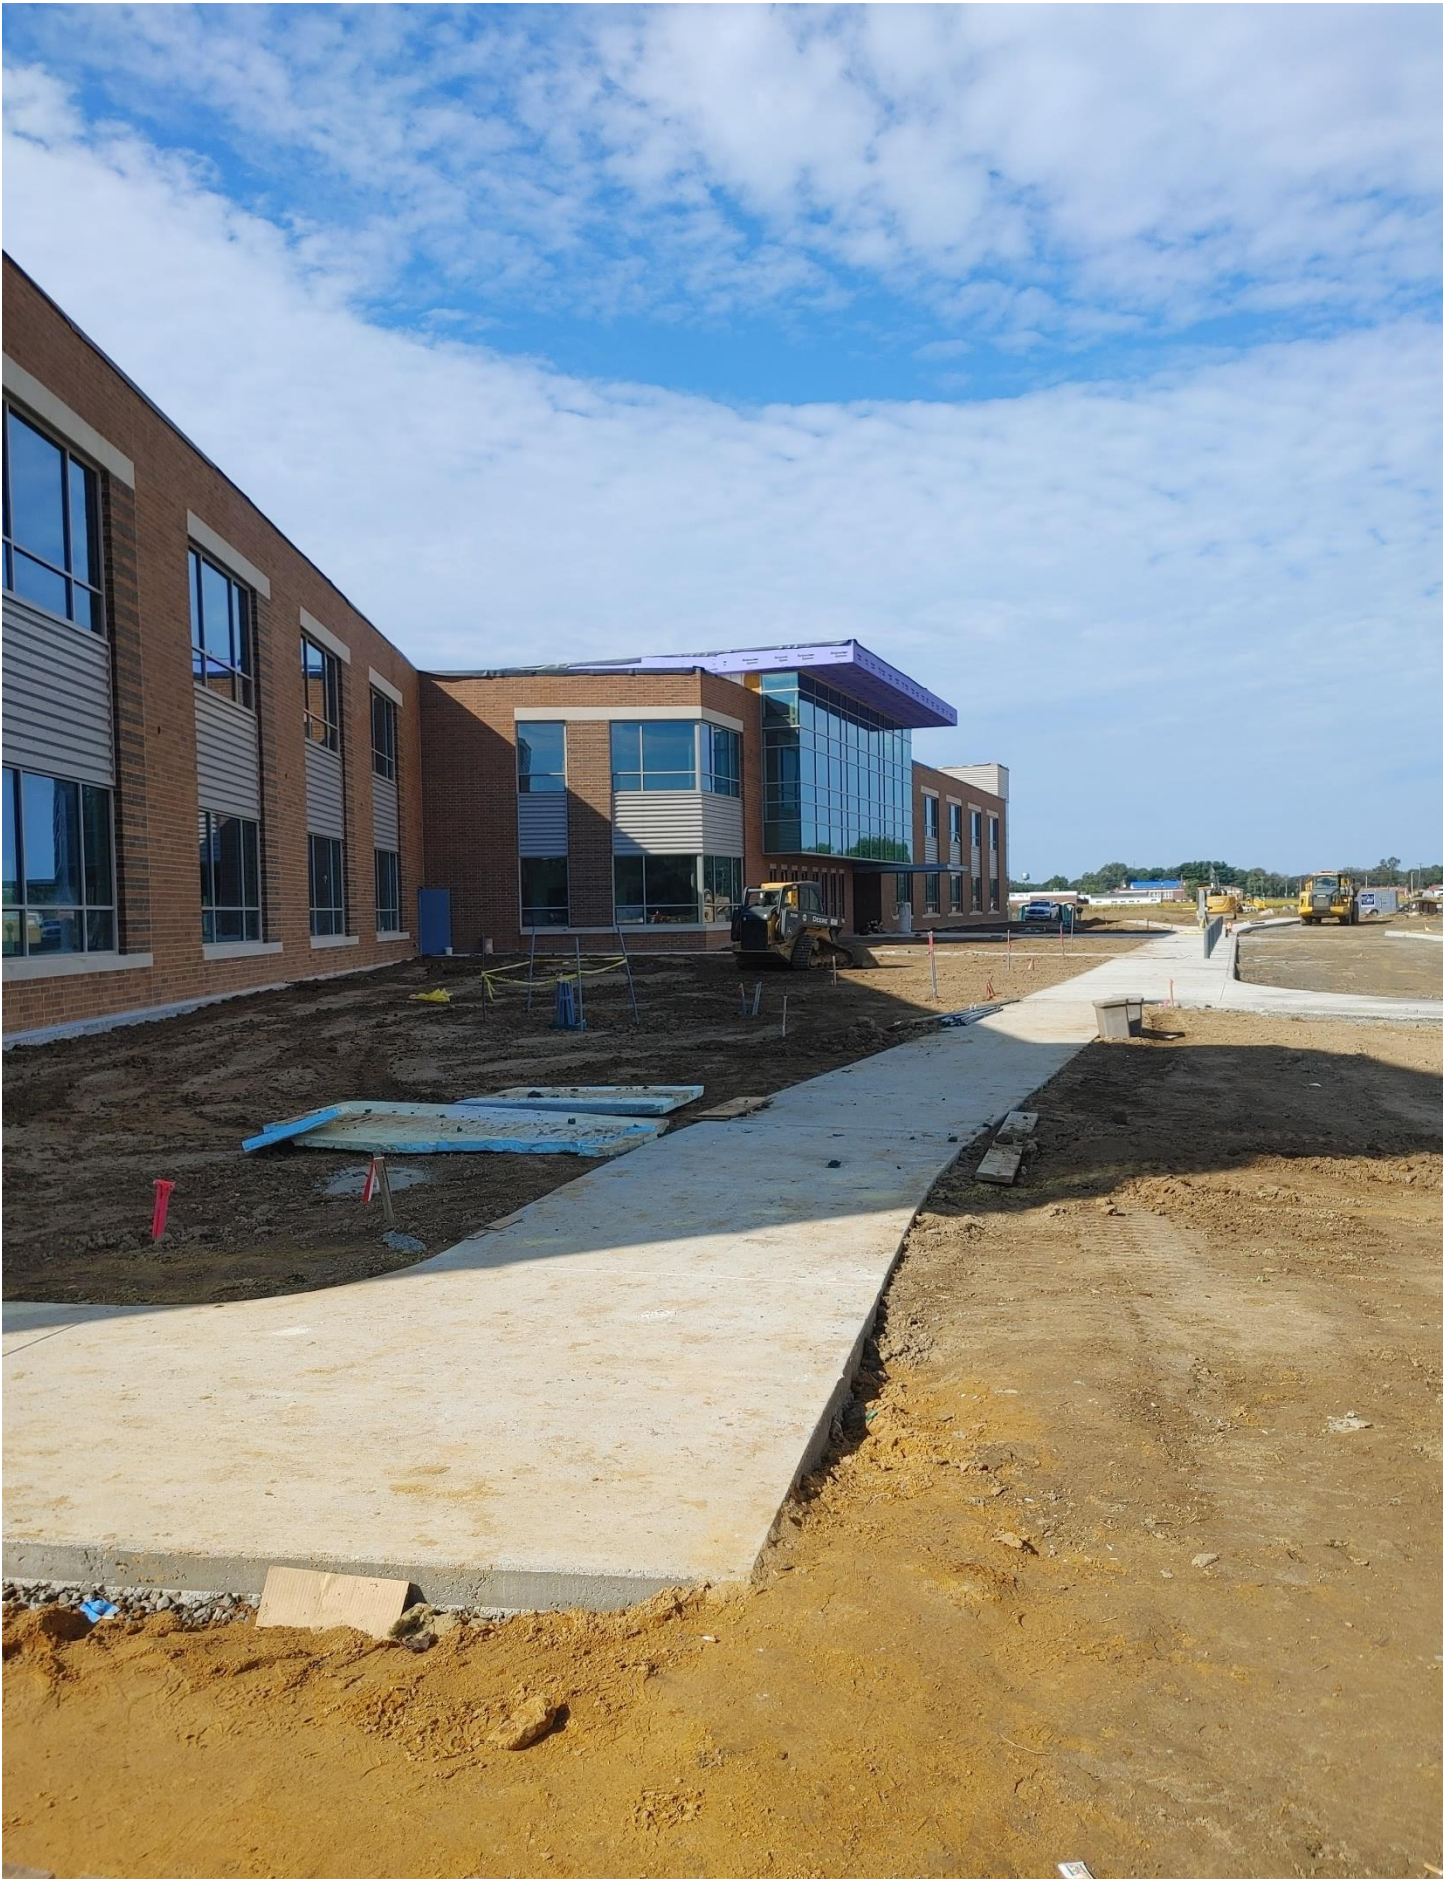
*Photo 1 - Sidewalks from Entrance and Stairwells have been completed.*

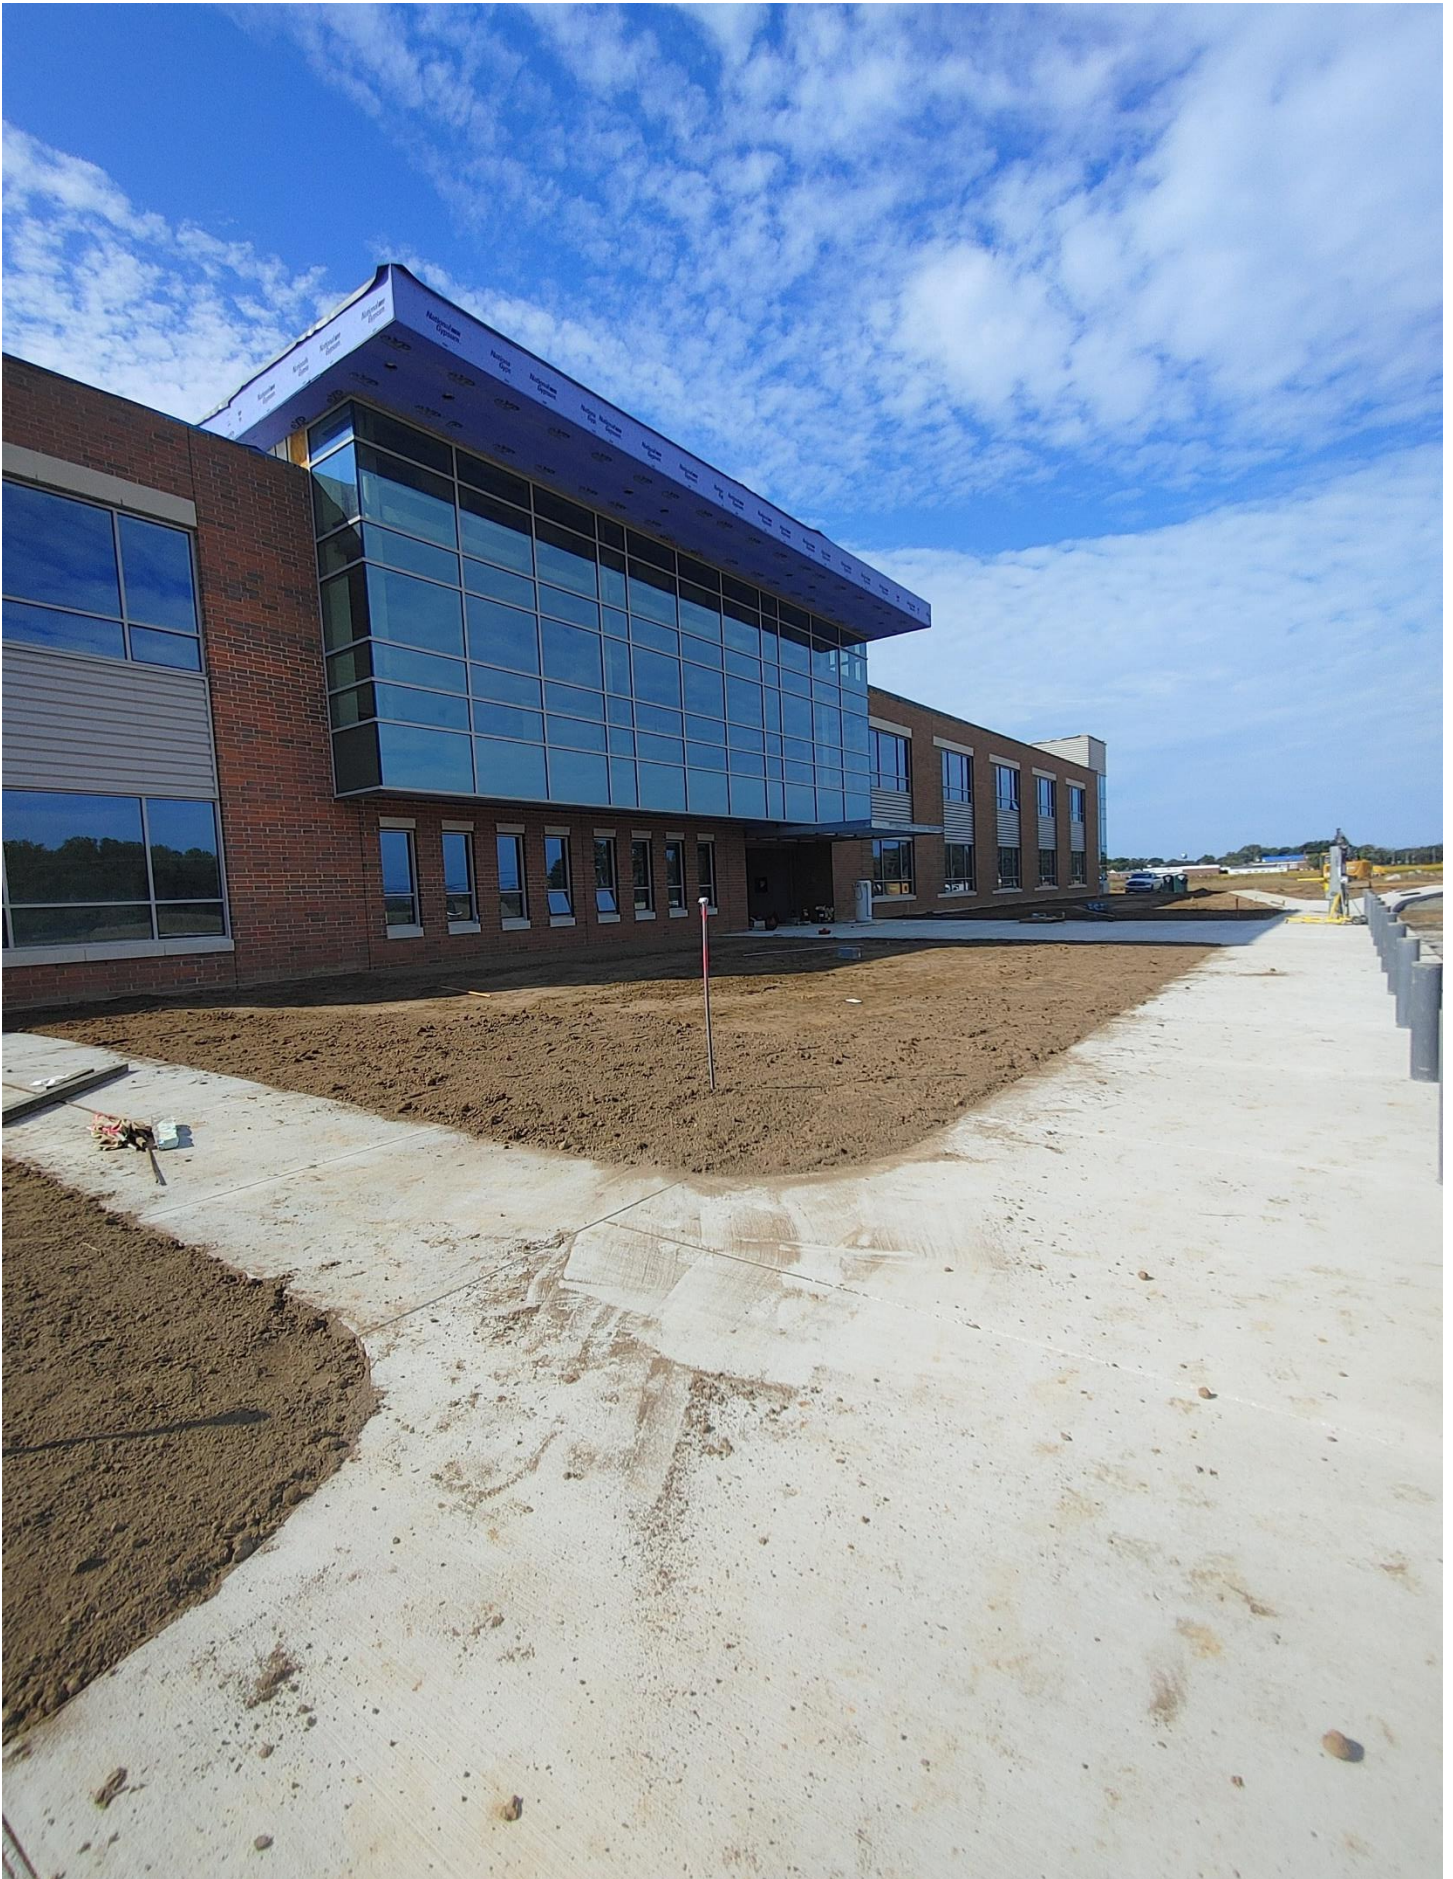
*Photo 2 - Top Soil in being spread & Bollards have been installed.*

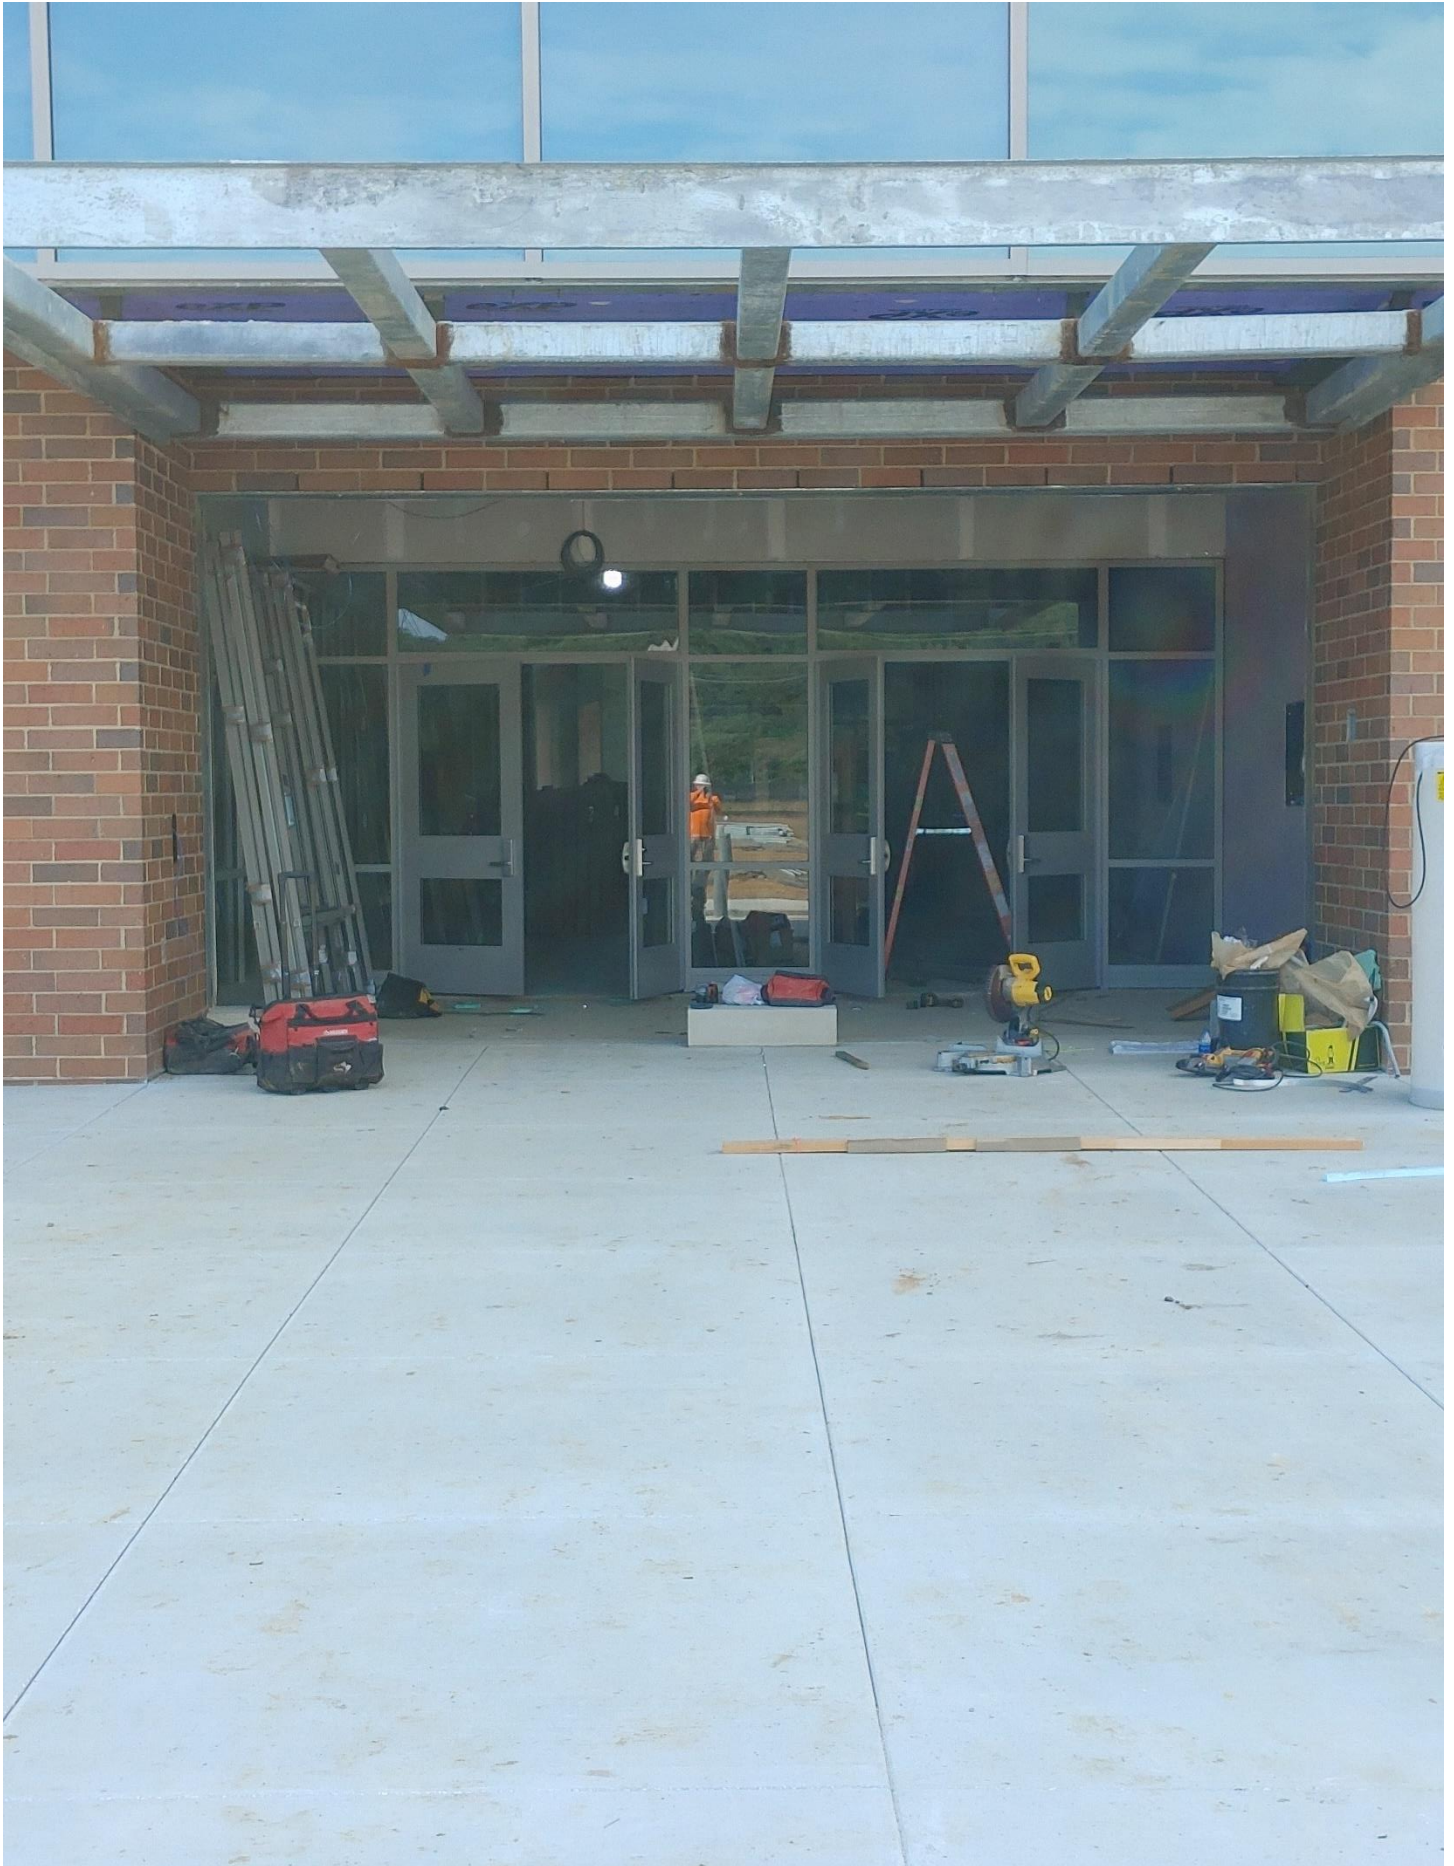
Photo 3 - Front Doors are being installed

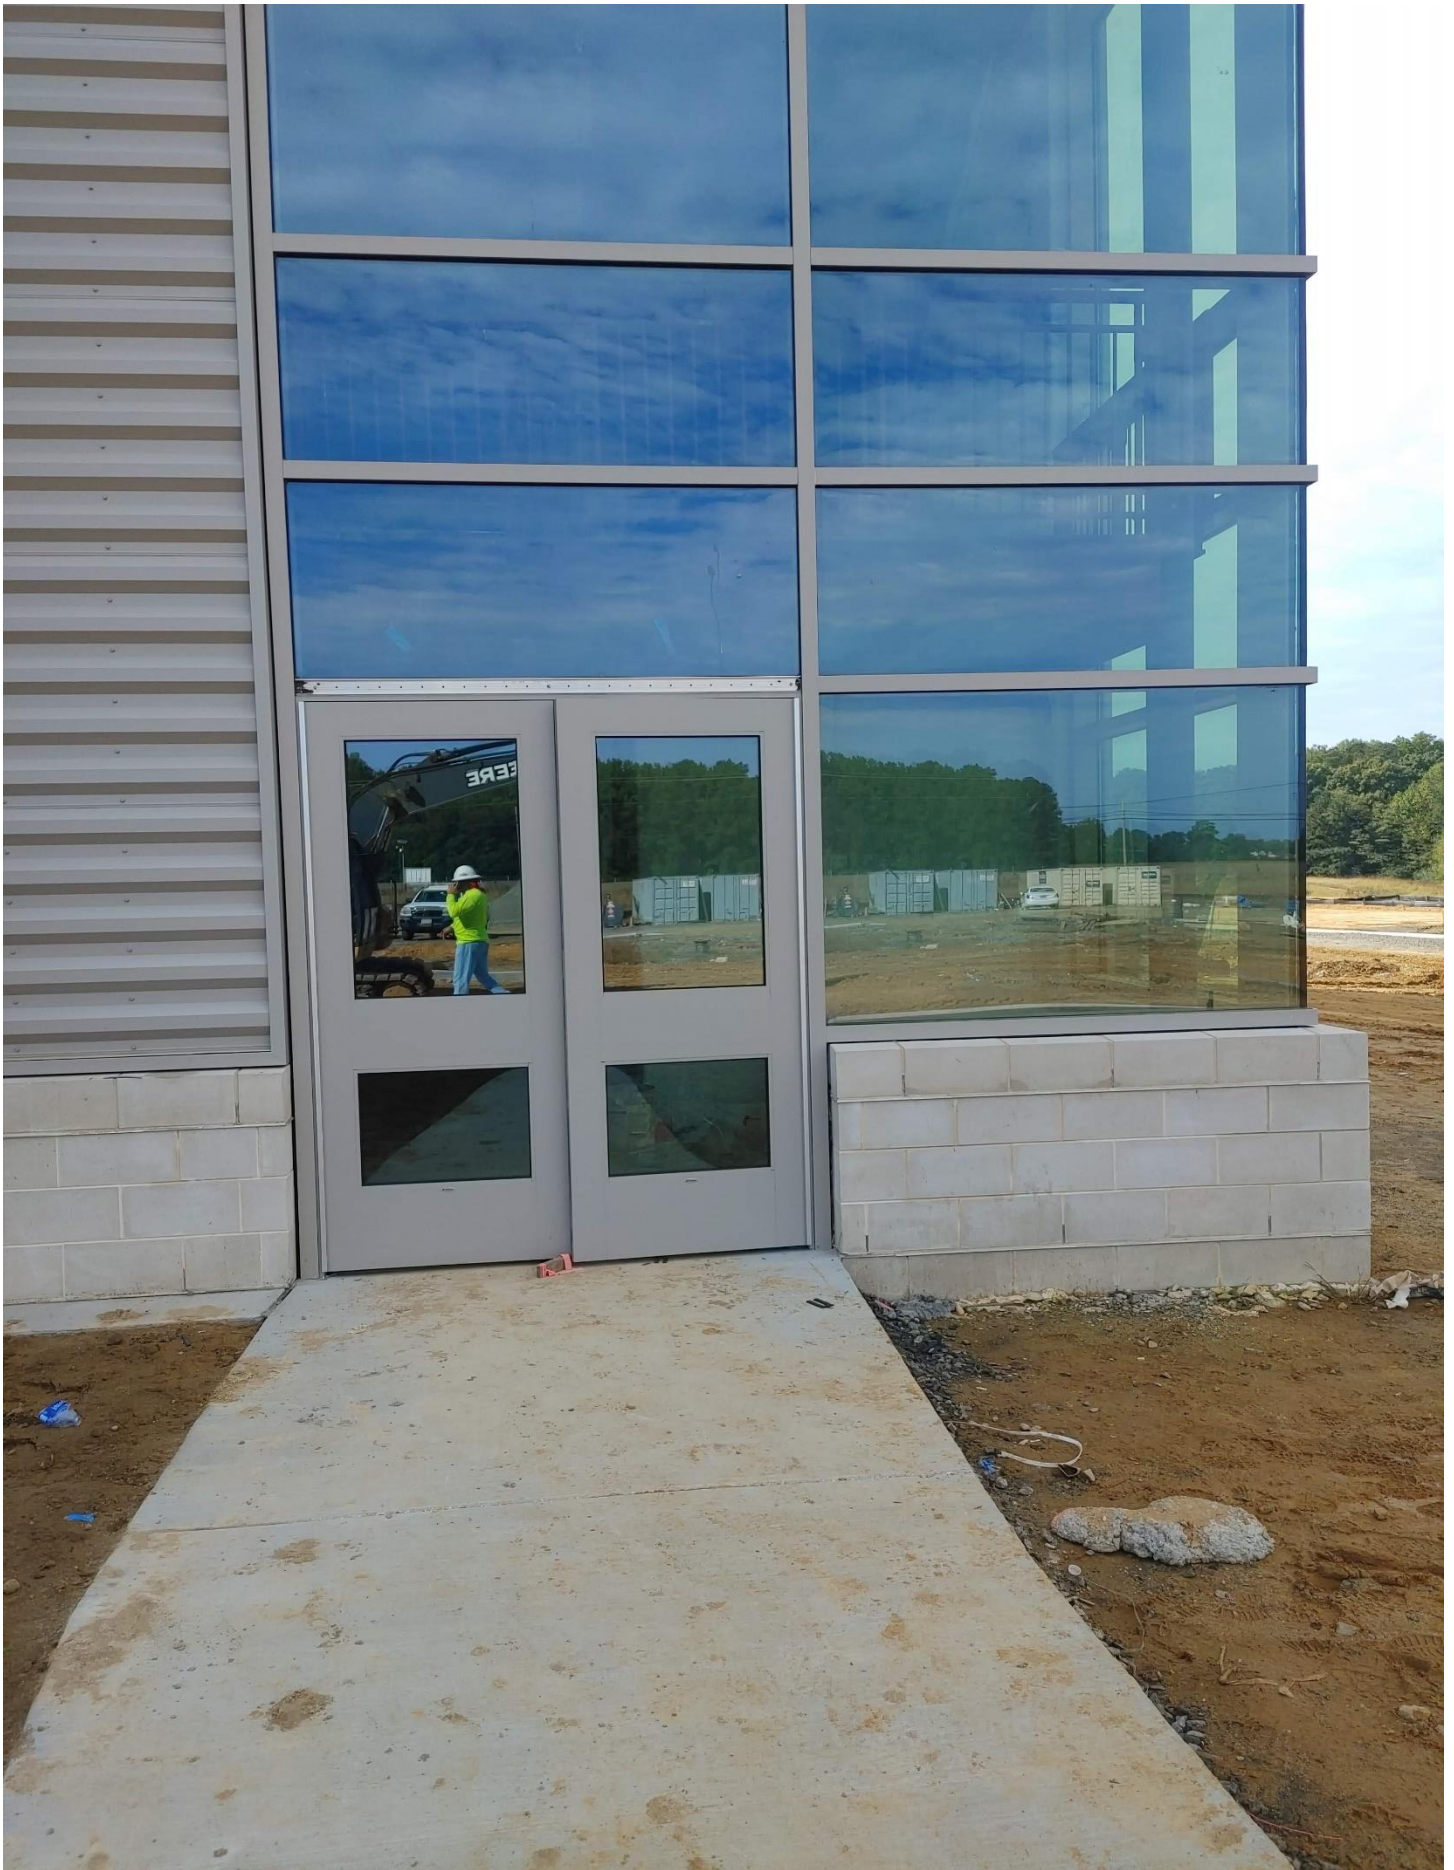
Photo 4 - Doors on Stairwell #2 have been installed

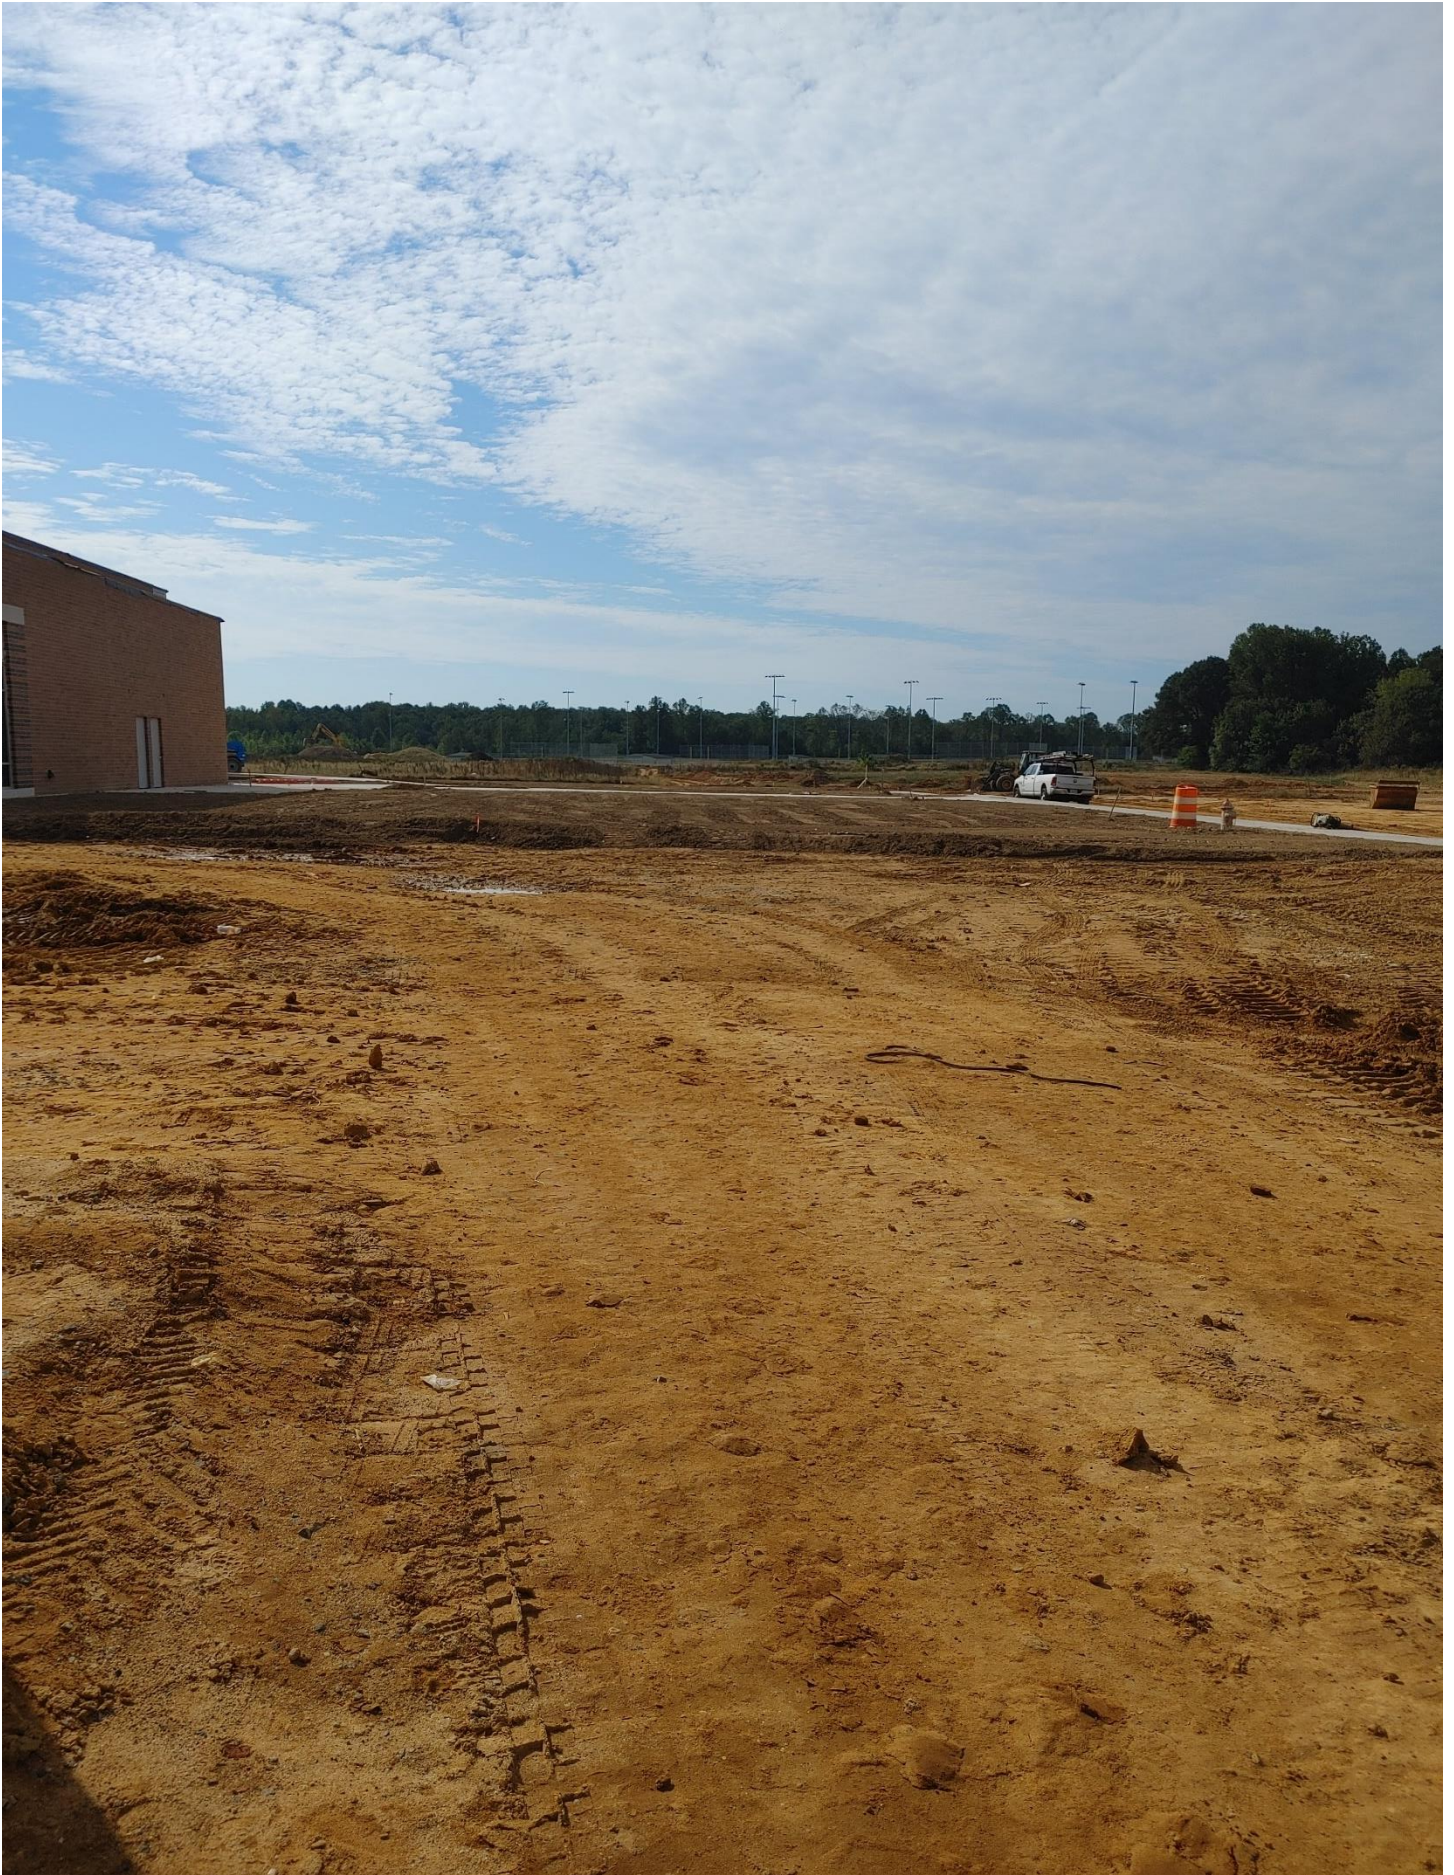
*Photo 5 - Topsoil is being spread on the West side of Area E*

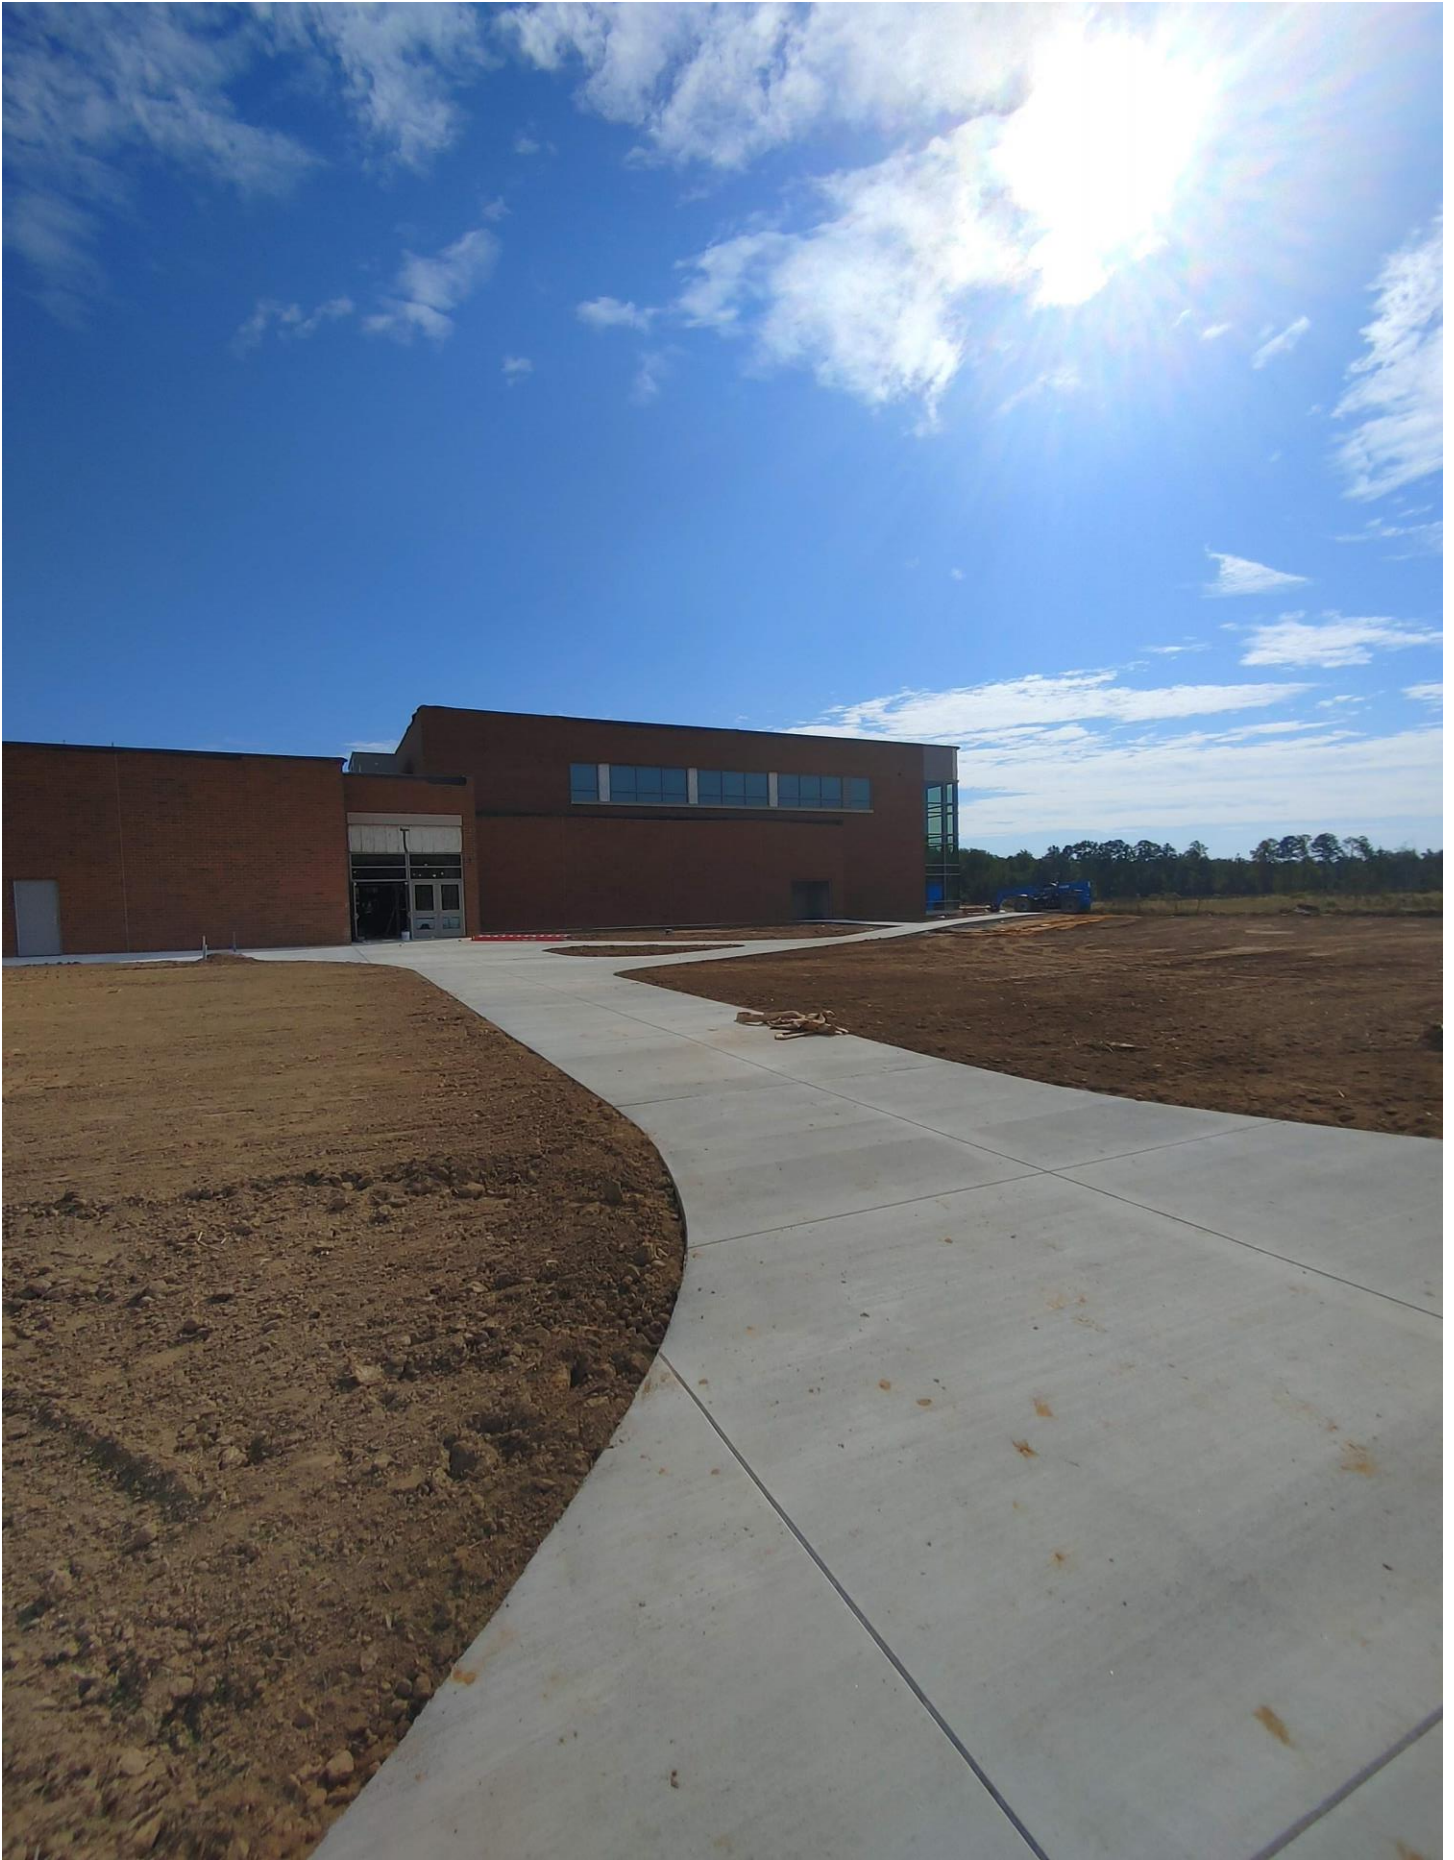
*Photo 6 - Topsoil has been spread and graded on the West side of the Gym*

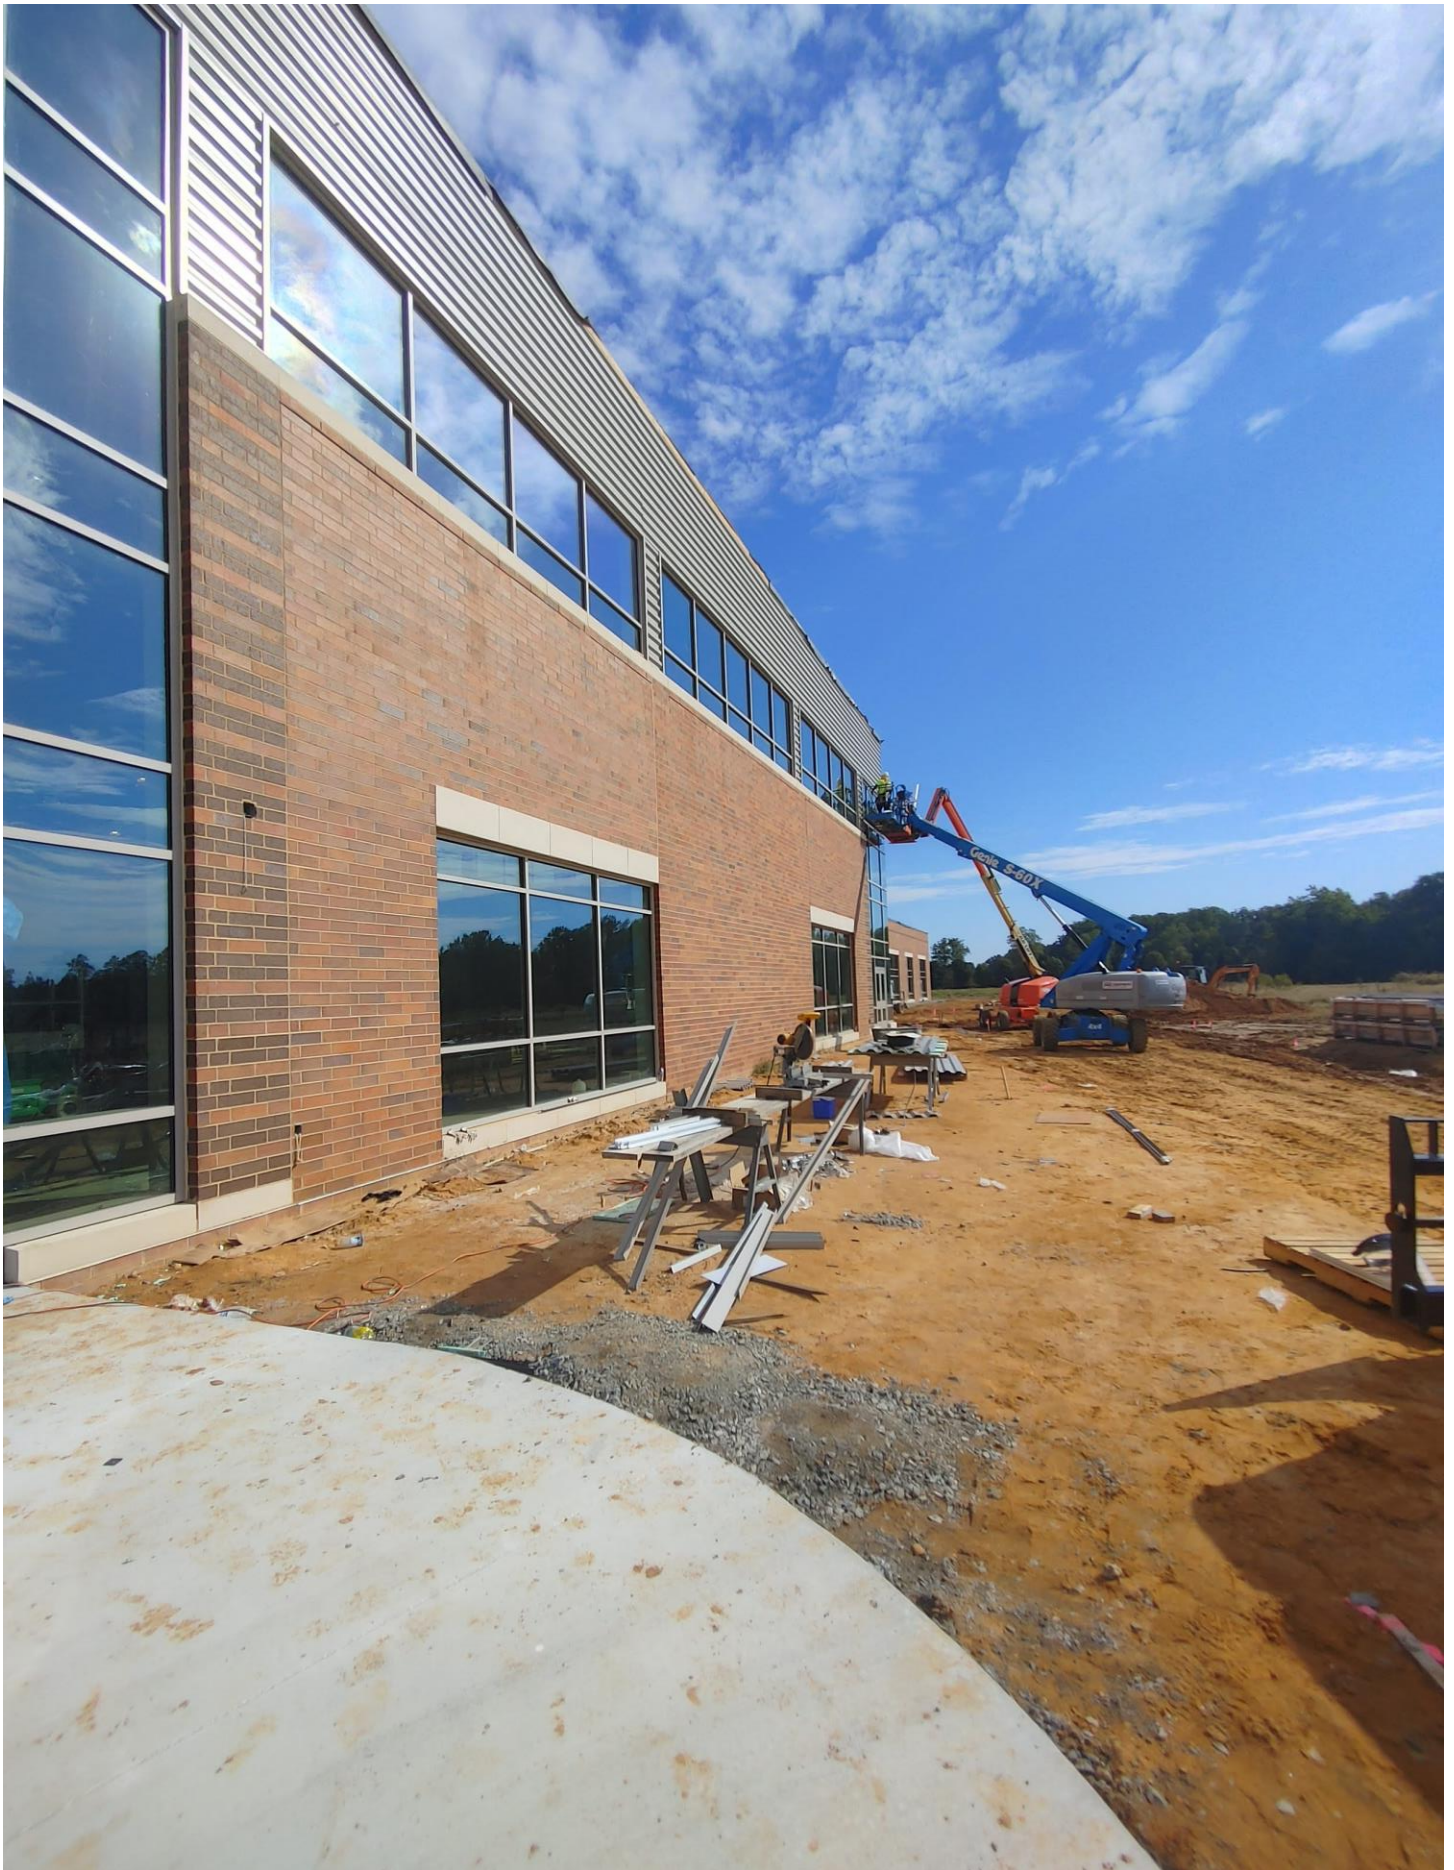
Photo 7 - Metal Panels are being installed on the South side of the Gym

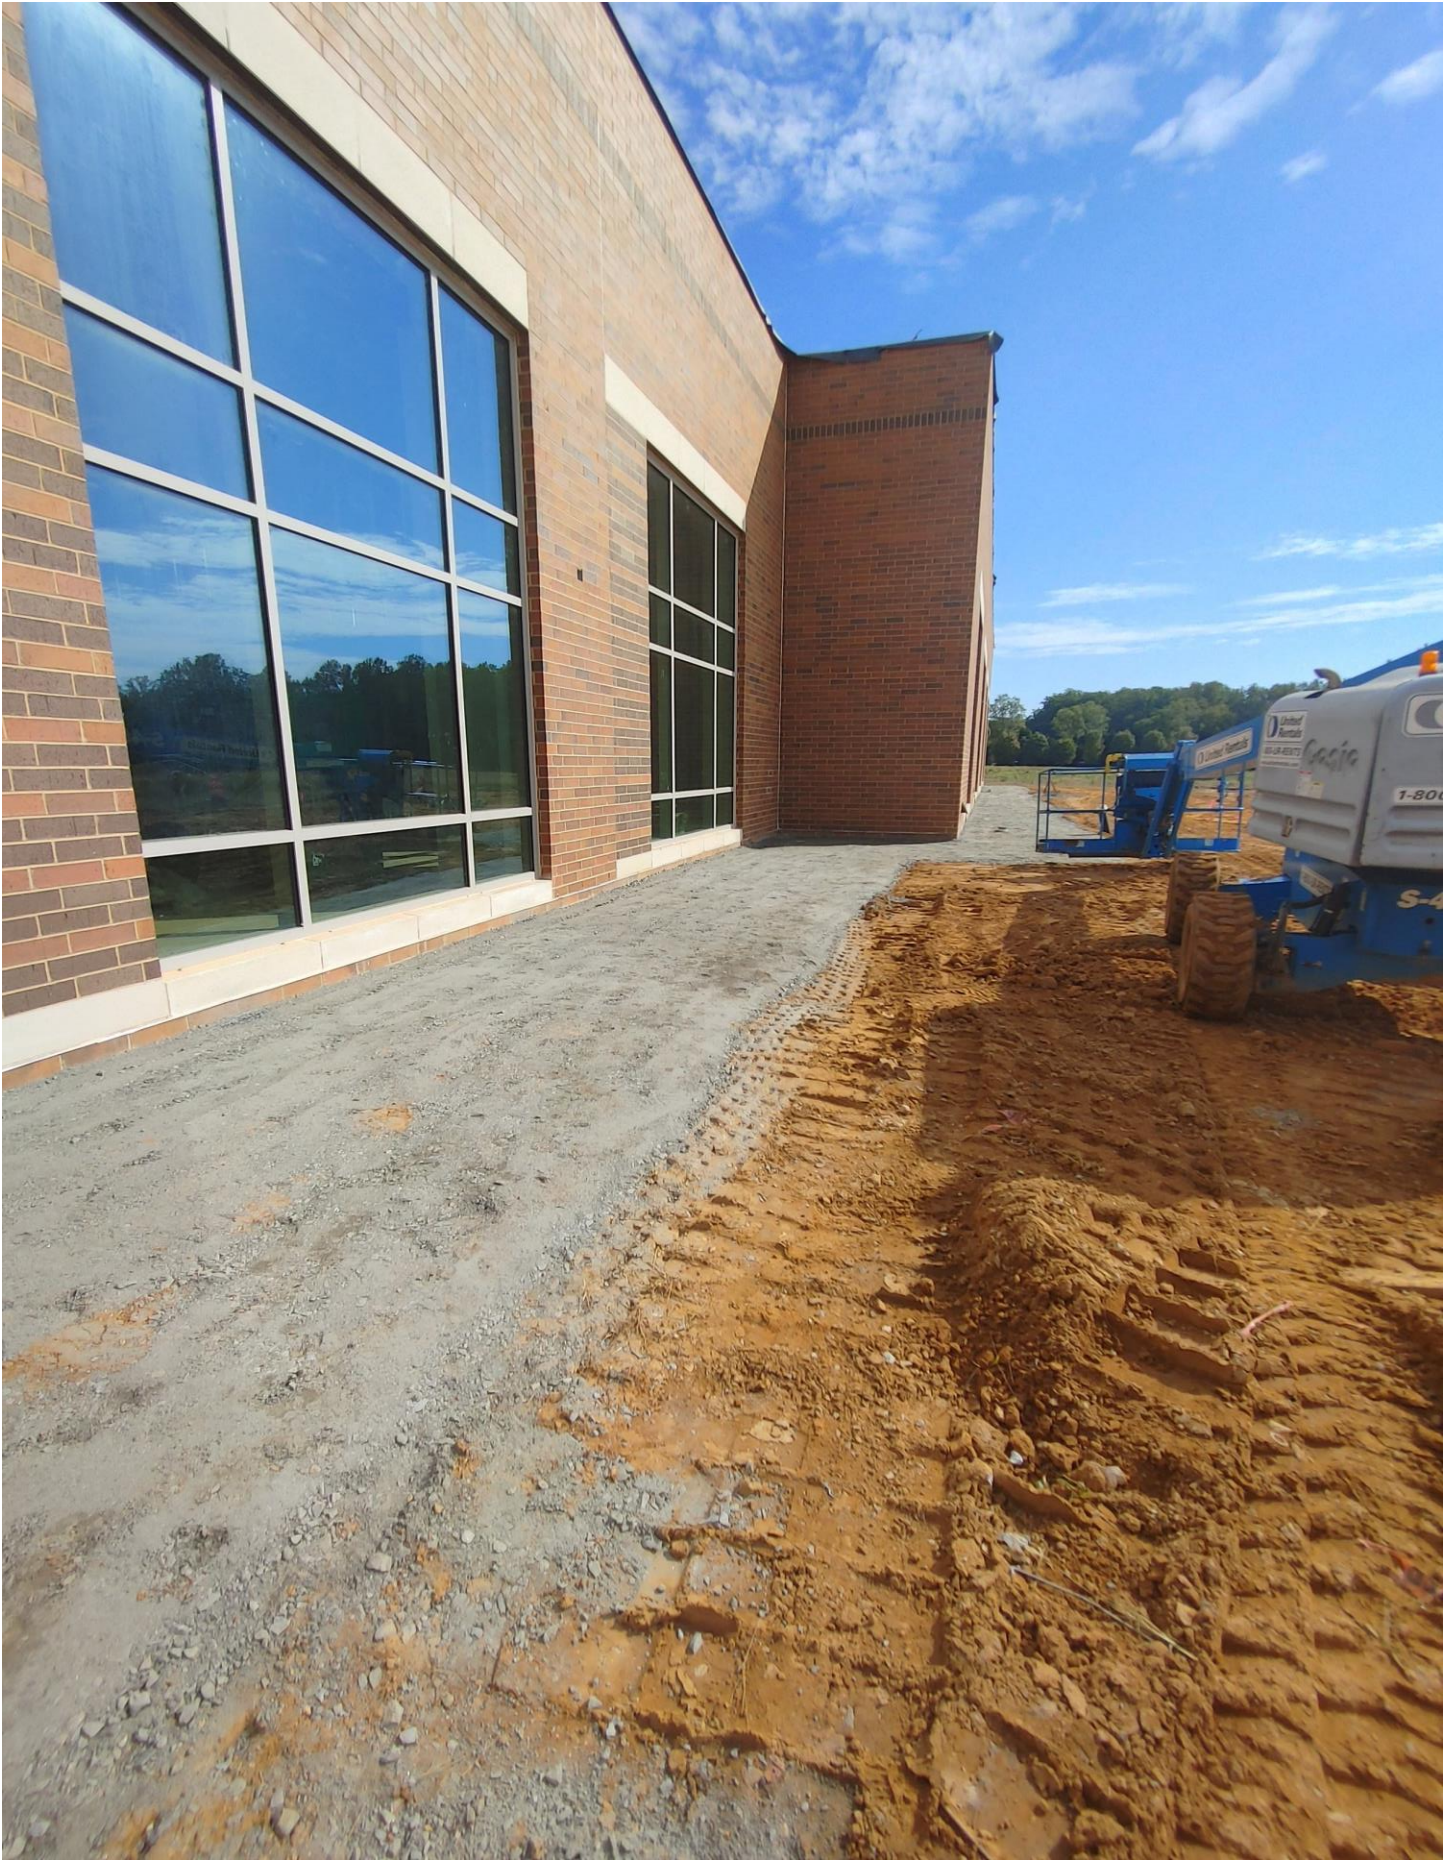
Photo 8 - South side of Area D prepped for Concrete
