**COMMONWEALTH  
BUILDING SOLUTIONS, LLC**

**FIELD REPORT**

**WESTMORELAND COUNTY HIGH SCHOOL**

Date: 10/15/2021

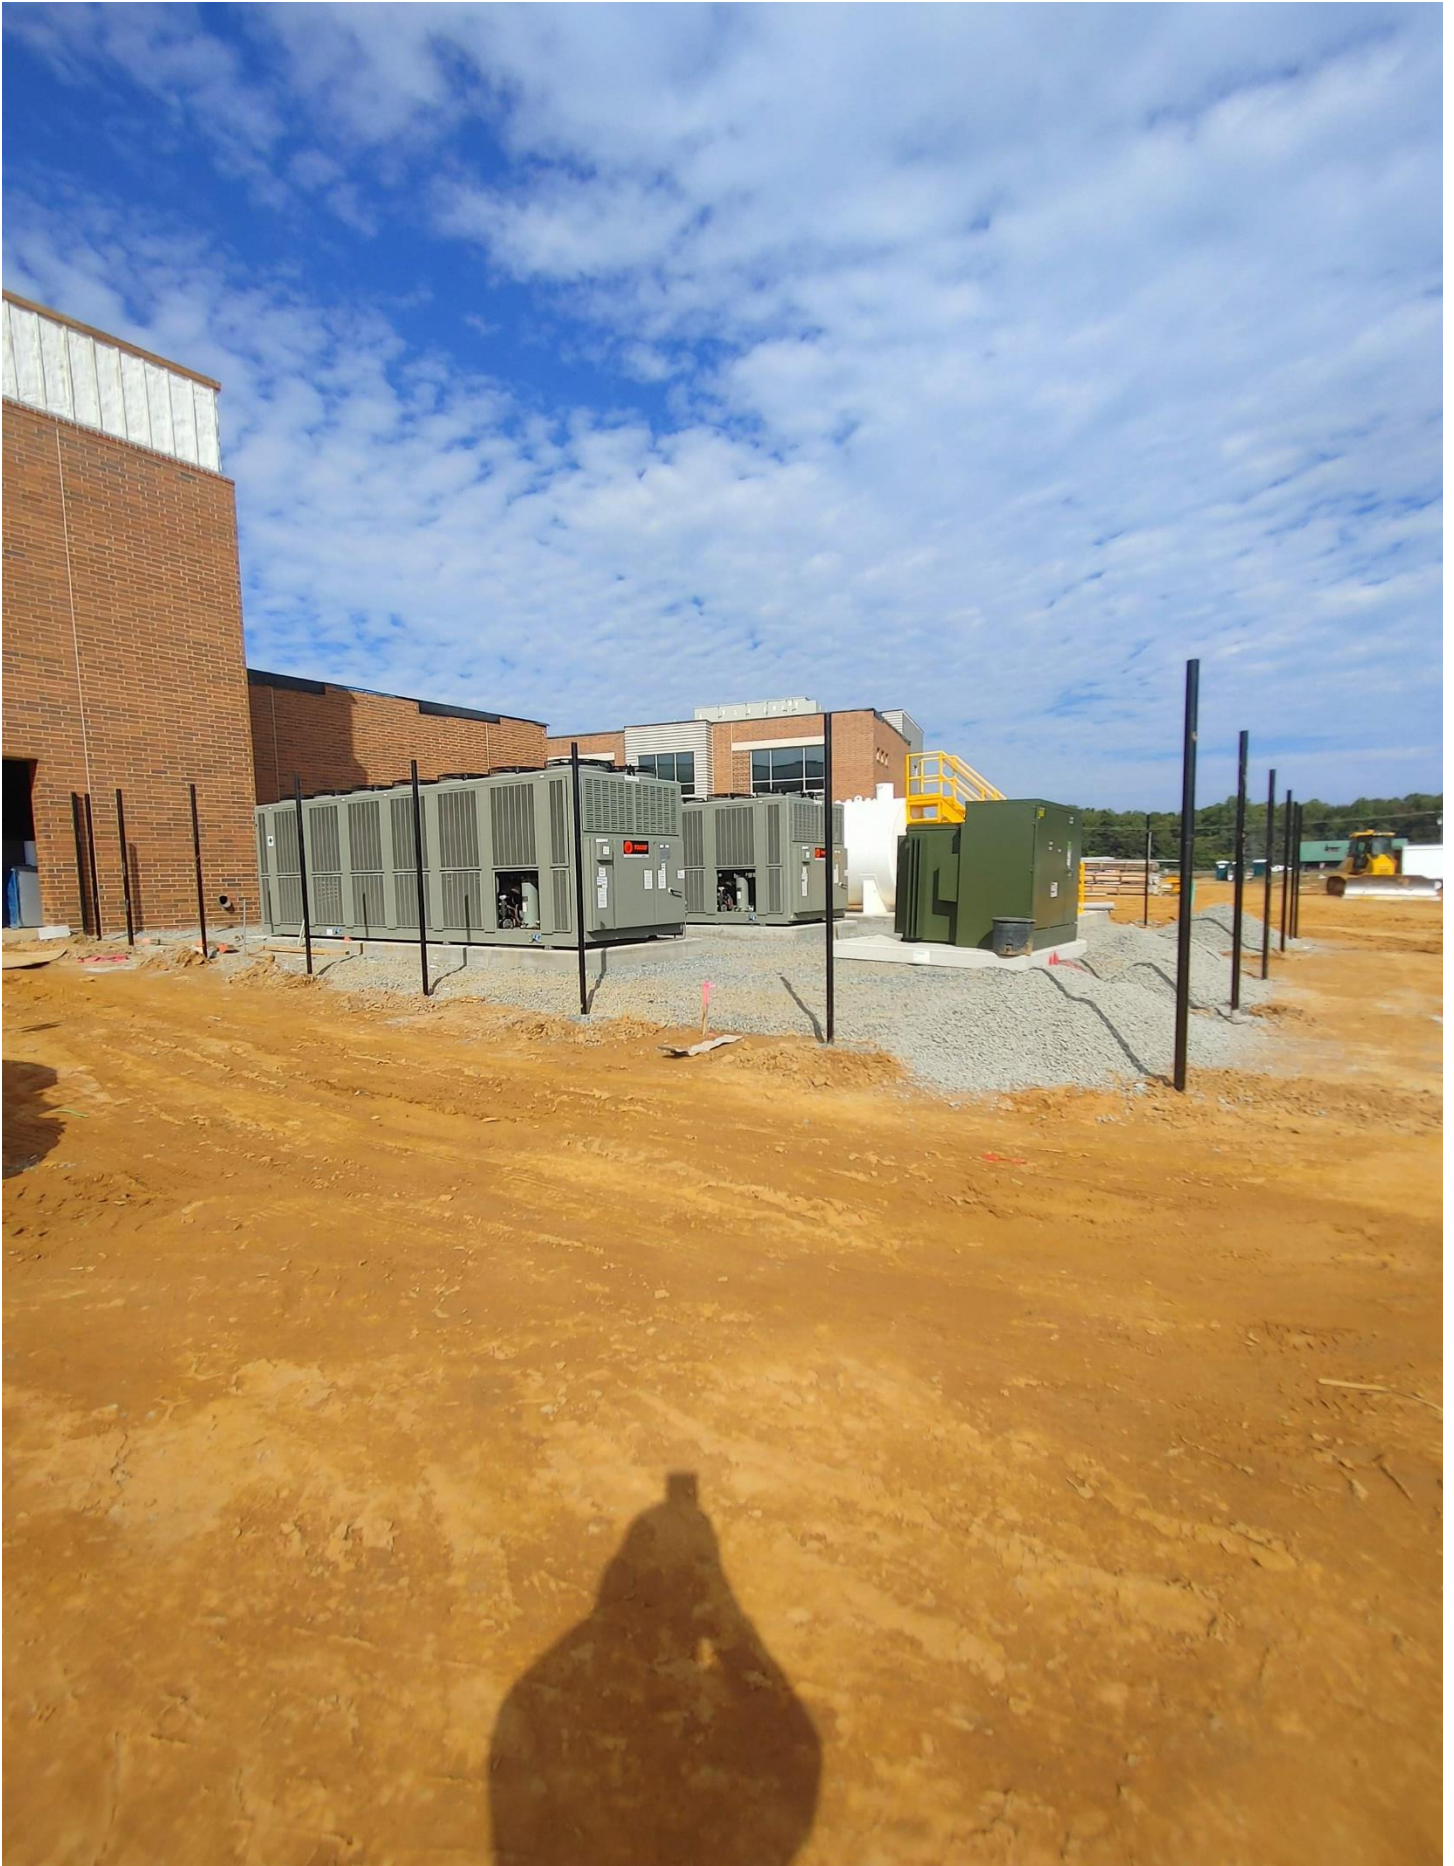
*Photo 9 - Fence Posts have been installed*

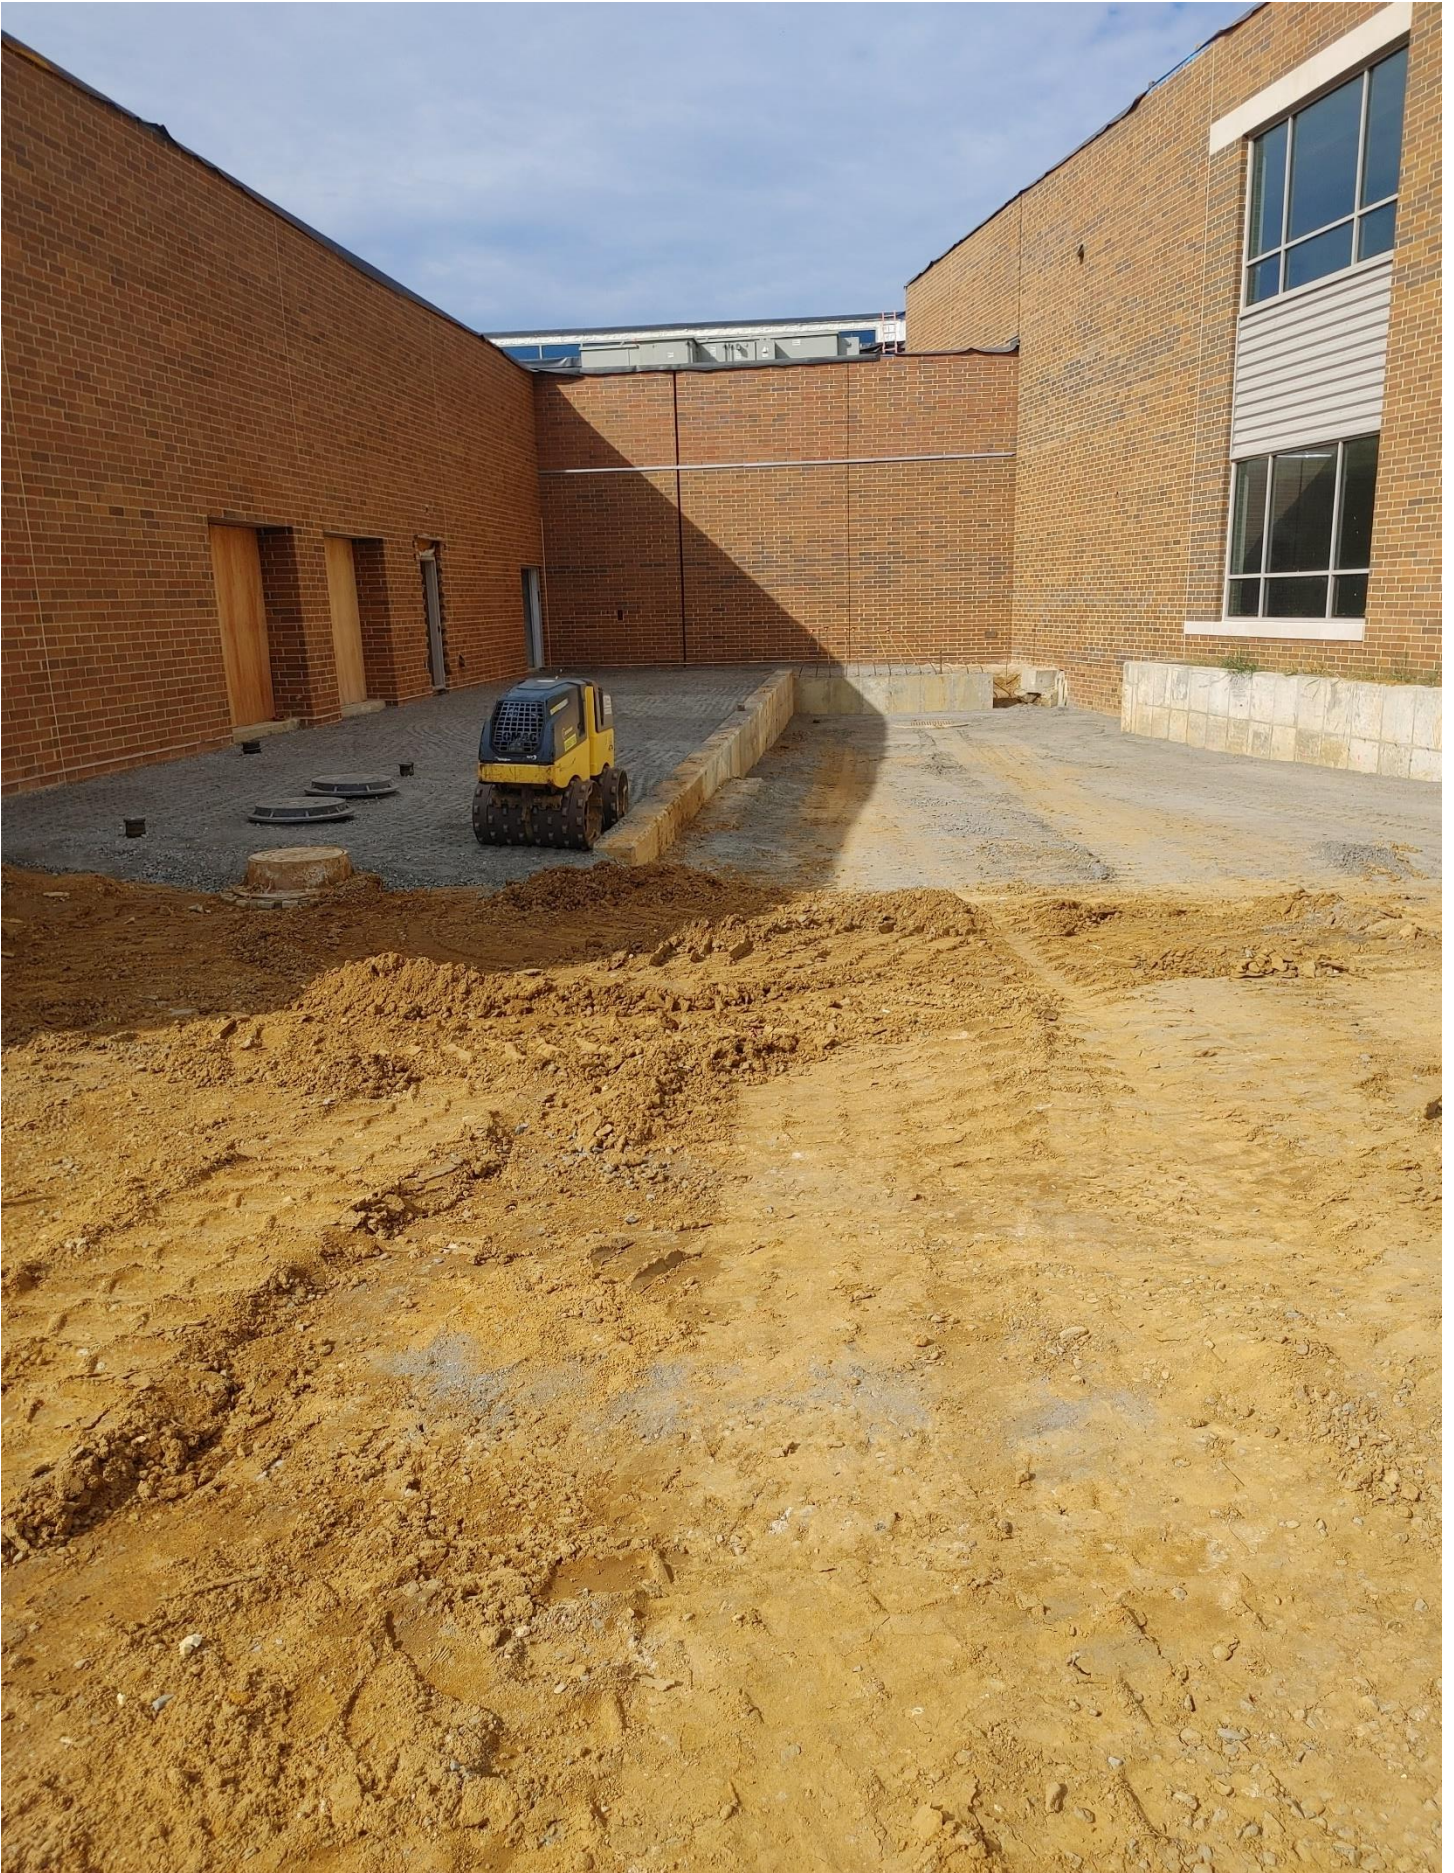
Photo 10 - Load Dock Area is being prepped for Concrete

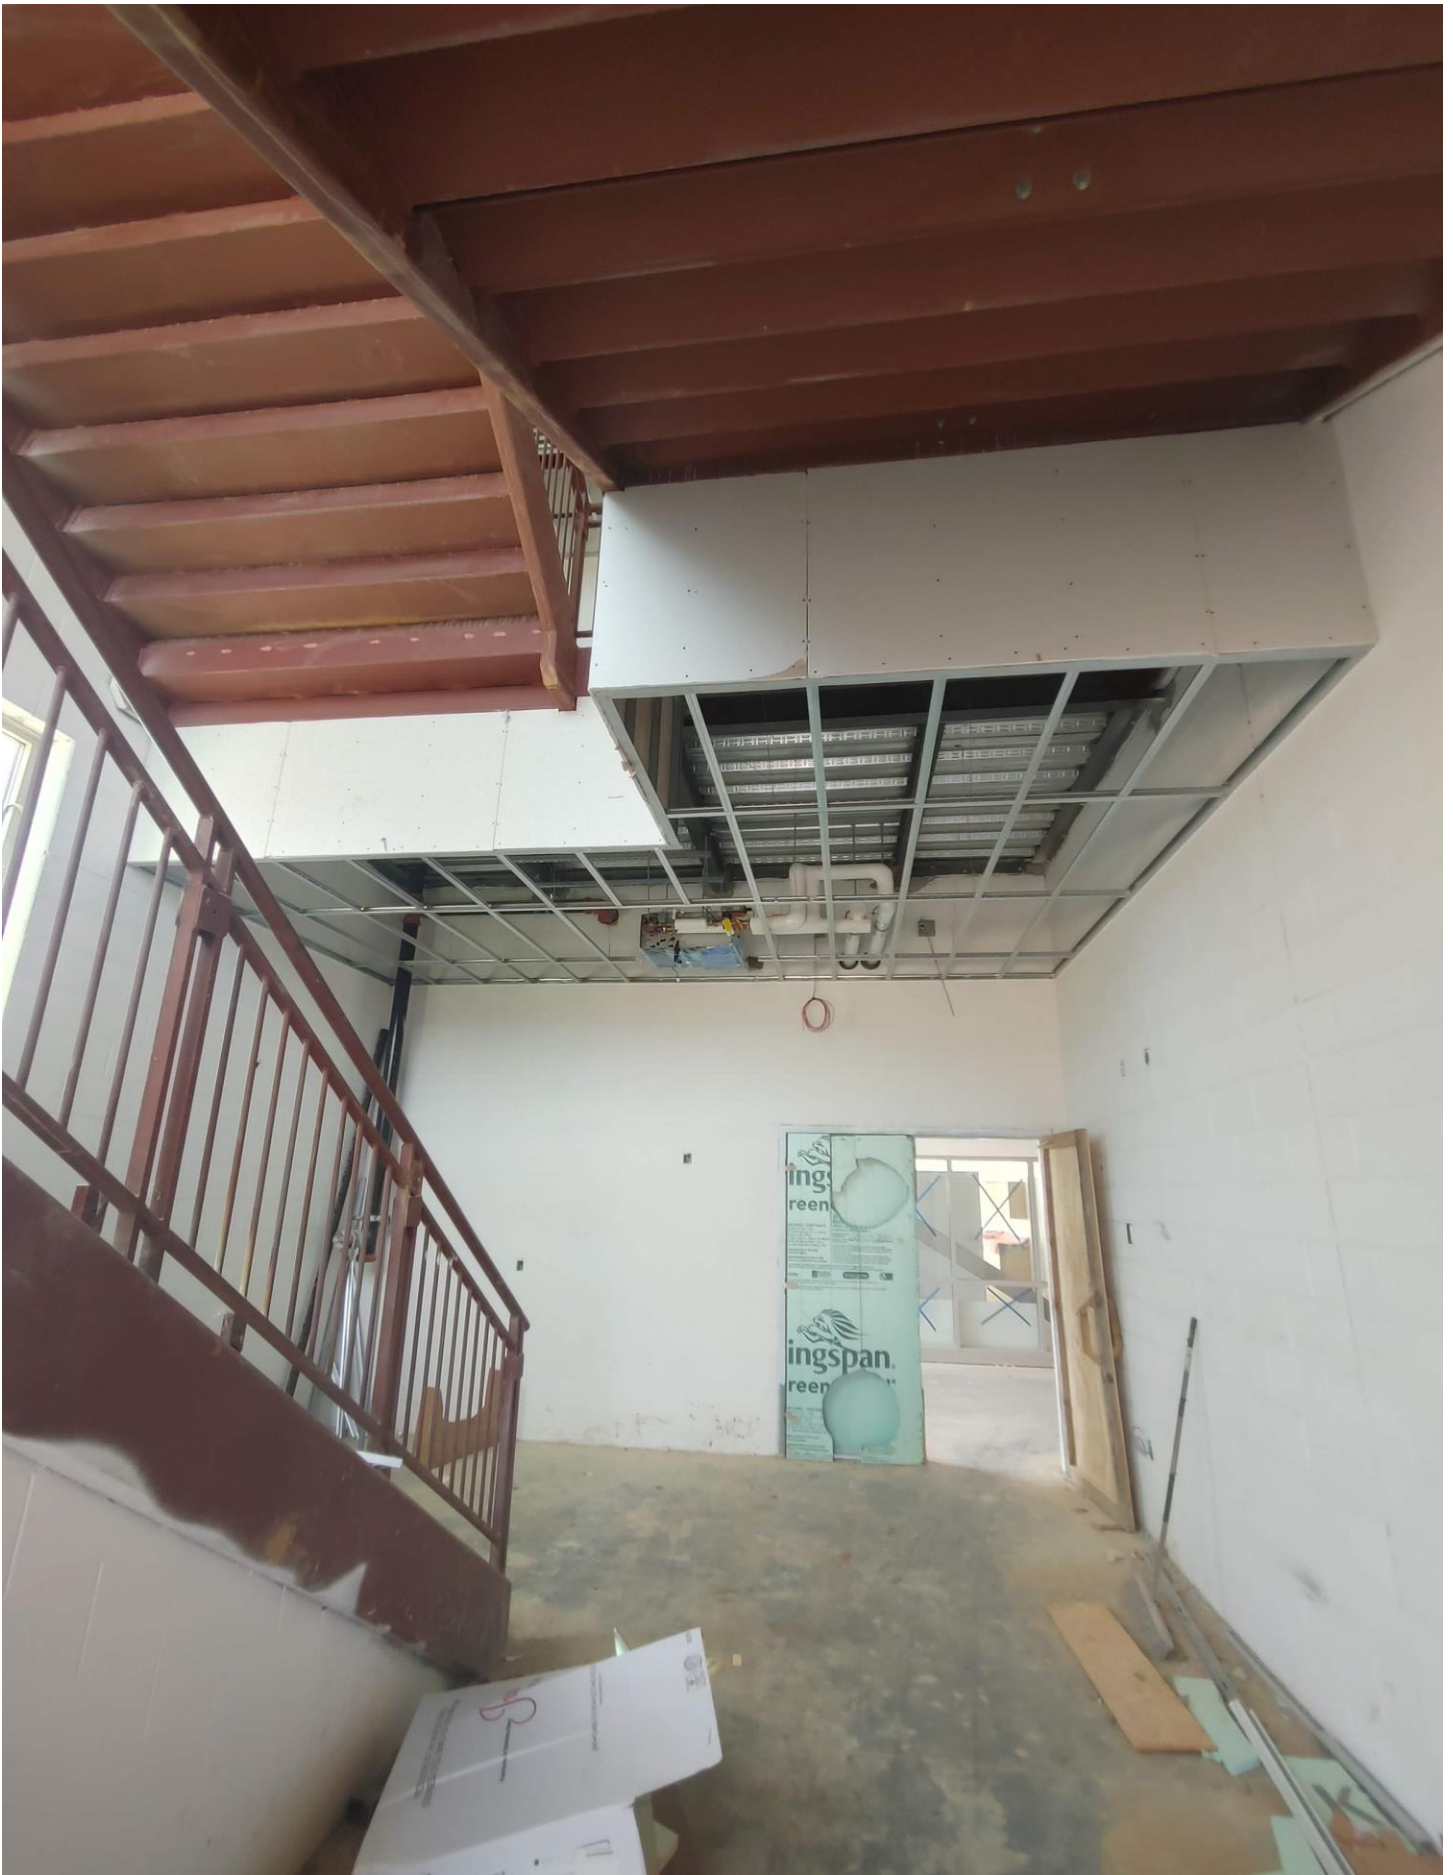
Photo 11 - Sheetrock hung on Bulkhead in Stairwell #1

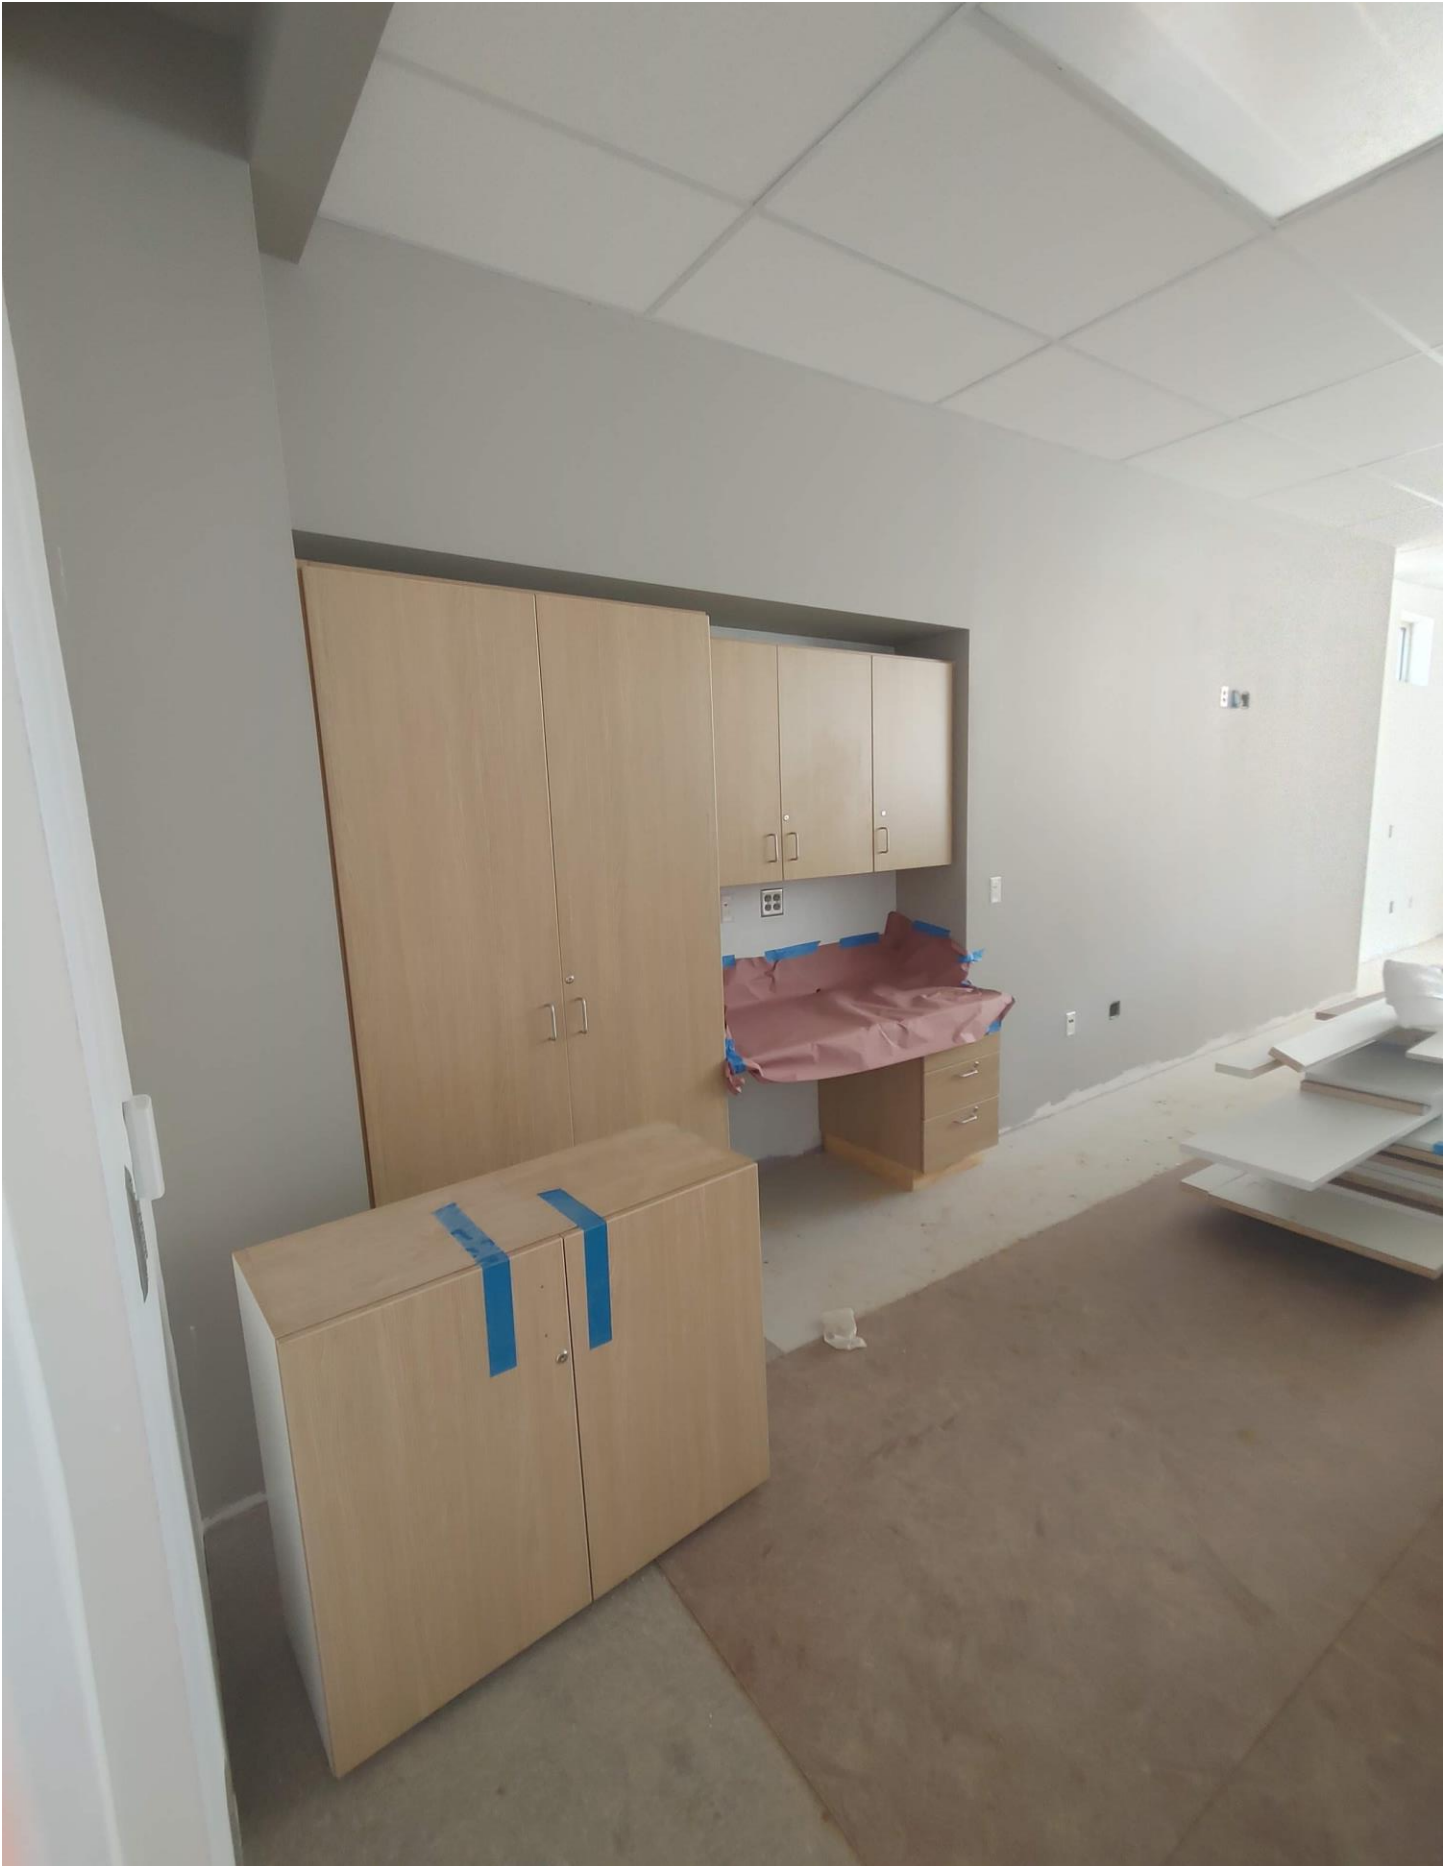
Photo 12 - Cabinetry has been installed in A105

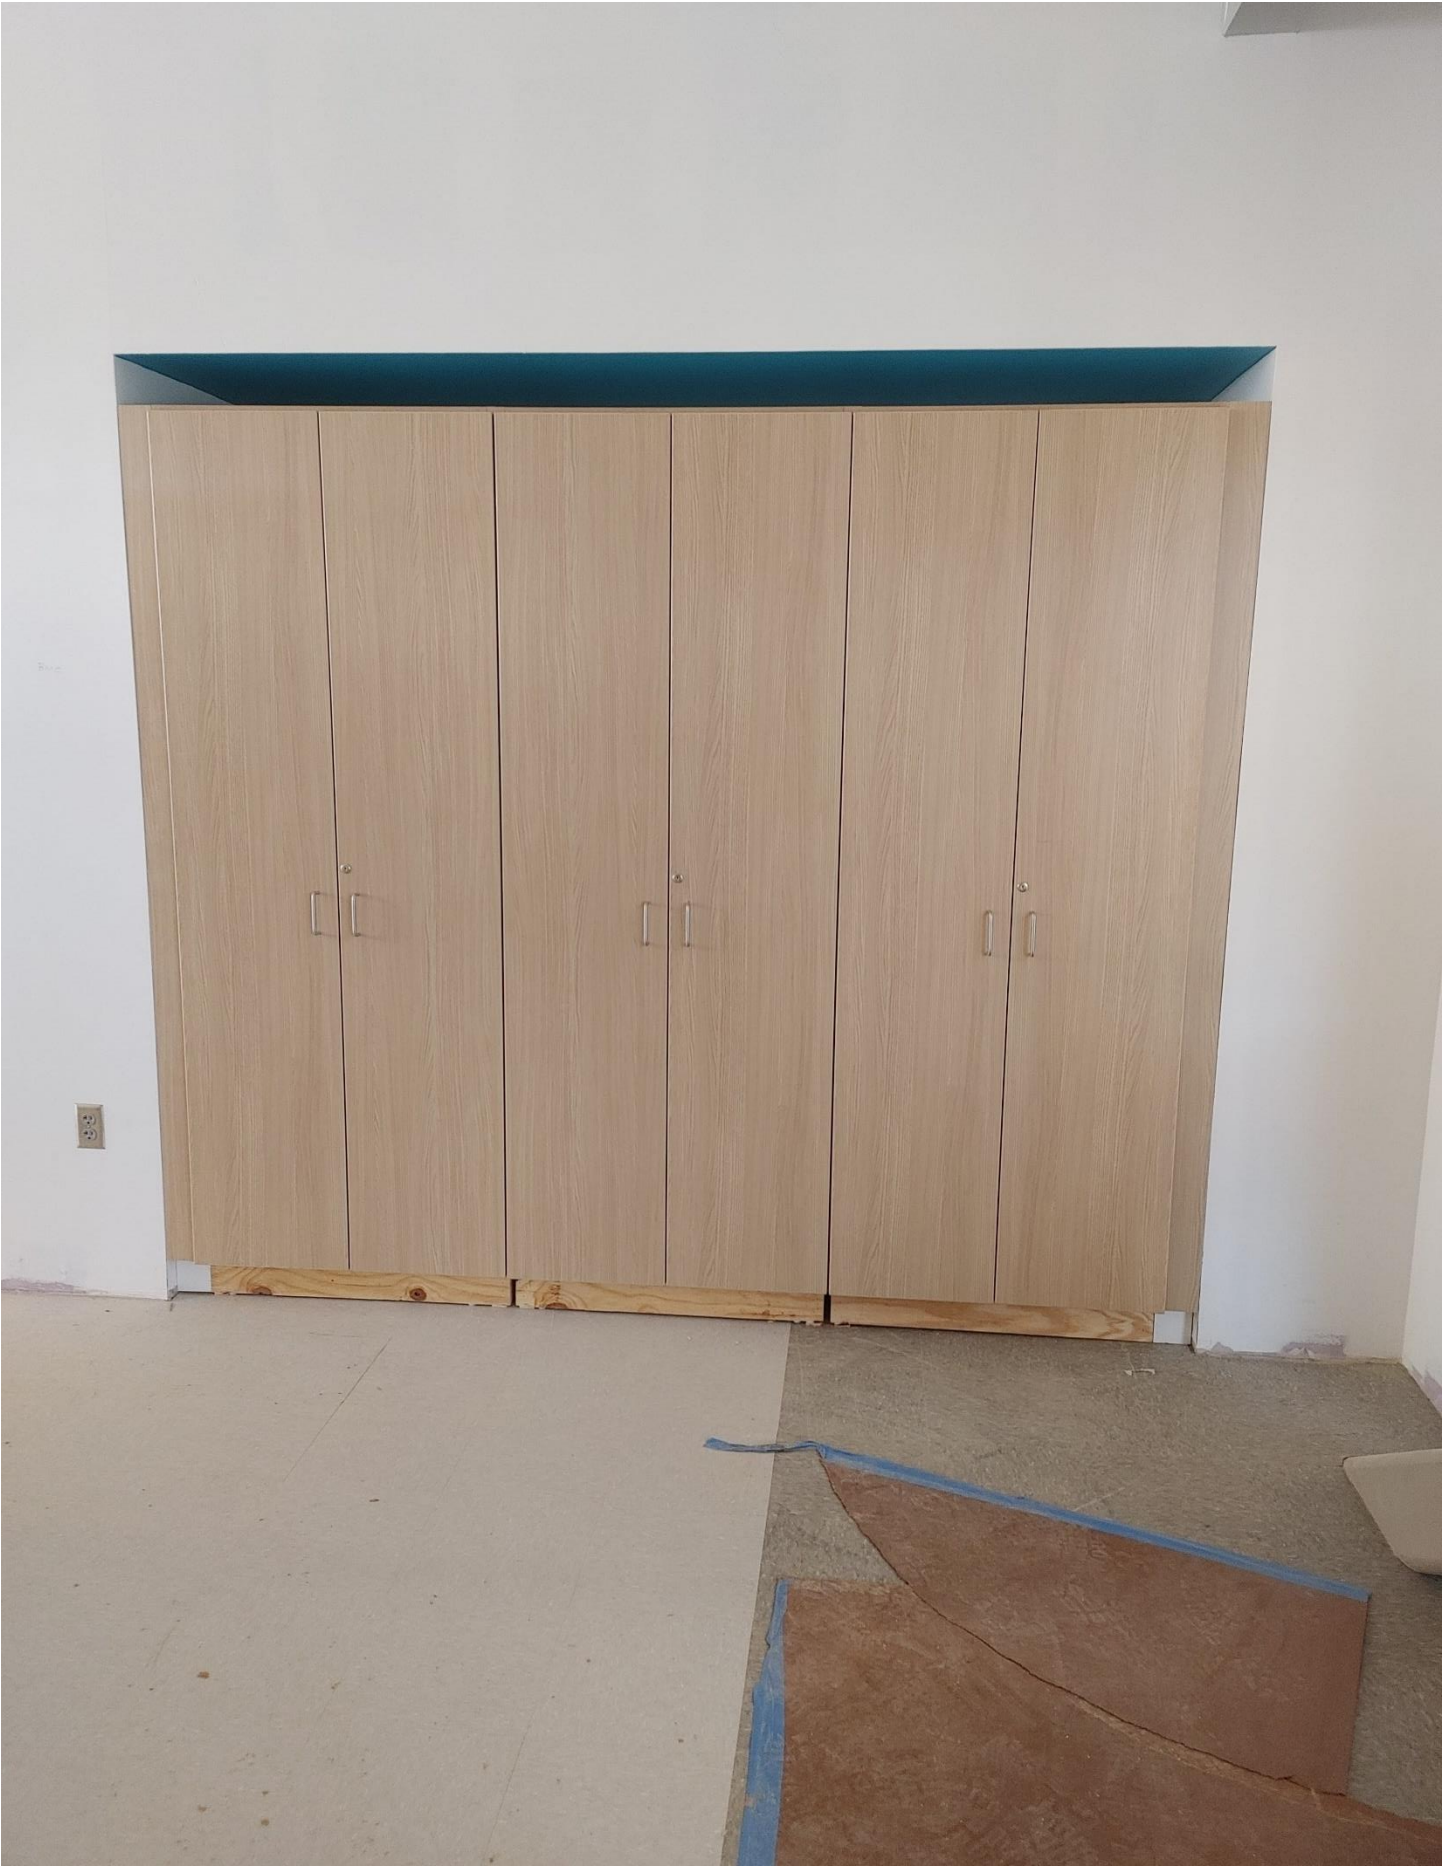
Photo 13 - Cabinetry in A105

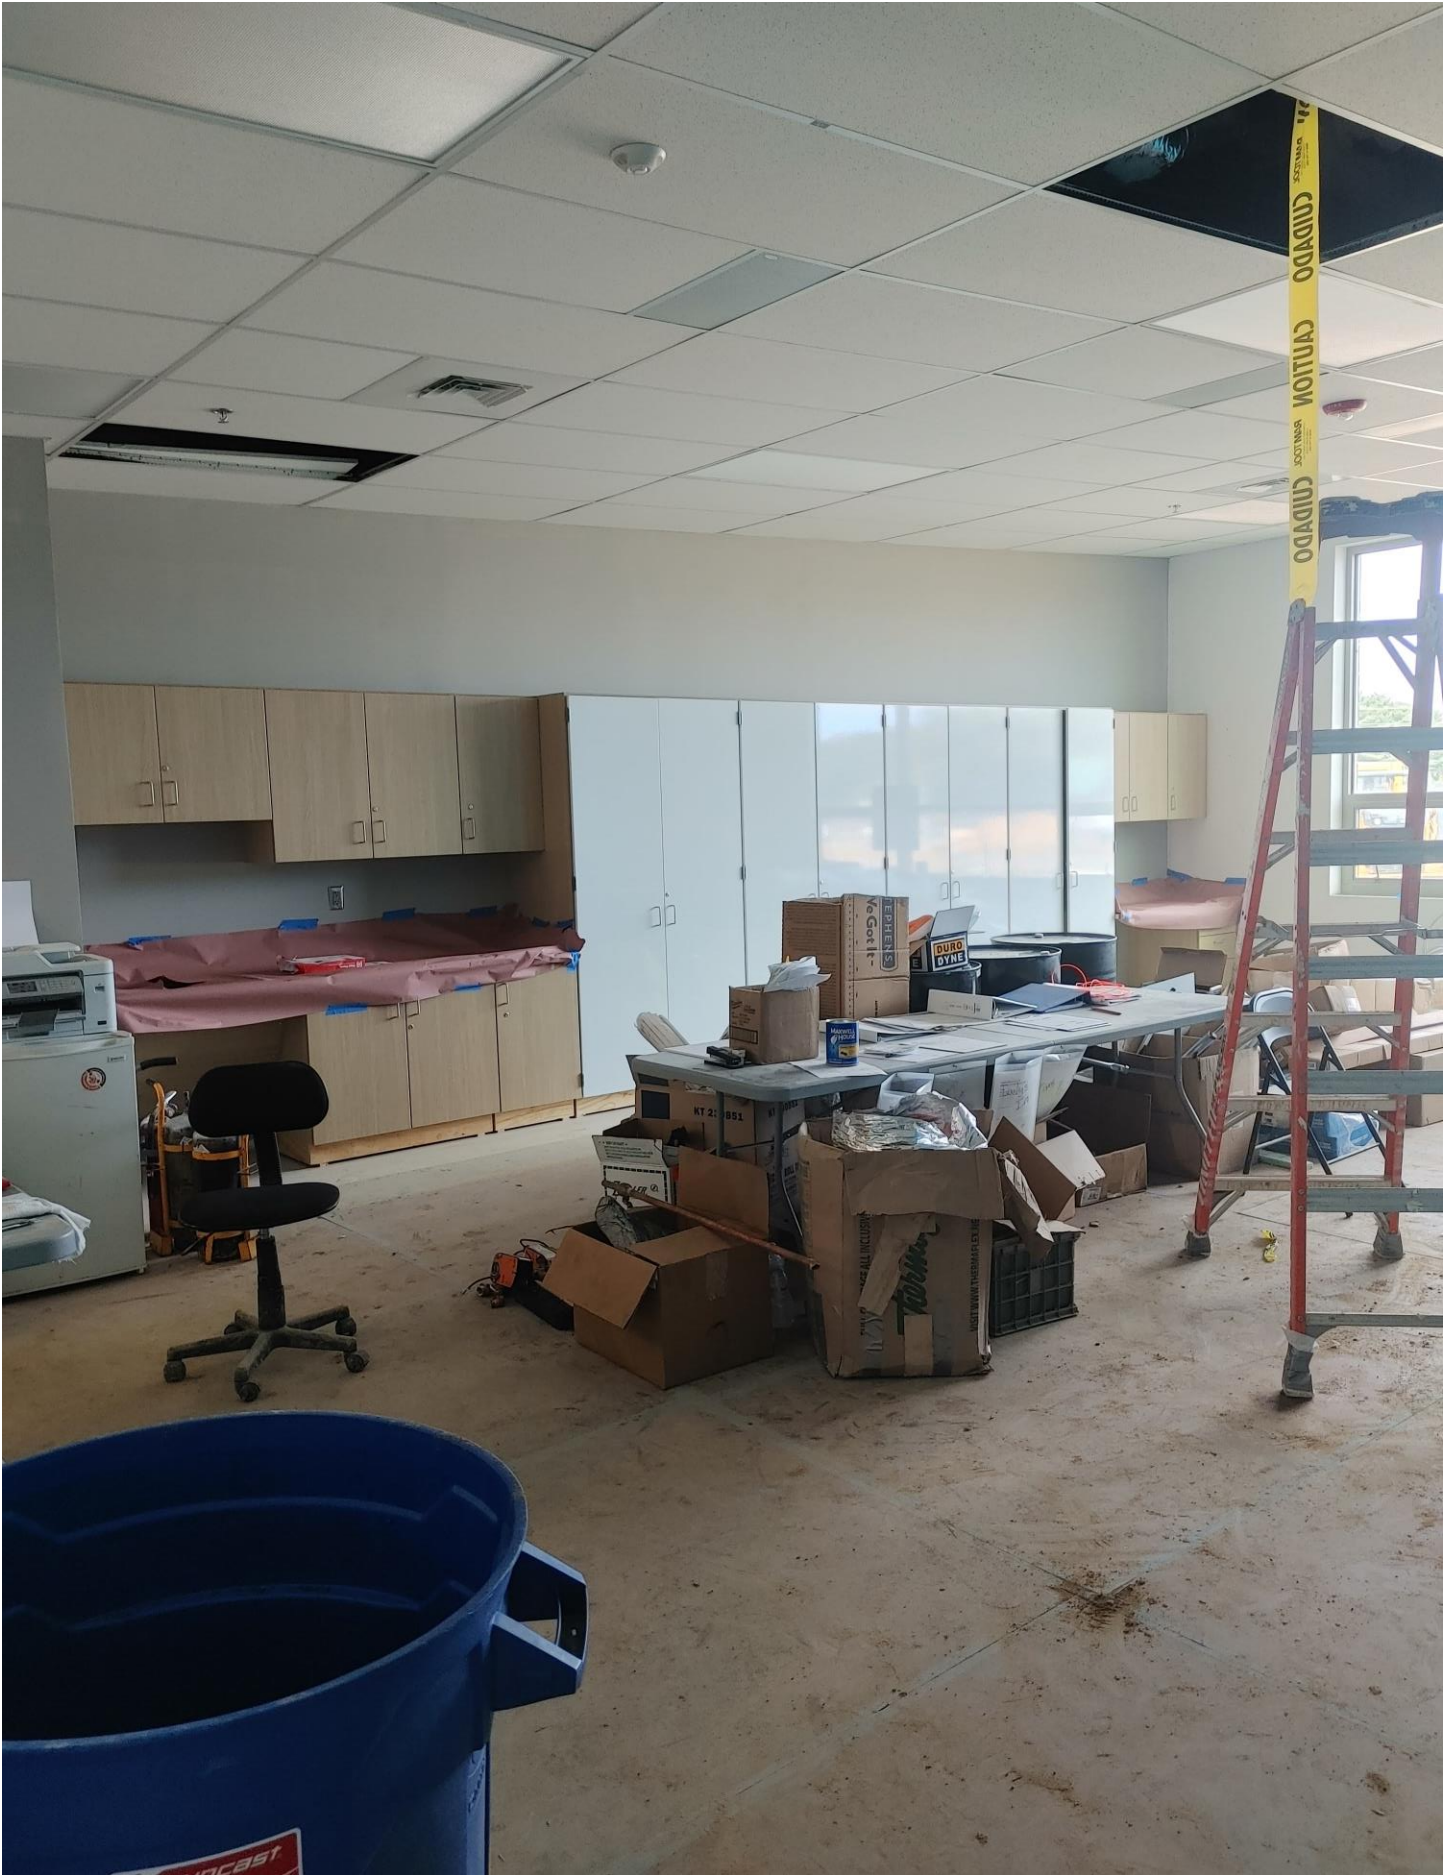
Photo 14 - Cabinetry installed in A103

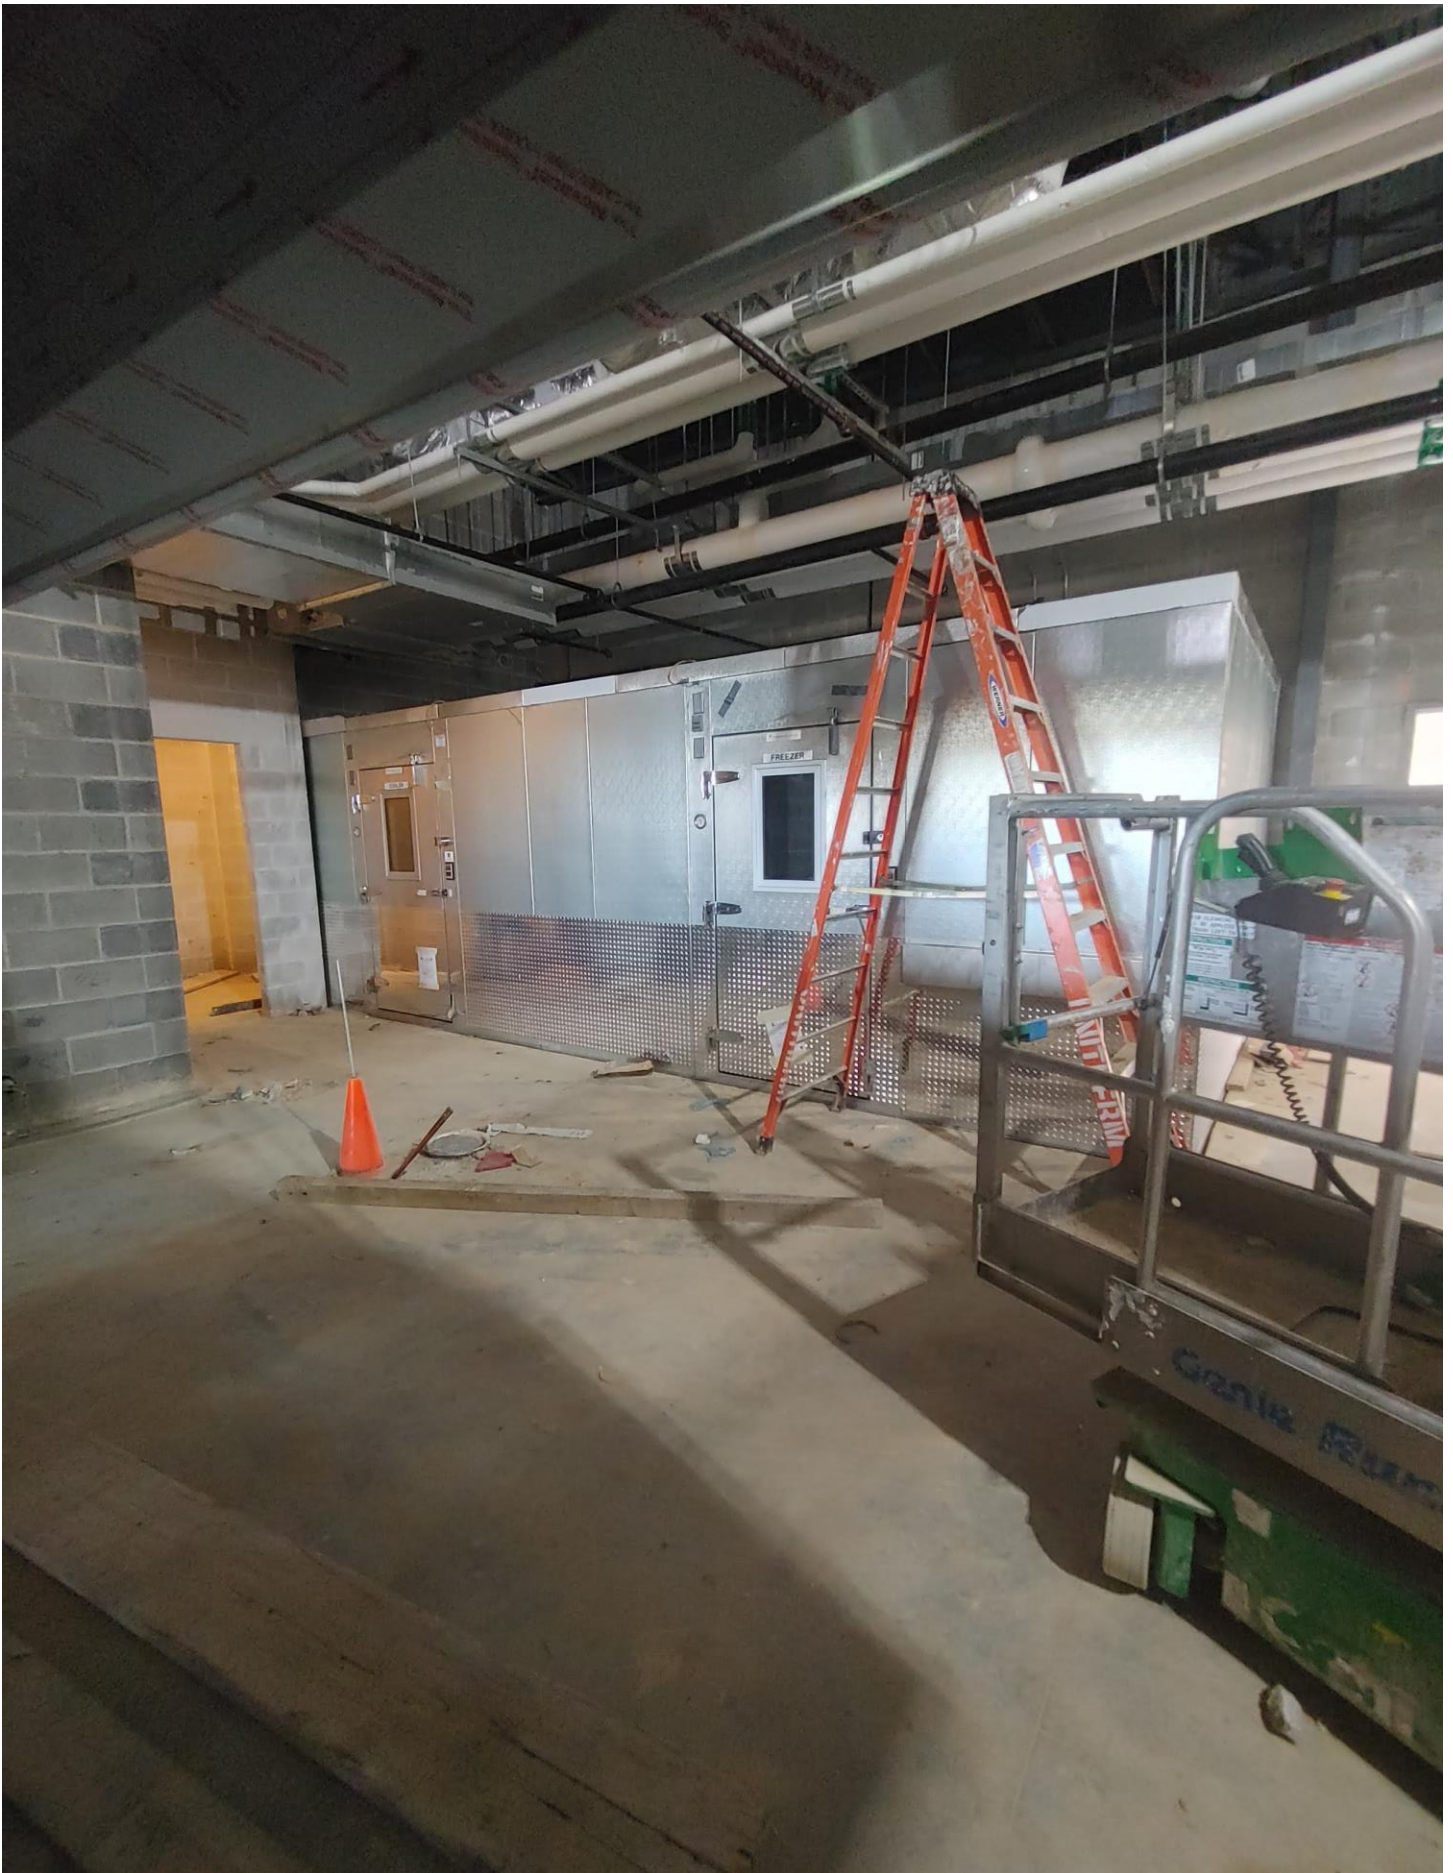
Photo 15 - Cooler and Freezer have been installed

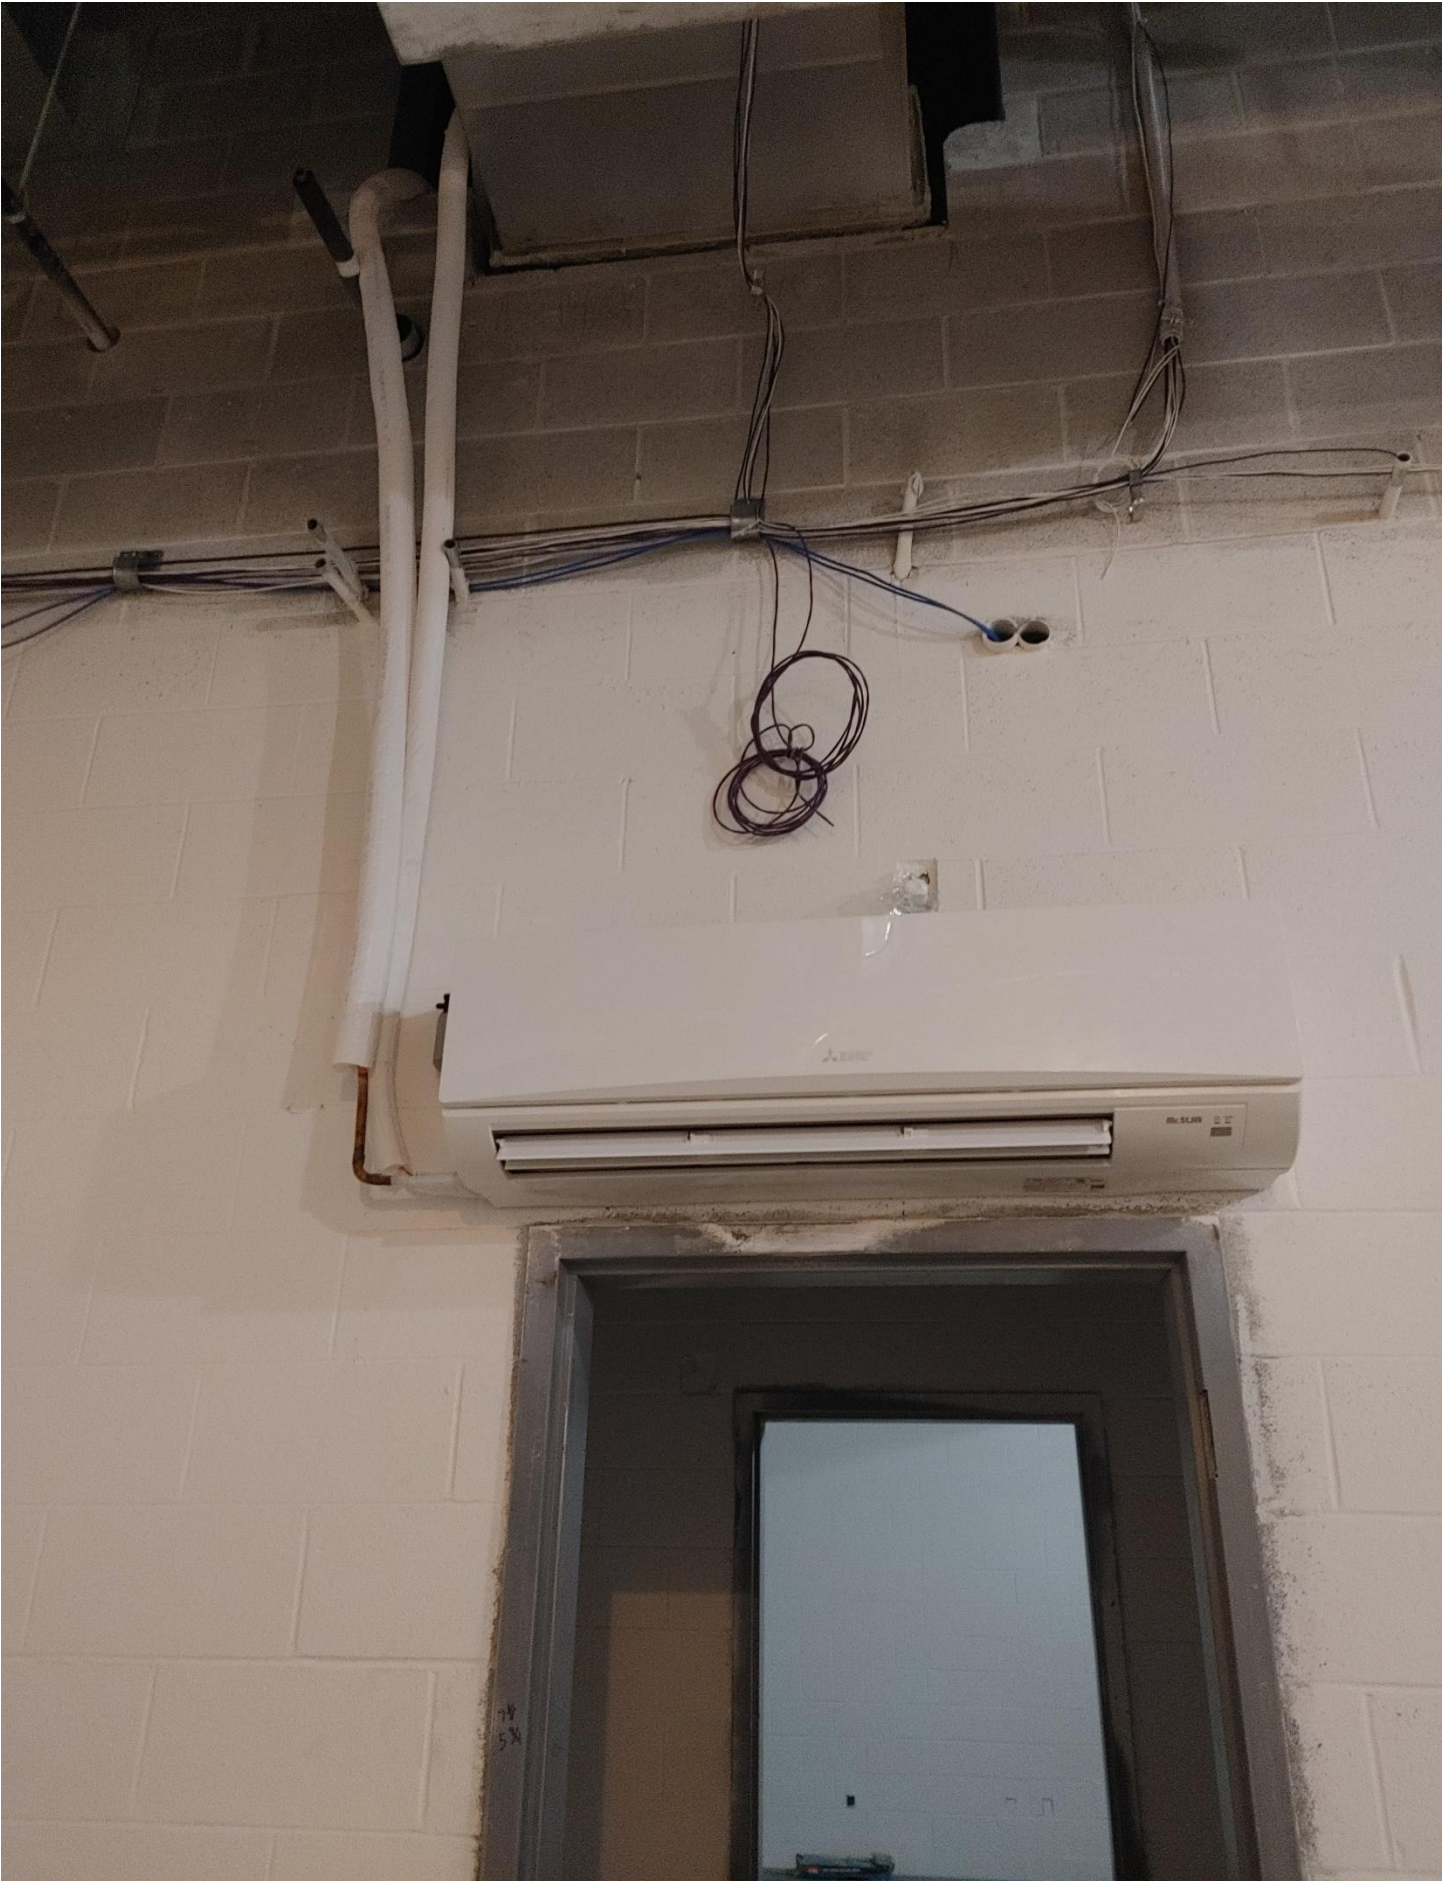
I showed Todd to pictures I had taken of two Mitsubishi head Units above doors D131 & D132 (pictures below). One of the Units is set directly above the Door Frame and the other is set 1-1/2 block courses above the frame. Todd ask that I send him the pictures and he would get the one setting on the Door frame moved.

Photo 16 - Mitsubishi Head unit install almost on Door Frame D132. (Todd will have unit moved).
