**COMMONWEALTH  
BUILDING SOLUTIONS, LLC**

**FIELD REPORT**

**WESTMORELAND COUNTY HIGH SCHOOL**

Date: 10/15/2021

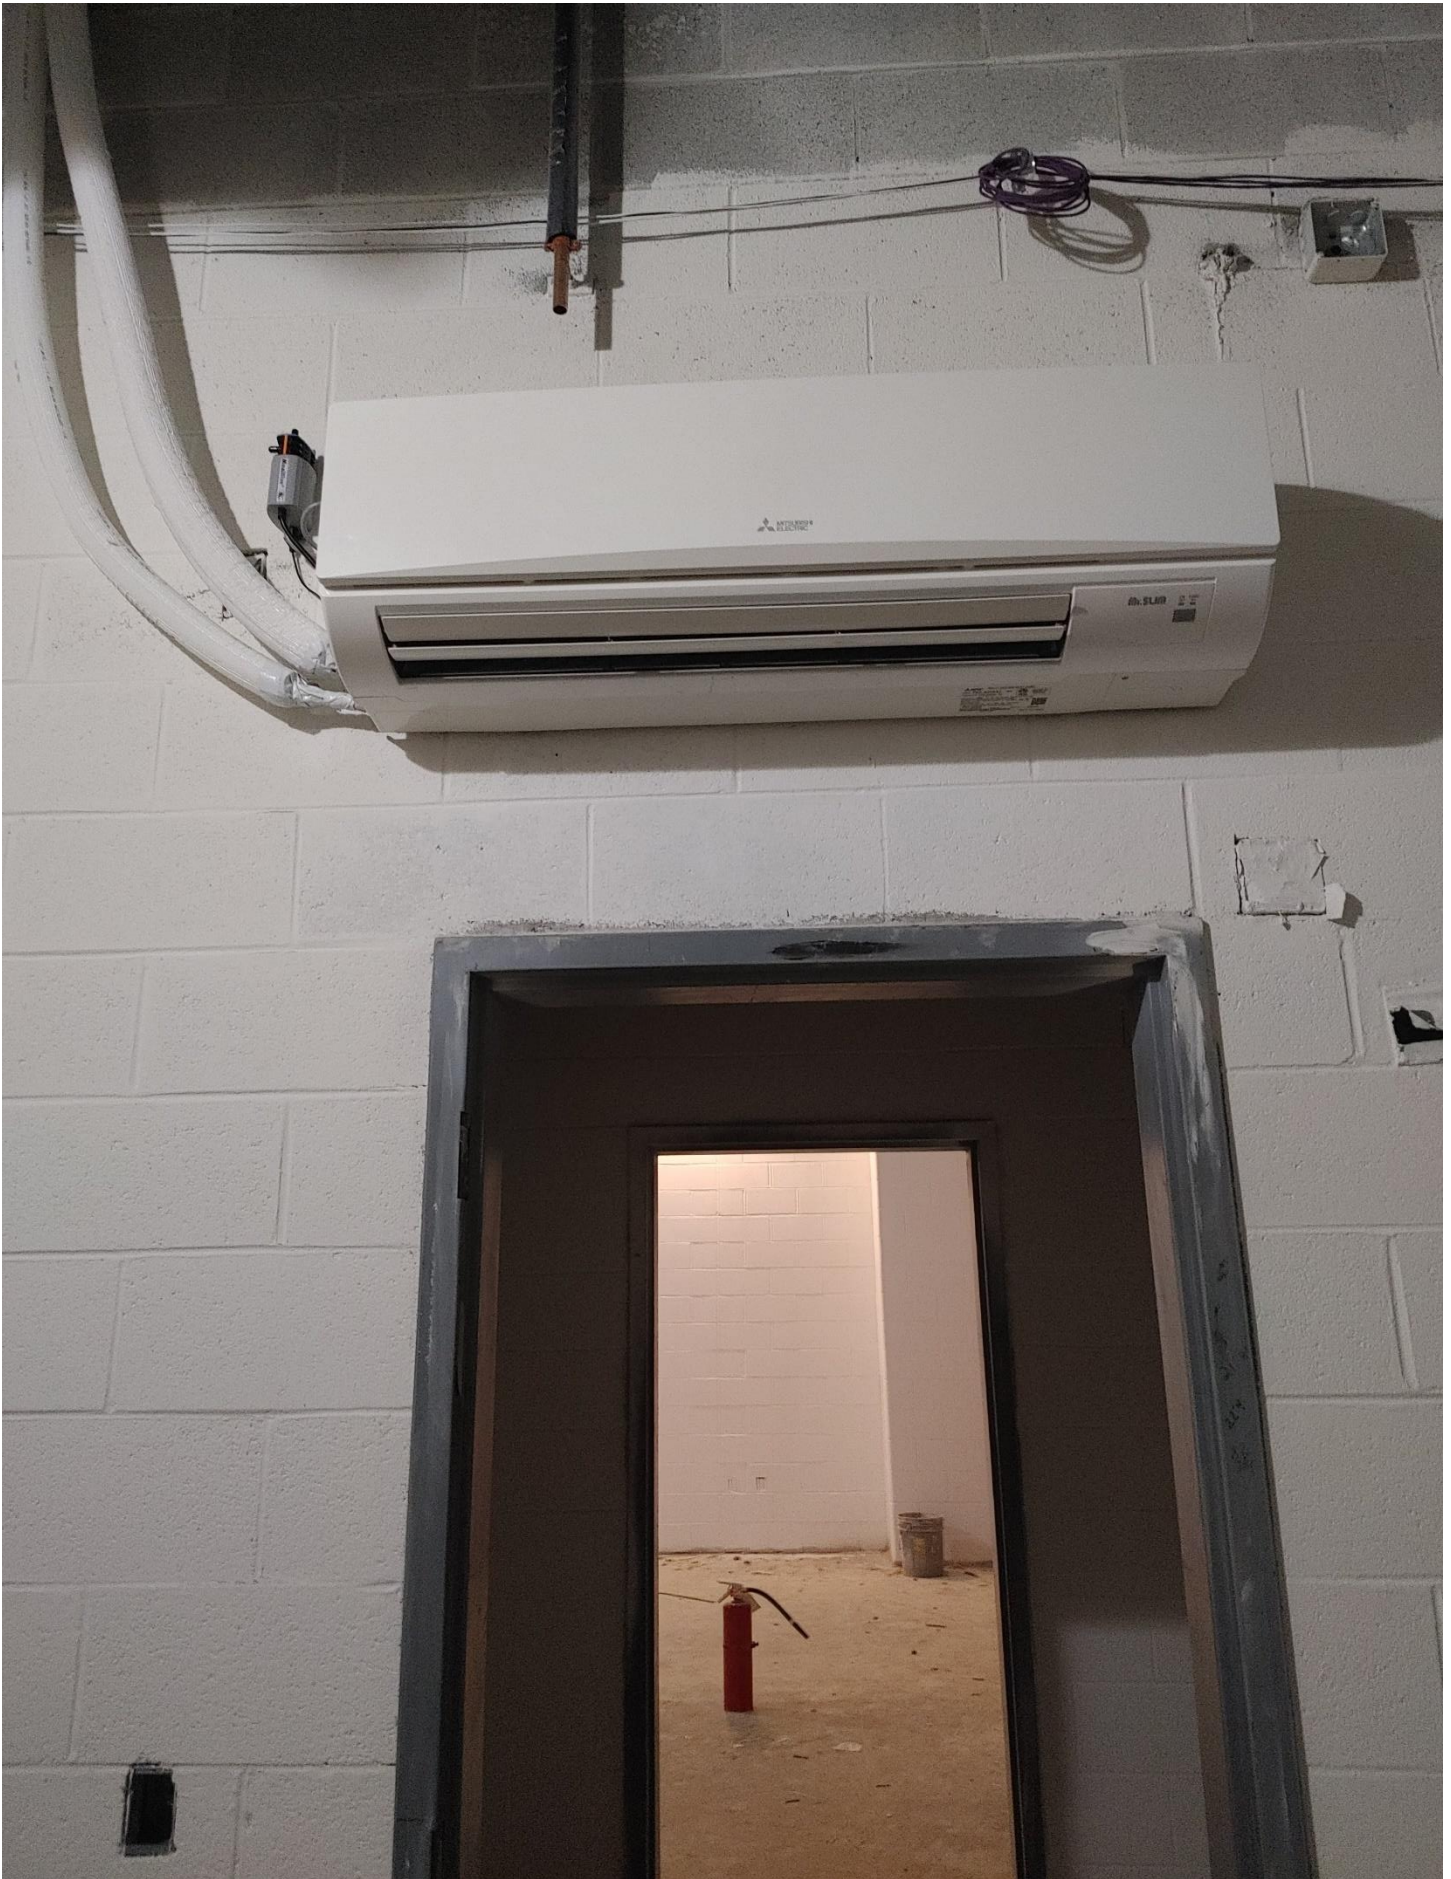
I showed Todd to pictures I had taken of two Mitsubishi head Units above doors D131 & D132 (pictures below). One of the Units is set directly above the Door Frame and the other is set 1-1/2 block courses above the frame. Todd ask that I send him the pictures and he would get the one setting on the Door frame moved.

Photo 17 - Mitsubishi Head unit install almost on Door Frame D131.

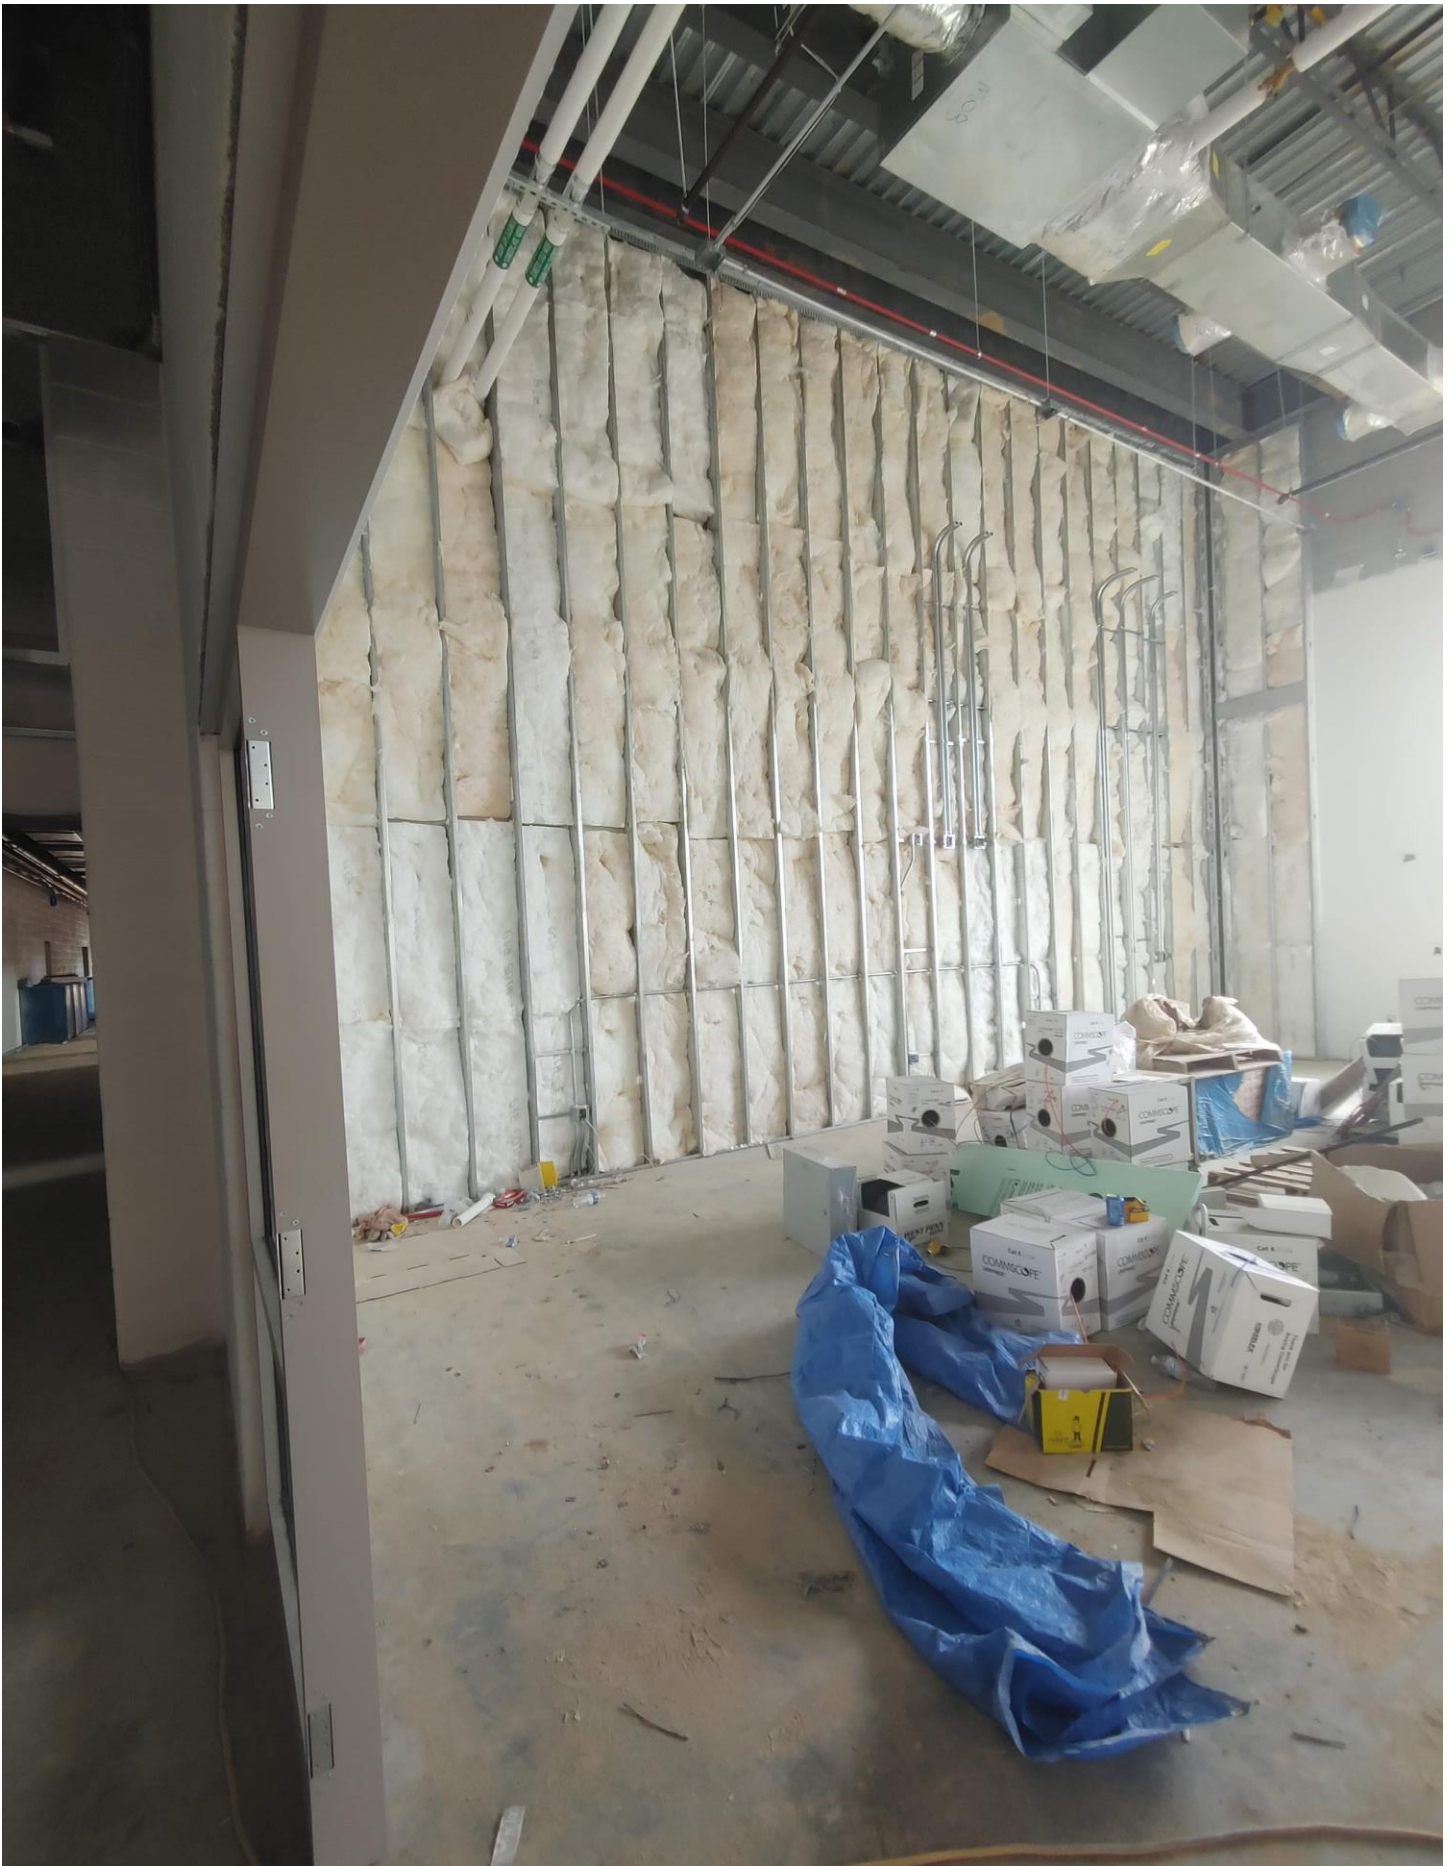
Photo 18 - Insulation has been installed on the East wall of Room D112

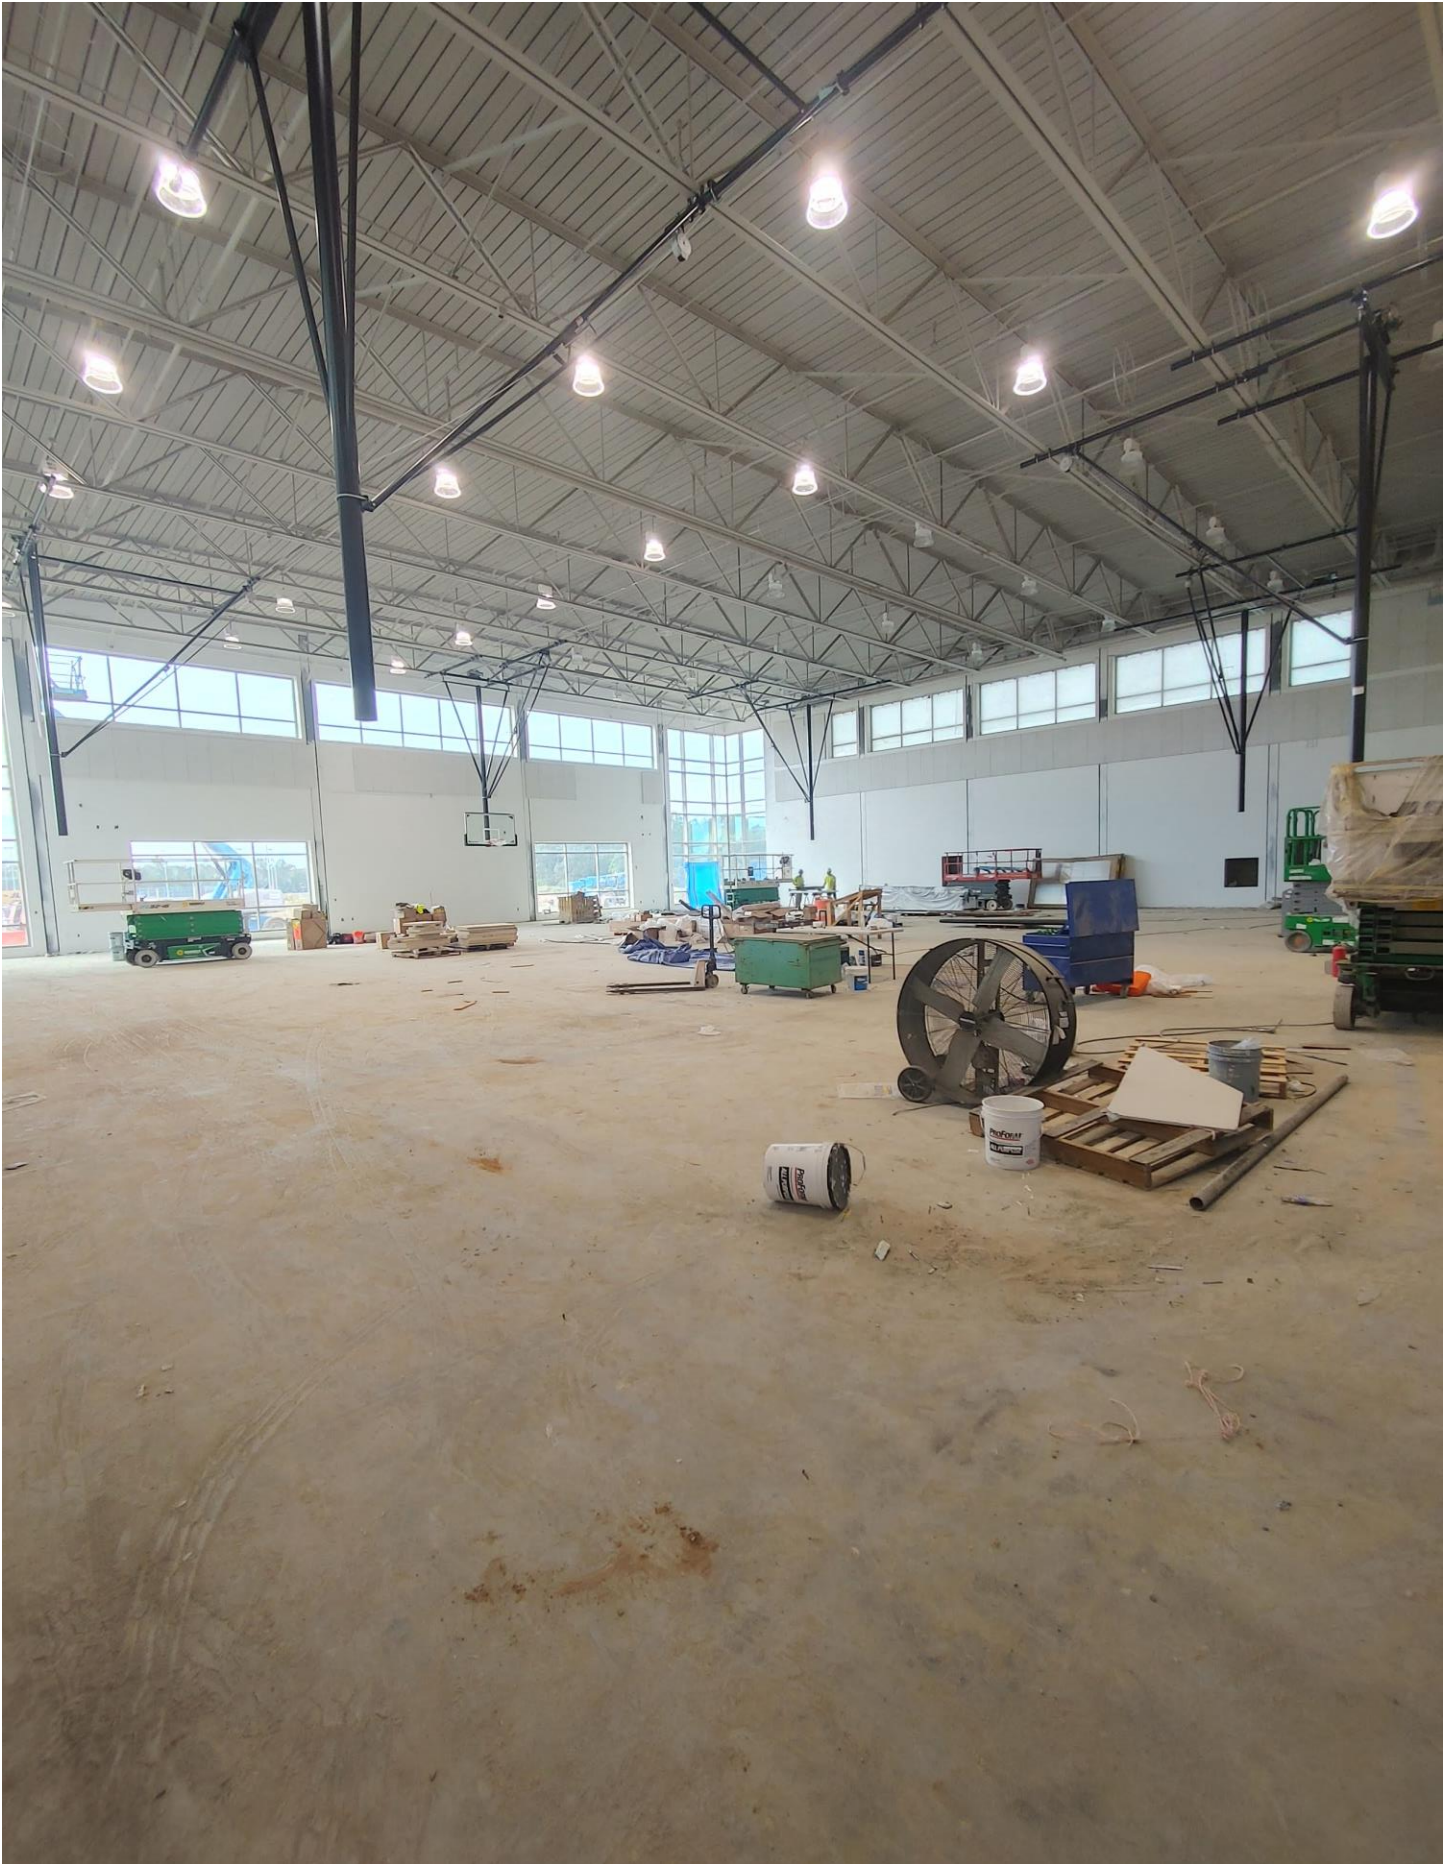
Photo 19 - Backboards are being installed

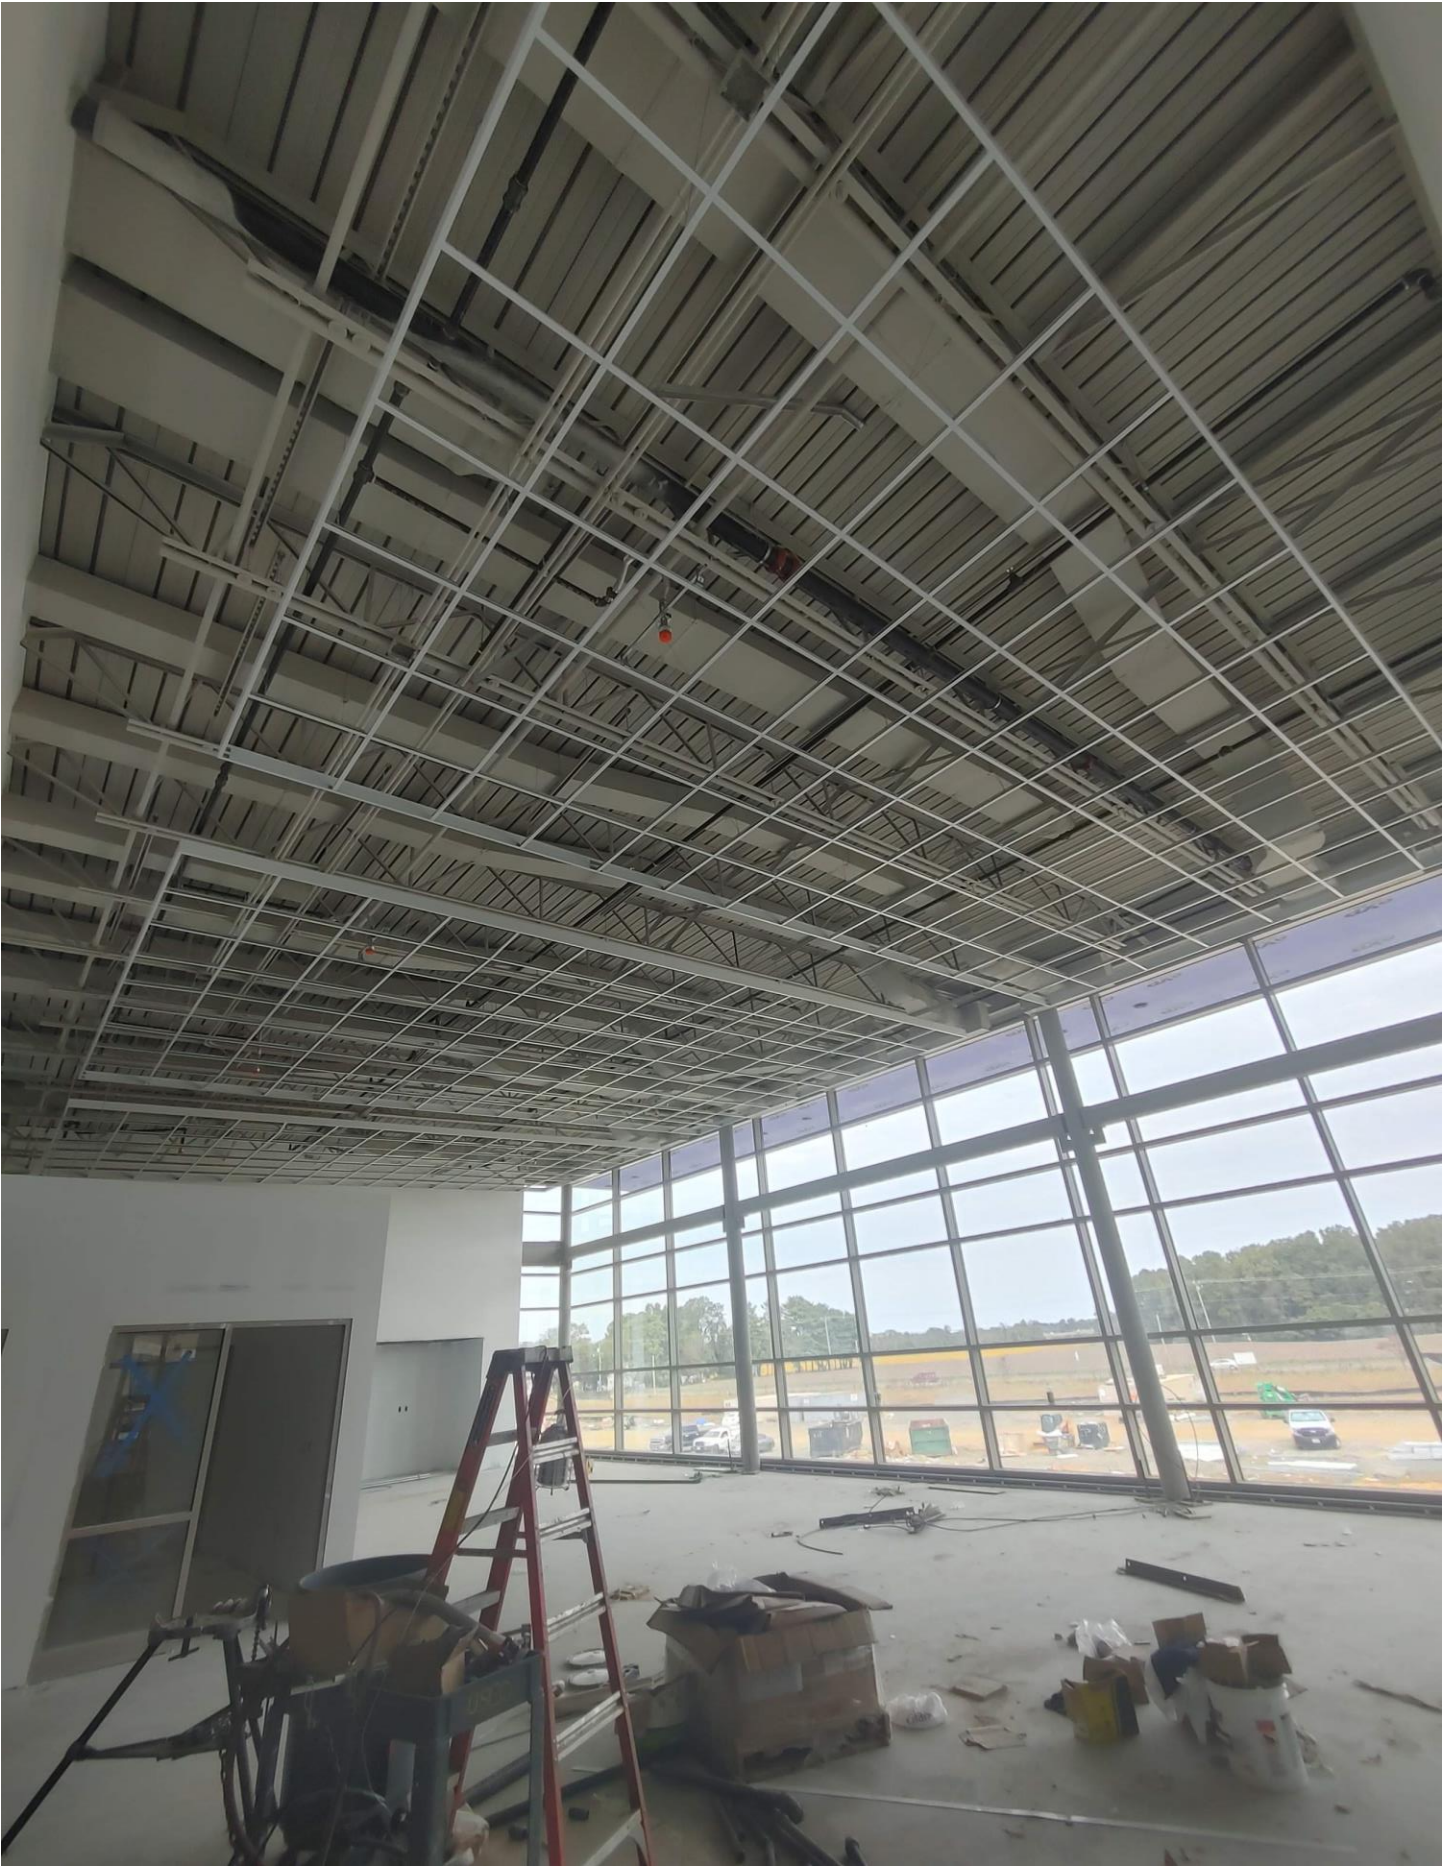
Photo 20 - Track has been installed for Cloud Ceiling in Area A
