## **FIELD REPORT**

## WESTMORELAND COUNTY HIGH SCHOOL

Date: 10/29/2021

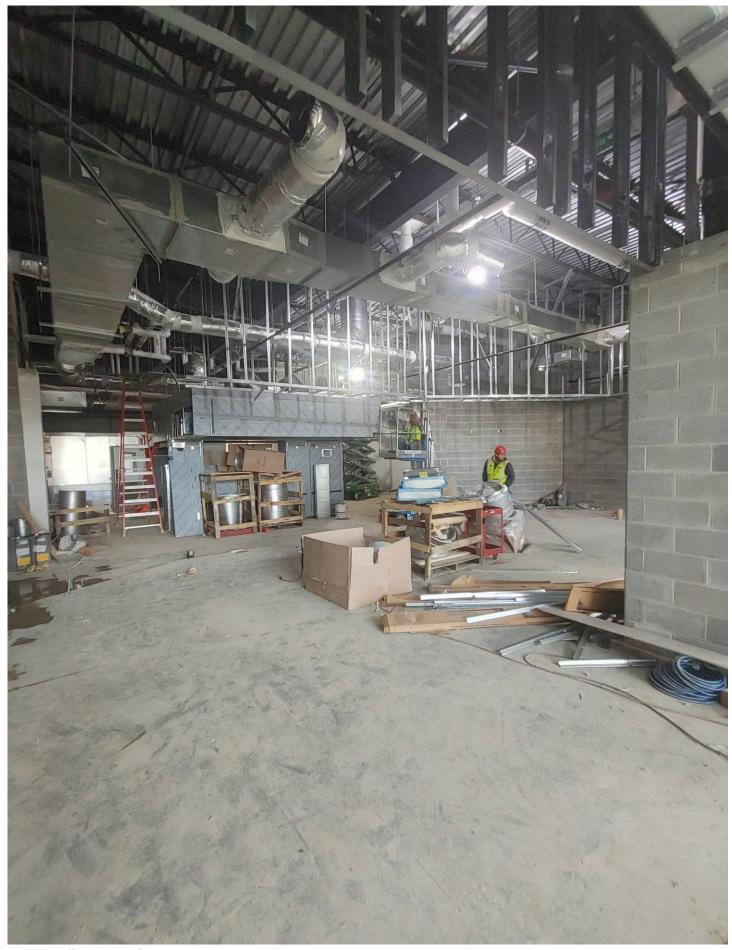
Photo 1 - Soffits are being framed in the Kitchen

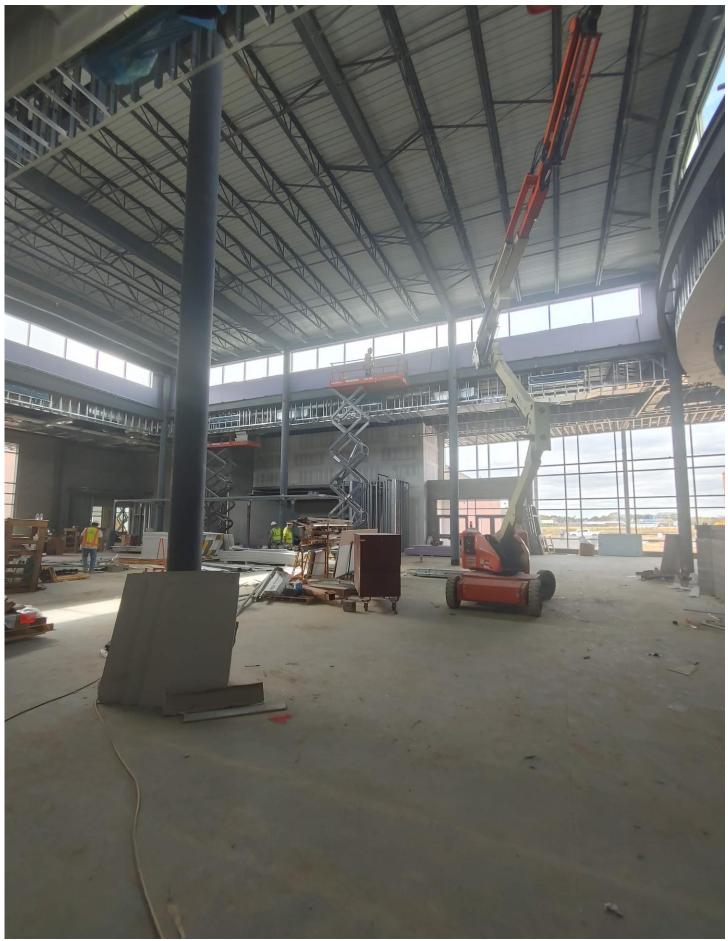
Photo 2 - Sheetrock is being hung in Area C

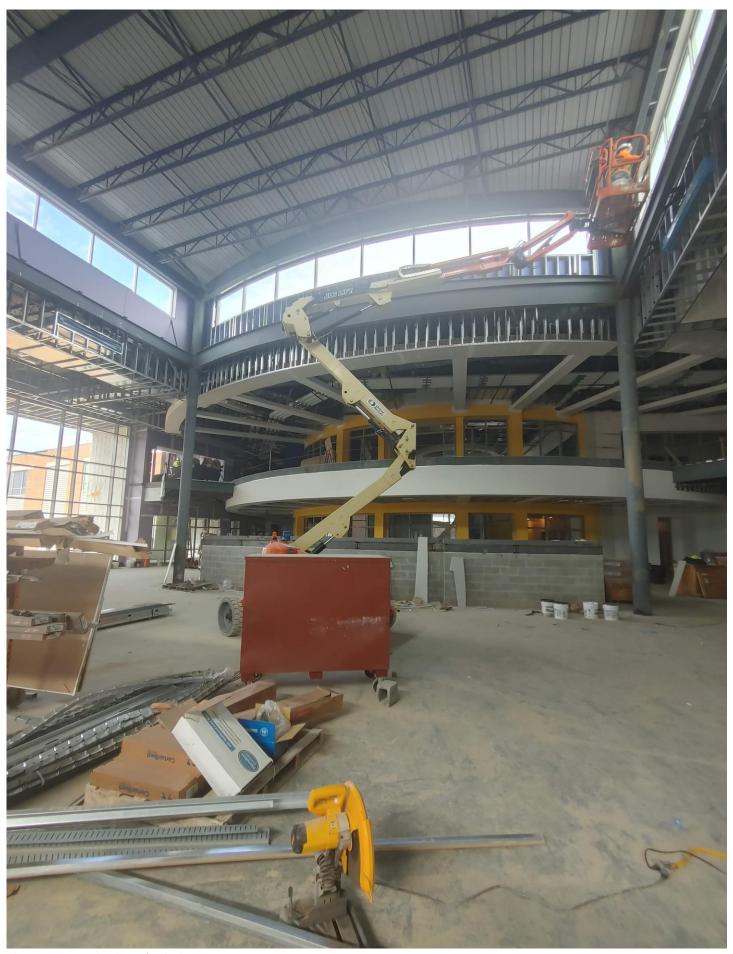
Photo 3 - Sheetrock is being finished in Area C.

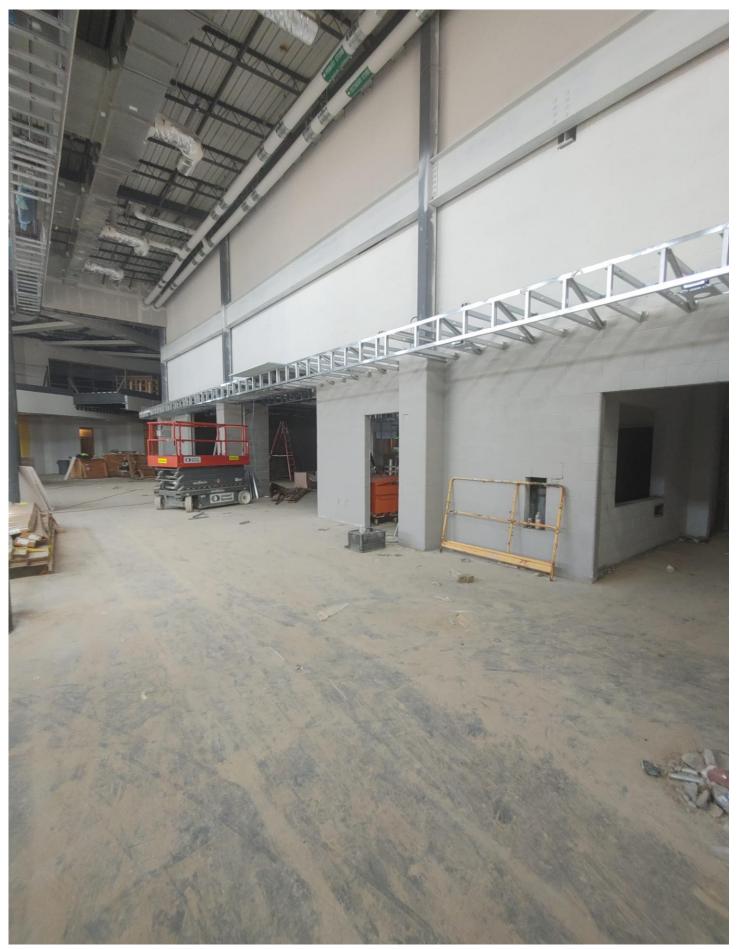
Photo 4 - Soffits have been framed in Area C.

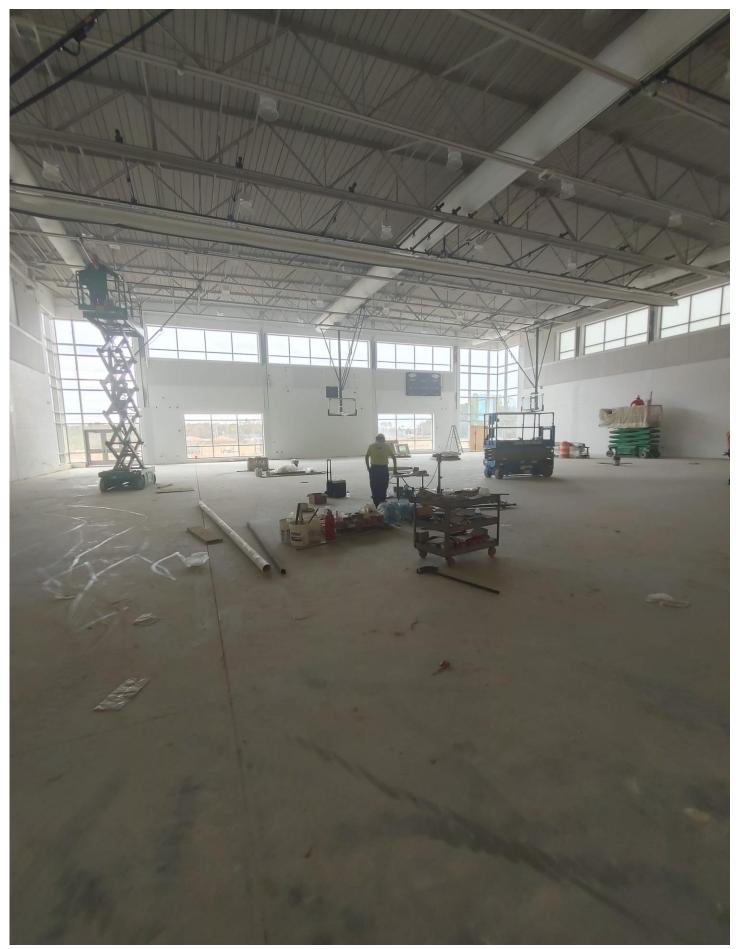
Photo 5 - Curtain has been hung in the Gym

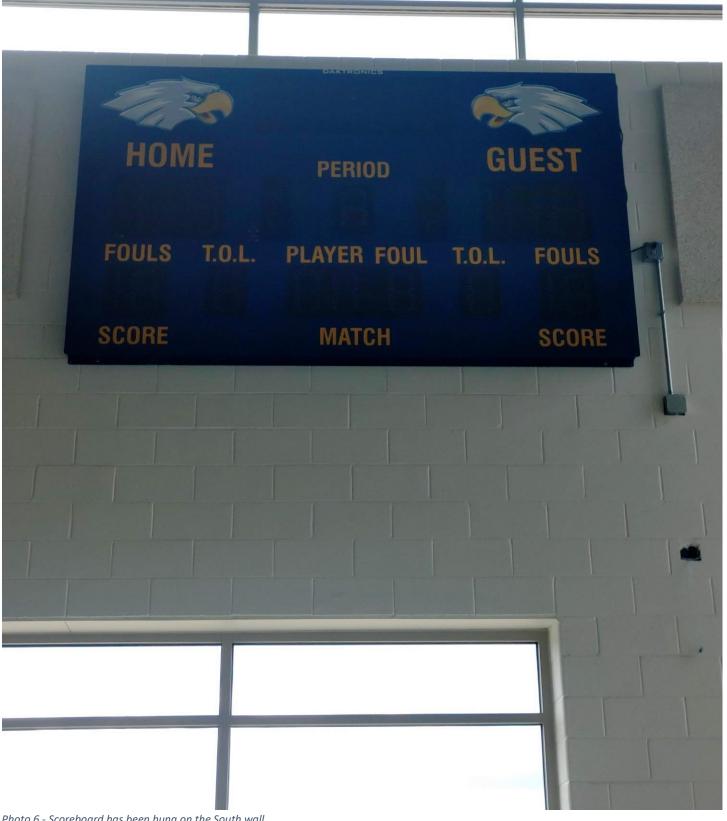
Photo 6 - Scoreboard has been hung on the South wall.

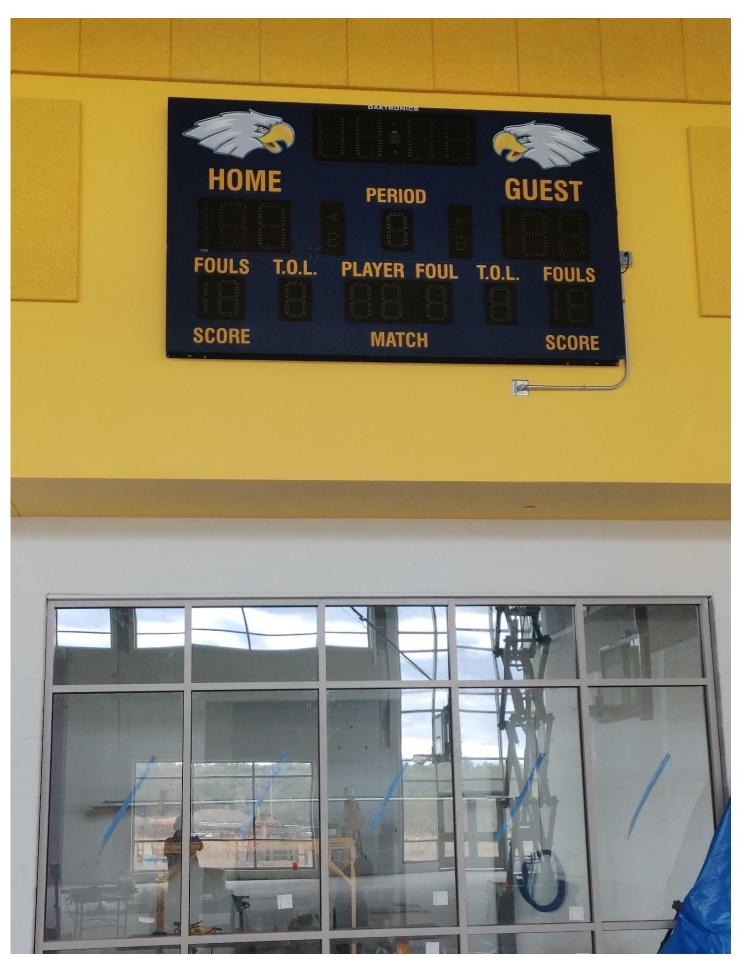
Photo 7 - Scoreboard has been hung on the North wall.

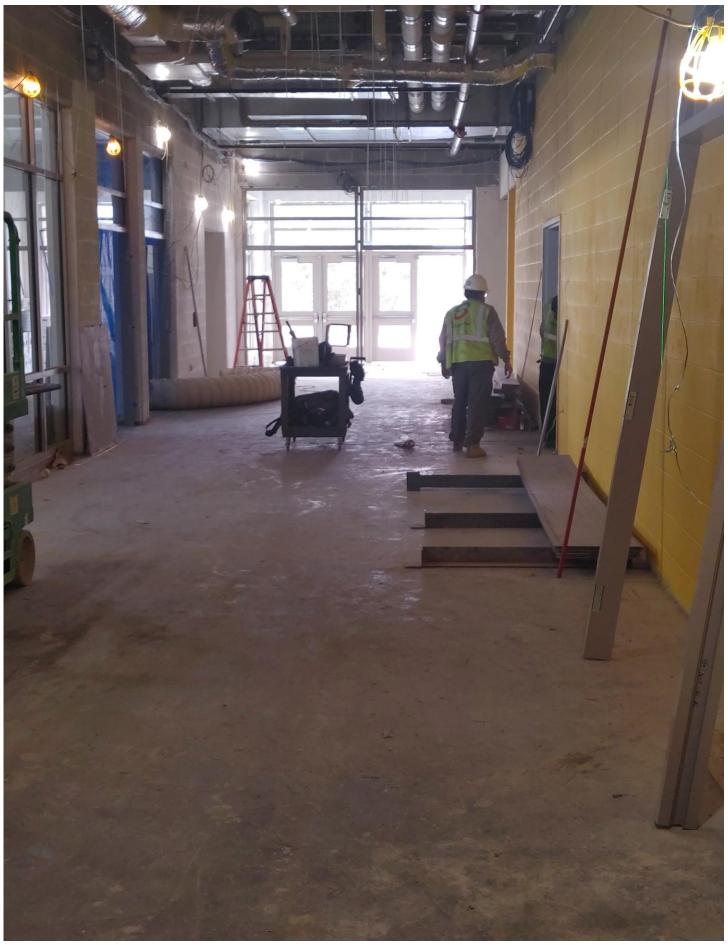
Photo 8 - SF5A has been installed in Area E.

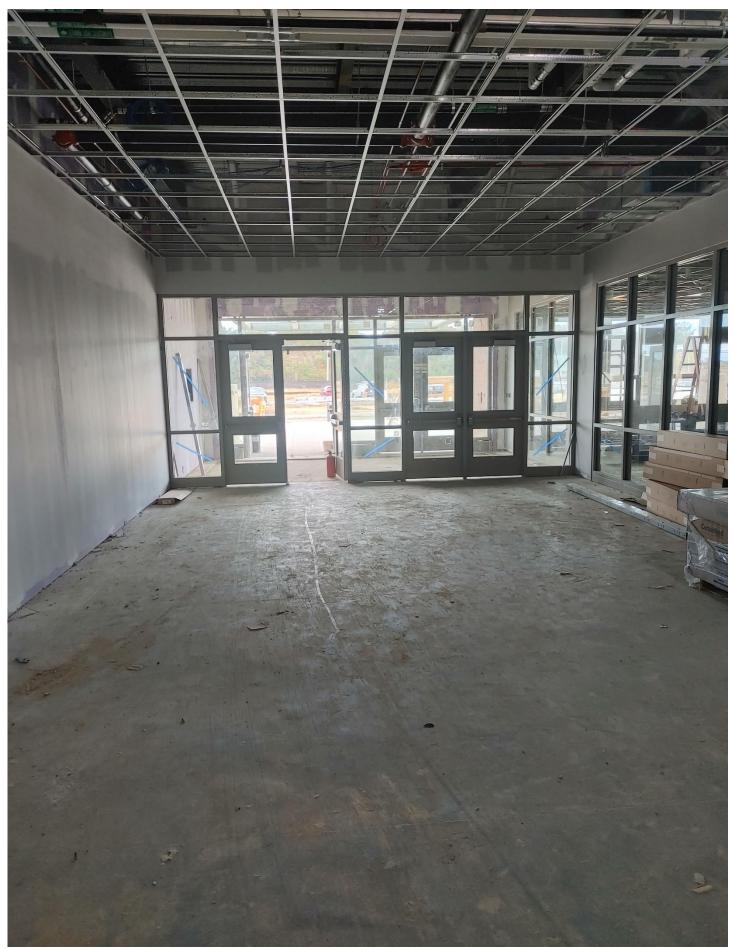
Photo 9 - SF39 has been installed in Area A

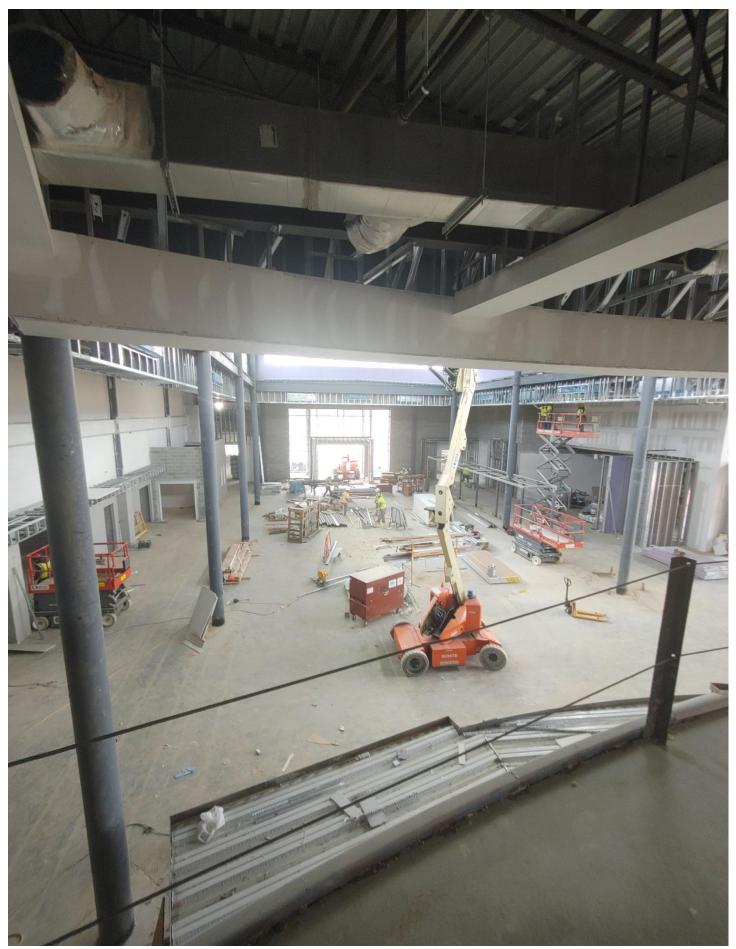
Photo 10 - Sheetrock is being hung in Area C.

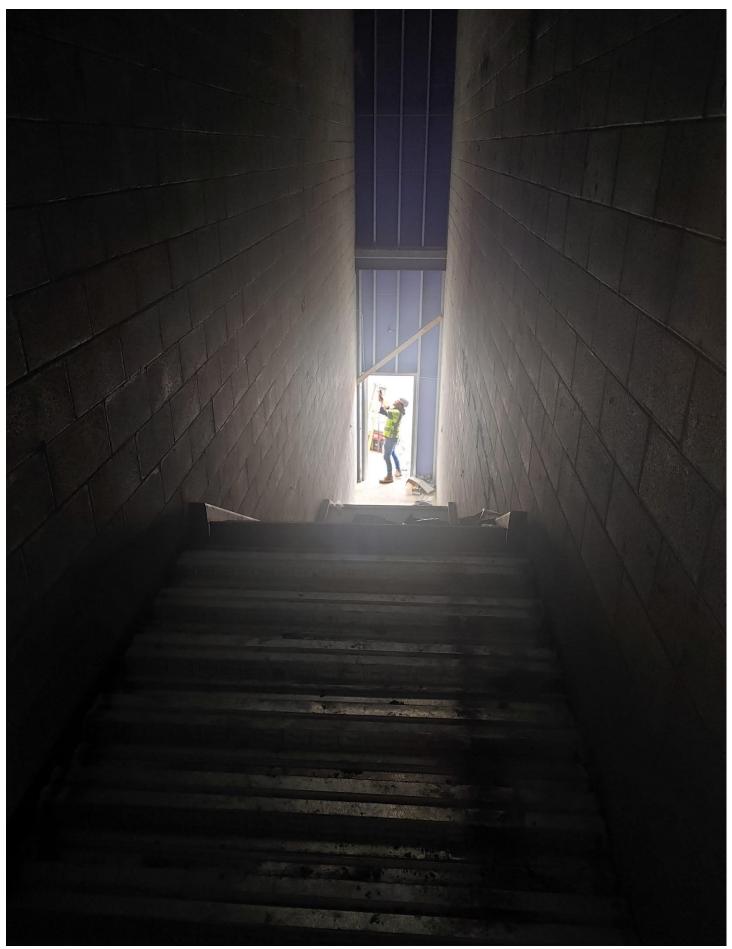
Photo 11 - XA03 Door Frame and Door is being installed at the bottom of Stair #4

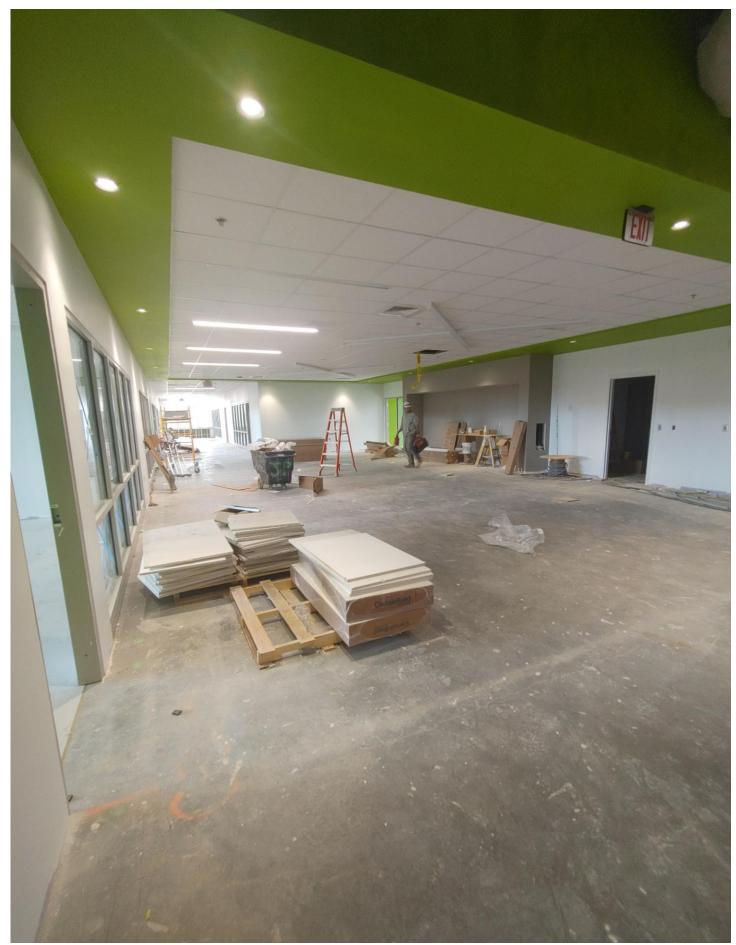
Photo 12 - Painting continues in Area A.

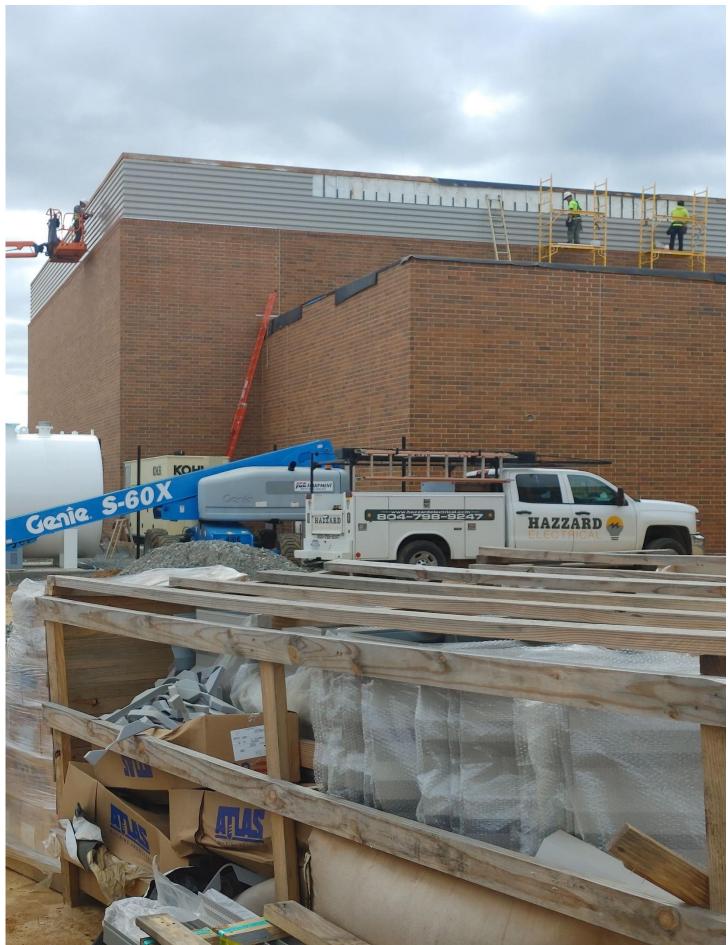
Photo 13 - Metal Panels are being installed on the East and North sides of Area D.

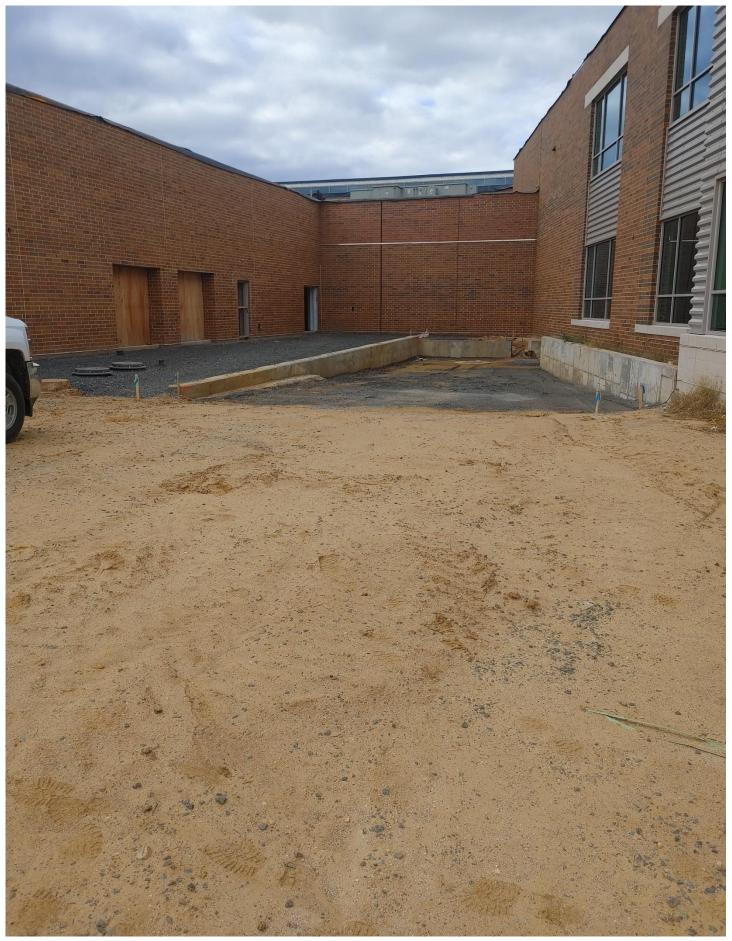
Photo 14 - Stone laid in Loading Dock Area.

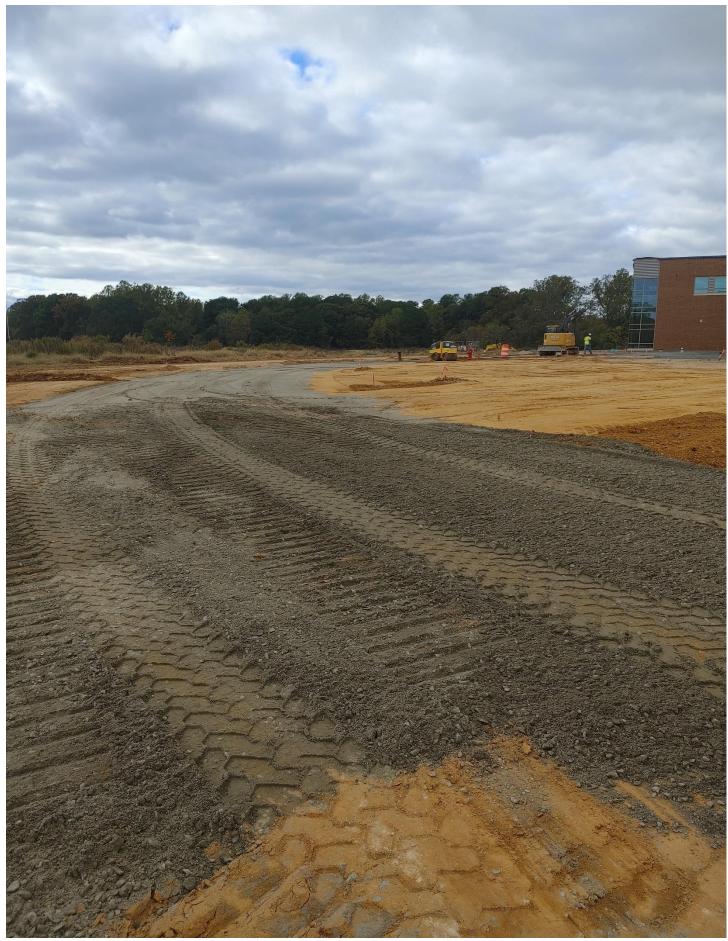
Photo 15 - Stone is being laid around the South side of the site for the access road

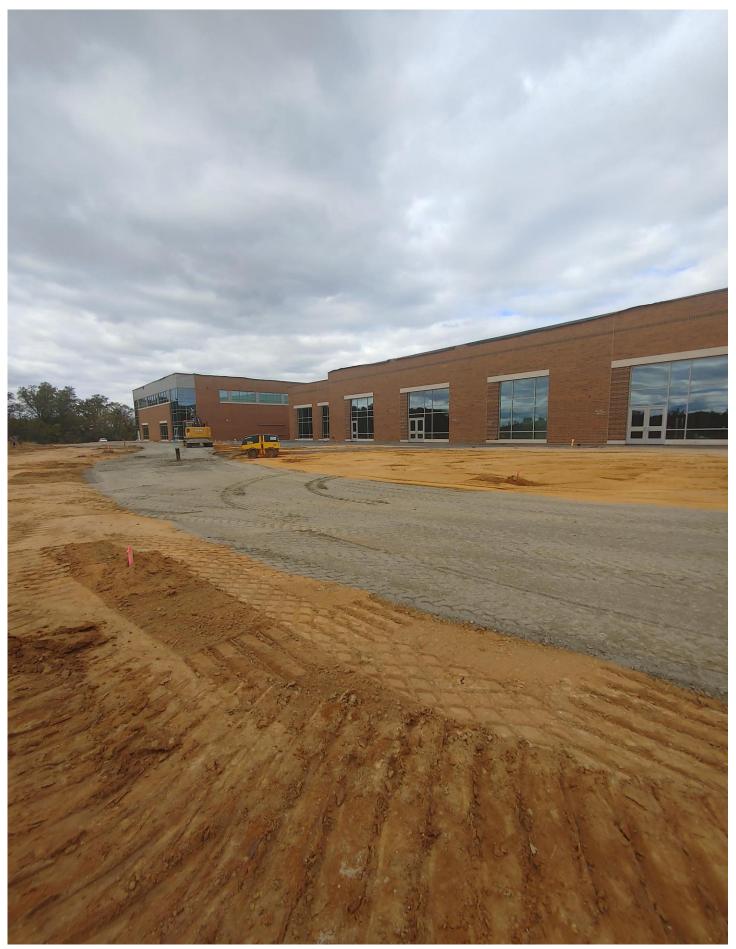
Photo 16 - South side of Areas D & E

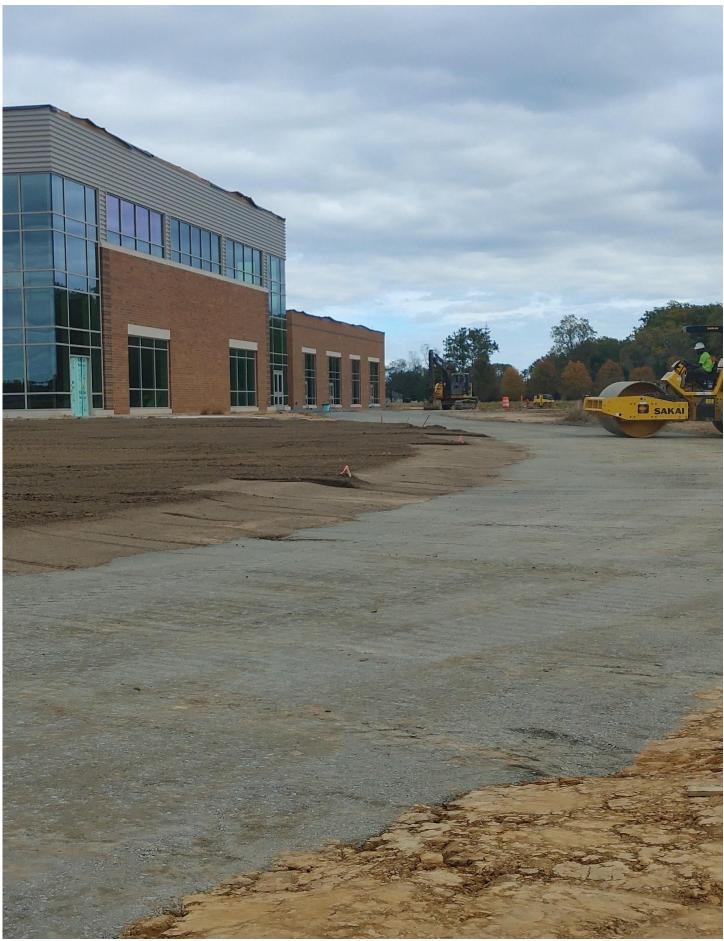
Photo 17 - Access Road on the South side of the Building.

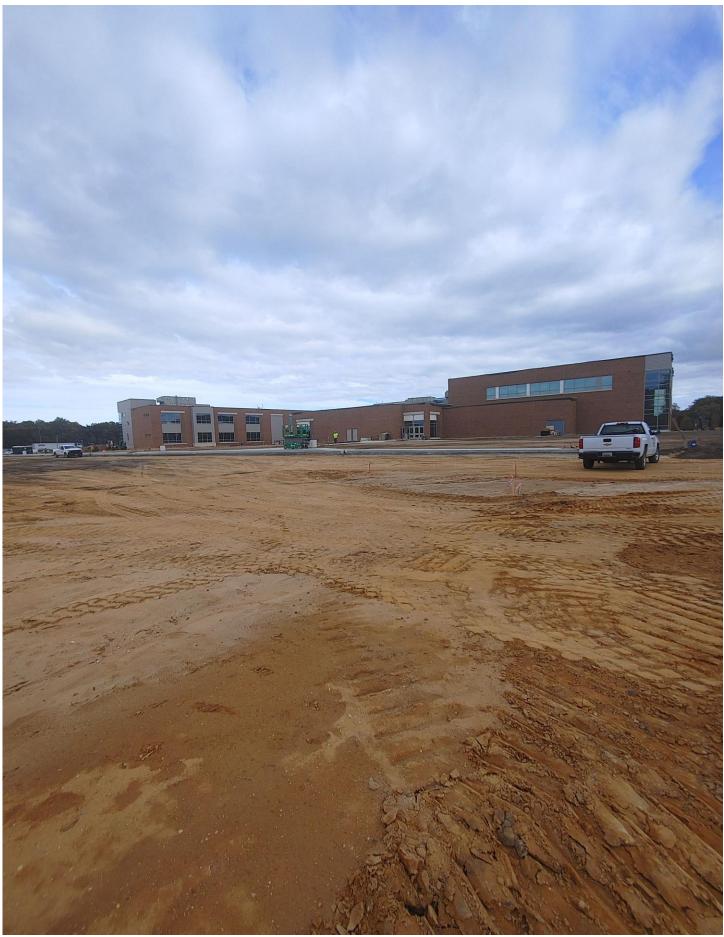
Photo 18 - West side of Building with Bus Loop area.

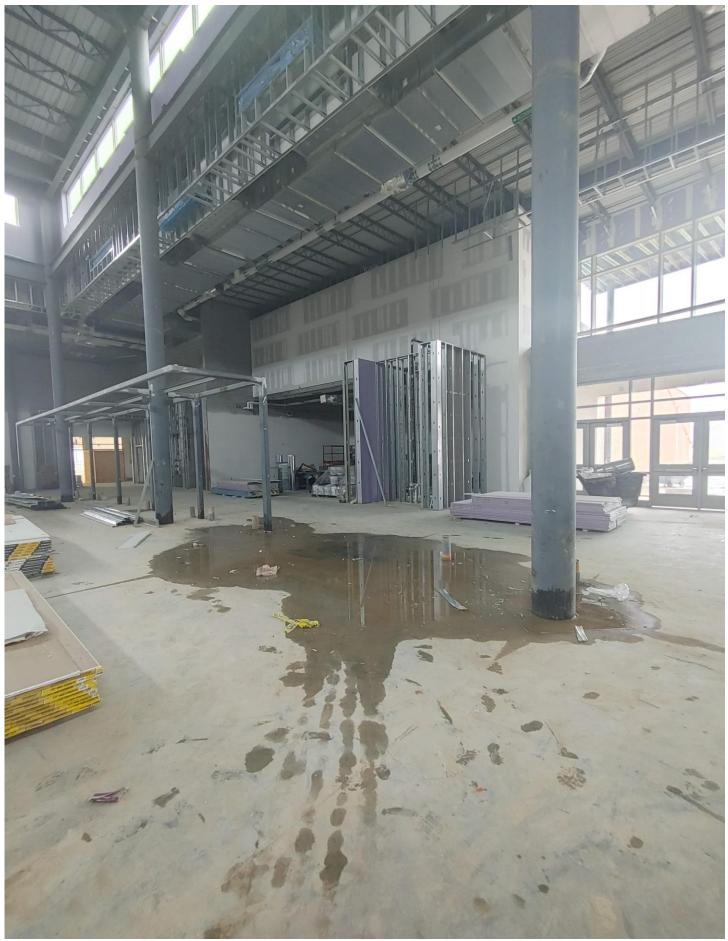
Todd advised that the Grand Stairs would be delivered on Monday. Todd also pointed out that a few of the High windows in Area C were leaking around the frames and needed caulk. I noted various other areas that were leaking in Areas C & D (pictures below). In area C it was from the high windows and around a few roof penetration. In area D in appears that the various areas that are leaking are below the Parapet wall that needs to Flashed and capped.

Photo 19 - Water leaking into Area C from windows above on the West side.

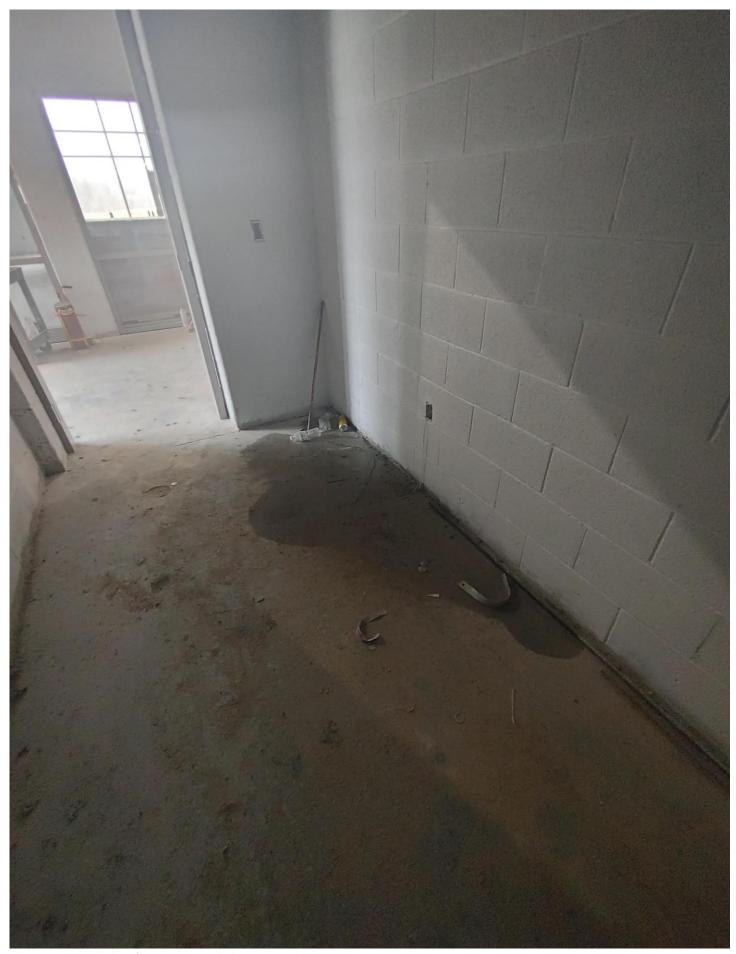
Photo 20 - Water leaking from parapet wall above in Corridor D13.

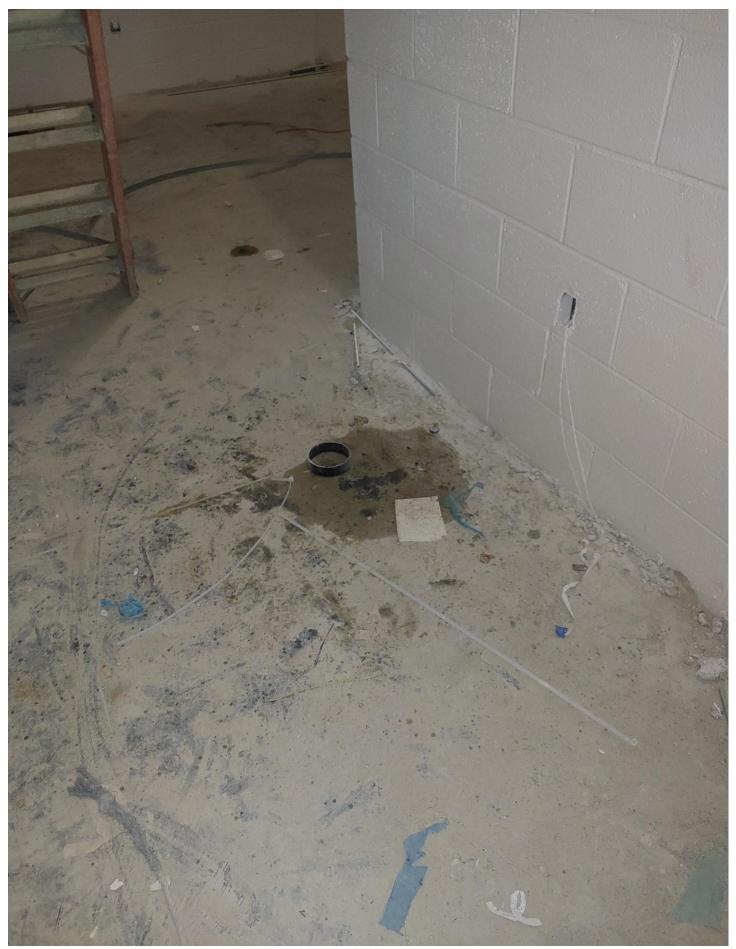
Photo 21 - Water leaking from roof above in Room D132

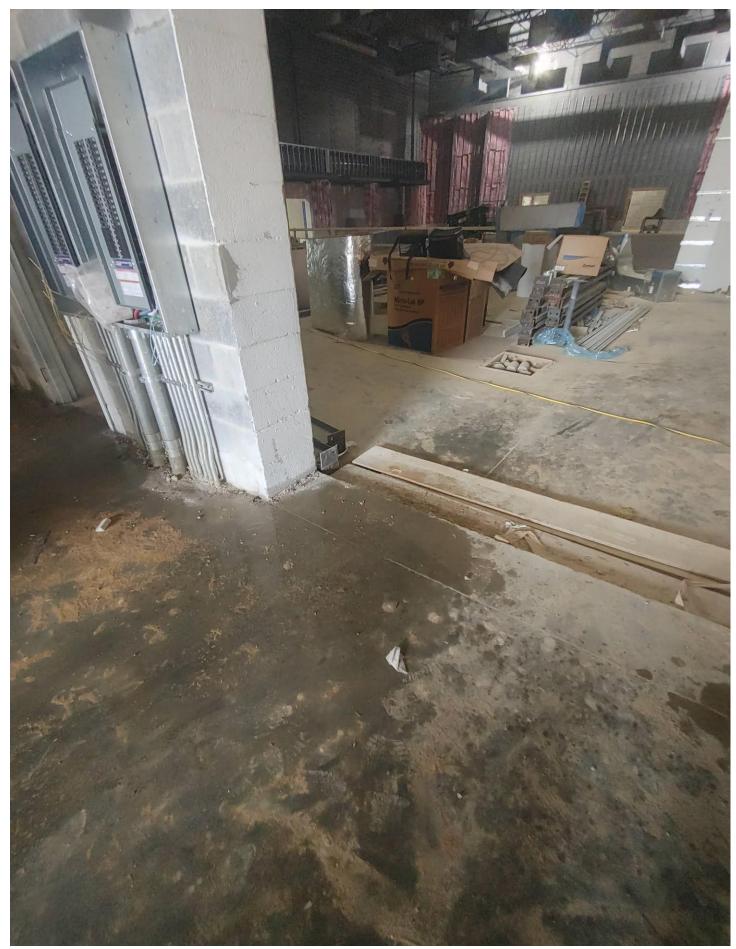
Photo 22 - Water dripping from Parapet wall above in Room D105

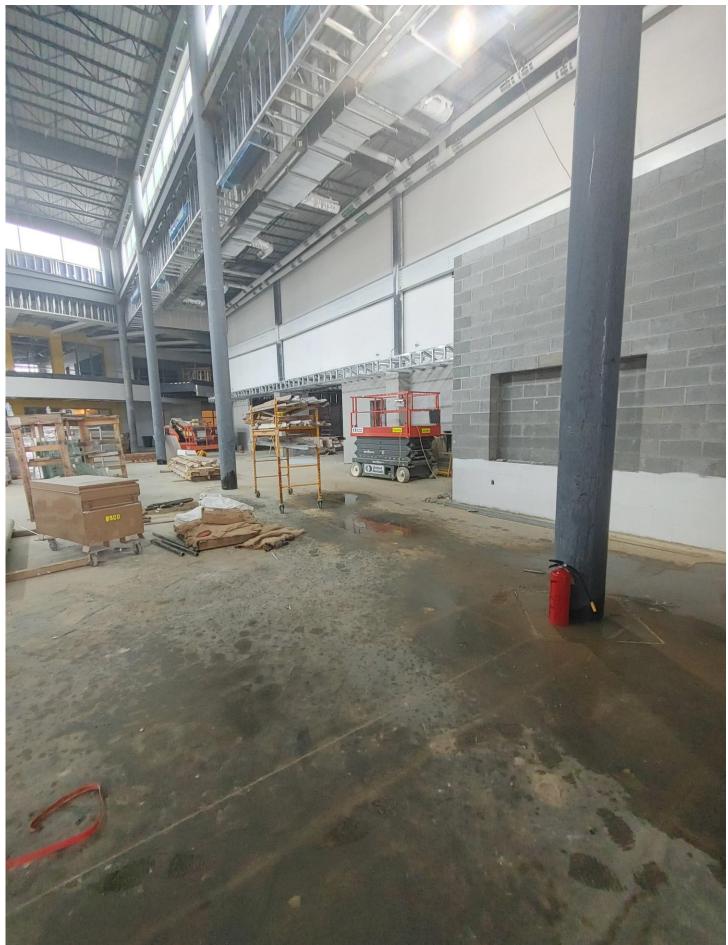
Photo 23 - Water leaking from windows above on the East side of Area C.

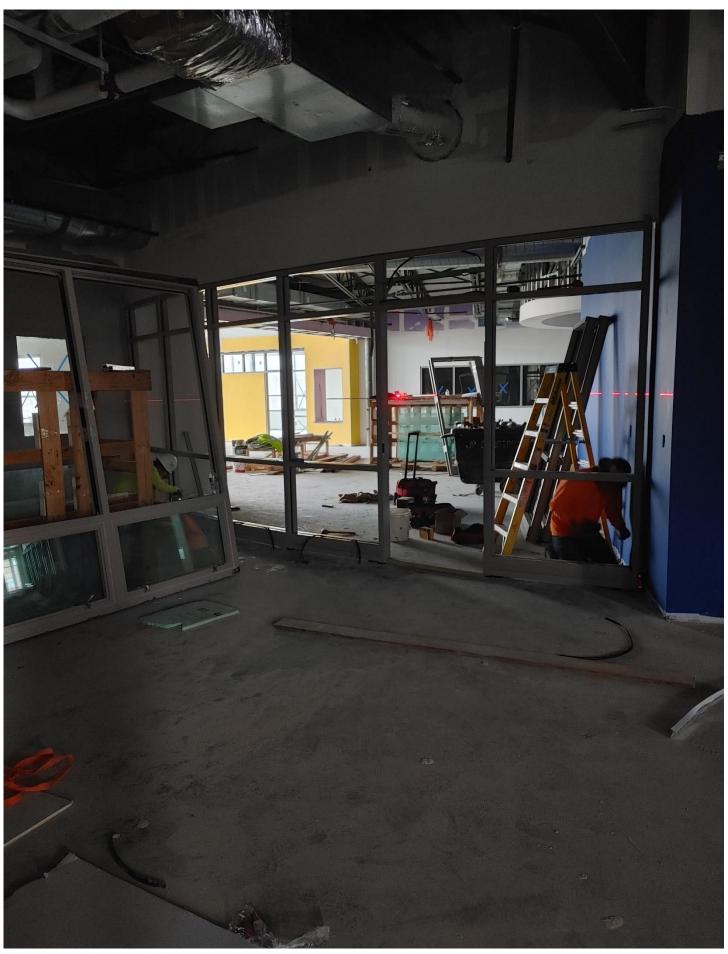
Photo 24 - SF62 is being installed.
