FIELD REPORT

WESTMORELAND COUNTY HIGH SCHOOL

Date:	11/02/2021
Weather:	52 degrees. Rain. High of 54 degrees today.
Hours Worked:	10:30 – 13:30hrs (3hrs)
	Beuchert Excavation: Five (5) men are on site today working on the West side of the School. Stone is also being delivered. Rain cause them to call it an early day.
	Industrial Concrete: One (1) man is on site today grinding down Diamond that are sitting high.
	J.D. Long, Masons: I did not observe anyone on site during my visit.
	Hazzard Electric: Twelve (12) men are on site. They are running conduit out to the Student Parking area and setting light fixtures and Emergency Egress signage in Area A. They hope to energize the fixtures in the Administrative Office area later this week.
	Colonial Webb : I observed two men on site today. I advised there site Superintendent that there was one of their ladders sticking out of the Water Meter Vault on the East side of the Site. I had the ladder removed and the lid shut because it was raining and the Vault does not have a Sump Pump. He indicated that someone must of borrowed the ladder because they have no reason to be in the pit. I told him he may want to get his ladder so that it doesn't

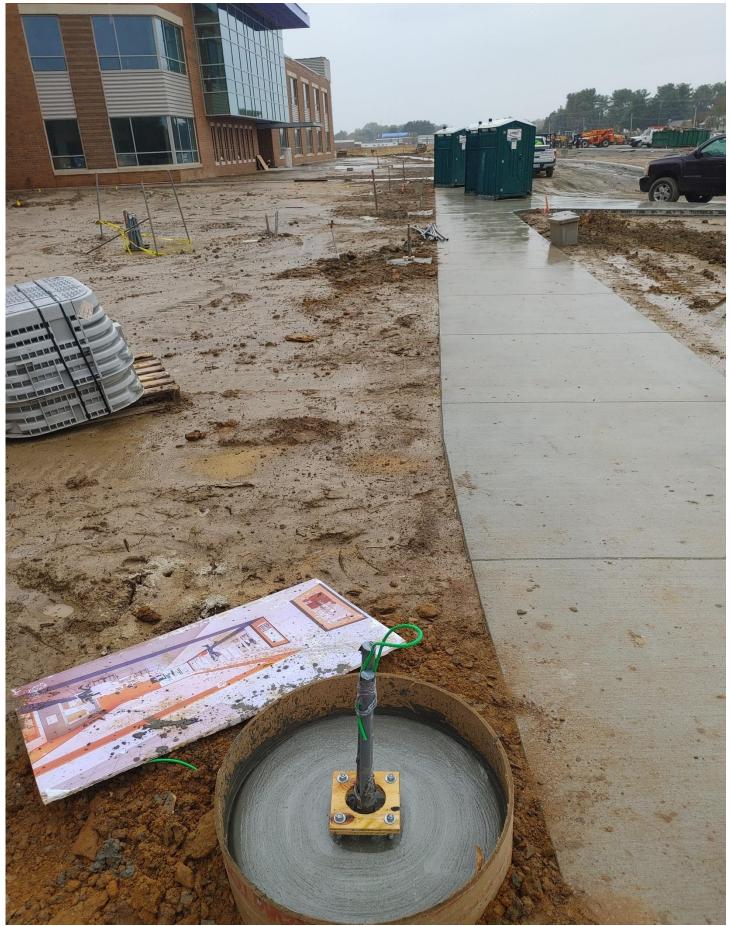
Photo 1 - They have begun to pour Light Poles Bases in front of the School.

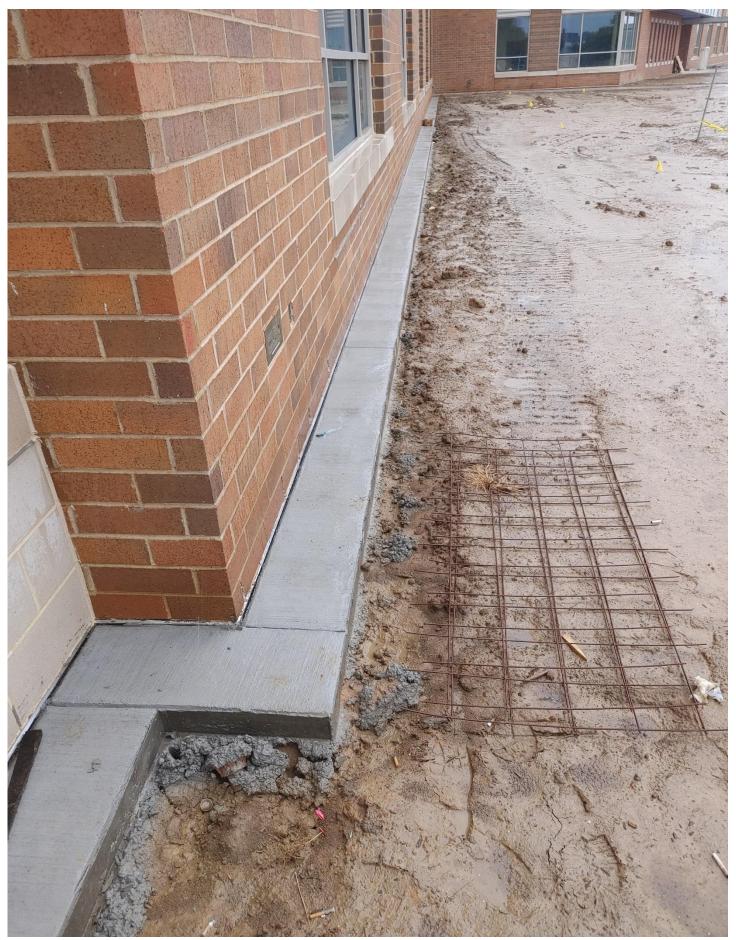
Photo 2 - The Mow Strip has been poured on the North side of Area A.

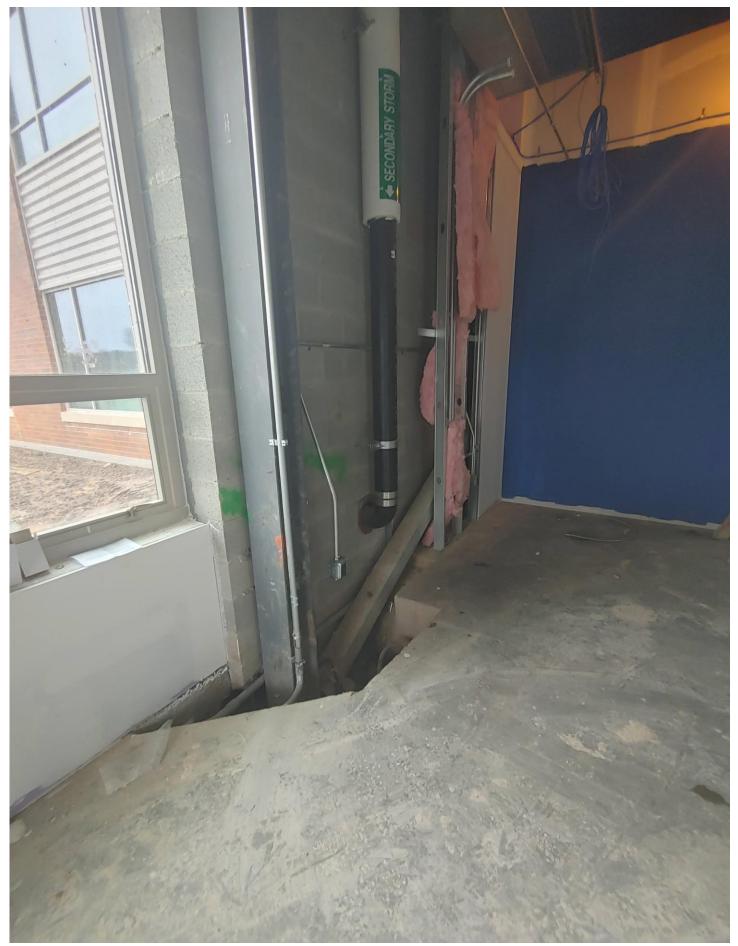
Photo 3 - Concrete has yet to be poured in the North East corner of the Administrative Office Area.

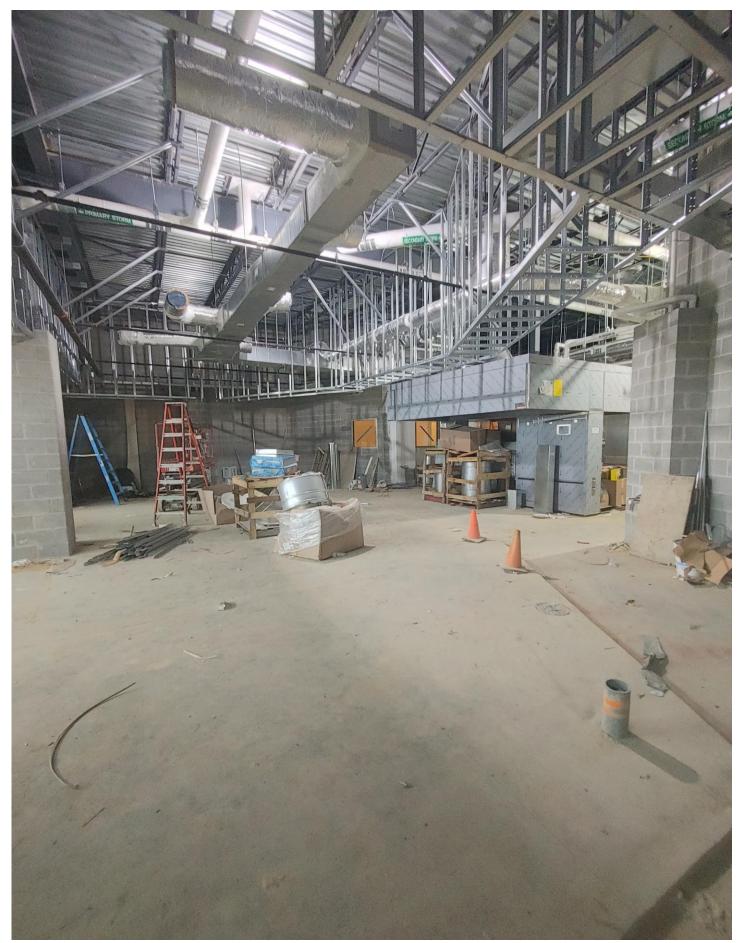
Photo 4 - Bulk Head Framing continues in the Kitchen Area.

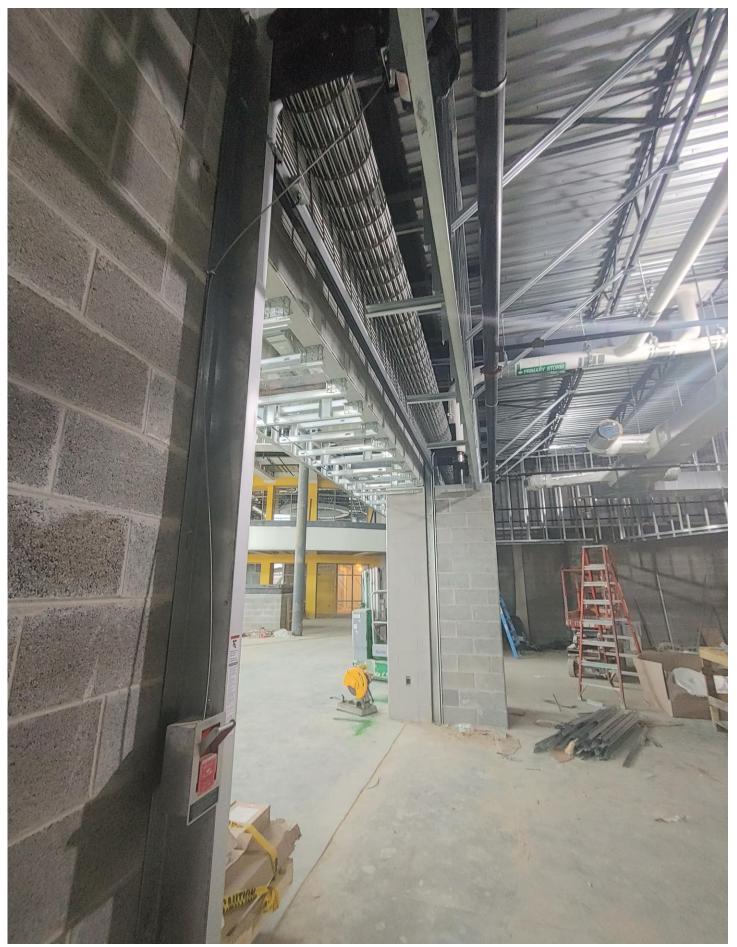
Photo 5 - Overhead Doors have been installed in the Kitchen.

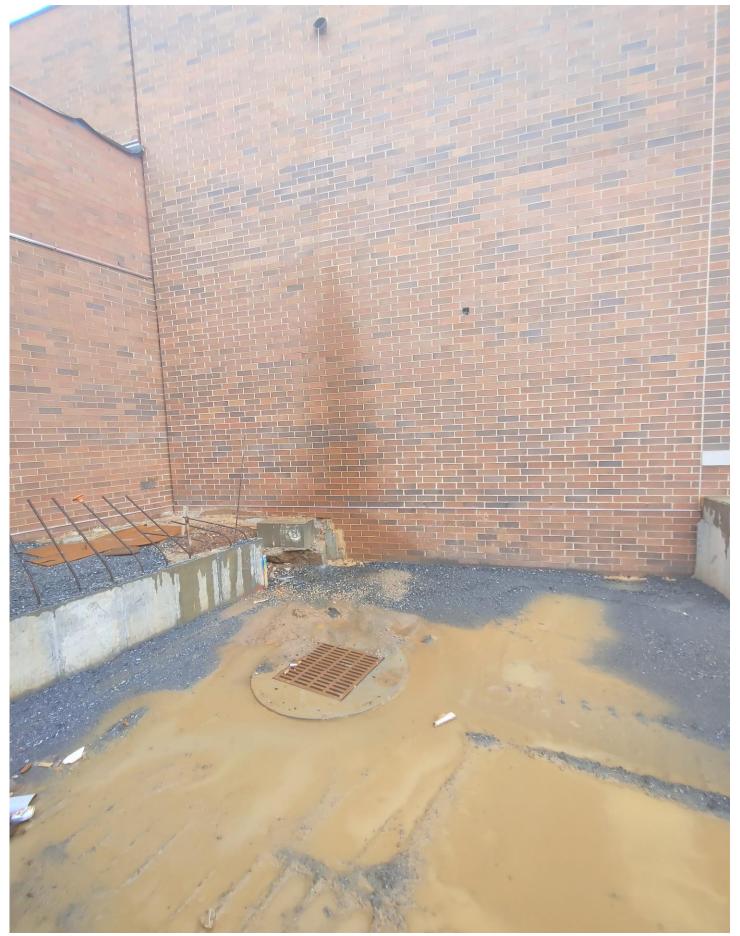
Photo 6 - Unprotected Drop Inlet in the Loading Dock Area allowing silt into the Storm Water Management System.

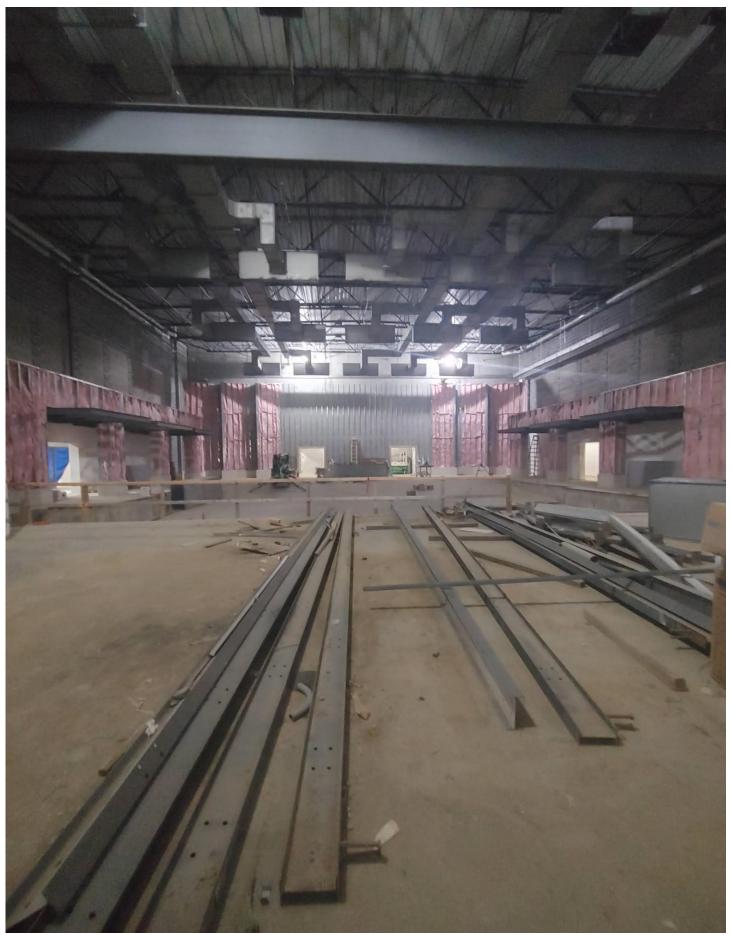
Photo 7 - They have begun to install Insulation in the Auditorium.

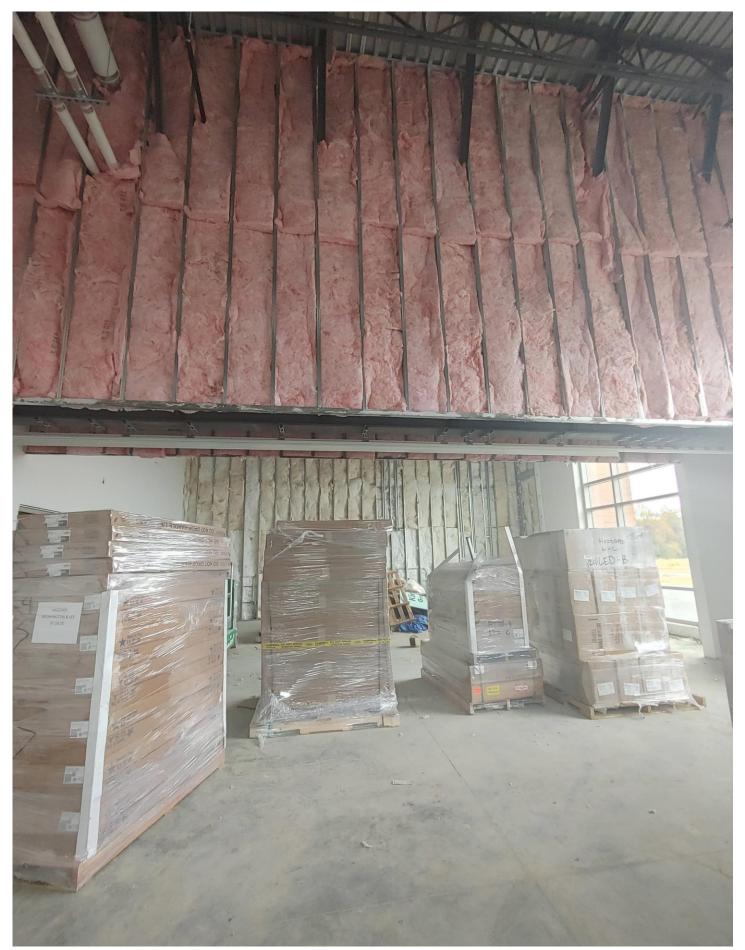
Photo 8 - Insulation has been installed in Area D

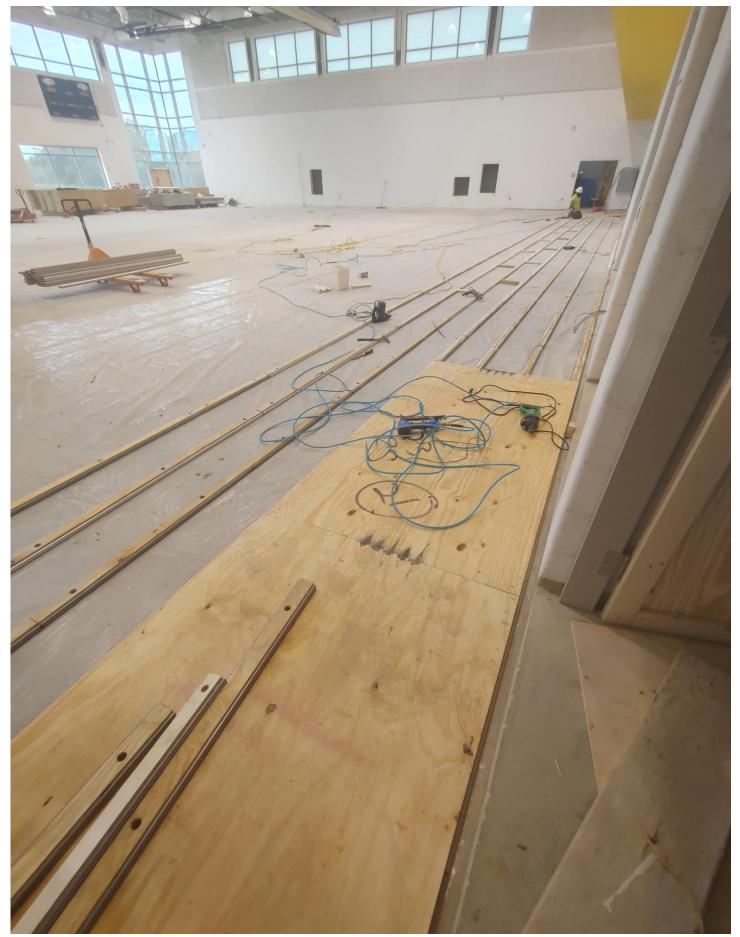
Photo 9 - They have begun to lay the floor in the Gymnasium.

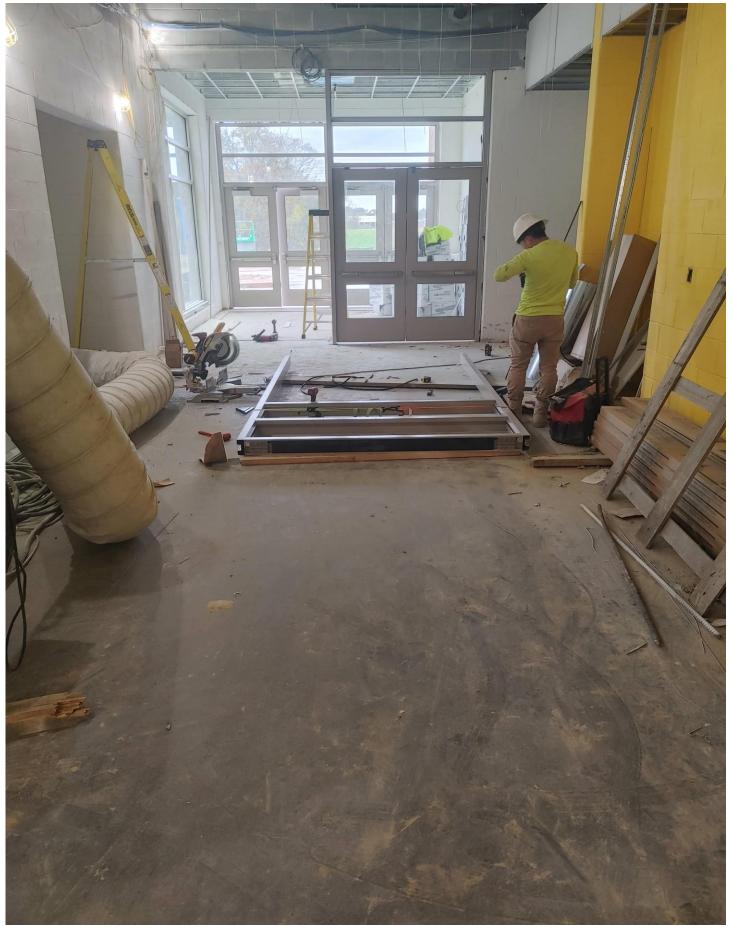
Photo 10 - FG&M continue to work on SF5A in Area E.

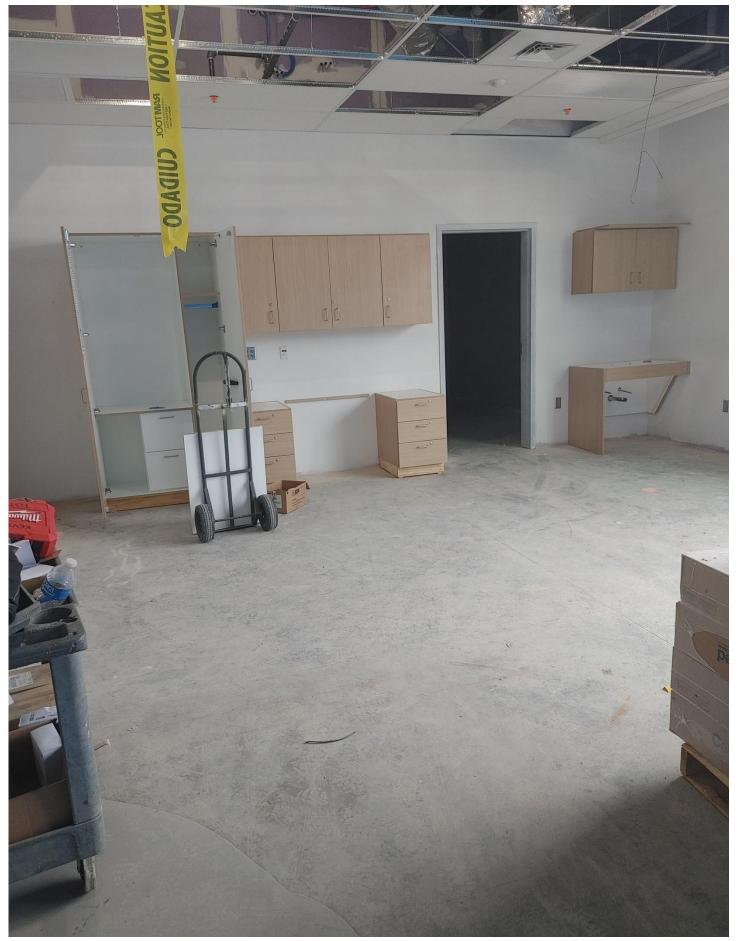
Photo 11 - Cabinetry has been installed throughout Area B

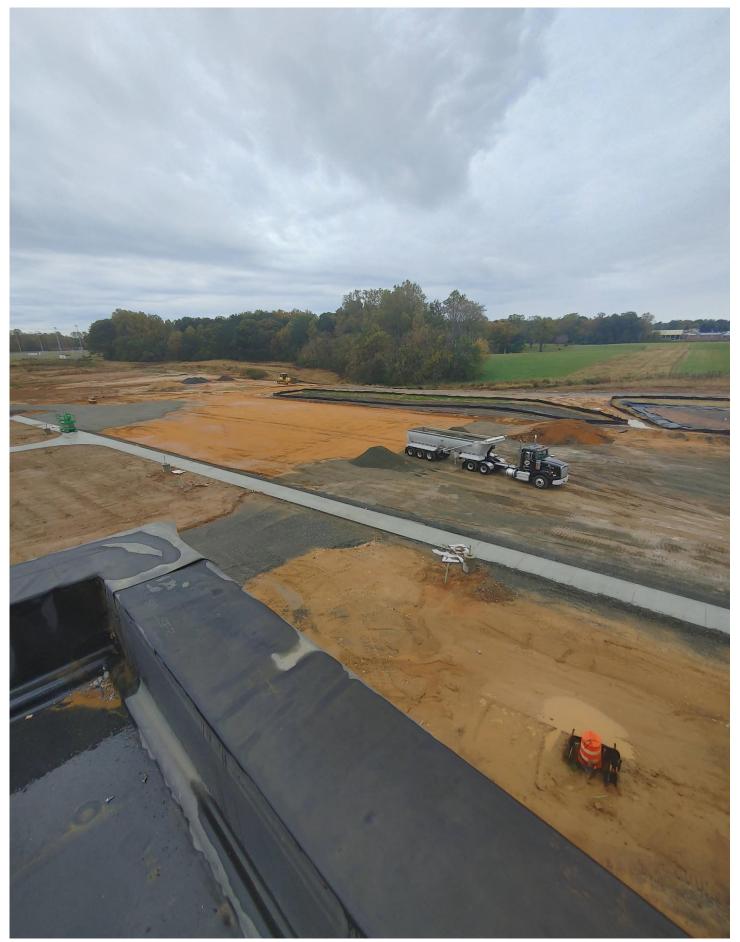
Photo 12 - Stone is being delivered on the West side of the site.

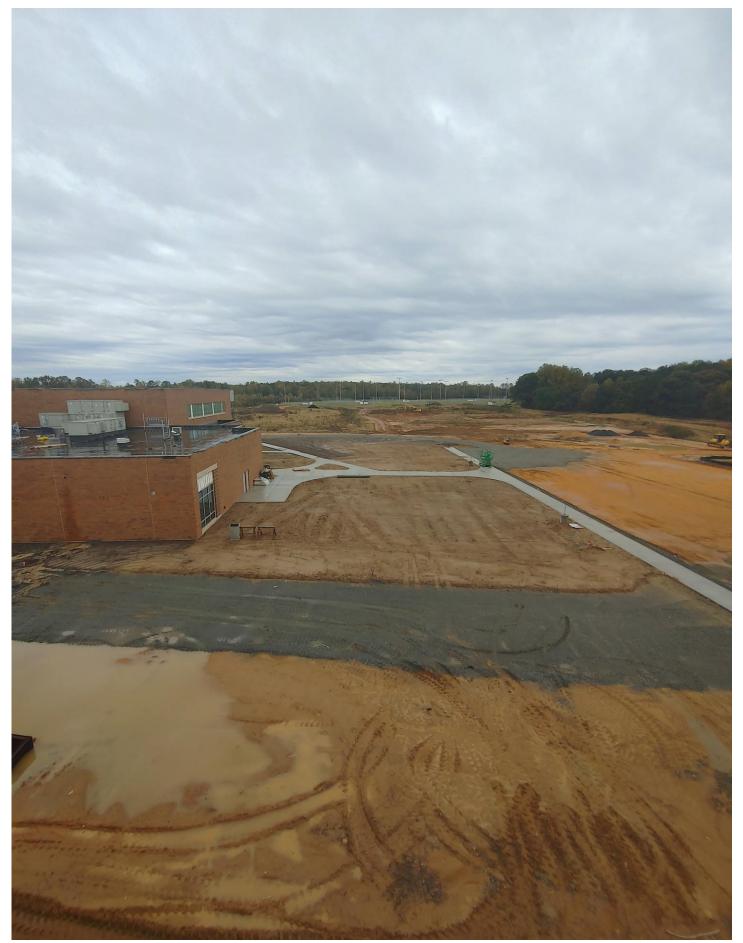
Photo 13 - View from the roof of the South West side of the site.

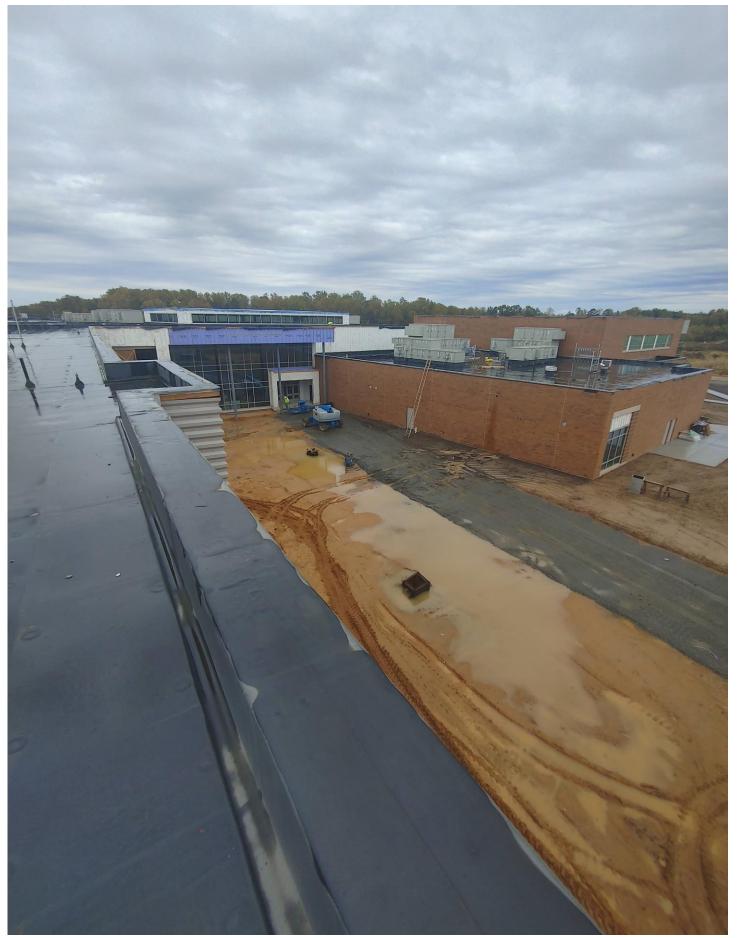
Photo 14 - Stone has been laid between Area B & E.
