FIELD REPORT

WESTMORELAND COUNTY HIGH SCHOOL

Date: 12/03/2021

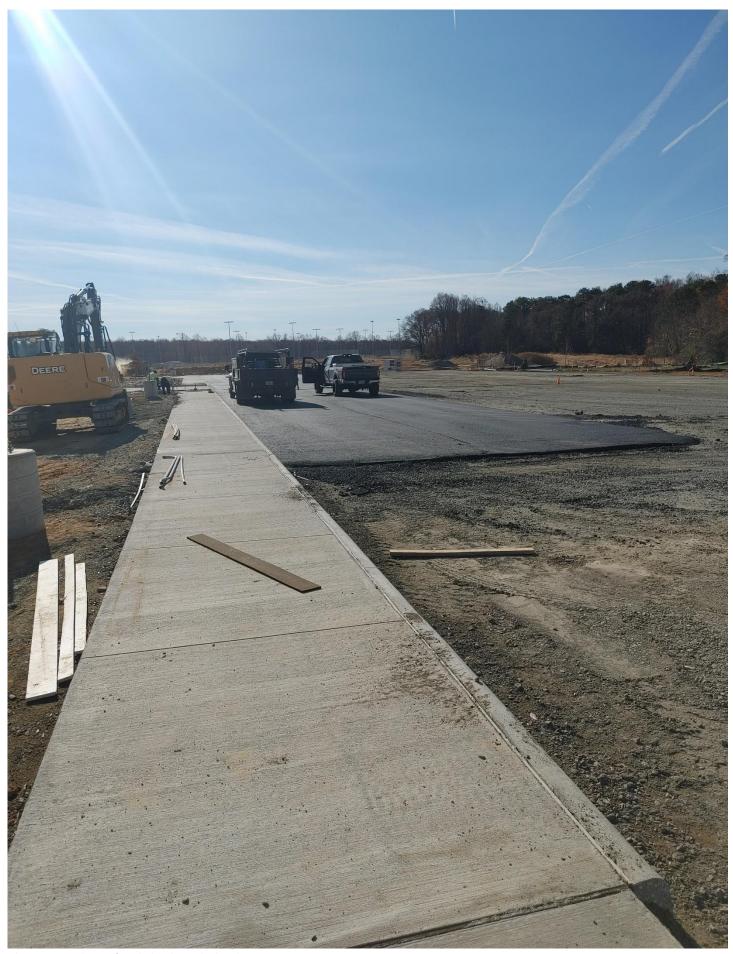
Photo 1 - Base layer of Asphalt is being laid in the Bus Loop area

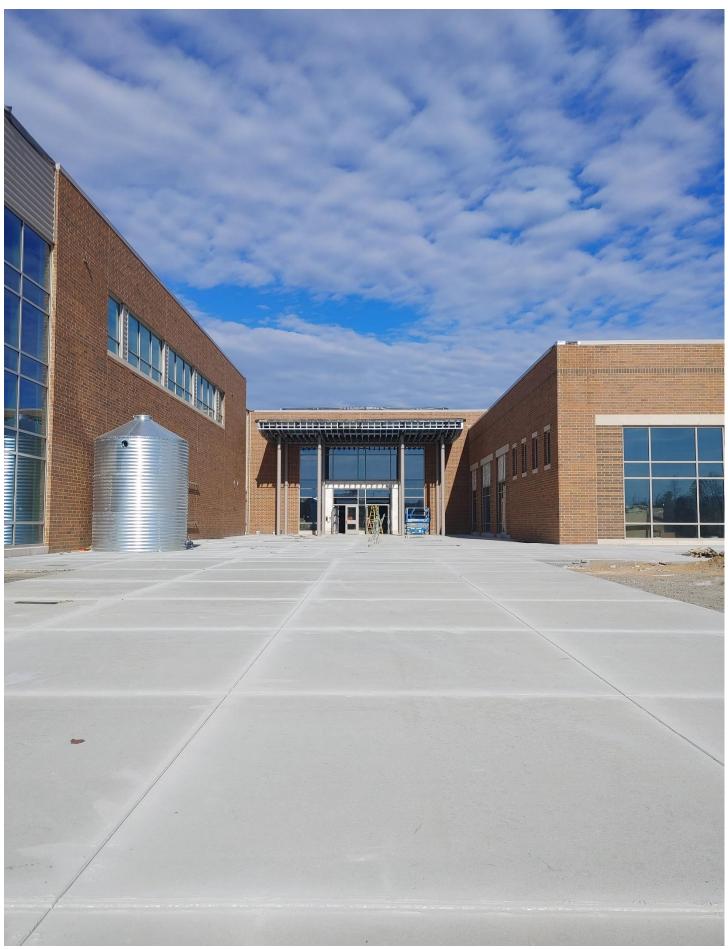
Photo 3 - Concrete has been completed and Cistern has been set

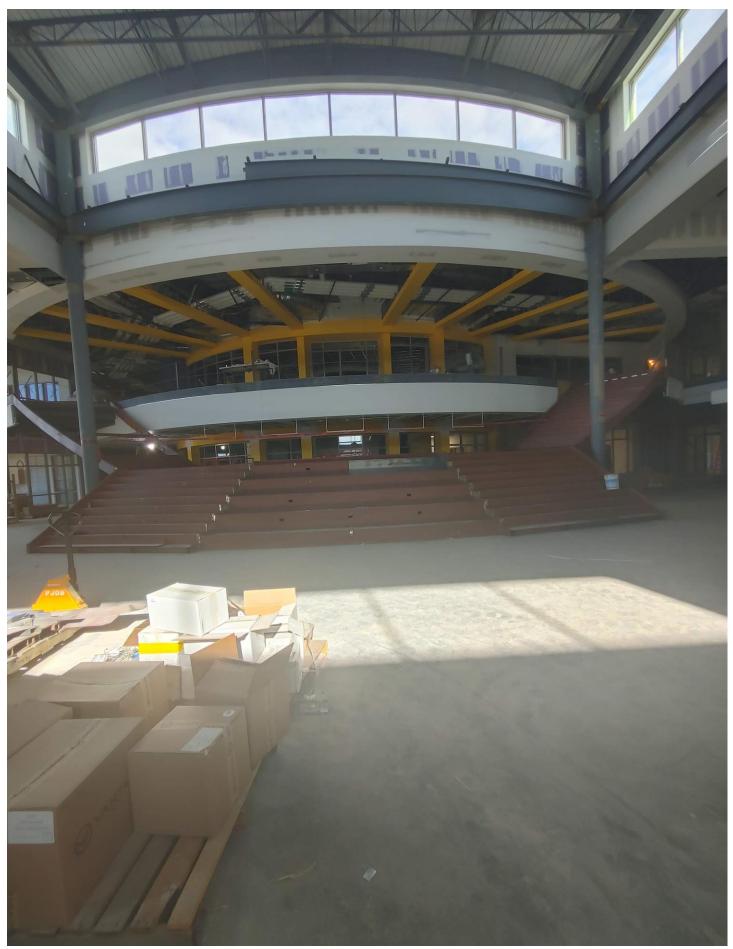
Photo 5 - Grand Staircase is being constructed.

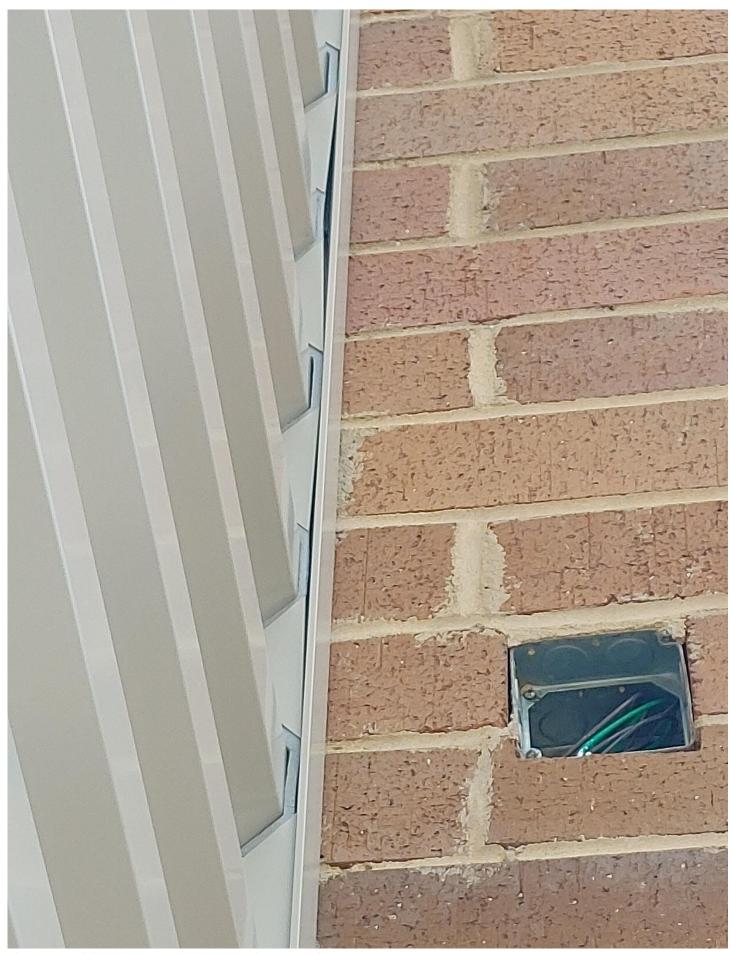
Photo 8 - Metal Channel areas to not be set properly on Stairwell #1

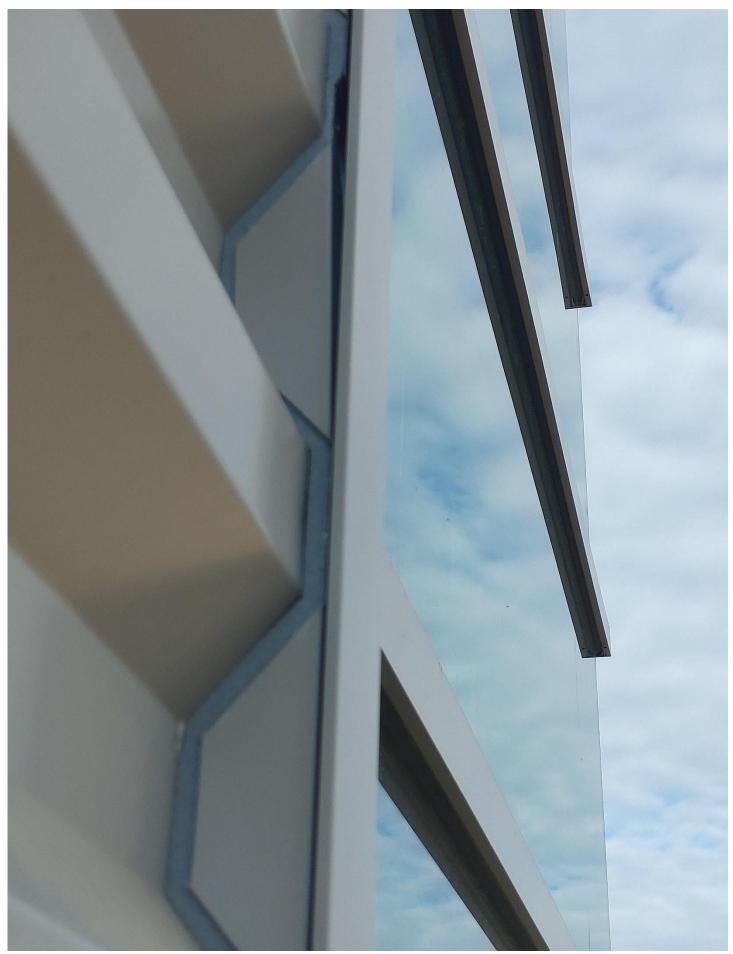
Photo 9 - Another area on Stairwell #1 where the Channel does not appear to be set properly

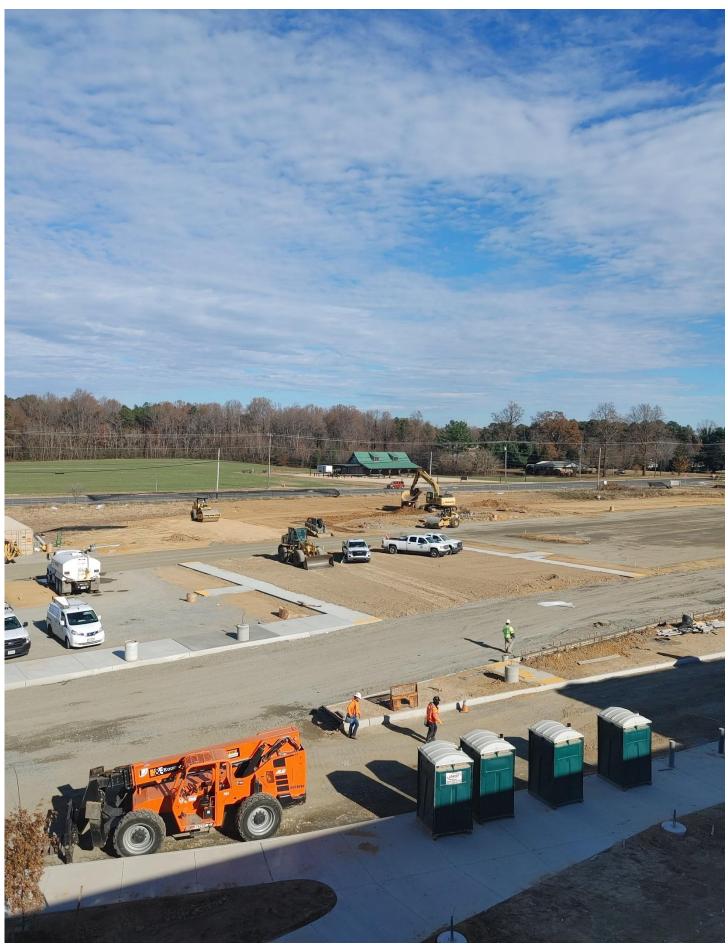
Beuchert Excavation: Is on site working on the North East corner of the site. I spoke with Paul because I noted that the Asphalt Crew where not on site today. He said they had to pull off the site and would be back on Monday. There plane is to completed the Base Coat of Asphalt on the entire site next week.

Photo 10 - Beuchert working on the North East corner of the site.

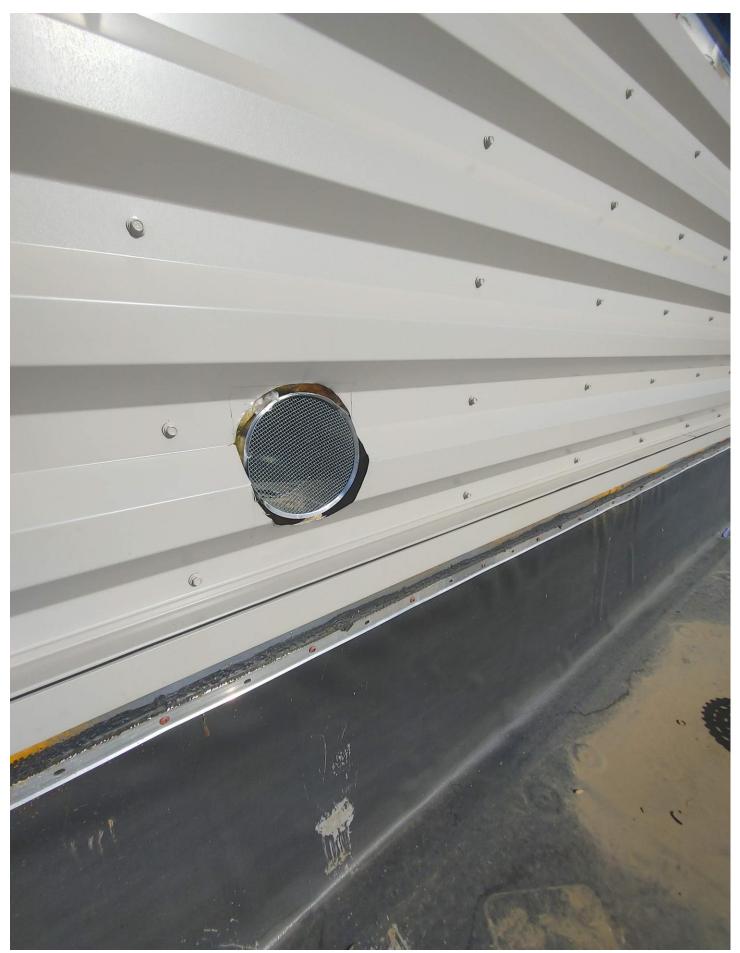
Photo 12 - Vent cut out on the South side of the high roof of Area A. Needs proper flashing.

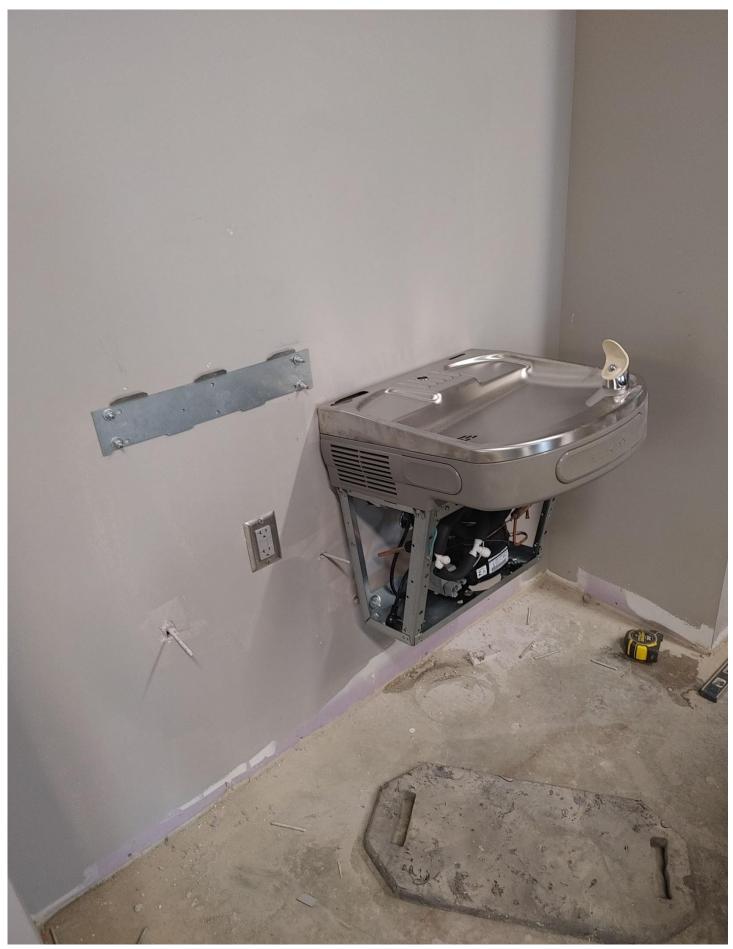
Photo 13 - Drinking Fountains are being set in Area A

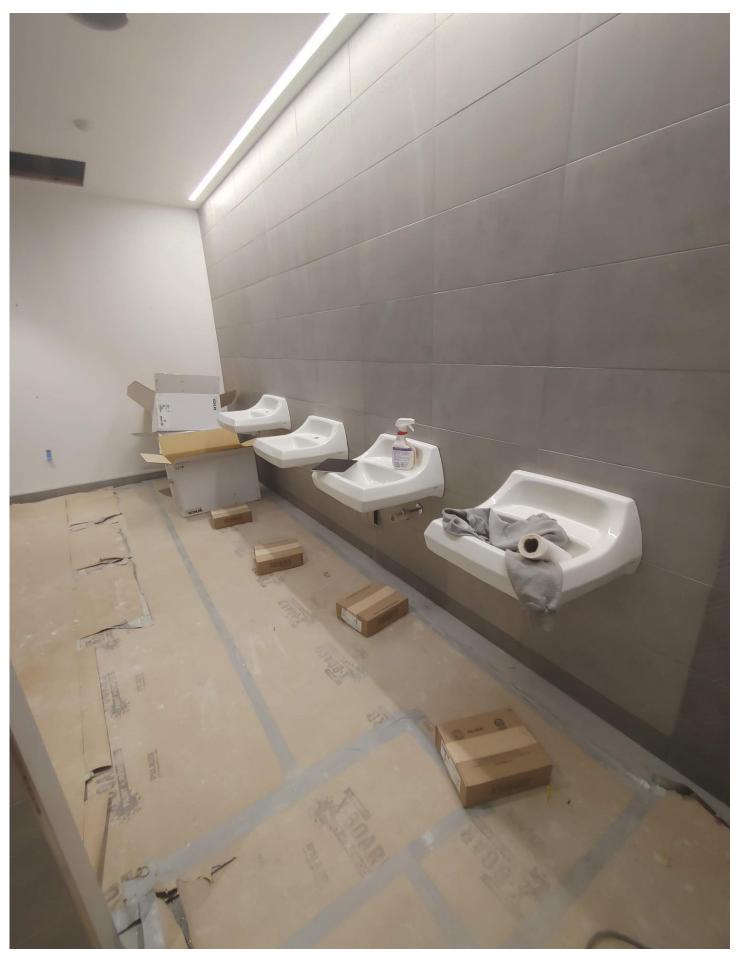
Photo 14 - Fixtures are being set on the first floor of Area A in A116.

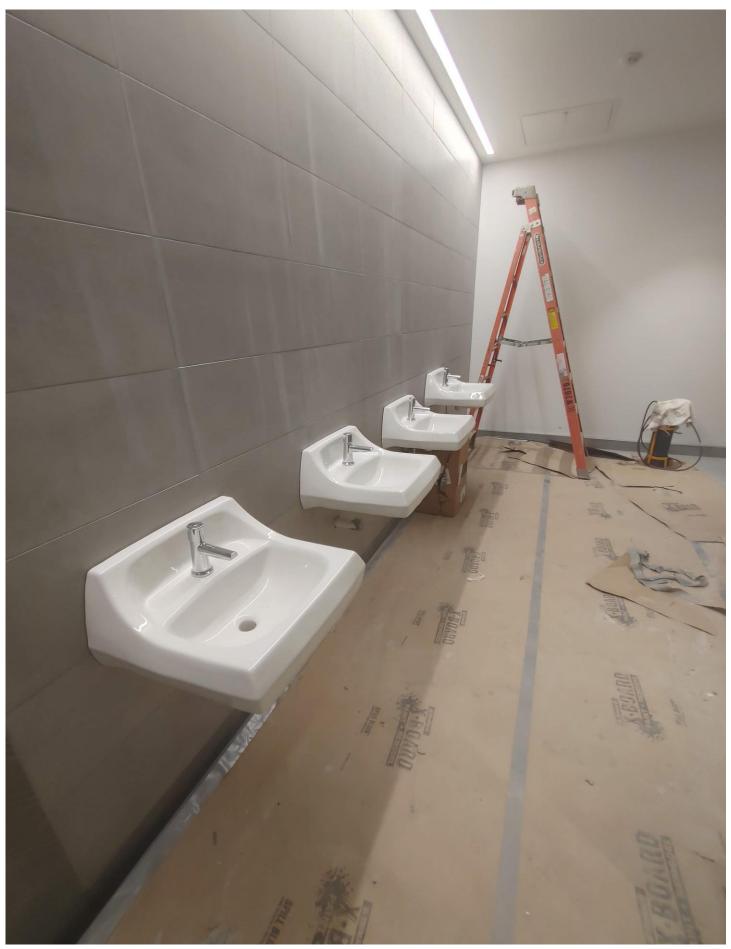
Photo 15 - Fixtures being set in A118

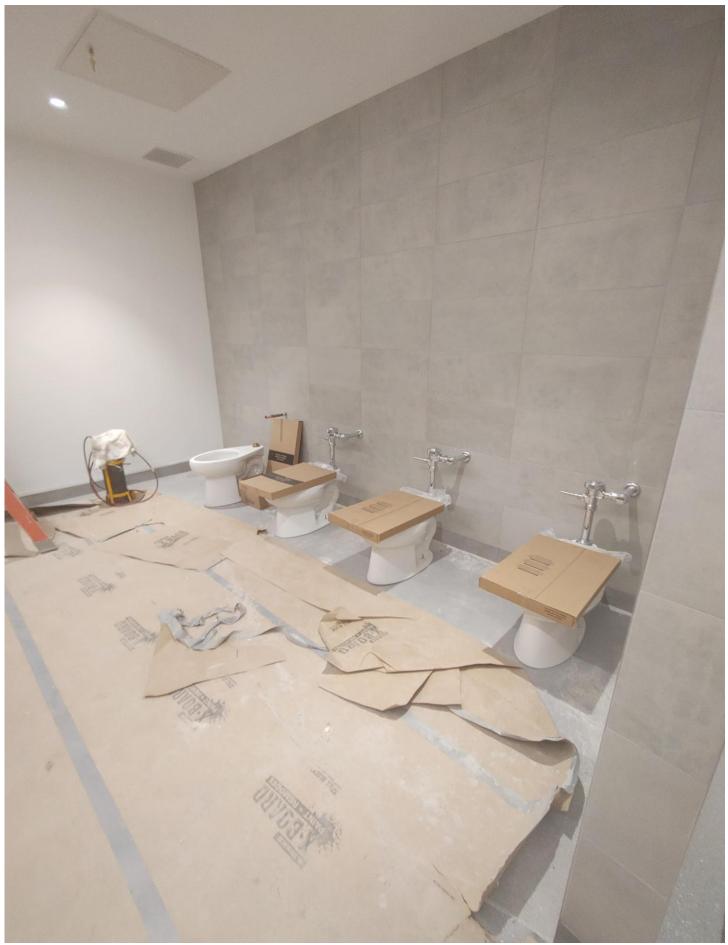
Photo 16 - Toilets have been set in A118

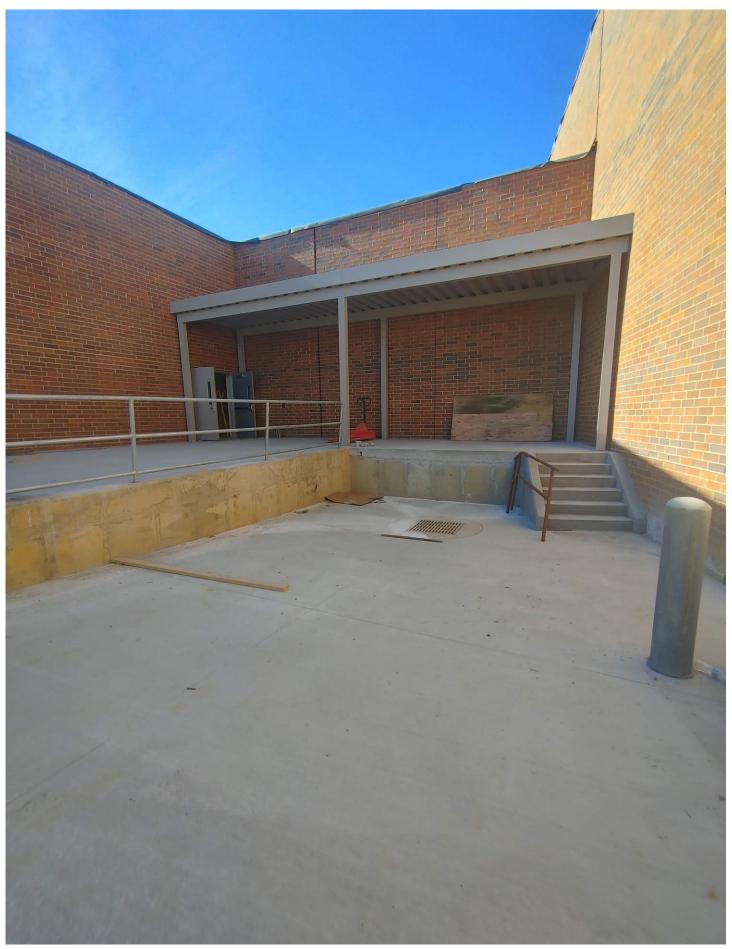
Photo 17 - Railing is being set in the Loading Dock Area.

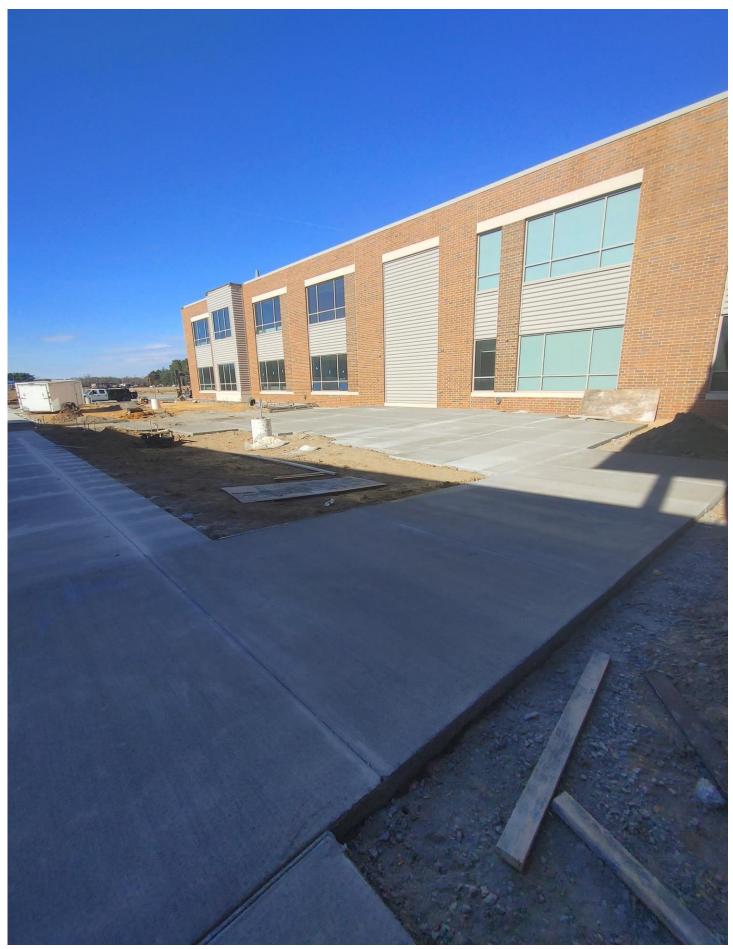
Talley & Armstrong (Sub-Contractor of Beuchert): They are pouring concrete on the West side of the site between Areas E and B.

Photo 18 - Concrete between Areas B & E.
